THE VIABILITY OF STEEL-CONCRETE COMPOSITE GIRDER BRIDGES WITH
CONTINUOUS PROFILED STEEL DECK

Thesis submitted to the Faculty of the Virginia Polytechnic Institute and State University in
partial fulfillment of the requirements for the degree of

VIABILITY OF STEEL-CONCRETE COMPOSITE GIRDER BRIDGES WITH CONTINUOUS PERMANENT STEEL DECK FORM

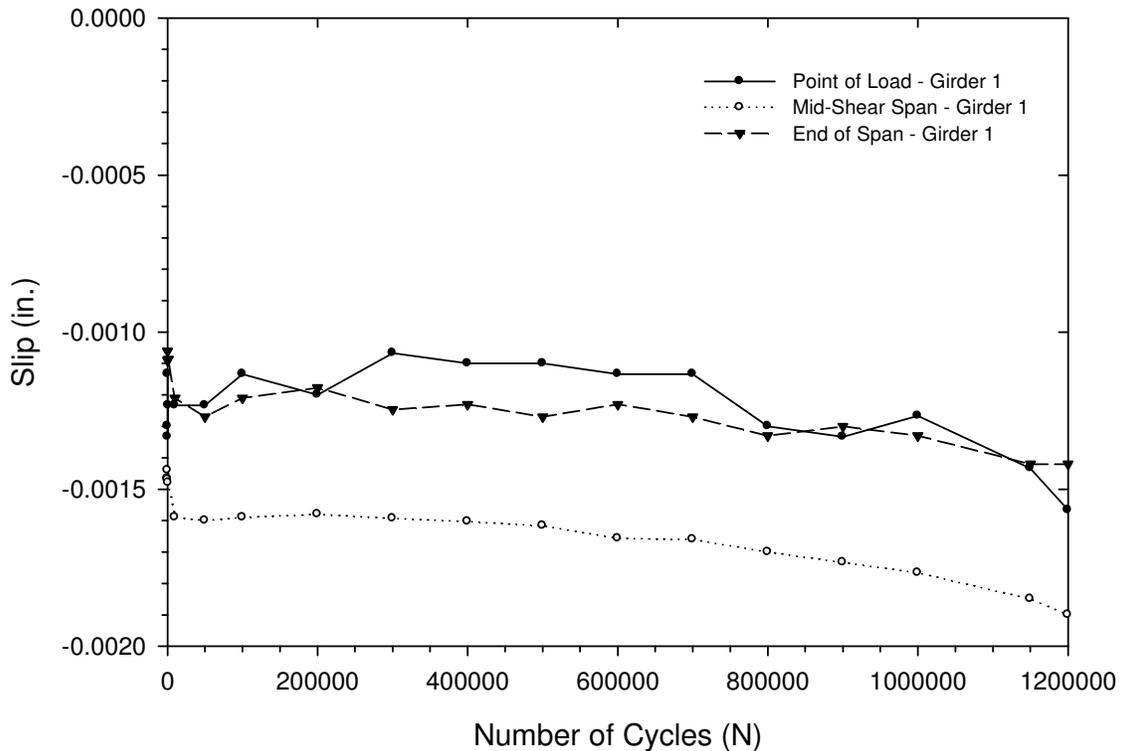
Figure 5.5: Interface slip results at 50 kips in Girder 1 in Fatigue Test 1

(location B) for both girders increased at a non-linear rate, with that rate increasing as the test moved forward, indicating that the slip was getting larger for the same number of cycles as the test continued. What is interesting is that the slip at both locations increased at nearly the same rate, with each following almost the exact same trend for both girders, indicating that once the girder had settled the increase in slip was consistent for the entire shear span outside of the large interface friction zone near the point of loading. At the point of loading (location A), the increase in slip was significantly less than at the other locations for Girder 2, as was expected due to how close it was to the point of maximum moment and the resulting effects of interface friction. The slip at location A stayed relatively constant until 1 million cycles had been reached, at which point it increased rapidly along with locations B and C, possibly indicating that the friction force had been overcome. Slip at location A on Girder 1 was recorded using a dial gauge and it does not appear that the data taken was as consistent as it should have been, as evidenced by the sudden jumps in slip values, and therefore is taken as inadmissible.

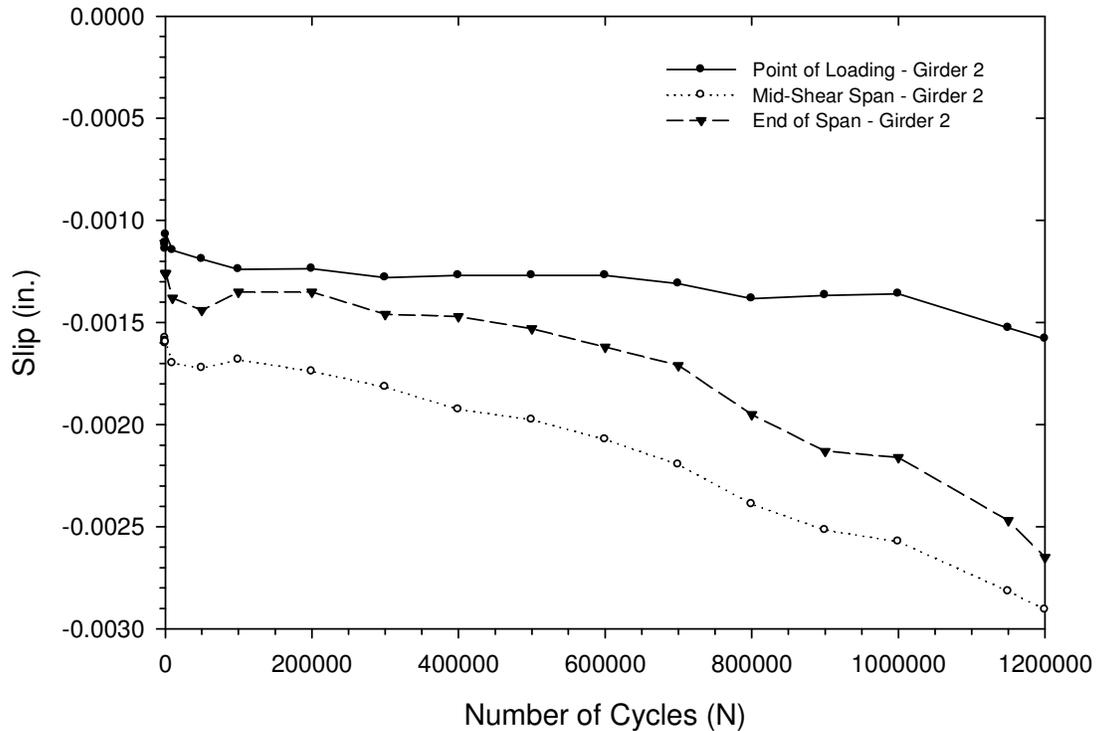
Figure 5.6: Interface slip results at 50 kips in Girder 2 in Fatigue Test 1

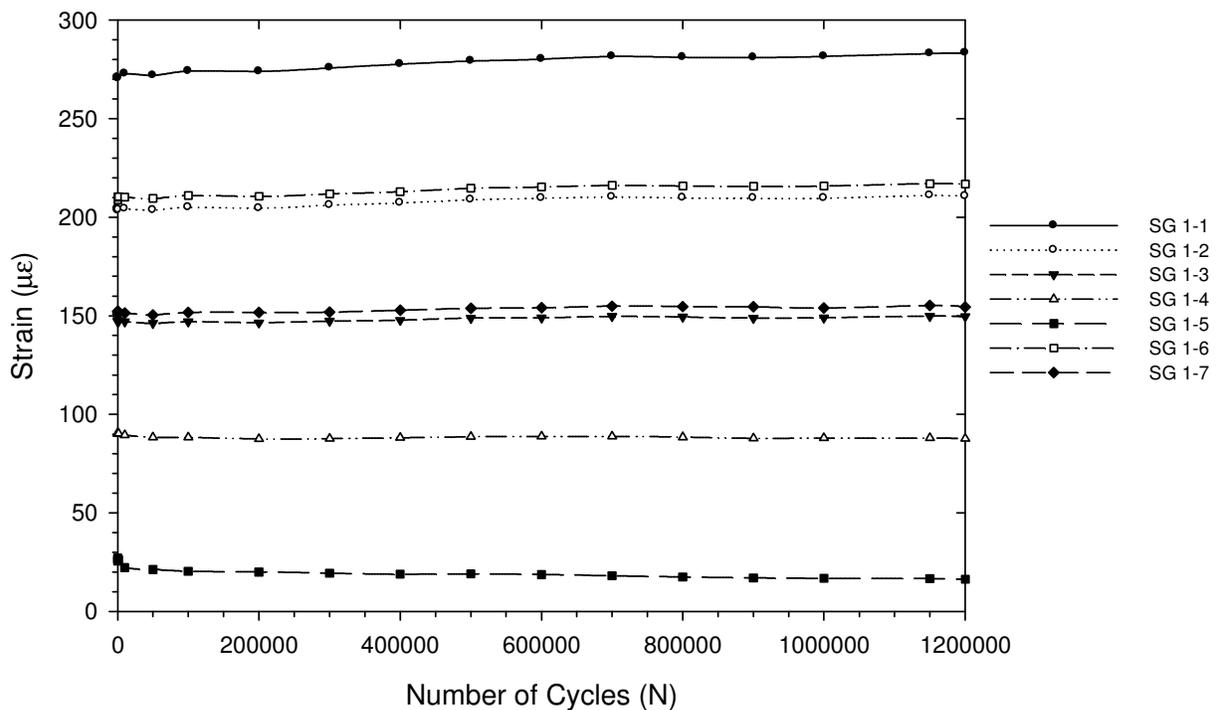
Figure 5.7: Strain results for 50 kip loading in Girder 1 in Fatigue Test 1

load was well within the linear elastic range of the composite system and therefore all gauges were used in the analysis. Tables F.3 and F.4 provided in Appendix F gives the calculated values for every strain gauge location as well the their relative change given as a percentage of the gauge values at 1 cycle (the beginning of testing) for Girder 1 and Girder 2, respectively. Results presented for each gauge location at each cycle interval represent an average of the measured values for each gauge from the three static tests conducted at each stopping point. These results are shown plotted for Girder 1 in Fig. 5.7 and for Girder 2 in Fig. 5.8 and show that the change in strain over time is approximately linear. These tables and plots illustrate that the change in strain at each gauge location is minimal over the course of the test for both girders, as indicated by the very minor slope of each line. There were no significant jumps in values at any location on either girder that would result from a change in the composite system, such as the breaking of a shear stud, and therefore it can be implied that a minimal amount of damage was done to the system over the course of the first test. Both girders behavior was almost exactly the same during the test, with the percent changes in Girder 2 being slightly higher than those in Girder one, which can be accounted for by the larger Girder 2 load. These results correlate almost exactly with vertical deflection results for both girders.

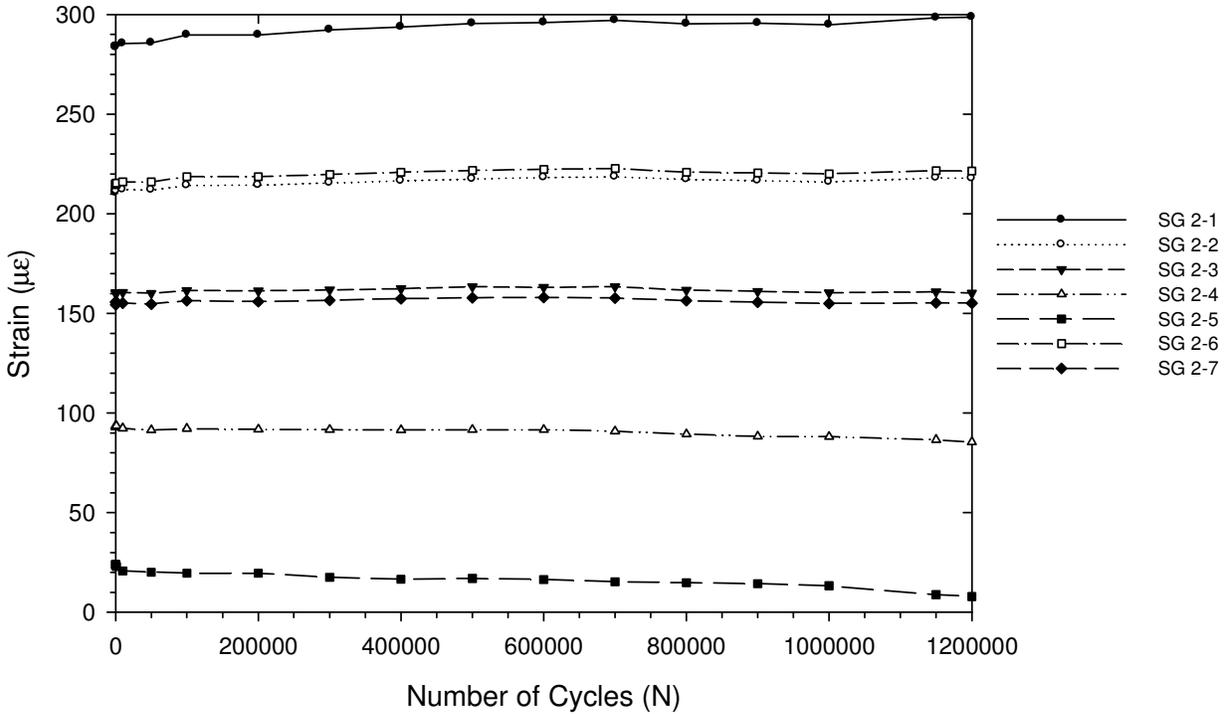
Figure 5.8: Strain results for 50 kip loading in Girder 2 in Fatigue Test 1

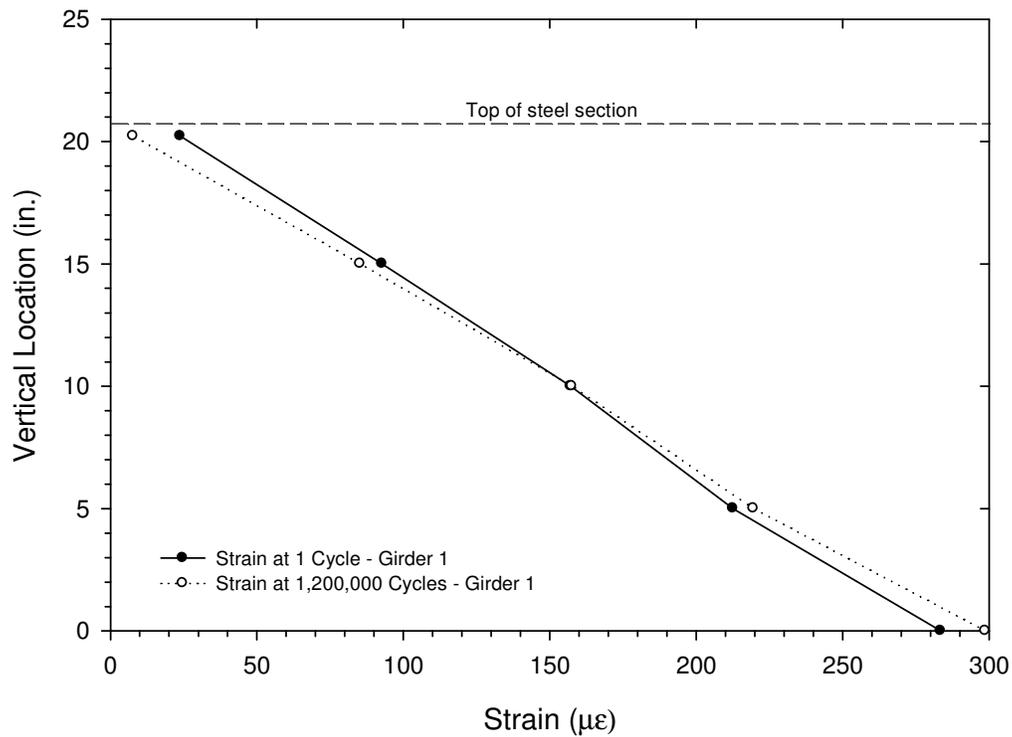
Figure 5.9: Vertical strain distribution at 50 kips in Girder 1 in Fatigue Test 1

results and most of the Girder 2 results, there are no significant jumps in strain values and all strain gauge plots are nearly linear, which further correlates with the vertical deflection results from the point of loading location. The only visible departure from linearity in strain degradation comes in Girder 2 between 1,000,000 cycles and 1,150,000 cycles where the rate of change in all the gauges increases suddenly, which correlates with a slight jump in deflection and elastic neutral axis location, which is explained below. This is more than likely the result of the jump and then leveling off of slip observed in Girder 2 as noted in the “Slip Results” section.

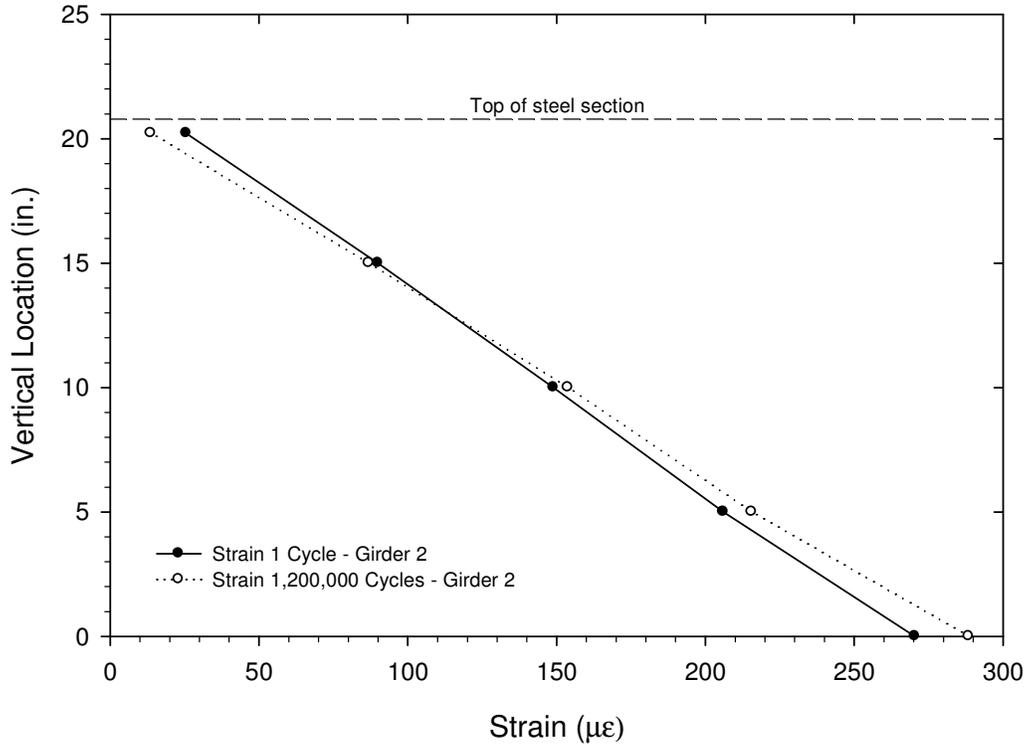
Figure 5.10: Vertical strain distribution at 50 kips in Girder 2 in Fatigue Test 1

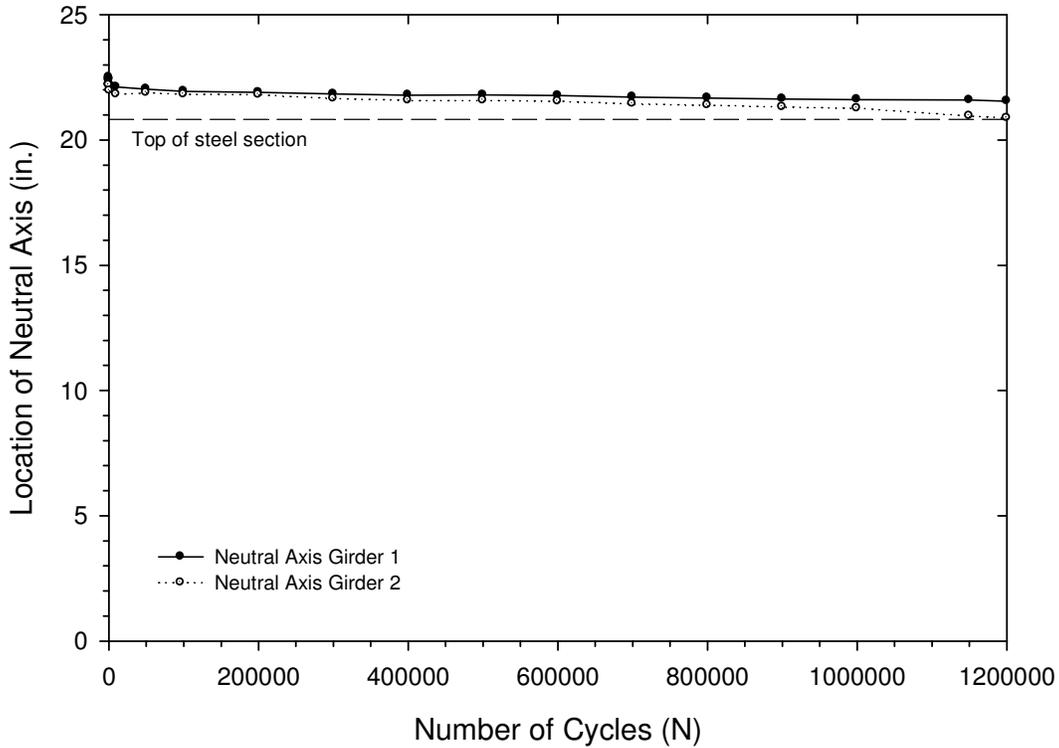
Figure 5.11: Steel girder elastic neutral axis from bottom of section in Fatigue Test 1

As can be seen in Fig. 5.11, the calculated elastic neutral axis (ENA) falls within the upper and lower bounds given, indicating partial composite action as expected. The ENA dropped rapidly in the first 50,000 cycles for both girders as the test specimen settled; however after this point in the testing it leveled out and then approached the bottom of the section at a nearly linear rate, with values and rate of decrease in Girder 2 slightly greater than that in Girder 1, which agrees with slip data presented previously (Girder 2 slip values are greater and increase faster than Girder 1 values). At the end of the design number of cycles (1,000,000), the ENA in Girder 1 only dropped 0.77 in., which represents only 3.7% of the steel girder depth, with 45.5% of the movement occurring in the first 50,000 cycles (5% of the total cycles). The same trend continued in Girder 1 to 1.2 million cycles. Likewise, through the design number of cycles in Girder 2, the ENA dropped 0.93 in., representing 4.5% of the total number of cycles with 32.3% of that movement occurring in the first 50,000 cycles. However, after 1 million cycles the rate of decrease of the ENA increased in Girder 2, with the change becoming 1.32 in. from initial position, which is 6.3% of the steel girder depth. This increase correlates with jumps in strain gauge and deflection values noted previously and is explained by the fact that the rate of slip increased at all measured locations at that point as well, which caused the slight loss of composite action that resulted in the loss of stiffness and therefore the increase in deflection and movement of the ENA. However, this loss of stiffness is still minor. This increase in slip was not observed in Girder 1 and therefore the ENA did not drop in the same way as in Girder 2. Based on these results, there is no indication that significant damage has been done to the system as a result of the fatigue loading on either girder, especially within the design number of cycles.

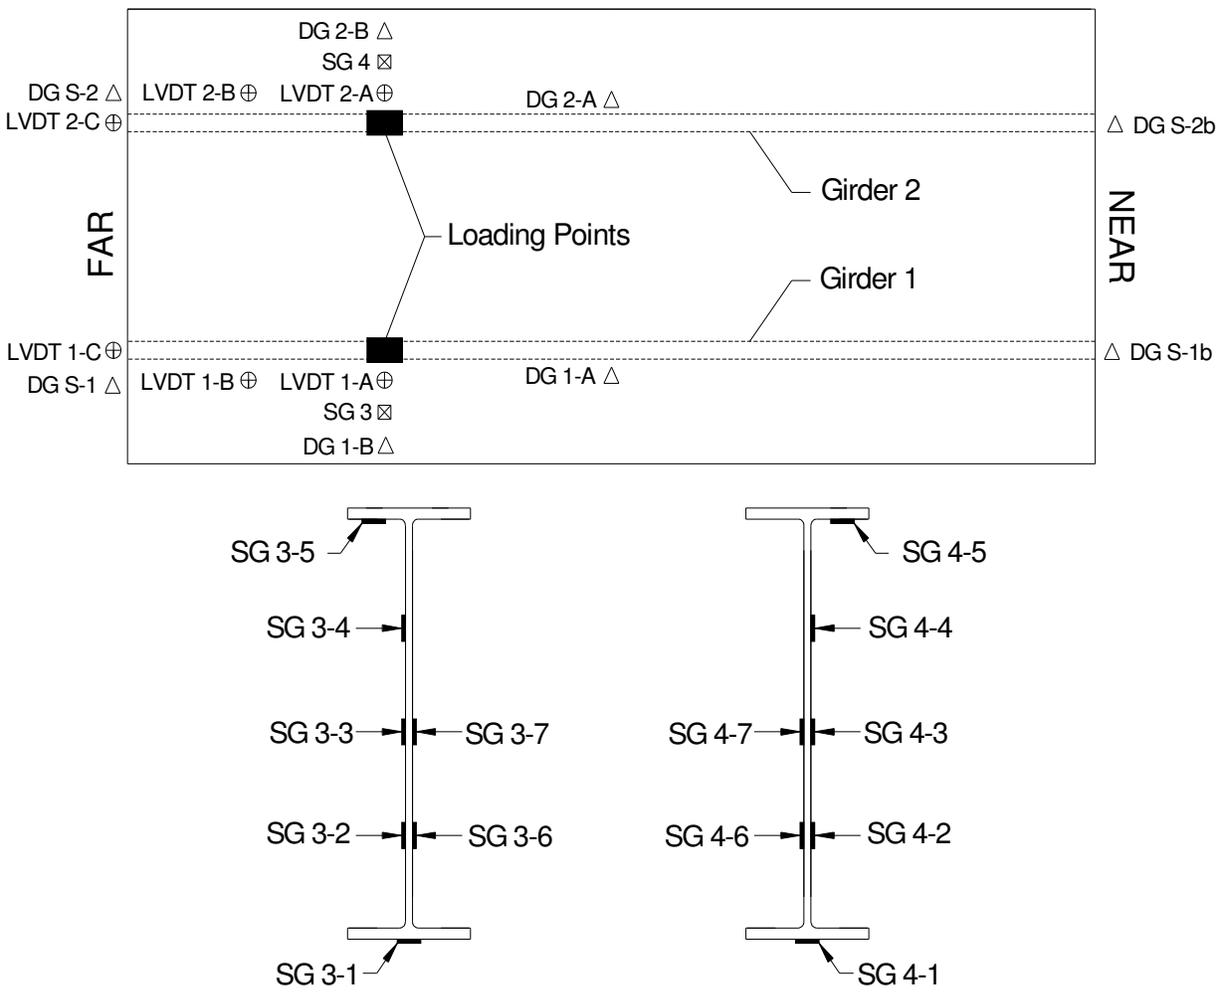
Figure 5.12: Fatigue Test 2 sensor locations and labels

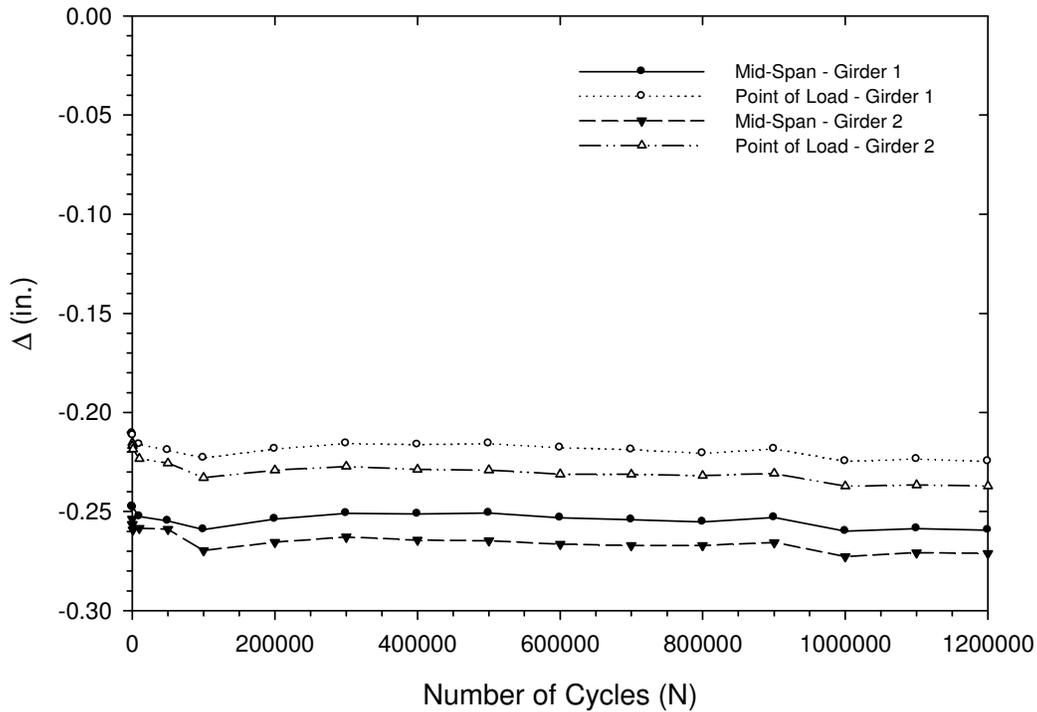
Figure 5.13: Vertical deflection results for 95 kip loading in Fatigue Test 2

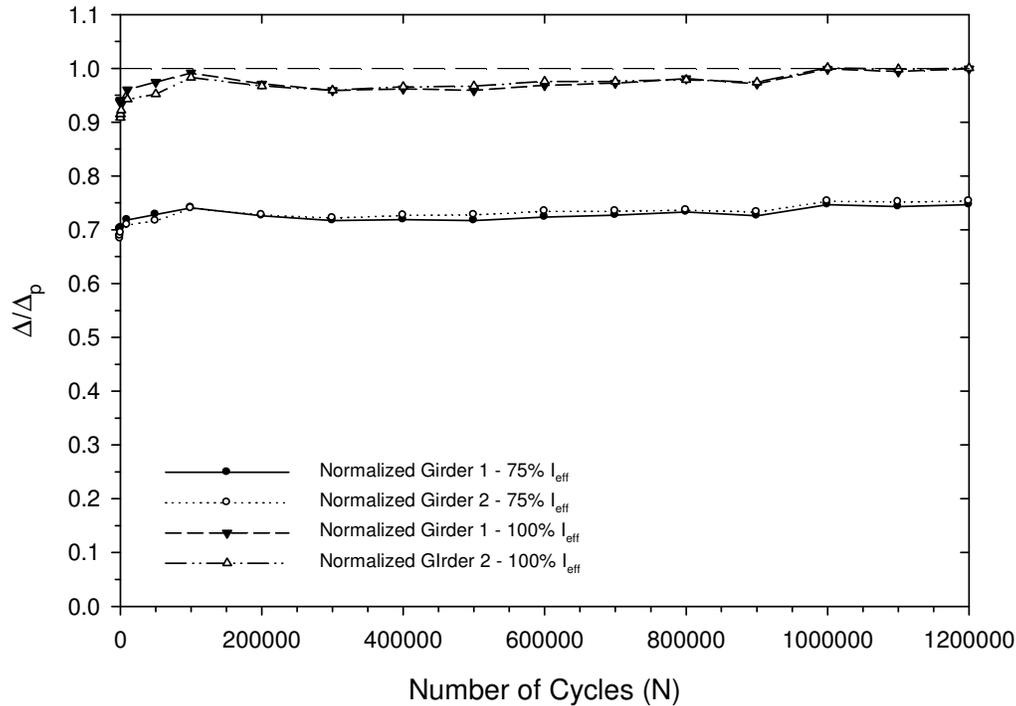
Figure 5.14: Point of loading deflections normalized to predicted values in Fatigue Test 2

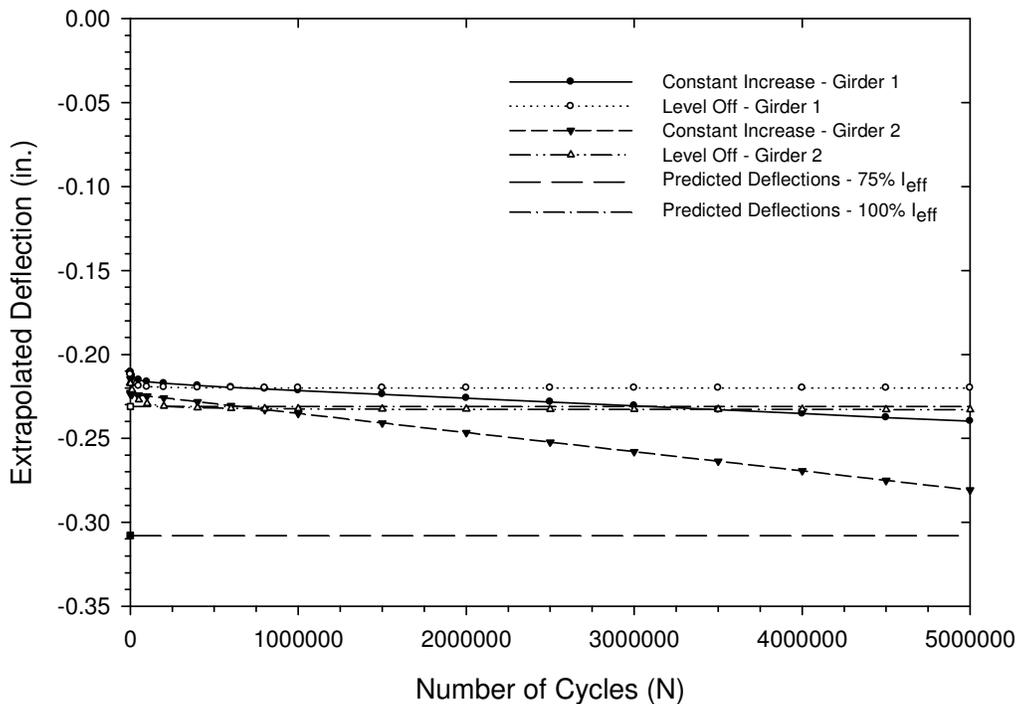
Figure 5.15: Vertical deflections extrapolated to 5 million cycles in Fatigue Test 2

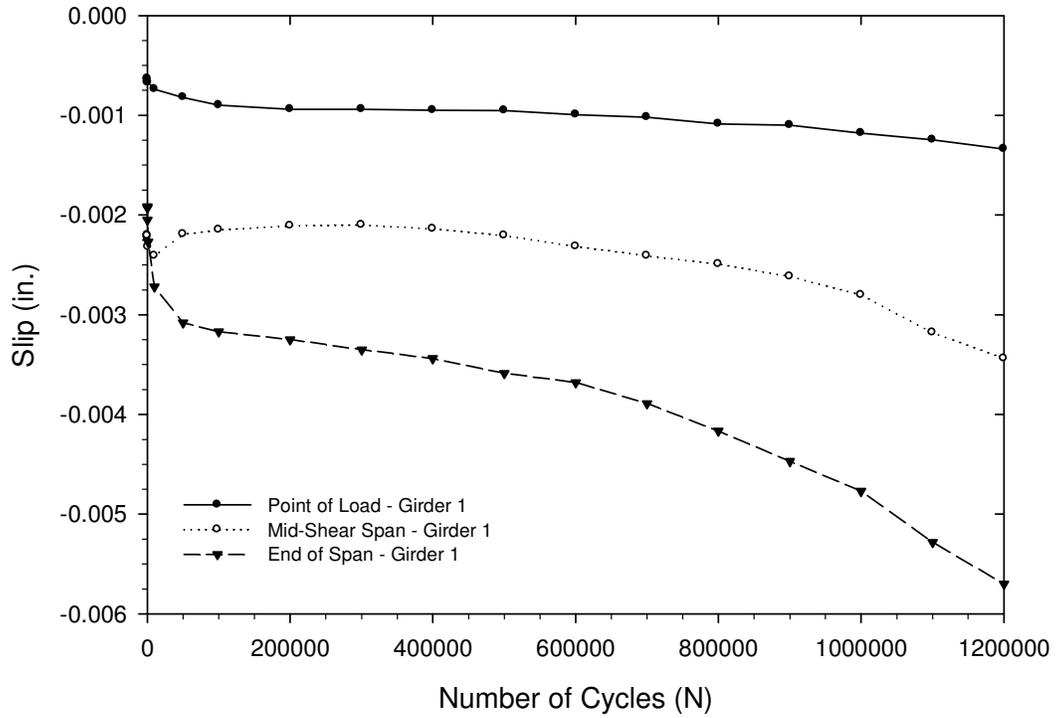
Figure 5.16: Interface slip results at 95 kips in Girder 1 in Fatigue Test 2

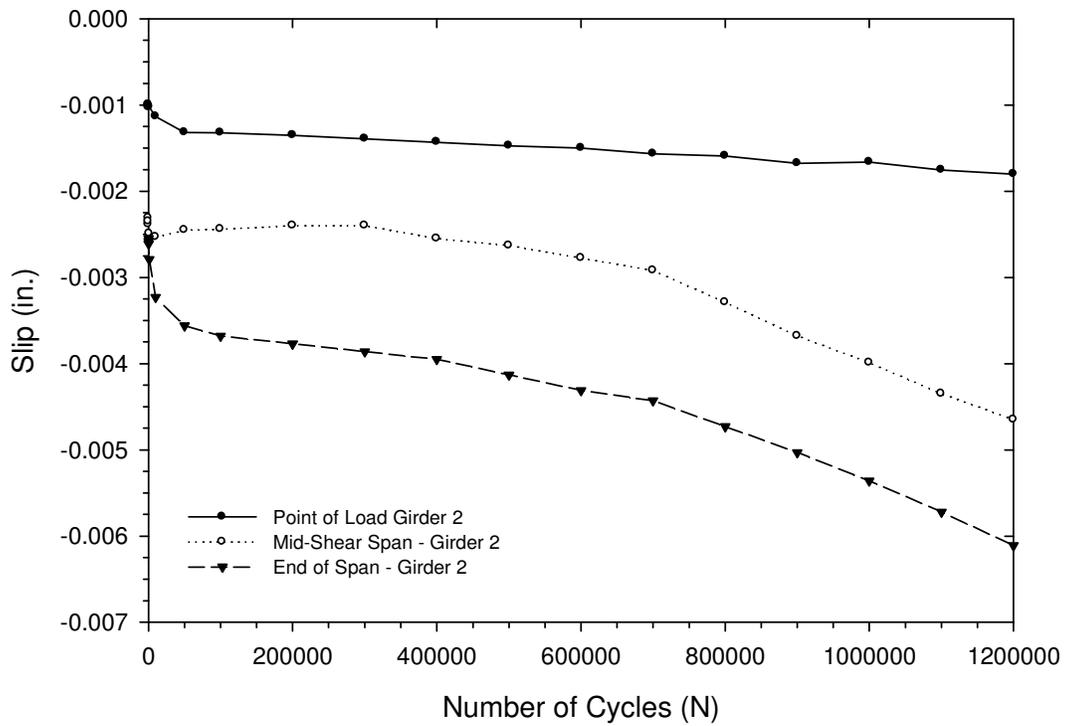
Figure 5.17: Interface slip results at 95 kips in Girder 2 in Fatigue Test 2

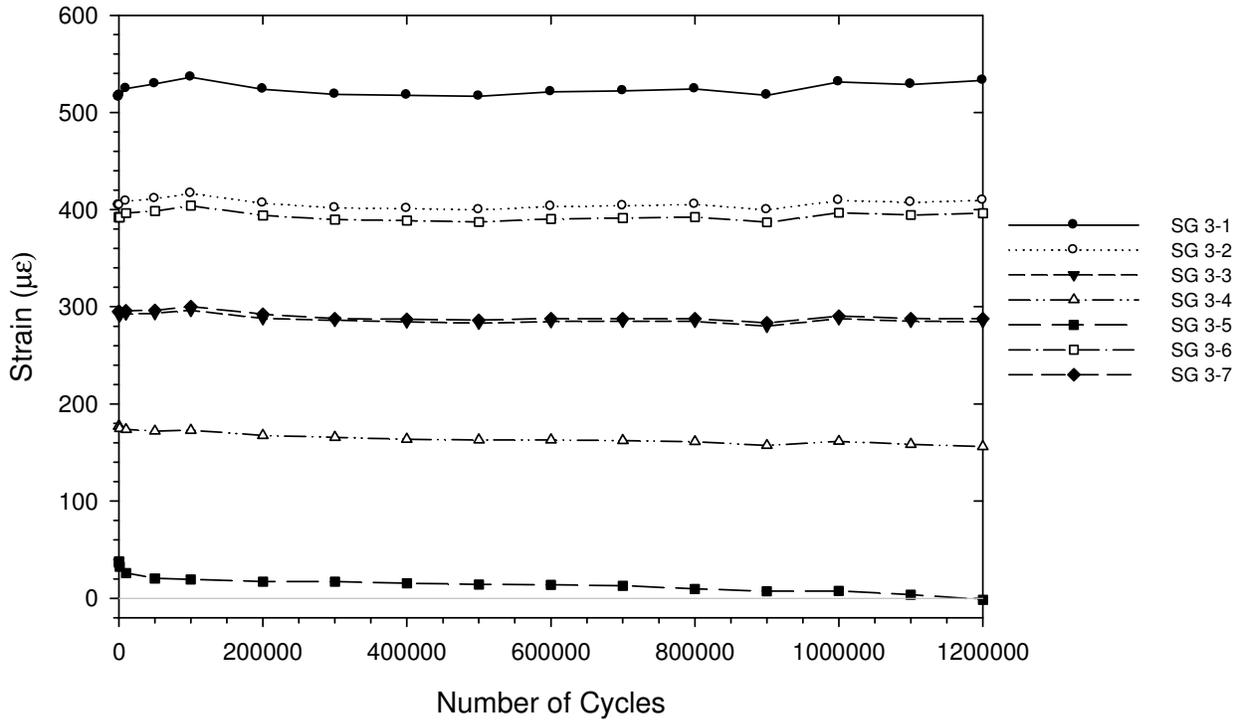
Figure 5.18: Strain results for 95 kip loading in Girder 1 in Fatigue Test 2

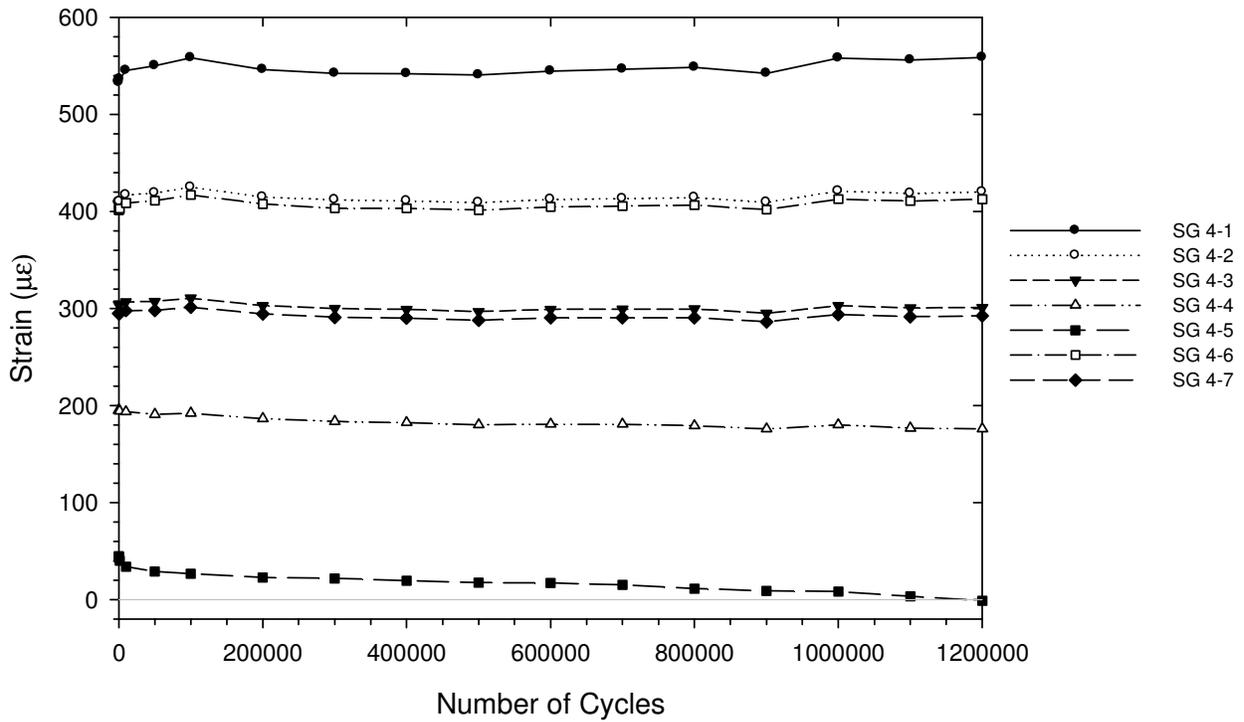
Figure 5.19: Strain results for 95 kip loading in Girder 2 in Fatigue Test 2

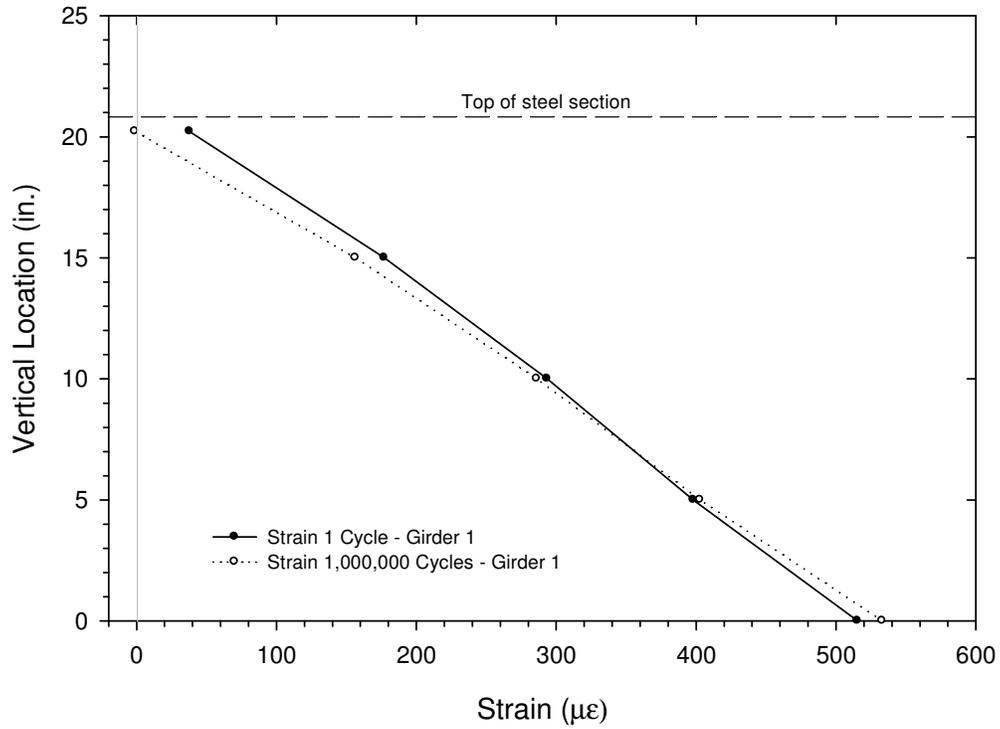
Figure 5.20: Vertical strain distribution at 95 kips in Girder 1 at start and end of Fatigue Test 2

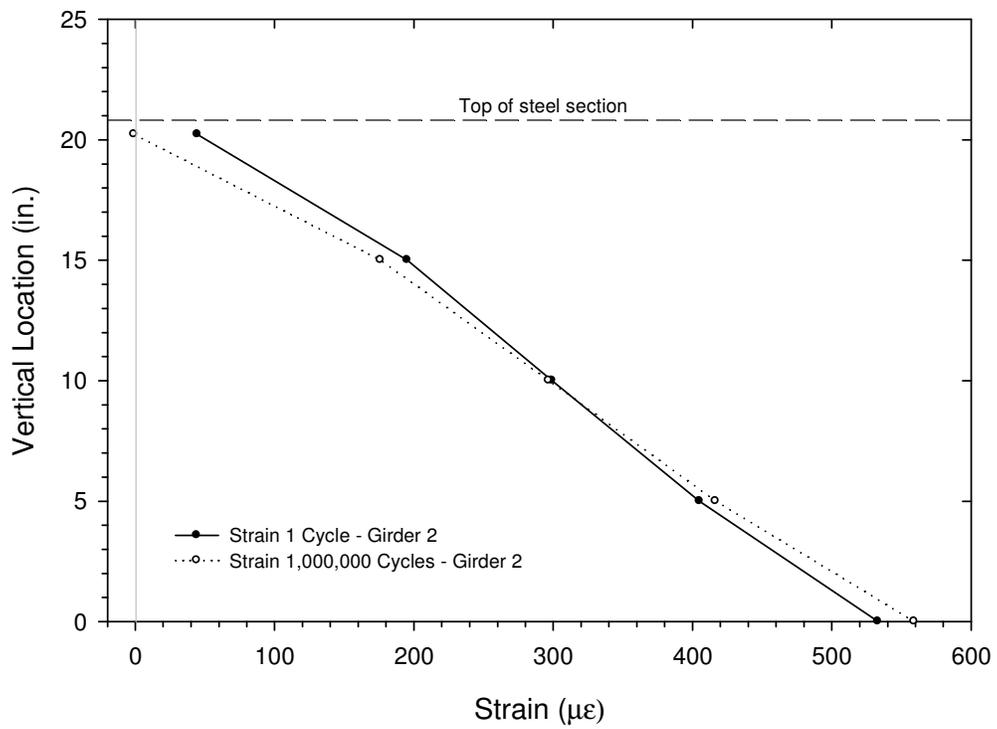
Figure 5.21: Vertical strain distribution at 95 kips in Girder 2 at start and end of Fatigue Test 2

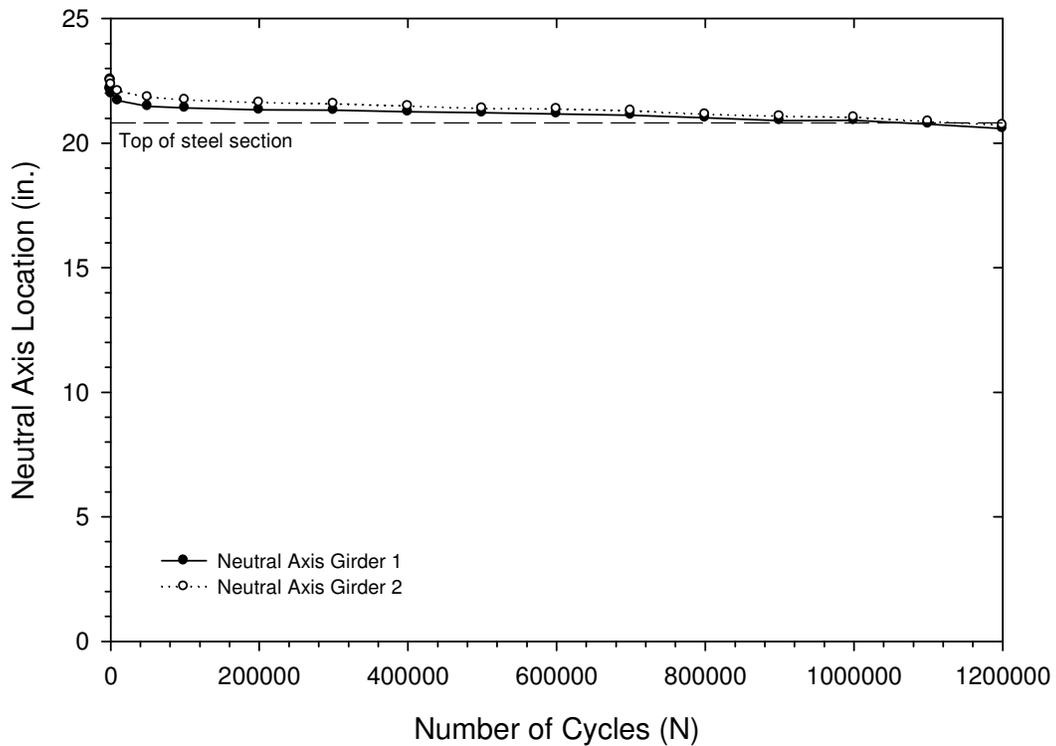
Figure 5.22: Steel girder elastic neutral axis from bottom of section Fatigue Test 2

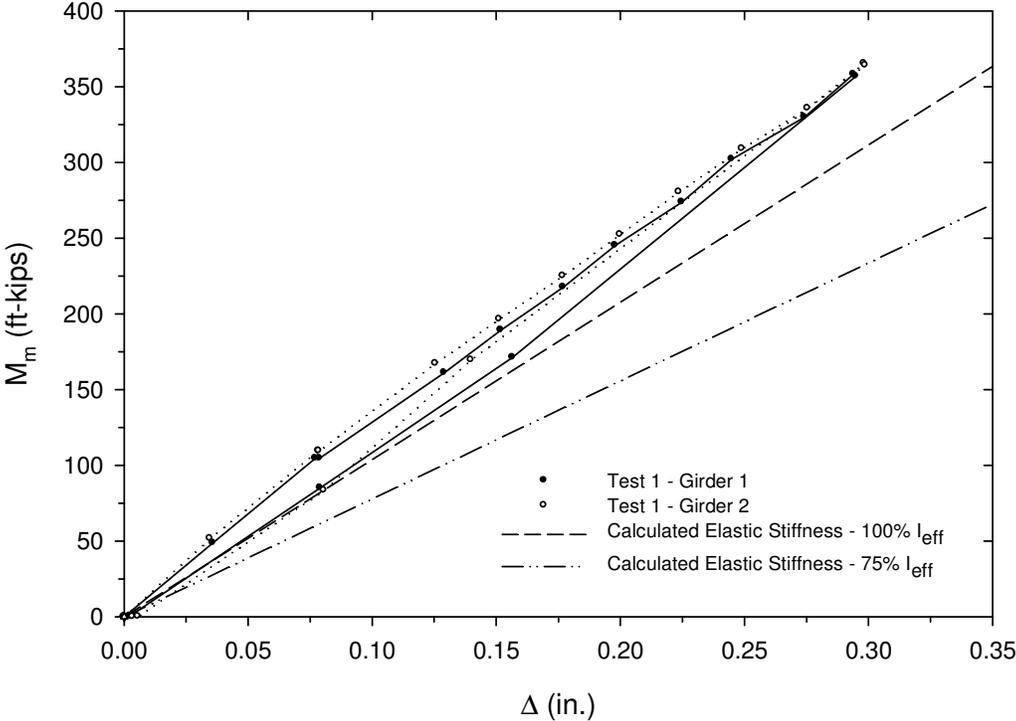
Figure 6.1: Static Test 1 point of loading measured moment versus deflection

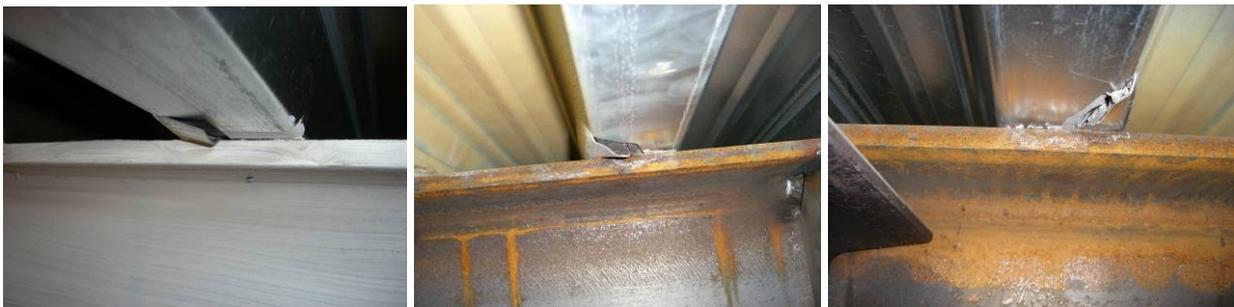
Figure 6.2: Examples of shear stud failures at the end of Static Test 2

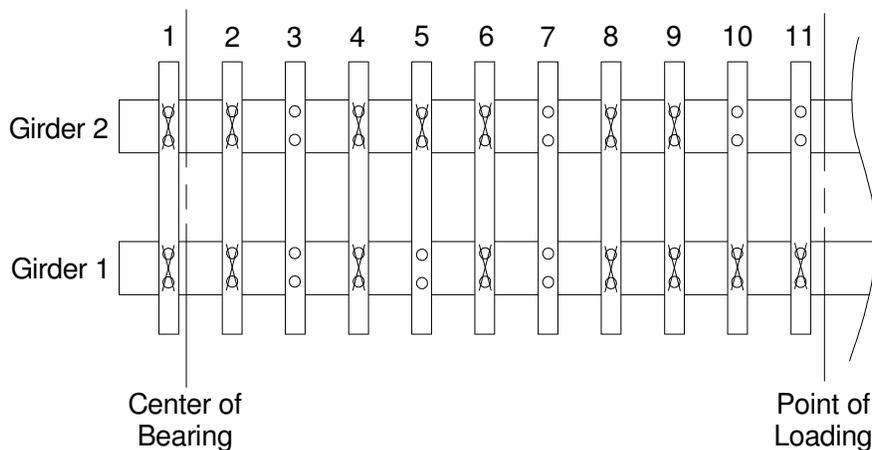
Figure 6.3: Shear stud blowout locations at the end of Static Test 2

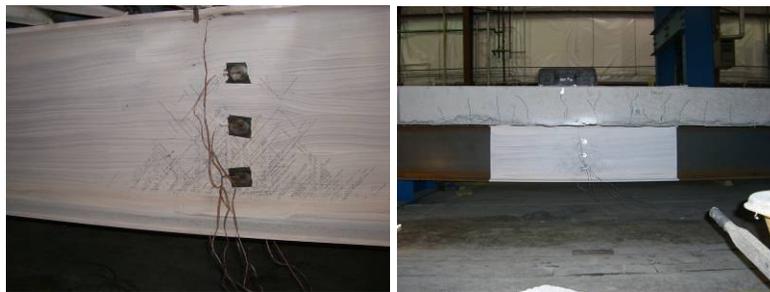
Figure 6.4: Specimen damage in girders and deck at the end of Static Test 2

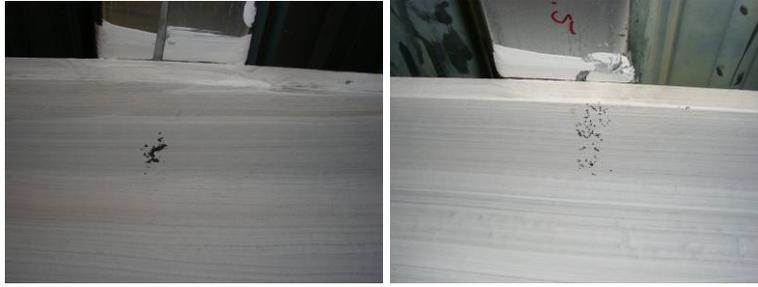
Figure 6.5: Localized top flange yielding under shear studs

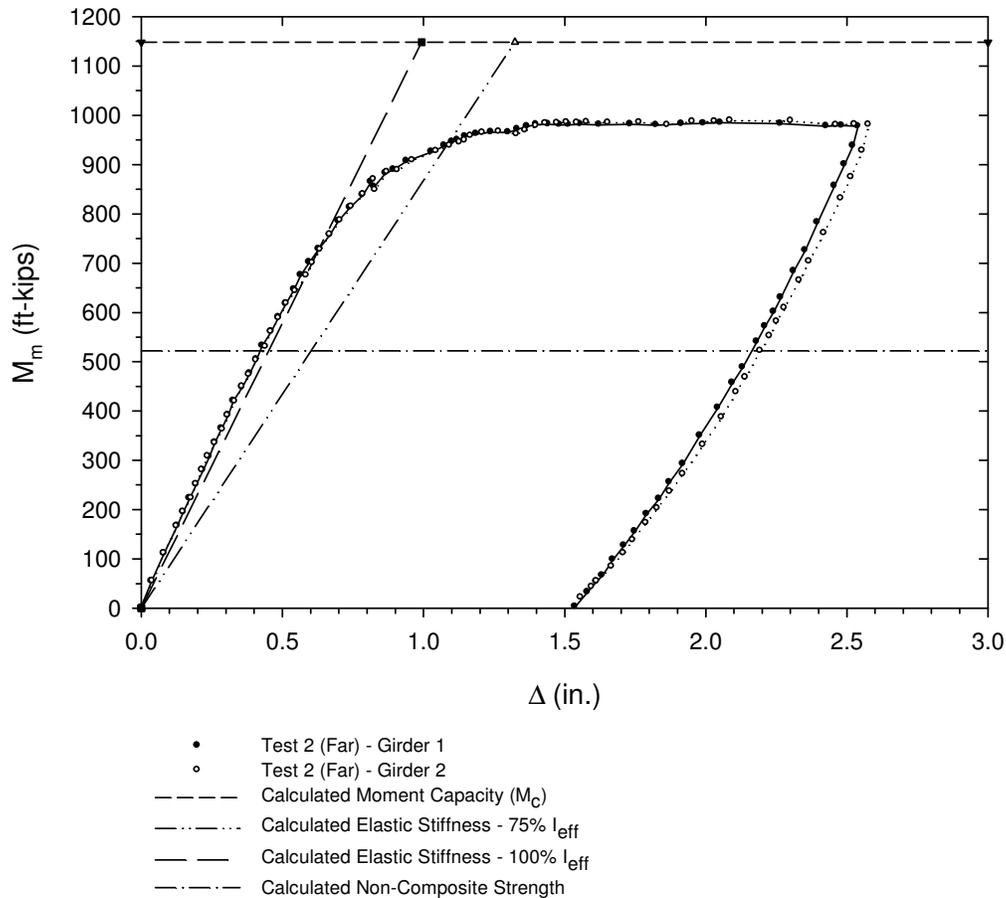
Figure 6.6: Test 2 point of loading measured moment versus deflection

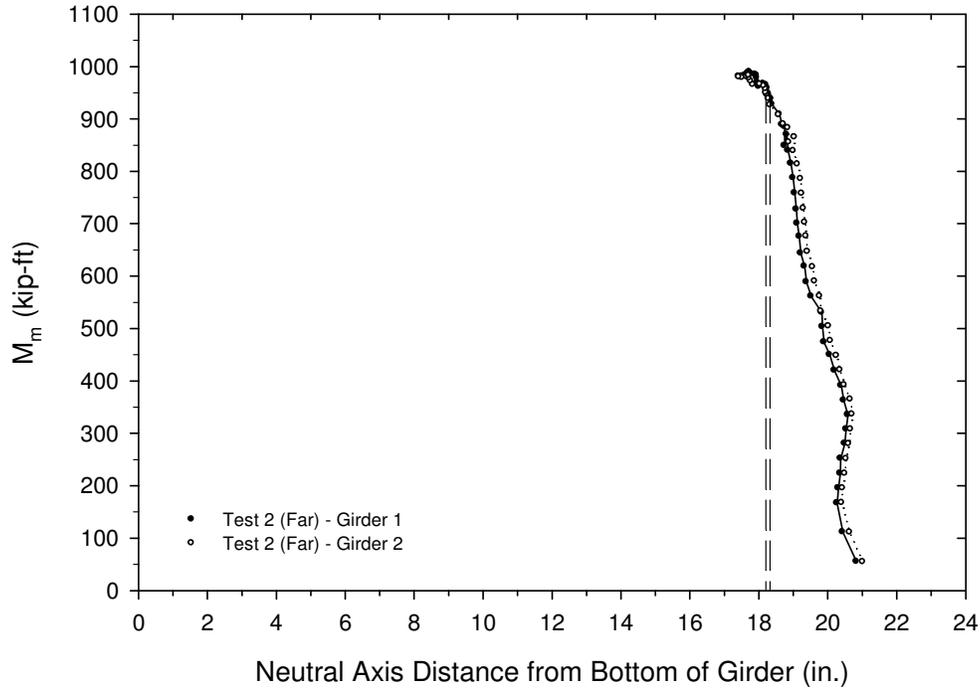
Figure 6.7: Static Test 2 neutral axis distance from bottom of girder

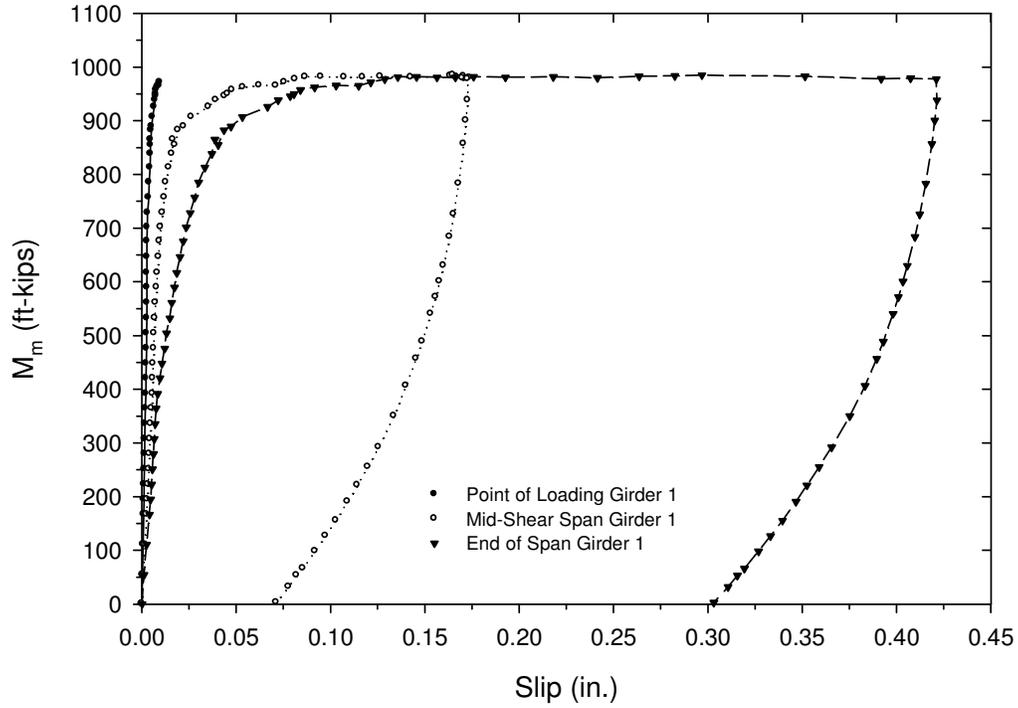
Figure 6.8: Interface slip results for Girder 1 in Static Test 2

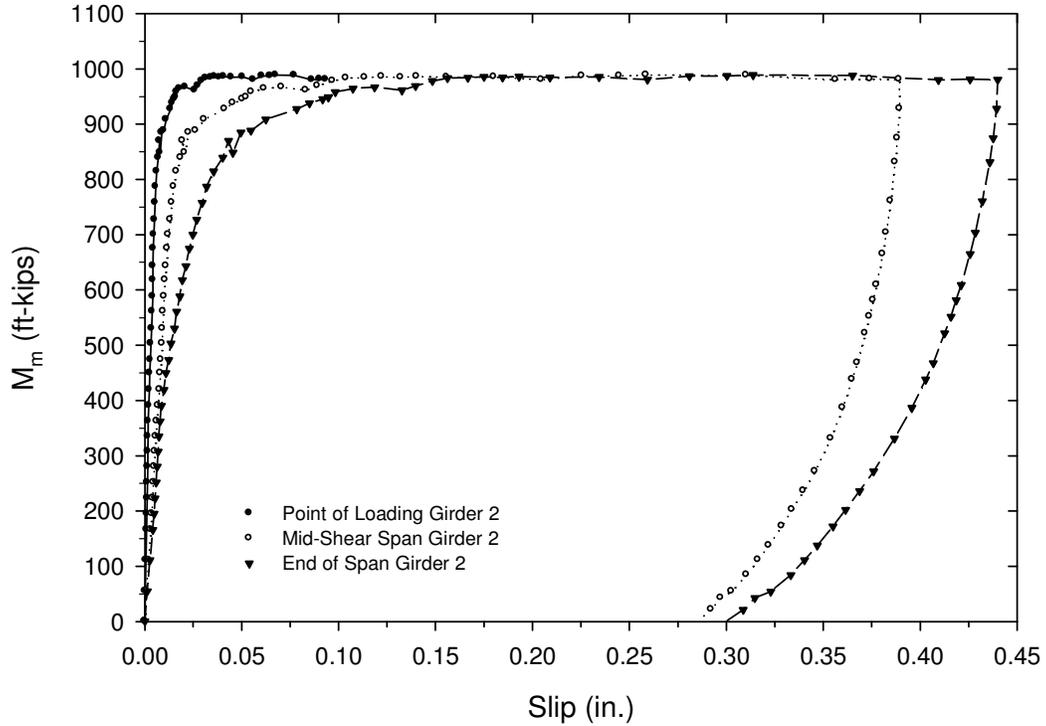
Figure 6.9: Interface slip results at for Girder 2 in Static Test 2

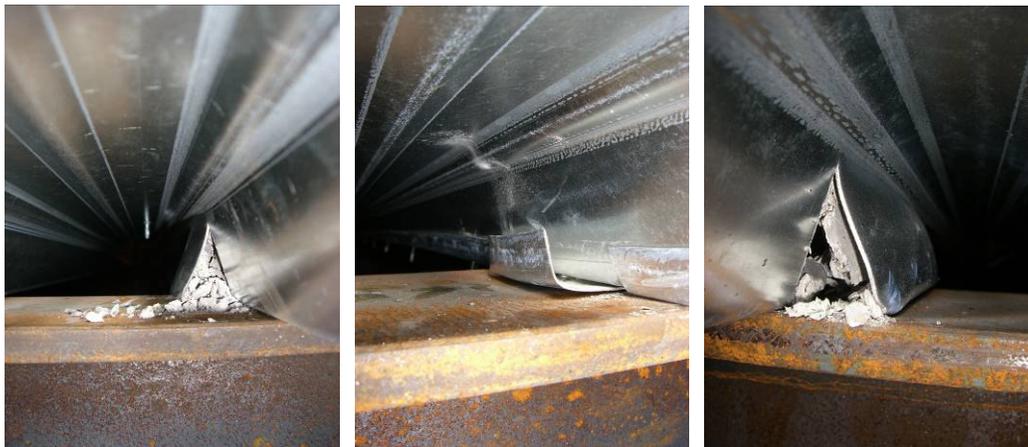
Figure 6.10: Examples of shear stud failures at the end of Static Test 3

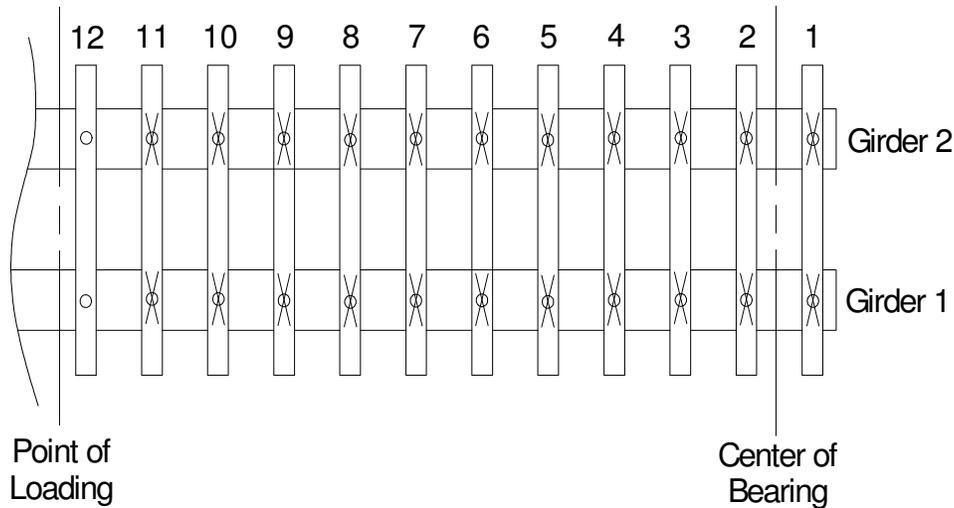
Figure 6.11: Shear stud blowout locations at the end of Static Test 3

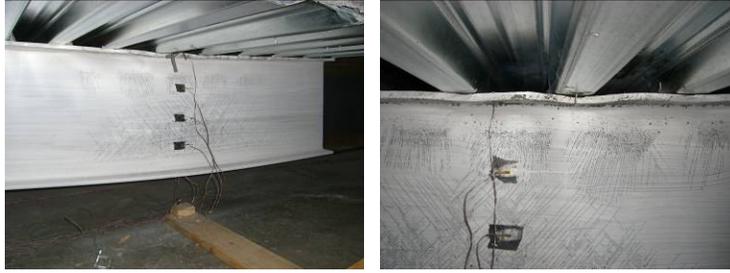
Figure 6.12: Specimen damage in steel girders at the end of Static Test 3
