THE VIABILITY OF STEEL-CONCRETE COMPOSITE GIRDER BRIDGES WITH
CONTINUOUS PROFILED STEEL DECK

Thesis submitted to the Faculty of the Virginia Polytechnic Institute and State University in
partial fulfillment of the requirements for the degree of

VIABILITY OF STEEL-CONCRETE COMPOSITE GIRDER BRIDGES WITH CONTINUOUS PERMANENT STEEL DECK FORM

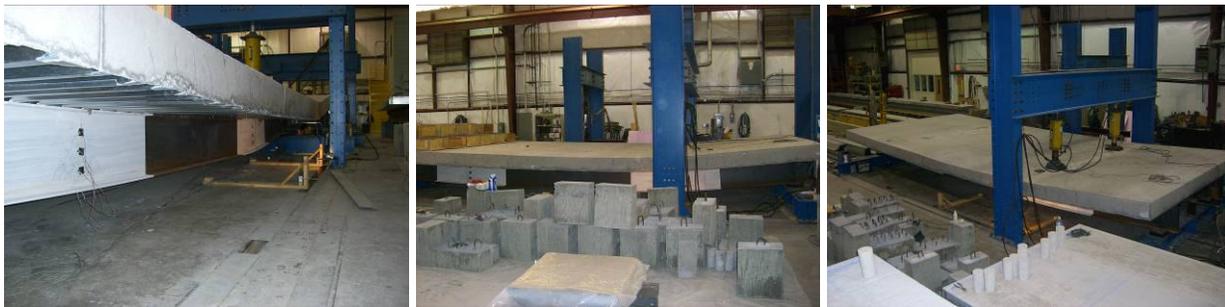
Figure 6.13: Specimen at the end of Static Test 3

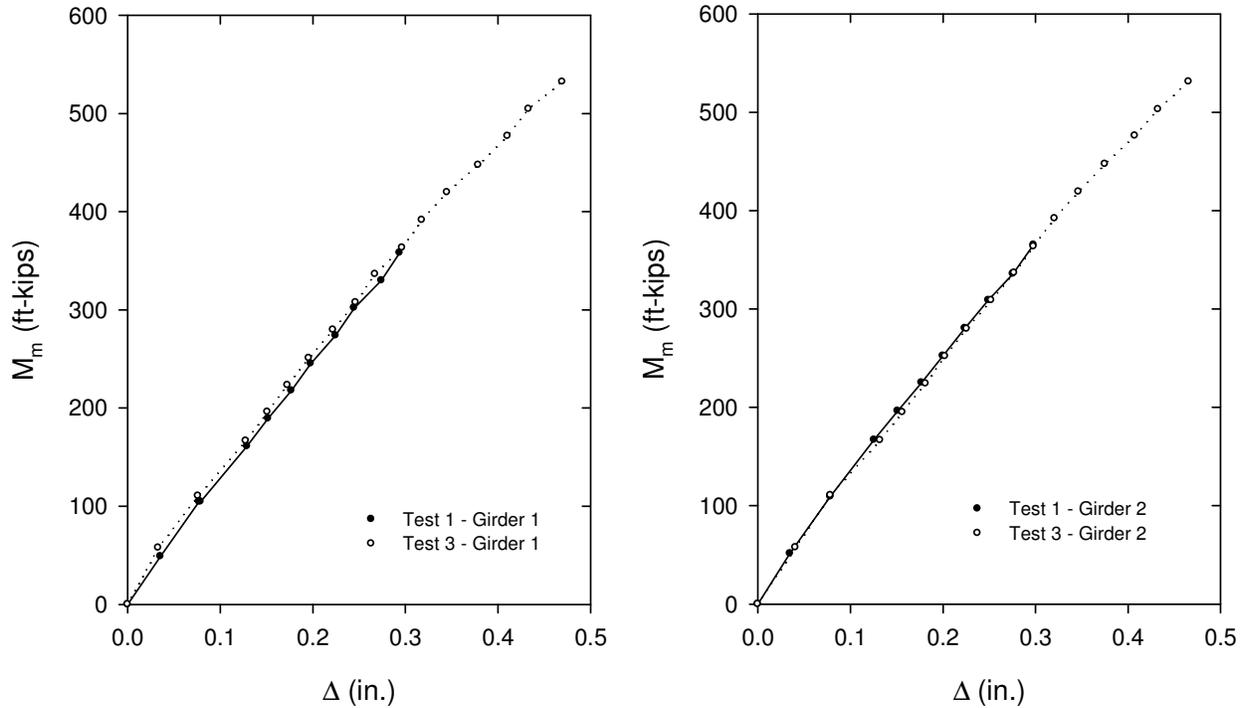
Figure 6.14: Comparison of measured elastic deflections of Static Test 1 to Static Test 3

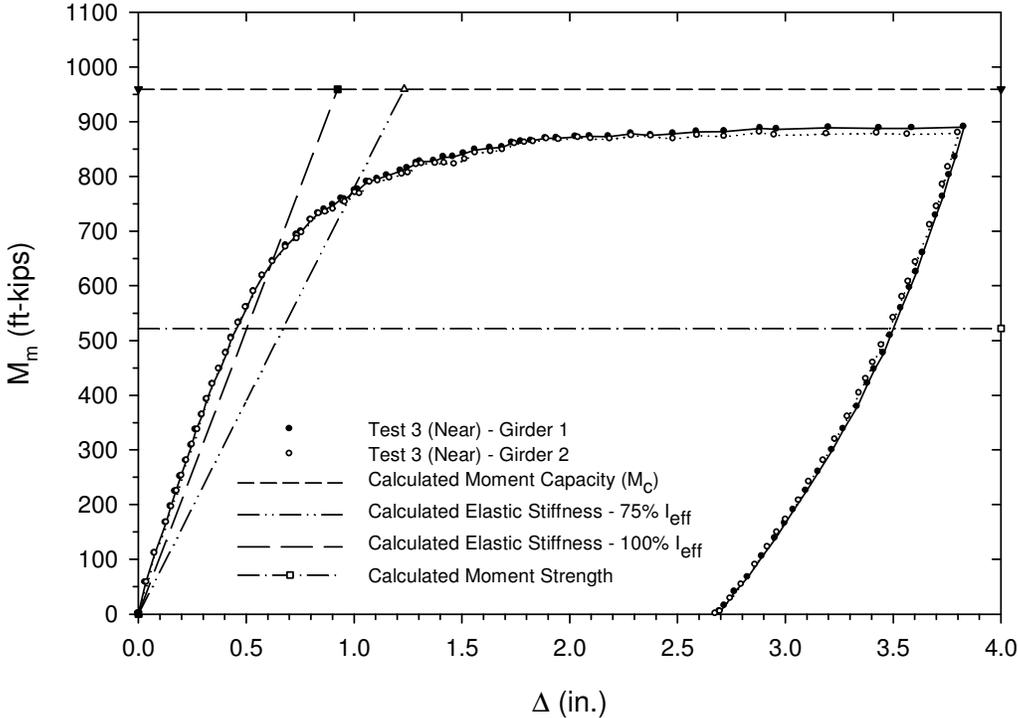
Figure 6.15: Static Test 3 point of loading measured moment versus deflection

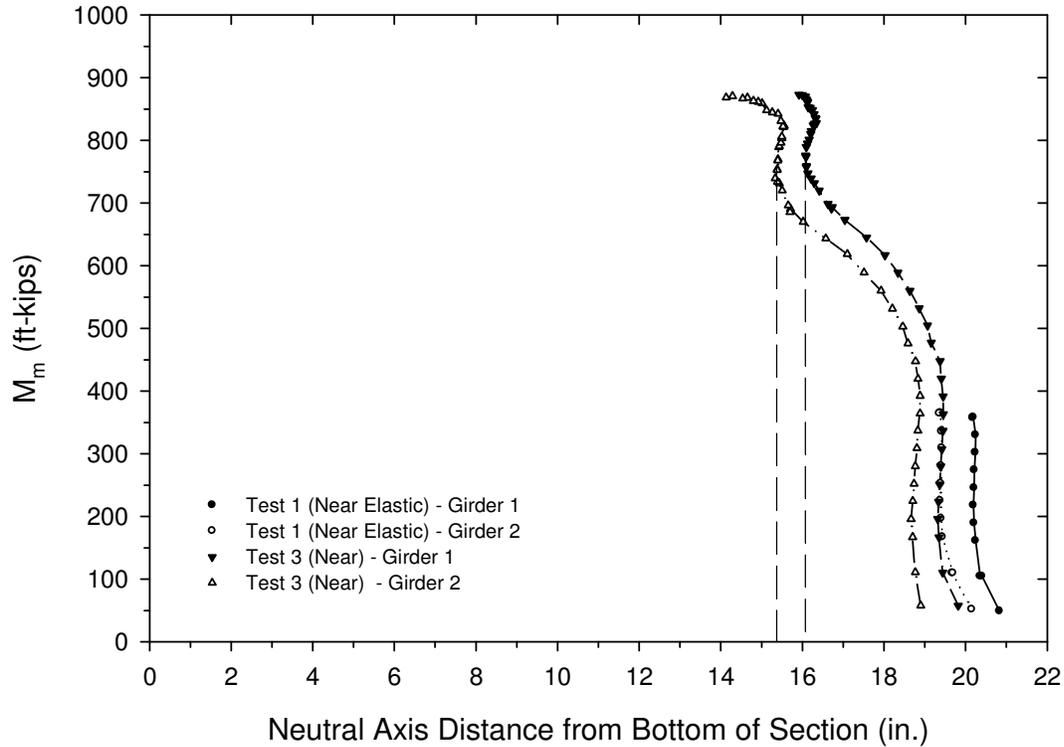
Figure 6.16: Static Test 3 neutral axis distance from bottom of girder

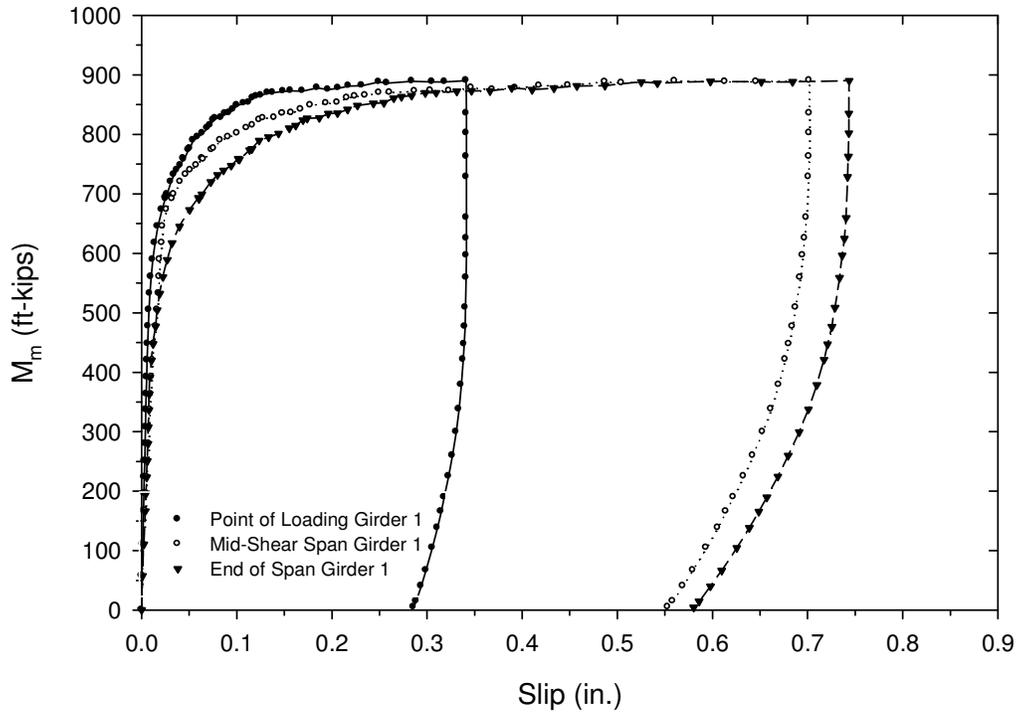
Figure 6.17: Interface slip results at for Girder 1 in Static Test 3

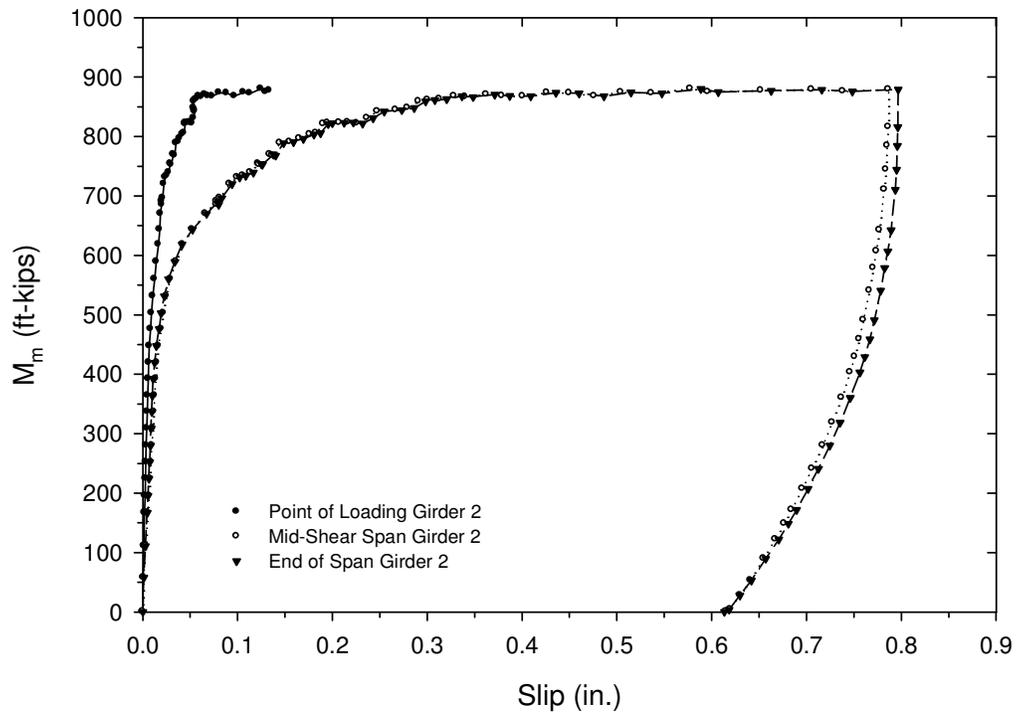
Figure 6.18: Interface slip results at for Girder 2 in Static Test 3

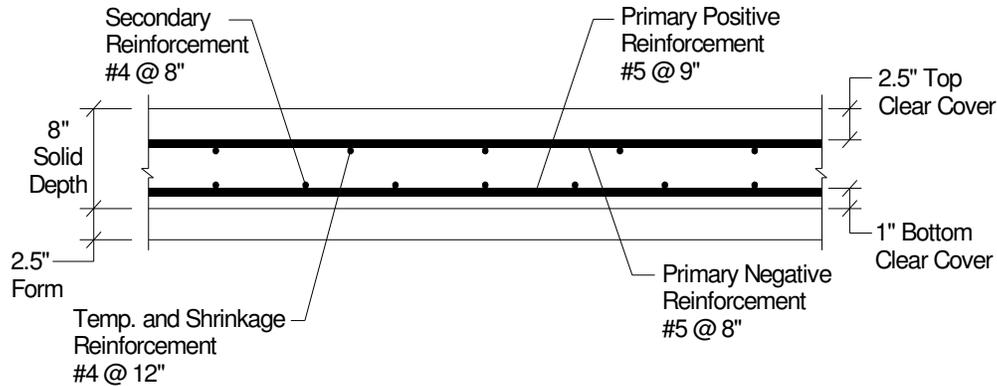
Figure A.2: Final deck reinforcement layout

\therefore Use No. 4 bars at 12 in spacing (S_{max})

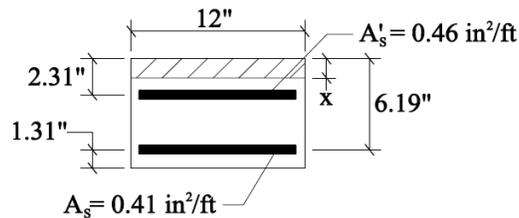
Figure A.3: Positive moment crack control cross-section

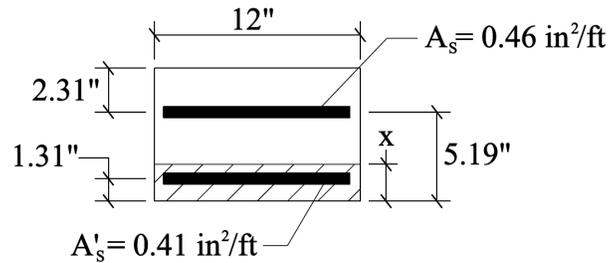
Figure A.4: Negative moment crack control cross-section

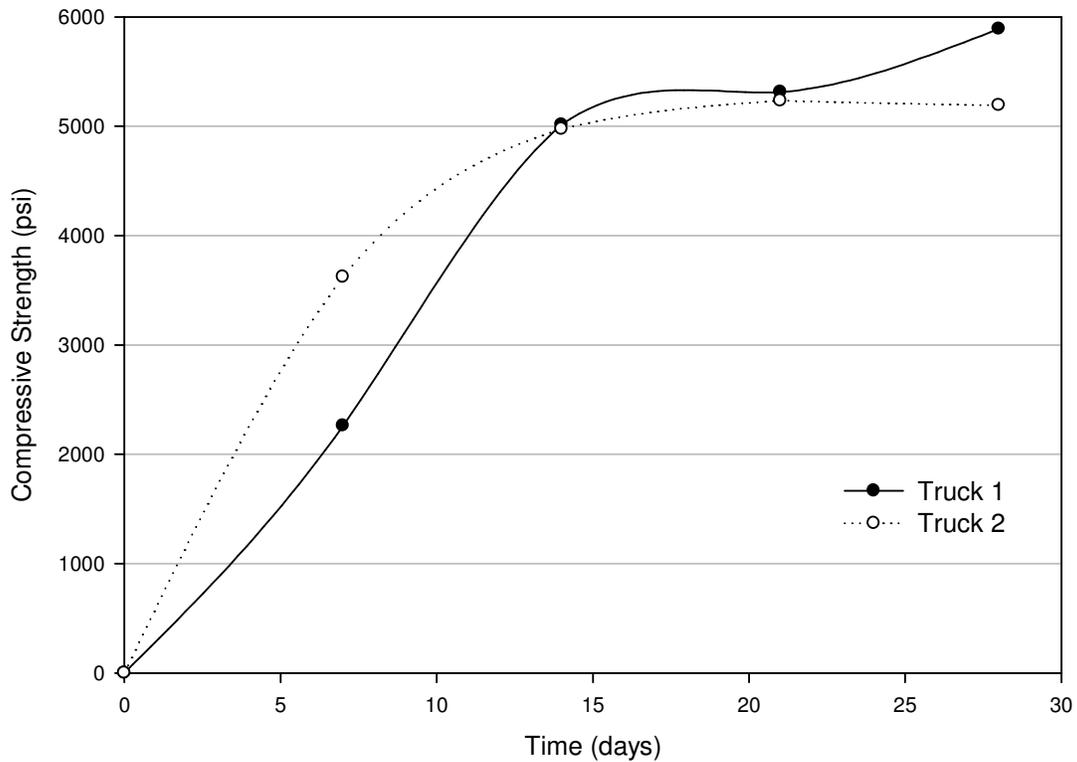
Figure C.1: Concrete compressive strength gain

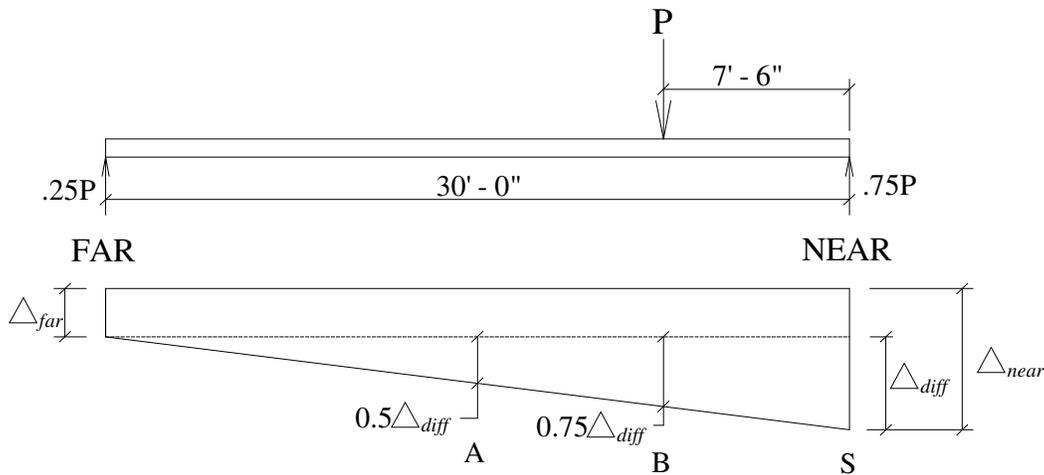
Figure E.1: Support deflection – Fatigue Test 1

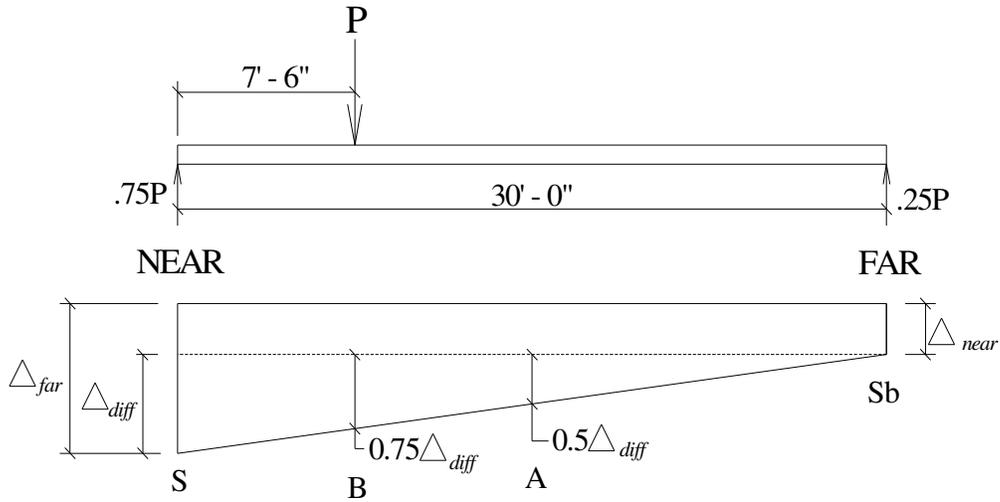
Figure E.2: Support deflection – Fatigue Test 2
