ADVANCING THE UNDERSTANDING OF WATER  
DISTRIBUTION SYSTEM CORROSION:  
EFFECTS OF CHLORINE AND ALUMINUM ON COPPER  
PITTING, TEMPERATURE GRADIENTS ON COPPER  
CORROSION, AND SILICA ON IRON RELEASE

Jason Clark Rushing

Master of Science  
in  
Environmental Engineering

July 24, 2002  
Blacksburg, Virginia

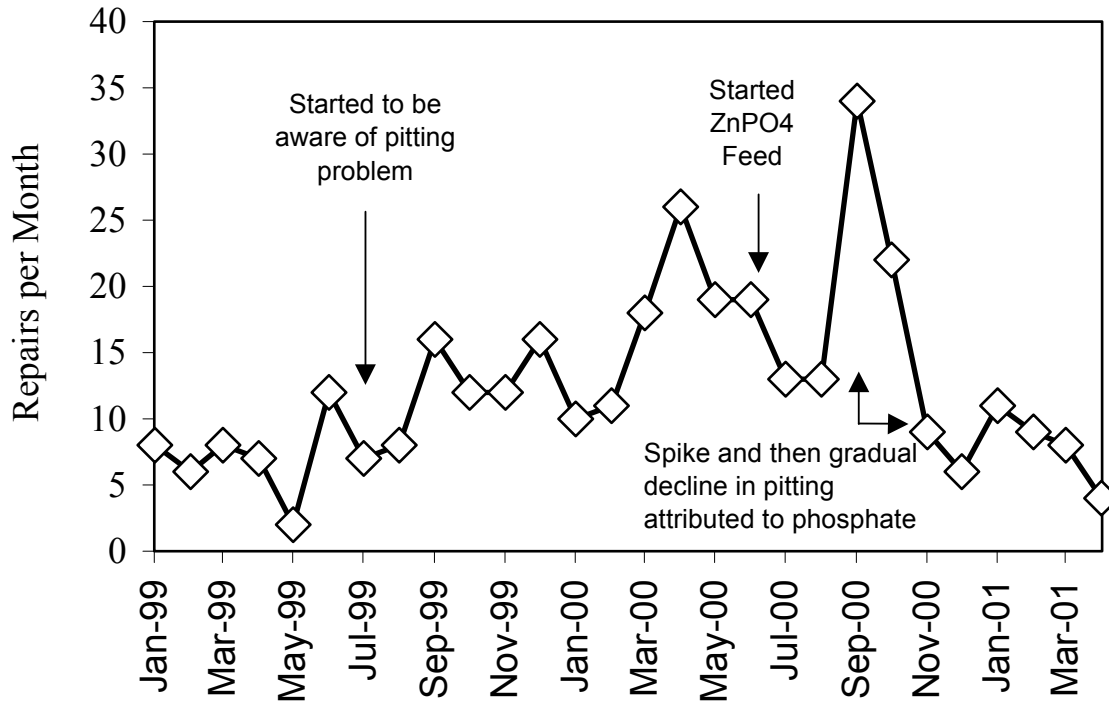
Figure 1-2. Repair of copper service lines due to copper pitting at a utility in Carroll County Maryland. In 1996, Zinc orthophosphate dosing was discontinued. In 1997, coagulant was changed from ferric chloride to poly-aluminum chloride. Pitting frequency was just a few leaks per month at that time. Data courtesy of Charles Singer, Carroll County.

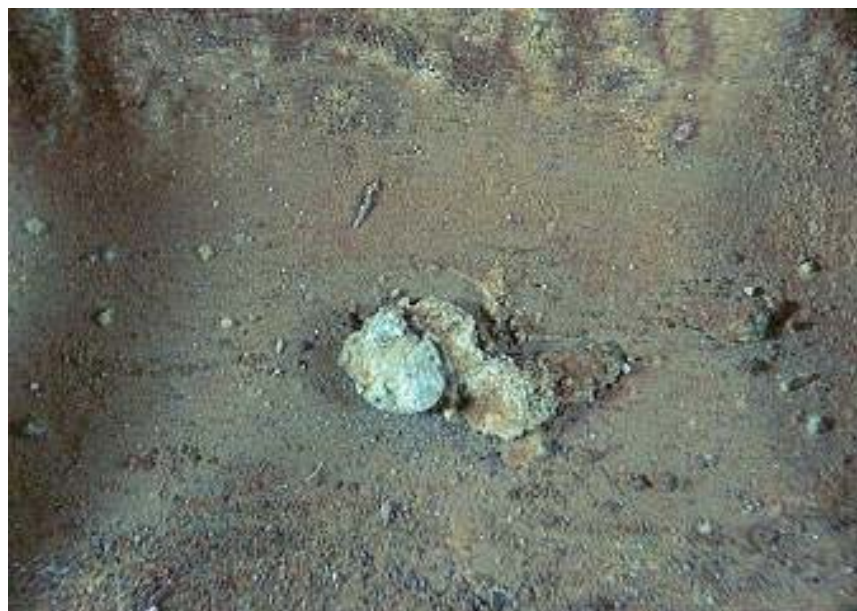
Figure 1-3 A large isolated pit on WSSC residential copper tubing typical of the type used to develop polarization scans. The mound, or tubercle, is formed by rapid copper corrosion underneath the pit.

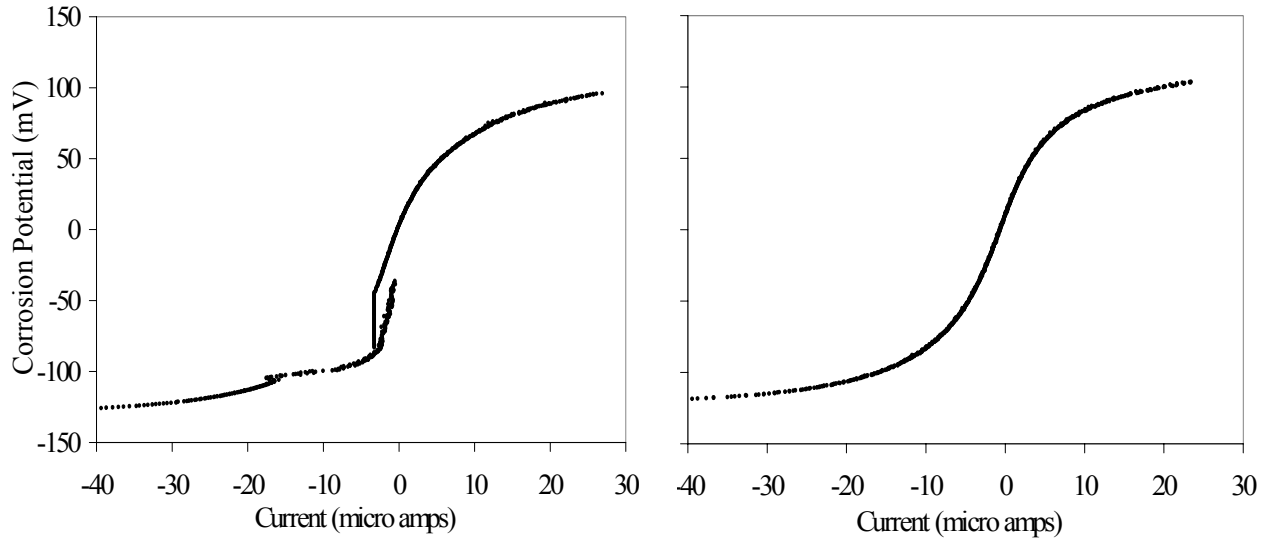
Figure 1-4. Polarization scans of WSSC copper specimens. Left: Actively pitting copper with tubercle cap in place. Right: Same sample 96 hours after tubercle cap removal. The scan on the right is also typical of copper corrosion in pipes without pits.

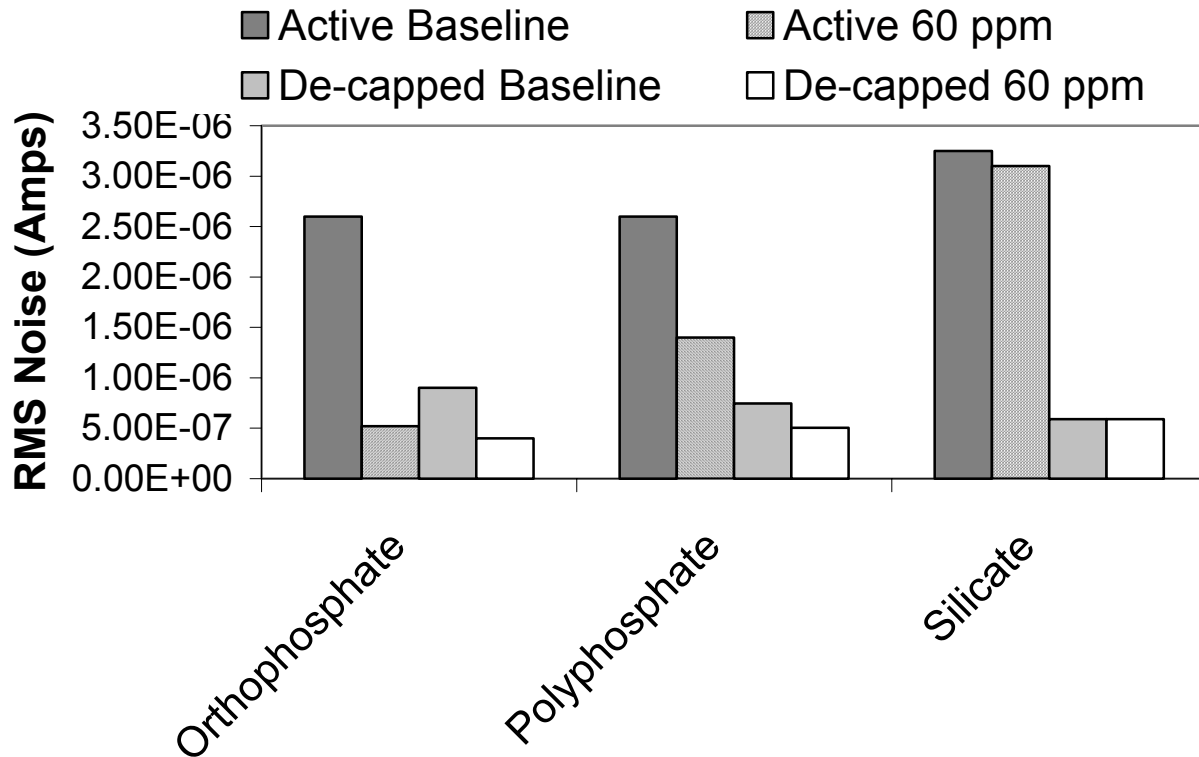
Figure 1-5. Effect of corrosion inhibitors on RMS noise measurements for samples with active pits and removed tubercles before and after 60 mg/L of corrosion inhibitor dosing.

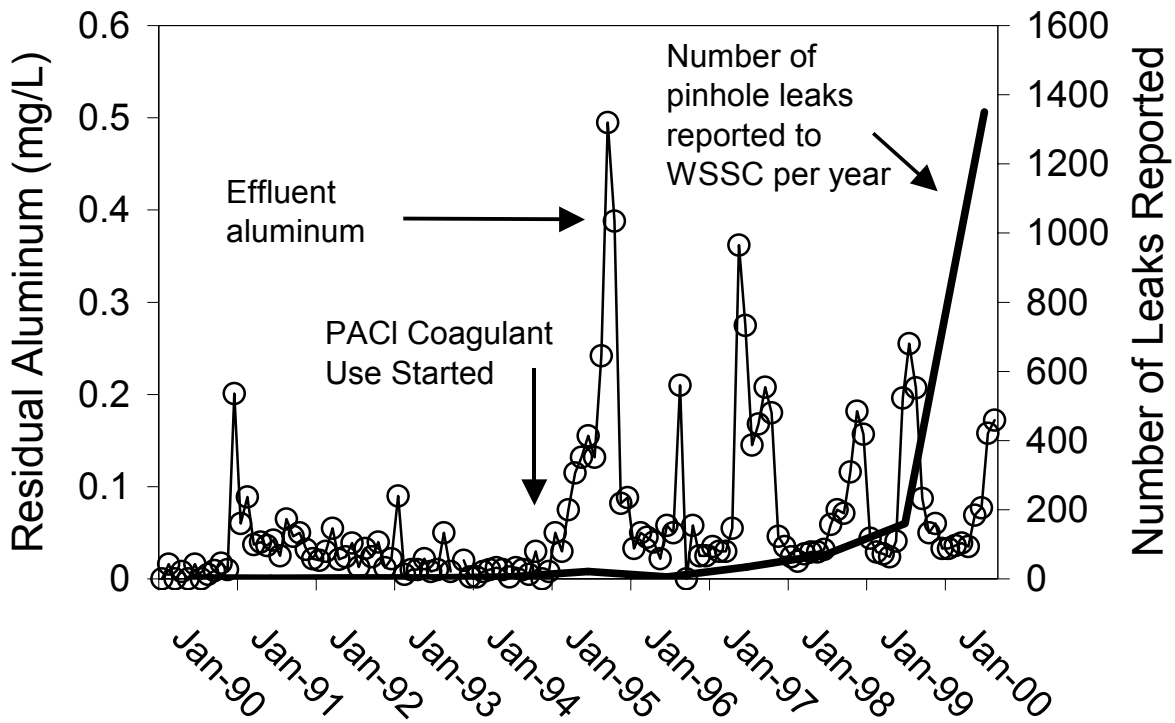
Figure 1-7. Monitoring results of finished water residual Al at the Potomac plant and yearly number of pinhole leaks reported to WSSC.

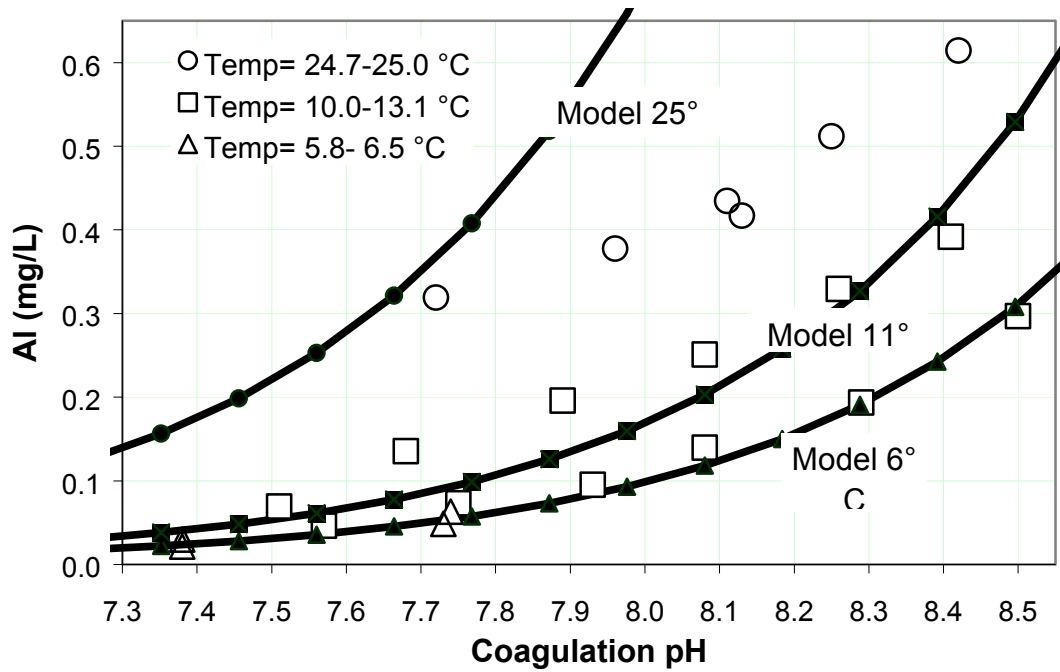
Figure 1-8. Comparison of soluble aluminum data collected at the treatment plant during jar tests with expectations based on chemical model predictions

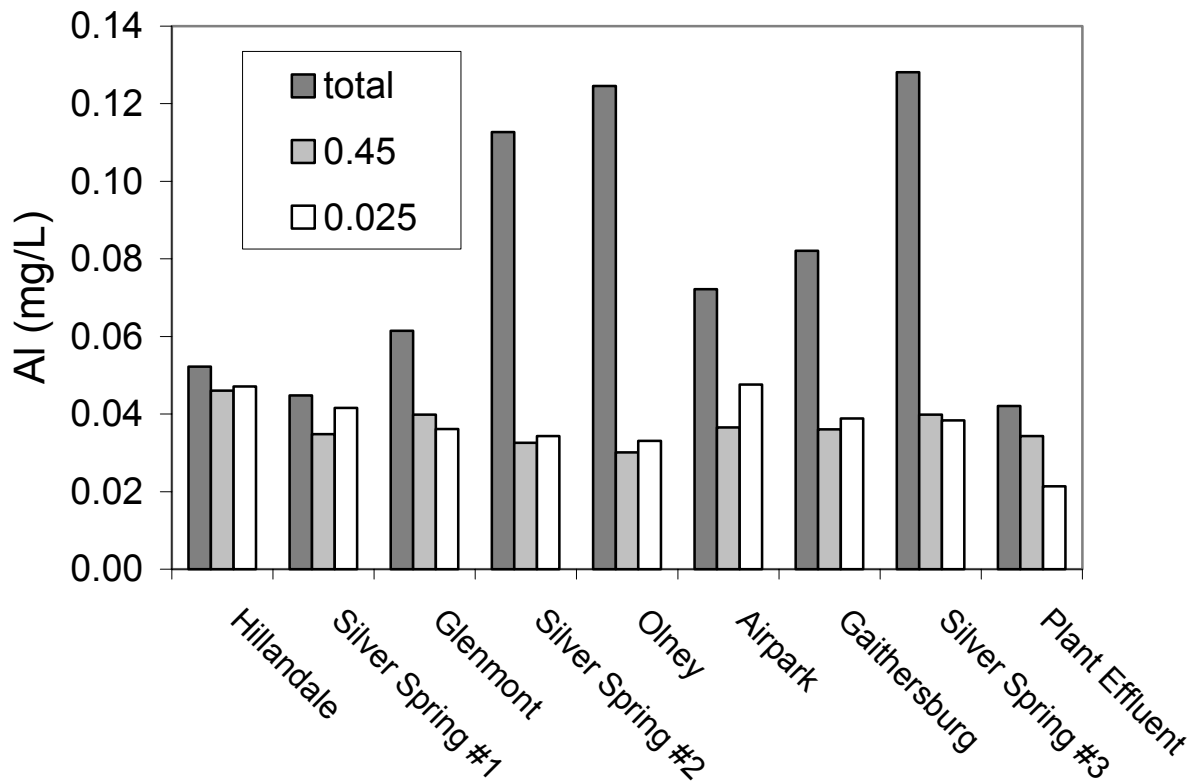
Figure 1-9. Aluminum at indicated sampling locations in the distribution system. Categories denote amount of aluminum that passed through a filter of that pore size in  $\mu\text{m}$ . Total samples not filtered before analysis.

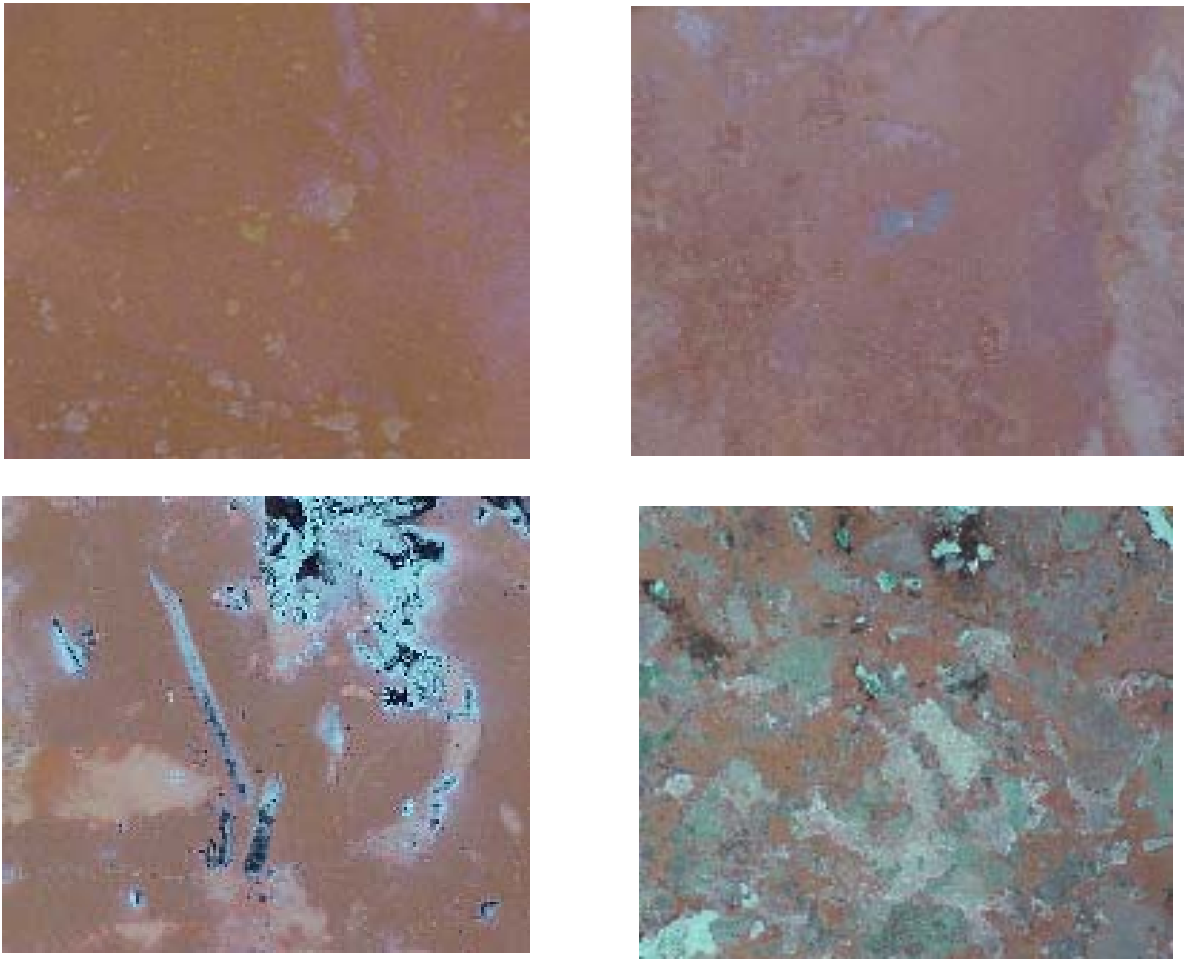
Figure 2-1: Dried copper surfaces after 10 weeks of exposure to WSSC water. Top left: No chlorine or aluminum solids. Top right: Aluminum solids only. Bottom left: 10 mg/L free chlorine as  $\text{Cl}_2$ . Bottom right: 10 mg/L free chlorine as  $\text{Cl}_2$  plus aluminum solids. Surface areas of each picture are approximately  $100 \text{ cm}^2$ .

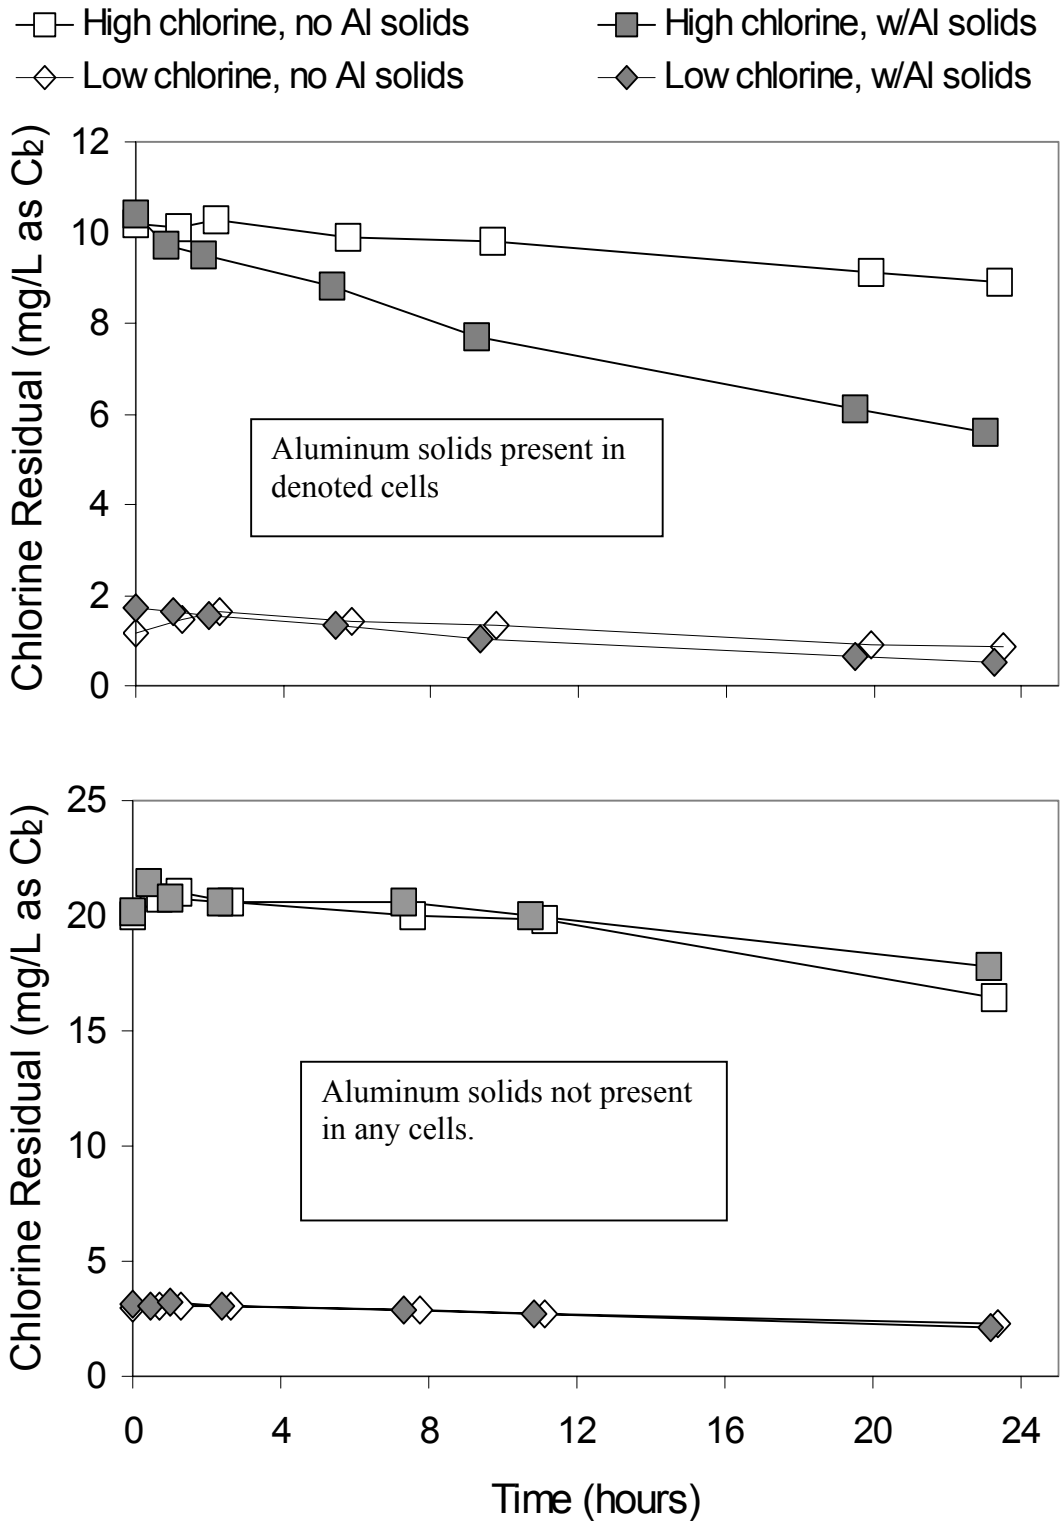
Figure 2-2: Free chlorine decay during week 4 (top) and week 10 (bottom). Aluminum solids were removed from cells during week 5. Cl<sub>2</sub> in bulk water (residual) in bottom graph is greater due to the use of a fresh bleach solution.

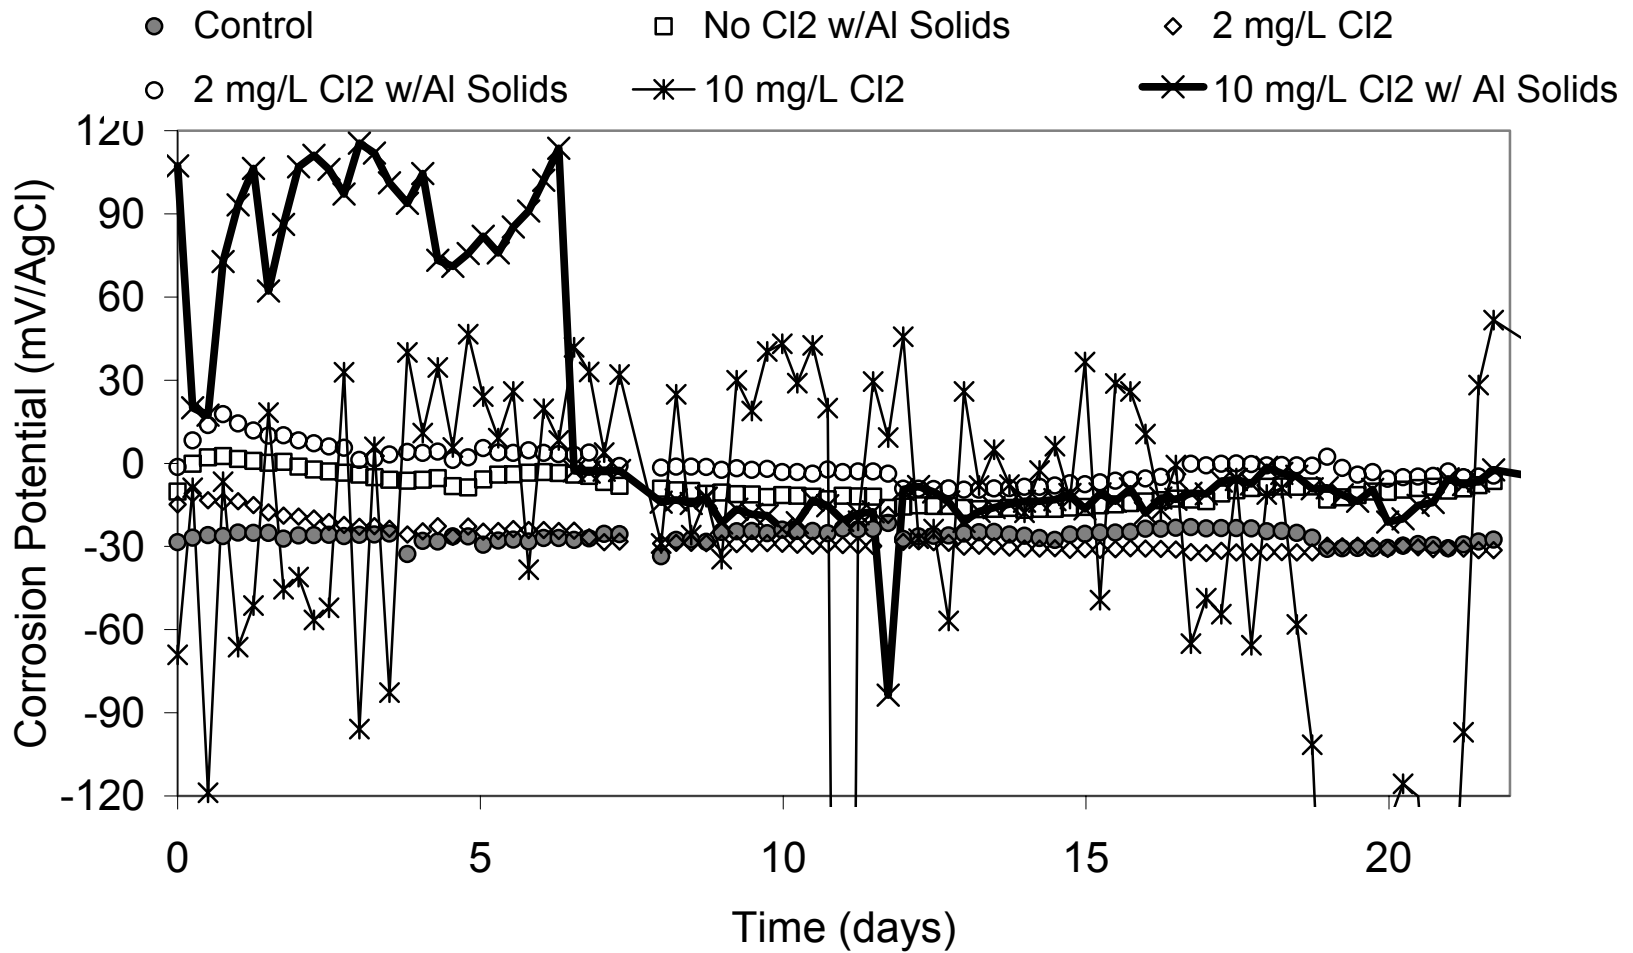
Figure 2-3: Corrosion potential results ( $E_{corr}$ ) from first phase of experiments with chlorine and aluminum.

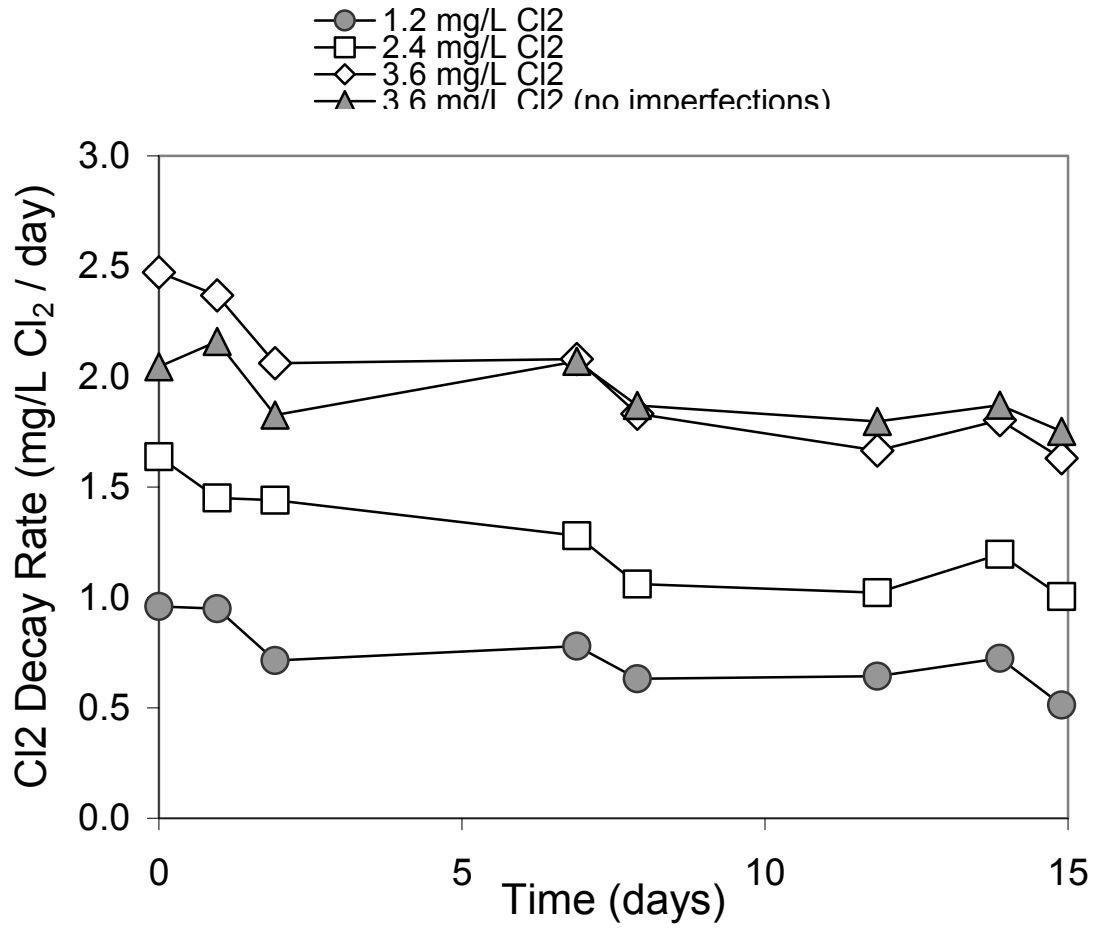
Figure 2-4: Chlorine decay rates from 2<sup>nd</sup> phase of chlorine and aluminum experiments. Rates calculated from amount of free chlorine decay over 24 hours.

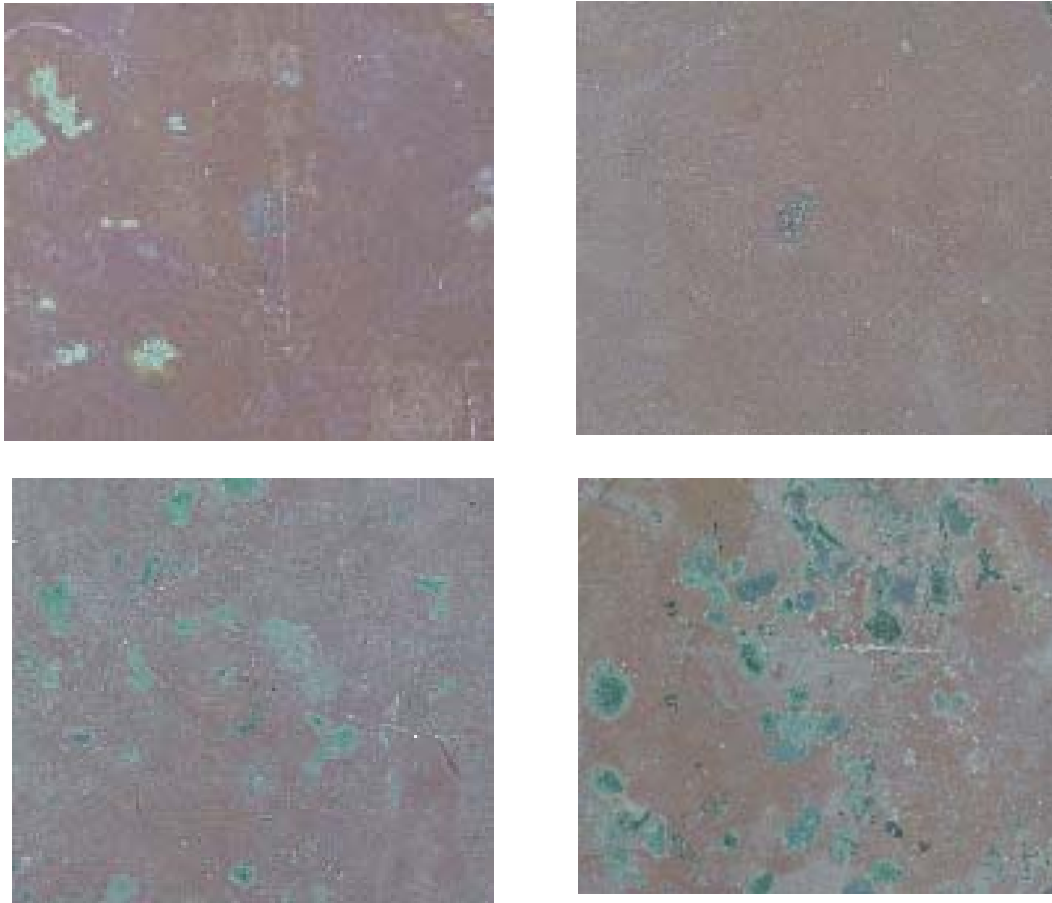
Figure 2-6: Picture of dried copper surfaces after 6 month exposure to WSSC water and aluminum solids. Top left: 0 mg/L free chlorine. Top right: 1.2 mg/L free chlorine. Bottom left: 2.4 mg/L free chlorine. Bottom right: 3.6 mg/L free chlorine. All samples exposed to 30 mg/L aluminum solids. Surface areas of each picture are approximately 100 cm<sup>2</sup>.

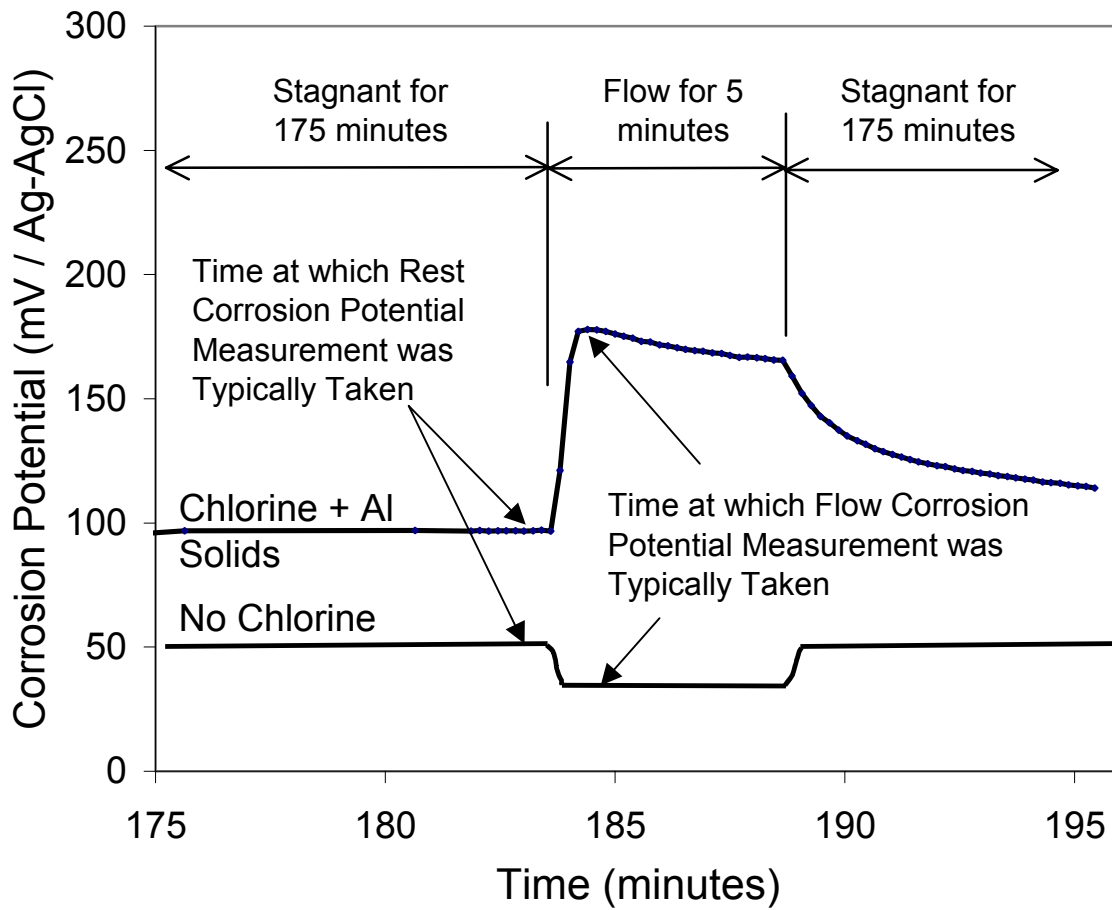
Figure 2-7. Typical corrosion potential response under flow or stagnant conditions for conditions with  $\text{Cl}_2$  and Al solids, and no  $\text{Cl}_2$  and no Al solids after 3 months of exposure. Arrows correspond to times flow and at rest corrosion potential measurements typically taken.

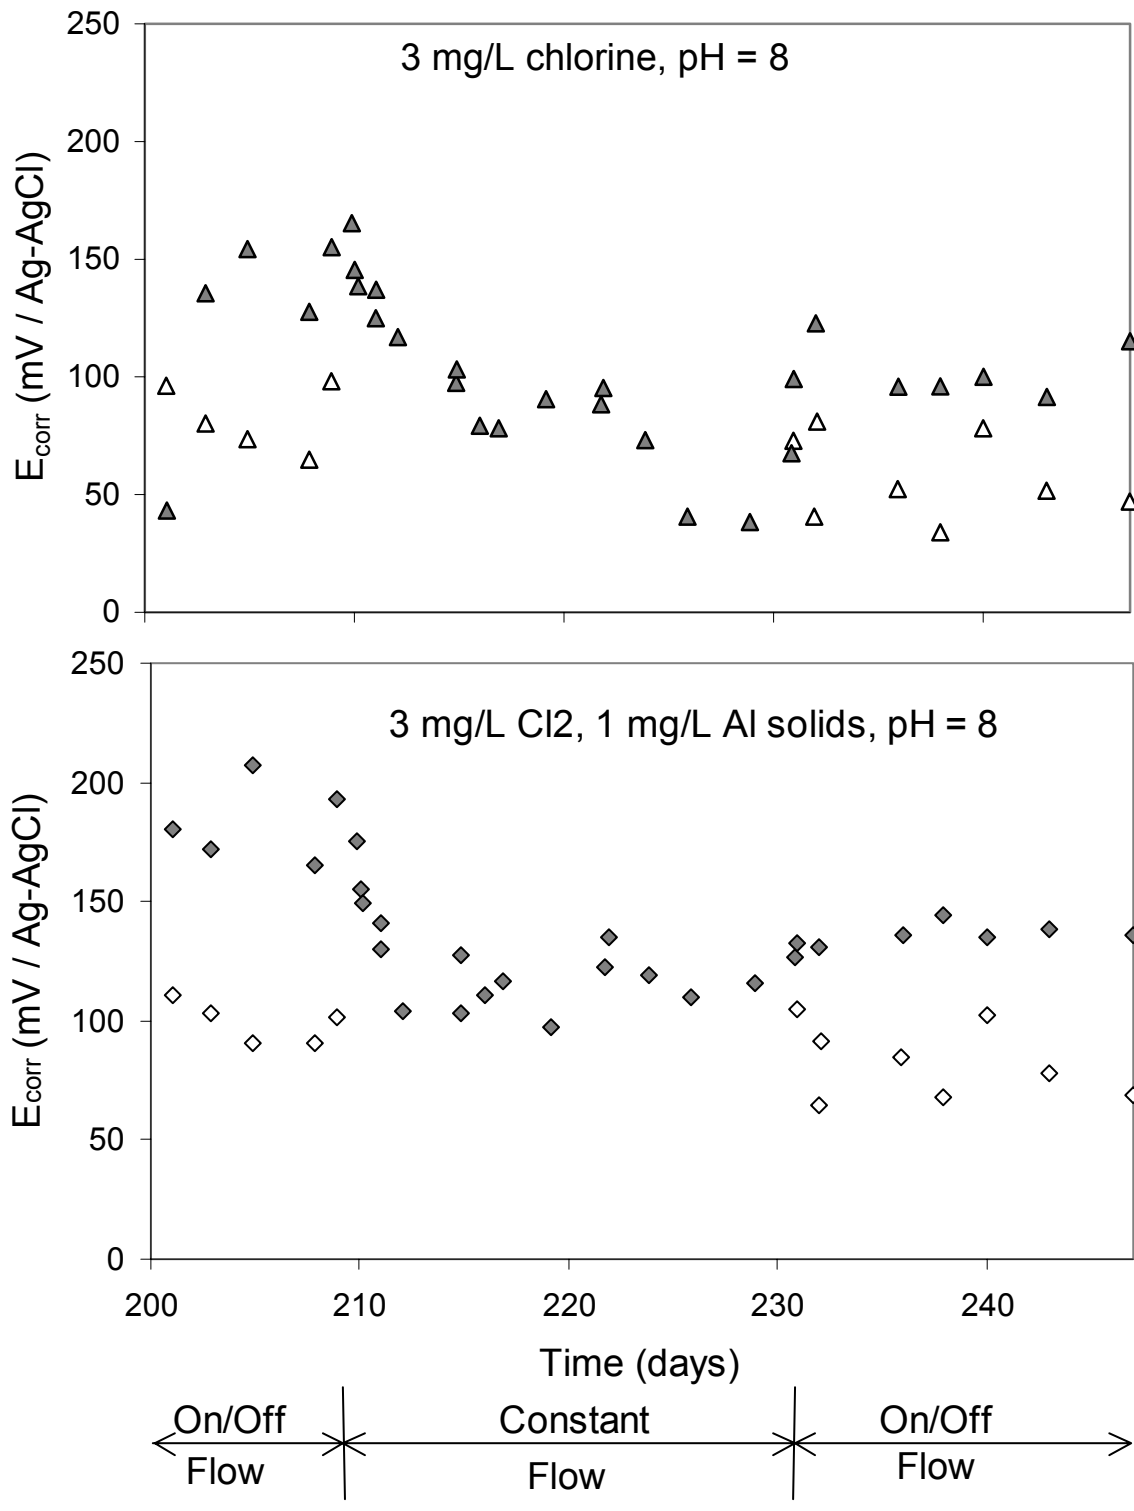
Figure 2-9: Corrosion potential measurements before and after 20 day period of constant flow. Filled and unfilled shapes denote E<sub>corr</sub> during flow and stagnation, respectively.

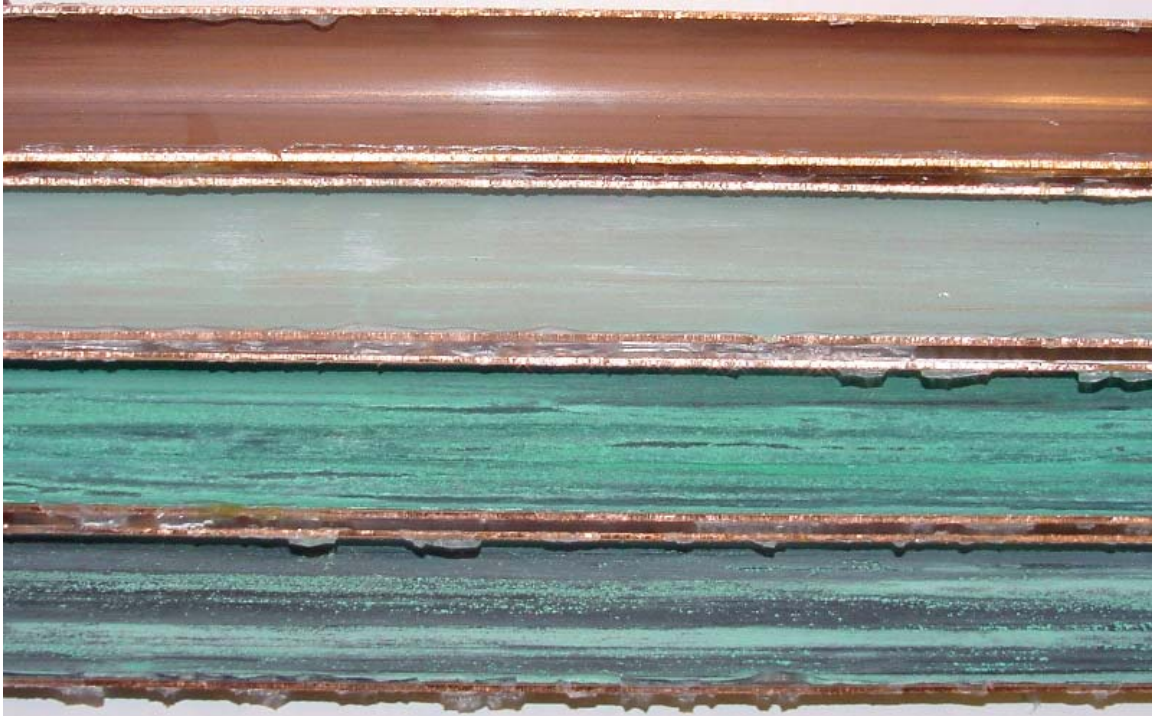
Figure 2-11: Dried copper pipe samples at the end of the experiment. From top to bottom: Control, 1 mg/L Al, 3 mg/L Cl<sub>2</sub>, 1 mg/L Al plus 3 mg/L Cl<sub>2</sub>.

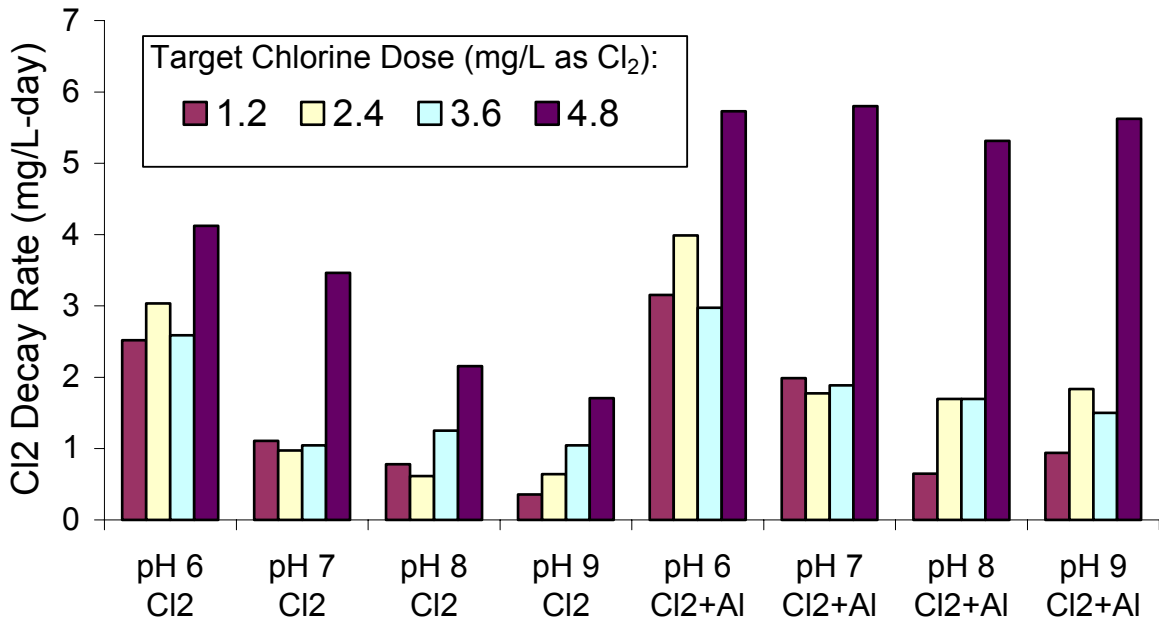
Figure 3-1. Average chlorine decay rates based on duplicates for various target chlorine doses. Chlorine decay measured over an 8-hour period, and rate is presented in mg/L Cl<sub>2</sub> lost per day.

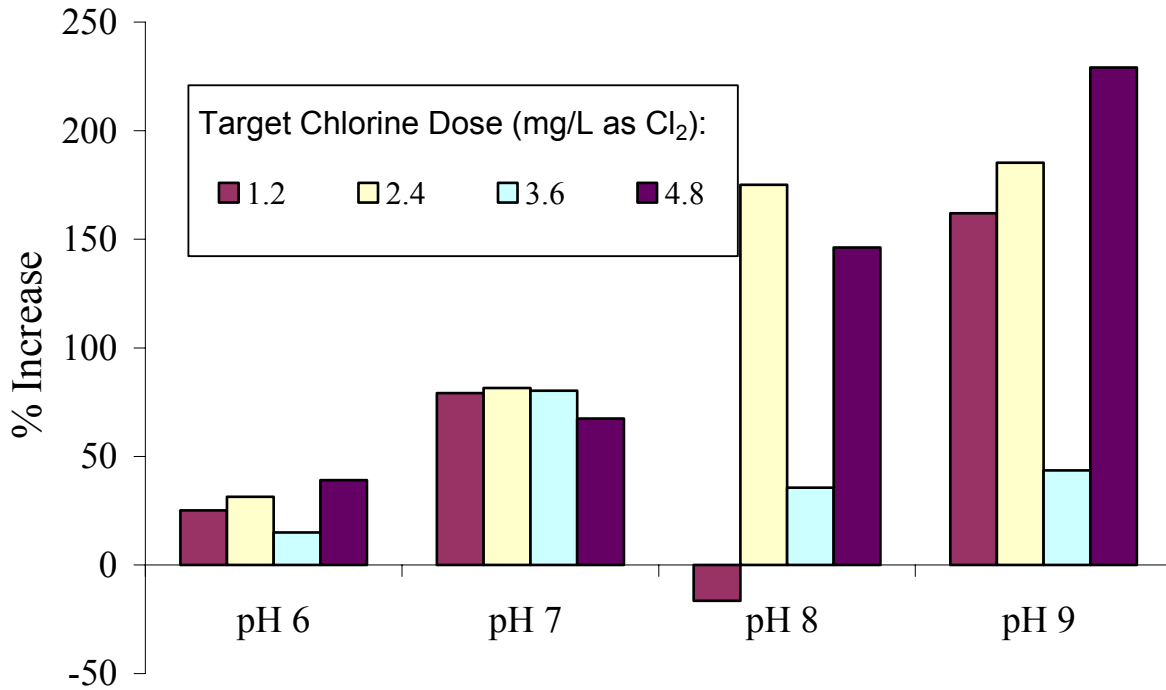
Figure 3-2. Percent increase in chlorine decay rate for given target dose with 2 mg/L aluminum solids present compared to same system without aluminum.

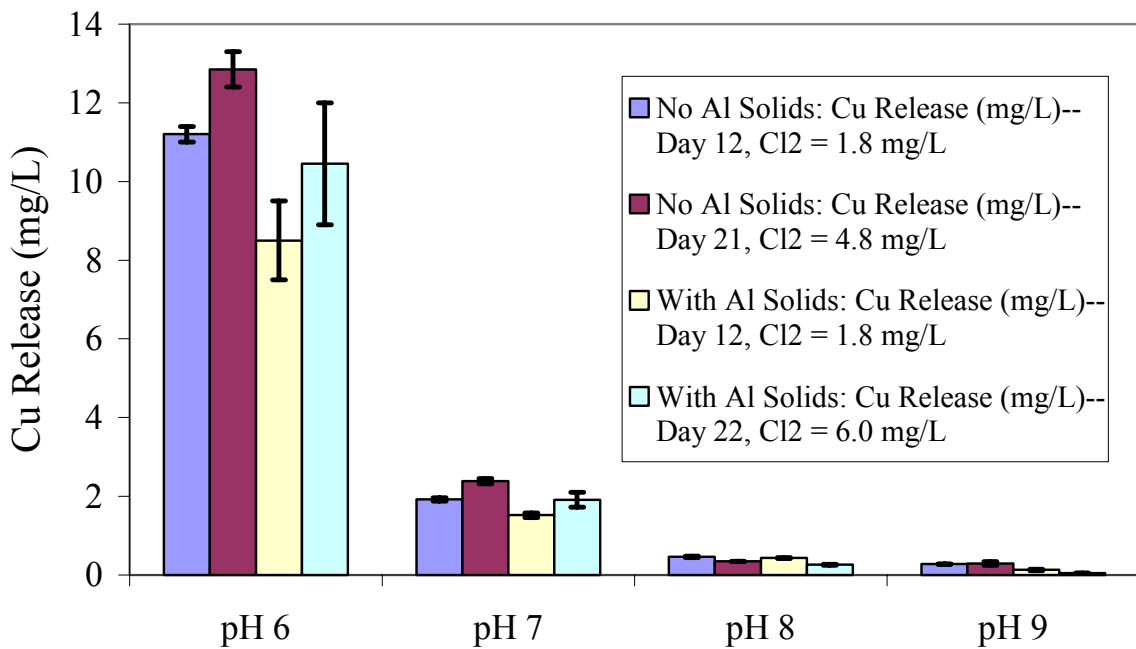
Figure 3-6. Average Copper Release based on duplicates measured before water change on Day 12 and end of experiment. Error bars represent the low and high measurements of the duplicate samples.

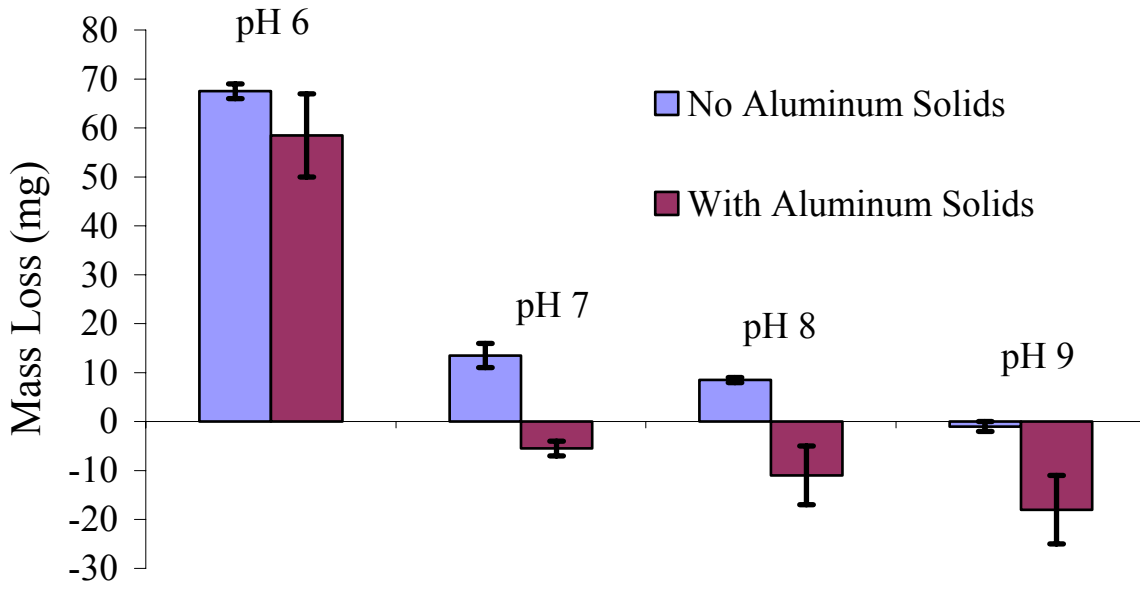
Figure 3-7. Average mass loss from copper samples based on duplicates. Negative values indicate a mass gain. Error bars represent the low and high measurements of the duplicate samples.

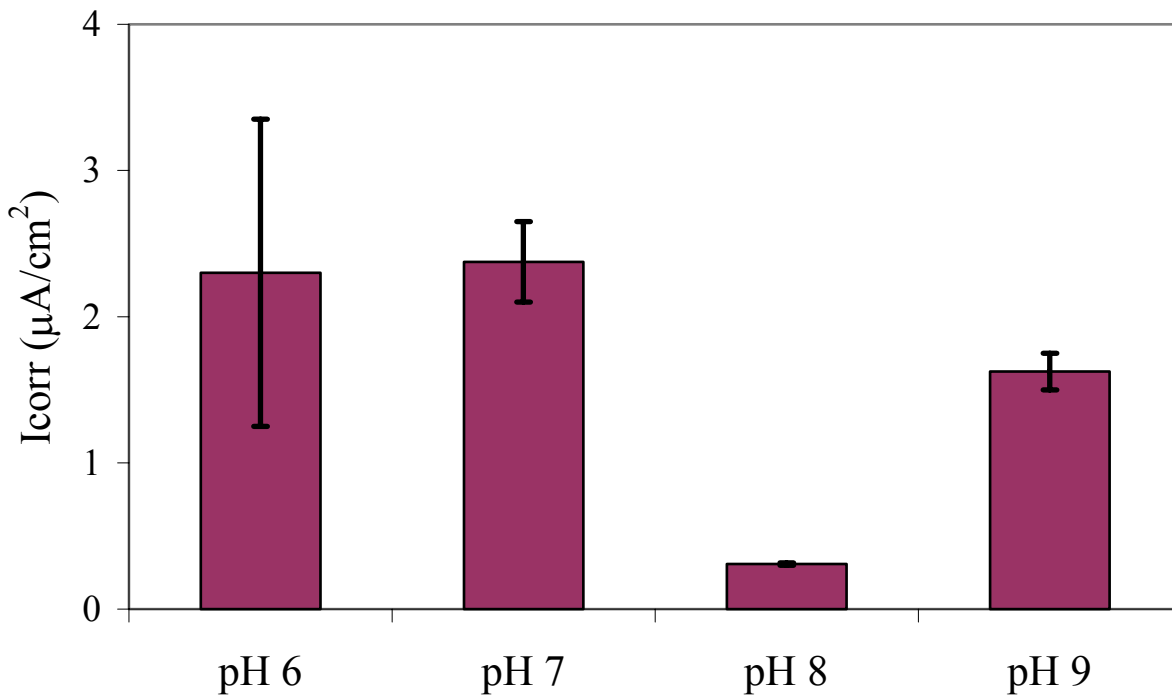
Figure 3-8. Average corrosion rate during day 23 with aluminum solids present. Water changed 18 hours before data was collected. Cl<sub>2</sub> = 6.0 mg/L. Error bars represent the low and high measurements of the duplicate samples.

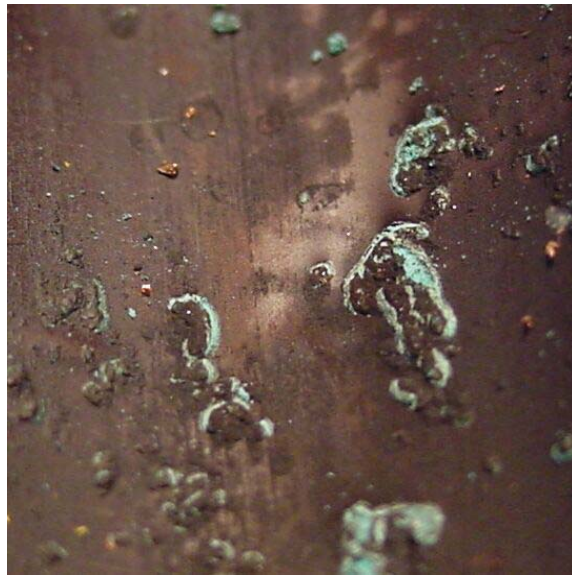
Figure 3-10. Close up of corrosion byproducts formed on pH 9 sample exposed to aluminum solids and chlorine.

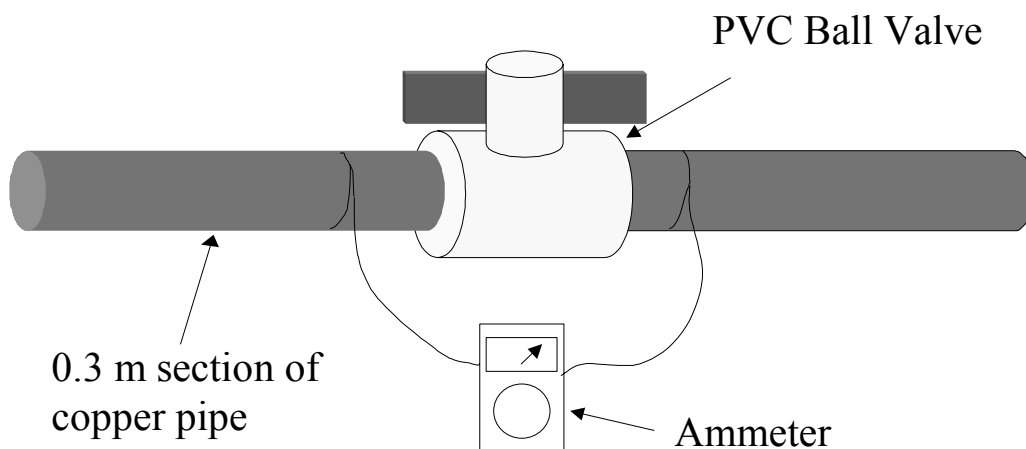
Figure 4-1. Pipe setup and current measurement technique for pipe sample with PVC ball valve dielectric

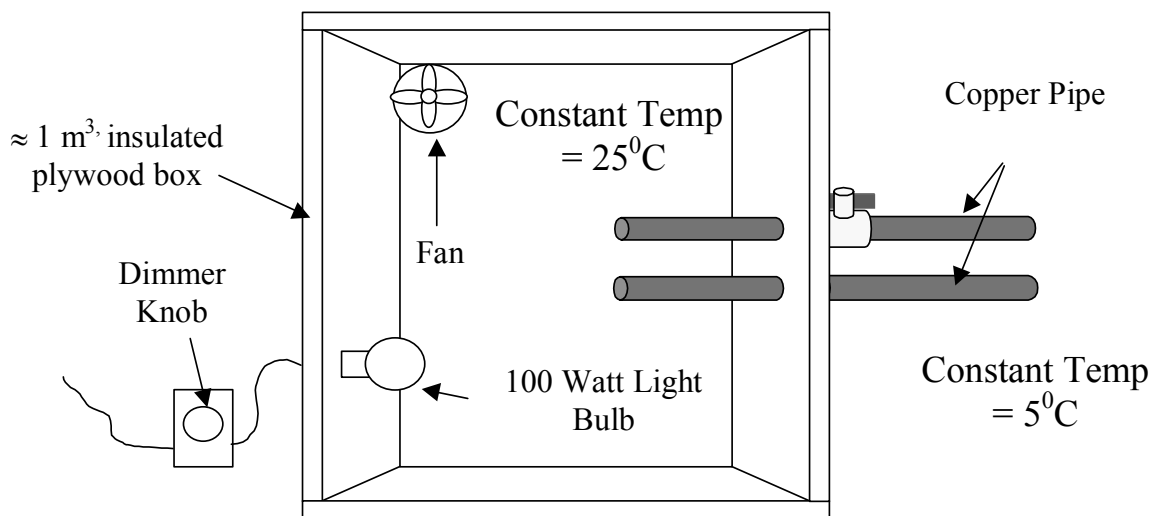
Figure 4-2. Experimental rig set up. Copper pipe setup in picture was replicated in ceiling and floor of insulated box. Pipe samples also placed inside and outside to expose samples to a constant 5 or 25 °C.

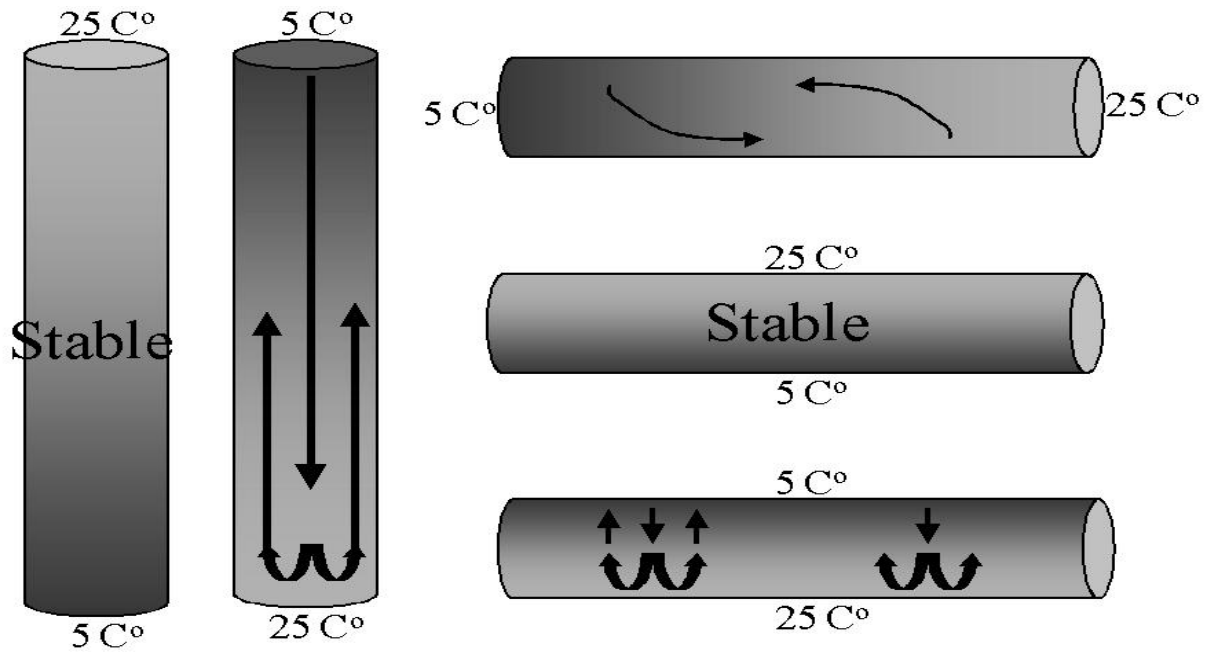
Figure 4-3. Schematic illustrating how temperature differences on different ends of a copper pipe would set up convection currents that enhance or act to prevent mixing during stagnation.
