ADVANCING THE UNDERSTANDING OF WATER  
DISTRIBUTION SYSTEM CORROSION:  
EFFECTS OF CHLORINE AND ALUMINUM ON COPPER  
PITTING, TEMPERATURE GRADIENTS ON COPPER  
CORROSION, AND SILICA ON IRON RELEASE

Jason Clark Rushing

Master of Science  
in  
Environmental Engineering

July 24, 2002  
Blacksburg, Virginia

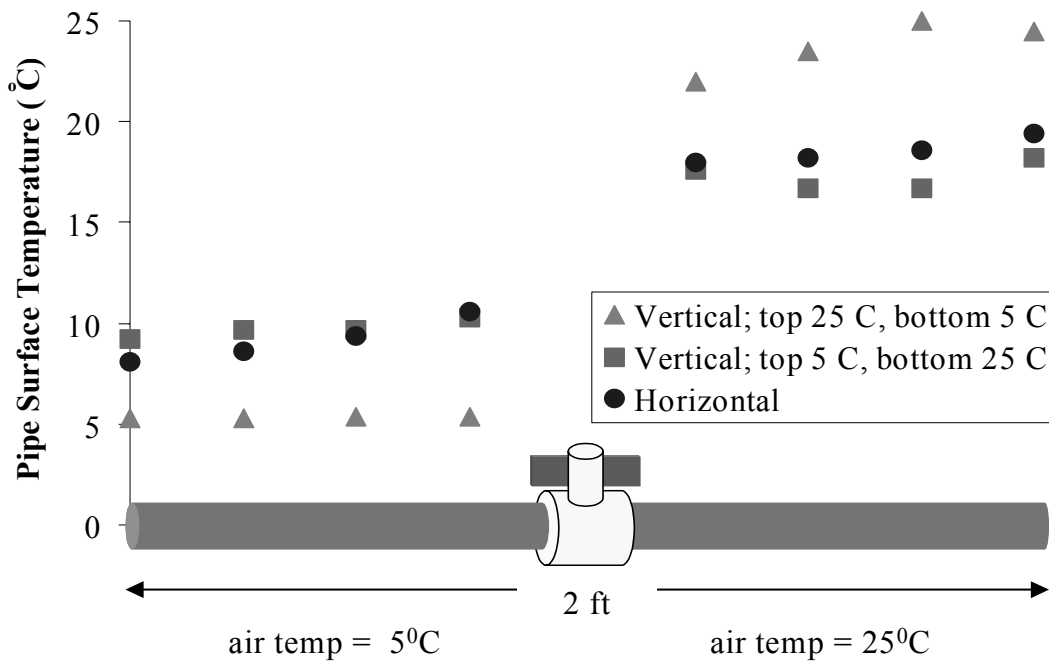
Figure 4-4. External surface temperatures for copper pipes joined by PVC ball valve.

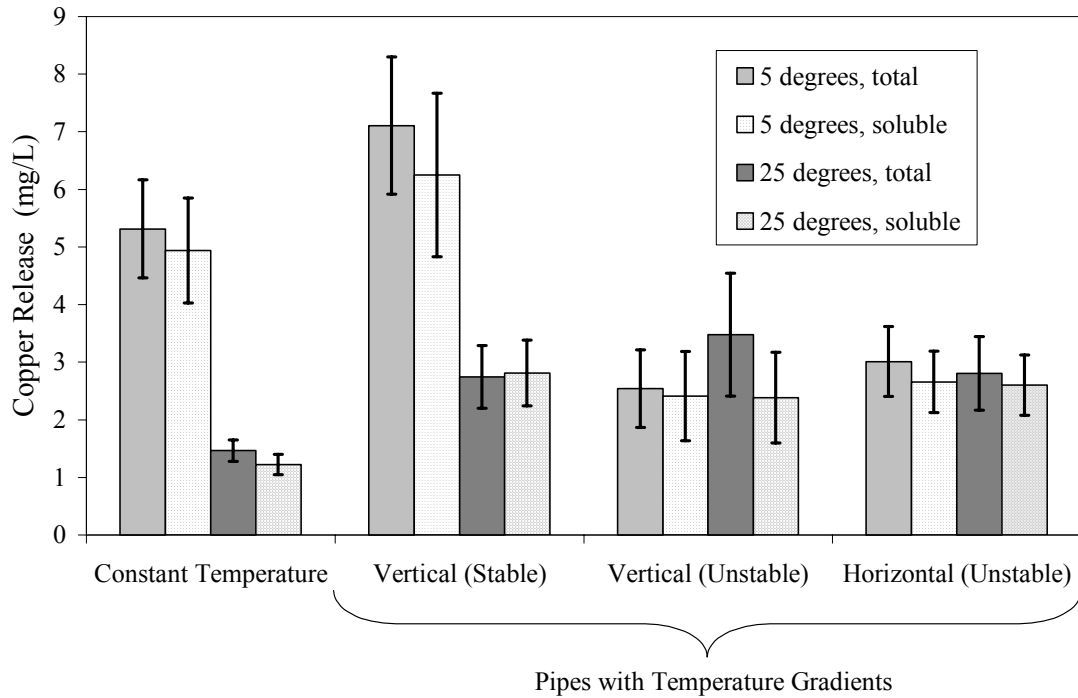
Figure 4-5. Average copper release for days 42-98. Data derived from 6 samplings during this period. Error bars represent 95% confidence intervals.

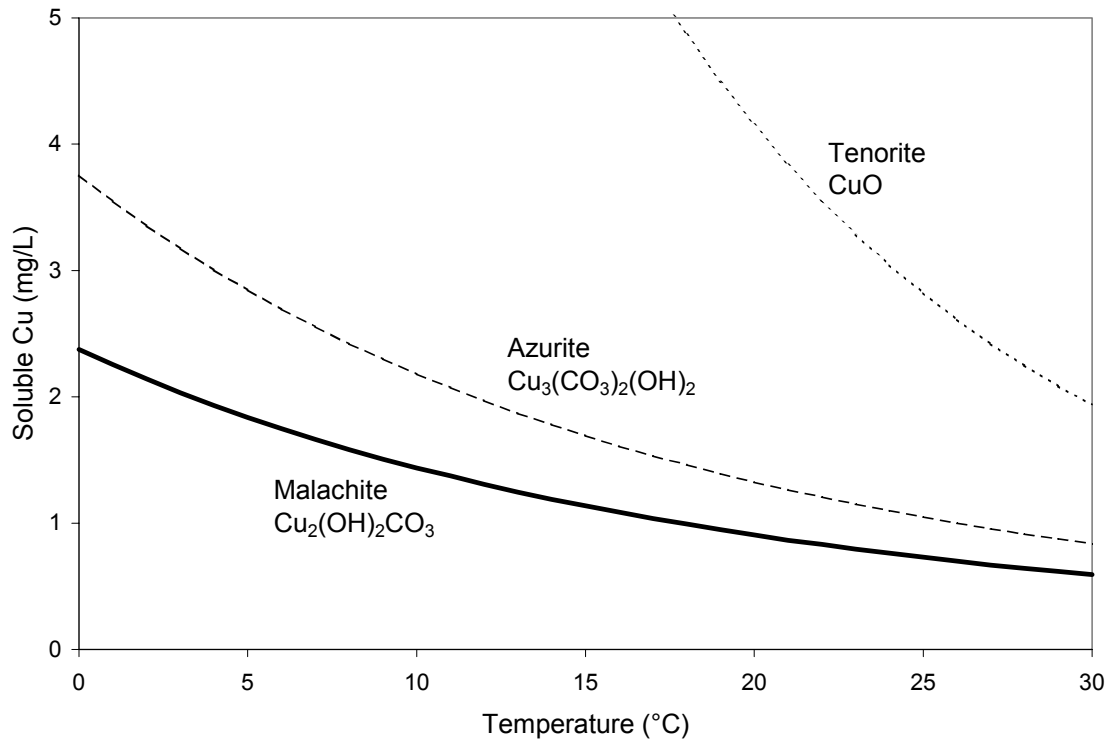
Figure 4-6. Predicted cupric solid formation as function of temperature for the water chemistry used in this experiment

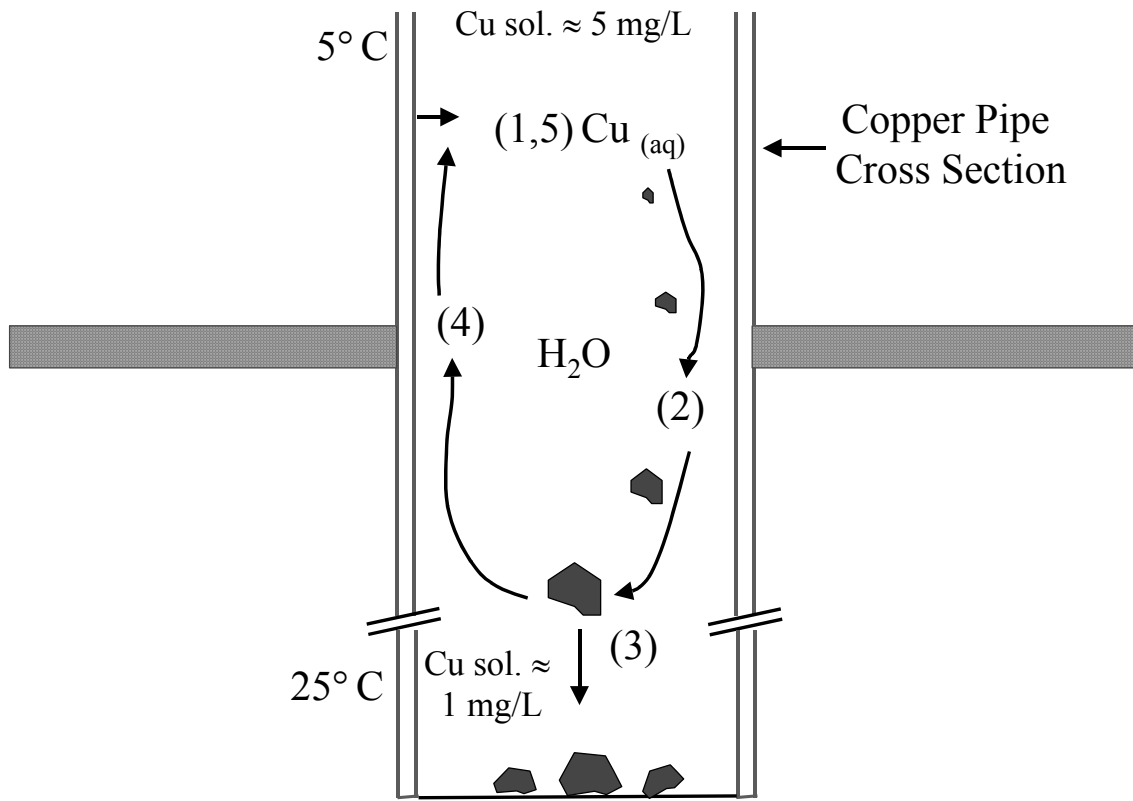
Figure 4-7. Mechanism causing elevated particulate copper levels in pipe exposed to temperature gradients after stagnation: (1) soluble copper release, (2) soluble copper transport to warm section due to convection currents, (3) copper solid precipitation and settling due to decreased solubility, (4) water return to cold section without soluble copper, (5) more soluble copper release.

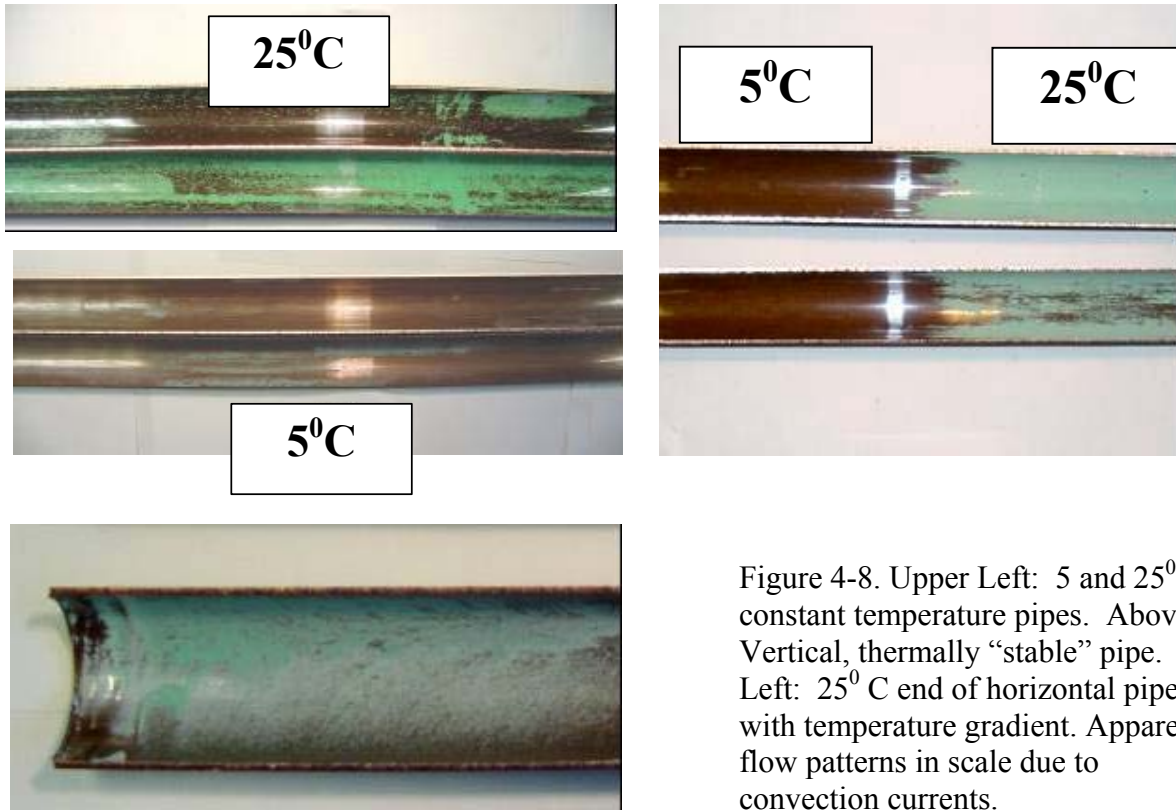
Figure 4-8. Upper Left: 5 and 25<sup>0</sup> C constant temperature pipes. Above: Vertical, thermally “stable” pipe. Left: 25<sup>0</sup> C end of horizontal pipe with temperature gradient. Apparent flow patterns in scale due to convection currents.

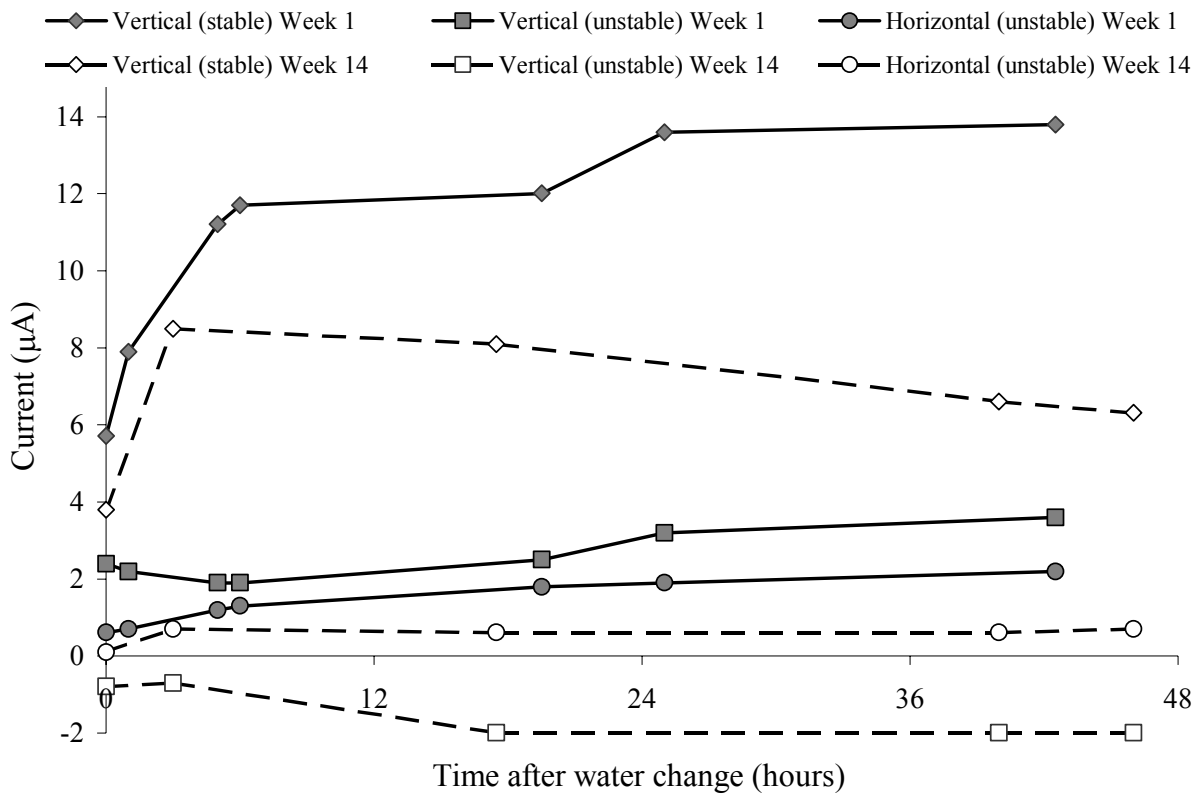
Figure 4-9. Thermogalvanic currents over two 48 hour periods, 14 weeks apart.

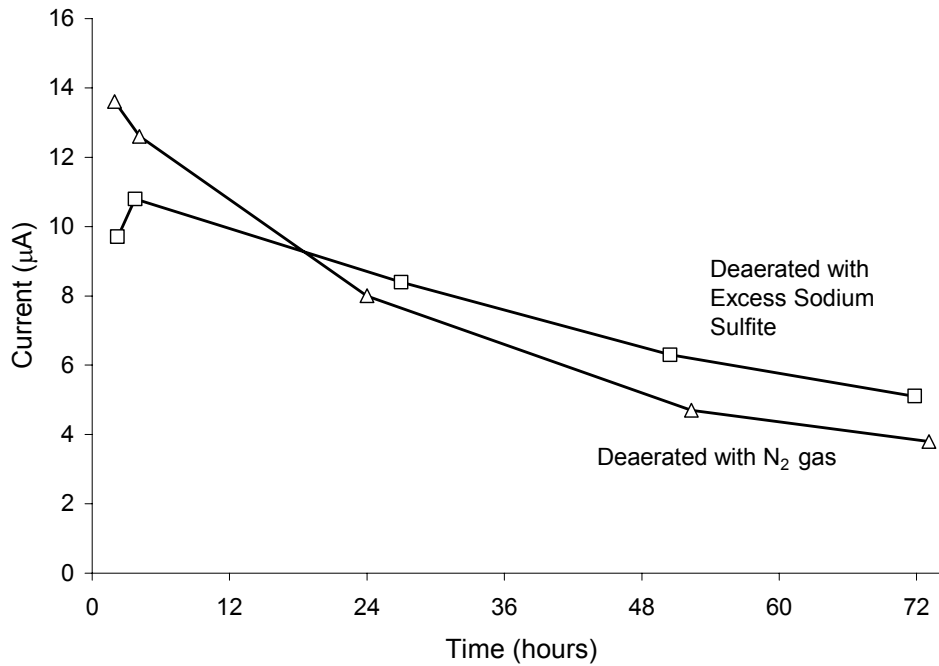
Figure 4-10. Thermogalvanic currents after oxygen removal with N<sub>2</sub> gas stripping or addition of excess sodium sulfite to scavenge all O<sub>2</sub> from the water

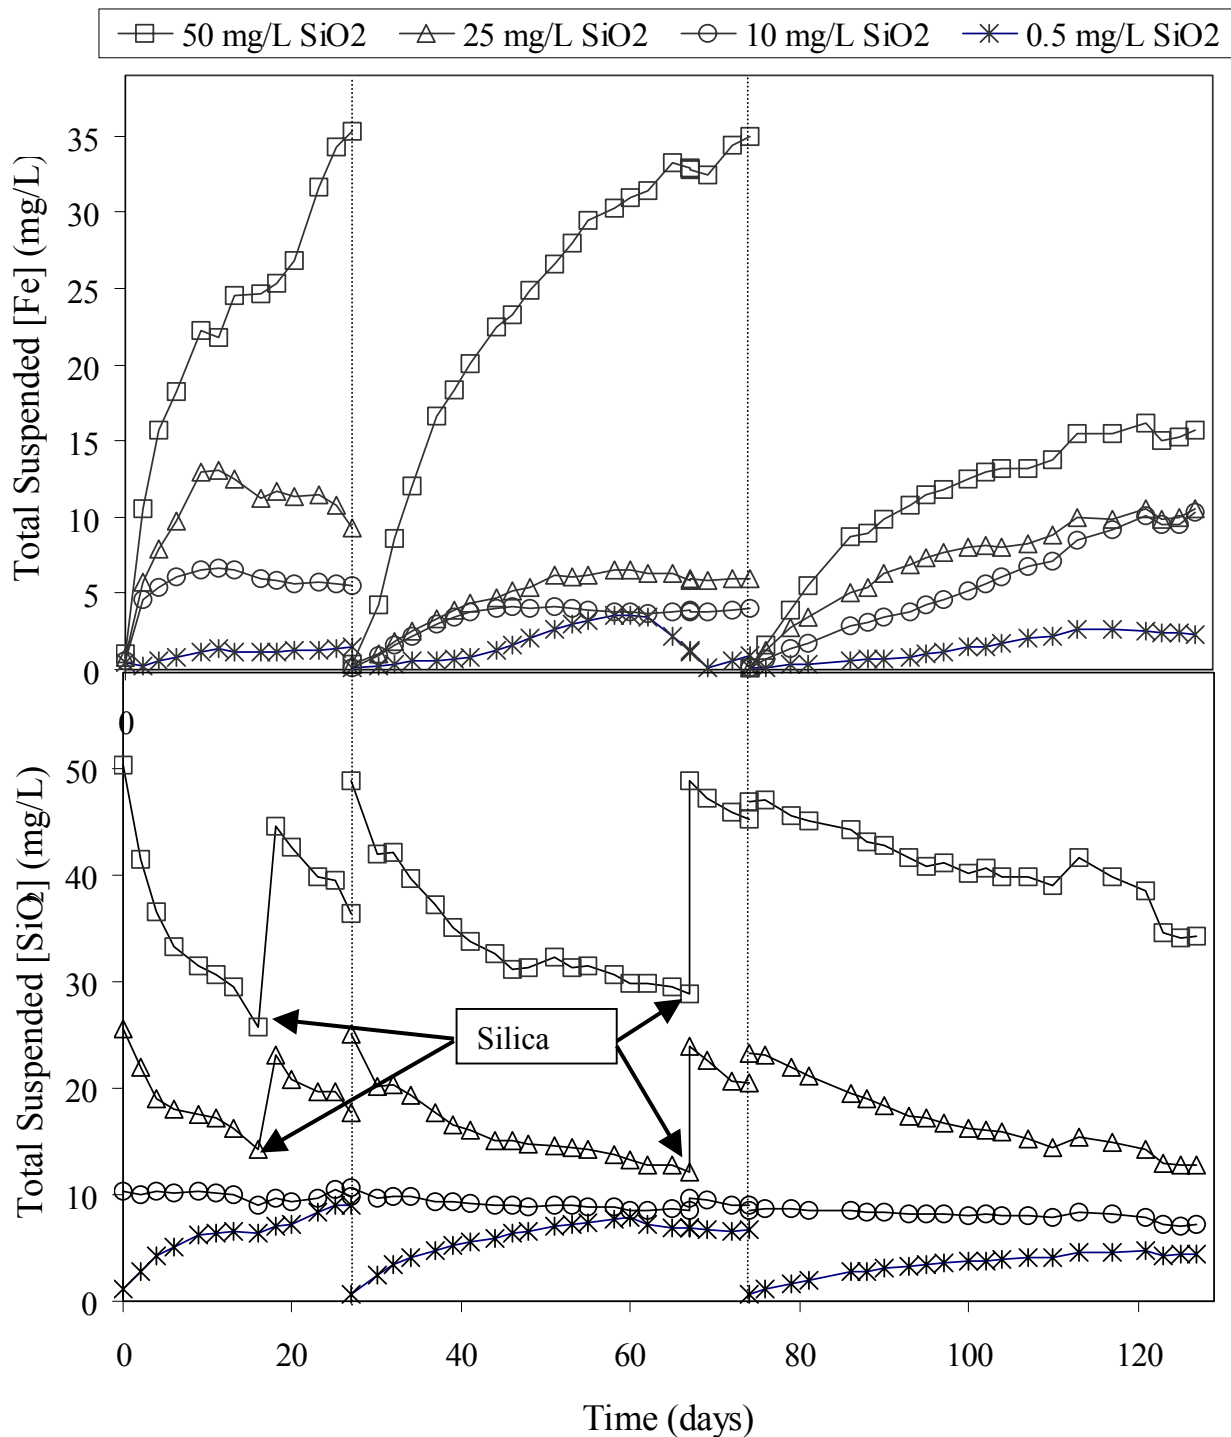
Figure 5-1: Iron (top) and silica (bottom) concentrations in 20<sup>0</sup> C reactors. Water changes occurred at days 27 and 74 and are indicated by vertical dashed lines. Silica was manually dosed to the 50 and 25 mg/L SiO<sub>2</sub> reactors on days 16 and 67 (indicated by arrows) to restore silica to initial concentrations. Same trends seen at 5<sup>0</sup> C.

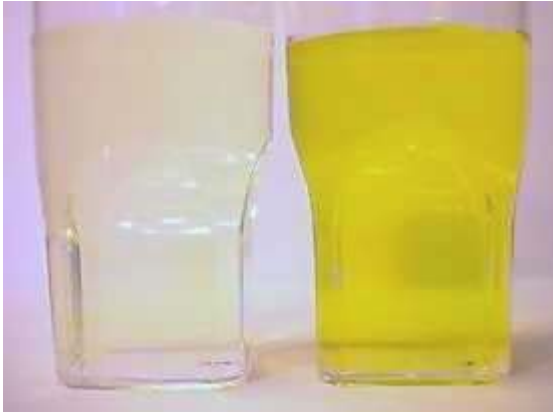
Figure 5-2: Color difference in water from 0.5 mg/L silica container (left) and 50 mg/L silica container (right) at 20<sup>0</sup> C.

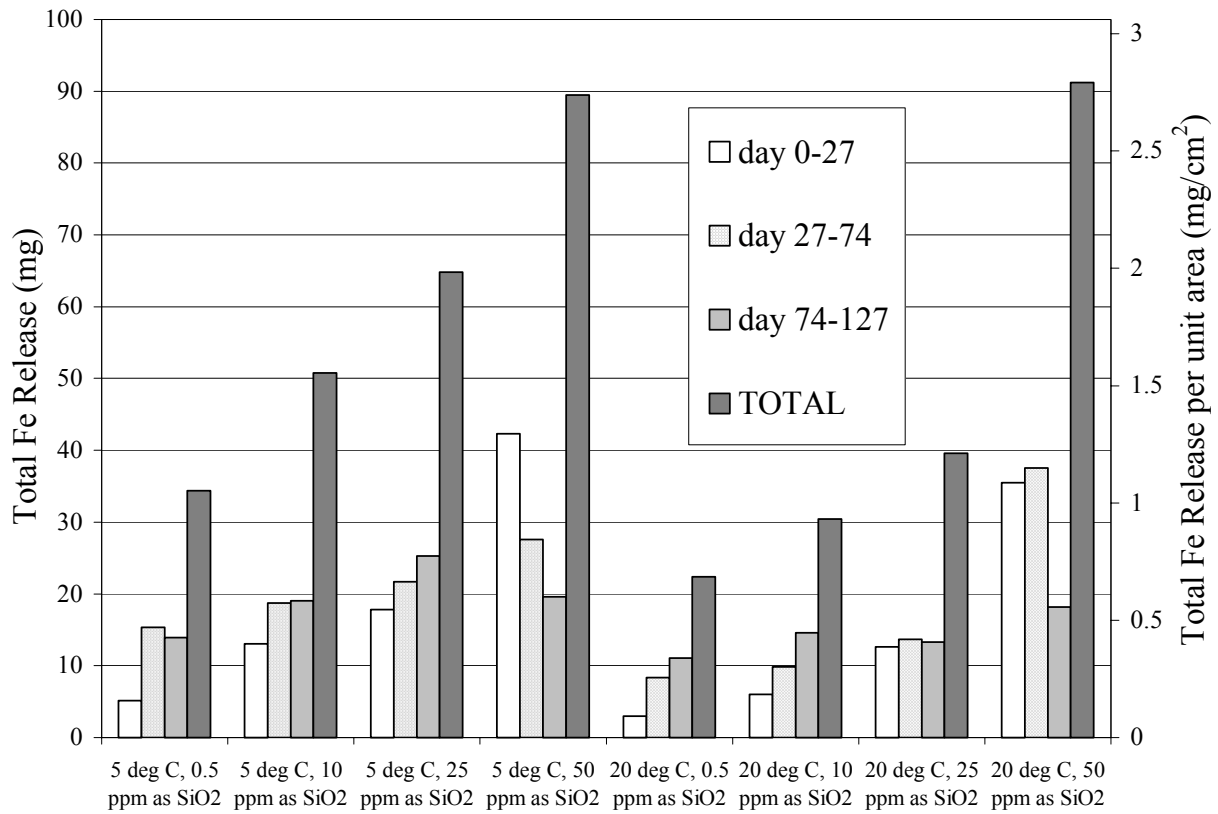
Figure 5-3: Total iron release in reactors at 5 and 20<sup>0</sup> C. Measured after water changes and at end of experiment.

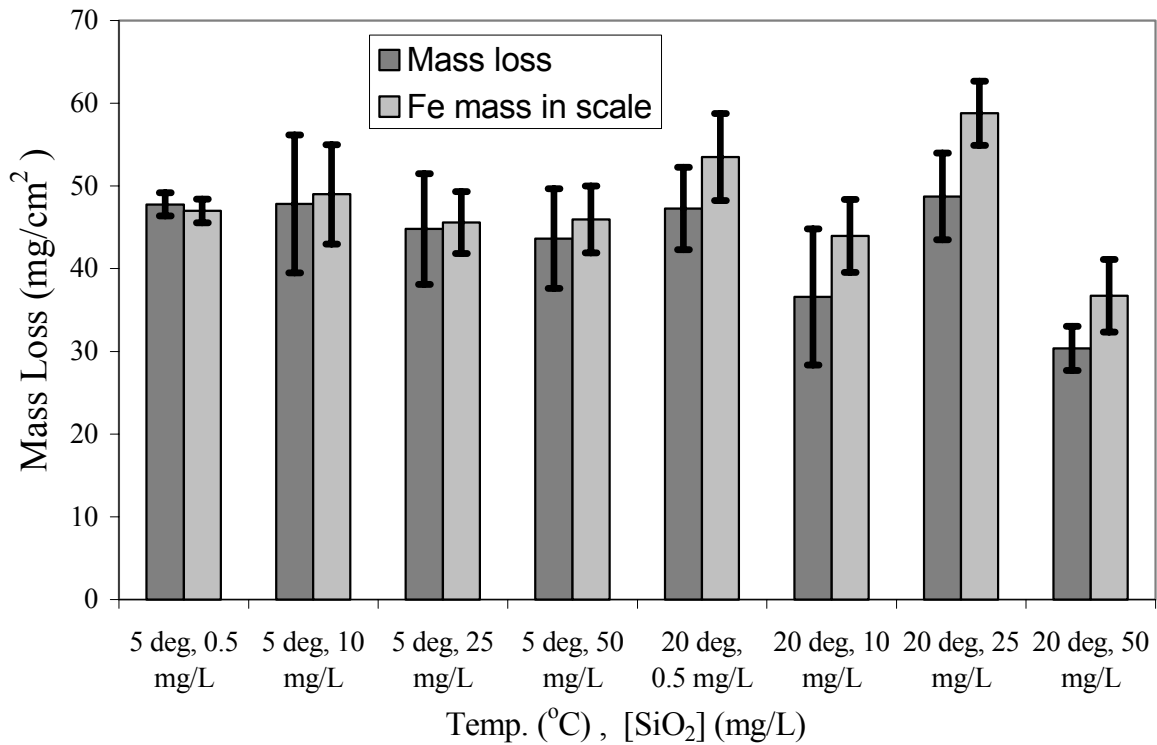
Figure 5-4: Iron coupon mass loss after 4 months. Error bars represent 95% confidence intervals.

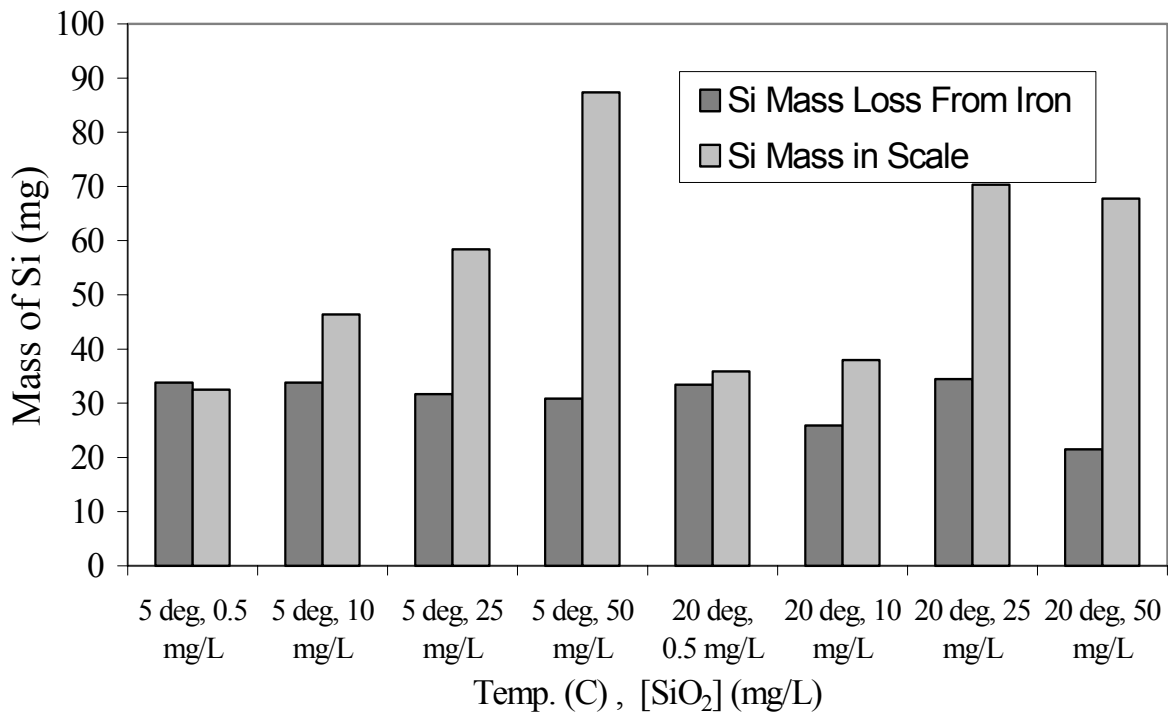
Figure 5-5: Silica loss from and incorporation in iron scale. Silica loss to the water assumed to be 2.5% of the total mass loss of the cast iron coupons.

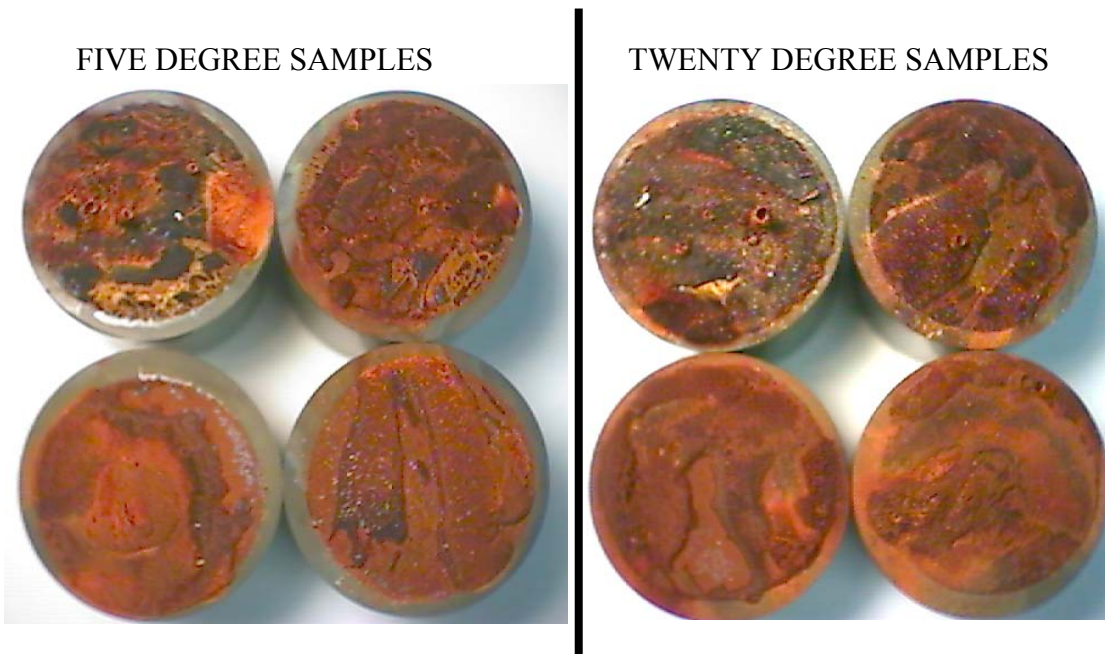
Figure 5-6: Representative corroded iron coupons after end of experiment. For both left and right pictures, from upper left and going clockwise: sample from 50, 25, 10, 0.5 mg/L silica reactor.

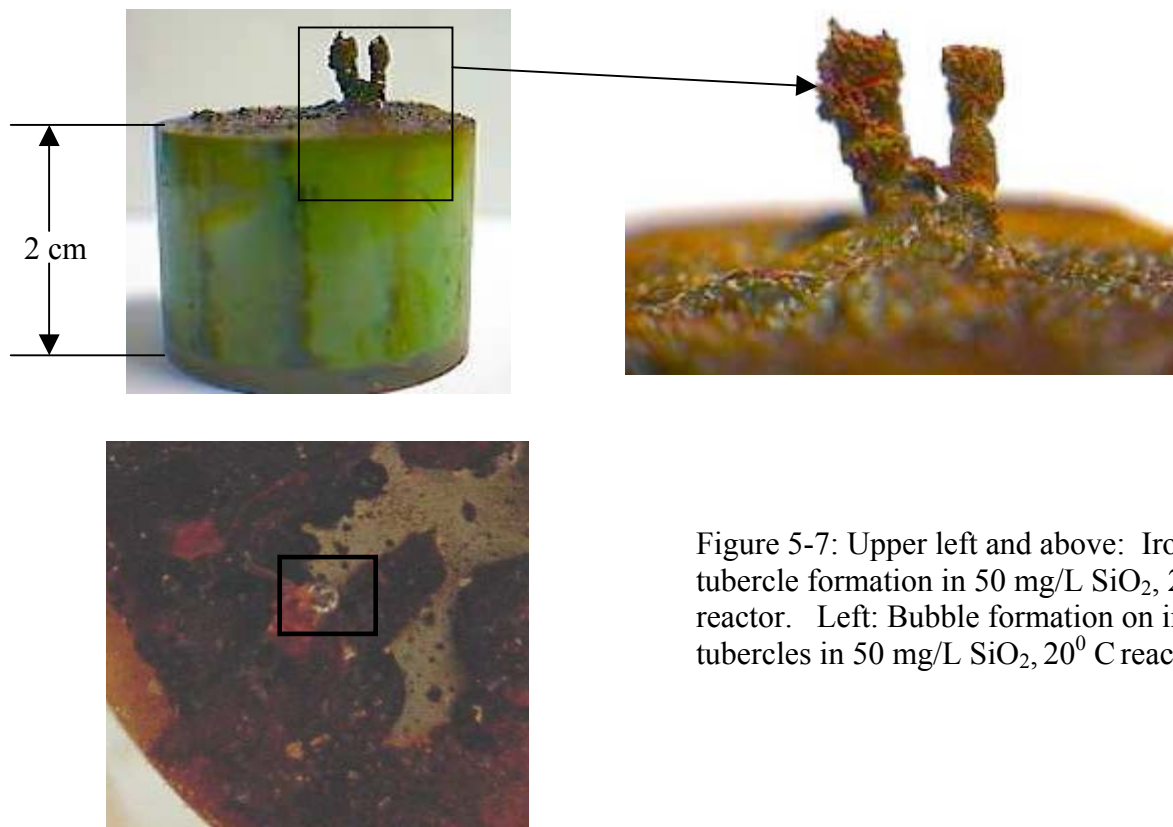
Figure 5-7: Upper left and above: Iron scale tubercle formation in 50 mg/L  $\text{SiO}_2$ ,  $20^\circ\text{C}$  reactor. Left: Bubble formation on iron tubercles in 50 mg/L  $\text{SiO}_2$ ,  $20^\circ\text{C}$  reactor.

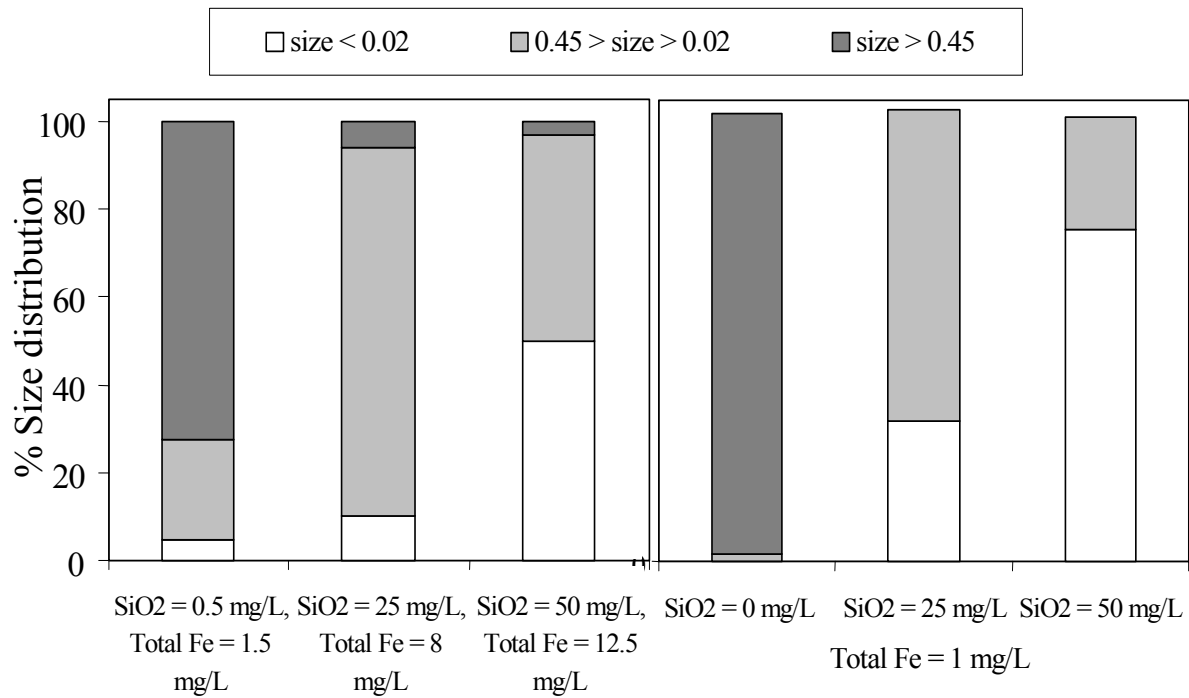
Figure 5-8: Particle size distribution. Sizes in micrometers. On left: Particles from 20<sup>0</sup> C reactors. On right: Particles formed after addition of 1 mg/L Fe<sup>+2</sup> to aerated water.

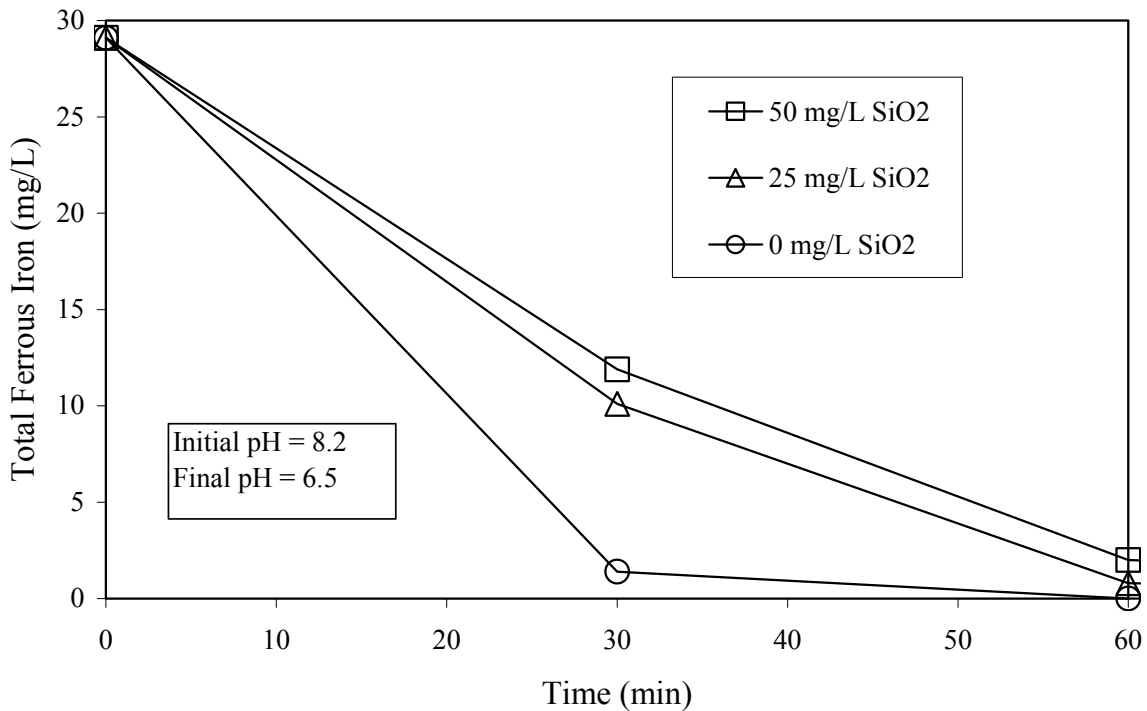
Figure 5-9: Ferrous oxidation under aerobic conditions in the presence of varying amounts of silica.

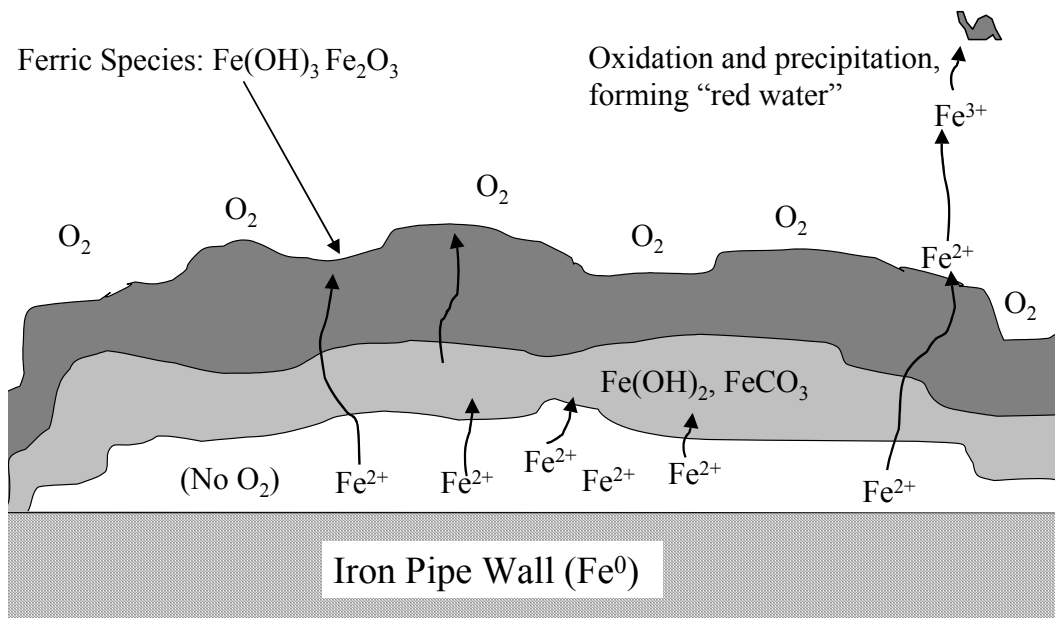
Figure 5-10. Diagram showing possible mechanism of iron release and "red water" formation. The rate of iron released to the water is a function of the amount of  $\text{Fe}^{2+}$  that is at the scale/water interface of an iron pipe.
