Microstructural Evolution in Thermally Cycled Large-Area Lead and Lead-Free Solder Joints

Masters Thesis submitted to the Faculty of the
Virginia Polytechnic Institute and State University
in partial fulfillment of the requirements for the degree of

Master of Science
In
Material Science and Engineering

Keywords: Lead-Free Solder, Thermal Cycling, Microstructure, Reliability,
Large-Area Solder Bonds, Electronic Power Devices

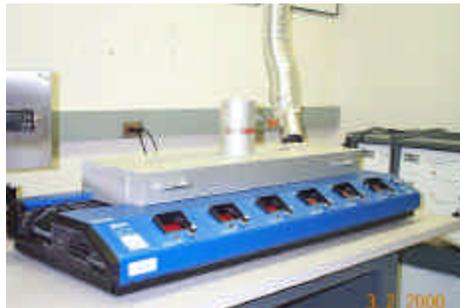
A belt oven was used for the reflow process (Figure 2.1-4). The oven was characterized using thermocouples to create thermal profiles for each solder reflow schedule in coordination with the solder manufacturer’s recommendations. Figure 2.1-5 shows, on the left, the profile provided by Kester for eutectic Sn/37Pb solder. On the right is the profile used to reflow the devices containing Sn/37Pb solder for this research. In addition, visual verifications of the reflow process were used to gauge the success of the profile. A piece of solder, with flux, was placed on a plain piece of copper DBC and run through the profile. The solder was expected to

Figure 2.1-4: Reflow belt oven.

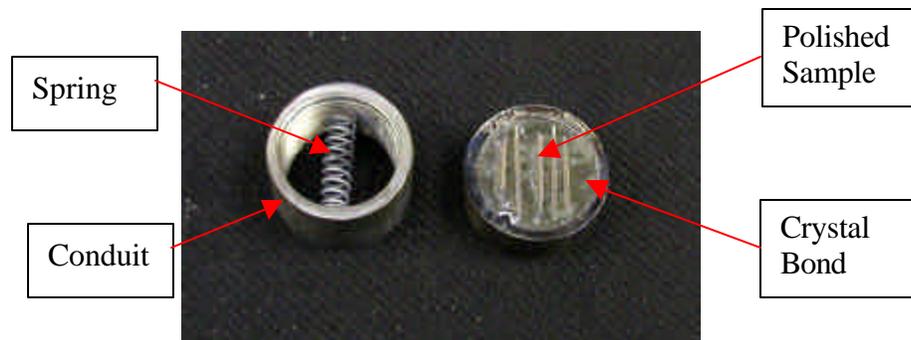
The mounts were made of electrical conduit, which had been cut in half and polished smooth on one side (Figure 2.1-6). The conduit was found to fit into the automatic polishing fixture perfectly. Springs were then placed across the diameter of the conduit inside to keep the samples vertical. The samples were placed vertically in the springs with the side of interest facing up. Kapton tape was placed over the top of the conduit. The whole assembly was then flipped and the side with the Kapton tape was placed on a flat surface. Tweezers were used to manipulate the samples such that the side of interest was against the flat surface. The tape held the sample in place and the spring kept the samples from tilting off vertical. The crystal bond was then heated in a beaker on a hotplate to approximately 150 °C, or until fully melted. The sample assembly containing the samples was placed on the hotplate for approximately 15 seconds to warm the metal conduit and the spring. The Crystal Bond was then poured over the samples until all spaces between the samples and the conduit were filled. The Kapton tape kept the Crystal Bond from running out of the bottom of the assembly. The whole assembly was then promptly removed from the hotplate and placed on a flat block of aluminum until cooled. In total the assemblies were on the hotplate for no longer than 45 seconds. The tape was then removed and the samples were ready to be polished. Crystal Bond was chosen as the mold material because the samples could be removed by placing the whole assembly in acetone. The Crystal Bond would dissolve away and the samples could be retrieved.

Figure 2.1-6: Specially designed sample preparation mounts, (left) conduit and spring assembly, (right) assembly ready for polishing containing five samples and Crystal Bond.

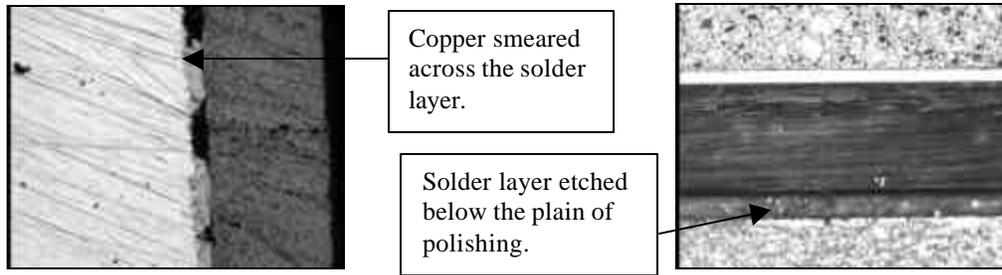
Several problems arose with the techniques used for this preparation attempt. Initially the pressures and speeds for the grinding stage were too aggressive and the copper layer was found to smear over the solder layer (Figure 2.1-8). In addition, the etchants were too aggressive for these composite like samples and the solder layers were corroded to well below the polished surface such that they could not be seen with the optical microscope (Figure 2.1-8 and Figure 2.1-10). It was later determined that the copper layer in the samples was likely causing accelerated corrosion through Galvanic corrosion. Copper is more cathodic while tin and lead are more anodic, so the copper in the samples drove the corrosion process of the etchant forward. Therefore, the pressures and speeds for grinding and polishing were modified and etchants were not used in future methods.

Figure 2.1-8: Optical image of the layered power device with smearing of the copper layer, (left to right) copper, solder, silicon.

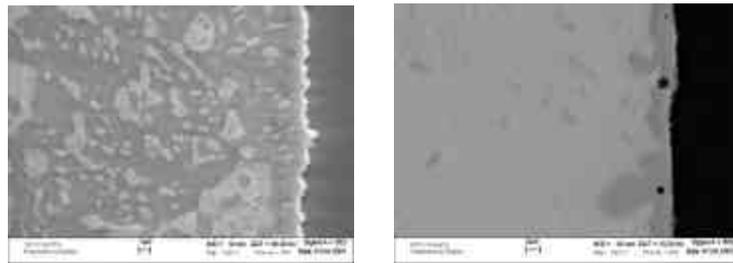
Figure 2.1-12: SEM images of Sn/37Pb solder (left) and Sn/3.5Ag solder (right) after sample preparation (solder on the left and copper substrate on the right).

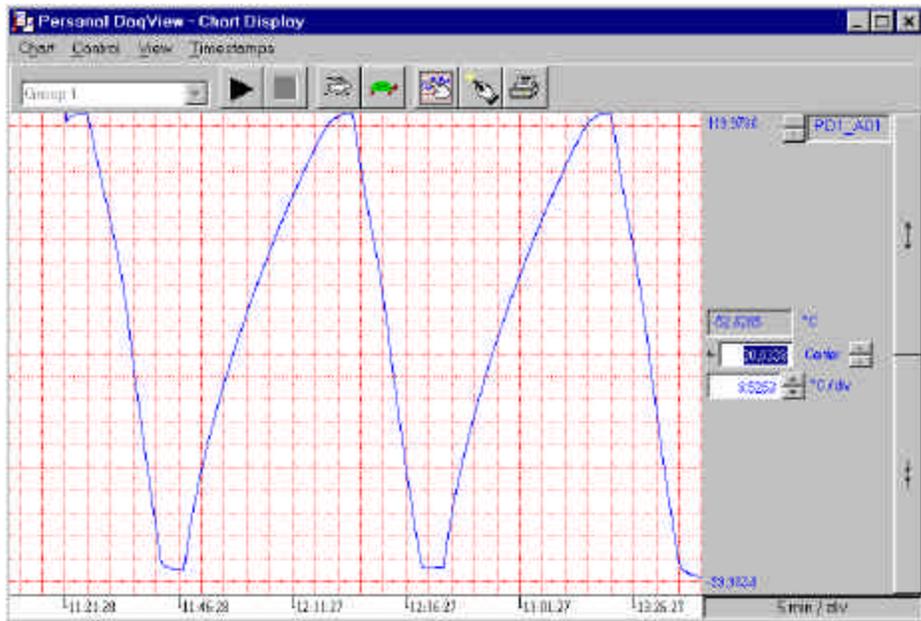
Figure 2.2-1: Initial thermal cycling profile where one cycle is approximately 50 minutes.

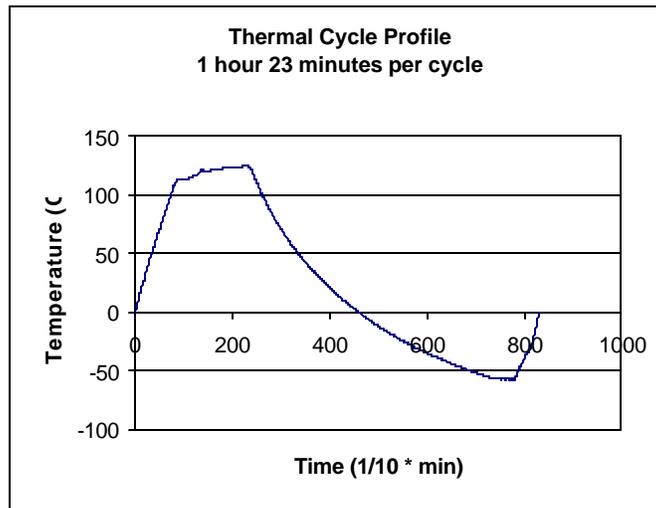
Figure 2.2-2: Final thermal cycling profile where one cycle is approximately 90 minutes.

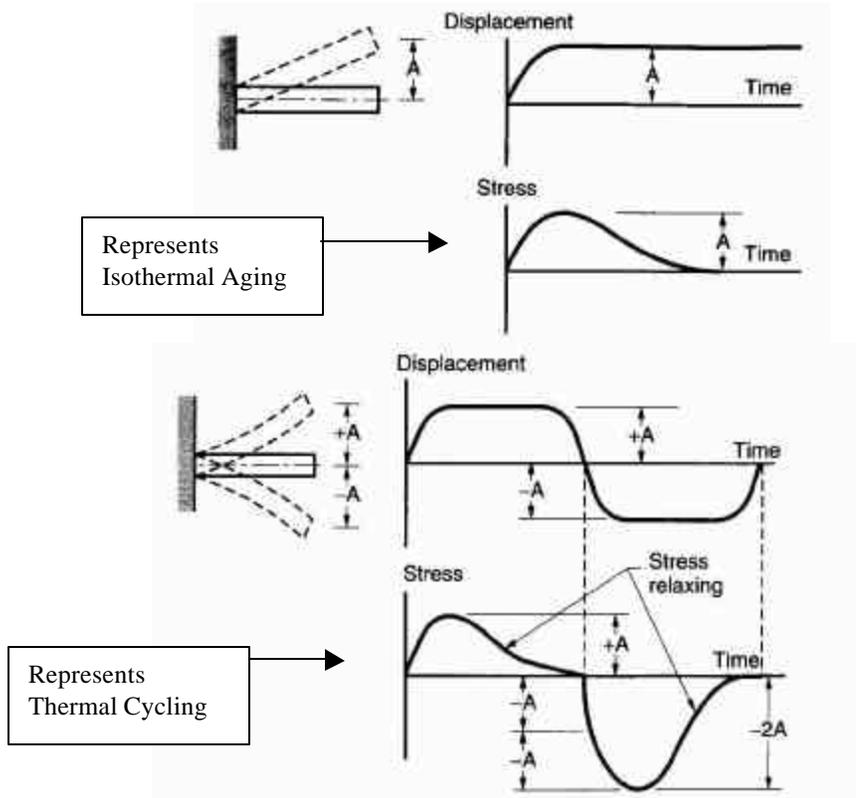
Figure 3.2-4 is an illustration representing the stresses experienced by the samples during thermal cycling with hold periods, which allow for relaxation, and at constant temperatures, which again allow for relaxation. As compared with thermal cycling, which also experienced a brief relaxation period.

Figure 3.2-4: Effects of cyclic stress loads.^{xvi}

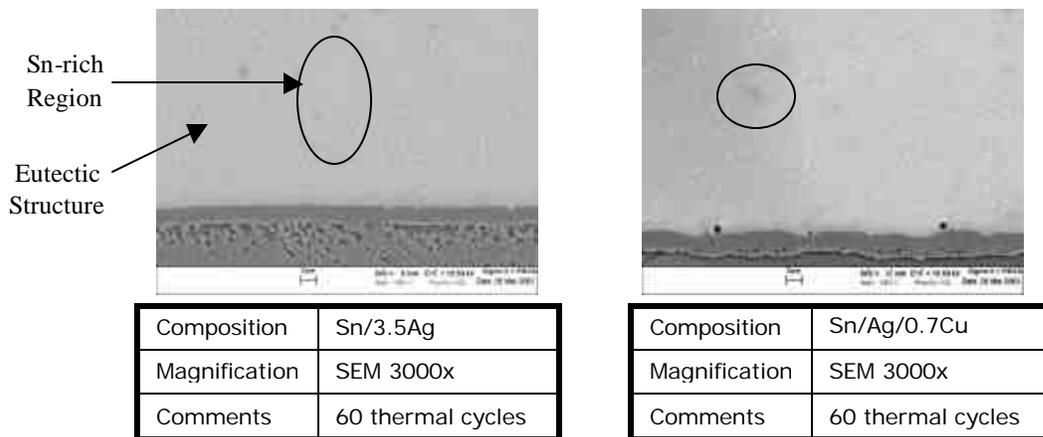
Because the damage observed in the samples was different for the different solder types, observations were made of the microstructure of these materials. A distinctive microstructure was formed in the lead-free solder alloys. It has been identified as dendrites. The microstructure is made up of distributed circular patterns of Ag-phases (Figure 3.2-5). The areas in the middle of the Ag-phase circles are where the eutectic structure is located, or the Sn-rich regions. These regions do not contain the Ag phase.

Figure 3.2-5: Circular microstructure pattern due to dendrites.

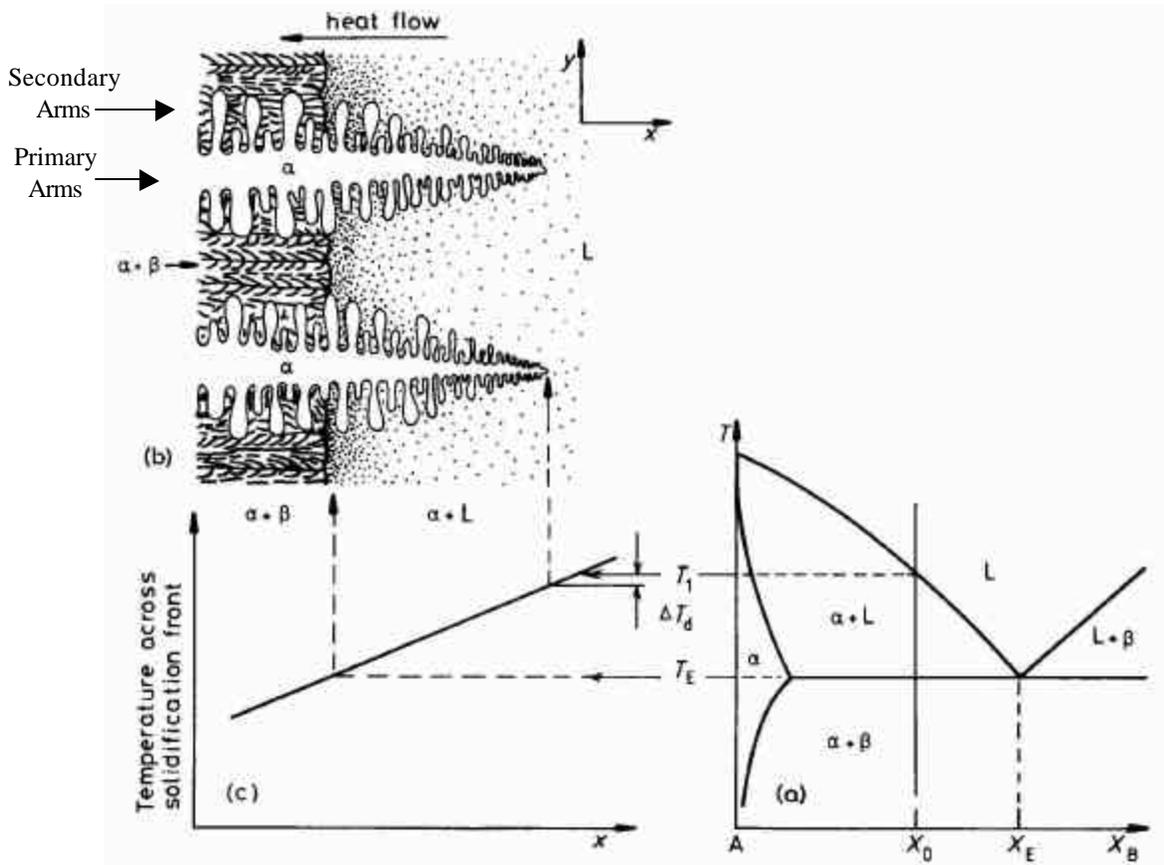
Figure 3.2-6: Schematic of a binary, off-eutectic alloy in a temperature gradient.^{xix}

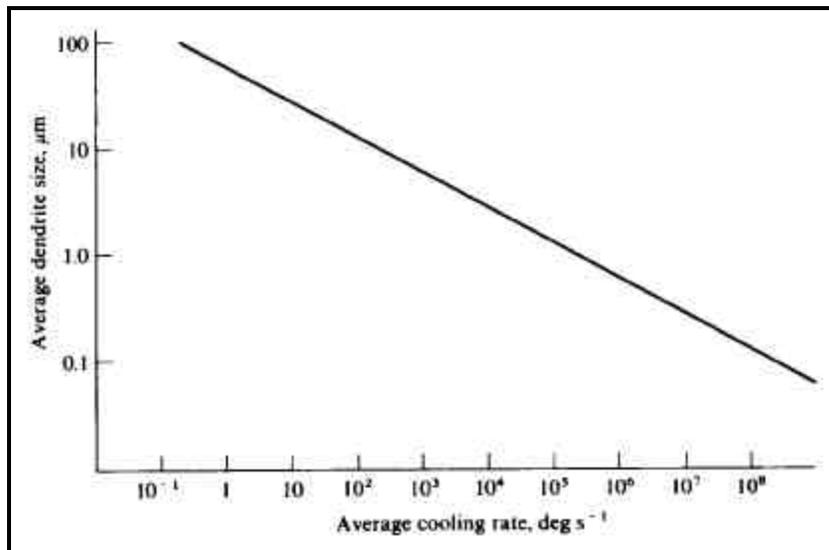
Figure 3.2-7: Plot of dendrite size versus cooling rate for an aluminum alloy.^{xx}

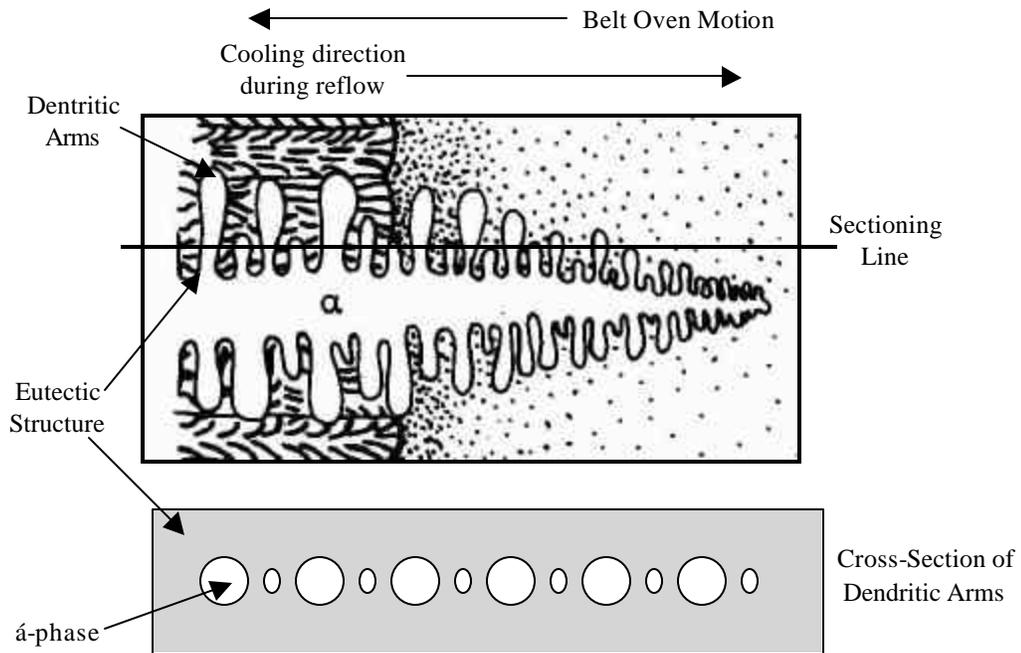
The samples were sectioned perpendicular to the heating gradient reflow. The microstructure of the solder was viewed two dimensionally; hence, the circular patterns are likely a cross-section of the dendrite arms as illustrate in Figure 3.2-8.

Figure 3.2-8: Illustration of a cross-section through the dendritic arms, resulting in a 2-D image.

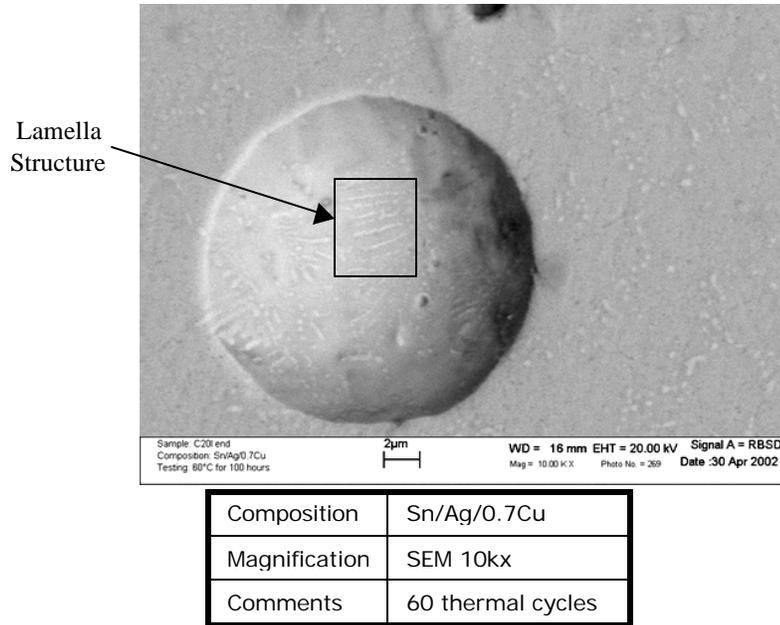
Figure 3.2-10: Lamella structure observed at the surface of the void region.

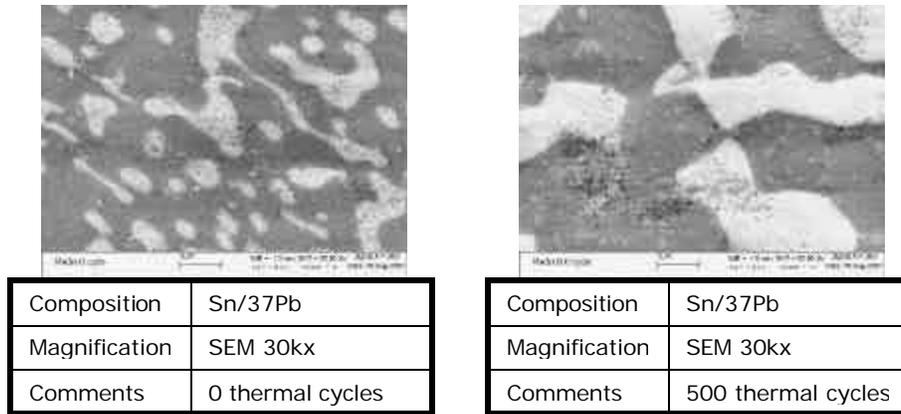
Figure 3.2-11: Thermally cycled solder ball samples illustrating phase coarsening.

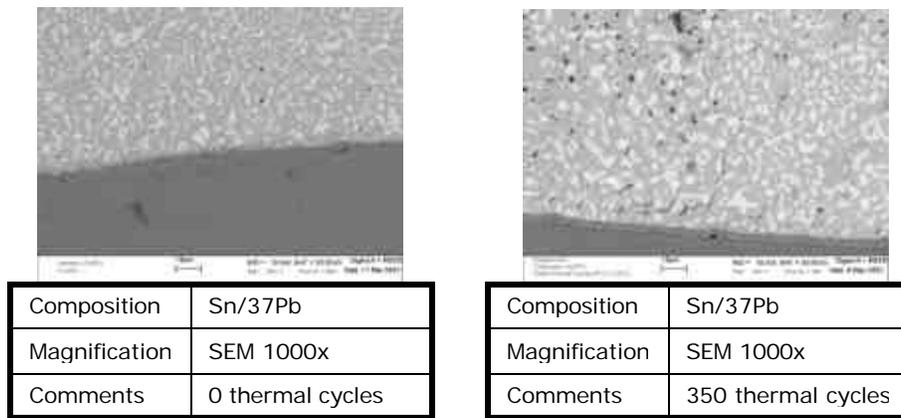
Phase coarsening was observed only as a slight change during this study and therefore was not a significant factor. This may have been due to equipment error with respect to the SEM imaging analysis. There appeared to be variations between different sets of data collected. The magnifications did not seem to be repeatable, which may have been related to the working distance of the detectors in the SEM being different during different data collection sessions. In addition, a change in the experimental procedure by imaging the samples at higher magnification may have resulted in images that would have been more easily comparable. Nonetheless, some images were successfully obtained as seen in Figure 3.2-11 and Figure 3.2-13, which illustrate the slight coarsening found during this study.

Figure 3.2-12: Slight phase coarsening in a tri-layered sample after 350 thermal cycles.

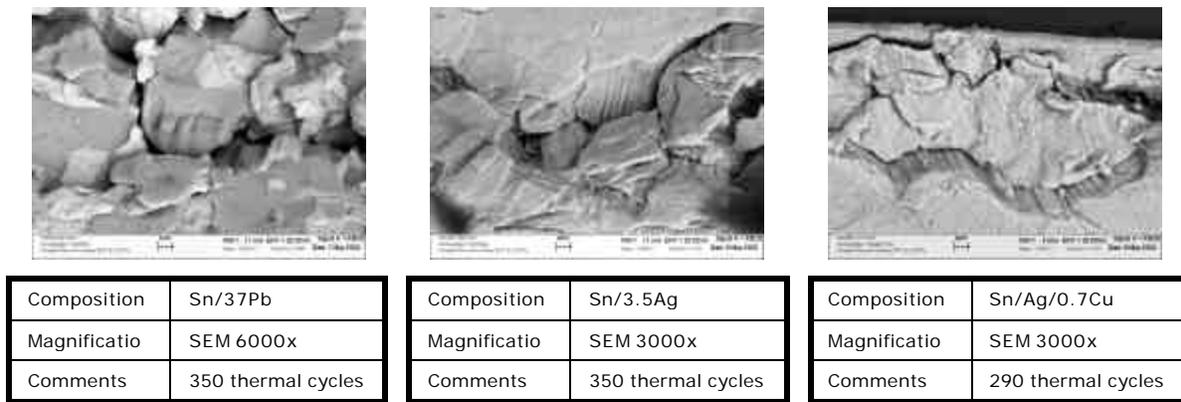
The un-polished surfaces of all of the solder alloys dislocation motion in the form of slip bands, extrusions and intrusions, and grain boundary sliding were observed (Figure 3.2-14). As discussed in the previous section, dislocations lead to the plastic deformation and the damage resulting from the plastic deformation in the samples were also revealed after polishing.

Figure 3.2-14: Extrusions observed for all three of the solder alloys tested under thermal cycling conditions.

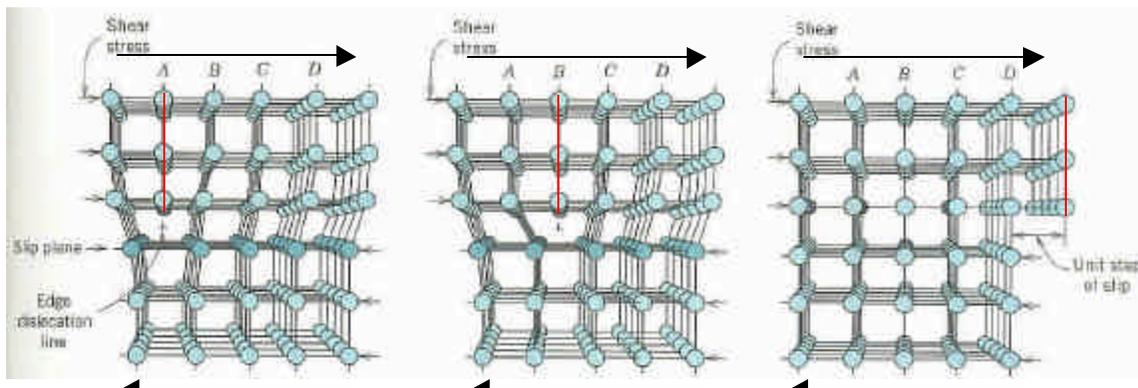
Plastic deformation is the permanent or non-recoverable deformation left after release of the applied load or shear stress.^{xxviii} It corresponds to the motion of large numbers of dislocations where there are permanent atomic displacements. A dislocation is a linear crystalline defect around which there is atomic misalignment.^{xxviii} Slip in turn is the term for the dislocation motion resulting plastic deformation, where the crystallographic plane along which the dislocation line traverses is the slip plane. A slip band is a group of closely spaced slip lines that appear to be a single large slip line at low magnification.^{xxxii} Macroscopic plastic deformation simple corresponds to permanent deformation that results from the movement of dislocations, or slip, in response to an applied shear.^{xxviii} Figure 3.2-15 illustrates an edge dislocation as it moves through the lattice.

Figure 3.2-15: Dislocation motion of an edge dislocation.^{xxviii}

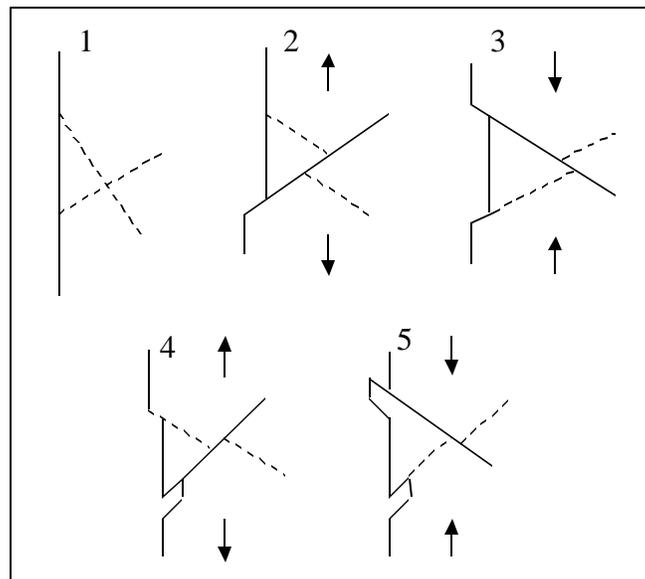
Cottrell and Hull suggested that Frank-Read sources on two intersecting slip planes might coordinate to produce an intrusion-extrusion pair on the same side of the specimen.^{xxix} If the cyclic slip is repeated the depth and the length of the notch and the ridge would become deeper but the width would not increase.^{xxix,xxx} This is illustrated in Figure 3.2-16 where a series of cyclic moments activates the slip bands and produces an extrusion and an intrusion. The cyclic movements, which create the extrusions and intrusions, can thus grow into cracks that propagate because of stress concentrations associated with the newly formed flaw.^{xxx,xxx} Figure 3.2-17 is another illustration of an extrusion and an intrusion.

Figure 3.2-16: Sequence of slip movements producing an extrusion and an intrusion.^{xxx,xxx}

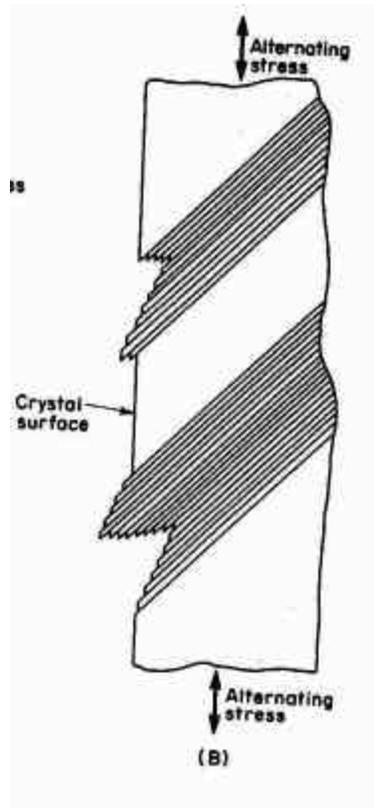
Figure 3.2-17: The difference in surface contour where slip bands intersect the surface.^{xxxii}

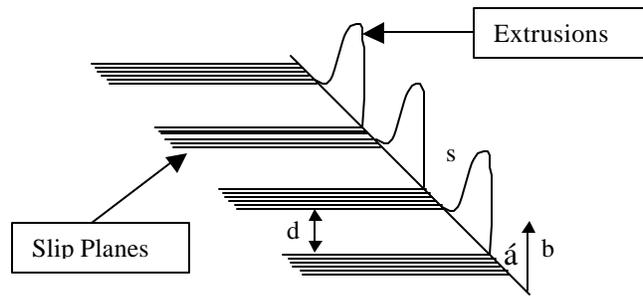
where s is the spacing between the extrusions, d is the spacing between the slip bands and α is the intersecting angle between the Burger's vector, b , and the primary slip plane.

Figure 3.2-18: Schematic of the relation between the internal structure of dislocations and the surface relief in a fatigued crystal.

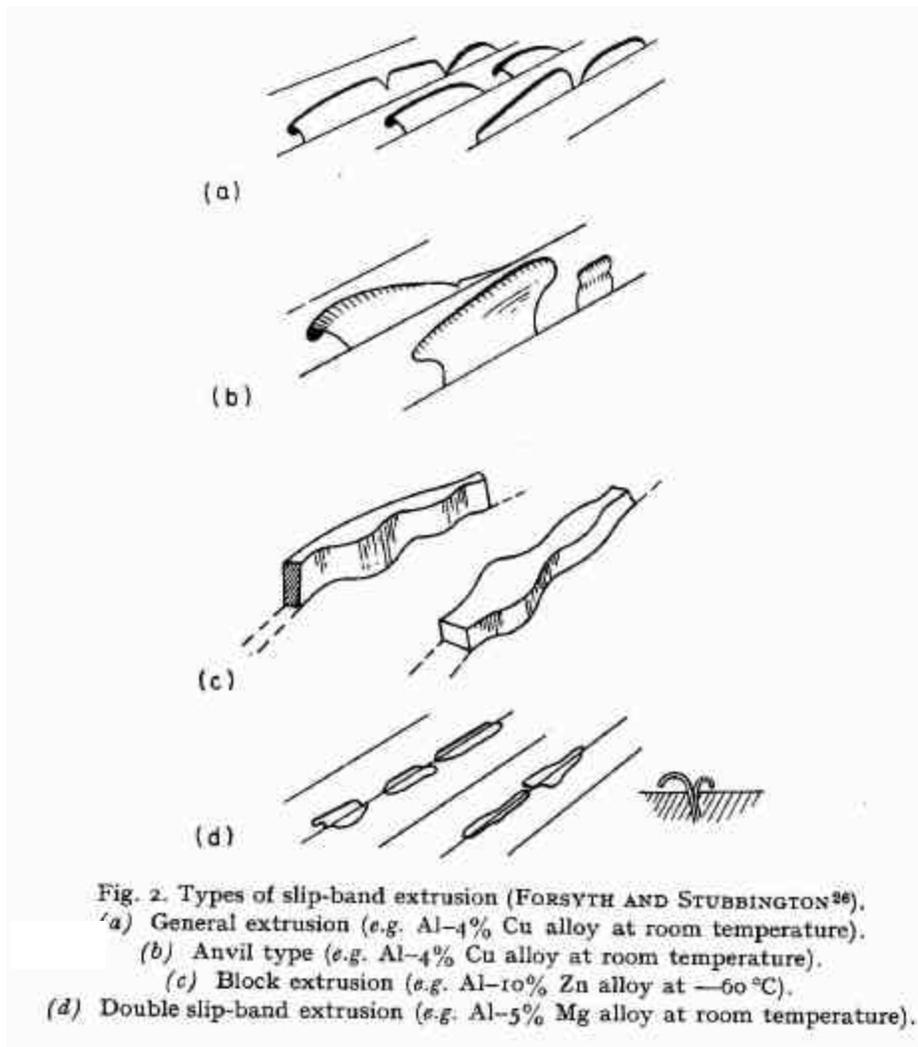
Figure 3.2-20: Illustration of some types of extrusions.^{xxxi}

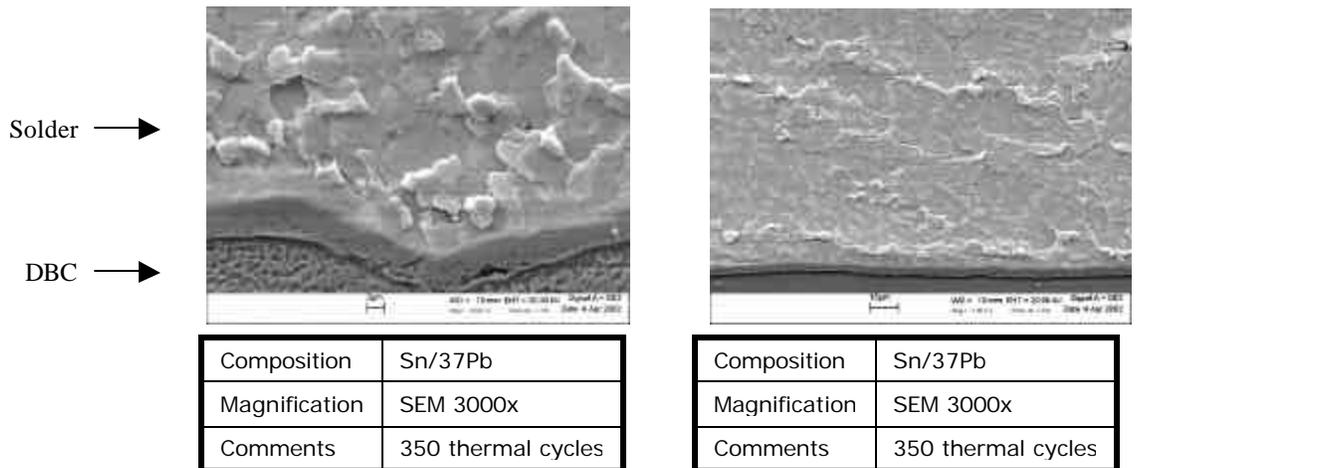
by Lee and Stone discuss the fact that the sliding between colonies in the eutectic structure of Sn/37Pb plays a significant role in the rheology of the solder joint, or the deformation and flow of material in the solder joint.^{xxxv} Because their tests were at 1/hr cycling frequency and grain boundary sliding is a low strain rate phenomenon, it was determined that the presence of this phenomenon would be found during thermal or mechanical cycling at frequencies lower than 1/hr. However, grain boundary sliding would not occur under high frequency cycling conditions.

Figure 3.2-21: Evidence of grain boundary sliding in the Sn/37Pb solder alloy.

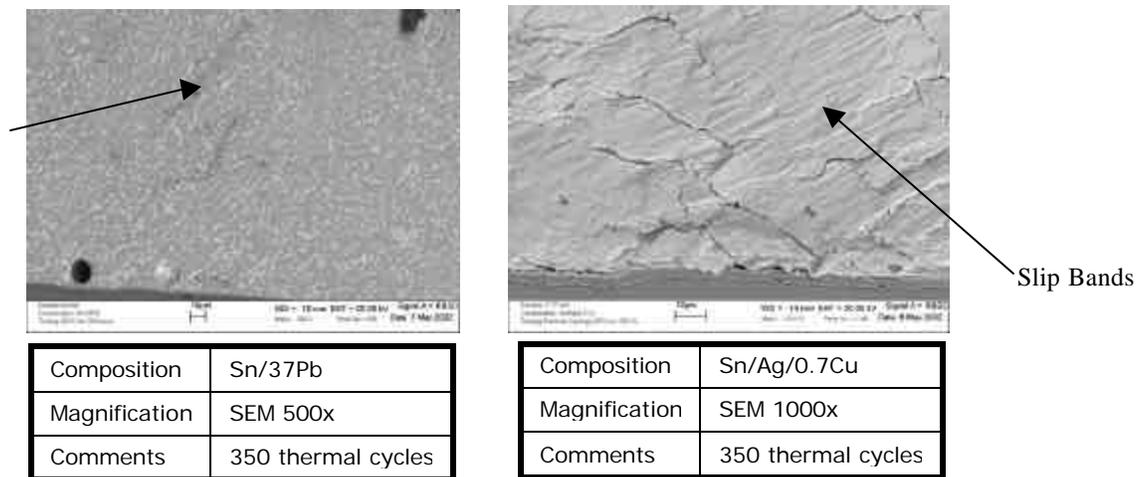
Slip bands on a polished surface take on a wavy pattern when cross-slip within the material is easy called wavy glide.^{xxxvi} Slip bands were seen on the surface of the lead-free solder alloys. In the lead-free alloys studied the slip bands appeared to be wavy and angled across the solder layer. These wavy slip bands were both perpendicular and parallel to the cracks seen in the lead-free alloy samples (Figure 3.2-22 and Figure 3.2-23). Likewise, after re-polishing, the Sn/37Pb samples showed evidence of damage with the same characteristics as the slip bands observed in the lead-free alloys (Figure 3.2-22). This may be in an indication that the ratcheting action of the stresses during thermal cycling caused damage in both directions. These characteristics were observed in both the dual-layer and tri-layer sample constructions.

Figure 3.2-22: Slip bands seen on the surface of a thermally cycled sample.

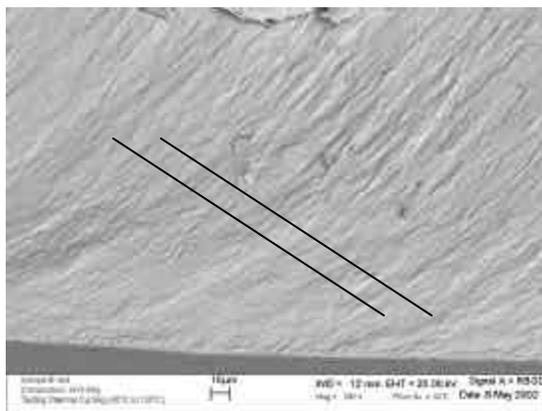
A closer look revealed that the Ag phases in the lead-free samples appeared to follow a diagonal pattern perpendicular to the wavy slip bands (Figure 3.2-24). These characteristics were observed mostly in the dual-layer sample constructions. Figure 3.2-25 is an SEM image of a tri-layer, Sn/Ag/0.7Cu sample with a similar lined pattern of the Ag phases. Within the pattern are also elongate oval shapes outlined by the Ag phases. These are likely evidence of a dendritic structure.

Figure 3.2-24: The Ag phases in the lead-free solder alloys were found in straight-line patterns.

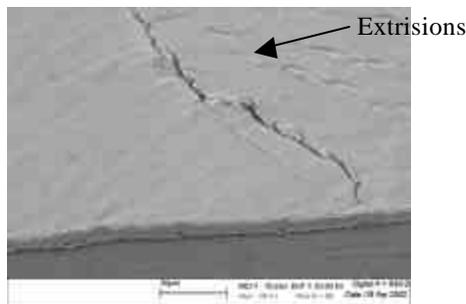
Figure 3.2-26: Dislocations found the Sn/3.5Ag solder samples.

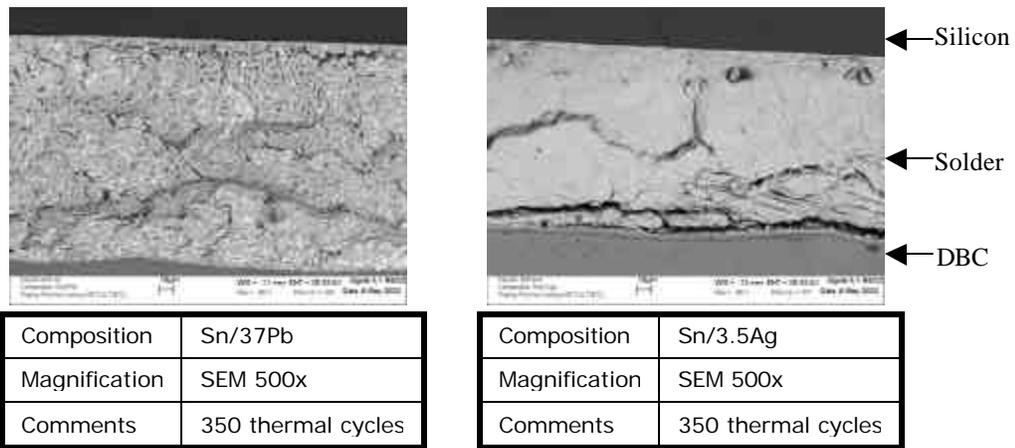
Figure 3.2-28: SEM images of Sn/37Pb and Sn/3.5Ag samples at 350 thermal cycles.

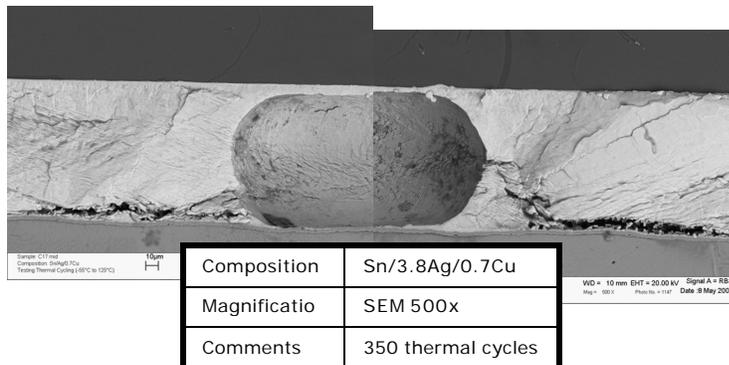
Figure 3.2-29: SEM image of a crack propagating through a void in an Sn/Ag/0.7Cu solder layer.

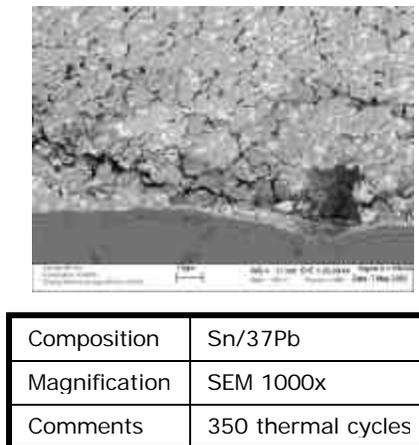
Figure 3.2-30: SEM image of a crack propagating through a void in an Sn/37Pb solder layer.

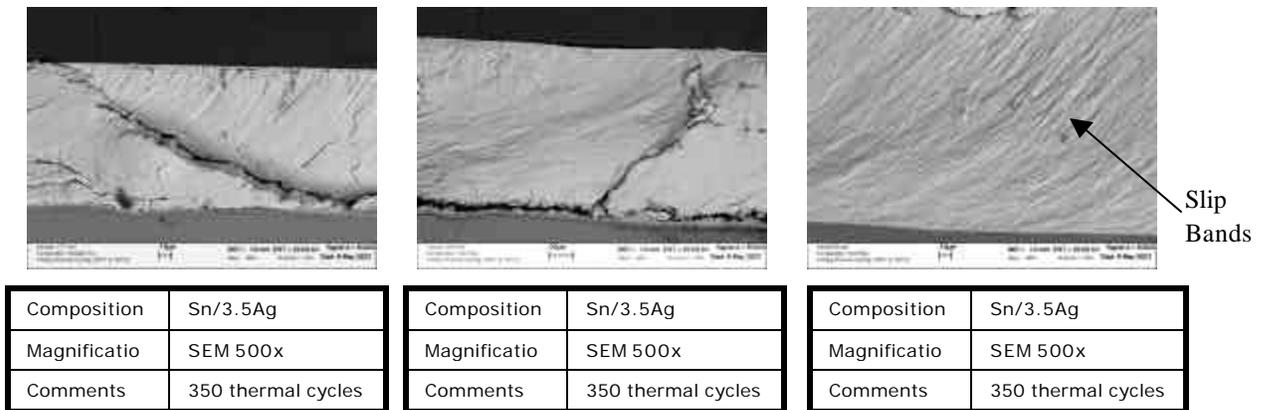
Figure 3.2-31: Cracks and slip bands at a ~45° angle across the solder layer.

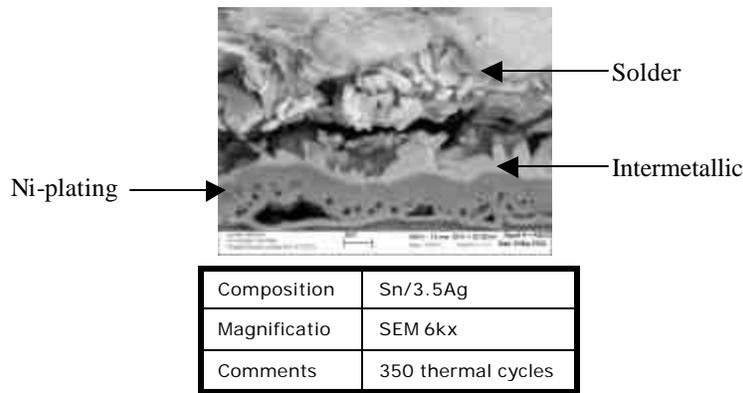
Figure 3.2-34: Crack propagating through the solder material adjacent to the intermetallic.

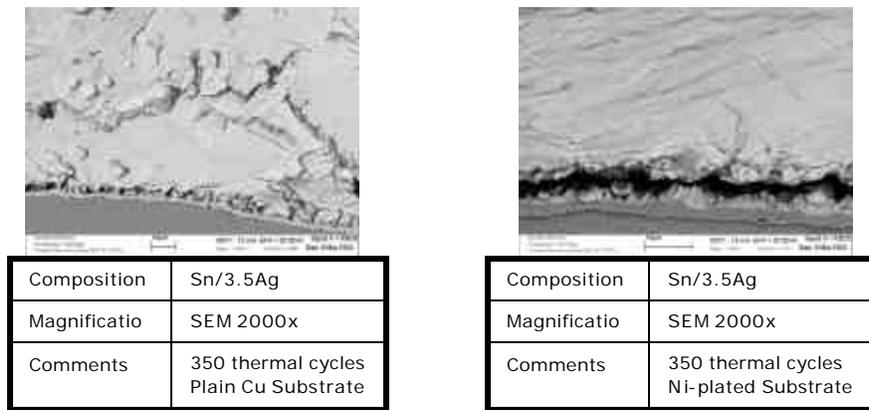
Figure 3.2-35: Cracking adjacent to the intermetallic regardless of the substrate surface metallization.

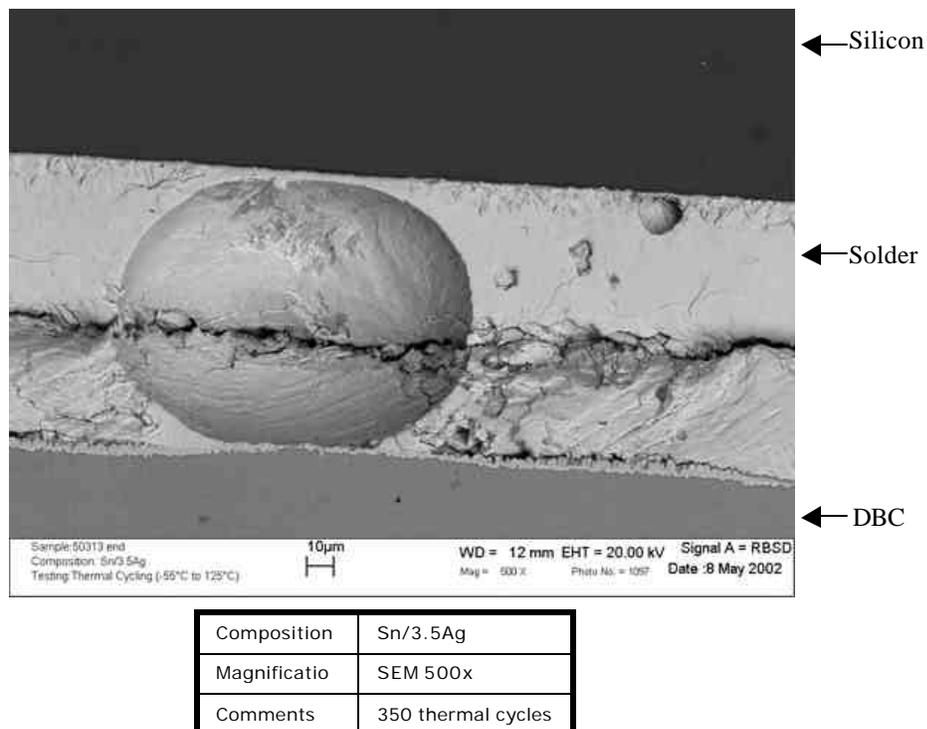
Figure 3.2-36: Crack propagating through the middle of the solder layer separating two regions of differing stress.

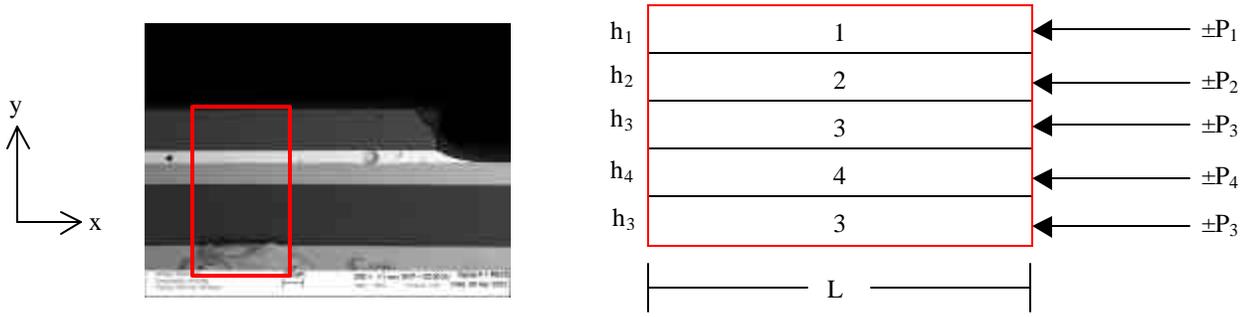
Figure 3.2-37: SEM image at 100x magnification of a cross-sectioned device (left) and a schematic of the model used to calculate the stresses in each layer (right).

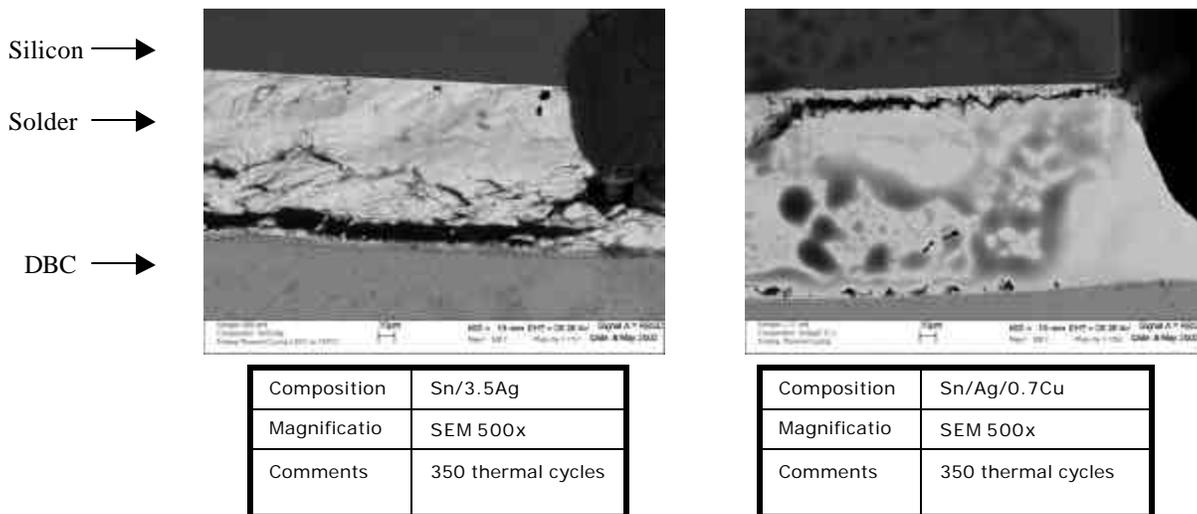
Figure 3.2-39: Images of cracks found at the edge of the solder under at the point of highest calculated strains.

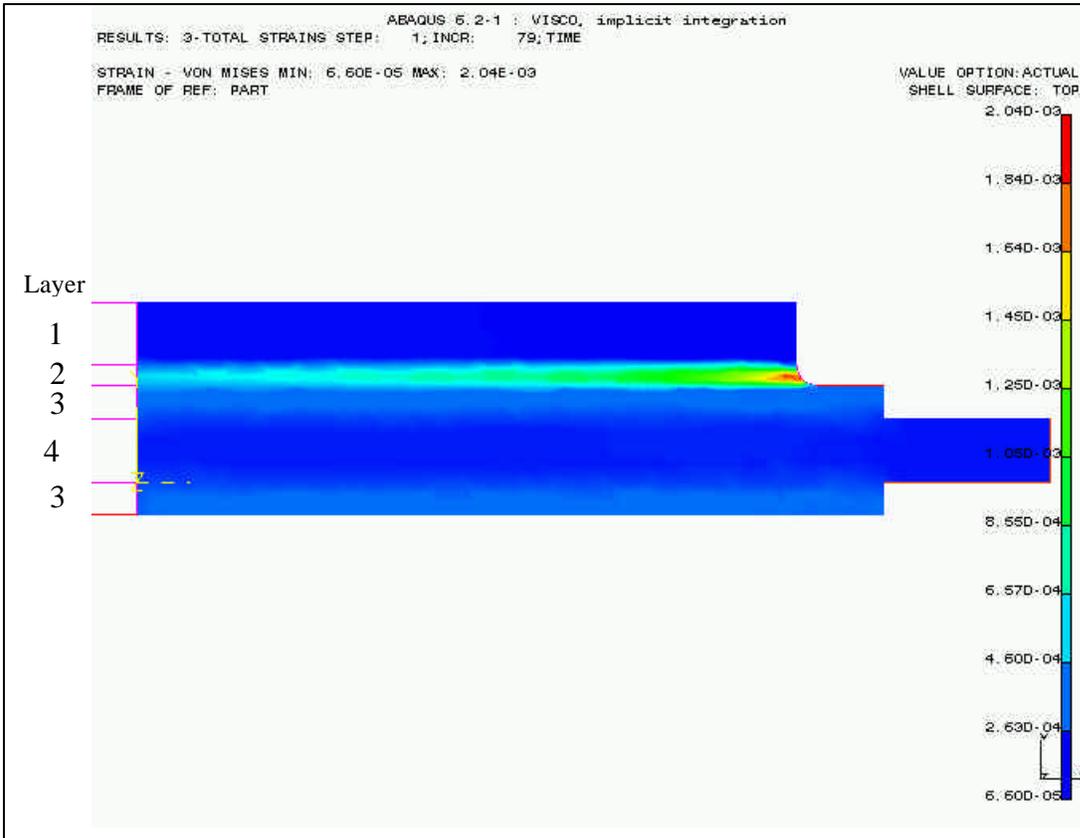
Figure 3.2-40: Von Mises strains calculated for a layered power device temperature cycled between 125 C and -55 C.

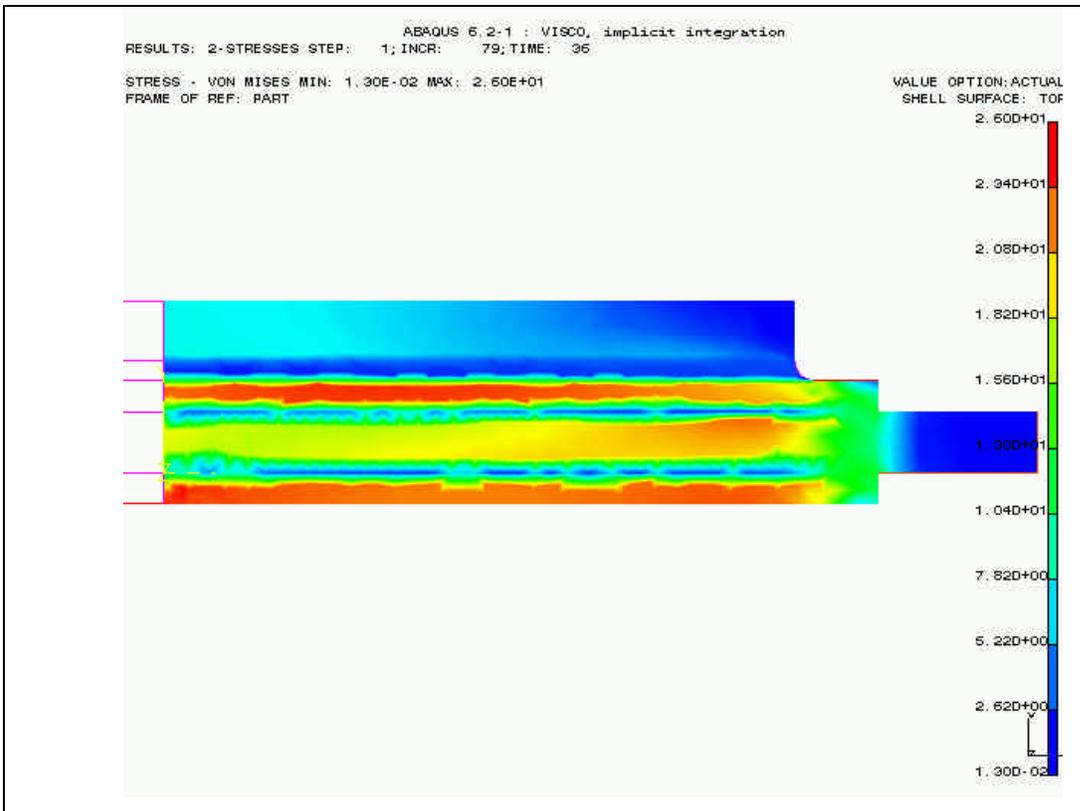
Figure 3.2-41: Von Mises stresses calculated for a layered power device temperature cycled between 125 C and -55 C.

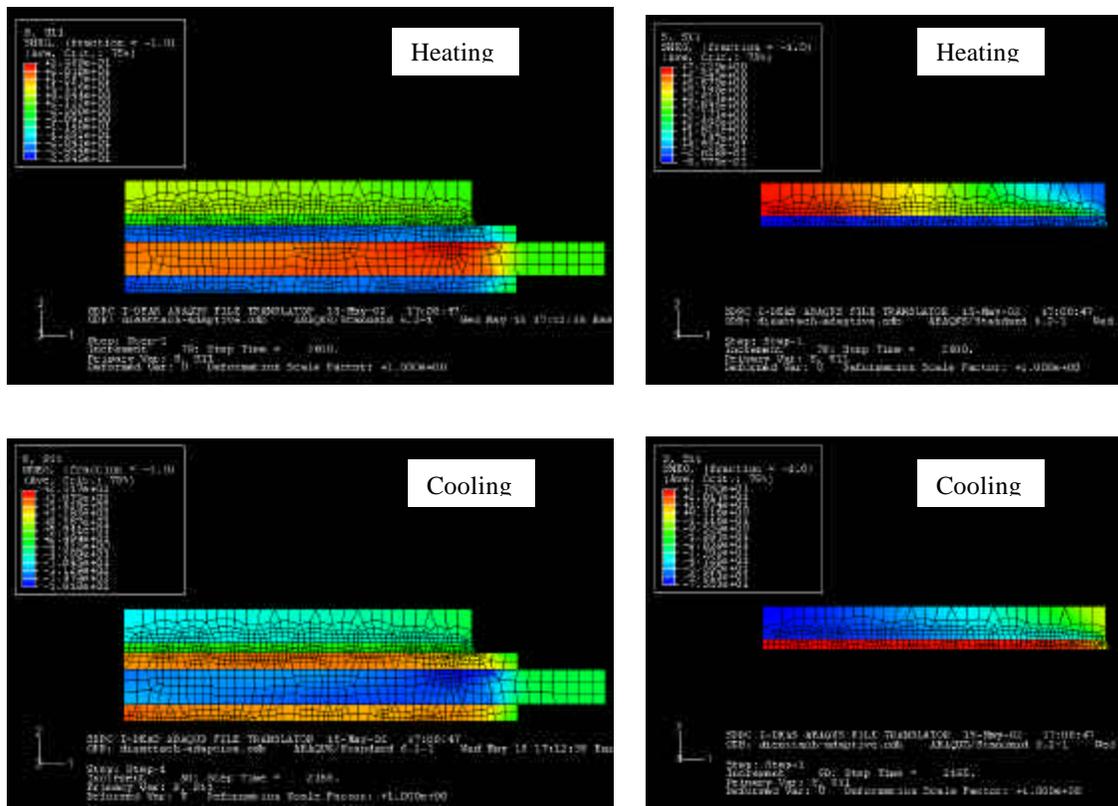
Figure 3.2-42: Stresses for heating (top) and for cooling (bottom) in the x-direction. The images on the left are of the whole modeled structure. The images on the right are close-up evaluations of the silicon and solder layers.

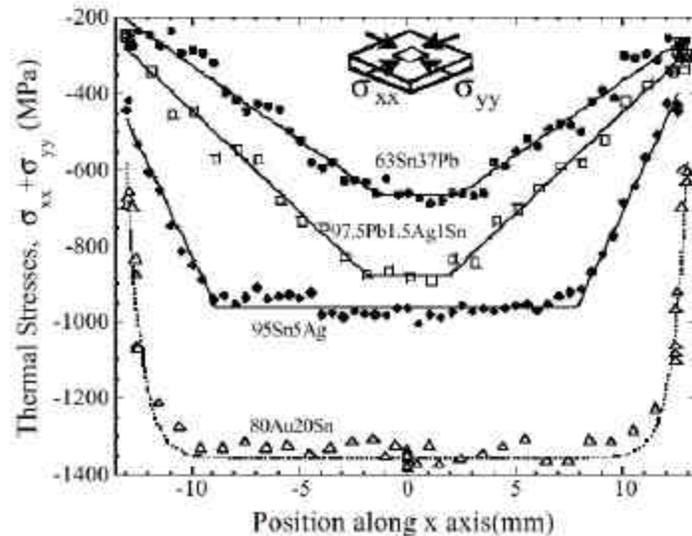
Figure 3.2-43: Stress distributions in silicon die attach on copper after fabrication.^{xvii}

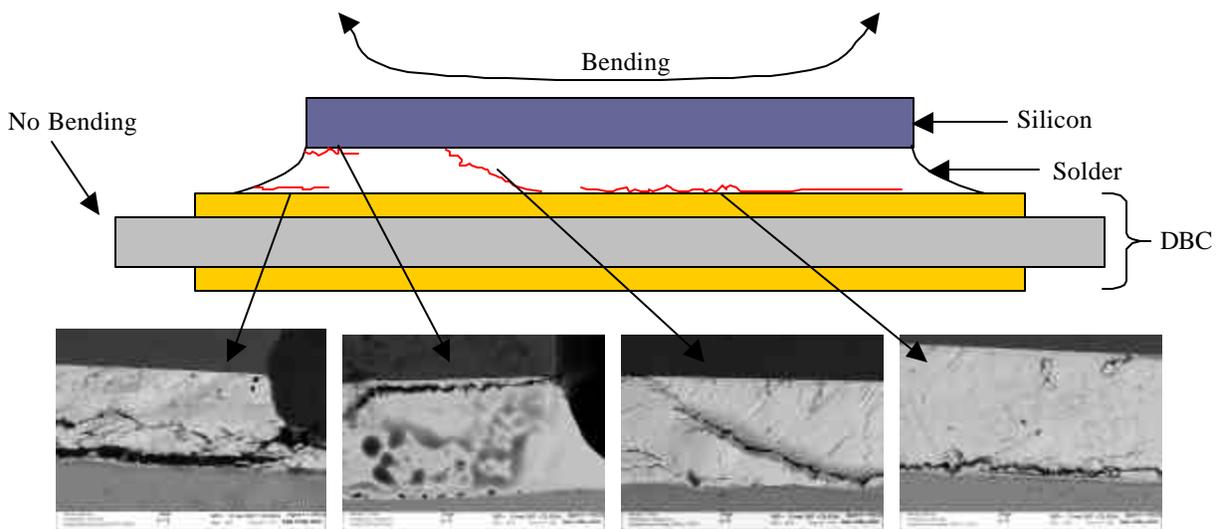
Figure 3.2-44: Cracking characteristics across a sample.

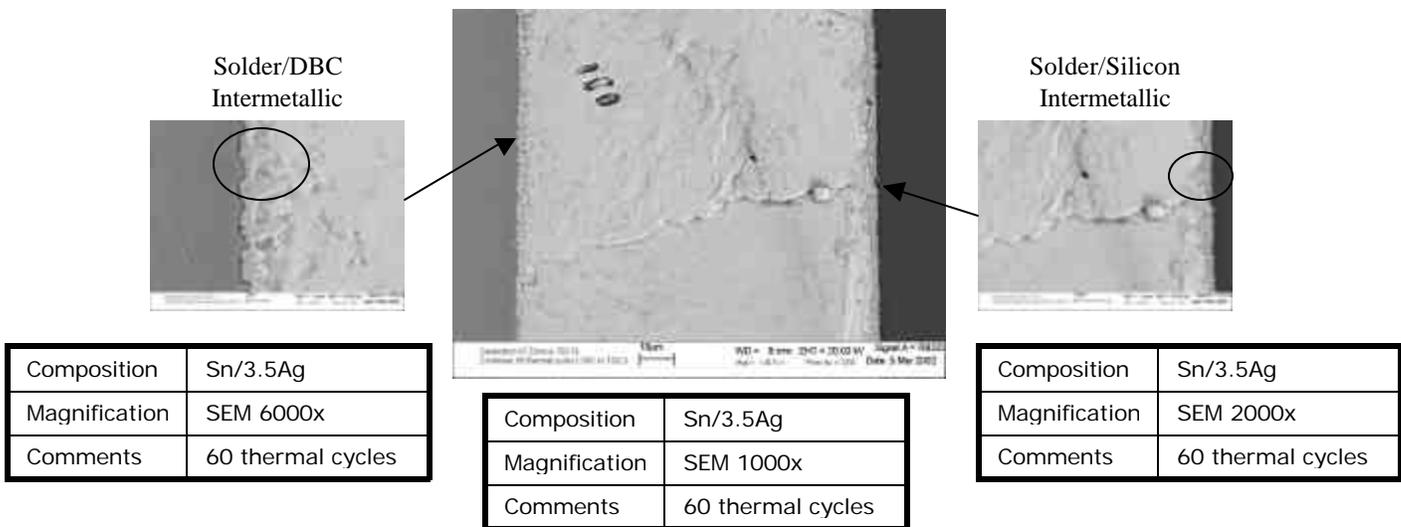
Figure 3.2-45: Intermetallic growth adjacent to the DBC substrate on the left and adjacent to the silicon on the right.
