Microstructural Evolution in Thermally Cycled Large-Area Lead and Lead-Free Solder Joints

Masters Thesis submitted to the Faculty of the
Virginia Polytechnic Institute and State University
in partial fulfillment of the requirements for the degree of

Master of Science
In
Material Science and Engineering

Keywords: Lead-Free Solder, Thermal Cycling, Microstructure, Reliability,
Large-Area Solder Bonds, Electronic Power Devices

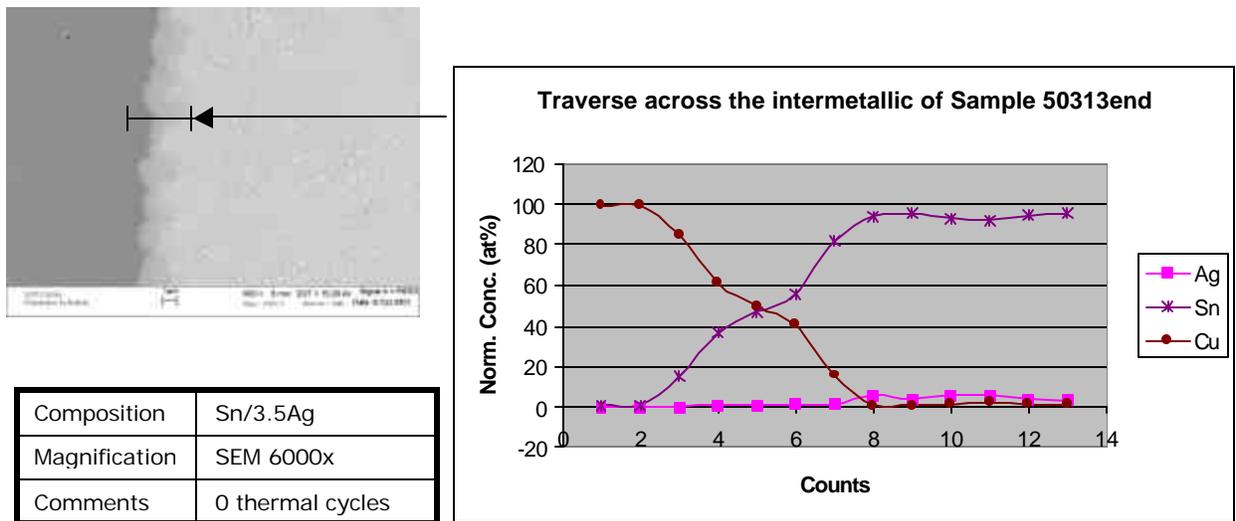
Figure 3.2-46: Traverse of the intermetallic formed between a Sn/3.5Ag solder and a plain copper DBC substrate.

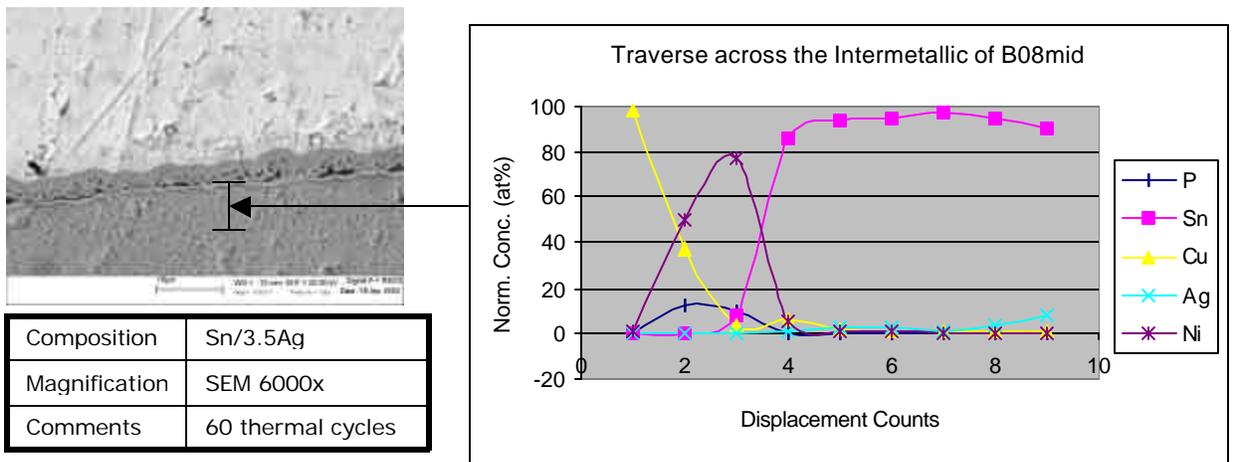
Figure 3.2-47: Traverse of the intermetallic formed between a Sn/3.5Ag solder and a Ni-plated DBC substrate.

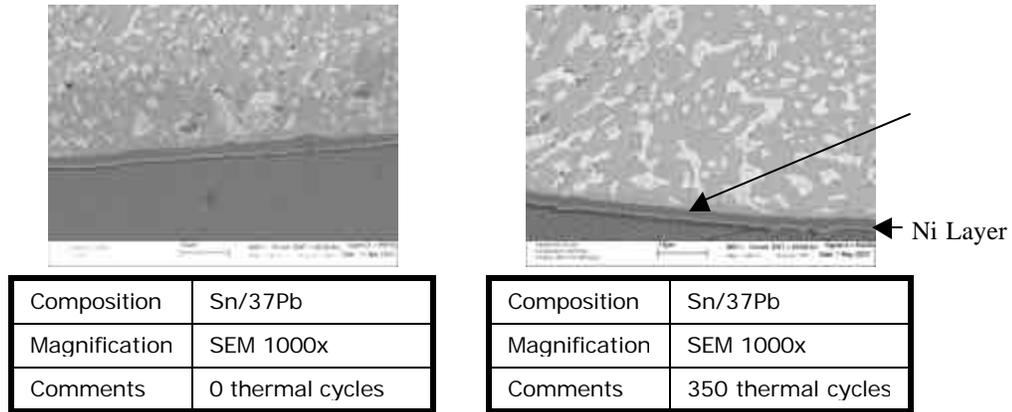
Figure 3.2-48: Illustration of the intermetallic layers between the Sn/37Pb solder and a Ni-plated surface.

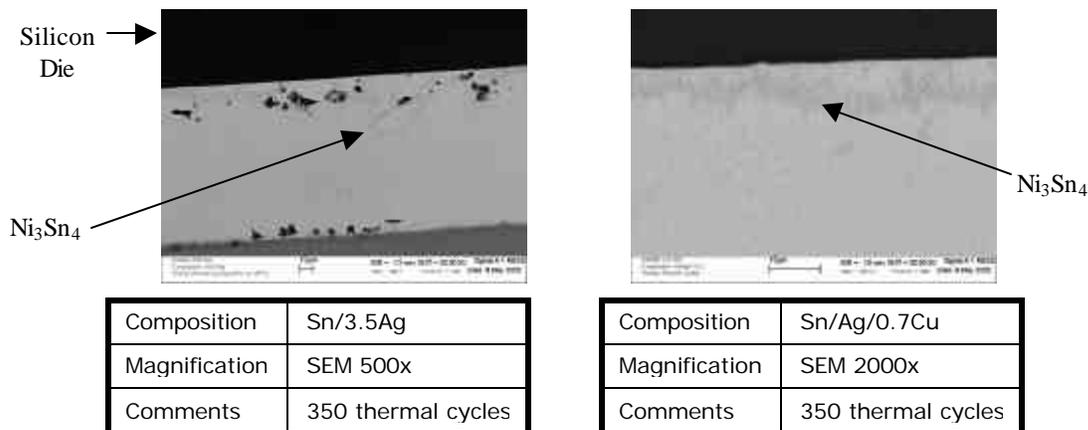
Figure 3.2-49: Intermetallic migrating into the solder layer.

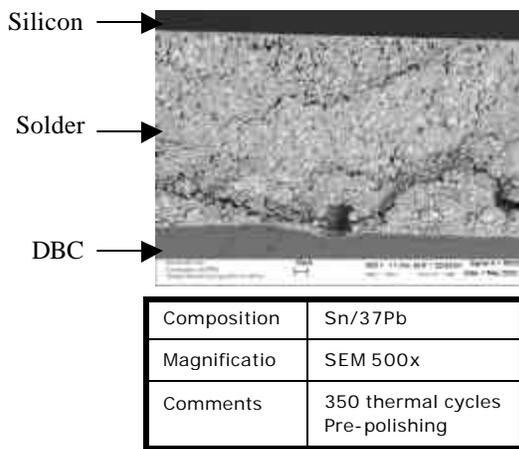
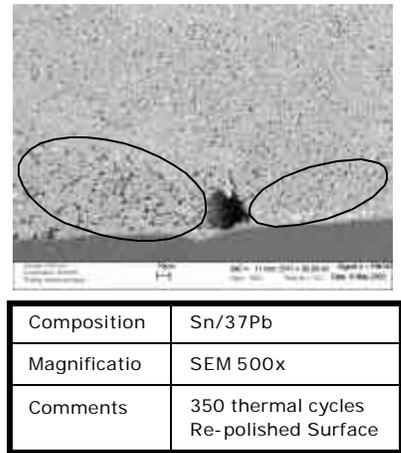
Figure 3.2-51: Damage visible in the same sample at 350 thermal cycles before and after polishing.

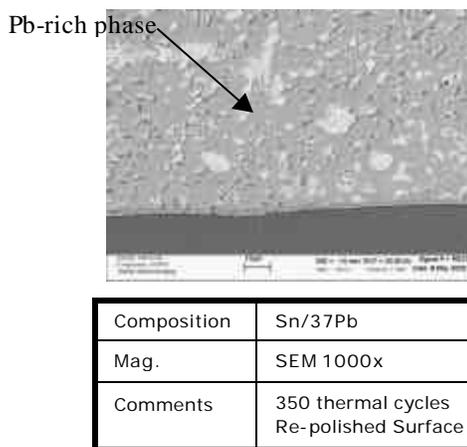
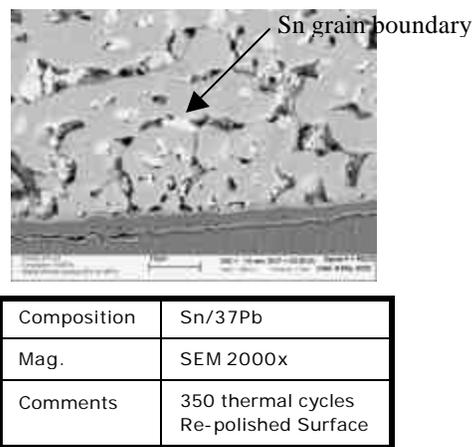
Figure 3.2-52: Re-polished Sn/37Pb samples where the pitting is occurring in the Sn-rich regions and around the Pb-rich areas.

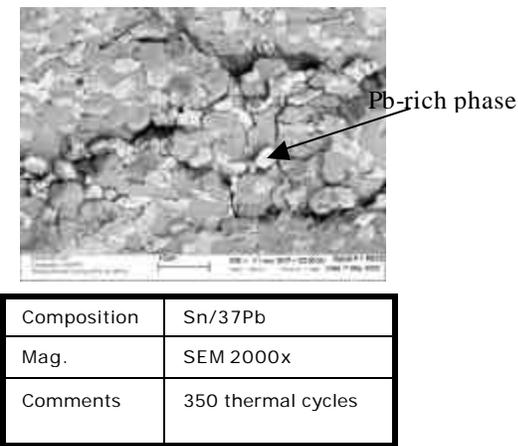
Figure 3.2-53: A Sn/37Pb sample prior to polishing, illustrating the damage after testing.

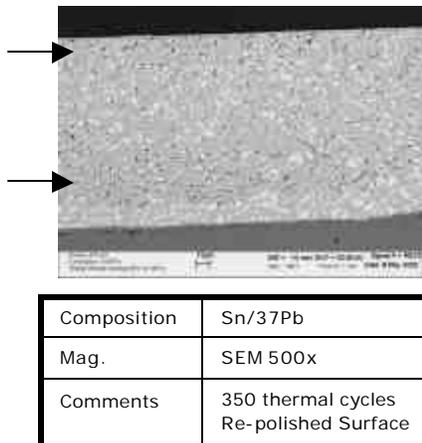
Figure 3.2-54: The pitting was found in patterns on the surface of the re-polished Sn/37Pb samples.

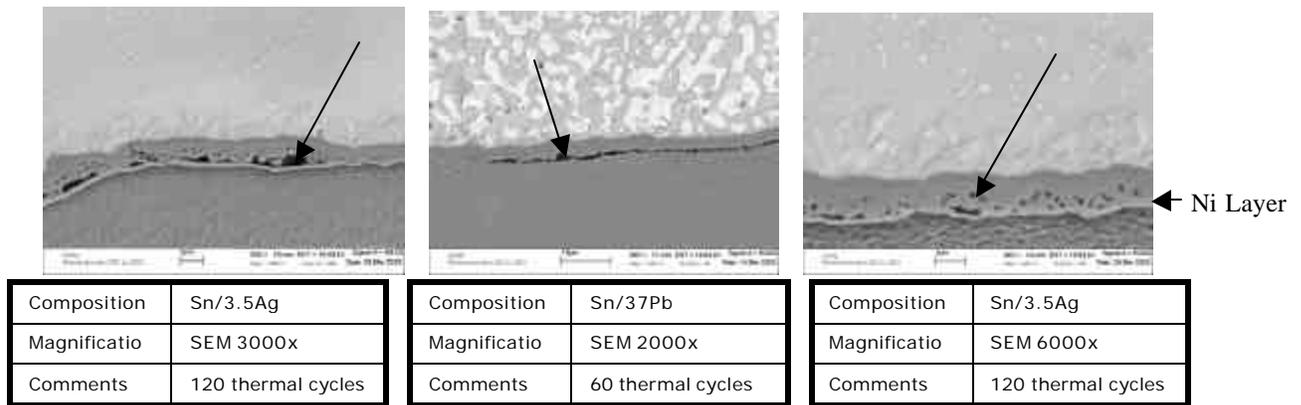
Figure 3.3-1: Voids and cracks between the Ni metallization and the Cu substrate due to the Kirkendall effect.

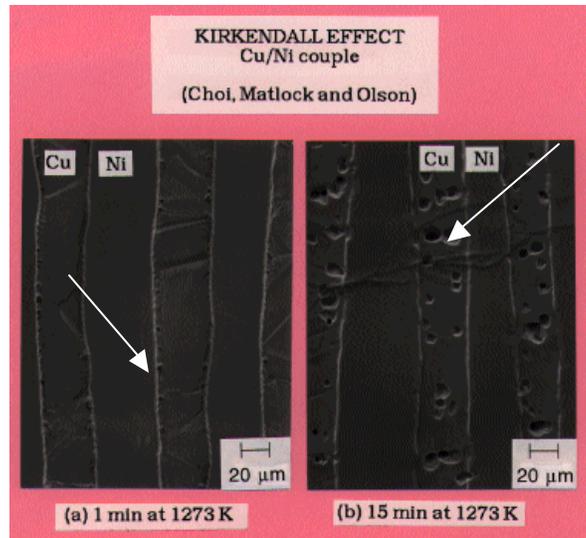
Figure 3.3-2: Kirkendall effect observed in a Cu/Ni couple over 1 minute and 15 minute periods at 1000 °C.

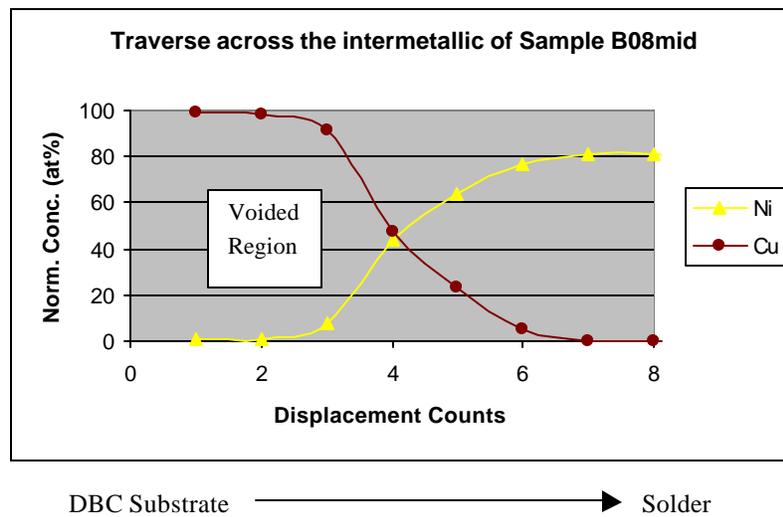
Figure 3.3-3: The Ni and Cu components of a compositional traverse across the intermetallic between a Cu DBC substrate and Sn/3.5Ag solder.

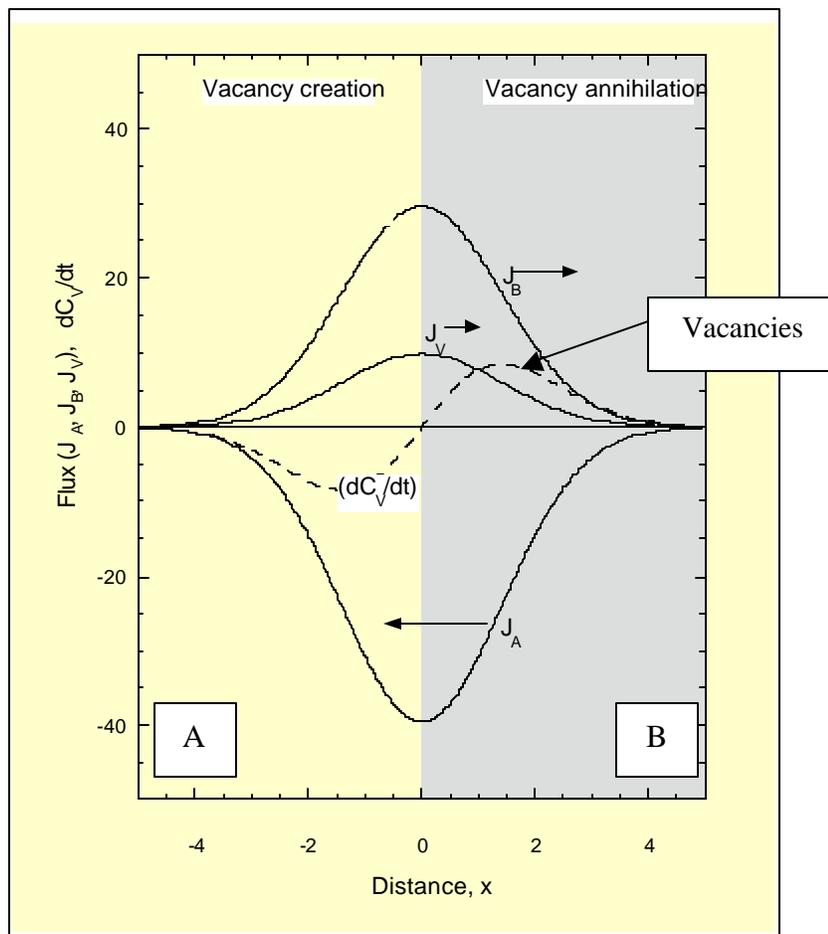
Figure 3.3-4: Fluxes representing Cu, Ni and the vacancies created during diffusion.^{xix}

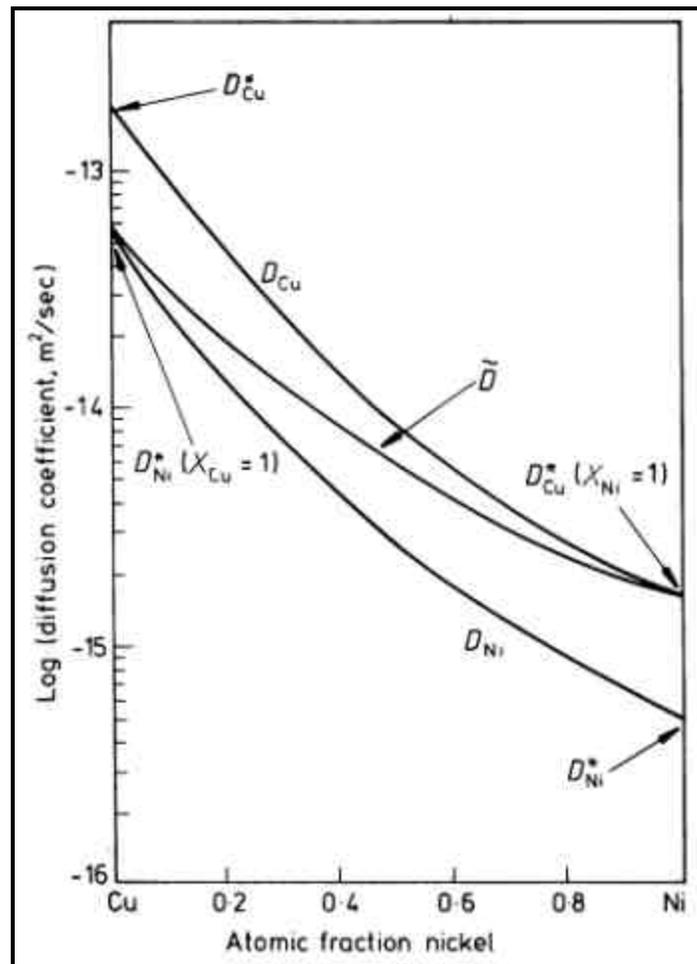
Figure 3.3-5: The relationship between the various diffusion coefficients in the Cu-Ni system at 1000 C.^{xix}

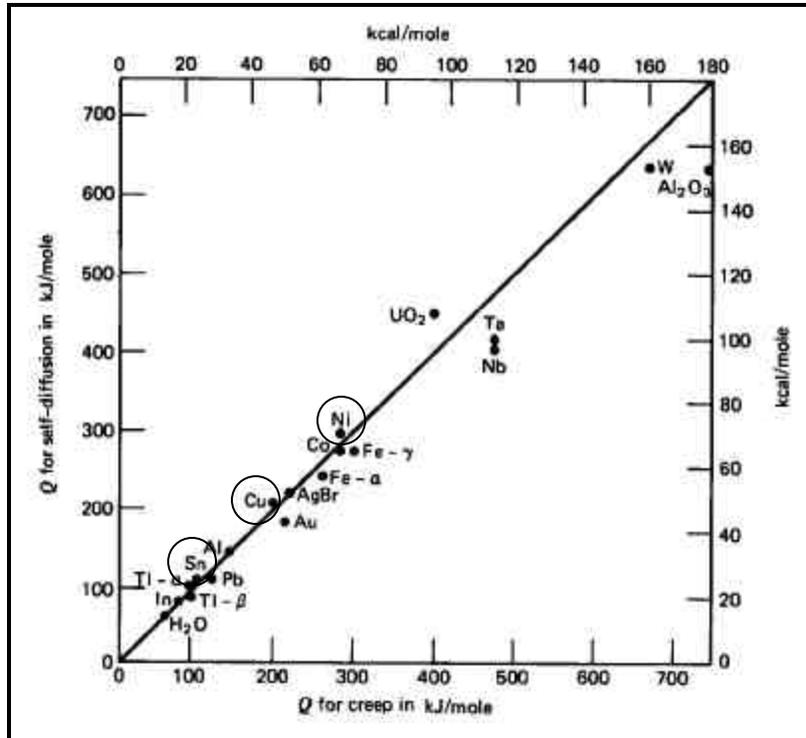
Figure 3.3-6: Correlation of the activation energy for self-diffusion versus creep diffusion for various metals and ceramics.^{xxxvi}

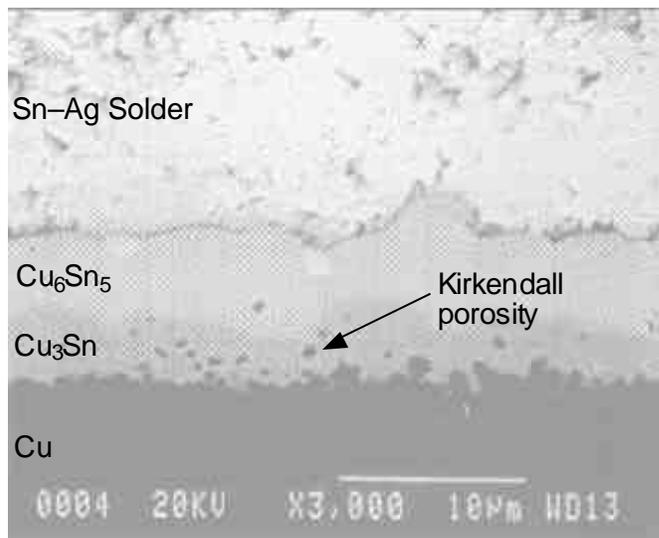
Figure 3.3-7: Kirkendall porosity in the intermetallic layer.^{lxi}

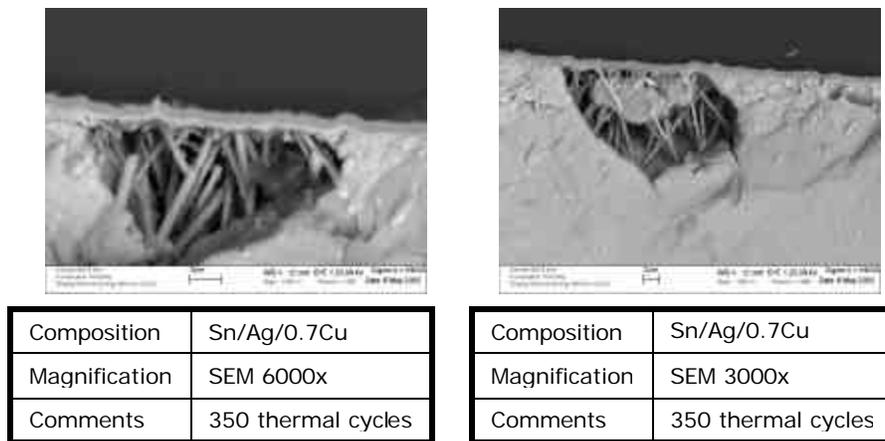
Figure 3.3-9: Tin whiskers, which developed in a Sn/3.5Ag solder sample.

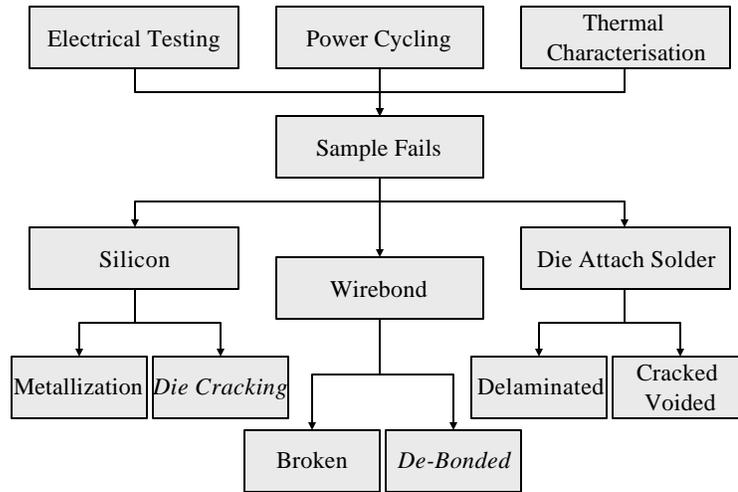
Figure 6.2-3: Flow chart indicating potential failure paths. The features discovered during this study are indicated in italics.

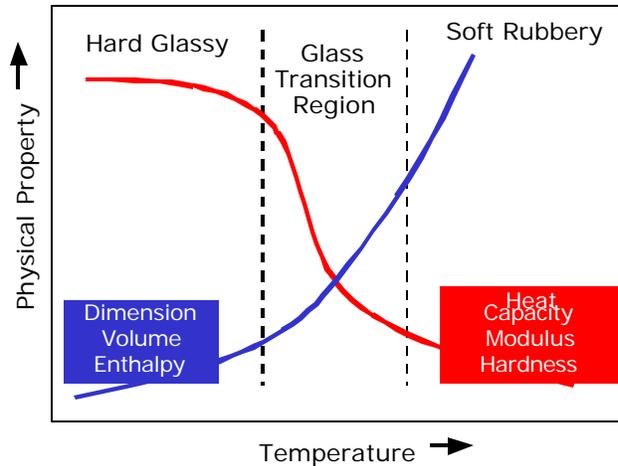
Figure 6.2-6: General property changes in encapsulants.^{lxix}

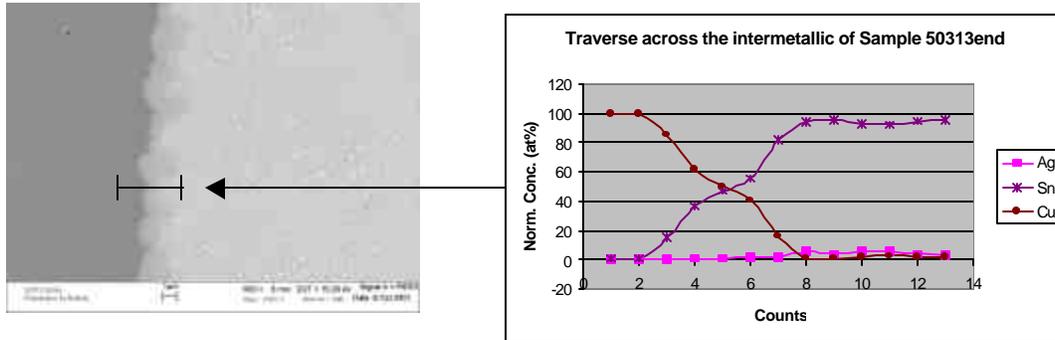
Figure 6.3-8: Traverse of the intermetallic formed between a Sn/3.5Ag solder and a plain copper DBC substrate.

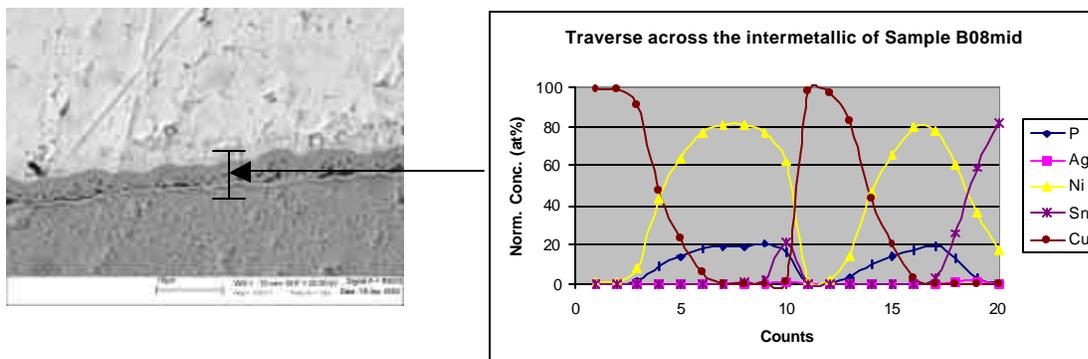
Figure 6.3-9: Traverse of the intermetallic formed between a Sn/3.5Ag solder and a Ni-plated DBC substrate.

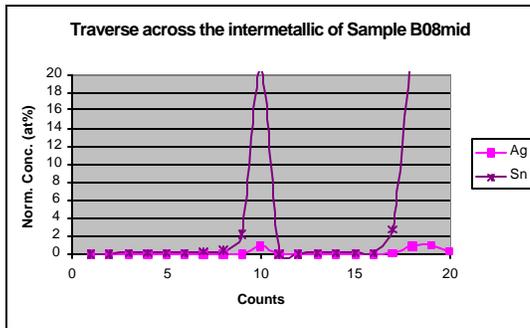
However, it is worth noting that the maximum amount of silver was found in the same regions where the tin was found to have maximum concentration. This reflects the solder alloy composition of Sn and Ag.

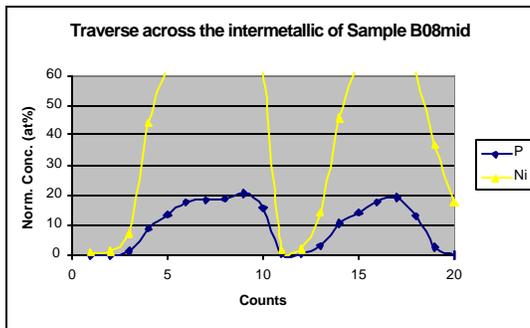
Likewise, the amount of phosphorous was maximum where the nickel was found to be concentrated.
