Evaluation of Hybrid-Composite Beam for Use in Tide Mill Bridge

Keywords: Hybrid-Composite Beam, Tide Mill Bridge, Skewed Bridge, Distribution Factors

ABSTRACT

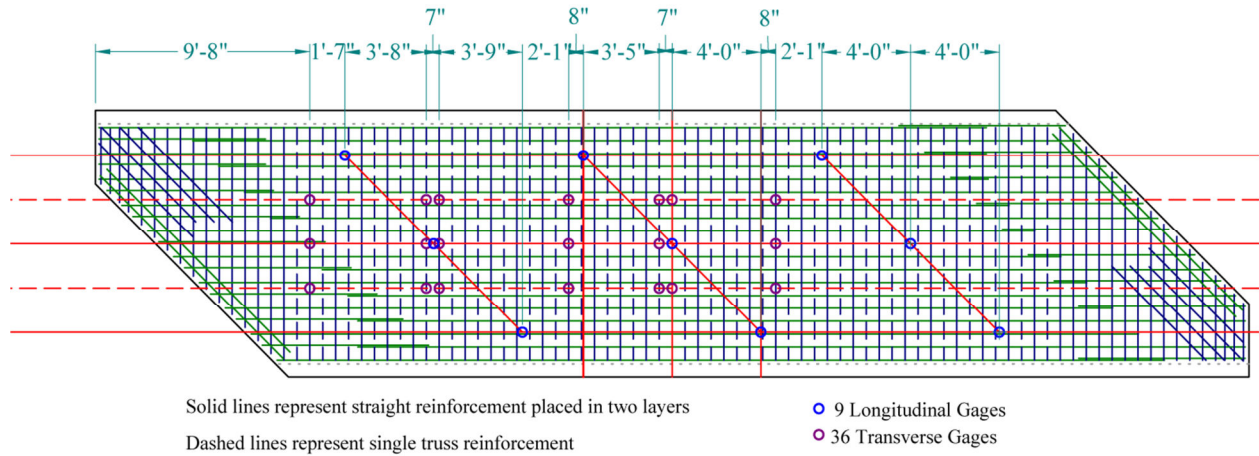
positive and negative moments. Gages were also placed towards the north support of the setup to examine effects of the skew. As the transverse reinforcement layout called for alternating truss reinforcement with top and bottom mat straight reinforcement, gages were placed on both types of reinforcement. A protective coating was applied to all gages to decrease the possibility of damage during the deck concrete placement.

Figure 3-16 Deck Strain Gage Layout

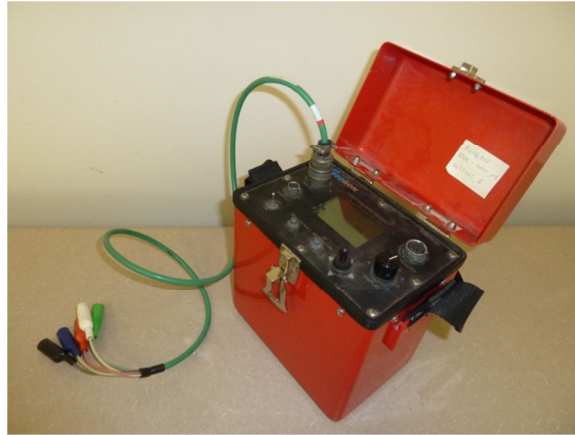
Figure 3-20 Geokon Readout Box

Vibrating wire strain gages were placed in the concrete arch. The vibrating wire gages consisted of a tube with two metal disks at each end (Figure 3-19). Inside of the tube is a steel wire that is attached to the metal disks. The tube fits into a housing that contains two coils. One coil is used to excite the steel wire; the other coil is used to measure the vibration in the wire. Also, within the housing is a thermistor for measuring temperature. The temperature affects the frequency of vibration of the wire thus needs to be recorded. A hose clamp was placed around the housing to hold the tube in place. A wire from the housing connects into either a readout box (Figure 3-20) or a data acquisition system.

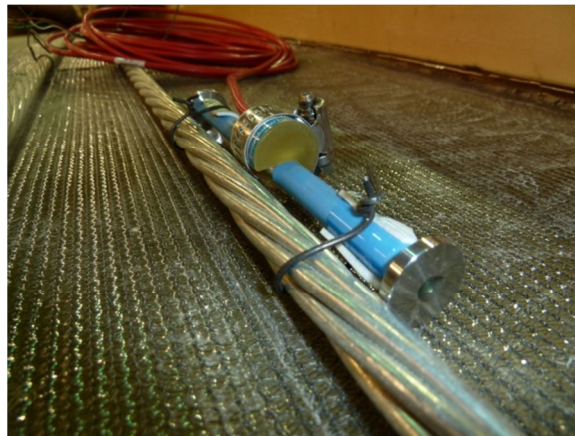
All of the gages were placed within the arch profile. At each location, one gage was placed near the top of the arch and the other was placed near the bottom. Gages located near the bottom were attached to one of the loose tension strands that ran along the length of the arch. The gages were attached using tie wire as shown in Figure 3-22.

Figure 3-22 Installation of VWG on Bottom of Arch

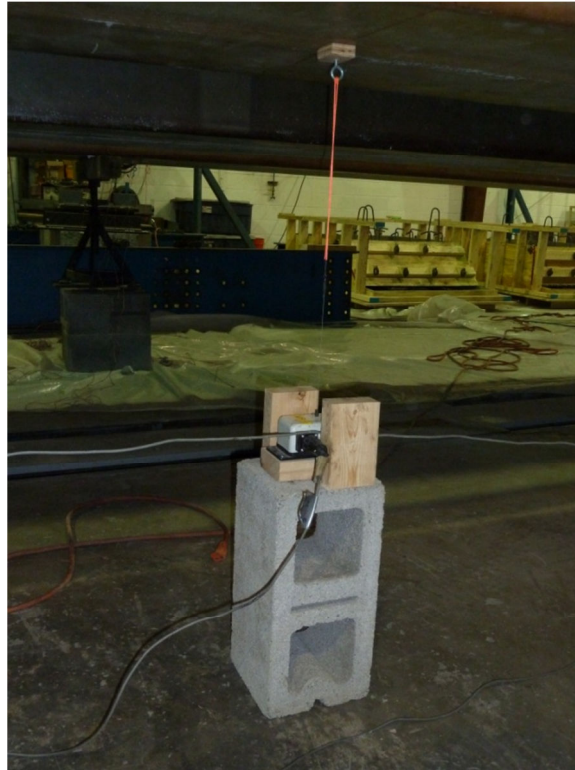
Figure 3-26 Potentiometer Attached to HCB

In addition to strain gages, potentiometers were used to measure deflections during testing. For the first two phases of testing, only three potentiometers were used as one beam was tested at a time. They were placed underneath the beam at the midspan and both quarter points. Nylon string was used to connect the potentiometers wires to the beam surface as the range of the potentiometers was around 8 in. and the height of the beams from the floor was 48 in. (Figure 3-26). Nine potentiometers were used in the third phase of testing. They were attached to each beam at the midspan and both quarter points (Figure 3-27). Potentiometers were calibrated with a height gage prior to each phase of testing. The accuracy of the potentiometers was to the nearest 0.005 in.

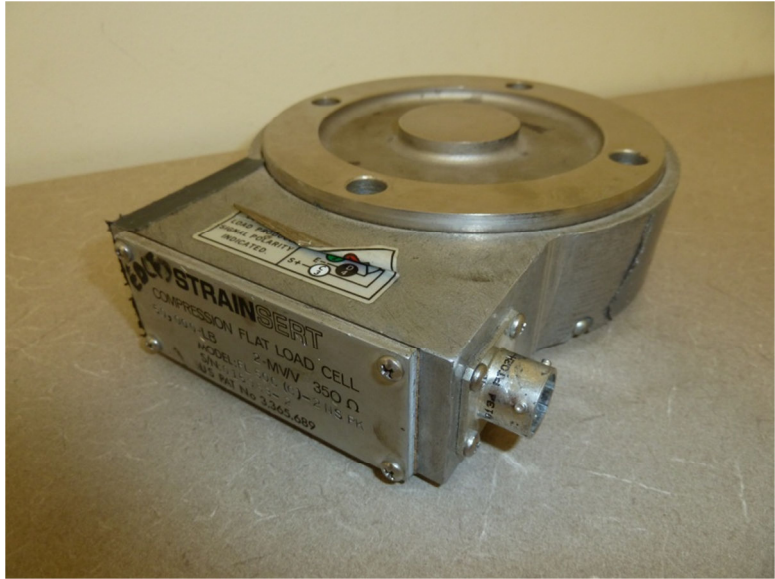
Figure 3-28 50 Kip Load Cell used for Phase II

Load cells were used to measure applied force and reactions. For the second and third phase, a load cell was placed between the actuator and the load frame to measure the applied force. A 50 kip load cell was used for the second phase (Figure 3-28), and a 300 kip load cell was used for the third phase (Figure 3-29). For the third phase of testing, six load cells were constructed and two cells placed underneath each beam at the northern end of the test setup (Figure 3-30). The load cells consisted of a solid steel 1.75 in. diameter cylinder cut to a length of 1 in. (Figure 3-31). A $\frac{1}{2}$ in. hole was bored through $\frac{3}{4}$ in. into the cylinder. The hole was made to distribute stress towards the outer surface of the steel cylinder where the strain gages would be attached. Four 0° - 90° $\frac{1}{4}$ in. adhesively bonded strain gage rosettes were placed around the outer circumference of the steel cylinders. Each rosette contained two strain gages; one was oriented to measure longitudinal strain and the other to measure the transverse Poisson strain. The strain gages were placed at each 90° quadrant around the circumference and were oriented to measure strain primarily along the length of the cylinder. The strain gages were connected in two parallel Wheatstone bridges. The Wheatstone bridge was able to account for varying strains due to eccentricity from loading. A protective coating was placed around each load cell to protect the solder connections. Each load cell was calibrated with the primary data acquisition system in a concrete cylinder testing machine. At the maximum calibration load of 28,000 lb, an error of approximately 1,000 lb was observed resulting in 3.6% error for the load cells at the supports.

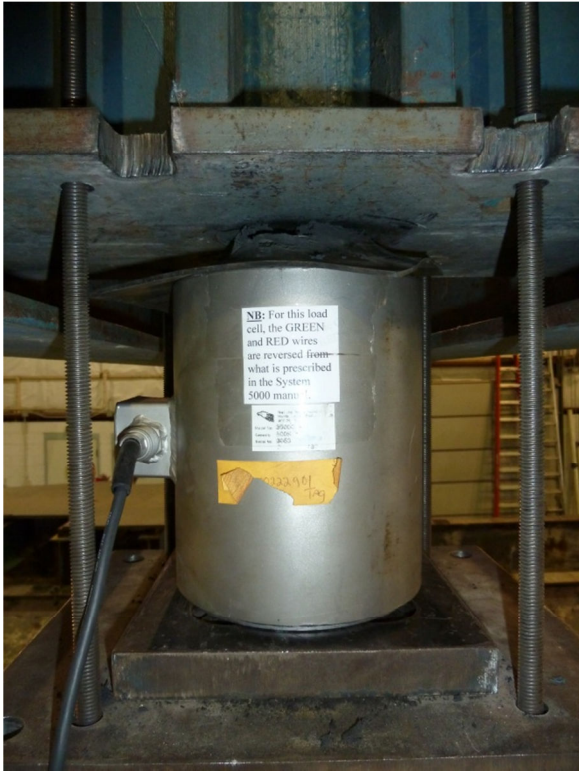
Figure 3-29 300 Kip Load Cell used for Phase III

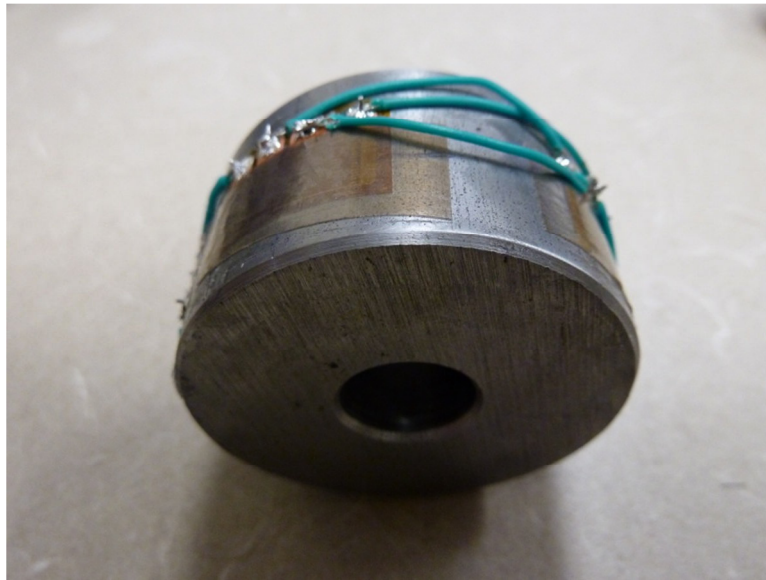
Figure 3-31 Support Load Cell Construction

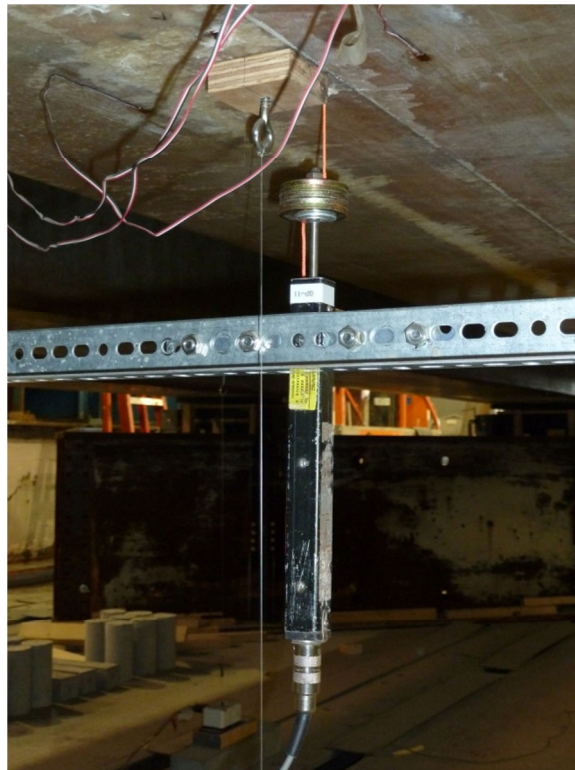
Figure 3-32 LVDT Mounted on HCB 1 at Midspan

Linear Variable Differential Transformers (LVDTs) were used to measure relative vertical movement between the concrete arch and the FRP box. The LVDTs were used on HCB1 only for phase II and III testing. The LVDT was mounted to a bracket that was attached to the FRP box using screws (Figure 5-31). Before the lid to the FRP box was attached, a hole was drilled through the foam and bottom flange at the midspan and the north quarter point at the

beam centerline. The hole extended from the bottom of the arch cavity to the bottom of the HCB. A string was threaded through the hole, and the top of the string was attached with a screw at the bottom of the arch cavity while the bottom end of the string was tied to the LVDT. Because the LVDT was not spring driven, a weight was placed on the LVDT to ensure the string remained taught. The results for these LVDT's for phase I and II were presented in *Out-of-Plane Web Deformation and Relative Arch Movement of Hybrid-Composite Beams Based on Photogrammetry* (Mascaro 2012).

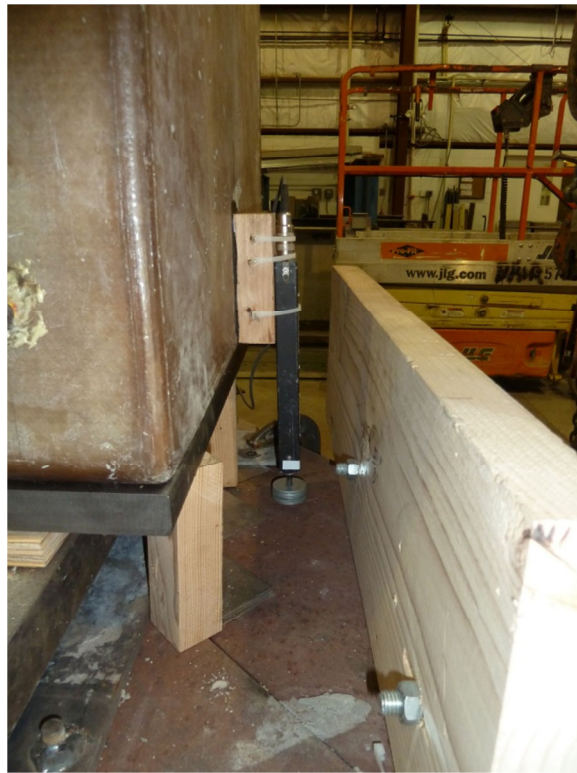
Figure 3-33 LVDT Mounted at Acute Corner

For phase III testing, LVDT's were added to the north end of HCB 1 and to the south end of HCB 3. These LVDT's were mounted on the centerline of the end face of each beam (Figure 3-33). The purpose of these instruments was to measure any potential uplift that may have occurred at the acute supports. During phase III testing, additional LVDT's were added to

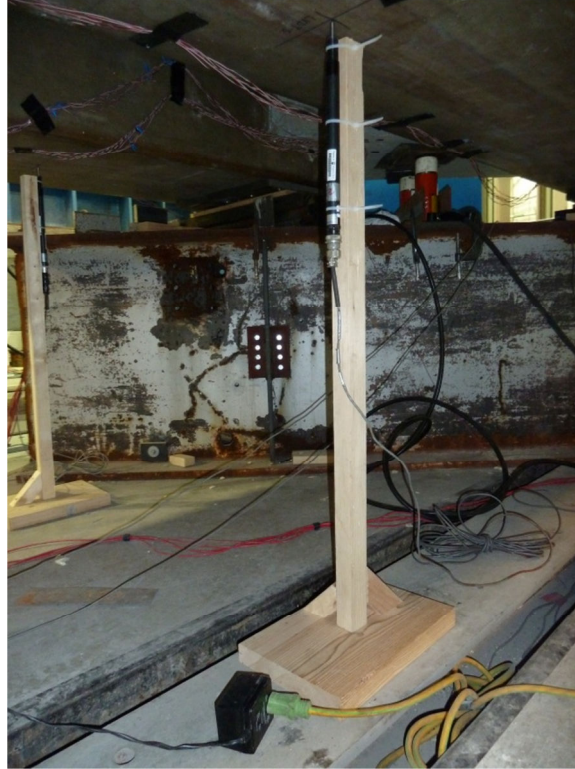
Figure 3-34 LVDT Mounted to Mobile Support

complement deflection measurements of the potentiometers. Spring driven LVDT's were attached to mobile stands to place perpendicular transversely to potentiometers of interest (Figure 3-34). For example, if HCB 1 was loaded for the maximum shear test, the LVDT's were placed perpendicular to WP-3 and so on.

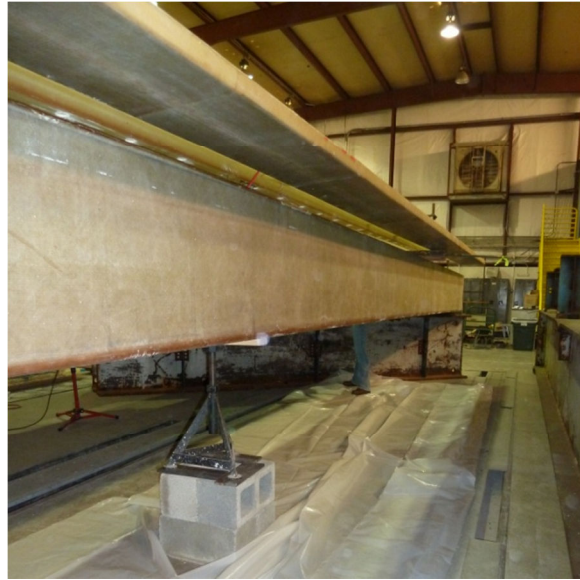
Figure 4-2 Screwjack Introducing Camber into HCB

In addition, data was recorded for HCB 1 when camber was introduced into the beam. Normally, the appropriate camber is introduced when the FRP box is fully assembled at the composites plant. Because the lids were not attached, the beams' stiffness was lower and the beams deflected more than anticipated when placed on their supports. Thus a 2 in. camber was introduced using screw jacks placed at the midspan before the FRP lid was glued on (Figure 4-2). The data system was zeroed, the system was set to record, and camber was introduced into the beam using the screw jack. The data for both the bottom component test and camber test

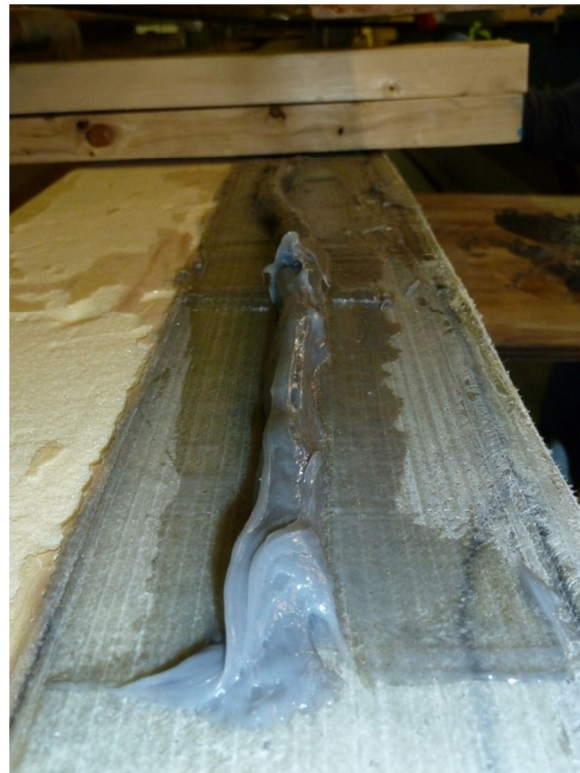
Figure 4-3 Epoxy used to Glue FRP Lid

were to be used for development of a future model of the beam. After the camber was introduced and the beam interior was instrumented, the lid was attached with epoxy and screws.

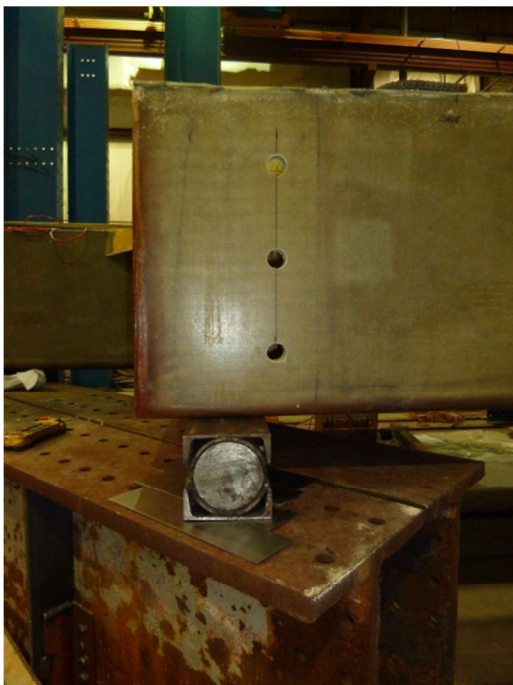
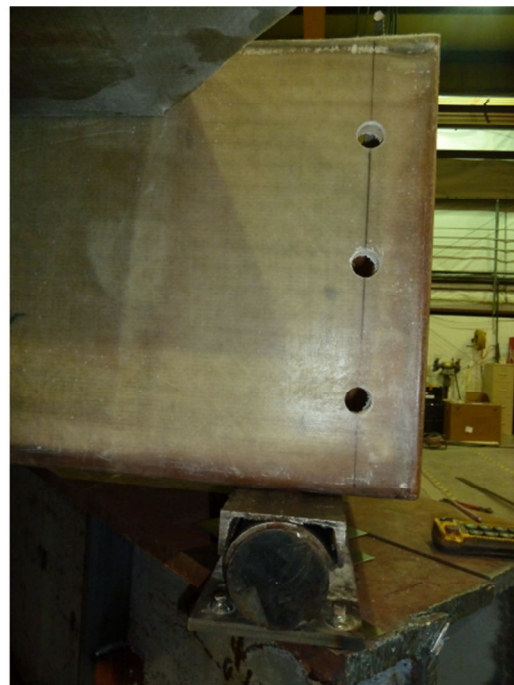
Pin Support
(a)

Roller Support
(b)

Figure 4-4 Pin and Roller Boundary Conditions

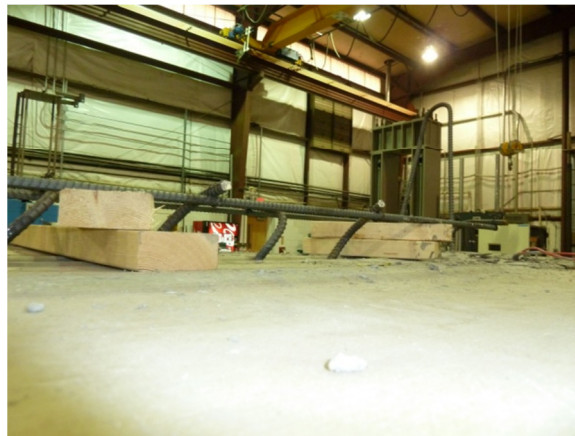
Figure 4-7 Reinforcement Tied to Shear Connectors

The projection of the stirrups above the top surface of the HCB was specified as 4 inches (Figure 4-6). In some cases, the shear connectors extended more than 4 in. due to obstructions from the FRP cross ties. To ensure the stirrups maintained this distance during the concrete pour, wooden blocks with reinforcement running in the longitudinal direction were placed underneath the shear connectors (Figure 4-7).

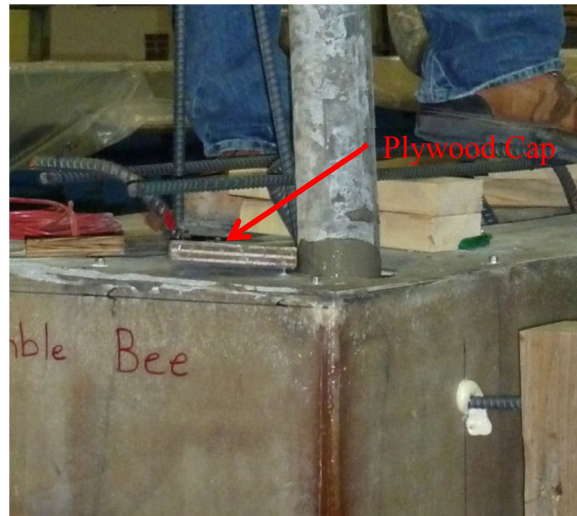
Figure 4-9 Plywood Cap at End of HCB

In addition to the placement of the shear connectors, plywood caps were installed at all holes on the FRP lids (Figure 4-8). The plywood caps prevented the concrete from overflowing through the holes (Figure 4-9). Drywall screws were screwed into one corner of the cap and into the FRP lid. A hole for another screw was predrilled at the opposite corner of the plywood piece, but the screw was not attached. The caps were rotated so that the holes were open. During the arch pour, when concrete reached the top of the lids, the cap was rotated so that the hole was completely blocked. The screw was then inserted and drilled in the pre-drilled hole in the cap and into the FRP lid. The wires from the concrete vibrating wire gages ran through the pour and vent holes at a number of locations. Finally, the reinforcement to tie the HCB's to the diaphragms was installed through predrilled holes at the beam ends (Figure 4-10). No. 4 bars with 90° bends were used.

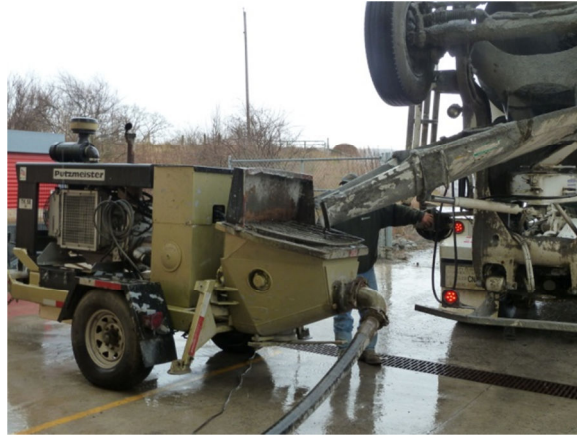
HCB 1 was placed on a pin and roller, and HCB 2 and 3 were placed on bearing pads during the concrete placement. Data from strain gages attached to the FRP box and prestressing strand of HCB 1 was recorded during the arch pour. In addition, the concrete vibrating wire gages were connected to a data logger. This system was set to record strain and temperature in the concrete. For the arch pour, a concrete pump was used to pump the concrete into the HCB's (Figure 4-11).

Figure 4-11 Concrete Pump Used for Arch Pour

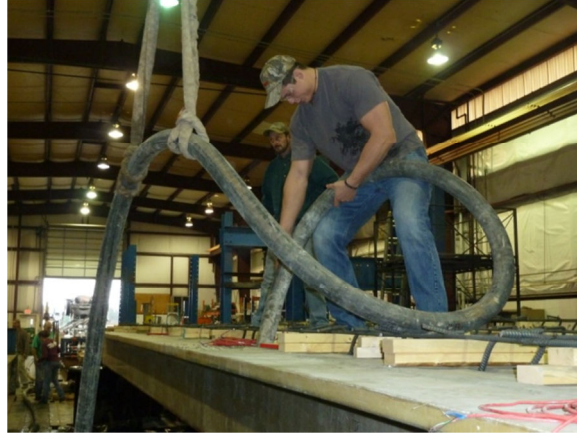
Each HCB had seven holes in the top flange that were used for filling. Concrete was first pumped into one of the quarter point holes (Figure 4-12). The concrete flowed down the arch channels to the voids at the ends of the arch. The concrete level at the end of the arch was observed through the vent holes. Once the concrete reached the top surface of the beam, the plywood caps were closed and screwed (Figure 4-13). Concrete pumping was continued for a short while to build up some pressure and force the concrete to go up the arch channel. The pump was stopped and the hose was moved to the quarter point on the opposite side of the beam. The process was repeated for the other half of the beam. The remaining holes were monitored; as soon as the concrete appeared to reach the surface of the FRP lid, the plywood caps were closed and screwed. Typically, the beams were “topped off” at the hole at the midspan. Once the concrete reached the surface of the lid, the plywood cap was closed and screwed. This process was repeated for the other HCB’s. The HCB’s were allowed to cure over a period of 28 days. Because the concrete was encased in the FRP box of the HCB’s, they were not moist cured.

Figure 4-12 Concrete Pumped into Hole at Quarter Point

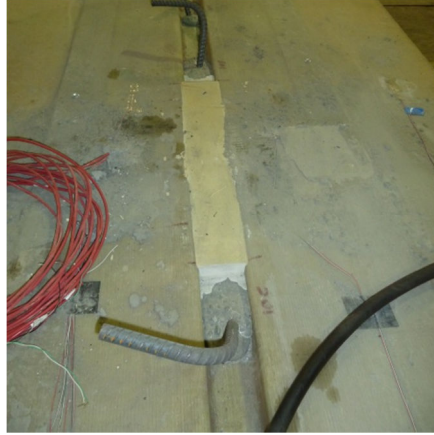
Figure 4-14 Plaster Placed in Channel of HCB

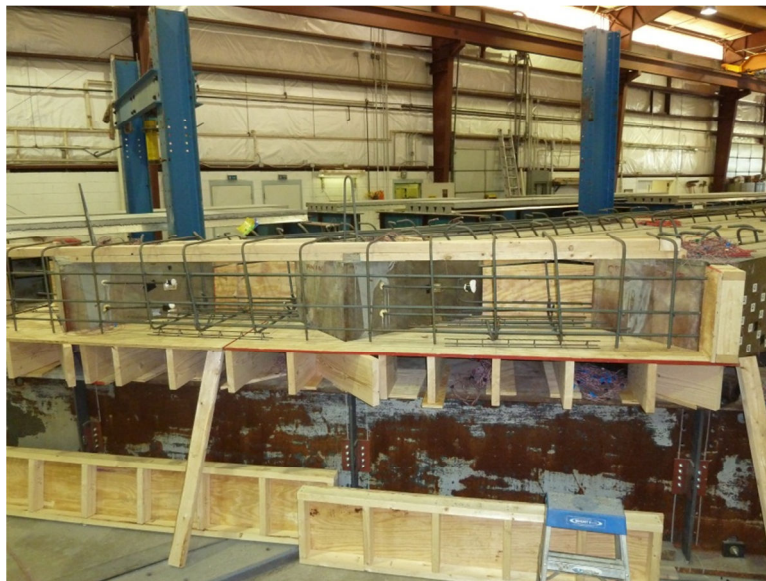
Figure 4-19 Diaphragm Reinforcement

In preparation for the diaphragm concrete placement, all the HCB's were aligned with the strong floor and the simulated abutments and placed in their final positions on pins and rollers (identical to those used in previous phases of testing). 1 in. tall 1 in. diameter steel disks were placed between the bottom surface of the beam and the pin supports. These disks were used as place holders for load cells that were installed at a later time. The disks were also placed at the end of the beam with the rollers to keep the beams' elevation equal at each end. A 1 in. thick bearing plate was used between the disks and the bottom of the beams to prevent local bearing damage. The reinforcement extending out of the beam ends was bent at a forty-five degree angle to match the angle of the end diaphragm. Because of the large weight of the three-girder system, it could not be easily moved after the deck was cast. Thus, it was crucial the beams were as closely aligned as possible. The diaphragms were 16 in. deep whereas the beam height was 21 in. The bottom of the formwork was raised and supported from the support beams by approximately 1 ft. This distance accounts for the height of the pins or rollers, steel bearing plates, steel disks, and the 5 in. offset of the diaphragms. The diaphragm reinforcement was placed afterwards. The diaphragm shape varied for the south and north ends, but the reinforcement layout was similar (Figure 4-17 & Figure 4-18). The diaphragm reinforcement consisted of longitudinal bars that

were placed at the skew angle and transverse reinforcement that were hoops and hooks. The resulting reinforcement layout is show in Figure 4-19.

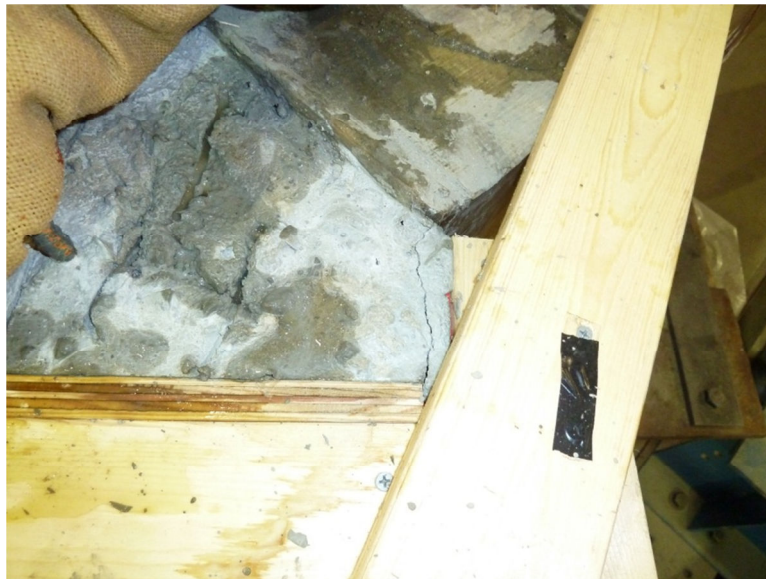
roughen the surface (Figure 4-20). This was done to improve the interface between the diaphragm and deck concrete. The diaphragms were moist-cured under burlap and plastic tarps for seven days. Erection of the deck formwork initiated after this seven day period.

Figure 4-20 Roughened Diaphragm Surface

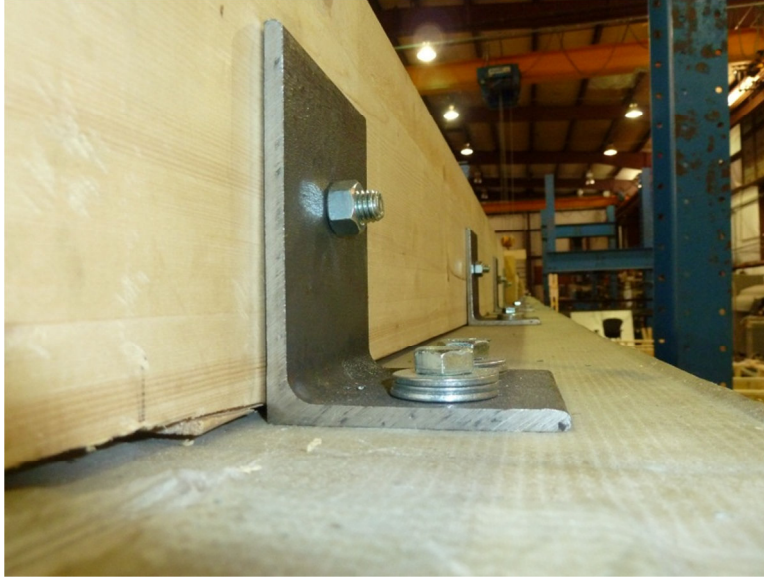
The formwork for the diaphragms was kept on after the seven day moist cure so that the deck formwork could be extended off of the existing formwork. Before erection of the deck formwork commenced, tape was used to seal the longitudinal joints between the beams. The formwork walls were erected before the deck reinforcement was placed. Along the span of the beams, the deck was set back by 7 in. from the edge of the beam flange to allow space for formwork (Figure 4-21).

Figure 4-21 Deck Side Walls

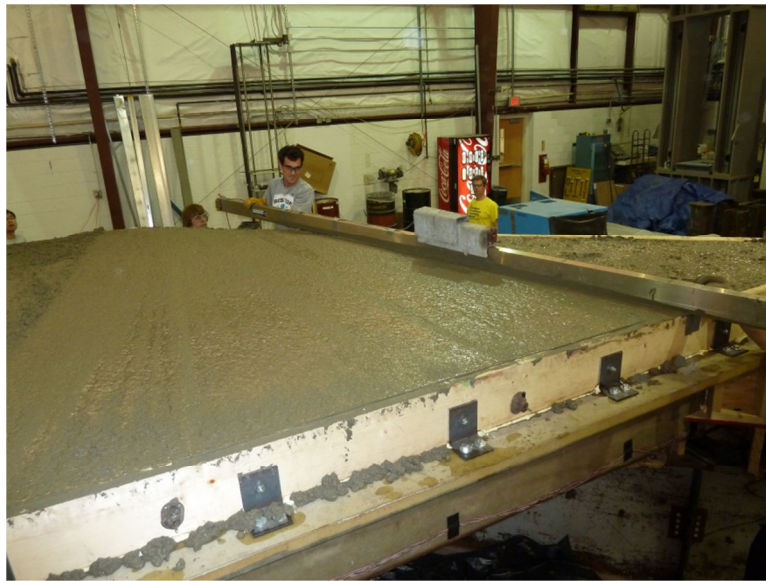
Figure 4-24 Screeding of Deck

commenced at the midpoint of where the first truckload of concrete was placed; the screeding progressed towards the northern end (Figure 4-24). Locations where the PVC pipe extended out of the deck were left unscreeded and finished by hand (Figure 4-25). The surface was finished with a bull float and then lightly brushed.

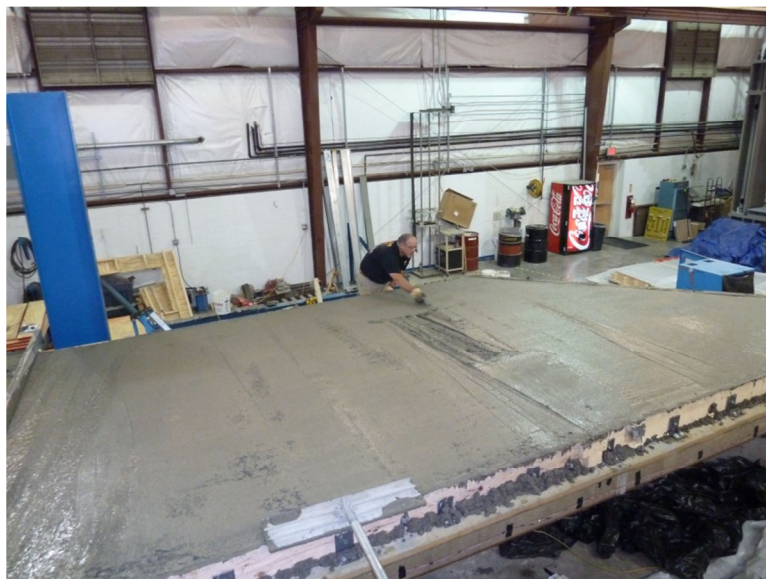
Figure 4-25 Finishing Done by Hand and Bullfloat

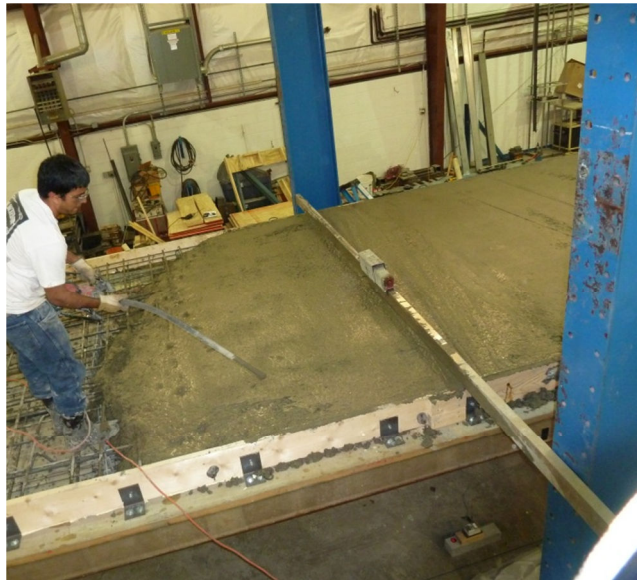
Figure 4-26 Edge of First Concrete Truckload

The second truckload arrived approximately 2 hours after the first truck arrived and half an hour after the last of the first truckload was placed. In order to reduce the influence of a cold joint where the two truckloads would meet, the concrete at the end of the first load was vibrated to reduce the amount of setting (Figure 4-26). The placement of concrete then shifted to the southern end of the setup and proceeded towards the midspan as was done with the first truckload. The surface was finished in the same manner as the northern end. Once all finished had been completed, wet burlap and a plastic tarp were laid over the deck. The burlap was remoistened every day for a 21 day period. During material testing of the second batch of concrete, the compressive strength was determined to be less than first batch. Thus moist curing was used for 21 days instead of the typical 7 days.

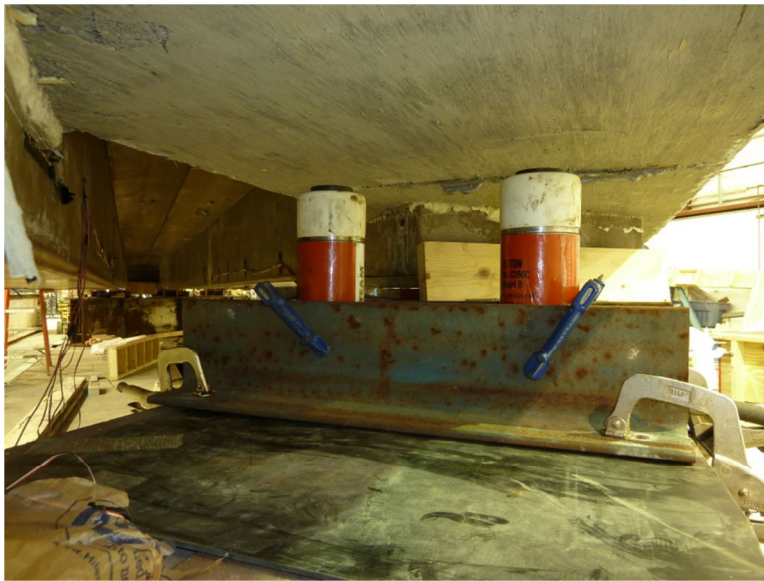
increase the bearing area. The actuators were used to jack the north end of the test specimen up 1 in. The steel disks were removed and replaced with the six constructed load cells. In some locations shim plates were necessary to ensure the HCB's remained level. After the placement of the load cells, the test specimens were ready to test.

Figure 4-27 Actuators Placed under Diaphragm
