Characterization of Shear Strengths and Microstructures for Charred Solid Rocket Motor Insulation Materials

Thesis submitted to the faculty of the Virginia Polytechnic Institute and State University
in partial fulfillment of the requirements for the degree of

Master of Science
in
Materials Science and Engineering

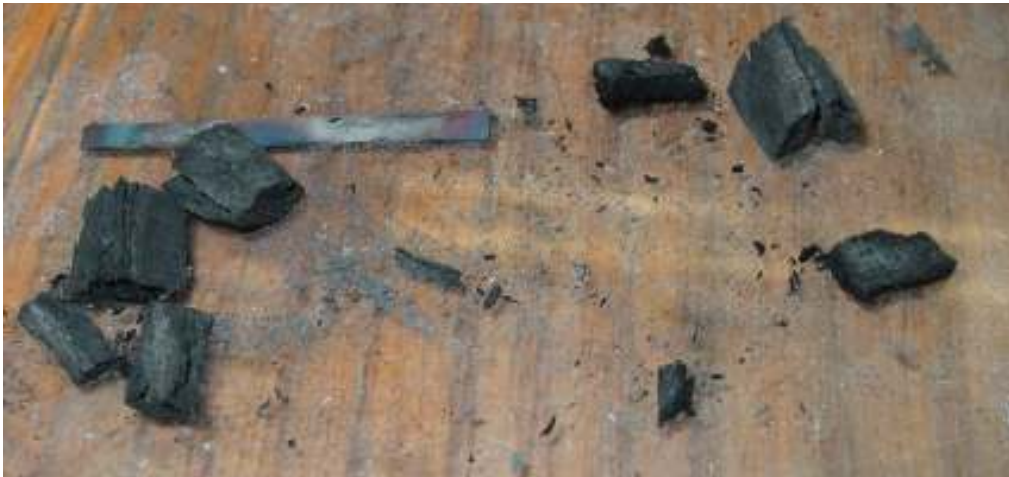
Figure 2-1: Charred ARI-2718 Specimens from Initial Char Procedure

Inspection revealed that there were cracks throughout the specimens, running both parallel and perpendicular to the notch direction. Similar results occurred for a second run, using the same procedure but replacing the ARI-2718 with ARI-2750. Thinking that these cracks may have come from thermal stresses in the constrained material, the next charring run did not include the ceramic spacers mentioned above. These specimens did not crumble, but still showed some cracking and would not have been adequate for shear testing. Places where the foil was close to the specimens caused them to warp to fit the surface of the foil upon expansion during the charring, as shown in Figure 2-2.

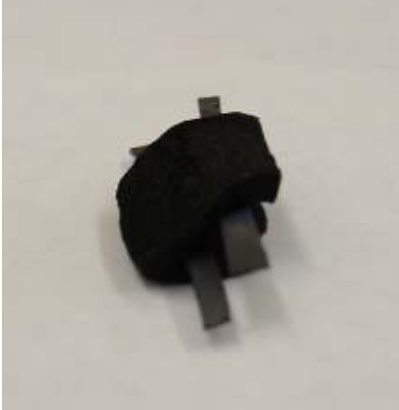
Figure 2-2: Charred ARI-2718 Specimen Showing Warping from Foil Surface

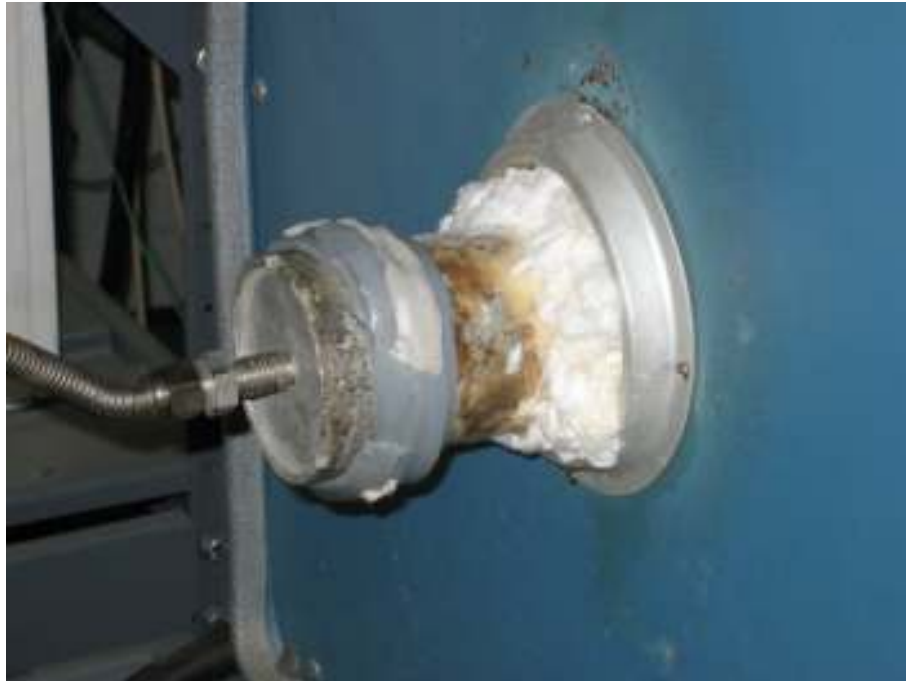
Figure 2-3: Sealed End of Alumina Tube

damage to the aluminum caps. Figure 2-3 below shows one end of the tube as prepared for this work.

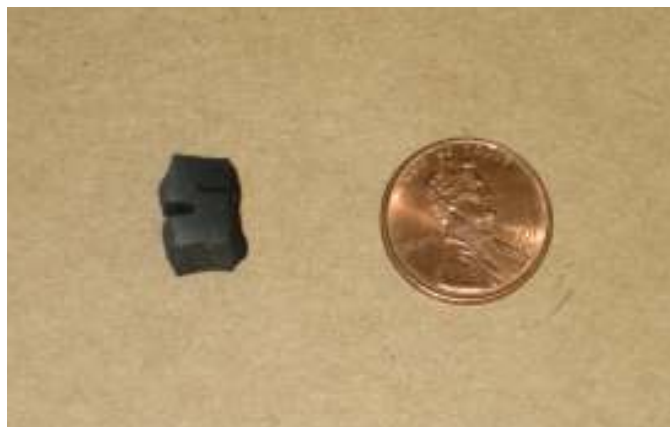
Figure 2-5: Warped Specimen of Charred ARI-2719

Specimens charred in this furnace turned out better than in the other furnace, though there was still some cracking visible in about half the specimens. Many specimens also showed varying amounts of warping, as shown in Figure 2-5 below.

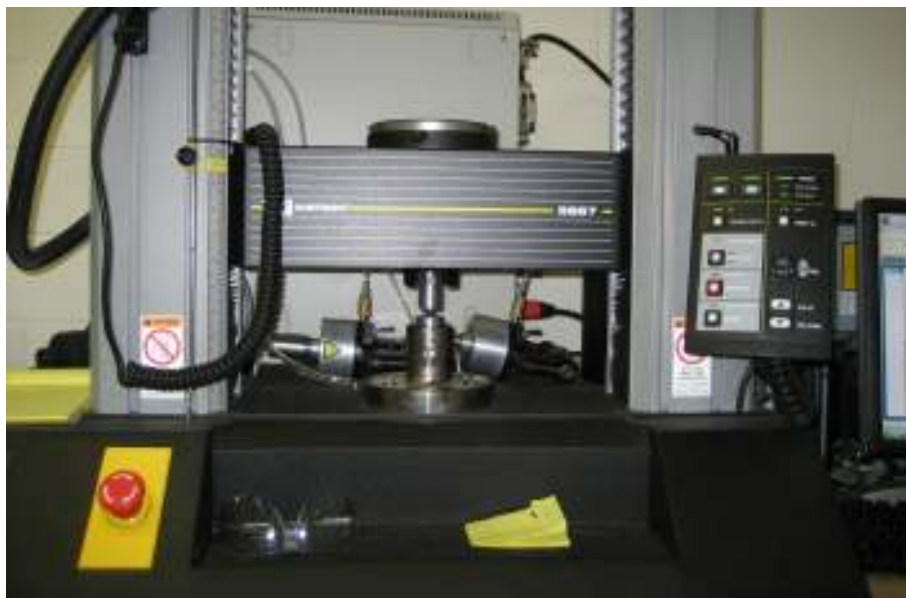
Figure 2-31: Instron 5867 Test Fixture

The remainder of the tests took place on an Instron 5867 test frame, shown in Figure 2-31 below.

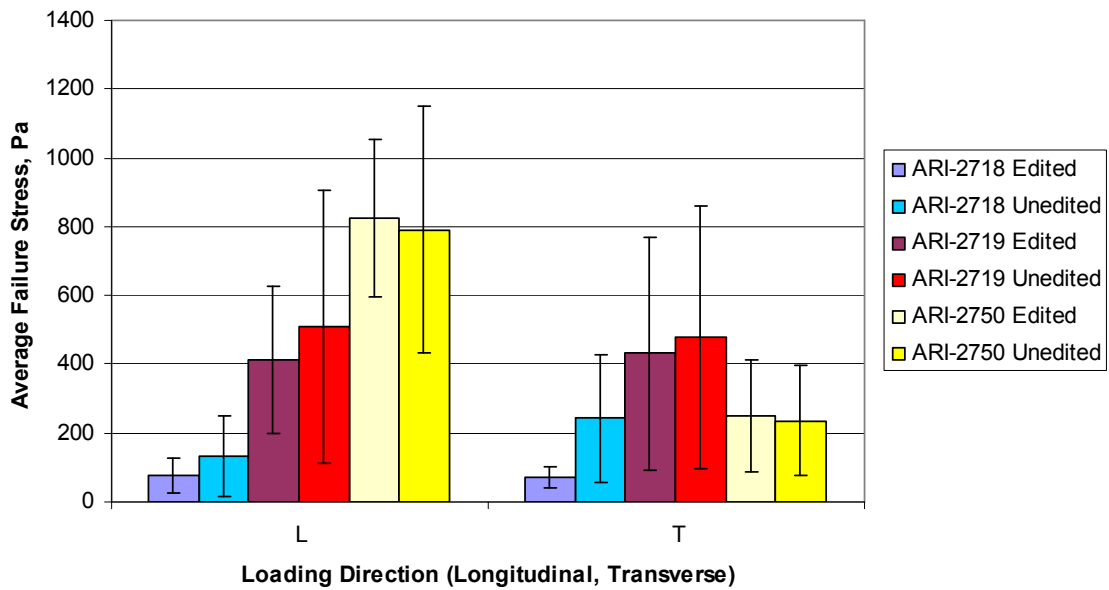
Figure D-1: Unedited Shear Strength Test Results

The only material to show any significant change in average strength was the ARI-2718, which showed an increase in strength when considering the results edited out above.
