Corrosion Assessment for Failed Bridge Deck Closure Pour

Thesis submitted to the faculty of the Virginia Polytechnic Institute and State University
in partial fulfillment of the requirements for the degree of

1.2 Interstate 81 Closure Pour Failure

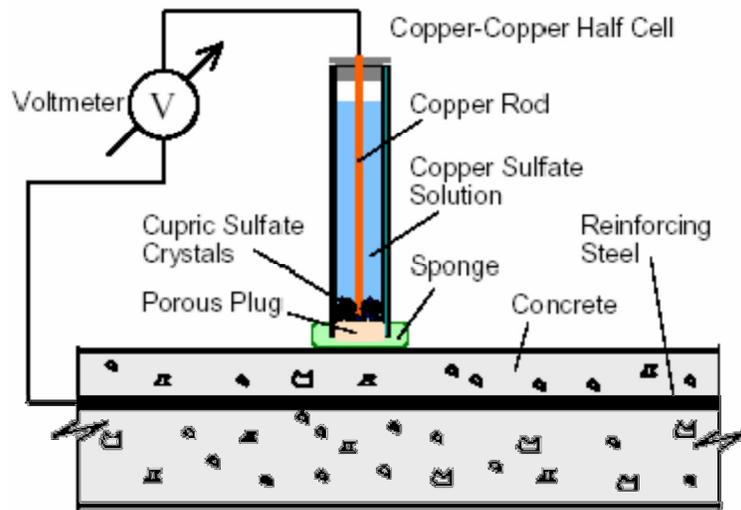
The Half-cell method is used to determine the corrosion activity of the reinforcing steel. The main requirement for this test to be successful is that the structure being tested is to have electrical continuity. The concrete being tested should be moist so it can maintain an electrical circuitry (ASTM C 876-91). The half-cell potential test is considered a simple device (Broomfield 2007). Also, it is considered a quick and inexpensive method to determine areas which require further investigation (Mehta and Monteiro 2006). The test setup consists of a copper rod submerged in a saturated copper-copper sulfate solution and confined in a rigid tube with a porous plug at its bottom, which is now a copper/copper sulfate electrode (CSE) half-cell. An electrical junction device is mounted at the bottom of the CSE half-cell to provide continuity between the concrete surface and the porous plug. A sponge pre-wetted with an electrolyte is used to provide a low electrical resistance. The potential difference between the half-cell and the reinforcing steel is measured using a high impedance voltmeter. Detailed test setup is presented in Figure 2.1 (ASTM C 876-91). Table 2.3 presents the data interpretation for the CSE half-cell potential.

Figure 2.1 Half-Cell Potential Apparatus

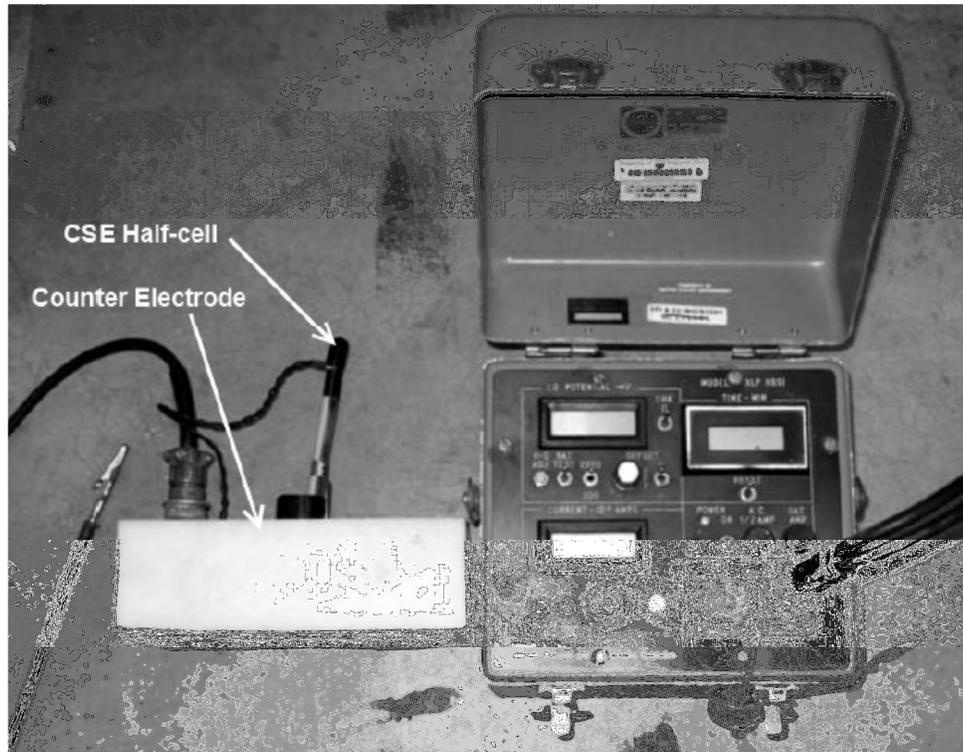
This method gives real time readings of corrosion rate and metal lost, but it cannot accurately calculate and predict total section loss or concrete spalling rate (Broomfield 2007). It gives a snapshot of corrosion rate based on concrete temperature and moisture condition (Liu and Weyers 2003). With current technology, corrosion rate is the closest we can get to measure the rate of deterioration (Grantham, Herts et al. 1997; Broomfield 2007). Gowers and Millard described corrosion by, “Corrosion is a dynamic process subject to fluctuations and the interpretation of corrosion rate measurements should focus on the order of magnitude rather than the precise value obtained (Gowers and Millard 1999)”.

Figure 2.2 3LP Device Setup (Photograph Taken By Soundar S. G. Balakumaran 2010) [Used under fair use guidelines, 2011]

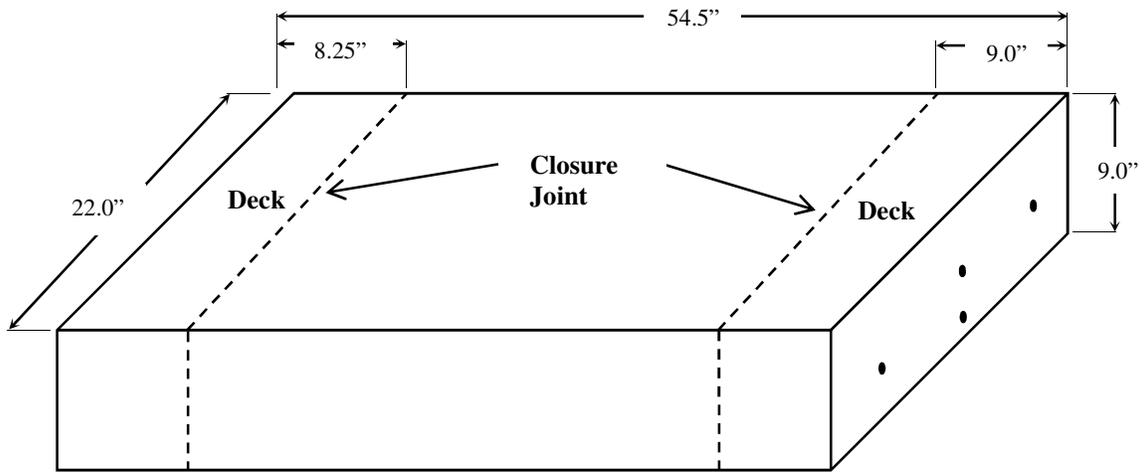
Visual inspection was conducted on the field slabs in addition to corrosion readings, mechanical properties, permeability characteristics, and density and saturation characteristics. After examining the section they were sawed transversely into strips with a width of about 22 in. each.

Figure 3.1 Specimen #6 Dimensions of Cut Section from the Bridge Deck

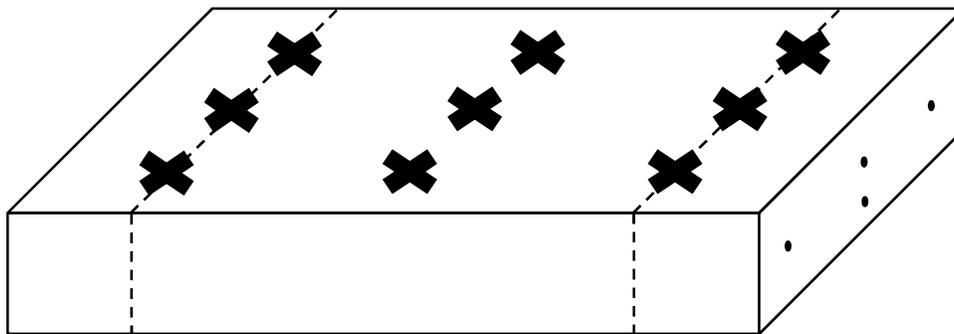
Visual inspection was conducted in two steps, using nondestructive and destructive methods. The nondestructive visual inspection measured dimensions of the slabs and specimens in addition to documentation of damage and a crack survey. Measurements were also made to determine the cold joints width using a feeler gauge. The destructive visual inspection required opening the specimens and checking the condition of the embedded ECR for corrosion and damage to the epoxy coating. Also for any deposits of calcium hydroxide, calcium carbonate and rust stains with the reinforcing bar trace.

Figure 3.2 Cover Depths Measurement Locations

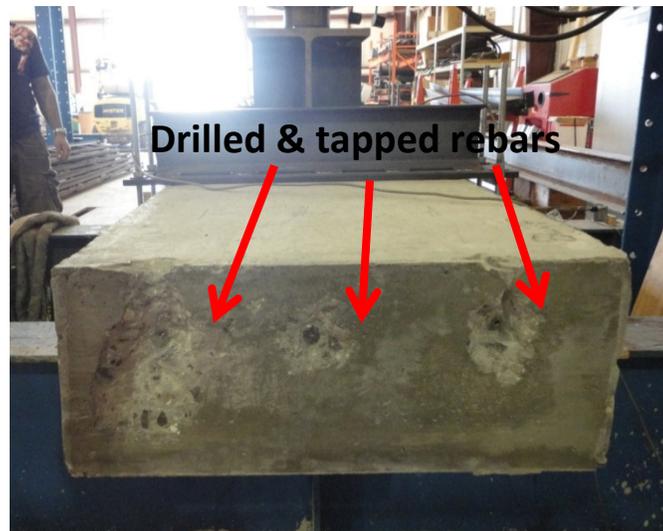
This test determines the corrosion activity of uncoated reinforcing steel, but it will be used for ECR.

Figure 3.3 Drilled and Tapped Rebars to Measure Corrosion Readings

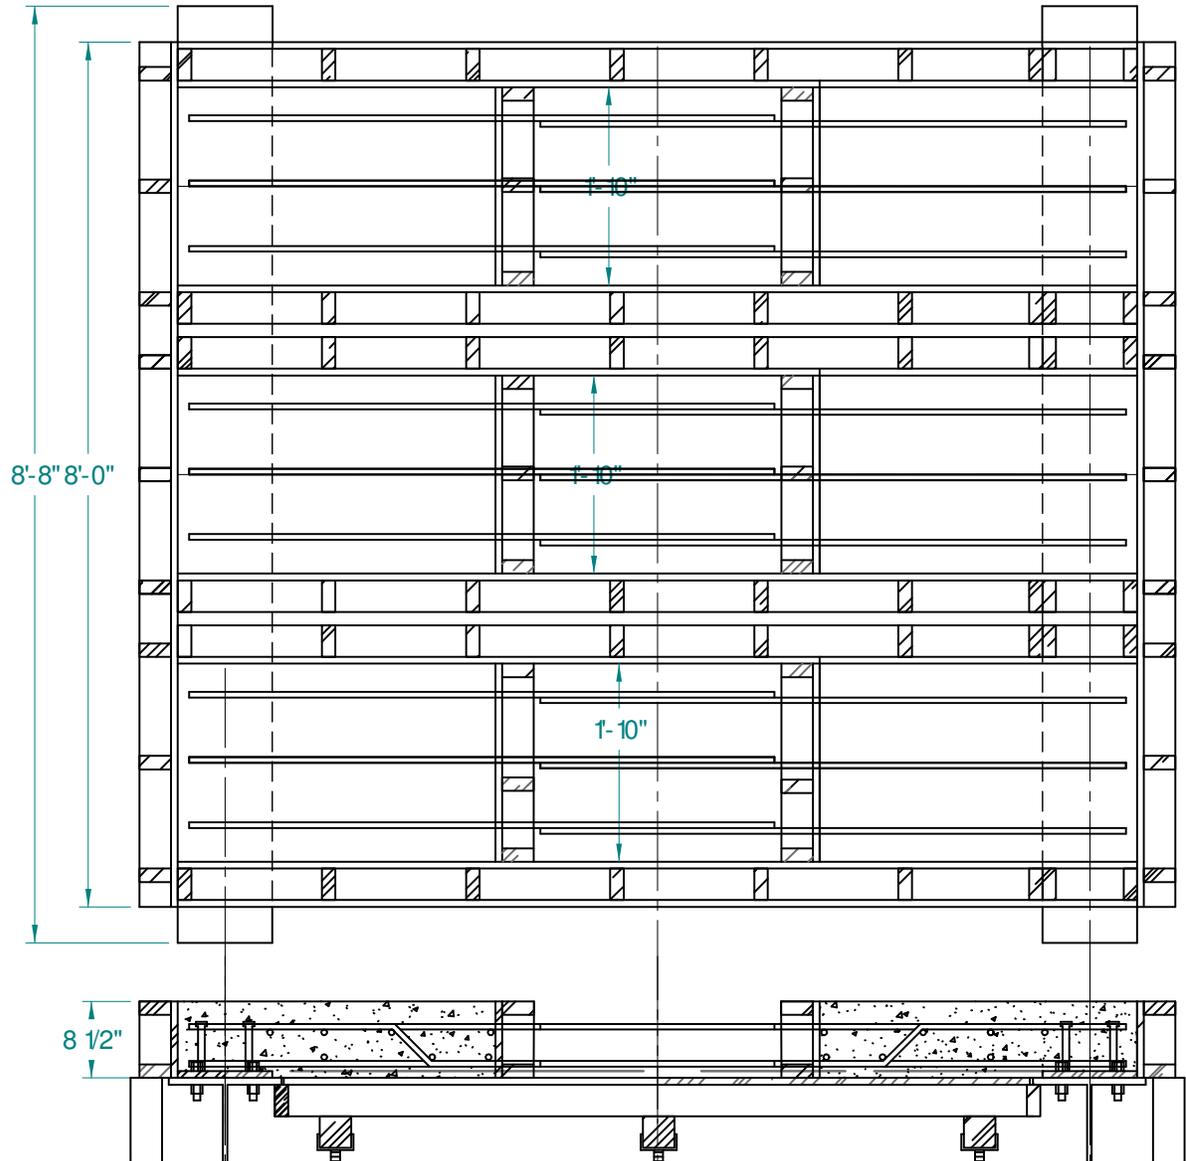
The actual bridge deck was constructed by closing one lane and shoulder of the bridge deck, and traffic was diverted to the other lane. After the construction work was completed the new deck lane and shoulder was opened to traffic and the other lane and shoulder were closed. Finally, when both lanes and shoulders were completed the two sections were connected using a closure pour. Whereas, the replicated laboratory slabs were cast by placing both bridge decks (exterior sides) at the same time then placing the closure pour after 30 days, as shown in Figure 3.5 and 3.6. The cast slabs had a width of 22 in., a thickness of 8.5 in., and a length of 8 ft-4 in. Slab cast sections were wet cured using wet burlap covered with a polyethylene sheet.

Figure 3.4 Lab Cast Slab Reinforcing Details

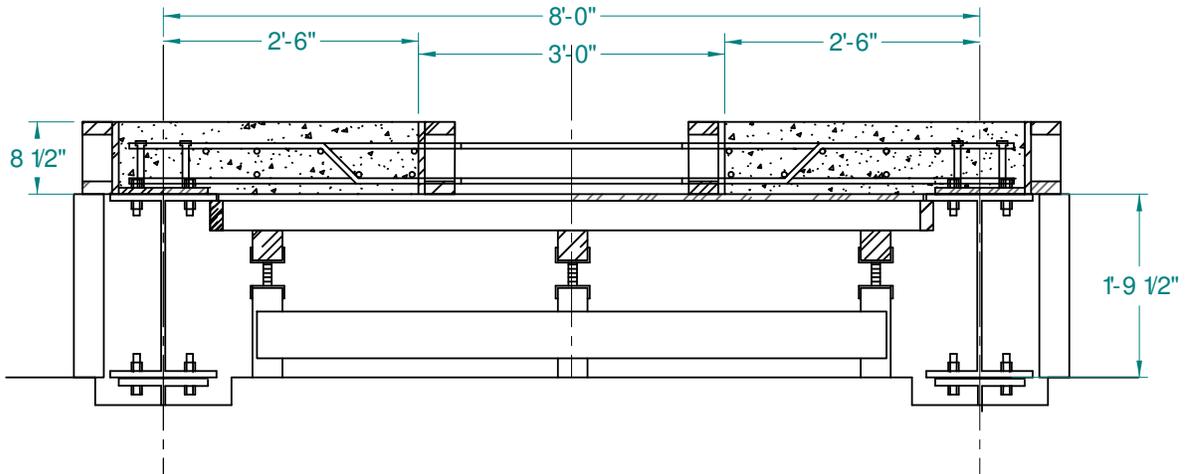
Figure 3.5 First Concrete Placement Setup

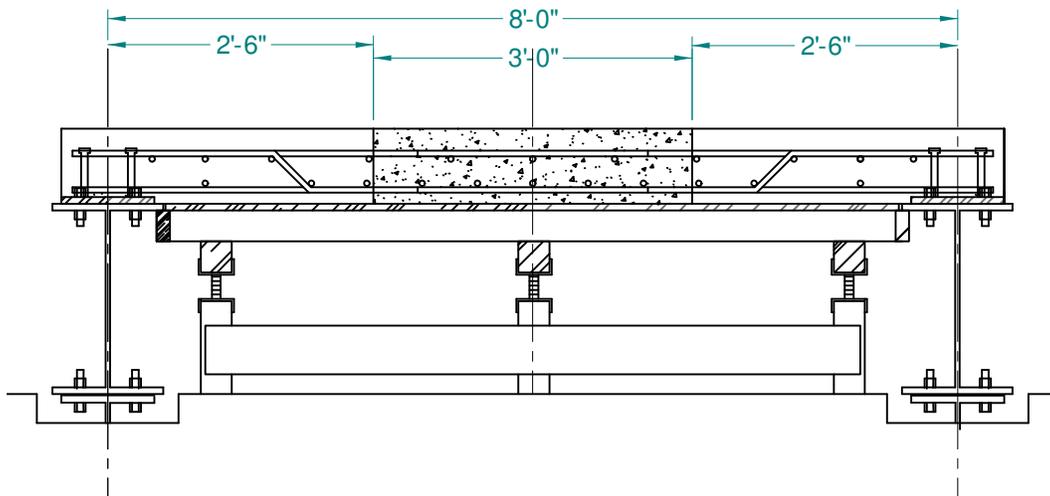
Figure 3.8 Second Concrete Placement Setup

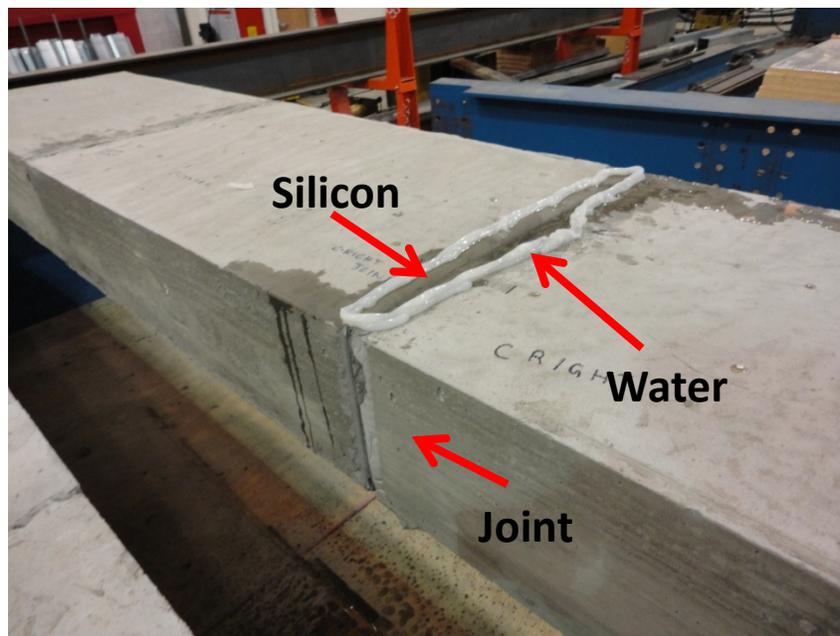
Ponding test was performed for each closure pour joint on each lab cast slab. Water was ponded for a period of 24 hours over each closure pour joints for each slab, see Figure 3.9. Water pond test was conducted to determine if the cast closure pour joints had opened wide enough to allow water leakage through the joint similar to the deck joints.

Figure 3.9 Water Ponding Test across the Joint

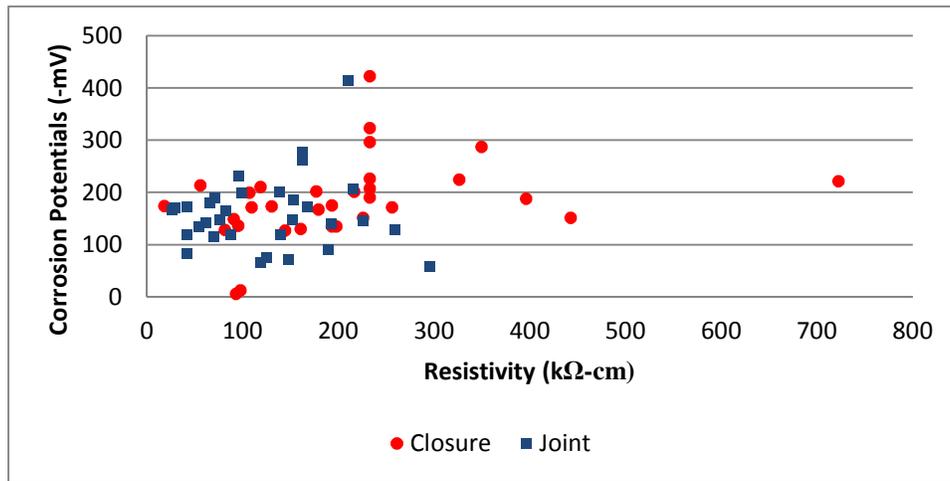
Figure 4.1 shows a scatter diagram for corrosion potentials versus resistivity for I81 deck slabs. It can be noticed that the corrosion potentials for the closure pour and the closure joints measurements are less than -200 mv which indicates low corrosion activity, although some values are showing higher corrosion activity. The resistivity measurements for the closure pour indicate higher resistivity compared to the closure joints measurements. Higher resistivity indicates better concrete quality or an interference from the epoxy coating since it is generally considered a nonconductive material if not saturated.

Figure 4.1 Corrosion Potentials vs. Resistivity for I81 Slabs

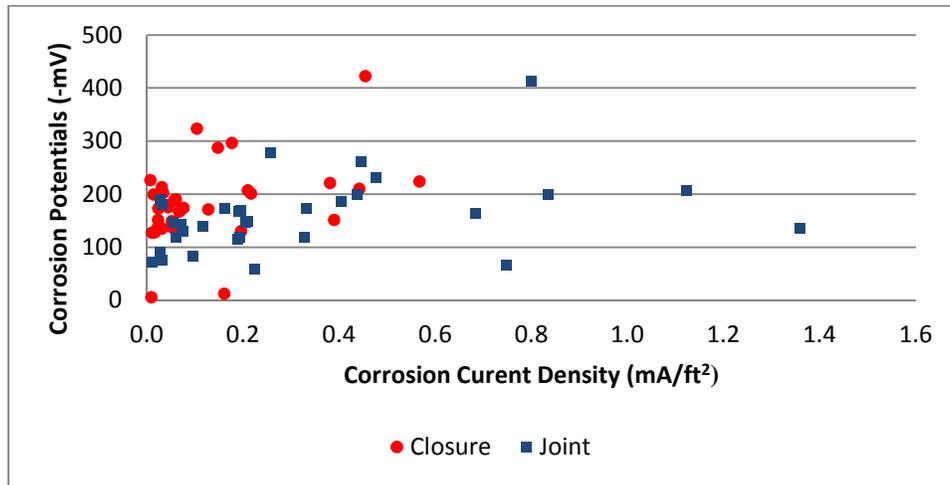
closure pour are less than $0.2\text{mA}/\text{ft}^2$, which indicates very low corrosion activity. While the closure joints measurements are highly variable showing low to high corrosion rates.

Figure 4.2 Corrosion Potentials vs. Corrosion Current Density for I81 Slabs

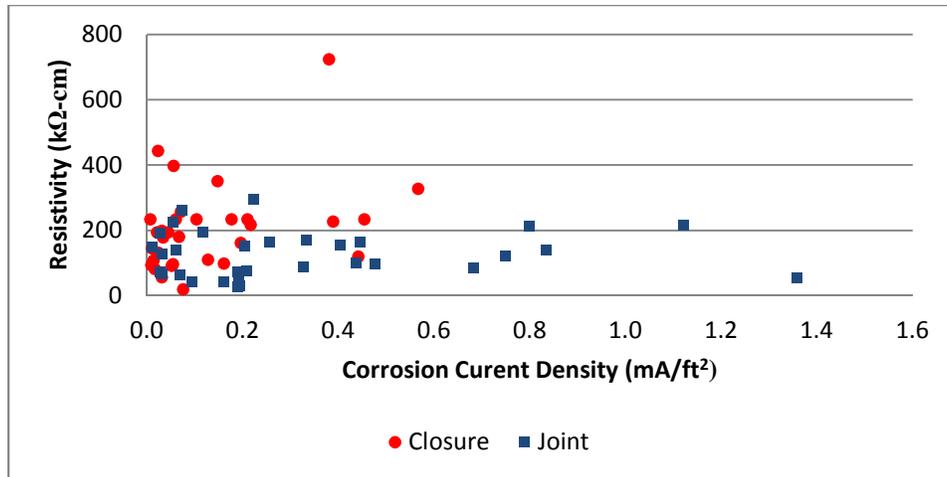
Figure 4.3 shows a scatter diagram for resistivity versus corrosion current density for I81 deck slabs. It can be noticed that the resistivity measurements for the closure pour indicate higher resistivity compared to the closure joints measurements. Higher resistivity indicates better concrete quality or an interference from the epoxy coating since it maybe more of a nonconductive material. Corrosion current density measurements for the closure joints indicate higher corrosion activity compared to the closure pour measurements. Most of the measurements of the closure pour are less than $0.2\text{mA}/\text{ft}^2$, which indicates very low corrosion activity. While the closure joints measurements are highly variable showing low to high corrosion activity.

Figure 4.3 Resistivity vs. Corrosion Current Density for I81 Slabs

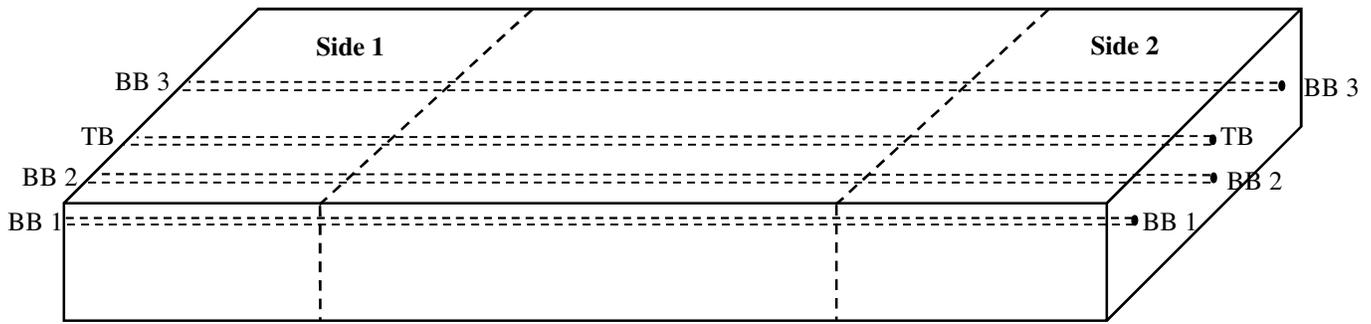
Tables 4.10 and 4.11 represent the results of the corrosion related measurements for the lab cast decks. Cover depths were measured with a range from 2.64 to 4.2 in. for the three slabs. Those results are similar to the deck slabs cover depths range. The tests were conducted on three bars (TB, BB 1, and BB 3) out of four bars on each side of the slabs. Since the top bar is located directly over the bottom middle rebar, this made the cover meter ineffective in locating the bottom bar. Electrical continuity checks were performed for each single bar between Side 1 and 2, and it showed that each spliced ECR bar is continuous between both sides, as shown in Figure 4.4.

Figure 4.4 Continuity Readings Locations for Lab Cast Slab

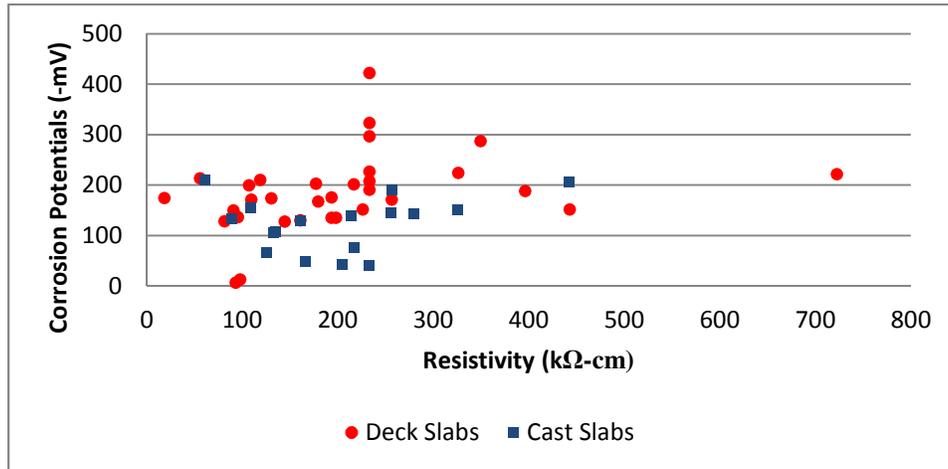
less than -200 mv which indicates low corrosion activity, while the I81 deck slabs measurements are indicating higher corrosion activity with corrosion potentials greater than -200 mv. The resistivity measurements for the I81 deck and lab cast slabs indicate high resistivity with a similar range of measurements.

Figure 4.5 Closure Pour Corrosion Potentials vs. Resistivity for Deck vs. Cast Slabs

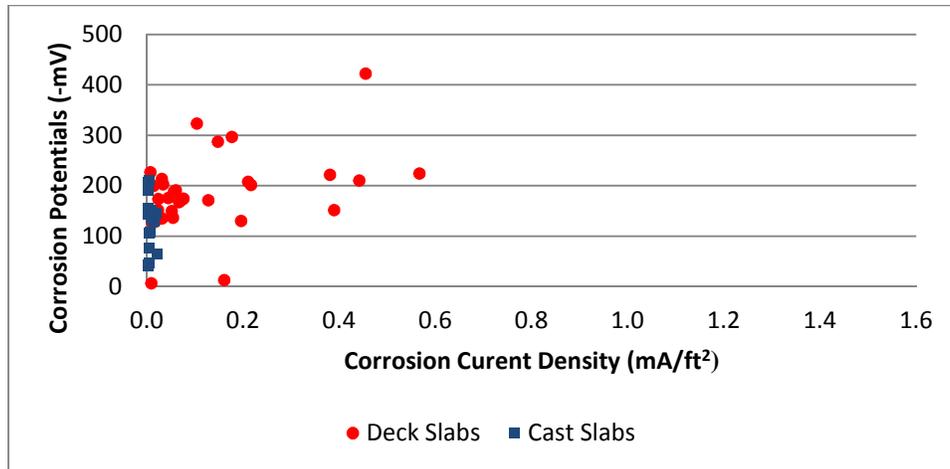
Figure 4.6 shows a scatter diagram for corrosion potentials versus corrosion current density for the closure pour of the I81 slabs versus the lab cast slabs measurements. It can be noticed that the corrosion potentials for the I81 deck slabs indicating higher corrosion activity compared to the lab cast slabs measurements. The lab cast slabs corrosion potentials are less than -200 mv which indicates low corrosion activity, while the I81 deck slabs measurements are indicating higher corrosion activity with corrosion potentials greater than -200 mv. Corrosion current density measurements for the I81 deck slabs indicate higher corrosion activity compared to the lab cast slabs measurements. All of the measurements of the lab cast slabs are less than 0.2mA/ft², which indicates no corrosion activity.

Figure 4.6 Closure Pour Corrosion Potentials vs. Corrosion Current Density for Deck vs. Cast Slabs

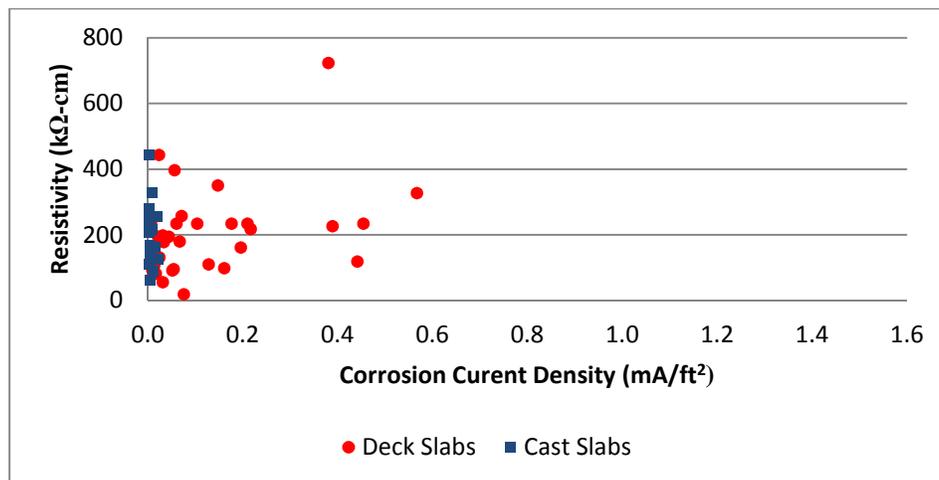
Figure 4.7 shows a scatter diagram for resistivity versus corrosion current density for the closure pour of the I81 slabs versus the lab cast slabs measurements. The resistivity measurements for the I81 deck and lab cast slabs indicate high resistivity with a similar range of measurements. Corrosion current density measurements for the I81 deck slabs indicate higher corrosion activity compared to the lab cast slabs measurements. All of the measurements of the lab cast slabs are less than 0.2mA/ft^2 , which indicates no corrosion activity.

Figure 4.7 Closure Pour Resistivity vs. Corrosion Current Density for Deck vs. Cast Slabs

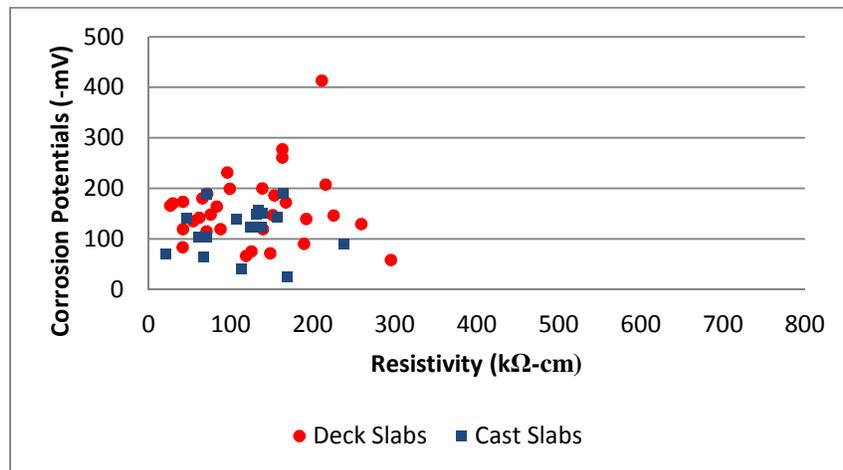
Figure 4.8 shows a scatter diagram for corrosion potentials versus resistivity for the closure pour joints of the I81 slabs versus the lab cast slabs measurements. It can be noticed that the corrosion potentials for the I81 deck slabs indicating higher corrosion activity compared to the lab cast slabs measurements. The lab cast slabs corrosion potentials are less than -200mv which indicates low corrosion activity, while the I81 deck slabs measurements are indicating higher corrosion activity with corrosion potentials greater than -200mv . The resistivity measurements for the I81 deck and lab cast slabs indicate high resistivity with a similar range of measurements.

Figure 4.8 Closure Joints Corrosion Potentials vs. Resistivity for Deck vs. Cast Slabs

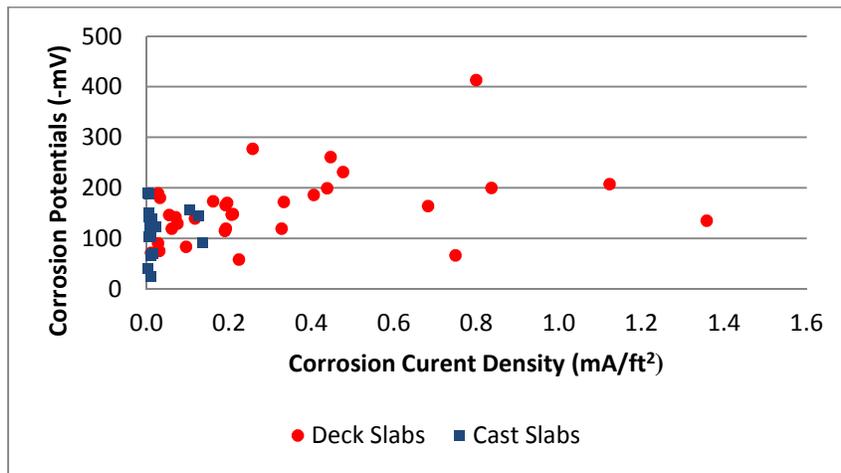
Figure 4.9 shows a scatter diagram for resistivity versus corrosion current density for the closure pour joints of the I81 slabs versus the lab cast slabs measurements. The resistivity measurements for the I81 deck and lab cast slabs indicate high resistivity with a similar range of measurements. Corrosion current density measurements for the I81 deck slabs indicate higher corrosion activity compared to the lab cast slabs measurements. All of the measurements of the lab cast slabs are less than 0.2mA/ft², which indicates no corrosion activity.

Figure 4.9 Closure Joints Corrosion Potentials vs. Corrosion Current Density for Deck vs. Cast Slabs

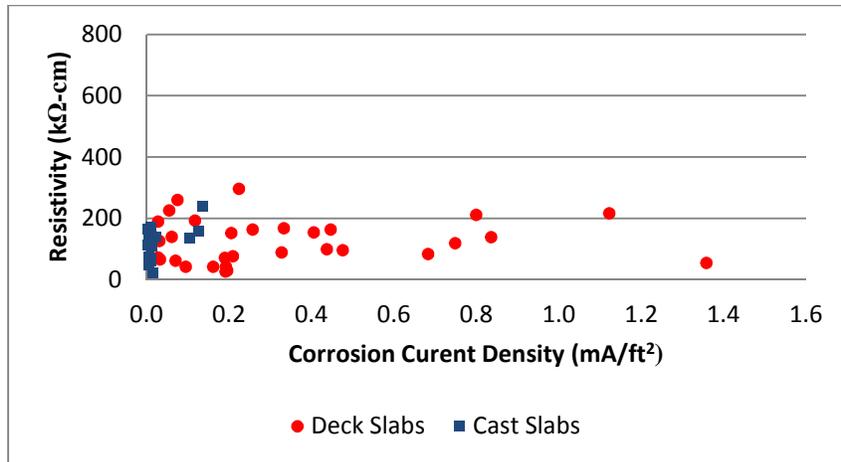
Figure 4.10 shows a scatter diagram for resistivity versus corrosion current density for the closure pour joints of the I81 slabs versus the lab cast slabs measurements. The resistivity measurements for the I81 deck and lab cast slabs indicate high resistivity with a similar range of measurements. Corrosion current density measurements for the I81 deck slabs indicate higher corrosion activity compared to the lab cast slabs measurements. All of the measurements of the lab cast slabs are less than 0.2mA/ft², which indicates no corrosion activity.

Figure 4.10 Closure Joints Resistivity vs. Corrosion Current Density for Deck vs. Cast Slabs

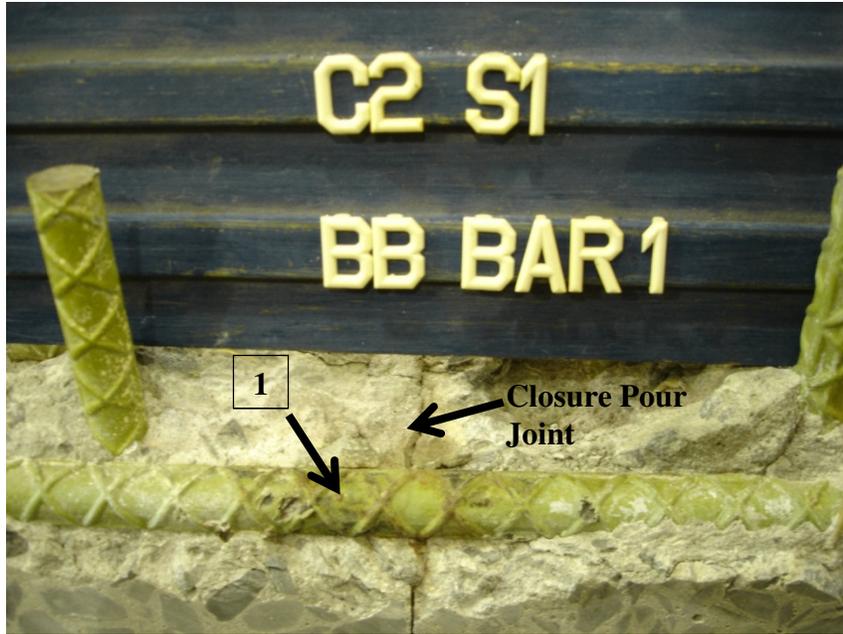
Figures 4.11 and 4.12 presents the visual inspection of samples C2-S1 Bottom Bar 1 and C2-S1 Top Bar 2, as shown in Appendix B. As shown in Figure 4.11 arrow 1, the bar is corroded across the joint and as shown by the change of epoxy color. Figure 4.12 shows signs of spotted deposits, arrow 2, on the bar surface, with less signs of corrosion, arrow 3, as compared to the top bar show in Figure 4.11. Figure 4.13 shows white and yellow deposits in the concrete along the bar trace underneath the bar, as shown by arrow 2 in Figure 4.12.

Figure 4.11 C2-S1 Bottom Bar from Side On

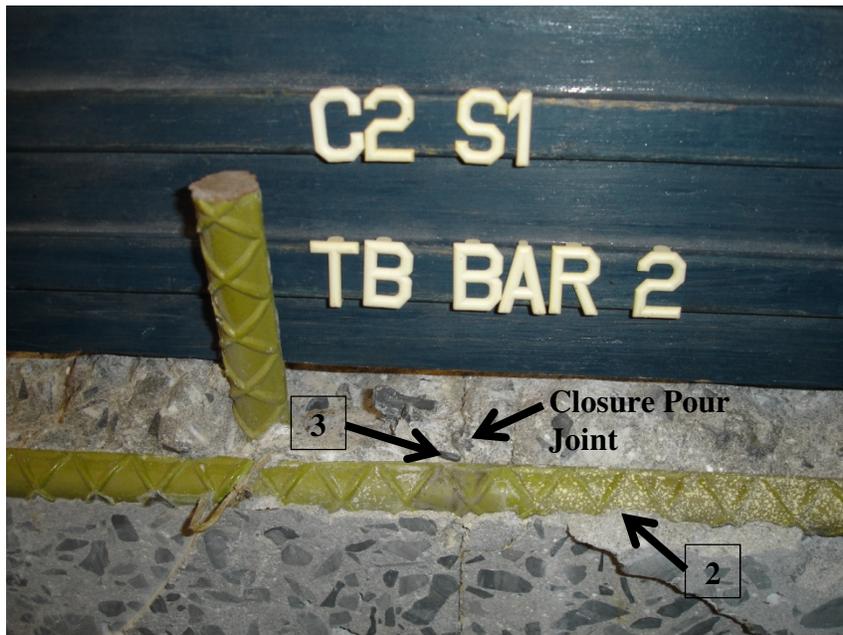
Figure 4.12 C2-S1 Top Bar 2

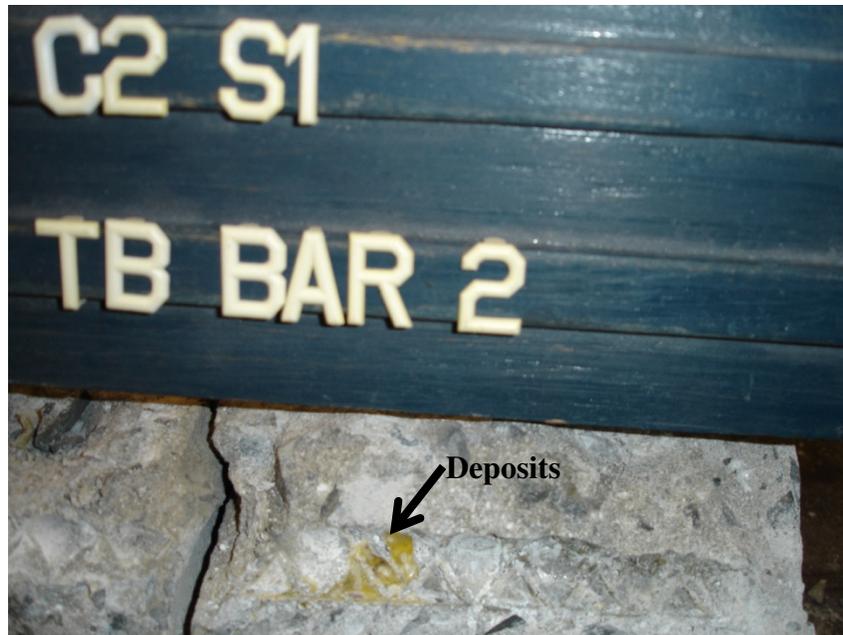
Figure 4.13 C2-S1 Top Bar 2 after Removing Bar

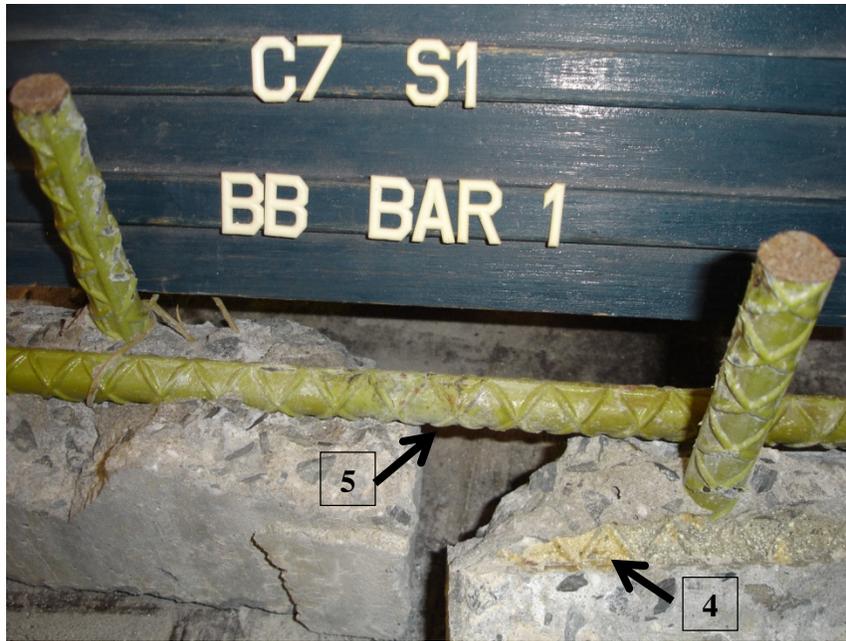
The sample shown in Figure 4.14 was taken from the bottom of slab three across joint one, as shown in Appendix B. Samples shown in Figures 4.15 and 4.16 were taken from the top of the same slab. Figure 4.14 shows some precipitation, arrow 4, at the top of the bar and corrosion, arrow 5, at the bottom of the bar. Figure 4.15 and 4.16 shows the bar corroded across the joint, arrow 6. Also, white and yellow deposits, arrow 7, can be seen on the concrete and bar on one side of the bar.

Figure 4.14 C7-S1 Bottom Bar 1

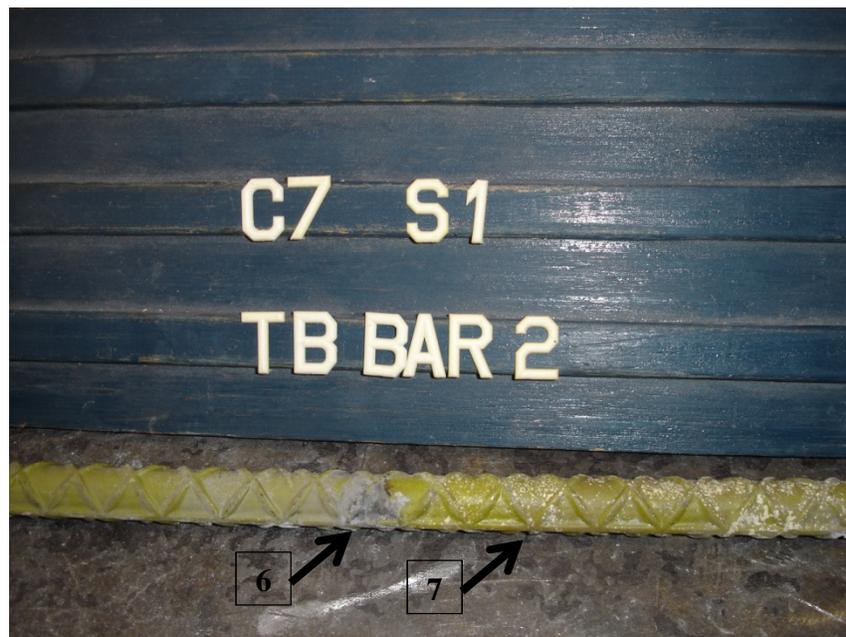
Figure 4.15 C7-S1 Top Bar 2 without Concrete

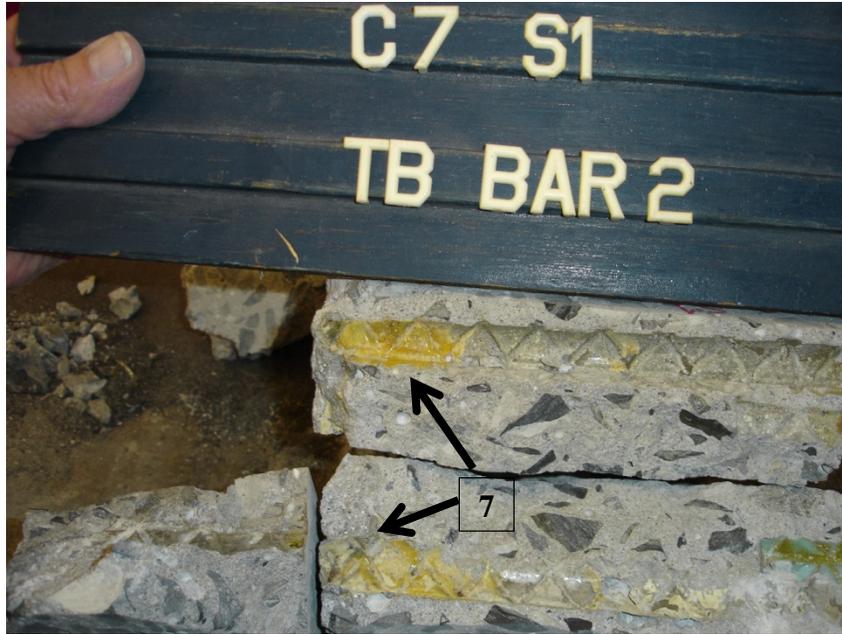
Figure 4.16 C7-S1 Top Bar 2 after removing Bar

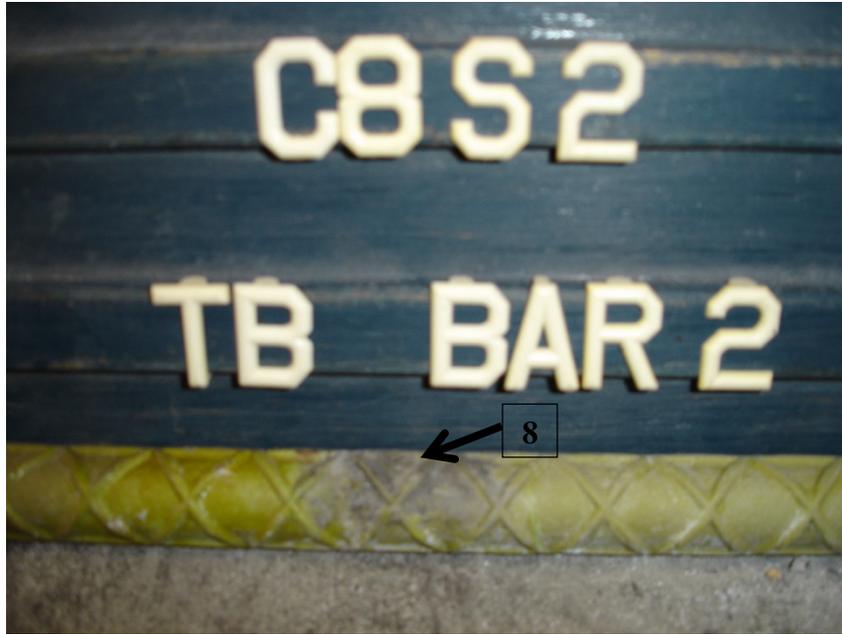
The samples shown in Figure 4.17 and 4.18 were taken from the top of slab four across joint two, as shown in Appendix B. Samples shown in Figures 4.19 and 4.20 were taken from the bottom of the same slab. Figure 4.17 and 4.18 shows some deposits, arrow 9, at the top of the bar and corrosion, arrow 8, at the bottom of the bar. Figure 4.19 and 4.20 shows the bar at the top of the bottom bar with some precipitation, arrow 11, and corrosion, arrow 10, at the joint.

Figure 4.17 C8-S2 Top Bar 2 without Concrete

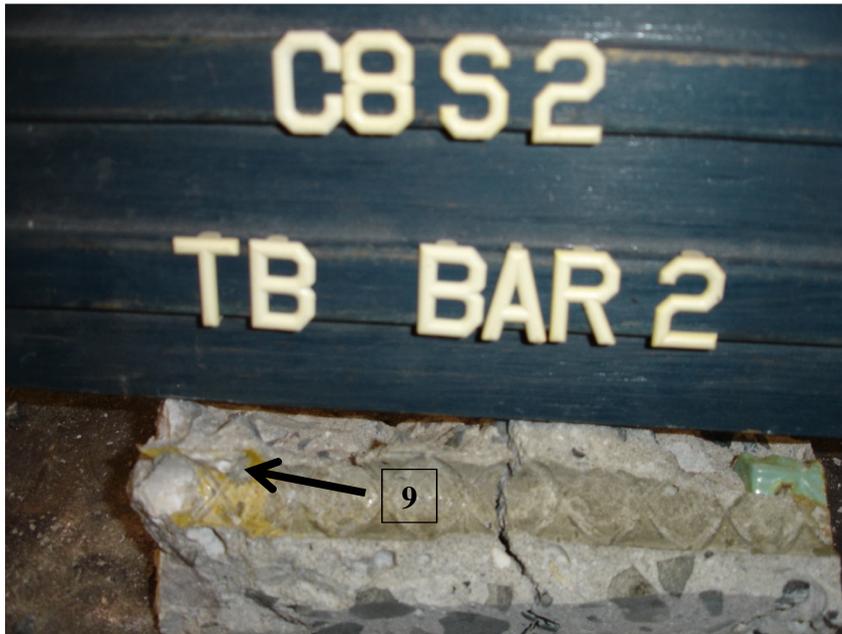
Figure 4.18 C8-S2 Top Bar 2 after Removing Bar

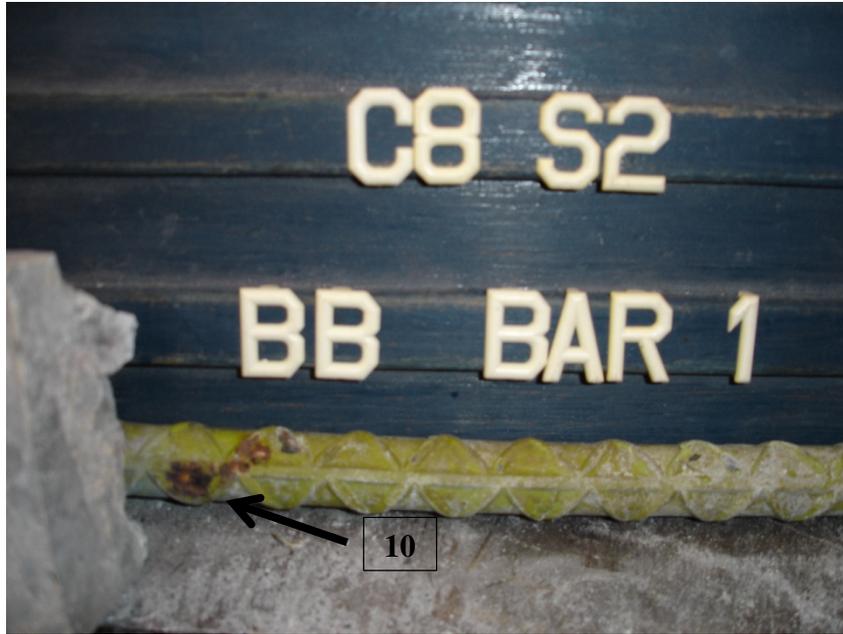
Figure 4.19 C8-S2 Bottom Bar 1 without Concrete

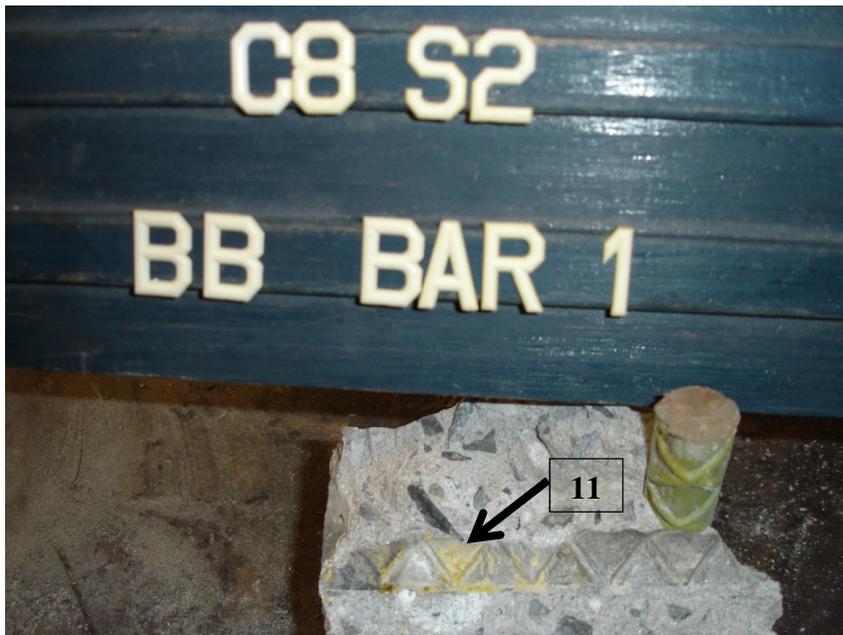
Figure 4.20 C8-S2 Bottom Bar 1 after Removing Bar

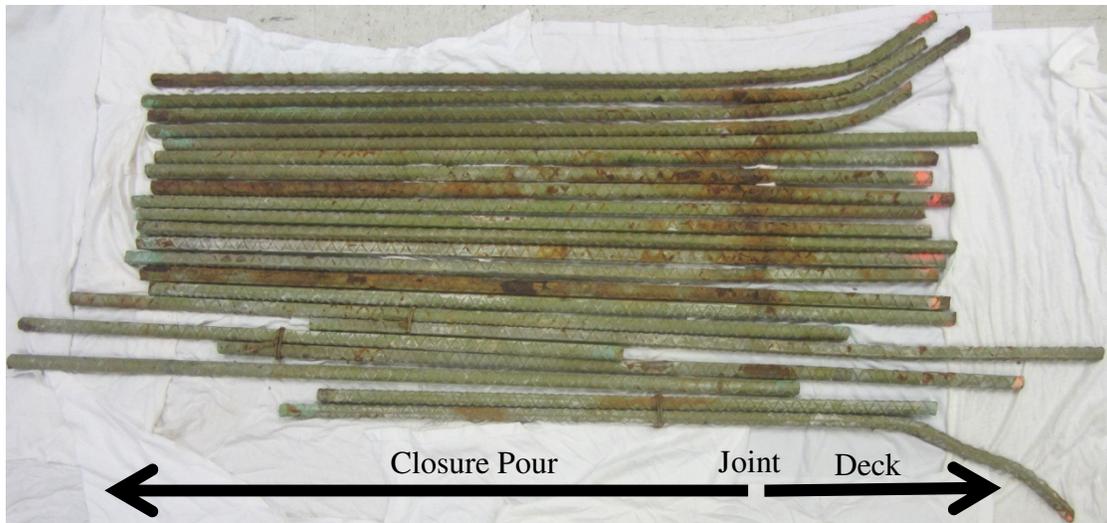
Figure 4.21 Corrosion Extent of Extracted ECR Bars

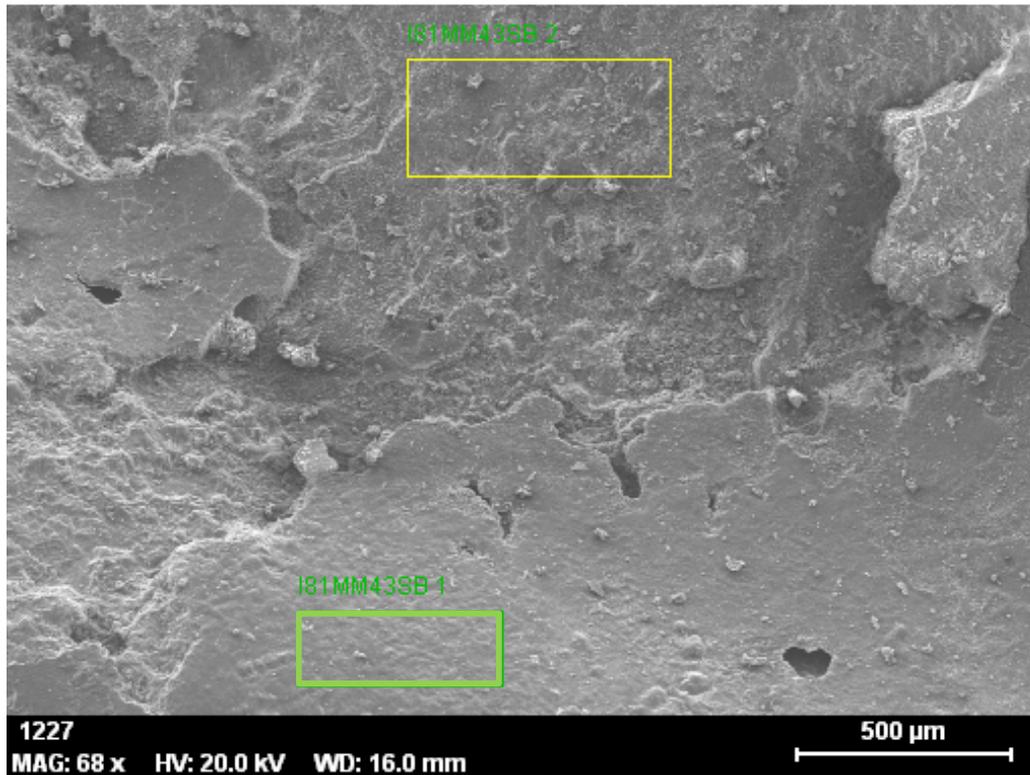
indicates that it is hydrated cement since silicates are commonly present in hydrated cement as tricalcium silicate (C_3S) and dicalcium silicate (C_2S).

Figure 4.22 Sample One SEM Micrograph I81MM43SB-1 and I81MM43SB-2

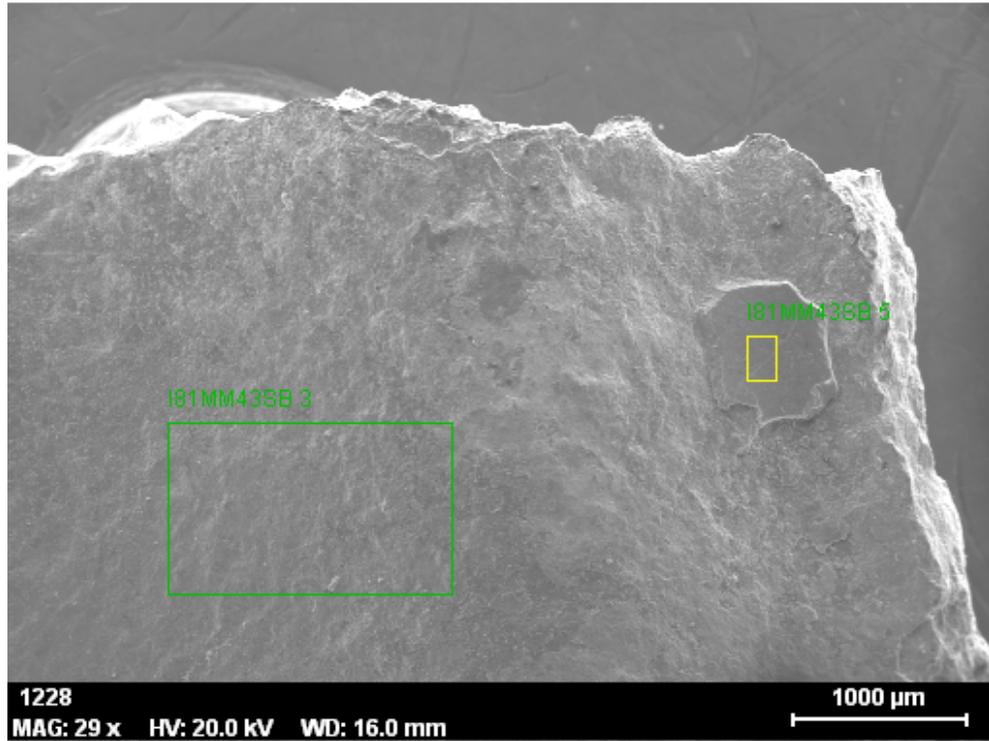
higher silicon content. This indicates that the hydrated cement carbonated when the sample was exposed to air.

Figure 4.23 Sample Two SEM Micrograph I81MM43SB-3 and I81MM43SB-5

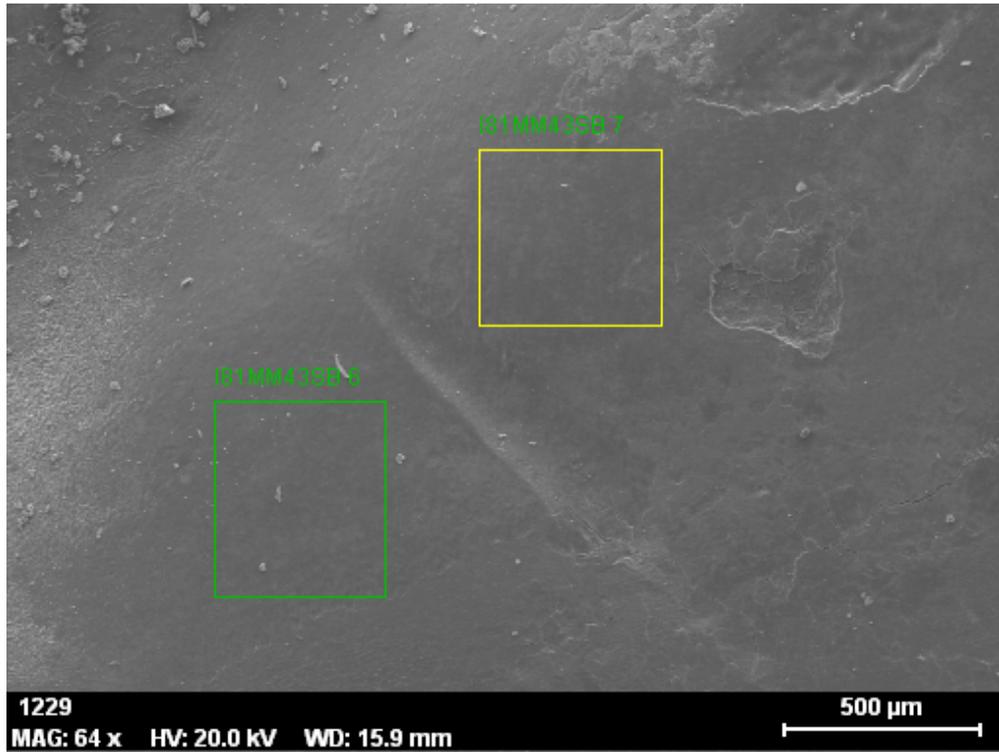
content, and lower calcium content. This may indicate that the hydrated cement carbonated over a longer period, as air and moisture moved along the ECR-concrete interface.

Figure 4.24 Sample Three SEM Micrograph I81MM43SB-6 and I81MM43SB-7

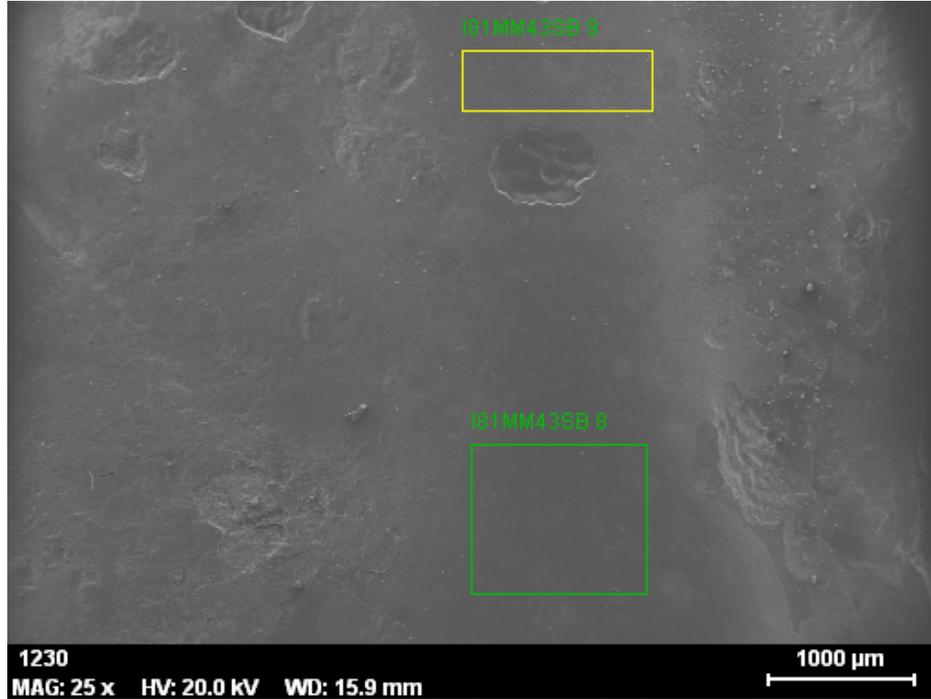
sample four. Locations 8 and 9 show high carbon and silicon content, and low calcium content, they have similar results to locations 6 and 7 discussed previously. This indicates that it is carbonated section of hydrated cement.

Figure 4.25 Sample Four SEM Micrograph I81MM43SB-8 and I81MM43SB-9
