Corrosion Assessment for Failed Bridge Deck Closure Pour

Thesis submitted to the faculty of the Virginia Polytechnic Institute and State University
in partial fulfillment of the requirements for the degree of

1.2 Interstate 81 Closure Pour Failure

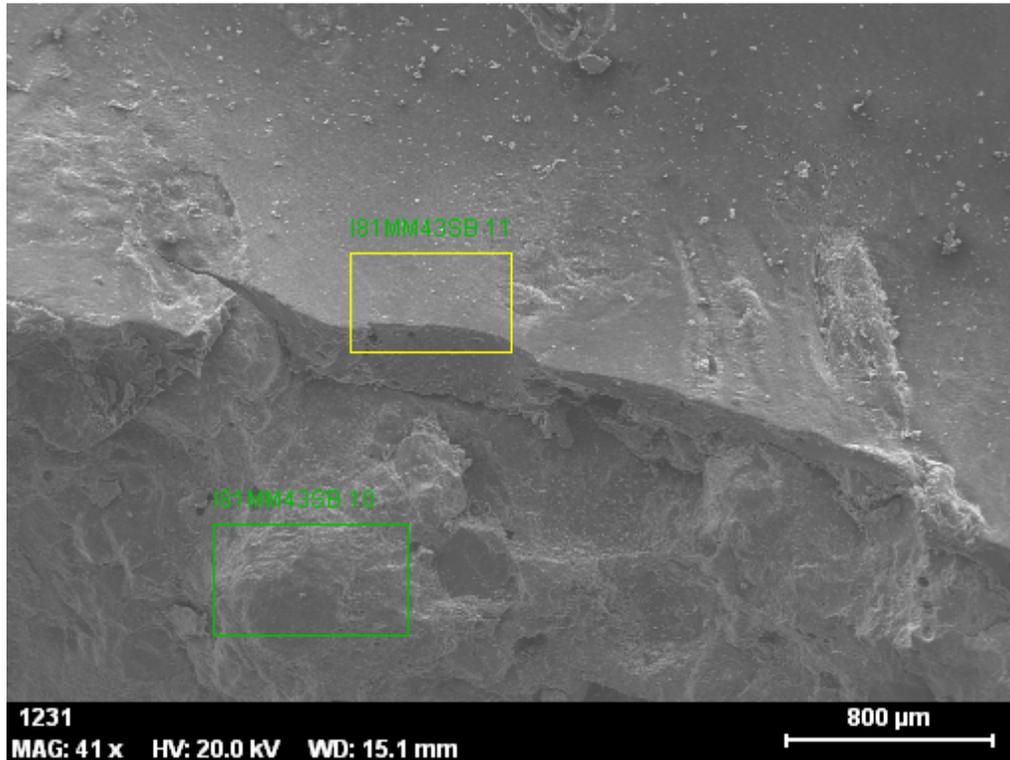
sample five. Location 11 shows higher carbon content, and lower calcium and silicon content from location 10. This can be concluded to be calcium carbonate in location 11, while location 10 is hydrated cement with some traces of carbon.

Figure 4.26 Sample Five SEM Micrograph I81MM43SB-10 and I81MM43SB-11

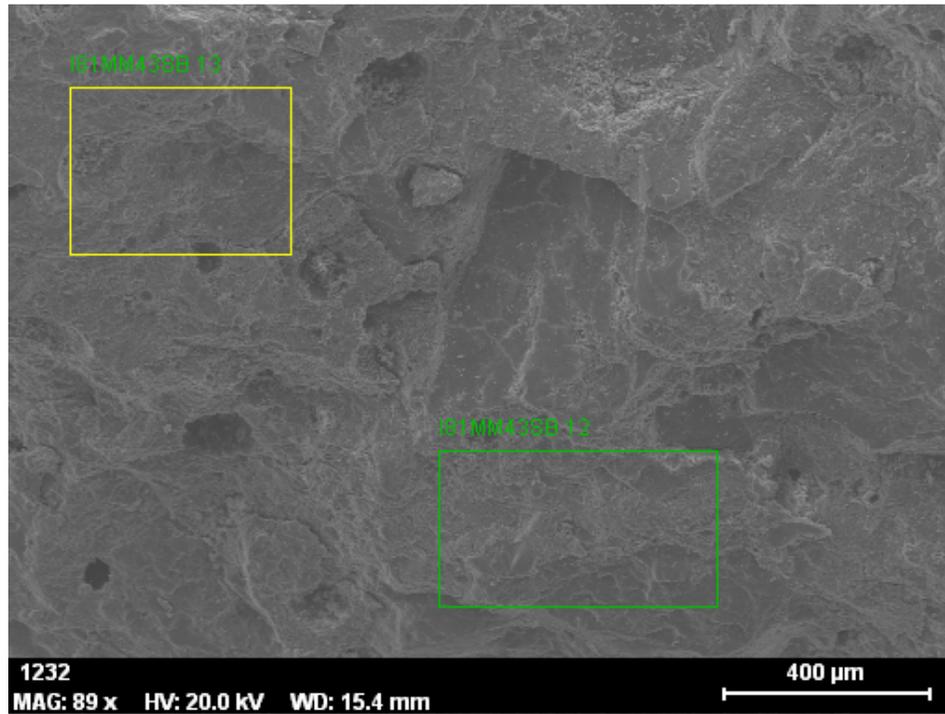
13 show low carbon content, and high calcium and silicon content. This can be concluded to be hydrated cement with traces of little carbonation. Silicates are commonly present in hydrated cement as tricalcium silicate (C_3S) and dicalcium silicate (C_2S).

Figure 4.27 Sample Six SEM Micrograph I81MM43SB-12 and I81MM43SB-13

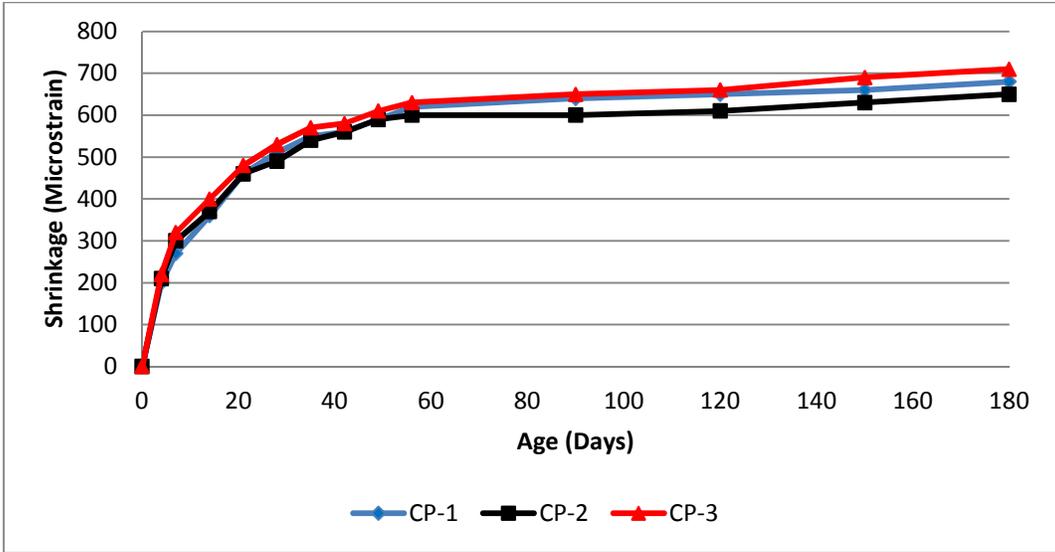
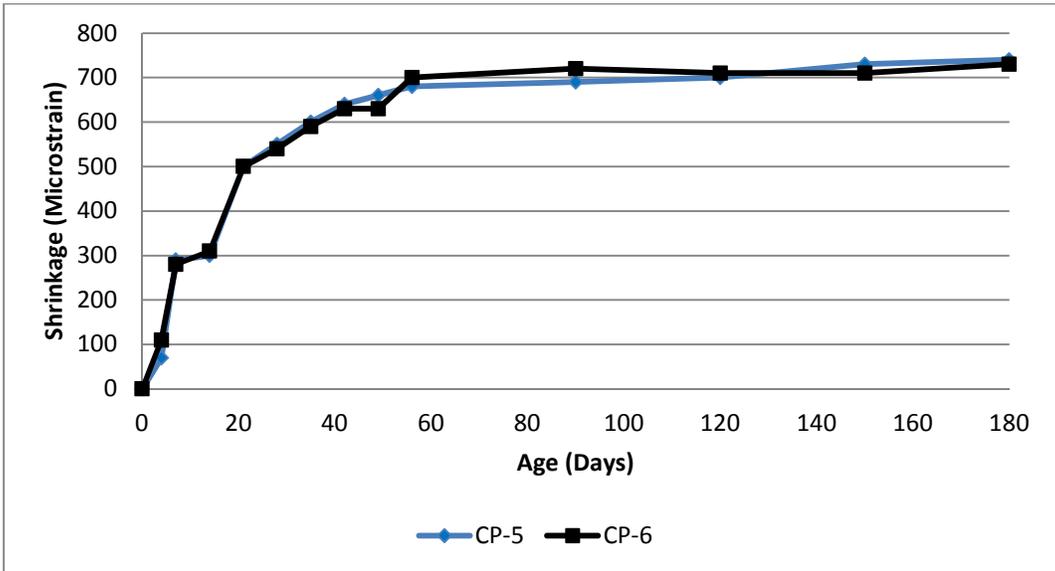
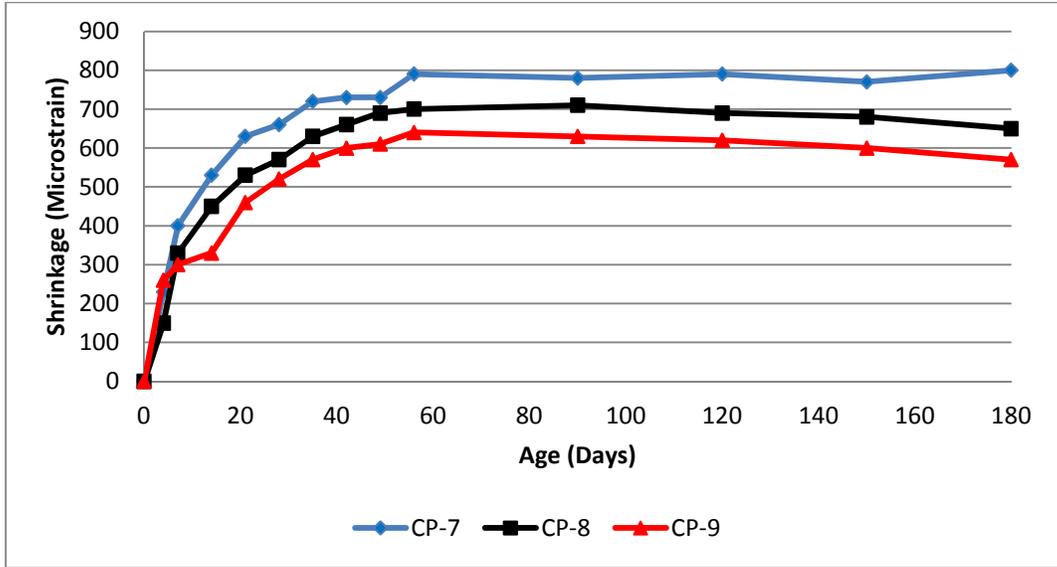
The shrinkage behavior of the first placement was similar for series one, two, and three, as shown in Figures 4.28 through 4.30. They exhibited a similar trend throughout the 180 days of testing duration, and the final readings at 180 days were 700 microstrain. Each series was averaged and compared with other series, as shown in Figure 4.31. Series one exhibited a slower shrinkage rate since it was placed in the shrinkage room, while series one and two were placed in ambient conditions next to the lab cast slabs.

Figure 4.28 Drying Shrinkage of First Placement (Series 1)

Figure 4.29 Drying Shrinkage of First Placement (Series 2)

Figure 4.30 Drying Shrinkage of First Placement (Series 3)

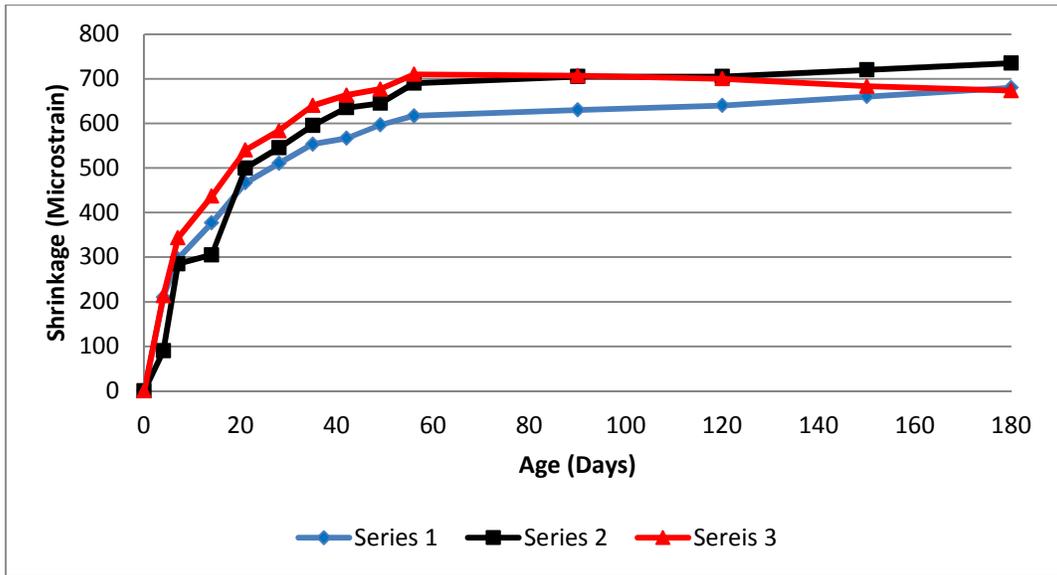
Figure 4.31 Average Drying Shrinkage for All Series of First Placement

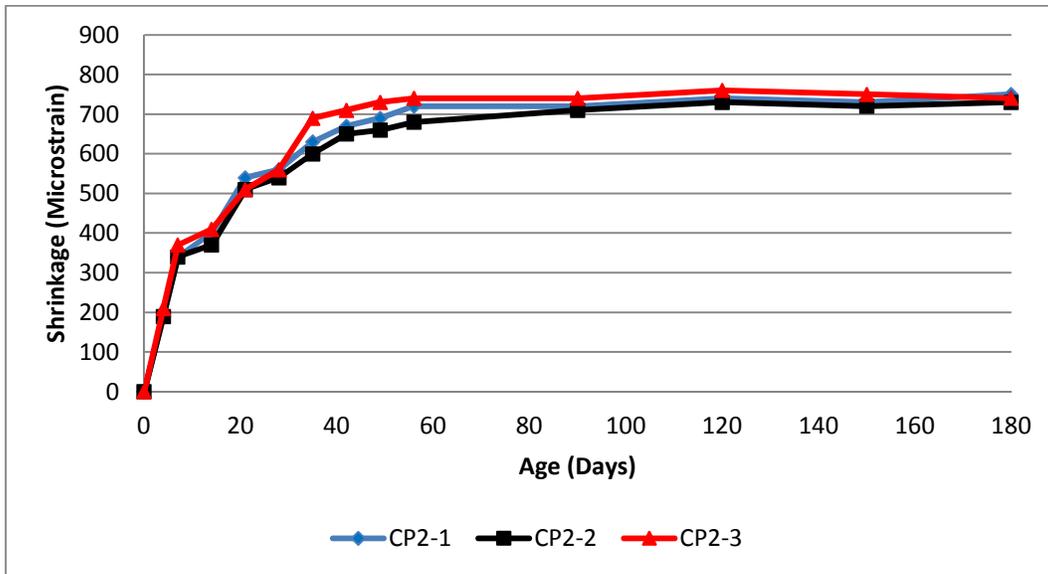
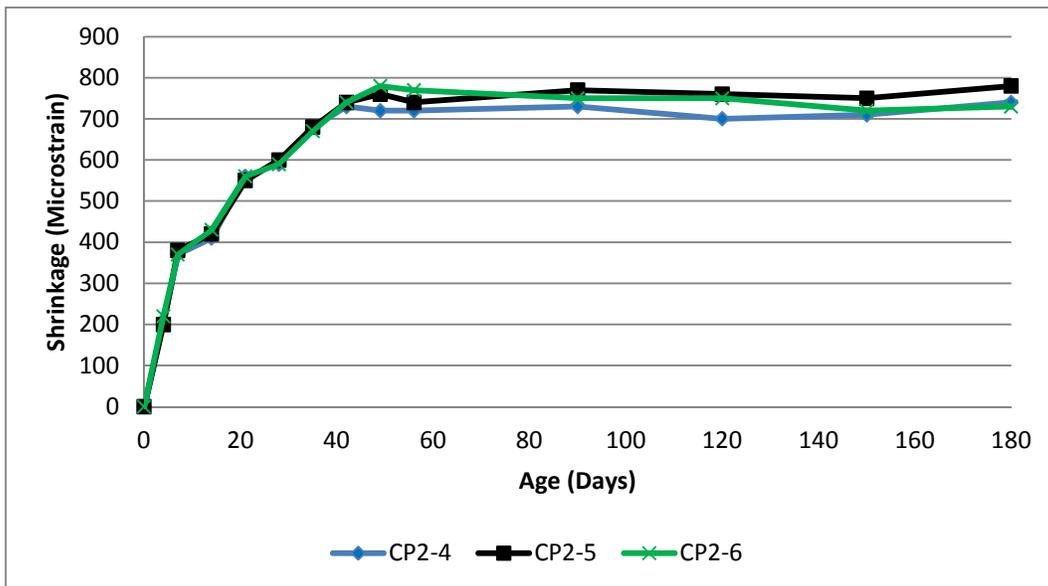
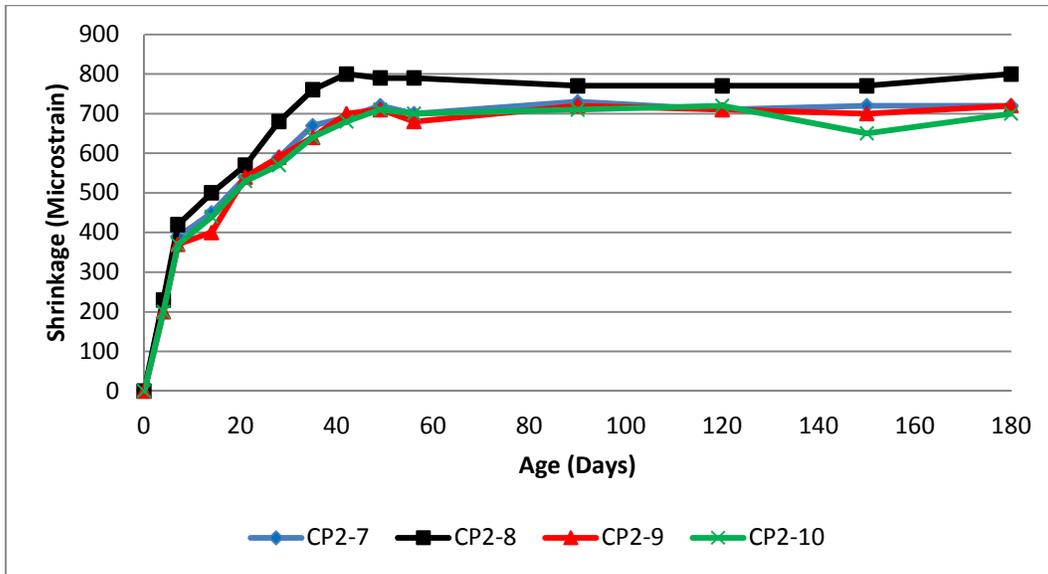
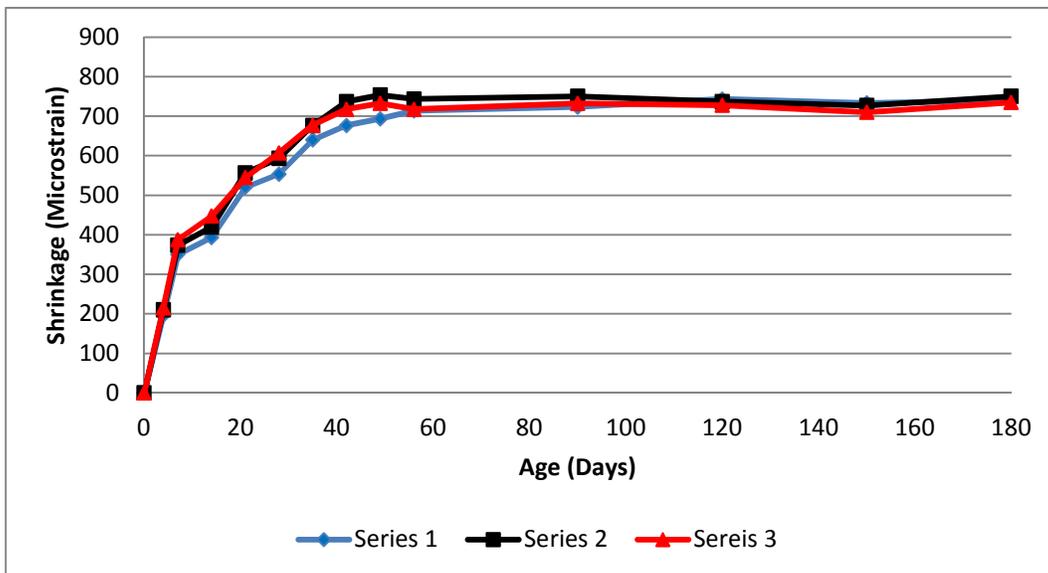
exhibited a slower shrinkage rate, while series two and three were placed in ambient conditions next to the lab cast slabs and they had a similar shrinkage rate.

Figure 4.32 Drying Shrinkage of Second Placement (Series 1)

Figure 4.33 Drying Shrinkage of Second Placement (Series 2)

Figure 4.34 Drying Shrinkage of Second Placement (Series 3)

Figure 4.35 Average Drying Shrinkage for All Series of Second Placement

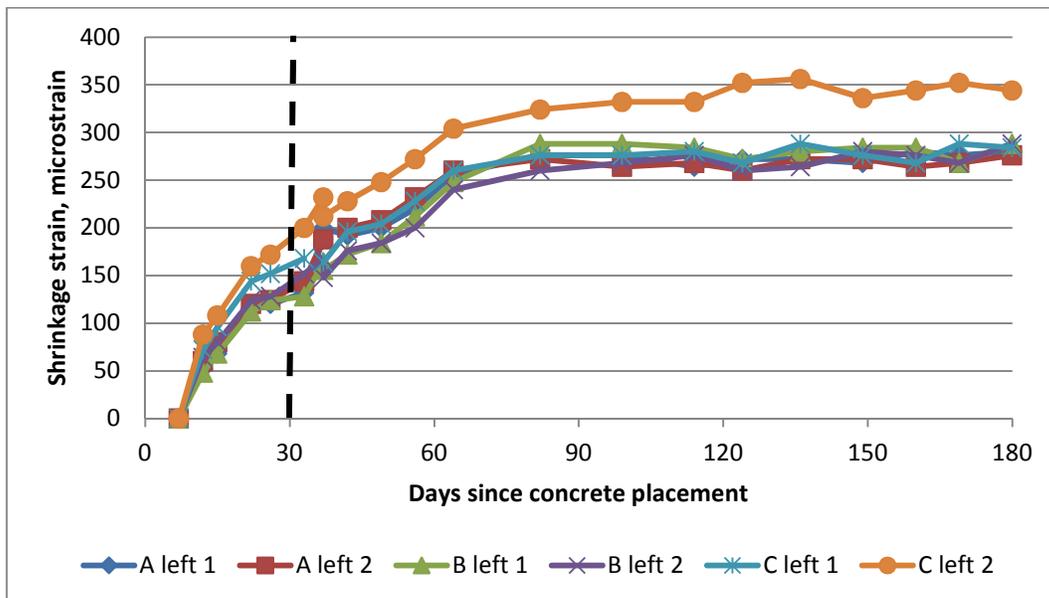
Figure 4.36 presents the shrinkage of the left side of the three slabs for the first placement of concrete. All of the shrinkage readings are following the same trend and a final reading of 285 microstrains at 180 days. Slab C Left-2 exhibited a higher shrinkage rate of 340 microstrains at 180 days among the other five readings. The second placement (closure pour) was placed after 30 days of the first placement, and it is represented with a dashed line in Figure 4.36. It can be noticed that by the time the closure pour was placed 50% of the shrinkage occurred. Before placing the closure pour the bottom part of the formwork was assembled, at that time it can be noticed that the shrinkage rate flattens while placing the closure pour and then shrinkage continues at a slower rate after the casting the closure pour.

Figure 4.36 Slab Shrinkage Readings for Left Side of First Placement

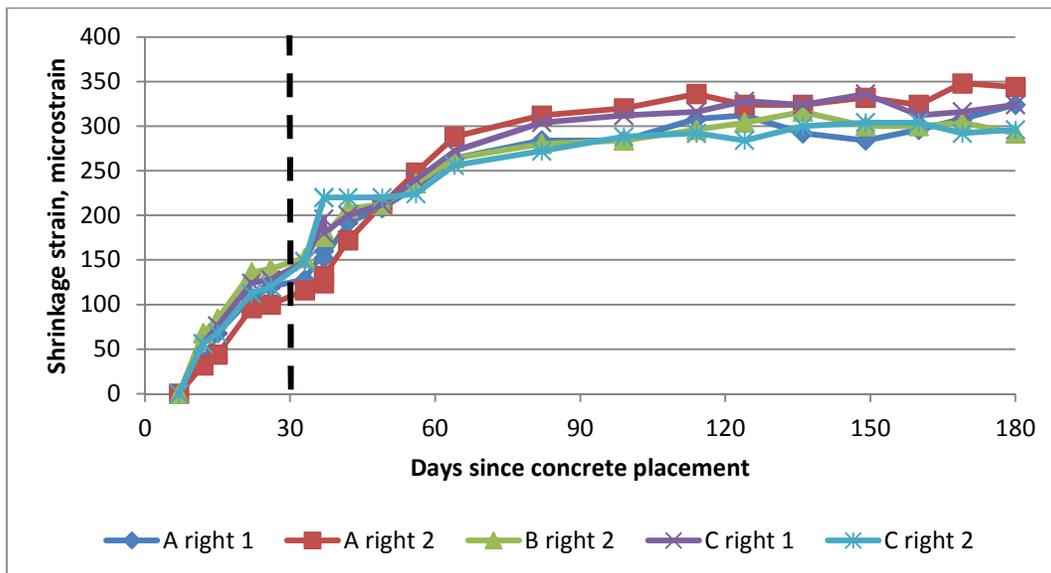
Figure 4.37 Slab Shrinkage Readings for Right Side of First Placement (Deck)

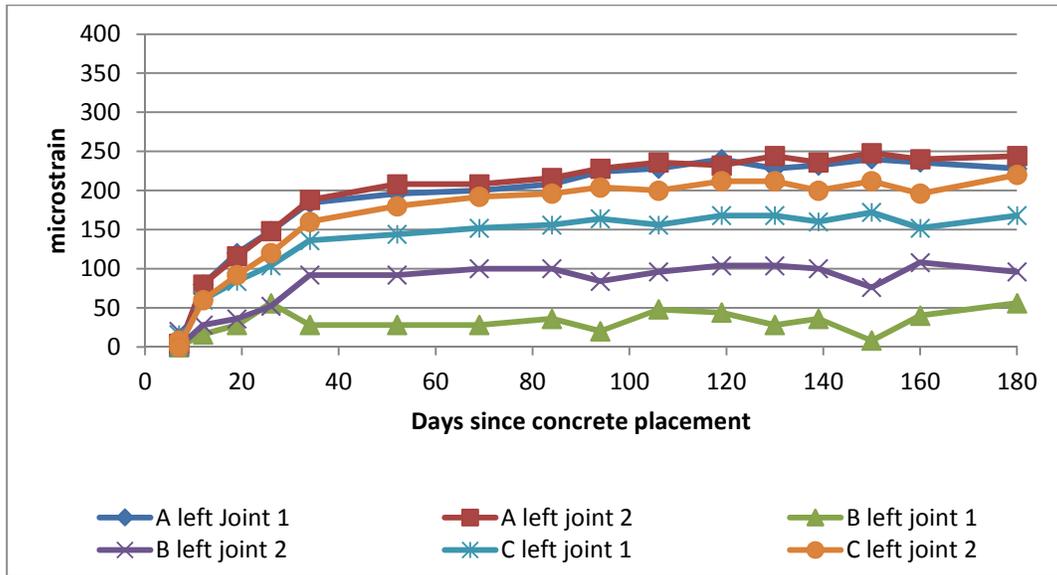
Figure 4.38 Slab Shrinkage Readings for Left Joint between Deck and Closure

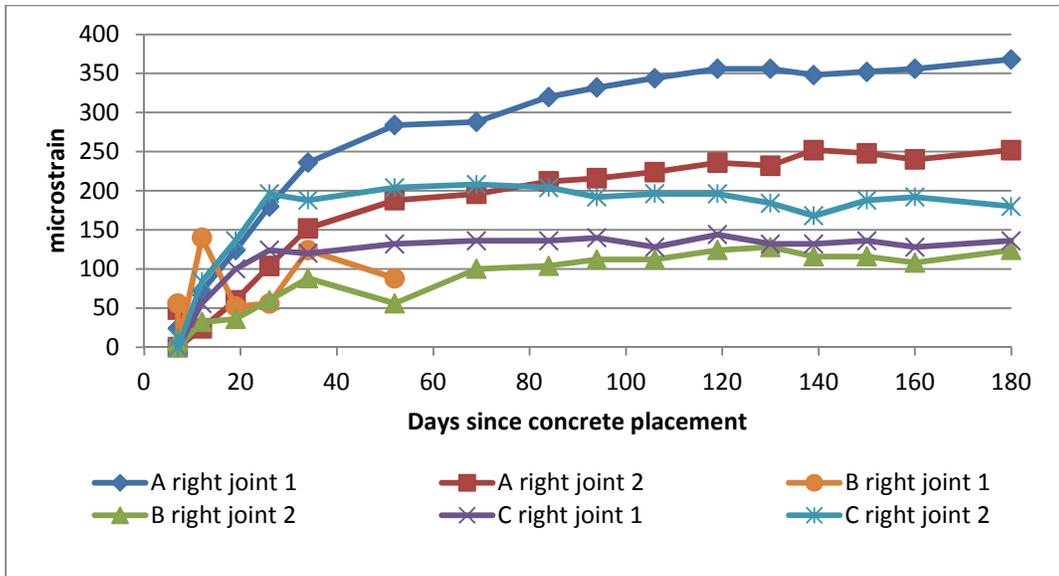
Figure 4.39 Slab Shrinkage Readings for Right Joint between Deck and Closure

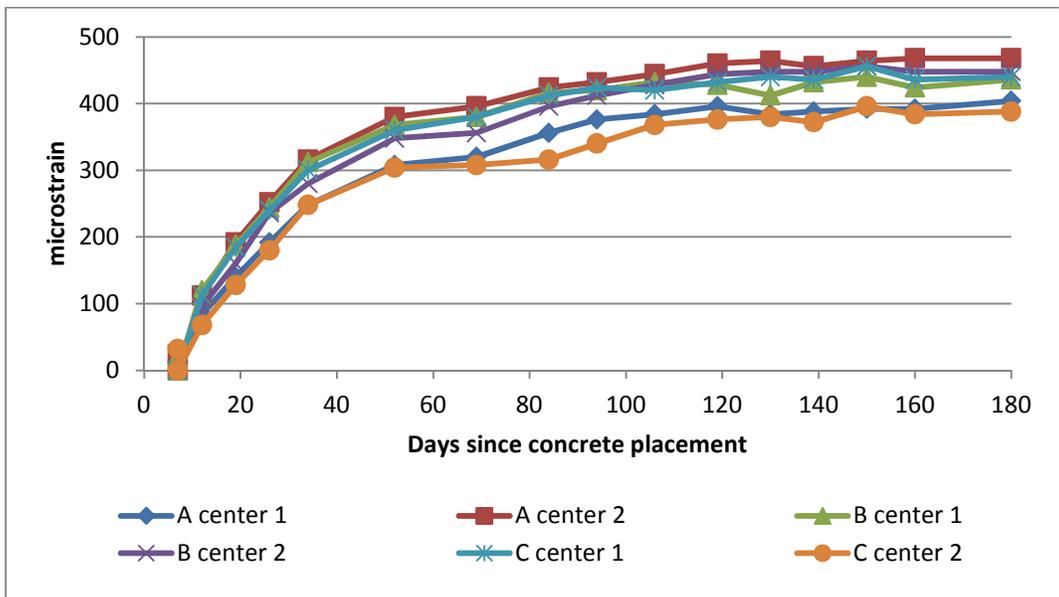
Figure 4.40 Slab Shrinkage Readings for Second Placement (Closure)

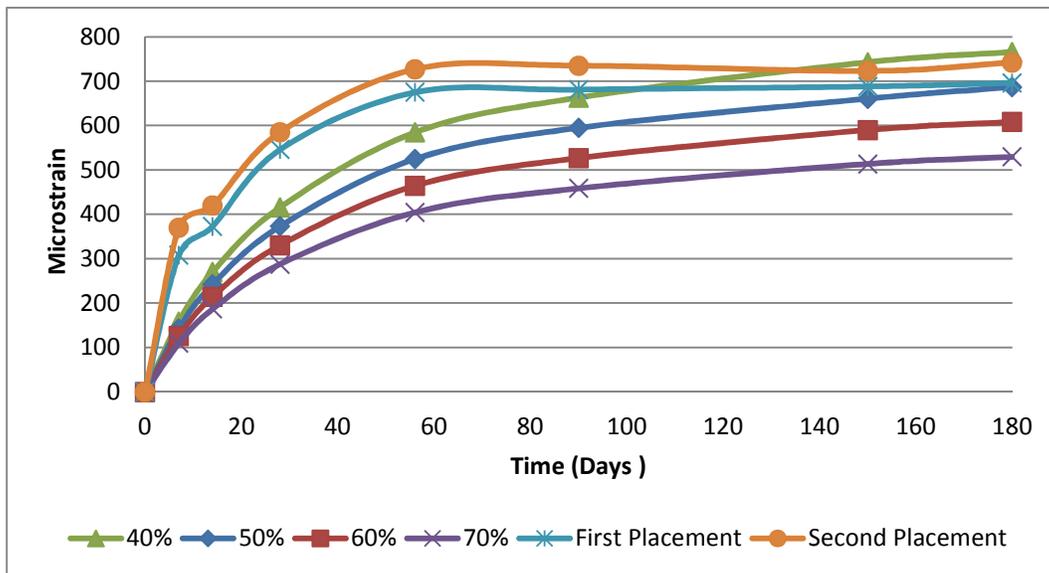
Figure 4.41 ACI 209R-92 Sensitivity Analysis for Relative Humidity

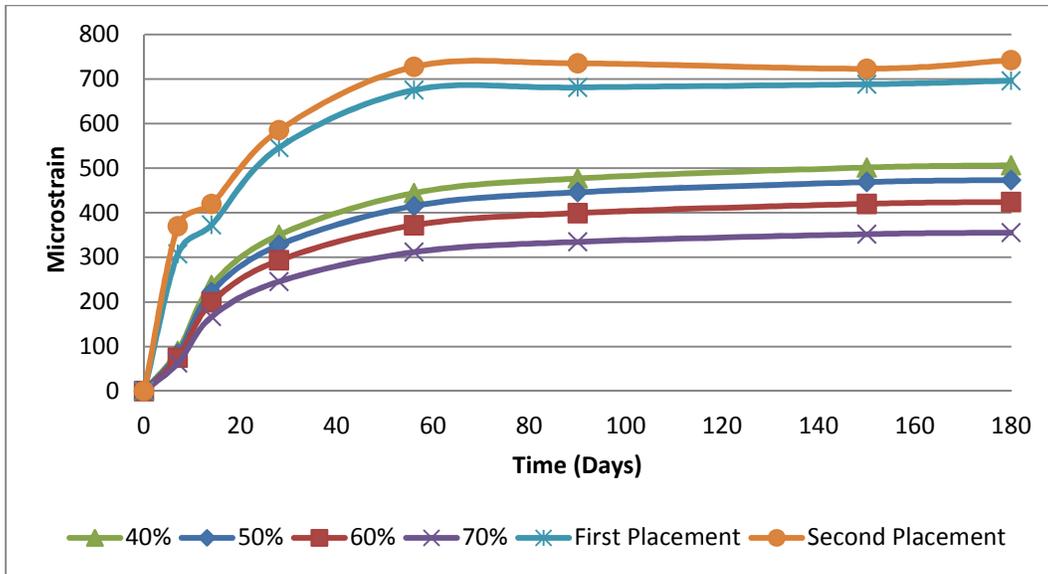
Figure 4.42 B3 Sensitivity Analysis for Relative Humidity (Cement Type I)

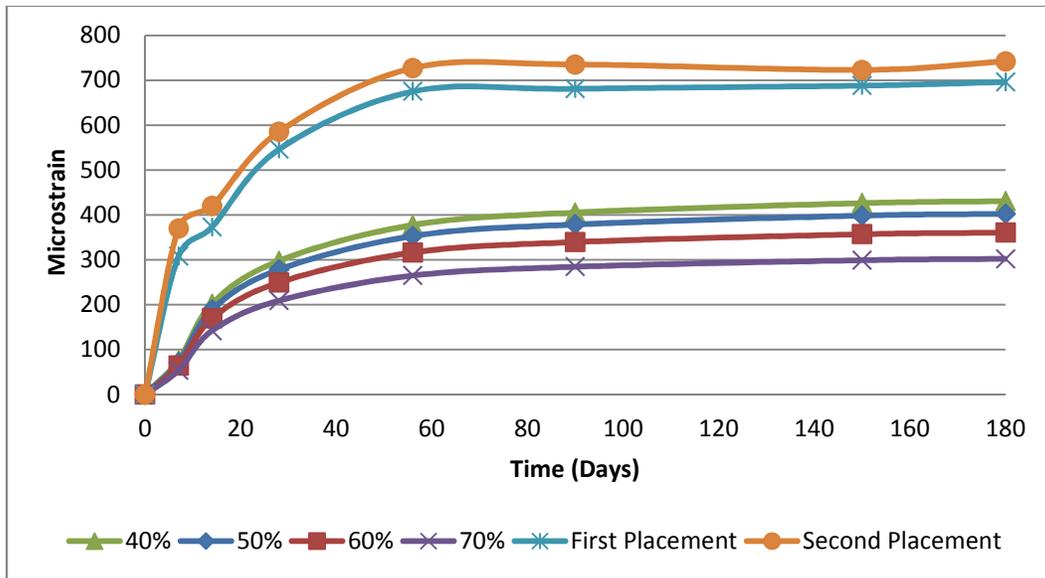
Figure 4.43 B3 Sensitivity Analysis for Relative Humidity (Cement Type II)

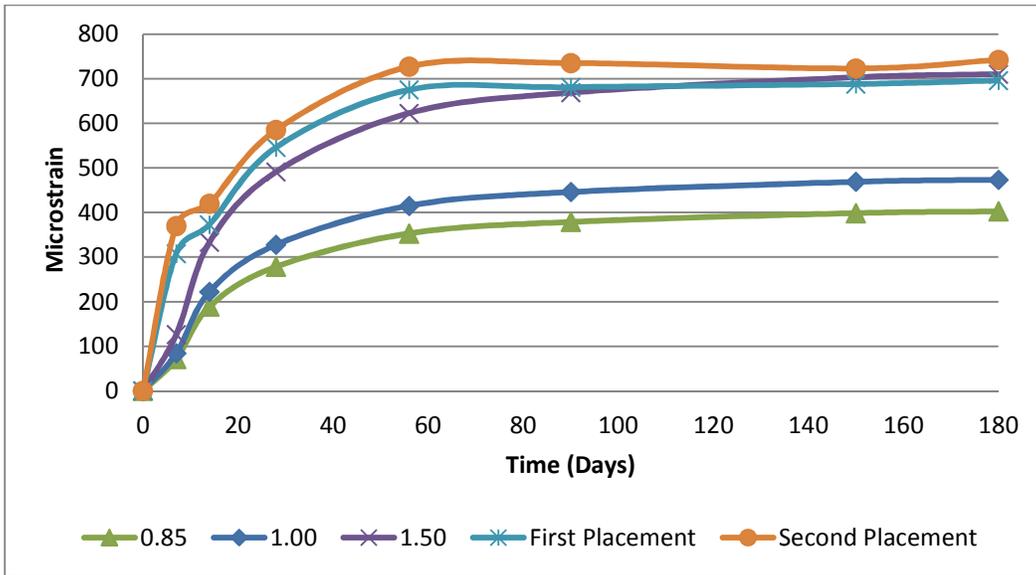
Figure 4.44 B3 Sensitivity Analysis for Cement Type

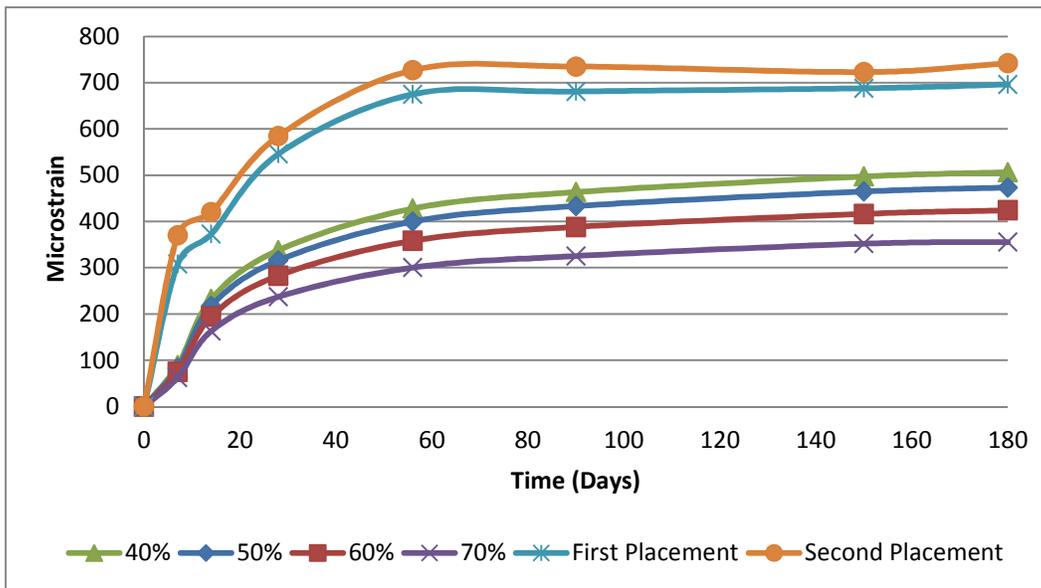
Figure 4.45 CEB 90 Sensitivity Analysis for Relative Humidity

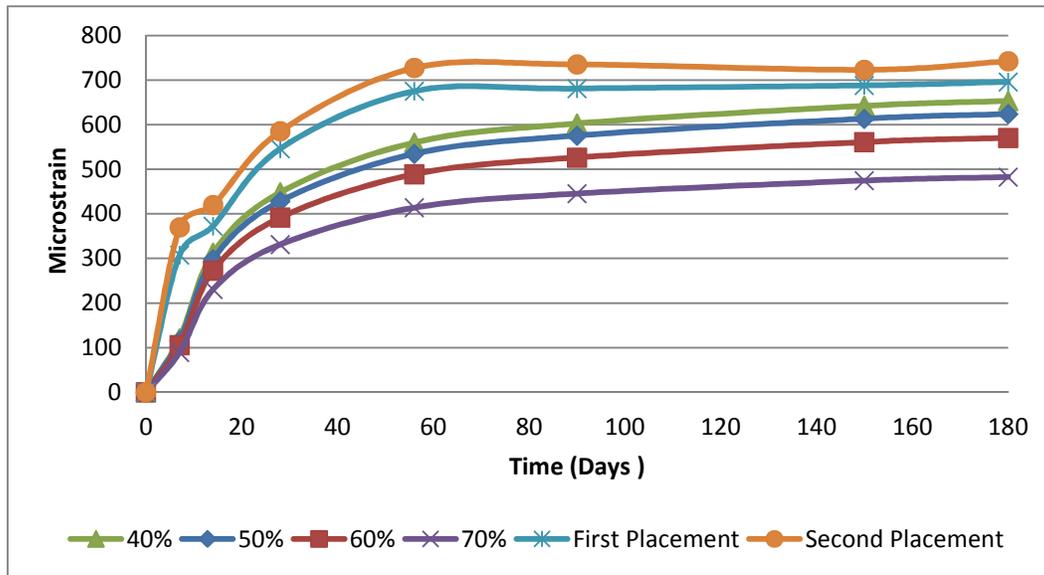
Figure 4.46 GL2000 Sensitivity Analysis for Relative Humidity (Cement Type I)

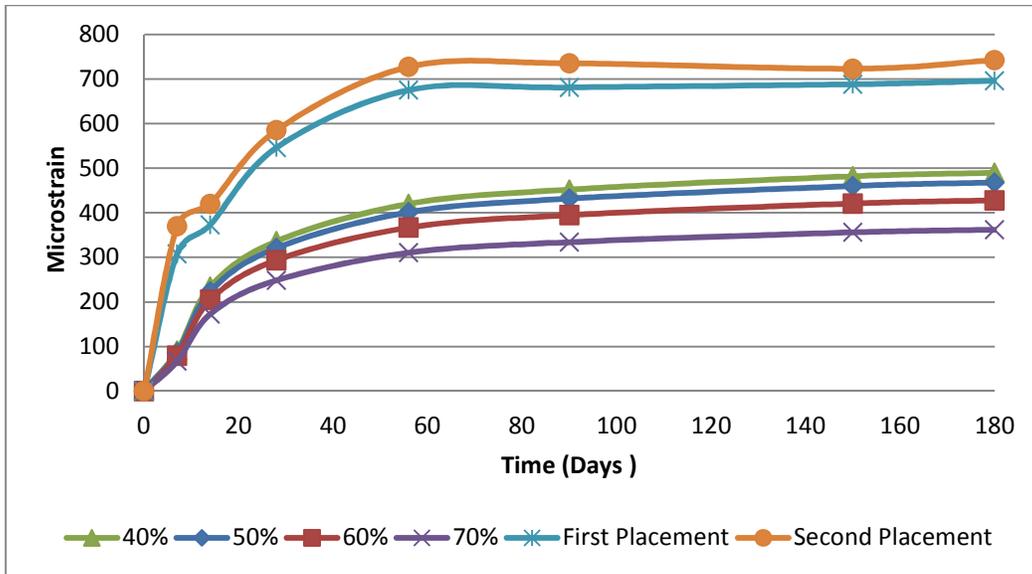
Comparing cement type I and II, cement type I had a better fit for the actual measurements for the first and second placement. While cement type II under predicted the actual measurements.

Figure 4.47 GL2000 Sensitivity Analysis for Relative Humidity (Cement Type II)

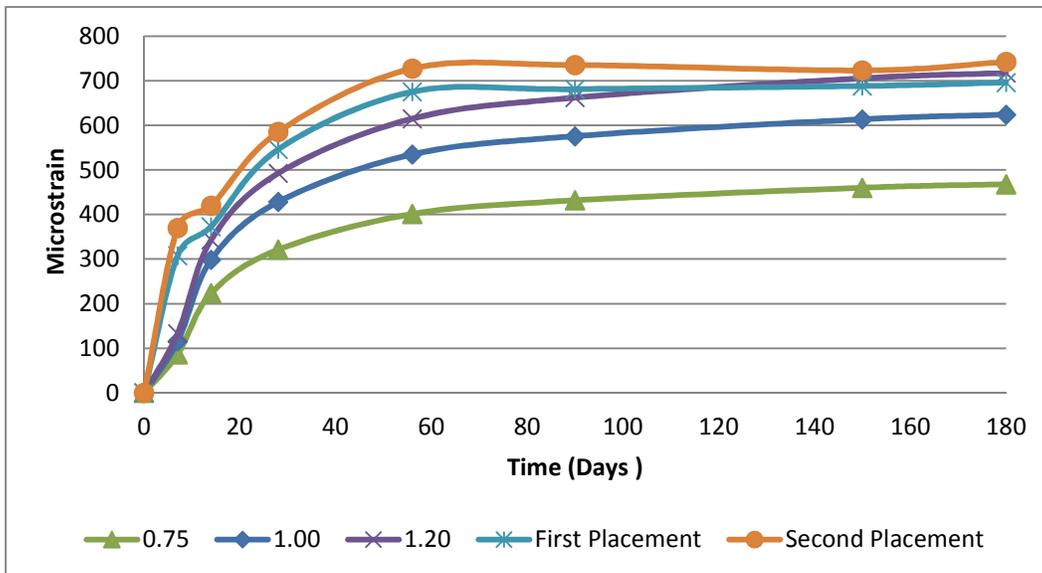
Figure 4.48 GL2000 Sensitivity Analysis for Cement Type

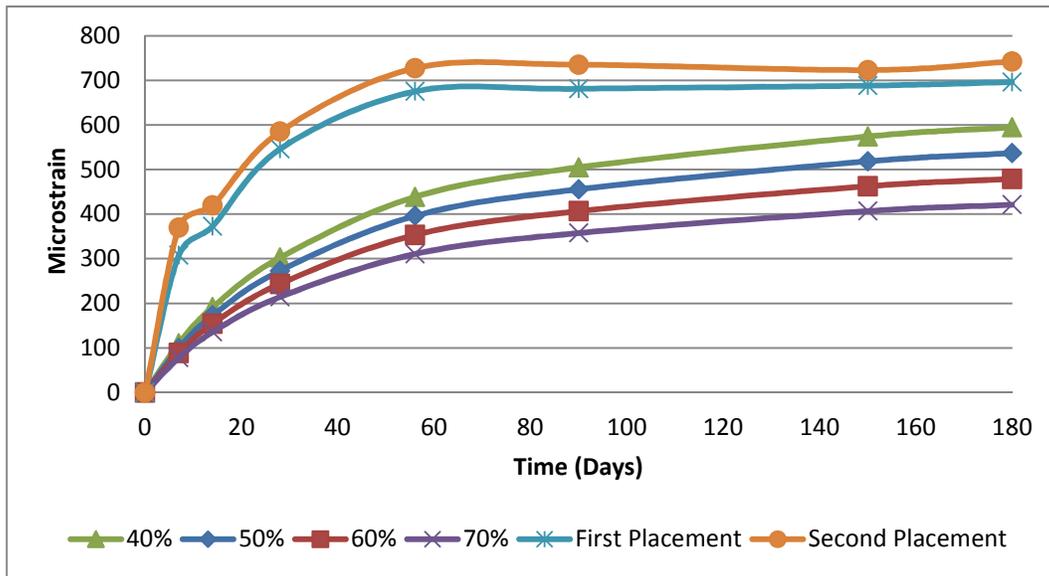
Figure 4.49 AASHTO-LRFD Sensitivity Analysis for Relative Humidity

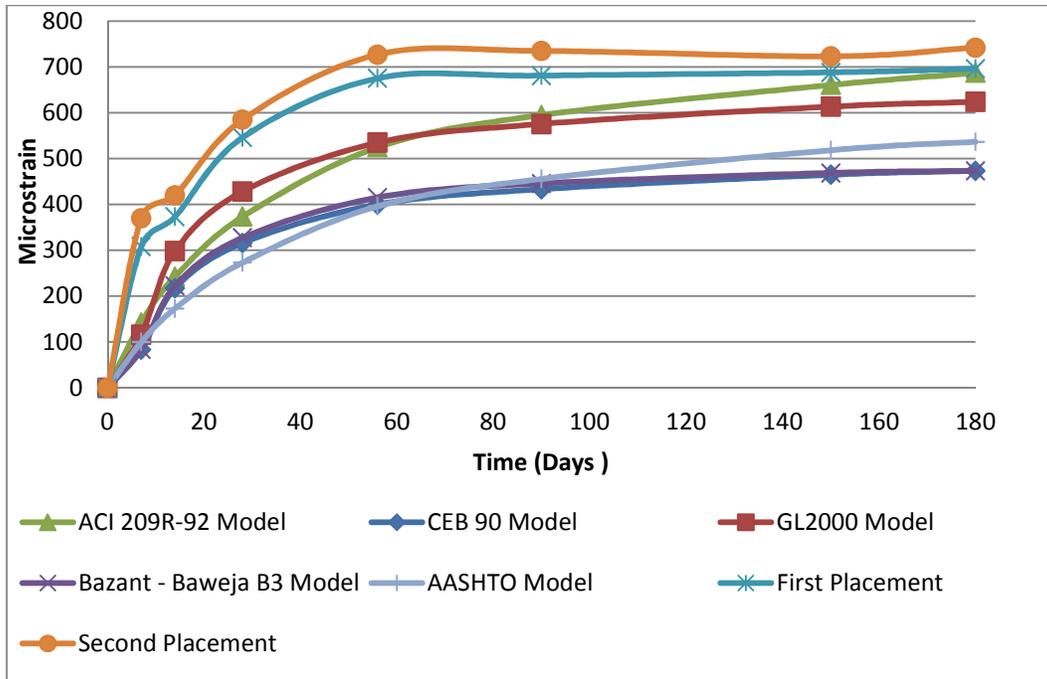
Figure 4.50 Shrinkage Models Comparison for 50% Relative Humidity

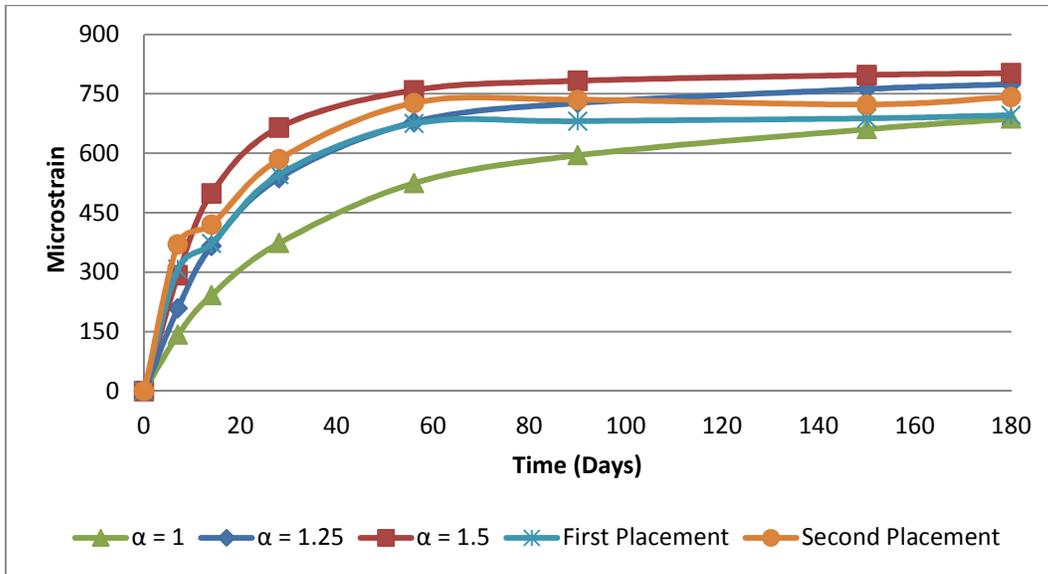
Figure 4.51 ACI 209R-92 Sensitivity Analysis for α with 50% RH

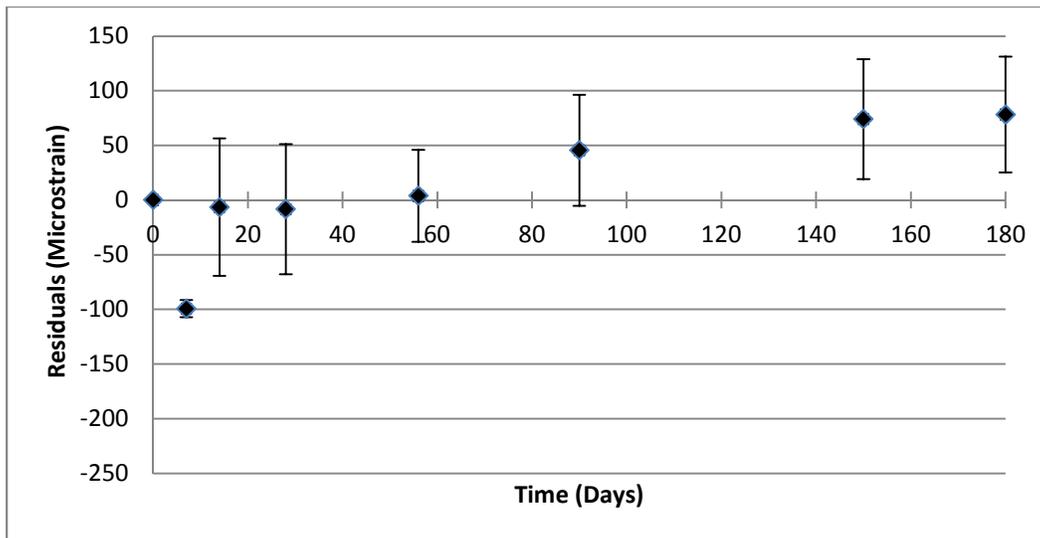
Figure 4.52 ACI 209R-92 Residuals for First Placement

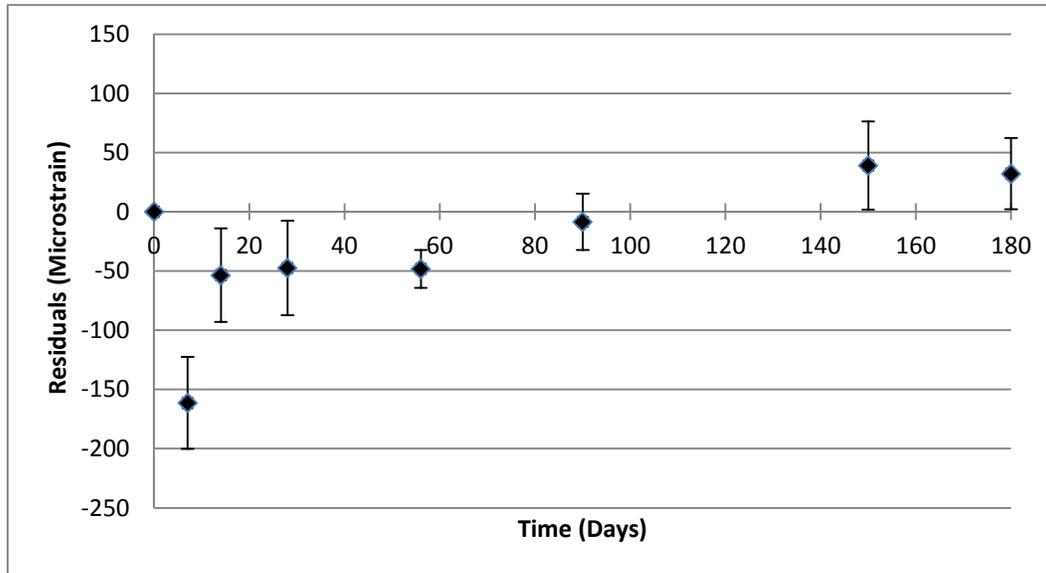
Figure 4.53 ACI 209R-92 Residuals for Second Placement

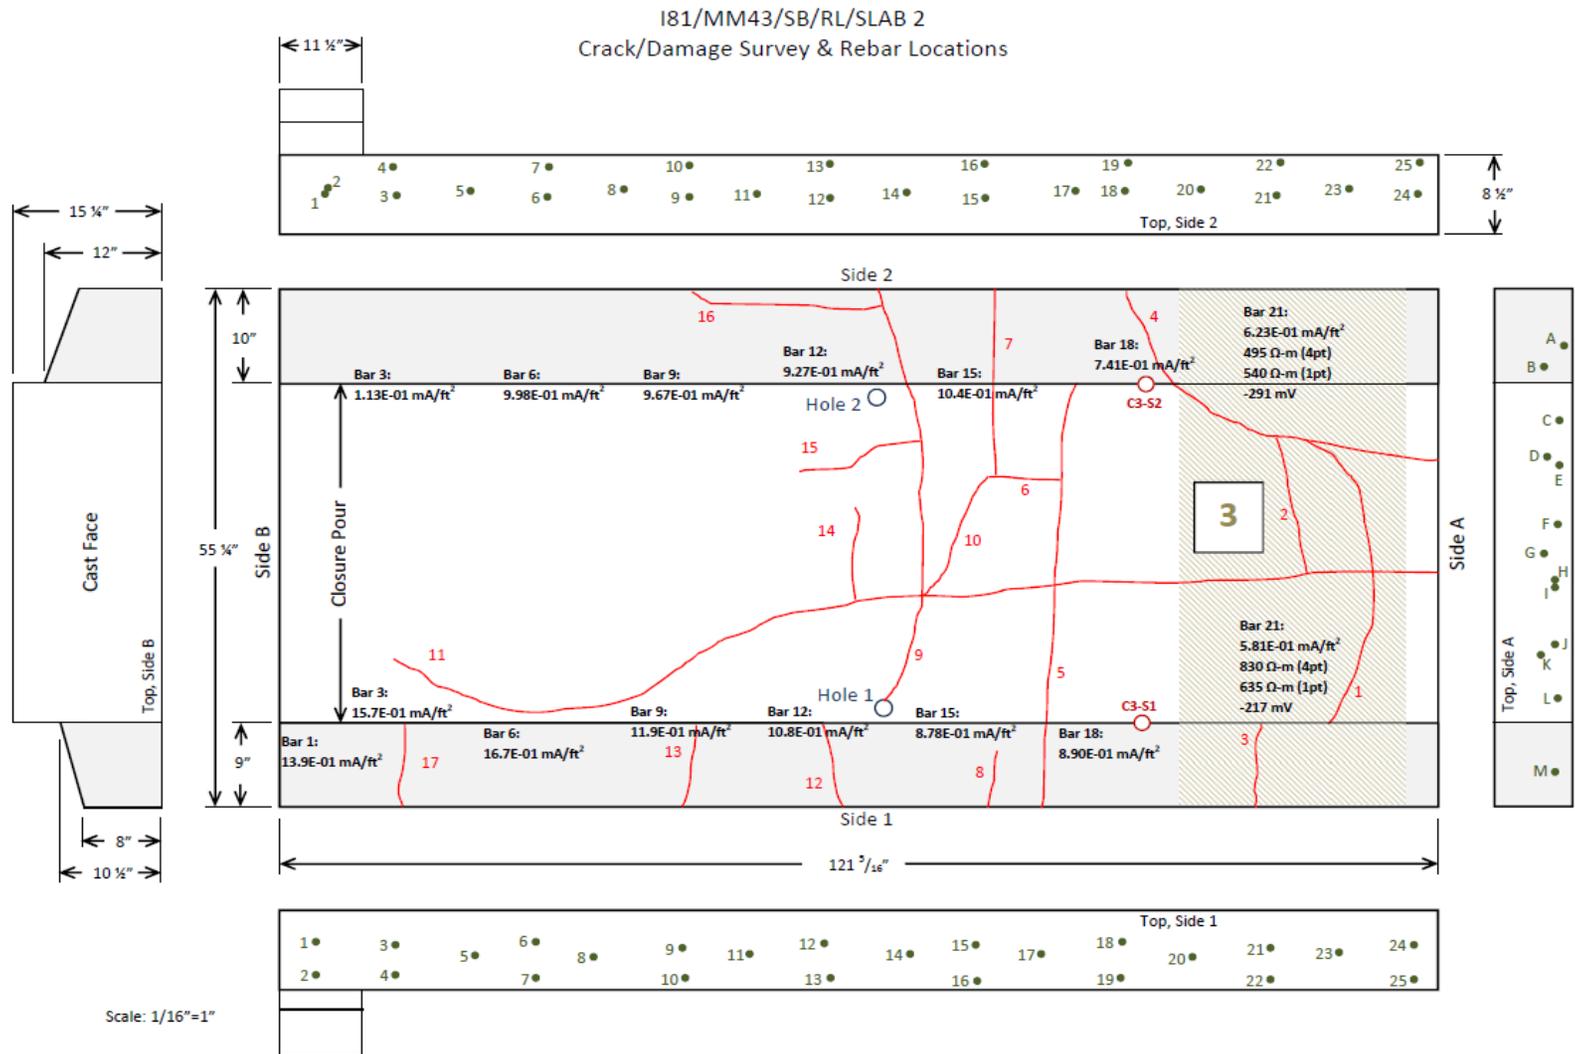
Figure B.2 Crack, Damage Survey and Rebar Locations for Slab 2

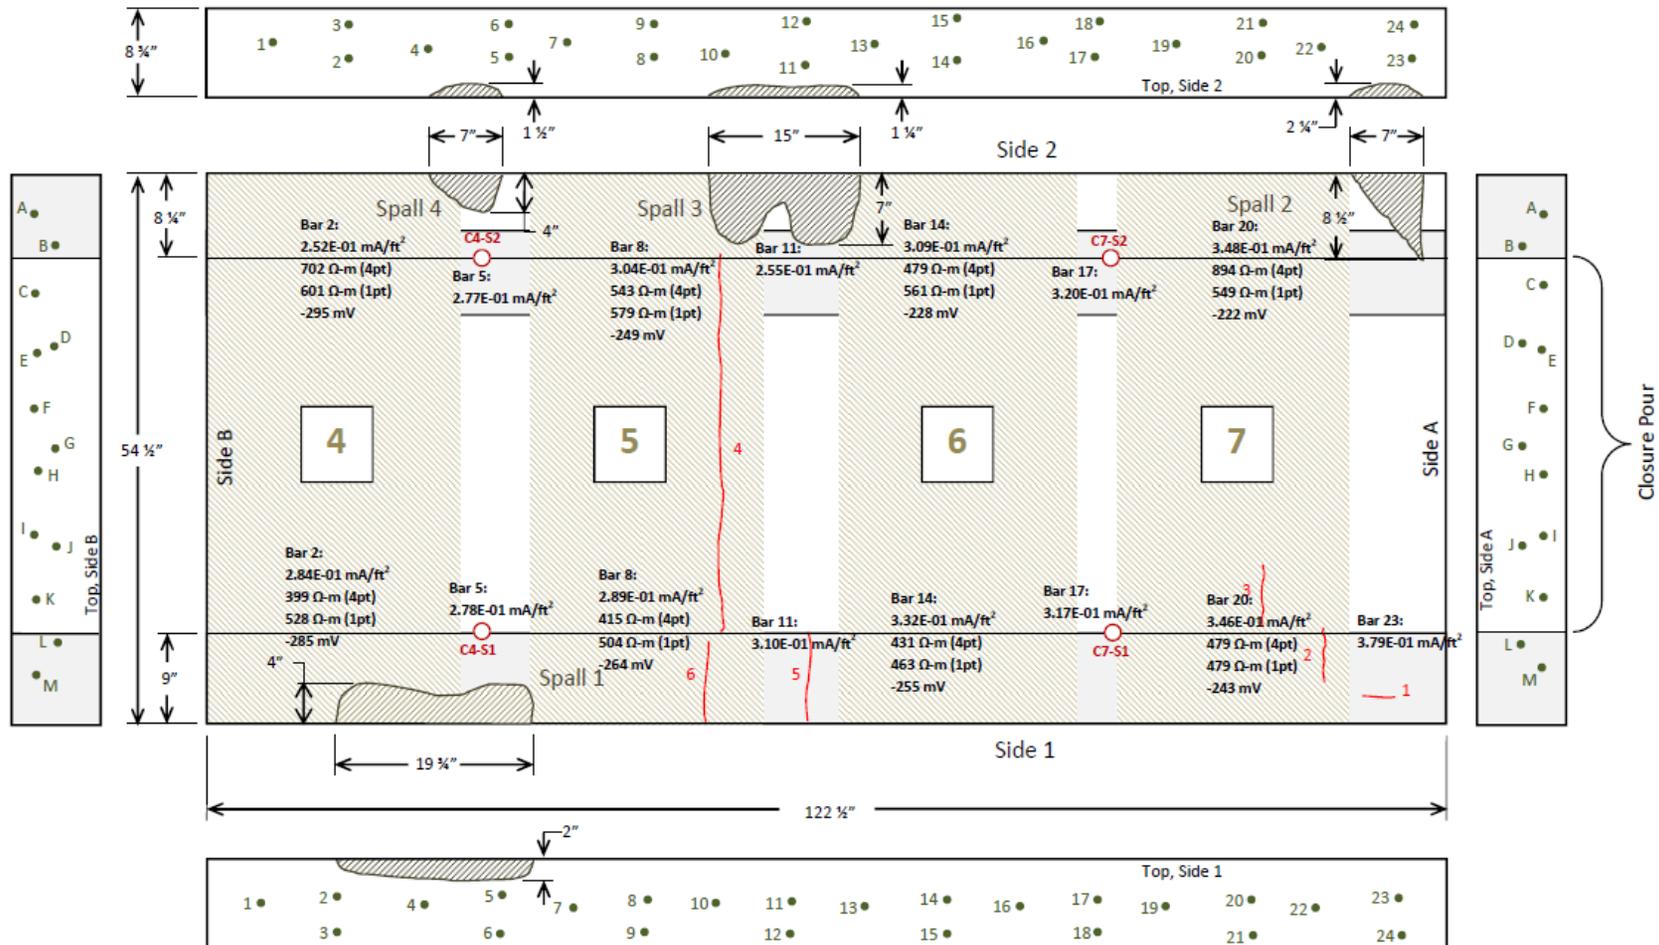
Figure B.3 Crack, Damage Survey and Rebar Locations for Slab 3

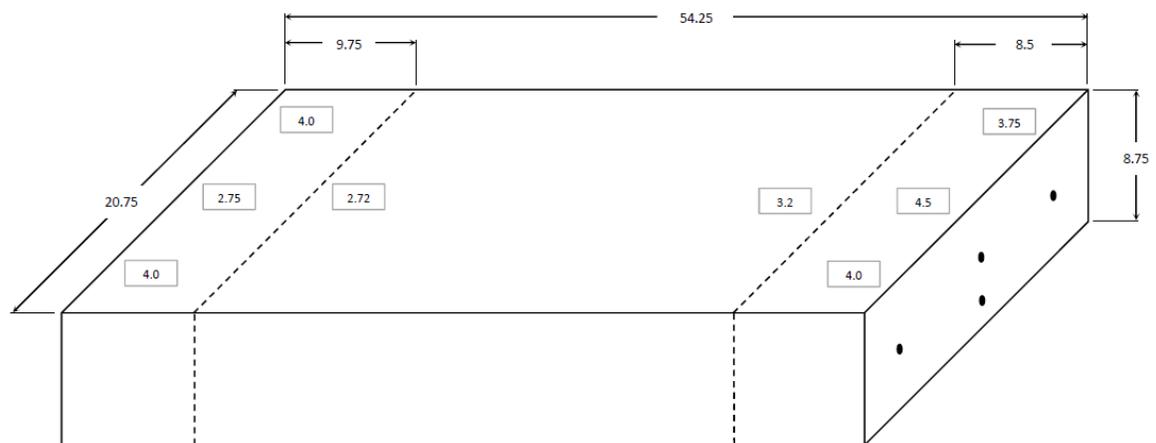
Figure C.2 Slab #2 Dimensions and Rebars Cover Depths

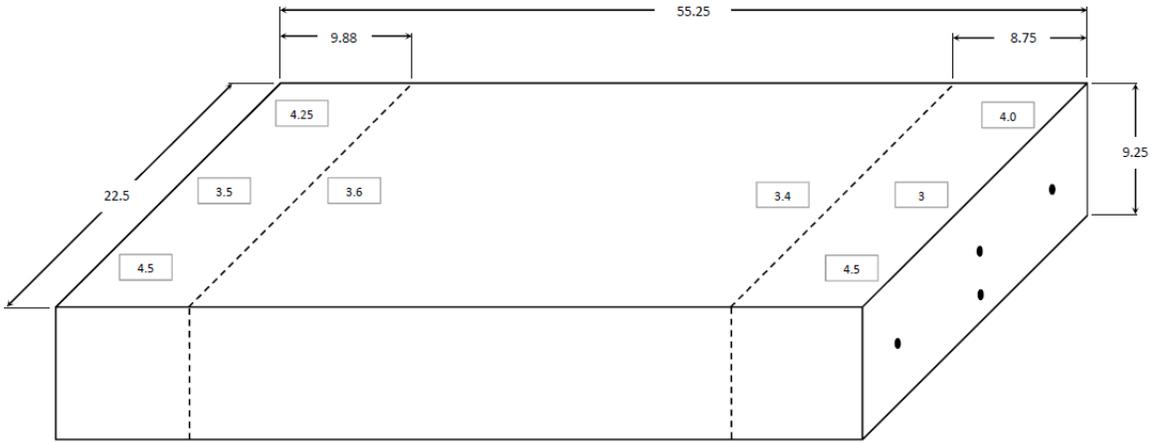
Figure C.3 Slab #3 Dimensions and Rebars Cover Depths

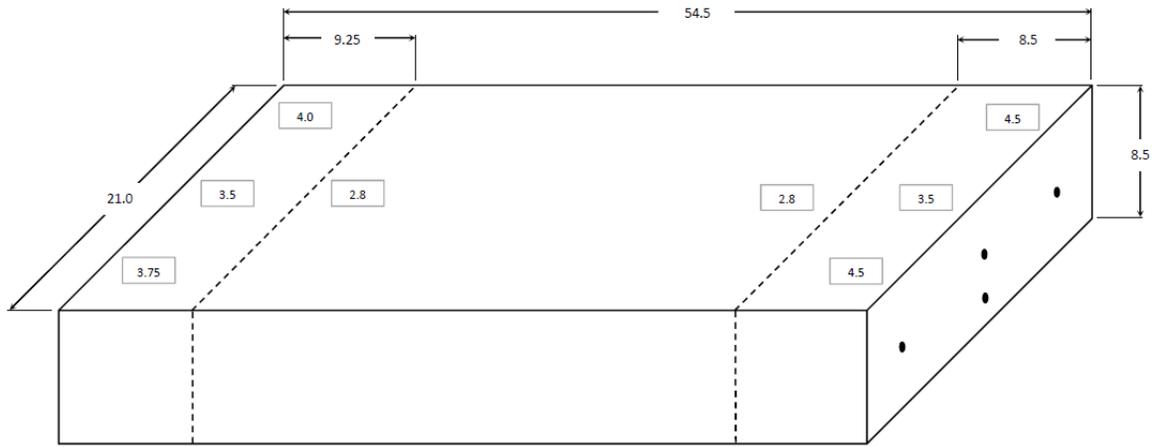
Figure C.7 Slab #7 Dimensions and Rebars Cover Depths
