Corrosion Assessment for Failed Bridge Deck Closure Pour

Thesis submitted to the faculty of the Virginia Polytechnic Institute and State University
in partial fulfillment of the requirements for the degree of

1.2 Interstate 81 Closure Pour Failure

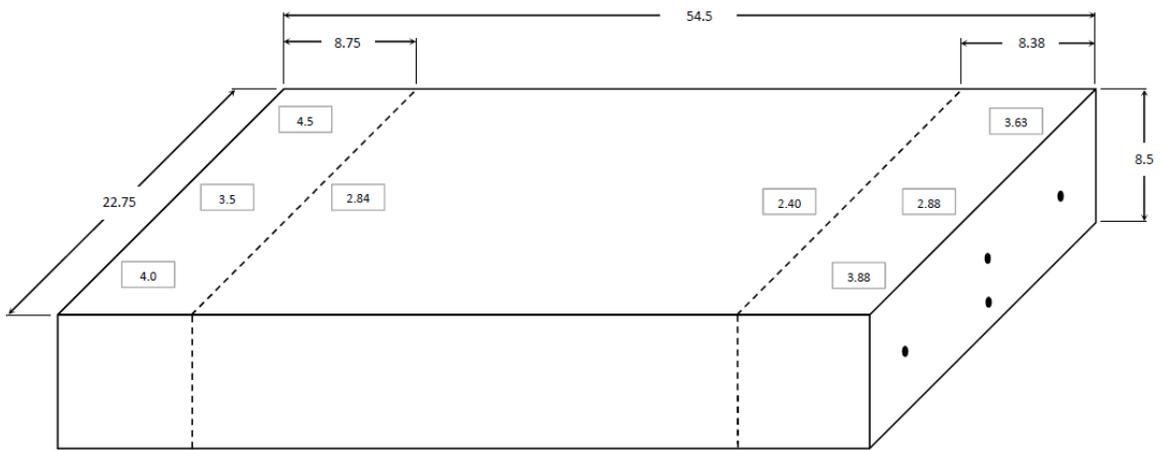
Figure C.8 Slab #8 Dimensions and Rebars Cover Depths
