## Chapter IV Description of Existing Conditions

### A. Biophysical Elements

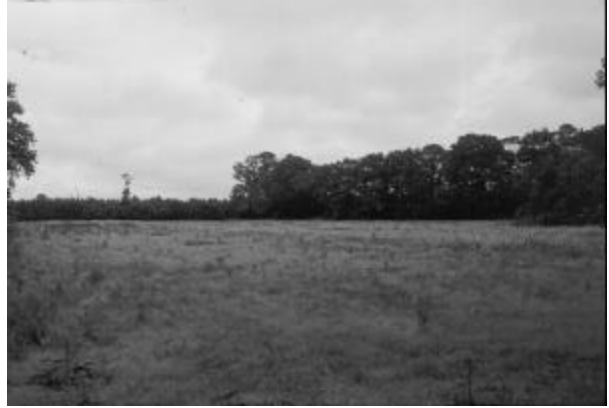
Figure 4.8 Typical Eastern Shore hammock. Author. May 1997.

Cultivated areas or hammocks on Woodlands Farm and Thomas’s Wharf site are dominated by the Bojac-Munden series, commonly found on broad flats and depressions. (Figure 4.8) They are composed of moderately drained sandy and loamy soils. Wooded areas are composed of Molena-Bojac-Munden series,

Geometric sections of the abandoned fields lying adjacent to presently cultivated hammocks are easily recognized by the size of tree and understory growth, as well as the type of vegetation growing. (see Figure 4.8) Successional species in the tidewater forest of the coastal plain include loblolly pine (*Pinus taeda*) and atlantic white cedar (*Chamaecyparis thyoides*), with a gradual shift to hardwood species including sweetgum (*Liquidambar styraciflua*) and white oak (*Quercus alba*).<sup>12</sup> The abandoned fields surrounding the hammocks are loblolly forest with a mixture of hardwoods containing sweetgum (*Liquidambar styraciflua*), american holly (*Ilex opaca*), and sassafras (*Sassafras albidum*), among other species, and were abandoned after 1875. This existing vegetation implies that these areas are in the process of succession from an old field to tidewater forest.

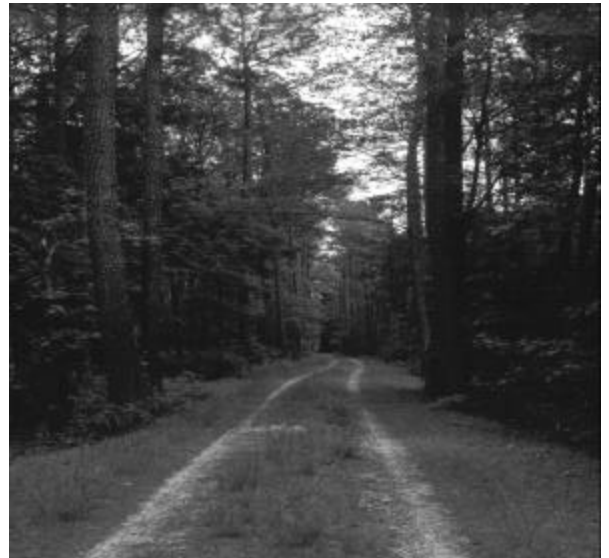
Figure 4.9 Loblolly forest. Author. May 1997

characterized by moderately drained soils on broad flats and side slopes. (Figure 4.9) Chincoteague-Magotha series is characteristic of tidal marshes with poorly drained silty and loamy soils.<sup>11</sup> (Figure 4.10) Soils typical of the present cultivated and wooded areas have a high level of productivity of loblolly pine, as well as good soil composition for agricultural production. Either land use can be supported on these soils; thus lands that are presently wooded could have been in cultivation at one time. Aerial photographs from the 1960's support the claim that certain hammocks were much larger than they are today. (Figures 4.11 and 4.12)

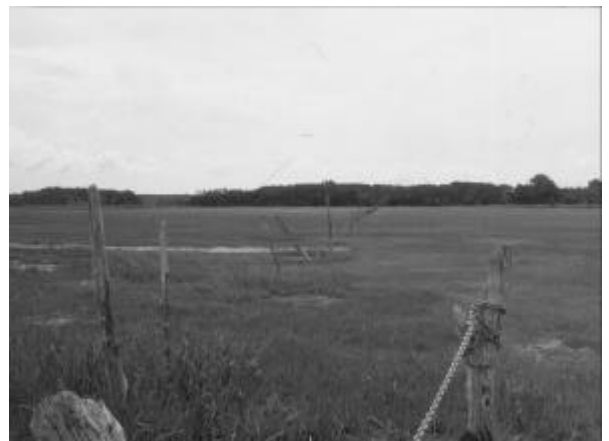
Figure 4.10 Tidal marsh. Author. August 1997.

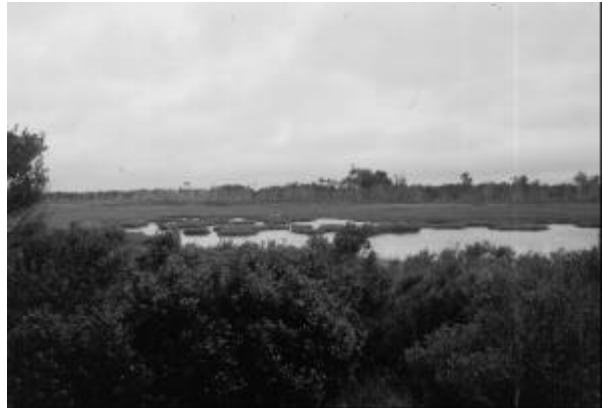
Figure 4.13 Looking over the marsh with shrub swamp in foreground. Author. August 1997.

Adjacent to the forest and also bounding the marsh is shrub swamp characterized by wet and salt tolerant species. (Figure 4.13) The shrub swamp “is an intermediate step in the slow succession of a wetland from marsh to tidewater forest;” hence the difference between marsh and upland can be determined by size and type of vegetative species.<sup>13</sup> Bayberry (*Myrica pensylvanica*) is common to the shrub swamps that form the transitional zone between salt marshes and the wooded and cultivated areas. Significant in this process of succession is the inundation of the land at high tide. (Figure 4.14) At the wharf area the high tide water line follows the five foot contour line. Barren areas in the plowed hammock, as well as shrub swamp vegetation surrounding the upland

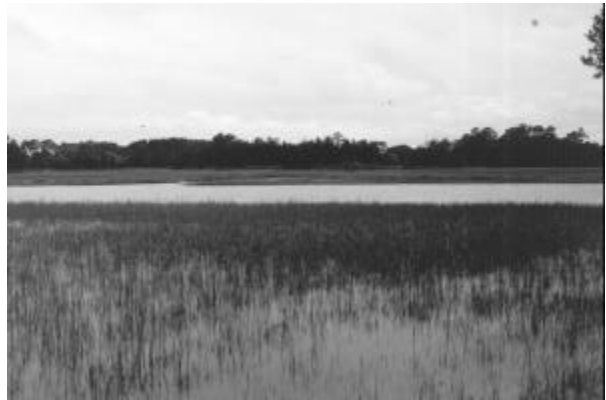
Figure 4.14 High tide at Thomas's Wharf. Author. August 1997.

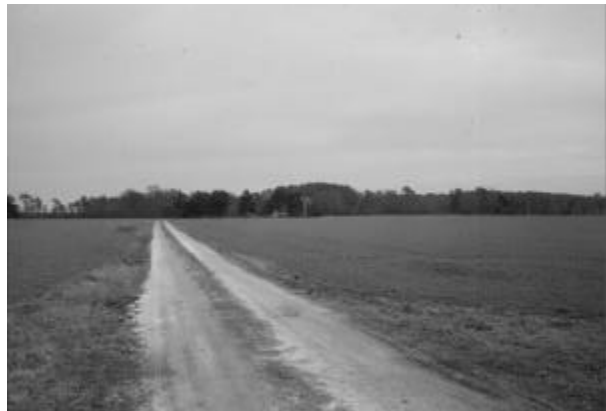
Figure 4.15 Entrance road to Woodlands Farm from Seaside Road. Author. August 1997.

the farm is from Seaside Road through a cultivated field to the dwelling and yard. (Figure 4.15) Aerial photographs from the 1960s show the entrance road to the south of the present road along a property/tree line. Some speculation as to the original entrance to Woodlands Farm abounds. Also visible on the aerial photographs are remnant roads that are no longer visible. They include a road from the dwelling and yard through the loblolly forest and marsh to the west edge of the first hammock. It appears that another road went across the marsh to the second hammock. Just east of this second hammock, there are remnants of a corduroy road that bridged the marsh to another area of narrow upland. (Figures 4.16, 4.17, 4.18, and 4.19) Finally a small length of road diverges from the shell road that leads to Thomas's Wharf. (Figures 4.20, 4.21, and 4.22) This was most likely the entrance to a dwelling and oyster house associated with commercial businesses at the wharf. Adjacent to this remnant road is a lone utility pole with the old insulator laying at its base.

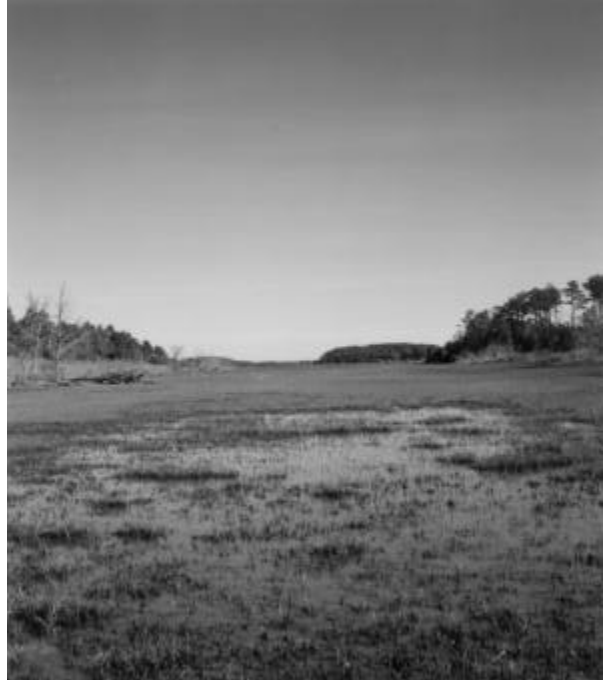
Figure 4.16 Looking north towards narrow strip of marsh between two masses of upland that once was bridged by a corduroy road. Author. February 1998.

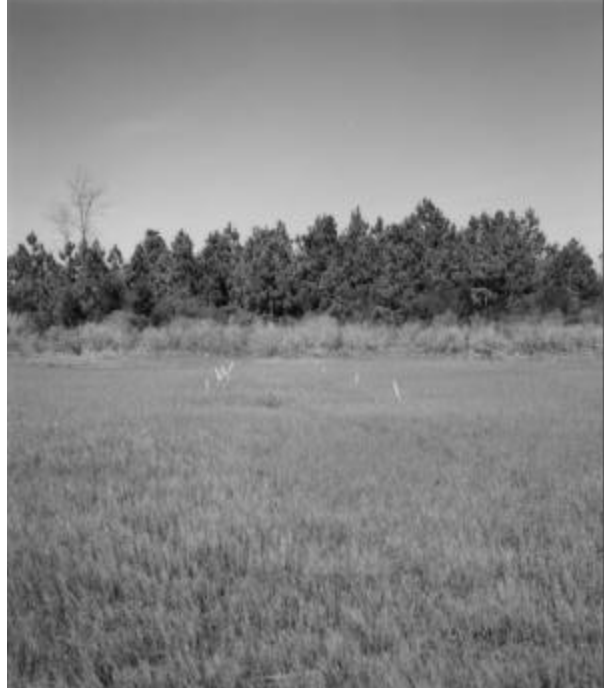
Figure 4.17 The limits of the edge of the corduroy road can be seen by the crossed timbers. Author. February 1998.

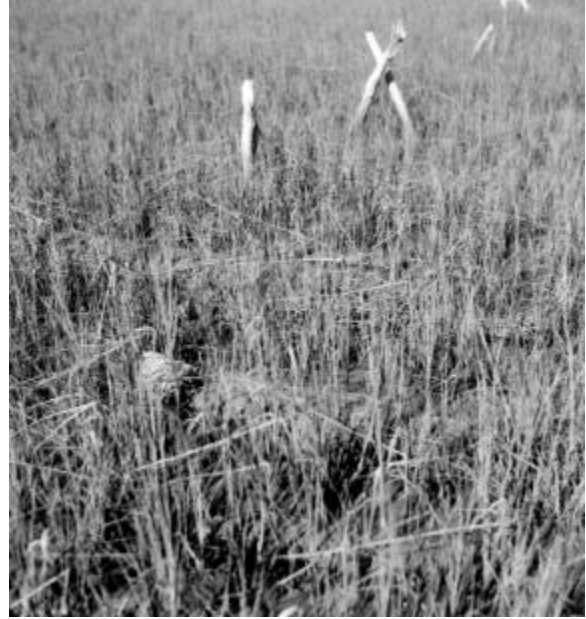
Figure 4.18 Wooden timbers for the road are held in place by stakes. Author. February 1998.

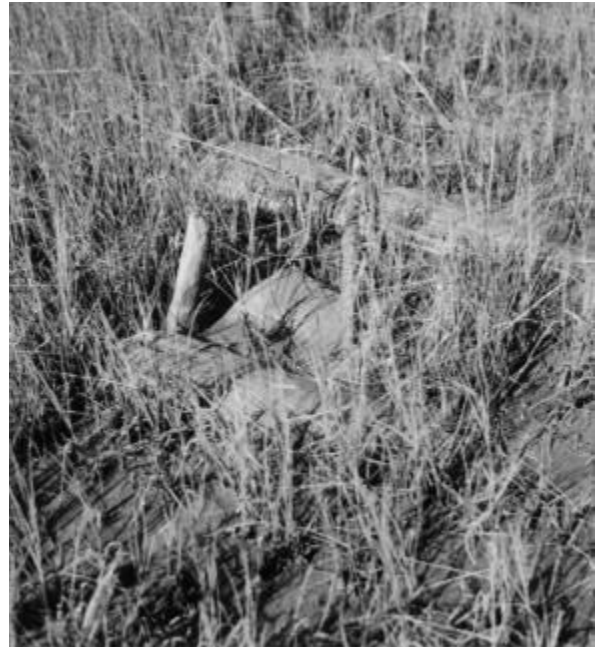
Figure 4.19 Many of the timbers are just under the surface layer of the tidal marsh. Author. February 1998.

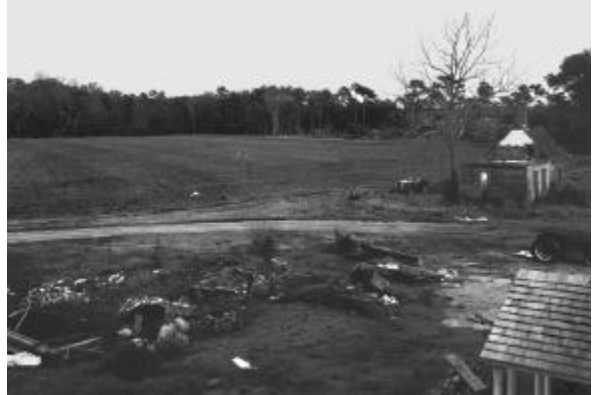
Figure 4.26 The weaving shed is in ruins and the schoolhouse in severe decline. Author. February 1998.

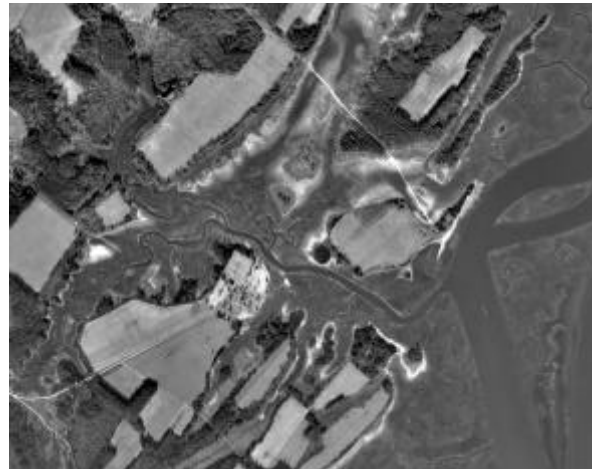
Figure 4.27 Aerial photograph showing the proximity of Thomas's Wharf to Brownsville. Most of the wharf is cleared and cultivated allowing for open views between the two properties. U.S. Department of the Interior. November 1967.

schoolhouse collapsed due to severe storms in the spring of 1998. At Thomas's Wharf, aerial photographs show that the establishment and growth of successive vegetation changed many of the views to and from the property. (Figure 4.27) Views to the wharf from Brownsville were open; one could see Thomas's Wharf from Brownsville. Because of change in land use and activity at the wharf, the vegetation around the edges of the cultivated field have grown too large to see the wharf area. (Figure 4.28) Yards around the dwellings and other farm outbuildings, once clear from trees and shrubs, now are covered with cedars. The vegetation has enhanced the boundaries and edges of the cultivated field, as well as delineating the edge of the marsh and upland.

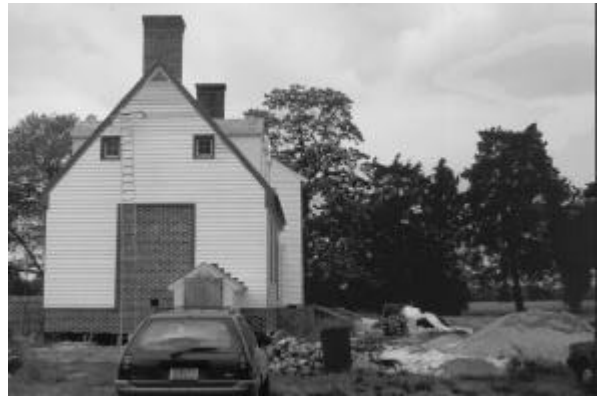
Figure 4.36 Woodlands in 1997. Note the difference in scale between the original colonnade-kitchen and the new addition. Author. June 1997.

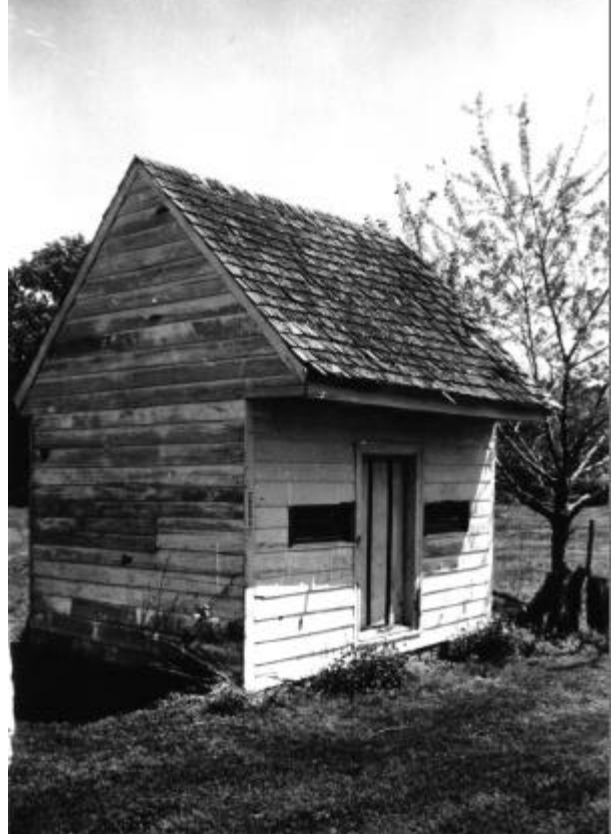
Figure 4.37 The dairy. Department of Historic Resources, Richmond, Virginia. 1966.

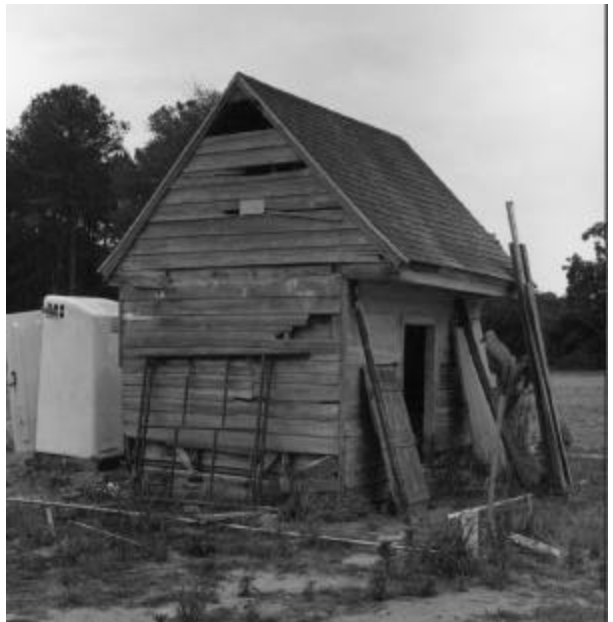
Figure 4.38 Looking southeast towards the dairy. In slight disrepair, but overall in good condition. Author. June 1997.

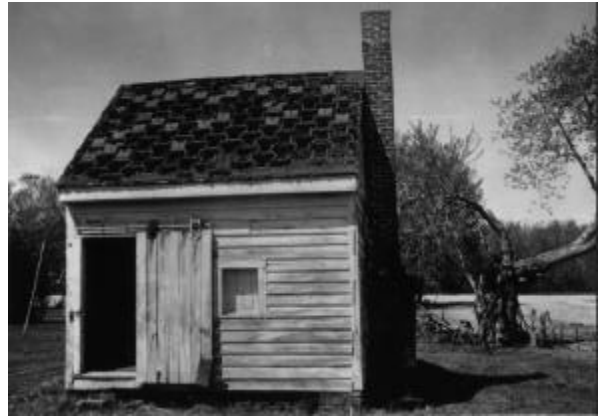
Figure 4.39 South face of outbuilding referred to as weaving shed. Department of Historic Resources, Richmond, Virginia. 1966.

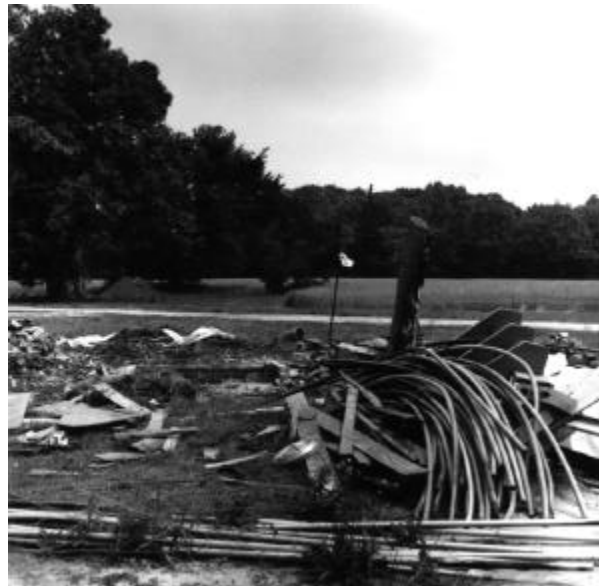
Figure 4.40 Looking north towards ruins of weaving shed. Rubble includes a brick hearth, brick piers, and a brick pit. Author. June 1997.

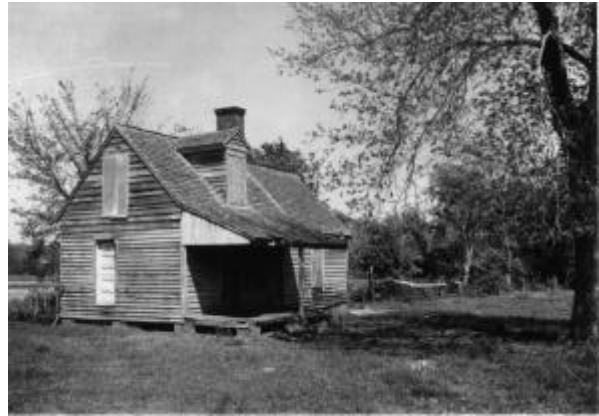
Figure 4.41 Looking northeast towards schoolhouse. Department of Historic Resources, Richmond, Virginia. 1966.

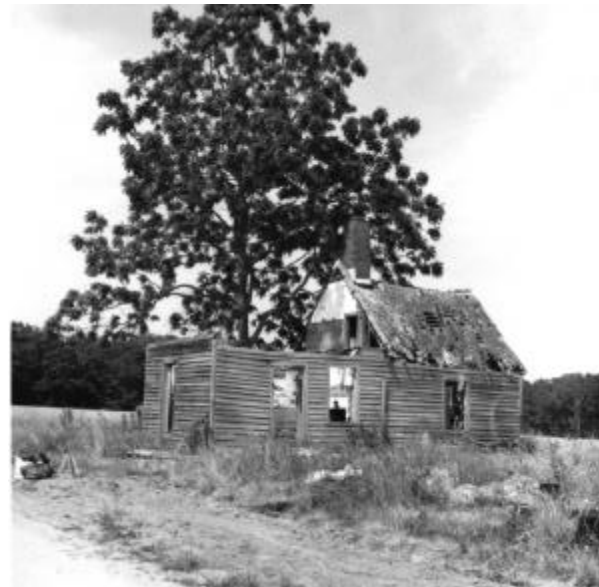
Figure 4.42 The schoolhouse, looking northeast. Since this photograph was taken, the wood structure of the building has collapsed with only the chimney standing. Author. June 1997.

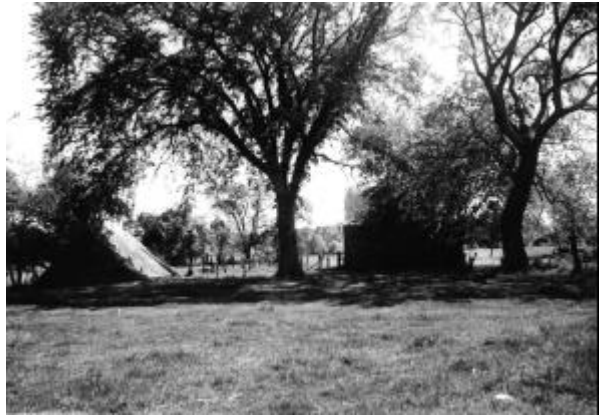
Figure 4.43 Looking south towards barn and another structure. The structure to the left of the photograph was not identified during the study and remains unknown. Department of Historic Resources, Richmond, Virginia. 1966.

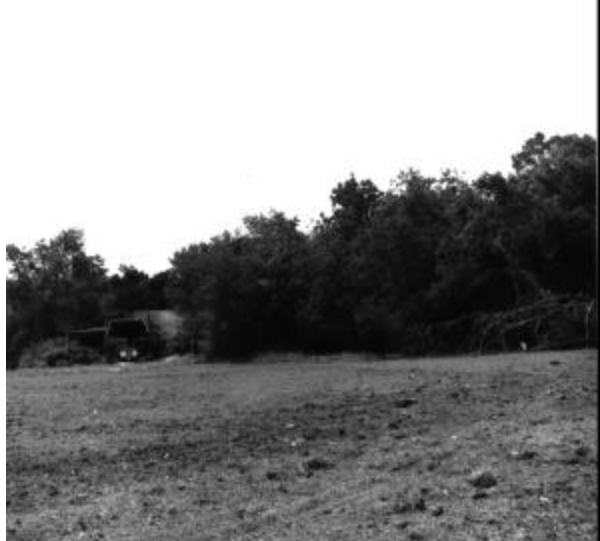
Figure 4.44 Looking south towards area where barn was located. A pole barn was erected sometime in the 1970s and remains standing in disrepair today. The barn was in disrepair and pulled down in 1997. Barn timbers were used in the remodeling of Woodlands. Author. June 1997.

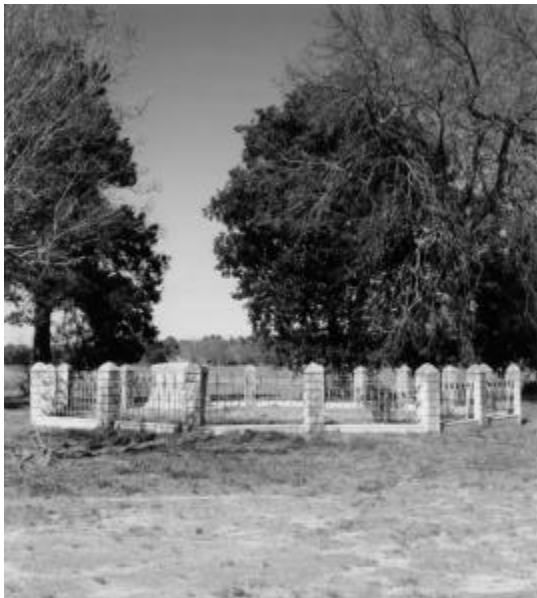
Figure 4.46 Woodlands graveyard. Few of the vines are still growing, but many of the surrounding trees are mature, including crapemyrtle, hackberry, and magnolia. Author. February 1998.

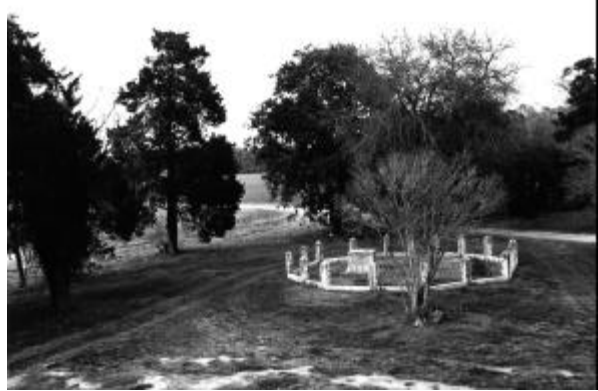
Figure 4.50 The north yard taken from the second floor of Woodlands. The new entrance road is visible, bisecting the yard. In the top right of the photograph, behind the road, are old boxwoods in decline; the only remaining remnant of a garden setting. Author. February 1998.

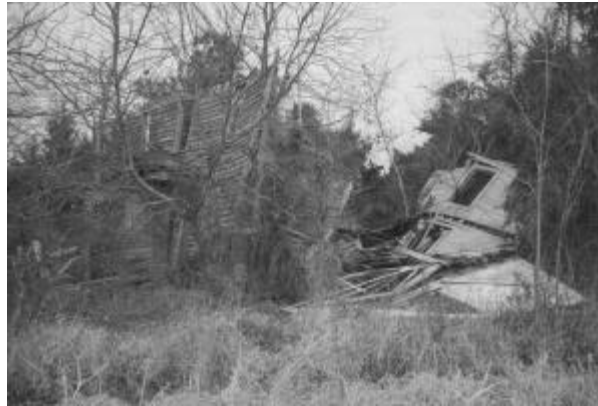
The farmsite at Thomas's Wharf is in complete ruin. (Figure 4.51) The yard and cleared spaces, with the exception of the hammock which is still in cultivation, are in the early stages of succession. (Figure 4.52) There are two distinct areas at the wharf: the farm dwelling, yard, and outbuildings; and the remains of the wharf keeper's dwelling and outbuildings near the existing wharf. (Figures 4.53 and 4.54) Fence posts, still visible today, running across the marsh indicate the legal boundaries of Thomas's Wharf. Fence posts continue to denote yard and pasture from field, and the early successional vegetation also suggests the areas of the farm in use during the twentieth century. Located just near the dwelling and yard are ditches edging the western limit of the cultivated field. (Figure 4.55) Today that small triangle of field has grown up with shrub swamp vegetation. (Figure 4.56) Several introduced species are present in the yard surrounding the dwelling on the hammock and include daffodils (*Narcissus sp.*), crapemyrtle (*Lagerstroemia sp.*), daylillies (*Hermerocallis sp.*), weeping willow

Figure 4.51 Decaying twentieth century farmhouse at Thomas's Wharf. Author. March 1997.

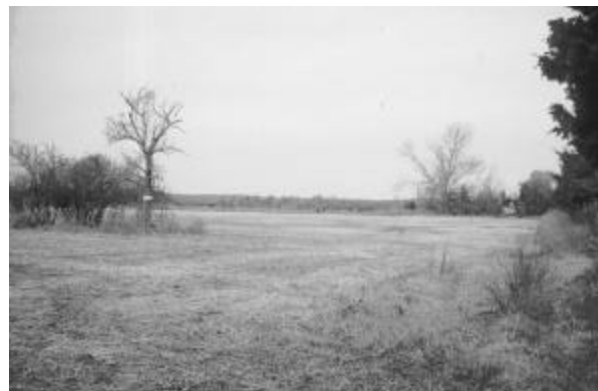
Figure 4.52 Hammock at Thomas's Wharf, with farmhouse in the background on the edge of the edge of the field. Author. March 1997.

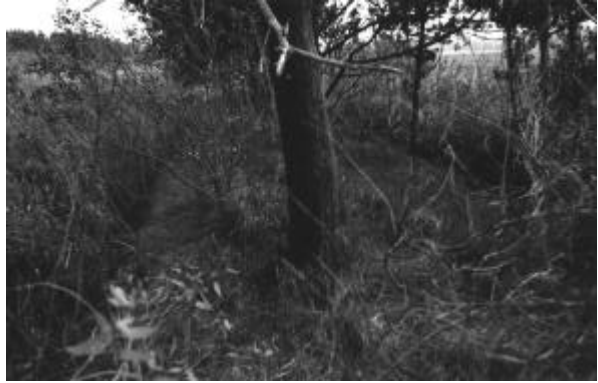
Figure 4.55 Looking along the length of an elevated strip of land with ditches on either side. Freshwater plants, including cattails, were found growing in standing water in the ditches. Frank Strassler. November 1997.

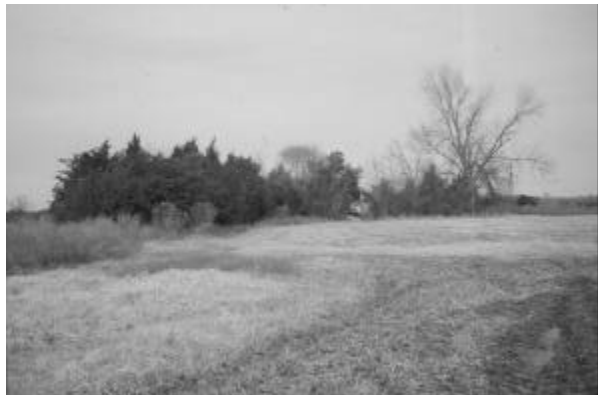
Figure 4.56 Looking north towards the farmhouse in the hammock at Thomas's Wharf. The triangle of field bordered by the ditches to the west and field to the east can be seen to the left of the photograph. Shrub swamp vegetation such as bayberry have taken over the old field. Author. March 1997.

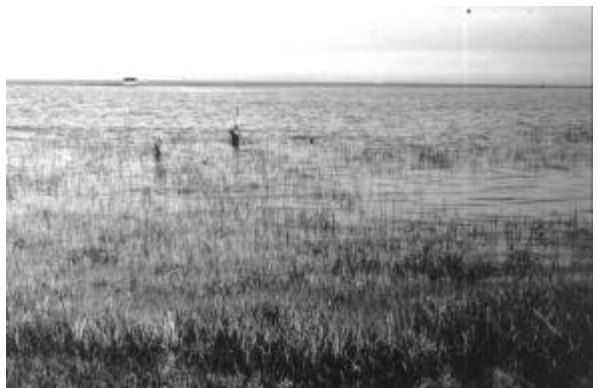
There appears to be two wharf areas, one more recent and in usable condition, and the other only partially visible with a few remaining cedar posts rising above the marsh. (Figures 4.57 and 4.58) The posts indicate that the wharf structure covered a much larger area than what is implied by the long narrow shape of the modern wharf. Certainly a larger area was necessary for docking, unloading, and loading the shipments of produce, among other products during the active shipping periods of Thomas's Wharf. Little remains of the dwelling and outbuilding that were associated with the wharf. (Figure 4.59 and 4.60) Also built in the early twentieth century was an oyster house for the commercial fishing operation. Built close to the water and wharf, the forces of nature and neglect have left only a brick scatter.

Figure 4.57 Decaying posts protruding above the surface of the marsh and water at high tide. Author. May 1997.

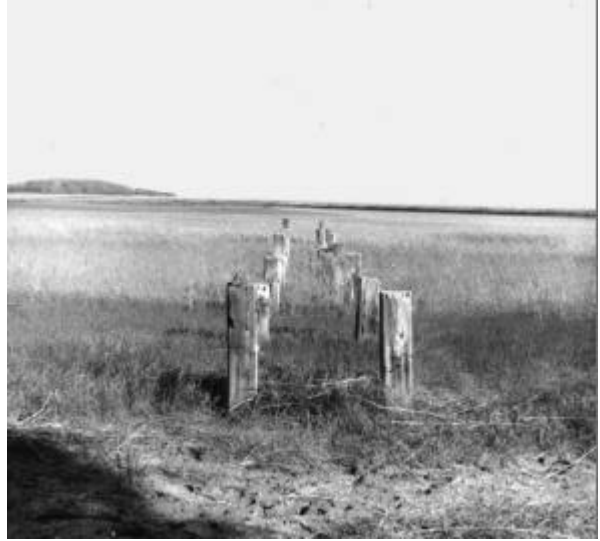
Figure 4.58 Posts for a wharf structure, most likely built during the twentieth century for use by the Battle Point Fish and Oyster Company. Frank Strassler. May 1997.

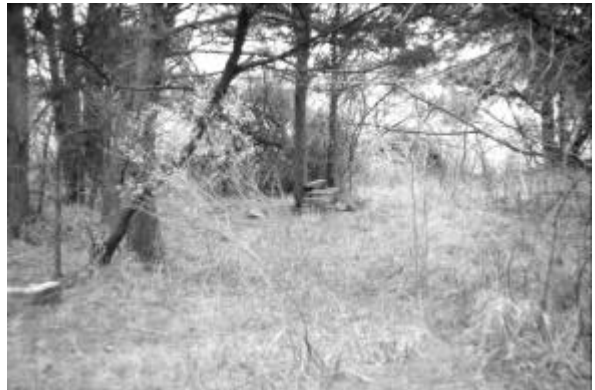
Figure 4.59 Remnant of brick piers for the house located near the more modern wharf. Author. February 1998.

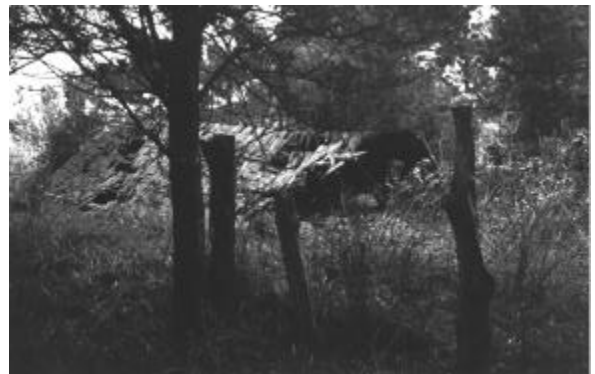
Figure 4.60 Wood shingled roof of a small outbuilding associated with the house near the wharf. Frank Strassler. November 1997.
