**IMPACT DAMAGE RESISTANCE AND TOLERANCE
OF ADVANCED COMPOSITE MATERIAL SYSTEMS**

Kuen Tat Teh

Dissertation submitted to the Faculty of the
Virginia Polytechnic Institute and State University
in partial fulfillment of the requirements for the degree of

Engineering Mechanics

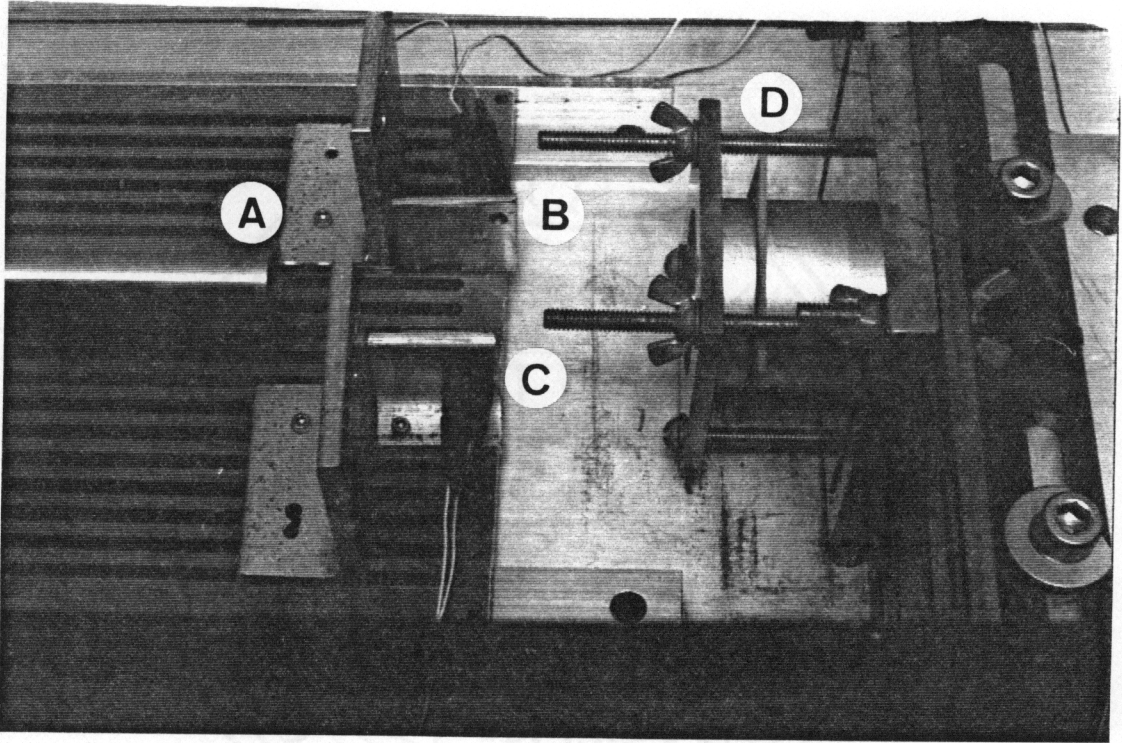
A Barrel end
B LED

C Photo-transistor
D Specimen

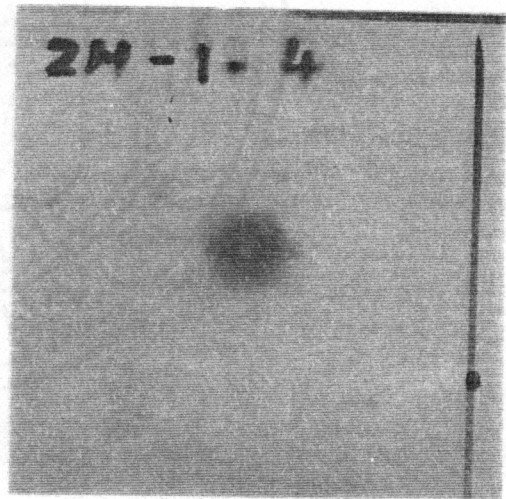
Fig. 3.7 Impact damage in S-2/8551-7A specimens observed in front of a light source.
Impact velocity = 8.1 m/s : (a) front view, (b) back view;
Impact velocity = 14.4 m/s : (c) front view, (d) back view.

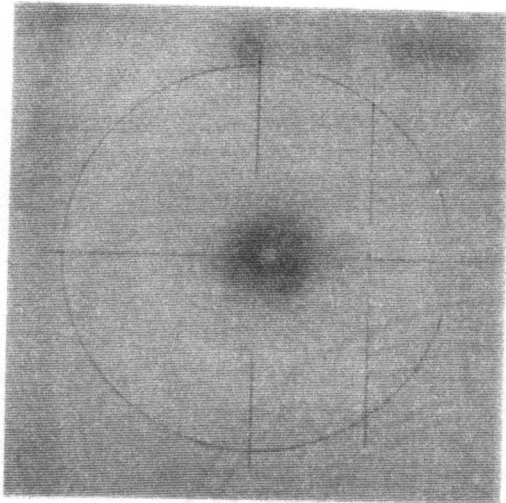
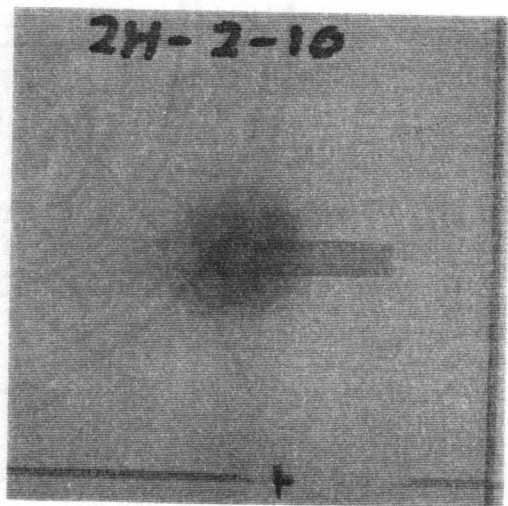
Fig. 3.8 Impact damage in S-2/8551-7A specimens observed in front of a light source.
Impact velocity = 19.9 m/s : (a) front view, (b) back view;
Impact velocity = 25.9 m/s : (c) front view, (d) back view.

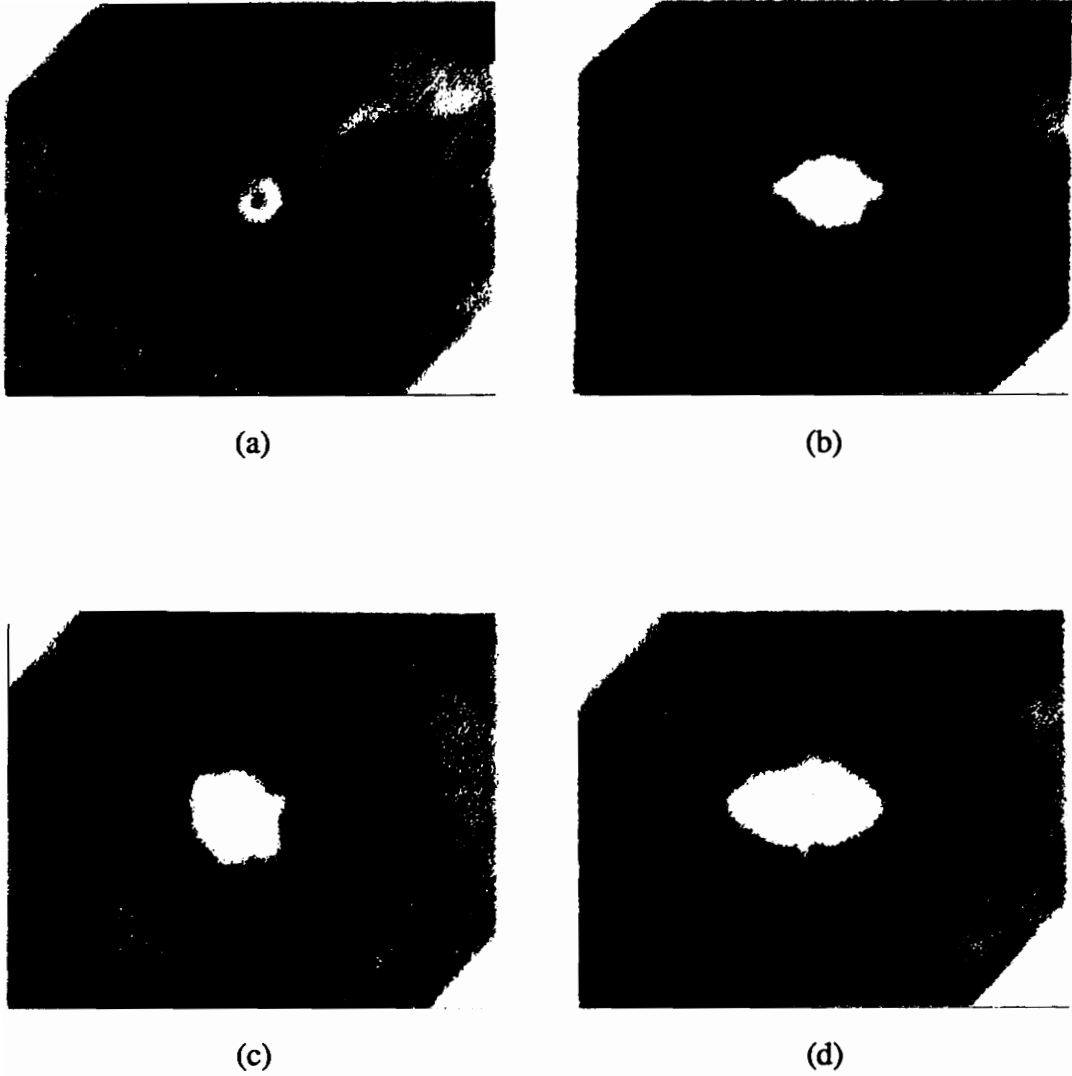
Fig. 4.5 Ultra-sonic C-scan images of G30-500/F185 specimens impacted with velocities of (a) 12.6 m/s, (b) 16.0 m/s, (c) 19.0 m/s, and (d) 20.5 m/s. The surface 0° ply is in horizontal direction.

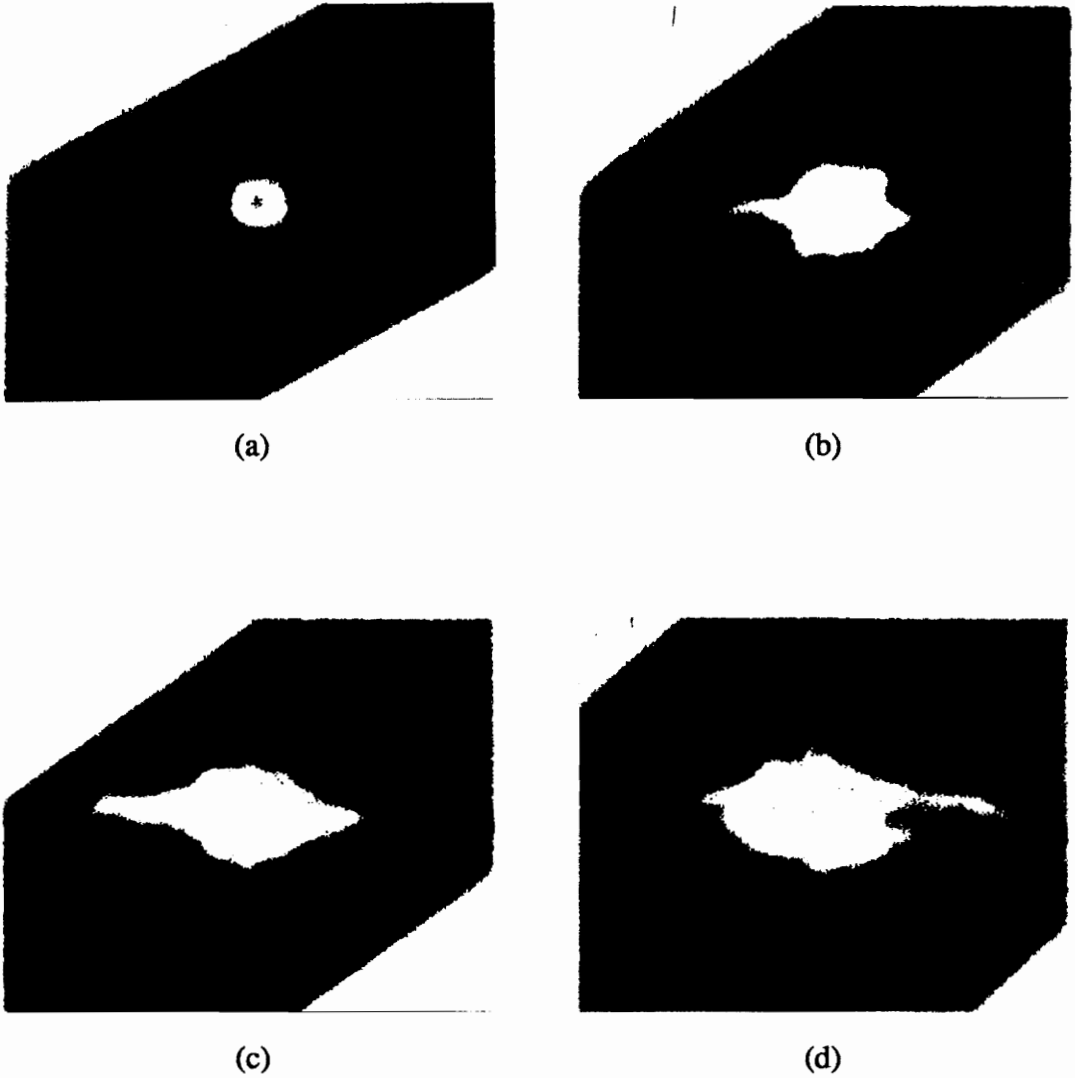
Fig. 4.13 Ultra-sonic C-scan images of IM7/F655-2 specimens impacted with velocities of (a) 12.7 m/s, (b) 16.7 m/s, (c) 19.5 m/s, and (d) 22.3 m/s. The surface 0° ply is in horizontal direction.

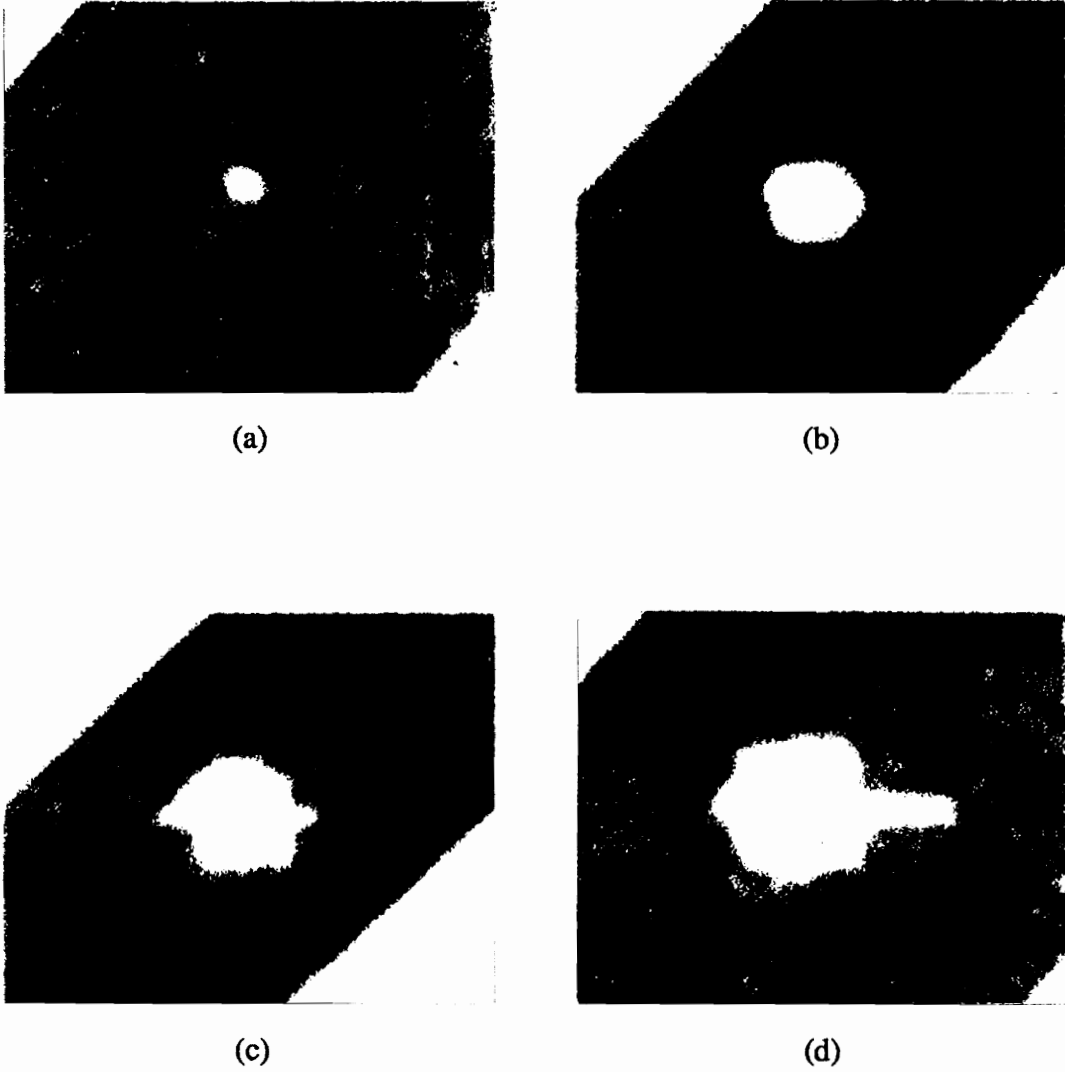
Fig. 4.17 Ultra-sonic C-scan images of S-2/8551-7A specimens impacted with velocities of (a) 8.1 m/s, (b) 14.4 m/s, (c) 19.9 m/s, and (d) 25.9 m/s. The surface 0° ply is in horizontal direction.

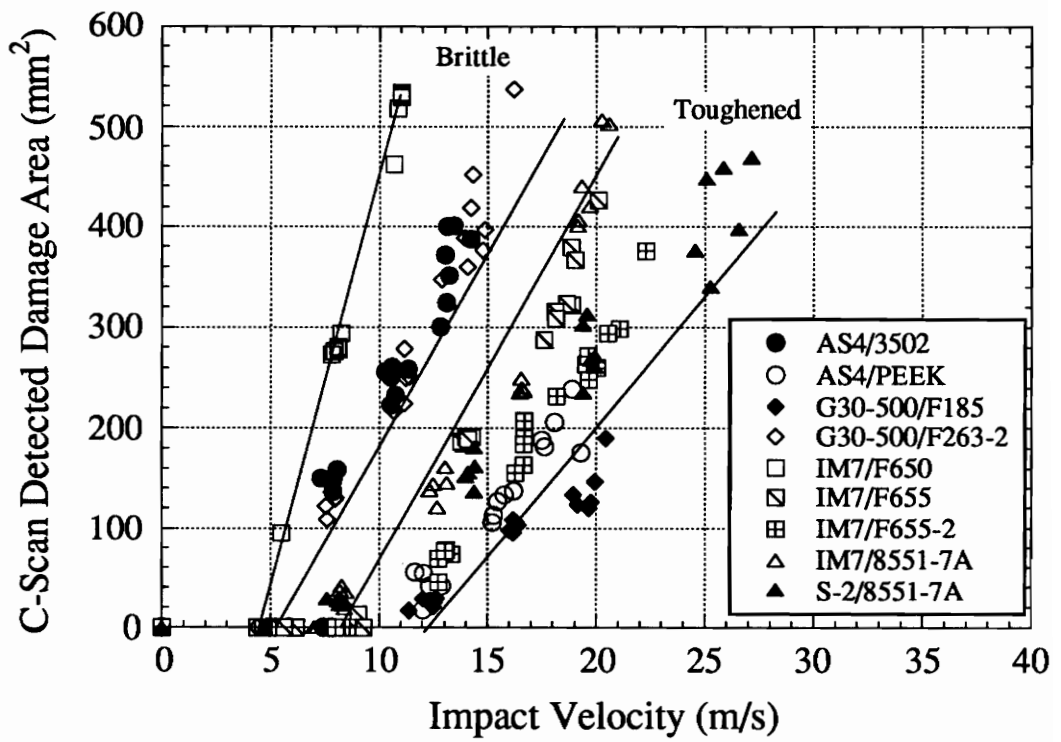
Fig. 4.19 Variation of C-scan detected damage area with impact velocity for each material system.

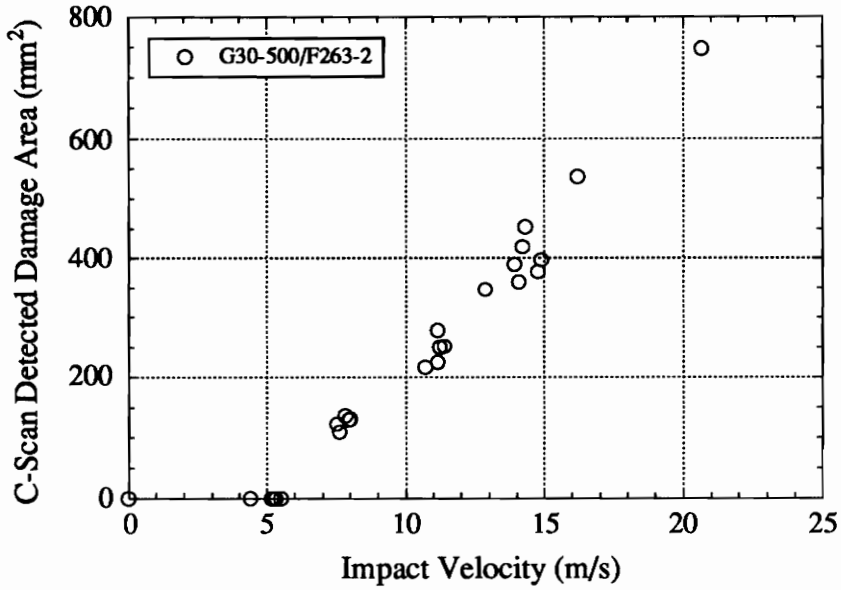
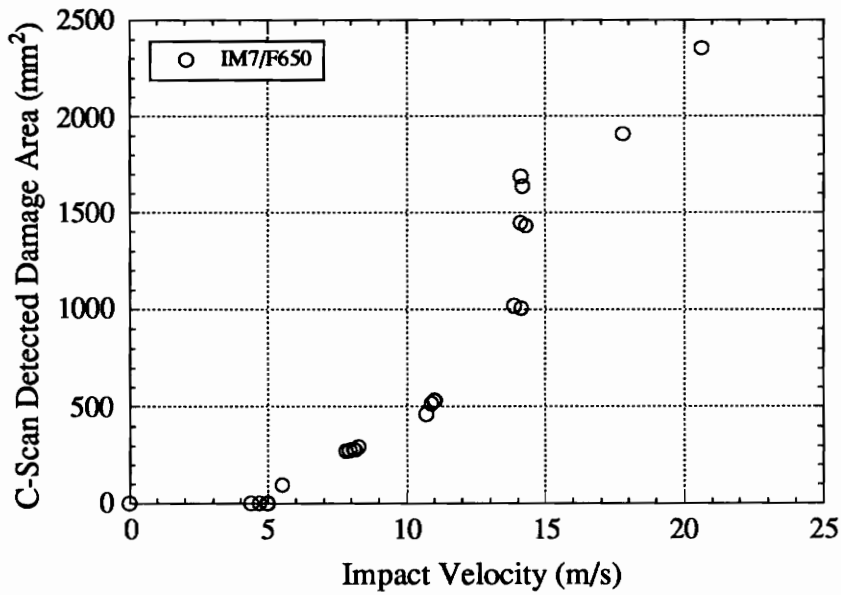
Fig. 4.20 Variation of C-scan detected damage area with incident energy for (a) G30-500/F263-2 and (b) IM7/F650.

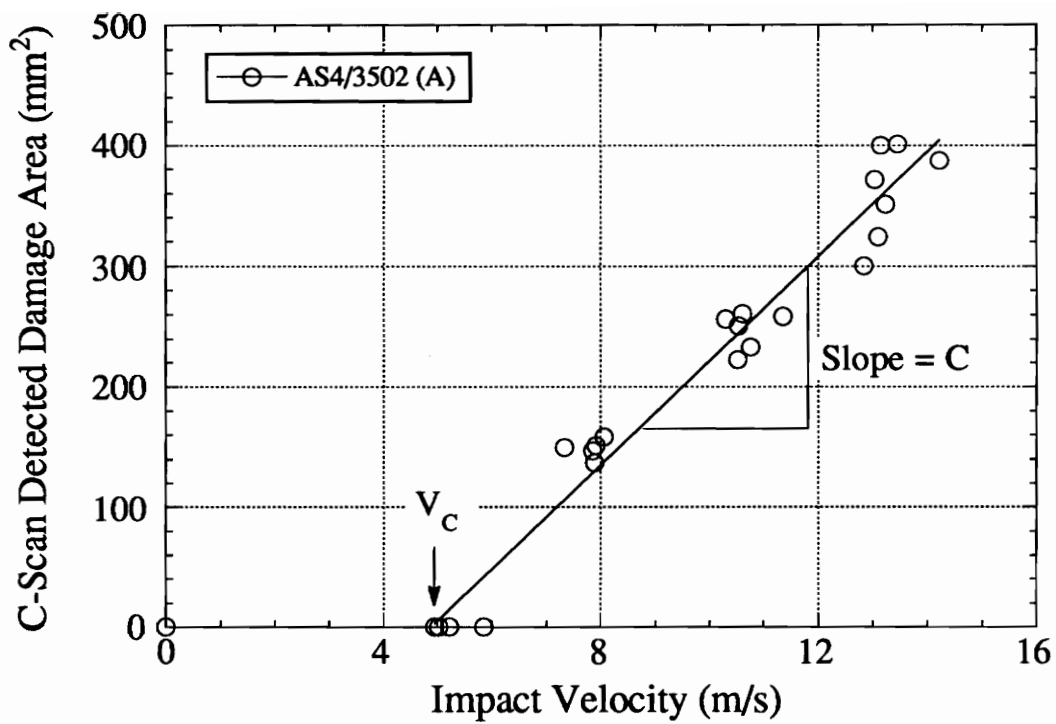
Fig. 4.21 Example of linear curve fitting to the damage area - impact velocity data for AS4/3502.

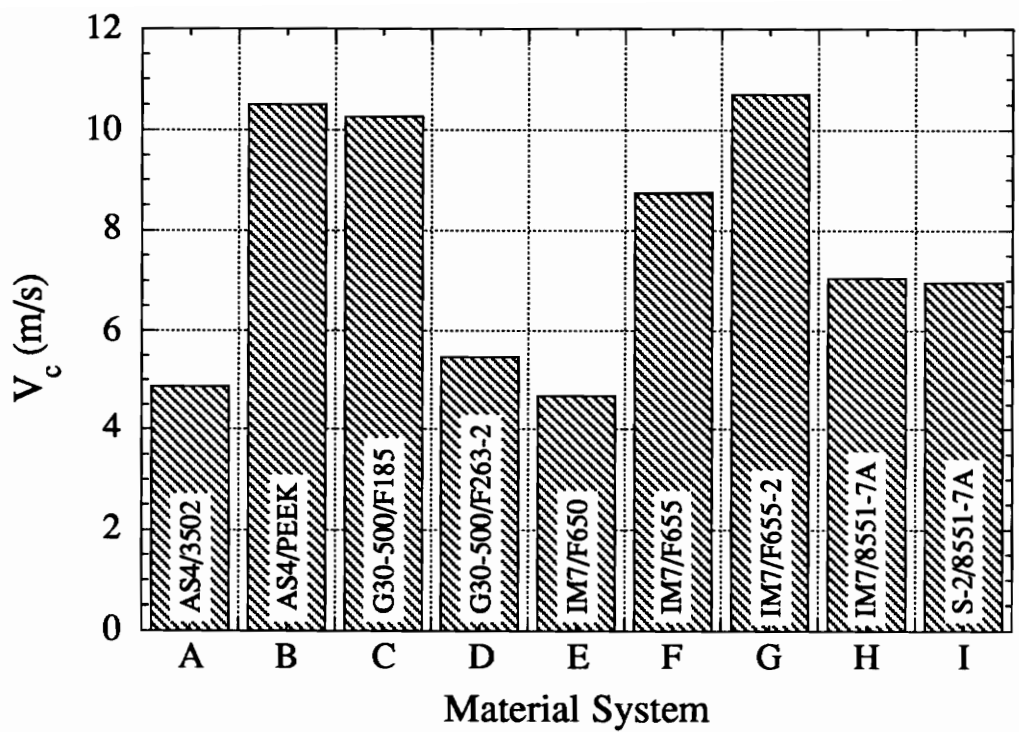
Fig. 4.22 Damage initiation impact velocity or threshold velocity of each material system.

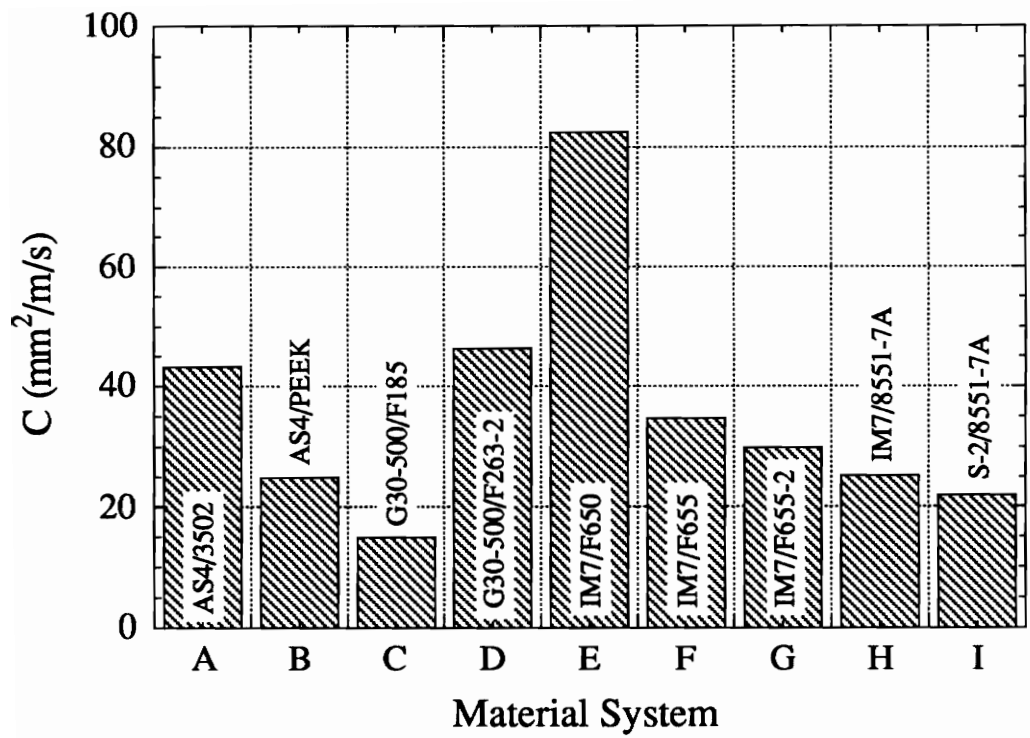
Fig. 4.23 Impact damage growth rate of each material system.

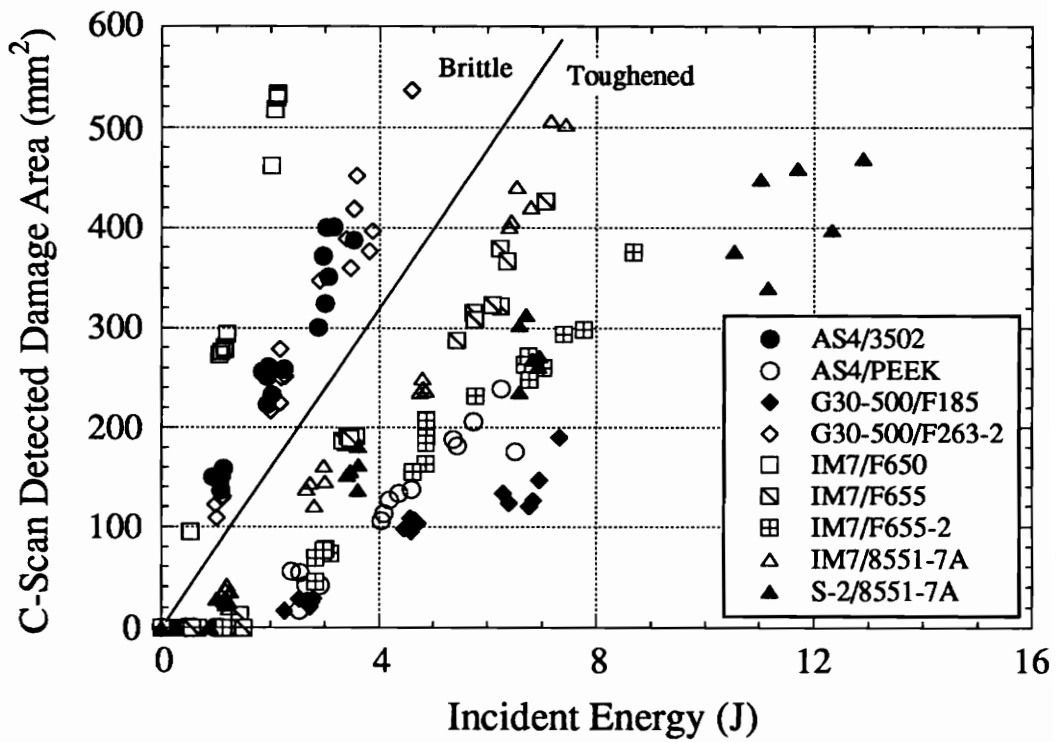
Fig. 4.24 Variation of C-scan detected damage area with incident energy for each material system.

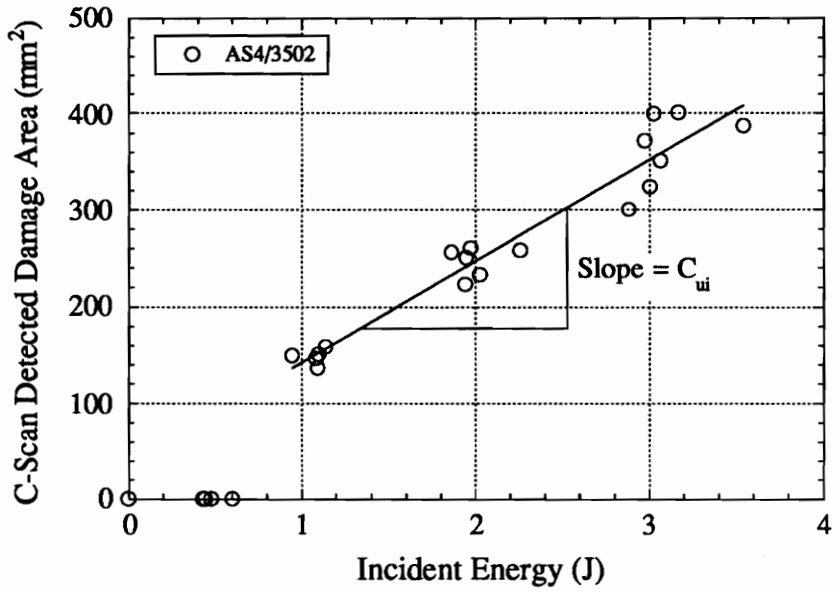
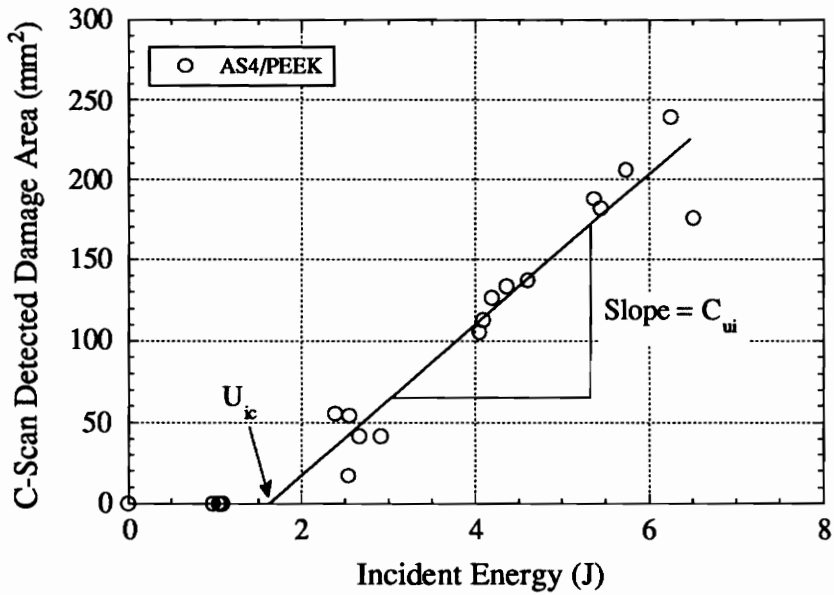
Fig. 4.25 Example of linear curve fitting to the damage area - incident energy data for (a) AS4/3502 and (b) AS4/PEEK.

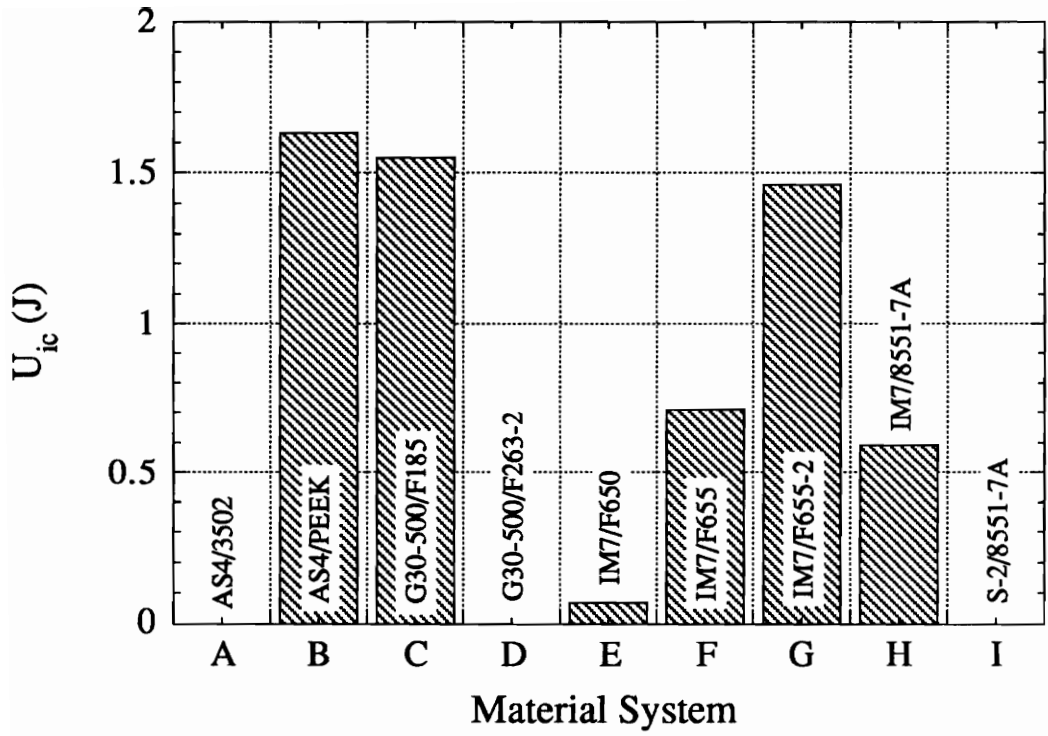
Fig. 4.26 Damage initiation incident energy of each material system.

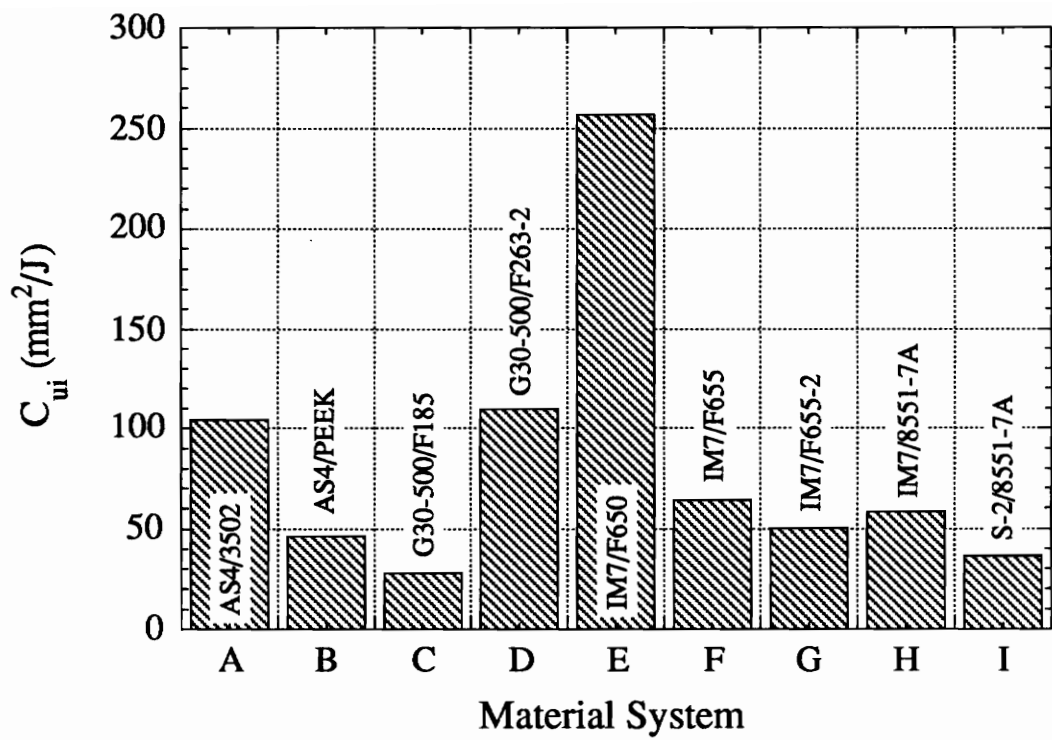
Fig. 4.27 Impact damage growth rate with respect to incident energy of each material system.

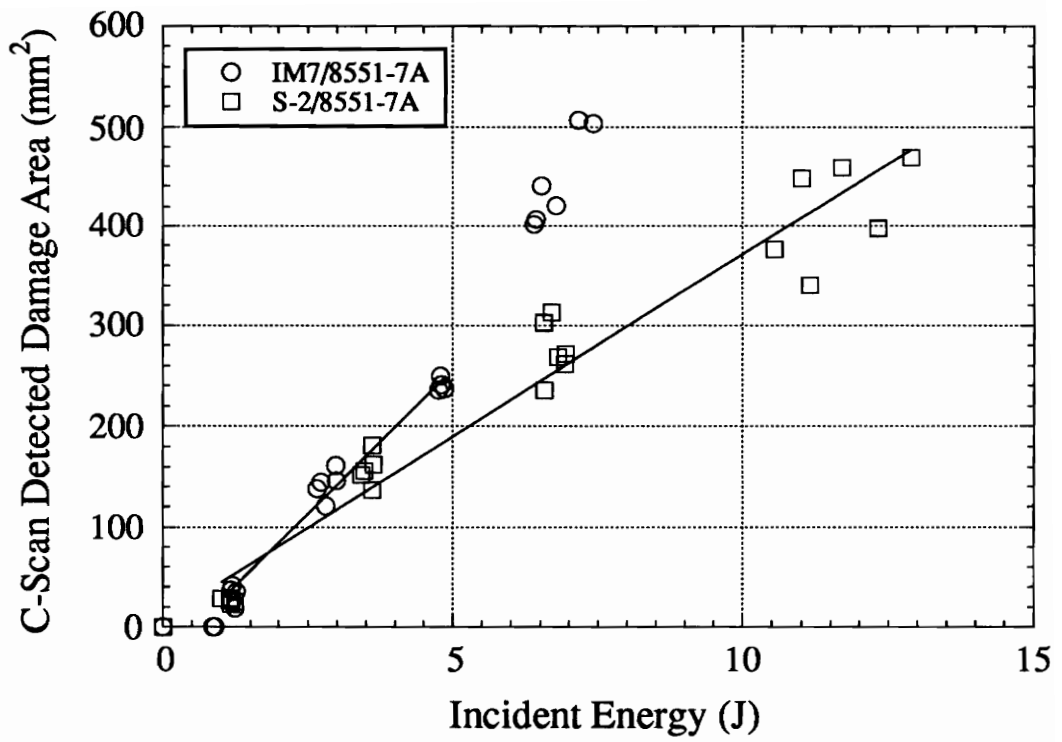
Fig. 4.28 Variation of C-scan detected damage area with incident energy for IM7/8551-7A and S-2/8551-7A.

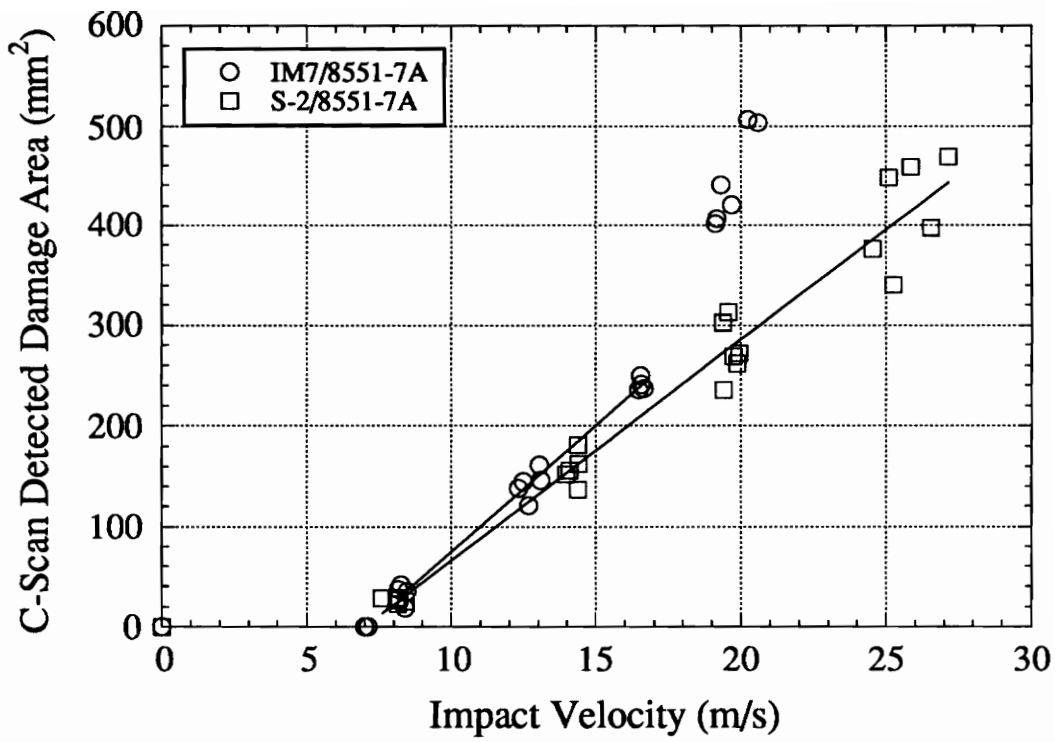
Fig. 4.29 Variation of C-scan detected damage area with impact velocity for IM7/8551-7A and S-2/8551-7A.

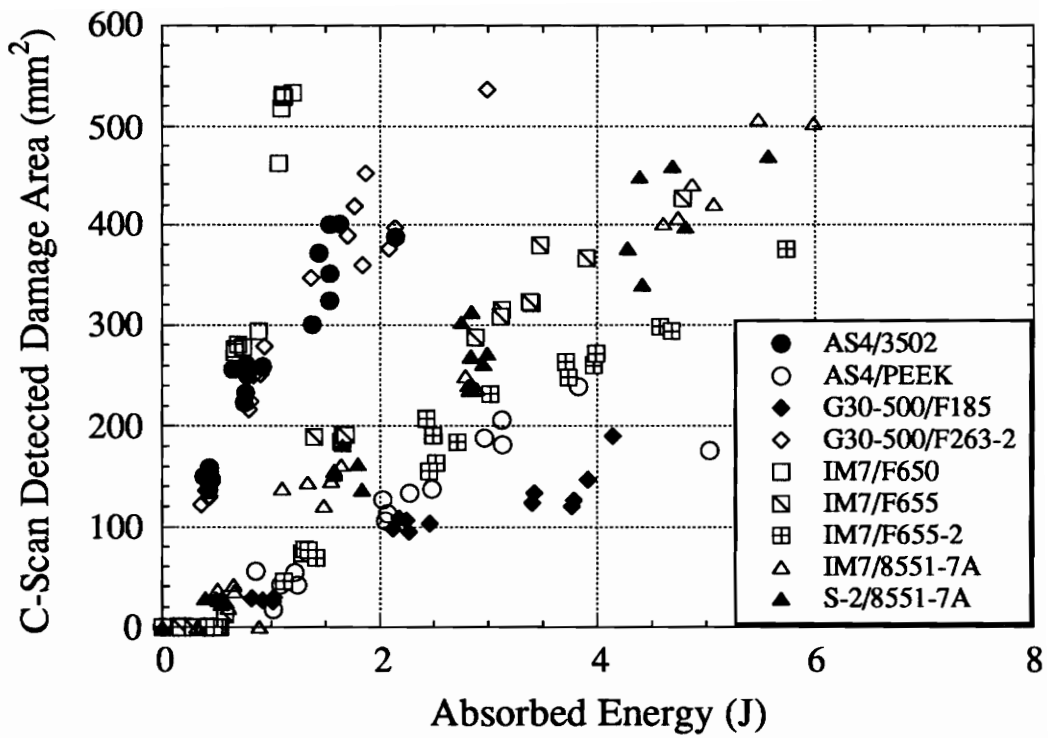
Fig. 4.30 Variation of C-scan detected damage area with absorbed energy (U_d) for each material system.

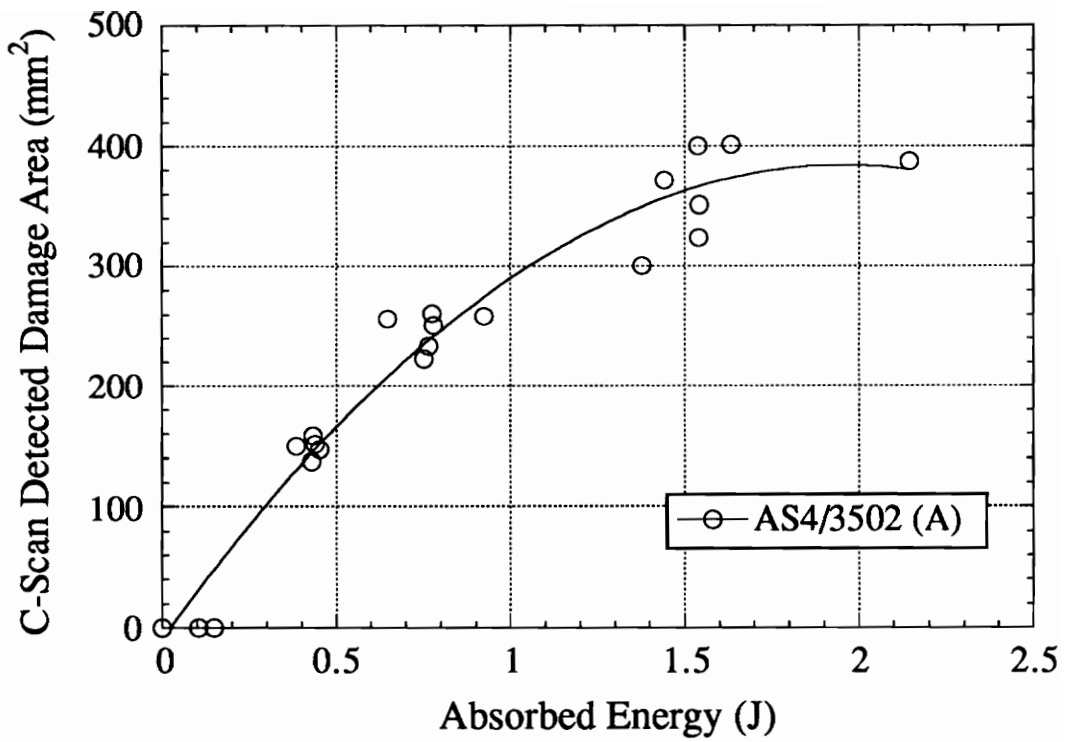
Fig. 4.31 Example of second degree polynomial curve fitting to the damage area - absorbed energy data for AS4/3502.

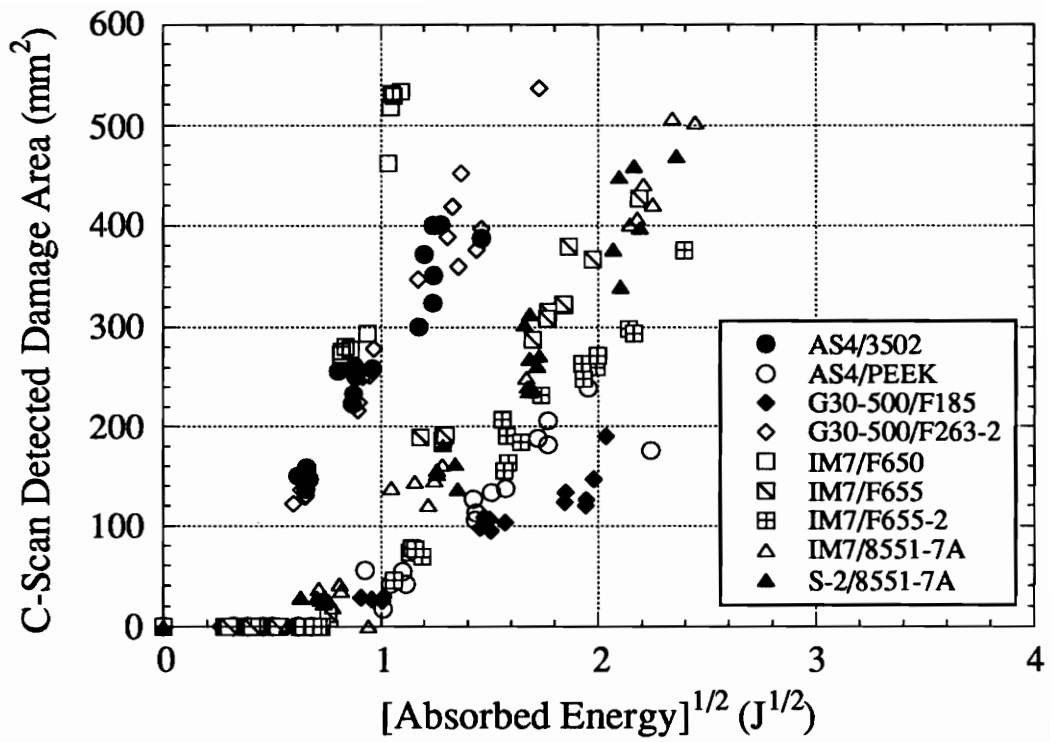
Fig. 4.32 Variation of C-scan detected damage area with [absorbed energy]^{1/2} for each material system.

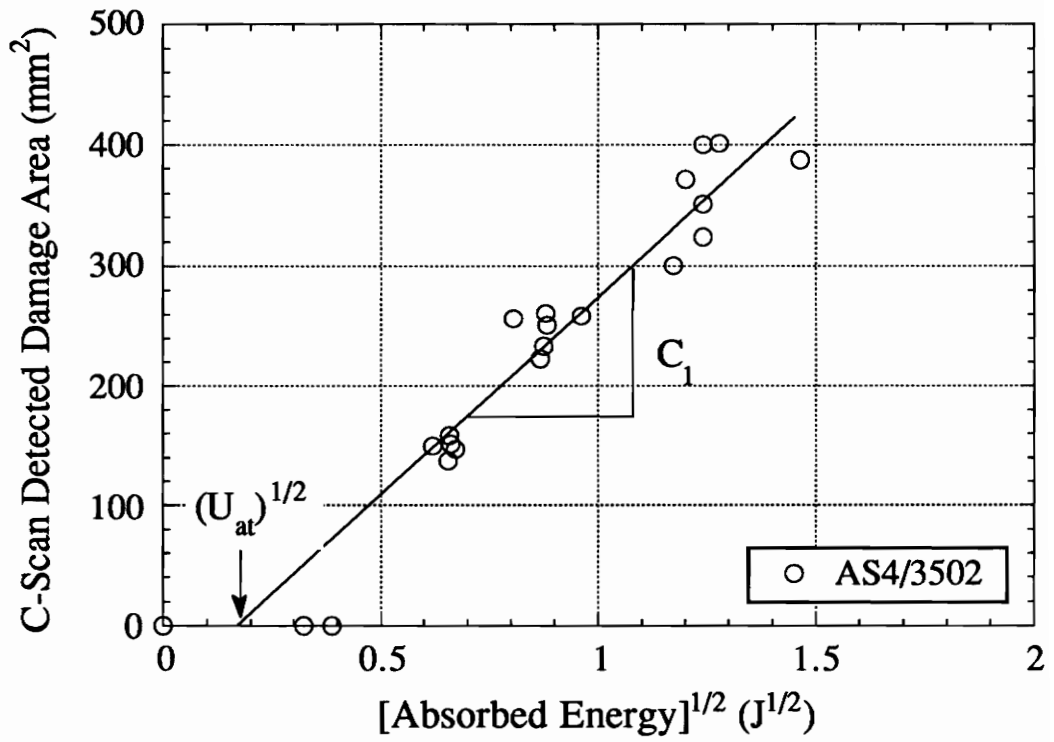
Fig. 4.33 Example of linear curve fitting to the damage area - [absorbed energy]^{1/2} data for AS4/3502.

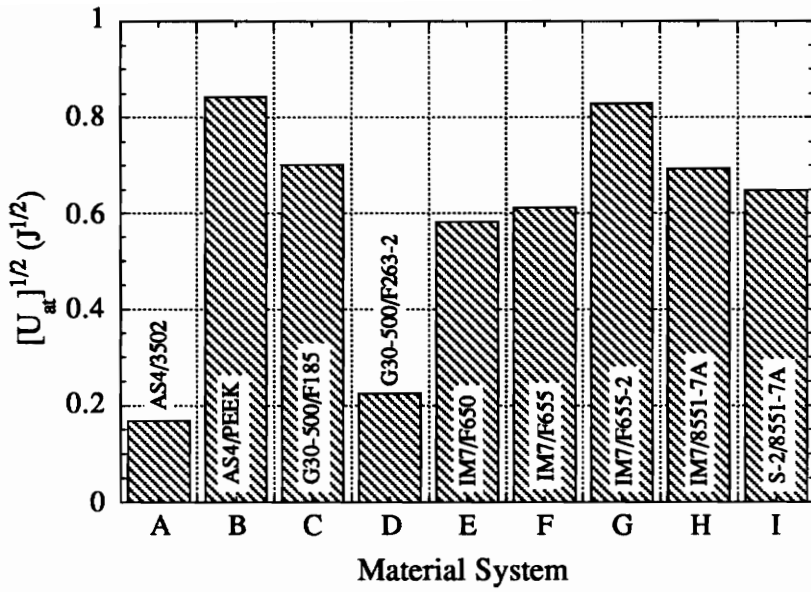
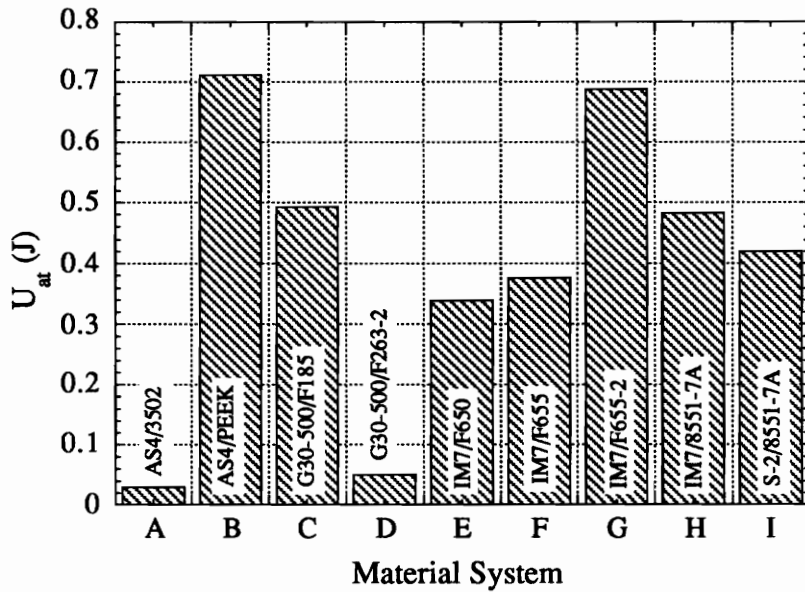
Fig. 4.34 Damage initiation absorbed energy of each material system.

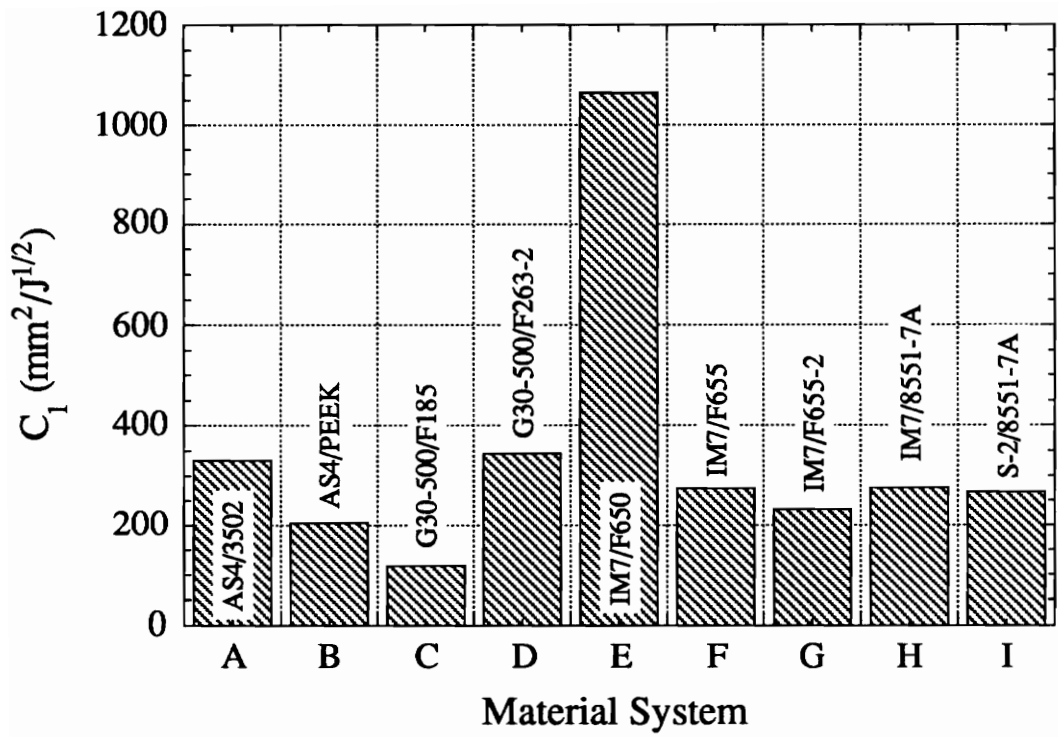
Fig. 4.35 Impact damage growth rate of each material system.

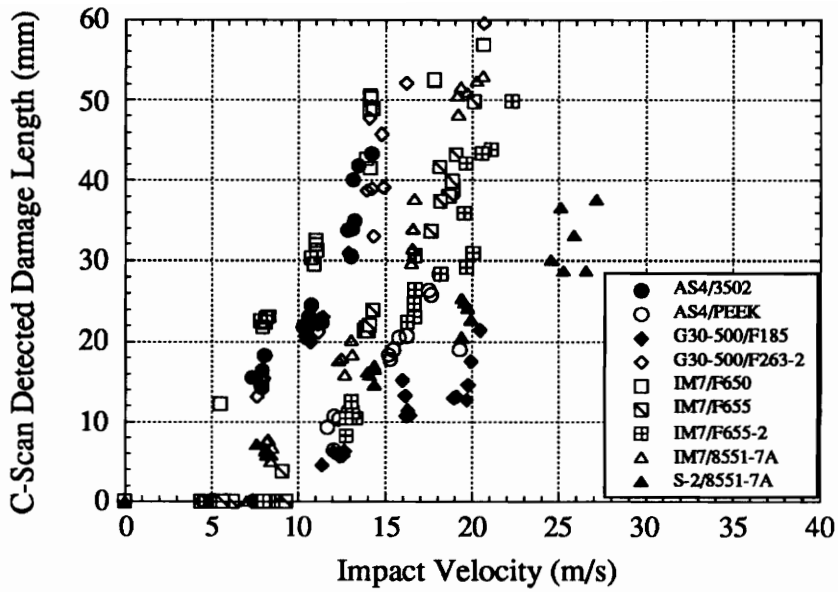
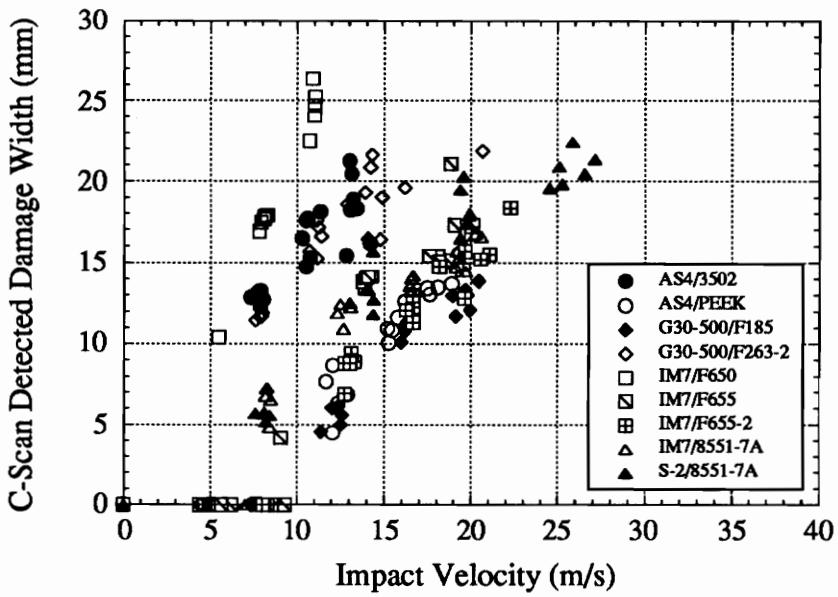
Fig. 4.36 Variation of (a) C-scan detected damage length and (b) width with impact velocity for each material system.

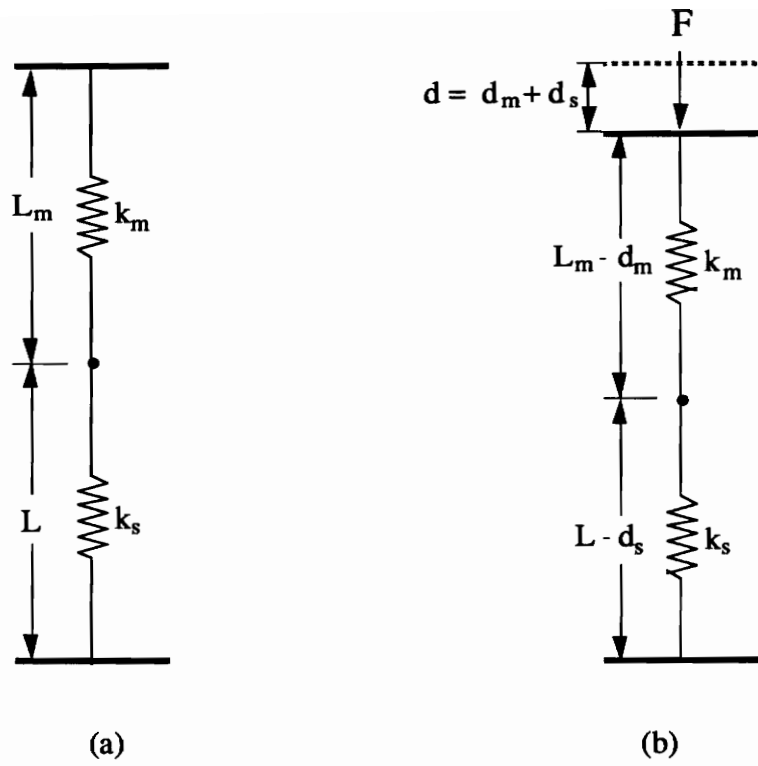
Fig. 5.5 The series spring model for the compression test loading condition.

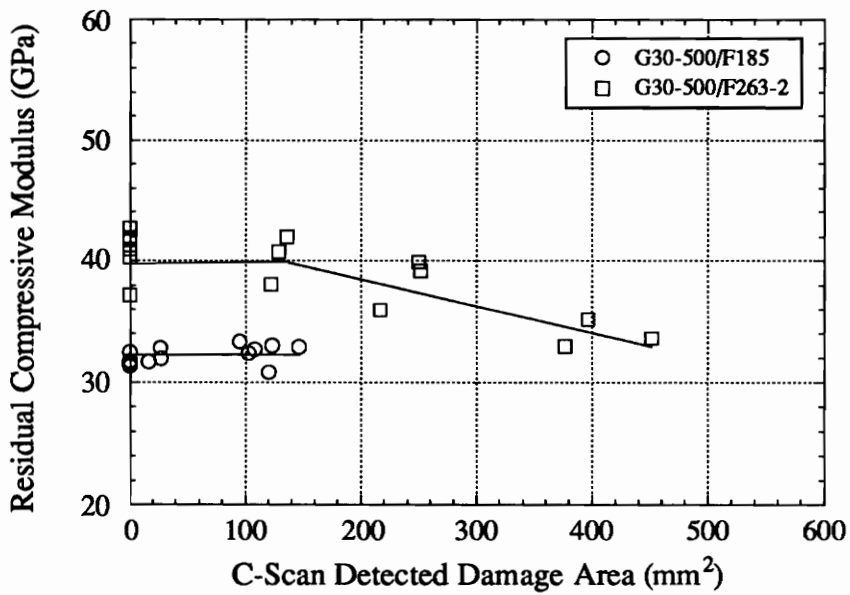
Fig. 5.14 Variation of residual compressive modulus with C-scan detected damage area for material systems with (a) AS4 and (b) G30-500 fibers.

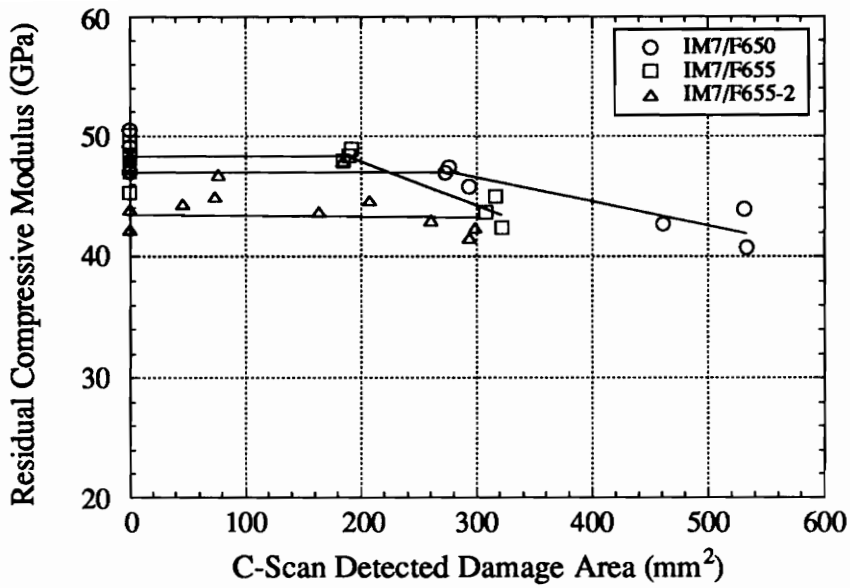
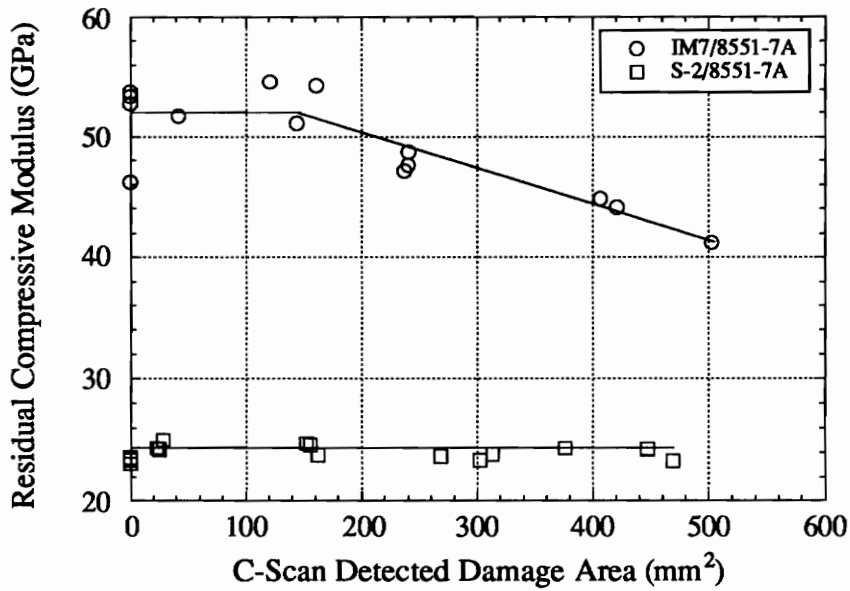
Fig. 5.15 Variation of residual compressive modulus with C-scan detected damage area for (a) bismaleimide and (b) rubber toughened epoxy systems.
