**IMPACT DAMAGE RESISTANCE AND TOLERANCE
OF ADVANCED COMPOSITE MATERIAL SYSTEMS**

Kuen Tat Teh

Dissertation submitted to the Faculty of the
Virginia Polytechnic Institute and State University
in partial fulfillment of the requirements for the degree of

Engineering Mechanics

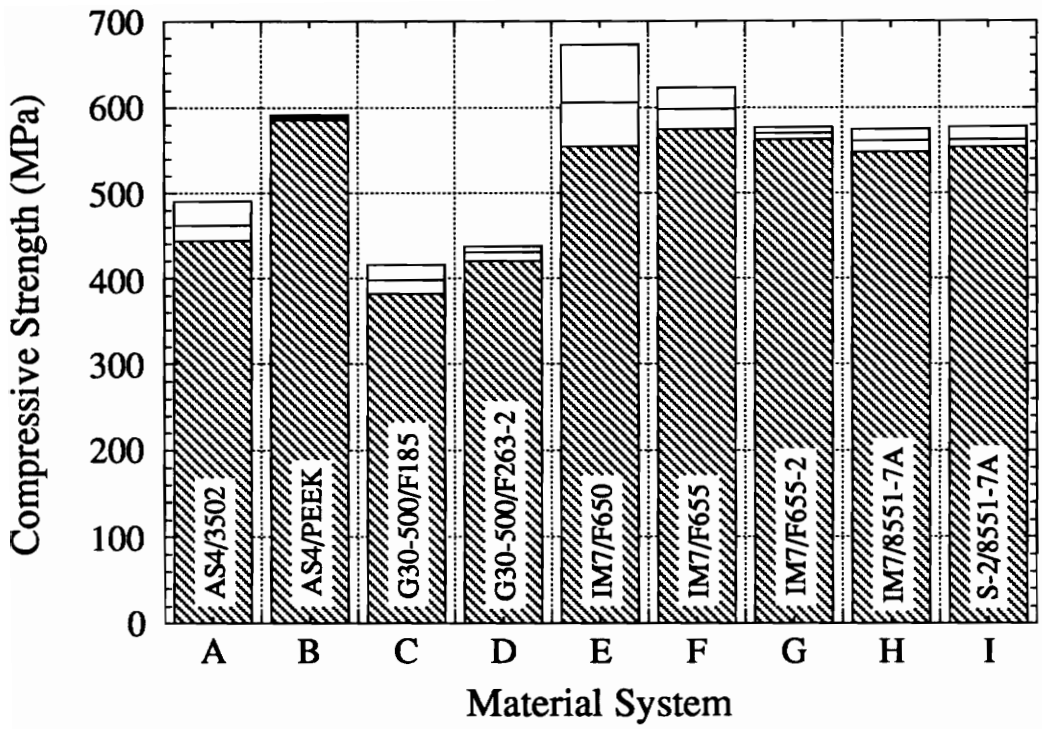
Fig. 5.16 Compressive strength of each material system.

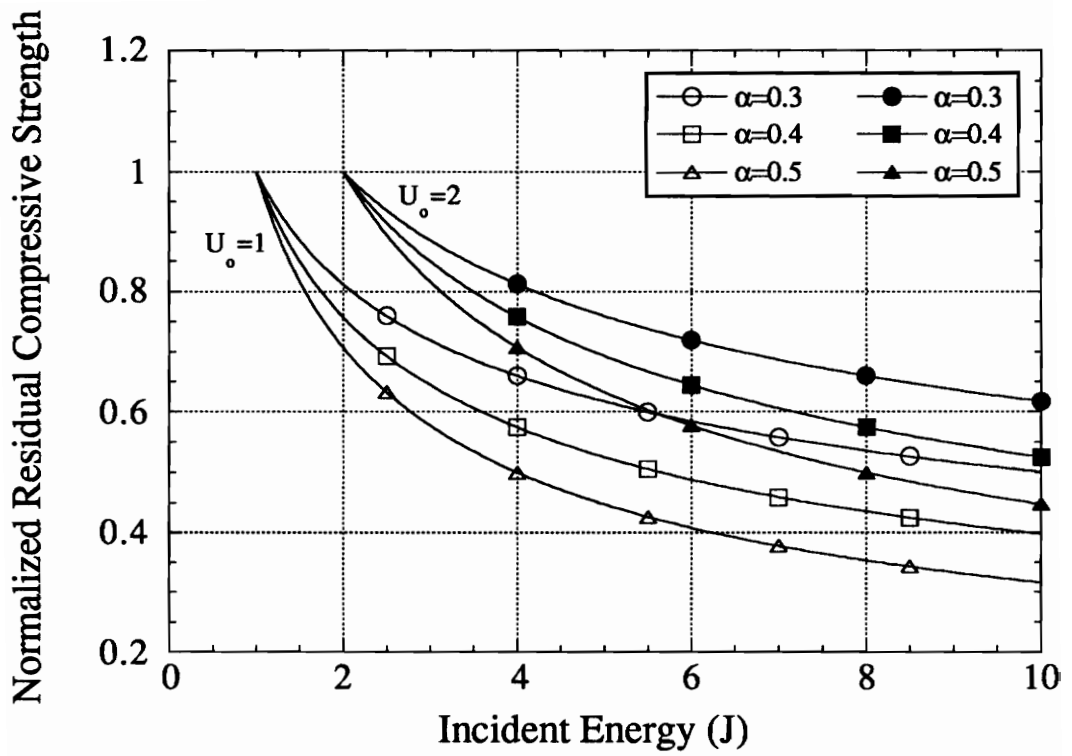
Fig. 5.25 Effects of U_o and α of Caprino model.

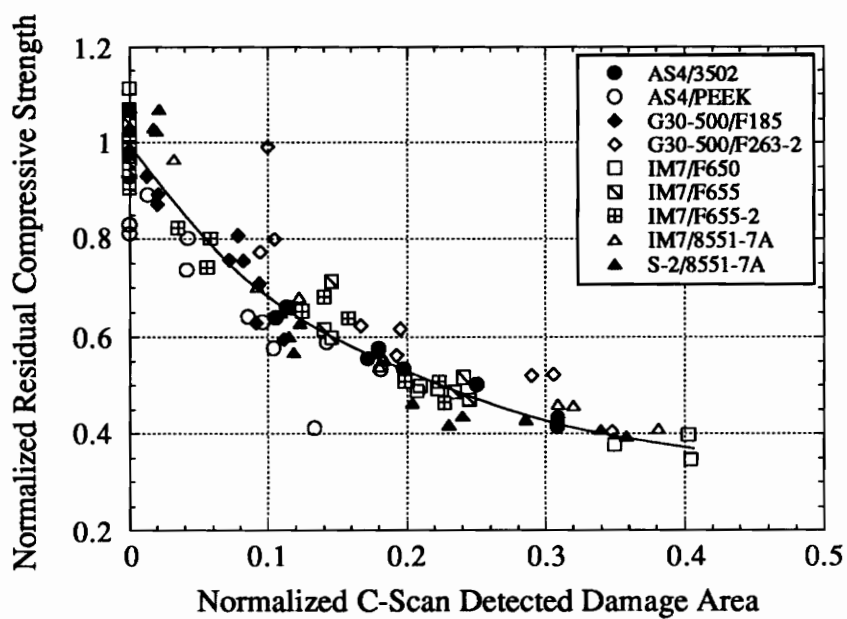
Fig. 5.29 Variation of (a) residual compressive strength with C-scan detected damage area and (b) normalized residual compressive strength with normalized C-scan detected damage area for each material system.

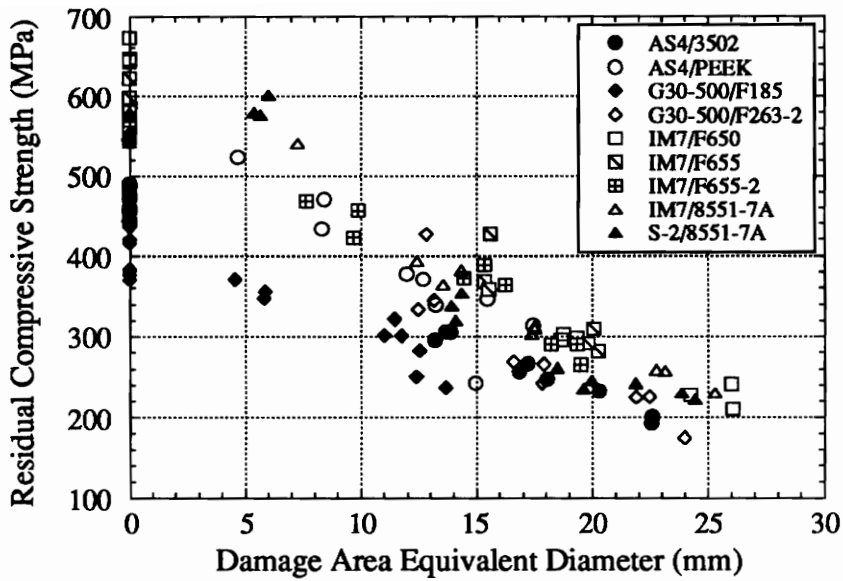
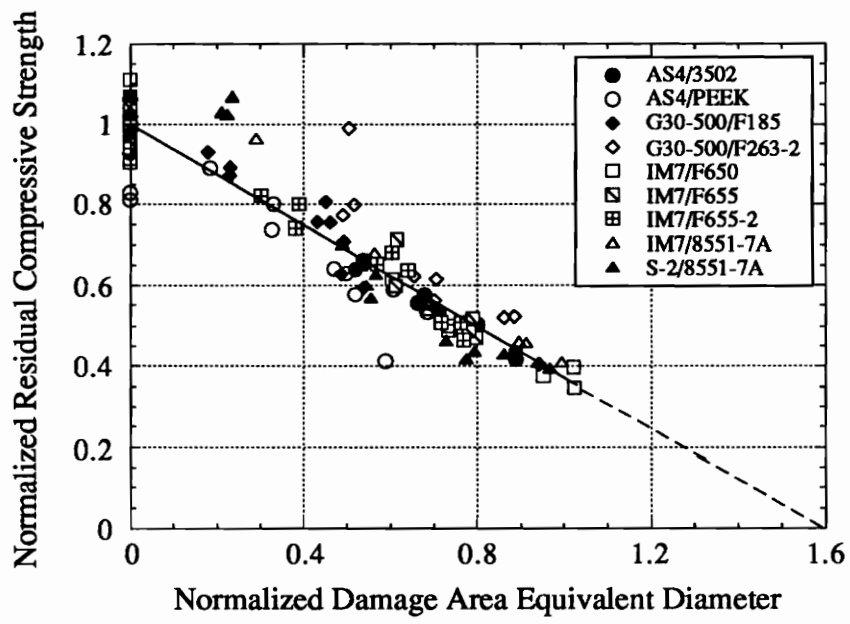
Fig. 5.30 Variation of (a) residual compressive strength with damage area equivalent diameter and (b) normalized residual compressive strength with normalized damage area equivalent diameter for each material system.

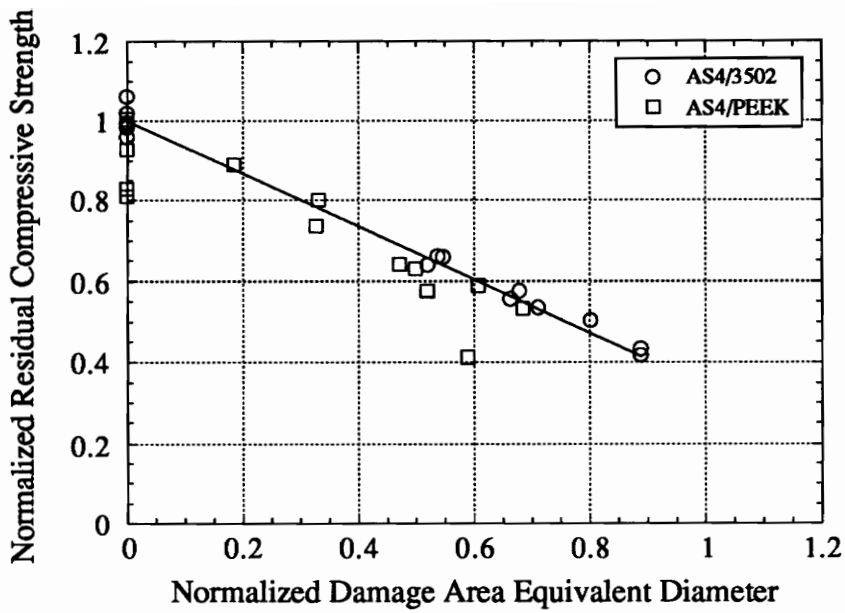
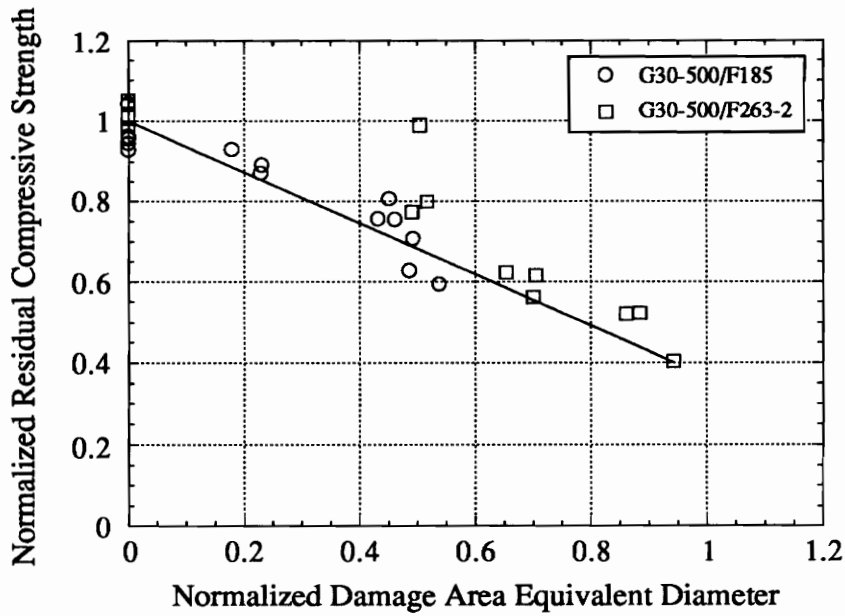
Fig. 5.31 Variation of normalized residual compressive strength with normalized damage area equivalent diameter for (a) AS4 and (b) G30-500 fiber material systems.

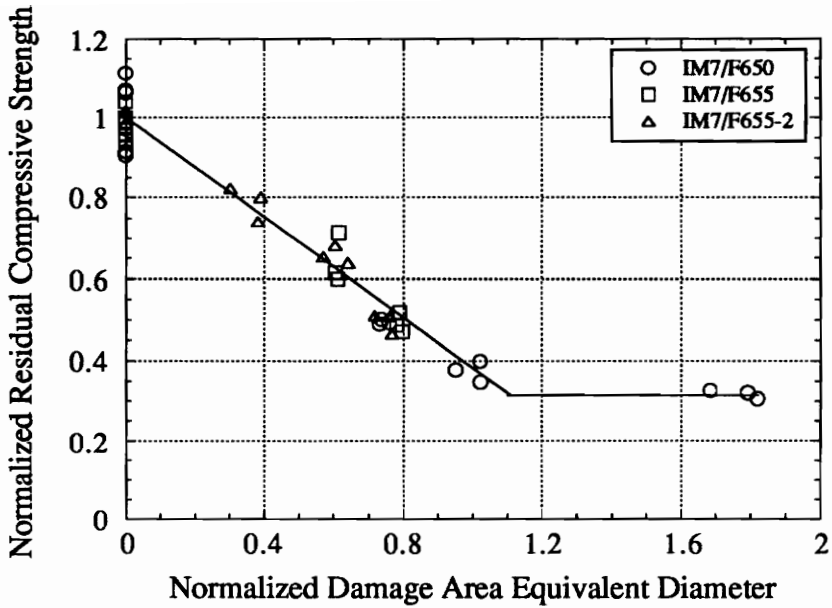
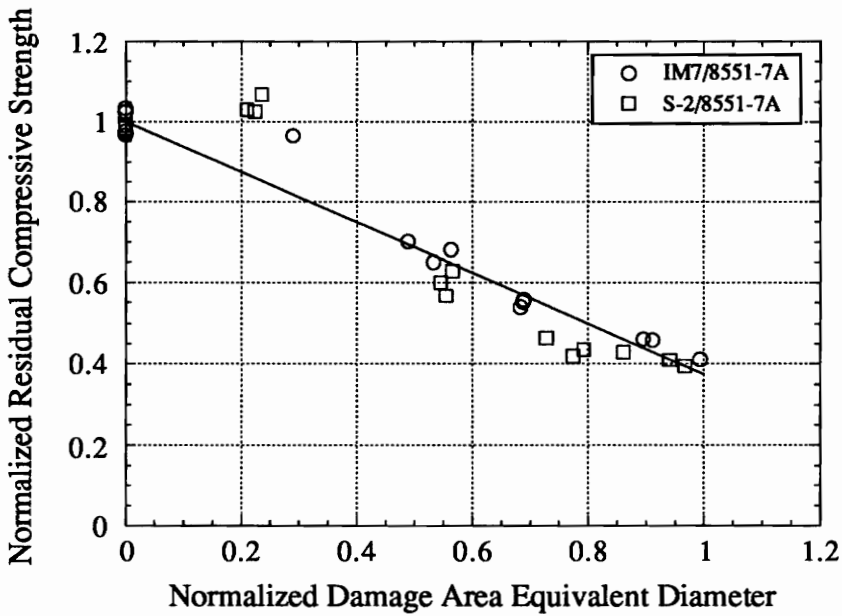
Fig. 5.32 Variation of normalized residual compressive strength with normalized damage area equivalent diameter for (a) BMI and (b) rubber toughened epoxy matrix material systems.

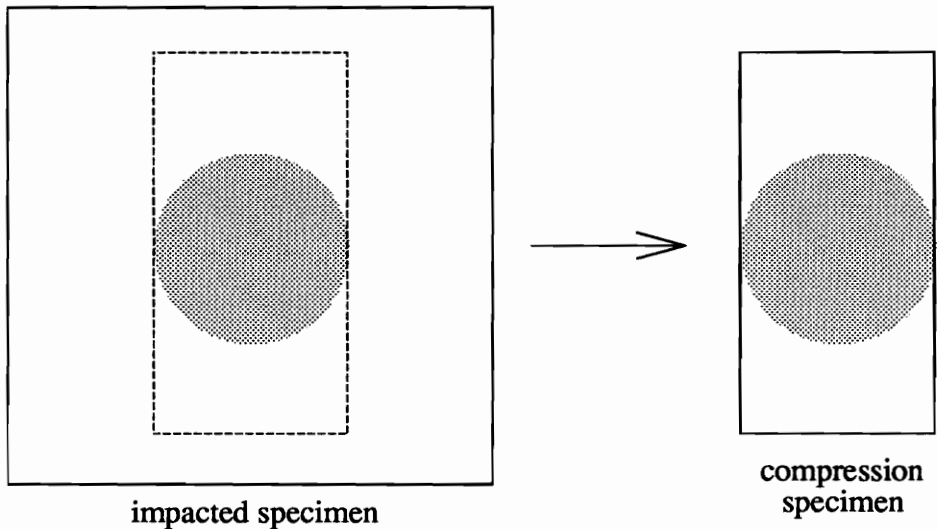
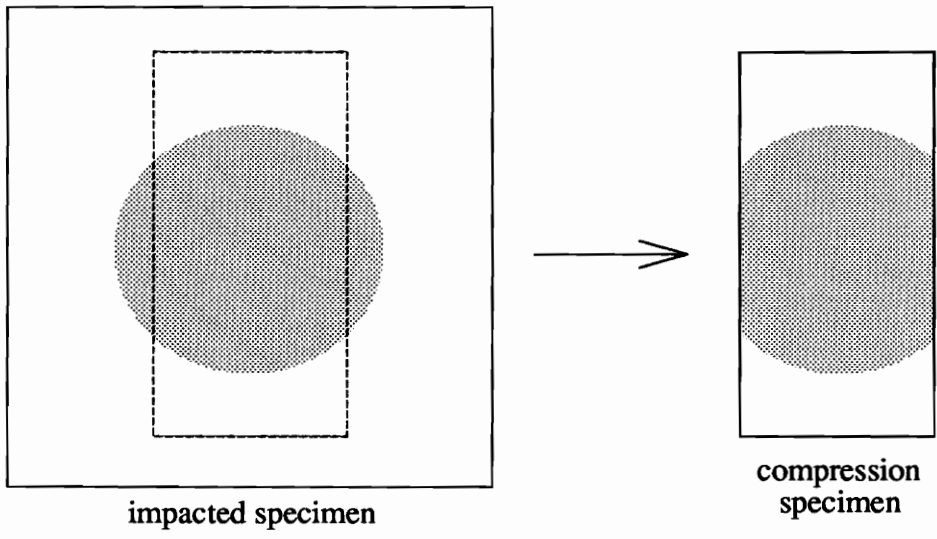
Fig. 5.33 The width of damage (delamination) size in compression specimens which are cut from impacted specimens after impacted with (a) lower and (b) higher velocities.

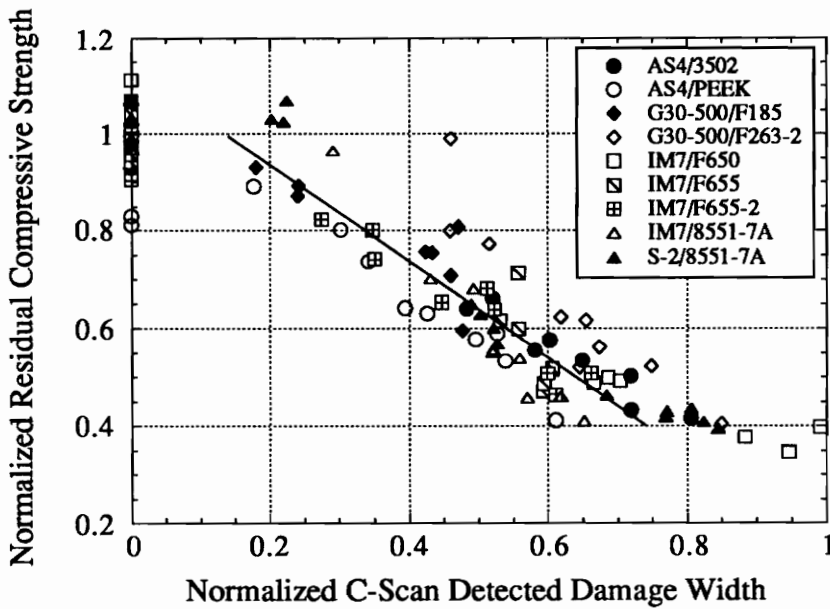
Fig. 5.36 Variation of (a) residual compressive strength with damage width and (b) normalized residual compressive strength with normalized damage width for each material system.

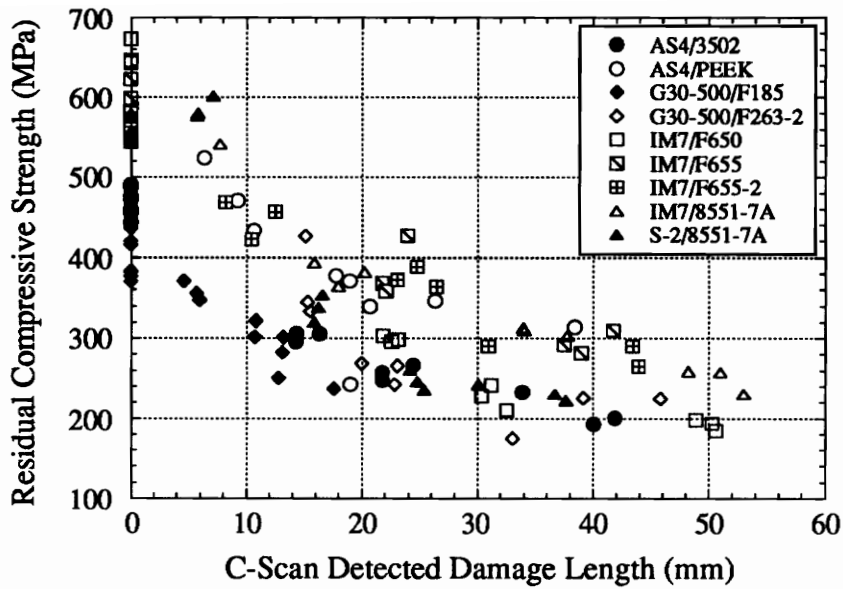
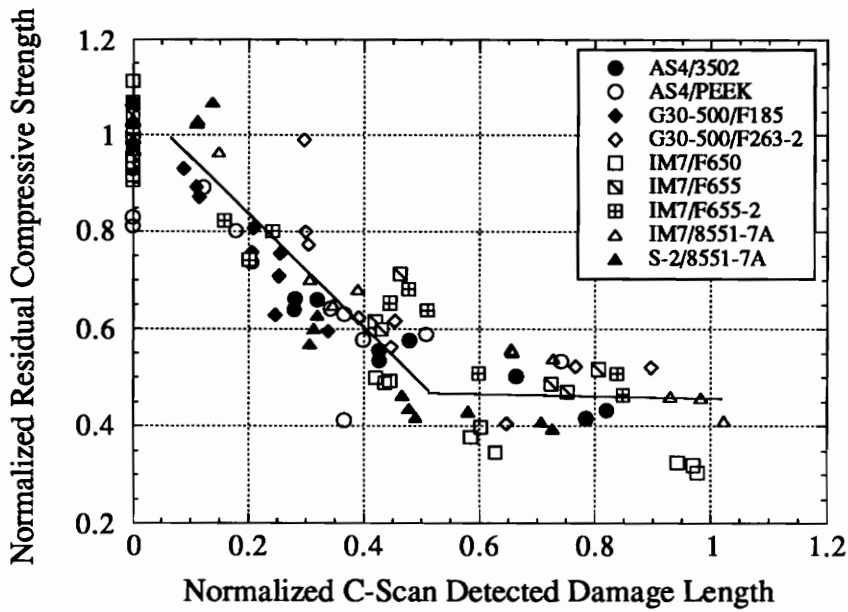
Fig. 5.37 Variation of (a) residual compressive strength with damage length and (b) normalized residual compressive strength with normalized damage length for each material system.

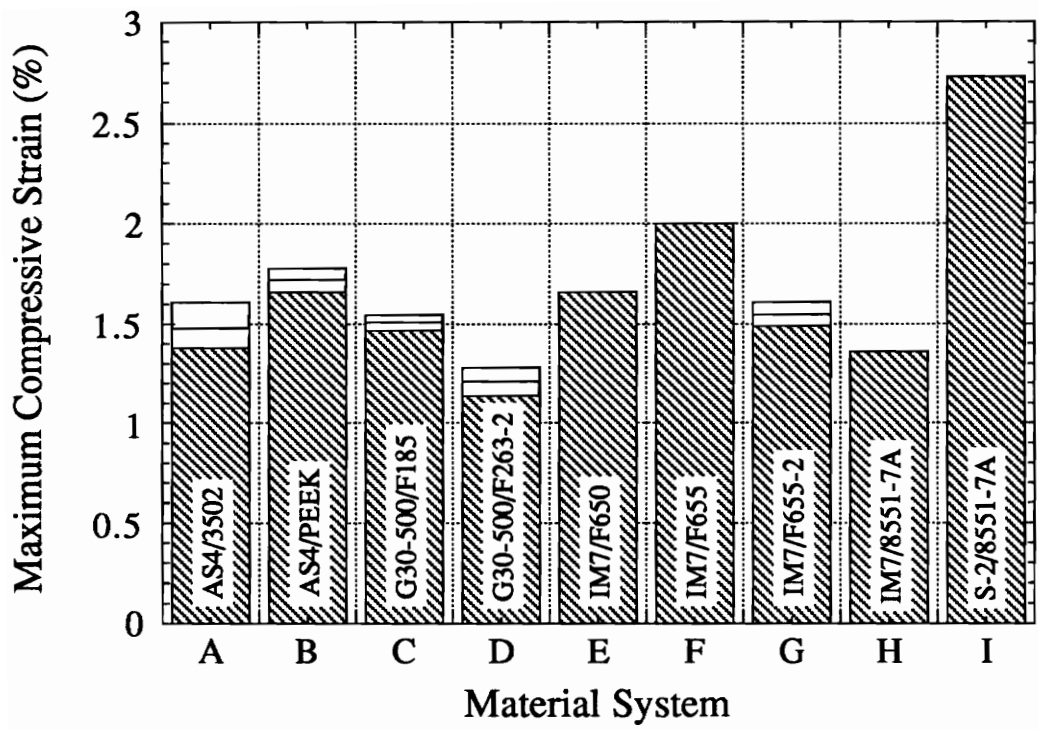
Fig. 5.38 Maximum compressive strain of each material system.

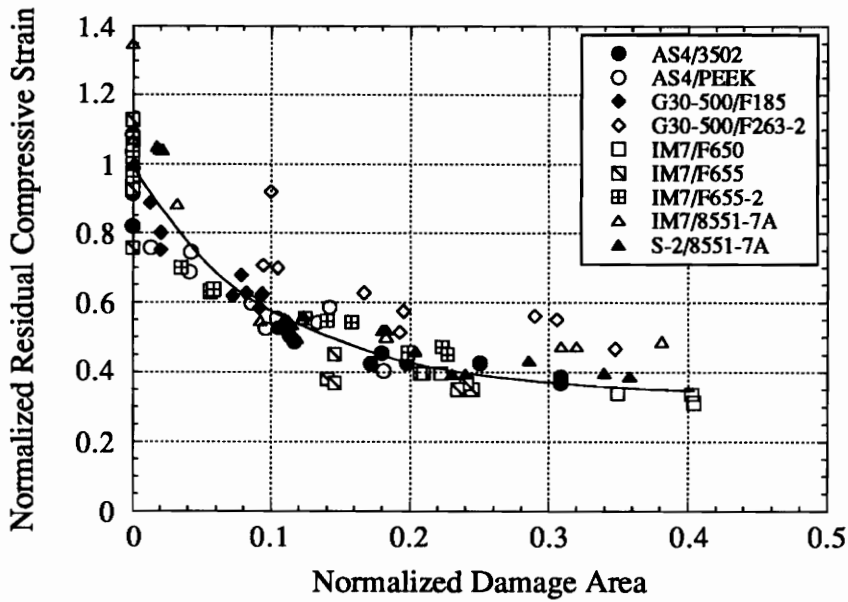
Fig. 5.42 Variation of (a) residual compressive strain with C-scan detected damage area and (b) normalized residual compressive strain with normalized damage area for each material system.

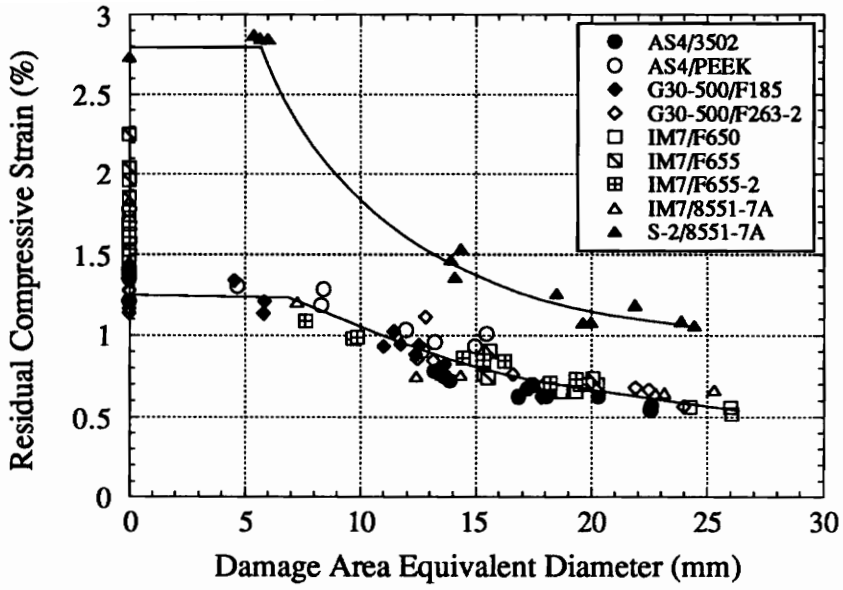
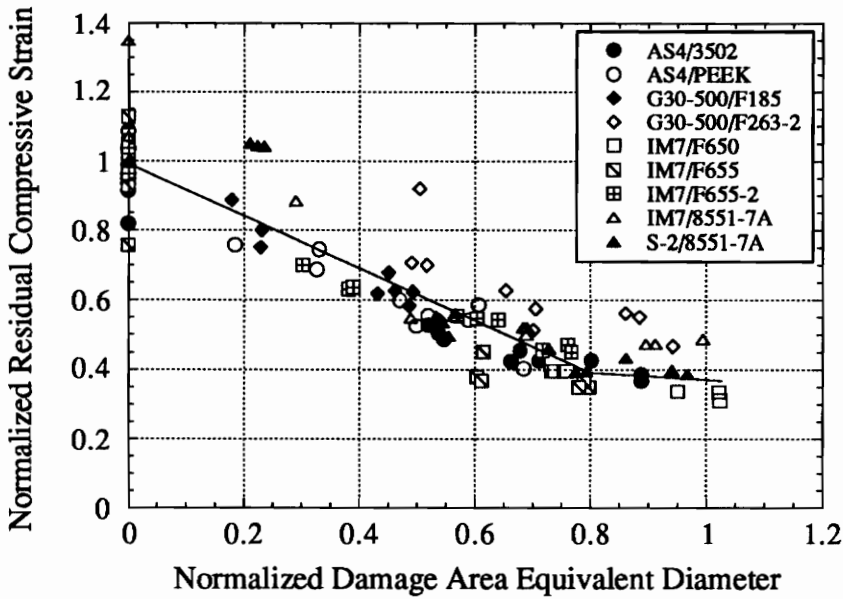
Fig. 5.43 Variation of (a) residual compressive strain with damage area equivalent diameter and (b) normalized residual compressive strain with normalized damage area equivalent diameter for each material system.

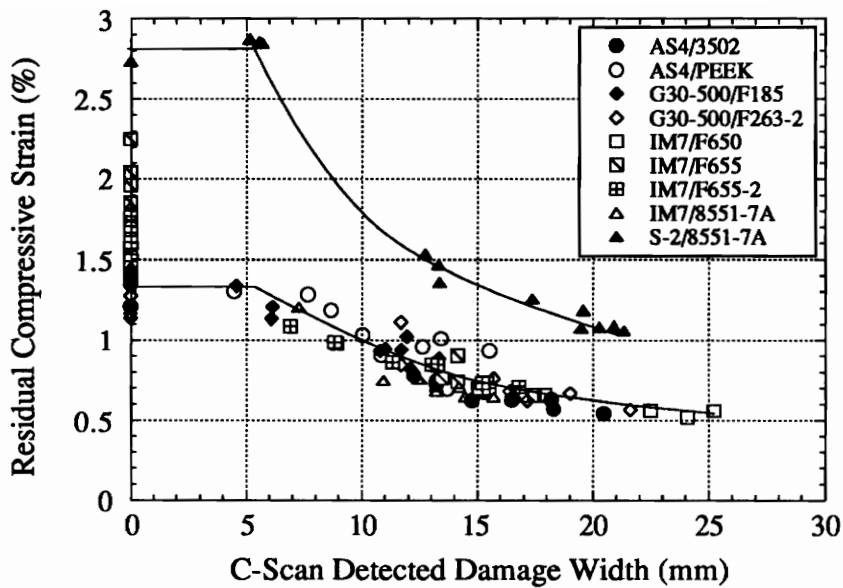
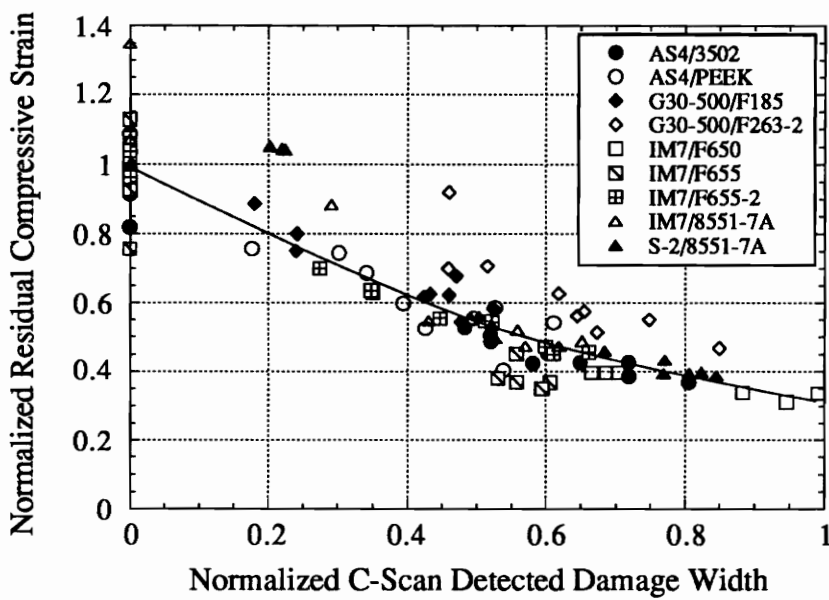
Fig. 5.44 Variation of (a) residual compressive strain with C-scan detected damage width and (b) normalized residual compressive strain with normalized C-scan detected damage width for each material system.

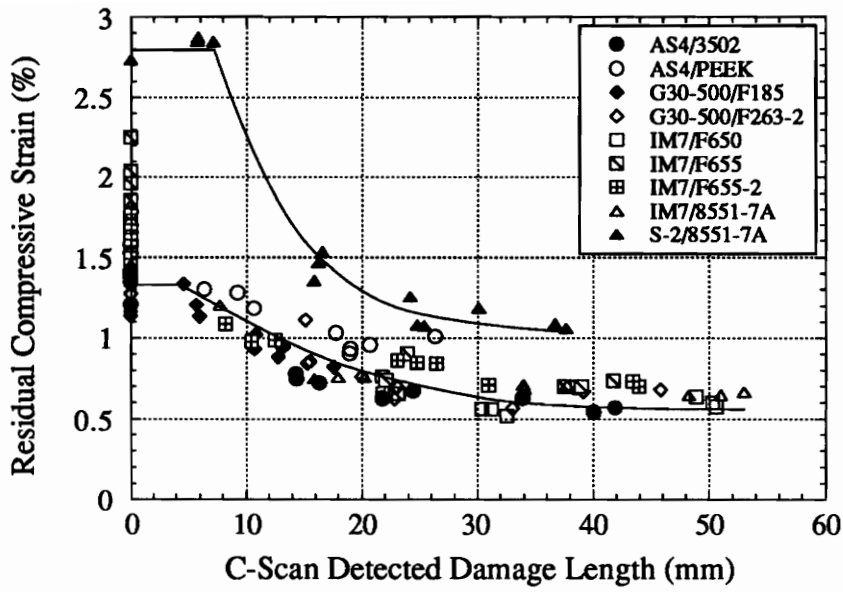
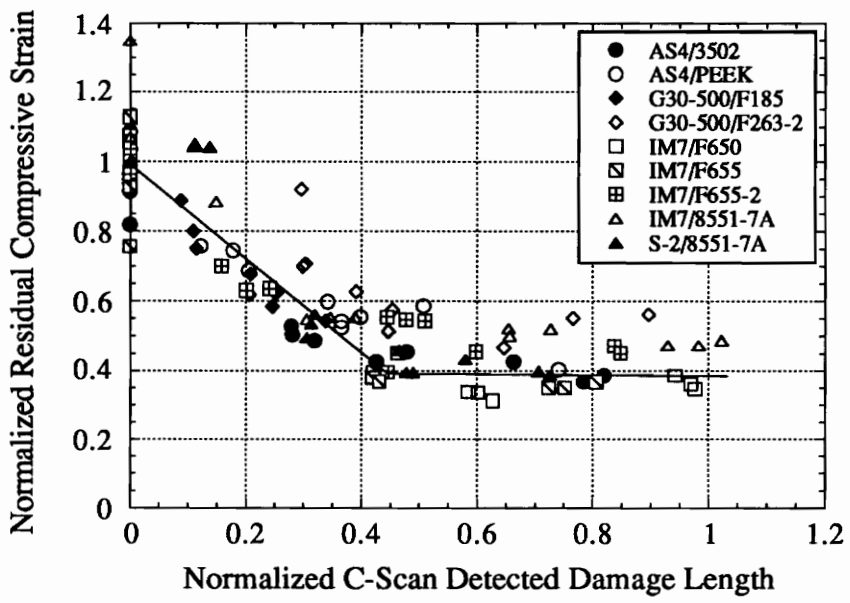
Fig. 5.45 Variation of (a) residual compressive strain with C-scan detected damage length and (b) normalized residual compressive strain with normalized C-scan detected damage length for each material system.

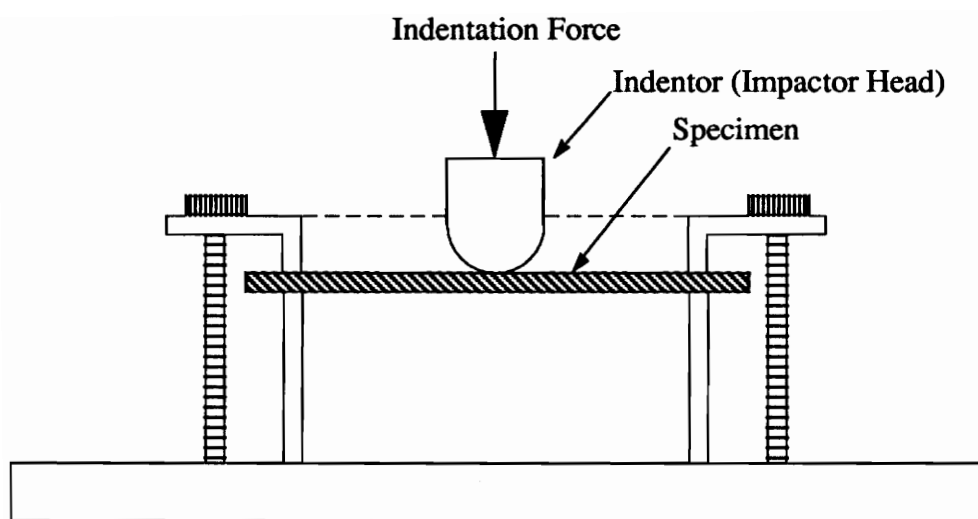
Fig. 6.1 Schematic diagram of the quasi-static indentation test setup.

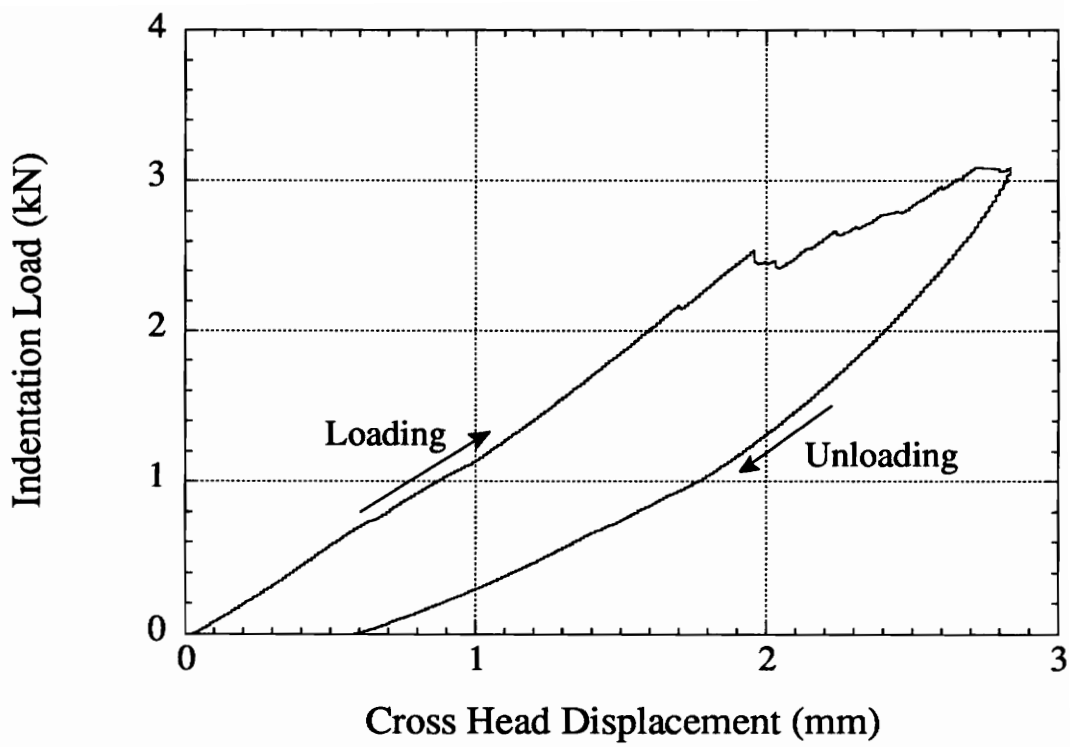
Fig. 6.2 The original recorded indentation load-crosshead displacement curve of a AS4/PEEK specimen.

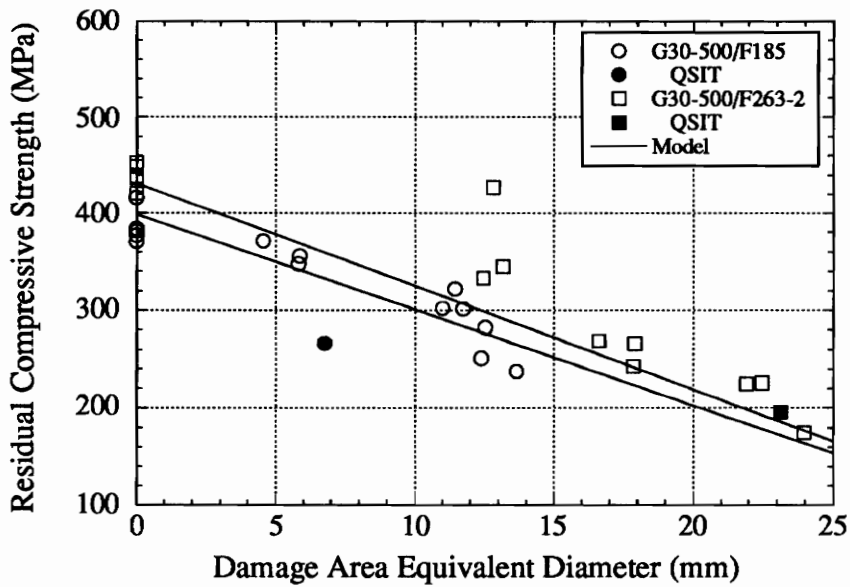
Fig. 6.13 Variation of residual compressive strength with damage area equivalent diameter resulted from impact and quasi-static indentation test (QSIT) for (a) AS4 and (b) G30-500 fiber material systems.

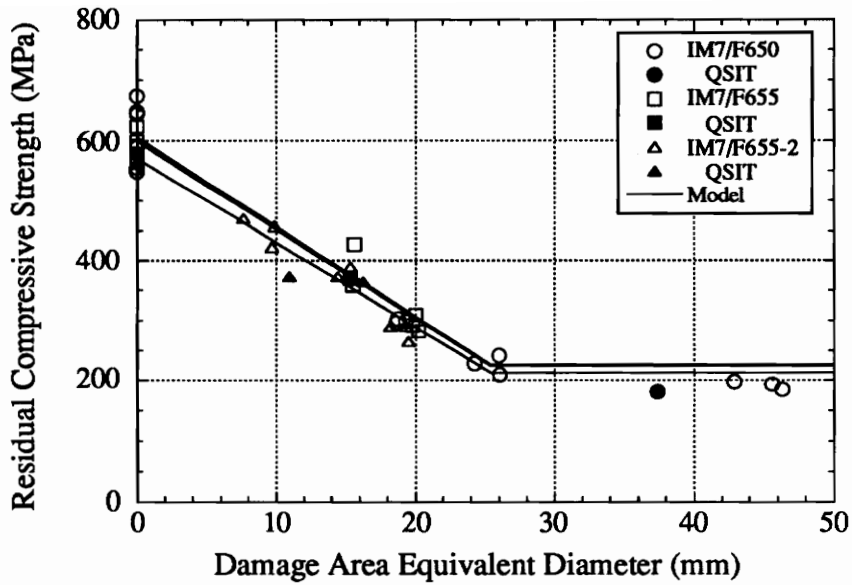
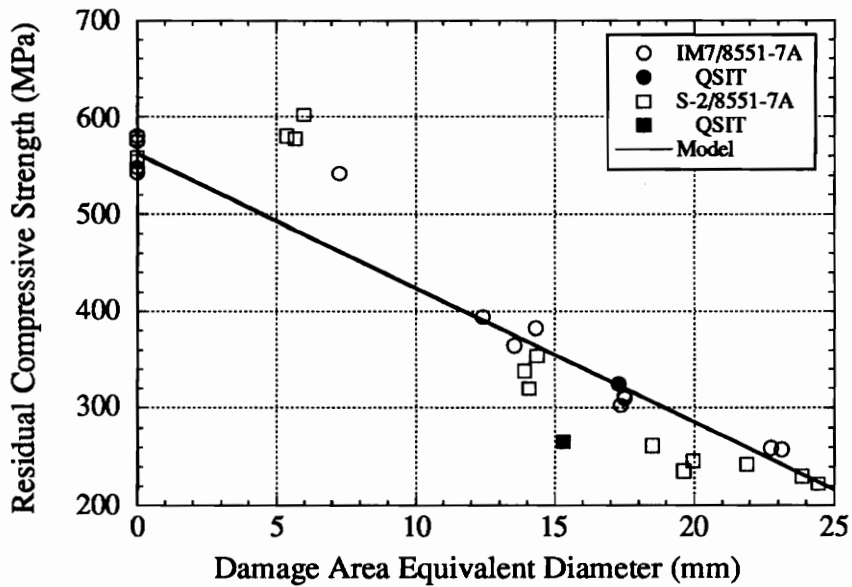
Fig. 6.14 Variation of residual compressive strength with damage area equivalent diameter resulted from impact and quasi-static indentation test (QSIT) for (a) BMI and (b) rubber toughened epoxy matrix material systems.

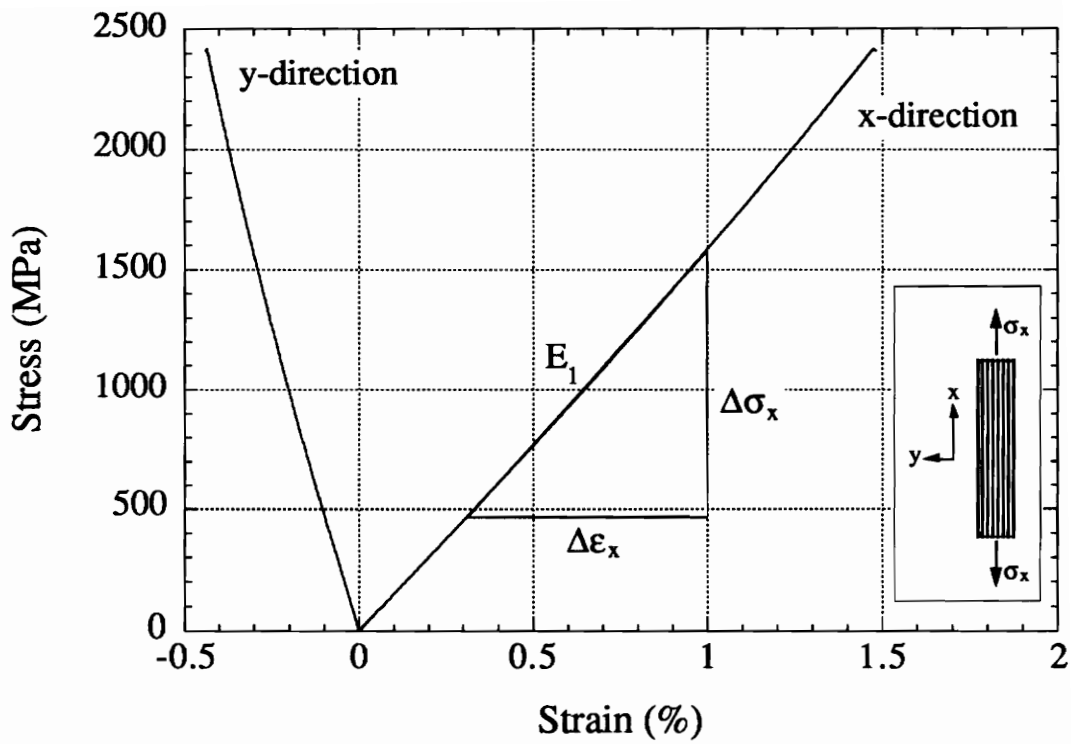
Fig. A.1 Tensile stress-strain curves for $[0^\circ]_8$ IM7/8551-7A. The strains in x and y directions are the longitudinal and transverse strains of the specimen.

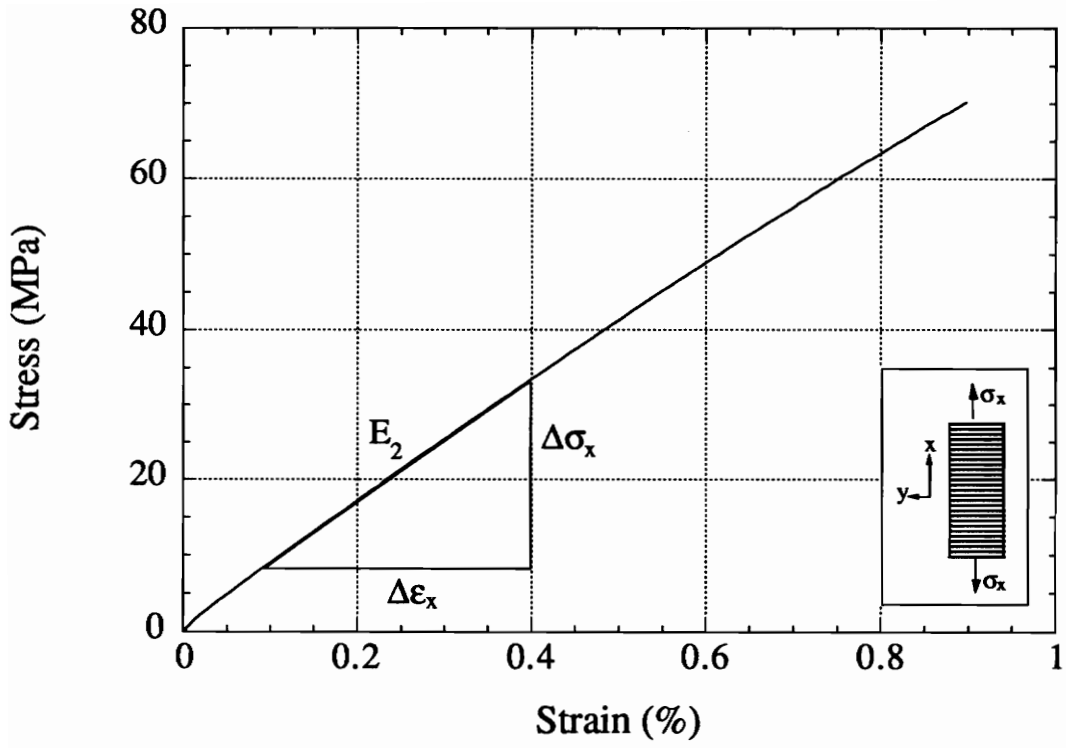
Fig. A.2 Tensile stress-strain curve for [90°]₈ IM7/8551-7A.

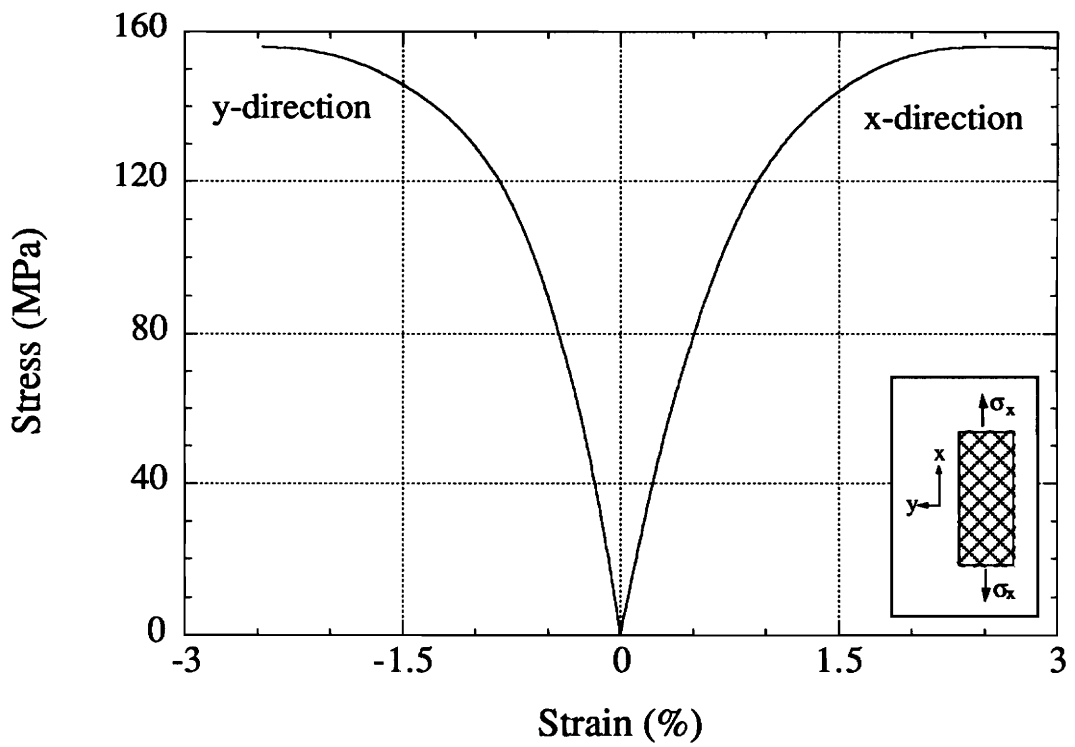
Fig. A.3 Tensile stress-strain curves for $[\pm 45^\circ]_{2S}$ IM7/8551-7A. The strains in x and y directions are the longitudinal and transverse strains of the specimen.

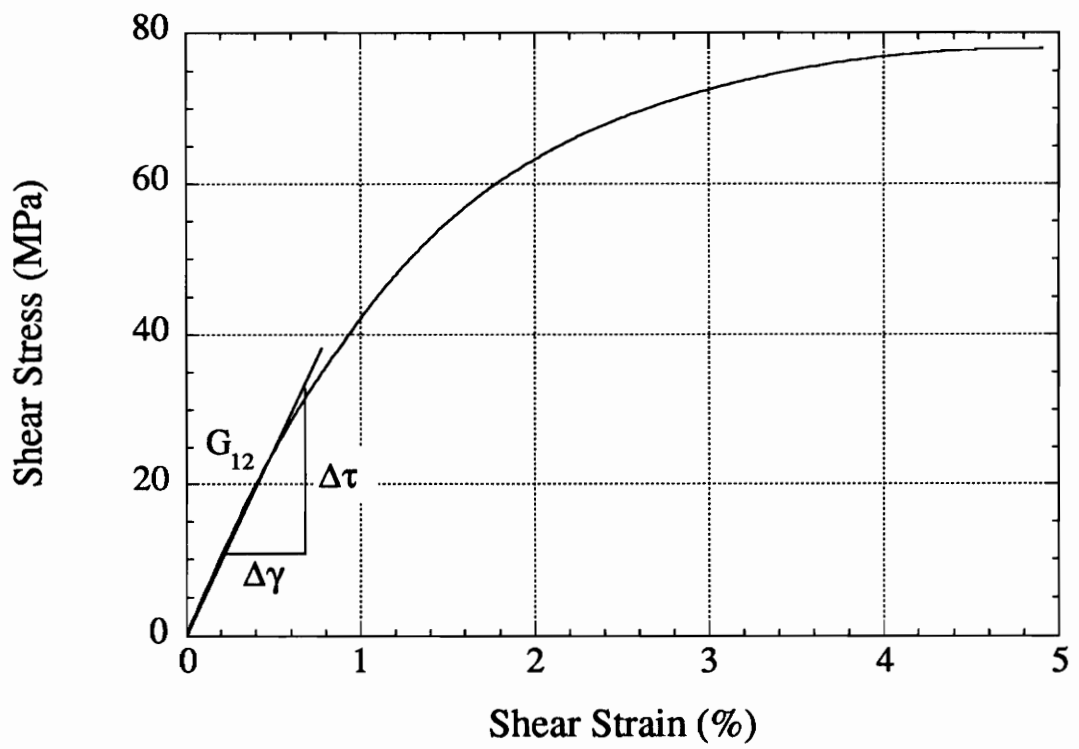
Fig. A.4 Shear stress-strain curve for IM7/8551-7A.

and the shear modulus G_{12} was measured from the slope of the shear stress-strain curve in Fig. A.4.
