**NONDESTRUCTIVE EVALUATION
OF A HIGH TEMPERATURE
CERAMIC MATRIX COMPOSITE MATERIAL**

Thesis submitted to the Faculty of the
Virginia Polytechnic Institute and State University
in partial fulfillment of the requirements for the degree of

Engineering Science and Mechanics

February 8, 1995

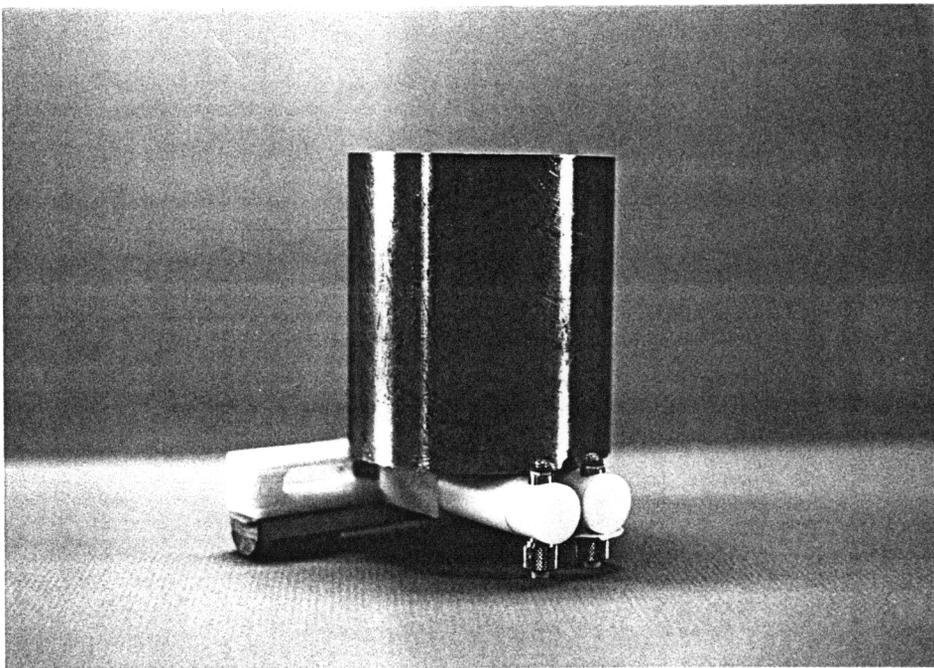
FIGURE 6a: The Harisonic fixture and dry-coupled transducers.

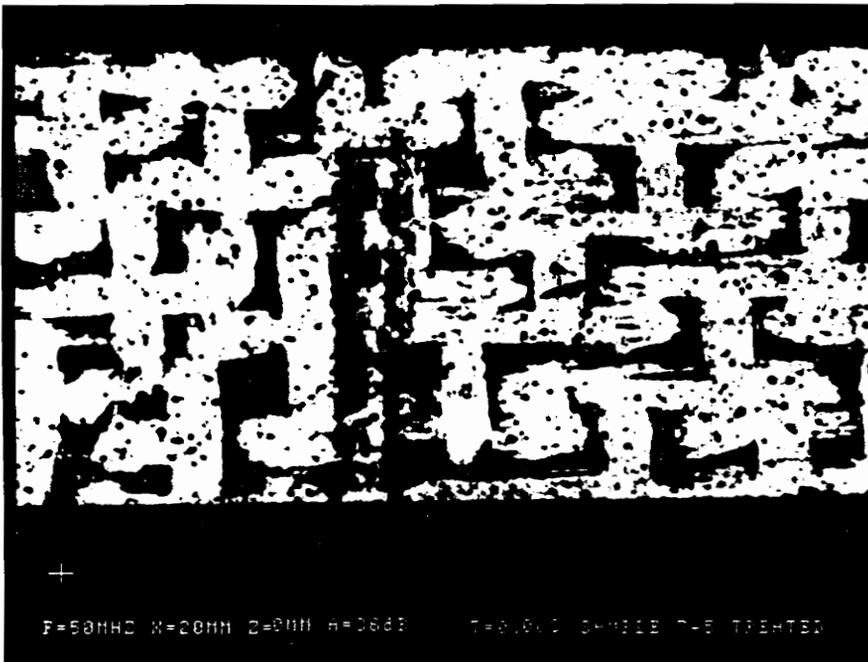
FIGURE 10: Acoustic micrograph of AM-7-5 before heat treatment. (z = 0 mm, A = 36 dB, T = 0 μ s)

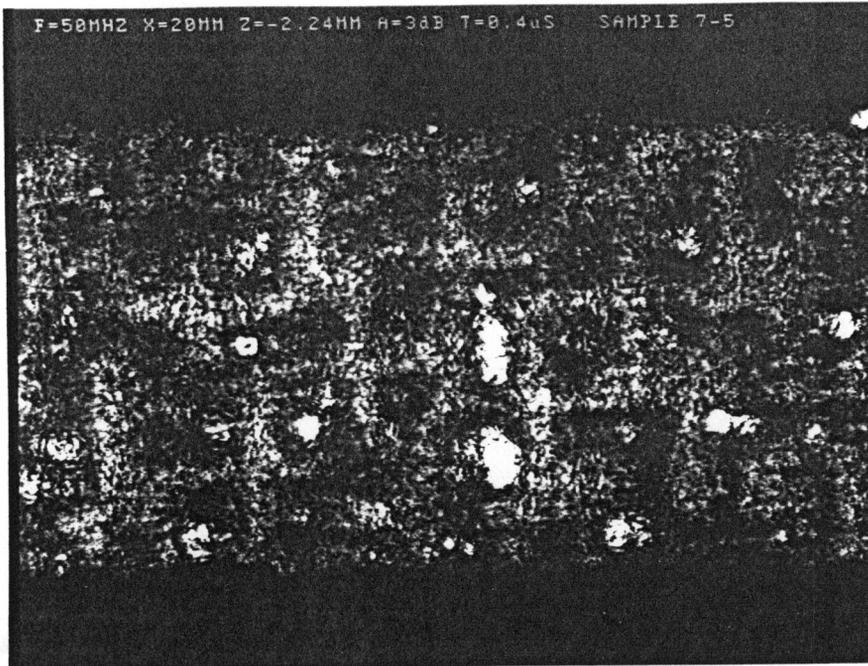
FIGURE 11: Acoustic micrograph of AM-7-5 after 100 hrs. of thermal ageing at 1400 °C. (z = 0 mm, A = 36 dB, T = 0 μ s)

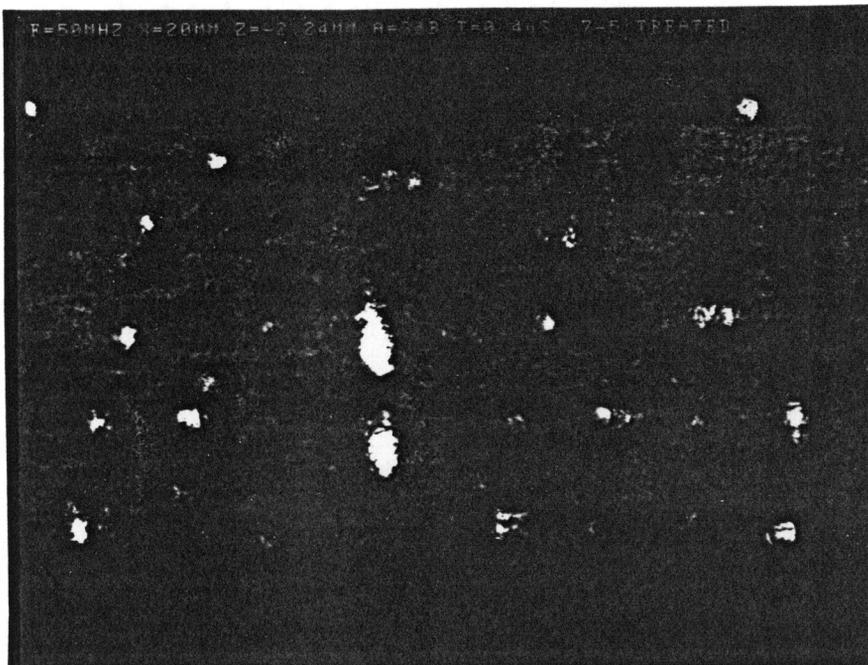
FIGURE 12: Acoustic micrograph of AM-7-5 before heat treatment.
($z = -2.24$ mm, $A = 3$ dB, $T = 0.4$ μ s)

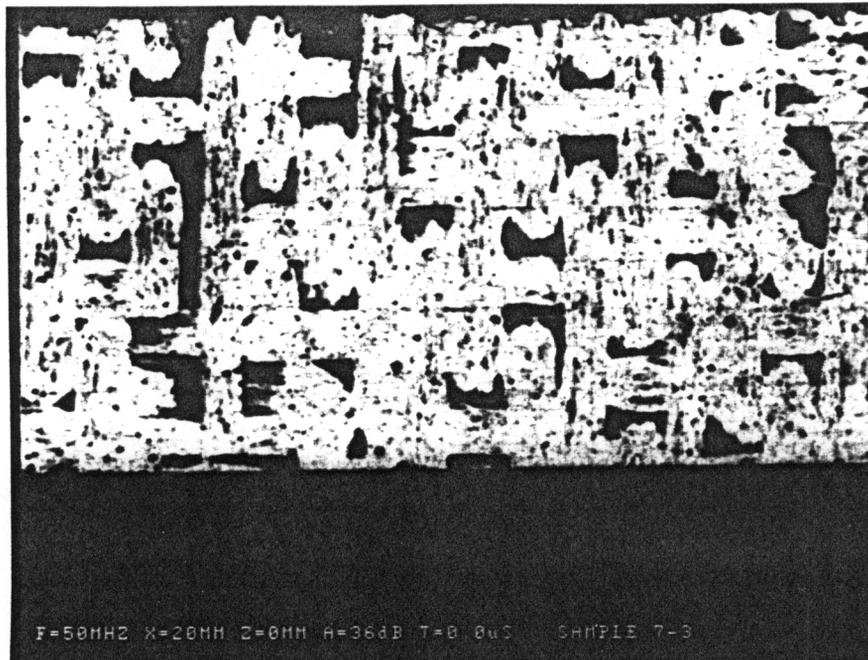
FIGURE 13: Acoustic micrograph of AM-7-5 after 100 hrs. of
thermal ageing at 1400 °C. ($z = 0$ mm, $A = 3$ dB, $T = 0.4$ μ s)

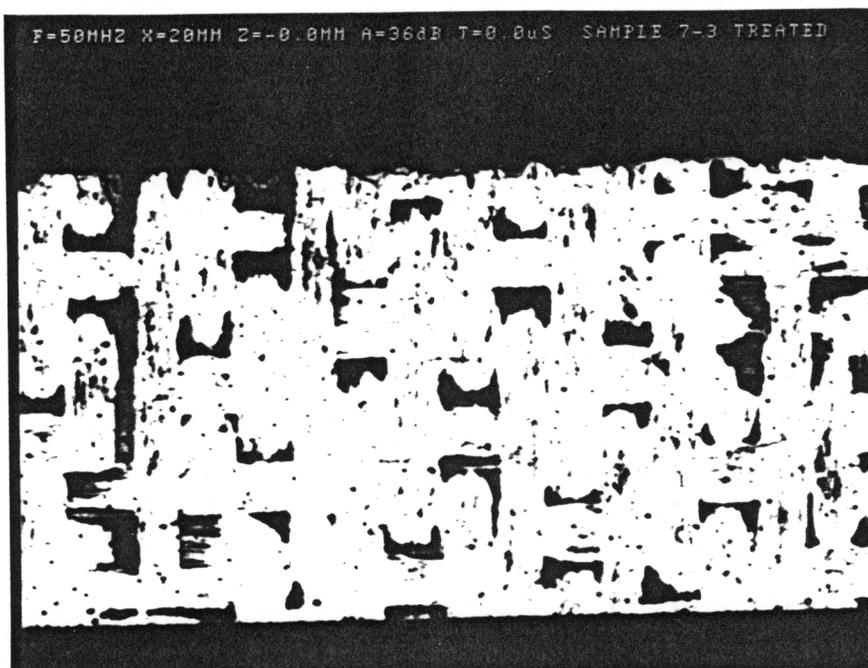
FIGURE 14: Acoustic micrograph of AM-7-3 before heat treatment.
($z = 0$ mm, $A = 36$ dB, $T = 0$ μ s)

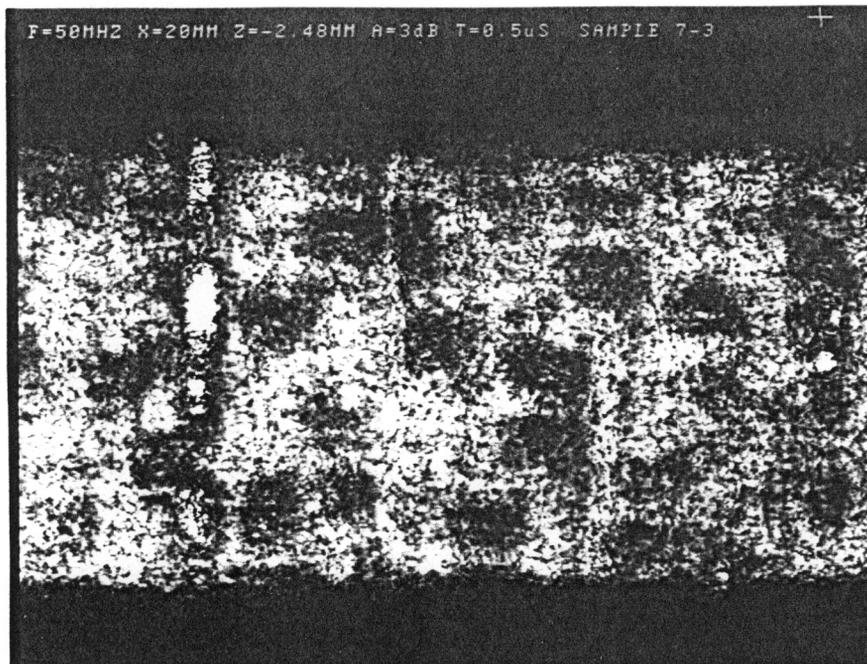
FIGURE 15: Acoustic micrograph of AM-7-3 after 100 hrs. of
thermal ageing at 1200 $^{\circ}$ C. ($z = 0$ mm, $A = 36$ dB, $T = 0$ μ s)

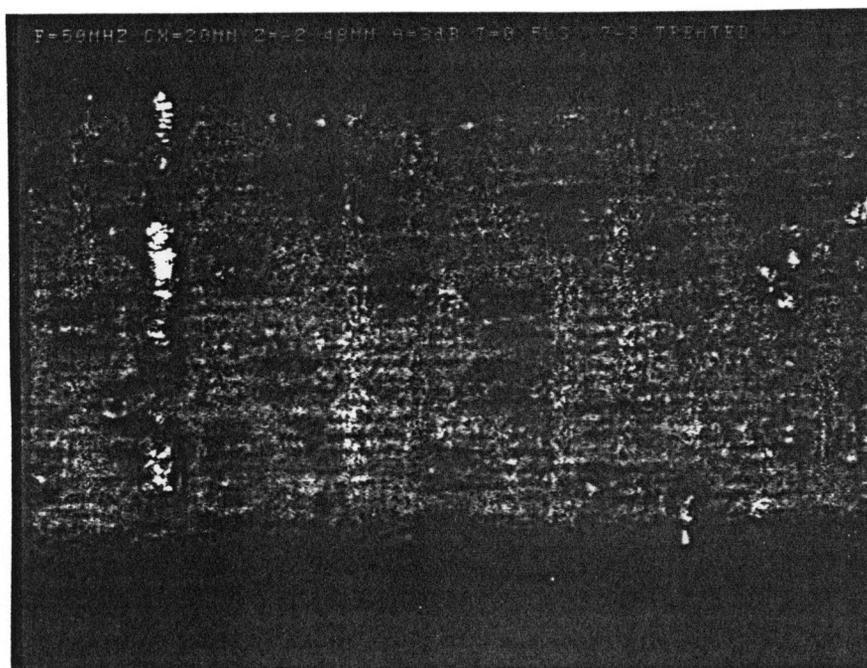
FIGURE 16: Acoustic micrograph of AM-7-3 before heat treatment.
($z = -2.48$ mm, $A = 3$ dB, $T = 0.5$ μ s)

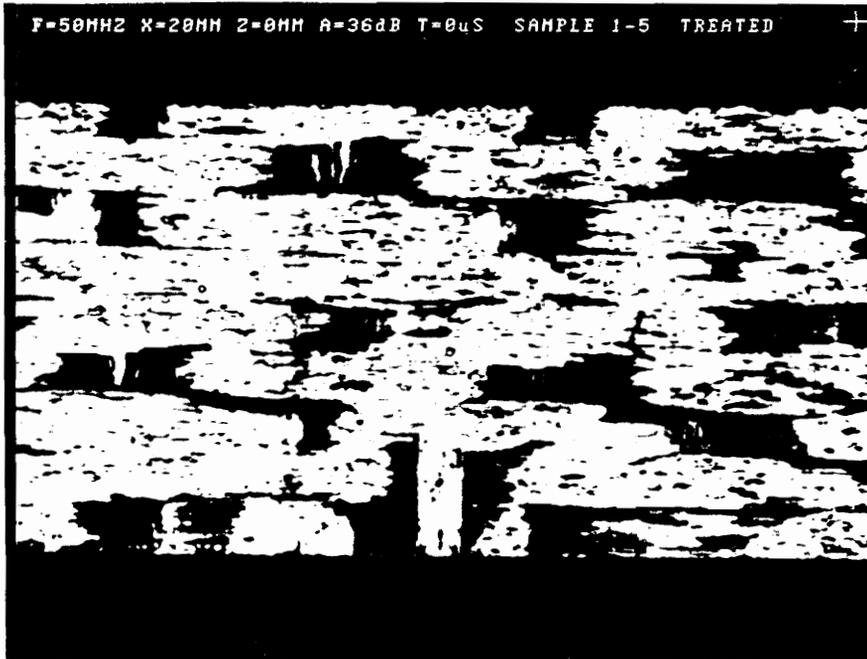
FIGURE 17: Acoustic micrograph of AM-7-3 after 100 hrs. of
thermal ageing at 1200 $^{\circ}$ C. ($z = -2.48$ mm, $A = 3$ dB, $T = 0.5$ μ s)

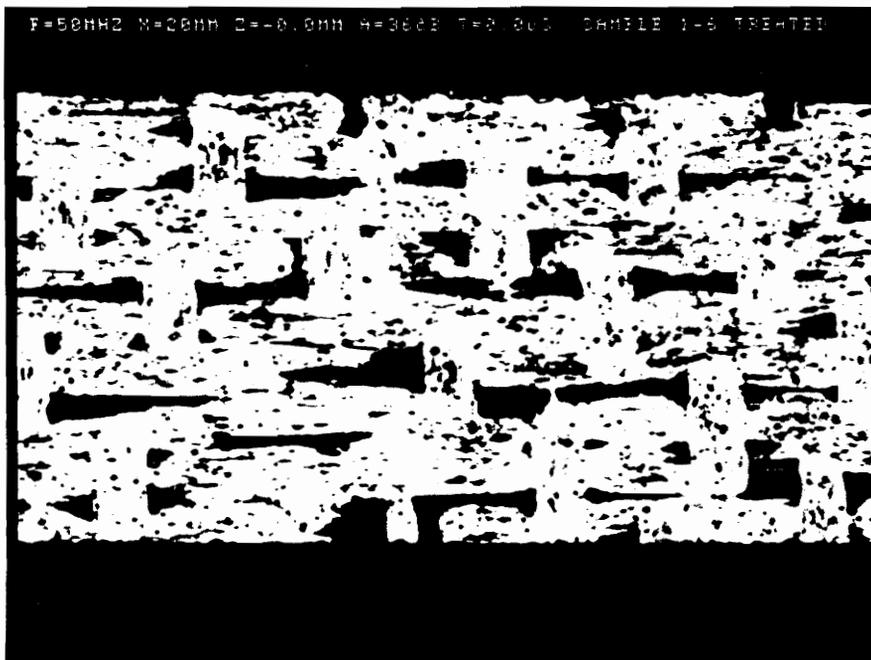
FIGURE 18: Acoustic micrograph of AM-1-5 after 100 hrs. of thermal ageing at 1400 °C ($z = 0$ mm, $A = 36$ dB, $T = 0$ μ s)

Figures 18 and 19 are surface images of uncoated specimens AM-1-5 and AM-1-6 after heat treatment. Specimen AM-1-5 was heat treated at 1400 °C, and specimen AM-1-6 was heat treated at 1200 °C. The same observations that were made about the SAM images of the coated specimens are also valid for the SAM images of these uncoated specimens. The surface images of the two uncoated specimens are shown in **Figures 18 and 19** to illustrate the differences in texture and weave appearance between the coated and uncoated specimens.

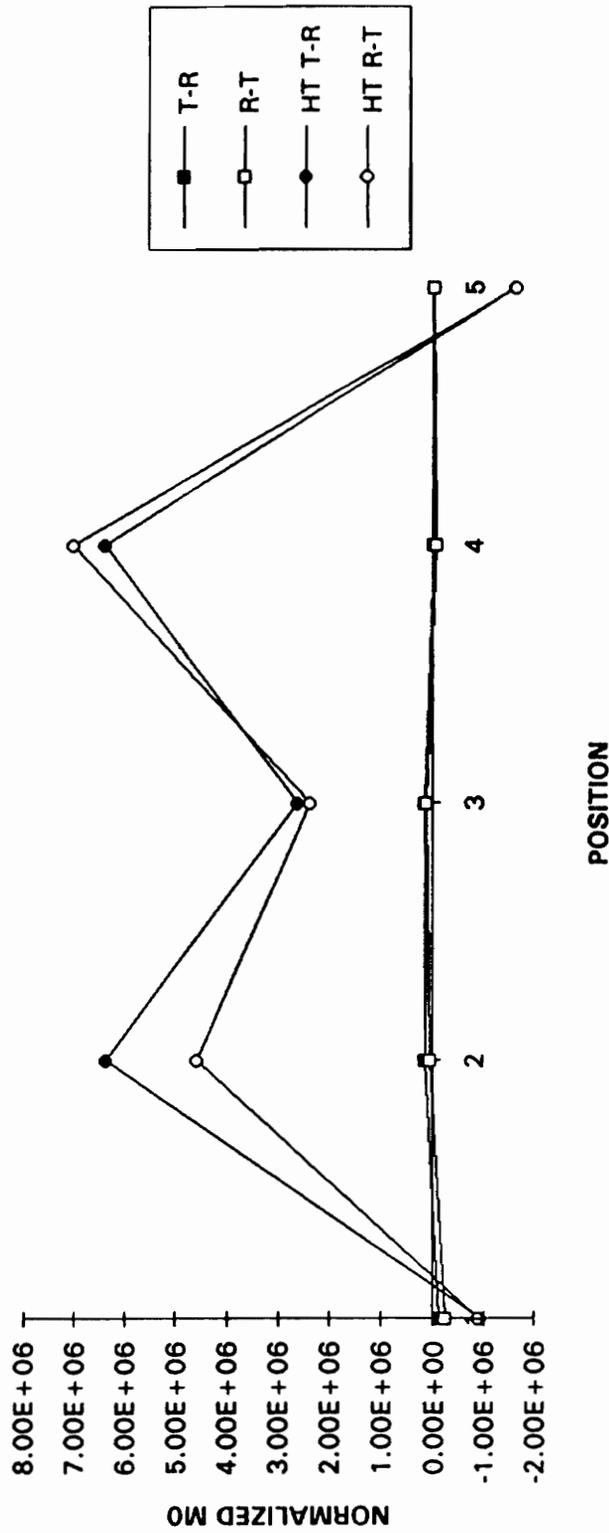
FIGURE 21: Normalized AU parameter M_0 vs. Transverse Position, specimen AM-8-1 before and after heat treatment at 1000 °C.

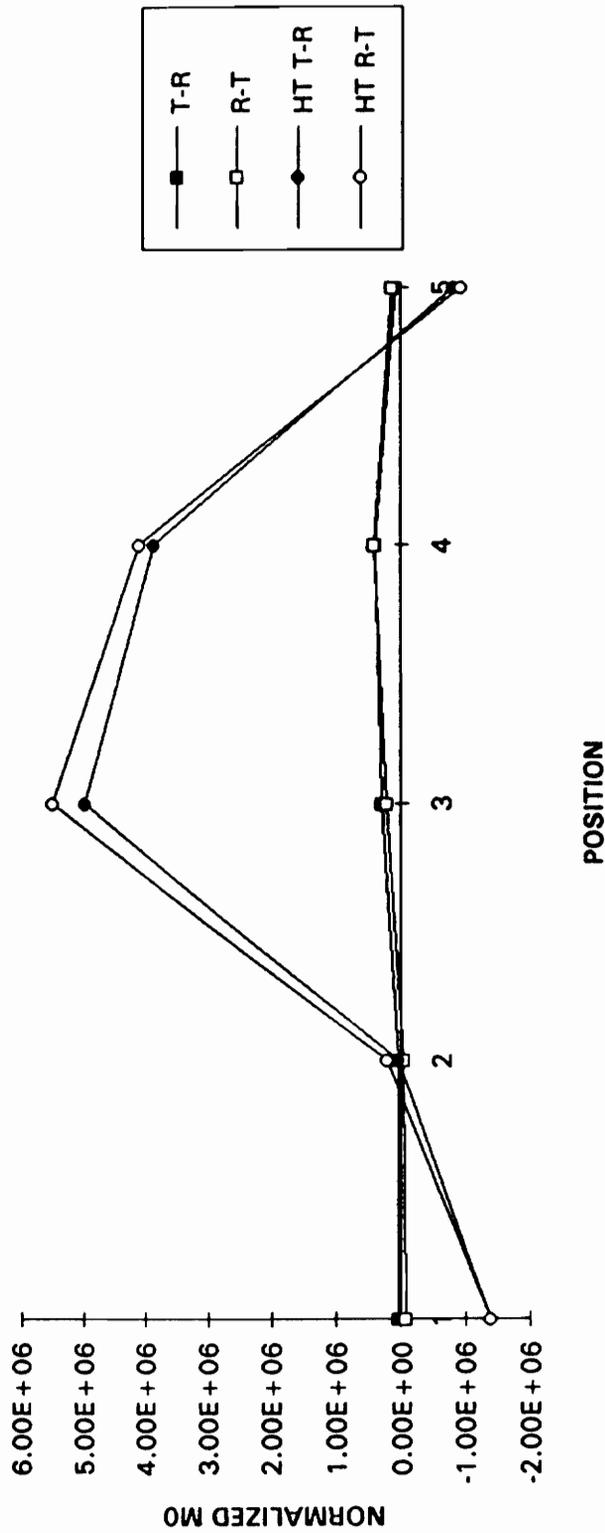
FIGURE 22: Normalized AU parameter M_0 vs. Longitudinal Position, specimen AM-1-7 before and after heat treatment at 1000 °C.

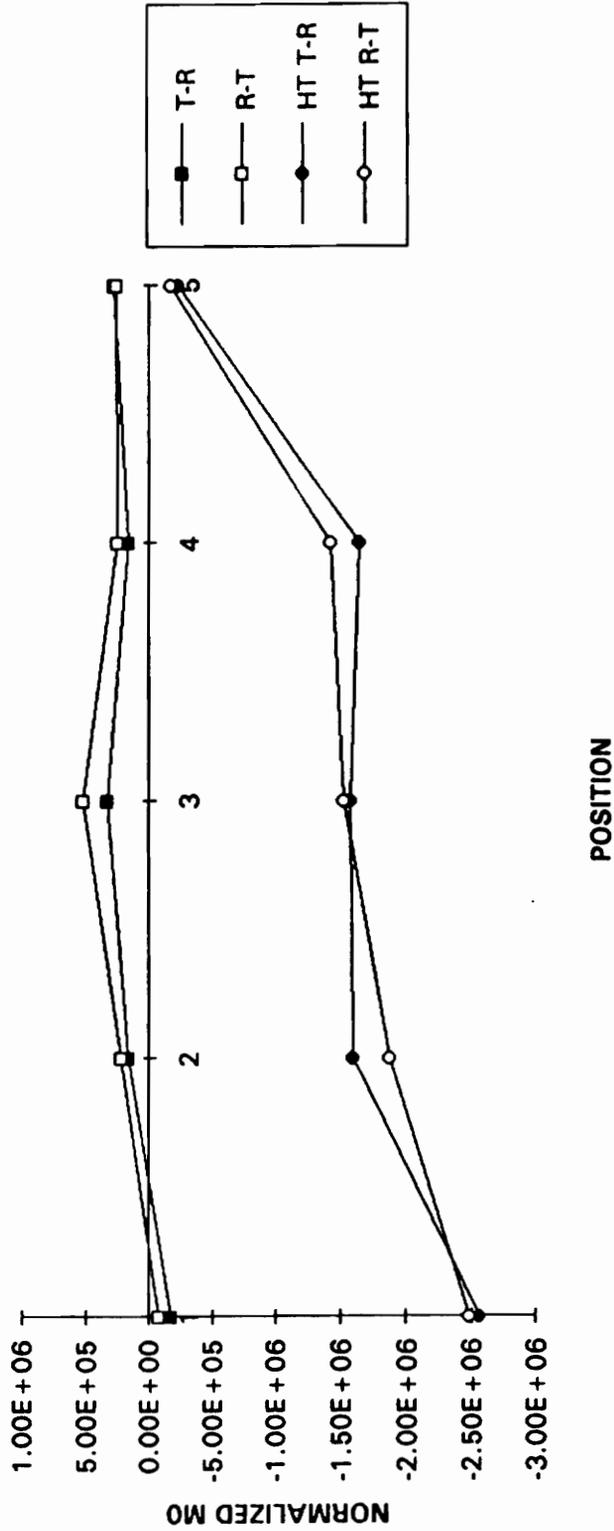
FIGURE 23: Normalized AU parameter M_0 vs. Longitudinal Position, specimen AM-2-1 before and after heat treatment at 1000 °C.

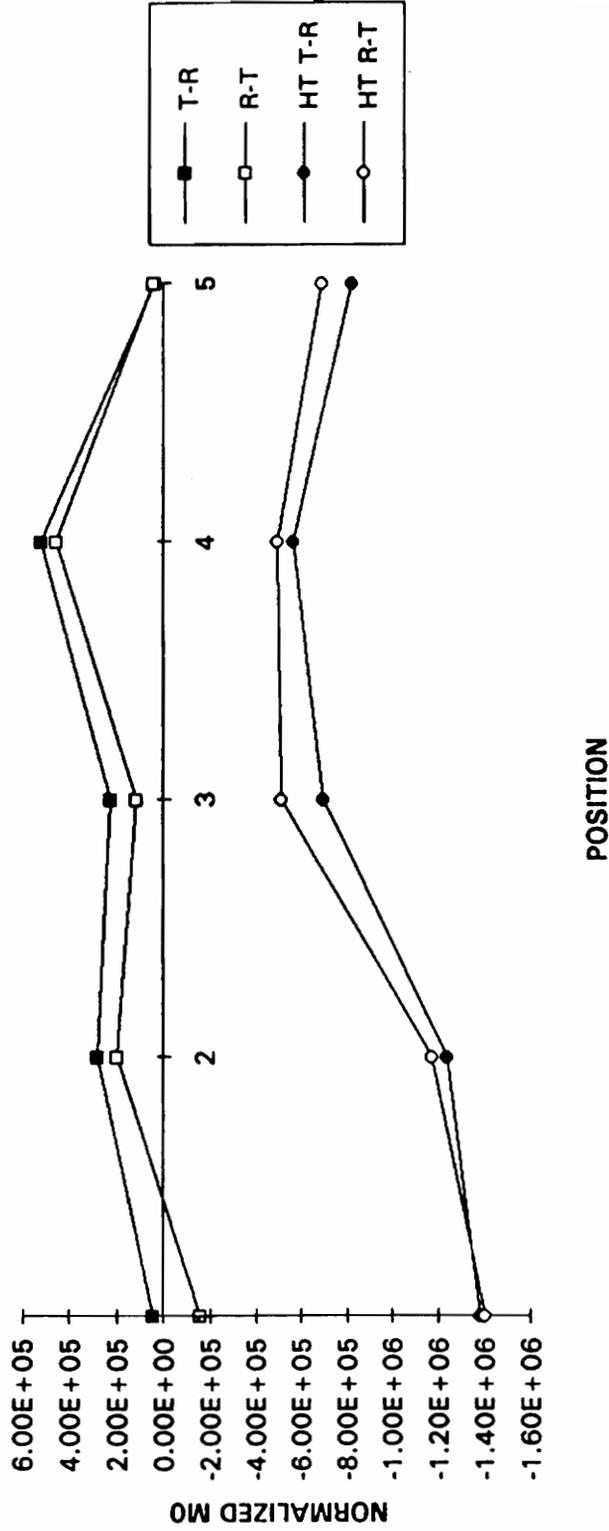
FIGURE 24: Normalized AU parameter M_0 vs. Longitudinal Position, specimen AM-7-3 before and after heat treatment at 1200 °C.

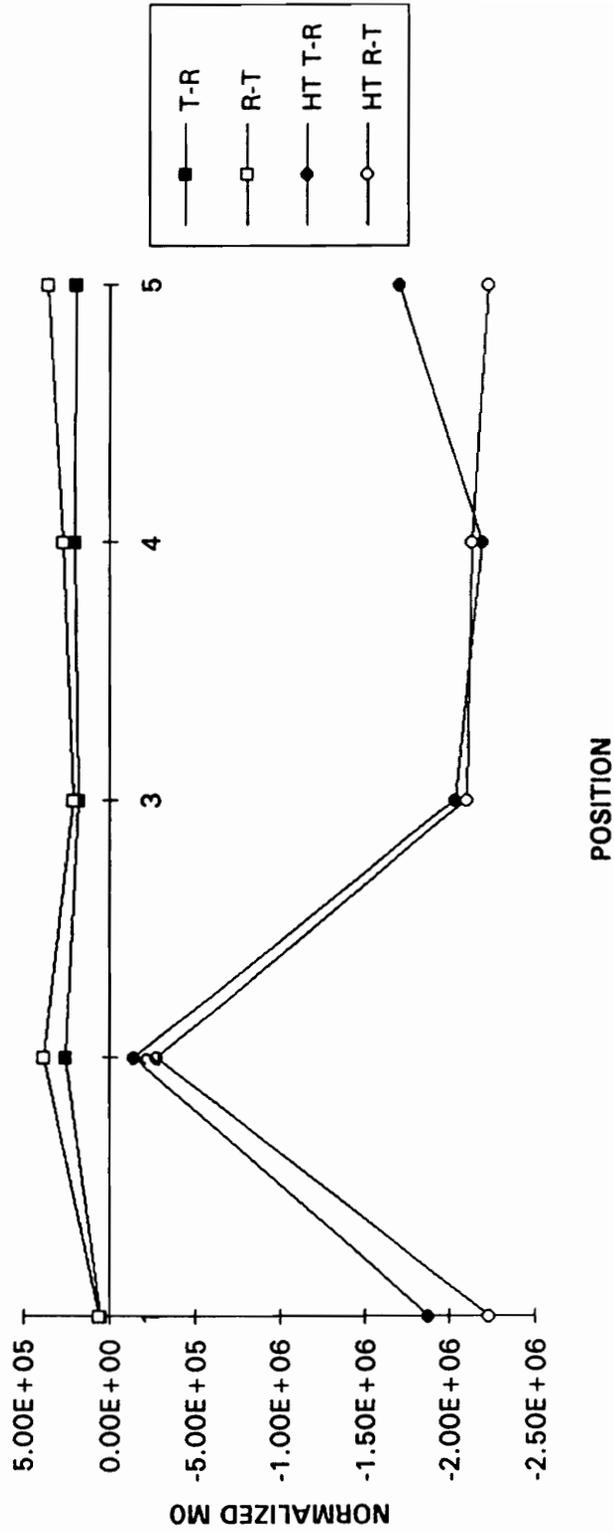
FIGURE 25: Normalized AU parameter M_0 vs. Longitudinal Position, specimen AM-7-4 before and after heat treatment at 1200 °C.

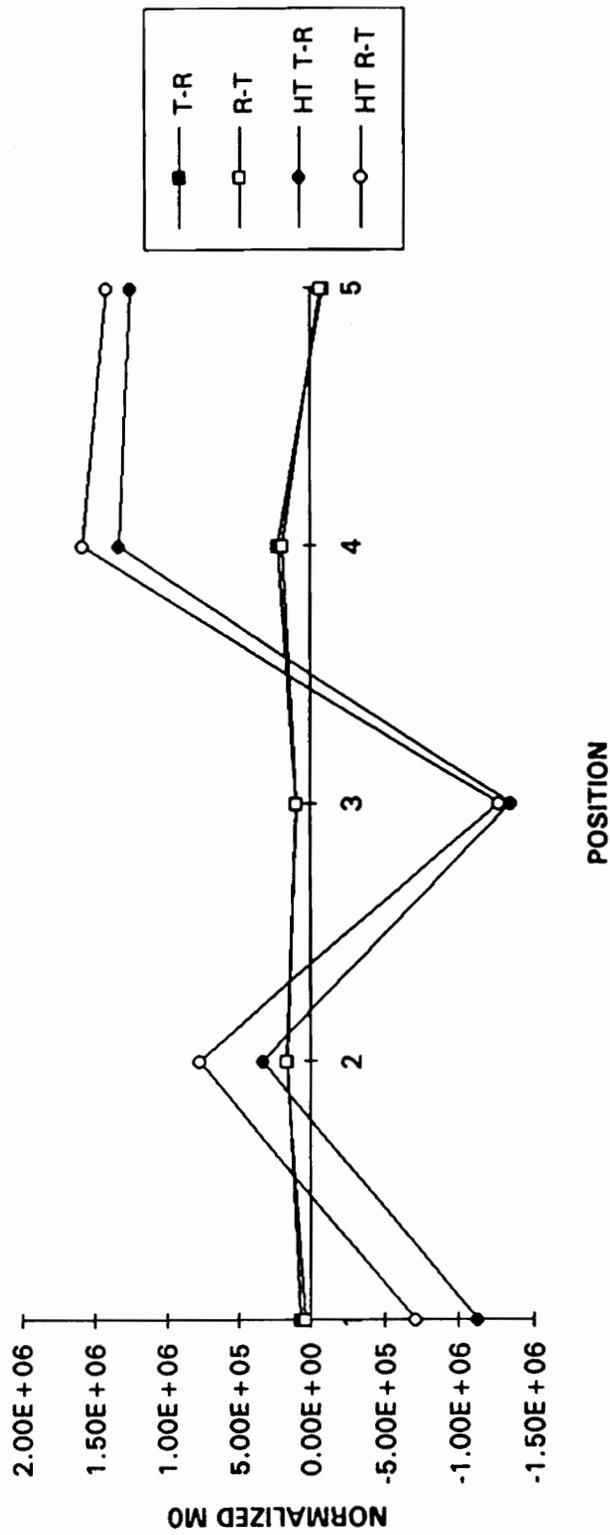
FIGURE 26: Normalized AU parameter M_0 vs. Longitudinal Position, specimen AM-1-6 before and after heat treatment at 1200 °C.

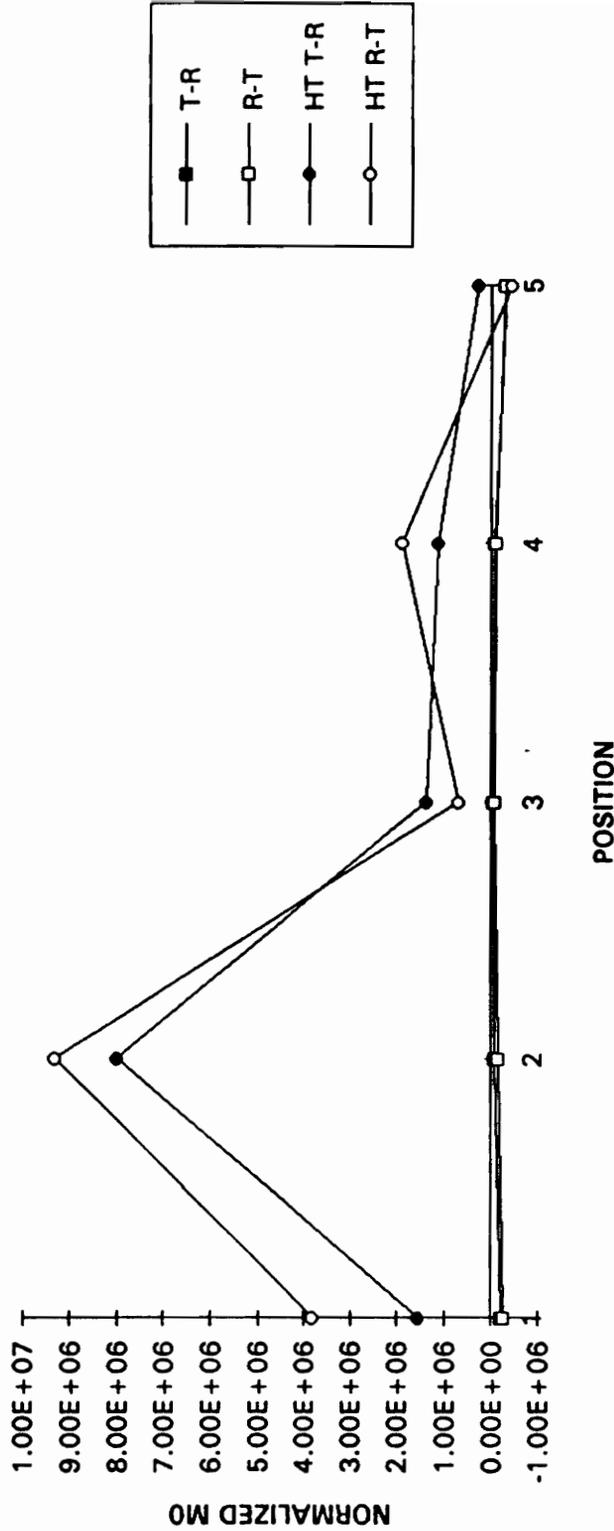
FIGURE 27: Normalized AU parameter M_0 vs. Longitudinal Position, specimen AM-7-5 before and after heat treatment at 1400 °C.

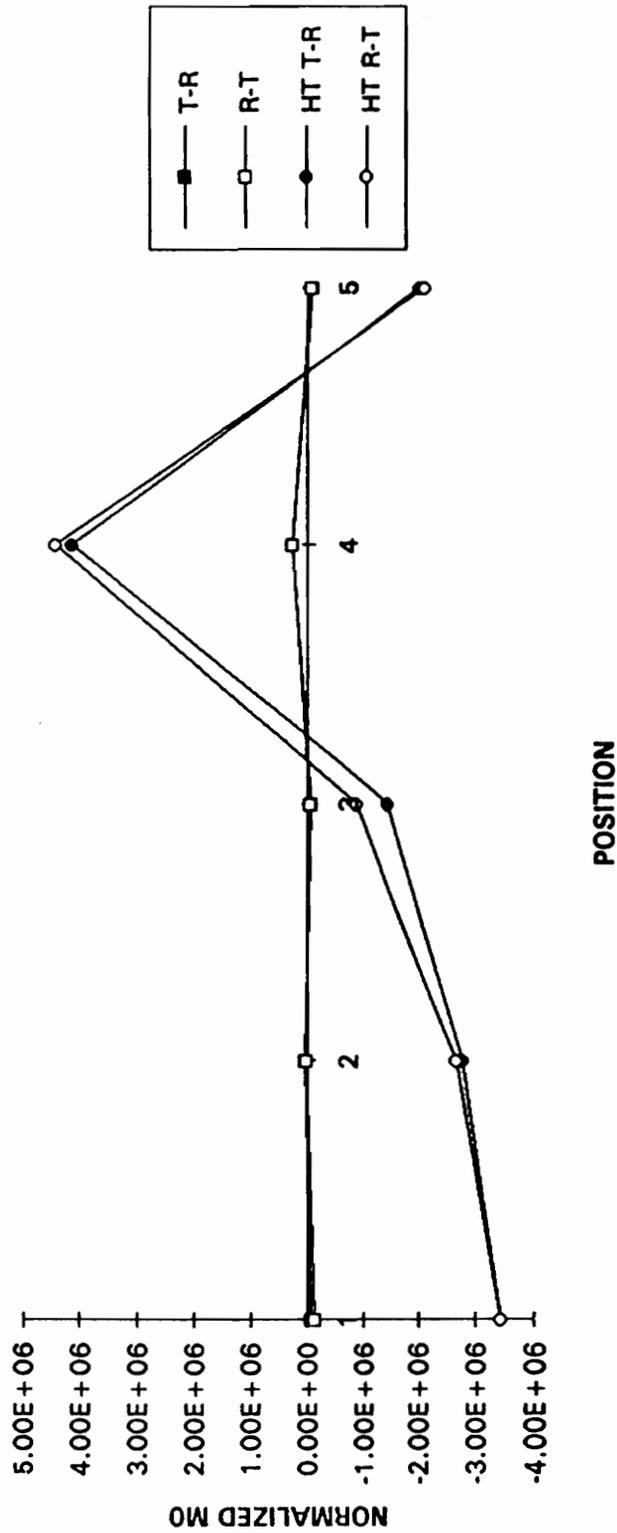
FIGURE 28: Normalized AU parameter M_0 vs. Longitudinal Position, specimen AM-7-6 before and after heat treatment at 1400 °C.

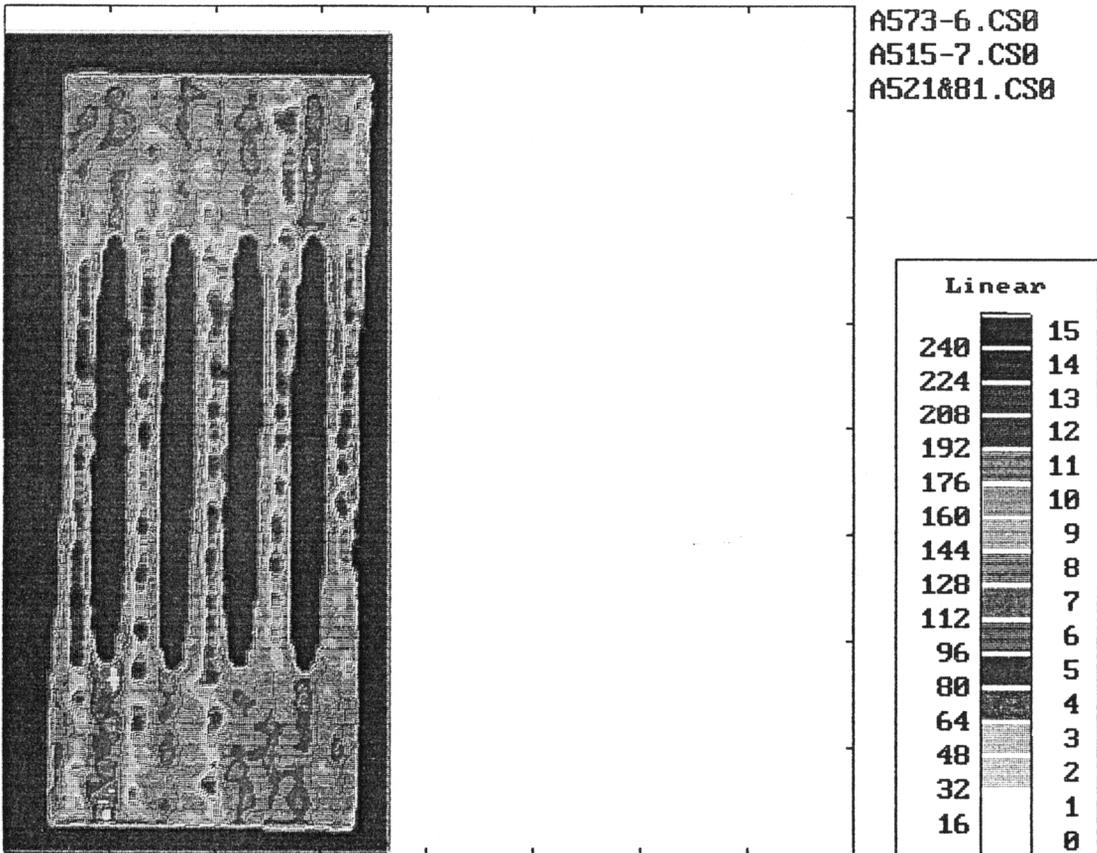
FIGURE 38: C-scan of (left to right) AM-7-2, AM-7-3, AM-7-4, AM-7-5, and AM-7-6 before heat treatment. *Color 0*: Low amplitude signal; *Color 15*: High amplitude signal.

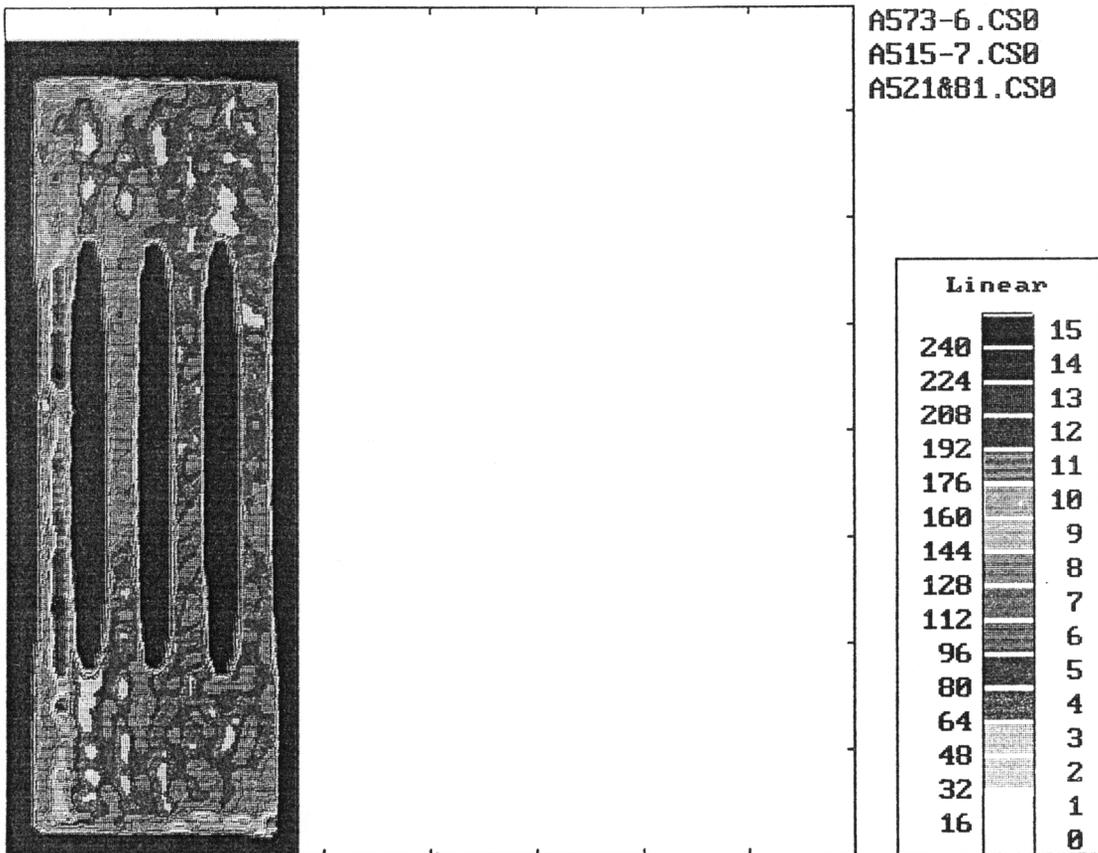
FIGURE 39: C-scan of (left to right) AM-7-2, AM-1-5, AM-1-6, and AM-1-7 before heat treatment. *Color 0*: Low amplitude signal; *Color 15*: High amplitude signal.

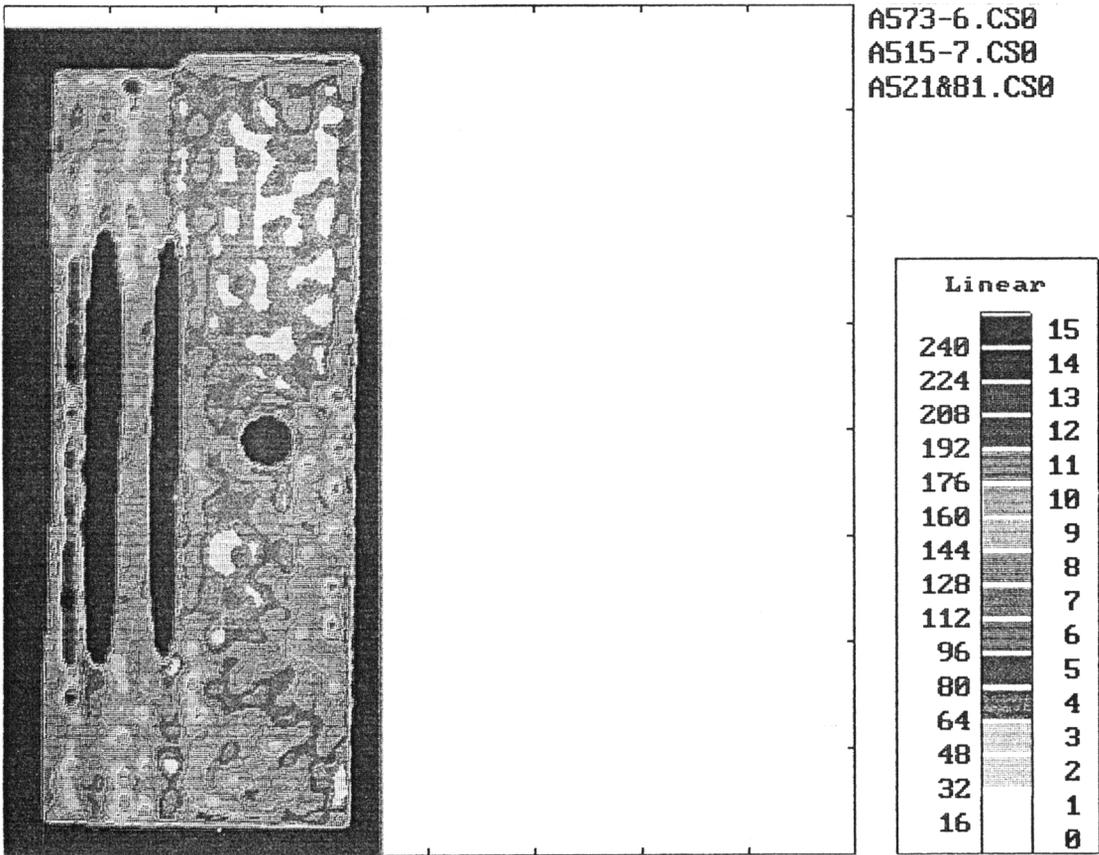
FIGURE 40: C-scan of (left to right) AM-7-2, AM-2-1, and AM-8-1 before heat treatment. *Color 0*: Low amplitude signal; *Color 15*: High amplitude signal.

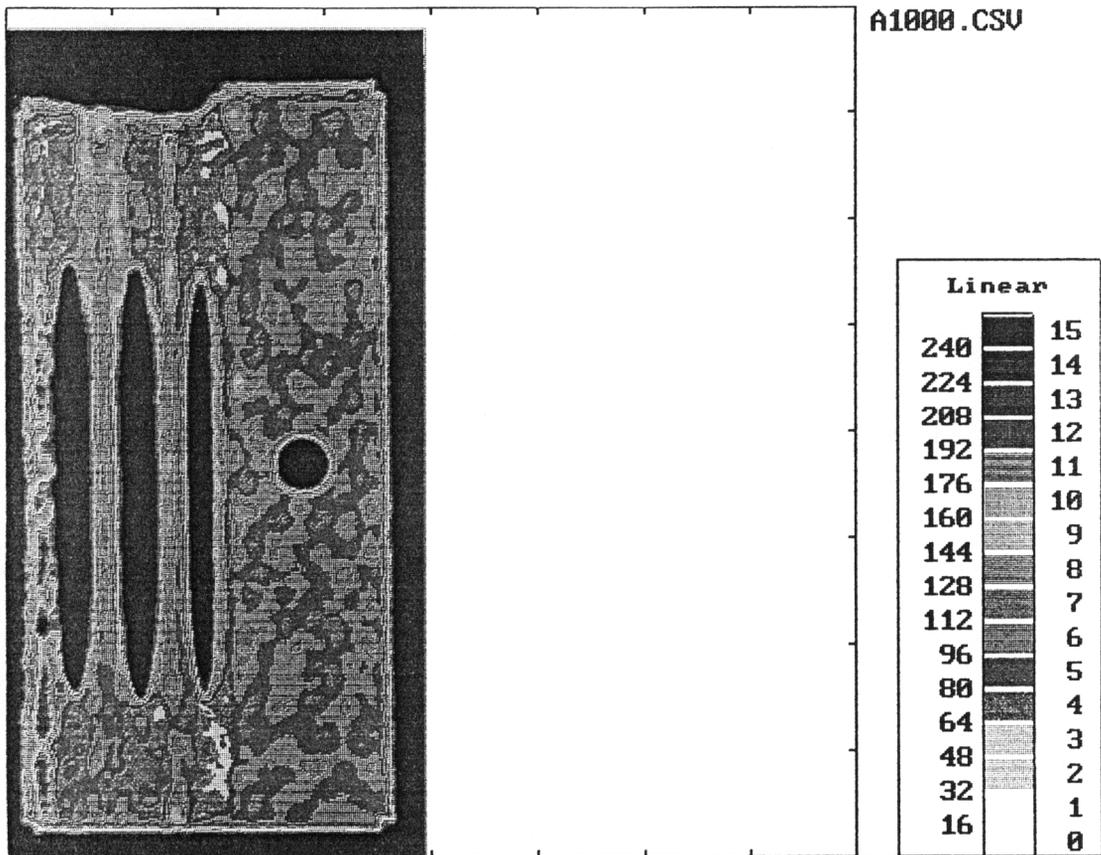
FIGURE 41: C-scan of (left to right) AM-7-2, AM-1-7, AM-2-1, and AM-8-1 after heat treatment at 1000 °C. *Color 0*: Low amplitude signal; *Color 15*: High amplitude signal.

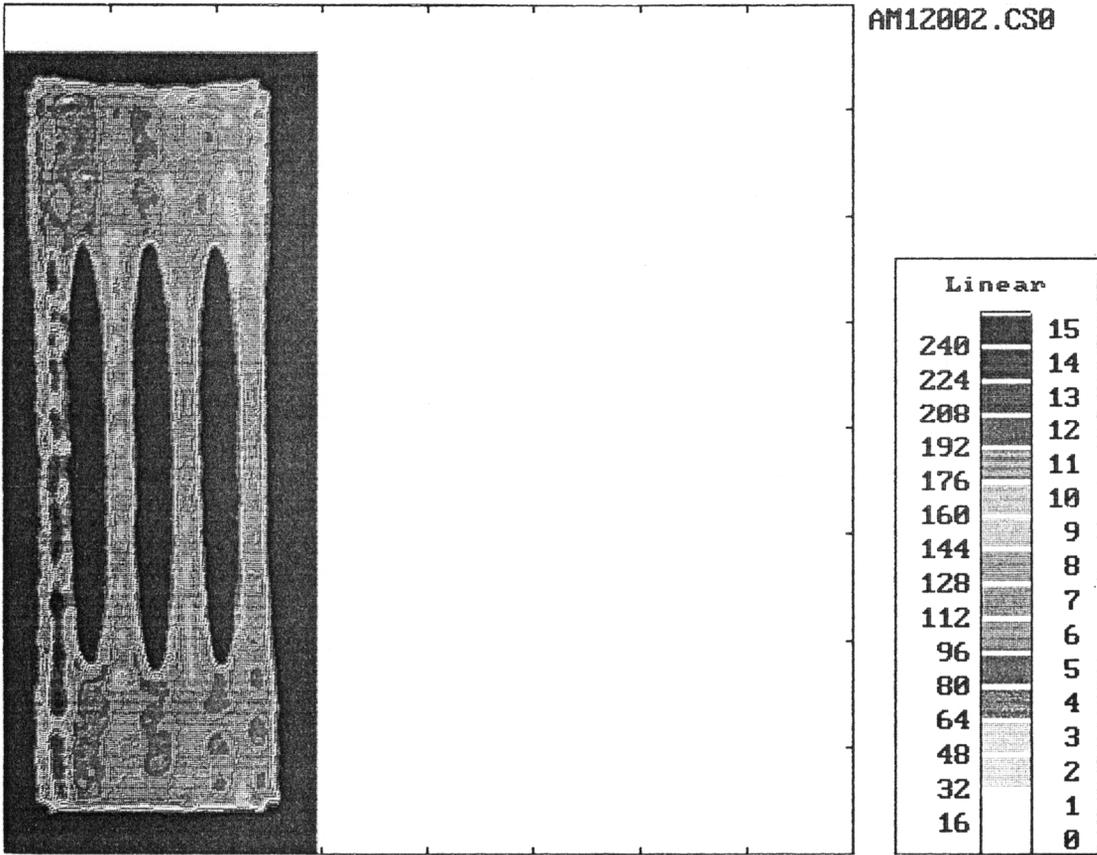
FIGURE 42: C-scan of (left to right) AM-7-2, AM-7-3, AM-7-4, and AM-1-6 after heat treatment at 1200 °C. *Color 0*: Low amplitude signal; *Color 15*: High amplitude signal.

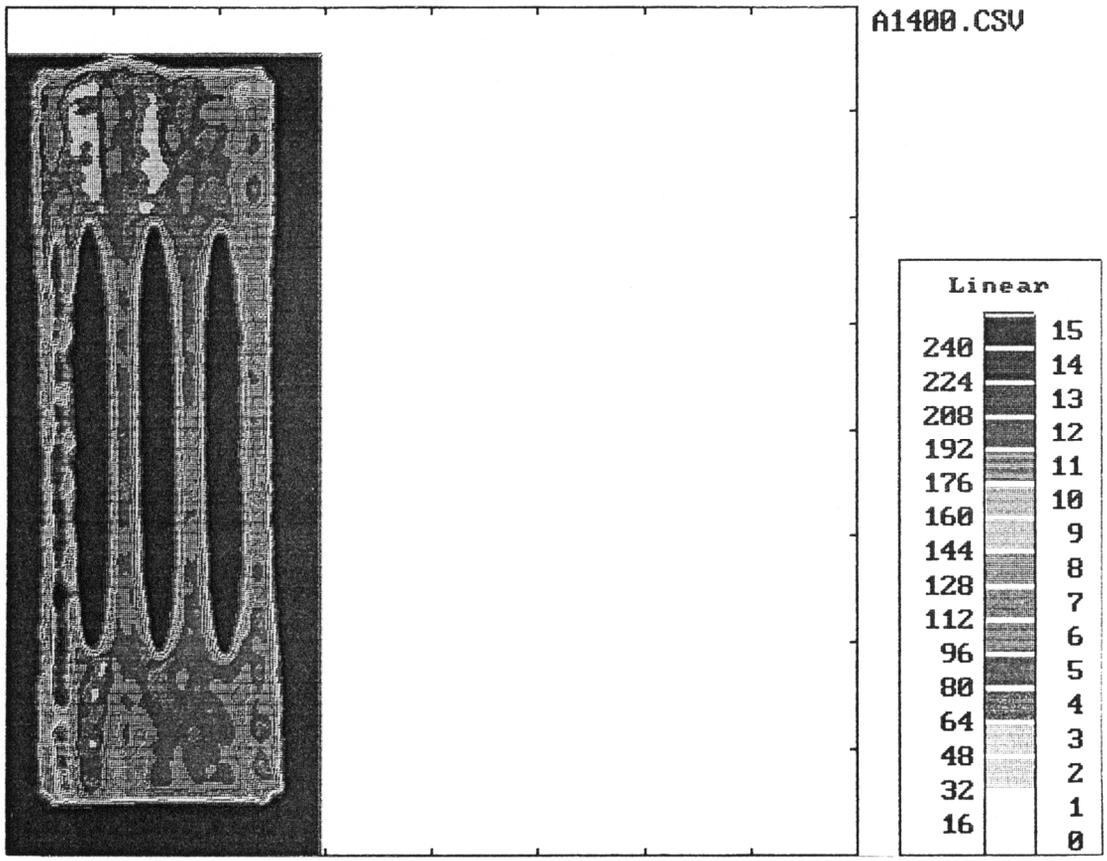
FIGURE 43: C-scan of (left to right) AM-7-2, AM-7-5, AM-7-6, and AM-1-5 after heat treatment at 1400 °C. *Color 0*: Low amplitude signal; *Color 15*: High amplitude signal.

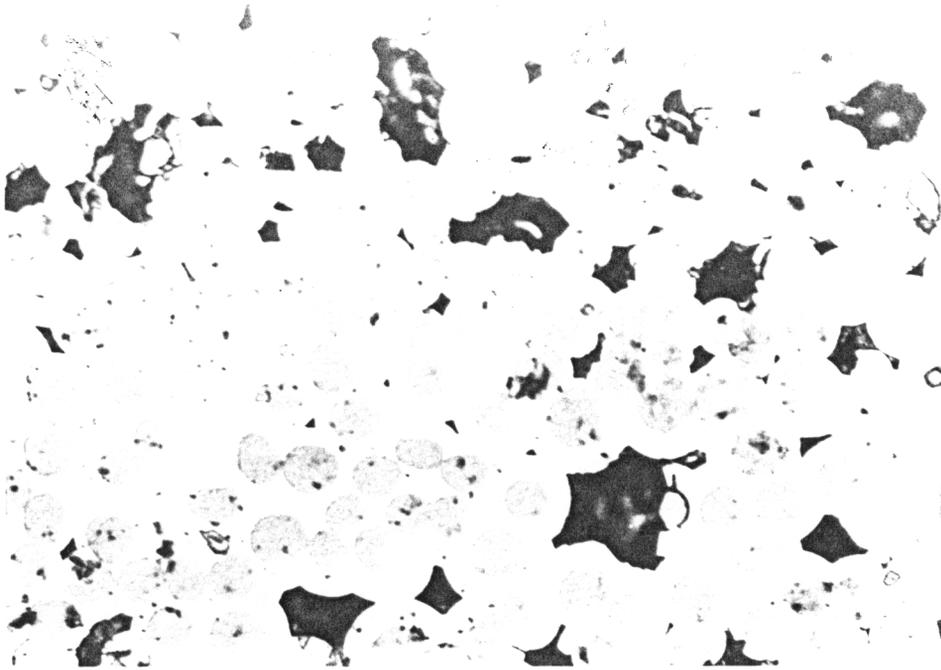
FIGURE 44: Optical micrograph of as-fabricated AM-2-1; 400X

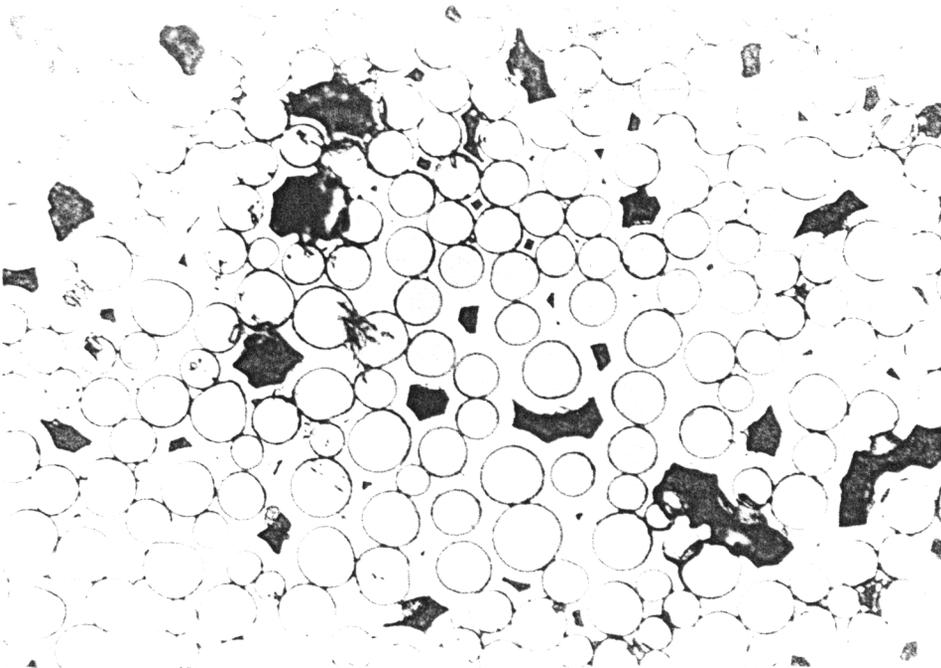
FIGURE 45: Optical micrograph of AM-8-1 after heat treatment at 1000 °C; 400X.

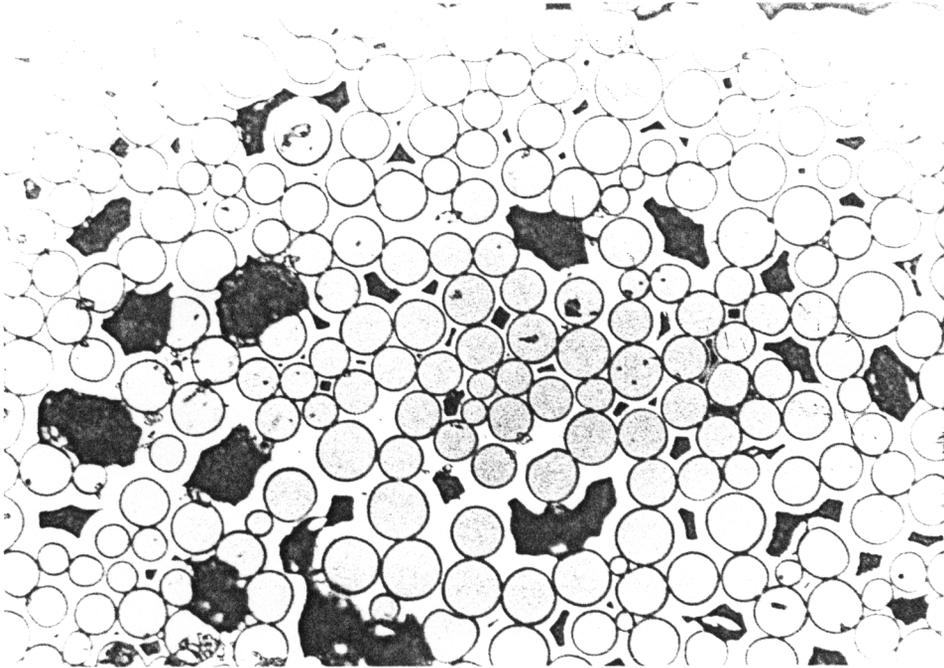
FIGURE 46: Optical micrograph of AM-2-1 after heat treatment at 1000 °C; 400X.

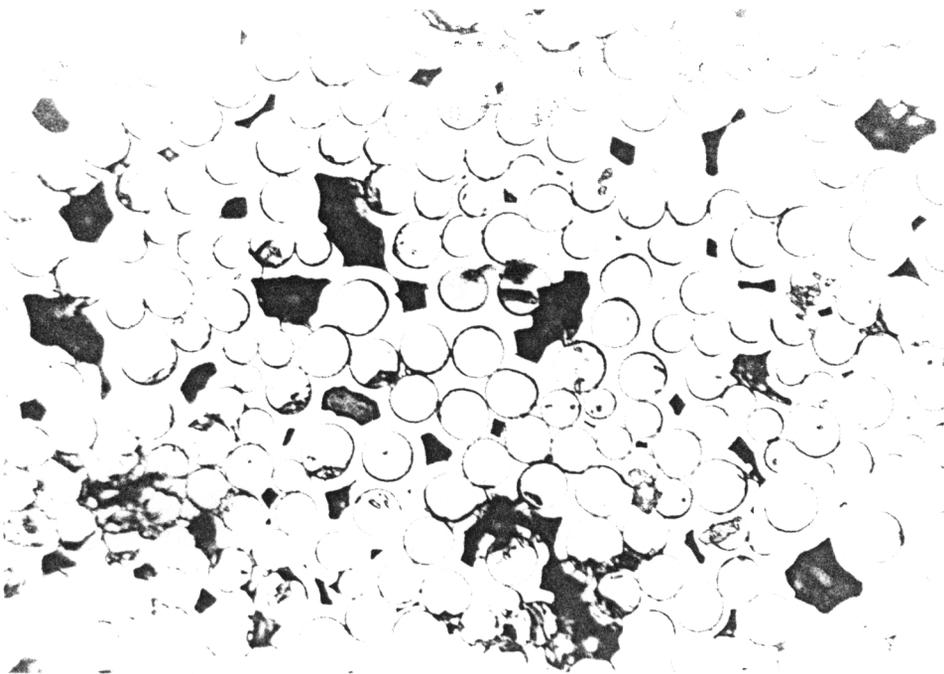
FIGURE 47: Optical micrograph of AM-7-3 after heat treatment at 1200 °C; 400X.

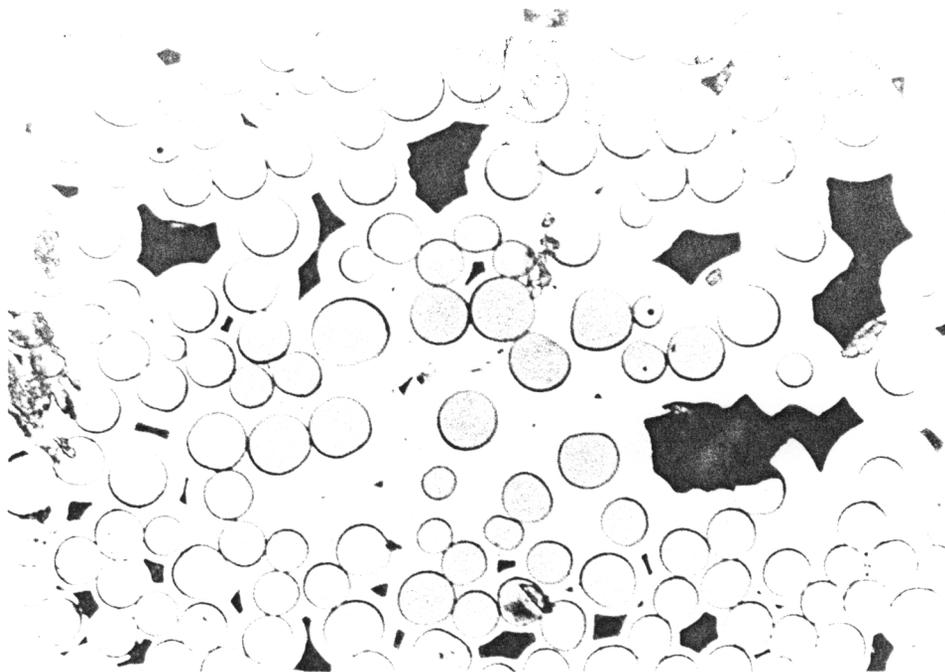
FIGURE 48: Optical micrograph of AM-1-6 after heat treatment at 1200 °C; 400X.
