**NONDESTRUCTIVE EVALUATION
OF A HIGH TEMPERATURE
CERAMIC MATRIX COMPOSITE MATERIAL**

Thesis submitted to the Faculty of the
Virginia Polytechnic Institute and State University
in partial fulfillment of the requirements for the degree of

Engineering Science and Mechanics

February 8, 1995

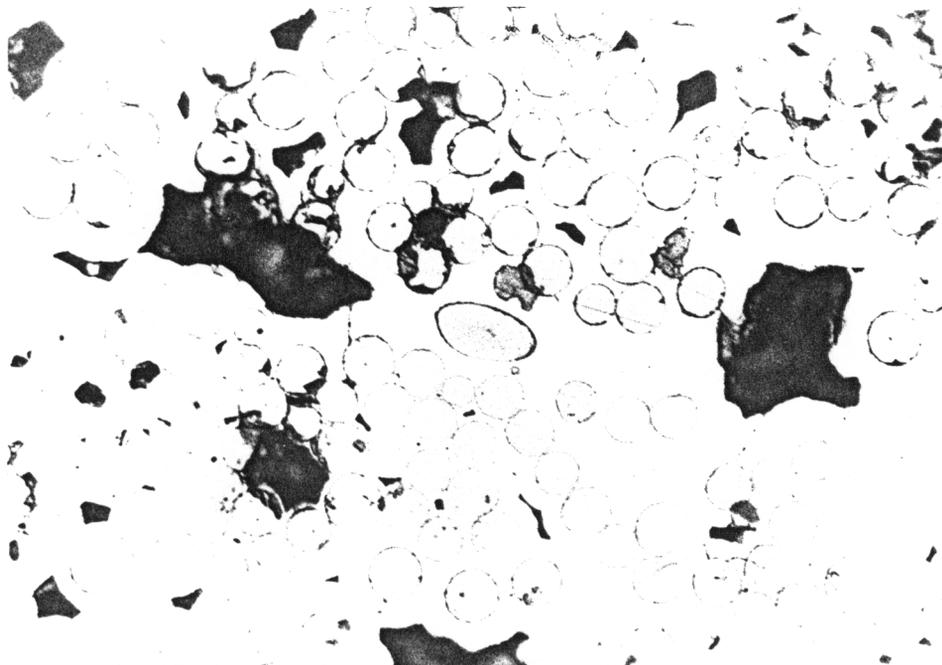
FIGURE 49: Optical micrograph of AM-7-6 after heat treatment at 1400 °C; 400X.

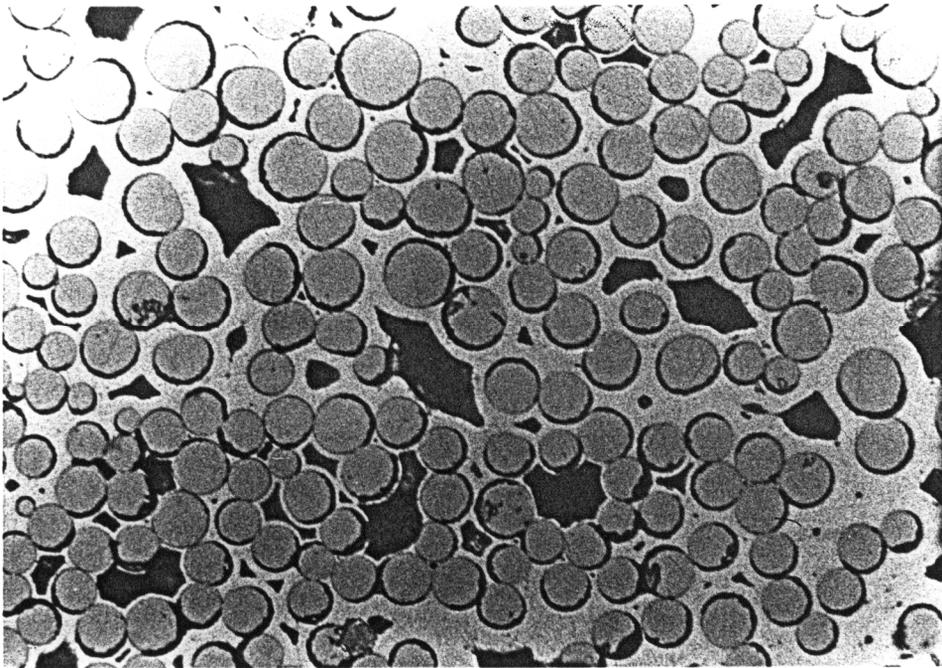
FIGURE 50: Optical micrograph of AM-1-5 after heat treatment at 1400 °C; 400X.

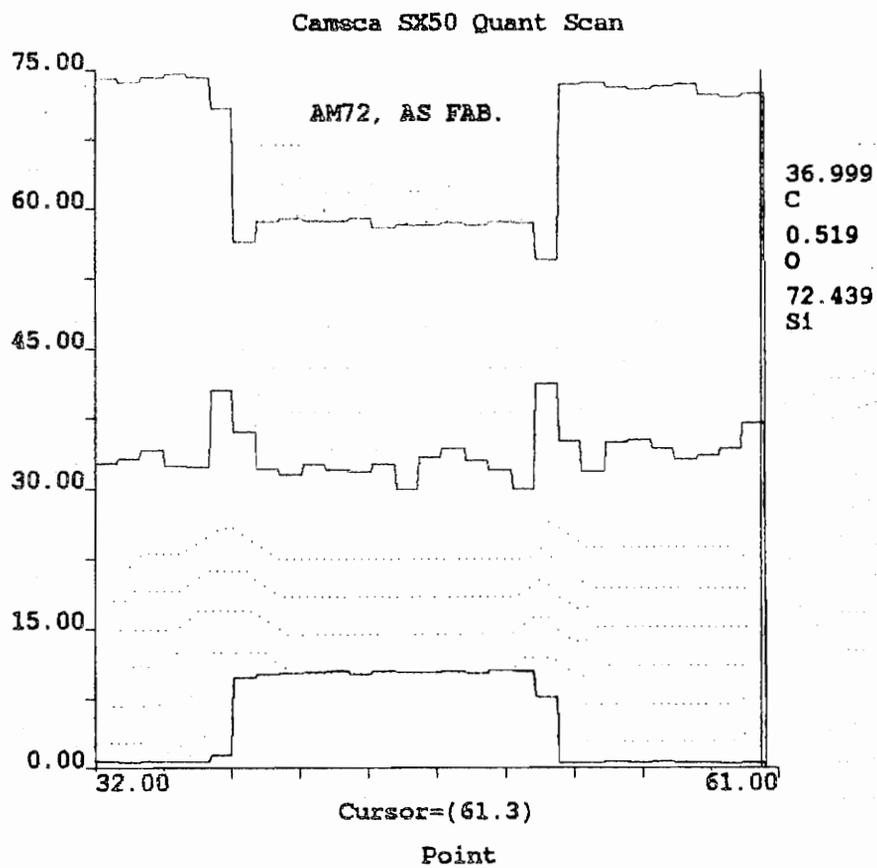
FIGURE 51: Trace scan of as-fabricated, coated AM-7-2.
X-axis: Position (1 μ m step); *Y-axis:* Elemental Composition
 (% atomic weight).

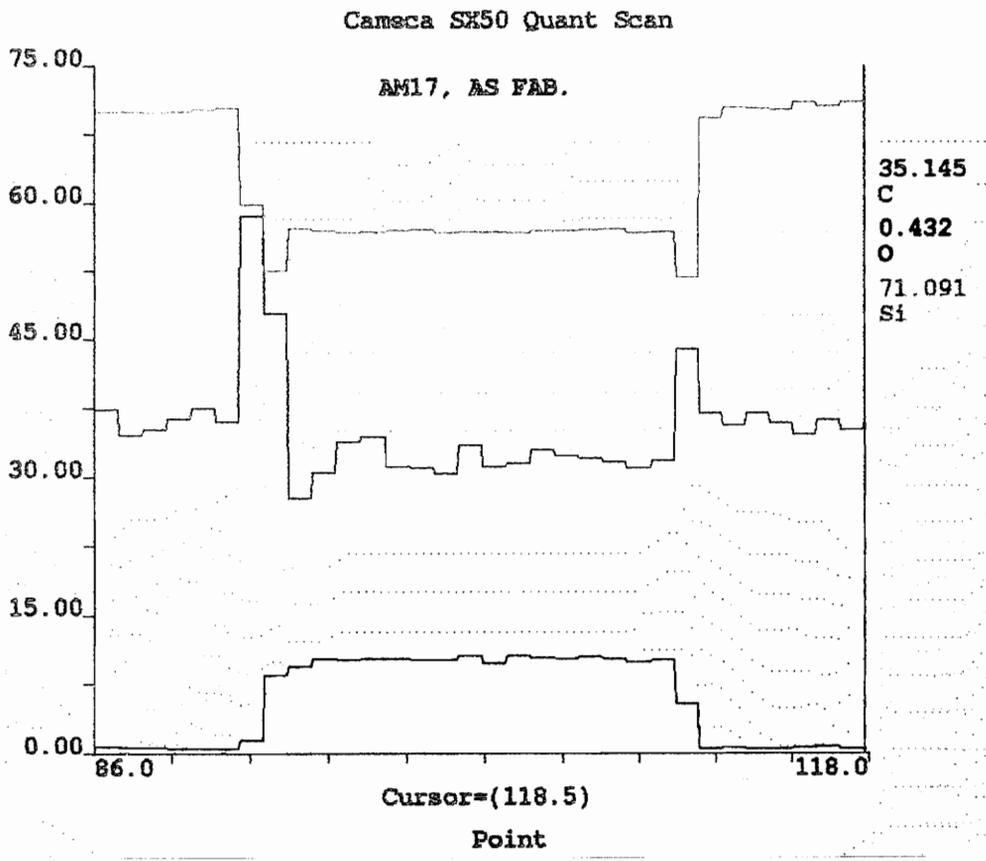
FIGURE 52: Trace scan of as-fabricated, uncoated AM-1-7.
X-axis: Position (1µm step); *Y-axis:* Elemental Composition (% atomic weight).

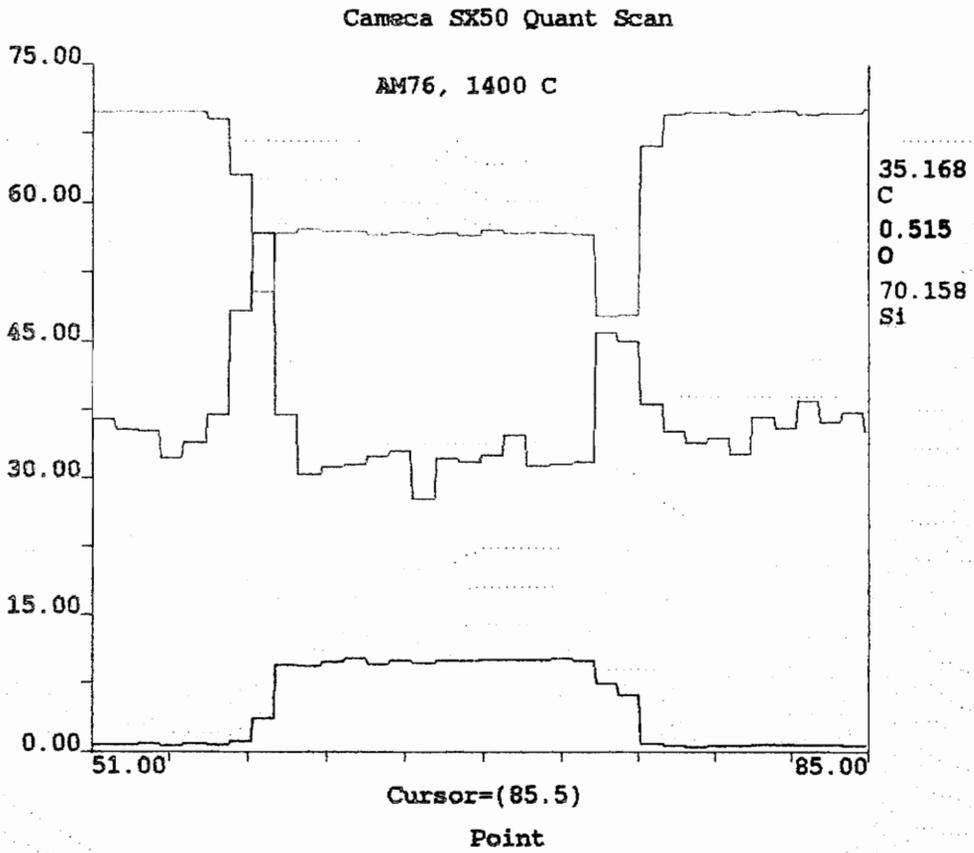
FIGURE 53: Trace scan of coated AM-7-6 after heat treatment at 1400 °C. *X-axis*: Position (1 μ m step); *Y-axis*: Elemental Composition (% atomic weight).

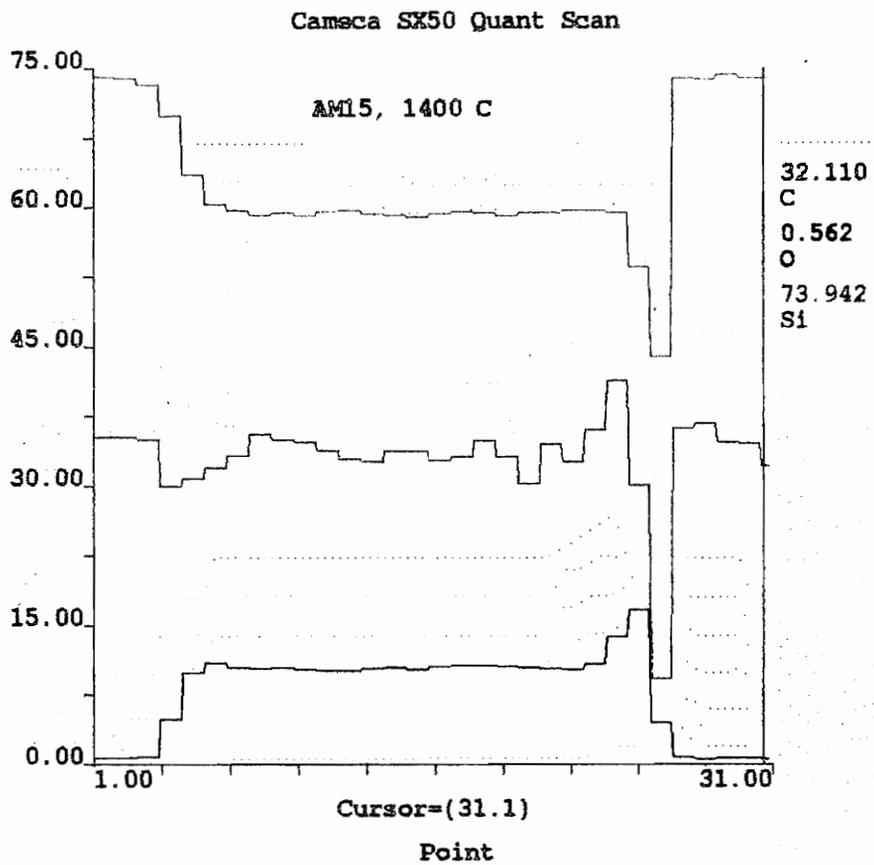
FIGURE 54: Trace scan of uncoated AM-1-5 after heat treatment at 1400 °C. *X-axis*: Position (1µm step); *Y-axis*: Elemental Composition (% atomic weight).

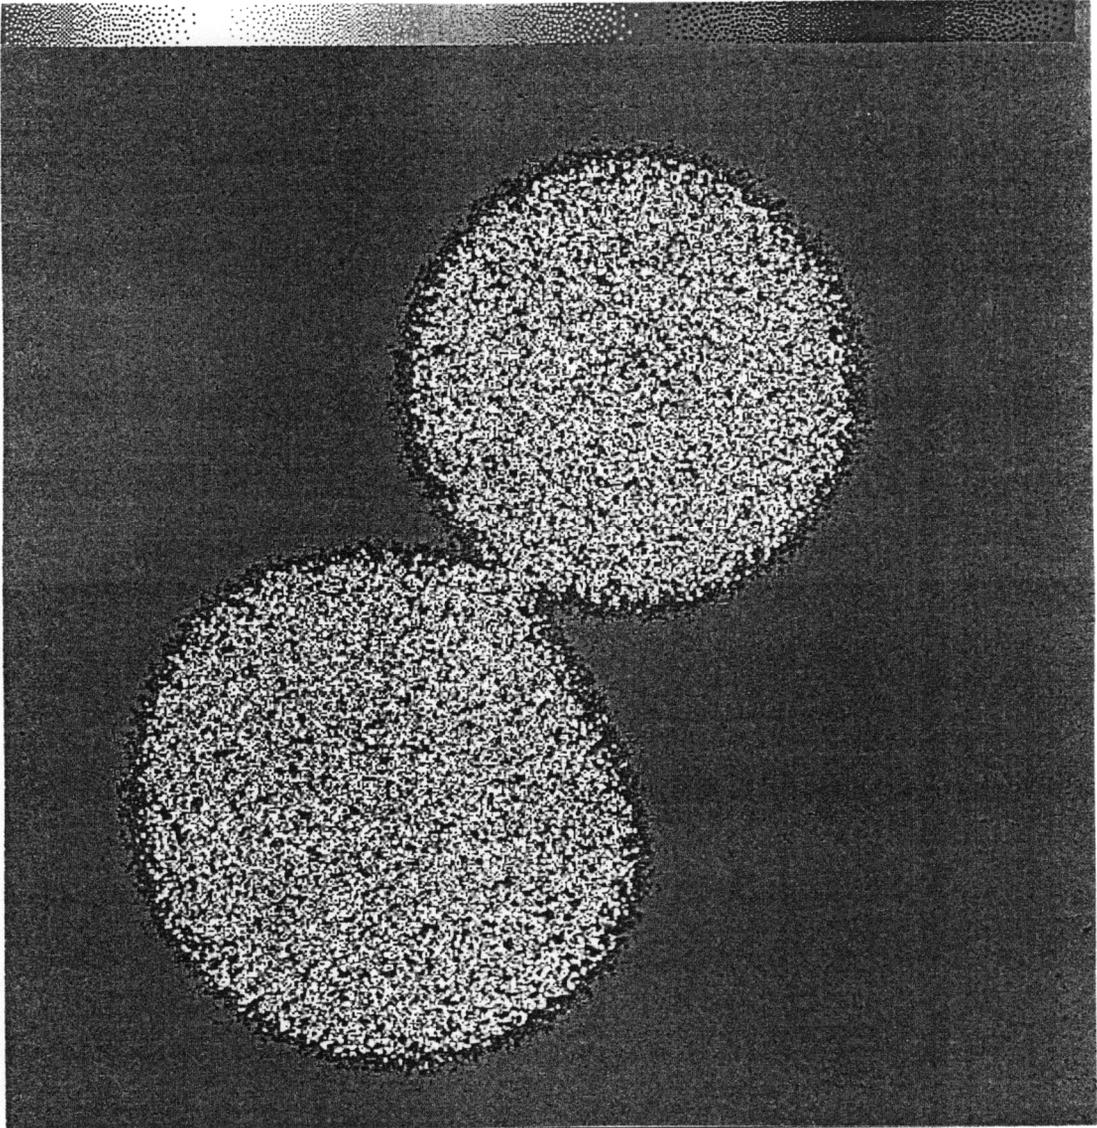
FIGURE 56: Oxygen map of as-fabricated AM-1-7.

In addition to the one-dimensional line scans, two-dimensional elemental maps are shown in **Figures 55, 56, and 57**. The elemental maps provide only qualitative results. Only the silicon, oxygen, and carbon maps for as-fabricated AM-1-7 are shown.

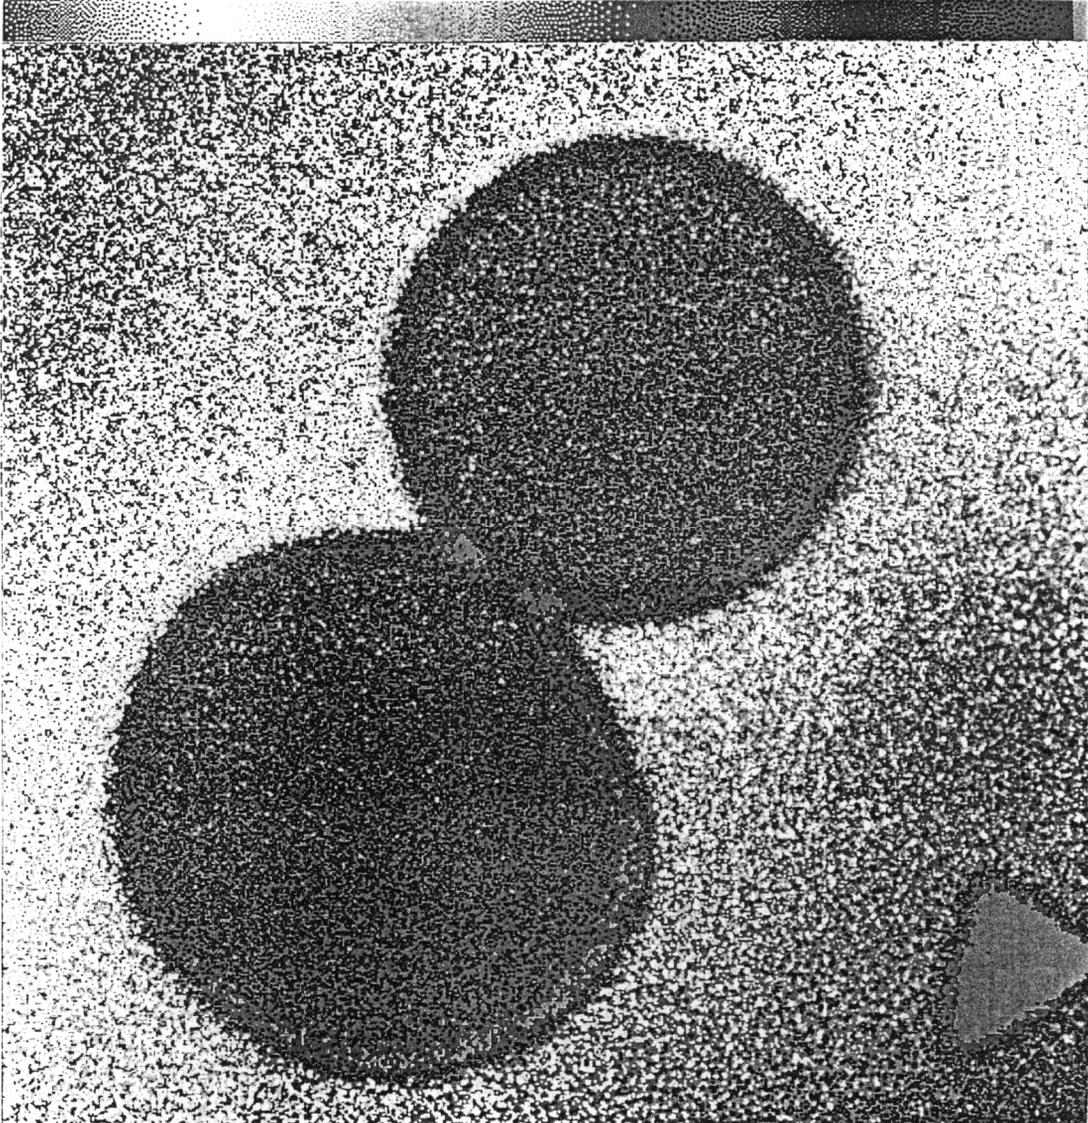
FIGURE 57: Silicon map of as-fabricated AM-1-7.

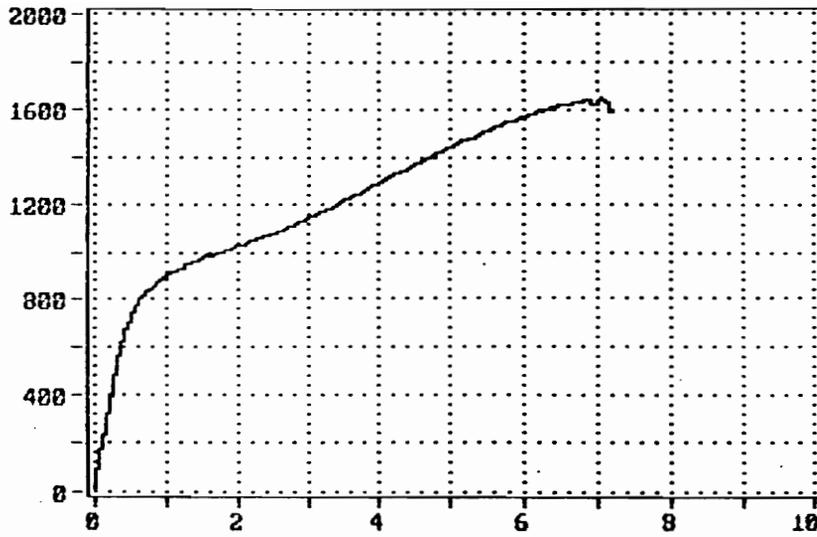
FIGURE 62a: As-fabricated AM-7-2 (coated):
Load (lbs.) vs. Strain (% x 10).

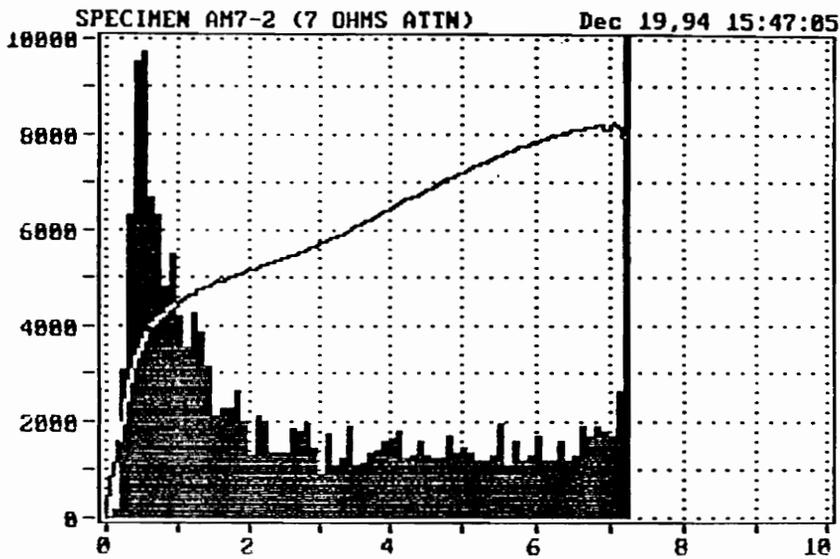
FIGURE 62b: Load and AE data for as-fabricated AM-7-2 (coated):
Counts vs. Strain (% x 10).

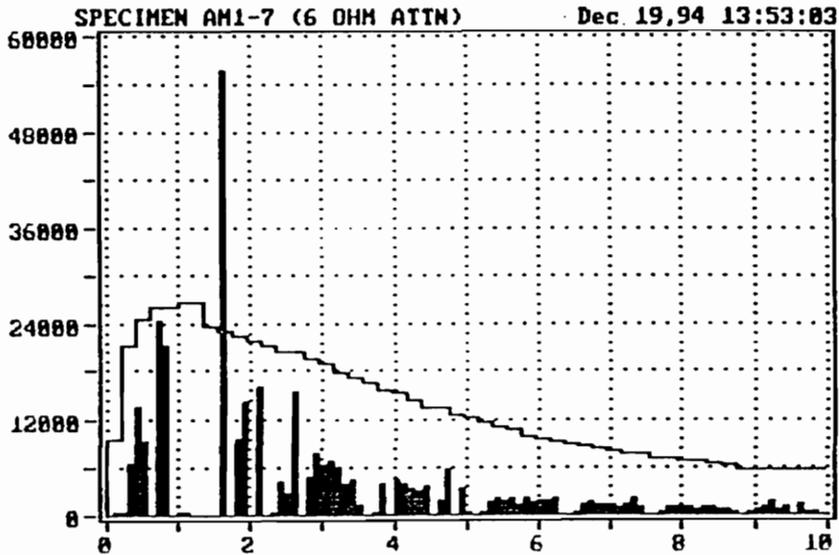
FIGURE 63b: Load and AE data for AM-1-7 (uncoated) after heat treatment at 1000 °C: Counts vs. Strain (% x 10).

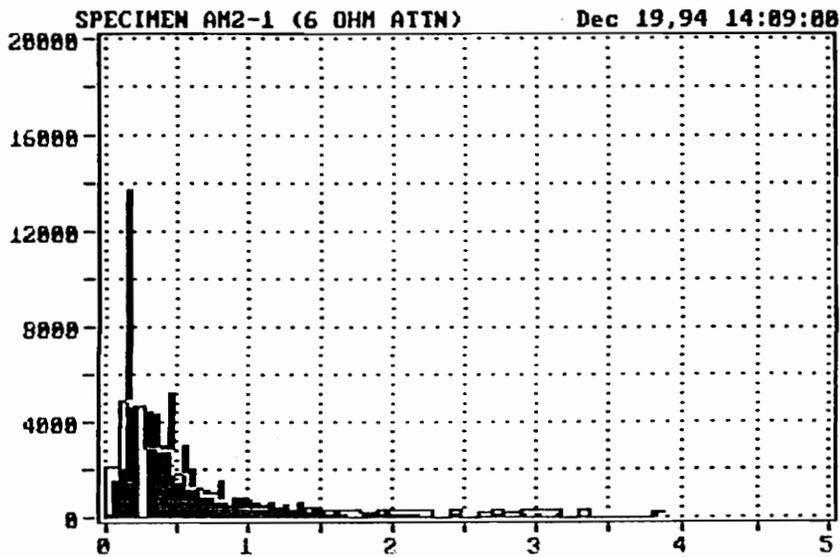
FIGURE 64b: Load and AE data for AM-2-1 (uncoated) after heat treatment at 1000 °C: Counts vs. Strain (% x 10).

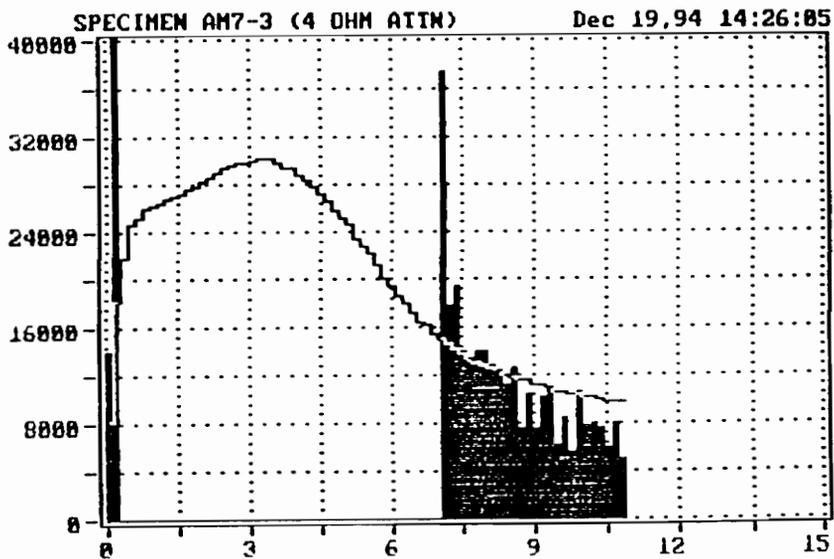
FIGURE 65b: Load and AE data for AM-7-3 (coated) after heat treatment at 1200 °C: Counts vs. Strain (% x 10).

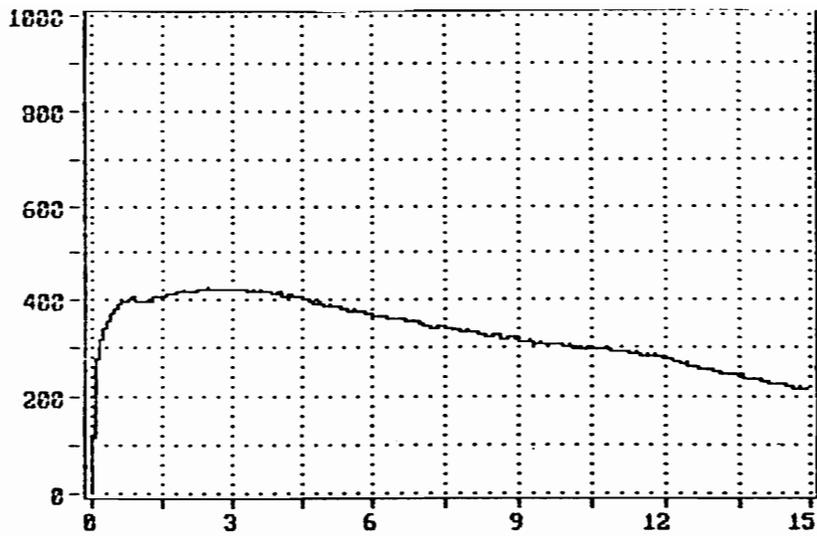
FIGURE 66a: AM-1-6 (uncoated) after heat treatment at 1200 °C: Load (lbs.) vs. Strain (% x 10).

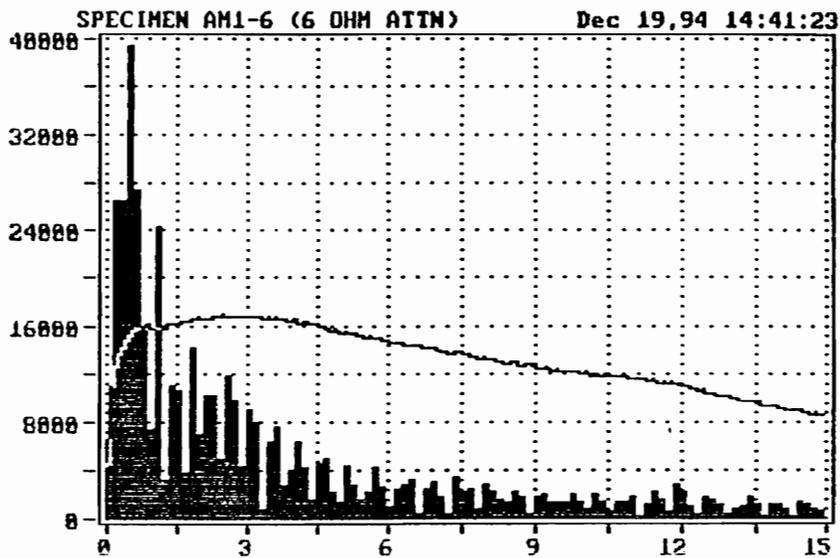
FIGURE 66b: Load and AE data for AM-1-6 (uncoated) after heat treatment at 1000 °C: Counts vs. Strain (% x 10).

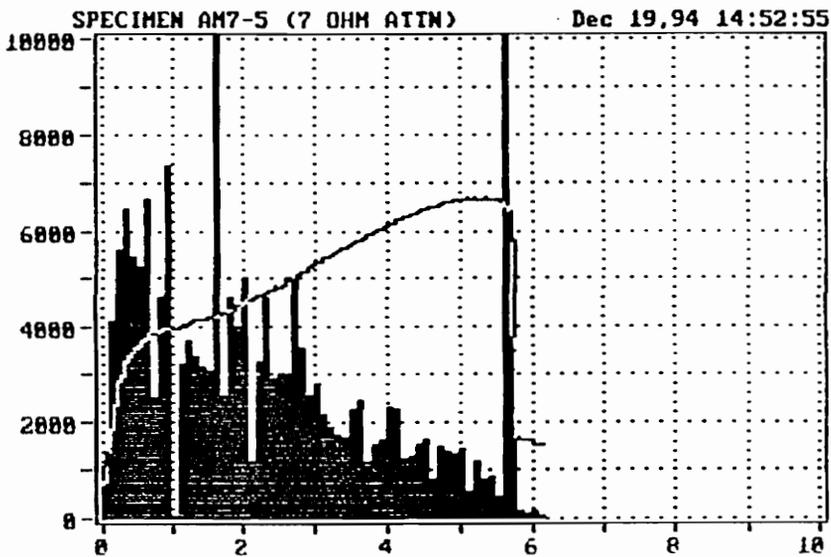
FIGURE 67b: Load and AE data for AM-7-5 (coated) after heat
treatment at 1400 °C: Counts vs. Strain (% x 10).

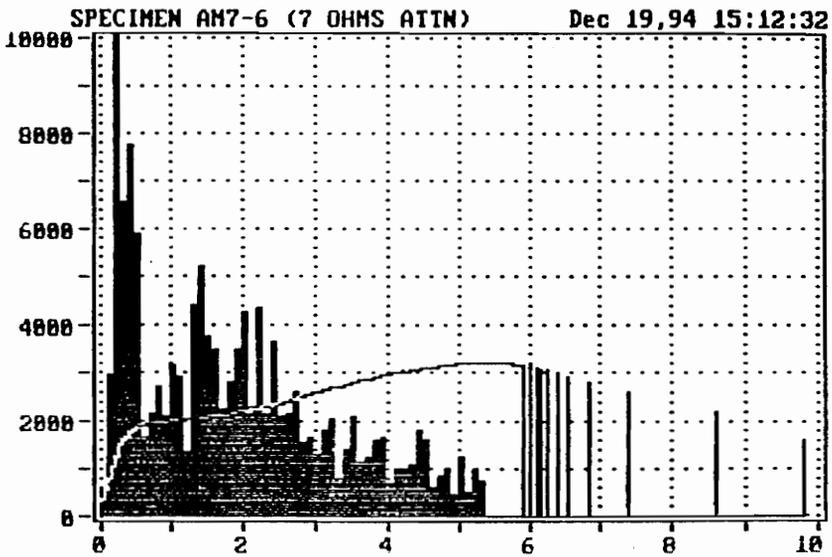
FIGURE 68b: Load and AE data for AM-7-6 (coated) after heat
treatment at 1400 °C: Counts vs. Strain (% x 10).

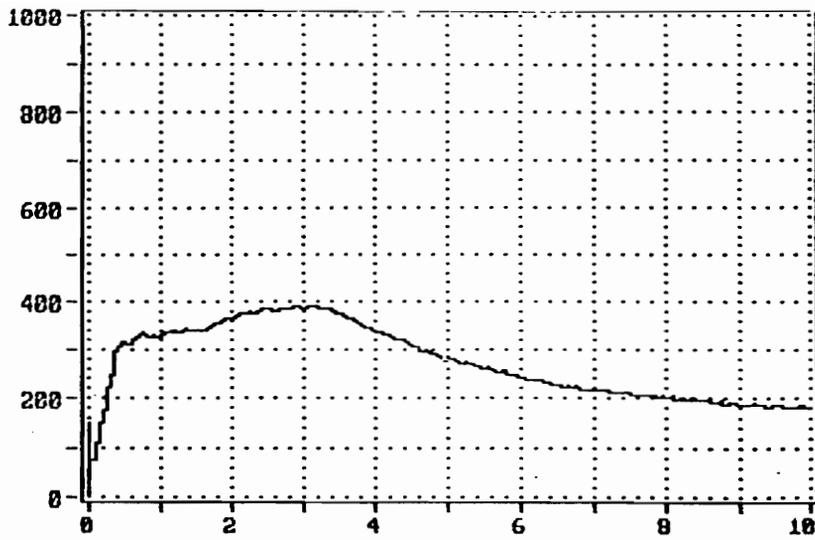
FIGURE 69a: AM-1-5 (uncoated) after heat treatment at 1400 °C: Load (lbs.) vs. Strain (% x 10).

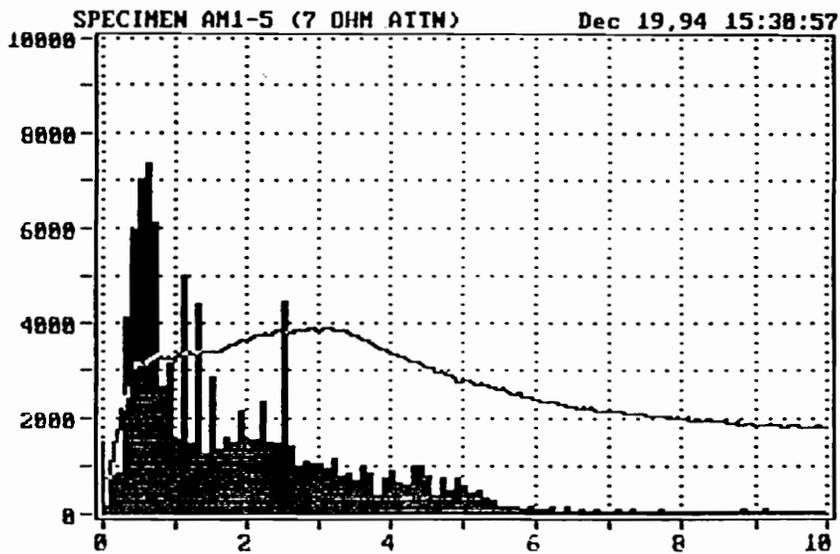
FIGURE 69b: Load and AE data for AM-1-5 (uncoated) after heat treatment at 1400 °C: Counts vs. Strain (% x 10).
