**TRIBOPOLYMERIZATION AS AN APPROACH TO
TWO-STROKE ENGINE LUBRICATION**

Thesis submitted to the Faculty of

Virginia Polytechnic Institute and State University

Mechanical Engineering

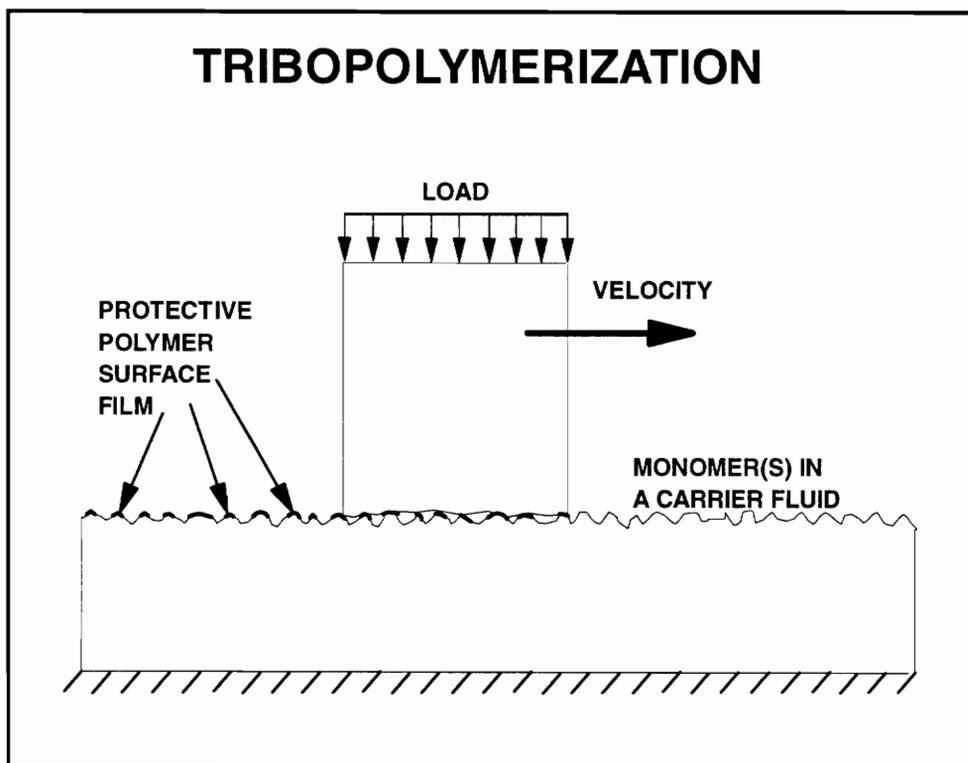
FIGURE 1.1: Tribopolymerization as a Mechanism of Boundary Lubrication.

The concept of tribopolymerization is that certain monomers, which are chemically capable of polymerization, will polymerize on highly stressed surface regions under loaded contact in relative motion. Past work with a variety of addition and condensation monomers has shown that monomers can react and form very thin, but extremely effective, protective polymeric films which reduce friction and wear [12-19]. The idea behind the use of these monomers as anti-wear additives is that they will only form a polymeric film on surfaces where there are high surface stresses and the presence of the film will reduce surface contact and thereby reduce the rate of film formation. A substantial amount of work has been conducted with monomers at very low concentrations in hydrocarbon carrier fluids which have produced very impressive reductions in

friction and wear. An oversimplified schematic representation of the tribopolymerization concept is shown in Figure 1.1.

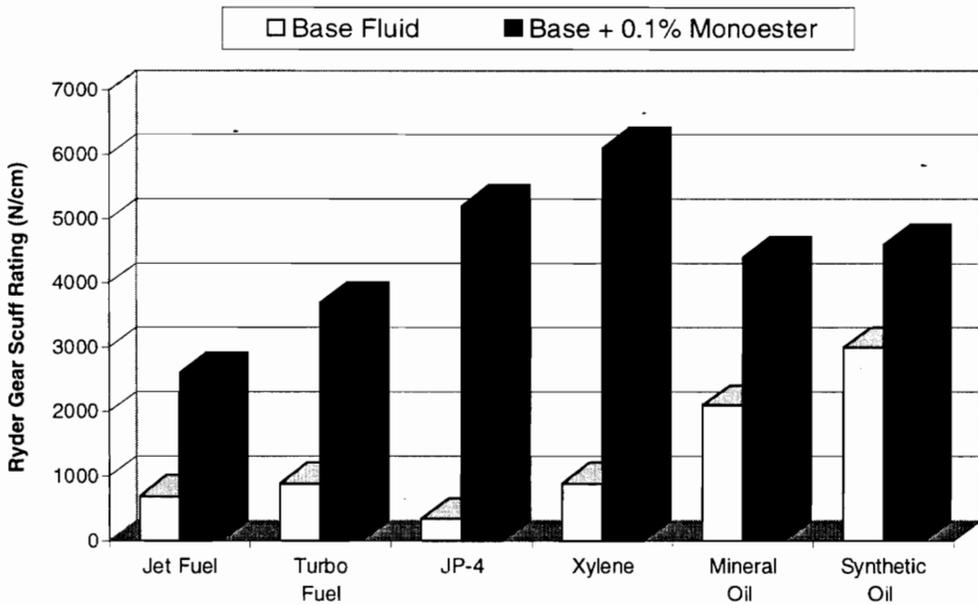
Figure 2.1: Anti-Scuff Rating for a Variety of Fluids With and Without the Addition of the C₃₆ Dimer Acid/Ethylene Glycol Monoester [12].

first presented by Furey [12], are summarized in Fig 2.1. The remarkable performance of the monomer in a variety of very different hydrocarbon carrier fluids demonstrates its potential in a wide variety of tribological applications. The monomer almost doubled the load carrying capacity of all the carrier fluids, and increased it by over an order of magnitude in JP-4. In fact, the addition of only 0.1% monoester to JP-4 increased the scuff rating above mineral oil and synthetic base aviation lubricants.

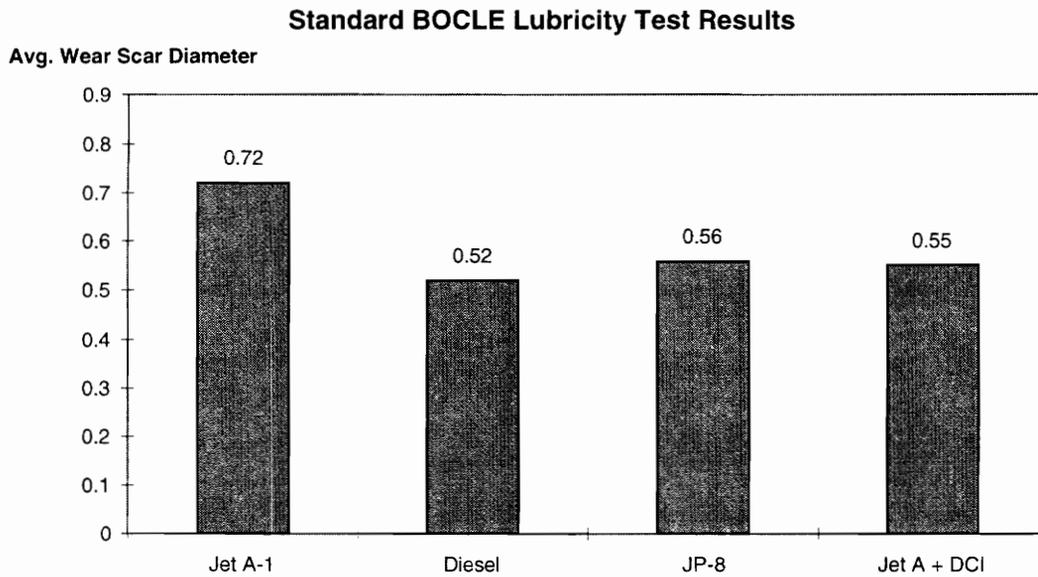
Figure 2.2 Results Obtained Using the Standard BOCLE Lubricity Test on Several Fuels [37]

In a fuel system however, there exist many different contact loads and geometries between parts in relative motion. A recent study conducted by Lacey [37] which involved the inspection of 15 military fuel pumps that had failed during operation desert storm indicated that corrosive wear was not the dominant source of fuel pump failure. In several cases, it was hypothesized that the source of failure was due to misalignment or parts out of spec., but the failure rate was significantly more recurrent after the substitution of diesel fuel with Jet A-1. The standard BOCLE testing procedure was used to compare the lubricity of different fuels, and the results obtained by Lacey are presented in Figure 2.2

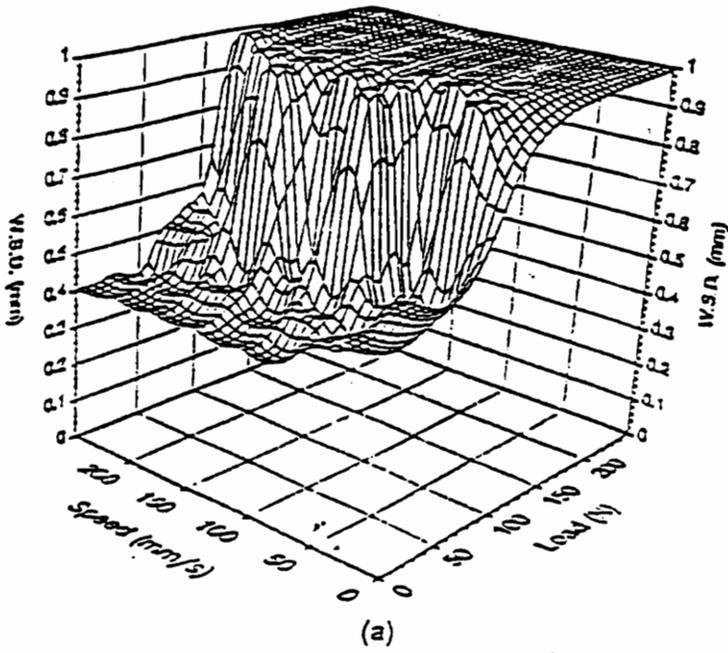
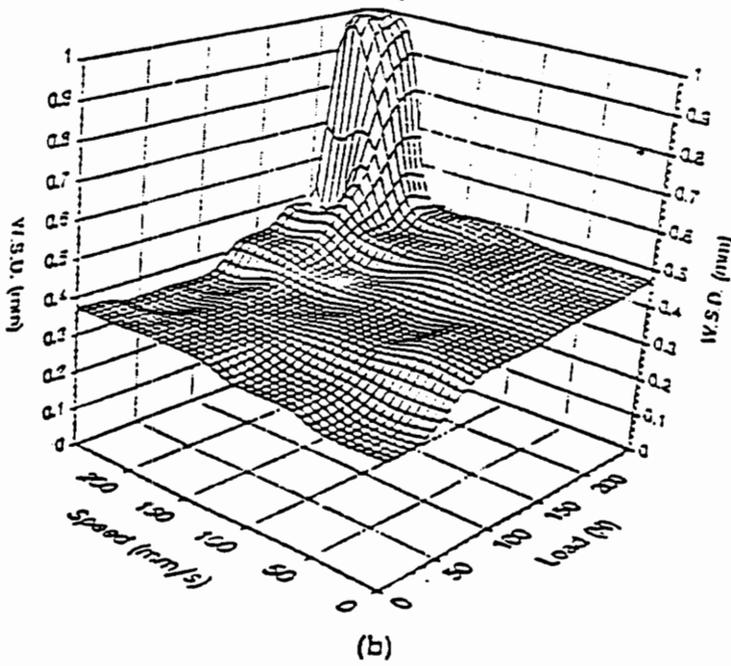
Figure 2.3: Wear Maps for a: (a) Poor Lubricity Fuel
 (b) Good Lubricity Fuel [39]

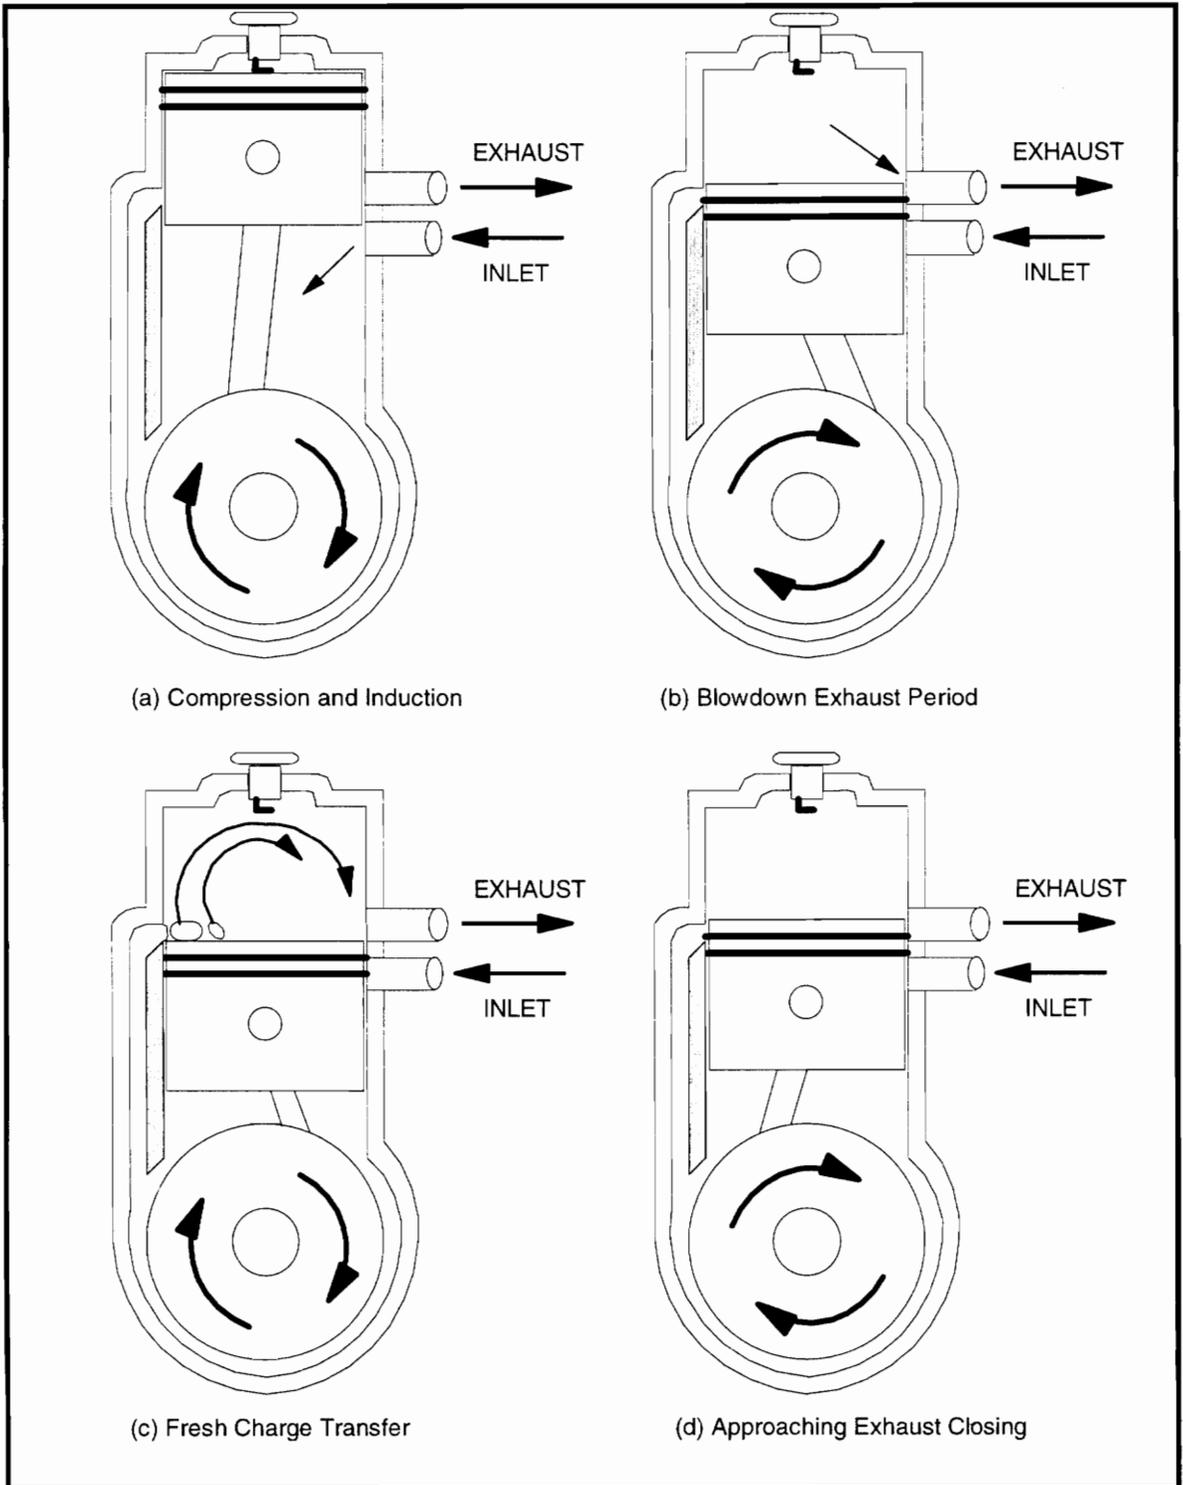
Figure 2.4 Two-Cycle Engine Stages of Operation [41]

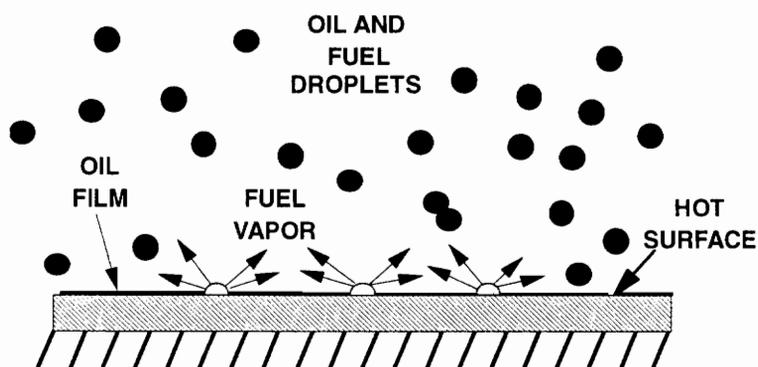
Figure 2.5: Oil Film Formation in Two-Cycle Engine Lubrication

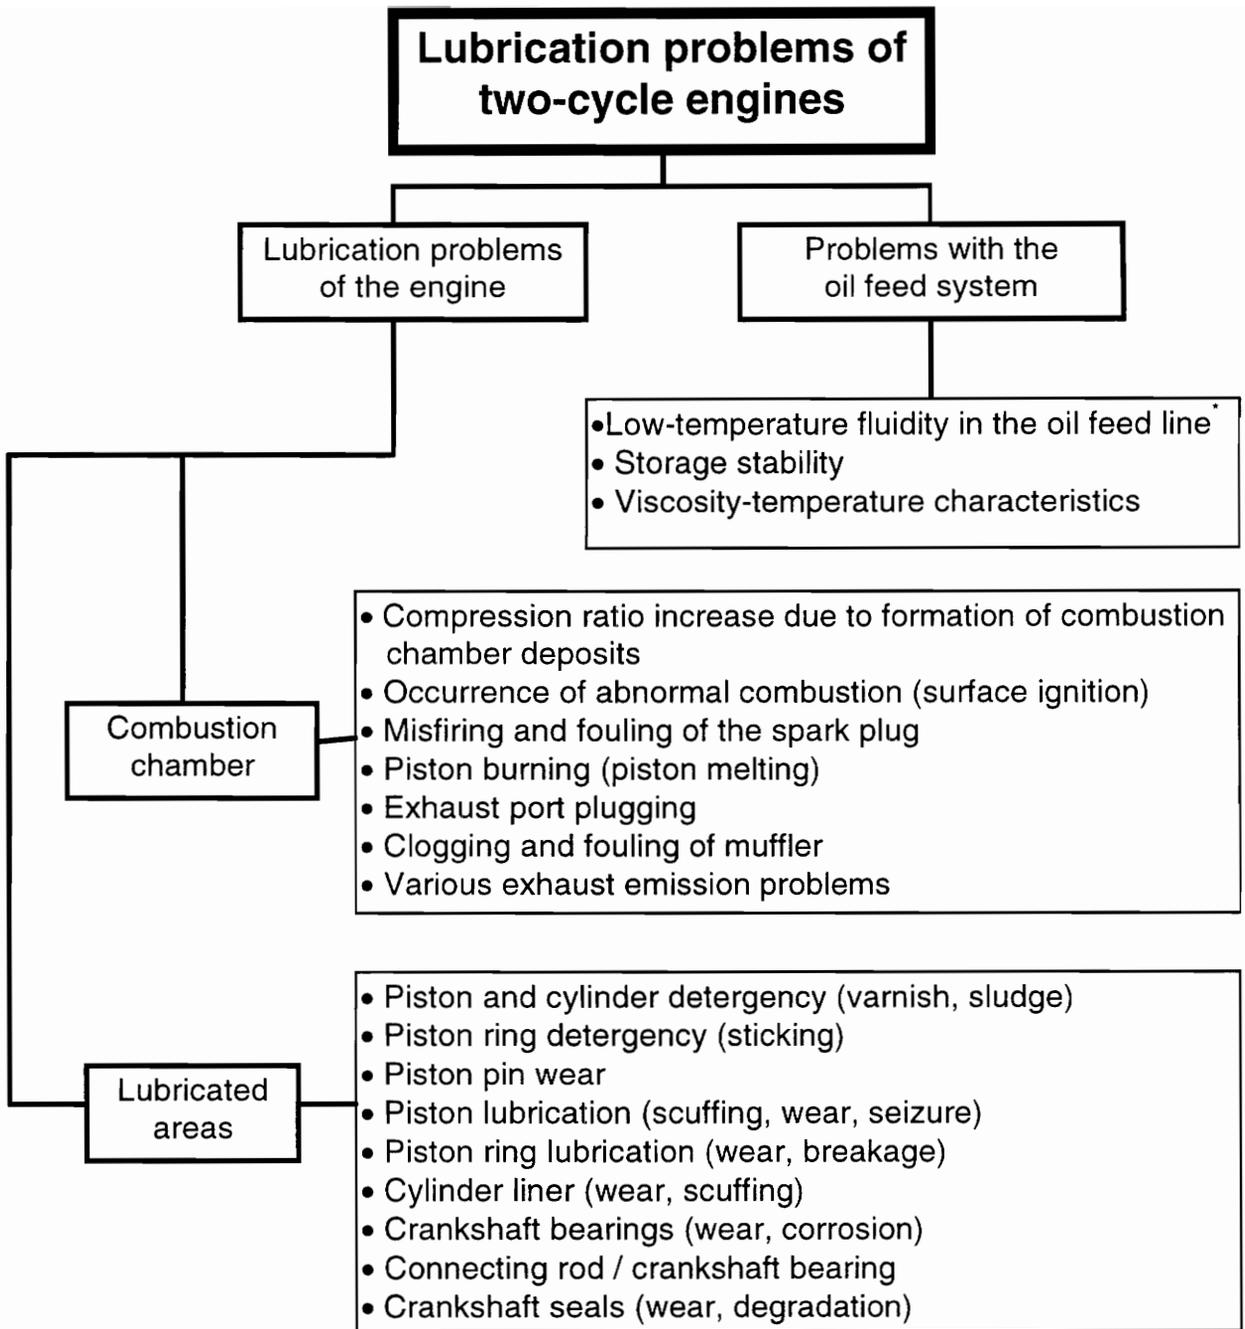
Figure 2.6: Lubrication Problems of 2-Cycle Engines
* Separate Lubrication Systems

A flow chart representation of lubricant requirements with respect to different engine areas is presented in Fig. 2.6.

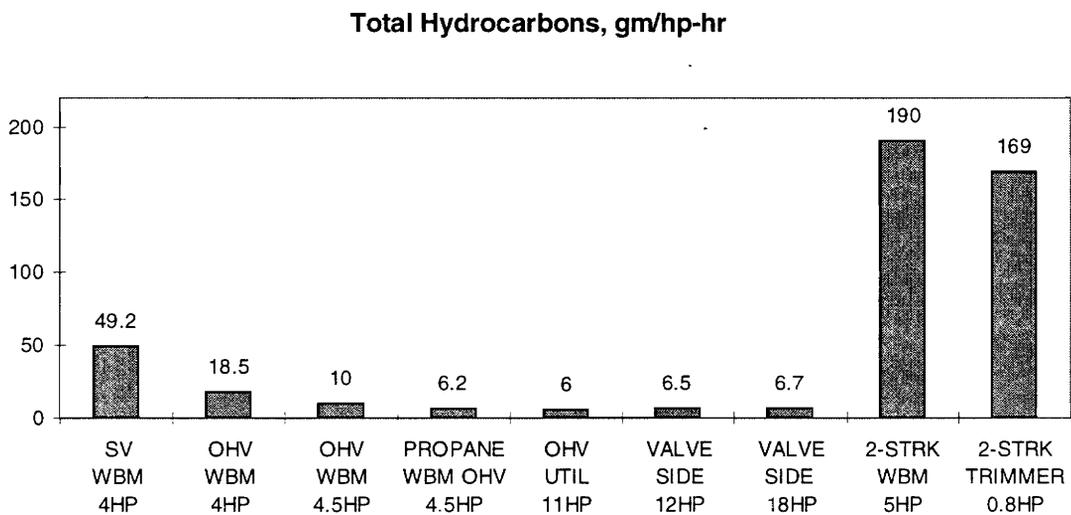
Figure 2.7: J1088 Small Engine Hydrocarbon Emissions [69]

As depicted in the figures, the two-cycle engines had total hydrocarbon emissions that were almost an order of magnitude higher than a comparable four-stroke engine, about 18 times the allowable CARB emission limits for 1994. Although current CARB standards for particulate matter presently pertain to diesel engines, the two-stroke gasoline engines output ten times the regulated amount. Particulate emission limits would undoubtedly be implemented on two-stroke gasoline engines, should the population of two-strokes continue to grow.

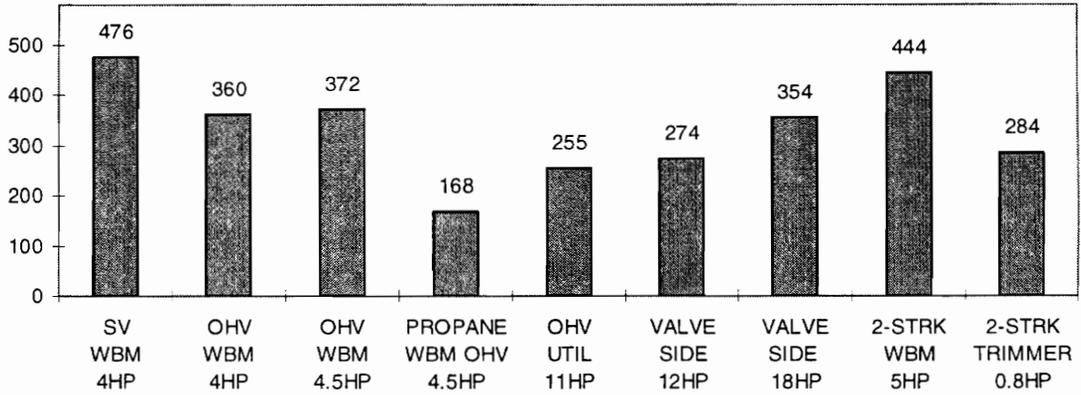
Figure 2.8: J1088 Small Engine Carbon Monoxide Emissions [69]

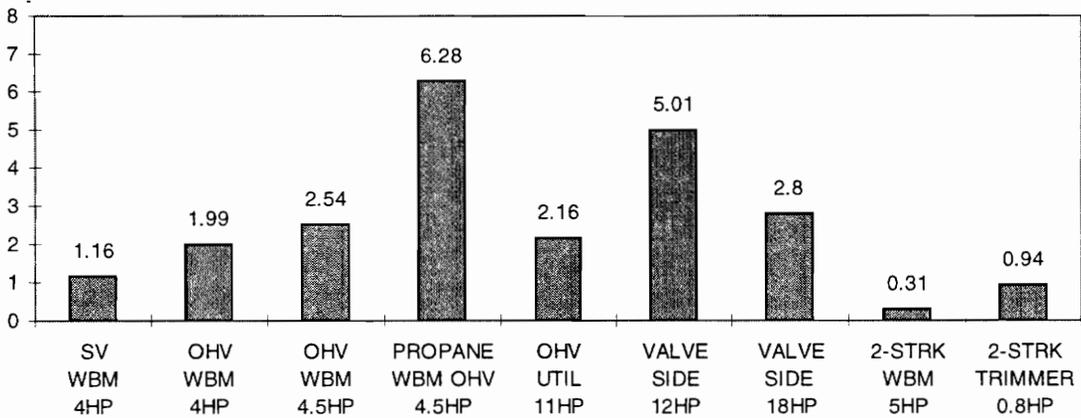
Figure 2.9: J1088 Small Engine Nitrogen Oxides Emissions [69]

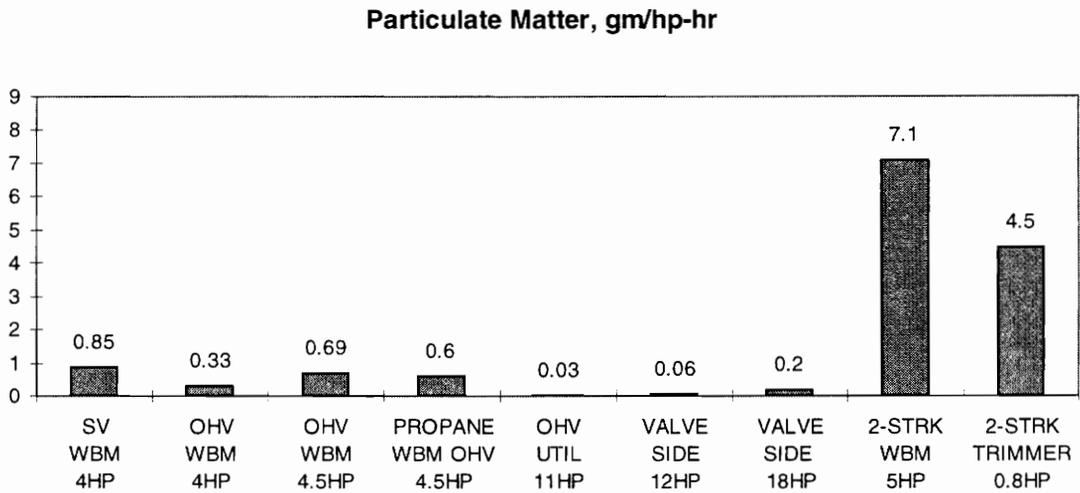
Figure 2.10: J1088 Small Engine Particulate Emissions [69]

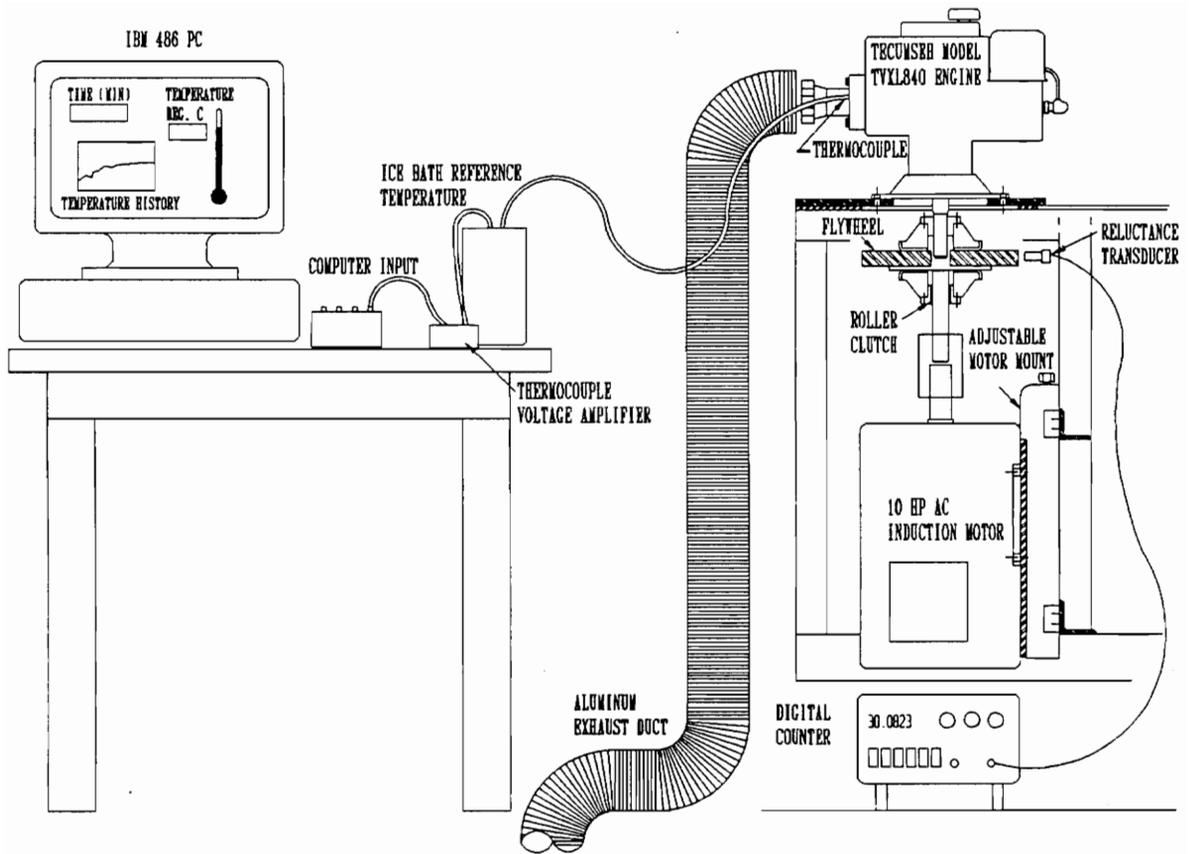
Figure 3.1: Experimental Set-up

connected to an IBM PC which was set-up to sample thermocouple voltage. A program was written using LabView VI software which had a variable sample rate and sample period to collect and save the thermocouple voltage data. Included in the VI was an algorithm to calculate the mean and standard deviation for each sample period. The standard deviation could be set as the criteria for saving each data block. A sudden temperature increase, for example, would result in a large standard deviation over a sampling period, telling the computer to save that data block with the time after the start of the test in which it had occurred. For the purpose of this testing it was decided to set this value at zero, and save the mean temperature over each 4 second sample period. This program also converted thermocouple voltage to temperature and displayed a strip chart temperature record on the screen during the test.

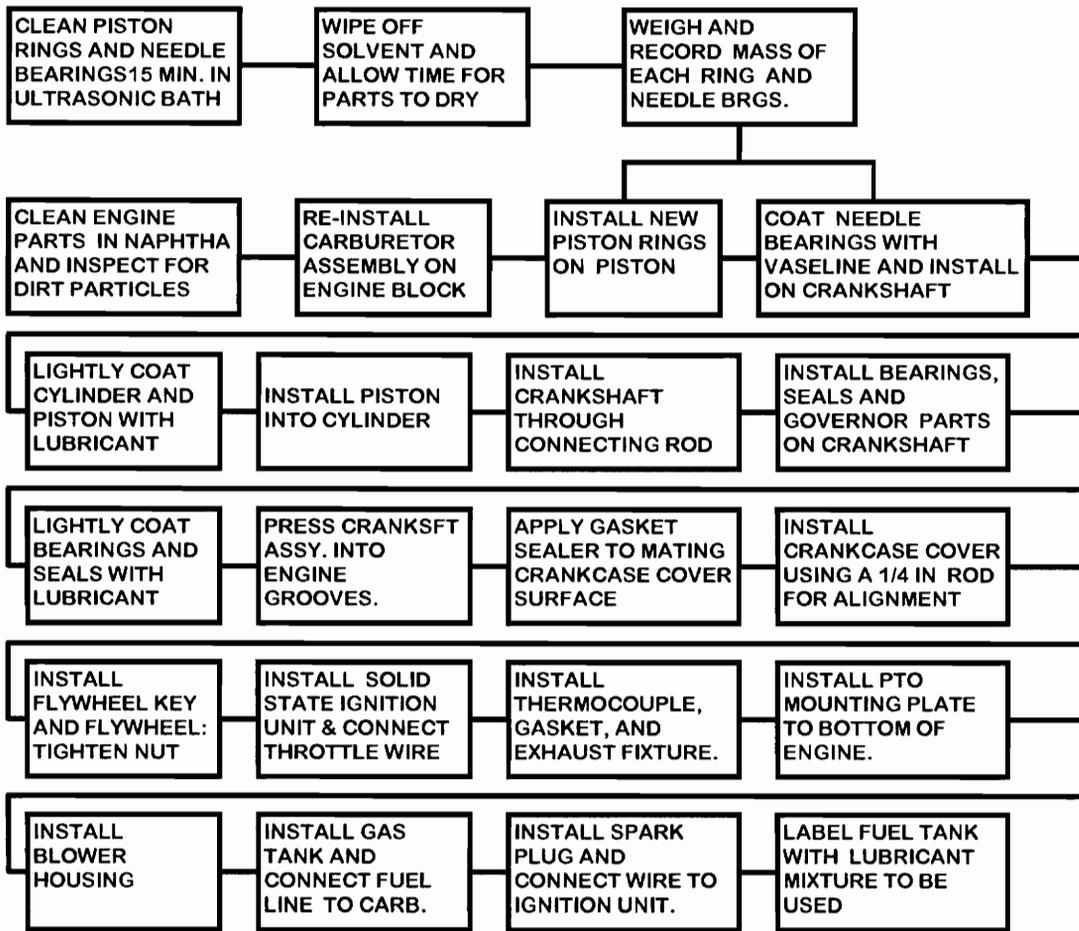
Figure 3.2: Block Diagram of the Engine Assembly Procedure

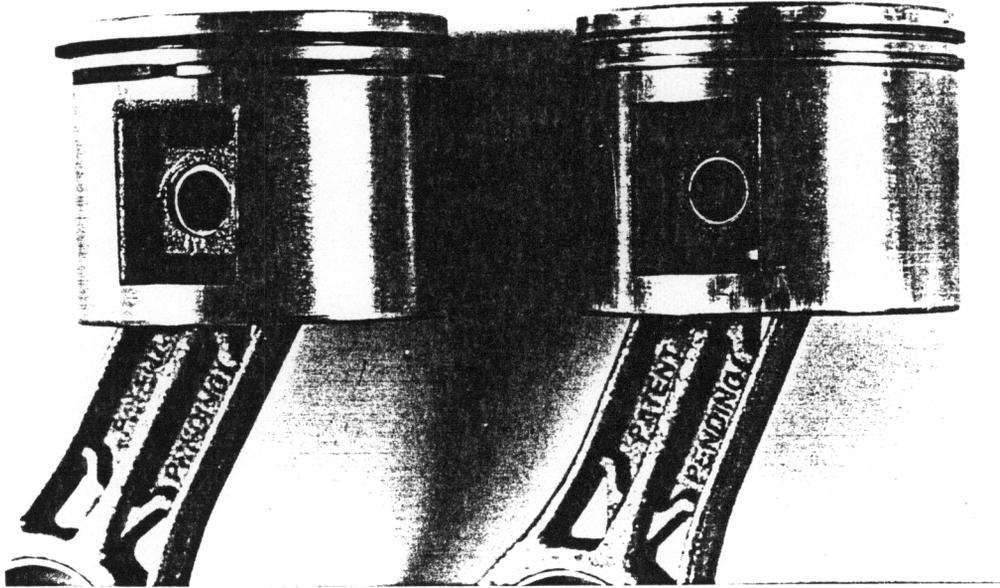
Figure 4.1: Photograph of a Replacement Piston (left) and One Removed From a New Engine (right) Which Shows Signs of Mild Run-in.

To learn more about these features, contact was made with the manufacturer [81]. The aluminum engine block is cast around the cast-iron cylinder sleeve. During the cooling process, the iron sleeve warps slightly, causing the intermittent contact regions which occur between the piston and cylinder. After assembly, the engines are run for approximately 1 minute with a very pure aviation fuel at no load, and a fuel:oil ratio of 24:1 at the factory. This explains the light signs of run-in on the piston and the intermittent smooth surface regions on the piston. The reason for the high surface roughness of the piston is to retain lubricating oil in the piston and cylinder region. Figure 4.1 is a photograph of a new replacement piston and a piston that was removed from a new engine. Slight signs of run-in can be seen on the piston on the right from the brief factory start-up, particularly near the upper and lower edges of the piston.

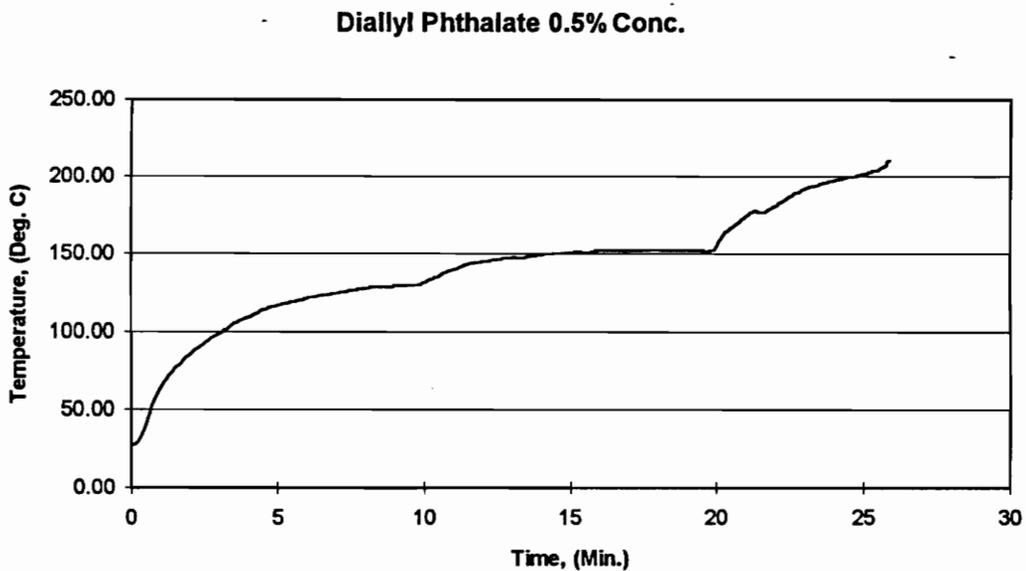
Figure 4.3: Engine Cylinder Wall Temperature History While Using 0.5% Diallyl Phthalate as a Lubricant.

The first engine bench test utilized a concentration of 0.5% diallyl phthalate by mass, in the fuel. The run-in procedure, as discussed in Chapter 3, was conducted at the three throttle settings of 2000, 2400, and 3000 rpm. After approximately 6 minutes of engine operation at 3000 rpm (26 minutes total), severe piston scuffing occurred, causing engine seizure. The temperature history of this test is shown in Fig. 4.3.

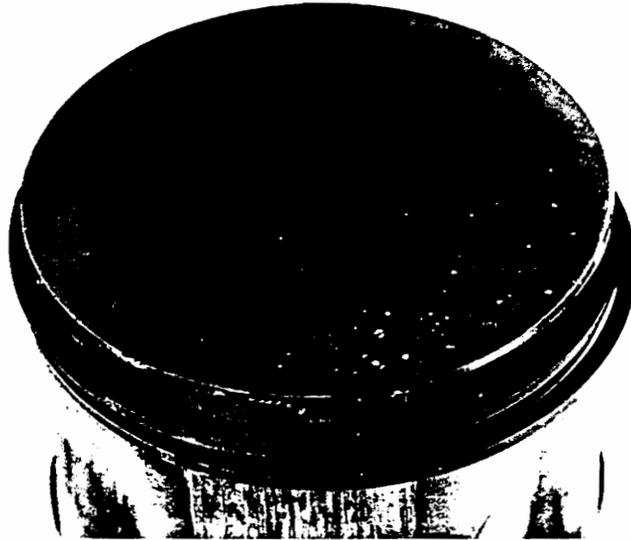
Figure 4.4: Photograph of the Top, Major Thrust Side of the Piston Using 0.5% Diallyl Phthalate as a Lubricant

Disassembly of the engine revealed that severe piston scuffing had occurred on the major thrust (exhaust port) and the minor thrust (carburetor side) of the piston. The wear scar on the carburetor side of the piston measured approximately 10 mm in width, and it covered the entire length of the piston, with the exception of about 5 mm at the lower edge of the piston skirt, where the wear scar tapered off. A photograph showing the top and the edge of major thrust side of the piston is presented in Fig. 4.4. This wear scar was about twice as wide as the wear scar on the minor thrust side of the engine, but most of the wear on this side of the piston occurred on the upper half of the piston. Very minor signs of run-in were noted on the remaining surface of the piston. The unscuffed surface was coated with very uneven gold-yellow and black deposits. These deposits were very thin and could be removed by lightly touching the surface.

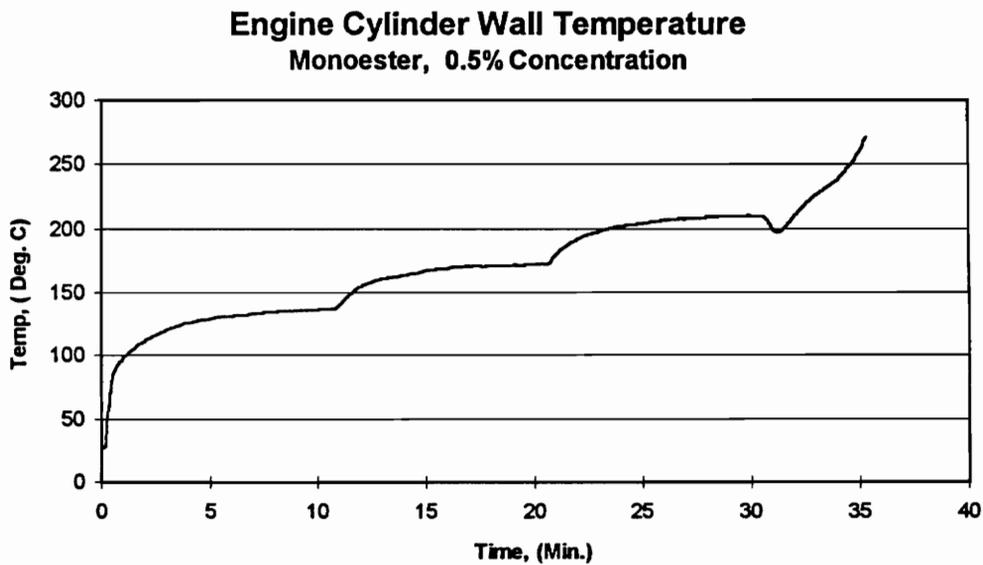
Figure 4.8: Temperature History Using 0.5% Monoester as a Lubricant.

The engine ran for approximately 4 minutes after the load was applied and the cylinder temperature increased steadily during this period. When the cylinder temperature reached approximately 270 °C, engine seizure occurred. The total running time was approximately 35 minutes.

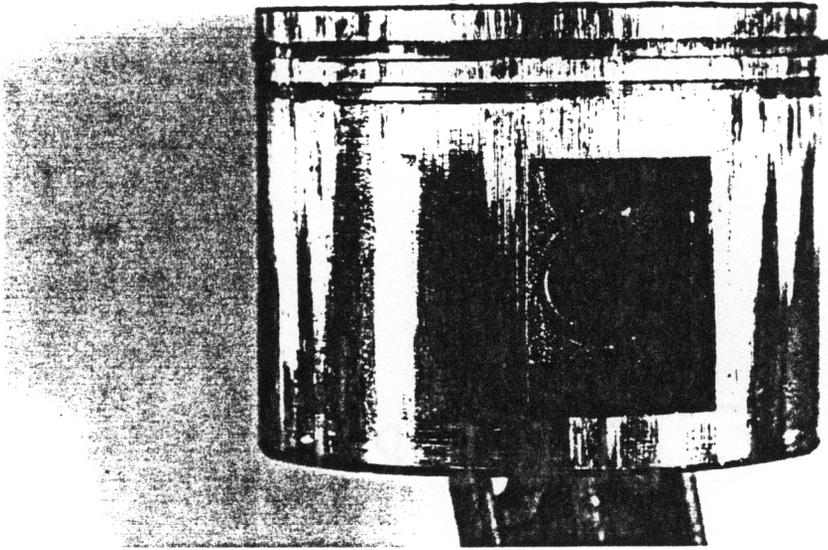
Figure 4.9: Photograph of the Scuffed Piston Using 0.5% Monoester as a Lubricant

piston is shown in Fig. 4.9. The most severe wear scars were close to the piston rings; they tapered off and became much narrower towards the piston skirt.

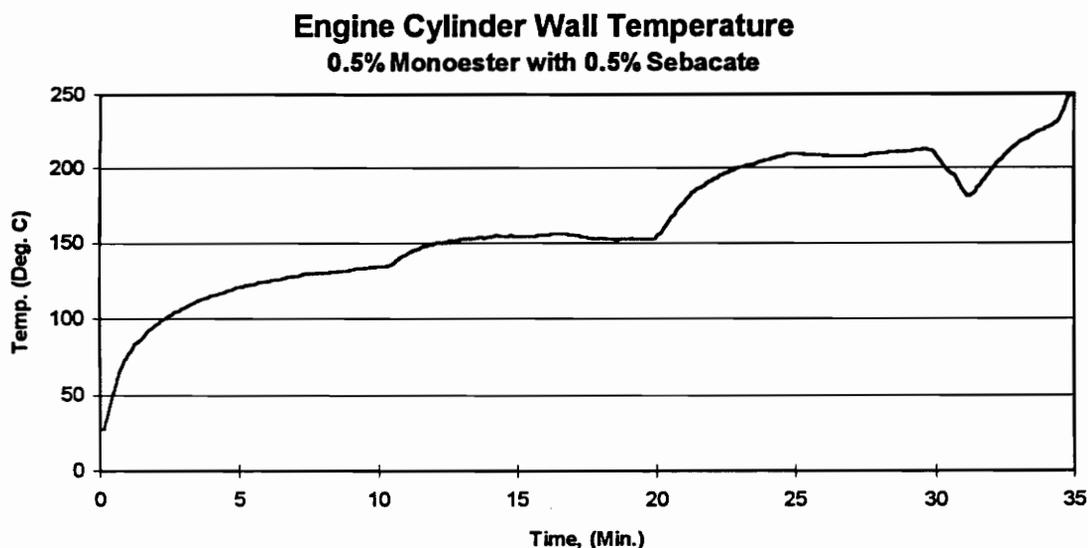
Figure 4.13: Engine Temperature History Using 0.5% Monoester Plus 0.5% Sebacate

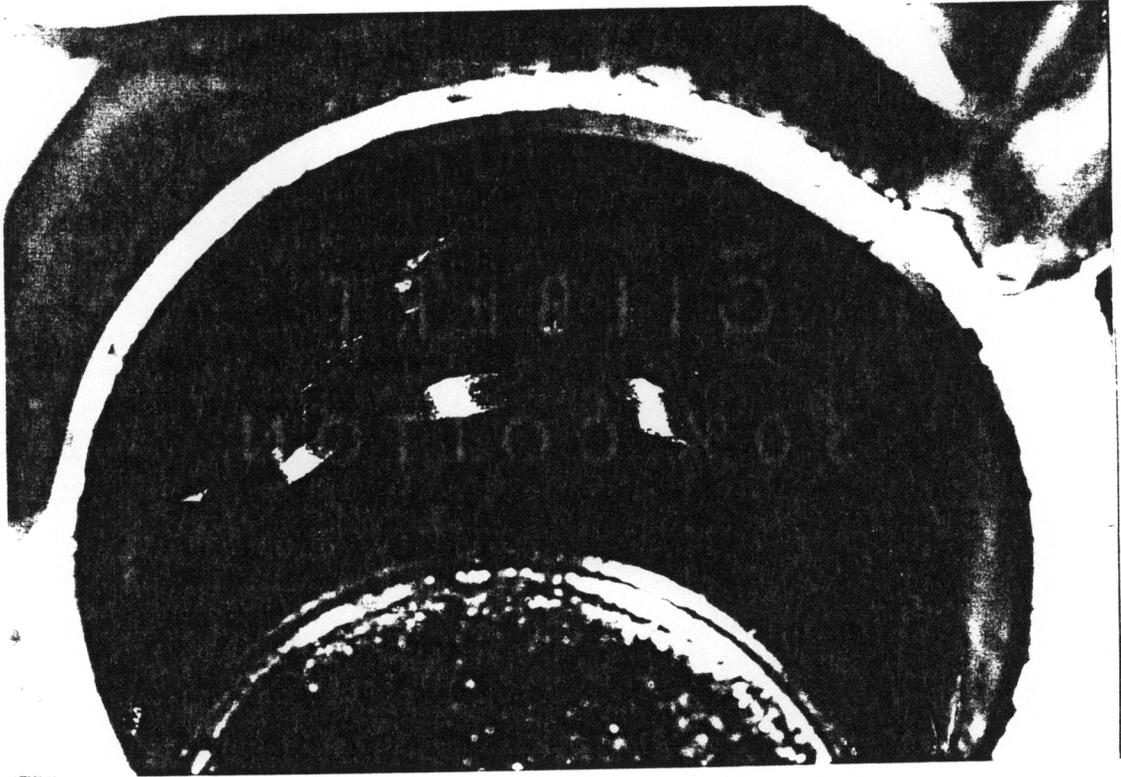
Figure 4.16: Photograph of the Engine Cylinder After Piston Scuffing Had Occurred Using 0.5% Sebacate and 0.5% Monoester as a Lubricant.

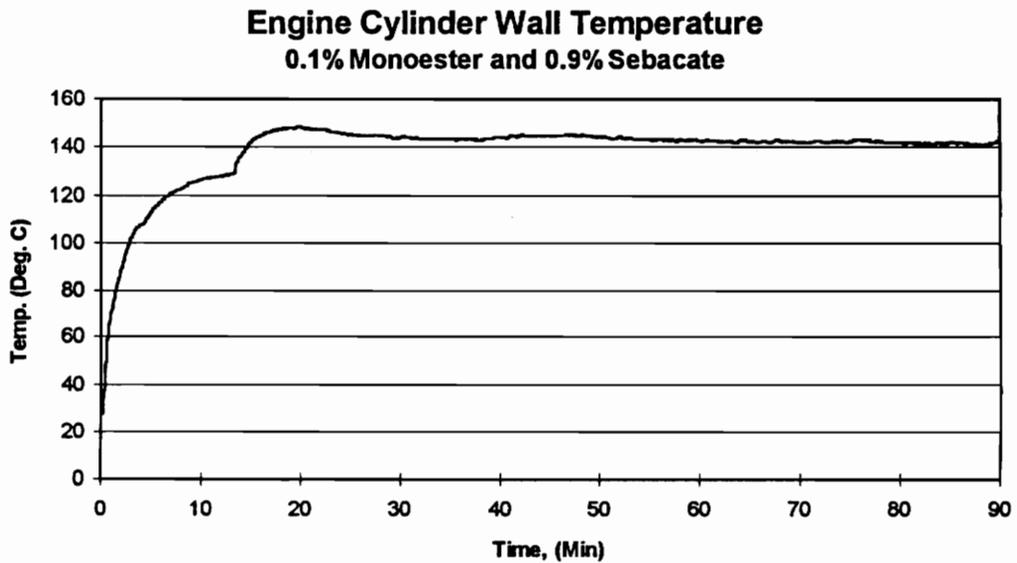
Figure 4.18 Engine Cylinder Wall Temperature Using 0.1% Monoester and 0.9% Sebacate at a Speed of 2400 rpm After Warm-up.

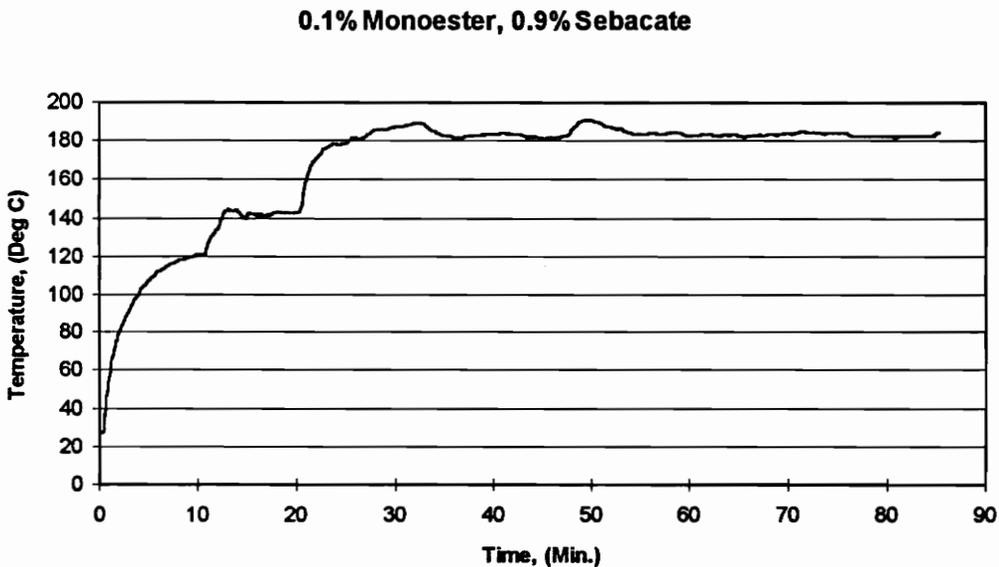
Figure 4.19: Temperature history Using 0.1% Monoester and 0.9% Sebacate as a Lubricant for 85 Minutes.

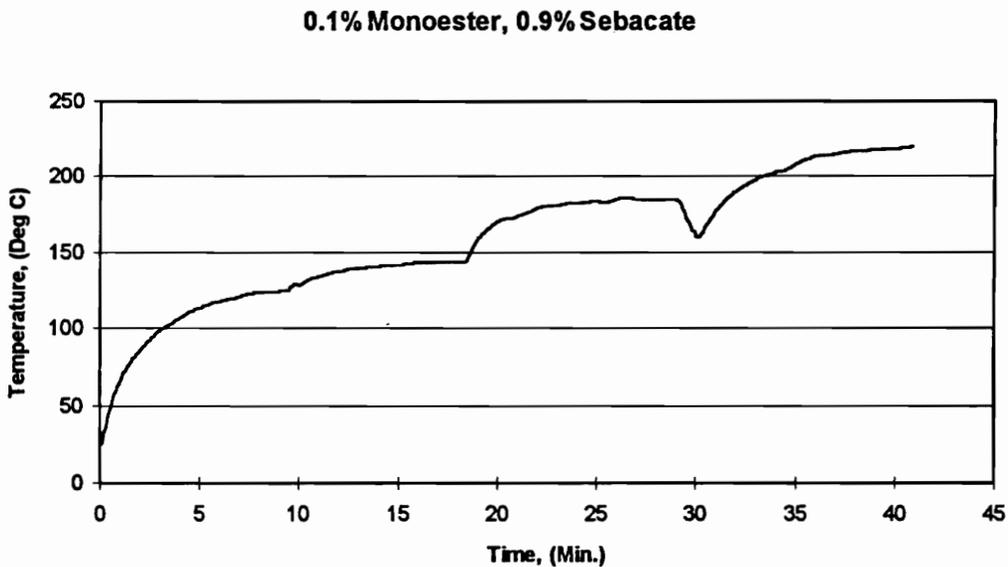
Figure 4.20: Temperature History for the Loaded Test using 0.1% Monoester and 0.9% Sebacate

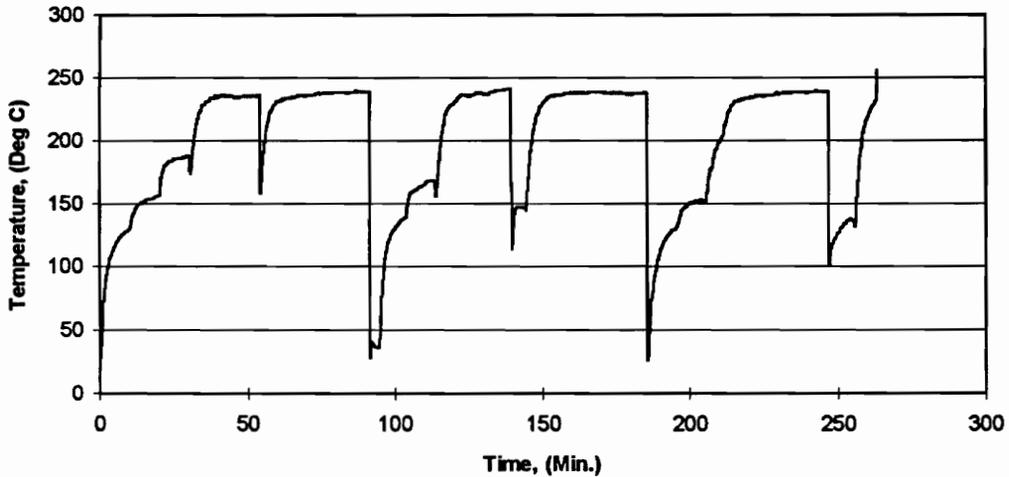
Figure 4.23: Temperature History for the Test Conducted Using 2.0% of the Conventional, Two-Cycle Engine Oil

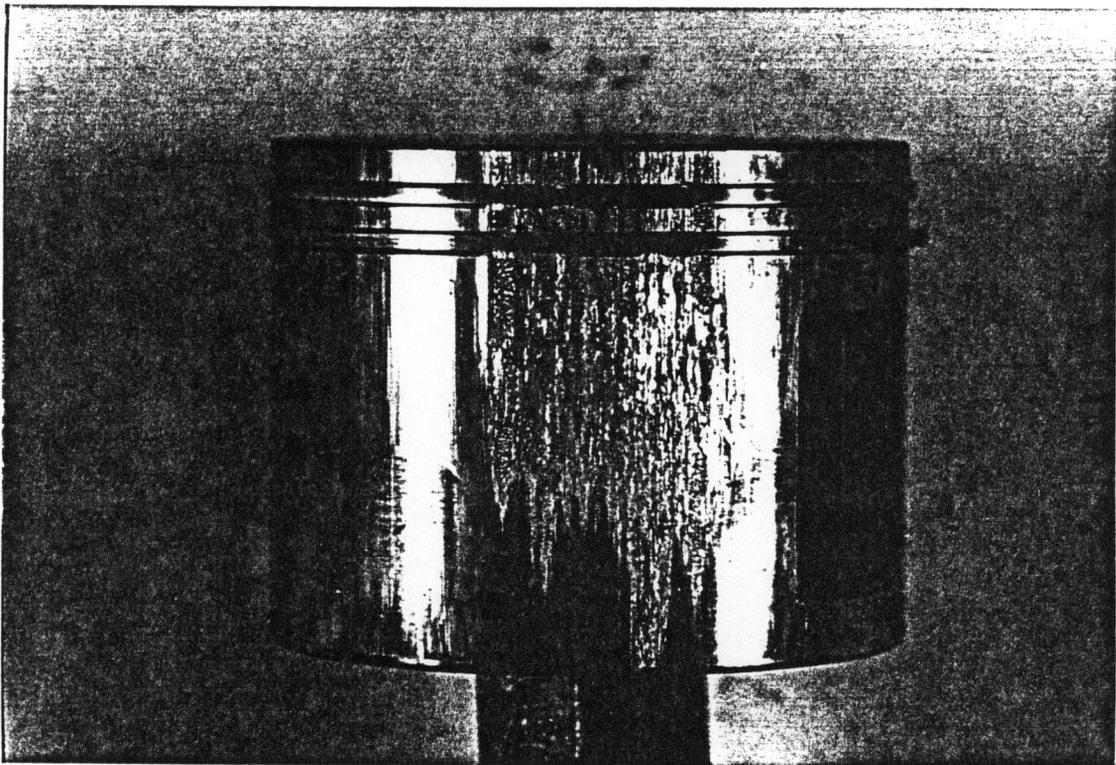
Figure 4.24: Photograph of a Scuffed Piston Obtained Using Conventional Lubricant at a Concentration of 2.0%

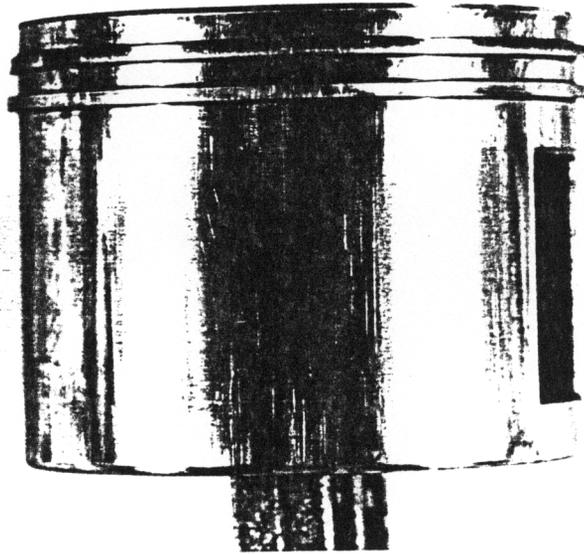
Figure 4.25: Photograph of the Undamaged but Well Run-in Side of the Piston After 345 Minutes of Operation with Conventional Lubricant at a Concentration of 2.0%

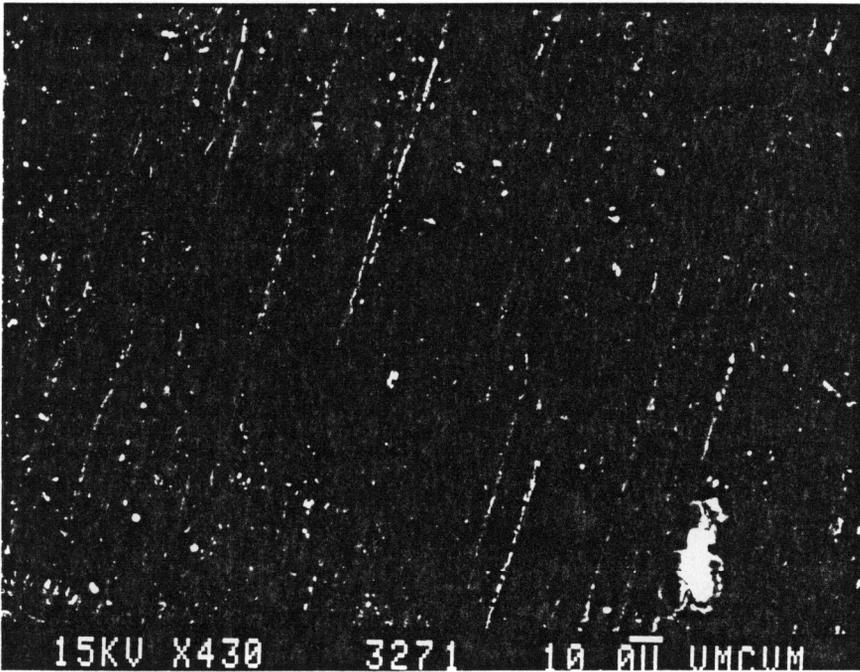
Figure 4.28: SEM Photograph of an Undamaged Portion of the Piston Surface After 27 Min. of Operation With 0.5% Diallyl Phthalate (430X Magnification)

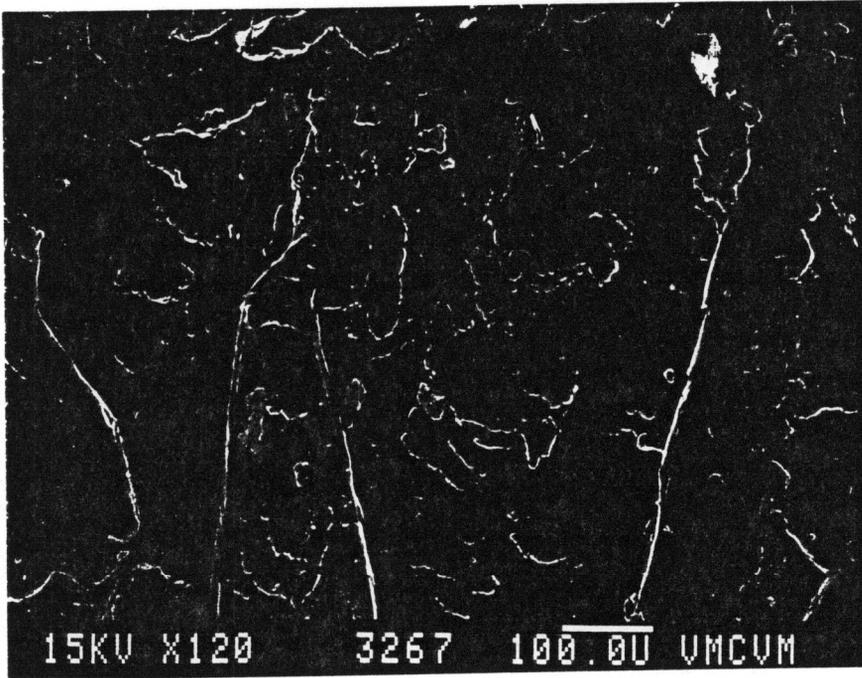
Figure 4.29: SEM Photograph of a Scuffed Region of the Piston After 27 Minutes of Operation with 0.5% Diallyl Phthalate (120X Magnification)

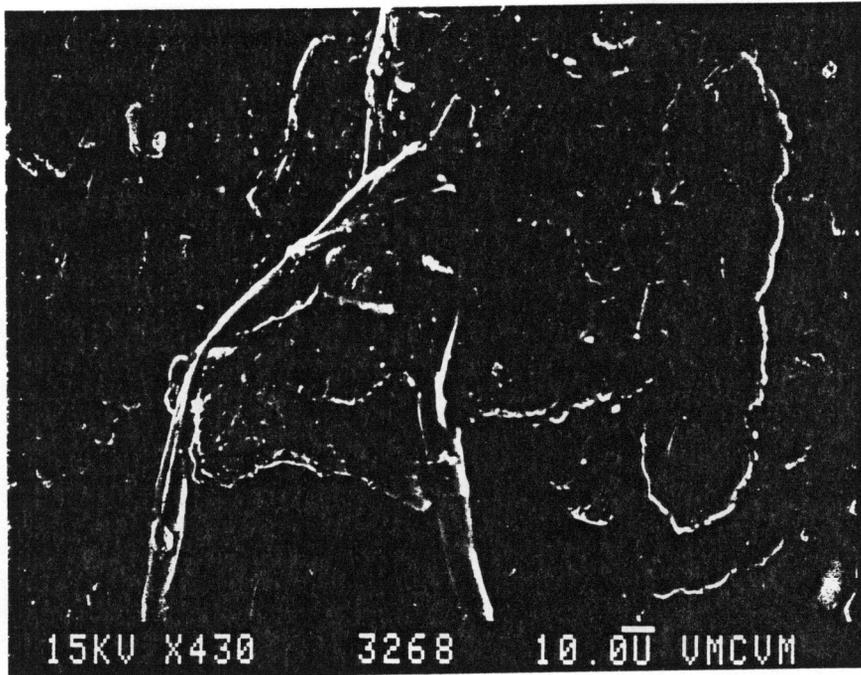
Figure 4.30: SEM Photograph of the Scuffed Region of the Piston Surface after 27 Minutes of Operation With 0.5% Diallyl Phthalate (430X Magnification)

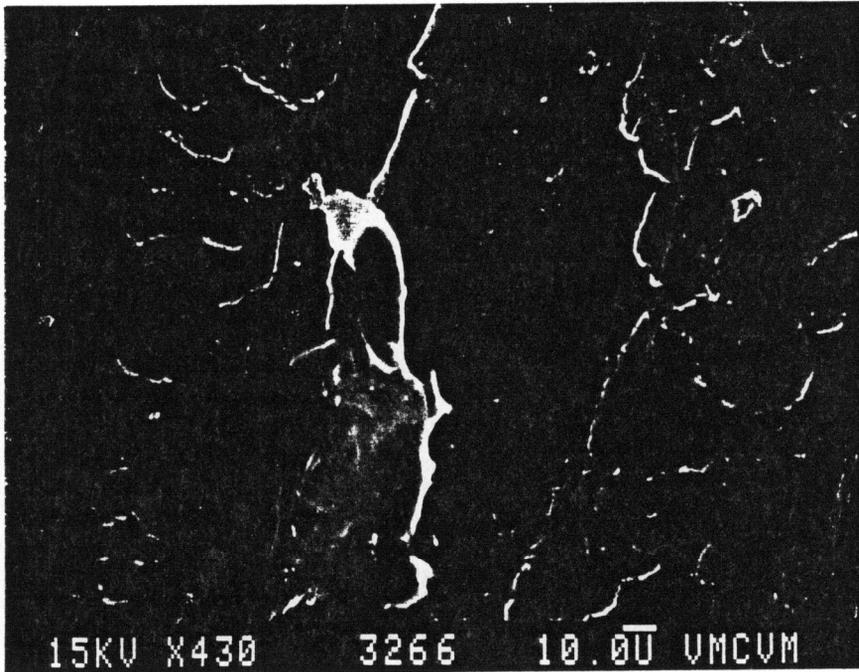
Figure 4.31: SEM Photograph of the Scuffed Region of the Piston Surface after 27 Minutes of Operation With 0.5% Diallyl Phthalate (430X Magnification)
