**TRIBOPOLYMERIZATION AS AN APPROACH TO
TWO-STROKE ENGINE LUBRICATION**

Thesis submitted to the Faculty of

Virginia Polytechnic Institute and State University

Mechanical Engineering

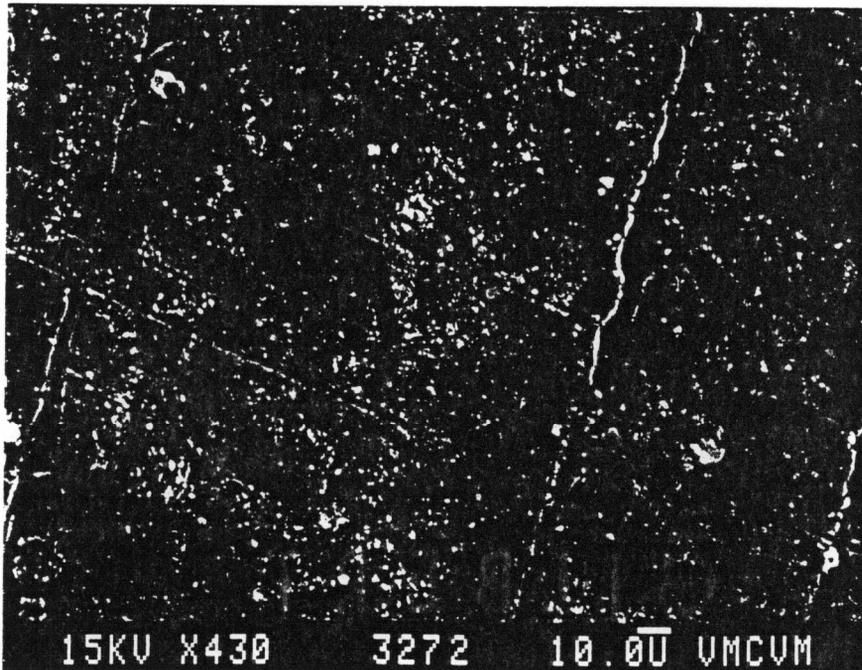
Figure 4.32: SEM Photograph of a Very Smooth Region of the Piston Surface After Operation for 27 Minutes using 0.5% Diallyl Phthalate (430X Magnification)

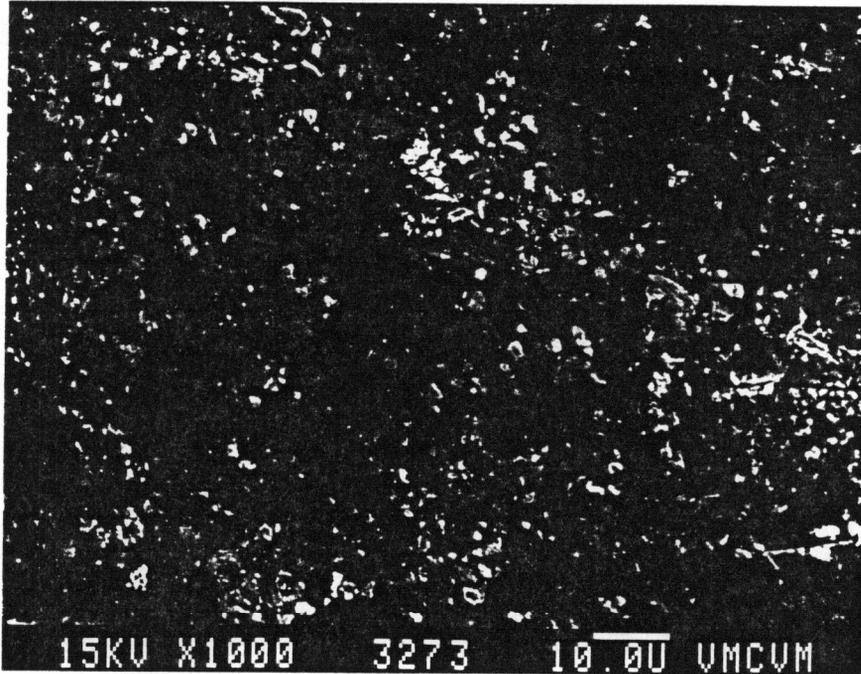
Figure 4.33: SEM Photograph of a Well Run-in Portion of the Piston Surface After 27 Minutes of Operation Using 0.5% Diallyl Phthalate. (1000X Magnification)

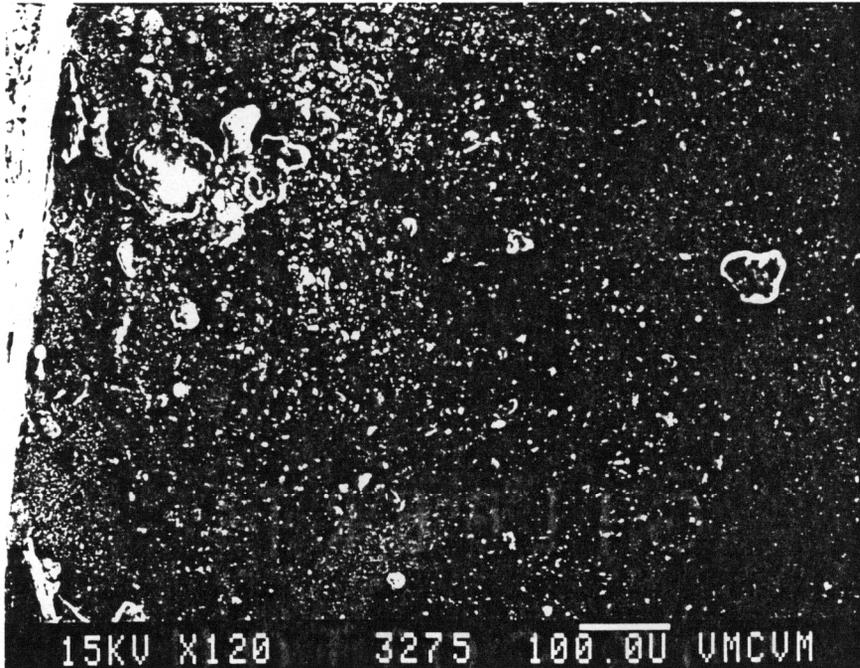
Figure 4.34: SEM Photograph of the Edge of the Lower Piston Ring after 27 Minutes of Operation Using 0.5% Diallyl Phthalate. (120X Magnification)

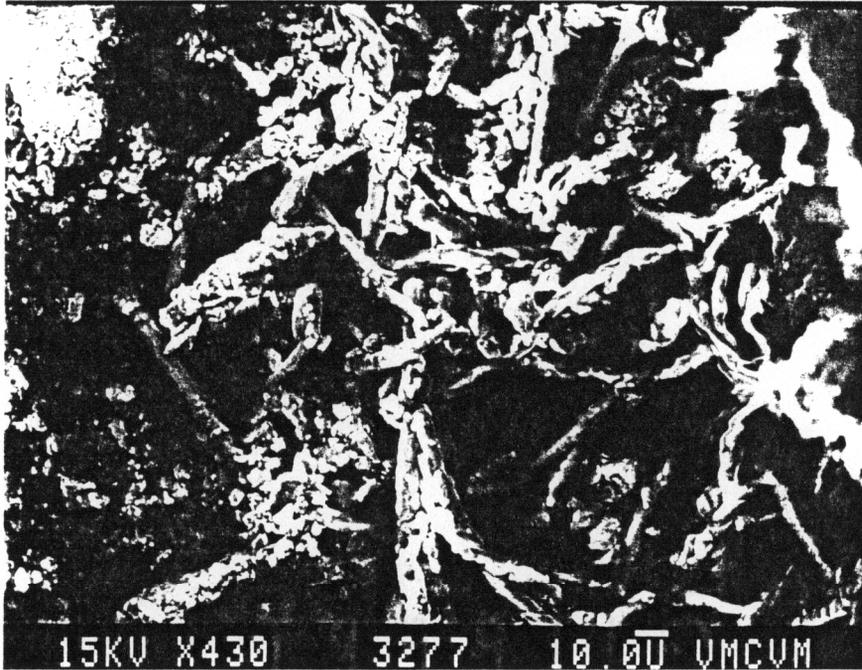
Figure 4.35: SEM Photograph of the Piston Ring Groove After 27 Minutes of Operation With 0.5% Diallyl Phthalate (430X Magnification)

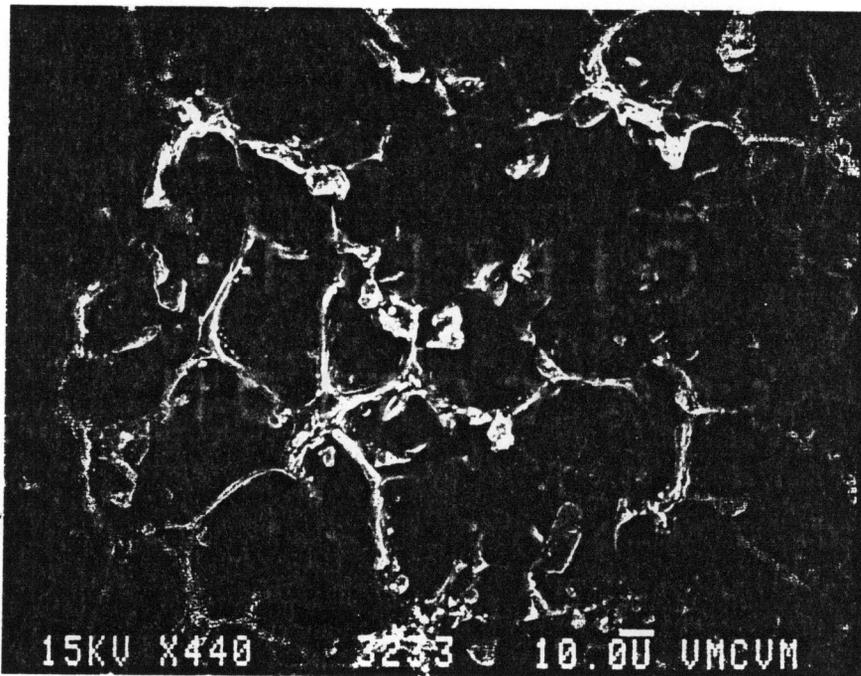
Figure 4.36: SEM Photograph of Typical Deposits Found on the Piston Surface After 35 Minutes of Operation Using 0.5% Monoester (440X Magnification)

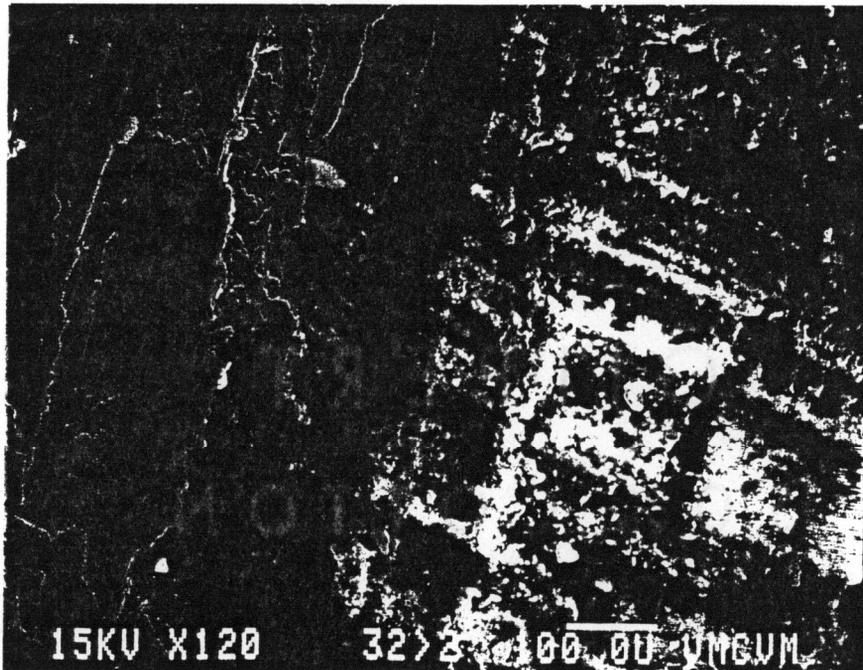
Figure 4.37: SEM Photograph of the Edge of a Damaged Portion of the Piston Using 0.5% Monoester as a Lubricant (120X Magnification)

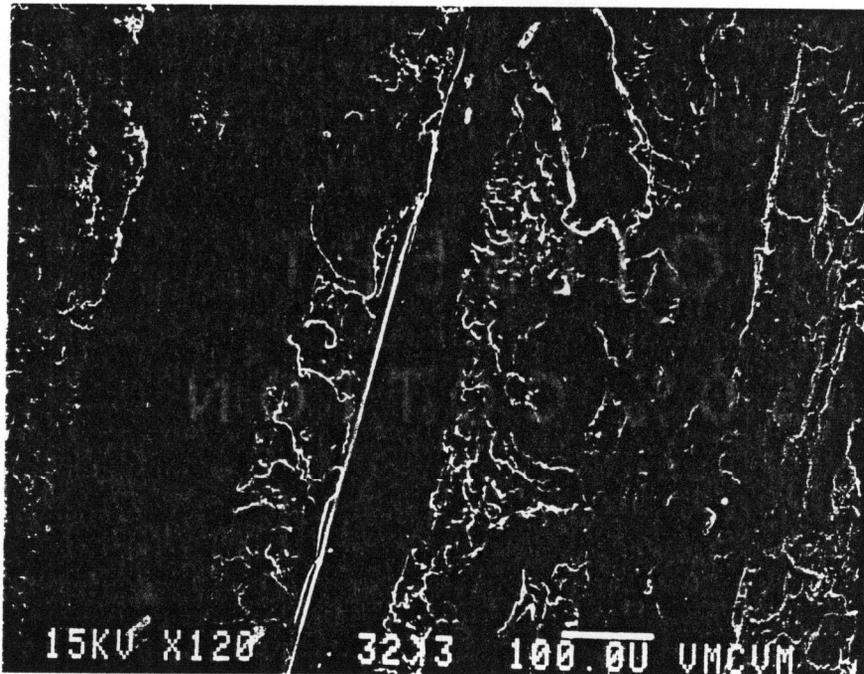
Figure 4.38: SEM Photograph of Typical Surface Features Observed Near the Center of the Wear Scars of the Piston from the 0.5% Monoester Test (120X Magnification)

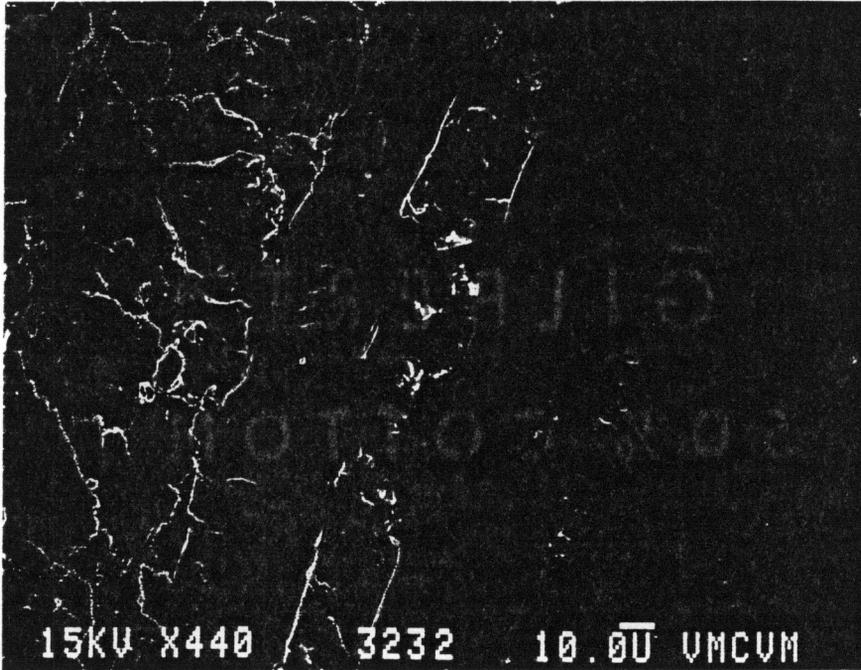
Figure 4.39: SEM Photograph of the Damaged Piston Surface Using 0.5% Monoester as a Lubricant (440X Magnification)

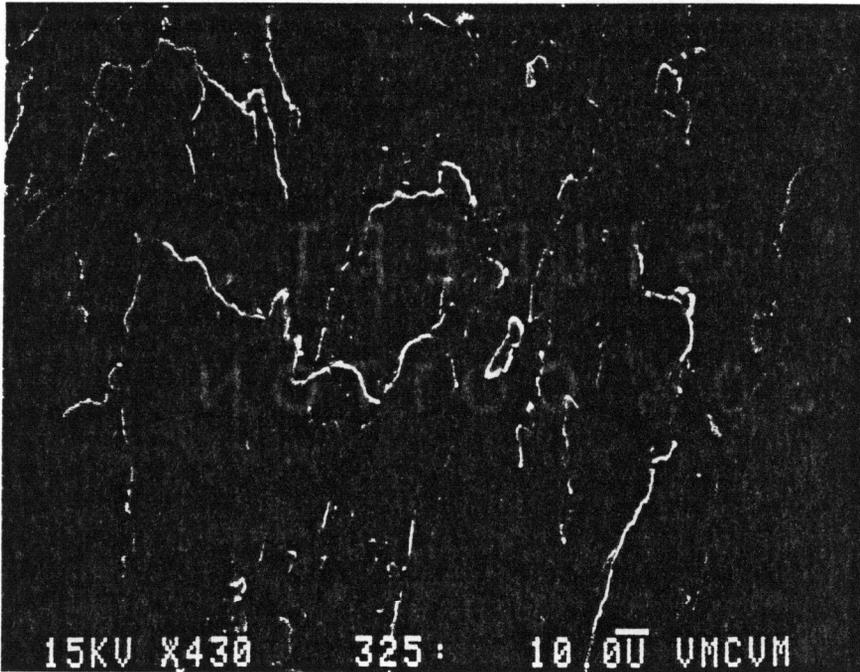
Figure 4.40: SEM Photograph of the Damaged Piston Surface Using 0.5% Monoester as a Lubricant (430X Magnification)

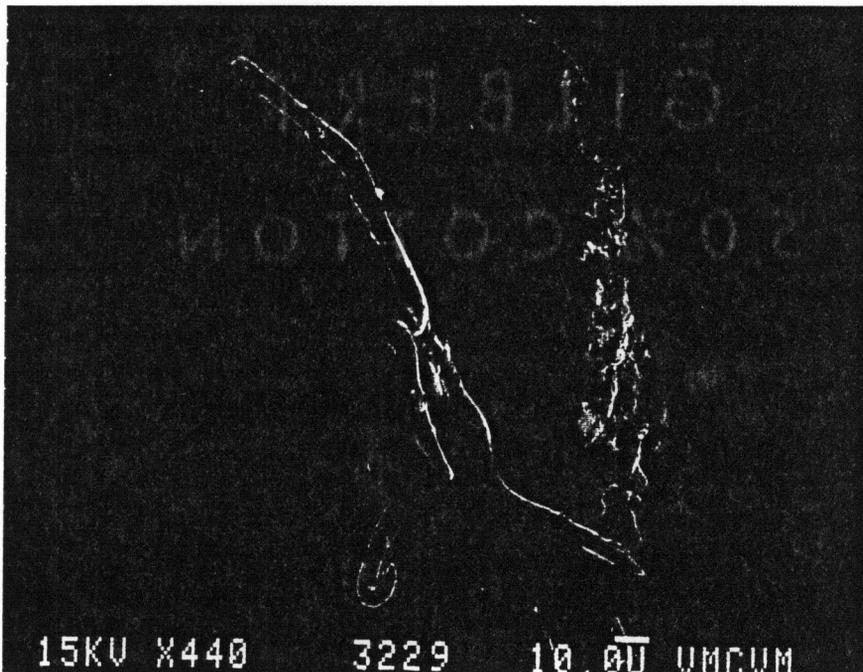
Figure 4.41: SEM Photograph of the Outer Edge of the Lower Piston Ring From the Engine Test Using 0.5% Monoester. (440X Magnification)

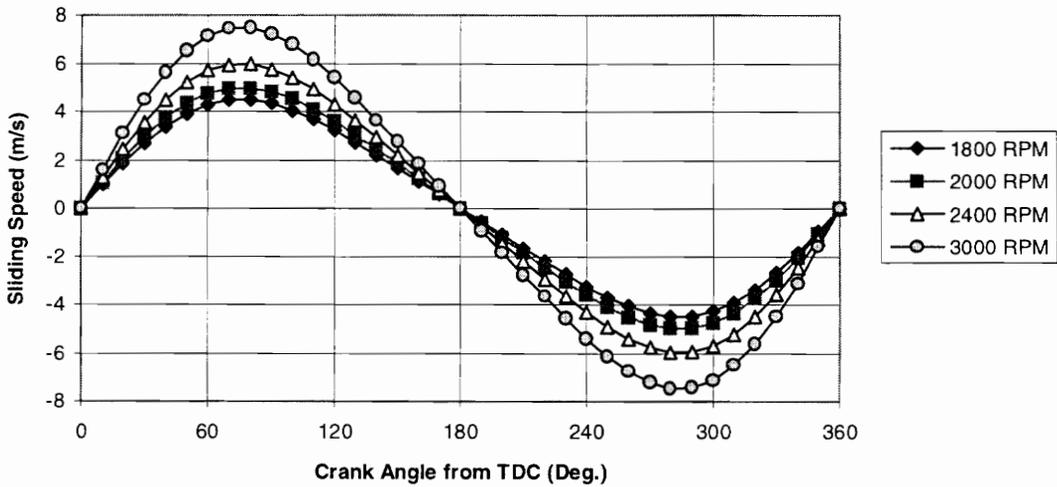
Figure 5.1: Piston Sliding Speed as a Function of Crank Angle at Various Engine Speeds

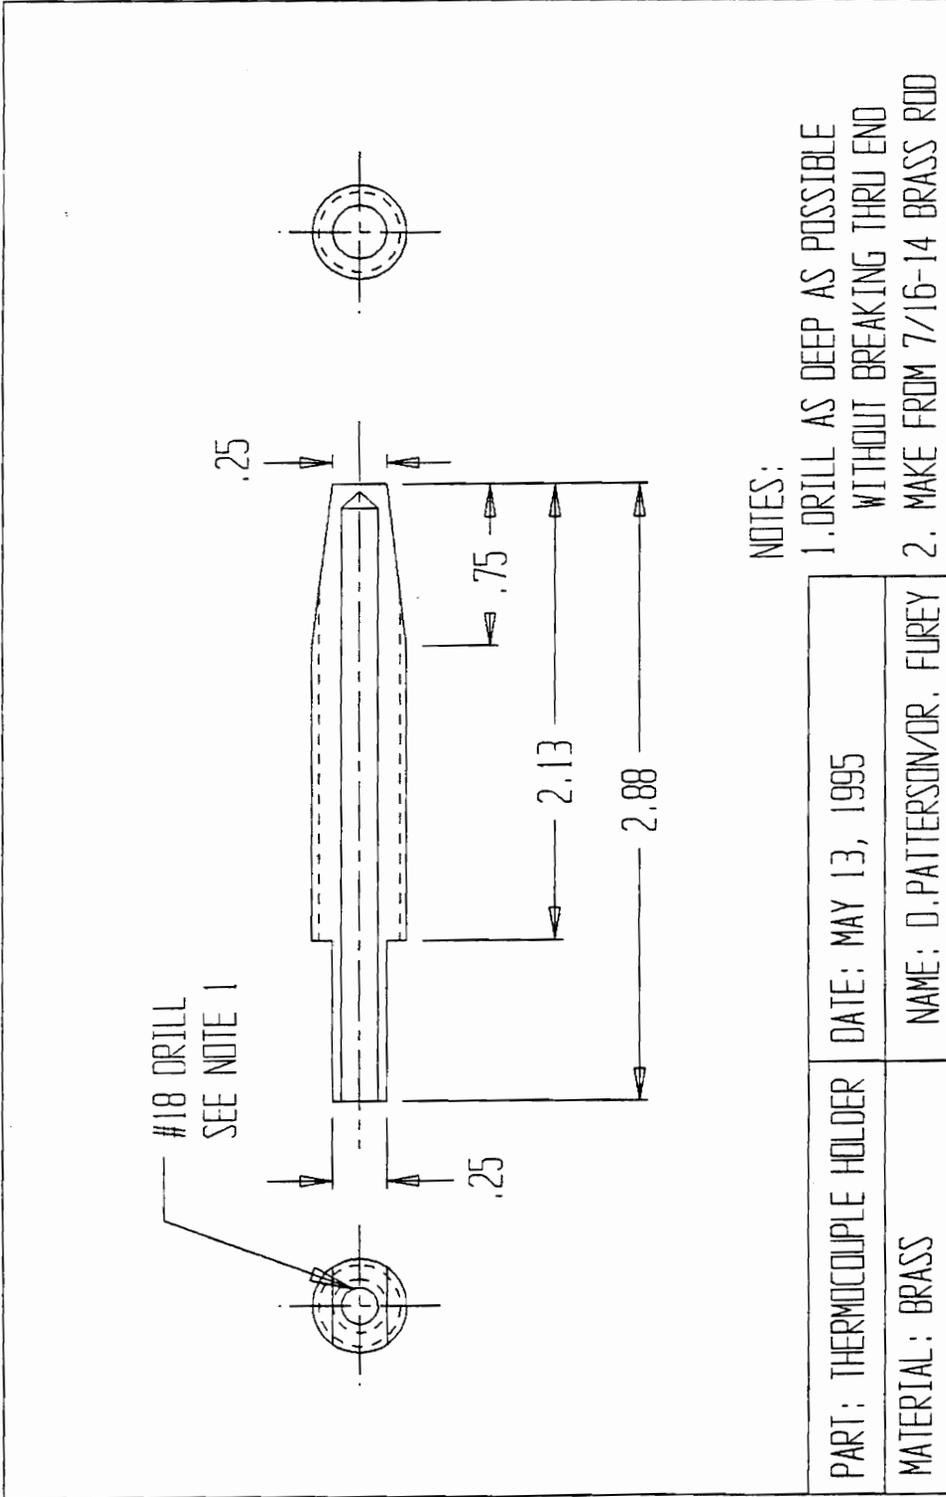
Figure B1: Thermocouple Holder

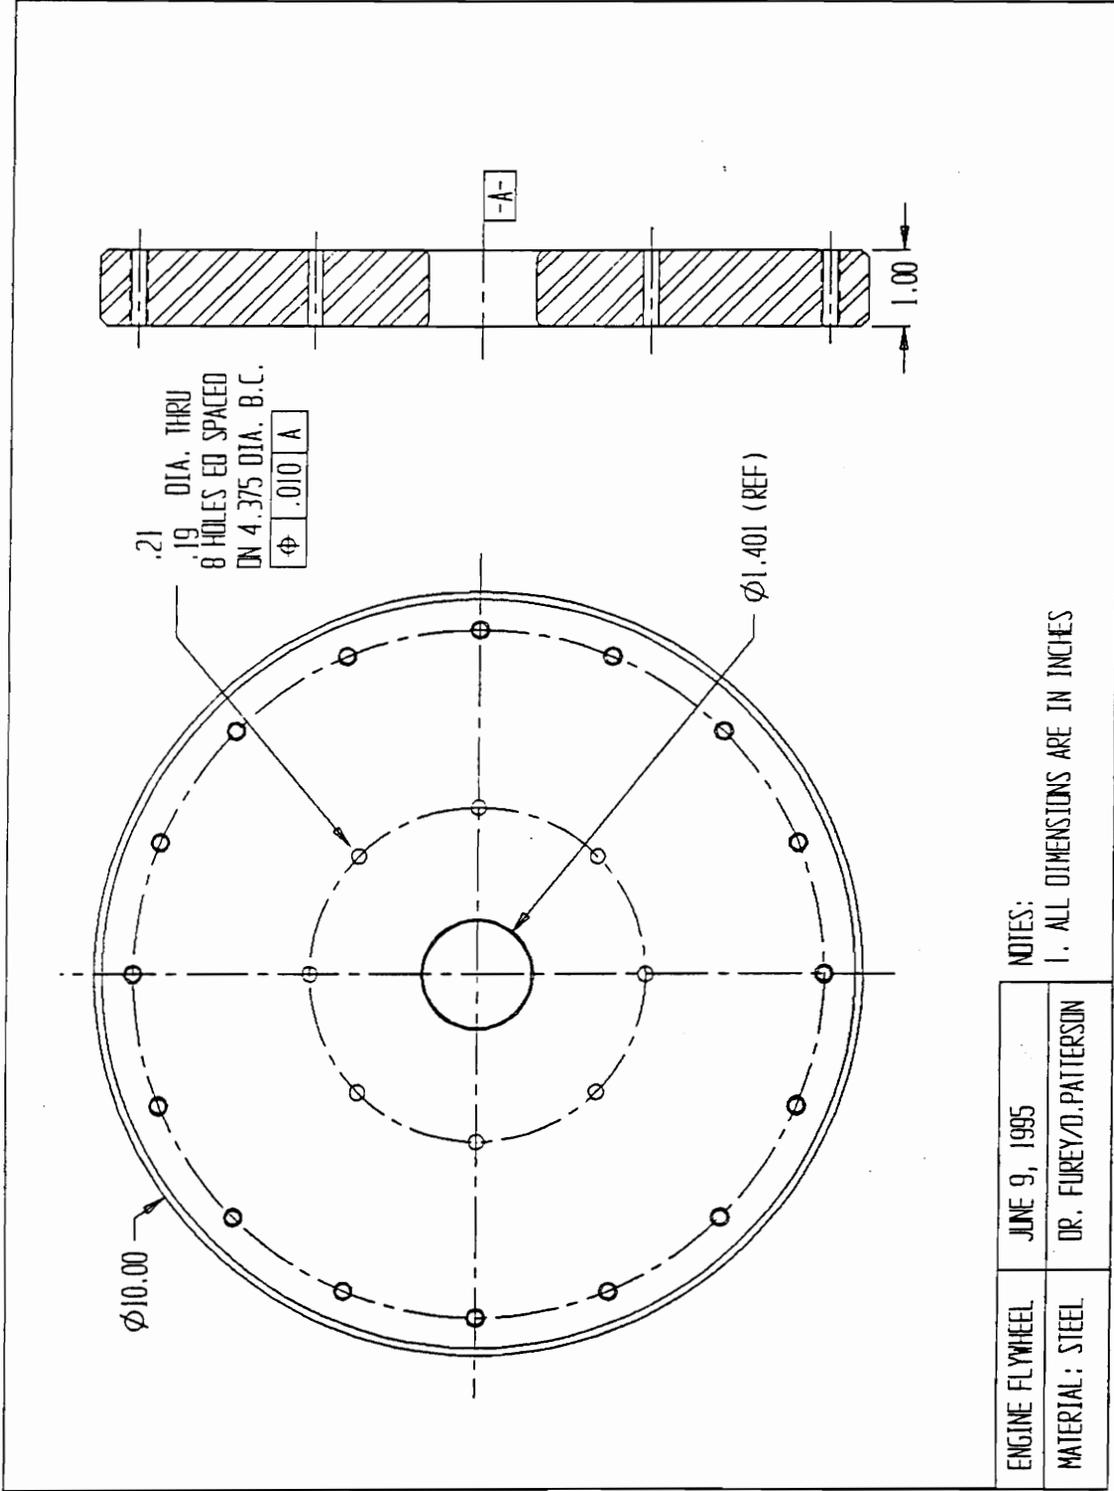
Figure B2: Shaft Flywheel

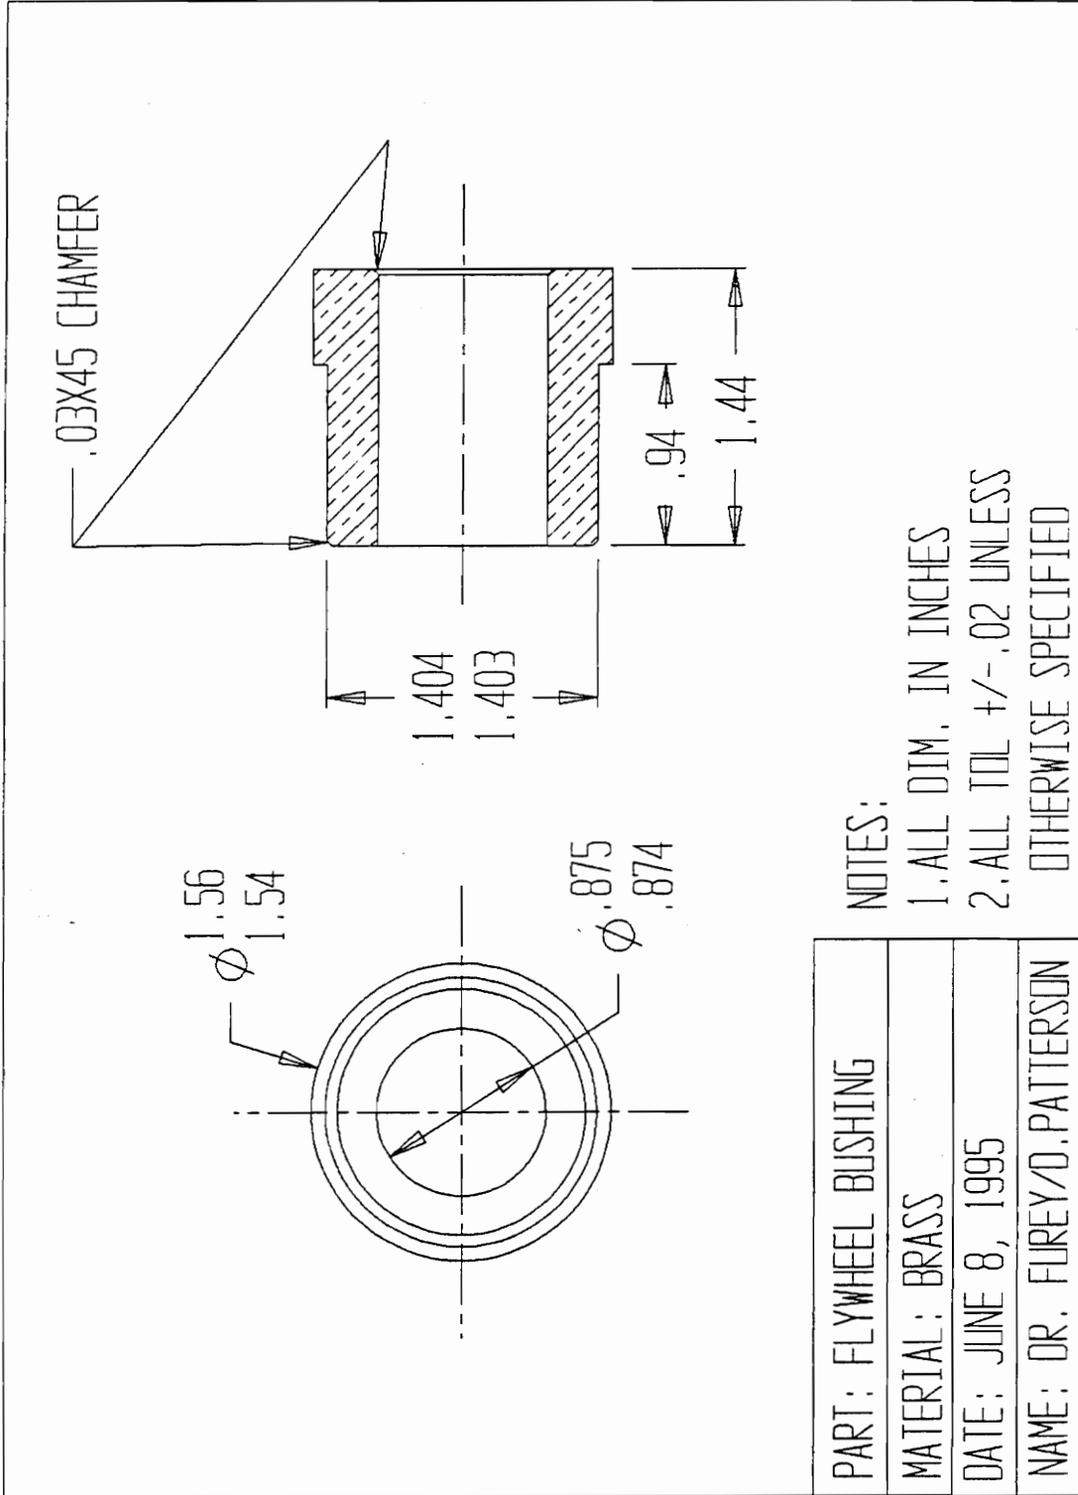
Figure B3: Flywheel Bushing

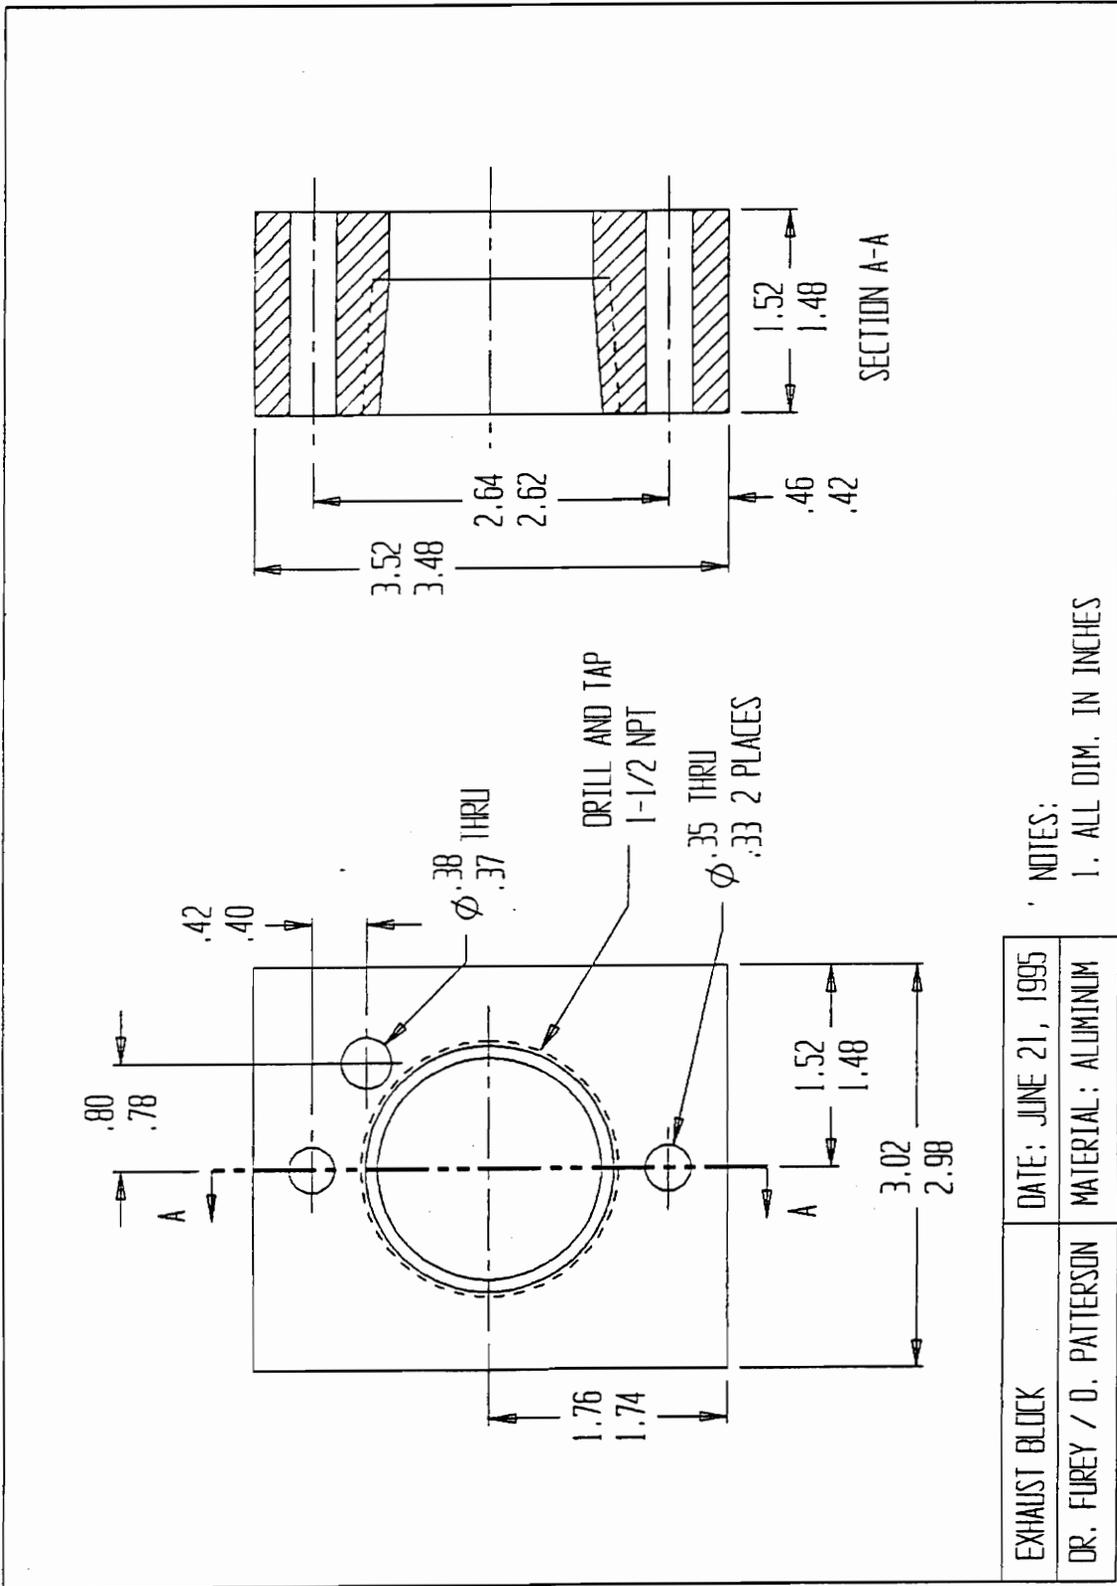
Figure B5: Exhaust Block

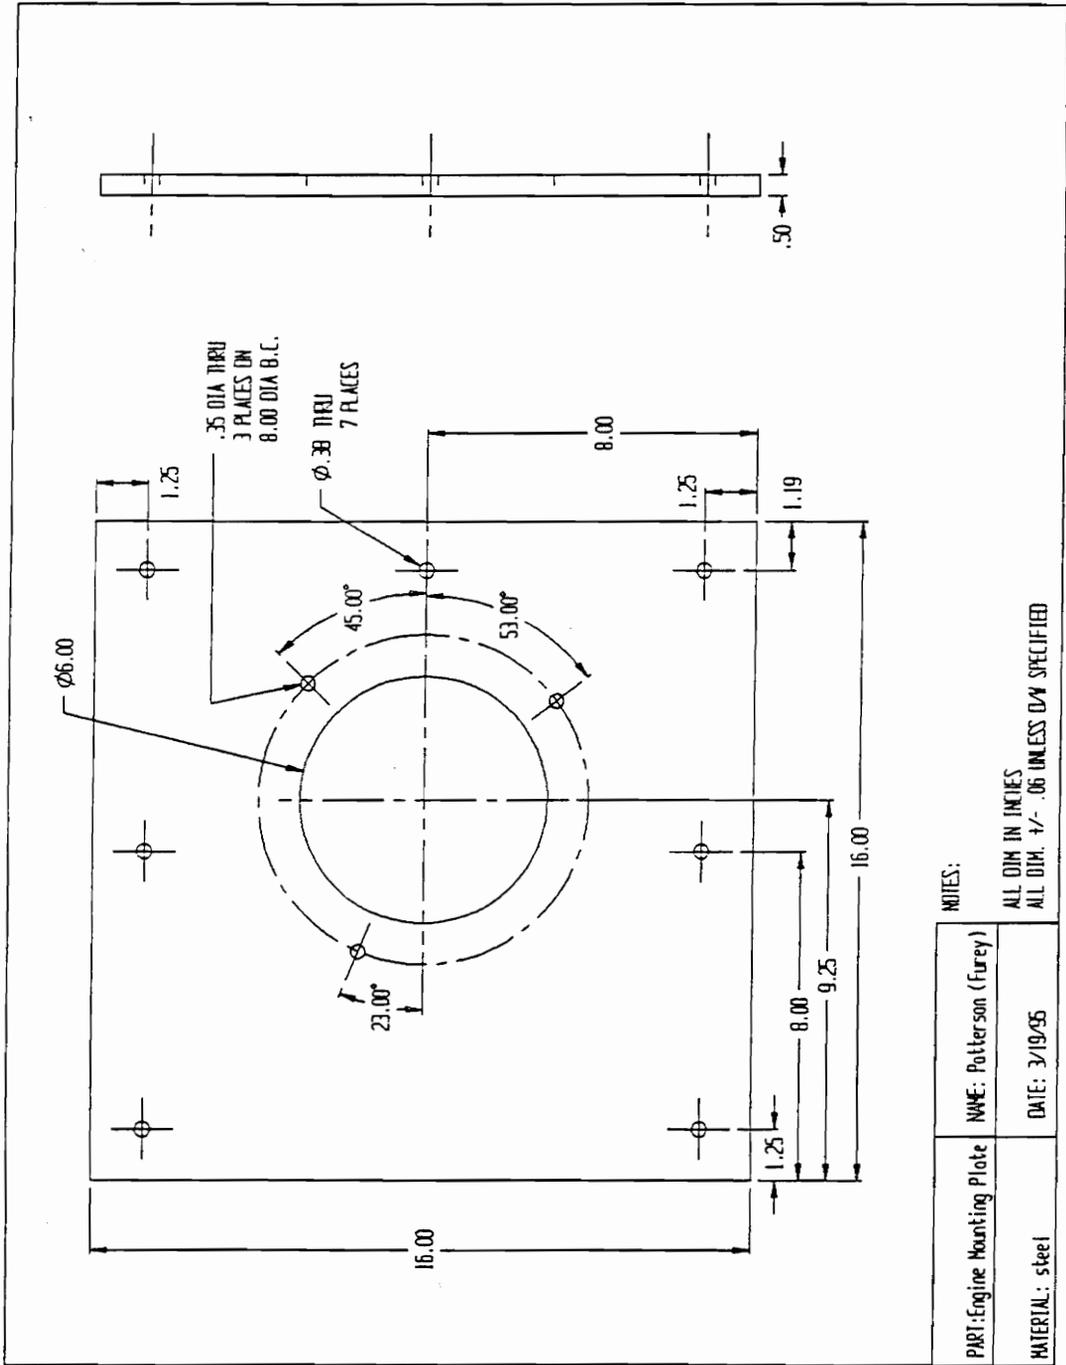
Figure B4: Engine Mounting Plate

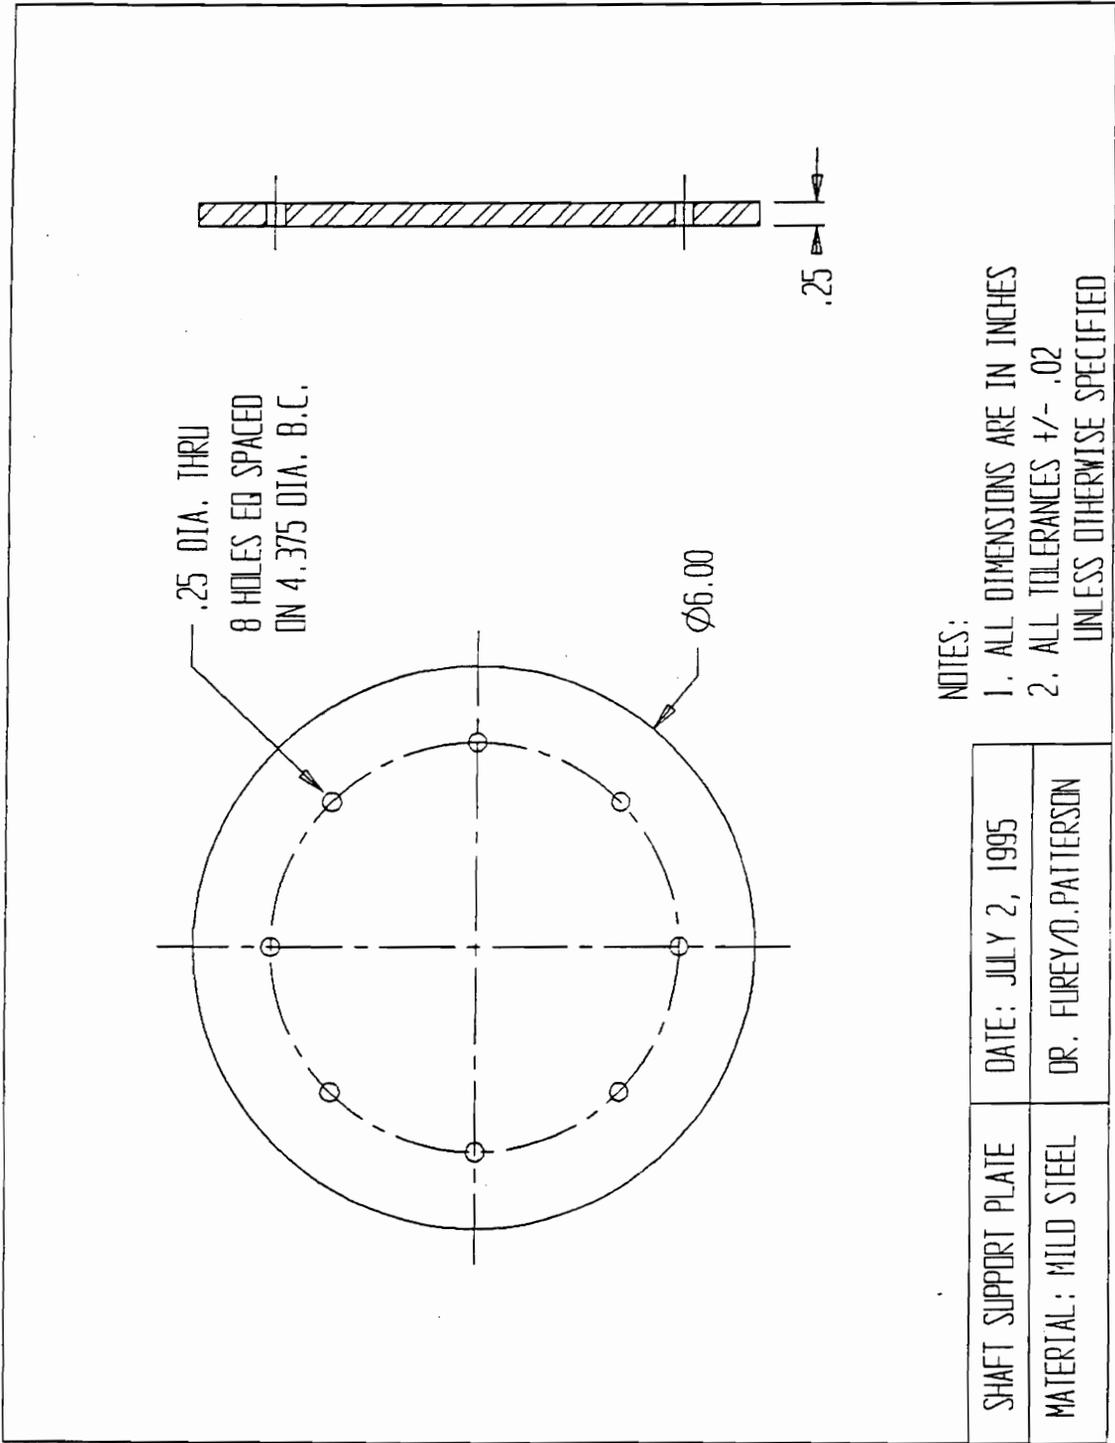
Figure B6: Shaft Support Plate

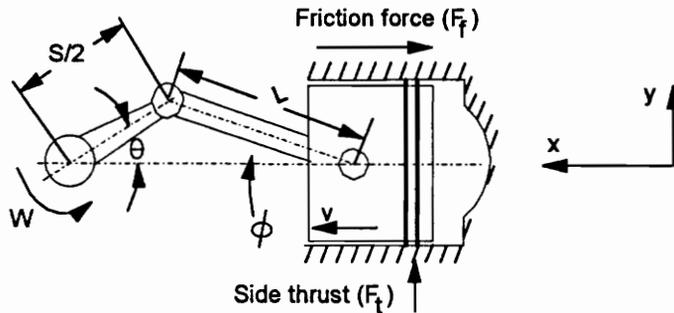
Figure C1 Simplified Piston Cylinder Geometry.

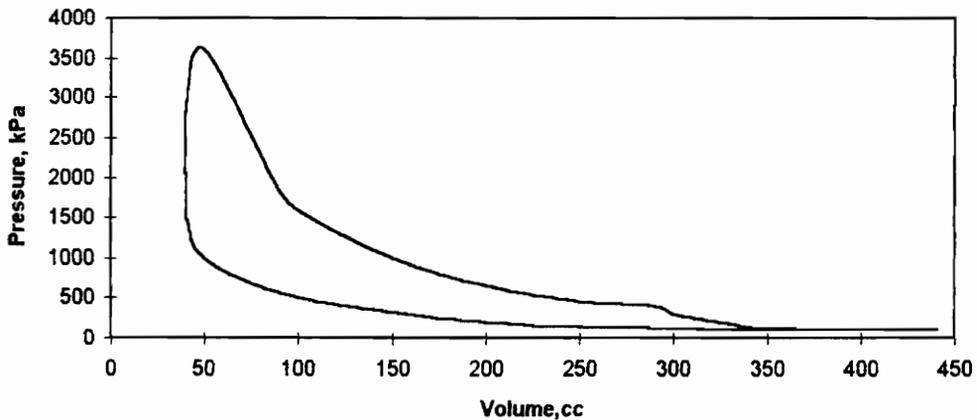
Figure C2: Measured Pressure-Volume Relationship for a Single Cylinder, 400cc Two-Stroke Engine [84]

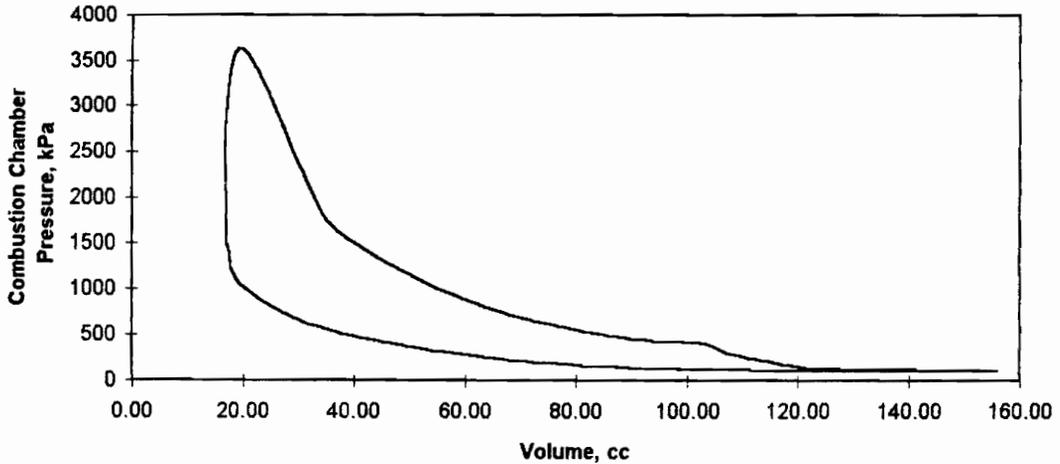
Figure C3: Pressure-Volume Relationship for the TVXL840 Operating at 3000 rpm (Estimated from Experimental Data from a Similar Engine at Wide Open Throttle)

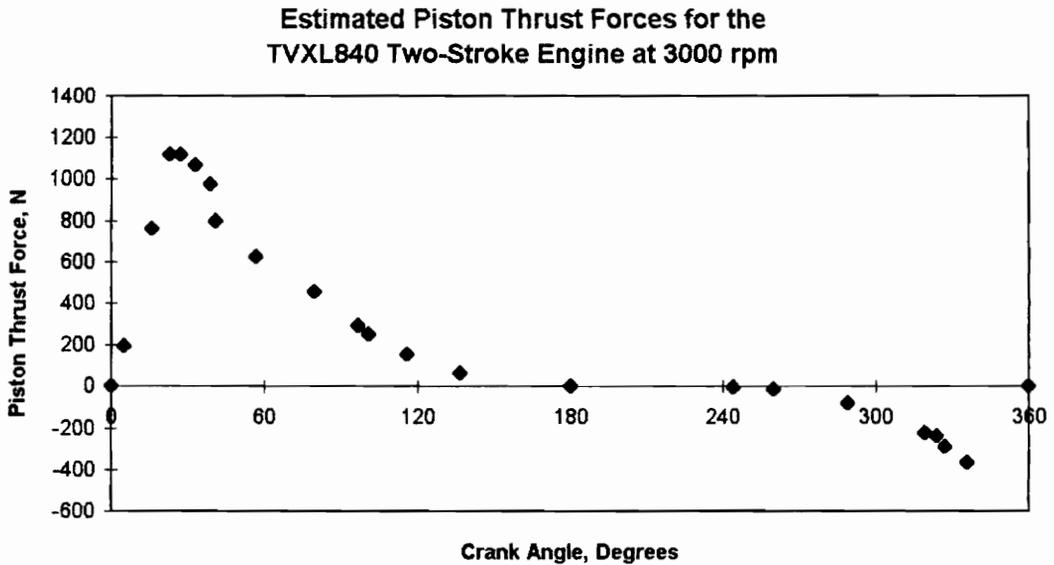
Figure C4: Estimated Piston Thrust Forces Produced During the Two-Cycle Engine Combustion Process at 3000 rpm.

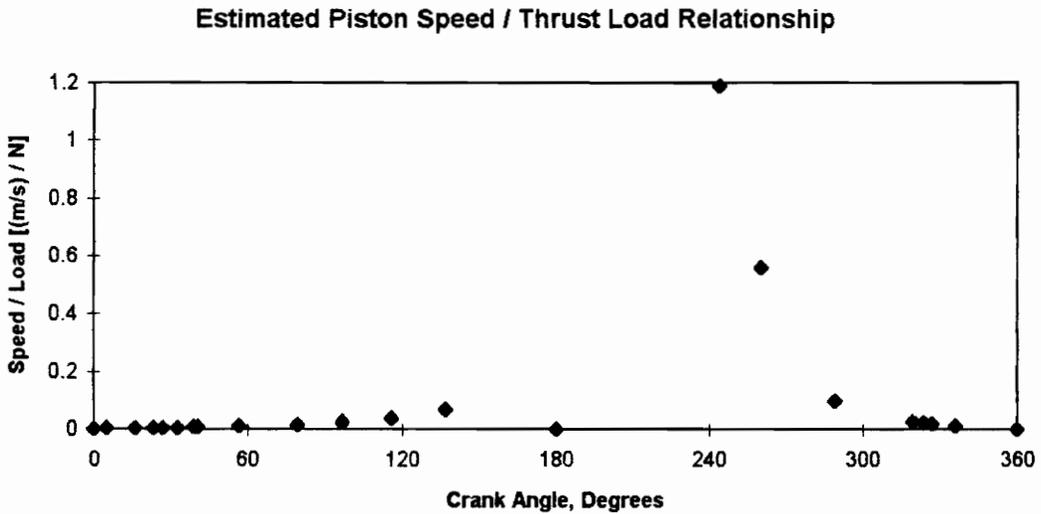
Figure C5: Calculated Piston Speed / Thrust Load Relationship
