4.2 Alumina A System

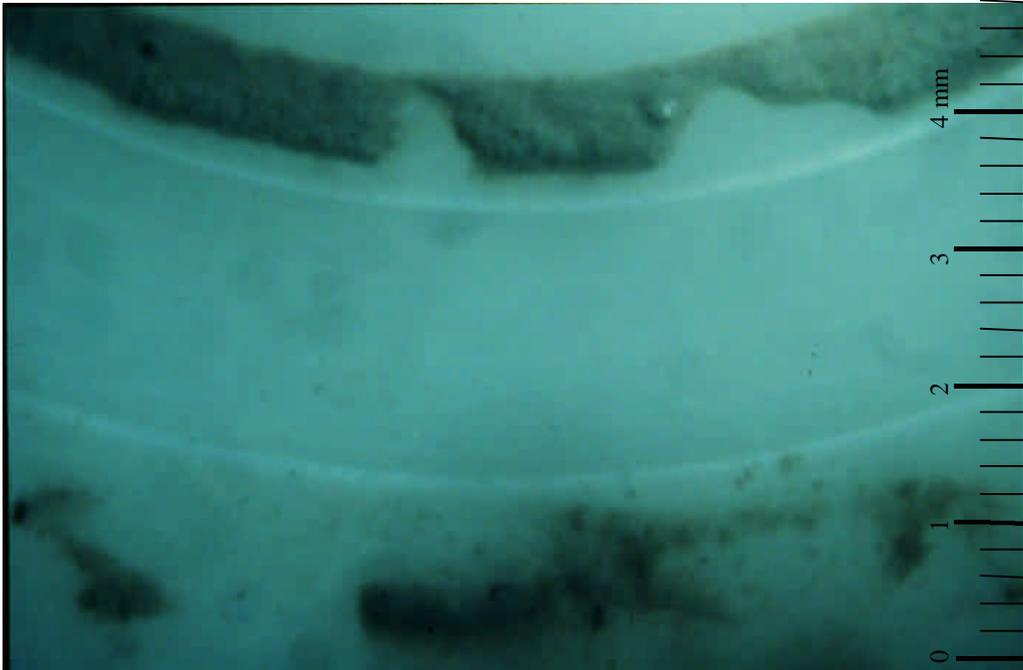
Figure 4.2.1.2 Alumina A System Reference, Test 26: Photomicrograph of Disk Wear Track (15.75 x)

Photomicrographs for the reference tests are presented in Figures 4.2.1.2 – 7. Large amounts of wear debris are noticeable in the photomicrographs of the disk wear tracks. In comparing the wear tracks of Test 26 and Test 27 in Figures 4.2.1.2-3, the difference in the severity of wear is clearly visible. The first photomicrograph shows a uniform wear scar while the second reveals dark wear debris trapped sporadically throughout the wear scar. The same dark wear debris pattern appears in other high wear tests to varying degrees. Tests 28 and 29 resulted in large wear volumes and similar wear debris as shown in Figures 4.2.1.4-5. Figure 4.2.1.6 shows the smoother wear track of Test 40 coinciding with a lower wear volume. Shown in Figure 4.2.1.7 is the final

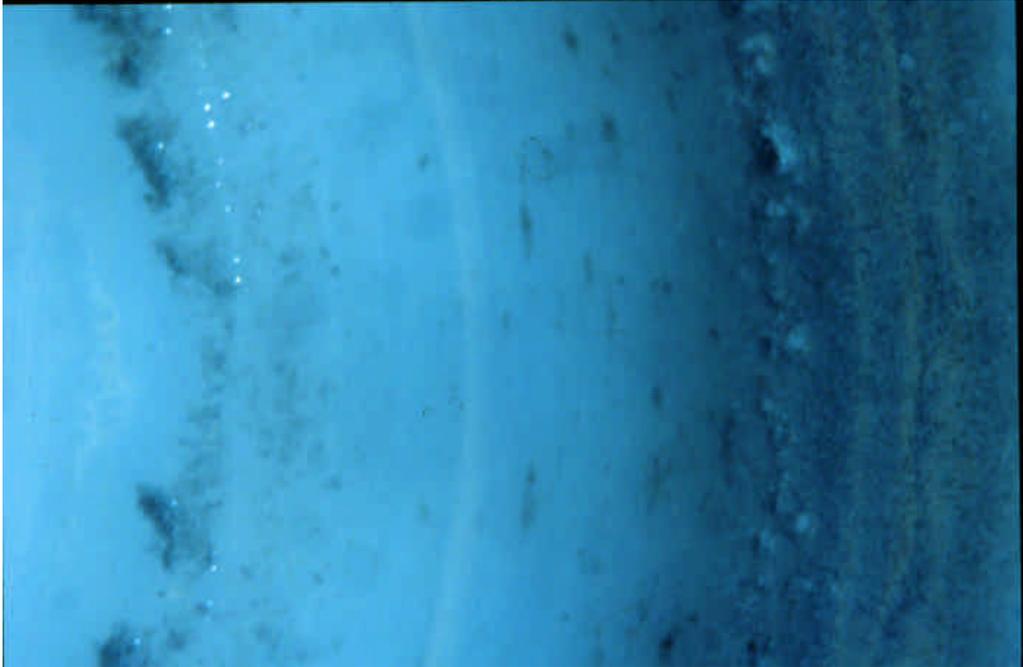
Figure 4.2.1.5 Alumina A System Reference, Test 29: Photomicrograph of Disk Wear Track (15.75 x)

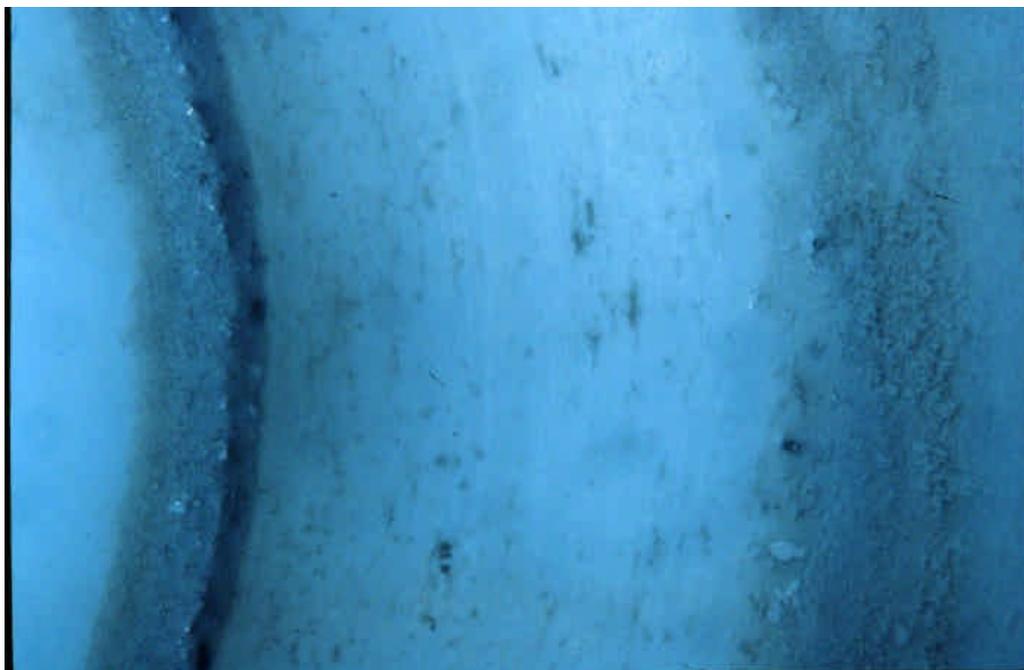
Figure 4.2.1.7 Alumina A System Reference, Test 41: Photomicrograph of Disk Wear Track (15.75 x)

reference, Test 41, which resulted in a high wear volume with wear debris remaining in the wear track. The debris remained attached to the disk despite the fact that the disk was upside down and undergoing rotation during the test. Patchy discoloration evident inside several of the wear tracks remained even after ultrasonic rinsing in a solvent. High local temperatures and pressures may have caused this strong reattachment of the wear debris.

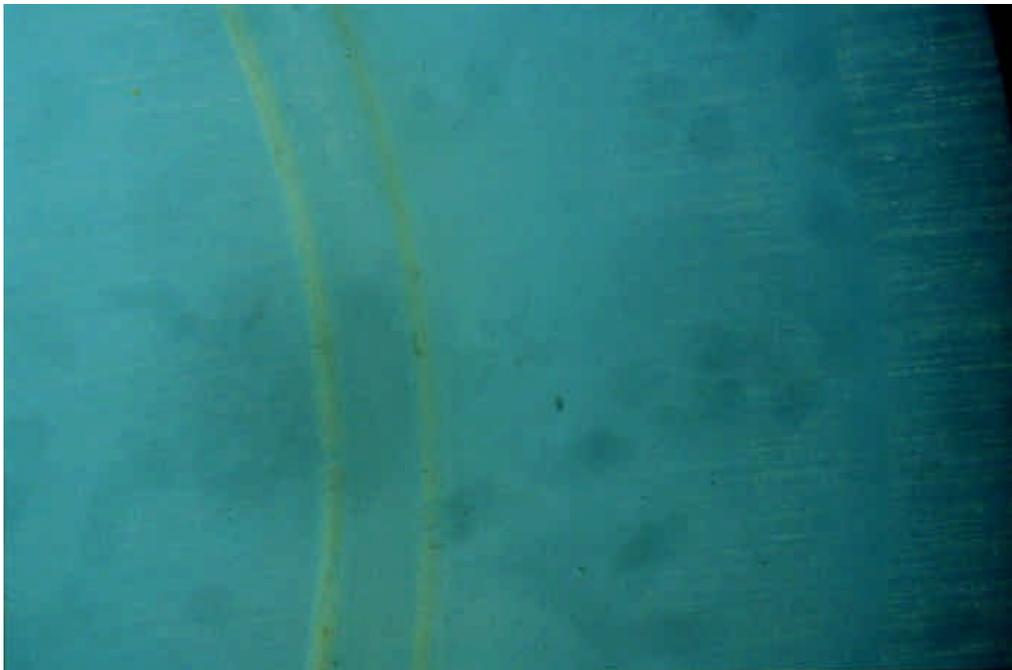
Figure 4.2.2.3 Ethyl-4-Amino Benzoate in Alumina A System, Test 32: Photomicrograph of Disk Wear Track (15.75 x)

Changing the carboxylic acid group of the previous compound to an ester resulted in the wear reduction shown for ethyl-4-aminobenzoate in Figure 4.2.2.2. The single test of this compound gave significant wear reduction even after filtering. This suggests that effective anti-wear protection is provided by concentrations much less than the 1% of the original solution as the compound was only partially soluble. Photomicrographs of the 1% ethyl-4-aminobenzoate wear specimens are given in Figures 4.2.2.3-5. Yellow reaction products are present on the outer edges of the disk wear track in Figure 4.2.2.3. A patch of yellow is evident above the ball wear area as shown in Figure 4.2.2.4. The original compound and the hexadecane mixture were white indicating that a tribochemical reaction occurred in the presence of this compound to produce the yellow products. Direct internal lighting revealed the distribution and thickness of the reaction film on the disk wear track as shown in Figure 4.2.2.5.

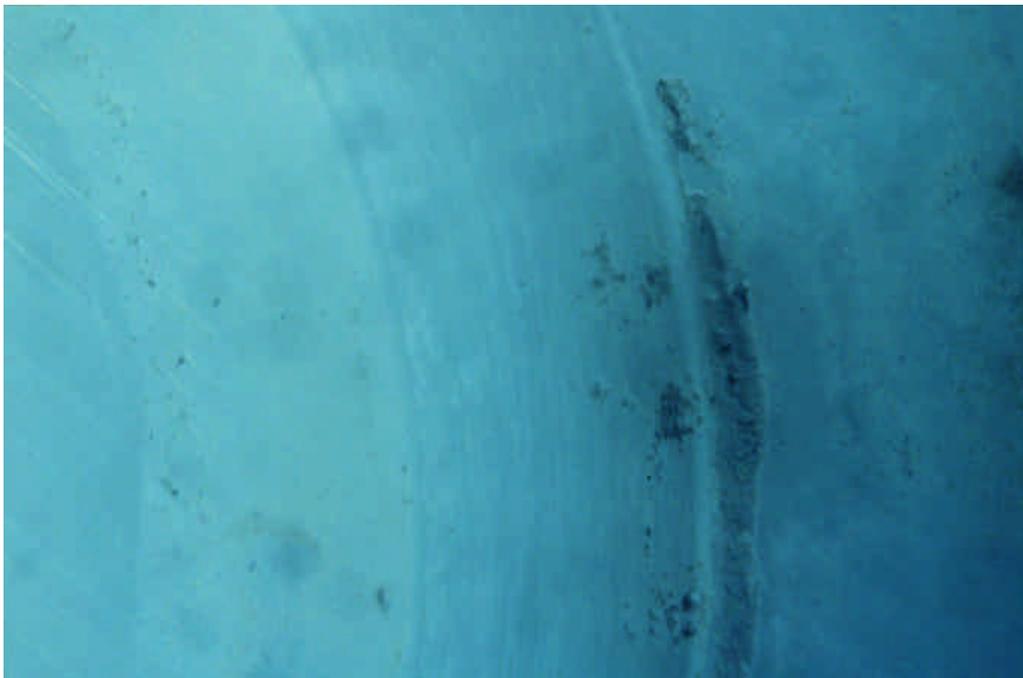
Figure 4.2.2.6 Filtered Ethyl-4-Amino Benzoate in Alumina A System, Test 42:
Photomicrograph of Disk Wear Track (15.75 x)

Figures 4.2.2.6-9 show the wear areas for the filtered test. Filtration resulted in less visible film formation as depicted in Figure 4.2.2.6. Interesting photomicrographs of the ball wear scar in Figures 4.2.2.7-9 document remarkable evidence of an attached debris layer. Figure 4.2.2.7 reveals a slight yellowish reaction product around the edge of the ball wear scar and large amounts of fine debris deposited away from the contact area. A combination of direct internal and indirect external lighting reveals the nature of the layer as the lower half of the ball wear scar reflects light and reveals its smooth nature in Figure 4.2.2.8. The upper portion of the ball wear scar scatters the direct light and indicates a rougher surface after apparent flaking, spalling, delamination or other removal of a portion of the compacted debris layer. Figure 4.2.2.9 shows the formation of a crack in the debris layer under higher magnification, which suggests a delamination wear mechanism is responsible for removal of the compacted debris layer.

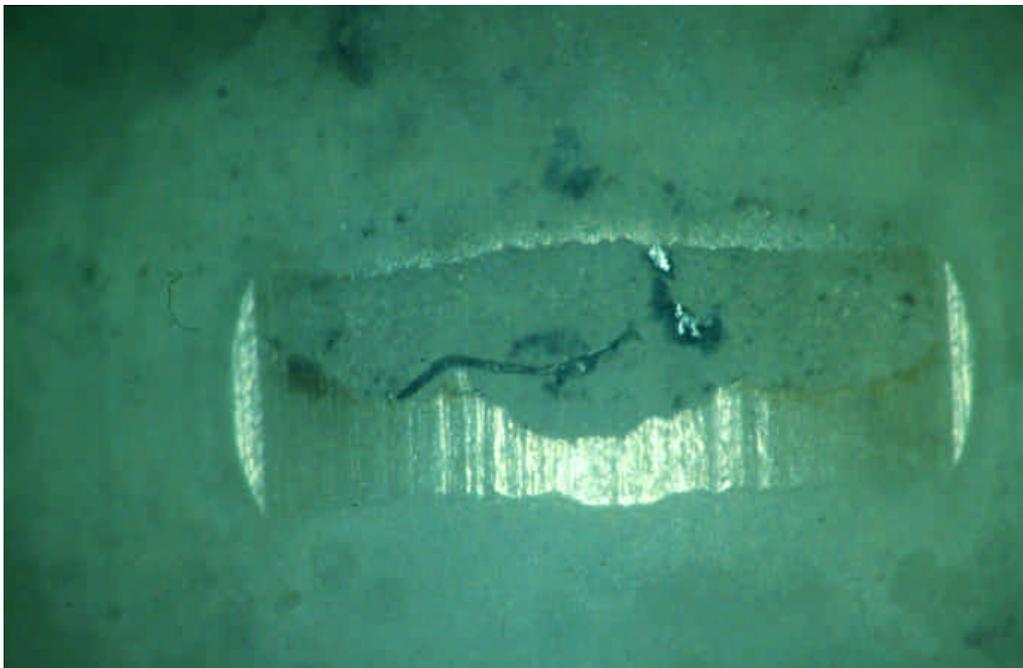
Figure 4.2.2.8 Filtered Ethyl-4-Amino Benzoate in Alumina A System, Test 42:
Photomicrograph of Ball Wear Area (40 x)

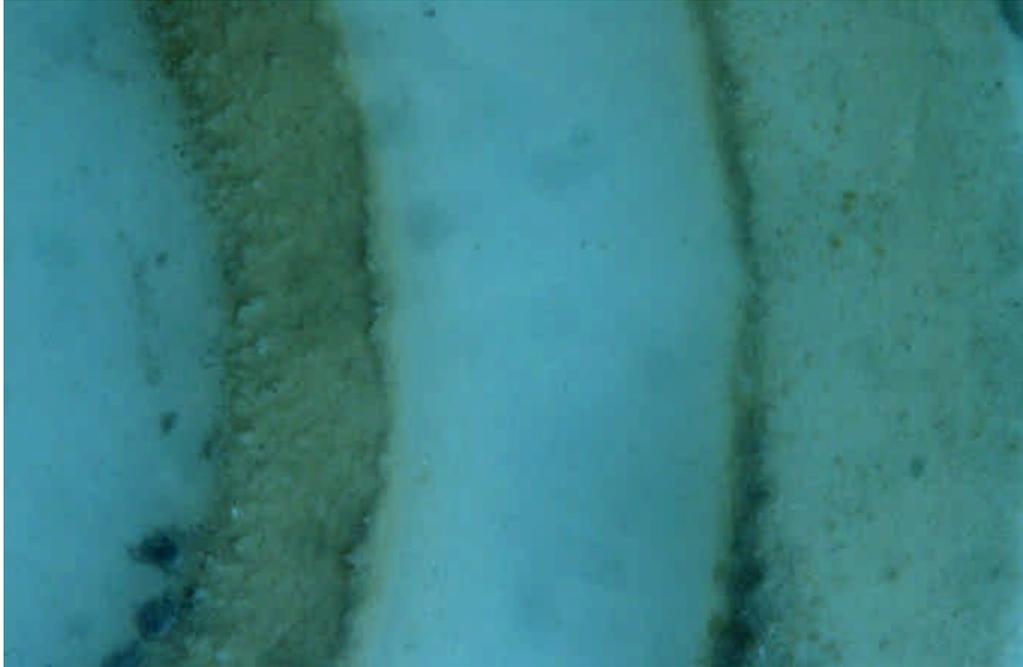
Figure 4.2.2.11 Methyl-4-Hydroxy Benzoate in Alumina A System, Test 34:
Photomicrograph of Disk Wear Track (15.75 x)

The photomicrograph of Figure 4.2.2.11 shows typical wear debris alongside the disk wear track. Remarkable evidence of a ball debris reaction layer appears in Figures 4.2.2.12-14, where at various magnifications a fingerlike detachment is seen breaking off of the top of the ball wear scar.

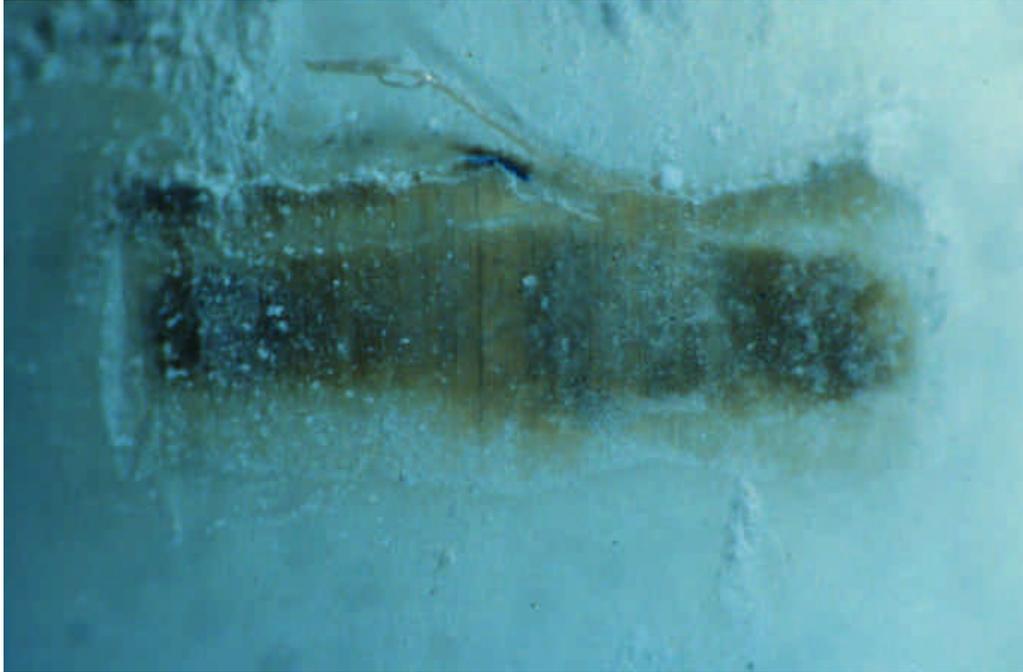
Figure 4.2.2.13 Methyl-4-Hydroxy Benzoate in Alumina A System, Test 34:
Photomicrograph of Ball Wear Area (40 x)

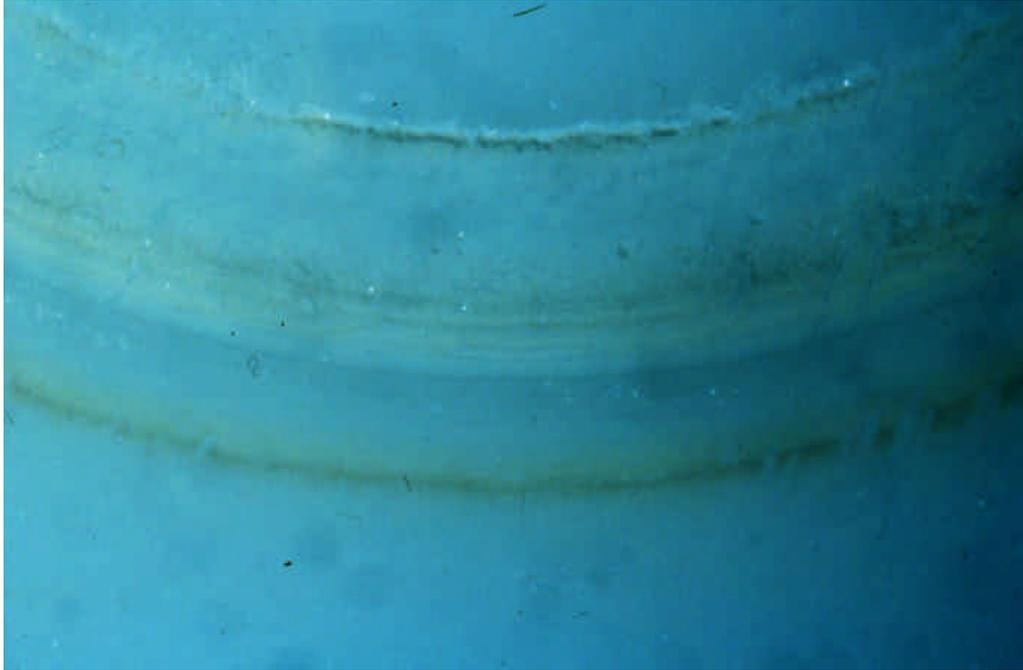
Figure 4.2.3.3 Dimethyl Terephthalate and Tert-Butyl Hydroquinone in Alumina A System, Test 38: Photomicrograph of Disk Wear Track (15.75 x)

Photomicrographs of the disk wear tracks in Figures 4.2.3.2-4 show dark tribochemical reaction products at the edges of the contact zone. The inner track (left-most) of Figure 4.2.3.2 is likely a hydrodynamic artifact representing the edge of the wake from the ball. However, it reveals that the debris is attracted sufficiently to the disk to lightly reattach given conditions other than high-pressure tribological contact. Figure 4.2.3.3 shows orderly edges of lightly reattached debris formed away from the contact zone. The presence of similar artifacts in other photomicrographs suggests a charged

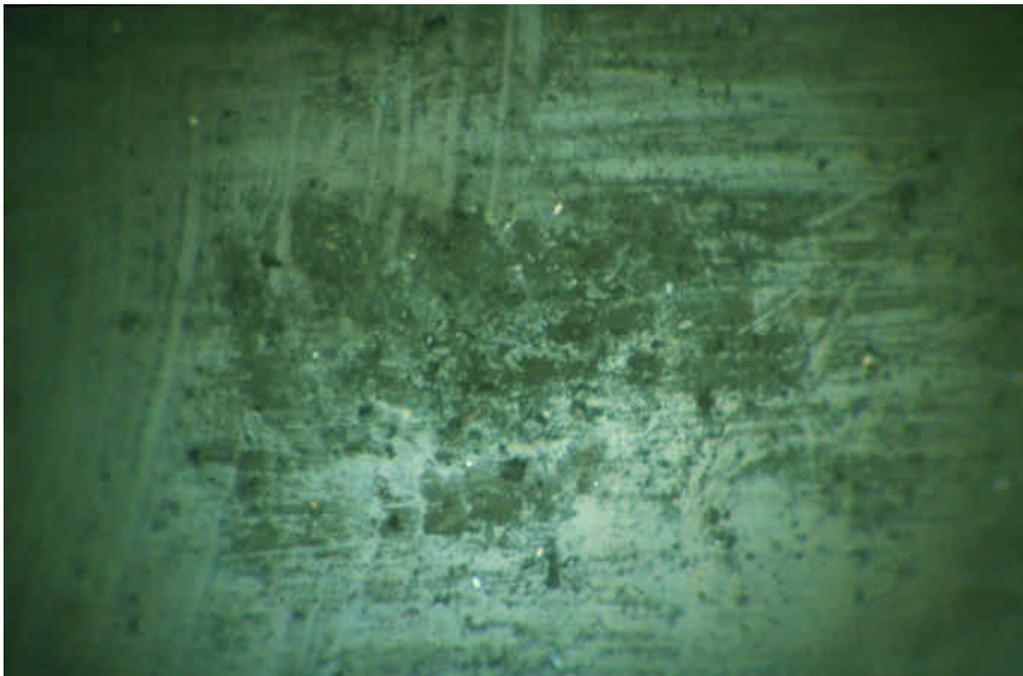
Figure 4.2.3.6 Dimethyl Terephthalate and Tert-Butyl Hydroquinone in Alumina A System, Test 38: Photomicrograph of Ball Wear Area (80 x)

nature of the debris as it clings to the disk surface. Figure 4.2.3.4 shows the reflective nature of a portion of the disk wear track under higher magnification and direct internal lighting. Rinsing the ball wear area with hexane left some debris directly on the scar as shown in Figures 4.2.3.5 - 6. Figure 4.2.3.7 shows the same area after wiping with lab tissue. The ball wear photomicrograph from a similar test in Figure 4.2.3.8 shows slightly darker debris at the upper edge of the scar.

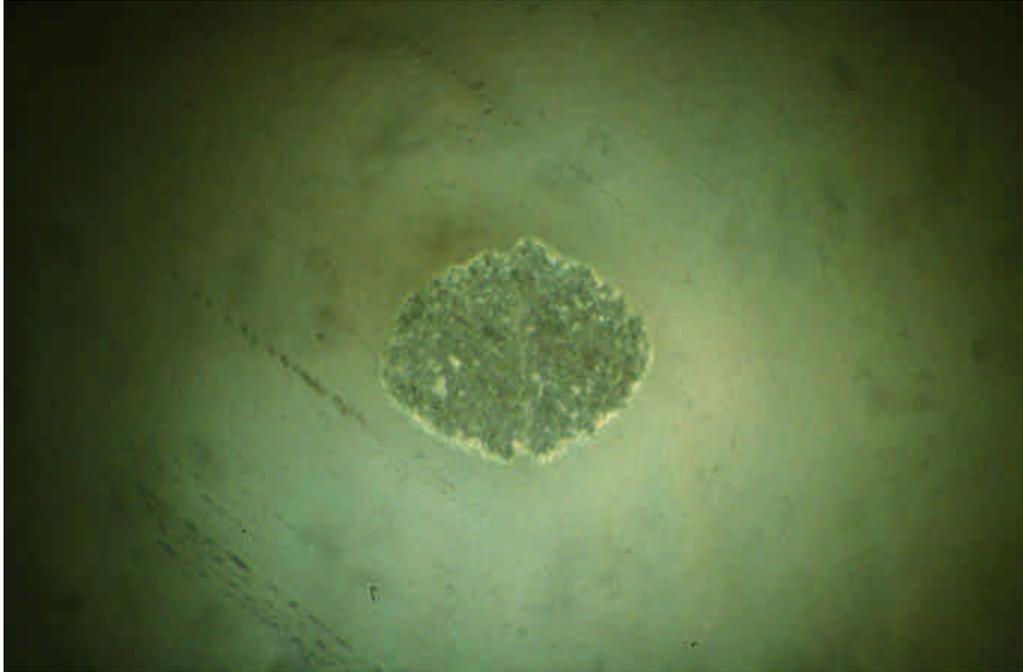
Figure 4.2.3.7 Dimethyl Terephthalate and Tert-Butyl Hydroquinone in Alumina A System, Test 38: Photomicrograph of Ball Wear Area (80 x)

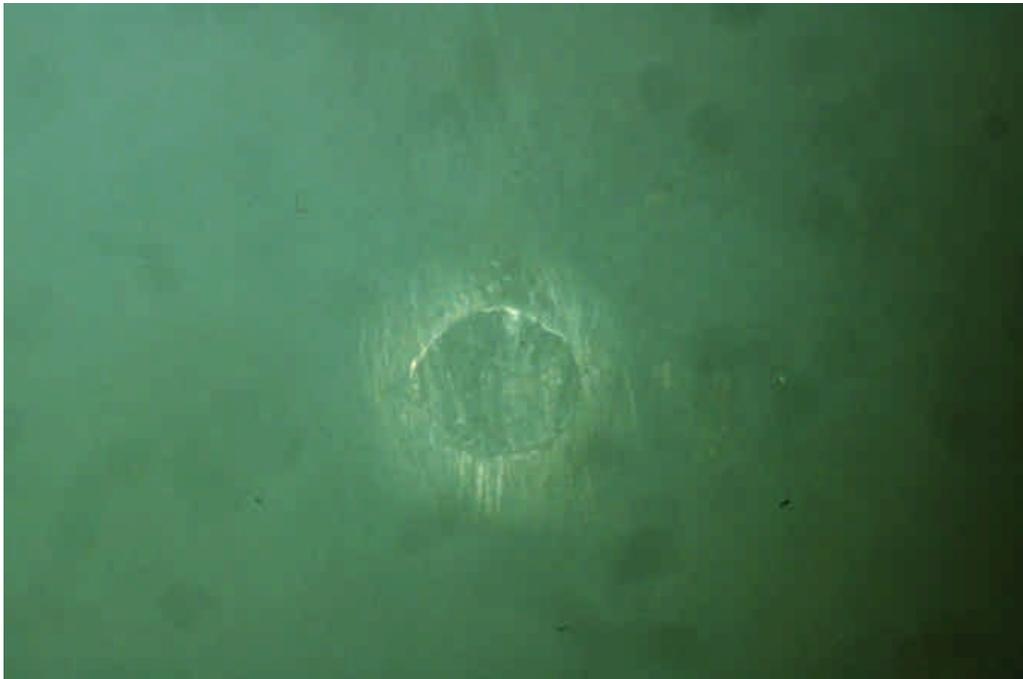
Figure 4.2.3.11 Filtered Dimethyl Terephthalate and Tert-Butyl Hydroquinone in Alumina A System, Test 44: Photomicrograph of Ball Wear Area (40 x)

Filtration of the mixture of dimethyl terephthalate and tert-butyl hydroquinone resulted in similar wear reductions. Figures 4.2.3.9-10 show an even and fine distribution of debris and/or compound covering the surface. Centrifugal effects probably prevented the material from reaching the inner (left) portion of the disk surface as shown in Figure 4.2.3.9. The edge of the outer ring (right) represents the area where the specimen was in contact with the disk holder. In Figure 4.2.3.10, two bands appear near the wear track which are distinctly darker than the outer ring. This suggests that dissipating thermal energy near the contact zone enhances adsorption of the additive and/or wear debris. The ball wear area of Figure 4.2.3.11 partially reflects the direct internal lighting and thus reveals a thin covering of adsorbed species on and near the ball wear scar as well.

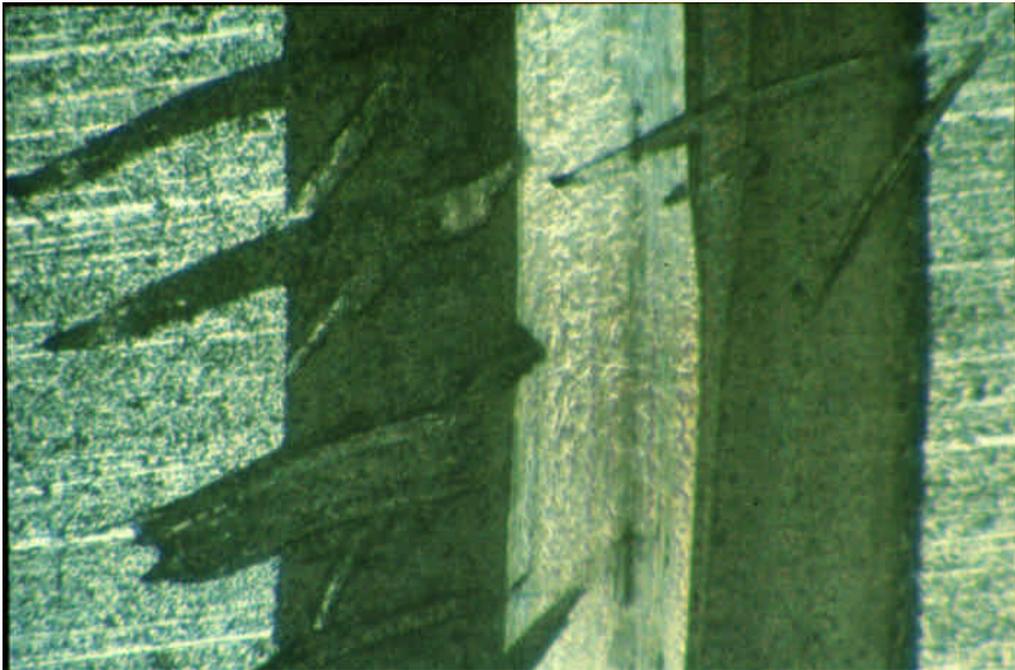
Figure 4.2.4.3 Caprolactam in Alumina A System, Test 31: Photomicrograph of Disk Wear Track (40 x).

Photomicrographs of caprolactam wear tests are given in Figures 4.2.4.2 - 9. The wear areas of Figures 4.2.4.2 and 4.2.4.3 reveal a wear track with negligible amounts of debris. Dark bands present on each side mask the directional finishing marks visible inside and far outside the worn area. The fact that finishing marks are still visible within the wear track is additional testimony to the excellent anti-wear behavior of this compound. The crystals seen in both figures grew soon after removing the specimen from the holder.
