RURAL VERNACULAR BUILDING TRADITION:
THE DESIGN, CONSTRUCTION, AND USE OF
SPRINGHOUSES IN MONTGOMERY COUNTY,
VIRGINIA

Thesis submitted to the Faculty of the
Virginia Polytechnic Institute and State
University in partial fulfillment of the
requirements for the degree of
Master of Science
in
Architecture and Urban Studies

The purpose of this study was two-fold: first, to document existing springhouses in Montgomery County, Virginia, using photographs and an evaluation form; and secondly, to provide analysis and interpretation of regional springhouse design, construction, and use, based on fieldwork.

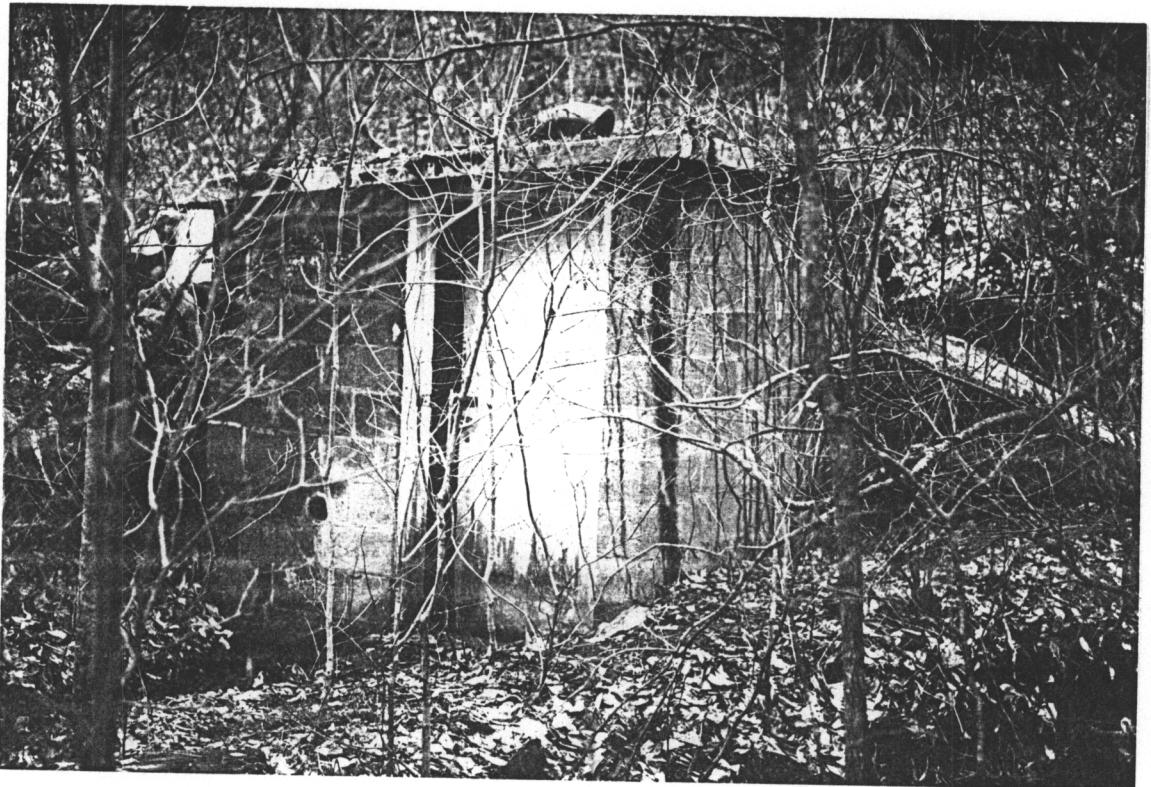
60-29

This 7½x10' concrete block springhouse at Yellow Sulphur Springs has a shed roof and a trough that runs from the back of the building to the front along the side wall.

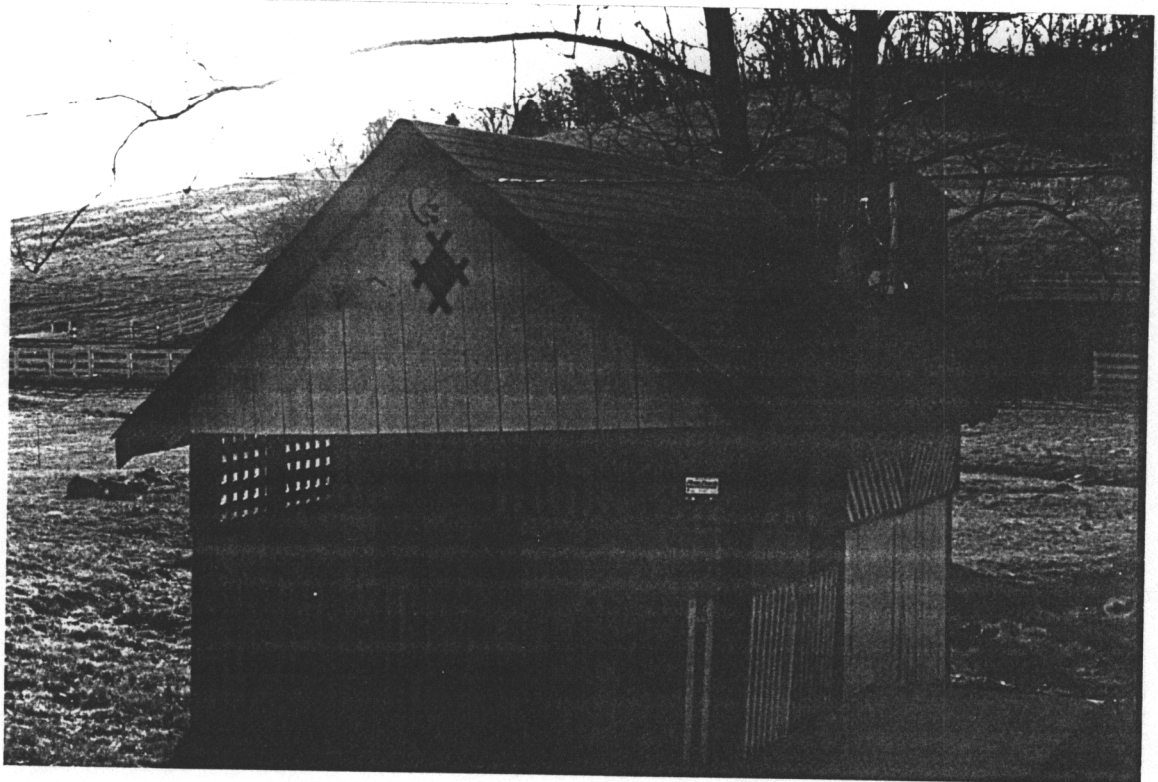
60-69
Riner

This robust and well-cared for 12x16' frame springhouse has a two-and-a-half foot high band of lattice that runs around the entire building. The trough is divided into thirds by three-inch wide strips of concrete with openings in them to regulate water flow.

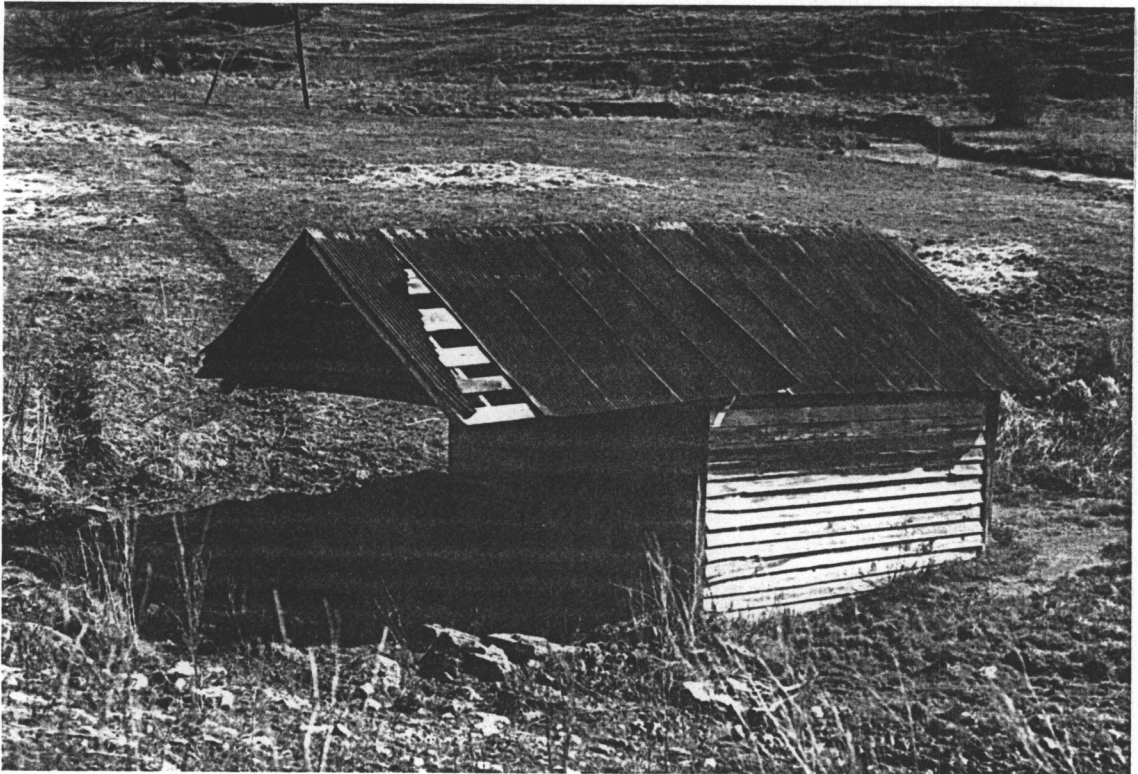
60-70

This small (63 ft²), frame springhouse adjacent to an abandoned house is in poor condition.

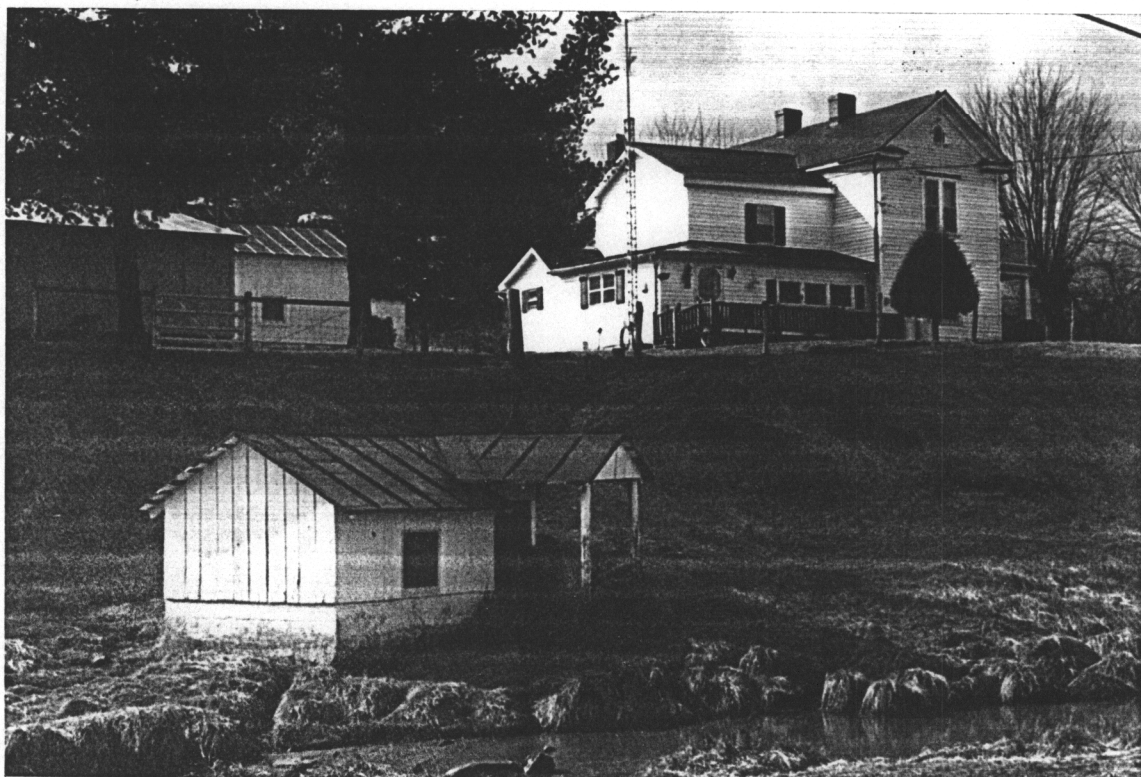
60-84

This 8x10', frame and poured concrete springhouse has a gable overhang supported by posts, and an L-shaped trough.

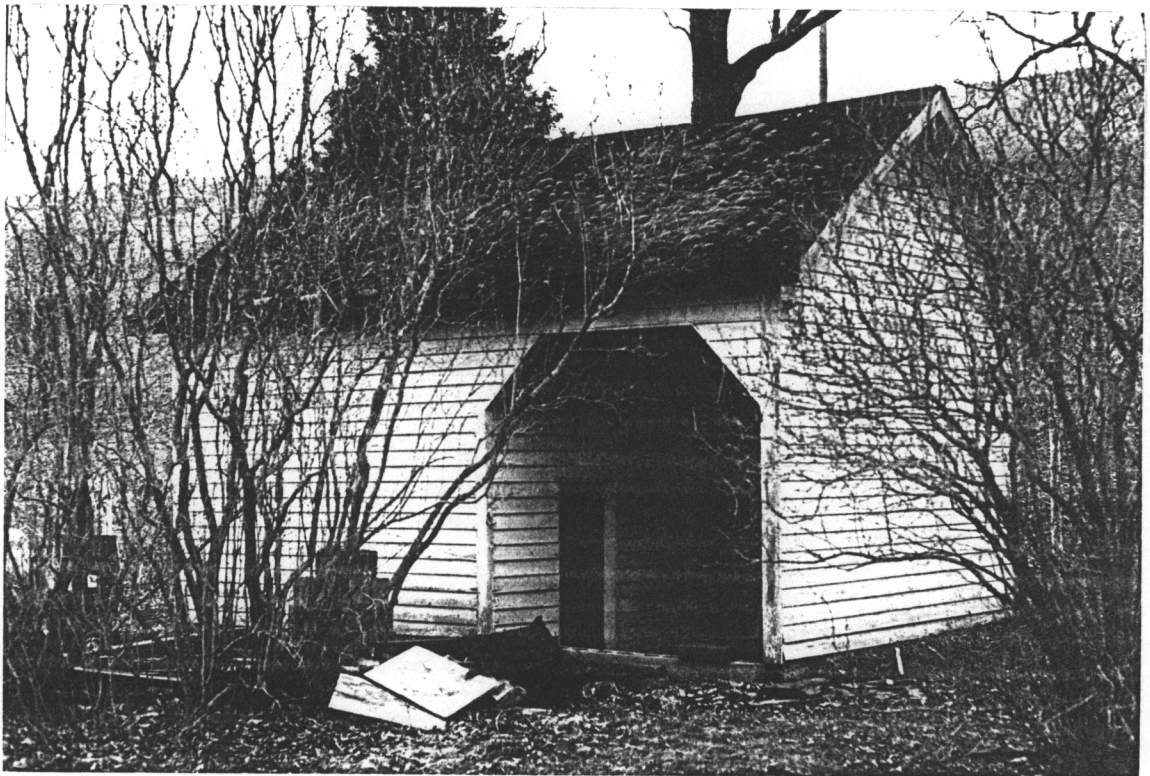
60-91

This frame springhouse at the Bowyer-Trollinger house is notable for its complex, two-story plan, large dimensions (12x20'), and its five-sided entrance. It was the only springhouse surveyed with a central trough.

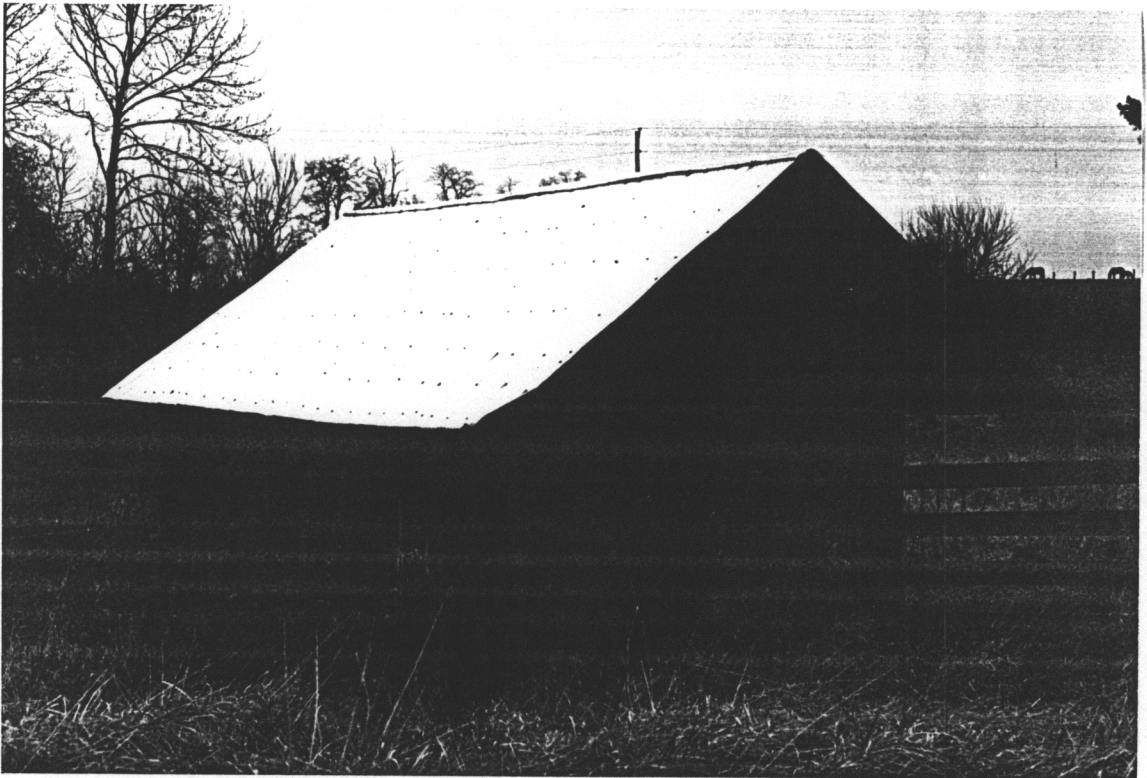
60-121

Constructed of frame in the popular gable-front form, the unusual feature of this medium-sized (154 ft²) springhouse is its L-shaped trough.

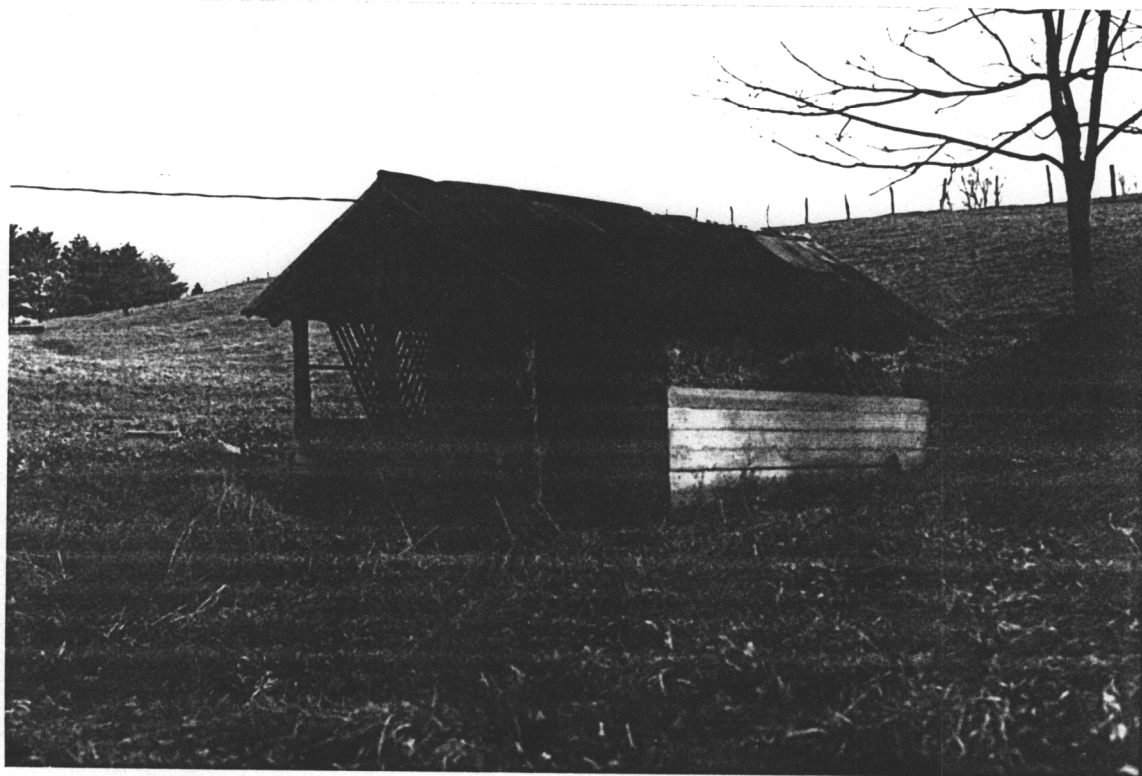
60-152

Currently in poor condition, this small (83 ft²), poured concrete springhouse faces out of a gentle slope.

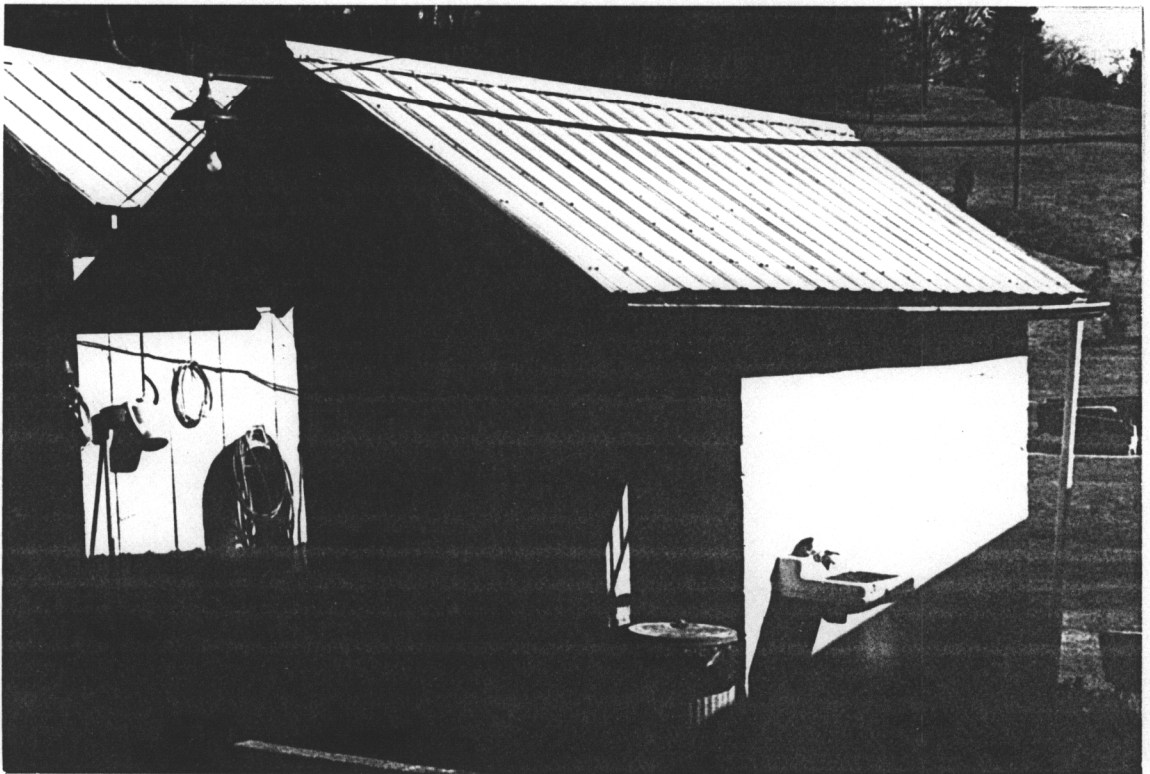
60-180

One of eight surviving concrete block springhouses in the county, this small (80 ft²) building has been adapted for various uses. Note the water fountain at right.

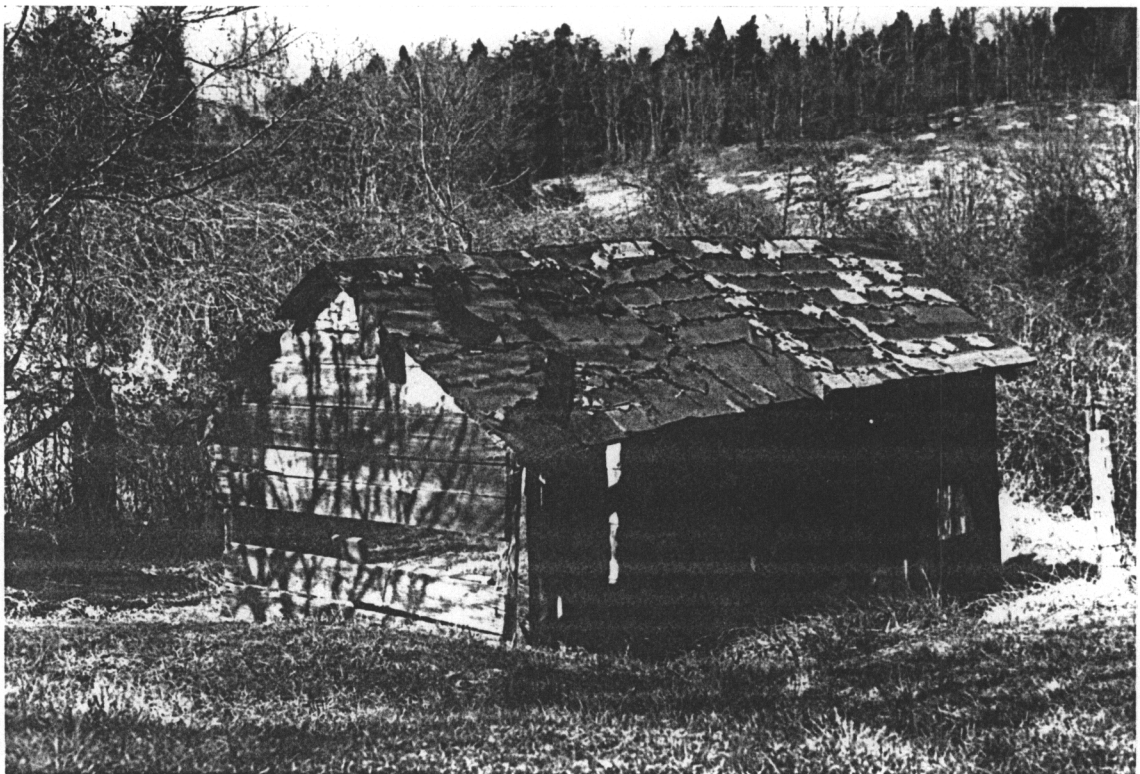
60-231

Distinguished by its small size (48 ft²), this modest frame springhouse was the only one located within Christiansburg town limits.

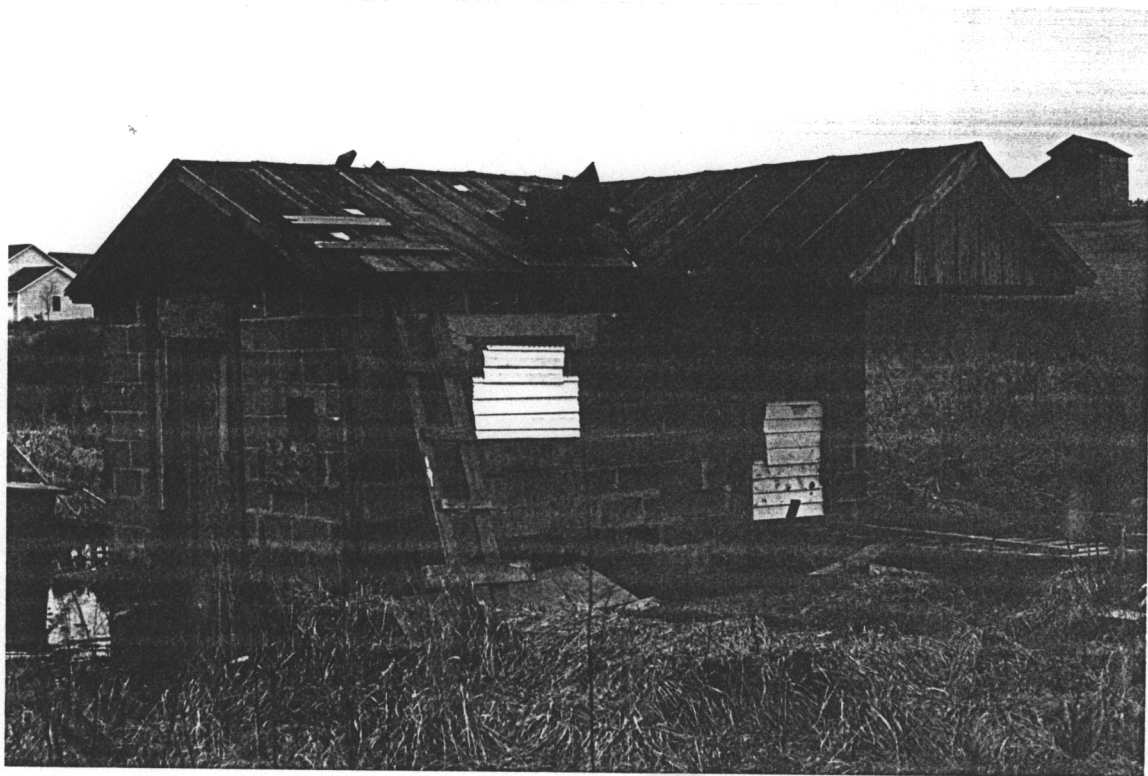
60-235

This 10x16', concrete block springhouse has a cross-gabled roof and a seven-foot unsupported overhang. It was the only springhouse located without an adjacent house, and it is in poor condition.

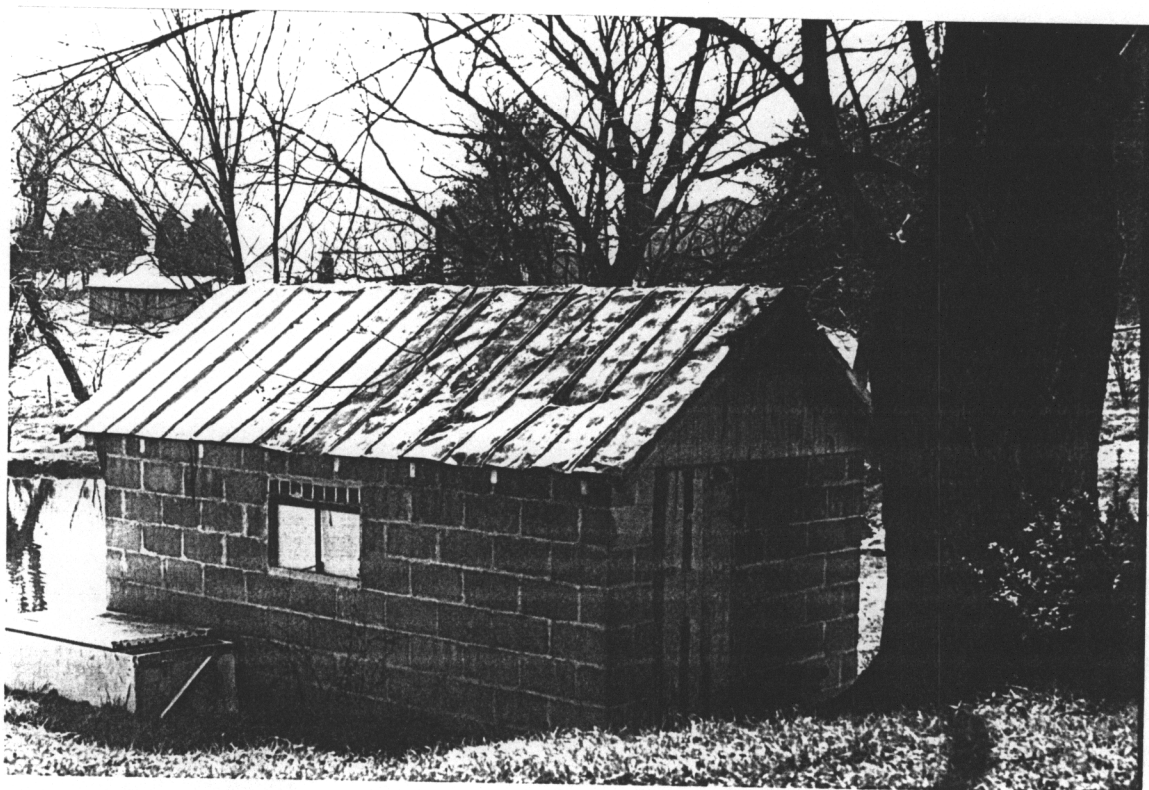
60-385

This typical concrete block springhouse faces into a gentle slope and has a trough that runs from front to back along the side wall. The building contains 116 square feet.

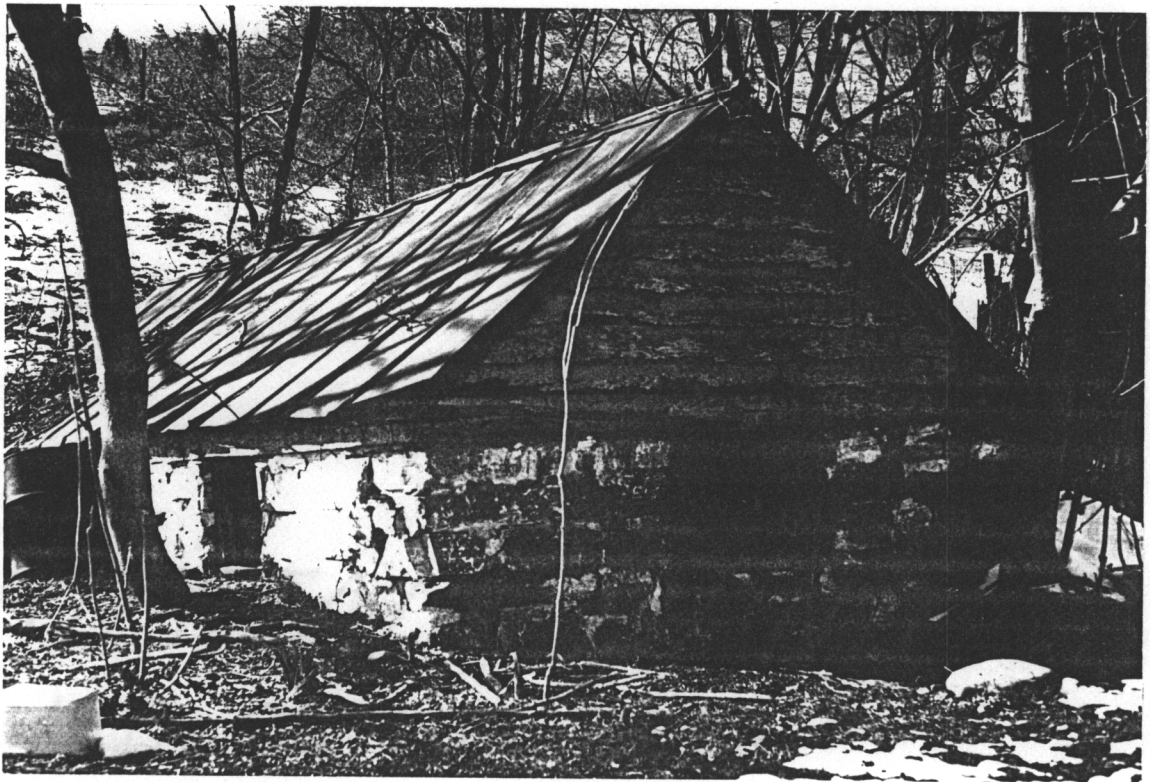
60-446

This large (14x28'), coursed rubble springhouse is in poor condition. A 14x12' addition considerably altered its original appearance.

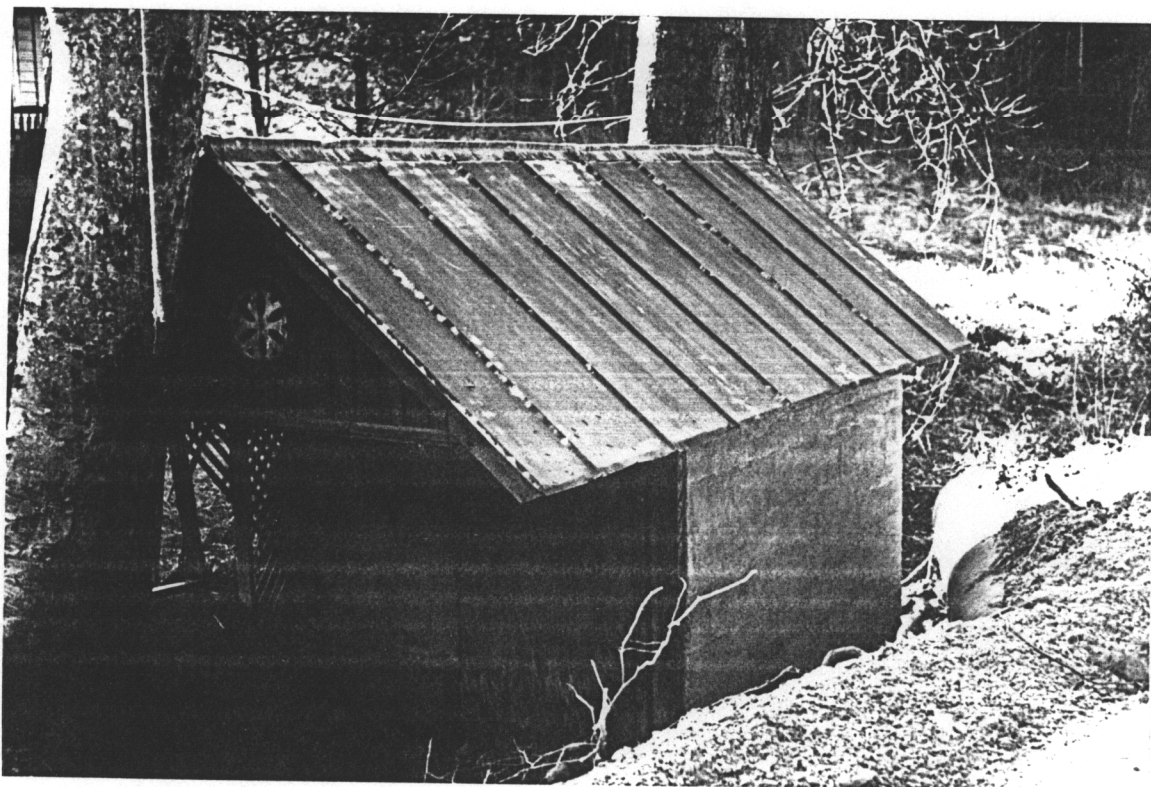
60-532

Like its neighbor (60-446), this poured concrete spring-house measures 7x10'. The decorative vents in both gables are unusual.

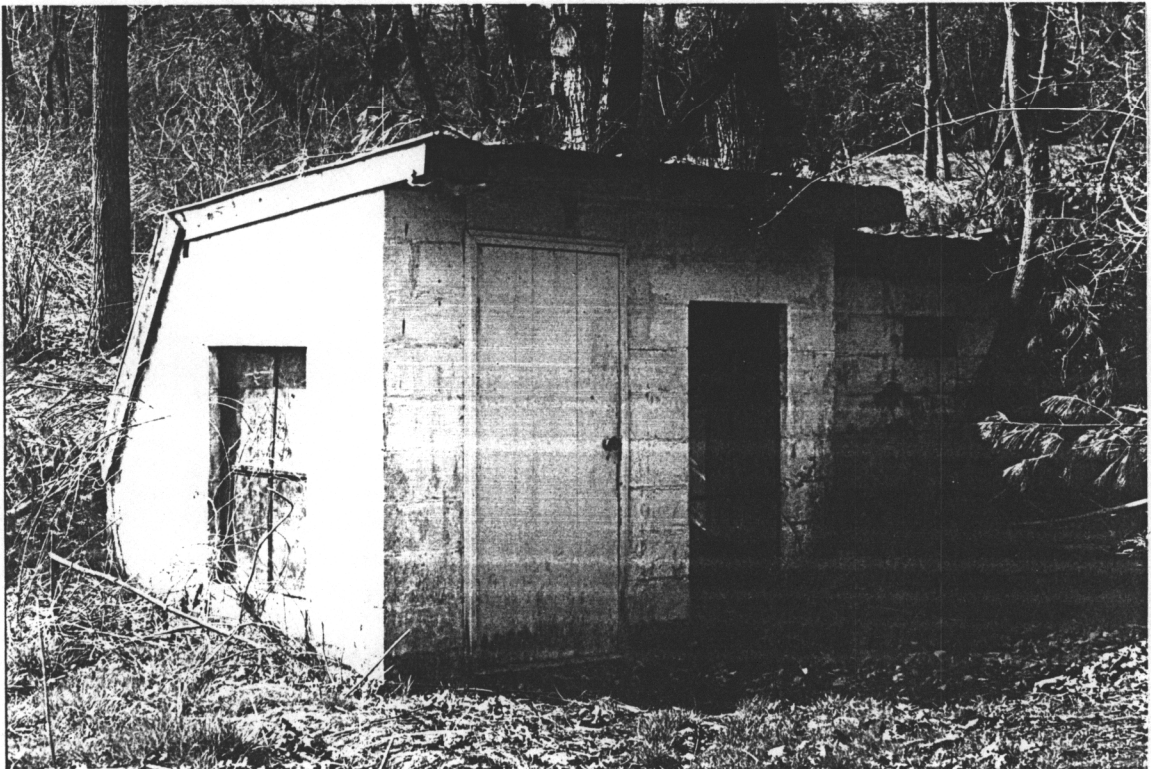
60-572

This small (66 ft²), concrete block springhouse has an unusual glass wall that lights the room adjacent to the food storage room. The structure is dilapidated.

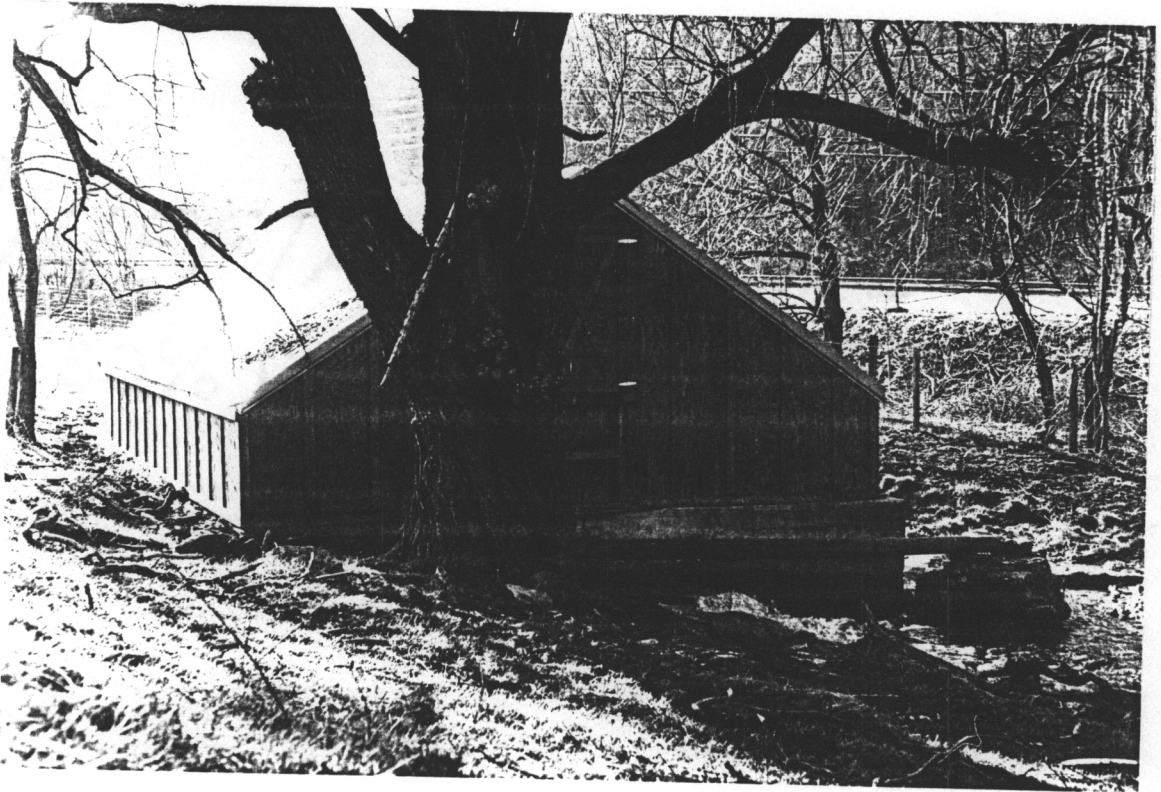
This frame and poured concrete springhouse is atypical for its late construction date and its large (20x26') size. It was intended only to protect a spring source, and is not equipped to store or cool perishables.

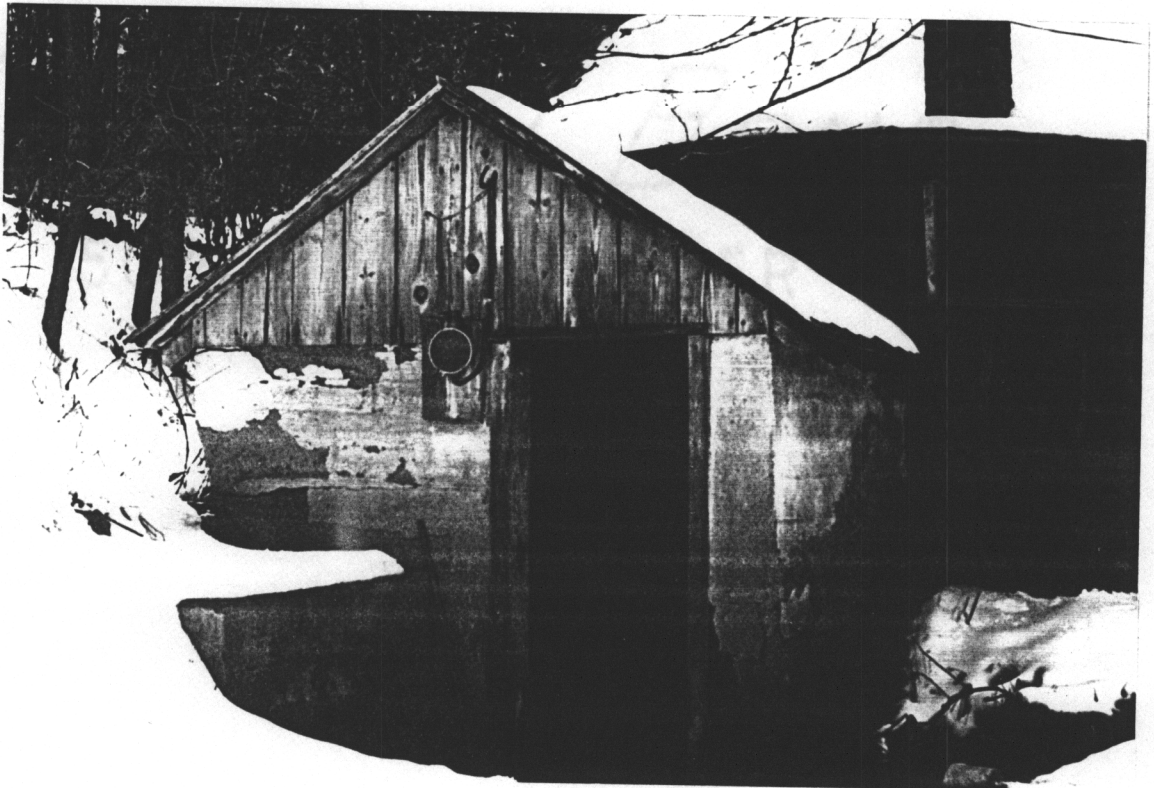
Constructed of poured concrete, this 8x10', front-gabled springhouse has two independent troughs perpendicular to each other. The eave of an adjacent building actually covers several feet of the springhouse.

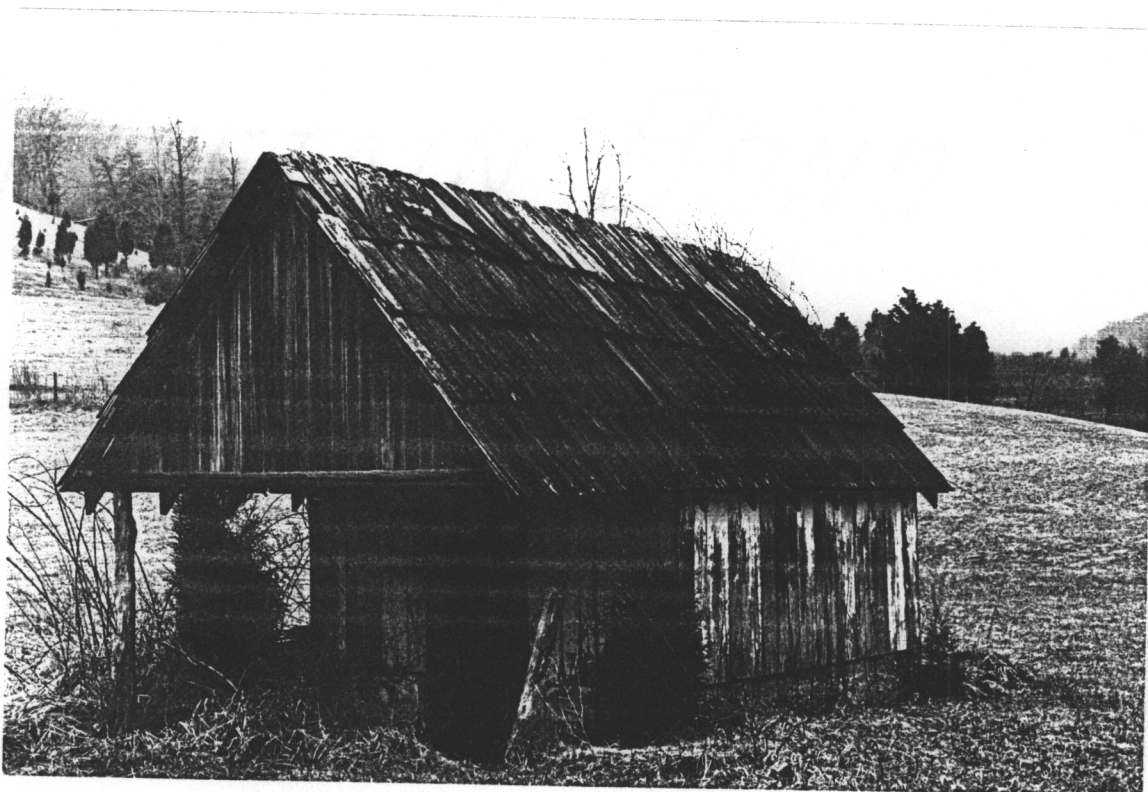
This frame springhouse has an unusually steep-pitched roof made of wooden shingles, and a six-foot overhang supported by posts. The building measures 9x12'.

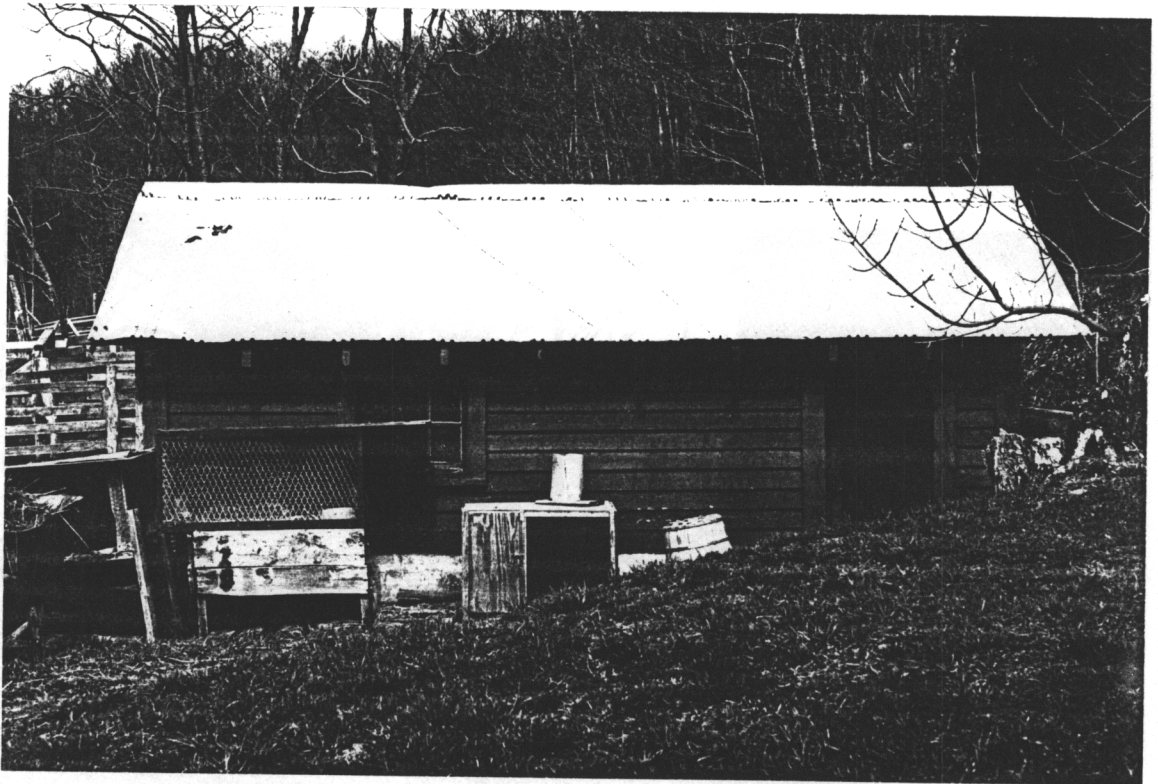
This medium-sized (180 ft²), frame, side-gabled springhouse has a trough that runs across the back wall.

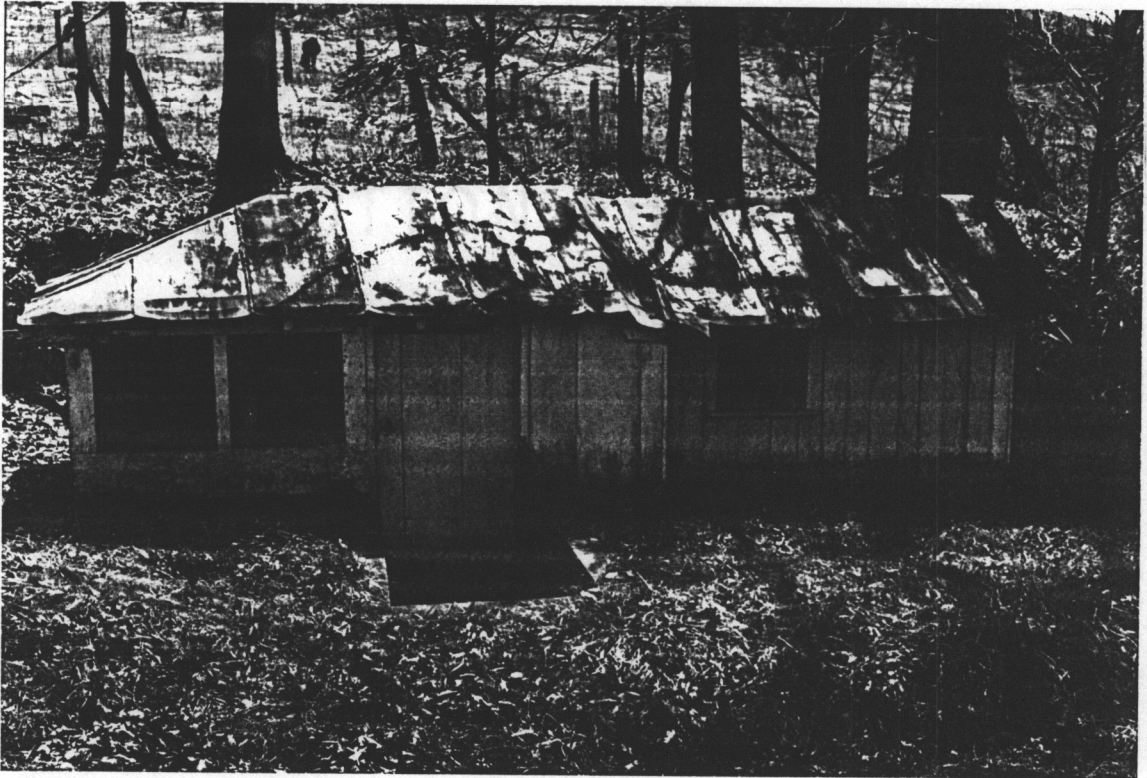
This quirky frame and poured concrete springhouse has a hip and gable roof, and a multi-sided trough that runs through two rooms along the back wall. The building contains 114 square feet.

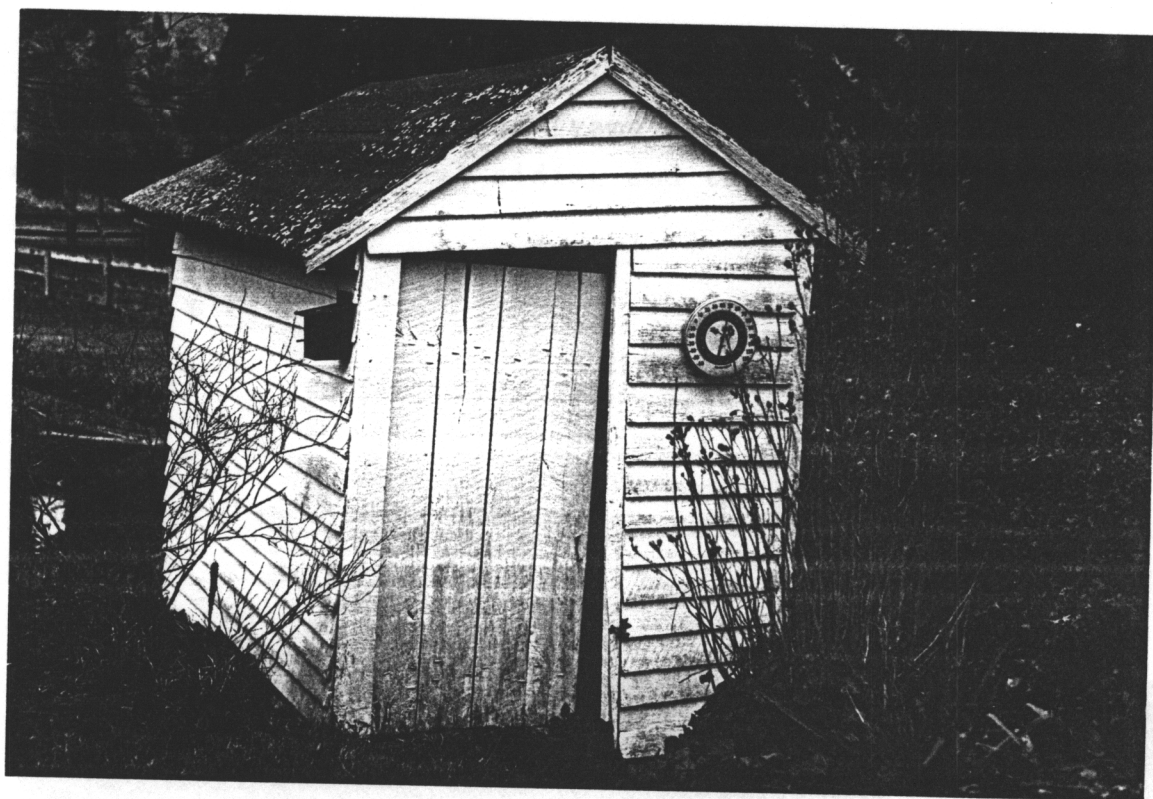
This frame, front-gabled springhouse is notable for its small size (48 ft²).

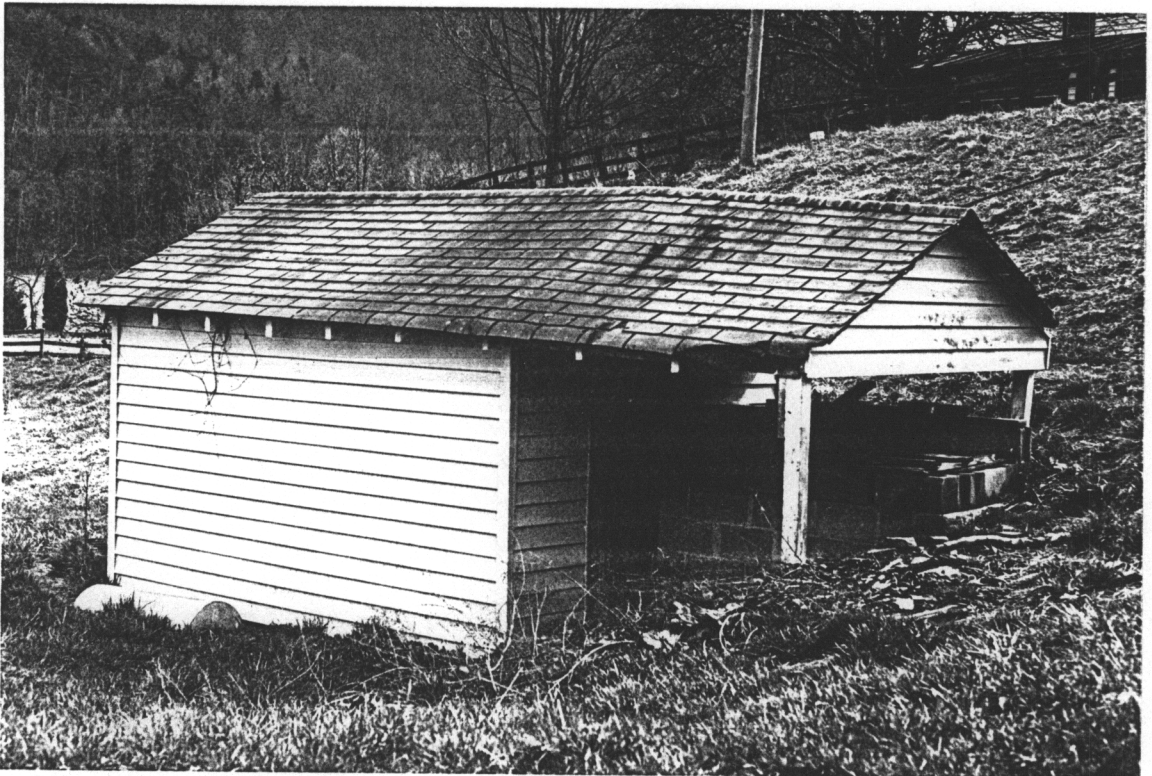
This medium-sized (10x11'), frame springhouse has been altered. Note the vinyl siding and the pump that blocks access to the door.

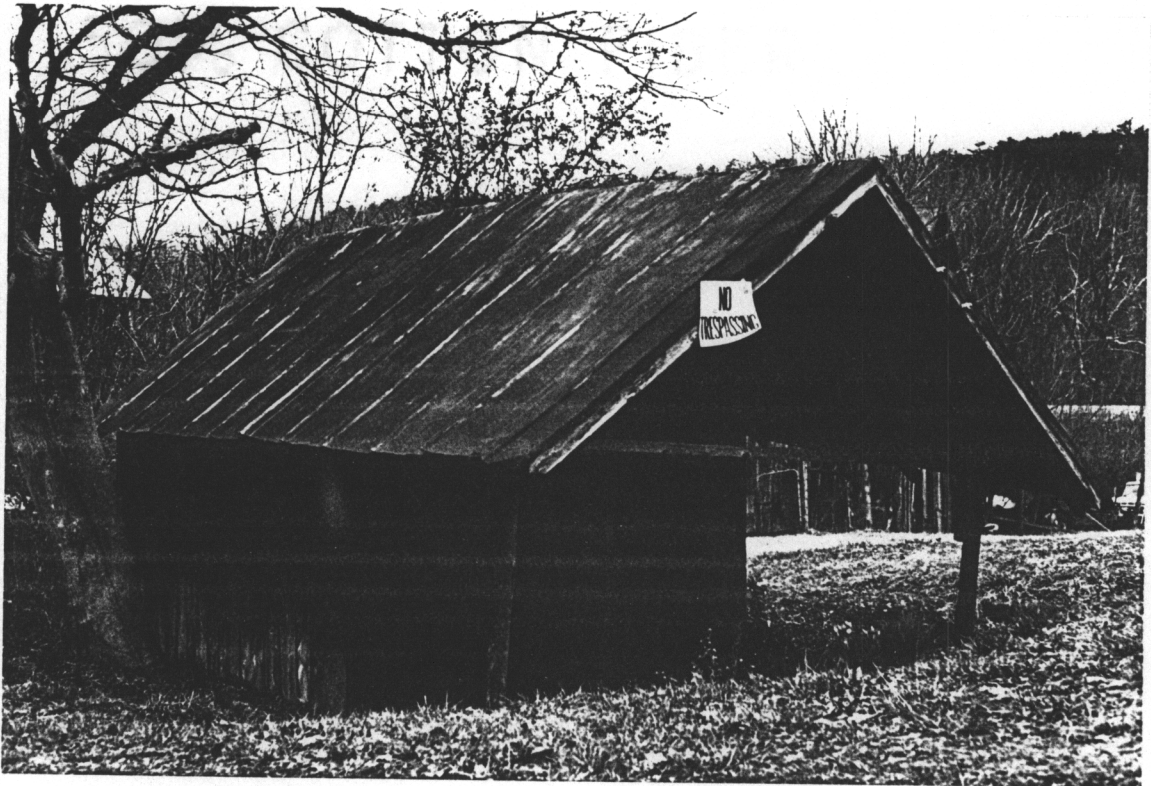
This typical frame, front-gabled springhouse has a ten-and-a-half foot overhang supported by posts, and a trough that runs from front to back along the side wall. The building measures 10x12'.
