## CHAPTER III

### DYNAMIC BEHAVIOR OF A LABORATORY SPECIMEN

### 3.1 DESIGN AND CONSTRUCTION OF THE FOOTBRIDGE

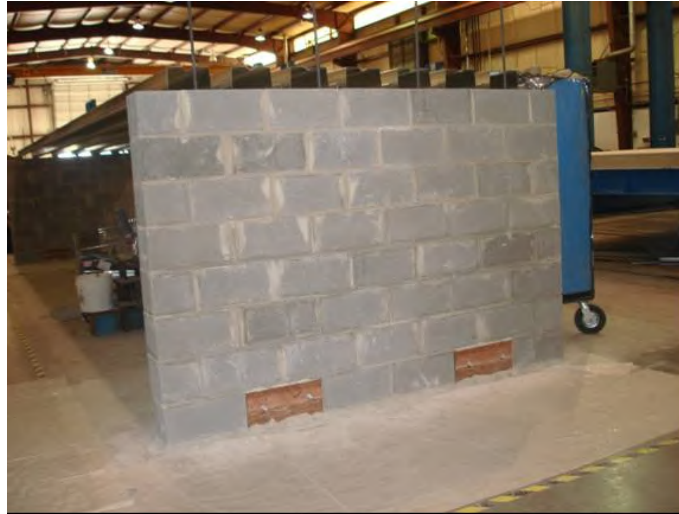
**Figure 3.5 Construction of the CMU Walls**

The footbridge construction started with the lower CMU walls. Eight courses of blocks were stacked to form the 5 ft-4 in. high by 7 ft CMU wall at each support location. The vertical and horizontal reinforcement bars were placed in their position, and the blocks were fully grouted. At the bottom, the walls were anchored to the floor with four L6x4x5/16 angles, as shown in Figure 3.5.

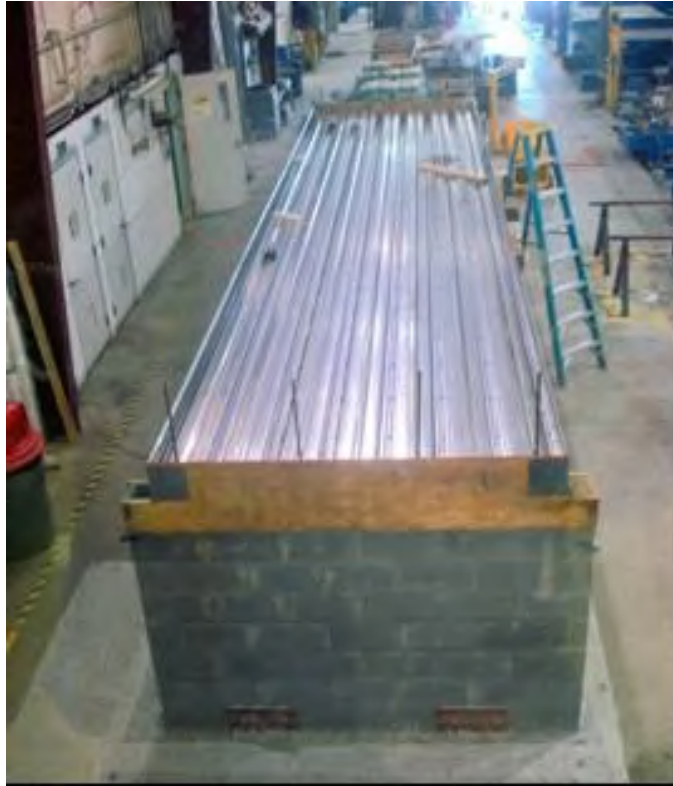
**Figure 3.6 Cold Formed Steel and Plywood Pour Stops**

The deck panels were then positioned on the top of the CMU walls, with the ends supported at the centerline of the blocks. The panels were connected using a deck crimping tool provided by CSi. Next, 8-3/4 in. deep cold-formed steel pour stops were installed along the long sides of the slab. Plywood was used as pour stops along the short sides. The welded wire reinforcement sheets were placed on the deck. Horizontal 1/4 in. diameter rods, transverse to the deck span, were used to brace the two cold-formed steel pour stops. The rods were installed every 5 ft, and prevented the pour stops from bending outwards during the concrete placement. Figures 3.6 and 3.7 show the structure condition before the concrete placement. Ready-mix, normal weight concrete (145 pcf,  $f'_c = 3500$  psi) was used for the slab.

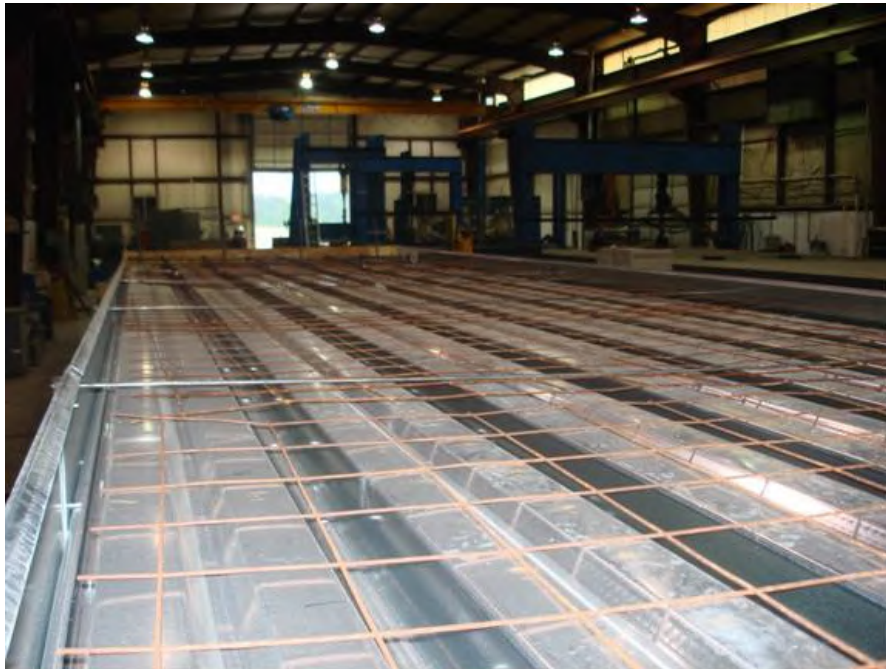
**Figure 3.7 WWR and Pour Stop Bracing Rods**

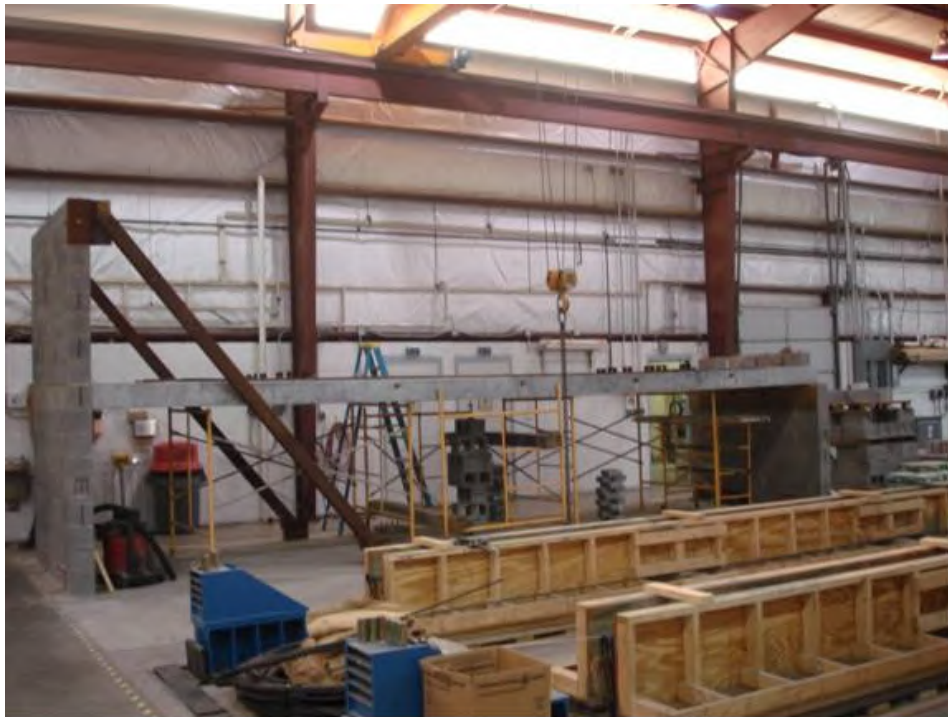
**Figure 3.8 Left Upper Wall with Braces (Stage 2)**

After completing the Stage 1 tests, the left upper wall was constructed, following the same procedure as for the lower walls. The braces were positioned and the experiments conducted again. Finally, for Stage 3, the right upper wall was erected with its braces, completing the construction of the footbridge. The walls and braces constructed during Stage 2 and 3 are shown in Figures 3.8 and 3.9.

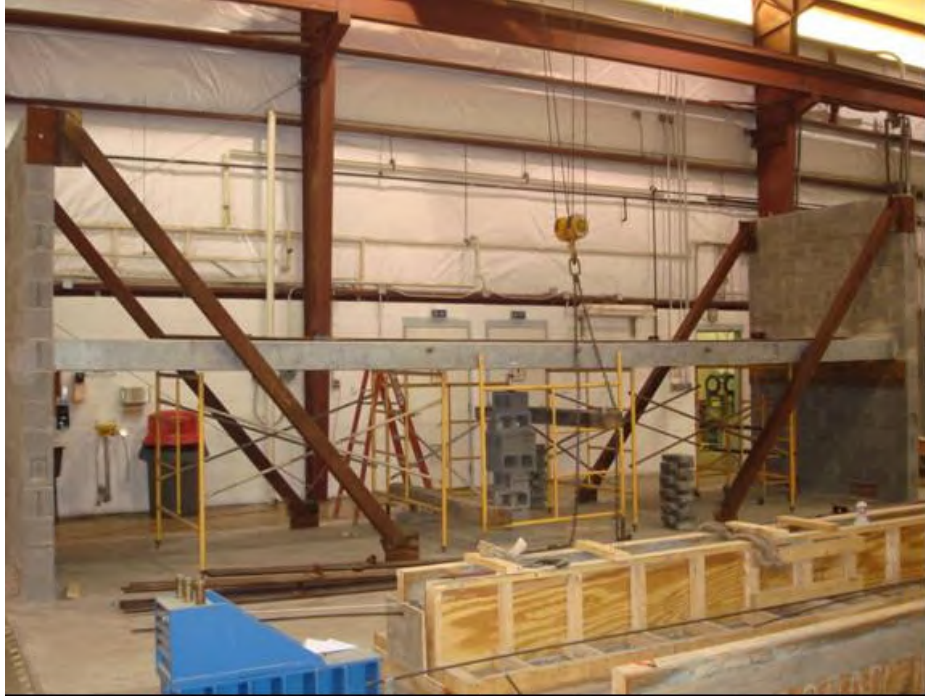
**Figure 3.9 Right Upper Wall with Braces (Stage 3)**

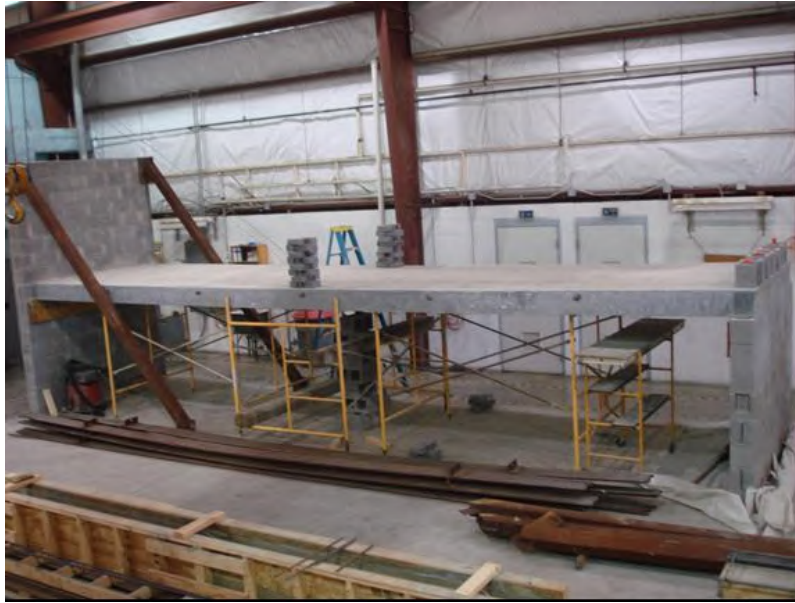
**Figure 3.10 Static Tests, Point Load (Stage 2)**

Two types of static loads were applied to the structure: two point loads of 550 lbs each and a uniform distributed load of 20 psf. The point loads were bundles of steel plates stacked in five increases of 100 lbs each and one of 50 lbs at the middle of the

floor span, as shown in Figure 3.10. The deflection at the center of the slab due to the load increase was measured with a dial gage placed at the bottom flange of the deck.

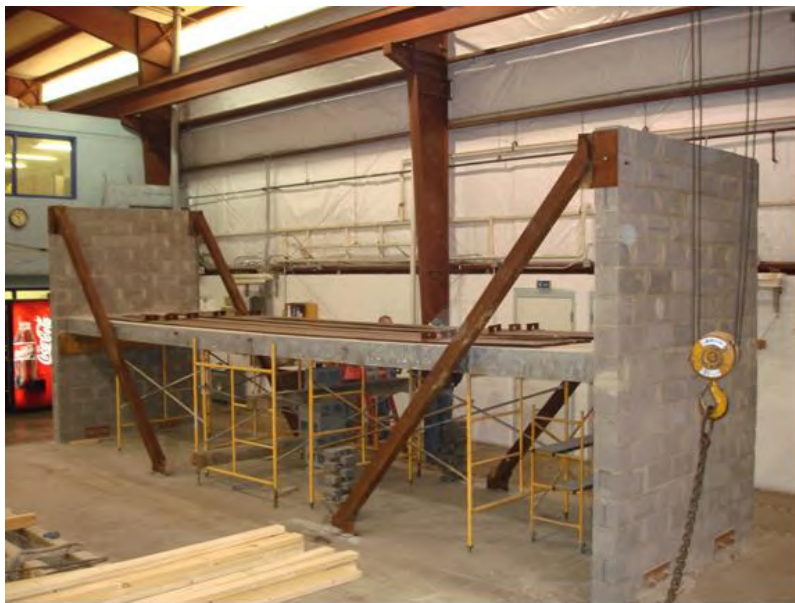
**Figure 3.11 Static Tests, Distributed Load (Stage 3)**

In the second test, a uniform distributed load was applied on the slab. The distributed load consisted of bundles of 24 long steel rods. The total applied load was 20 psf. The deflection was again measured using dial gages at mid-span. Figure 3.11 shows the structure during the test with the distributed load.

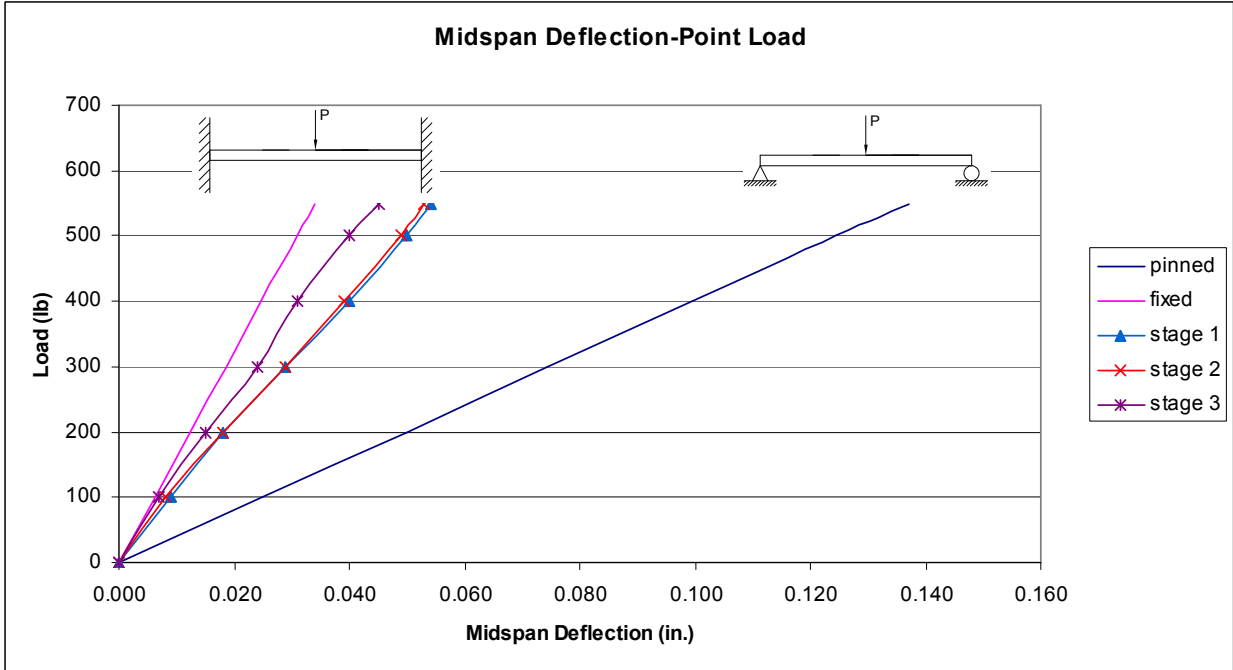
**Figure 3.12 Point Load vs. Deflection**

Static tests were conducted for the three stages of the project. For each stage the relationship between the load and the floor deflection was recorded and plotted. Figures 3.12 and 3.13 show the load-deflection plots for the tests performed with the point loads and the distributed load, respectively. In the figures, the leftmost line corresponds to the load-deflection relationship for a fully restrained beam. The rightmost line corresponds to the case of a simply supported beam. These lines are analytical predictions calculated using classical equations for beam deflections due to point and distributed loads (Hibbeler, 2006). They are plotted to bound the expected response of the floor with the three tested support conditions. The three lines that lay between the analytical predictions are the measured results for Stages 1, 2, and 3, respectively. The measured load-deflection curves ideally should be straight lines, as those shown for the beams with fixed and pinned ends. However, the error associated with the experimental procedures and the instrumentation prevents to obtain better plots.

As shown in Figure 3.12, the load-deflection curve for Stage 1 indicates that the footbridge behavior approaches the behavior of a beam with fixed supports. Apparently, the connection between the lower CMU walls and the slab prevents relative rotation between the slab and the end of the walls. In Stage 2, the addition of the left upper wall was expected to increase the rotation constraint at the left end of the slab. However, as shown in the plot the measured deflections for Stage 1 and 2 are the same. The additional constraint given by the right wall constructed in Stage 3 barely increased the stiffness of the slab. This is shown in the Stage 3 curve, where there is a small reduction of the midspan deflection when the point loads are applied.

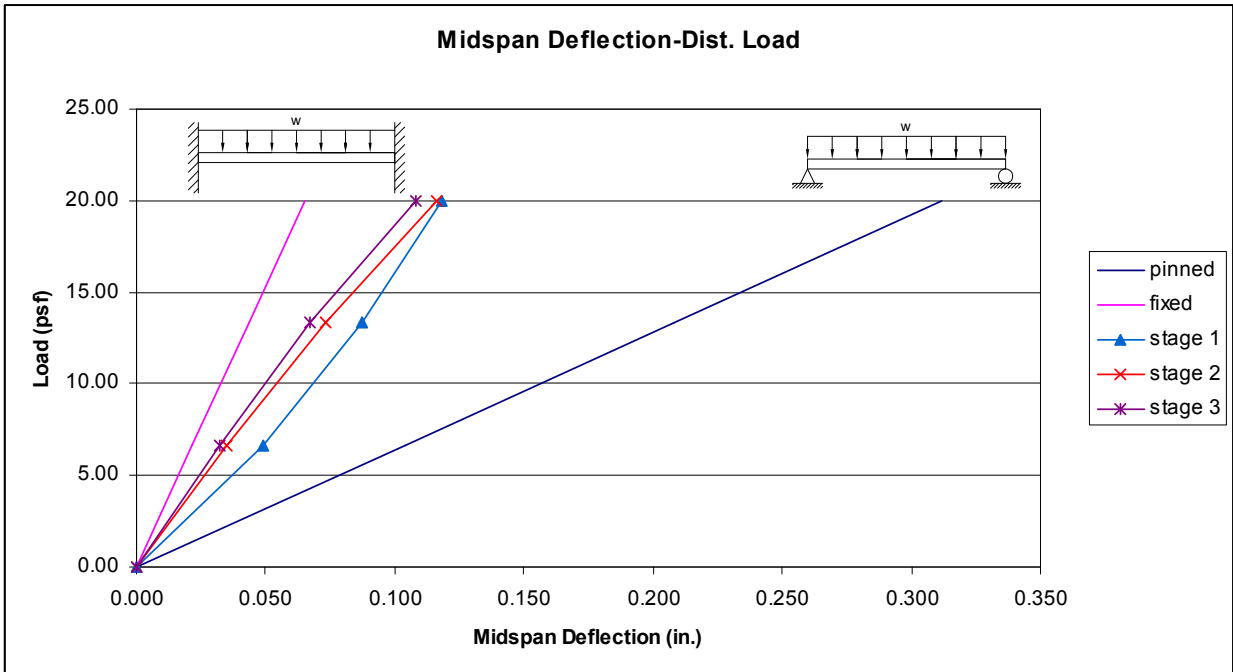
**Figure 3.13 Distributed Load vs. Deflection**

Figure 3.13 presents the measured deflections at midspan when the distributed load is applied. As shown in this figure, the results are almost the same results obtained with the point loads. The load-deflection curve for Stage 1 approaches the ideal case of a beam with fully fixed ends. The curve for Stage 2 is quite similar to the Stage 1 curve; in fact, the final deflection attained in both stages are the same. In Stage 3, the addition of the right upper wall barely stiffened the slab end, and the measured deflections decreased in a small amount.

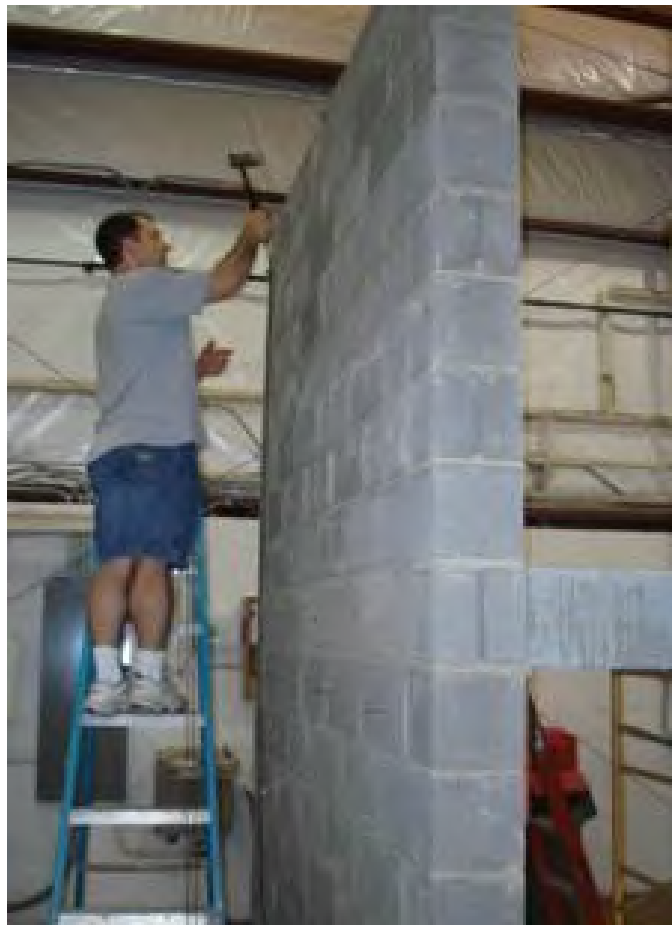
**Figure 3.14 Strike in the Structure with the Impulse Hammer**

In this test the structure was struck with an instrumented impulse hammer, and the free vibration response of the structure due to the strike was measured. The strike was applied at the connection between the slab and the lower CMU wall for Stage 1. For Stages 2 and 3, the structure was stricken at the tip of the left upper wall, as shown in Figure 3.14. To capture the acceleration response in the walls, the accelerometers were placed every 1 ft 4 in. in the vertical direction along the centerline of the wall. In the floor, the accelerometers were placed every 3 ft along the centerline, capturing the accelerations at eleven points, along the 30 ft span.

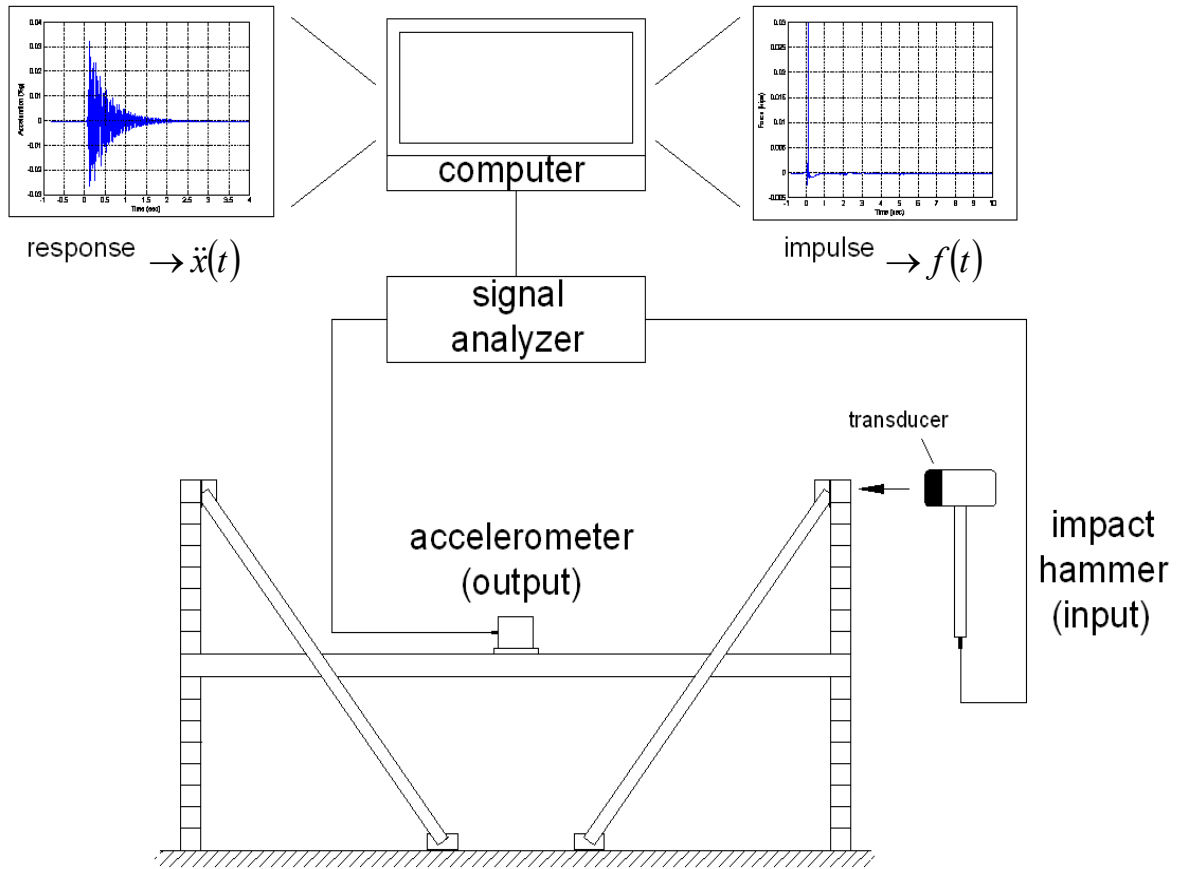
**Figure 3.15 Schematic of the Impulse Hammer Test**

In this experiment, the characteristics of the excitation (applied force) and the response of the structure due to the excitation were captured to evaluate the dynamic properties of the system. In the case of the impulse hammer test, the input signal (force) is measured with a transducer that is mounted in the head of the hammer. The output signal is measured with accelerometers that are placed in the structure at the locations mentioned previously. Hence the characteristics of the impulse and the structure response are captured to determine the dynamics of the system. Figure 3.15 shows a schematic representation of the test setup.

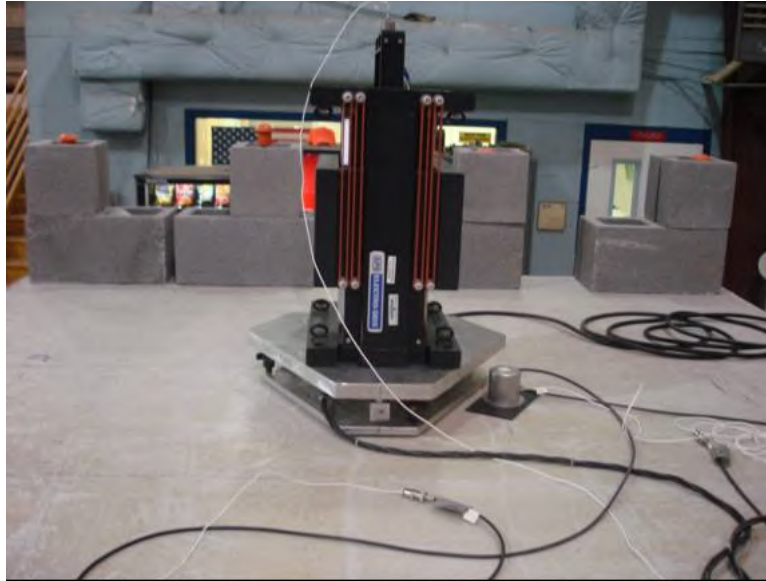
**Figure 3.19 Electrodynamic Shaker**

The shaker shown in Figure 3.19 is an actuator that delivers a force to the structure in form of a sinusoidal function. The force is measured by an instrumented force plate that is positioned between the shaker and the floor. The frequency of the forcing function varies within a determined range while its amplitude remains constant. The minimum and maximum frequencies of the sinusoidal force are set such that the structure natural frequency lies between these two values. Since the natural frequencies of the floor were between 5.44 and 6.30 Hz, the shaker was setup to apply the dynamic load with frequencies ranging between 4 Hz and 7 Hz. When the forcing frequency matches the floor natural frequency, it causes resonance, which is captured in the FRF. The forcing function amplitude was calibrated to cause accelerations that resemble the vibrations experienced in the floor due to walking. Thus, the accelerations induced by the shaker were between 0.5 to 1.0 %g. For testing, the shaker was positioned at three feet from the right end of the floor. It was determined that the force glitches and FRF determination

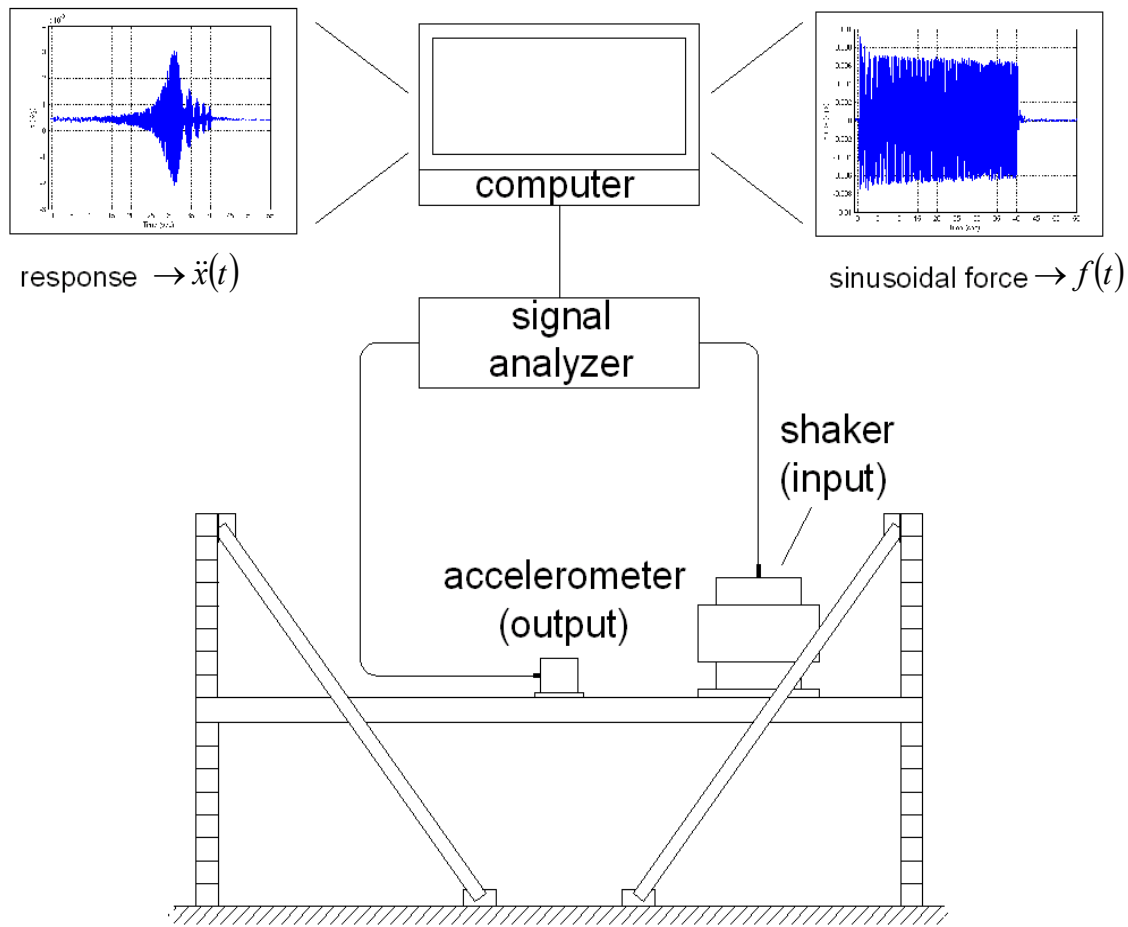
**Figure 3.20 Schematic of the Dynamic Test Using the Shaker**

errors were minimized when the shaker was positioned in that location (Davis et al, 2007). Figure 3.20 is a schematic representation of the test setup.

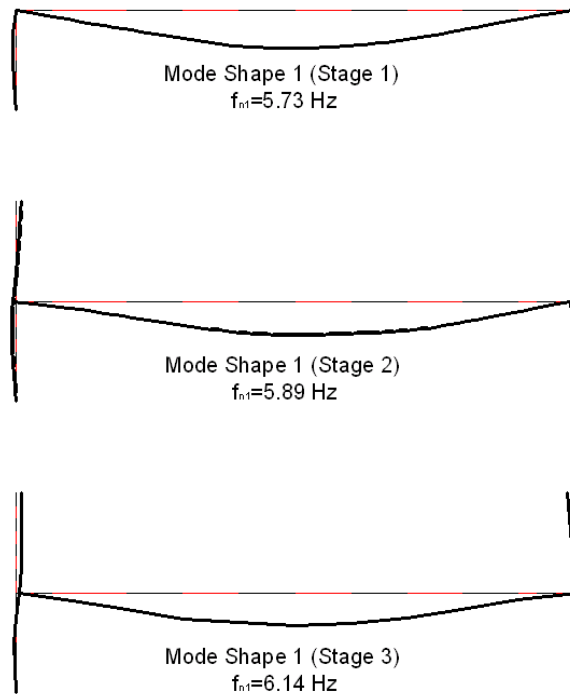
**Figure 3.23 Mode Shapes Determined from EMA Using the Shaker**

The resultant measured mode shapes for the dynamic tests using the shaker are presented in Figure 3.23.

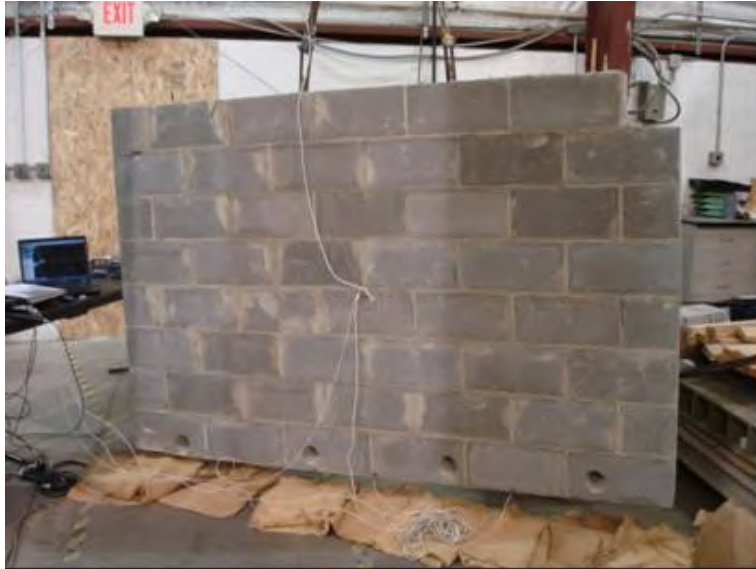
**Figure 3.24 Vibration Tests in the CMU wall**

with the support (Ewins, 2000). To conduct tests, the CMU wall was hanged using the laboratory crane as shown in Figure 3.24. Tests were conducted to determine the modal properties of the wall with free-free conditions. A similar procedure was followed to test the 6 ft x 6 ft slab section. A photograph of the slab section during the tests is shown in Figure 3.25.

From the tests, it was determined that the dynamic modulus of elasticity of the CMU wall is 1,150 ksi. Besides, the measured slab dynamic modulus of elasticity was 4,741 ksi for bending about the weak axis and 20,208 ksi for bending about the strong axis.

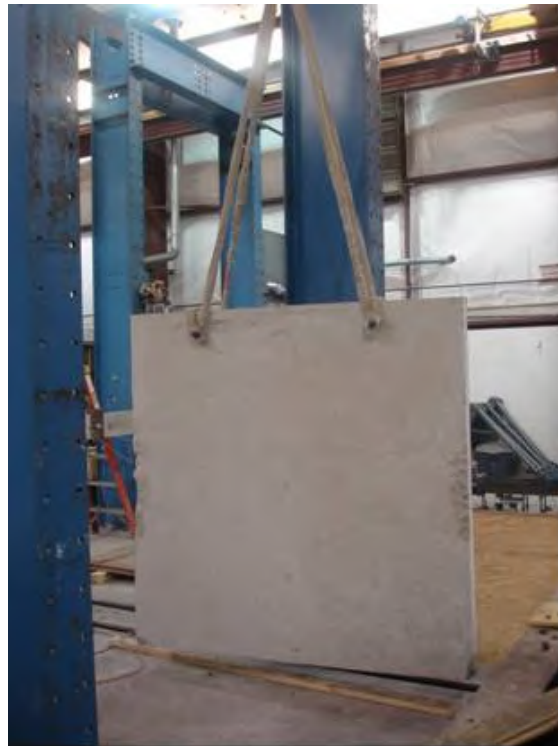
**Figure 3.25 Vibration Tests in the Slab Section**
