INVESTIGATION OF COPPER PITTING PROPENSITY USING BENCH AND FIELD SCALE TESTING

Thesis submitted to the Faculty of the
Virginia Polytechnic Institute and State University
in partial fulfillment of the requirements for the degree of

Master of Science
in
Environmental Engineering

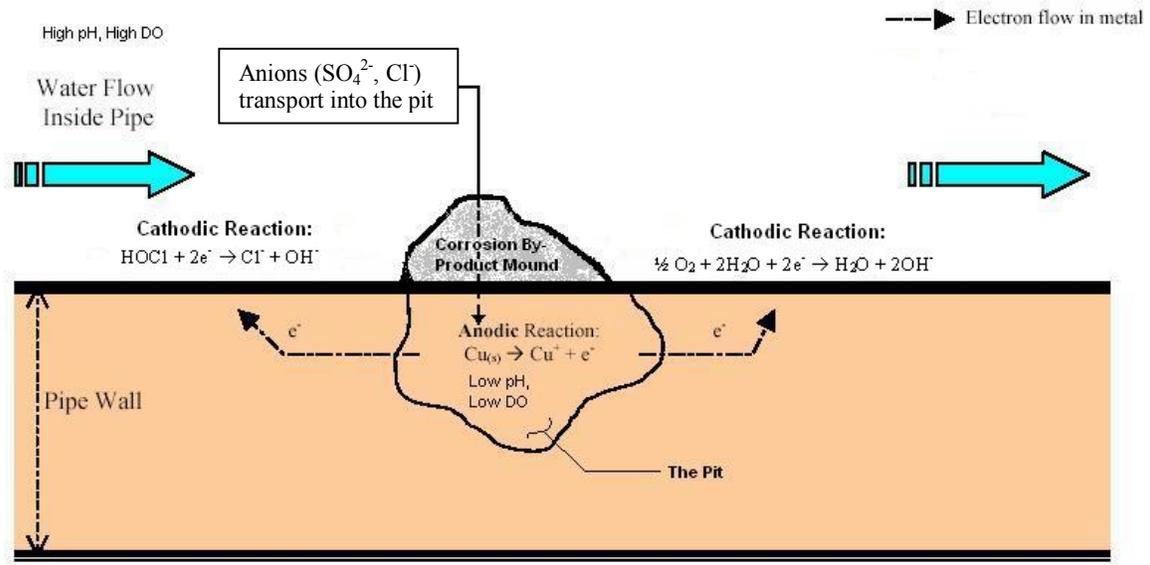
Figure 1-1. Key reactions, locations, and elements of copper pitting.

Essential features of a growing pit corroding through a copper pipe wall are illustrated schematically in Figure 1-1. The pit is the location of the anodic corrosion reaction which consumes the pipe wall. During the anodic reaction, copper metal is oxidized, cuprous ions are released, and electrons are produced. The electrons are transferred through the conductive copper pipe wall to a cathodic portion of pipe surface where they are consumed by oxygen and/or chlorine. Although no visible attack is occurring at cathodic pipe surfaces surrounding a pit, cathodic reactions are critical to pit growth. In accordance with the overall copper corrosion reaction, anodic and cathodic reactions must proceed in lockstep.

The pitting process as described by Figure 1-1 can be conceptualized as a divided cell in which copper samples are exposed to different environments representative of pitting conditions at anodic and cathodic locations (Figure 1-2). Specifically, the cathodic copper surface is in contact with water of relatively high pH, high dissolved oxygen and/or chlorine, and low Cu^+ and Cu^{2+} concentrations. However, the small anodic copper surfaces representing pits are exposed to an environment of low pH, low DO, and high Cu^+ and Cu^{2+} concentrations. As a result of different chemical environments, a battery develops between anodic copper samples and the copper cathode. Theoretically, an ammeter connected between anodic samples (collectively or individually) and the copper cathode would measure a current indicative of electron flow from the anode(s) to the cathode.

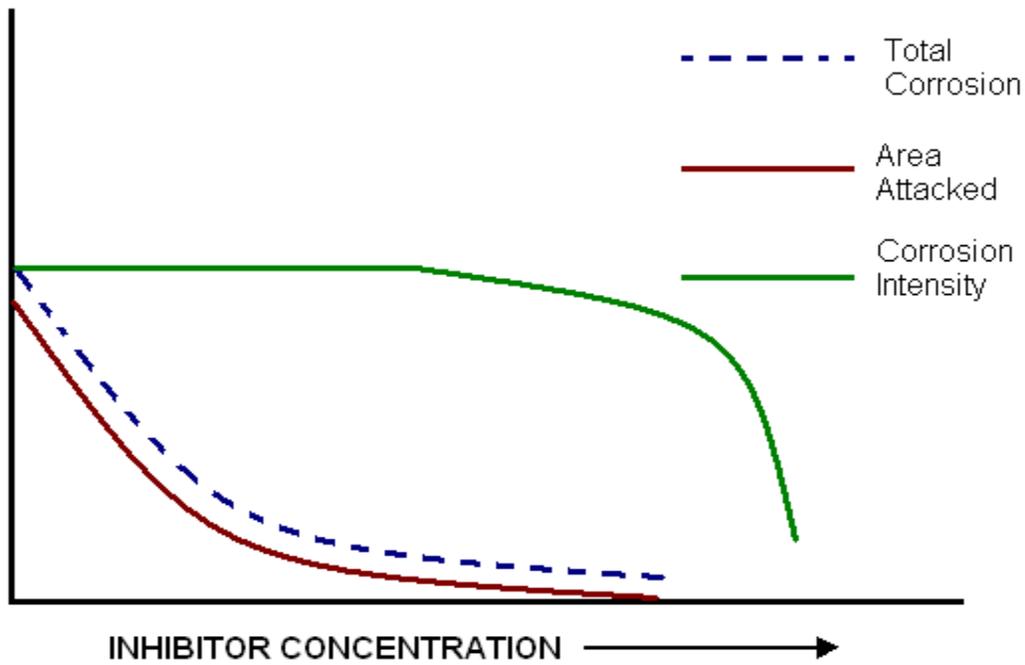
Figure 1-3. Case I - Anodic Control; Anodic Inhibitor – Plot of corrosion measurements per inhibitor concentration.

In this case, the addition of an anodic inhibitor will increase the probability of forming an insoluble precipitate on the metal surface and lead to stifling of the attack considering that the attack is anodically controlled. Thus, it can be expected that the area attacked will decrease proportionally with the amount of inhibitor added, and since the anodic reaction controls the corrosion rate, the expected quantity of metal corroded will proportionally decrease as well. Thus, assuming that the addition of inhibitor is sufficiently small such that the probability of corrosion somewhere on the metal surface is nearly a certainty, the expected intensity of corrosion should remain unaffected. However, as the number of affected corrosion sites becomes increasingly unlikely, the expected intensity will begin to decrease as well.

In summary for Case I, adverse effects due to corrosion are decreased as the concentration of inhibitor is increased according to total corrosion, area attacked, and corrosion intensity. Although anodic inhibitor addition to an anodically controlled corrosion process may not always be very effective, it is a safe treatment in the regards that matters can not become worse than if no inhibitor was added. Figure 1-3 illustrates a qualitative plot of how each measure of corrosion is affected as inhibitor dose is increased in Case I conditions.

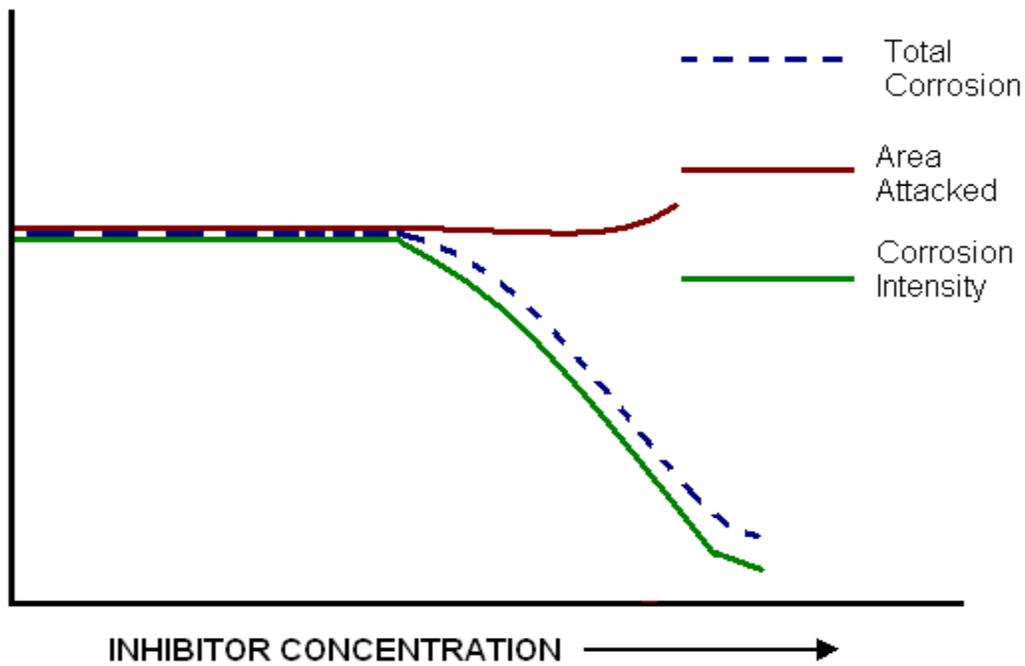
Figure 1-4. Case II - Anodic Control; Cathodic Inhibitor – Plot of corrosion measurements per inhibitor concentration.

In this situation, the addition of a cathodic inhibitor will not immediately decrease the total corrosion, but eventually a stage will be reached at which the cathodic reaction becomes so much impeded that it will be comparable to the anodic reaction rate and total corrosion will begin to decrease. The area suffering from corrosion is not likely to be decreased, and, if anything, will increase. This is due to interference from the cathodic inhibitor which prevents sites from supporting cathodic reactions, yet, in some instances, can allow these sites to turn anodic. As the total corrosion is decreased and the expected area attacked remains constant (or is increased in unusual circumstances), the intensity of

corrosion is consequently decreased as the concentration of inhibitor increases. Thus, similar to Case I, the addition of a cathodic inhibitor to an anodically controlled corrosion process should be a safe proposition and there is no threat of increasing corrosion rates. Figure 1-4 illustrates a qualitative plot of how each measure of corrosion is affected as inhibitor dose is increased in Case II conditions.

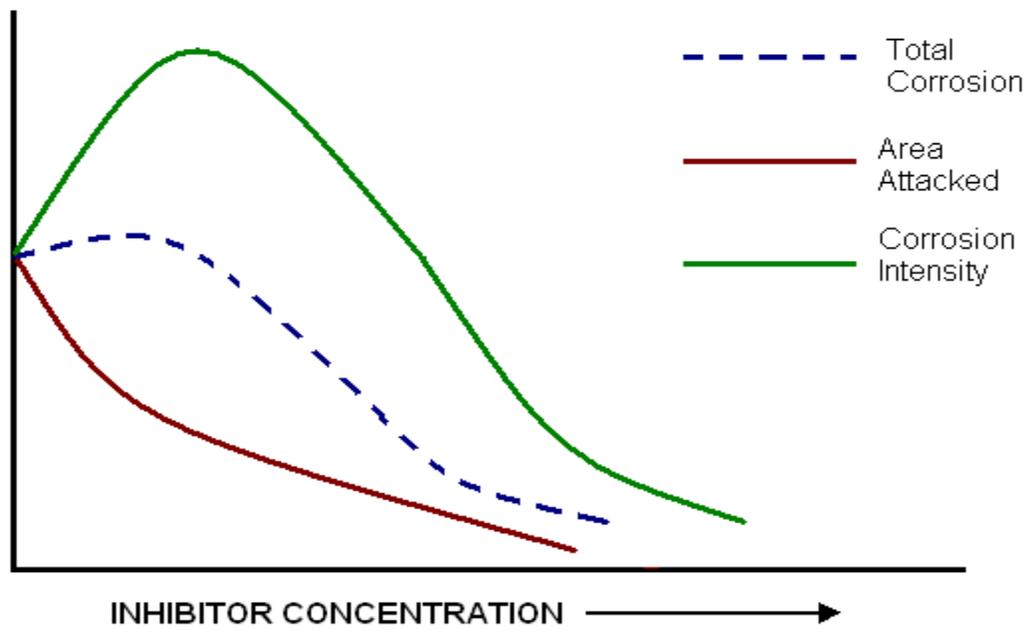
Figure 1-5. Case III - Cathodic Control; Anodic Inhibitor – Plot of corrosion measurements per inhibitor concentration.

Interestingly, consequences are unique in the case of an anodic inhibitor being added to a cathodically controlled corrosion process. Similar to Case I, the addition of an anodic inhibitor will clearly reduce the available *anodic area* subject to attack. However, since corrosion is controlled by the cathodic reaction, total corrosion will actually begin to increase considering that a larger *cathodic area* is now available for the remaining active anodic sites. Thus, as small additions of inhibitor have decreased the expected corroded area yet increased total corrosion, the intensity of corrosion is augmented. In other words, although the area of active anodic sites has been decreased, the active anodic sites will corrode at an increased intensity proportional to the increase of anodic area which has been inactivated. Throughout the process, cathodic corrosion reaction rates will remain relatively unaffected. This condition is a dangerous proposition if the amount of added inhibitor is underestimated and, as stated, can initiate and/or accelerate localized attacks such as pitting.

Only when a sufficient concentration of inhibitor is added will benefits become realized as the reduction of active anodic areas is such that the anodic reaction rate is one comparable to the cathodic reaction rate. At this stage, the expected total corrosion will be reduced and, subsequently, the corrosion intensity will soon decrease as well.

In summary, if an anodic inhibitor is added to a cathodically controlled corrosion reaction in quantities insufficient to completely stop attack altogether, active corrosion area will decrease more quickly than the total destruction of metal, and thus increase the intensity of corrosion. Again, this is a dangerous proposal which is prone to intensify corrosion relative to the situation if no inhibitor was added at all. Figure 1-5 illustrates a qualitative plot of how each measure of corrosion is affected as inhibitor dose is increased in Case III conditions.

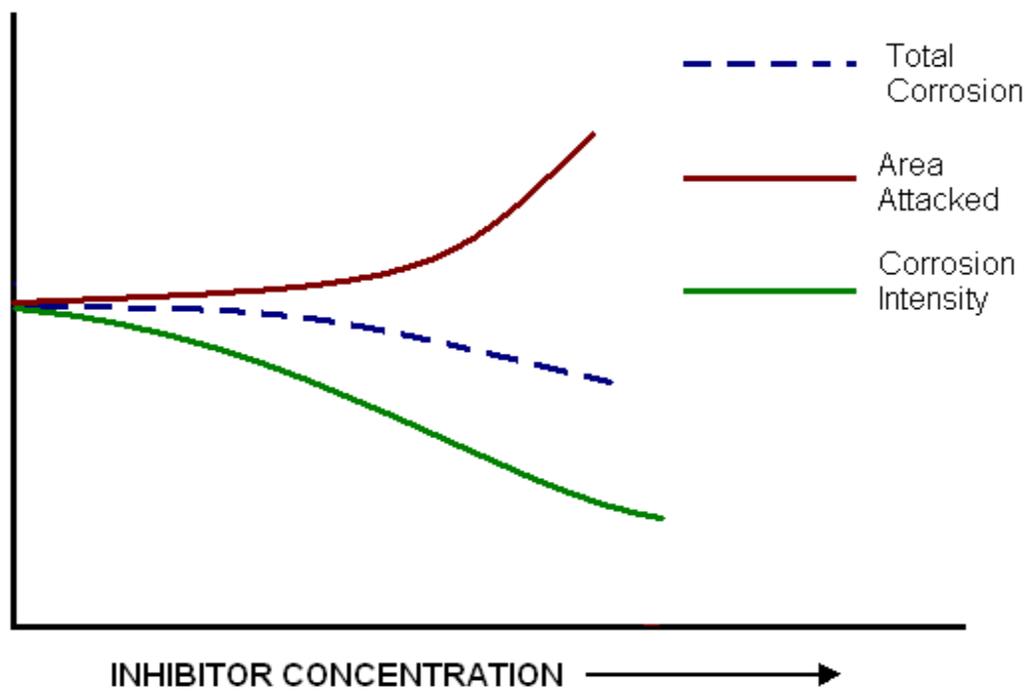
Figure 1-6. Case IV - Cathodic Control; Cathodic Inhibitor – Plot of corrosion measurements per inhibitor concentration.

In a corrosion process controlled by the cathodic reaction, the addition of a cathodic inhibitor will steadily lower the total corrosion attack. Although the area available for anodic corrosion will, if anything, slightly increase as seen in Case II, the intensity of attack will decrease steadily as intensity is defined as corrosion per unit area of affected surfaces. Therefore, for corrosion controlled by the cathodic reaction, the addition of a cathodic inhibitor is a 'safe' approach and usually sufficient for practical purposes. Figure 1-6 illustrates a qualitative plot of how each measure of corrosion is affected as inhibitor dose is increased in Case IV conditions.

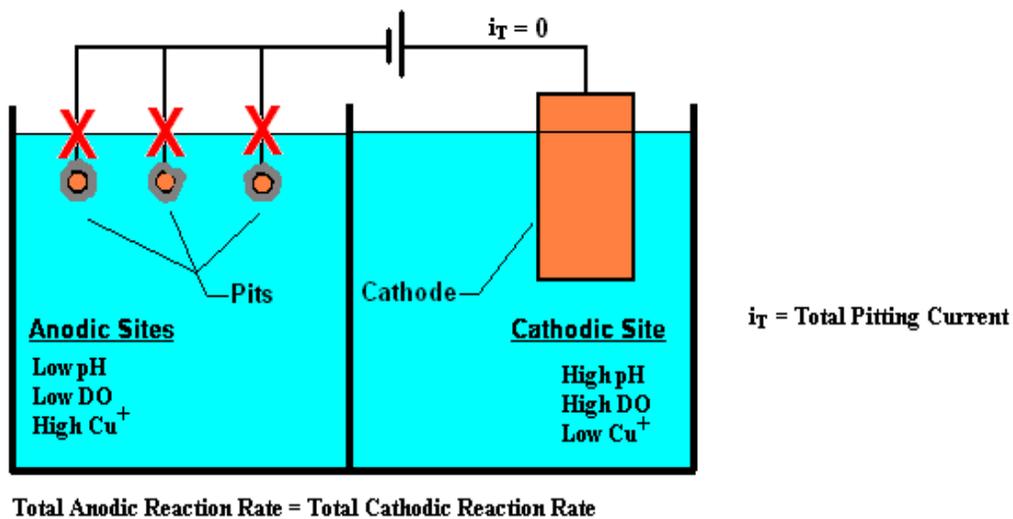
Figure 1-7. Divided Cell - Conceptual illustration of effective anodic inhibition.

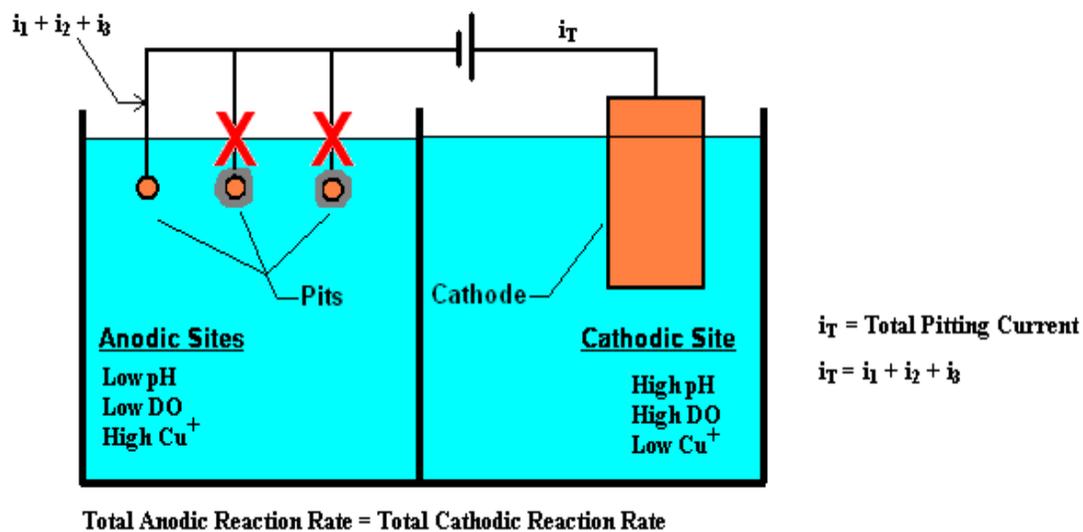
Figure 1-8. Divided Cell - Conceptual illustration of ineffective anodic inhibition.

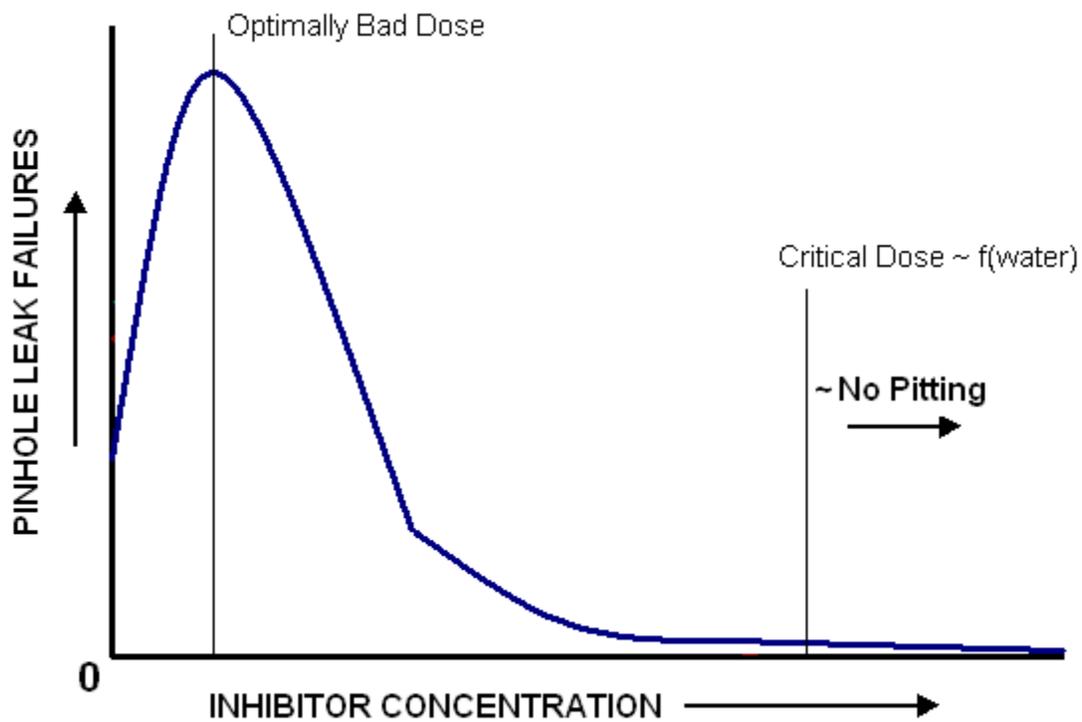
Figure 1-9. Typical anodic inhibitor response curve.

For a given anodic inhibitor, it would obviously be desirable for a water utility to know the dose response curve so that dangerous doses could be avoided. However, given the difficulty and length of time to measure a response as well as the expense of corrosion studies, establishing the dose response curve of an inhibitor for a given utility is not only costly, but impractical. Moreover, for numerous reasons including the complicated solubility of reaction products formed between copper species and anodic inhibitor products such as phosphates, it is likely that dose response curves are specific to a given water as a function of pH and other water quality parameters.

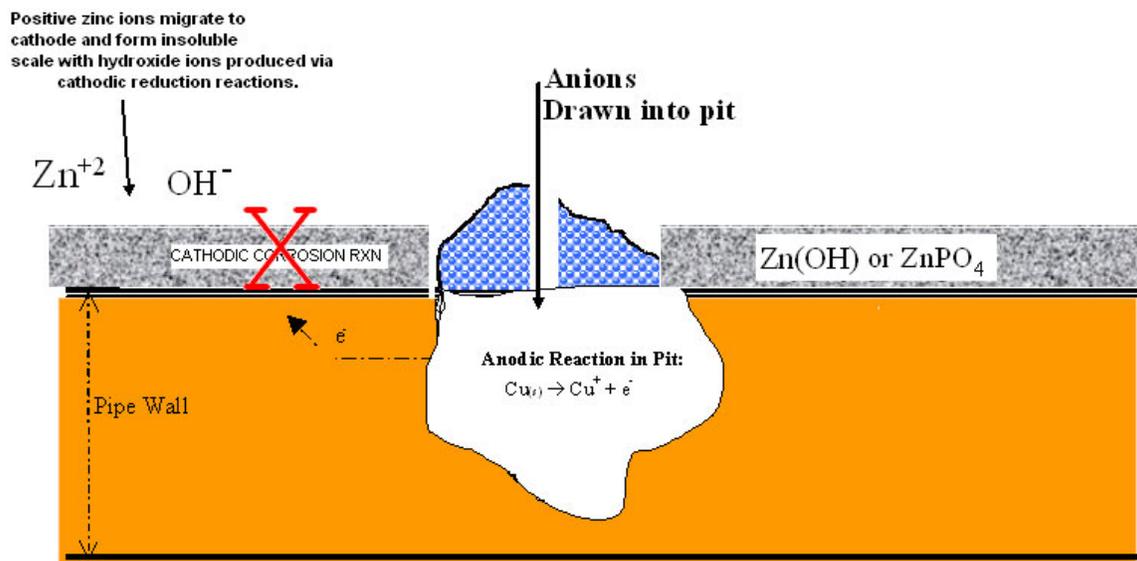
Figure 1-12. General schematic of copper pitting inhibition via zinc-based cathodic inhibitors.

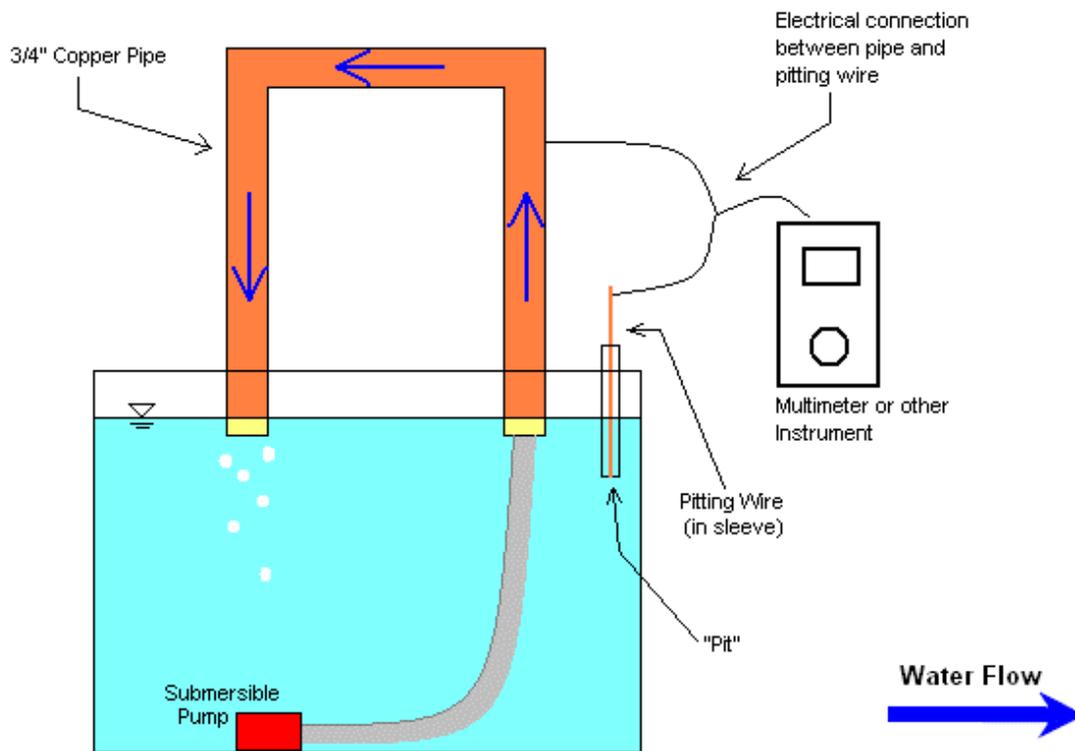
Figure 1-13. General schematic of experimental setup and pitting wire installation.

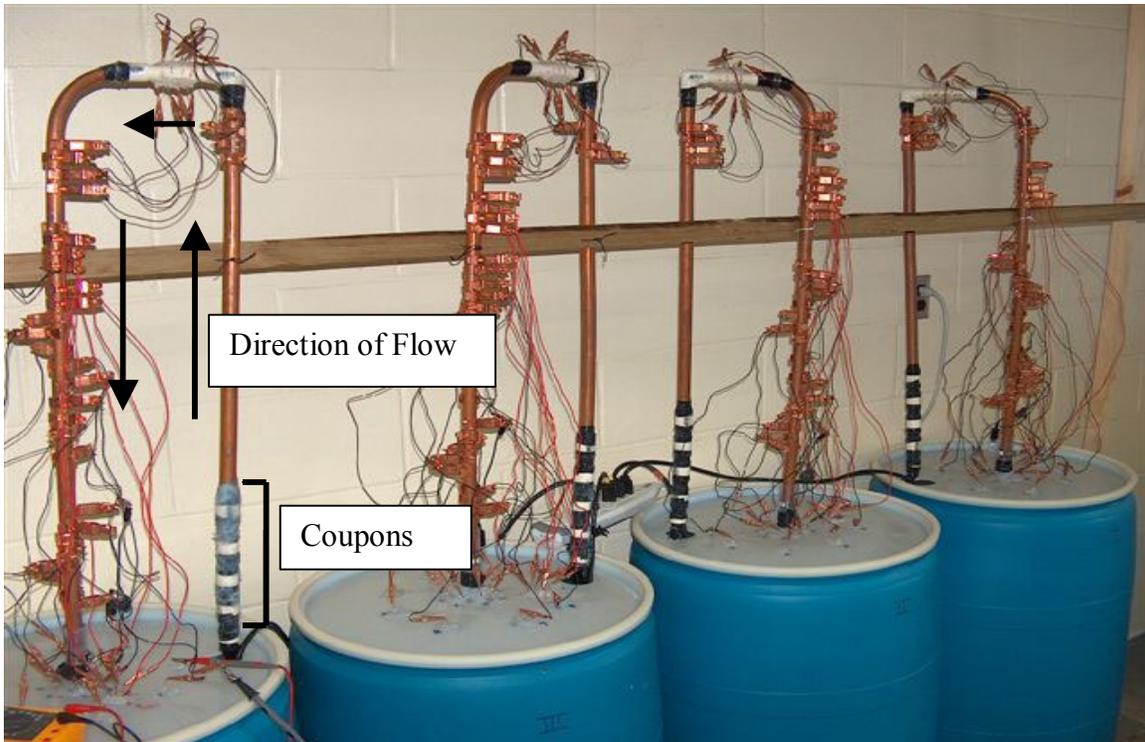
Figure 2-1. General pitting rig experimental setup.

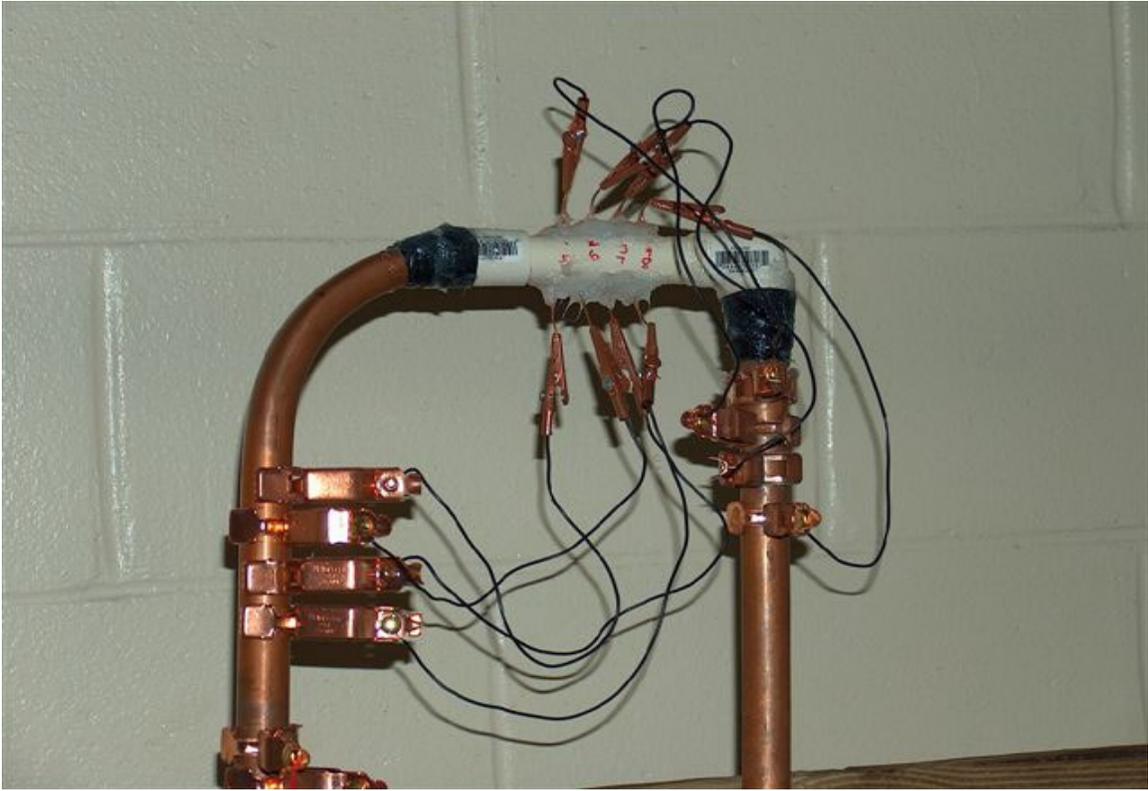
Figure 2-3. Electrical connection between 90 degree in-flow pit wires and pipe.

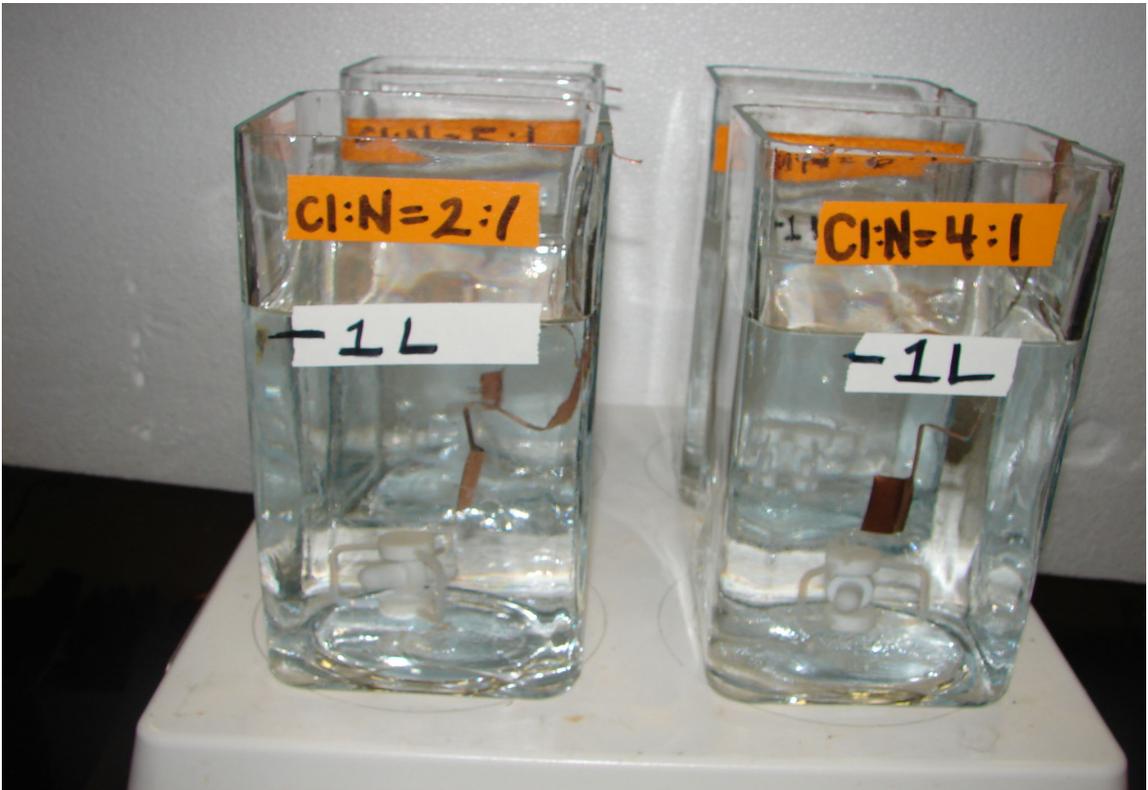
Figure 2-4. Jar tests with copper coupons installed.

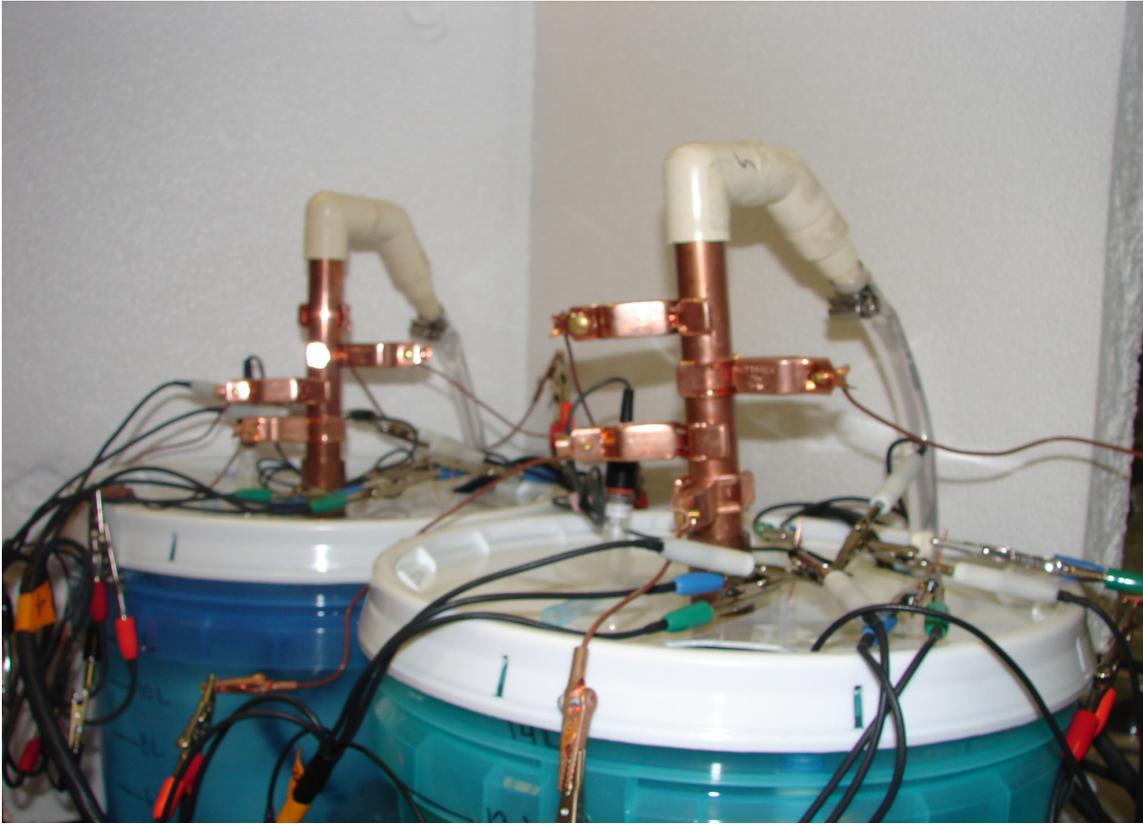
Figure 2-5. General short term rig experimental setup.

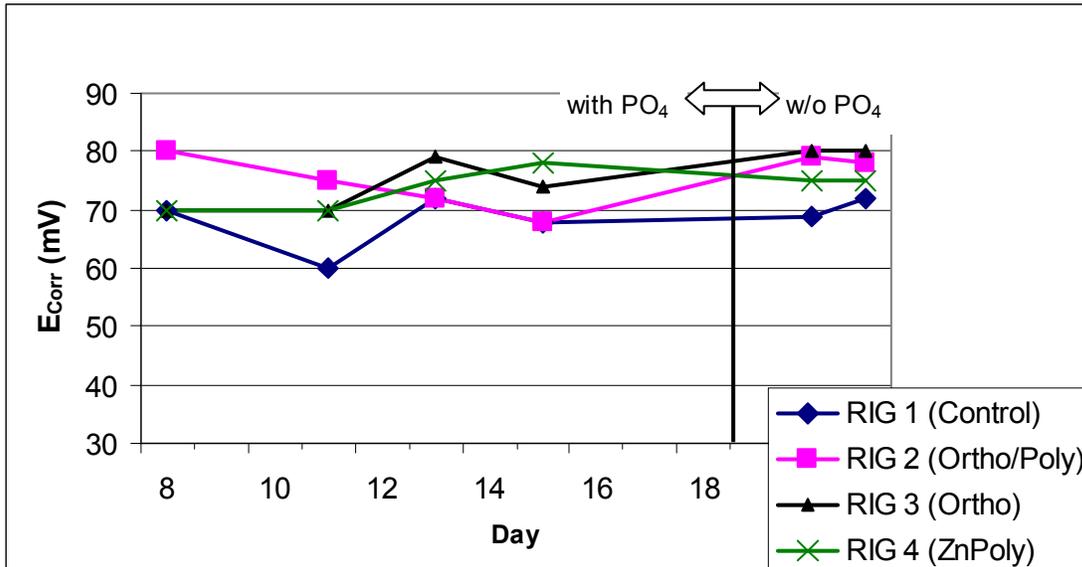
Figure 2-6. E_{Corr} of utility distribution water prior to addition of inhibitors.

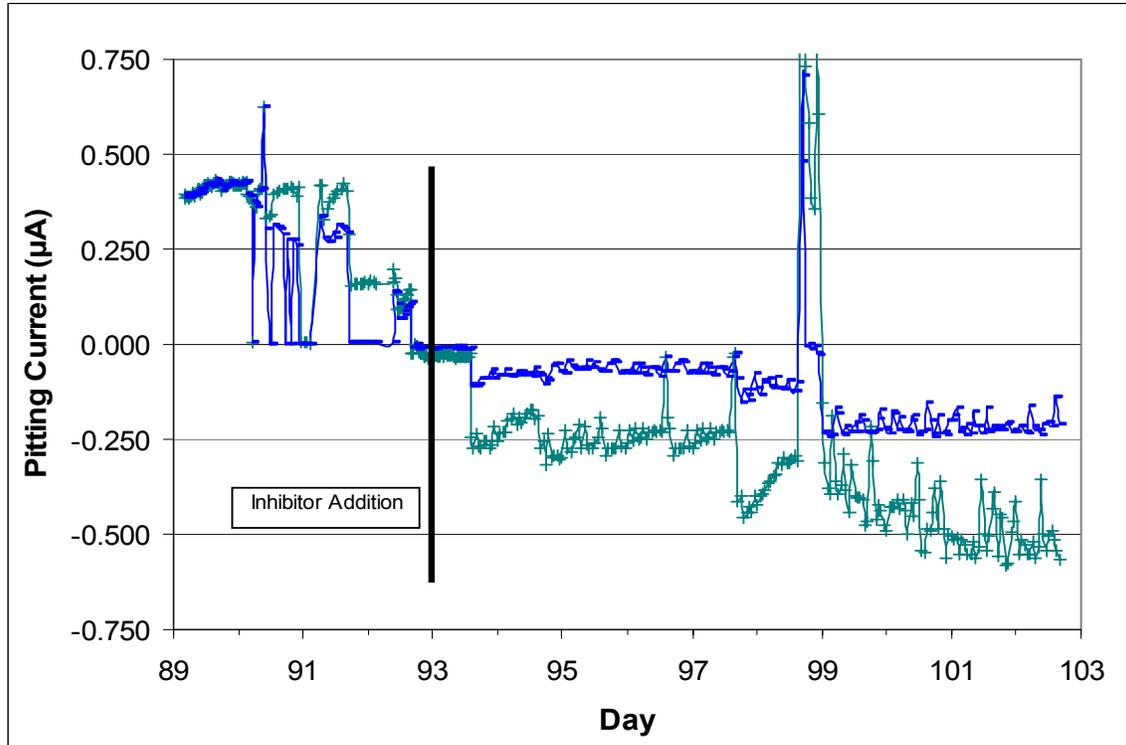
Figure 2-7. Pitting currents before and after addition of inhibitors – Zinc Polyphosphate Rig.

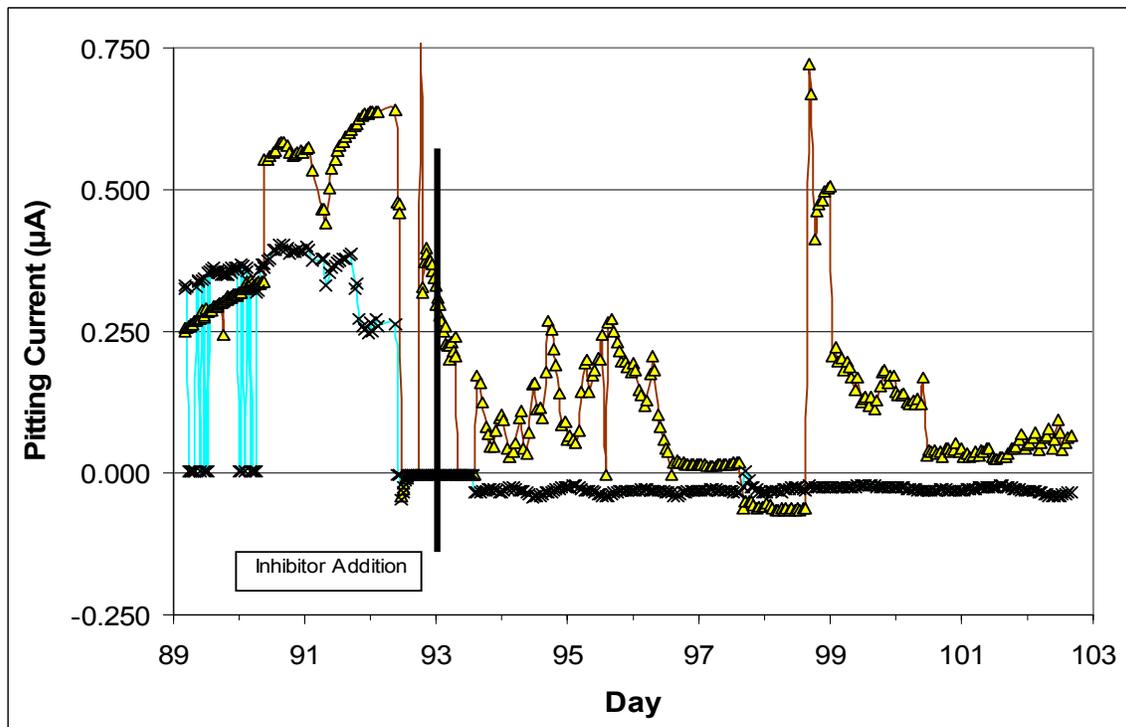
Figure 2-8. Pitting currents before and after addition of inhibitors - Orthophosphate-Polyphosphate Rig.

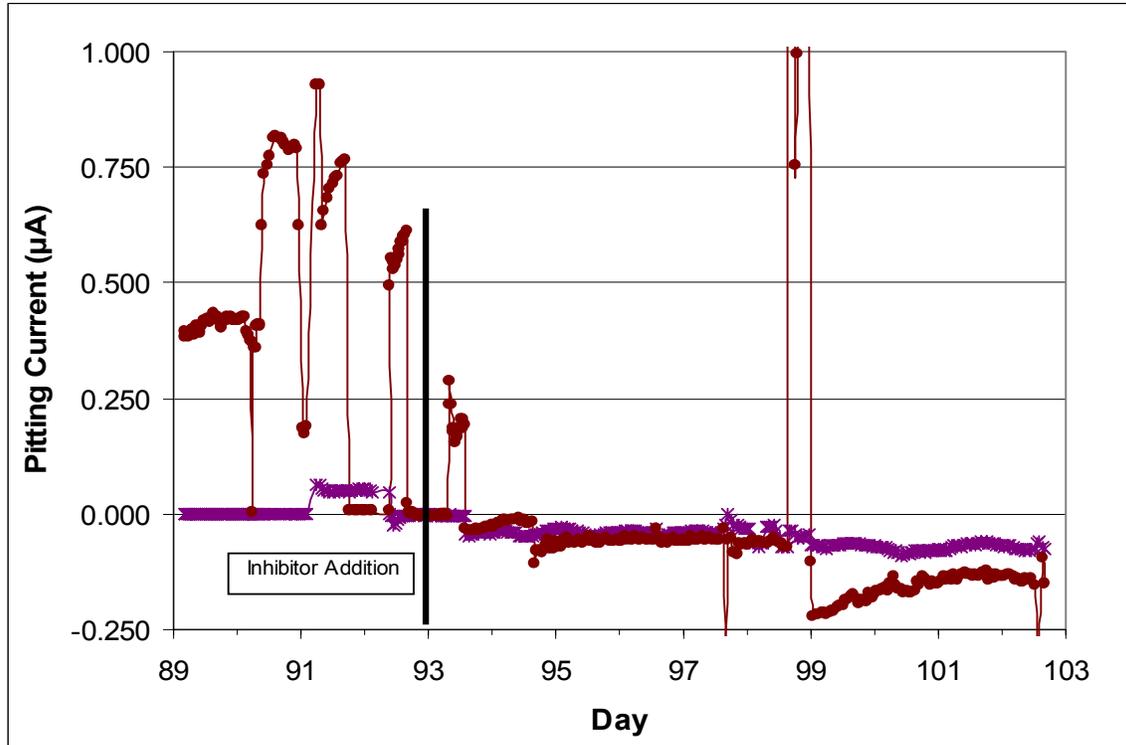
Figure 2-9. Pitting currents before and after addition of inhibitors - Orthophosphate Rig.

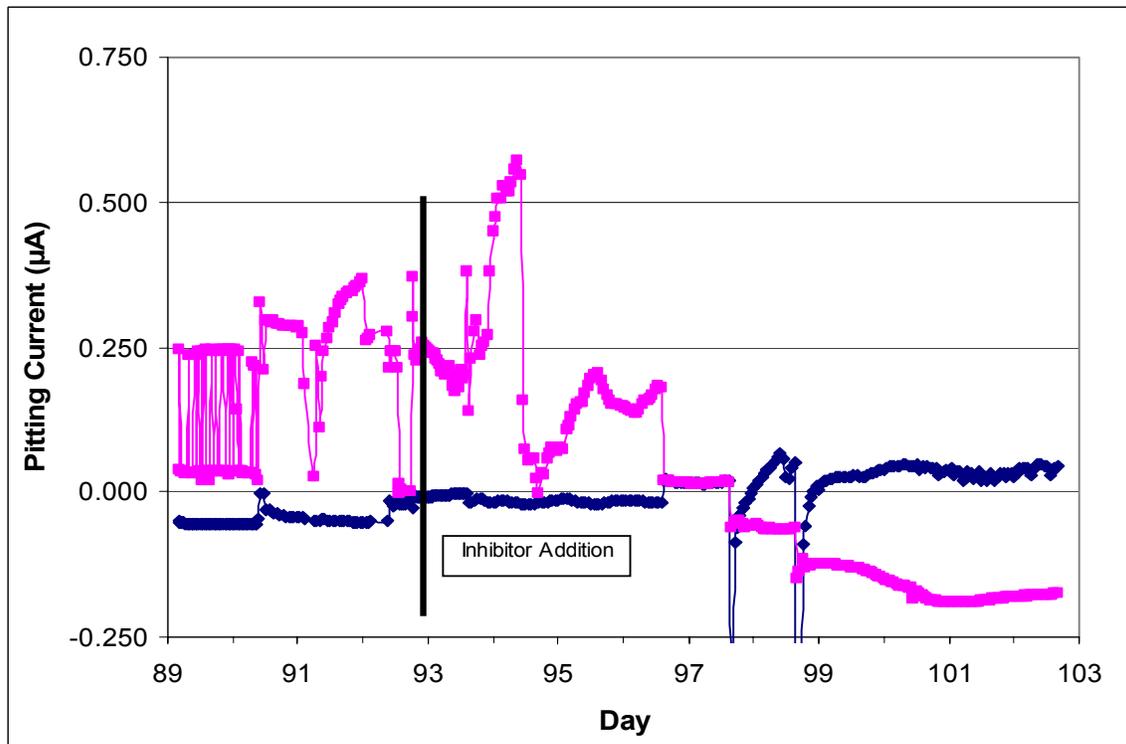
Figure 2-10. Pitting currents before and after the addition of inhibitors - Control Rig.

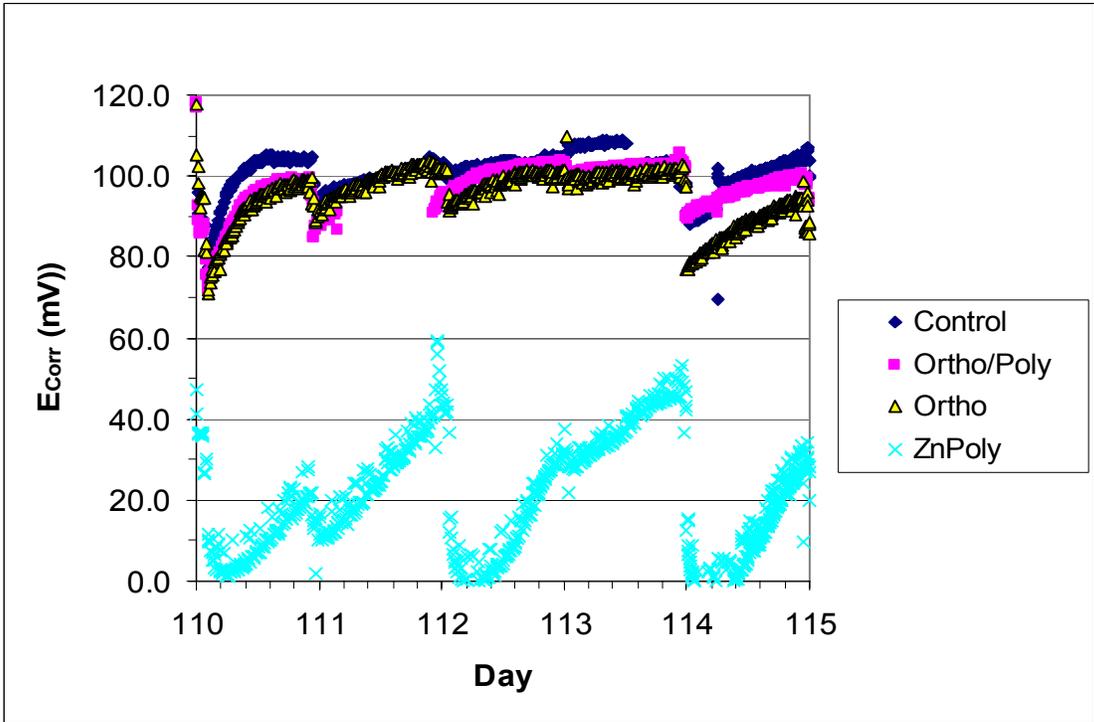
Figure 2-11. E_{Corr} measurements at pH 8.5.

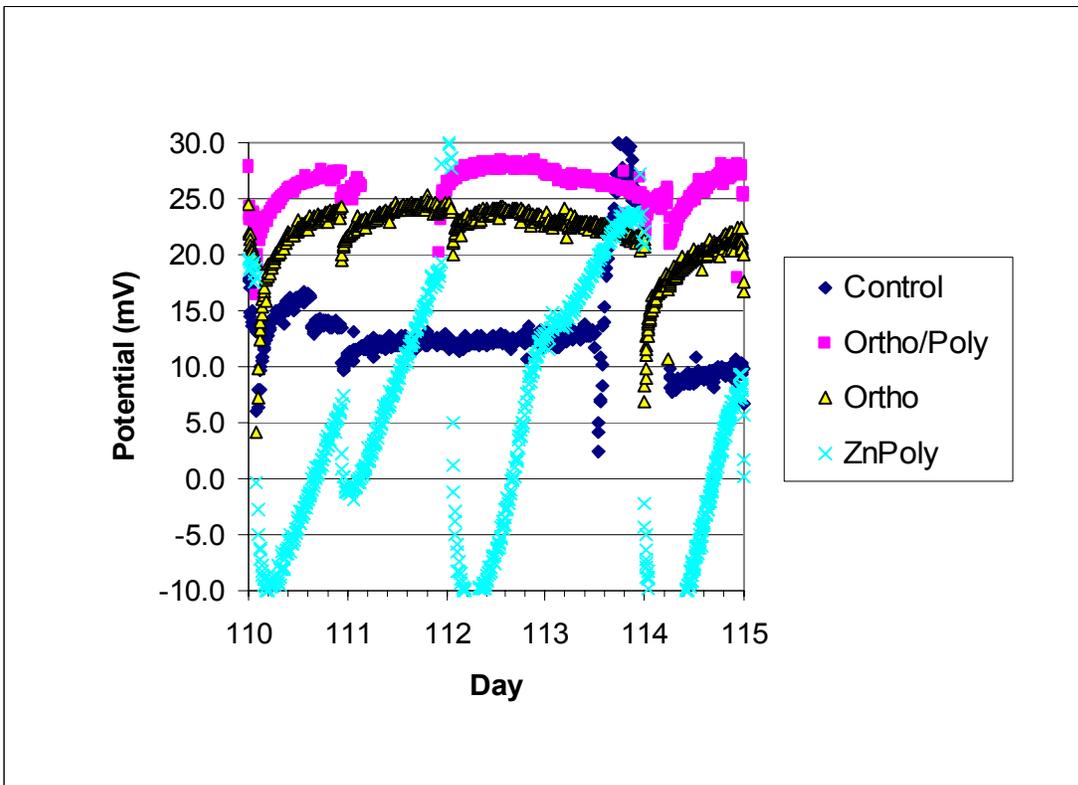
Figure 2-12. Potential between sections of pipe at pH 8.5.

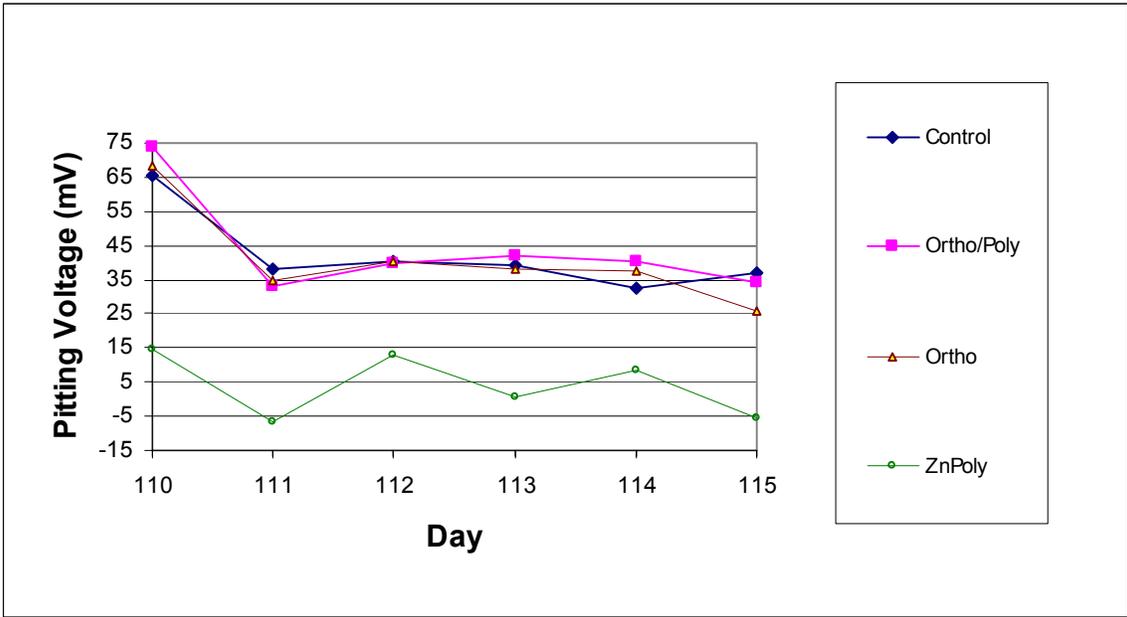
Figure 2-13. Average pitting voltages at pH 8.5. Data shown for low-flow pitting wires installed on Day 110.

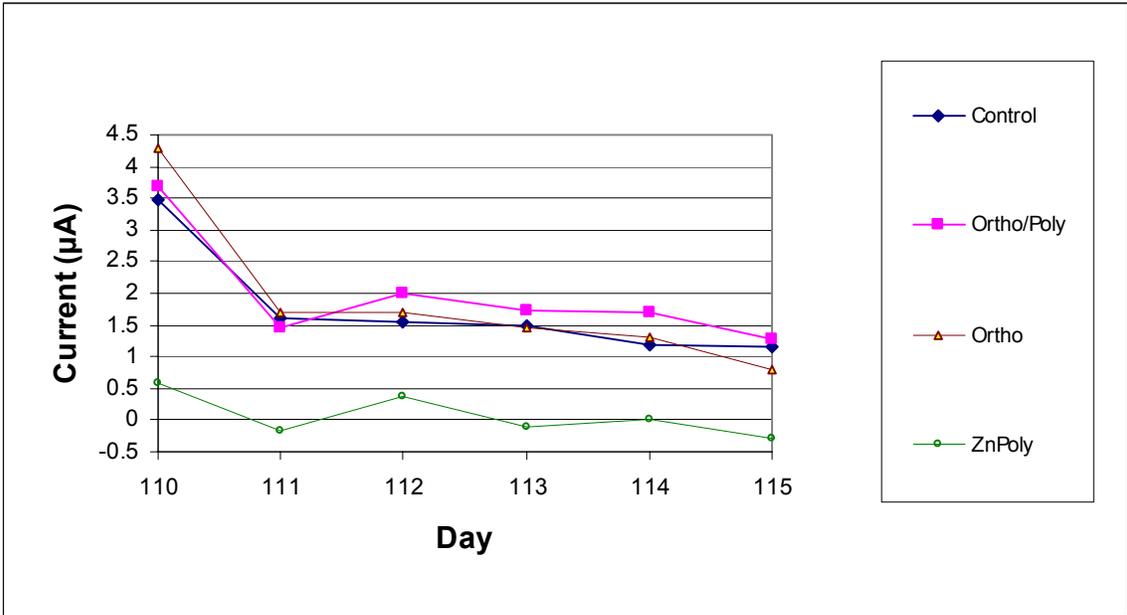
Figure 2-14. Average pitting currents at pH 8.5. Data shown for low-flow pitting wires installed on Day 110.

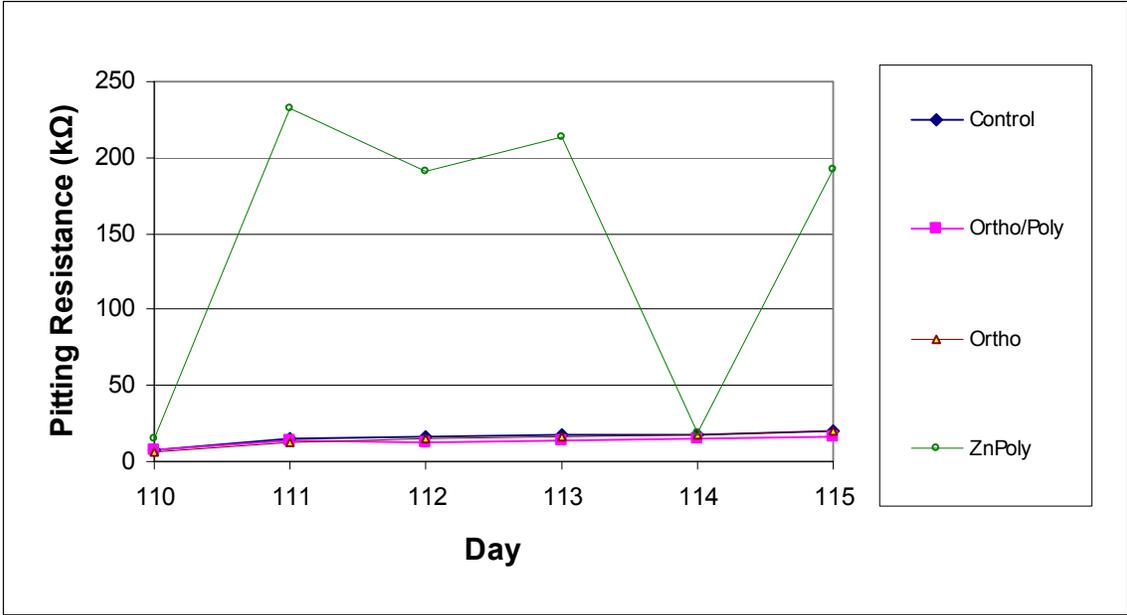
Figure 2-15. Average pitting resistances at pH 8.5. Data shown for low-flow pitting wires installed on Day 110.

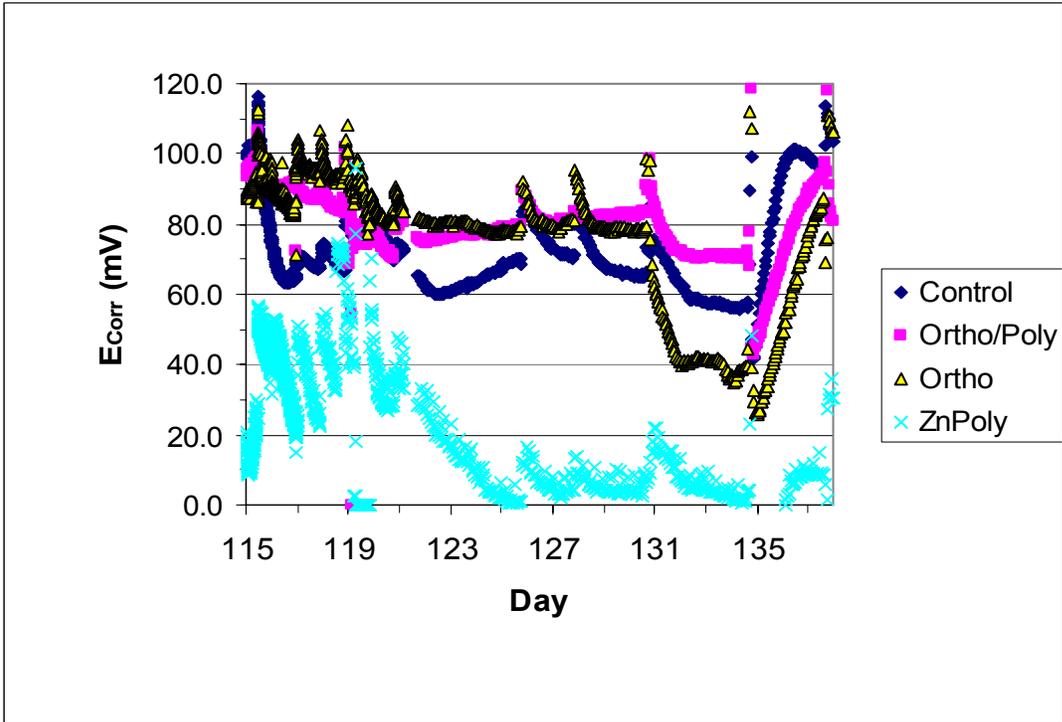
Figure 2-16. E_{Corr} measurements at pH 7.5.

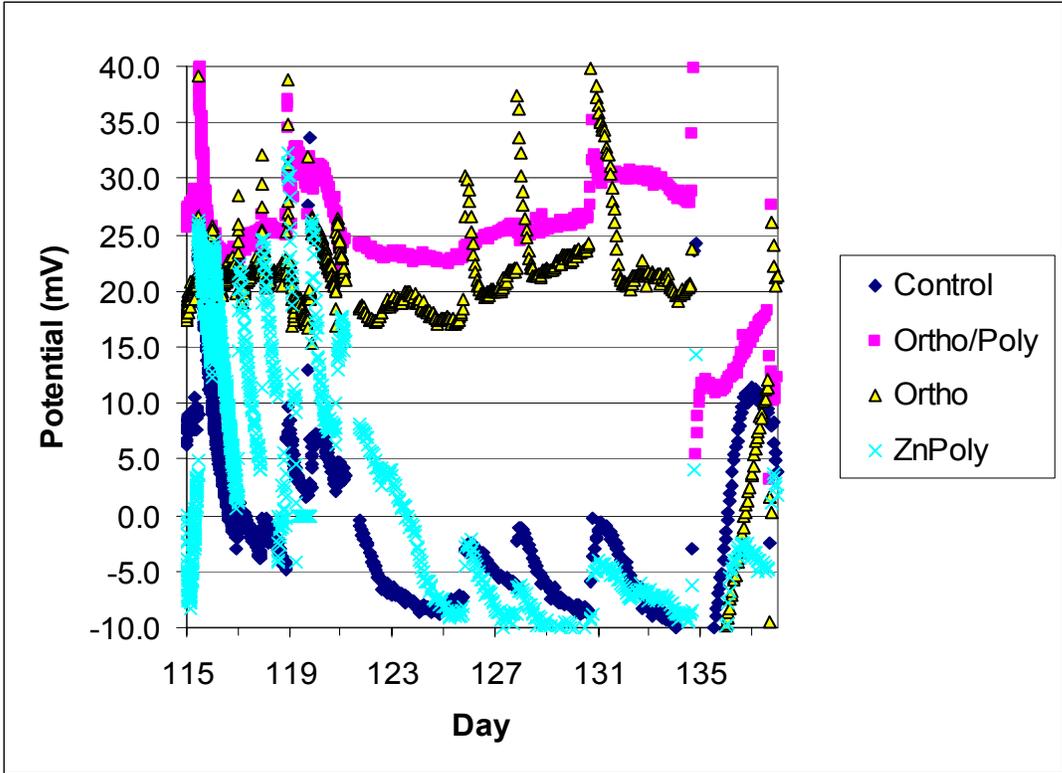
Figure 2-17. Potential between sections of pipe at pH 7.5.

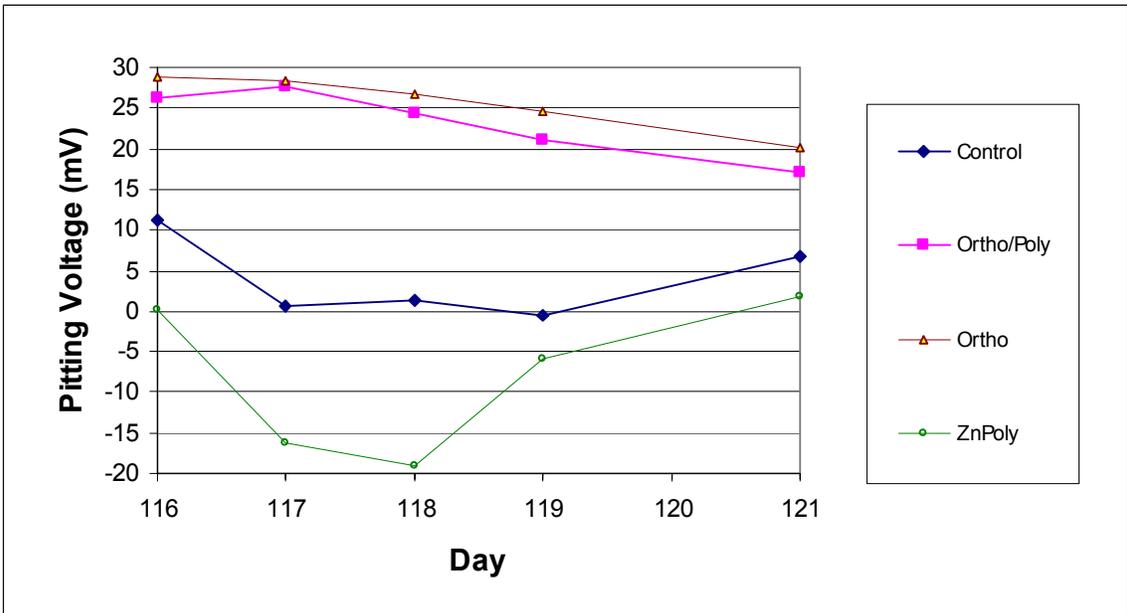
Figure 2-18. Average pitting voltages at pH 7.5. Data shown for low-flow pitting wires installed on Day 110.
