INVESTIGATION OF COPPER PITTING PROPENSITY USING BENCH AND FIELD SCALE TESTING

Thesis submitted to the Faculty of the
Virginia Polytechnic Institute and State University
in partial fulfillment of the requirements for the degree of

Master of Science
in
Environmental Engineering

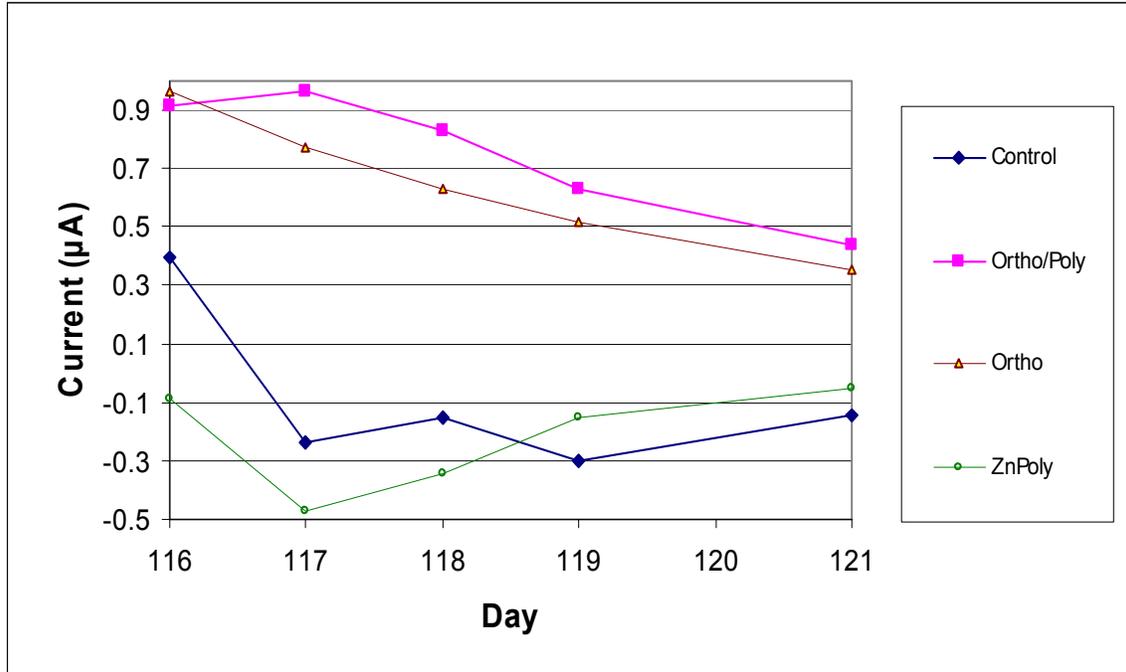
Figure 2-19. Average pitting currents at pH 7.5. Data shown for low-flow pitting wires installed on Day 110.

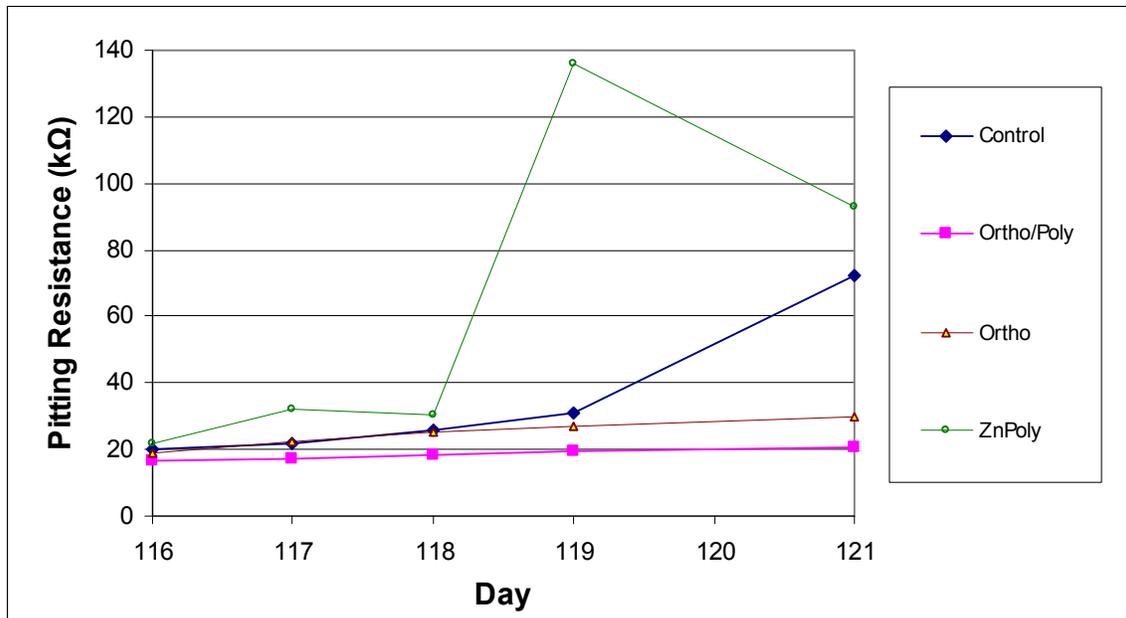
Figure 2-20. Average pitting resistances at pH 7.5. Data shown for low-flow pitting wires installed on Day 110.

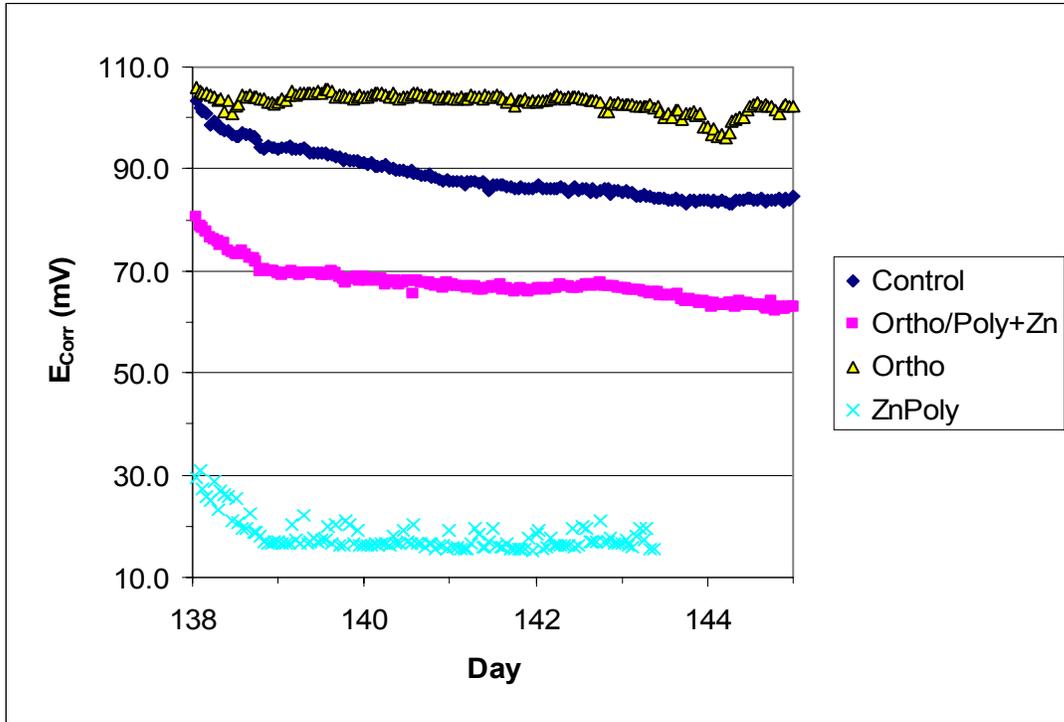
Figure 2-21. E_{Corr} measurements at pH 7.5 with zinc added to Orthophosphate-Polyphosphate Rig.

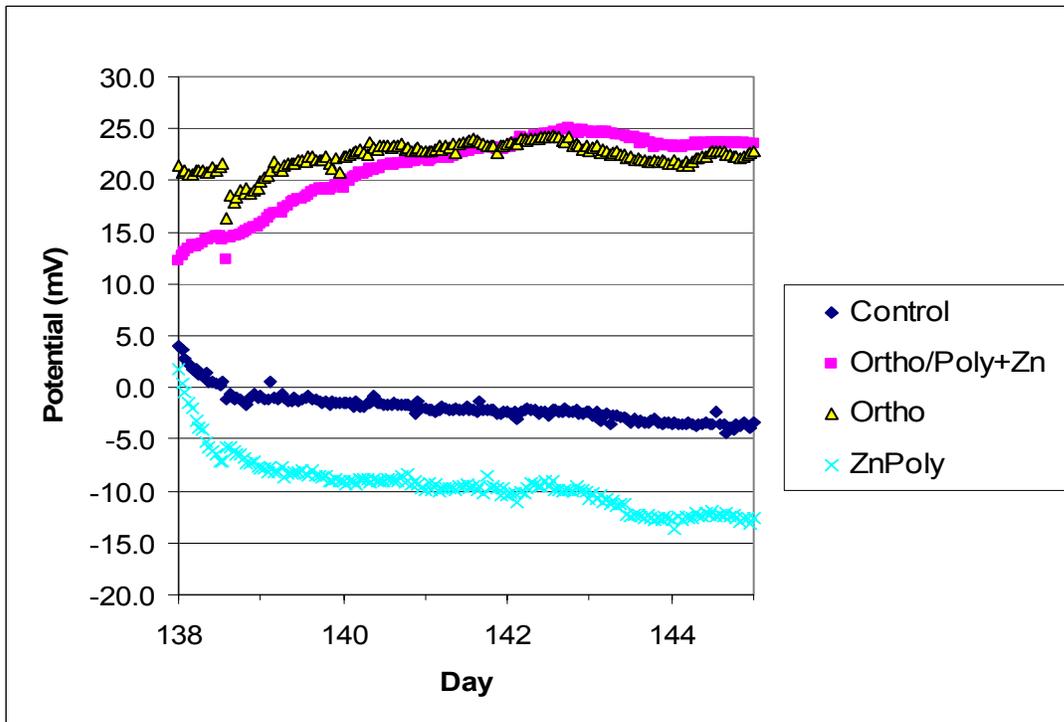
Figure 2-22. Potential between sections of pipe at pH 7.5 with zinc added to Orthophosphate-Polyphosphate Rig.

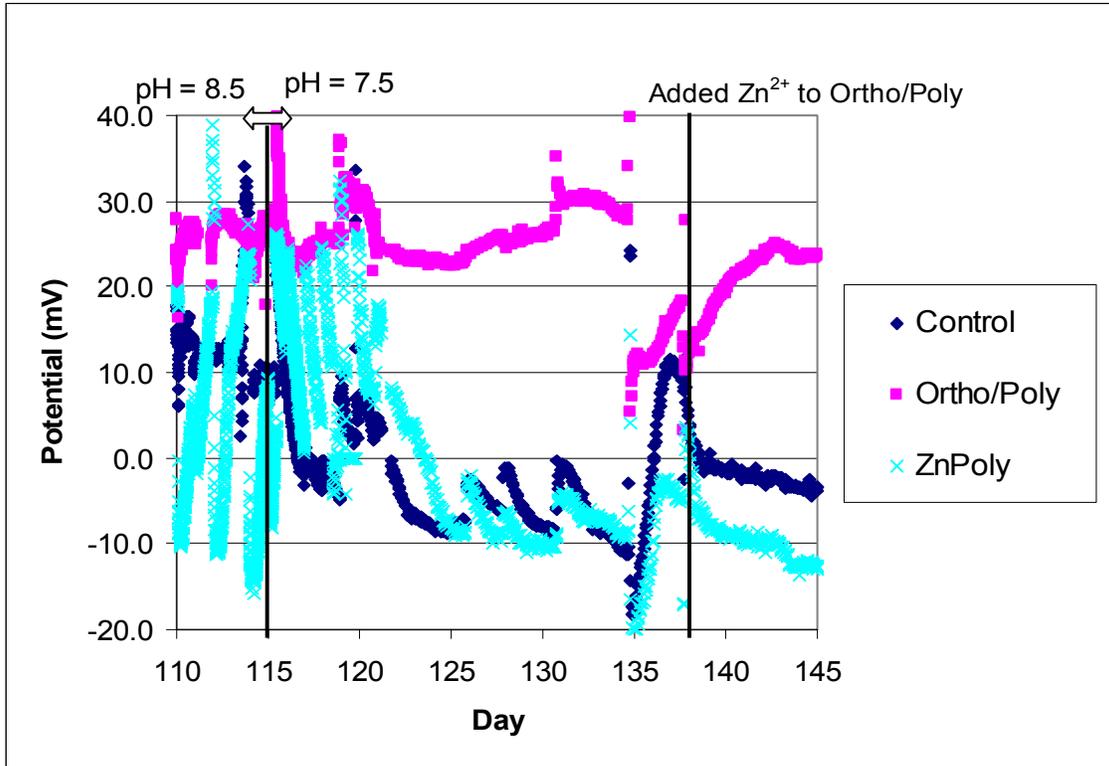
Figure 2-23. Potential between sections of pipe over the life of experiment.

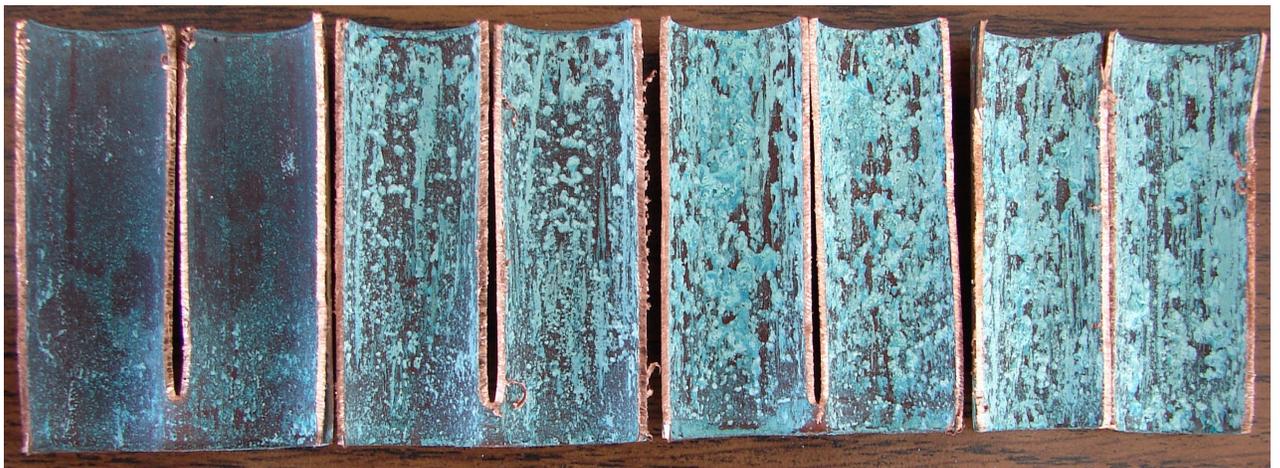
Figure 2-24. Control Rig Coupons. Coupons A – D shown left to right.

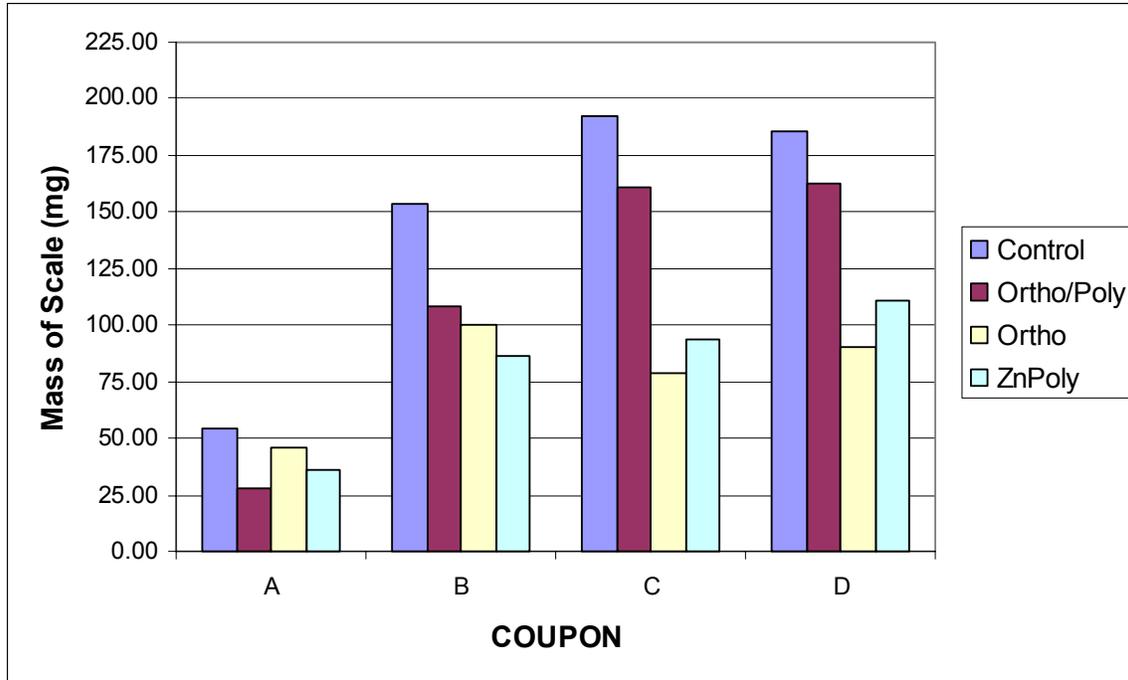
Figure 2-28. Mass of scale accumulation on coupons.

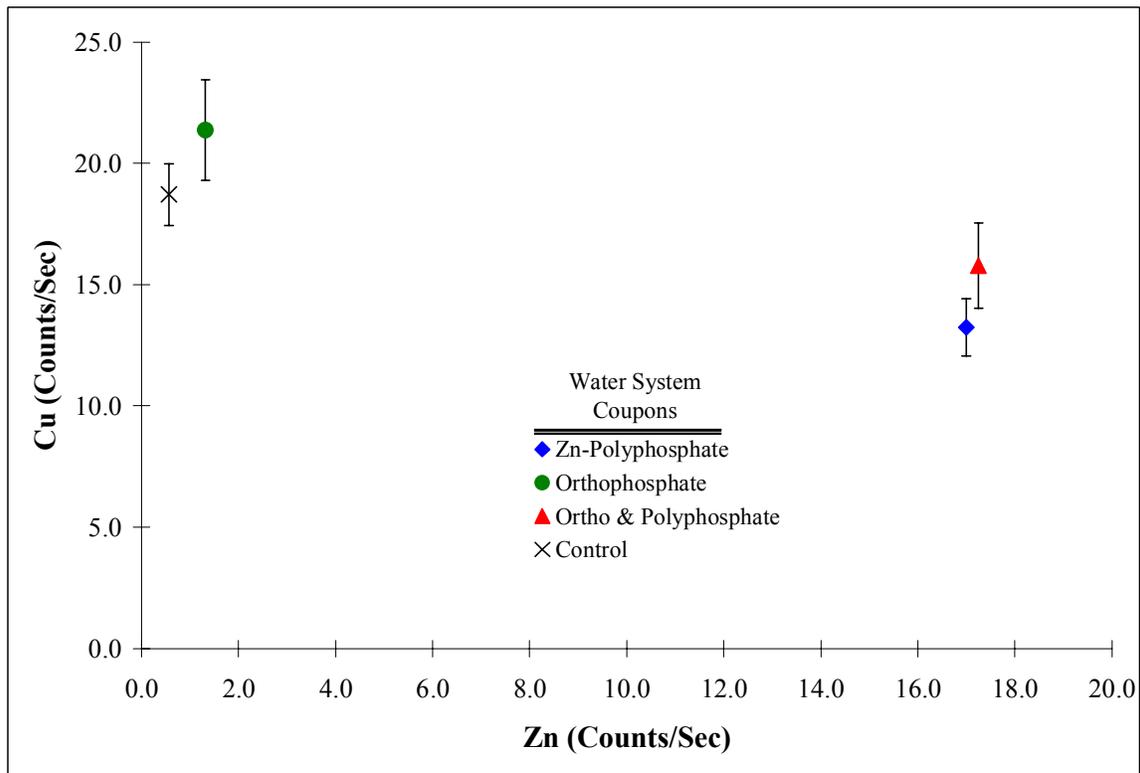
Figure 2-29. Raw Cu and Zn Data as collected by the SEM-EDS during surface analyses. Error bars represent 90% confidence intervals.

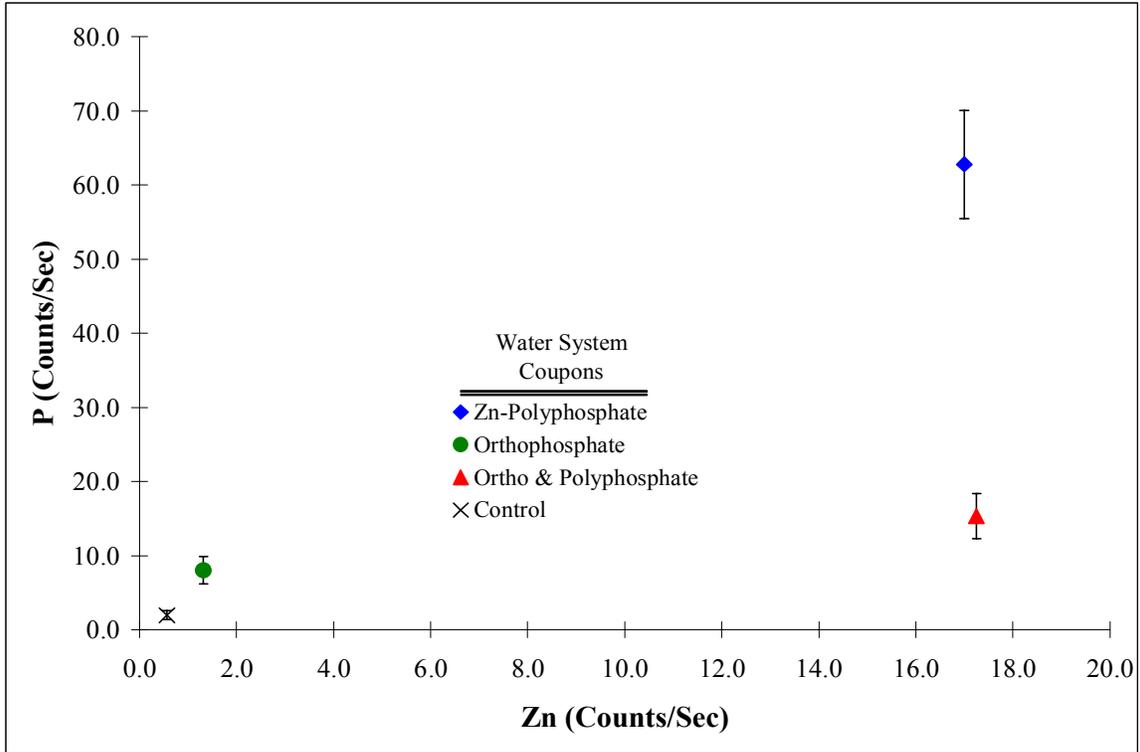
Figure 2-30. Raw P and Zn Data as collected by the SEM-EDS during surface analyses. Error bars represent 90% confidence intervals.

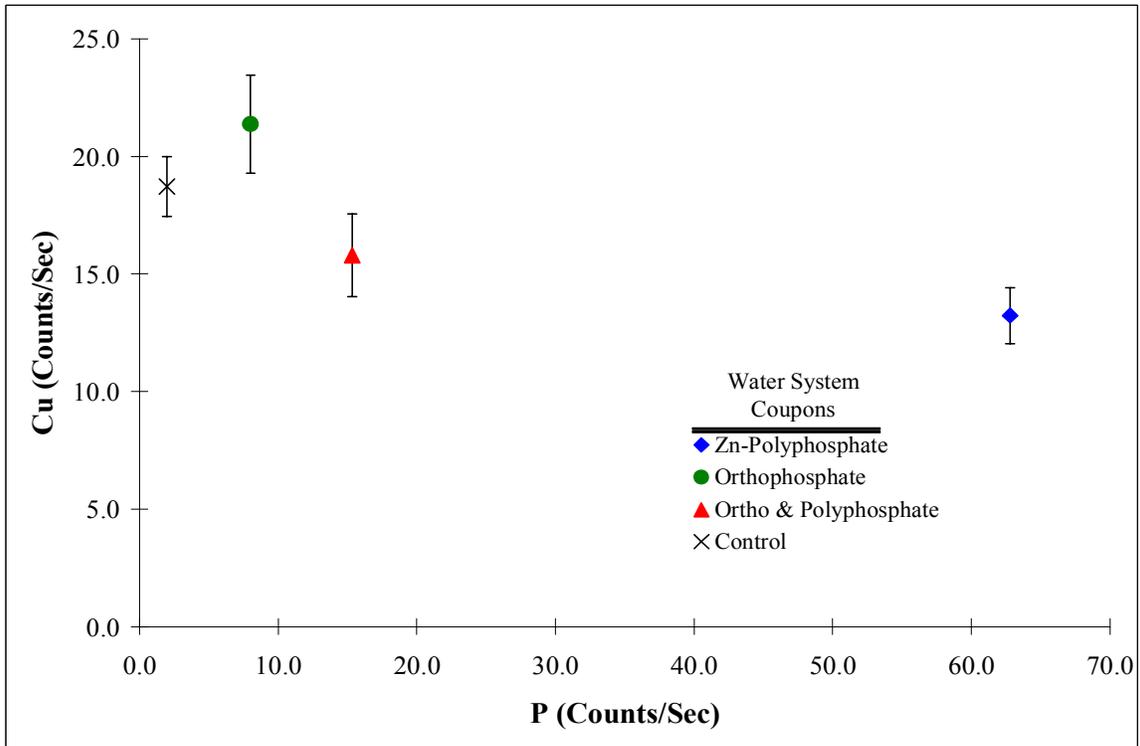
Figure 2-31. Raw Cu and P Data as collected by the SEM-EDS during surface analyses. Error bars represent 90% confidence intervals.

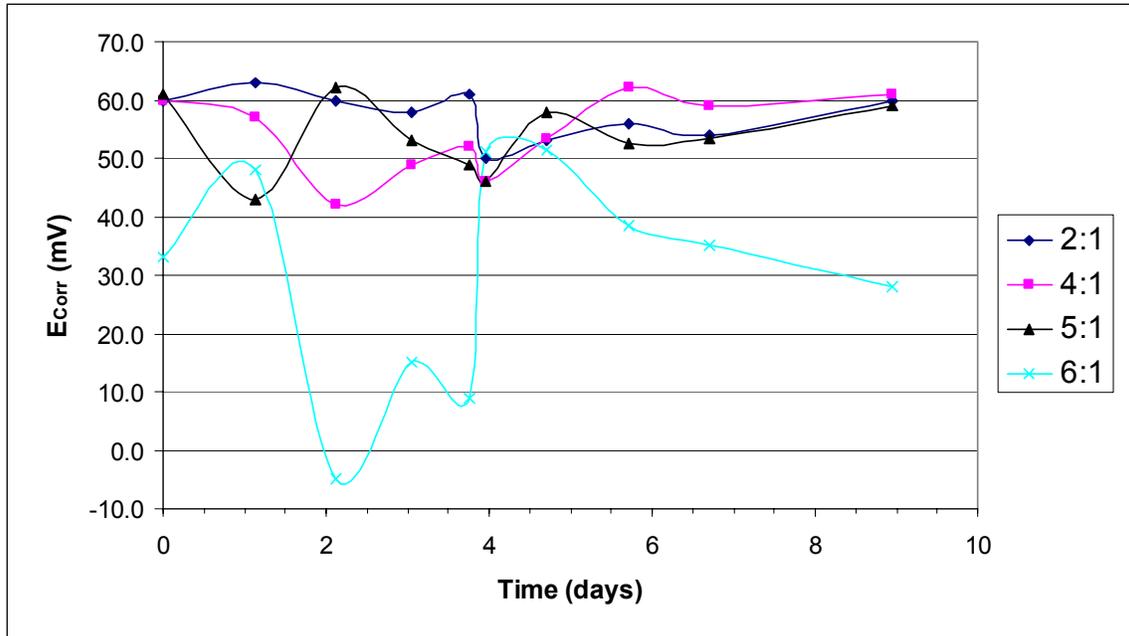
Figure 2-32. Jar Test - Effect of chlorine to ammonia ratio on E_{Corr} .

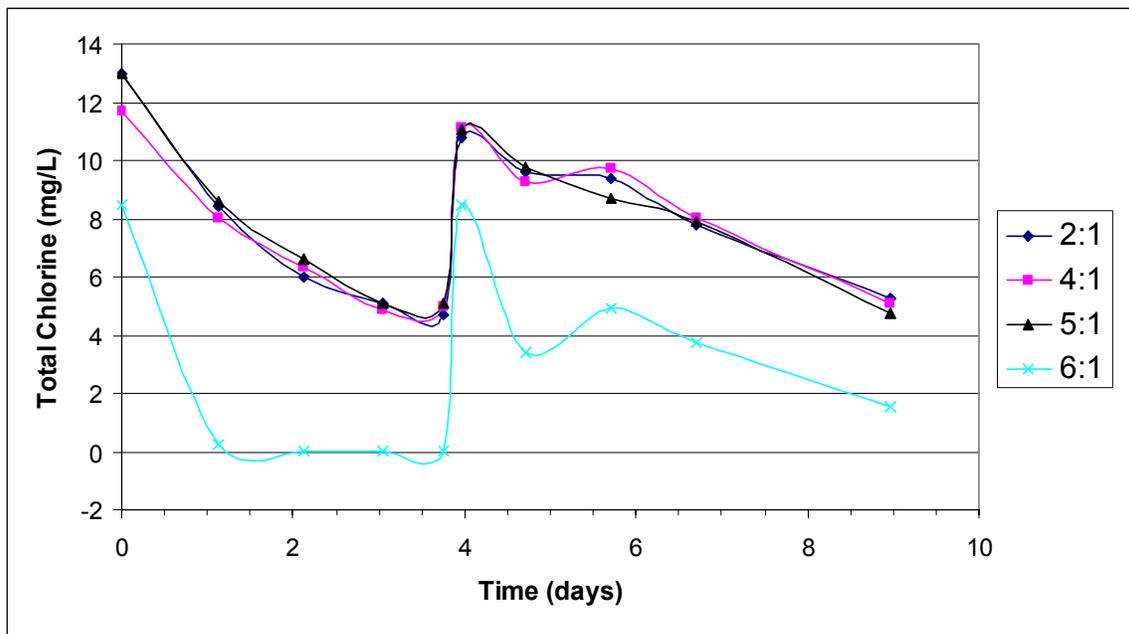
Figure 2-33. Jar Test - Effect of chlorine to ammonia ratio on chlorine decay.

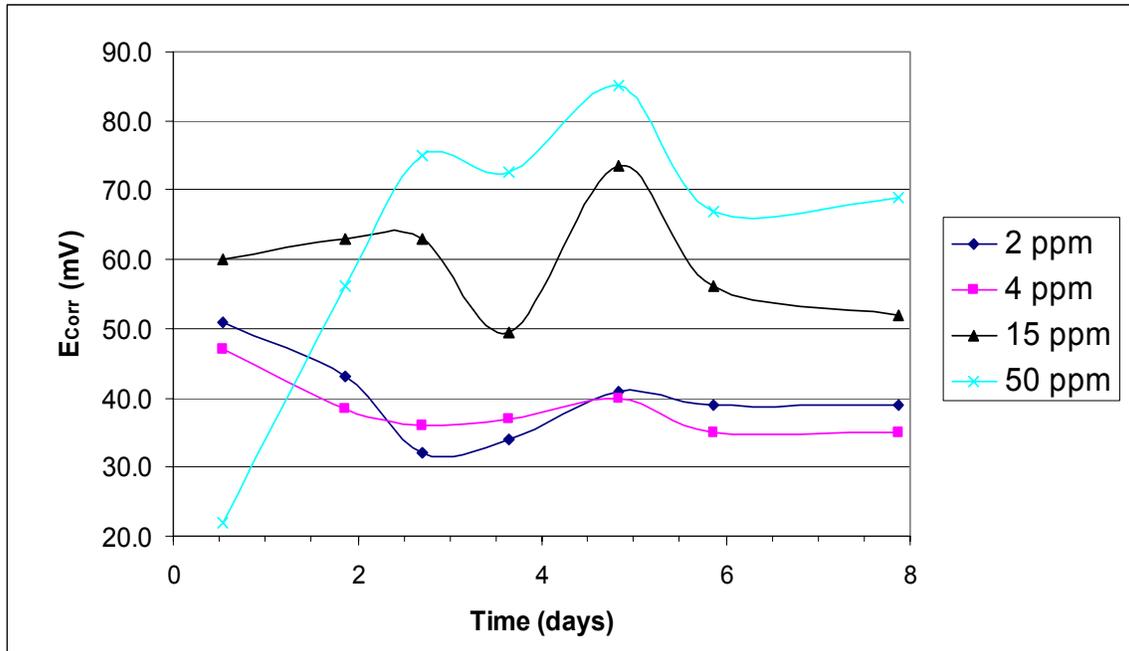
Figure 2-34. Jar Test - Effect of total chlorine on E_{Corr} .

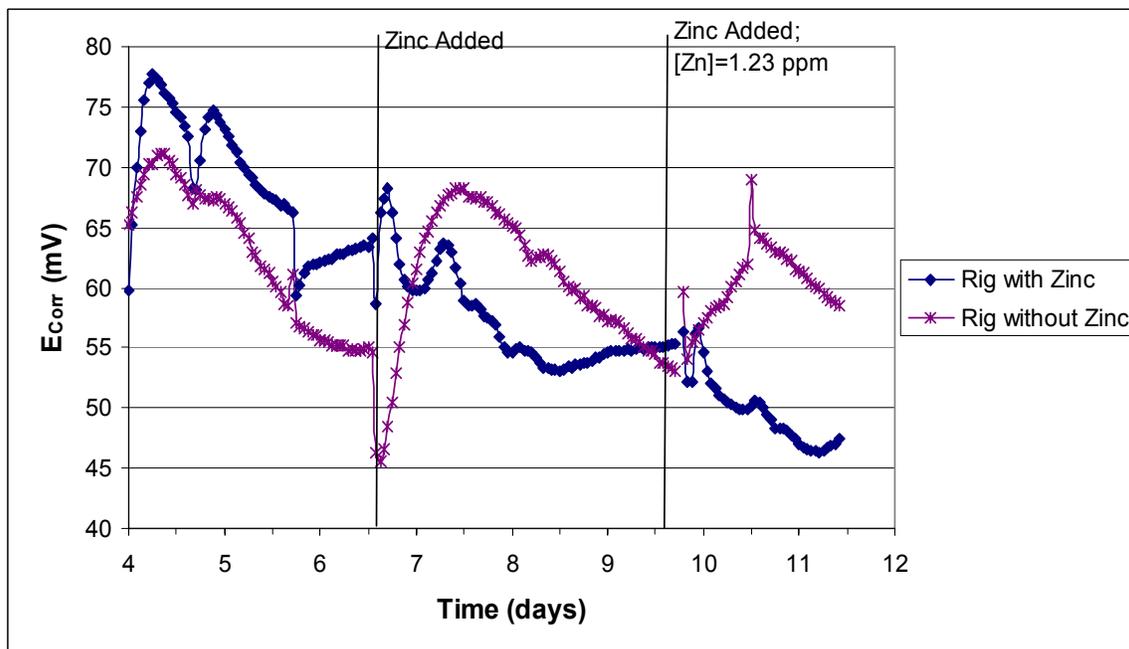
Figure 2-35. Rig Test - Effect of adding zinc to orthophosphate-polyphosphate on E_{Corr} .

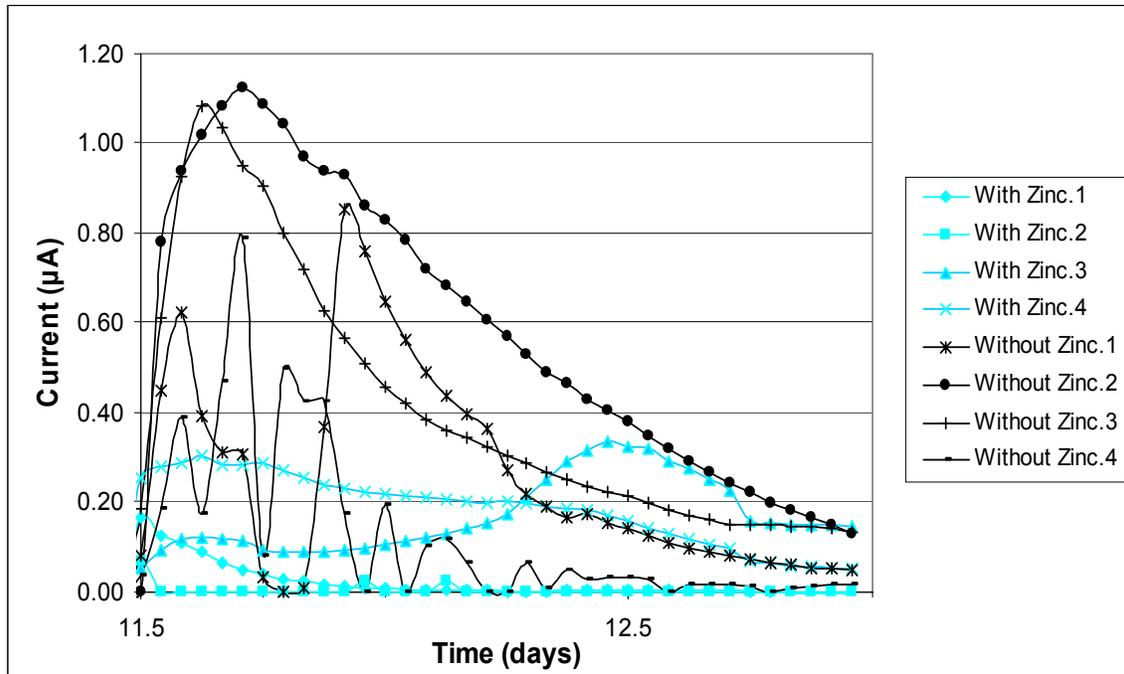
Figure 2-36. Rig Test - Effect of adding zinc to orthophosphate-polyphosphate on pitting currents.

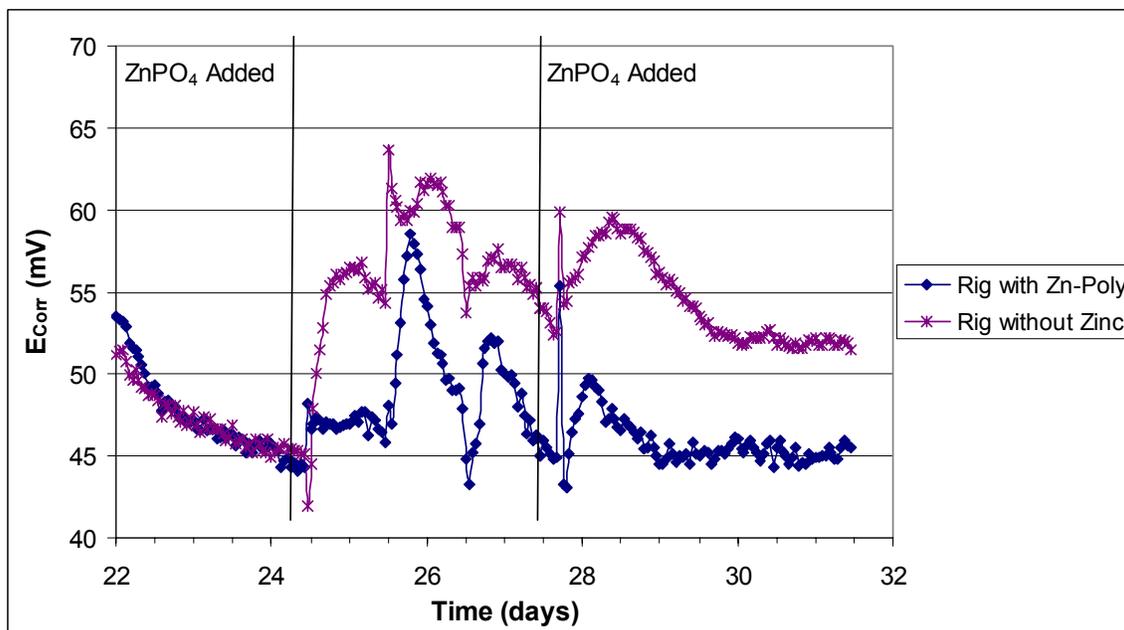
Figure 2-37. Rig Test - Effect of adding zinc polyphosphate to orthophosphate-polyphosphate on E_{Corr} .

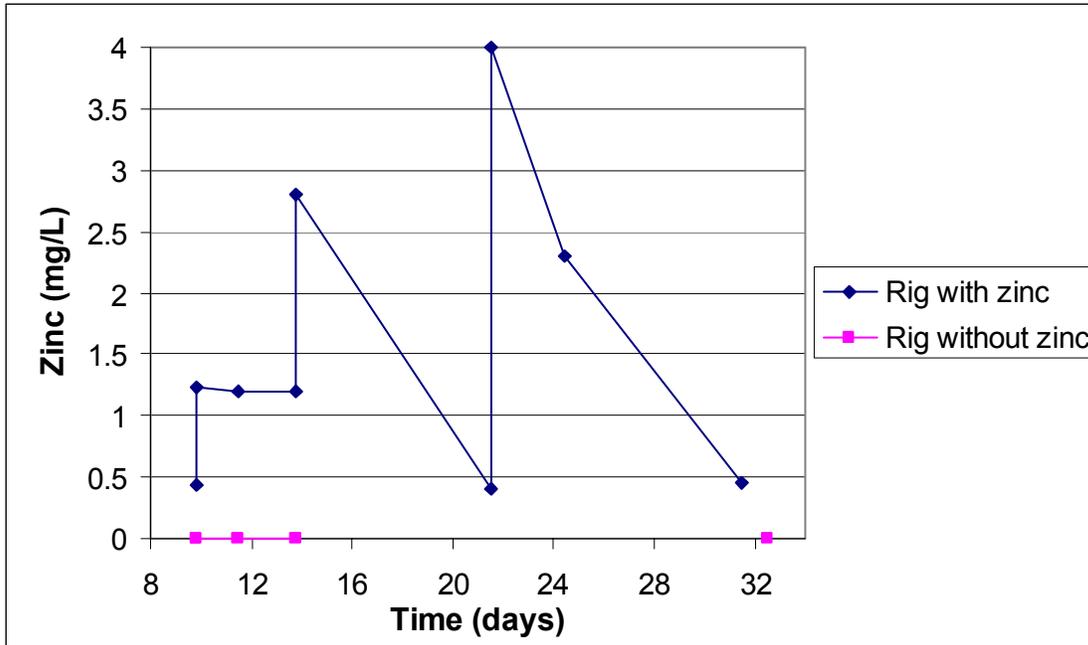
Figure 2-38. Zinc concentration measured in short term pitting rigs.

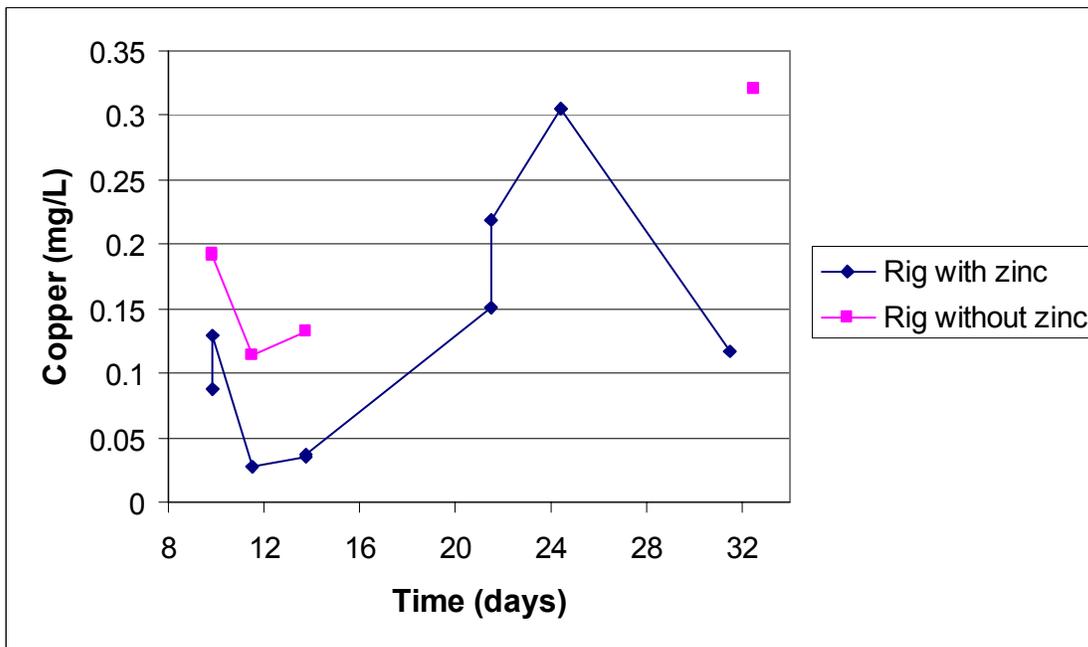
Figure 2-39. Copper concentration measured in short term pitting rigs.

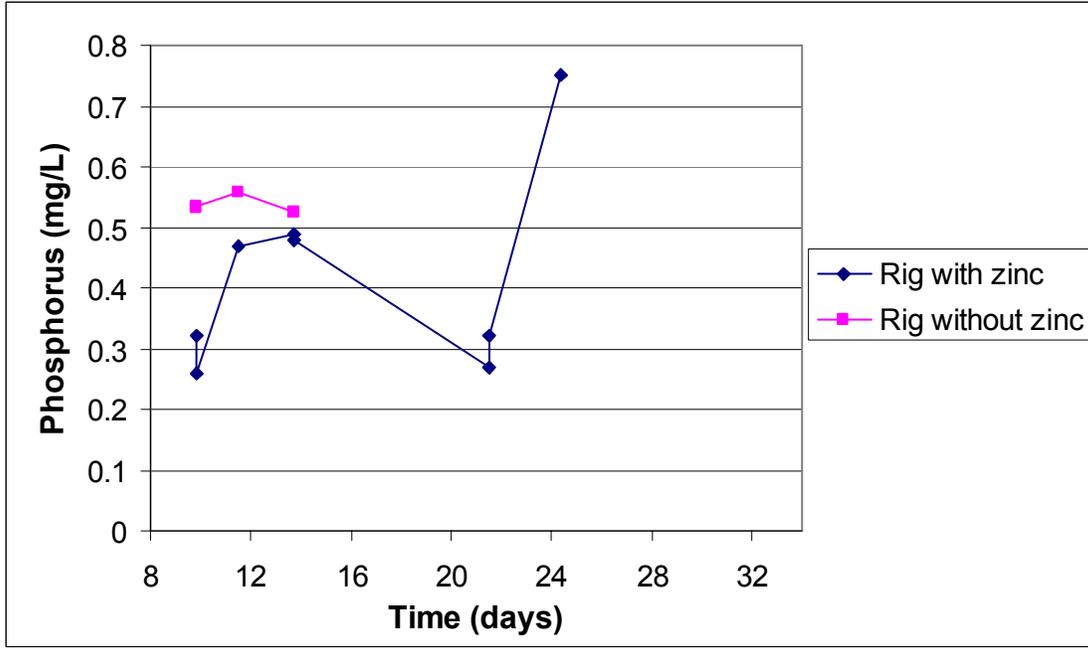
Figure 2-40. Phosphorus concentration measured in short term pitting rigs.

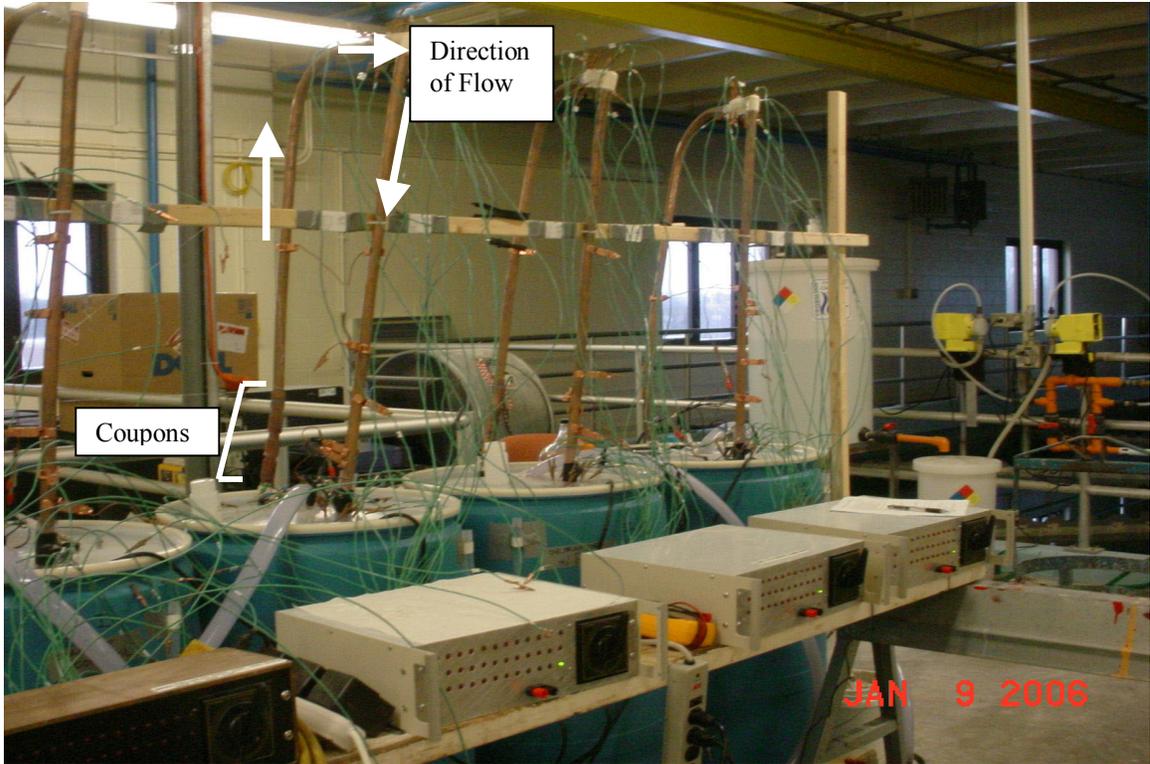
Figure 3-1. General pitting rig experimental setup with relay boxes.

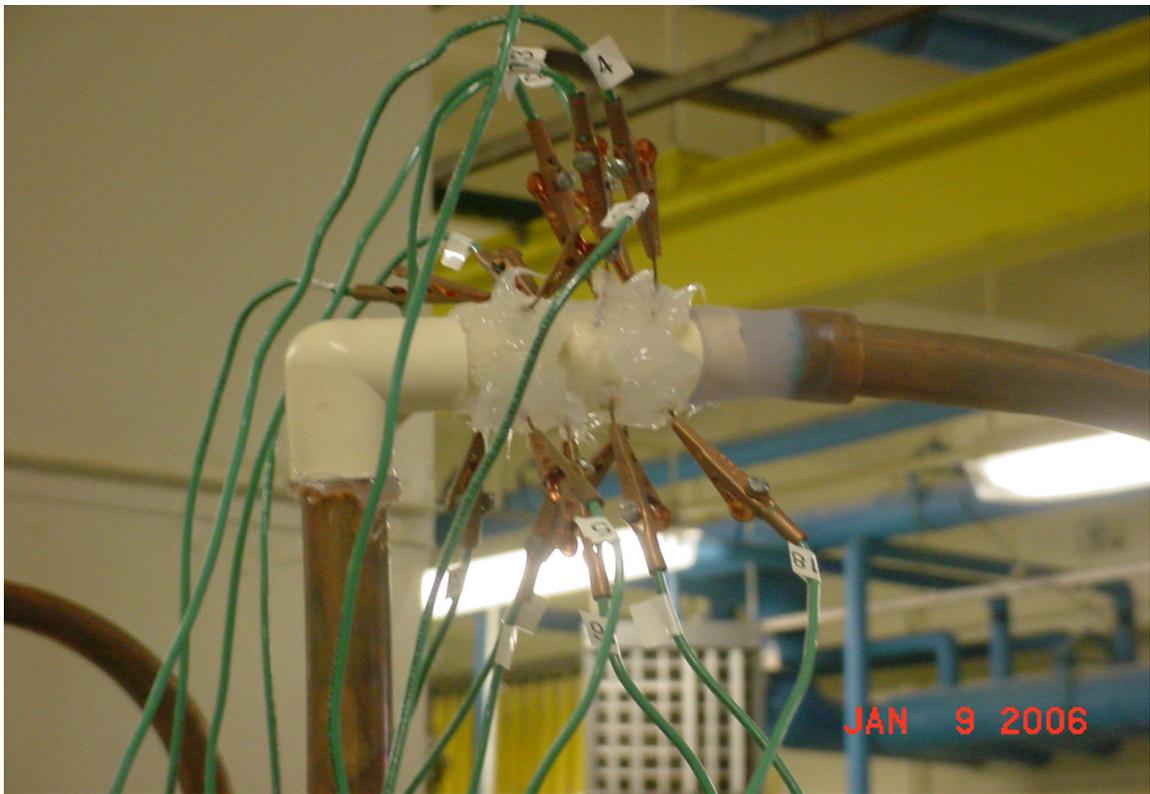
Figure 3-2. 90 Degree in-flow pit wires.

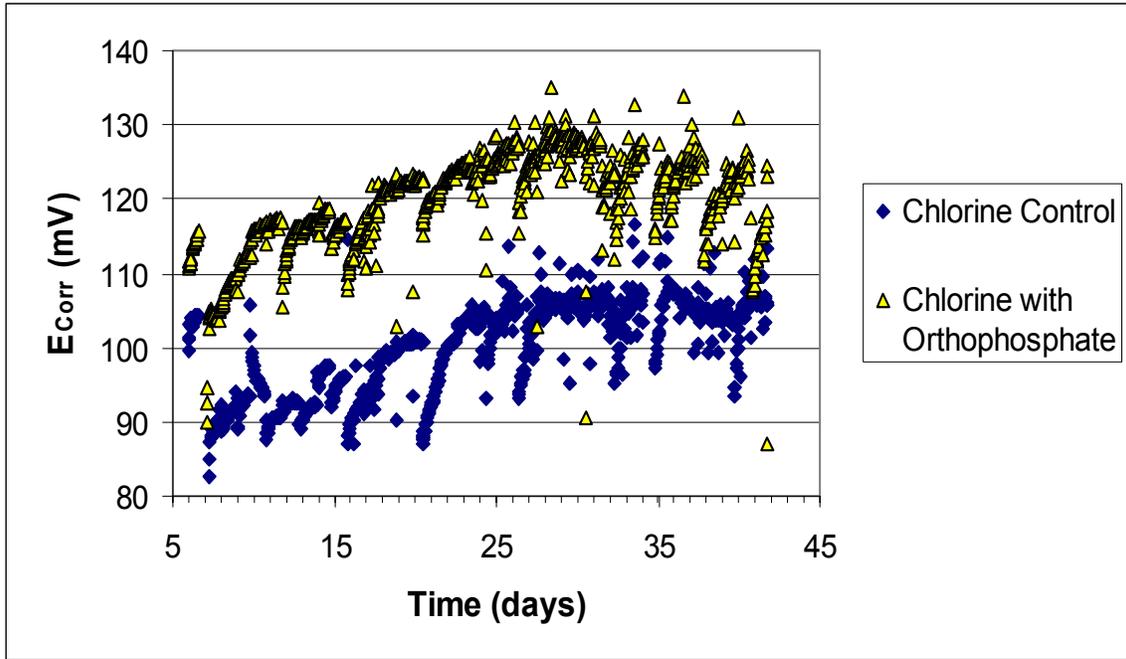
Figure 3-3. E_{Corr} measurements in free chlorine systems with and without orthophosphate.

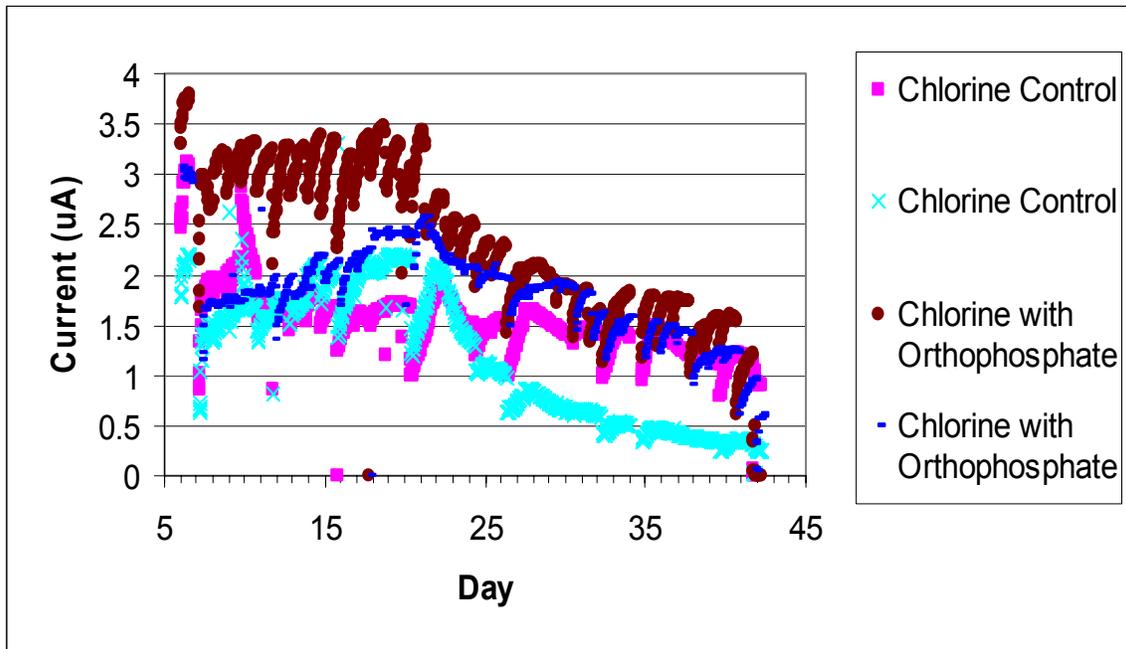
Figure 3-4. Pitting currents in free chlorine systems with and without orthophosphate.

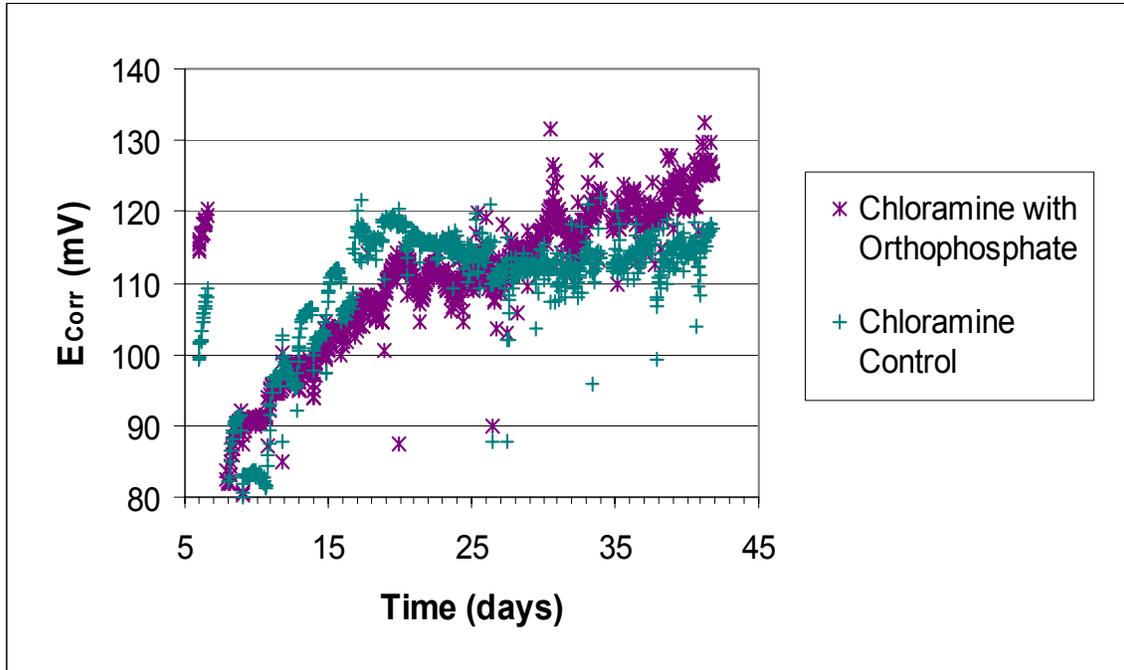
Figure 3-5. E_{Corr} measurements in chloramine systems with and without orthophosphate.

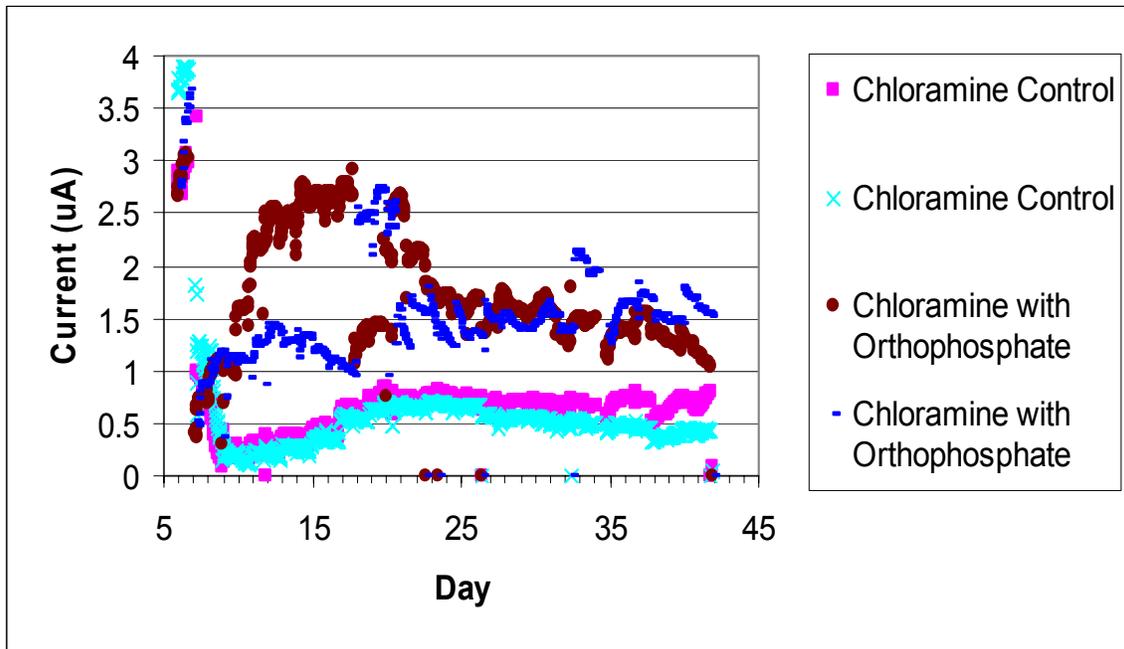
Figure 3-6. Pitting currents in chloramine systems with and without orthophosphate.

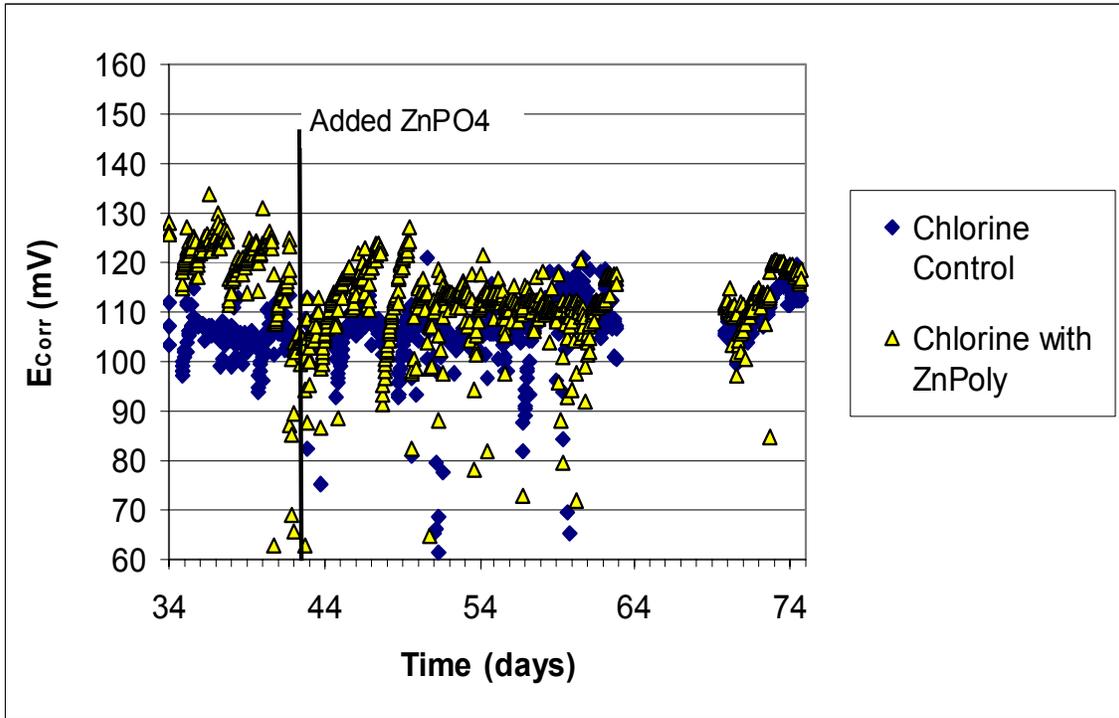
Figure 3-7. E_{Corr} measurements in free chlorine systems with and without zinc polyphosphate.

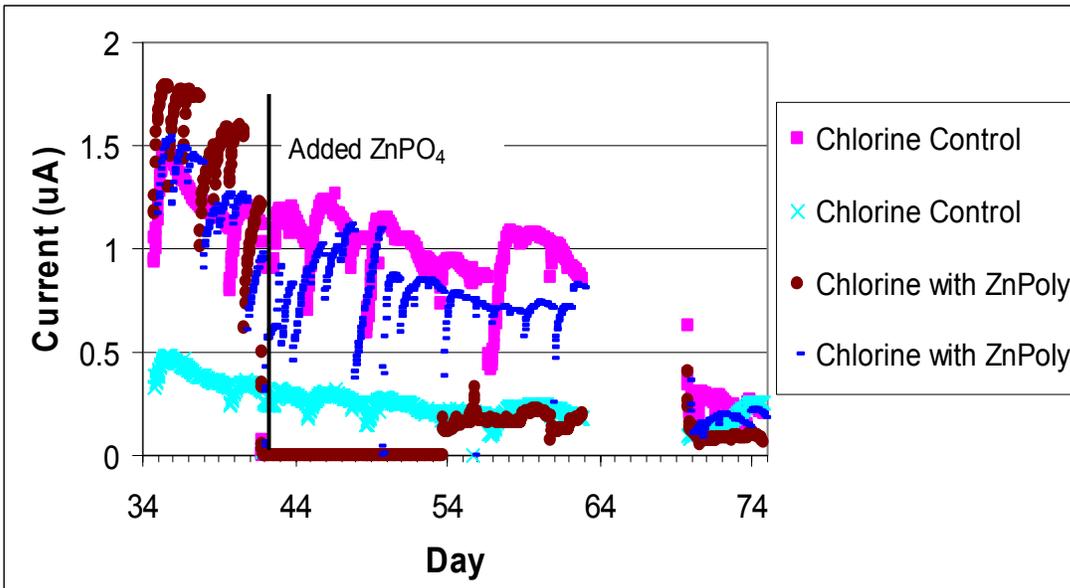
Figure 3-8. Pitting currents in free chlorine systems with and without zinc polyphosphate.

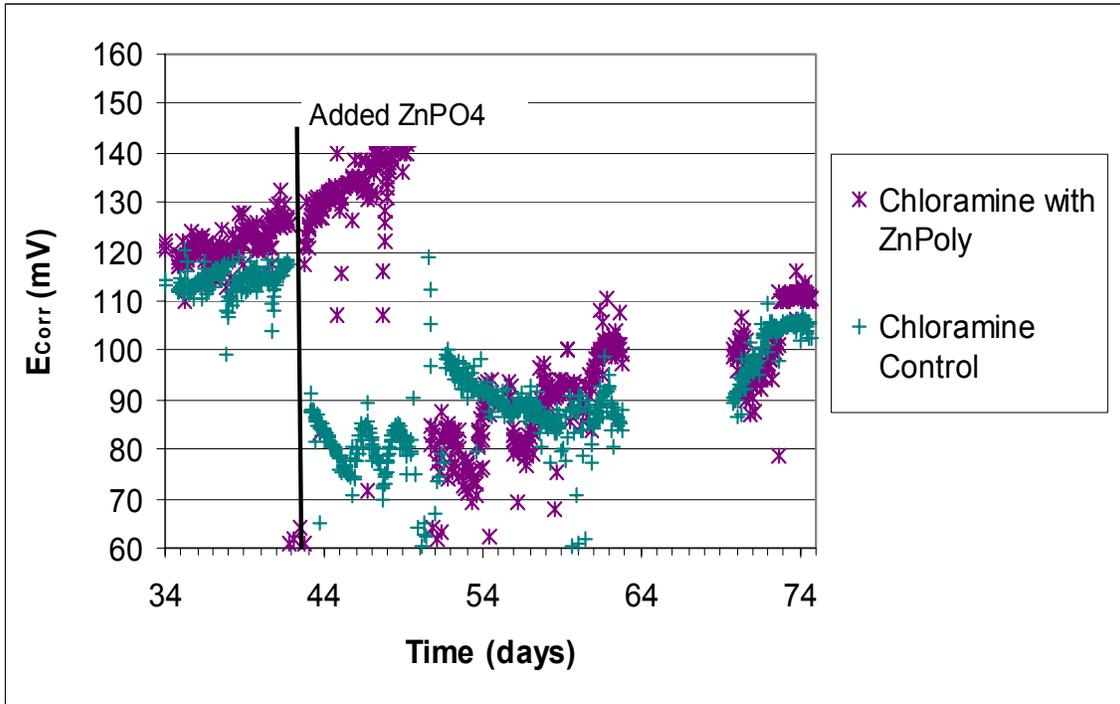
Figure 3-9. E_{Corr} measurements in chloramine systems with and without zinc polyphosphate.

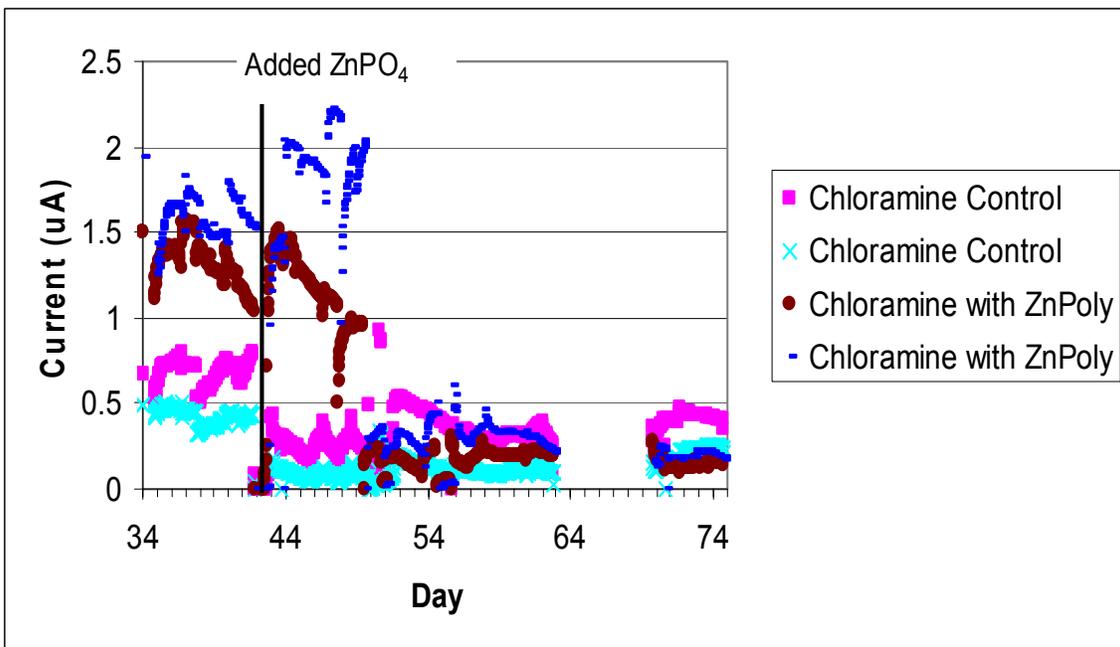
Figure 3-10. Pitting currents in chloramine systems with and without zinc polyphosphate.
