INVESTIGATION OF COPPER PITTING PROPENSITY USING BENCH AND FIELD SCALE TESTING

Thesis submitted to the Faculty of the
Virginia Polytechnic Institute and State University
in partial fulfillment of the requirements for the degree of

Master of Science
in
Environmental Engineering

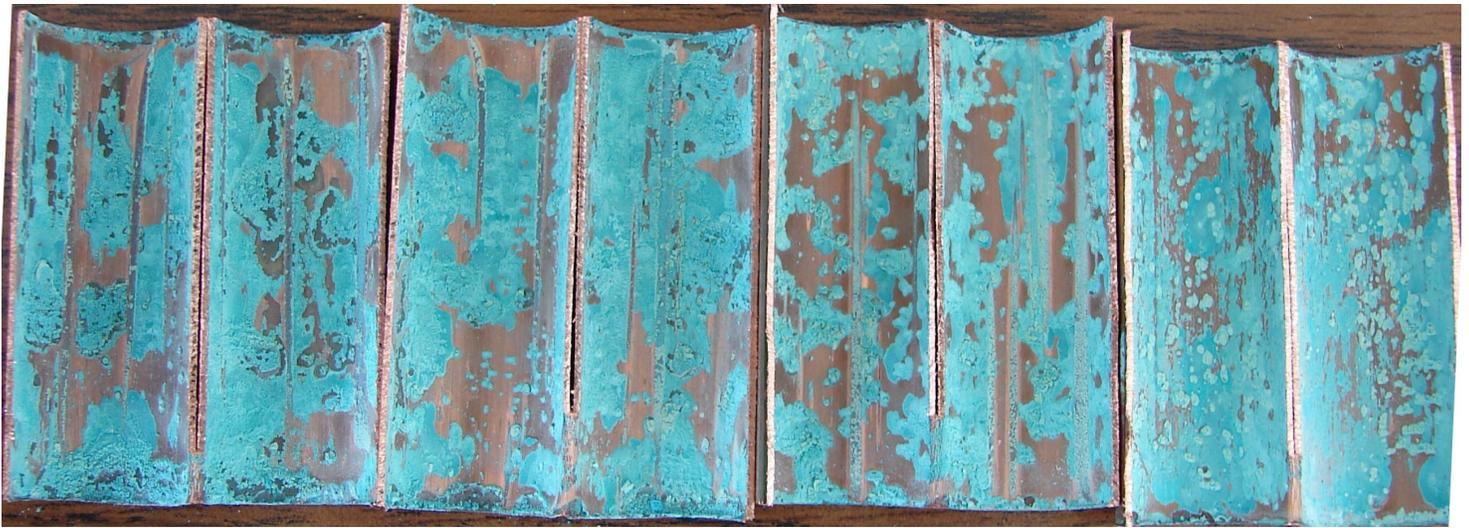
Figure 3-11. Free Chlorine Control System - Coupons. Coupons A – D shown left to right.

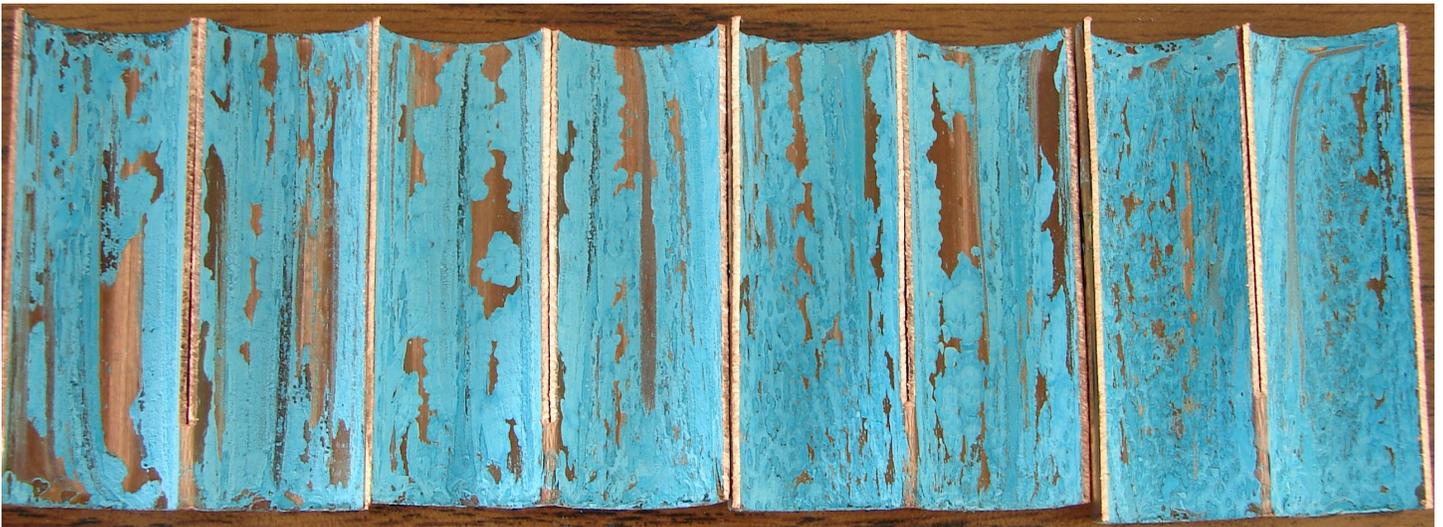
Figure 3-12. Chloramine System with Inhibitor - Coupons. Coupons A – D shown left to right.

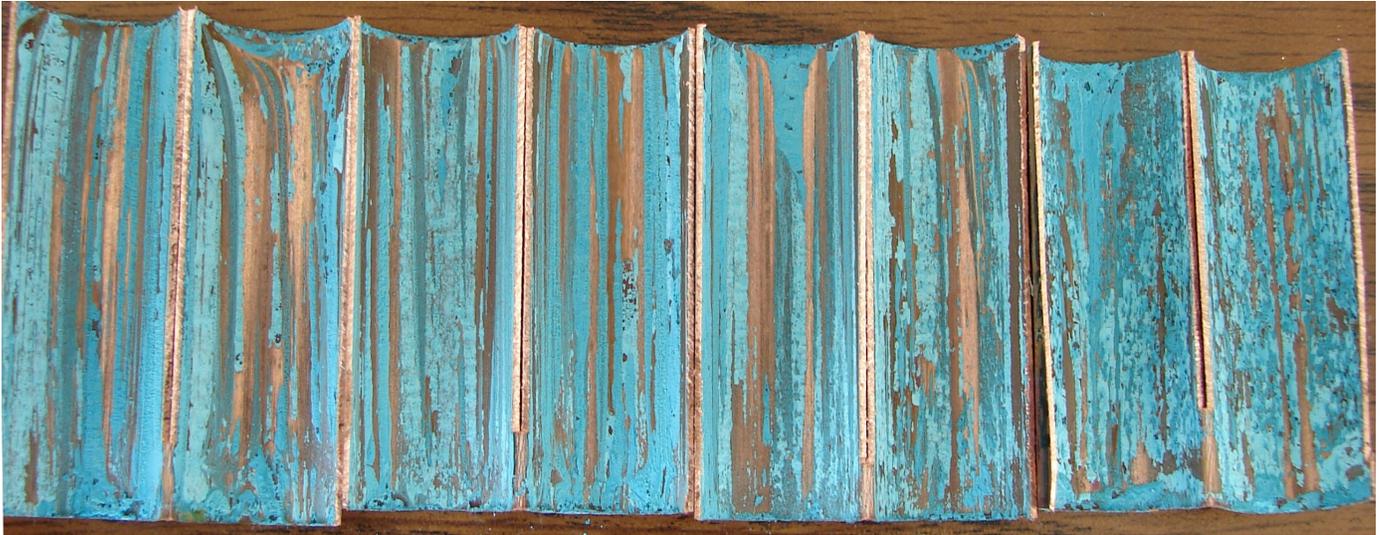
Figure 3-13. Chloramine Control System - Coupons. Coupons A – D shown left to right.

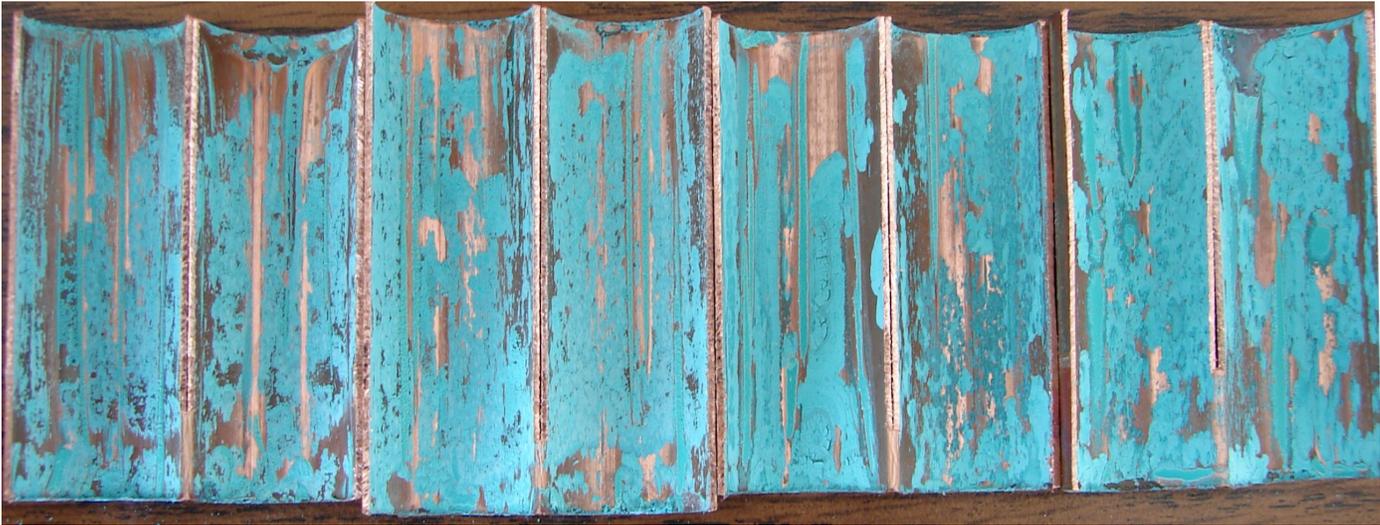
Figure 3-14. Free Chlorine System with Inhibitor – Coupons. Coupons A – D shown left to right.

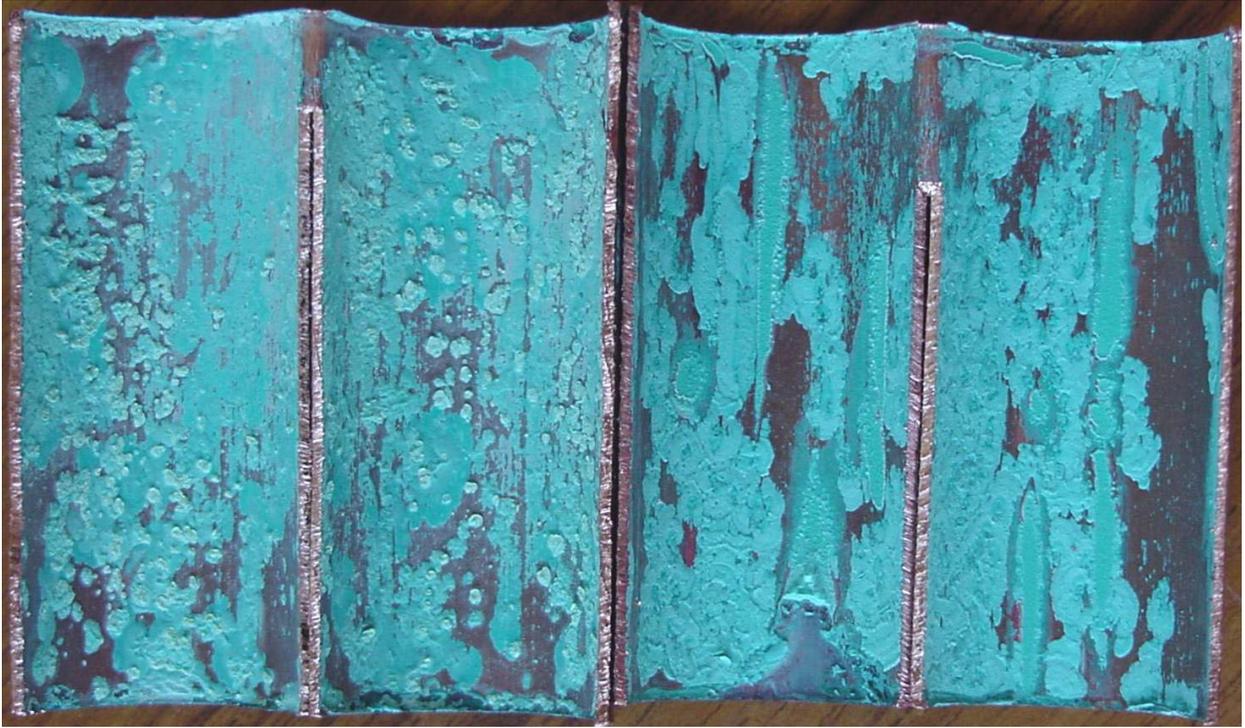
Figure 3-15. Free Chlorine Systems – Coupon D Comparison. Free chlorine control system (left) and free chlorine system with inhibitor (right).

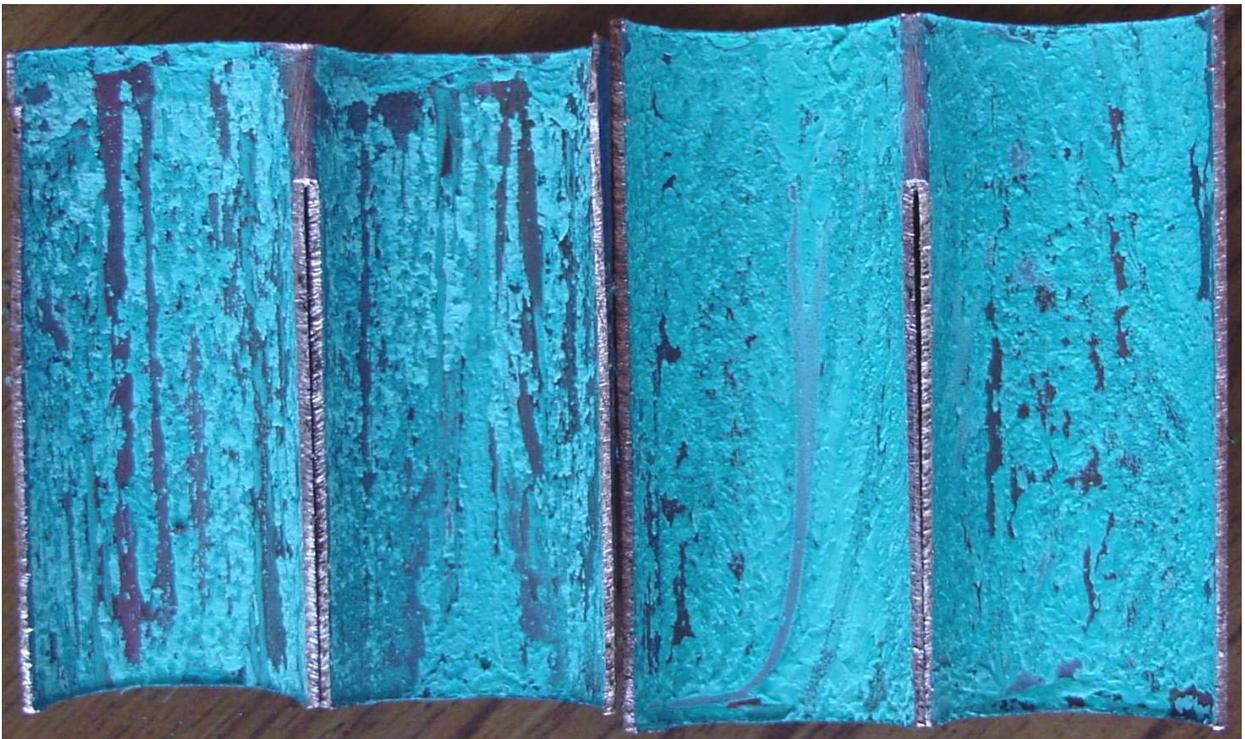
Figure 3-16. Chloramine Systems – Coupon D Comparison. Chloramine control system (left) and chloramine system with inhibitor (right).

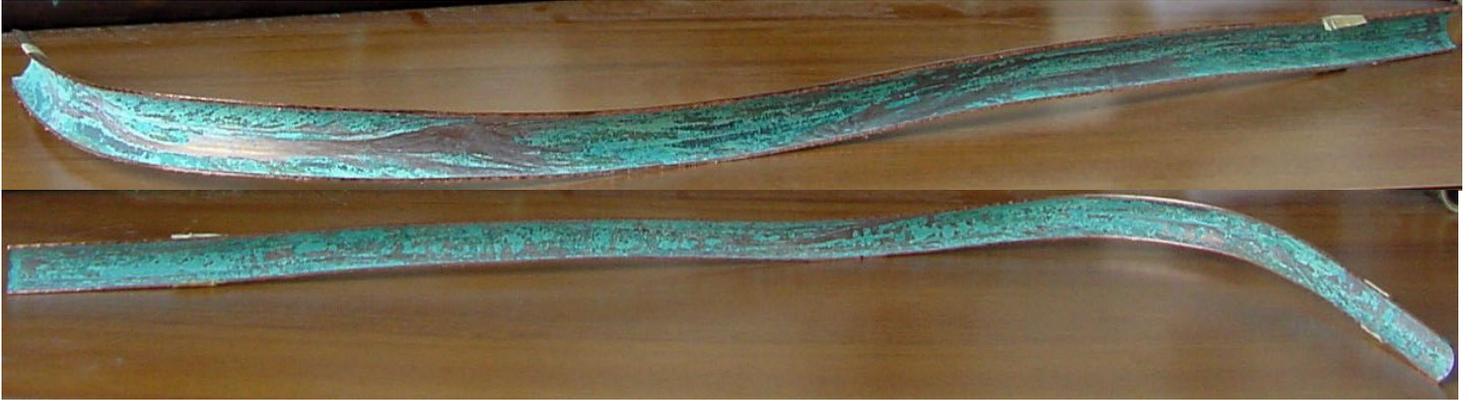
Figure 3-17. Free Chlorine Control System – Pipe Section.

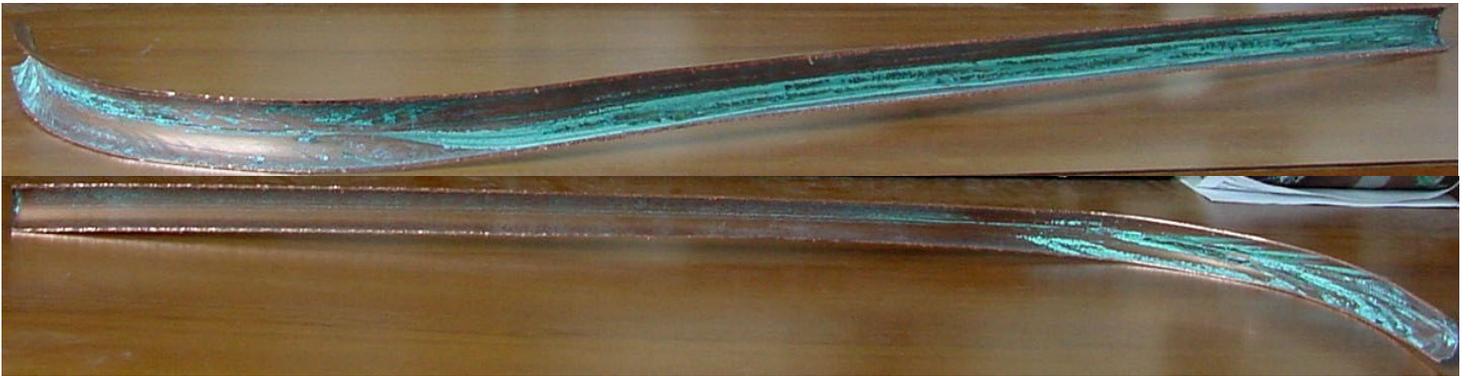
Figure 3-19. Chloramine Control System – Pipe Section.

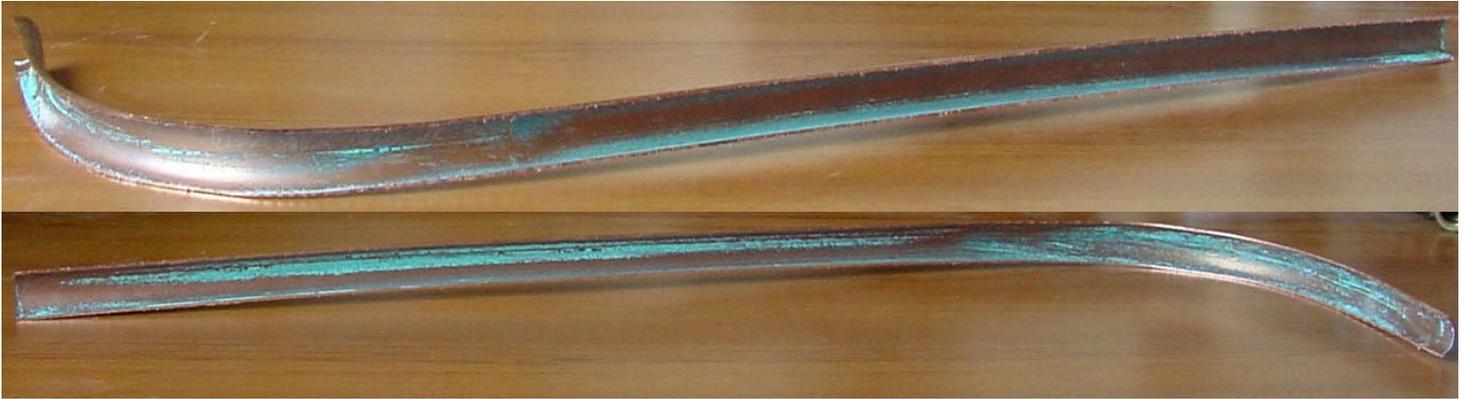
Figure 3-20. Free Chlorine System with Inhibitor – Pipe Section.

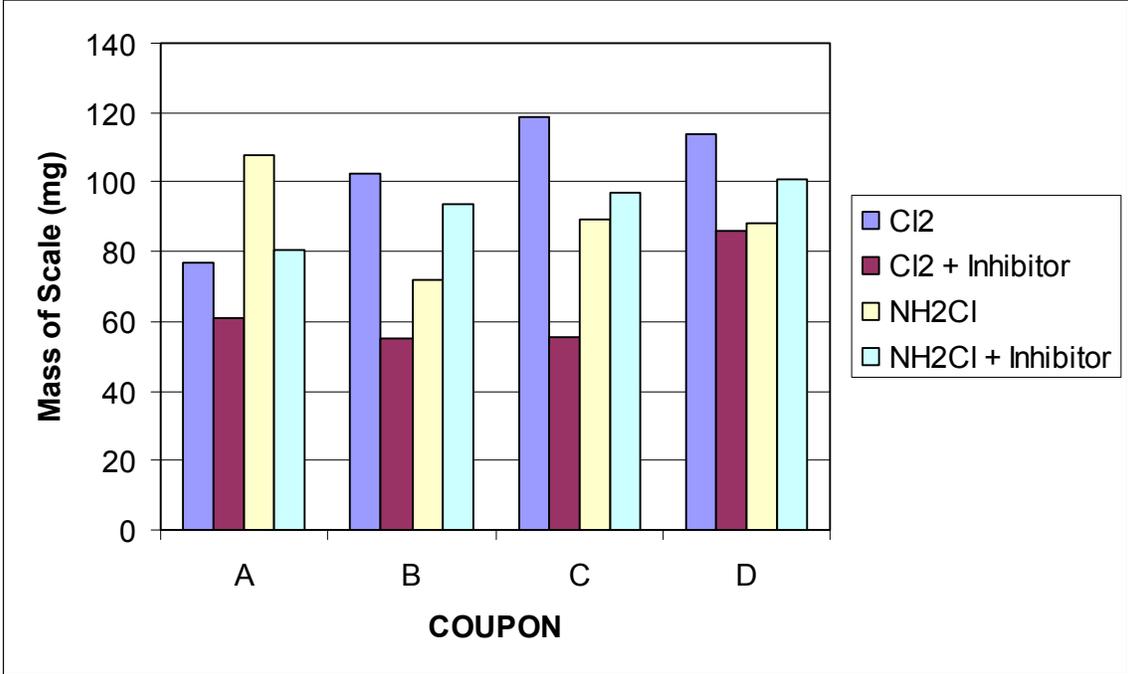
Figure 3-21. Mass of scale accumulation on coupons.

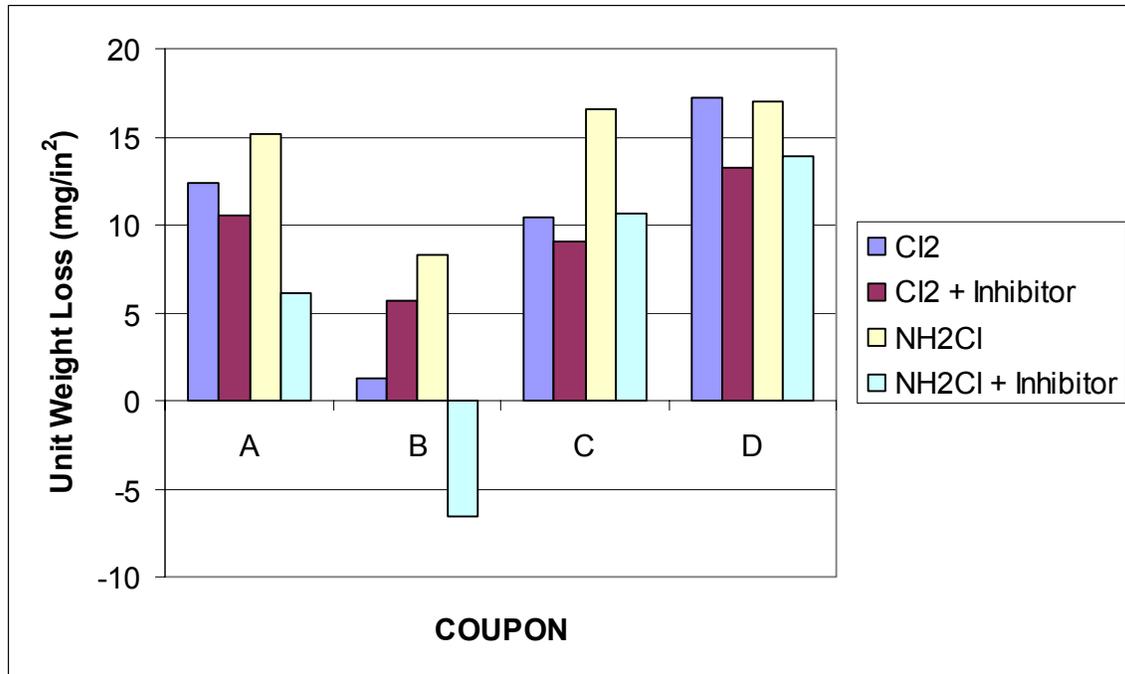
Figure 3-22. Unit weight loss of coupons.

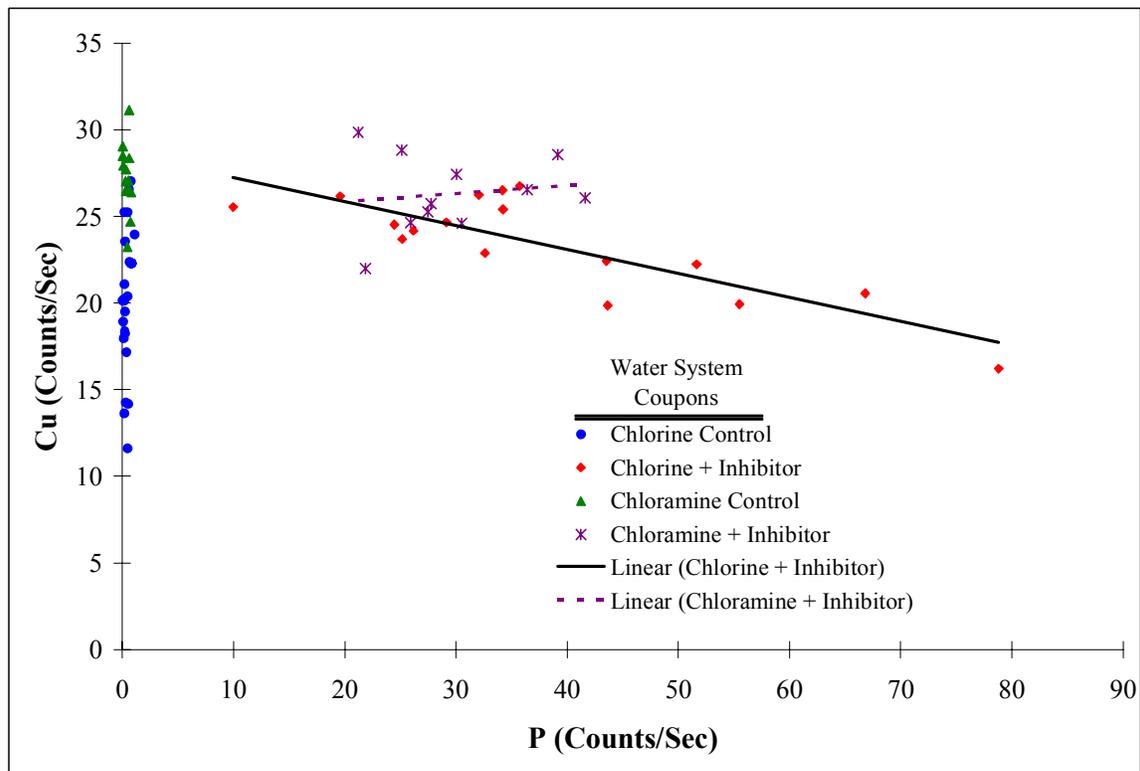
Figure 3-23. Raw Cu and P Data as collected by the SEM-EDS during surface analyses.

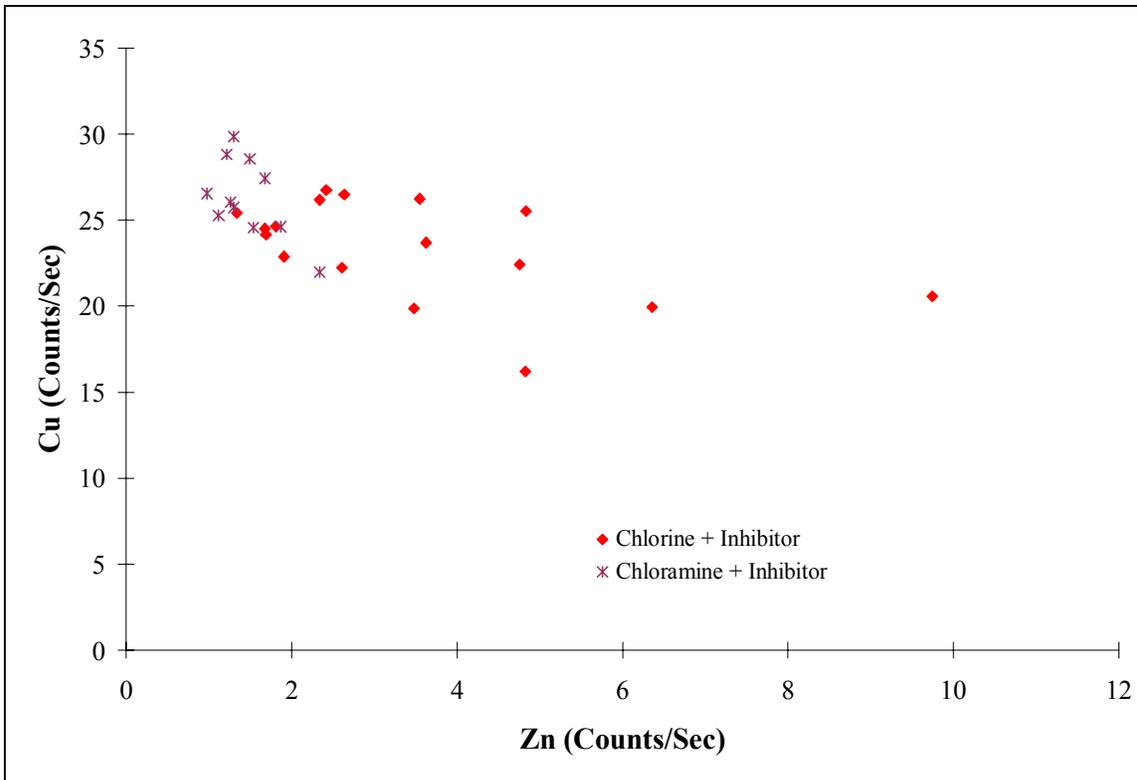
Figure 3-24. Raw Cu and Zn Data as collected by the SEM-EDS during surface analyses.
