HEALTH MONITORING OF POST-TENSION TENDONS IN BRIDGES

Report No. VTRC 03-C13R	Report Date February 2002	No. Pages 17	Type Report: Final Period Covered: 1/02 – 12/02	Project No.: 60162
				Contract No.
Title: Health Monitoring of Post Tension Tendons				Key Words: bridge, monitoring, sensors, corrosion, post-tensioning, tendons
Authors: John C. Duke, Jr.				
Performing Organization Name and Address: Virginia Transportation Research Council 530 Edgemont Road Charlottesville, VA 22903				
Sponsoring Agencies' Name and Address Virginia Department of Transportation 1401 E. Broad Street Richmond, VA 23219				
Supplementary Notes				
<p>Abstract</p> <p>Post-tensioned (PT) concrete has been used in a number of bridge structures and is expected to be used more in future construction in Virginia. This type of detail offers unique advantages for improving the performance of concrete members. Recent problems in the United Kingdom and the State of Florida have increased concern over the condition of post-tensioned tendons in Virginia bridges. There is a need for efficient, cost-effective methods of assessing and monitoring the condition of aging tendons in-situ.</p> <p>This study was carried ou

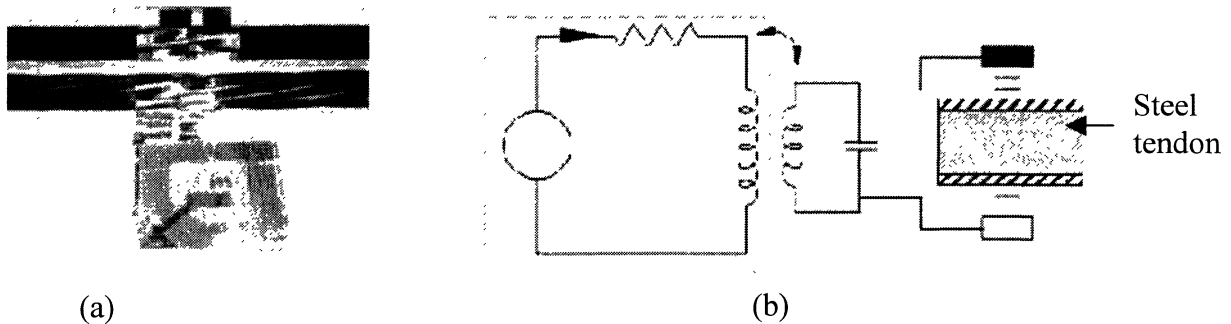
Figure 1. (a) A wireless sensor for corrosion monitoring⁴ attached to a steel tendon and (b) the schematic diagram

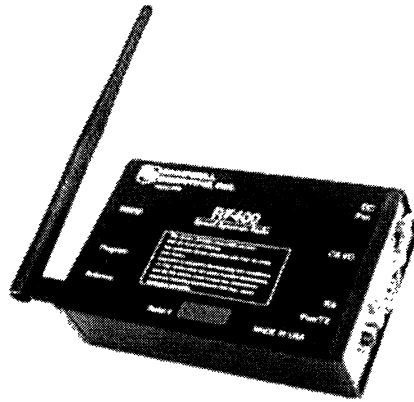
Figure 2. Campbell Scientific RF 400 Spread Spectrum Radio⁵

Using such wireless technology, multiple measurement sites can report to one central processing site, avoiding the need to string wires long distances, which might require considerable effort as well as traffic control.

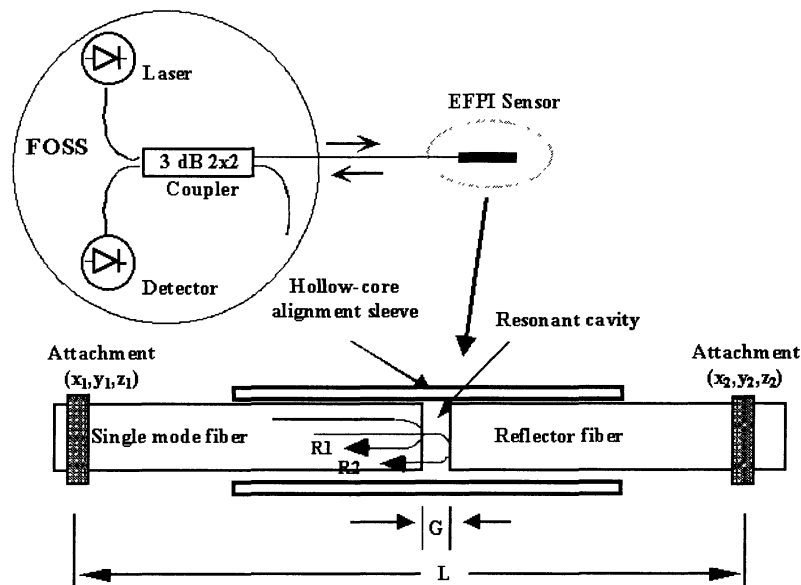
Figure 3. Extrinsic Fabry-Perot interferometric sensor for detecting displacement, temperature, or acoustic emission

Extrinsic Fabry-Perot Interferometer. The configuration of fibers shown in Figure 3, where the light exits and re-enters the fiber to form an “extrinsic” Fabry-Perot interferometer. This optical fiber device can be used for displacement detection comparable to a resistance wire strain gage and with some special adjustment can detect transient displacements typical of acoustic emission. The sensor could be used to detect failure of tendon strands. Due to the nature of this configuration, only one such sensor can be placed on a single fiber. However, it is possible to also use this sensor to measure the temperature at the location of the sensor.

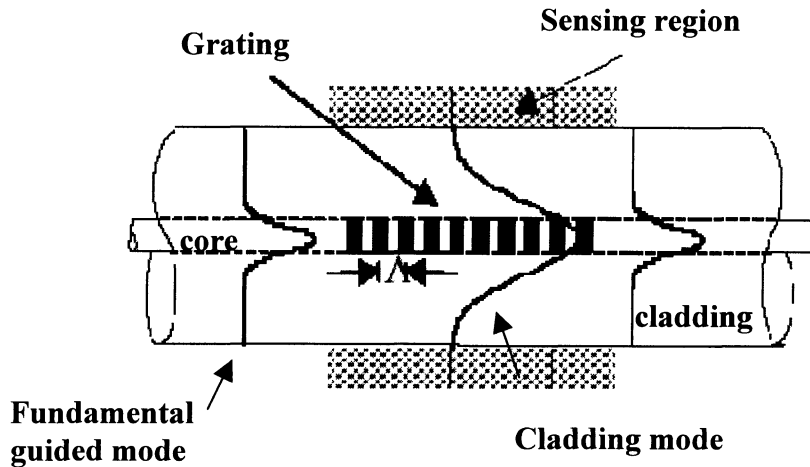
Figure 4. Long-Period grating with sensing layer specially formulated for detecting moisture

Long-Period Grating (LPG). Using a configuration (Figure 4) referred to as a long-period grating that incorporates an “intrinsic grating” and a specially modified surface coating, different chemical species can be detected. Luna Innovation, using funding from a NIST Advanced Technology Project,⁶ has developed an LPG sensor that detects moisture level. It is possible to place as many as five LPG sensors on a single fiber; the spacing between sensors can be arranged to suit the application. As the specially modified surface coating absorbs moisture, the index of refraction of the fiber changes, which in turn changes the amount of light lost through the coating.

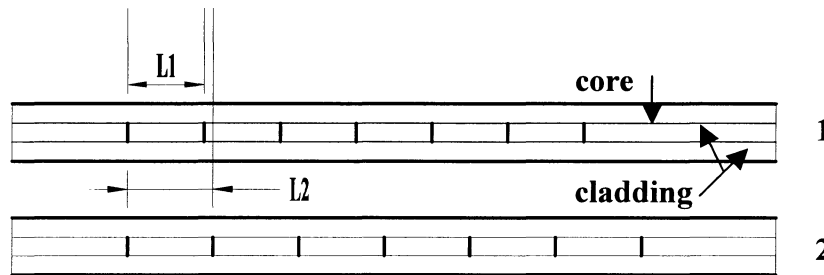
Figure 5. Schematic of how a fiber Bragg grating is used for detecting strain. 1 and 2 represent the optical fiber containing the Bragg grating in different states of elongation. The optical interference is different for these different conditions and allows the spacing of the deformed grating lines to be determined. The spacing for the two different situations can then be used to determine the change in strain from condition 1 to condition 2, $\epsilon = (L_2 - L_1) / L_0$.

Bragg Grating. The Bragg grating sensor is intrinsic and involves an internal modification of the optical fiber that partially reflects light. The spacing of these modified regions and the interference that results can be used to determine the strain of the fiber in the area of the grating (Figure 5). It is possible to place very large numbers of Bragg grating sensors on a single fiber. Scientists at NASA developed a method for processing the optical signal in order to separate the strain data for, in theory, many thousands of sensors; this capability was demonstrated for a fiber with 800 separate Bragg grating sensors.⁹

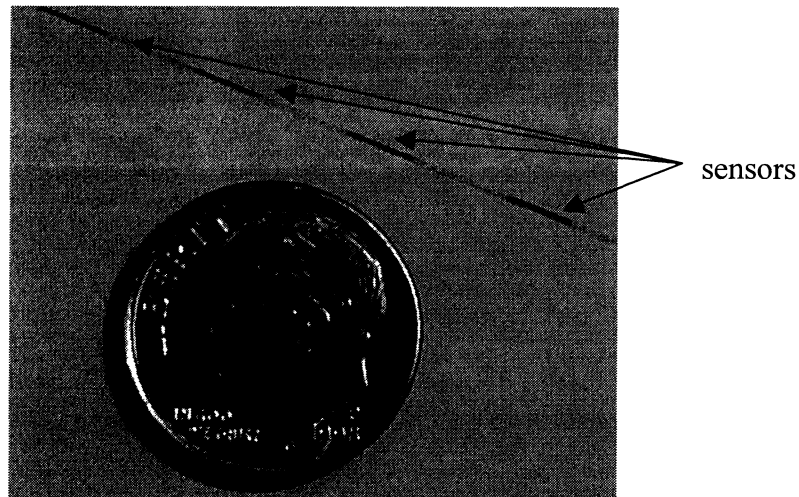
Figure 6. Image showing a segment of optical fiber with Bragg grating sensors every centimeter, dark regions, in comparison to a dime

Figure 6 shows a segment of optical fiber with Bragg gratings separated at a distance of 1 cm to provide the reader with a sense of the size. Despite the number of Bragg grating strain sensors on a single fiber, only one point of penetration, or attachment, is required. This offers enormous benefits for installation and, of course, cost savings over conventional strain monitoring instrumentation. For conventional instrumentation, at least two wires and a separate strain gage amplifying unit are required for each gage along with whatever instrumentation is needed to collect and store the data.

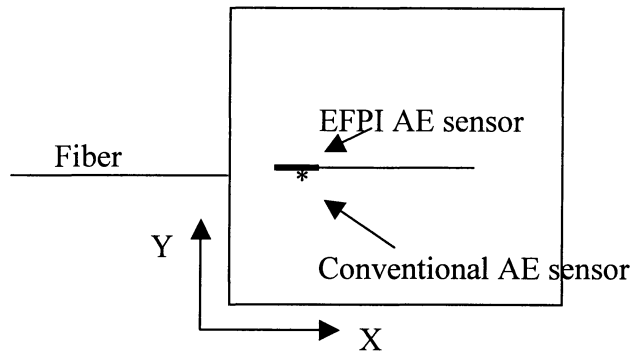
Figure 7. Testing configuration of 330.2 x 330.2 x 3.175 mm 6061 Al plate with attached EFPI AE sensor and conventional sensor, and a glass fiber, used to simulate a strand break, bonded to the edge face of the plate

To demonstrate the capability of the EFPI AE sensor for detecting strand or fiber breakage, a test configuration used by other investigators, Prosser et al.,¹⁰ for which actual displacements due to the sudden release of energy could be predicted was used. The test configuration involved a 330.2 x 330.2 x 3.175 mm 6061 aluminum plate. A long glass fiber was bonded to the center of the edge face of the plate, loaded in tension, and then cleaved to initiate a simulated break. The EFPI AE sensor was located on the surface of the plate in-line with the fiber (Figure 7). The locations were selected to try to provide as long a time interval as possible without reflections from the lateral boundaries. In addition, this configuration was selected because the disturbance is dominated by in-plane displacements, as would be a strand break if detected at a position along the strand away from the break point. Figure 8 shows the signals detected using the EFPI AE sensor and the conventional AE sensor. The EFPI AE response is much stronger, as was expected because of its in-plane displacement sensitivity. Although the conventional AE sensor detects the event, in a post-tension structure, the sensor is normally attached to the concrete structure and relies on mode conversion of the in-plane energy or structural vibrations excited by the strand break to provide a disturbance it can detect. However, detection of the in-plane displacements initially triggered by a strand break should provide the highest probability of detection.

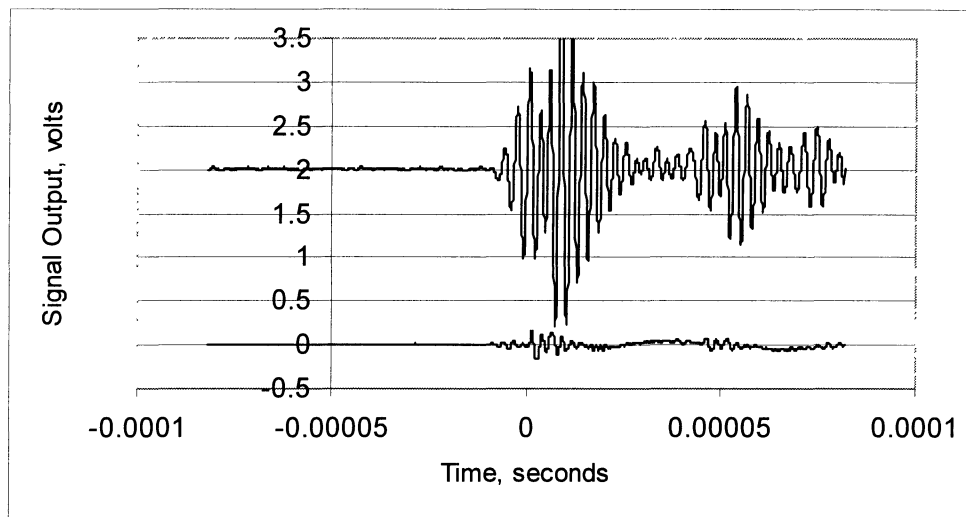
Figure 8. The signal output for an EFPI AE sensor (upper, offset by 2 volts) and a conventional AE sensor (lower) excited by a simulated glass fiber break with the fiber attached to the edge face of an aluminum plate at a location expected to excite predominantly in-plane displacements at the location of the AE sensors

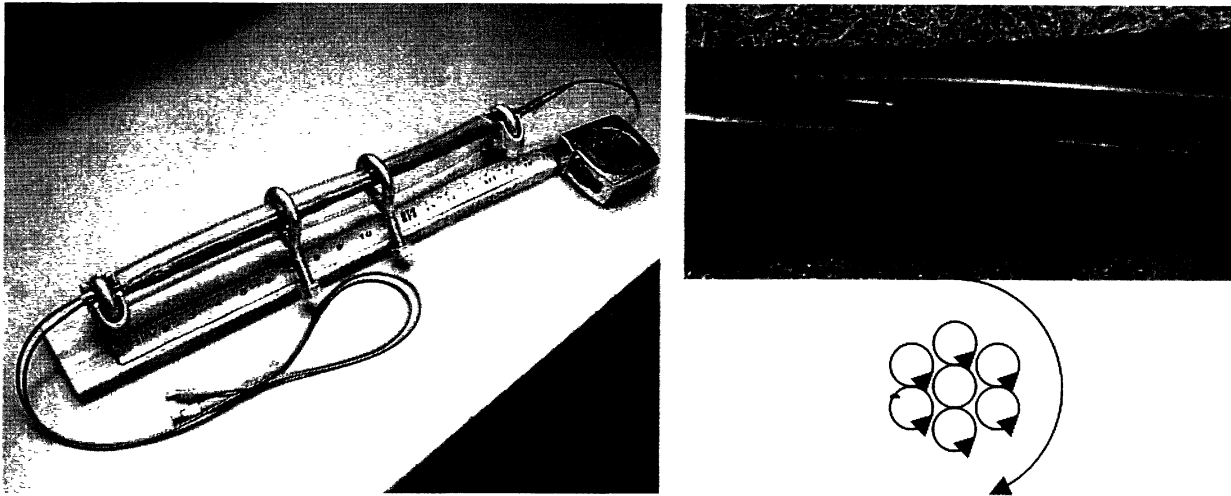
Figure 9. A small section of 7-strand tendon instrumented with an optical fiber with 37 Bragg gratings sensors every centimeter. The fiber is bonded with epoxy in the “valley” (arrow) between two strands that spiral around the central strand. [The diagram shows that care needs to be exercised so that the fiber (solid small dot) is attached to a strand so it will rotate away from the “pinch” point when the strands straighten during tensioning. The large arc indicates the orientation of the spiral, while the small arrowheads indicate the direction of rotation of the strands as they straighten.] Knuckle clamps at each end and two eyebolts are used to load the section in four-point bending. A clear polymer tube surrounds the tendon to allow for grouting at a later time. Note: the gages in the constant moment section experience different strains because they spiral about the neutral axis.

A piece of optical fiber with 37 Bragg grating sensors at 1-cm intervals was bonded in the “valley” between two strands that spiral about the central strand of a 17-inch-long section (Figure 9). (It is anticipated that by bonding the fiber in such a position of a 7-strand tendon the fiber would be protected by the larger diameter strands as it is towed through the duct even if the tendon is scuffed by being dragged over piers or across duct unions. Once in place the tendon can be loaded in tension by the hydraulic jacks and the tendon, and the attached optical fiber, strained to an approximate 1 percent strain before the tendon is anchored and released in order to force the concrete structure into compression. An effective means of connecting the optical fiber sensor would need to be developed that could pass through the anchorage and survive the tensioning process.) The instrumented section was encased in a clear section of polymer tubing to allow for grouting of the tendon at a later time. Knuckle clamps at the ends and two eyebolts located in the central region were used to load the tendon in four-point bending.

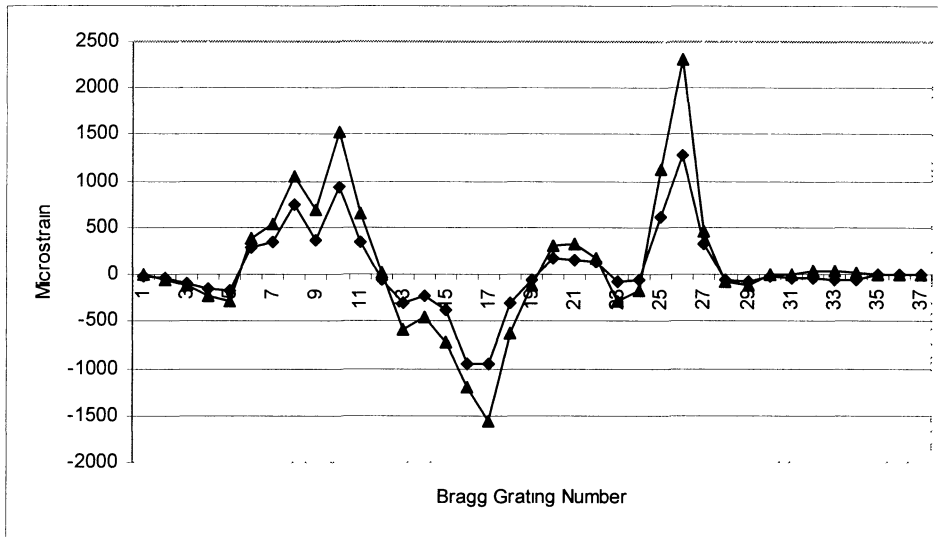
Figure 10. Display of strain values collected for each of the 37 Bragg grating sensors at two different deflections caused by different amounts of tightening of the eyebolts. The peak positive values are from grating sensors in the vicinity of the eyebolts.

Figure 10 displays the strains measured by each of the 37 Bragg grating sensors that spiraled about the tendon subject to four-point bending. Strains were collected at two different deflections. The assembly was set aside overnight, and then the strains were collected again (Figure 11). Most of the deflection of the tendon had relaxed because the epoxy attaching the optical fiber, not optimized for this application, had deformed viscoelastically during the intervening time.

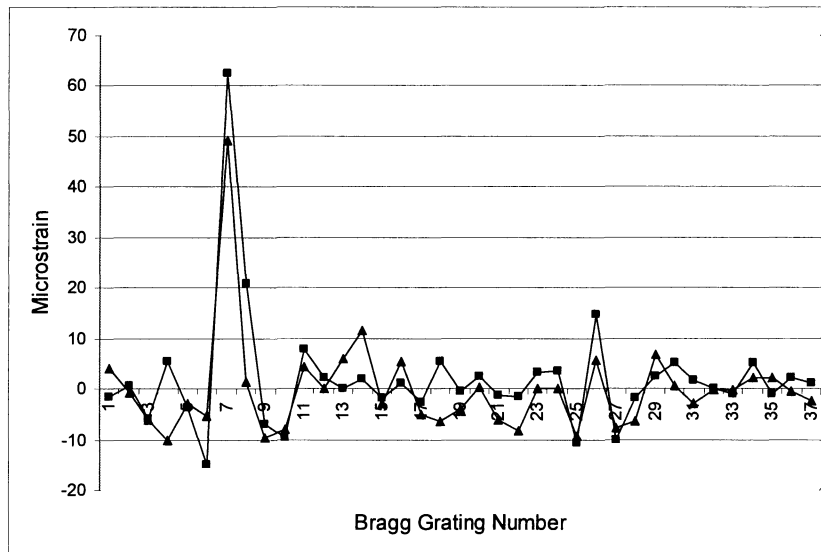
Figure 11. Two different data sets collected at slightly different times display strain values 17 hours after the final data collection shown in Figure 9 for each of the 37 gages. Most of the deflection of the tendon has relaxed as the epoxy, not optimized for this application, used to attach the optical fiber had deformed viscoelastically during the intervening period.
