FINAL
CONTRACT REPORT
VTRC 09-CR11

**SHEAR STRENGTH OF A PCBT-53 GIRDER
FABRICATED WITH LIGHTWEIGHT
SELF-CONSOLIDATING CONCRETE**

Standard Title Page - Report on Federally Funded Project

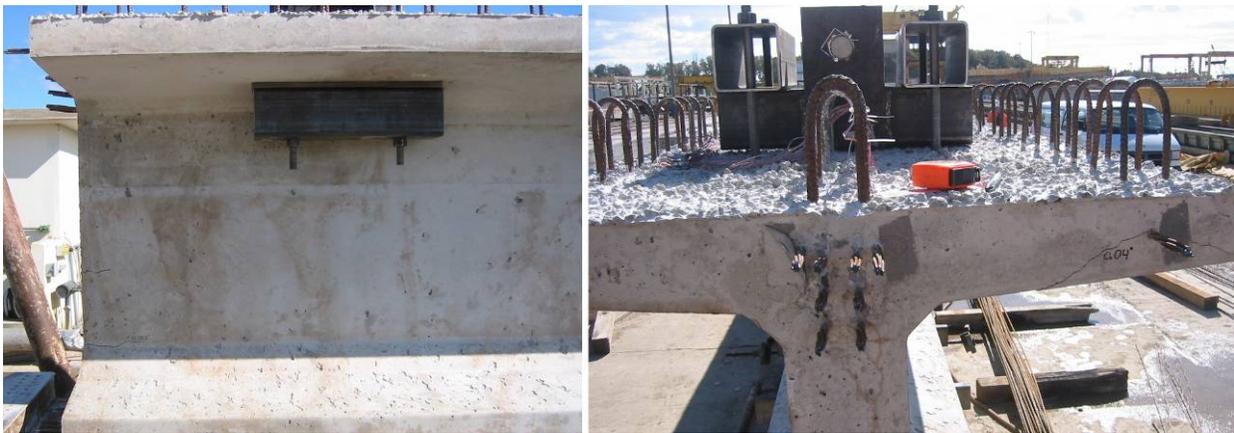
Figure 7. Girder lifting device

Non-standard lifting devices were used to handle the beam at the Bayshore plant and to unload it from the truck at the laboratory. These lifting devices, as shown in Figure 7, picked the girder up through the top flange using structural steel tubing. This is not the normal way that bridge girders are lifted. Typically, a bundle of prestressing strand is fashioned such that a loop of strand is left exposed for cranes to lift the beams, and the ends of the strand loops extend well into the web of the beam. This LWSCC beam was to be subjected to shear tests at the laboratory in the end region of the beam. Using these atypical lifting devices, no extra strand or stress was put in the test region. The PCBT-53 was lifted initially at Bayshore to test the devices, after which an initial camber measurement was taken. This value and any subsequent measurements that were taken are presented later in this report. The first lift of the beam was successful, and the girder was then transported to the Virginia Tech Structures and Materials Laboratory on December 13, 2006.

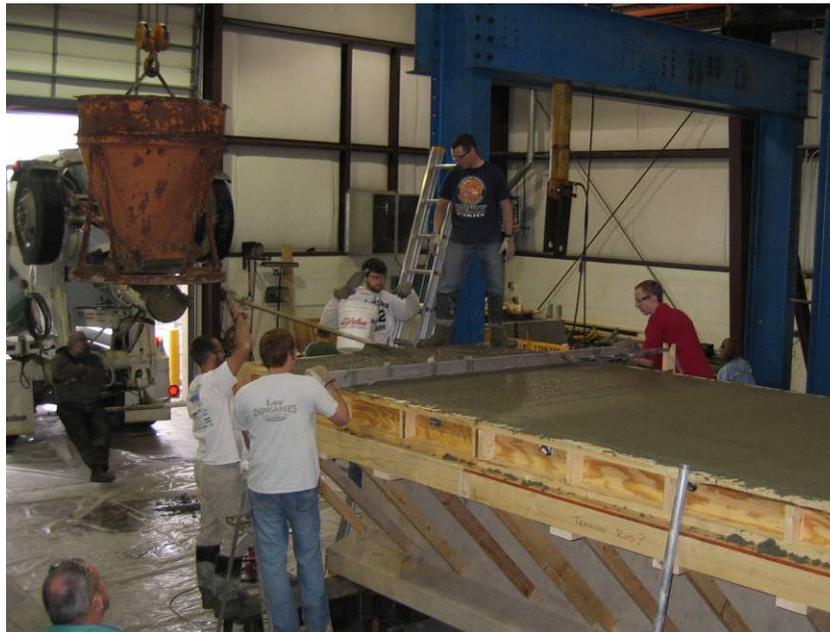
Figure 11. Deck concrete placement

During the casting of the deck, as seen in Figure 11, concrete was transported from the ready mix delivery truck to the girder by an overhead crane and 1 cy concrete bucket. On top of the girder and deck, pencil vibration was used to consolidate the concrete in the formwork. After all the formwork was filled with concrete, the top surface of the deck was bull floated and finished using hand trowels. The top surface of the deck and approximately half of the formwork was covered with water-soaked burlap and plastic sheeting following completion of all concrete finishing. This type of moist cure was applied to the deck for 14 days, even after the formwork was removed at seven days. The State of Virginia department of transportation typically requires a 14 day moist cure for new bridge and deck construction. Concrete cylinder specimens were also cast and subjected to the same curing conditions as the deck itself. The cylinder molds were stripped the same day the deck formwork was removed. The deck was allowed to cure beyond 28 days before the first test was started.

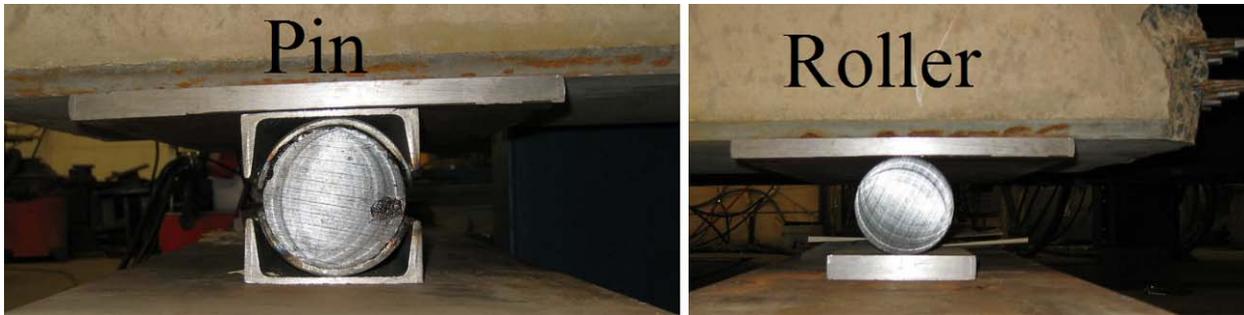
Figure 13. Beam end support conditions

A hydraulic actuator was mounted to a steel load frame to apply load at each point. These load frames were bolted to the reaction floor to ensure a closed loading system. These actuators applied a single point load through a series of plates increasing in size and ultimately sitting on the neoprene tire patch. The actuators were connected to an electric pump in parallel, and the hydraulic fluid pressure was monitored during testing.

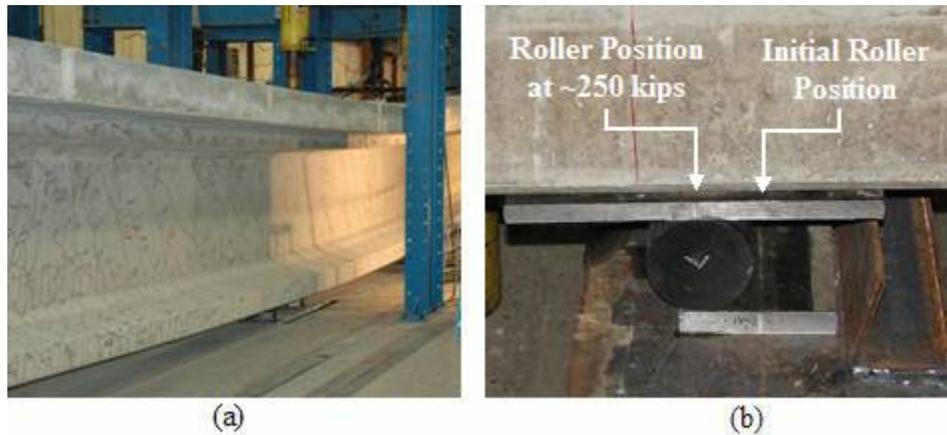
Figure 23. Support condition problems (a) large deflections (b) disconcerting roller position

A problem was encountered with this test setup, due to the large deflections occurring due to the flexural dominated loading. The roller supported end of the beam approached the support edge at large loads as shown in Figure 23. To avoid this problem during subsequent tests, steel angles were welded to the steel support beams to prevent the pin from completely rolling off. The girder was then lifted off of the support with hydraulic actuators to re-adjust the pinned support and allow it to roll farther.

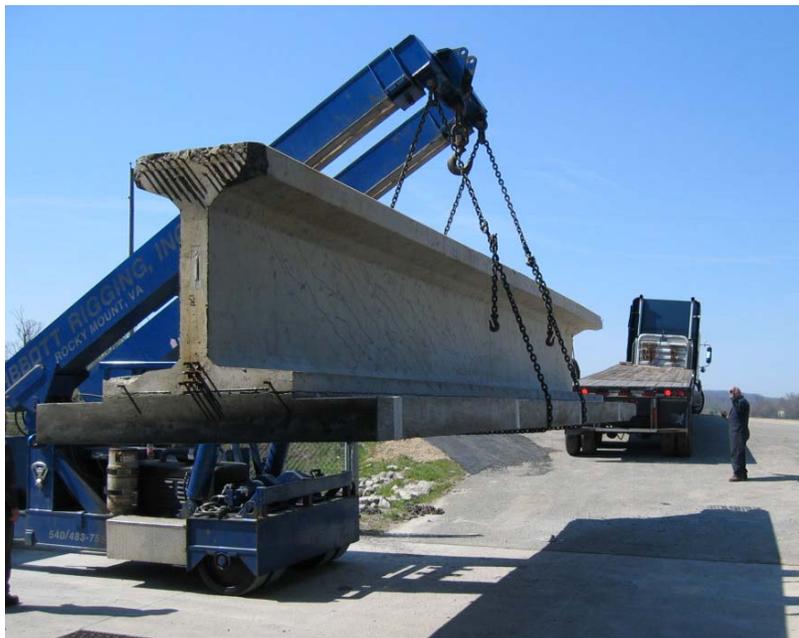
Figure 24. Removal of one half of the PCBT-53

Inc. as shown in Figure 24. This configuration allowed for the composite deck to sit directly on the truck bed eliminating any possibility of the section overturning during transportation.

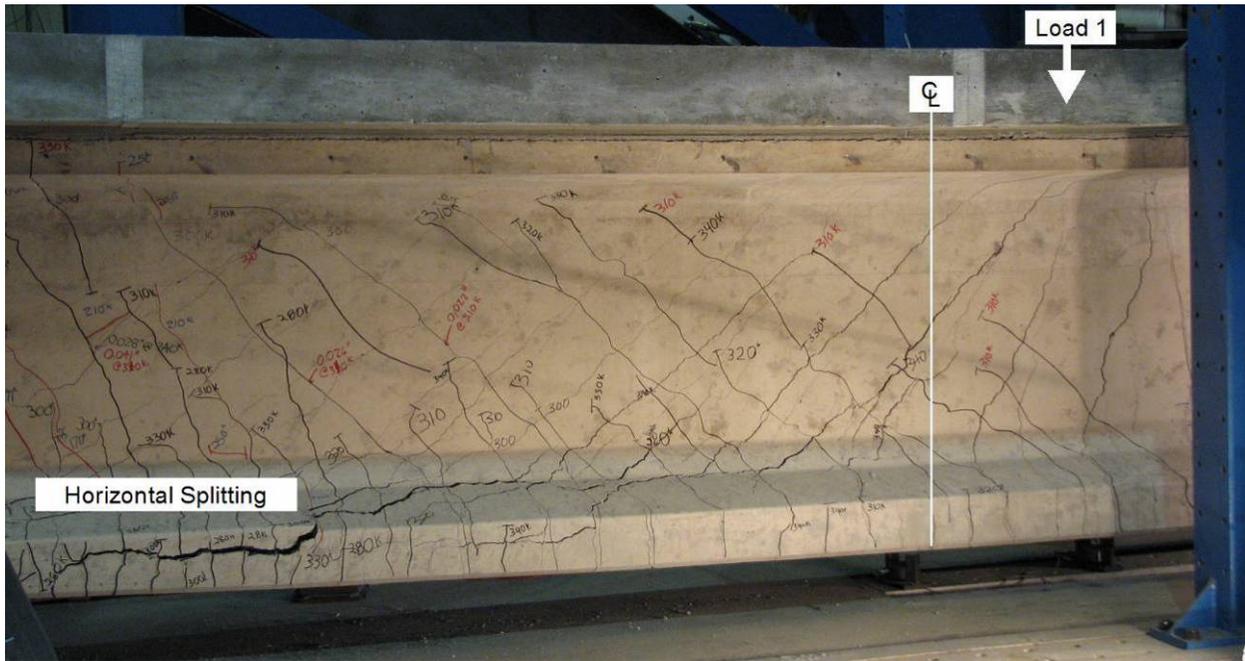
Figure 51. Horizontal bottom flange splitting failure

wide flexure-shear cracks and horizontal bottom flange splitting cracks between the loading point located at 30 ft from the end of the beam and Support 1.

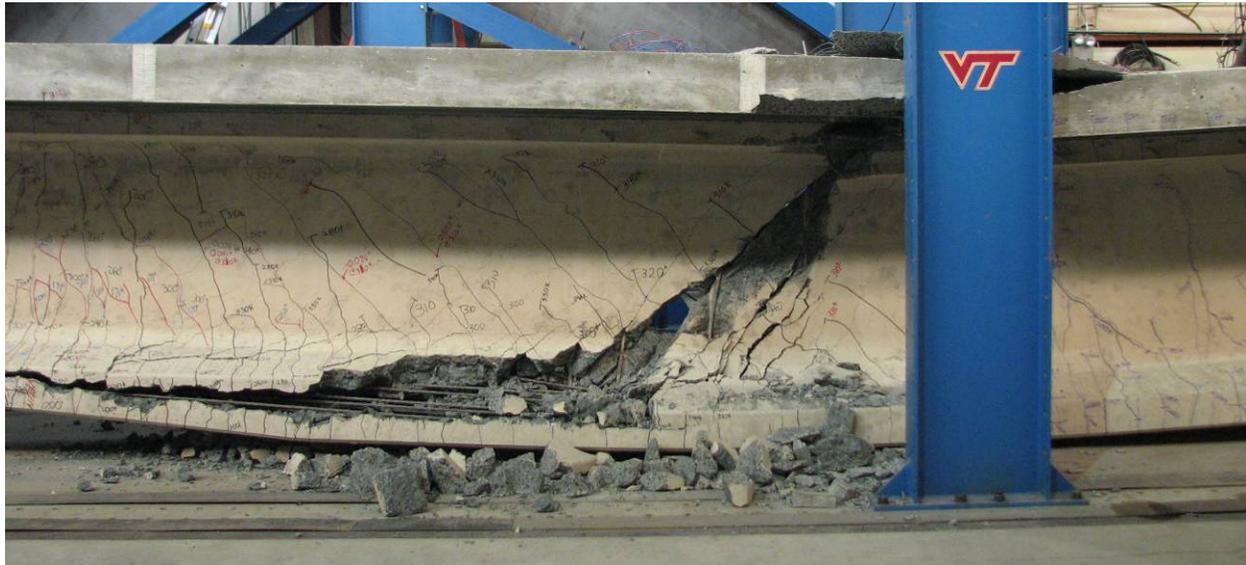
Figure 55. Ultimate failure of the PCBT-53

The final flexure-shear test (third overall stage) took place with a constant loading until 150 kips per actuator was reached. At this applied load, the adjusted roller and pin support conditions looked good upon inspection. The girder was then loaded continuously until 260 kips per actuator was reached. From this point, the girder was loaded at 10 kip increments until the final load of 303 kips per actuator was reached. The ultimate failure of the PCBT-53 was initiated with top flange crushing, and an extremely fast and sudden failure commenced. The web of the girder blew out, the bottom flange dropped off of the girder, and a compression strut formed in the web of the girder. During the abrupt failure, a single leg of one double leg vertical shear stirrup was also ruptured. The failure occurred very close to midspan of the girder, between midspan of the girder and the loading point 30 ft from the end of the beam. Figure 55

shows the girder after failure; the compression strut is visible to the left of the load frame. Figure 56 illustrates the crushing that occurred in the top of the composite system.
