*Final Report VTRC 09-R8*

## Evaluation of the Cargill SafeLane™ Surface Overlay

**EVALUATION OF THE CARGILL SAFELANE™ SURFACE OVERLAY**

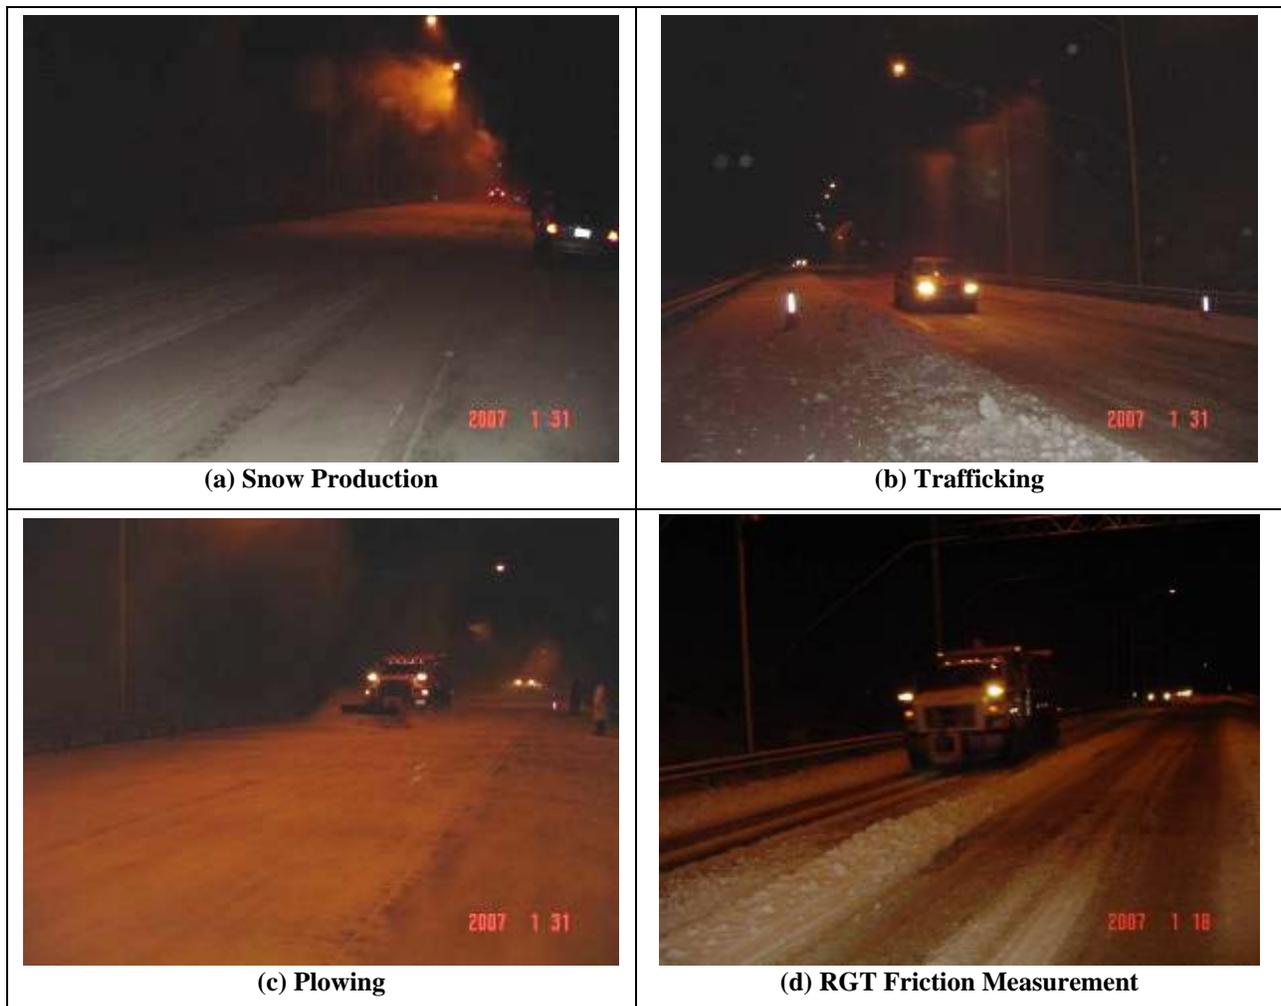
Figure 1. Selected Activities During Testing at Smart Road. RGT = Road Grip Tester.

Photographs of Steps 3 and 4 are provided in Figure 1.

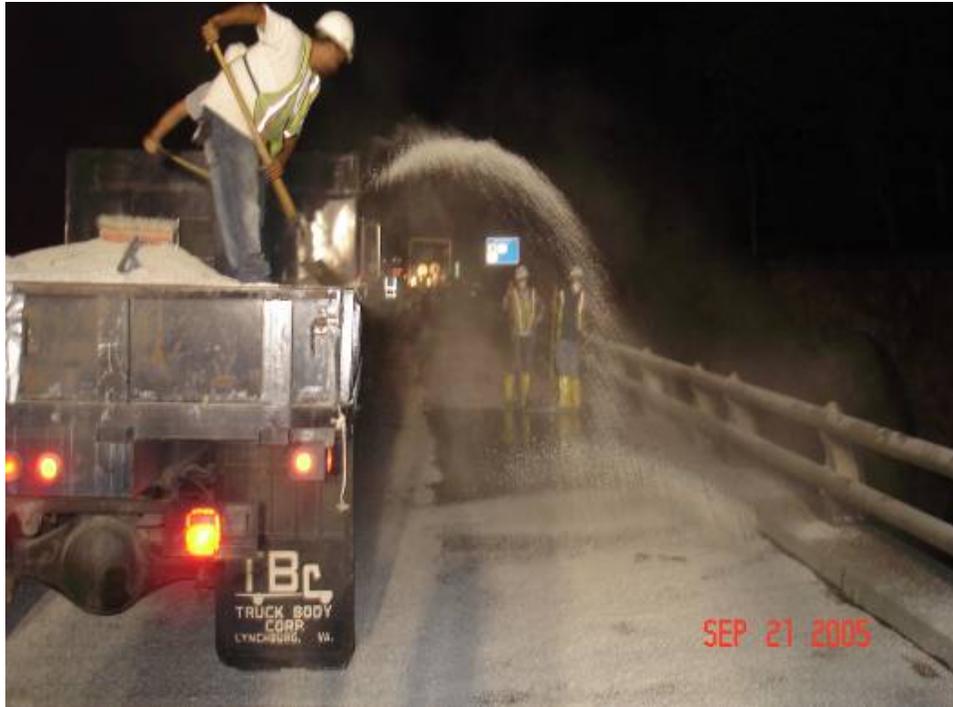
**Figure 2. SafeLane Overlay Being Placed on Shoulder of I-81 Structure 2037**

As discussed previously, the standard SafeLane overlay was placed on both lanes of Structure 2037 SB, as indicated in Tables 1 and 2. For Structure 2024 NB, placed in October 2005, all four spans of the passing lane were done with the standard SafeLane aggregate; Spans 1 and 2 of the travel lane were done with 25% of the SafeLane aggregate replaced with silica aggregate slightly larger than that used in VDOT overlays; and Spans 3 and 4 of the travel lane were done with 50% of the SafeLane aggregate replaced with the silica aggregate. The silica aggregate was substituted for a portion of the SafeLane aggregate to determine the impact on skid resistance and ice and snow melting performance. Figure 2 shows the SafeLane overlay being placed on Structure 2037.

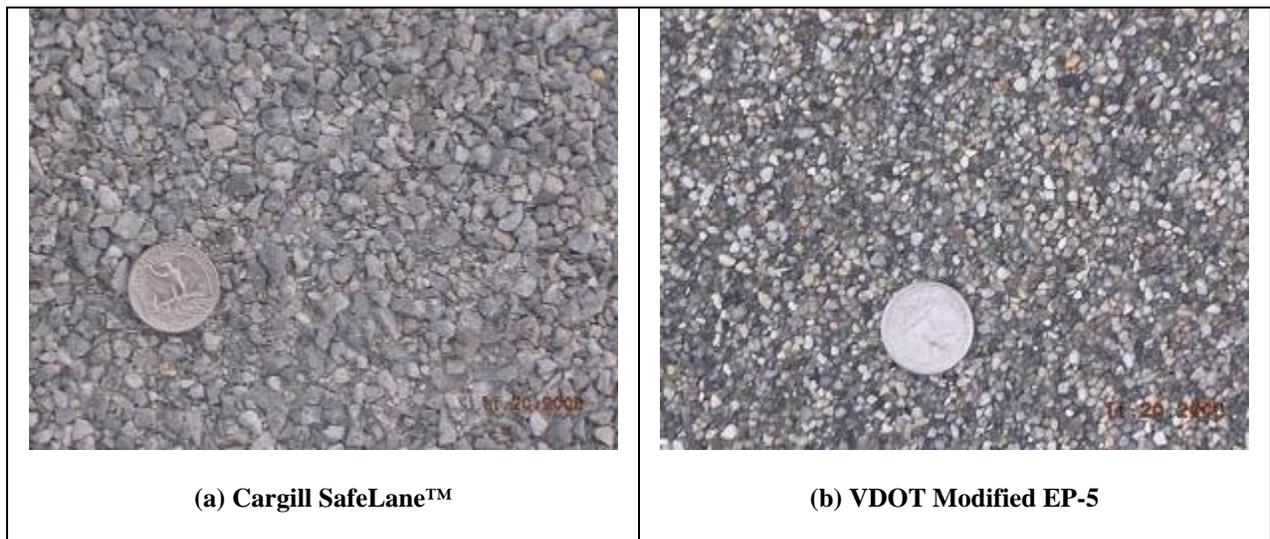
Figure 3. Comparison of Surface Texture of SafeLane and 2-Layer VDOT Modified EP-5 Overlays Constructed at Virginia Smart Road

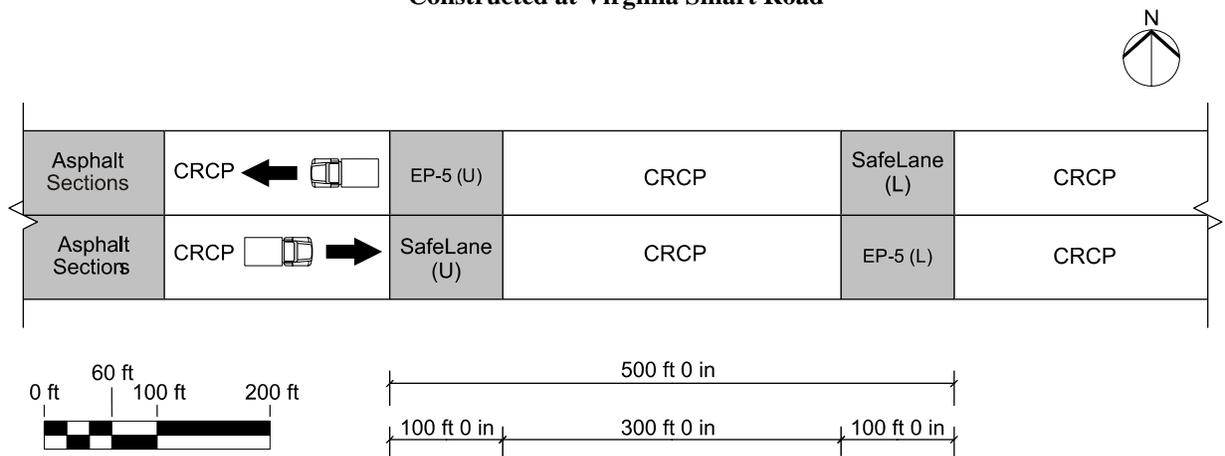
Figure 4. Layout of Experimental Sections at Virginia Smart Road. CRCP = continuously reinforced concrete pavement; EP-5 = 2-Layer VDOT modified EP-5 overlay; U = upper; L = lower.

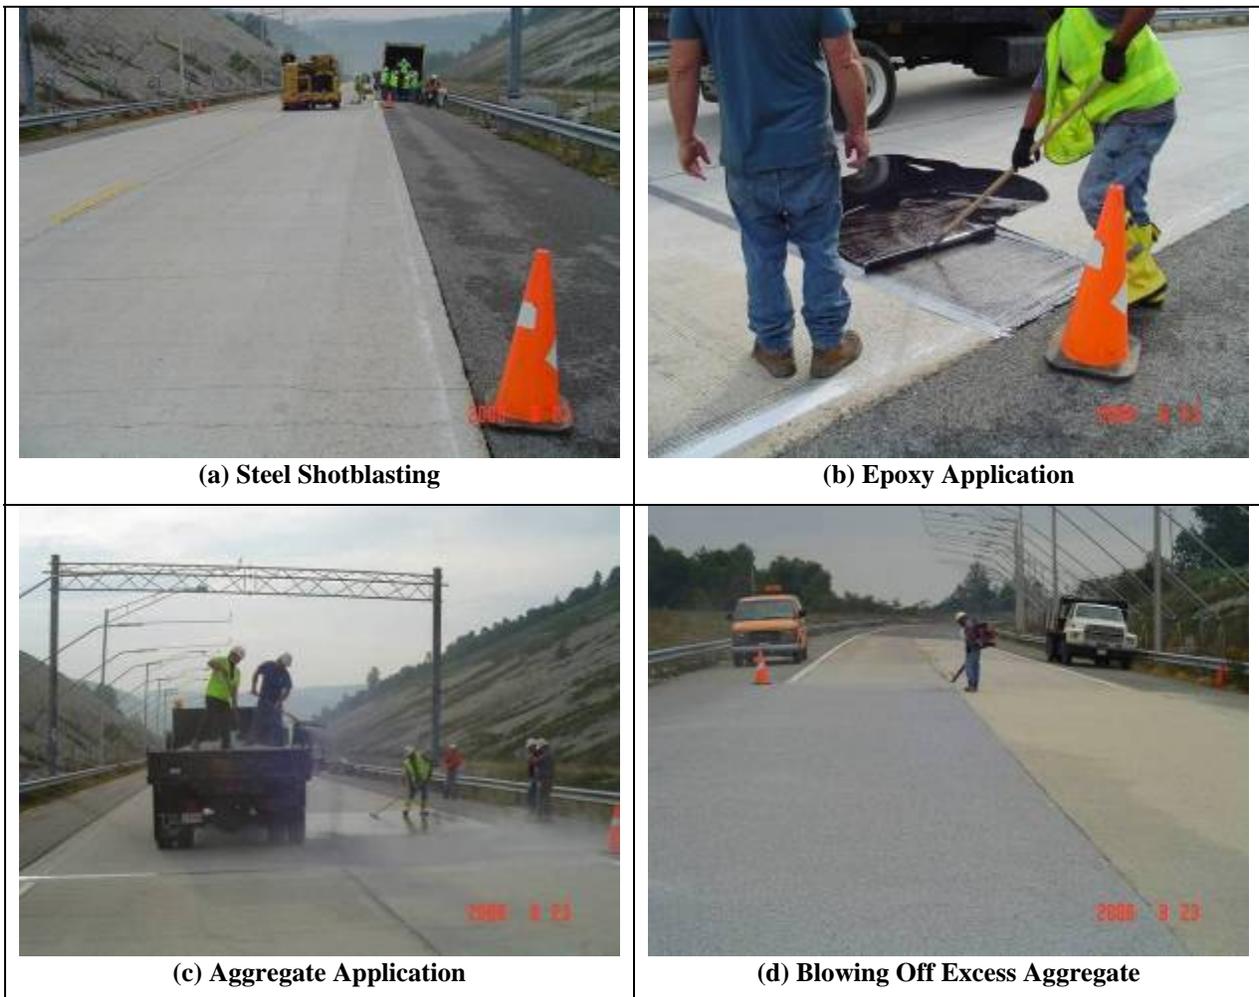
Figure 5. Summary of Construction Sequence at Smart Road

Prior to the installation of the overlays, the CRCP surfaces were thoroughly cleaned with a steel shot blasting process to remove pavement markings and/or oil spots and clean the concrete surface, as shown in Figure 5a.

After air blowing any leftover particles from the surface of the pavement, the epoxy was applied with a squeegee as shown in Figure 5b. Both types of overlays used the same type of epoxy. The aggregates were applied by manually shoveling them on the epoxy coat from dump trucks, as can be seen in Figure 5c. After the epoxy was cured, loose aggregate was removed

with a power broom and/or air blowers as shown in Figure 5d and the second application of epoxy and aggregates was done.

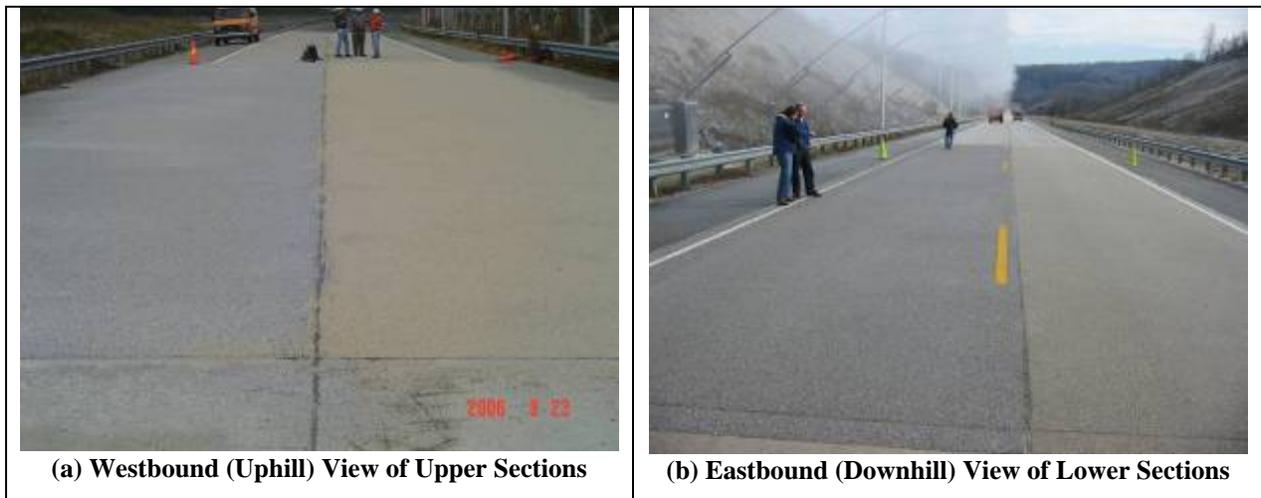
Figure 6. Side-by-Side Comparison of Overlay Systems at Smart Road. (a) VDOT Modified EP-5 overlay, (b) SafeLane overlay.

Photographs of the overlaid sections are provided in section in Figure 6. The application rates were as follows:

- *VDOT Modified EP-5*: 2.5 gal/100 ft<sup>2</sup> (Layer 1) and 5 gal/100 ft<sup>2</sup> of epoxy (Layer 2) with aggregate placed to excess.
- *SafeLane*: 4 gal/100 ft<sup>2</sup> (Layer 1) and 8 gal/100 ft<sup>2</sup> (Layer 2) of epoxy with aggregate placed to excess.

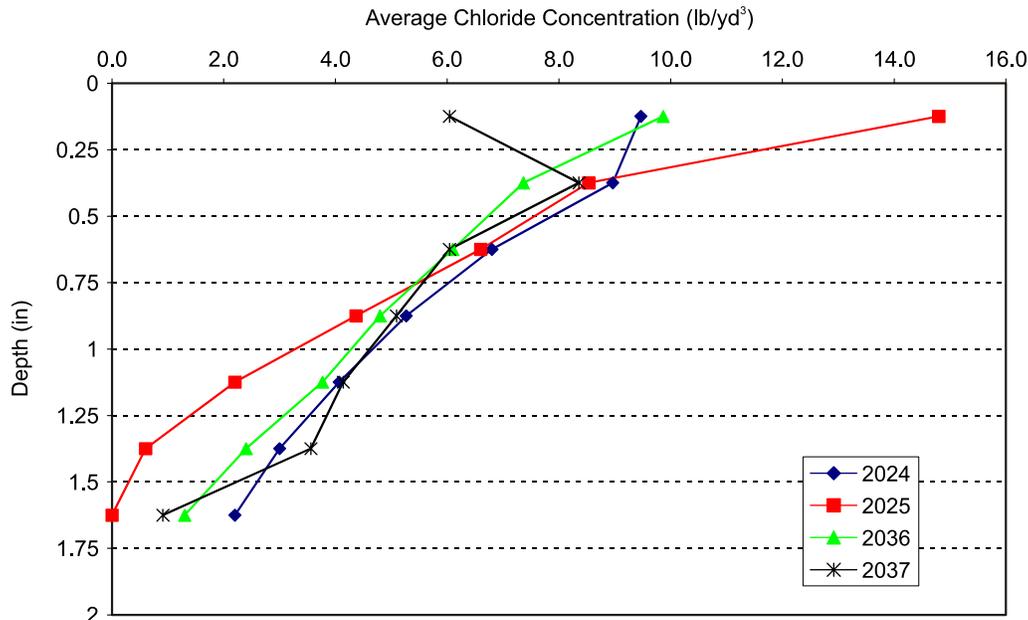
**Figure 7. Chloride Content Profiles for I-81 Decks Based on Cores Taken February 15, 2006. Numbers in box = structure numbers; 2-layer SafeLane structure numbers = 2024, 2037; 1-layer VDOT modified EP-5 structure numbers = 2025, 2036.**

Chloride content profiles based on the average of tests on the samples from the four bridges are shown in Figure 7. The chloride profiles were similar. The average chloride content

at the top level of reinforcement (approximately 1.75 in from the surface) ranged from 0 to 2 pcy. As a consequence, corrosion of the reinforcement and spalling of the deck under the overlays should not be a problem. Corrosion would likely initiate at locations with higher chloride contents with further ingress of chlorides. The epoxy overlays were applied at a good time to preserve the decks. Fortunately, a second layer was placed on the one-layer overlays before they failed so that protection was maintained. It is anticipated that the overlays will prevent further intrusion of chloride ion and the life of the decks will be extended by the life of the overlays.<sup>1-3</sup> Chloride profiles prepared in the future can be compared to the ones in Figure 7 and Appendix F to determine if chloride from the pretreatments of the overlays or from routine winter maintenance applications penetrated the overlays.

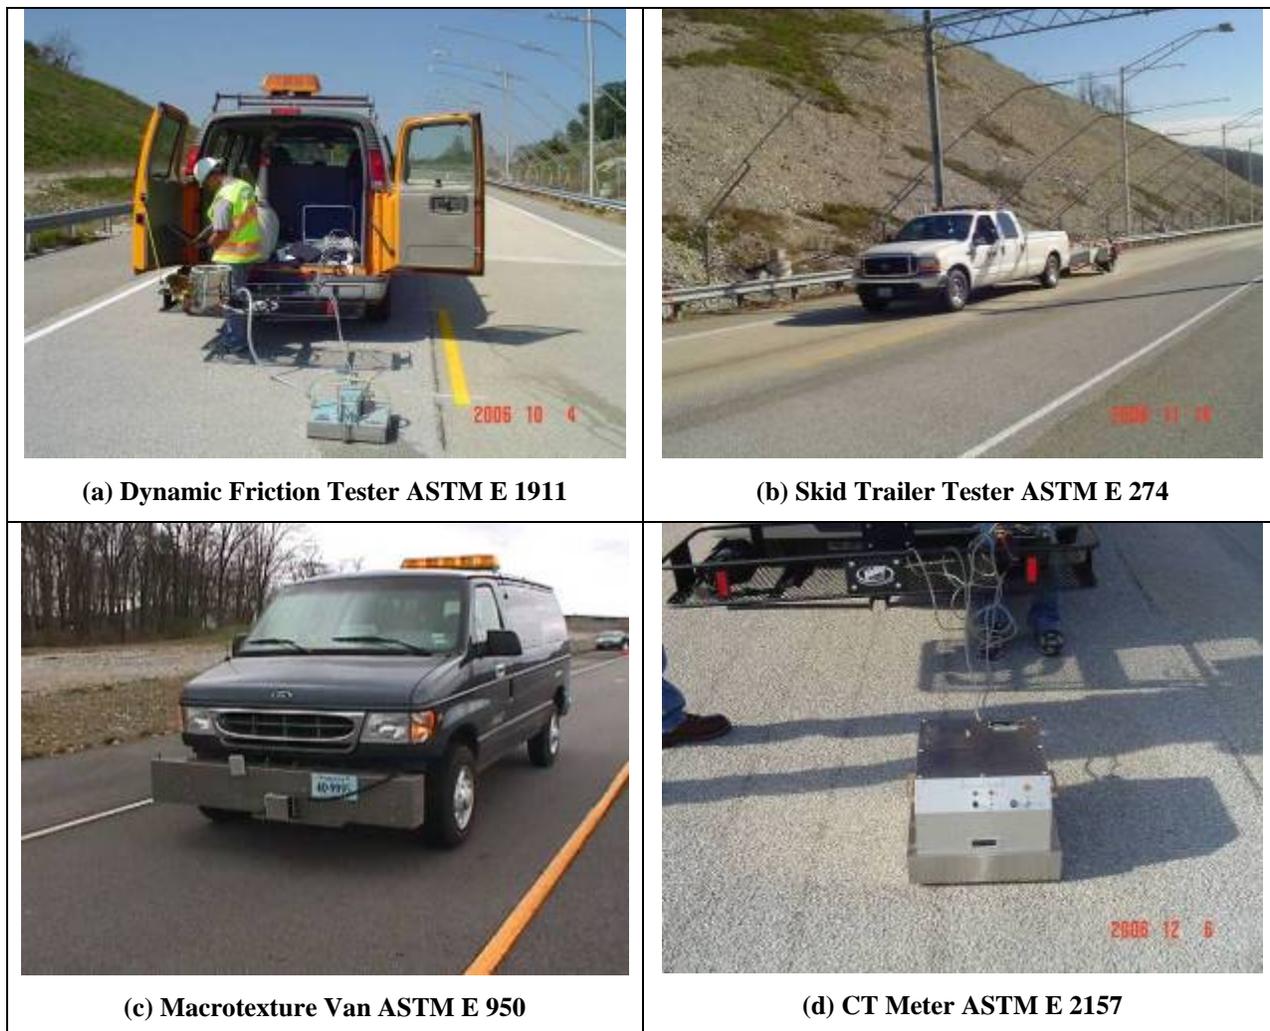
Figure 8. Friction and Macrotexture Measuring Devices Used

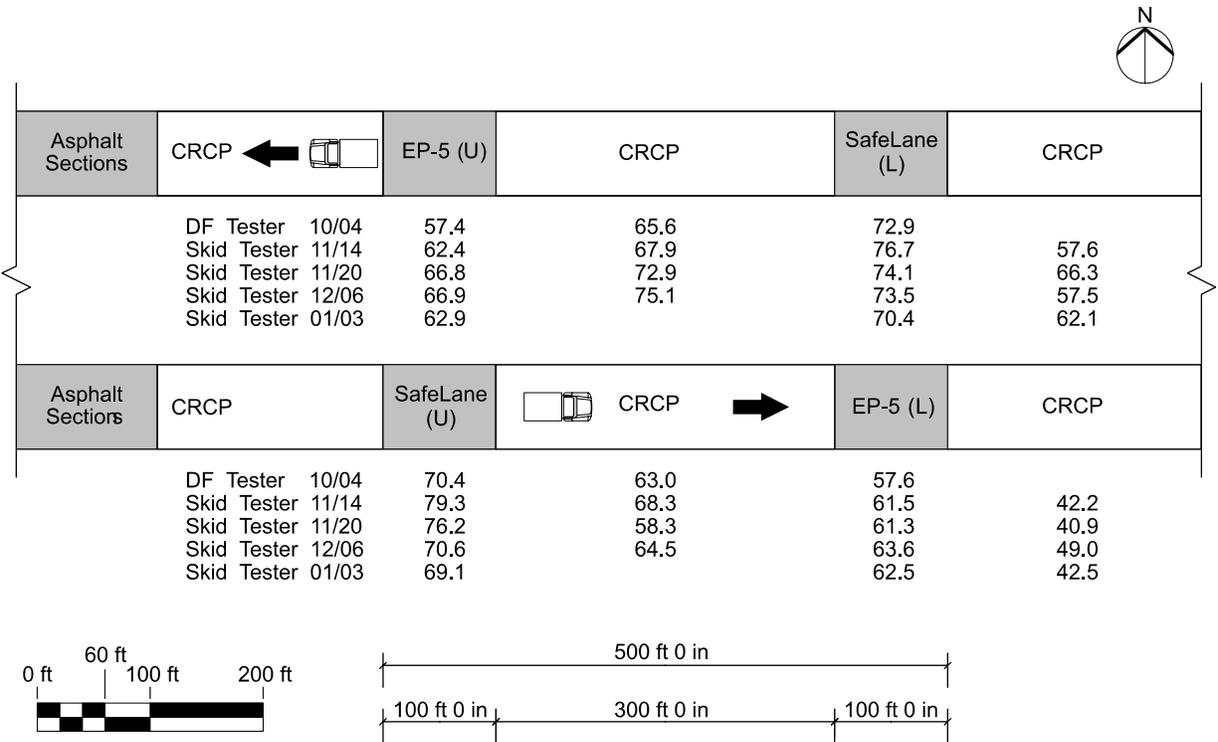
**Figure 9. Initial Friction Test Results at Smart Road. CRCP = continuously reinforced concrete pavement, U = upper, L = lower.**

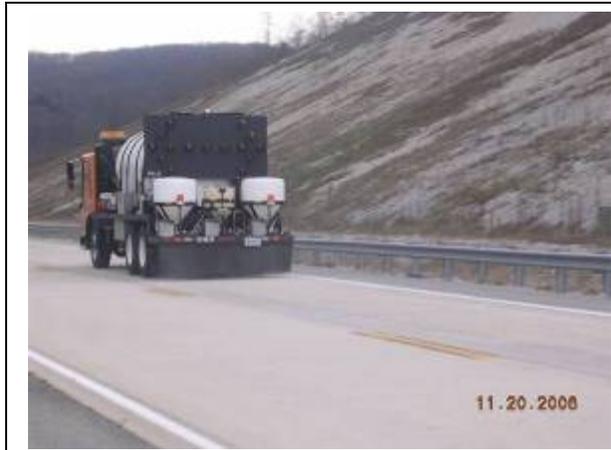
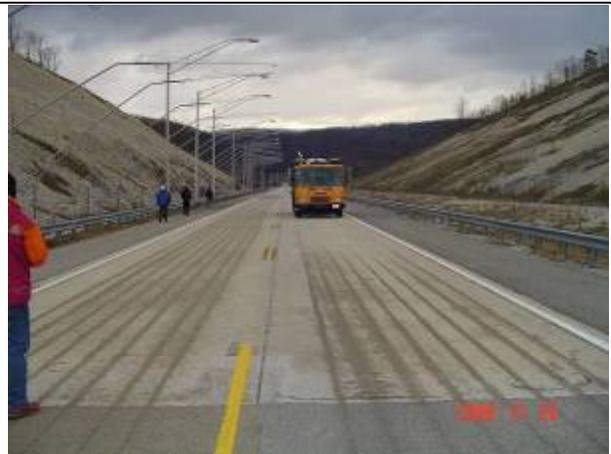
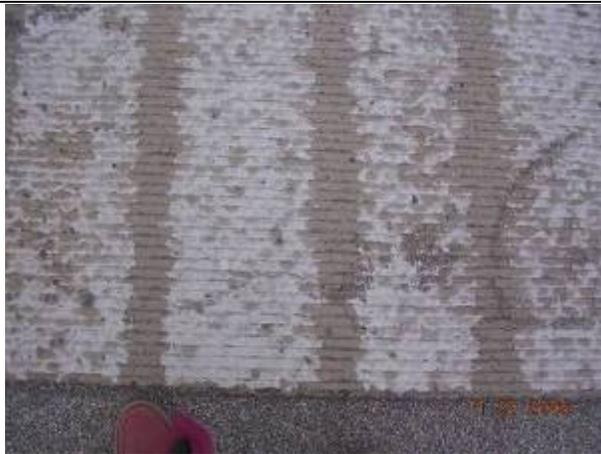
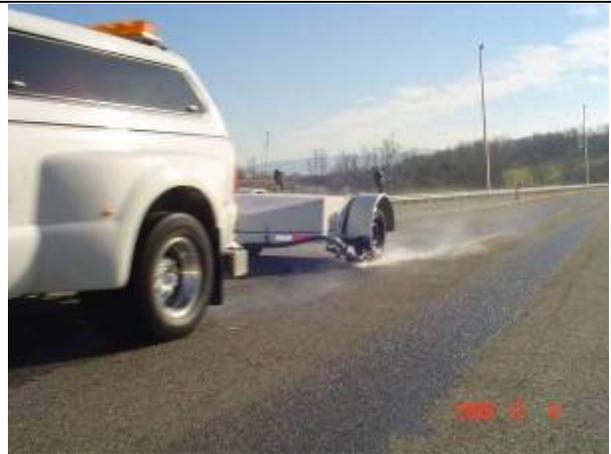
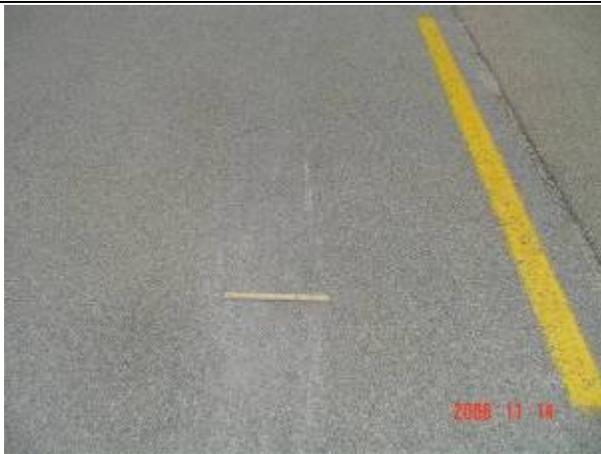
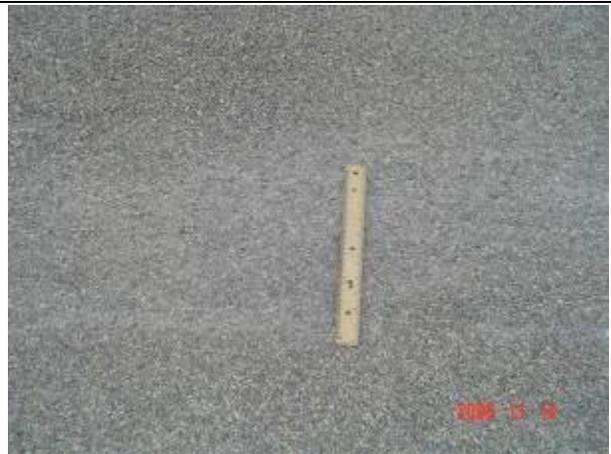
(a) Brine spreader

(b) Brine application marks

(c) Close-up of application marks

(d) Skid test

(d) Skid mark

(e) Close-up of skid mark

Figure 10. Brine Application, Initial Friction Testing, and Skid Marks at Virginia Smart Road

On November 20, 2006, both SafeLane sections and one of the VDOT modified EP-5 and CRCP sections were treated by a spray truck that applied salt (NaCl) brine liquid at a rate of 30 gal/lane-mile. The three sections (VDOT modified EP-5, CRCP, and SafeLane) on the WB lane were treated, and only the SafeLane section in the EB lane was treated. After the surfaces were dry, the skid trailer tester measured friction on these sections again. The truck covered an area only approximately 9 ft wide, and the application speed was low; thus, not all of the lane width was covered. The coverage was not very uniform; approximately 20 ft of the EB SafeLane section was not uniformly treated.

Better results were obtained with the revised procedure, which produced a more uniform coverage of the treated sections. After the surfaces were dry, the skid trailer tester measured friction on these sections again. Figure 10 shows photographs taken during the application of the brine and the skid marks left after the ASTM E204 friction tests. The schedule of subsequent applications and friction tests is presented in Table 10. No friction tests were conducted during the second set of treatments during the winter of 2007-08.

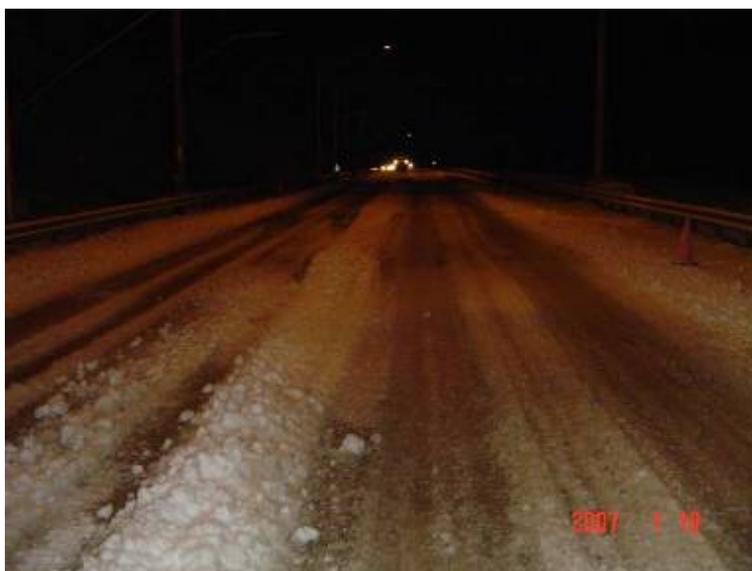
**Figure 11. Snow Accumulation During First Snow Experiment (January 18, 2007) at Virginia Smart Road**

The first experiment was used to refine the testing protocol. The snow accumulated faster than natural snow would accumulate (Figure 11) and, thus, did not represent typical conditions under natural snow. As a result of this preliminary test, the snow nozzles were replaced before the final two tests in February to slow down the rate of snow accumulation.

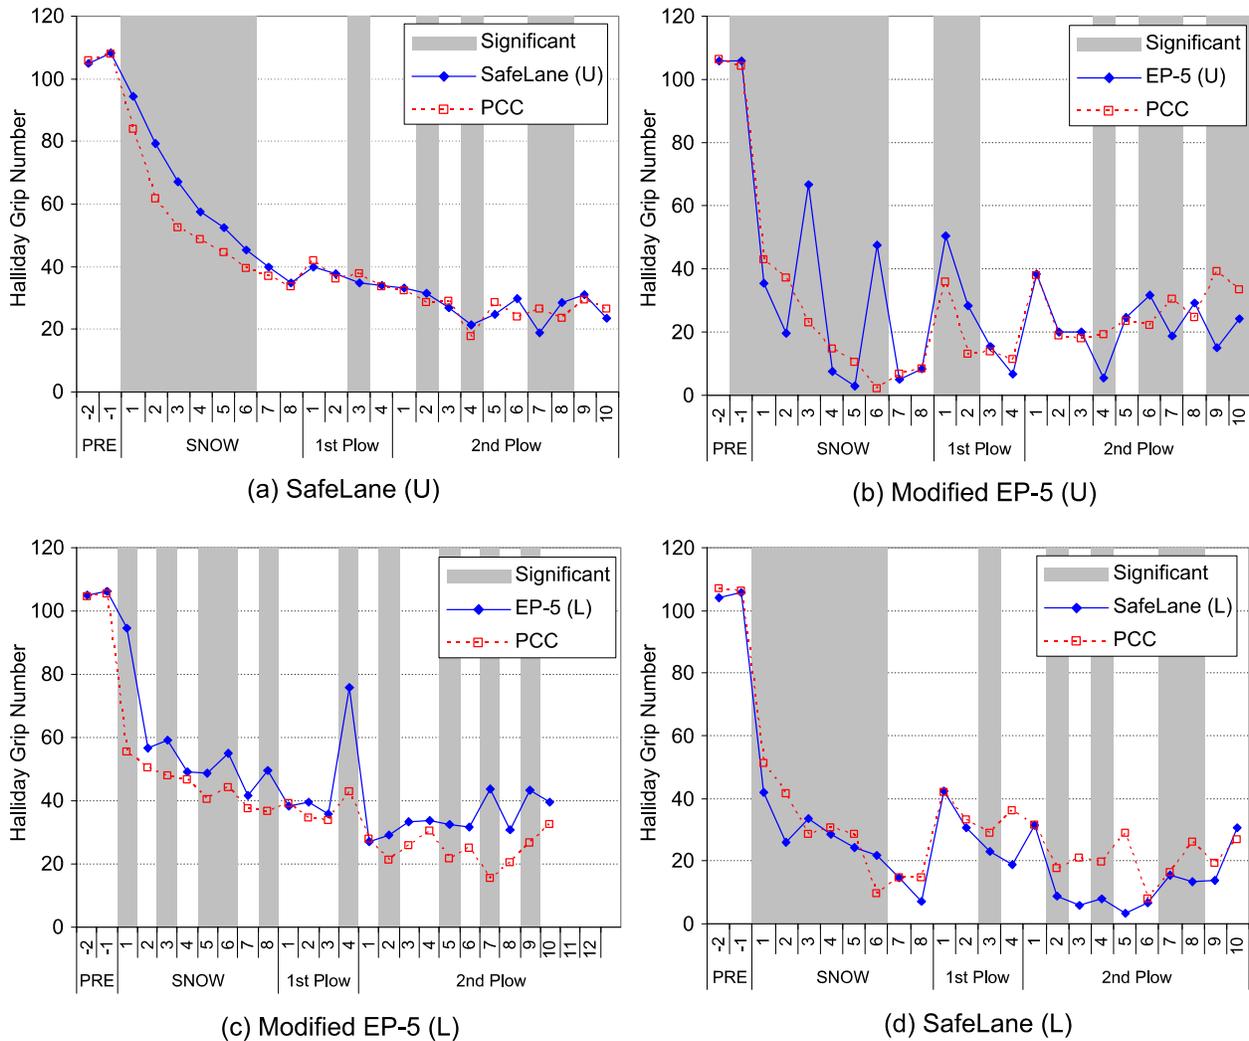
**Figure 12. Friction Comparison for First Snow Experiment (January 18, 2007) at Smart Road. Significant = passes for which results were statistically significant using a *t*-test with a 5% level of significance; U = upper; PCC = portland cement concrete; L = lower.**

The friction measurements are summarized and presented in Figure 12. The various plots compare the average friction results (measured every 0.1 sec) on the overlays with those of the closest bare-tined CRCP section. The shaded areas indicate the passes for which the results were found to be statistically significant using a *t*-test with a 5% level of significance. The results presented in Figure 12 show a statistically significant positive effect of both overlay treatments before the first plowing in the EB (downhill) direction. Both sections provided higher friction at the beginning of the experiment, which simulates the beginning of the precipitation storm before the snow-fighting crews begin treating the road. After the plowing, the friction values were similar. A consistent difference in friction was not found in the WB (uphill) direction. It is

hypothesized that this could be due to the very fast accumulation of snow on this WB lane, which was closer to the snow-making towers. This was one of the factors prompting the decision to replace the nozzles to reduce the rate of snow generation as discussed previously.

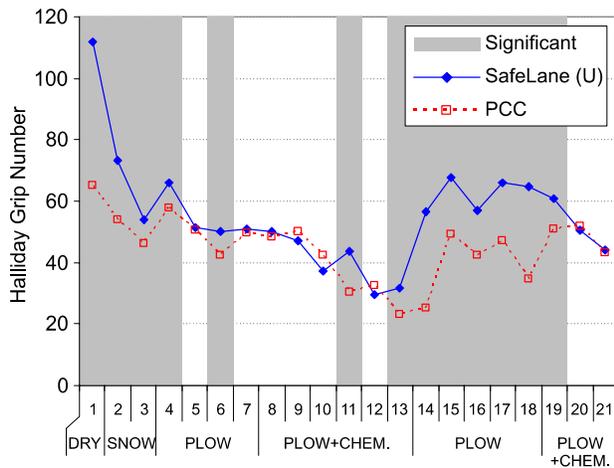
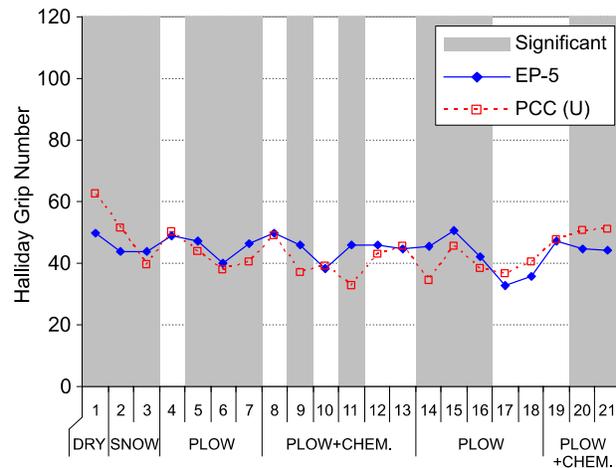
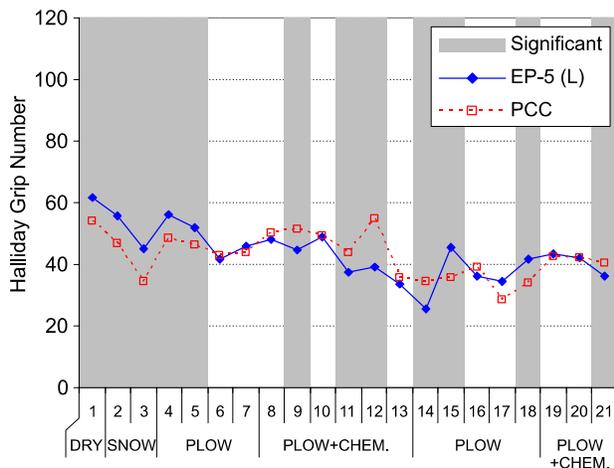
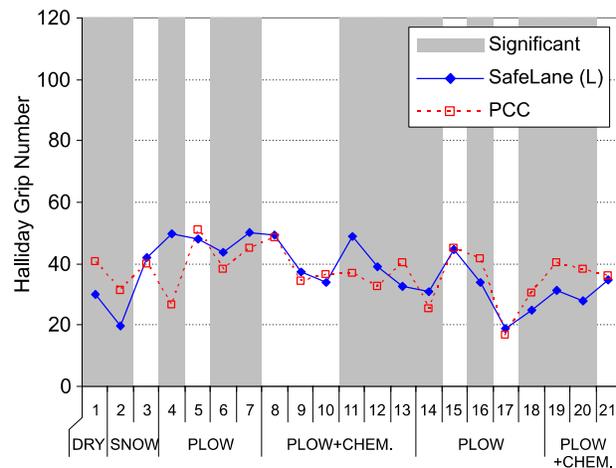
**Figure 13. Friction Comparison for Third Snow Experiment: January 31, 2007 (P.M.). Significant = passes for which results were statistically significant using a *t*-test with a 5% level of significance; U = upper; PCC = portland cement concrete; L = lower.**

The friction measurements collected are summarized in Figure 13. The results are similar to those obtained in the first experiment; the SafeLane and VDOT modified EP-5 sections in the EB (downhill) direction maintained higher friction than their respective adjacent bare-tined

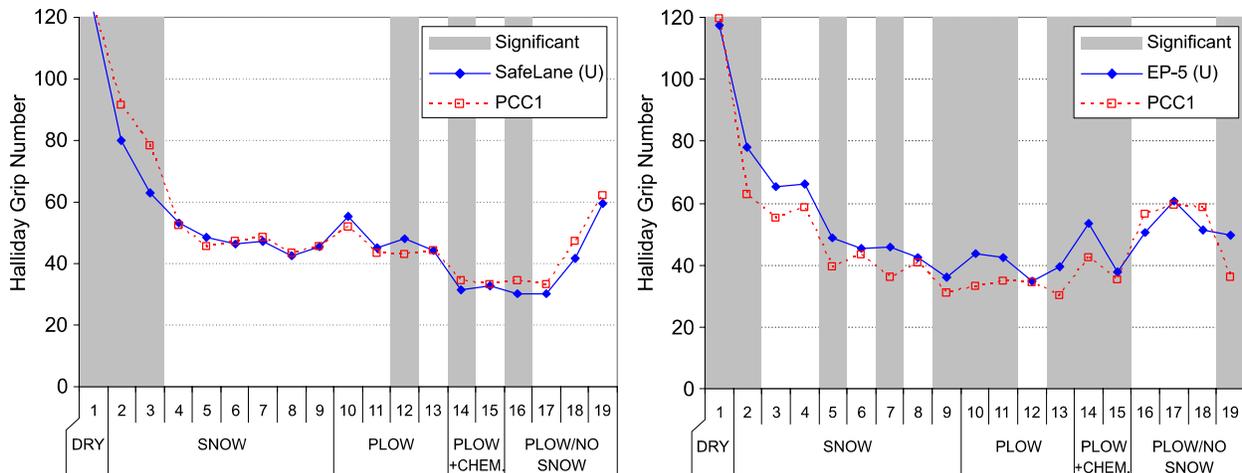
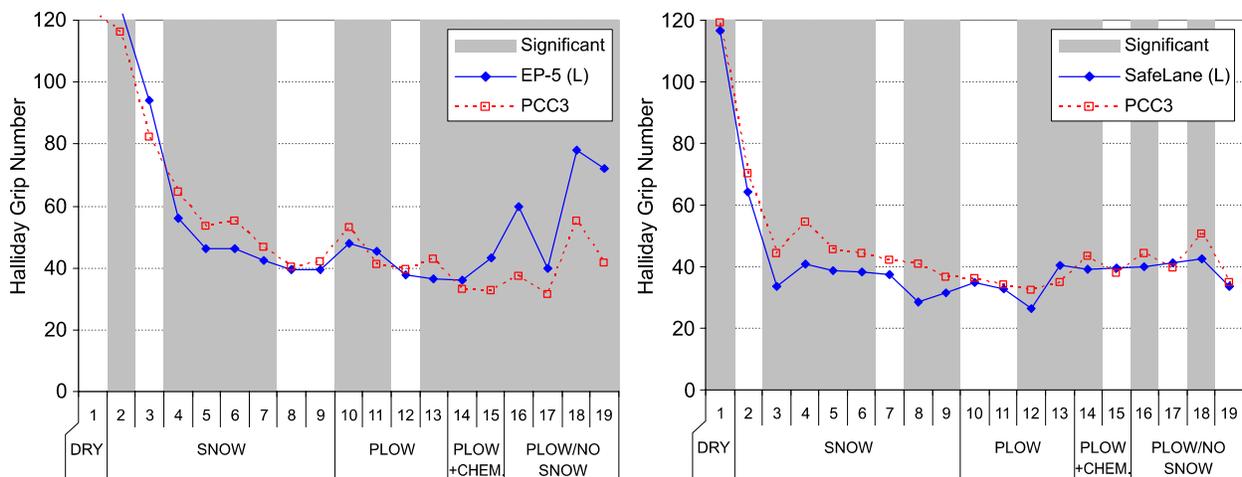
(a) SafeLane (U)

(b) Modified EP-5 (U)

(c) Modified EP-5 (L)

(d) SafeLane (L)

These tests were conducted using the smaller nozzles (No. 5005) and the final experimental protocol that called for the plowing to be triggered by the friction number (see Appendix D). Table 13 summarizes the experiment, and Figure 14 presents the friction measurements. No consistent significant skid resistance benefit in snow from the two-layer SafeLane or two-layer VDOT modified EP-5 overlay was found in this experiment.

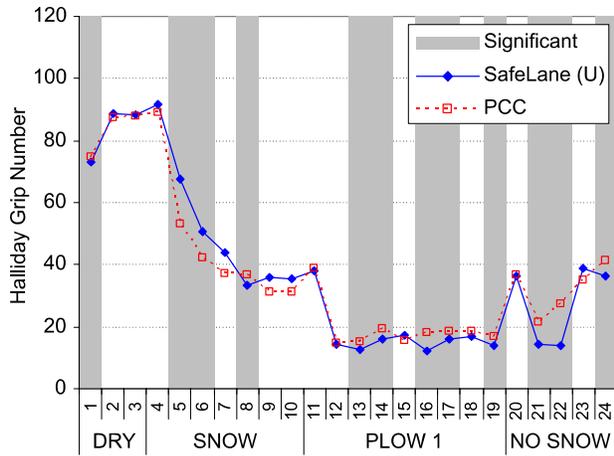
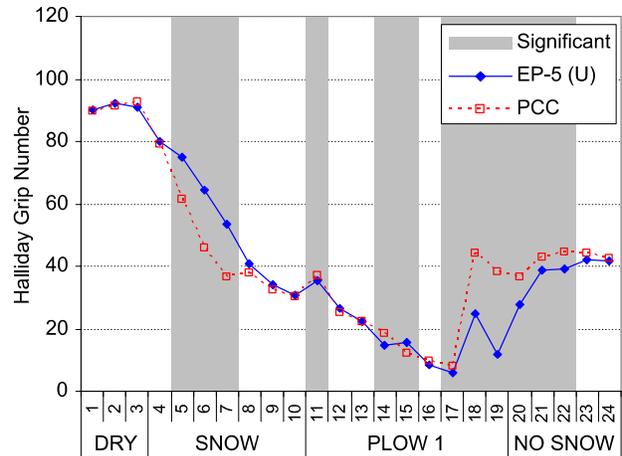
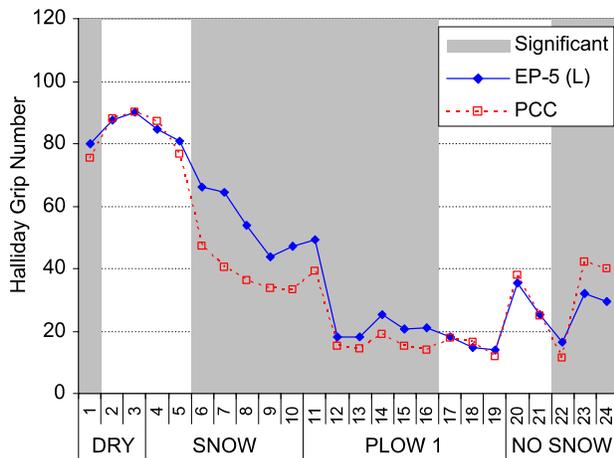
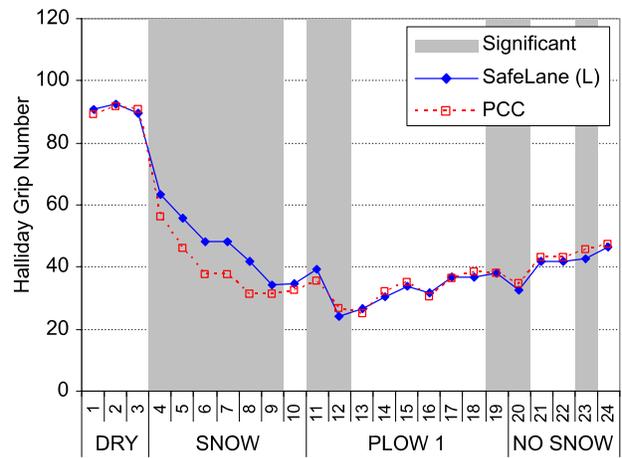
**Figure 15. Friction Comparison for Fifth Snow Experiment on Smart Road: February 19, 2007. Significant = passes for which results were statistically significant using *t*-test with 5% level of significance; U = upper; PCC = portland cement concrete; L = lower.**

In the final test, the snow was of good quality, but, unfortunately, once more, not all towers were working and the snow coverage was not uniform. In this case, the downhill (WB) sections were getting more snow cover because of the wind. The measured friction values are presented in Figure 15, and the log with the main events of the test is summarized in Table 14. The friction measurements showed either no difference or a statistically significant improvement in the friction values before the first plowing in the four overlay sections investigated with respect to the corresponding adjacent bare-tined concrete sections. On the other hand, it is interesting to note that the first plowing was not effective on any of the surfaces as the friction values measured were lower after the plowing. Friction started to improve after the snow was stopped.

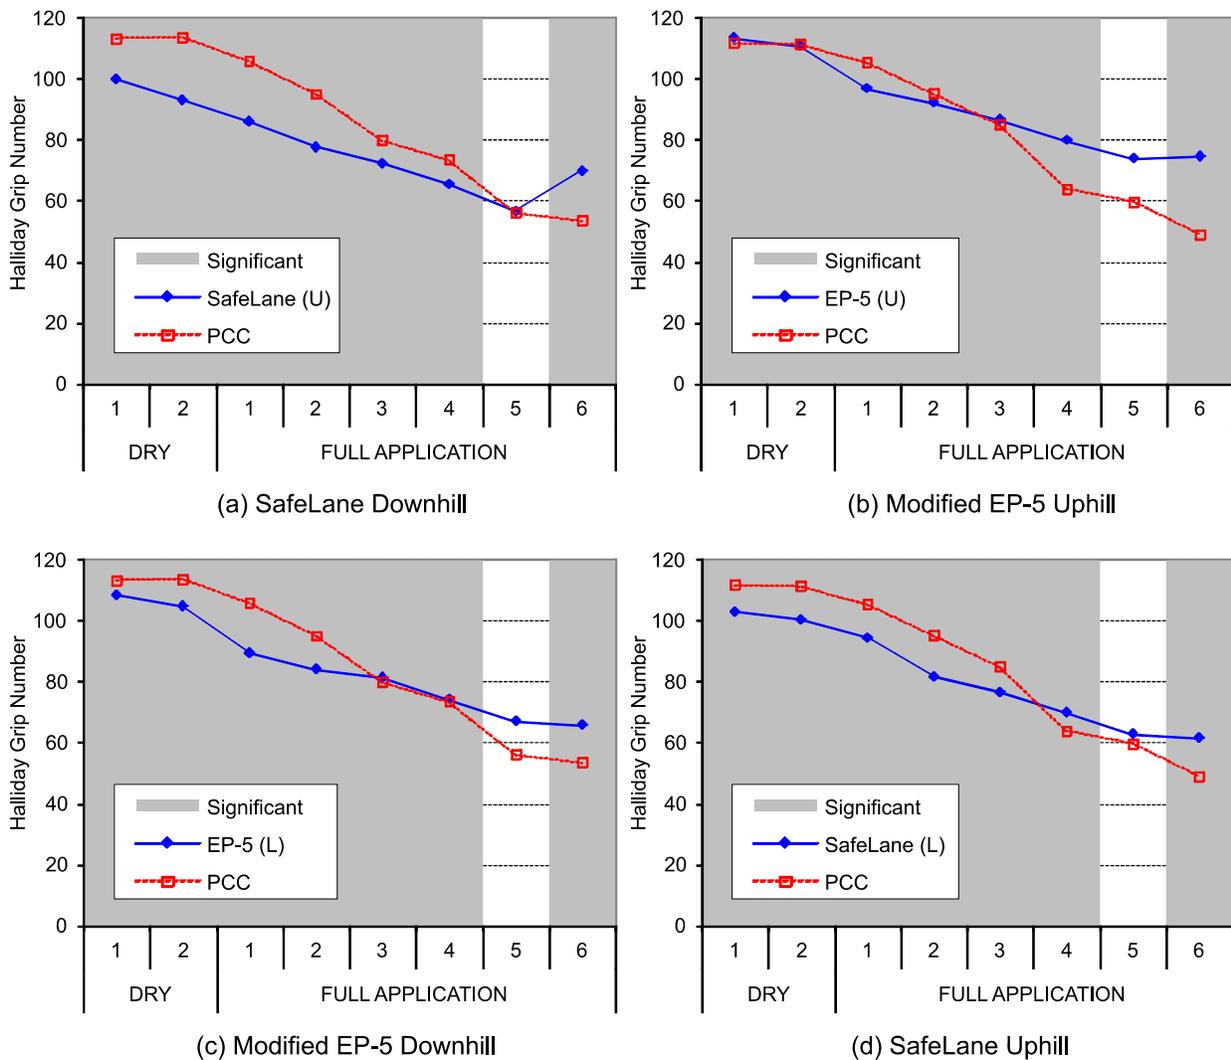
Figure 16. Friction Comparison for Ice Experiment, First Phase, 2/27/08. Significant = statistically significant; PCC = portland cement concrete; U = upper; L = lower.

A final testing event was performed to simulate the formation of ice on a road . For this purpose, a tractor with a liquid sprayer was retrofitted with small nozzles to spray a very fine mist of water that upon contact with the surface at freezing temperatures formed a very thin layer of ice on the road. Testing started when the pavement temperature reached 28° F. Two measurements were conducted on dry pavement before water was turned on to form the ice. Six passes with the water sprayer were made on the entire length of the testing sections (referred to as Full Application), which covered the four overlaid sections and the concrete pavement in between them. The continuous friction measurements (RGT) obtained during this first phase are presented in Figure 16. These measures show that at the beginning of the experiment the overlaid sections had lower friction than the adjacent bare concrete pavement. After the fourth or fifth pass water sprays, the friction of both overlaid sections started to improve.

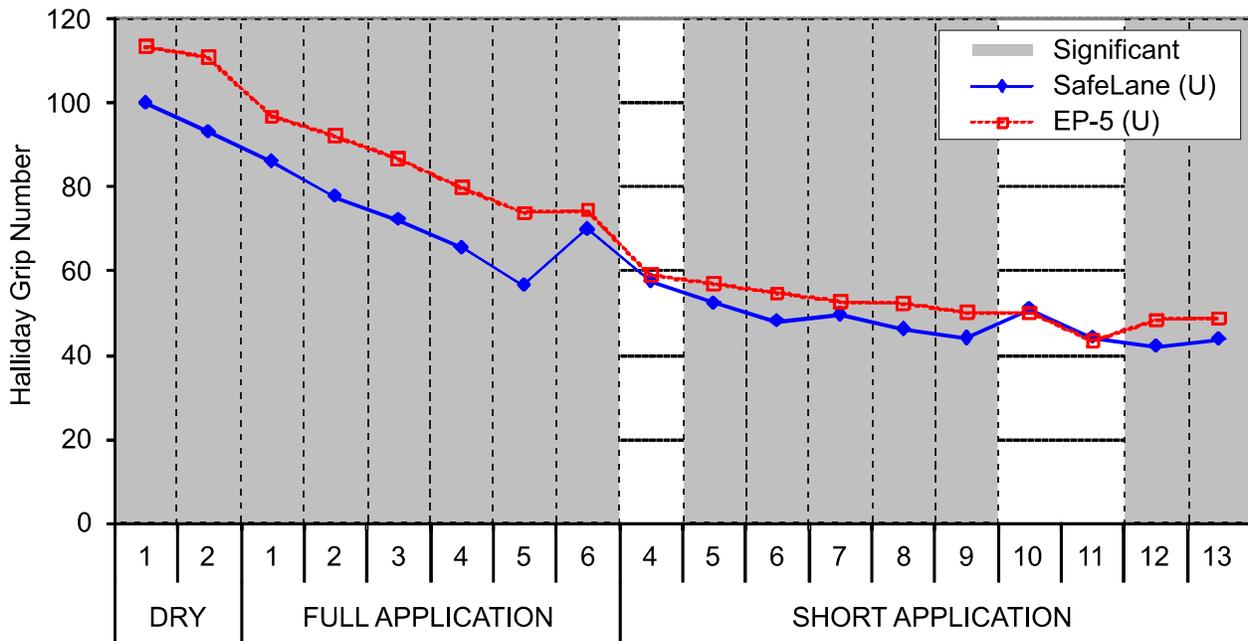
**Figure 17. Friction Comparison for Ice Experiment, Second Phase, 2/27/08. Significant = Statistically significant, U = upper.**

Unfortunately, all the water deposit on the tractor was used before a significant ice layer was formed on all the sections, thus forcing the experiment to be halted and continued after the tank was refilled. Because spraying all the sections was consuming too much time, a decision was made to spray only the adjacent top overlay sections in a shorter loop maneuver. This was done to form a thicker layer of ice on the road at a quicker rate. Figure 17 compares the continuous friction measurements on the two top overlay sections for both phases (Full/Short Applications). No comparison was made with the adjacent concrete sections since they were not sprayed with water in the second phase of the experiment. The first three passes of the Short Application were not measured. The shaded areas indicate a significant difference among the average measurements. All statistical tests were performed using a two-tailed *t*-test with different standard deviations of the samples with a significance level of  $\alpha=0.05\%$ .

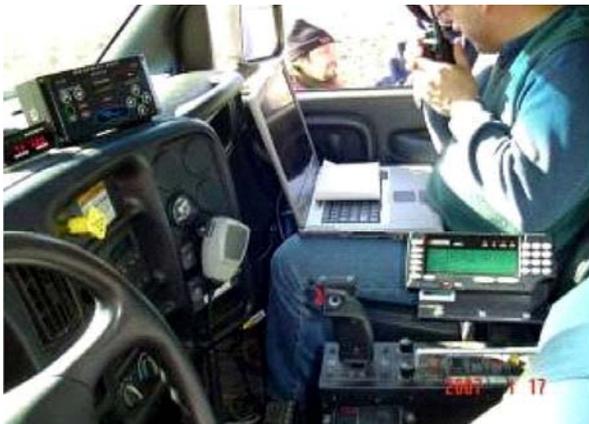
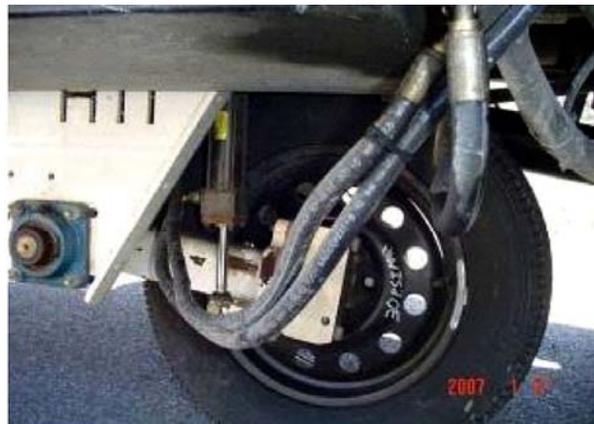
(a) Inside display units

(b) Fifth wheel

**Figure B1. Road Grip Tester Installed in Plow Truck**

Both methods produced abundant data. On a typical test day, about 3,000 records of 2-sec data and about 40,000 of the 0.1-sec data were recorded per hour. The RGT inside displays units are shown in Figure B1(a), and the friction wheel located under the truck in Figure B1(b).

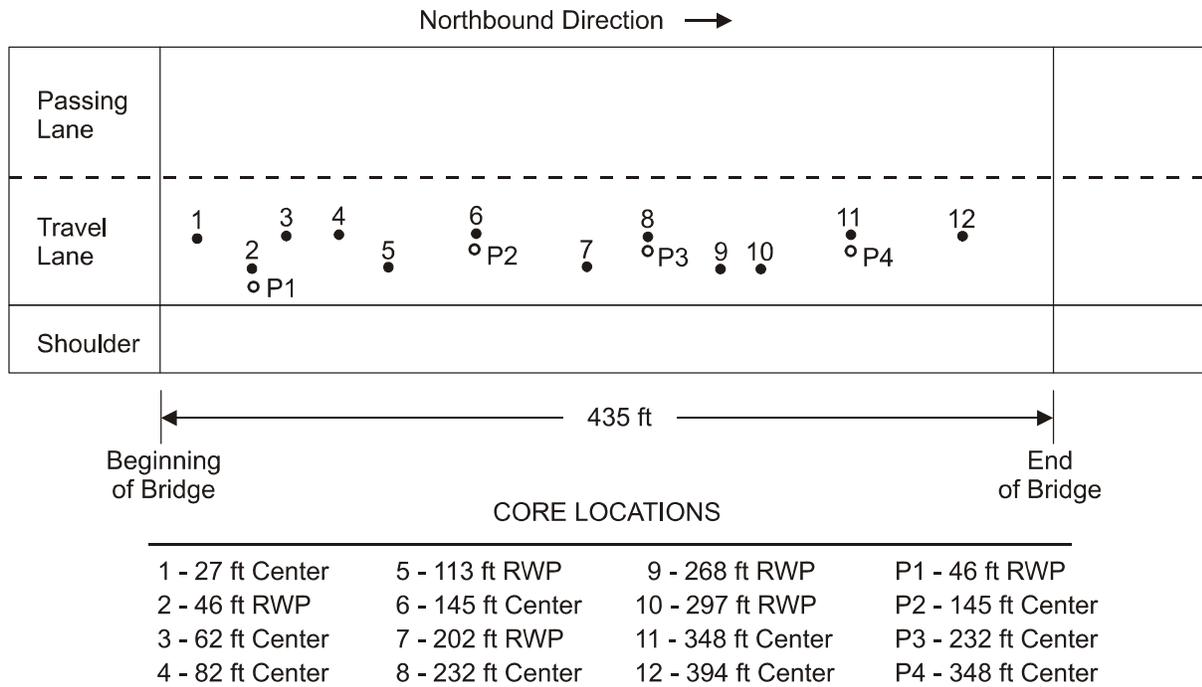
Structure Number: 2024

Cores 1 - 12 => 2 1/4 in diameter cores for tensile strength testing

Cores P1 - P4 => 4 in diameter cores for permeability to chloride ion testing

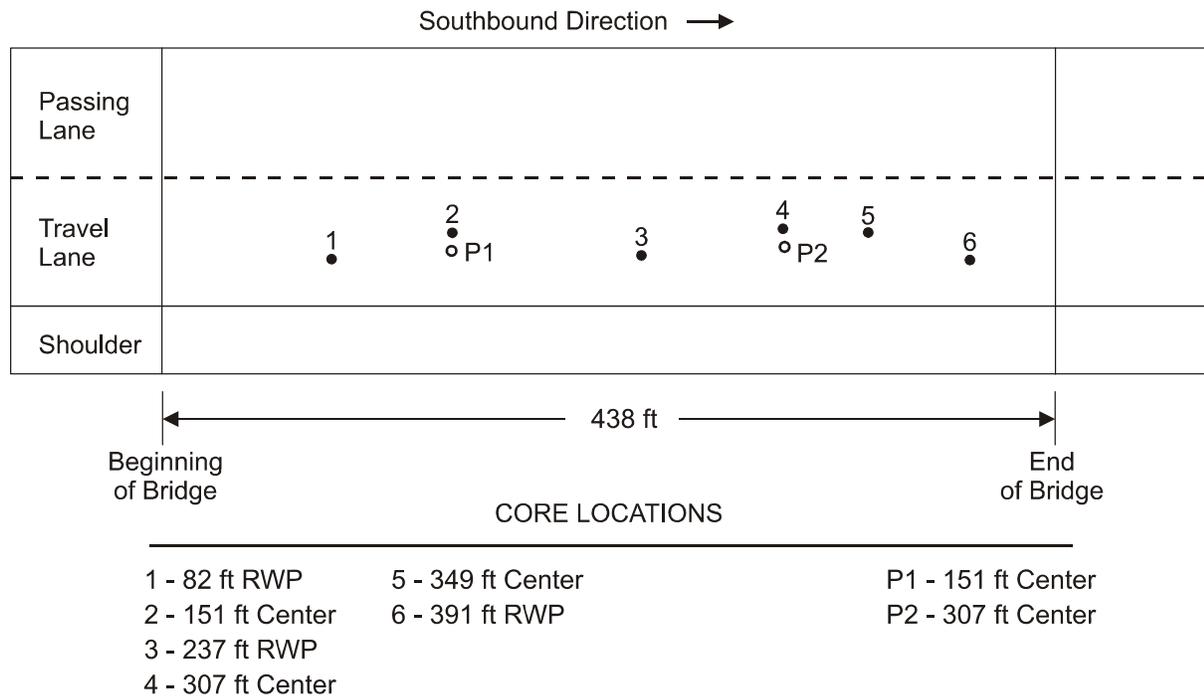
Structure Number: 2025

Cores 1 - 6 => 2 1/4 in diameter cores for tensile strength testing

Cores P1 - P2 => 4 in diameter cores for permeability to chloride ion testing
