*Final Report VTRC 09-R8*

## Evaluation of the Cargill SafeLane™ Surface Overlay

**EVALUATION OF THE CARGILL SAFELANE™ SURFACE OVERLAY**

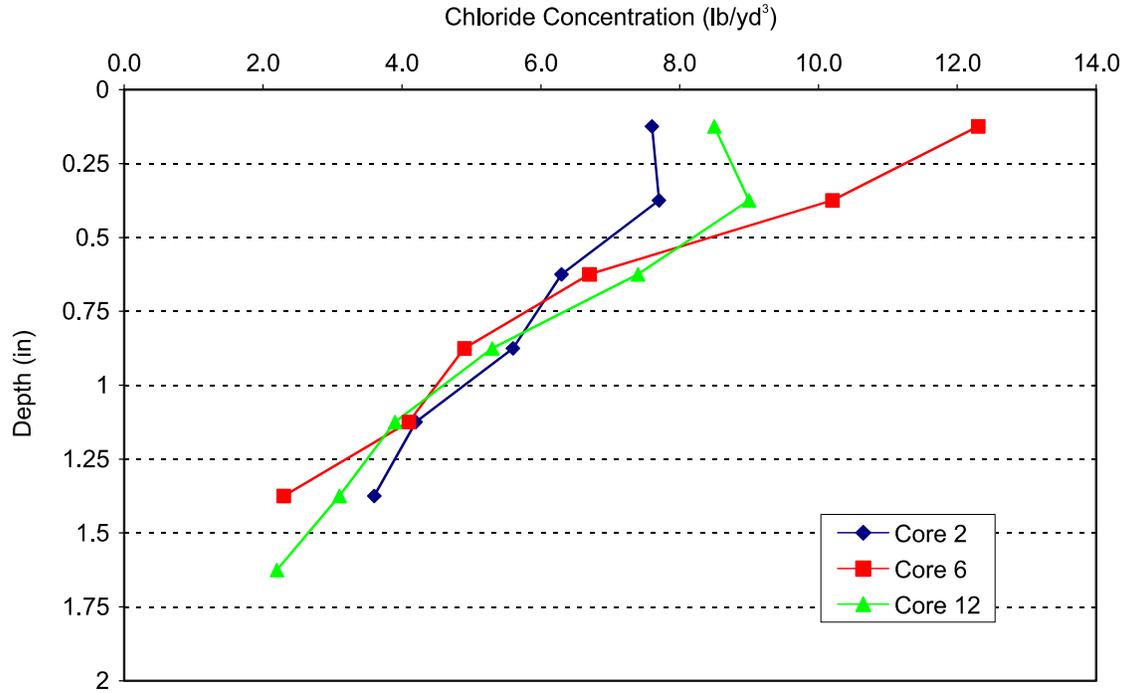
Figure F1. Chloride Profiles: I-81 NBL, Structure 2024, SafeLane with Blended Aggregate

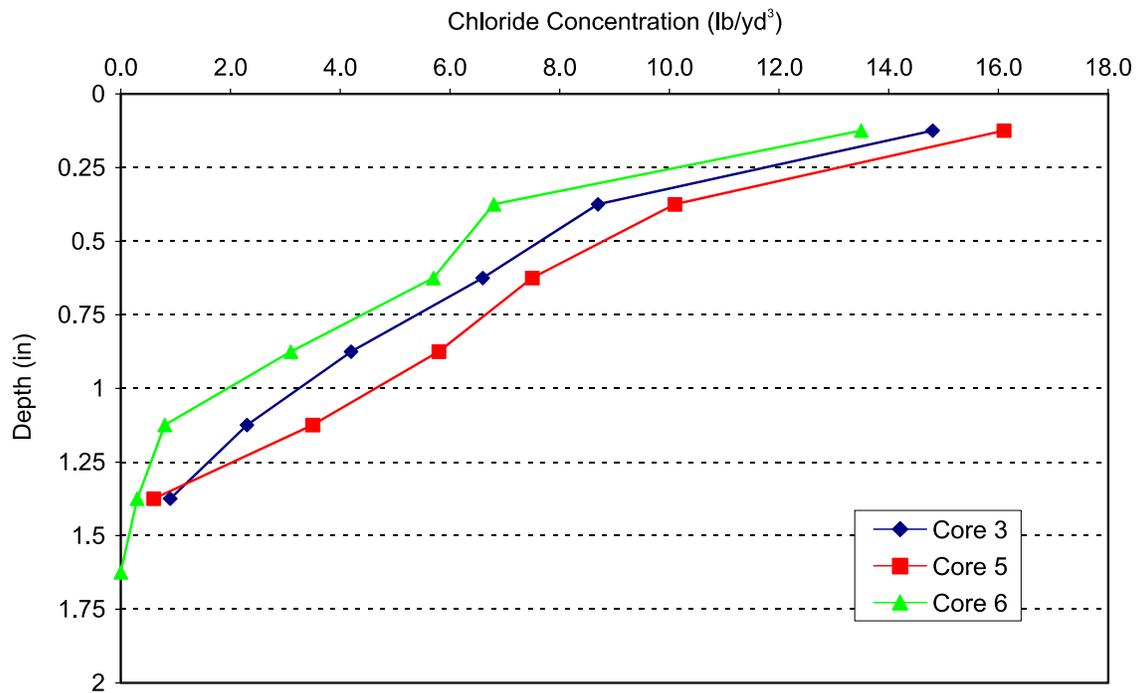
Figure F2. Chloride Profiles: I81 SBL, Structure 2025, One-Layer VDOT Modified EP-5

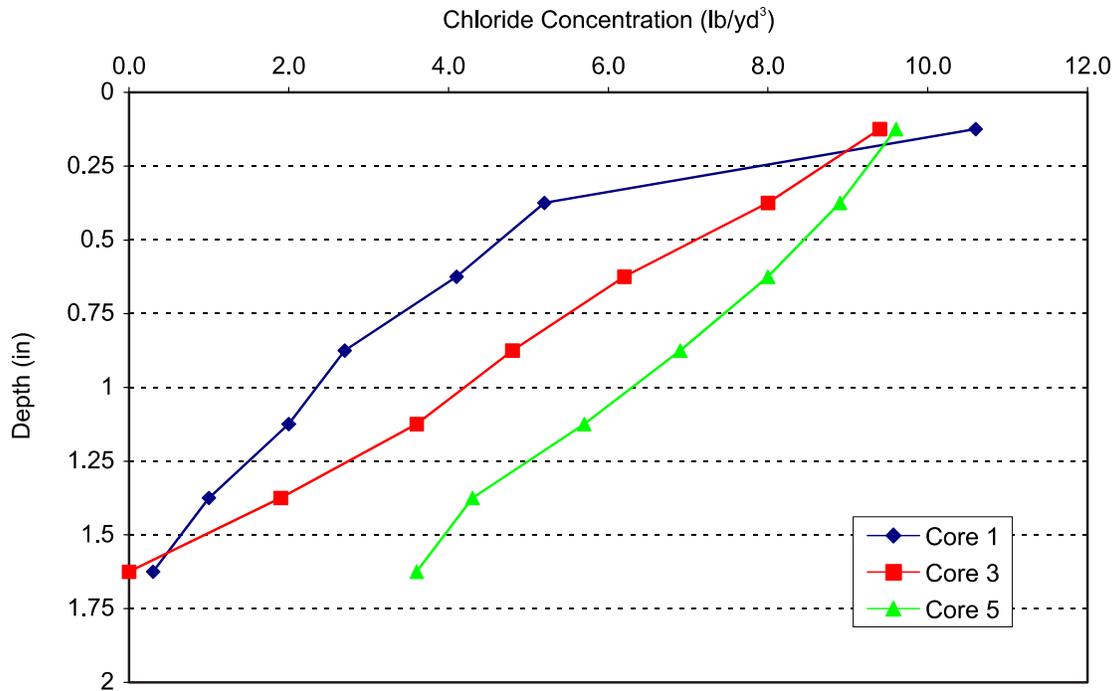
Figure F3. Chloride Profiles: I81 NBL, Structure 2036, One-Layer VDOT Modified EP-5

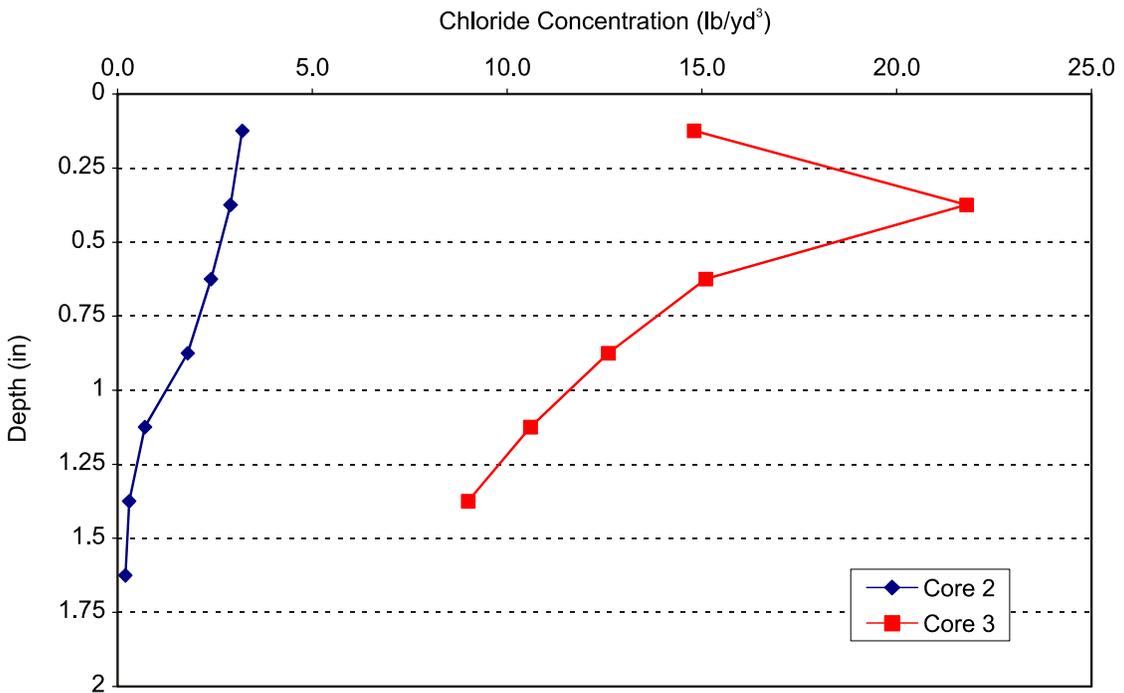
Figure F4. Chloride Profiles: I-81 SBL, Structure 2037, SafeLane
