FINAL
CONTRACT REPORT
VTRC 08-CR5

**PARAMETERS GOVERNING
THE CORROSION PROTECTION EFFICIENCY
OF FUSION-BONDED EPOXY COATINGS
ON REINFORCING STEEL**

Standard Title Page - Report on State Project

FINAL CONTRACT REPORT

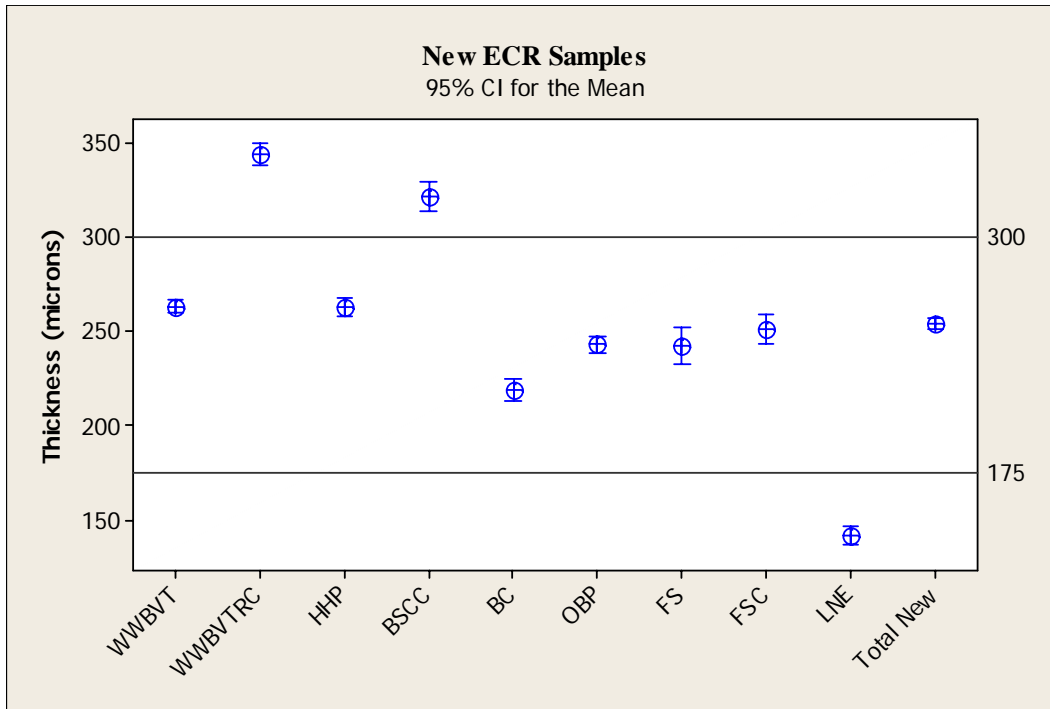
The average thickness measurements and the 95% confidence intervals are presented in Figure 6 for the individual samples with the minimum and maximum specified thickness represented by the two horizontal lines at 175 μm and 300 μm . Three sample sets, WWBVDOT, BSCC, and LNE failed to meet the current coating thickness specifications. The average thickness of WWBVDOT is 344 μm with a standard deviation of 46 μm , and the average thickness of BSCC is 321 μm with a standard deviation of 60 μm . The average thickness of both sample sets is above the maximum current specification. Inversely, the average thickness of LNE is below the current specified minimum of 175 μm at 141 μm with a standard deviation of 34 μm .

Figure 6. New ECR Coating Thickness

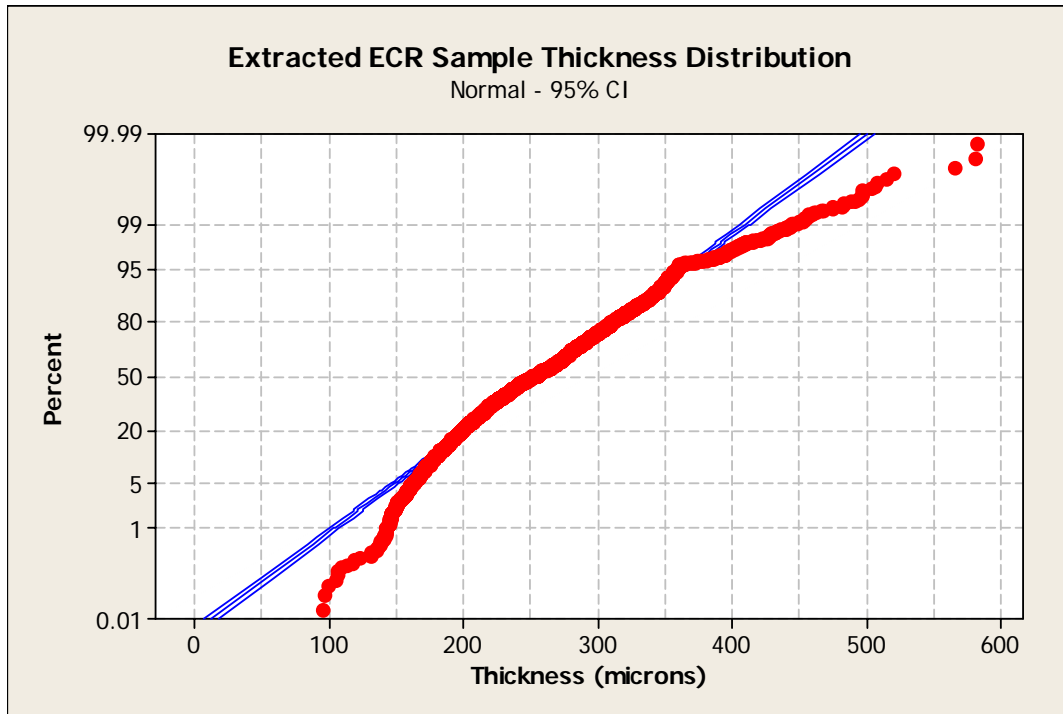
The thickness measurements were performed at 6 random locations along the bar sample. Three measurements were taken at each of the 6 locations and the results averaged. As illustrated in Figure 8, the thickness measurements were normally distributed.

Figure 8. EECR Epoxy Coat Thickness Measurements Distribution

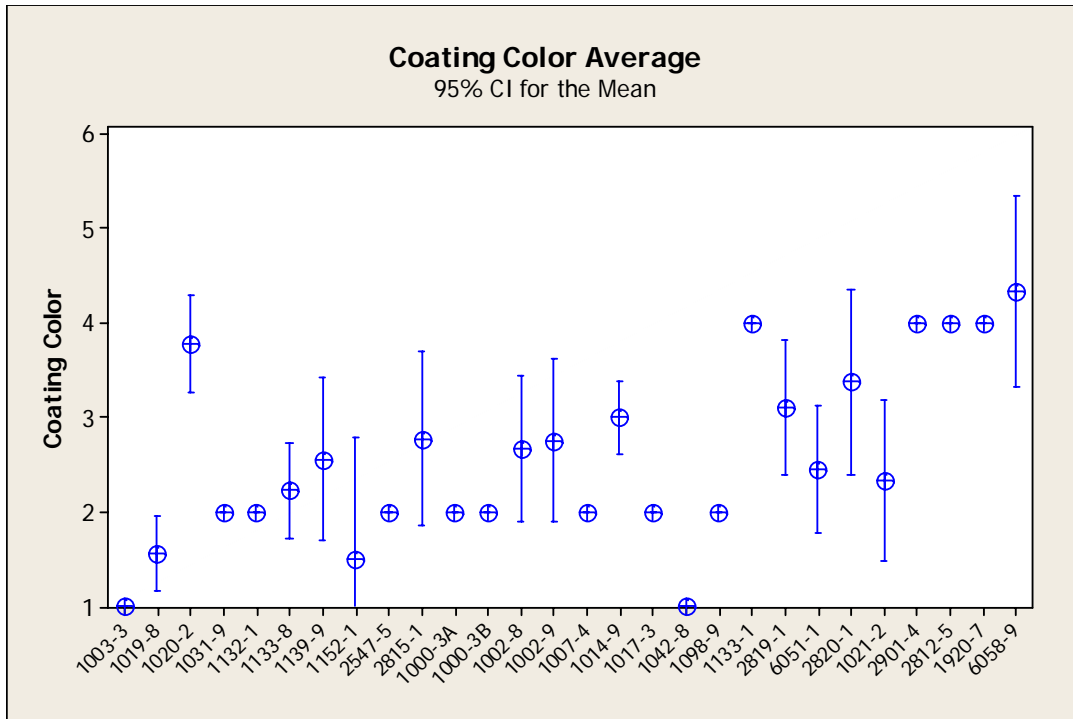
Since a change in color from the original glossy green can be an indicator of coating degradation, this color change was recorded on a scale from 1 through 5, and the interpretation scale is presented in Methods and Materials. From the sample population, the coating color of two structures showed no apparent change from new. The structures were 1003-3 and 1042-8. The remaining structures all presented some degree of coating color degradation with most experiencing loss of gloss rather than pigmentation. The distribution of color values is presented in Figure 10, while the mean and the standard deviation of each structure are presented in Figure 11.

Figure 11. EECR Coating Color

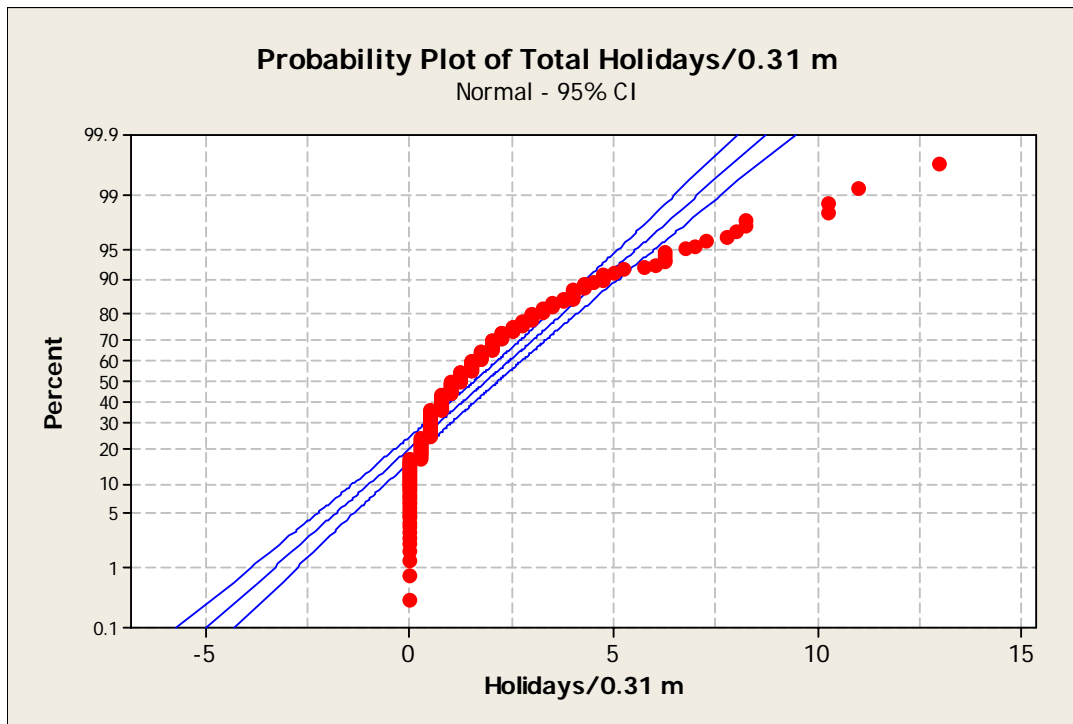
line at 1 holiday/0.31m. The number of holidays/m is also highly positively skewed as shown in Figure 15.

Figure 15. EECR Holiday Probability Plot

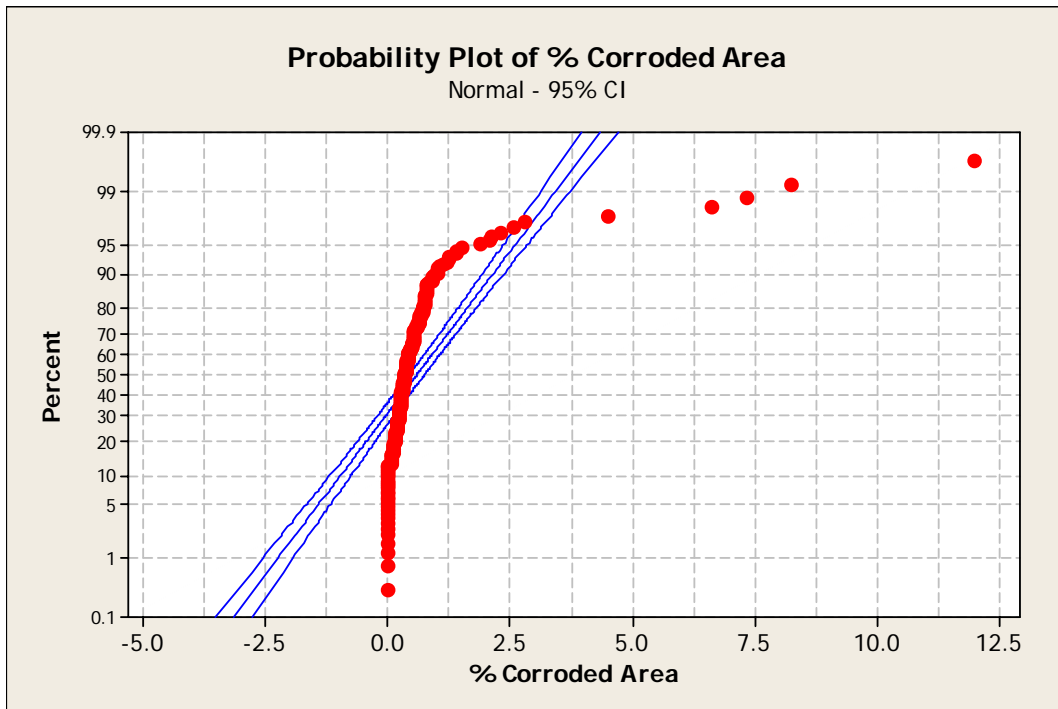
The probability distribution of the measured percent corroded area followed a pattern similar to the holidays and the number of damages as illustrated in Figure 18. As with the number of damages, there were no structures showing absolutely no signs of corrosion although there were individual bars that showed no visible signs of corrosion. The average percent corroded area and the standard deviation of each structure are presented in Figure 19. Out of 244 specimens, 28 showed no visible signs of corrosion leaving 216 specimens with corrosion ranging from a low of 0.05% to a high of 12%. From the investigated structures, 1132-1 showed the least average amount of visible corrosion with 0.15% corroded area and a standard deviation of 0.14. Structure 2820-1 had the greatest corrosion with an average of 3.57% corroded area and a standard deviation of 3.49. The total average for the sample population is 0.59% corroded area with a standard deviation of 1.22.

Figure 18. EECR Percent Corroded Area Probability Plot

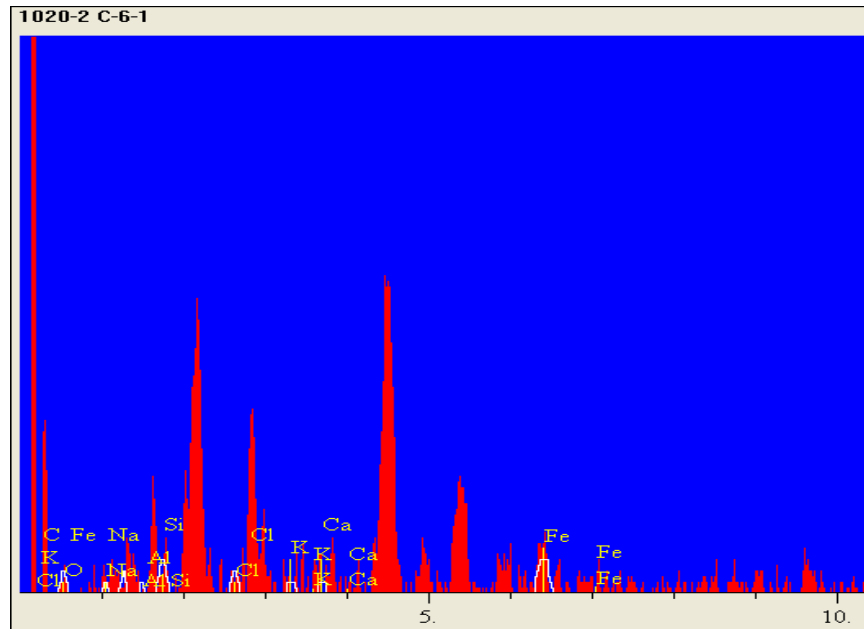
The spectrum at location 1 (Figure 28) would indicate that the pore in the coating is continuous to the steel substrate. Although the signals are weak due to interference from the

pore walls, iron still presents the strongest peak, followed by silica, chloride, potassium and calcium, which may all be found in the concrete pore solution. Location 2 (Figure 29) spectra is dominated by the carbon signature as expected from an organic coating. There are traces of other elements that are commonly found in concrete or the concrete pore solution. This is due to adsorption of the pore solution on the coating surface. Finally, the third spectrum (Figure 30) illustrates the typical signature of cement. There is no carbon present, as expected from an organic coating, but the calcium and the silica signatures dominate.

Figure 28. EDS Spectra 1020-2 C-6-1

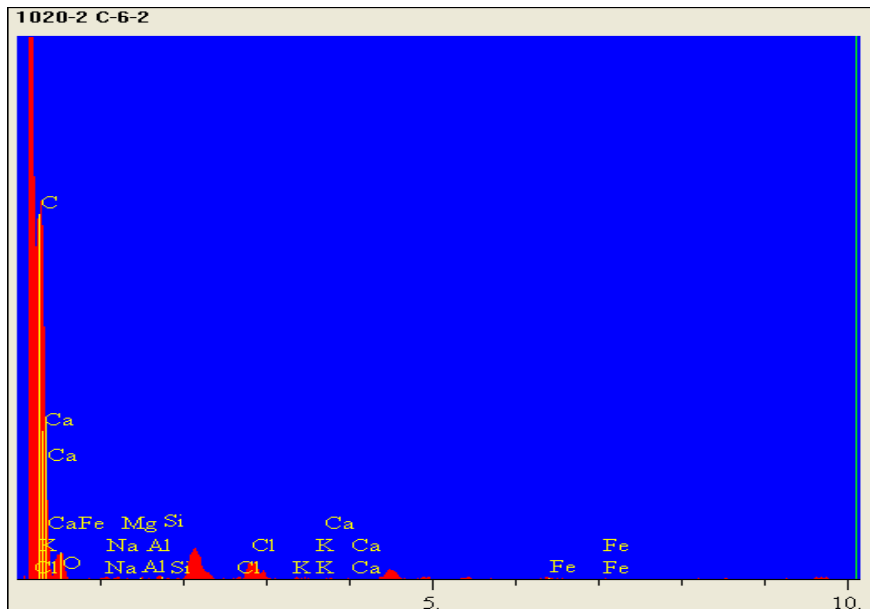
Figure 29. EDS Spectra 1020-2 C-6-2

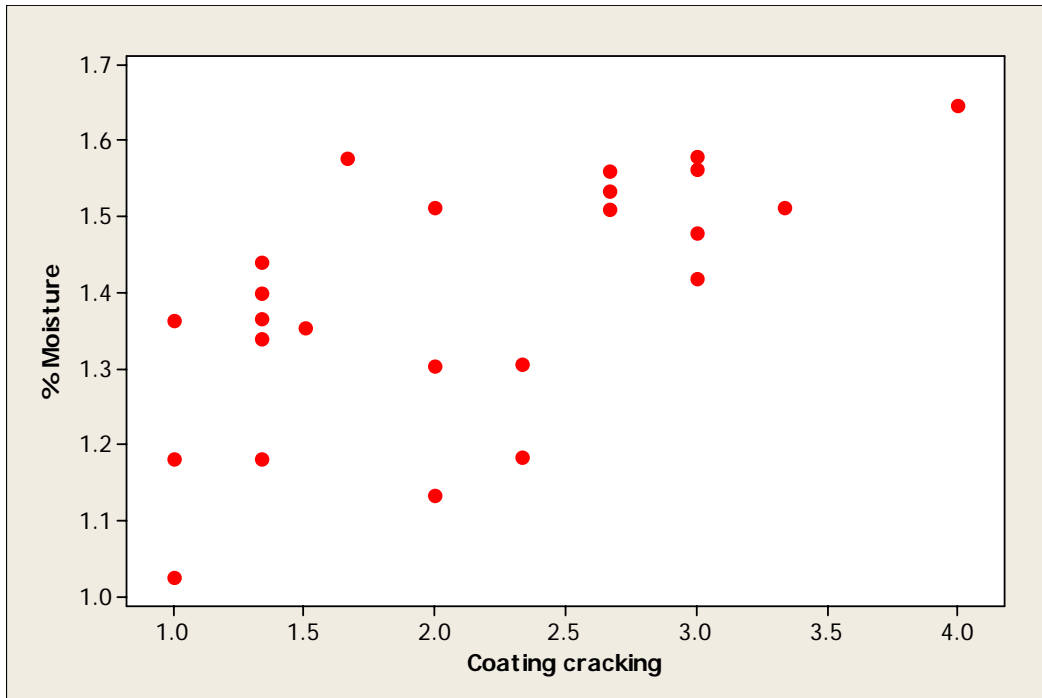
While the change in coating glossiness and/or color, residual adhesion, and the color of the corrosion products under the coating may simply be a result of and not the cause of coating degradation; percent moisture content relationship points to hydrothermal degradation coupled with chloride induced ageing. Furthermore, prior exposure to UV light exacerbates the effect of hydrothermal ageing in the presence of chlorides (Kotnarowska, 1999). Apicella showed that in a DGEBA based epoxy “micro-cavities can be formed by effect of crazing in the plasticized system exposed to high temperatures” in the presence of moisture (Apicella, 2003). Although the ECR steel embedded in concrete may not necessarily be exposed to high temperatures as were the samples tested by Apicella (i.e. 100°C), bridge deck concrete at bar level commonly reaches 40°C in Virginia while the relative humidity of the concrete at bar level can vary between 75 and 100% (Liu, 1996). Additionally, the bars themselves may be exposed to temperatures as high as 50°C prior to embedment in concrete. As such, hydrothermal ageing effects may not become evident for several years.

Figure 32. EECR scatter plot of % moisture vs. coating cracking

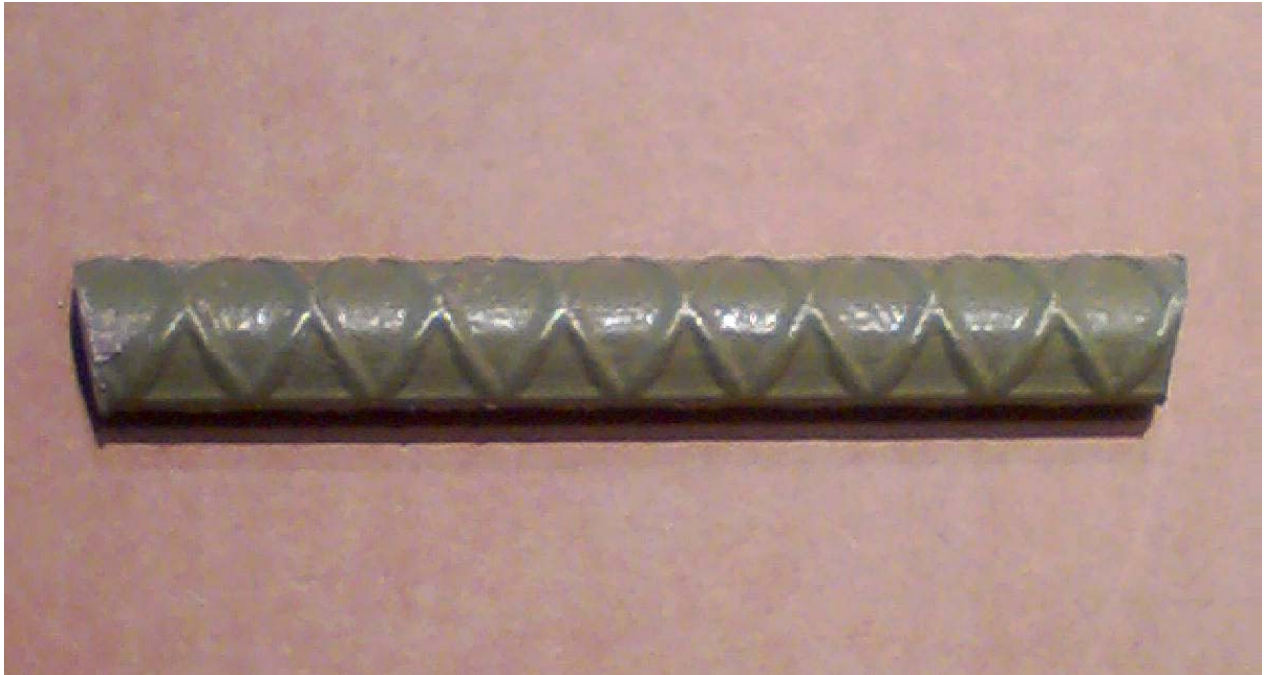
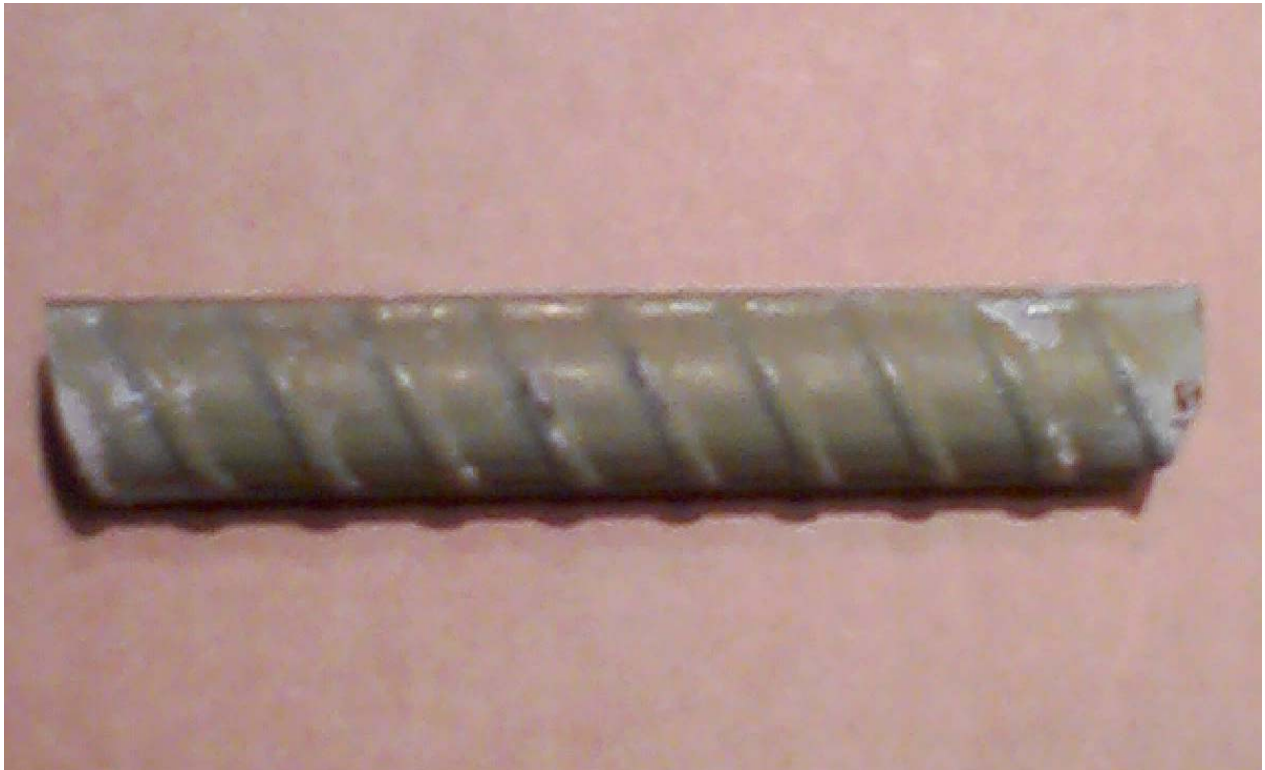
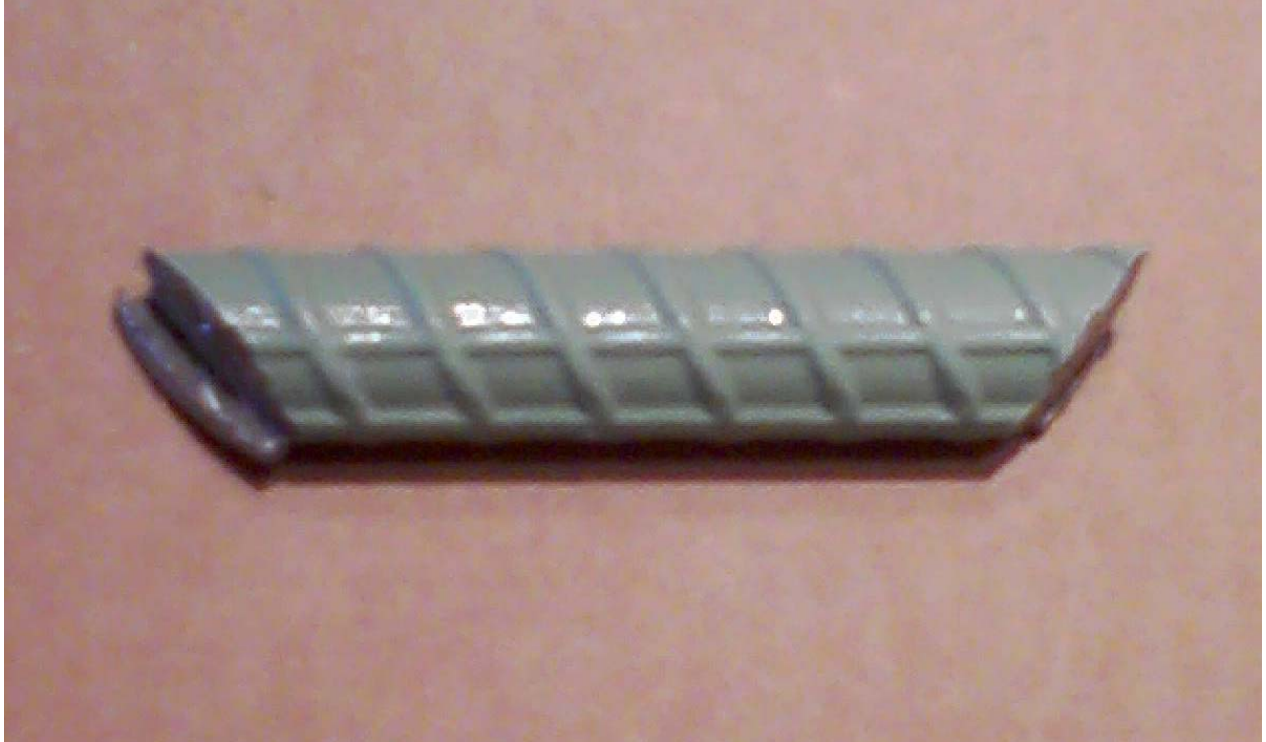
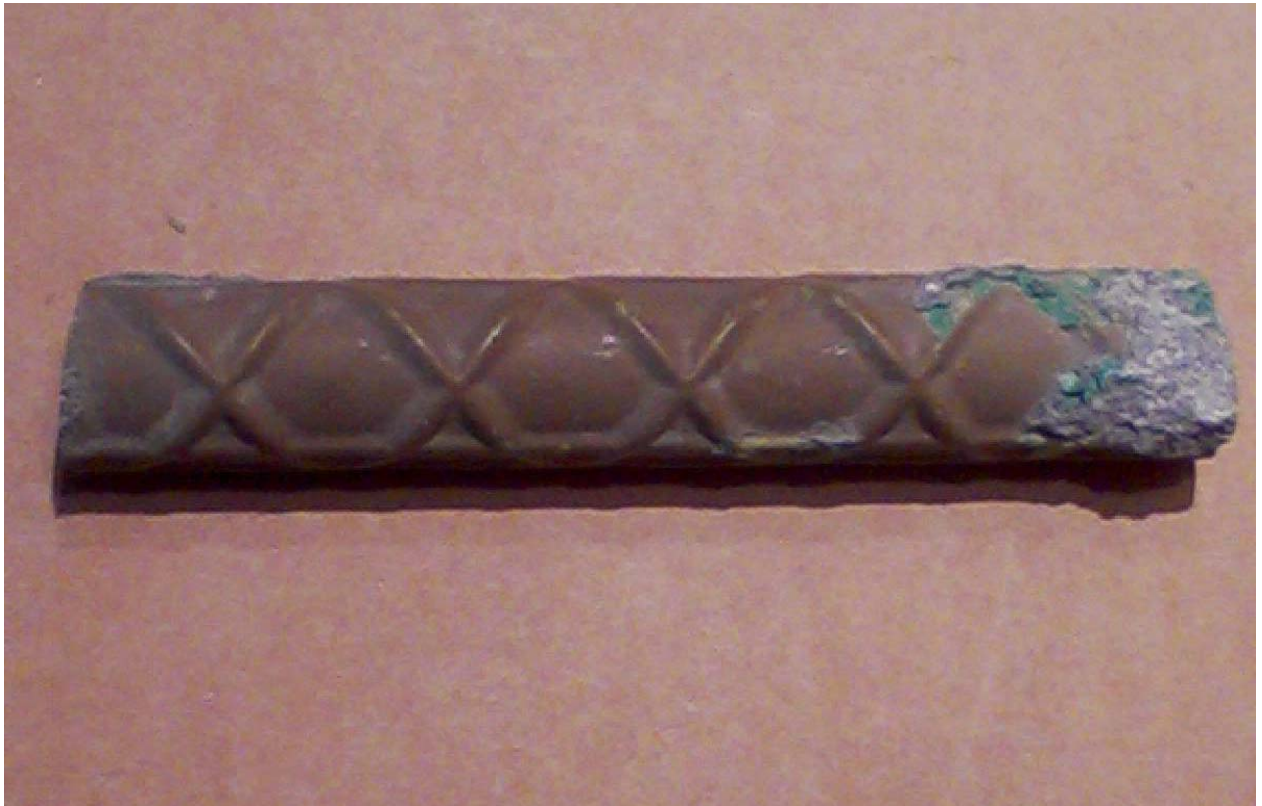
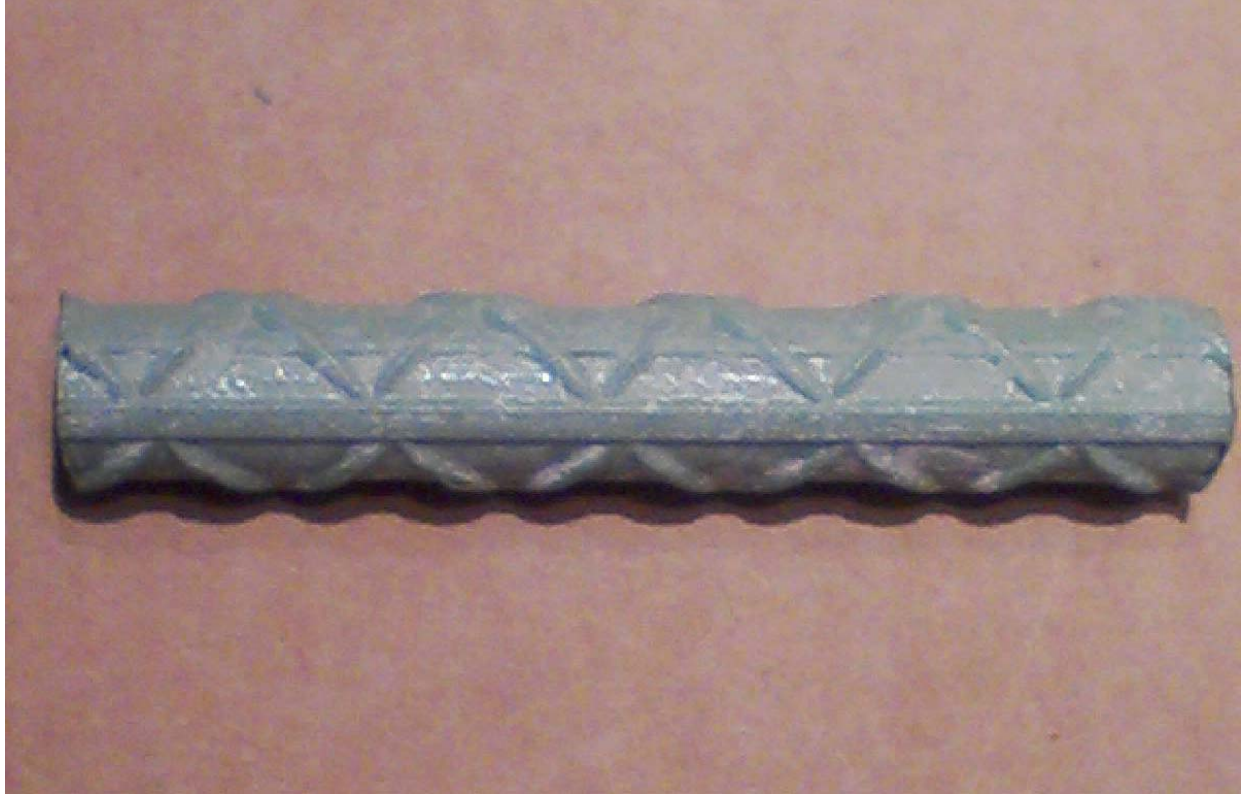
In addition to the color of the steel surface under the coating at the time of investigation, the color of the epoxy coating itself was also recorded. This was carried out based on the observation that the epoxy coating degradation (increase in brittleness) under certain exposure conditions is accompanied by color change. Five typical coating colors were observed. The colors are presented in Table 6 along with the values assigned and an interpretation visual guide is presented in the Appendix.

Figure A1. Glossy Green Rebar – 1

Figure A2. Dull Green Rebar – 2

Figure A3. Glossy Light Green – 3

Figure A4. Dull Dark Green – 4

Figure A5. Pale Green – 5
