FINAL CONTRACT REPORT

PERFORMANCE OF A BRIDGE DECK WITH GLASS FIBER REINFORCED POLYMER BARS AS THE TOP MAT OF REINFORCEMENT

June 2005
VTRC 05-CR24

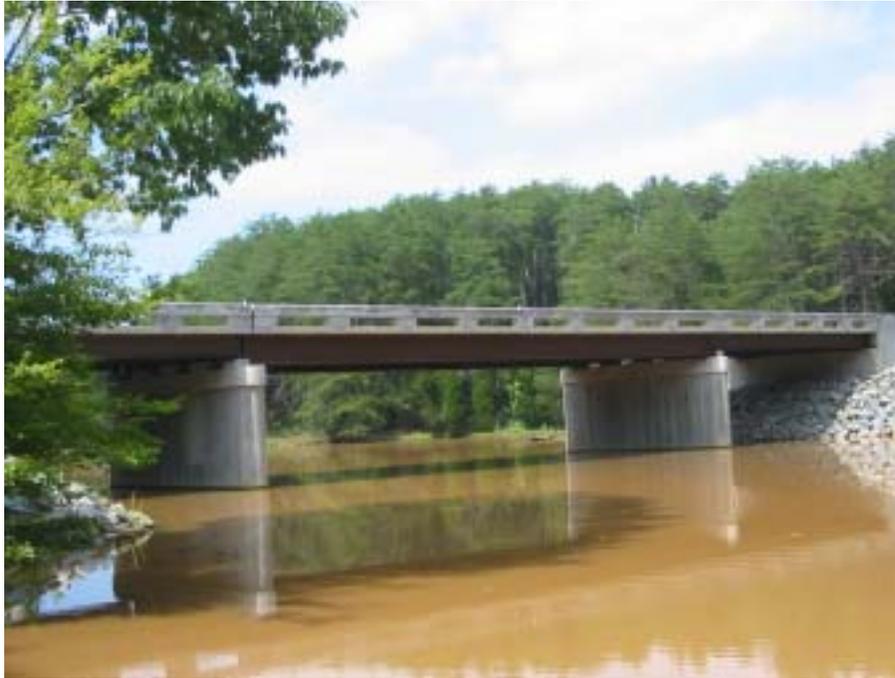
Administration's (FHWA) Innovative Bridge Research and Construction (IBRC) program worked with Virginia Tech to construct the Route 668 Bridge over Gills Creek in Franklin County, Virginia. The bridge was completed in July 2003 and is pictured in Figure 1. The deck of one span is reinforced with GFRP bars as the top mat and steel rebar as bottom mat. The other two spans are reinforced with steel bars as the top and bottom mat.

Figure 1. Route 668 Bridge Over Gills Creek

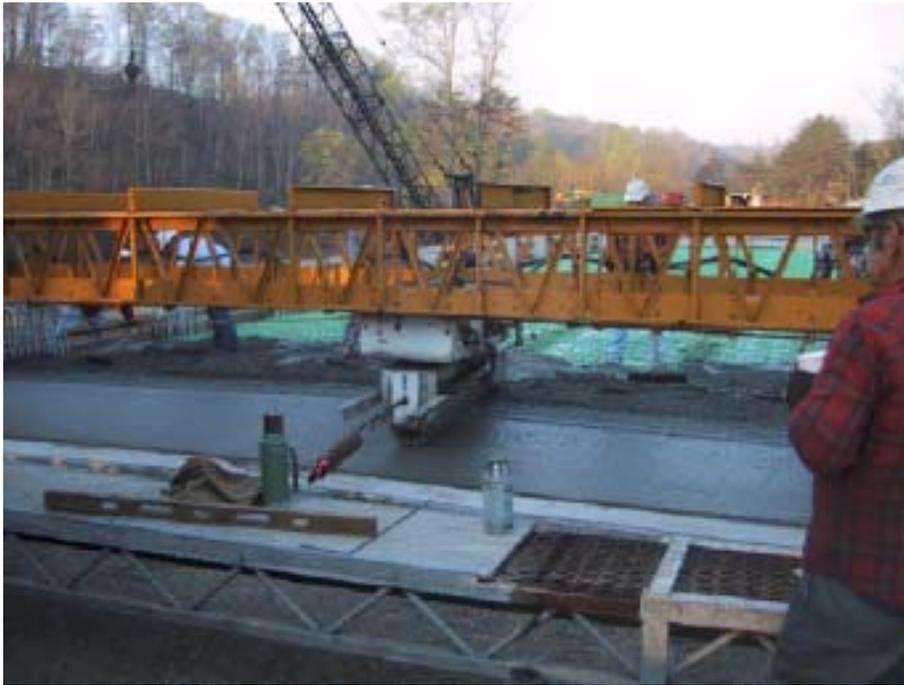
After the reinforcing bars were installed and the embedded gauges were secured in the deck, concrete was placed into the forms. The casting was accomplished in one day, with all three simple spans cast in one operation. The contractor started at the abutment side of Span C and continued across the bridge, finishing at the abutment side of Span A. Figure 6 shows the casting operation at the beginning of the day in Span C. Test cylinders of concrete placed in Spans A and C were made during the casting operation. The cylinders were then match-cured with the deck for approximately two weeks and then taken back to Virginia Tech for storage. When tested for 28-day compressive strength, the Span A cylinders averaged 7001 psi and the Span C cylinders averaged 6882 psi.

Figure 6. Span C Concrete Casting

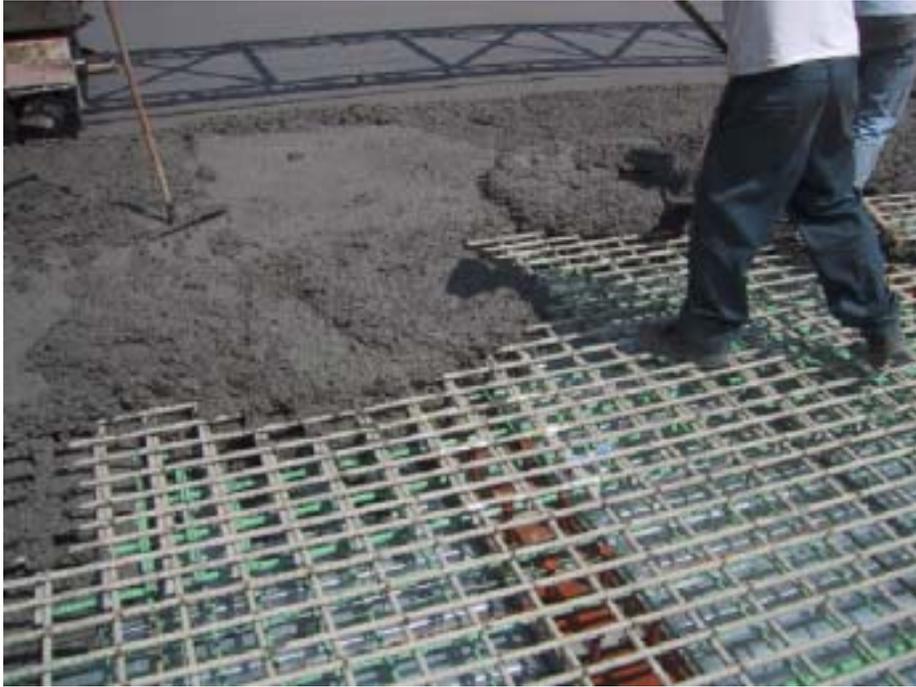
Great care was taken by the researcher as well as the construction workers to avoid contact with the installed gauges and wires during the casting operation. However, it should be noted that concrete was placed with a bucket about one to two feet above the bars, and in some cases this concrete was dropped directly on top of a section where gauges and thermocouples were present. Also, it should be noted that the workers tried to stay clear of the gauged sections while walking on the top mat of reinforcement. However, this was not always the case. Figure 7 shows the casting operation in the Span A end of the bridge.

Figure 7. Span A Concrete Casting

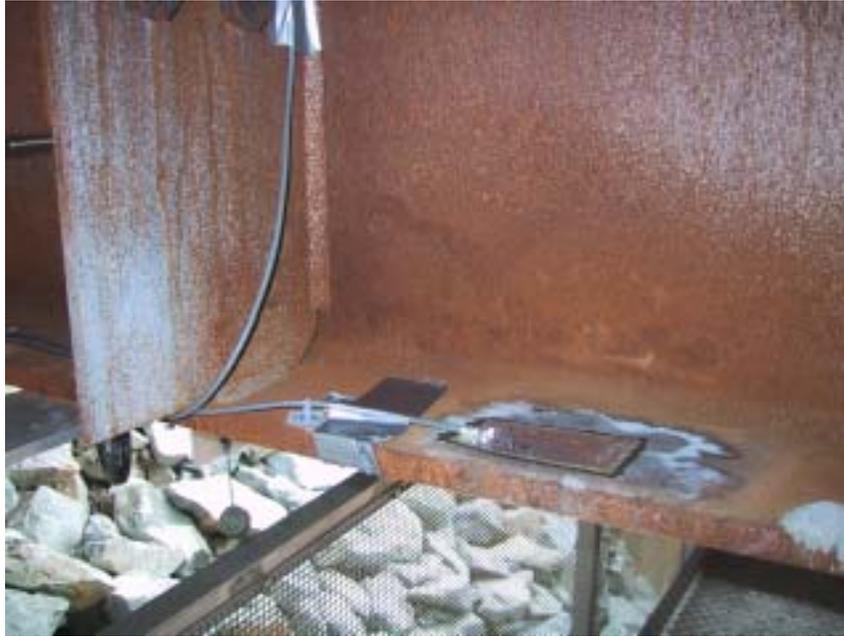
Figure 8. ER Strain Gauge on Steel Girder

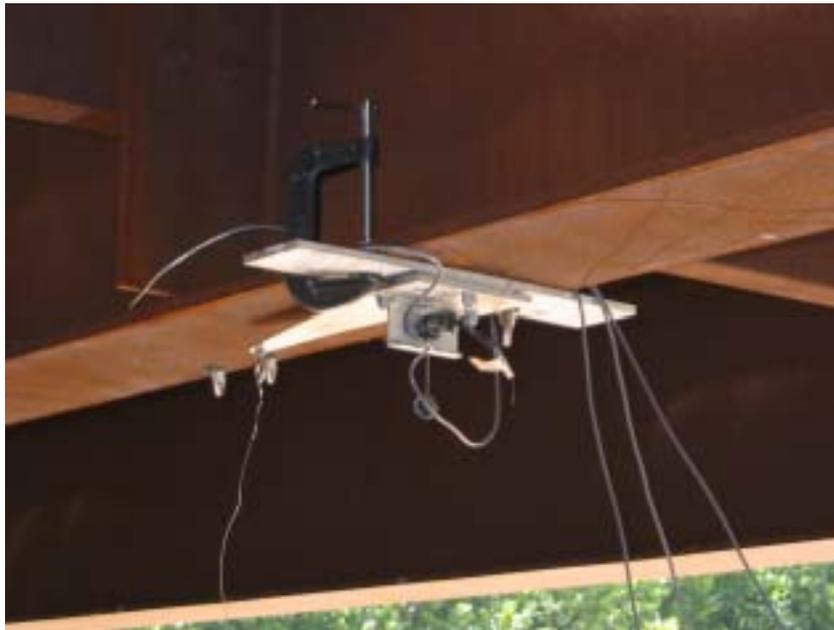
For the 2003 and 2004 tests, deflectometers were clamped to the bottom flange of each girder at the midspan of Spans A and C. A deflectometer is pictured in Figure 9. They are made of an aluminum plate between two thicker aluminum plates. The cantilevered plate in the middle is gauged with four strain gauges that are weatherproofed. At the end of the cantilevered plate is a metal loop. The metal loop was attached to a weight at ground level with wire, to pre-deflect the deflectometer approximately 1 in before the testing. The pre-deflection caused a strain in the top of the plate. When the truck ran over the bridge causing the girders to deflect, the decrease in strain was measured and converted to a corresponding deflection. During each test, the

Figure 9. Deflectometer Clamped to Steel Girder

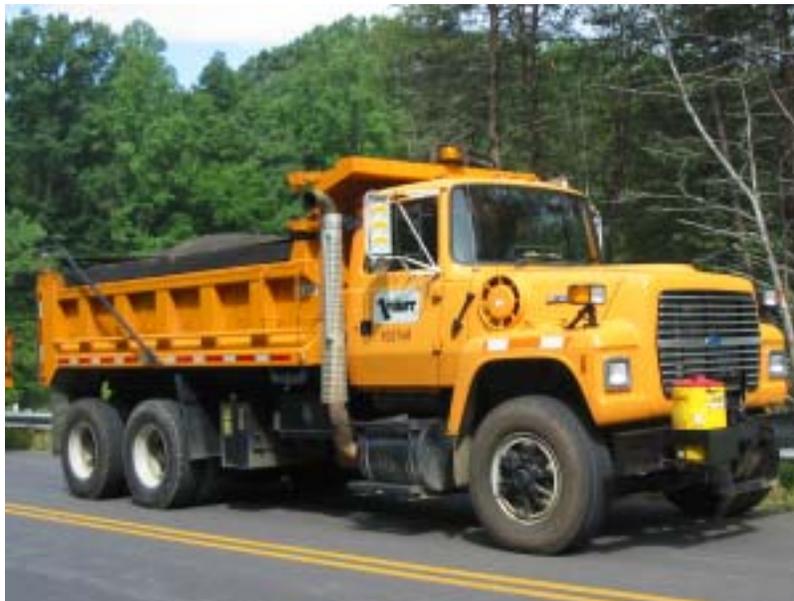
The second orientation was with the truck straddling the first interior girder. A line was marked 4 ft from the face of the parapet to indicate the location of the front wheel of the truck. This position created the greatest effect on the first interior girder.

Figure 10 VDOT Dump Truck Used for Live Load Testing

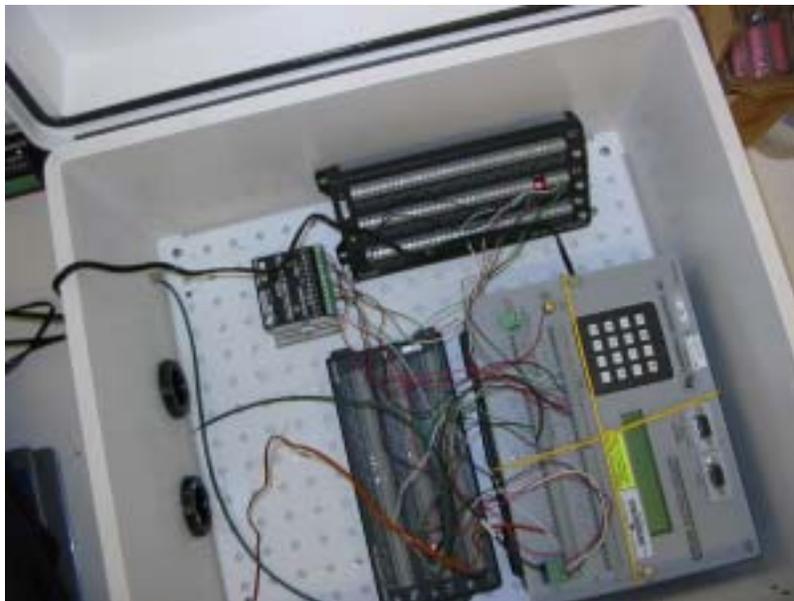
The Campbell was used to monitor the instrumentation of Span A of the Gills Creek Bridge. Since there were not enough ports to connect all of the instrumentation on the datalogger itself, additional boards had to be used. Two multiplexers were used, one for the ER strain gauges and one of the VW gauges. The thermocouples were connected directly to the Campbell. All of the components were screwed to a plate that was then secured in an environmentally resistant box. Figure 11 is a picture of the datalogger. After programming the datalogger in the lab, it was taken to the field location and the lead wires of the instrumentation were run through the access hole in the box and connected to the datalogger. Weatherproofing putty provided by the box manufacturer was placed in the access hole to fully seal the box, and desiccant packs were placed in the box to control the internal humidity. The box was locked and placed on the south abutment wall on the underside of the bridge. A solar panel was mounted on the parapet of the bridge to ensure that the datalogger had a constant power source.

Figure 11. CR23X Micrologger and Instrumentation Components
