| Report No. | Report Date | No. Pages | Type Report: Final | Project No.: 70983 |
| VTTC 05-CR9 | January 2005 | 36 | Period Covered: 10/01/03 to 12/31/04 | Contract No. 04-0627-10 |

FIELD INVESTIGATION OF HIGH PERFORMANCE PAVEMENTS IN VIRGINIA

February 2005
VTRC 05-CR9

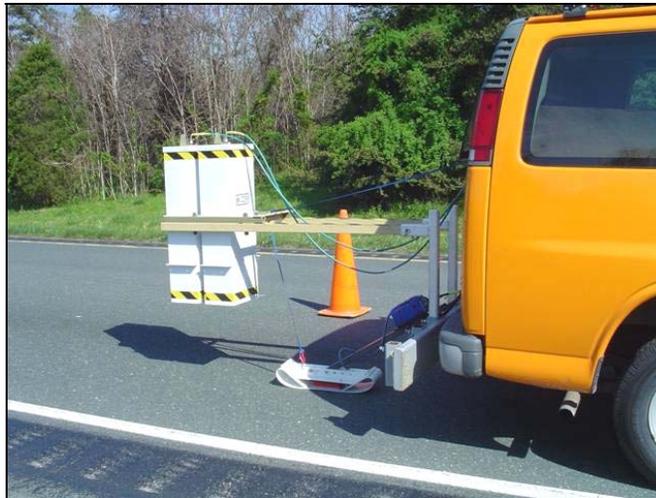
Figure 1. Van used for GPR data collection

All GPR surveys were conducted using the test van depicted in Figure 1. The van has an antenna fixture in the back that permits deployment of the GPR antennas at three transverse locations (right wheel path, center, and left wheel path). Additionally, the van has a high resolution distance measuring instrument (DMI) connected to its back wheel that allows accurate triggering of GPR scans at user-fixed intervals.

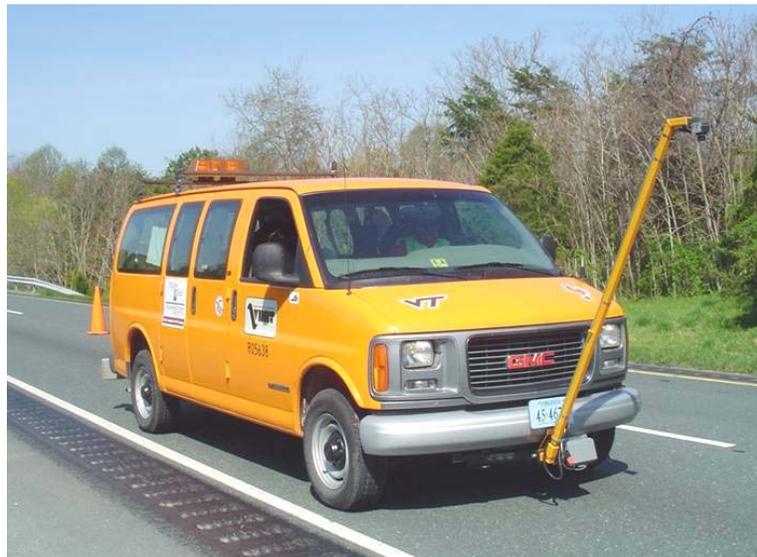
Figure 2. Deployment of the digital camera used for the video survey

As depicted in Figure 2, the digital camera used to collect the video was fixed to the GPR van and was synchronized with the same DMI used to control the GPR data acquisition. The digital camera provided 24-bit color images of the surface with a resolution of 656 \times 494 pixels. To get clear images of the surface even during high-speed surveys, the camera has a high shutter speed (exposure time as low as 20 ms) and a high frame rate (up to 75 frames/s).
