**FINAL CONTRACT REPORT**

**PLATE AND TUBE BRIDGE DECK EVALUATION IN THE DECK TEST BED  
OF THE TROUTVILLE, VIRGINIA, WEIGH STATION**

March 2004  
VTRC 04-CR12

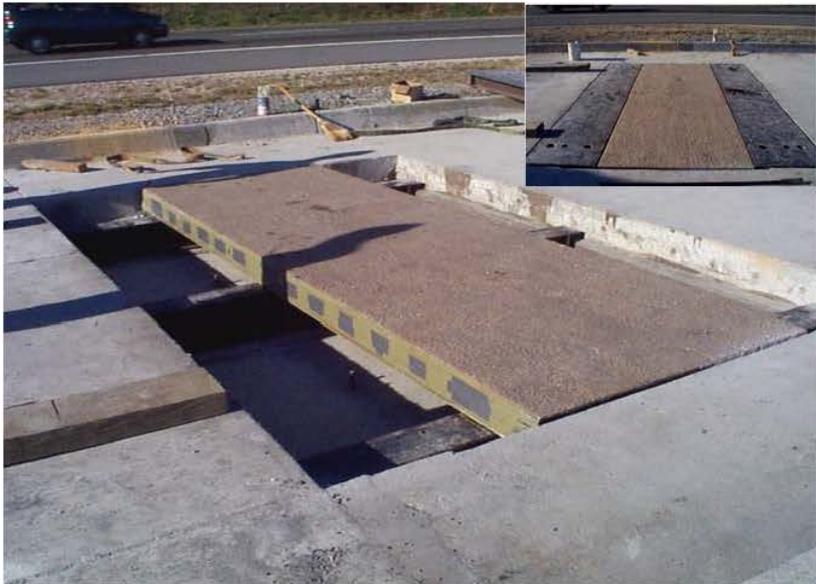
**Figure 8 FRP deck field testing facility at the weight station**

To assess long-term performance and investigate the field performance characteristics of FRP deck systems, a facility was constructed to examine FRP bridge decks in service. This testing facility was put in place at the Troutville, Virginia weigh station (Interstate-81 North, Mile 148) in November of 1999. The facility was constructed on the entrance ramp of the northbound lane (see Figure 8). The weigh station site is a low risk setting where the traffic can be controlled to allow for deck modifications, inspection and controlled vehicle field testing. Steel access panels positioned at the approaches of the deck section allow for instrumentation and inspection of the deck. In the present configuration the edges of the deck are unsupported representing a worst case scenario. Over 200,000 trucks (over 100,000 on each side) pass through the Troutville weigh station each month.<sup>14</sup> A typical truck traveling through the testing facility produces five loading peaks. Therefore, there are about 0.5 million cycles of fatigue loading on the deck each month. Because of this high volume of traffic, the deck is subjected to a significant number of cycles of a high load. The deck panel is also exposed to realistic environmental conditions (varying temperature and moisture etc.) allowing researchers to investigate the long-term durability of the bridge deck panel.

Phase II and Phase III decks were implemented in the deck testing facility and fully described by Temeles<sup>15</sup> and Coleman.<sup>16</sup> The decks were supported by three steel wide flange beams setting on a concrete slab (see Figure 8). The steel beams support the FRP deck and two 4.57 m × 0.76 m (15 × 2.5 ft) steel access panels on each side of the deck. The detailed design and installation procedures of the testing bed are provided by Temeles.<sup>15</sup>

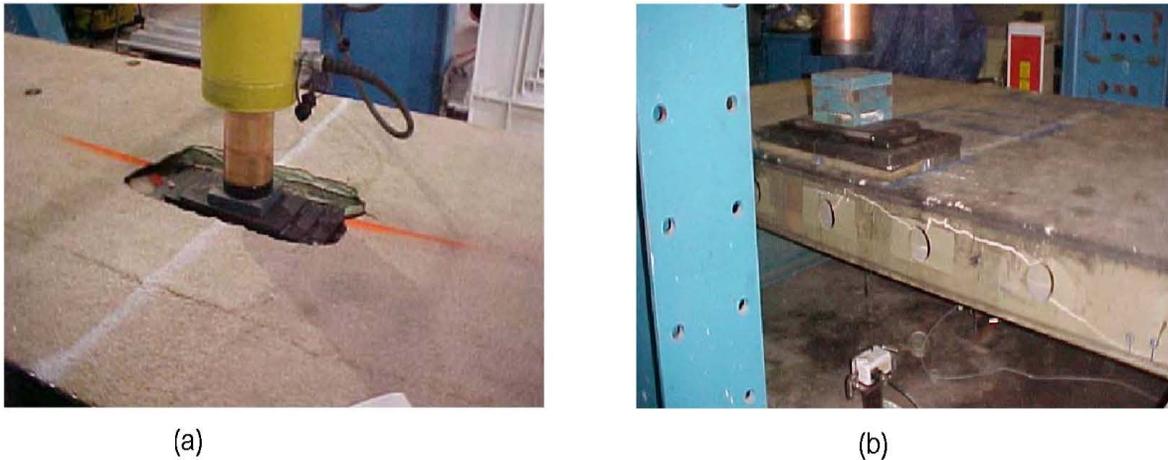
**Figure 10 Failure of Phase I Deck at the center (a) and Phase II Deck at the edge (b) using steel loading patch**

surface. The failure mode of the Phase II deck using steel loading patch is shown in Figure 10. Note that the failure mode of the Phase I deck was virtually identical to that of the Phase II deck. Detailed failure test data for the Phase II deck can be found in thesis of Temeles.<sup>15</sup> During failure testing, debonding (between the face sheets and tubes) was observed during the loading cycle at a load of about 245 kN (55 kips) for both decks. The Phase I deck failed at 476 kN (107 kips) for central span loading and consisted of a local punching shear failure (see Figure 10-a) directly under the steel patch edges. For the Phase II deck, one side was loaded at the center to failure and the other side loaded at the unsupported edge to failure. The failure mode of Phase II deck when loaded at the center was the same as Phase I deck (Figure 10.a) but with a larger ultimate capacity of 587 kN (132 kips). Shearing in the sidewall of the cell initiating from the underneath the loading patch (Figure 10-b) and controlled the failure of the other side of the Phase II deck when loaded at the unsupported edge, with the ultimate capacity of 378 kN (85 kips).
