**CLASSIFICATION
OF LONGITUDINAL WELDS
IN AN ALUMINUM BRIDGE DECK**

February 2000
VTRC 00-CR5

ABSTRACT

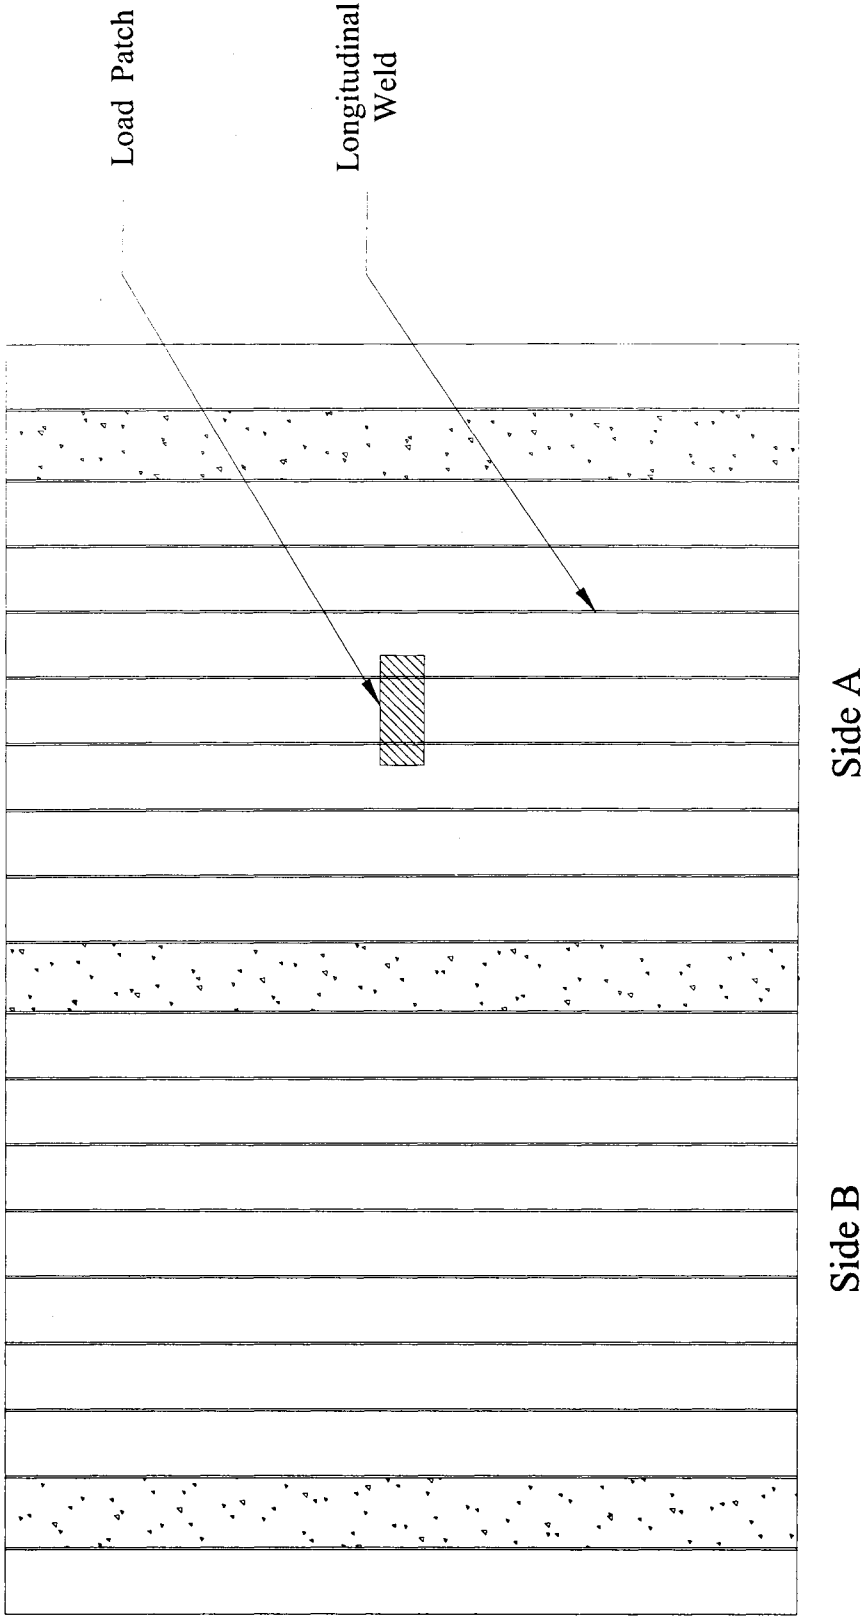
FIGURE 8. Location of Load Patch for Fatigue Test 1 and Residual Strength Test

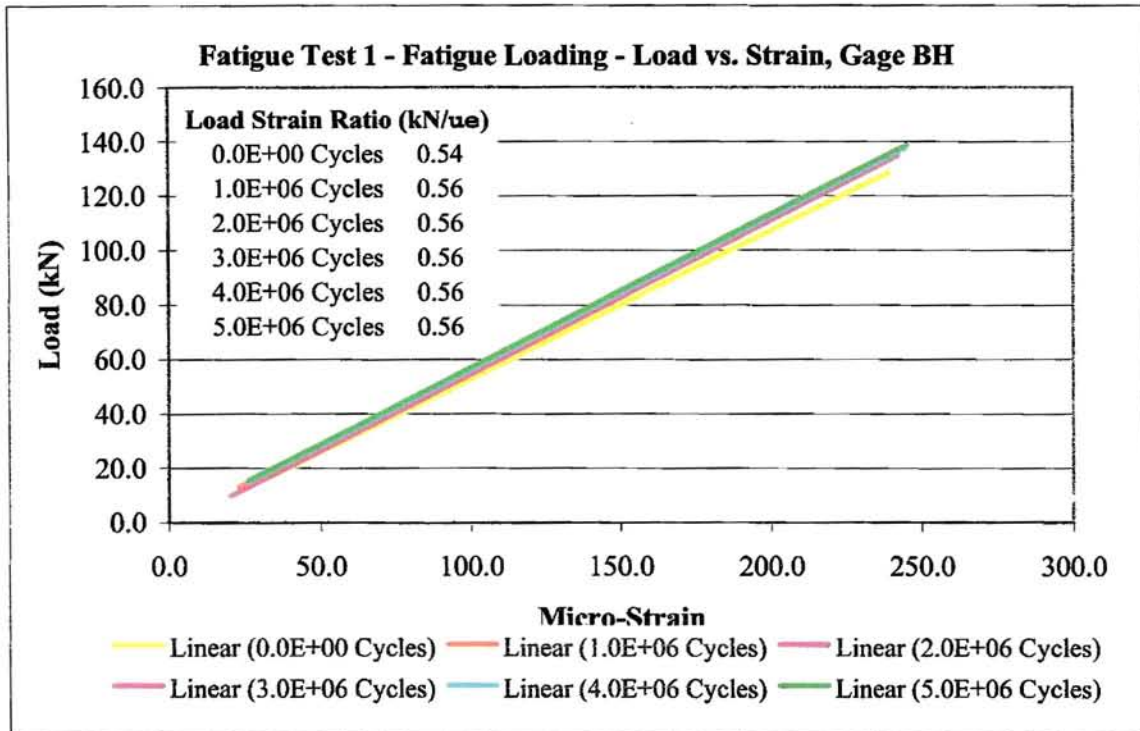
Figure 23. Fatigue Test 1 - Dynamic Loading - Load vs. Strain, Gage BH

Gage BH is located on a longitudinal weld directly beneath the load. The stresses at this gage location were the highest among any stresses measured during fatigue test. If a fatigue crack were to form during loading this would be a probable location because of this high stress range. The average stress in this gage location during the 5 million cycles of load was 15.5 MPa. Figure 23 shows that even though the strains at this location are high, there is not a significant change in the slope of the load-strain line. With this information and visual observations of the welds, it was determined that no fatigue cracks had formed near this location. The standard deviation of the stress range values in Table 2 is 0.6 MPa, 4.0% of the average stress range, less than the 0.7 MPa from signal noise.

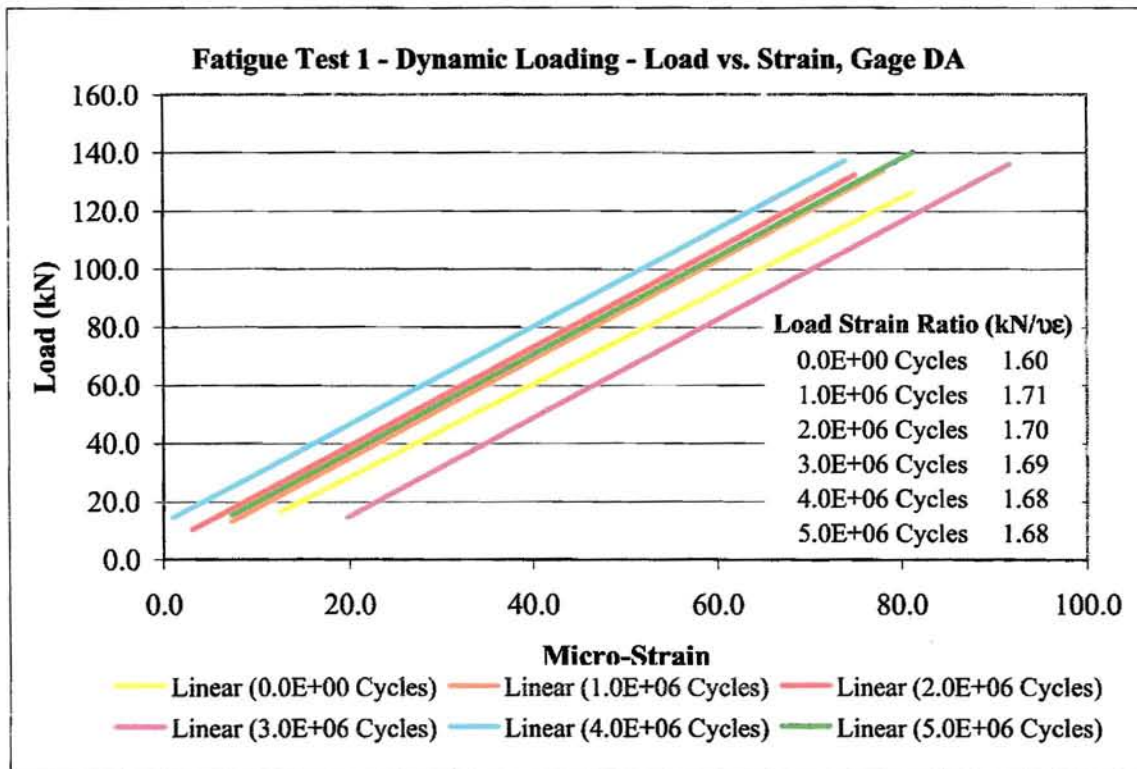
Figure 24. Fatigue Test 1 - Dynamic Loading - Load vs. Strain, Gage CF

Figure 25. Fatigue Test 1 - Dynamic Loading - Load vs. Strain, Gage CJ

Figure 26. Fatigue Test 1 - Dynamic Loading - Load vs. Strain, Gage DA

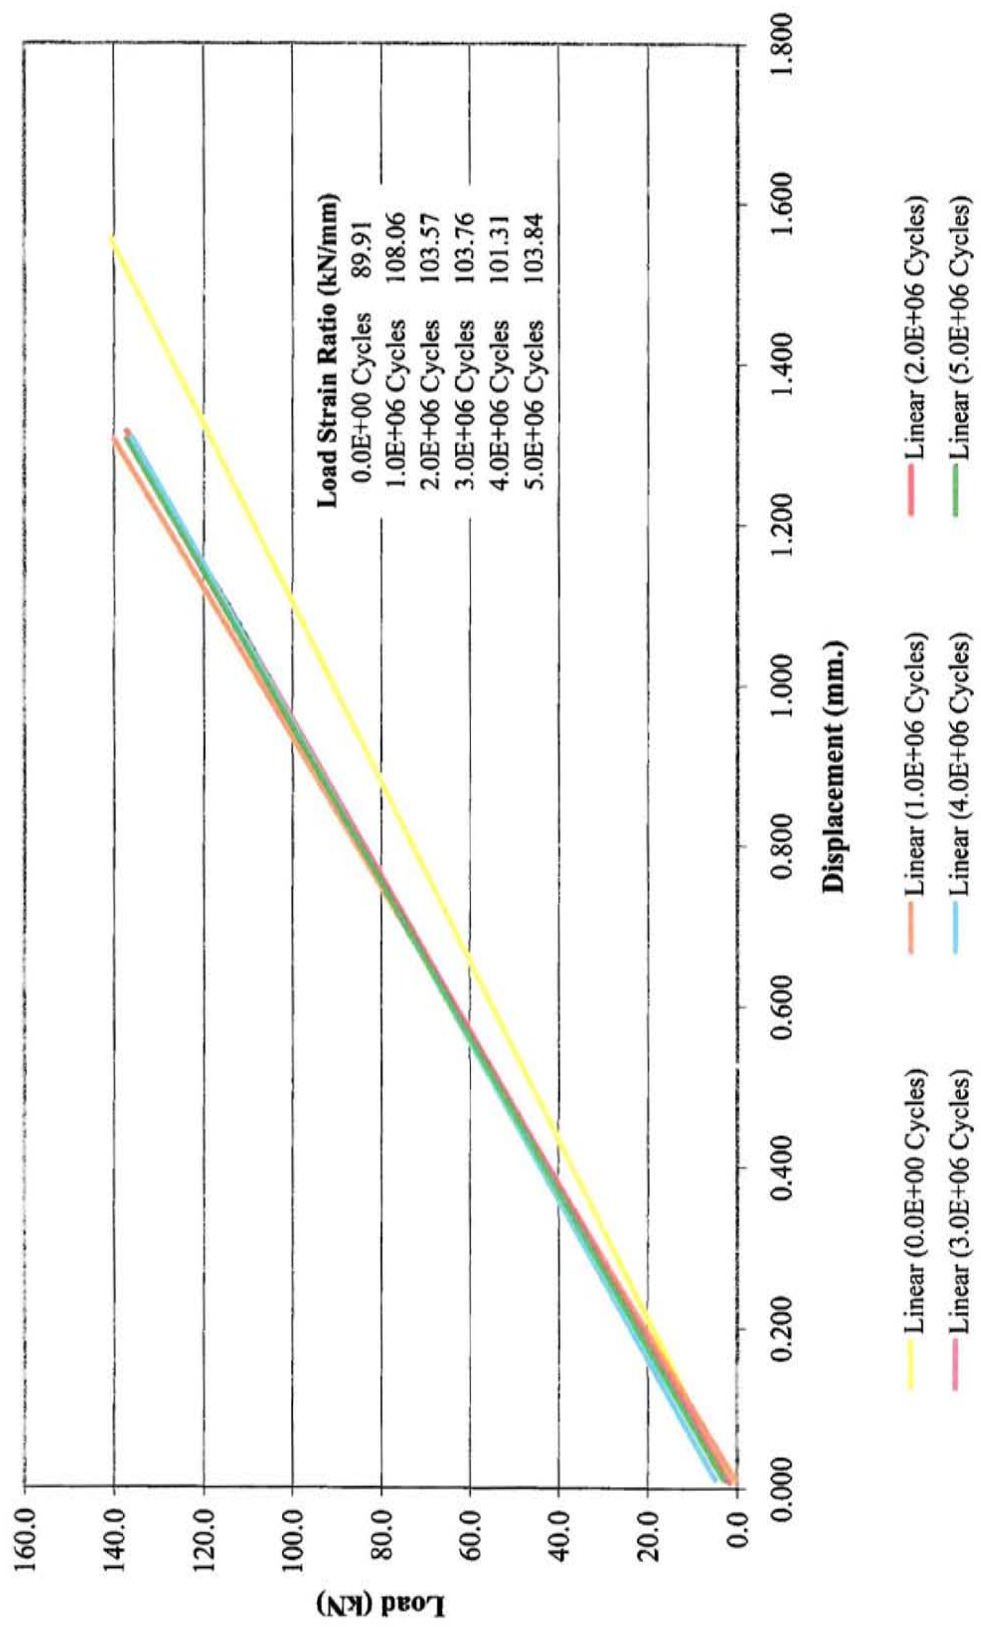
FIGURE 27. Fatigue Test 1 - Stiffness Loading - Load vs. Deflection, Midspan Side A

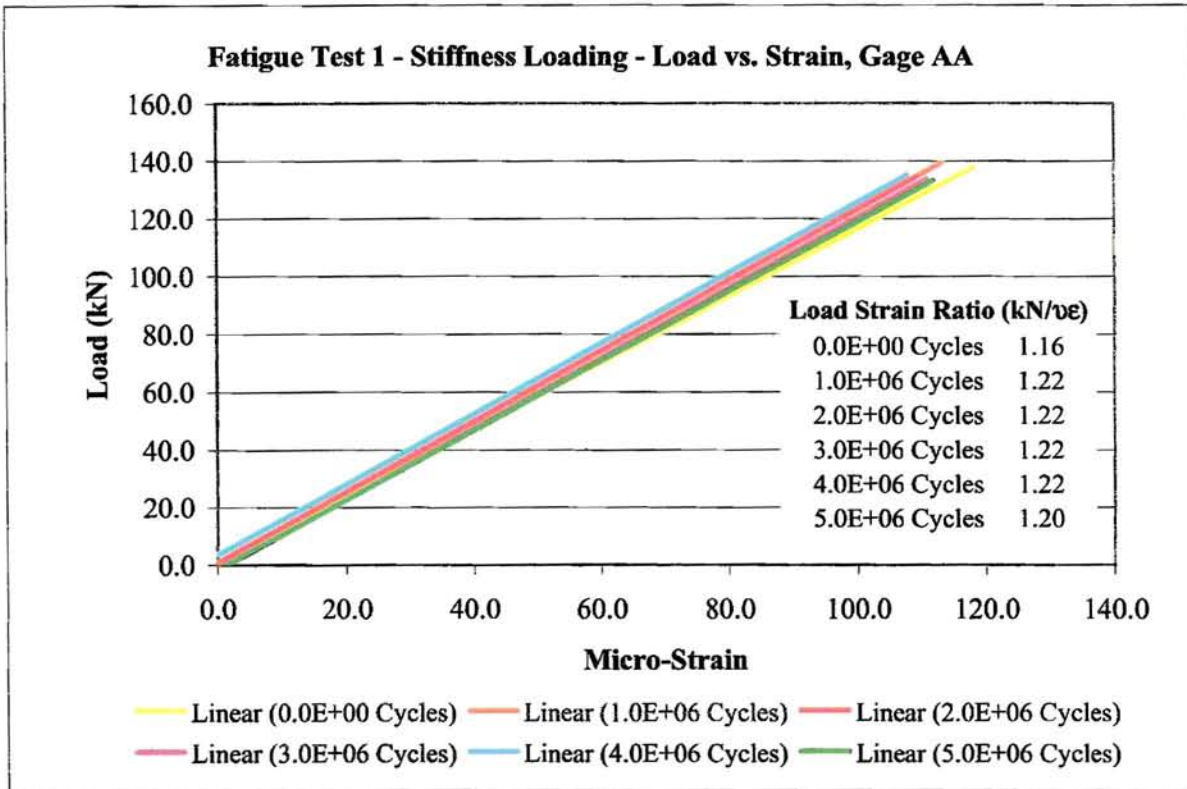
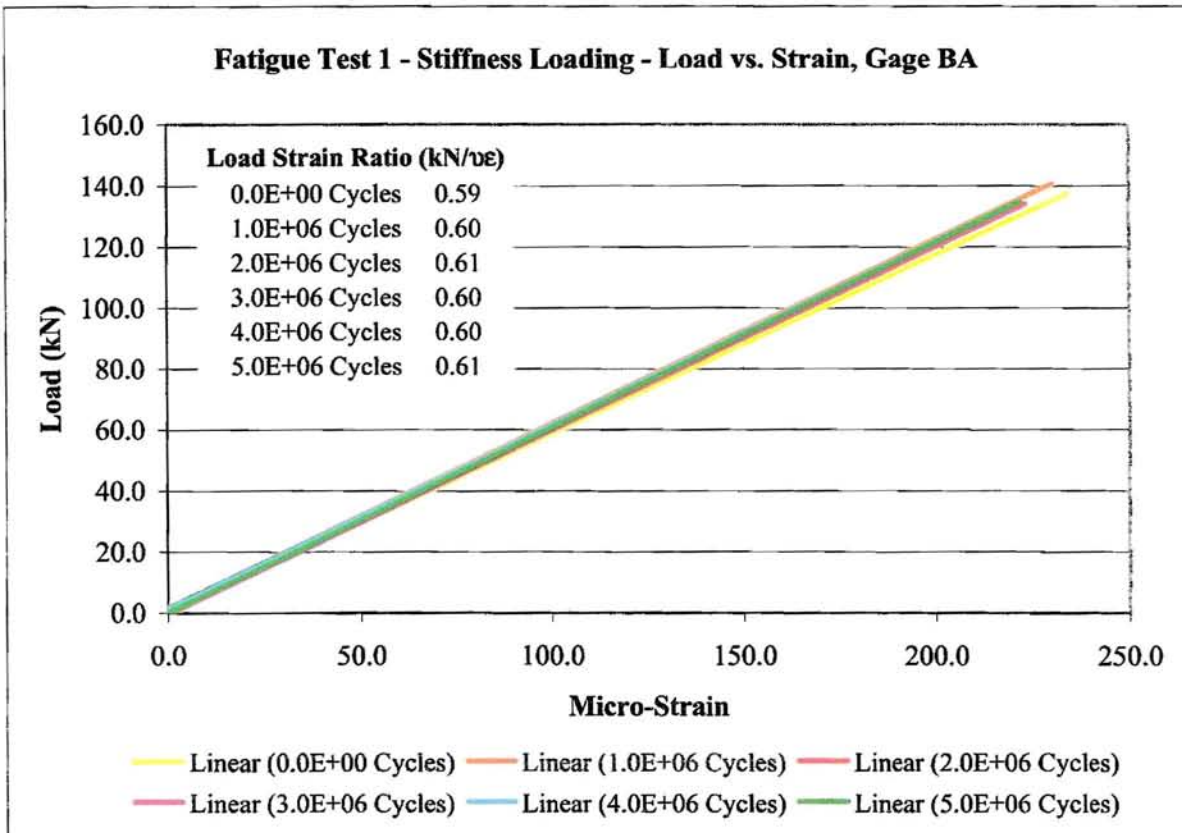
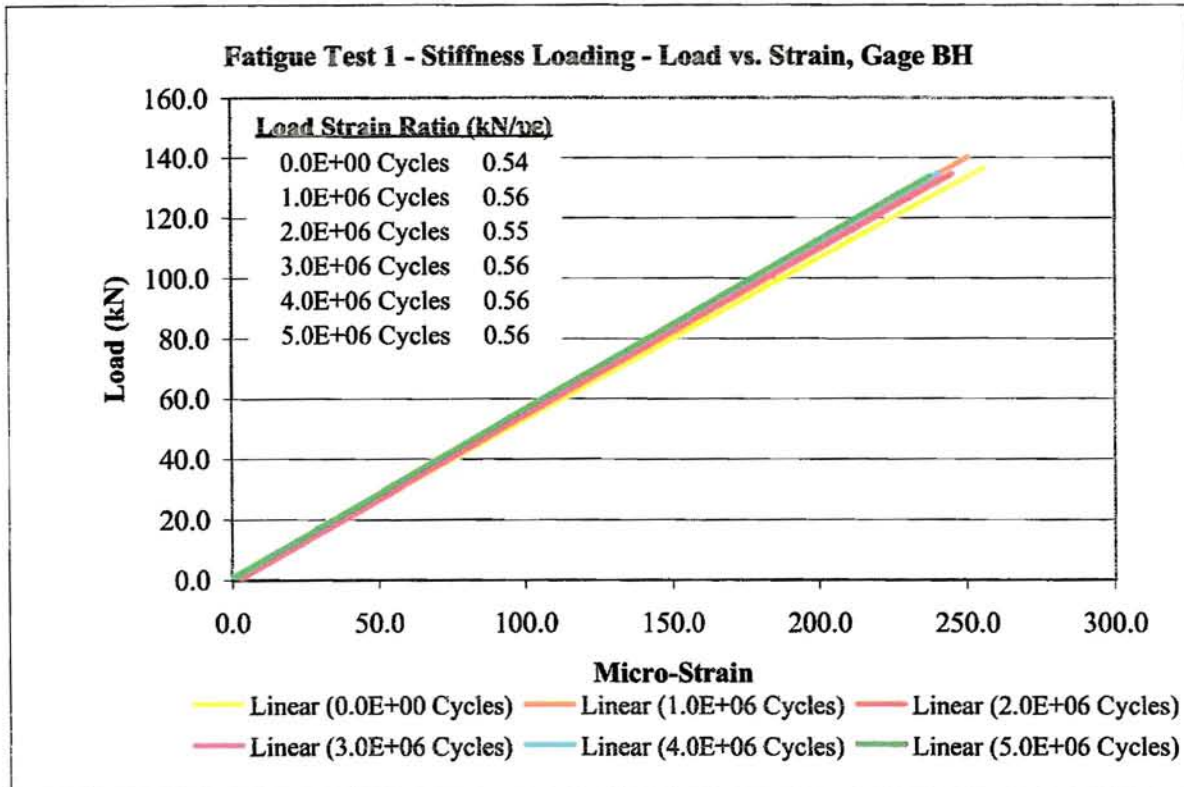
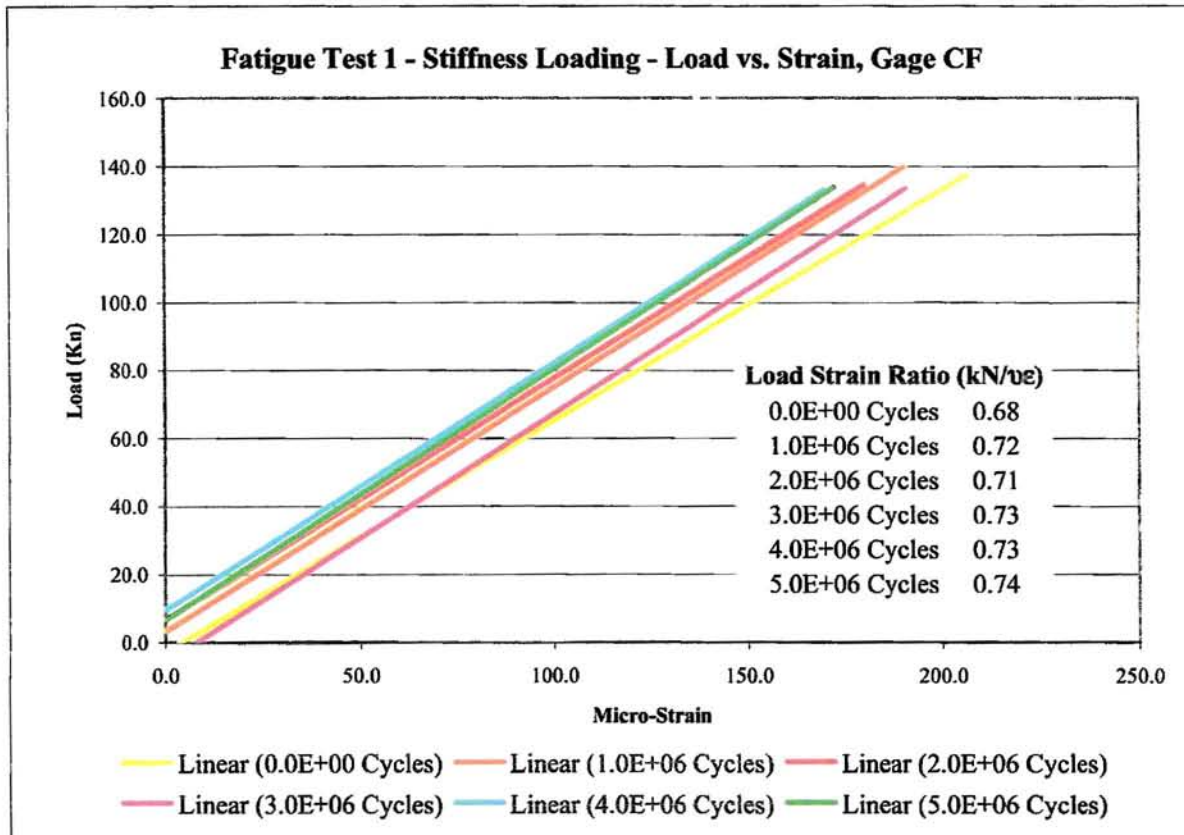
Figure 28. Fatigue Test 1 - Stiffness Loading - Load vs. Strain, Gage AA

Figure 29. Fatigue Test 1 - Stiffness Loading - Load vs. Strain, Gage BA

Figure 30. Fatigue Test 1 - Stiffness Loading - Load vs. Strain, Gage BH

Figure 31. Fatigue Test 1 - Stiffness Loading - Load vs. Strain, Gage CF

Figure 32. Fatigue Test 1 - Stiffness Loading - Load vs. Strain, Gage CJ

Figure 33. Fatigue Test 1 - Stiffness Loading - Load vs. Strain, Gage DA

The stiffness test took approximately one minute to perform. With the data collection rate set at 200 readings a second some of the stiffness test data files contained more than 15,000 data points for any particular sensor. In order to present this large amount of data a moving average of six data points was taken from the recorded data. Regression lines representing the data points collected were plotted for comparison and come from the load and strain and load and deflection graphs. The load-deflection plot can be found in Figure 27. The six gauge locations used for comparison in the Fatigue Test section for Fatigue Test 1 were used for comparison in this section. The six gauge locations represent the highest stress in the longitudinal welds during the stiffness test. The load versus strain plots for these six critical gage locations can be found in Figure 28 through Figure 33.

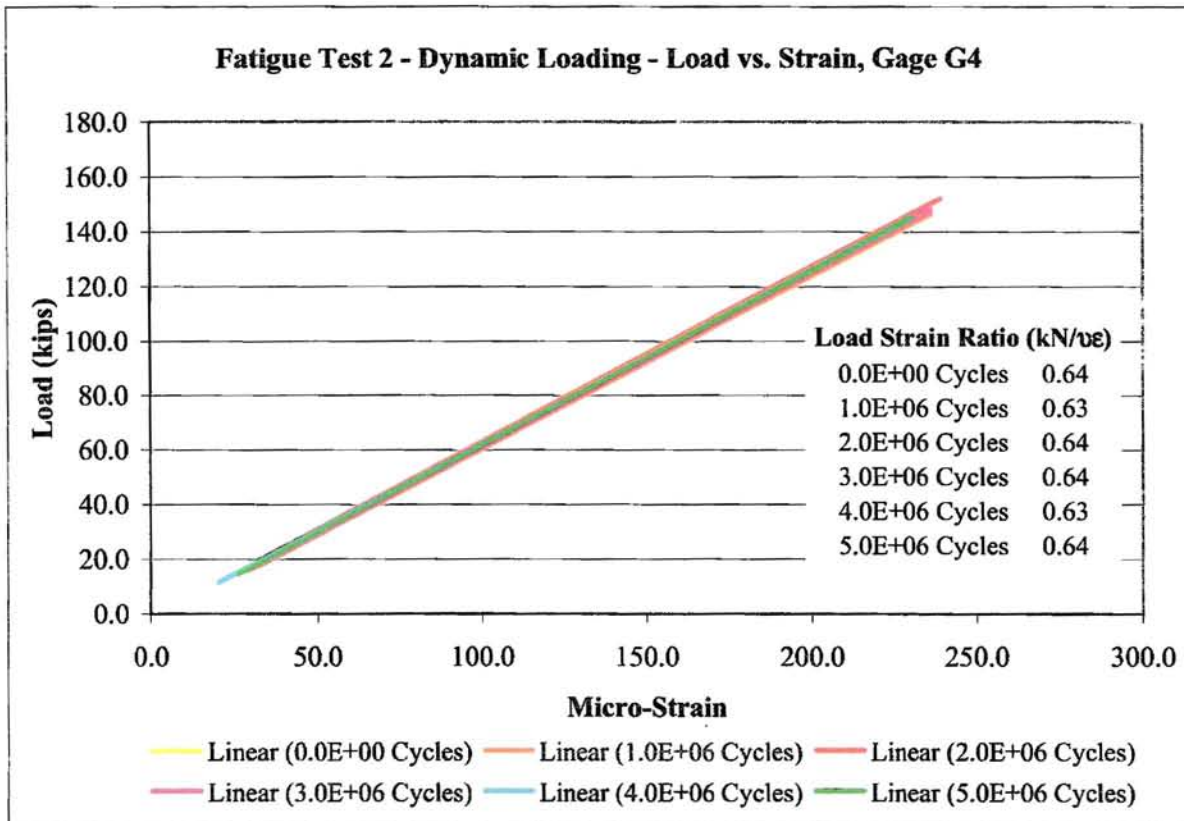
FIGURE 41. Fatigue Test 2 - Dynamic Loading - Load vs. Strain, Gage G4

Gage location G4 had the highest stress range of any of the gage locations in this fatigue test. During the testing it would be insured that this gage location would have at least a 13.8 MPa stress range, this location would also be monitored closely for the possibility of fatigue crack formation. The average stress range from Table 8 for this gage location was 14.6 MPa with a standard deviation of 0.3 MPa; little variation in the stress as the weld was subjected to 5 million cycles of loading. Comparison of the load-strain ratios in Figure 41 shows that there was little if no change throughout the 5 million cycles of loading.

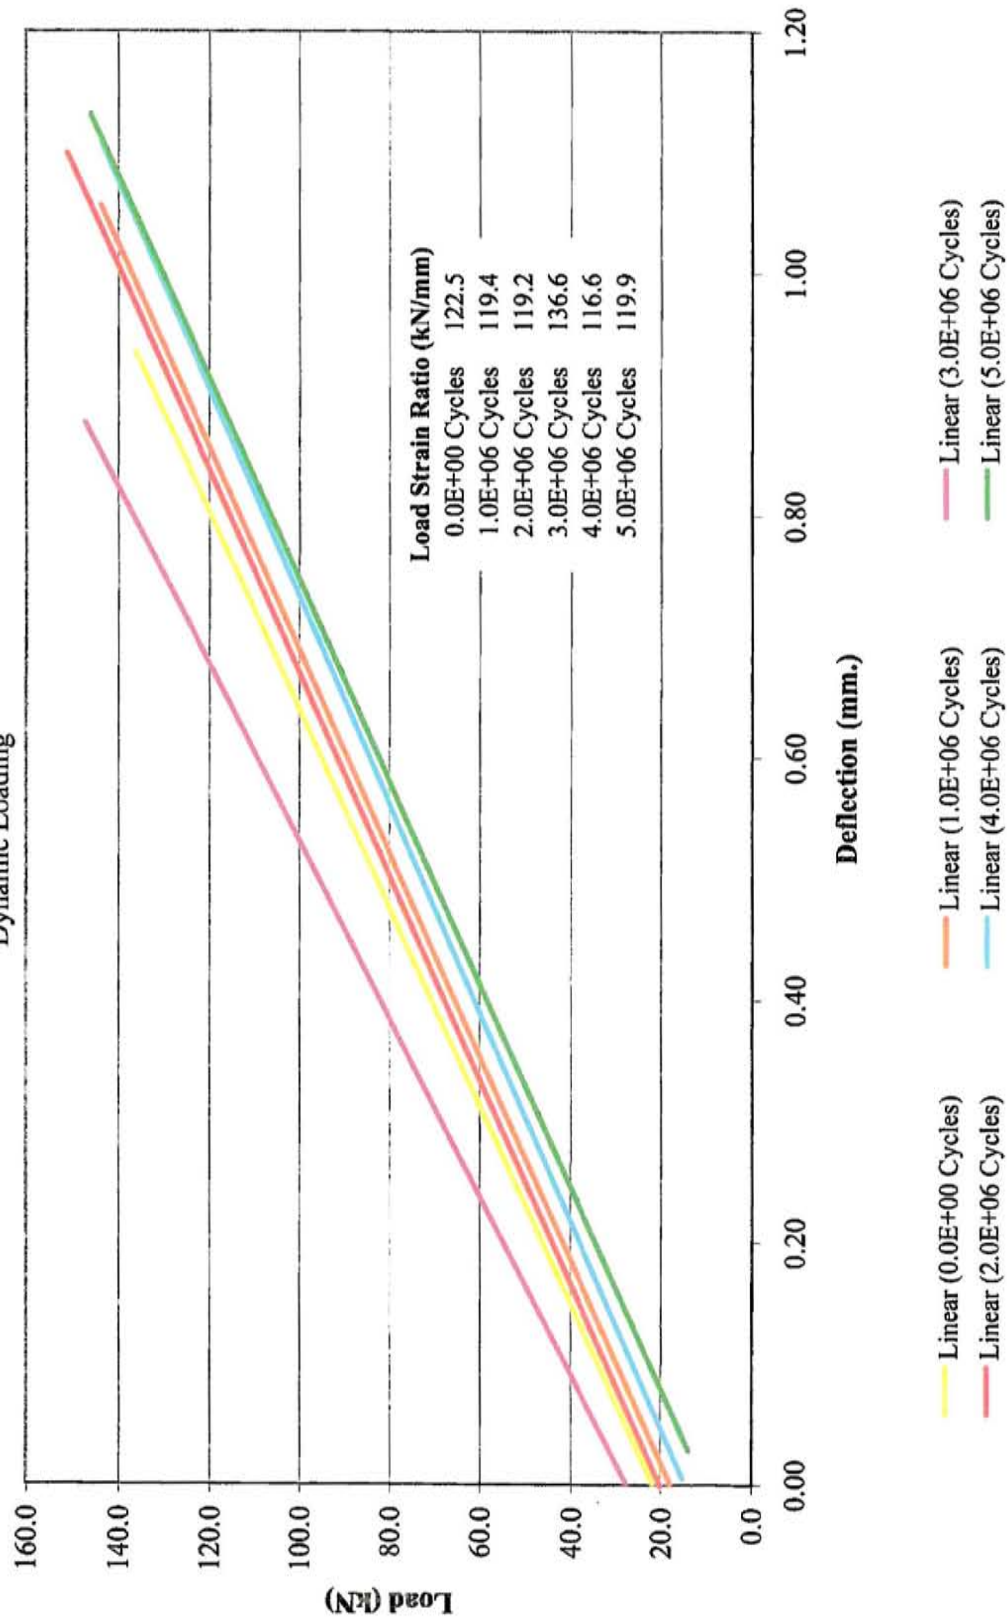
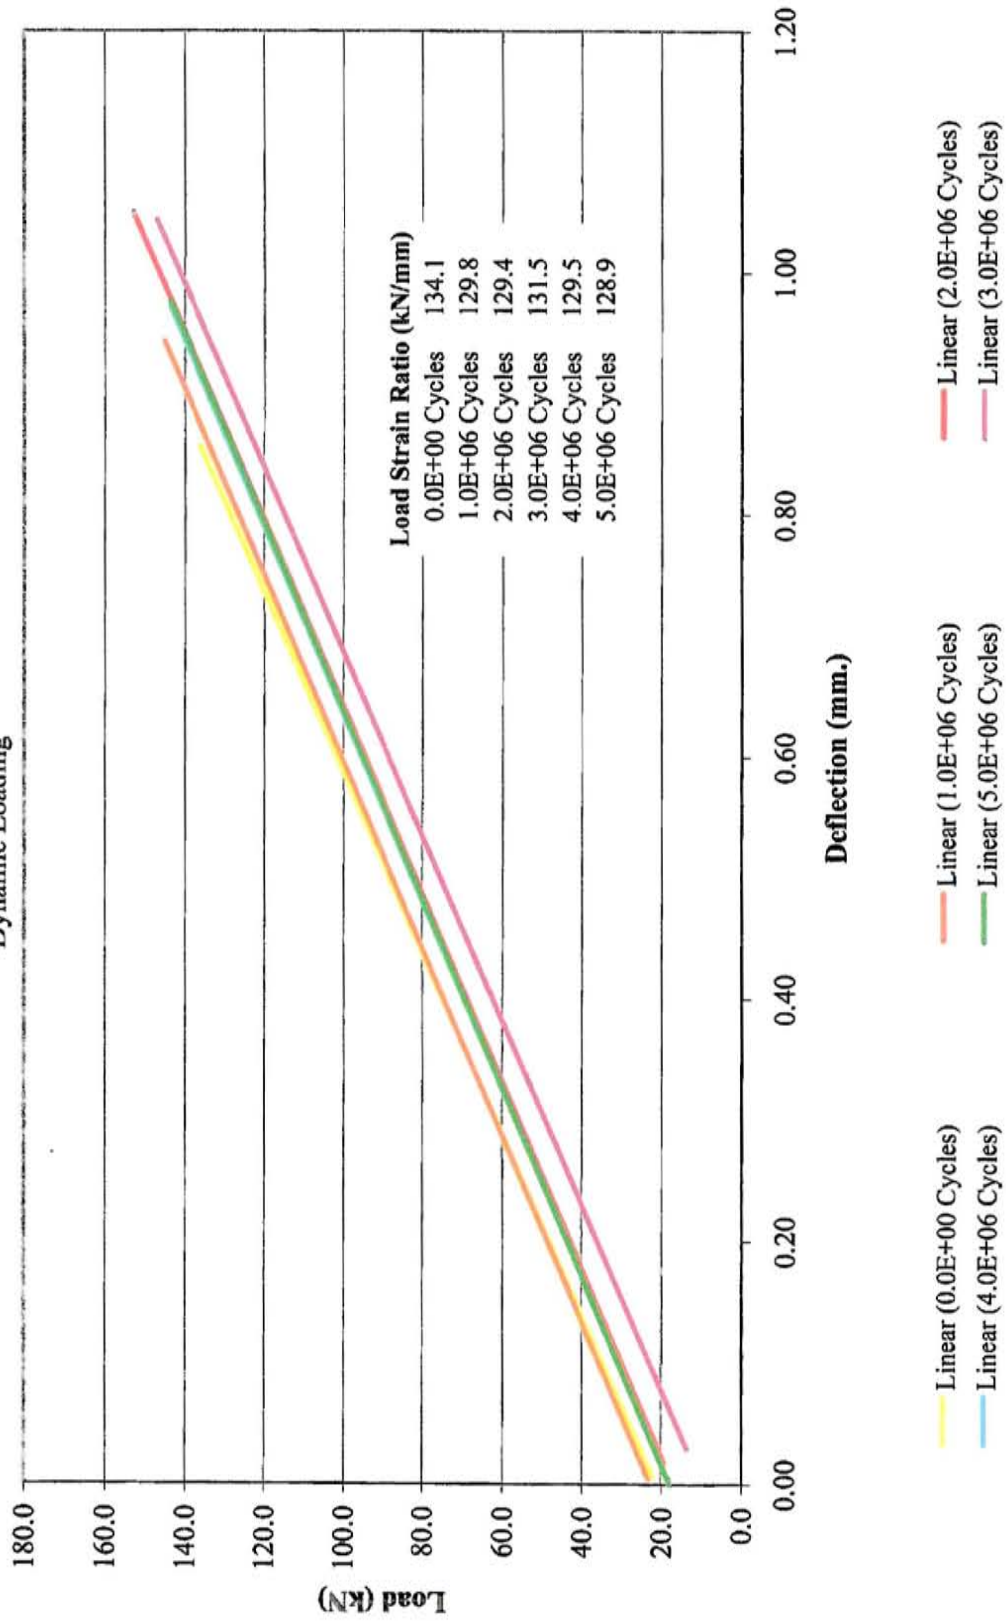
FIGURE 42. Fatigue Test 2 - Fatigue Loading - Load vs. Deflection, Midspan Side A

FIGURE 43. Fatigue Test 2 - Fatigue Loading - Load vs. Deflection, Midspan Side B

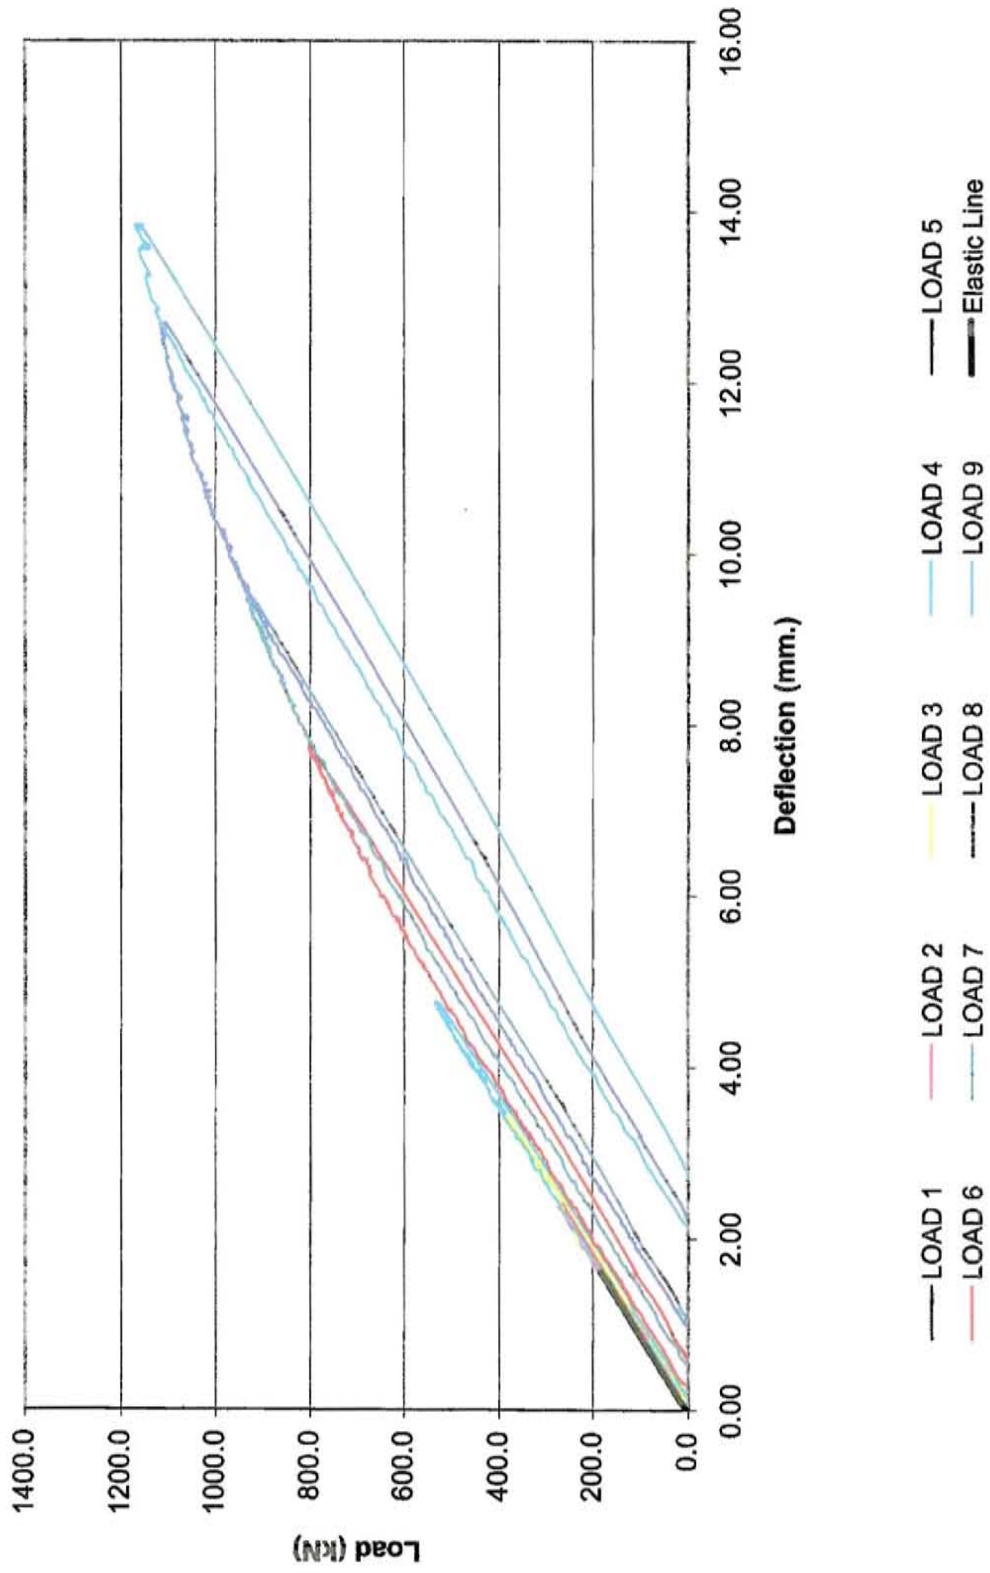
FIGURE 53. Residual Strength Test - Load vs. Deflection, Load to Failure

Load was applied in 133 kN increments until failure of the deck occurred. Nine load cycles were required before failure of the deck was achieved. The maximum load applied was 1170 kN with a 13.8 mm deflection at midspan. Maximum load and deflection values for all nine load cycles can be found in Table 12. Figure 53 is a plot of the load and deflection at midspan for all nine loading stages. By the end of the fourth loading phase (534 kN) the deck began to show some plastic behavior.

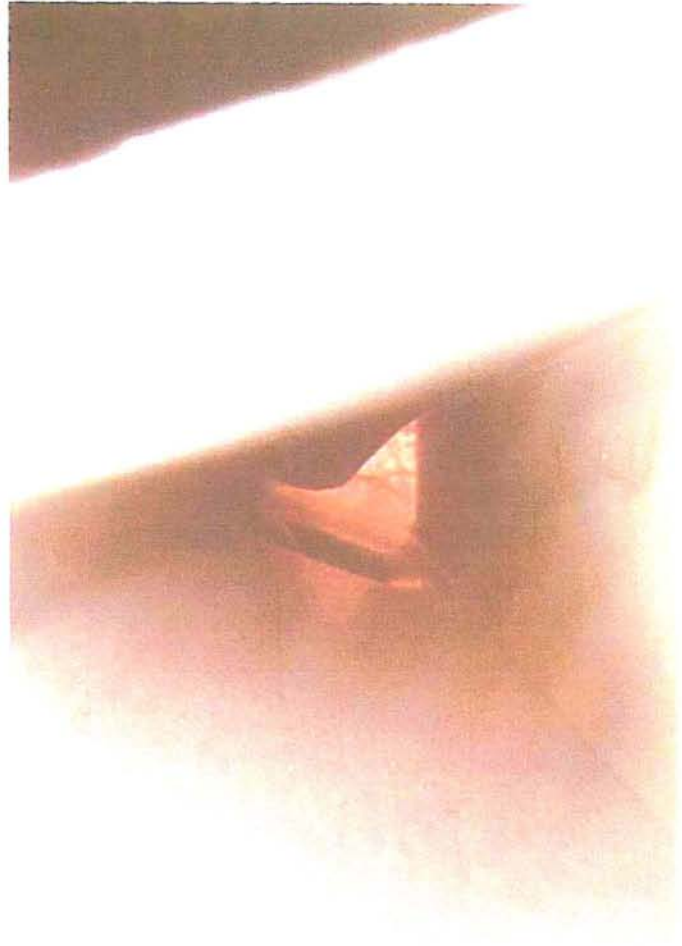
FIGURE 55. Buckled Web After Failure of Side A Occurred.

The failure of Side A was considered to be a local buckling failure of the web truss beneath the load patch. A picture of a buckled web can be found in Figure 55 and the location of the eight webs that buckled can be found in Figure 56. This failure is similar to the first failure test that was conducted by FHWA. Both ultimate load tests experienced local buckling under the load patch. This type of failure is significant in that even after 10 million cycles of constant amplitude loading of Side A it was not the welds that failed but rather the truss system in the web of the deck. This further supports the observation that fatigue cracks did not form along the longitudinal welds during the fatigue loading that took place in Fatigue Test 1 and Fatigue Test 2.
