Development of Improved Connection Details
for Voided Slab Bridges

Thesis submitted to the faculty of the Virginia Polytechnic Institute and
State University in partial fulfillment of the requirements for the degree of

Keywords: Voided Slab, Sub-Assemblage, Shear Key, Fiber Reinforced Concrete

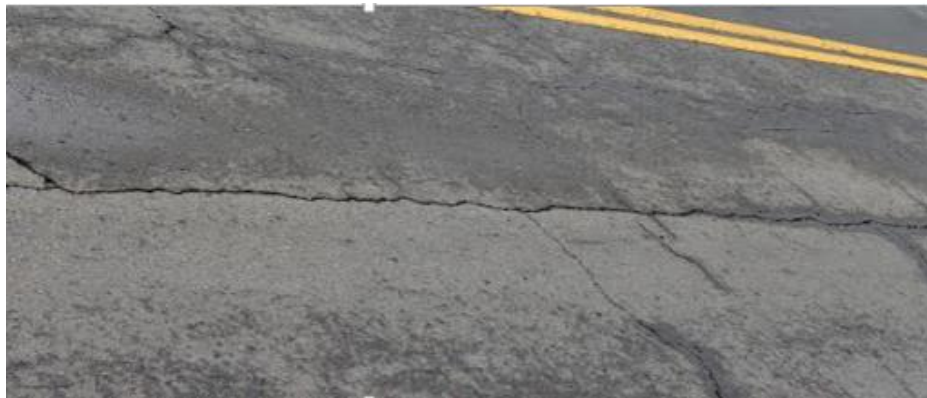
Figure 2: Longitudinal Reflective Cracking in asphalt overlay

The shear key not only serves as the longitudinal connection for the beams but it is responsible for transferring all of the vertical shear loads between the beams. This is an important structural component of these bridges because it distributes tire loads among adjacent beams and causes them to act compositely. This feature reduces deflections in the bridge. Unfortunately, it is the shear key that is the downfall of adjacent member bridges. Many adjacent member bridges show reflective cracking in the roadway surface that can be observed in Figure 2. Reflective cracking is attributed to failure in the shear key which is why the reflective cracking in Figure 2 runs longitudinally along the bridge.

Initially, the reflective cracking is just a maintenance issue, but over time it decreases the overall durability of the bridge. As water leaks through the cracks carrying deicing salts and other substances it tends to corrode the transverse post-tensioning and reinforcement within the concrete. This causes concrete to spall off exposing and corroding more reinforcing bars. Ultimately, this leads to a deteriorated bridge that will need to be replaced, usually short of its

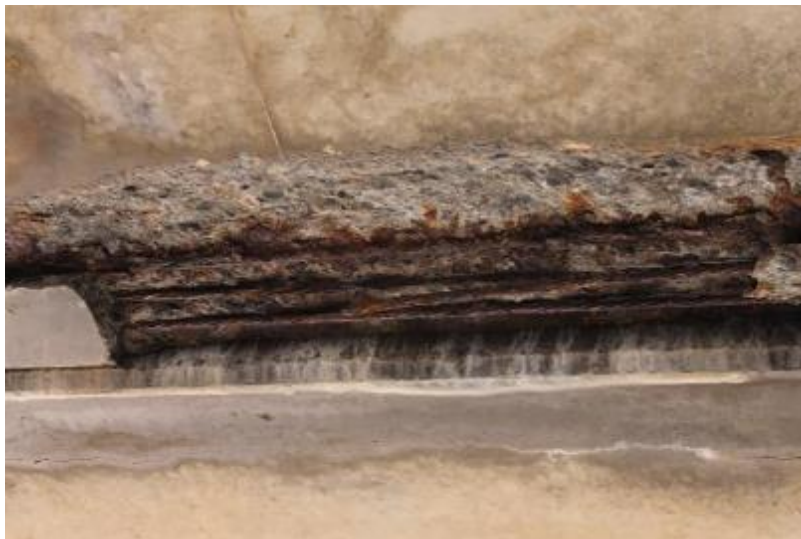
Figure 3: Concrete spalls, corroded prestressing strands, and staining under a shear key

The damage noted in the survey is most likely caused by cracking of the shear key which is due to a combination of tensile stresses initiated by temperature gradients, shrinkage, and live loads (Russel, 2009). The cracking is usually the result of a bond failure between the concrete and the grout. In some inspections that have taken place after the topping and beam elements have been removed, there have been observations of the grouted shear key falling cleanly out of the keyway leaving behind no parts that have bonded to the concrete (Gulyas et al., 1995). The shear key failure typically leads to relative displacements between adjacent girders causing failure of the topping waterproofing system (Huckelbridge et al., 1995). This allows the chloride and salt laden water to move down through the joint and capillary action wicks these corrosive materials into the concrete causing the corrosion of the reinforcement and prestressing strands (Gulyas et al., 1995). It is the corrosion that causes concrete spalling on the underside of the member. Severe corrosion of the prestressing strands may lead to concerns for the structural integrity of the bridge. For the most part, the cracked shear key will continue to transfer load between beams due to mechanical interlock. Although, in some severe cases the deterioration in the key is so great that there is no load sharing between adjacent beams causing unexpected loads in a single beam that can cause its failure.

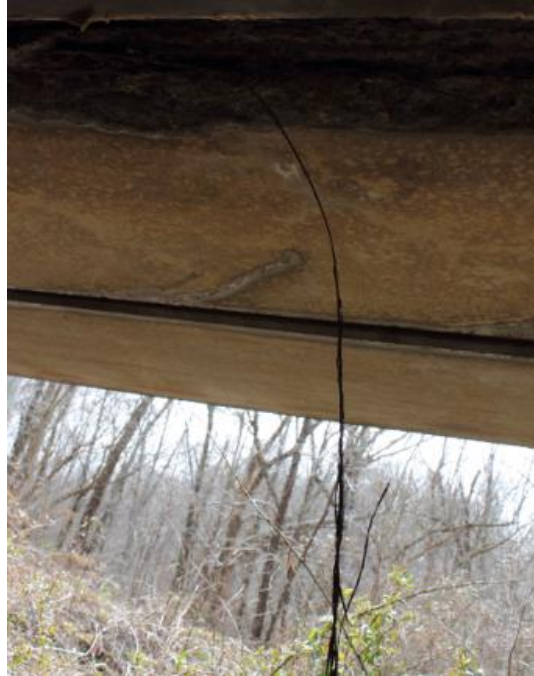
Figure 4: Corroded prestressing strand hanging from large concrete spall near a shear key

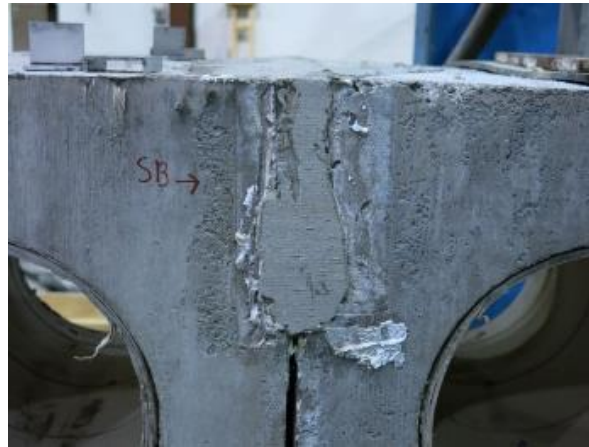
Figure 15: Hardened shear key from first specimen tested

concrete mixer and then placed in the joints. Figure 15 shows a cross section picture of the shear key after the grout has cured.

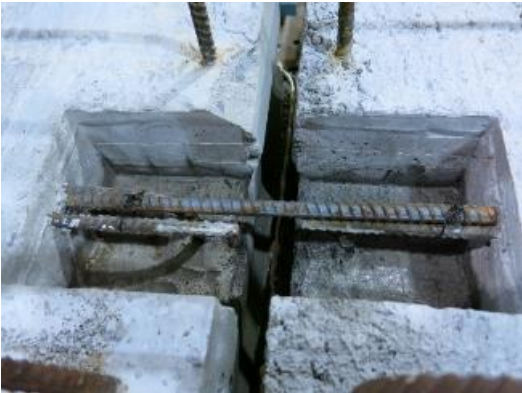
Figure 19: Picture of Blockout with tied in lap splice bar before UHPC placement

bar is lapped when the blockouts from adjacent beams are lined up next to each other. Figure 19 is a picture of two adjacent blockouts with the tied in reinforcing bar. This breakout connection idea was proposed because it was thought that the lap splice connection is better suited to handle the transverse flexural stresses that occur across the joint. It was thought that this connection would cause composite action between the adjacent beams which would reduce cracking. Since the sub-assembly represents a 2 ft section of a bridge, the spacing proposed for full scale implementation is 2 ft on center. There is research being done currently to see test the efficiency of this spacing. Hanna, Morcou, and Tadros (2011) did work using similar blockouts on adjacent member box beams. They too used lapped splice reinforcement connections inside of the breakout. In order to develop these lapped splices over short lengths they provided spiral confinement reinforcing with $\frac{1}{4}$ in wire. In order to negate the need for spiral reinforcement UHPC was used in this connection.

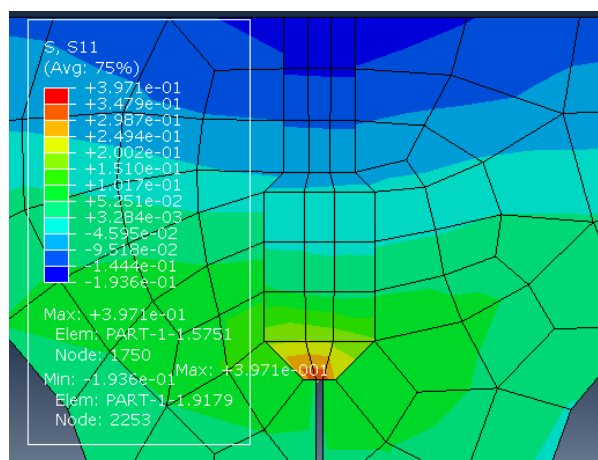
Figure 33: Screenshot showing the transverse shear stresses in the sub-assembly's shear key

The sub-assembly model was loaded by displacing a 12 in. by 6 in. section on the top of the middle section a set amount. This was done because in the test setup an actuator bearing against a 12 in. by 6in. rectangular plate on top of the middle section loads the sub-assembly under displacement control. The displacement amounts were altered until one resulted in a transverse stress distribution in the shear keys that was similar to the one found in the full bridge model. A set displacement of 0.03 in. resulted in the most accurate match. This displacement resulted in a max transverse stress of 0.397 ksi compared to a max transverse stress of 0.393 ksi in the full bridge model. The distribution was very similar to the full bridge model as well, with the max tensile stresses occurring right at the bottom of the shear key and the stresses decreased upward along the shear key and ultimately turning into compressive stresses near the top of the key. Figure 33 is a screenshot of the stress distribution in the shear key from Abaqus.

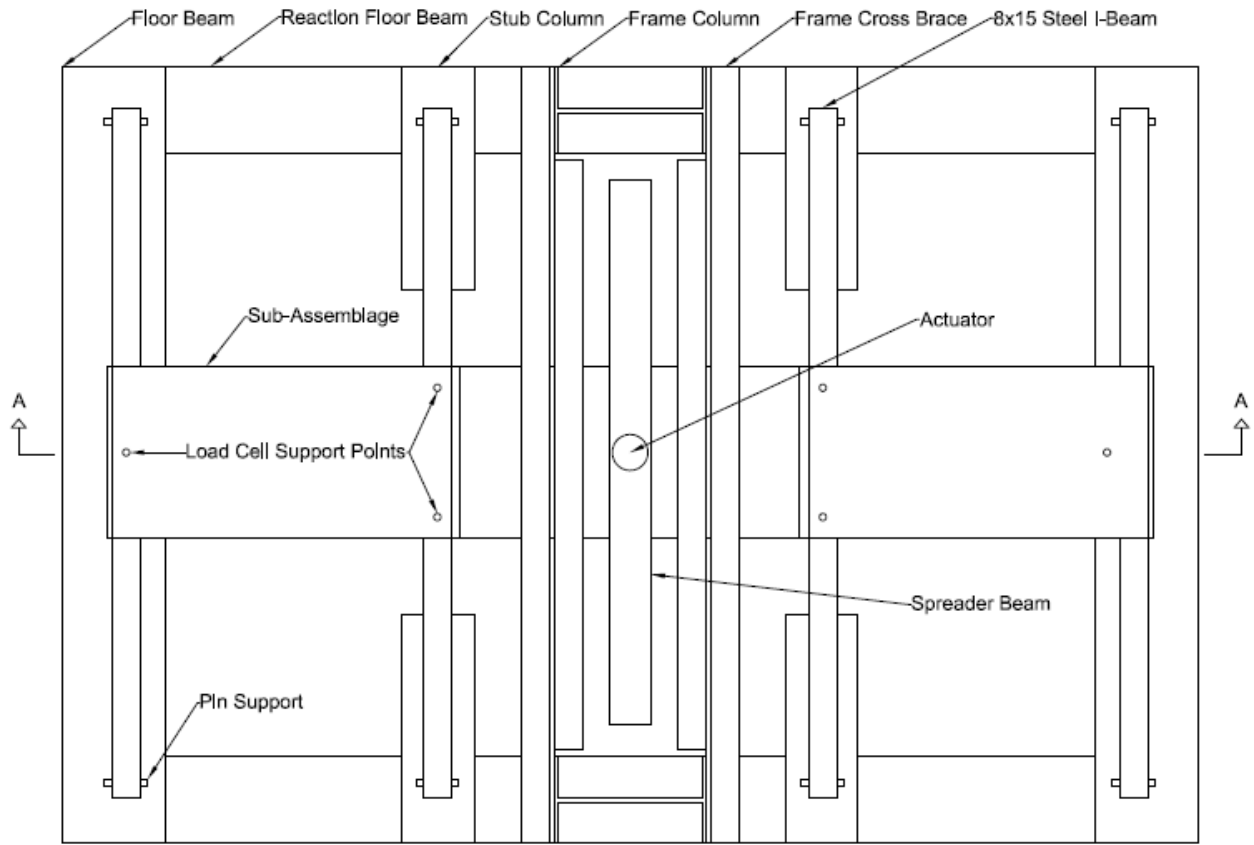
Figure 35: Top view of test setup

The actuator used was a MTS Series 244 actuator with a 55 kip capacity which was powered by an MTS series 505.11 hydraulic pump. The actuator and pump were controlled by a MTS 407 controller. The actuator system was capable of applying both static and cyclic loads under either load or displacement control. Since the top actuator connection is a hinge, the actuator was braced by two angles near its bottom to keep it plumb. Attached to the bottom of the actuator was a steel I-beam (spreader beam), which was clamped to the middle voided slab section. The spreader beam was connected to a T section that ran through the center void of the center voided slab. Half of a round HSS section was placed on top of the T section to better conform to the circular void. A thin neoprene pad was also placed on top of the HSS section in order to account for any imperfections on the concrete surface so that a uniform contact was kept between the HSS and the void. The purpose of clamping was to prevent the sub-assembly from becoming out of phase during the cyclic loading. Figure 35, Figure 36, and Figure 37 are sketches detailing the test setup. Figure 38 is a picture of the test setup without a sub-assembly present. The loading frame, actuator with spreader beam, floor sections, 8x15 I-beams, and load cells are all present in this photo.

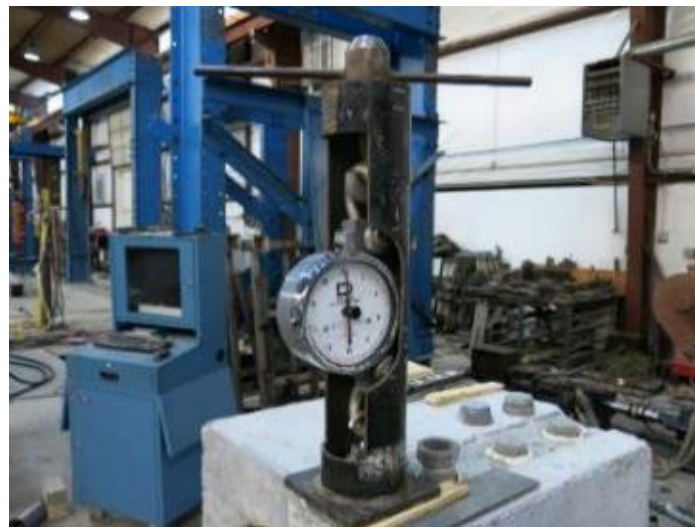
Figure 47: Picture of pull off test setup

Pull off tests were performed with the joint material and the voided slab concrete in an attempt to quantify the bond strength of the joint material to the voided slab concrete. These tests were performed by casting small cylindrical forms that were 2 in. in diameter and 1 in. high directly against the shear key of voided slab sections. The voided slab sections used for these tests were either previously tested exterior specimens that still had an unused joint or specimens that had yet to be tested. These surfaces were also sandblasted and kept moist prior to placement. In order to perform these tests a metal cap was epoxied to the concrete pull off specimens. An insert with a hook on the end was threaded into this metal cap. A tension load cell was hooked onto the insert and then pulled from the other end via a screw jack type device. Figure 47 is a picture of the setup. These pull off tests were run on the first day of testing and on the final day of testing. Table 6 summarizes the material testing performed for each specimen.

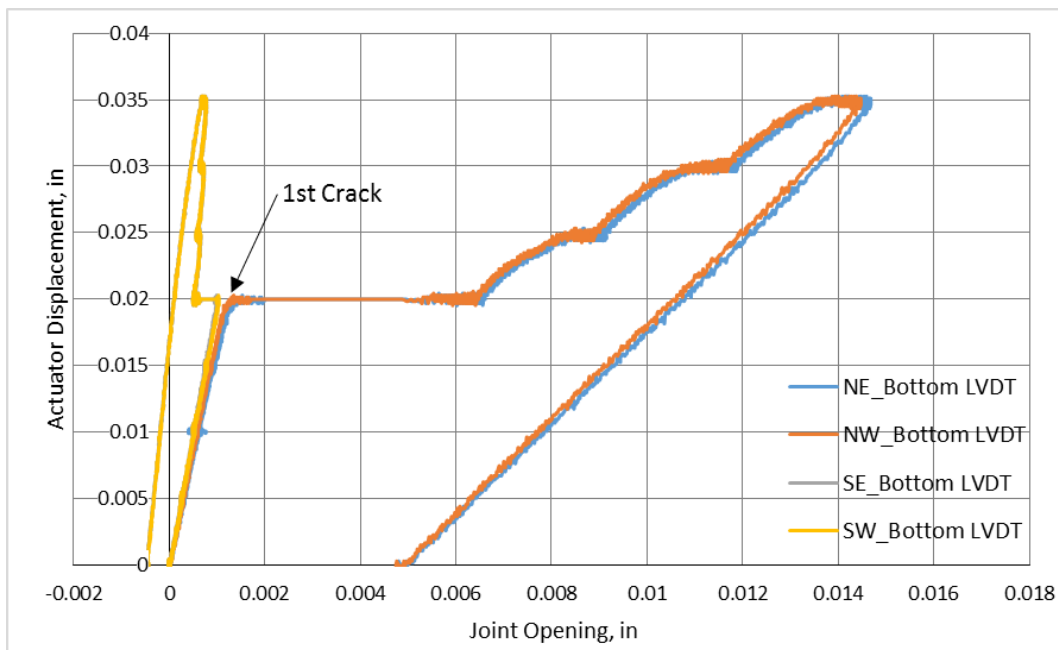
Figure 50: Joint openings versus actuator displacement for the first static test of specimen 1

Due to the concern of an early failure, the first static test was run slowly, so that the shear keys could be checked for cracks more frequently. Figure 50 is a graph showing the data collected for the first static test from the four horizontal LVDTs, located at the bottom of each joint face. Cracks were first noted in the north side shear key at 0.02 in. actuator displacement, which is apparent in the graph below, from the jump in both north side LVDT values. Also apparent from the graph is that the south side shear key did not crack, and shows some closure when the north side cracked. This occurred because once the north side cracked the boundary conditions for the test setup changed. The middle and south section then acted rigidly while rotating about the cracked north shear key, which behaved like a hinge. The unloading portion of the first static test shows two things. The first is that the joints did not close, which was to be expected after cracking. The second thing is that the slope of the unloading portion of the curve is much shallower for the north side LVDTs when compared to their pre-cracking loading slope, which is also expected. Although significantly cracked, the northern shear key did not completely fail after the first static test, and could still hold load.

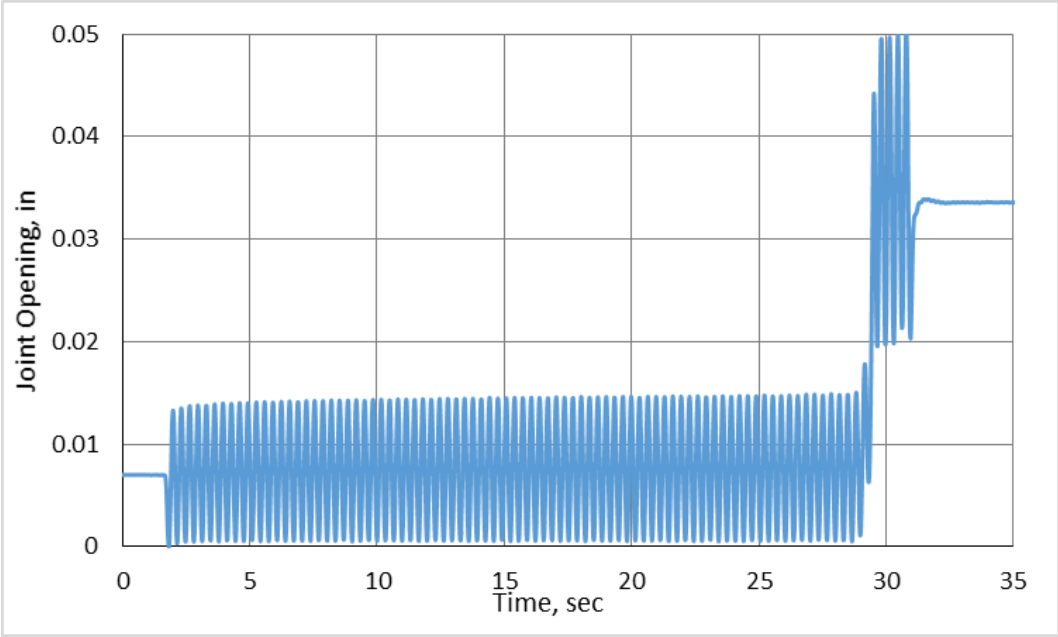
Figure 51: Graph showing north joint openings during the 100 cycle loading of specimen 1

collected during the first 100 cycles, via the horizontal LVDT located at the bottom of the north east shear key face. The graph shows that the key was intact until the 94th cycle when it drastically opened up. A large loss of load was also seen at this point signifying failure. Figure 52 is a picture of the failed joint which shows the flexural crack along the length of the shear key where it debonded from the middle specimen. Figure 53 is a picture of the bare shear key from the middle section. The picture shows that no grout pieces were left bonded to the precast concrete, which is indicative of the low bond strength between the grout and precast concrete.

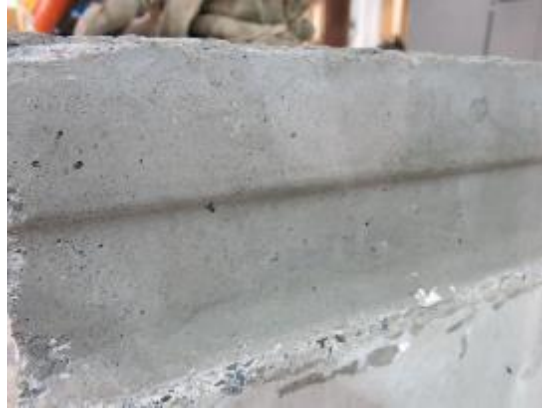
Figure 53: Shear key from middle section of the first specimen

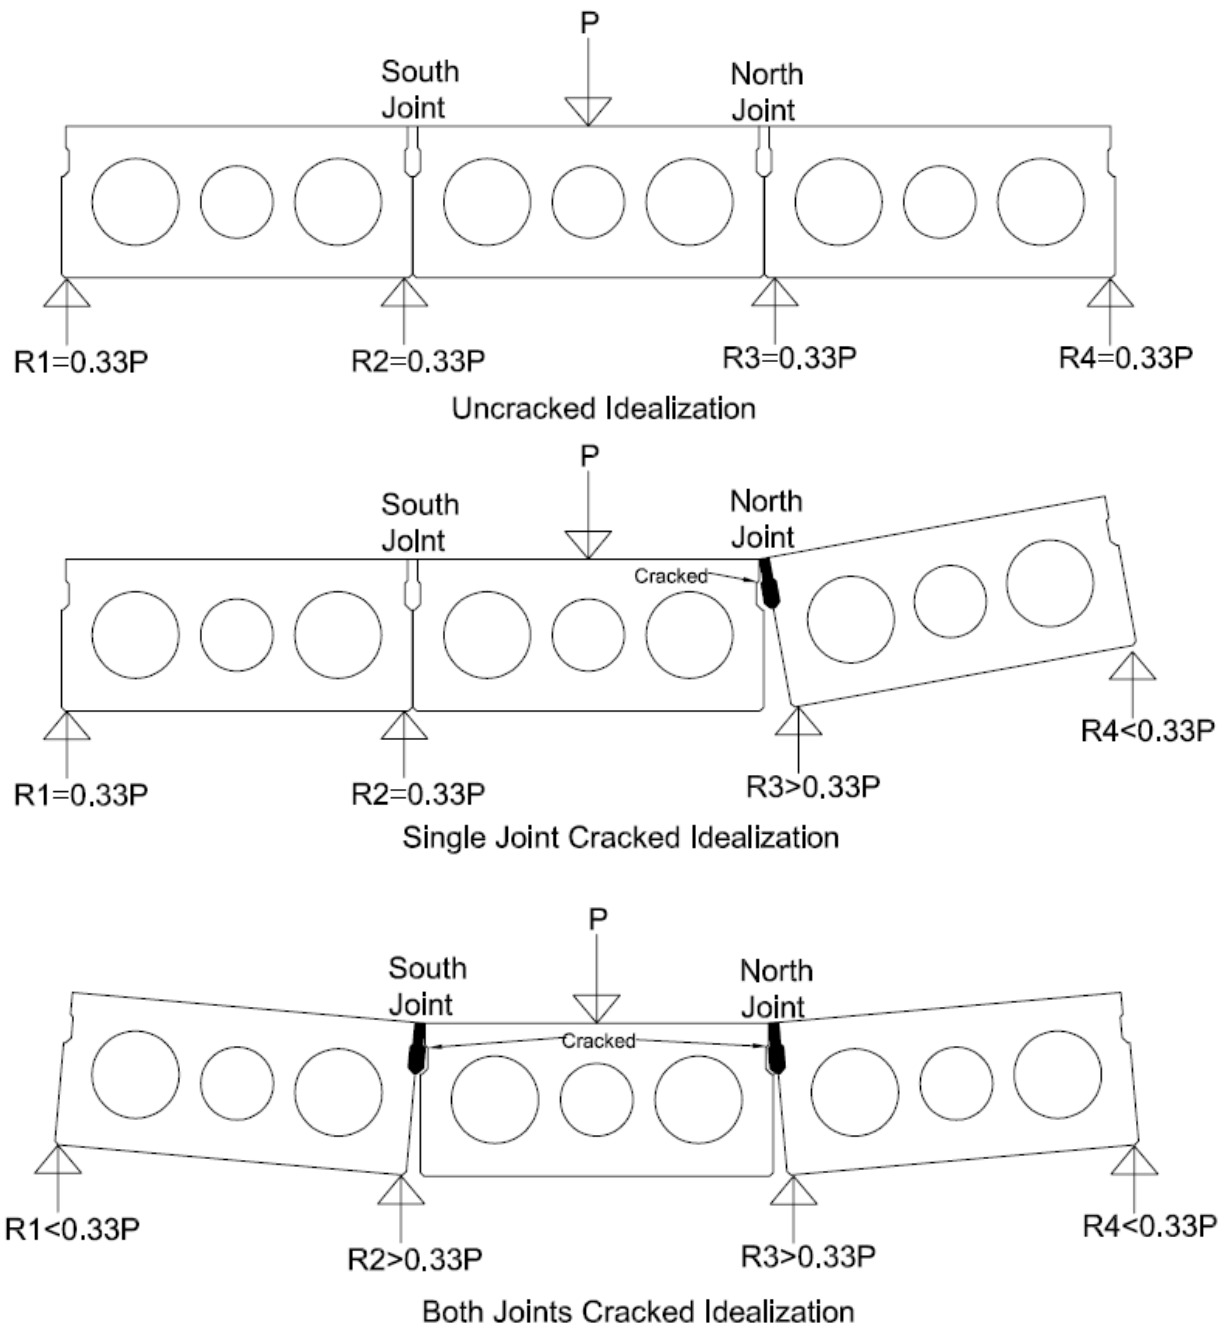
Figure 57: Schematic showing cracked idealizations

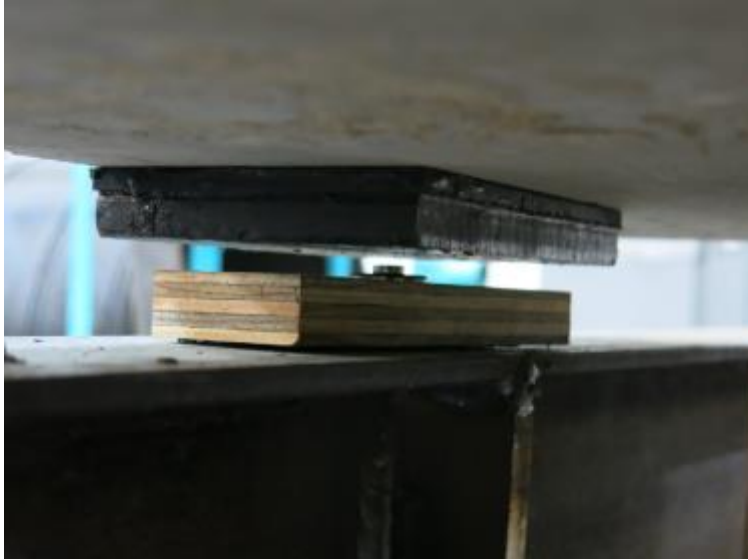
Figure 58: Uplift of south beam section at load cell

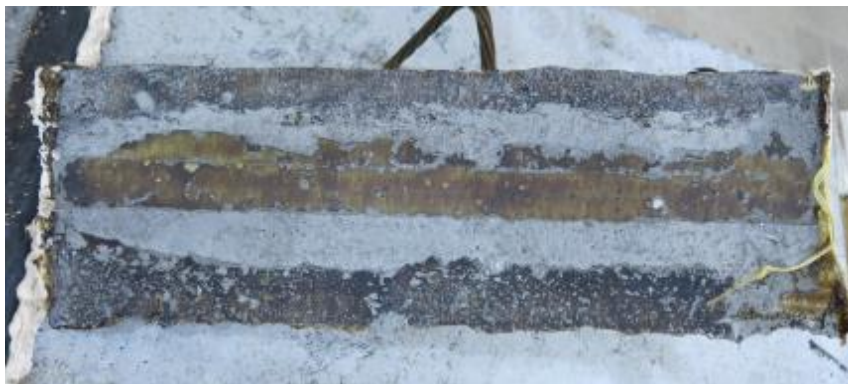
Figure 63: Picture of debonded, intact Kevlar reinforcement

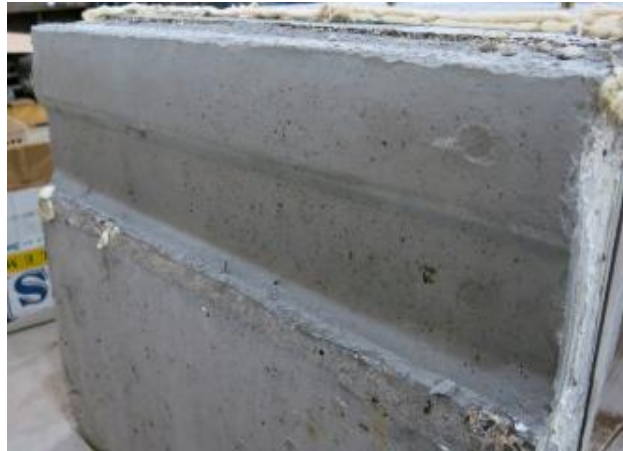
Figure 64: Picture of failed shear key of specimen 2 with no traces of bonded grout leftover

Due to the longevity of the test, the water ponding test was performed three times. No water was observed leaking through the joint, and the water was left standing all three times until it evaporated. Also due to the longevity of the test, the full schedule of material testing was conducted on both the first and last day of testing. The second specimen was made of concrete sections placed during the first and third batches, so the material testing was performed accordingly. As expected, the grout bond strength was low. Figure 64 is a picture of a shear key after failure showing no traces of grout left bonded to the concrete. Table 11 provides a summary of the data from the pull off tests again showing low bond strengths. Although specified as non-shrink grout, shrinkage cracks were observed along both of the joints. These cracks can be seen marked prior to the placement of the Kevlar in Figure 65. Shrinkage was tracked using two 1 in. x 1 in. x 11 in. bars, and shrinkage strains measured 1000 microstrain by the start of testing in both bars and reached 1350 microstrain by the last day of testing. Table 12 summarizes the strength and modulus of elasticity for the grout and concrete. All of the material test data can be found in Appendix D.

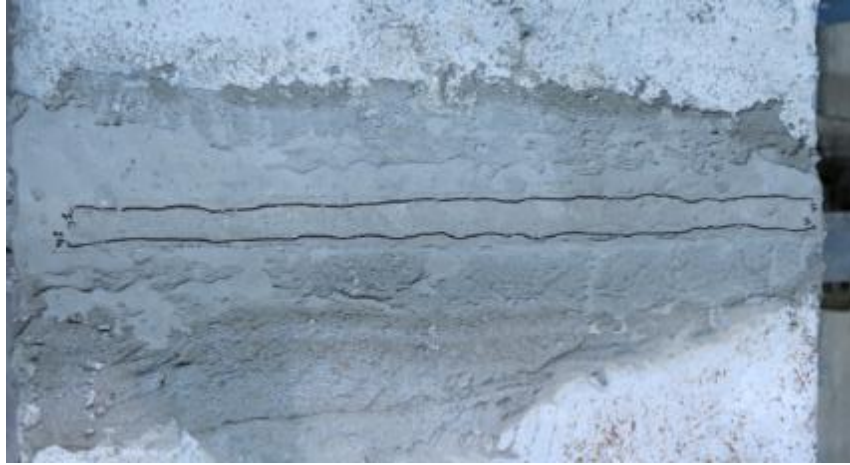
Figure 65: Picture showing marked shrinkage cracks before placement of the Kevlar

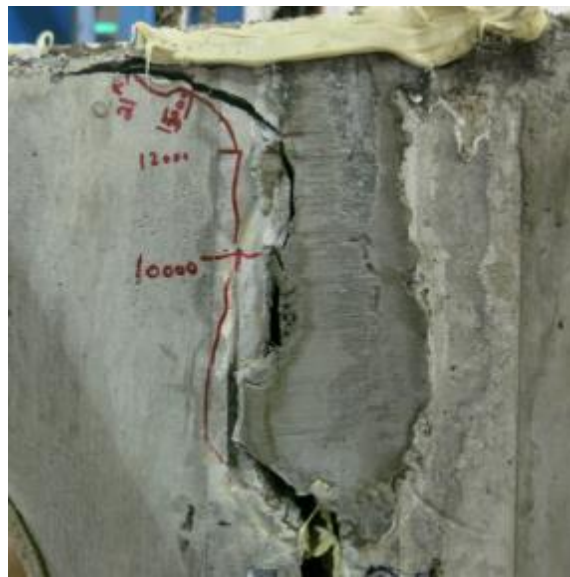
Figure 73: Picture showing the cracked south shear key of specimen 3

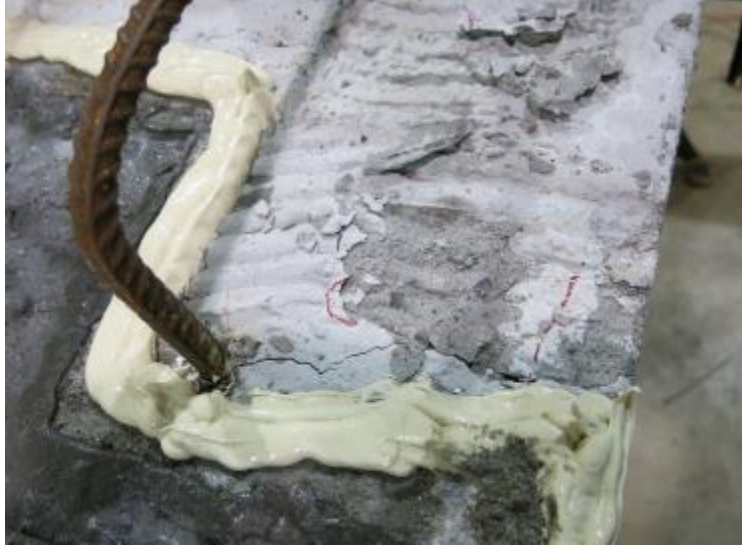
Figure 74: Picture of concrete crushing and concrete spalls on top of specimen 3

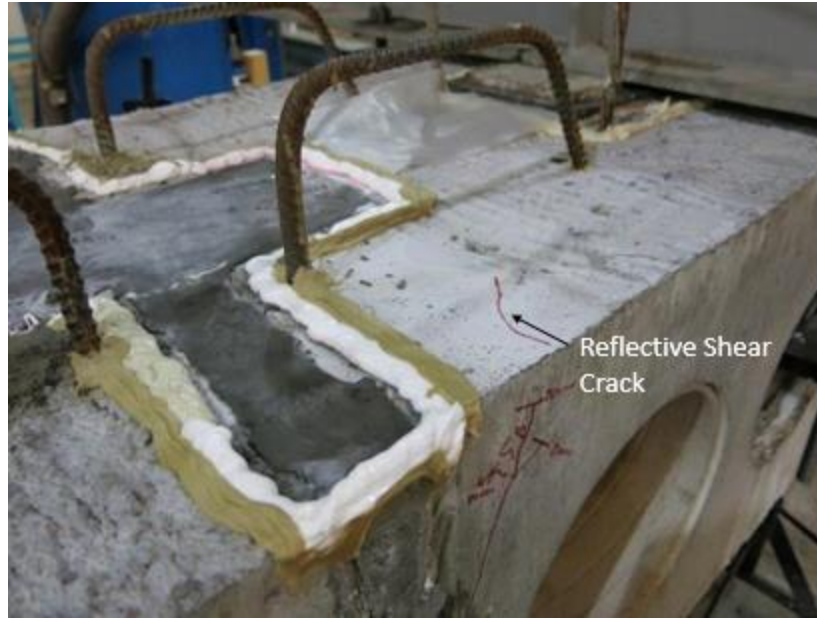
Figure 83: Picture showing reflective cracks on the middle section near the south joint

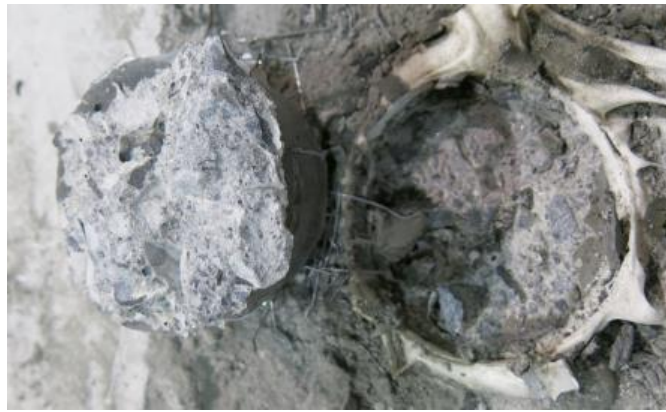
Figure 85: Picture of a VHPC pull off specimen with bonded concrete stuck to specimen

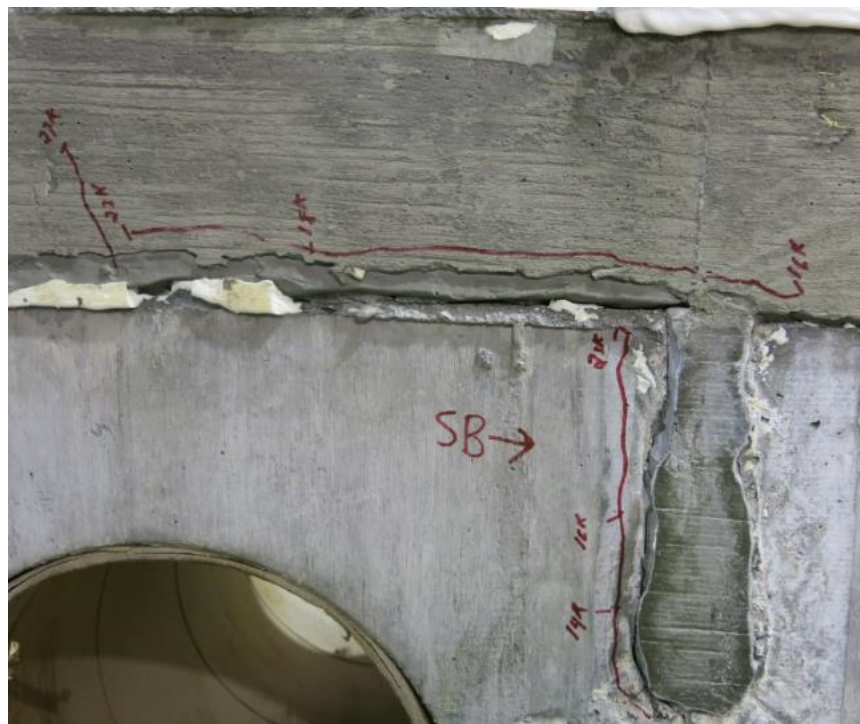
Figure 91: South joint showing typical cracking pattern observed during final static test

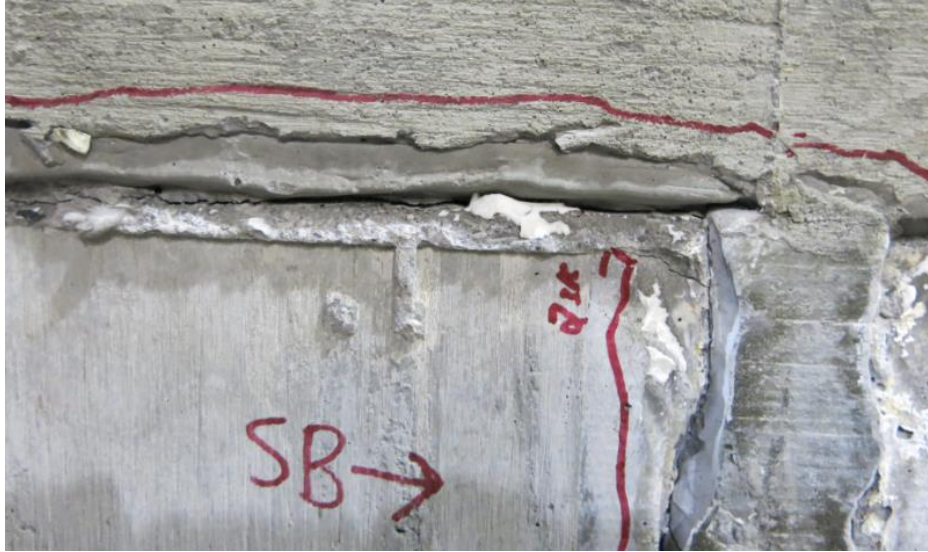
Figure 92: Close up showing cracking along topping voided slab interface

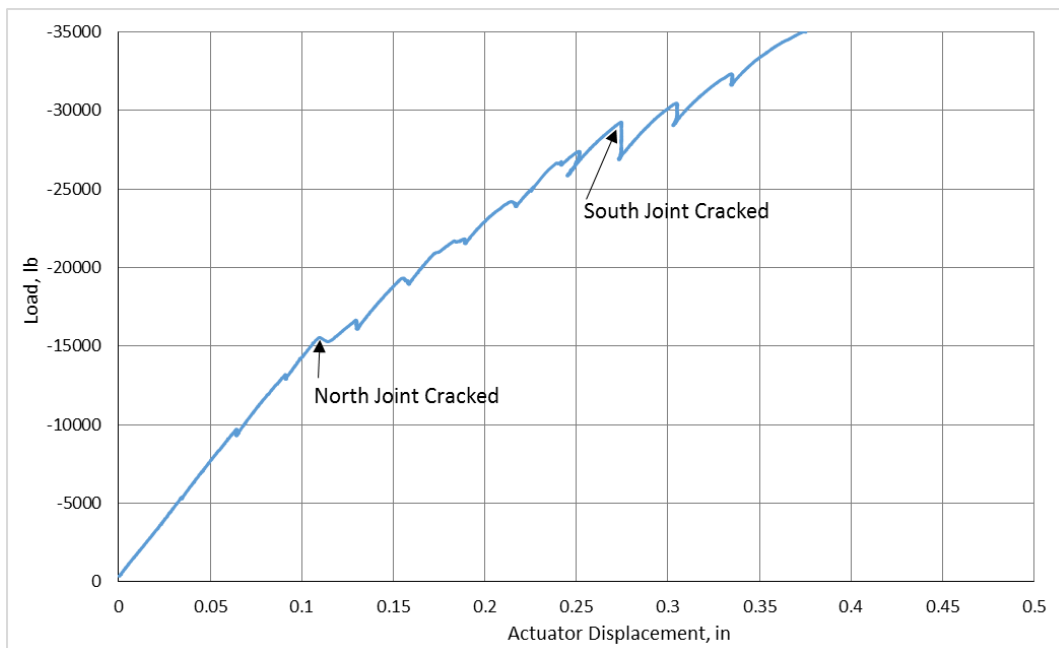
Figure 96: Load vs displacement plot for specimen 6's final static test

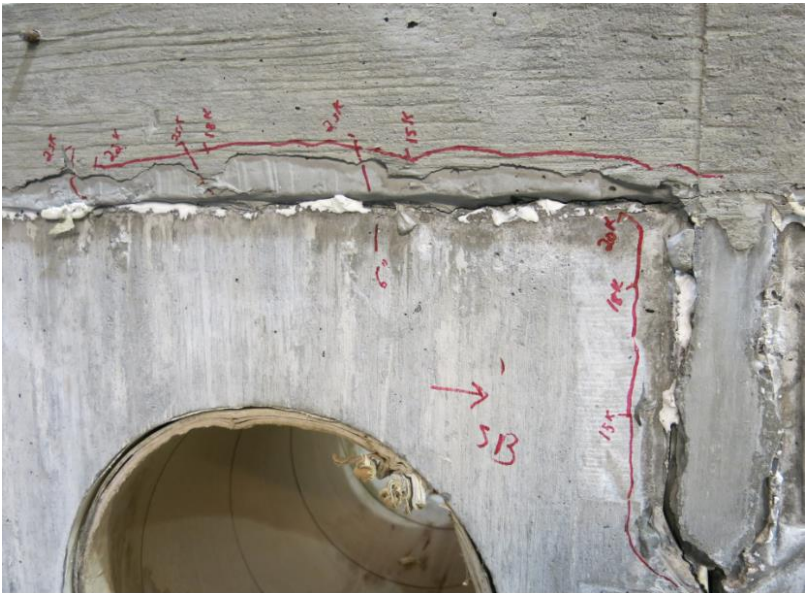
Figure 98: Typical cracking pattern for specimen 6 key

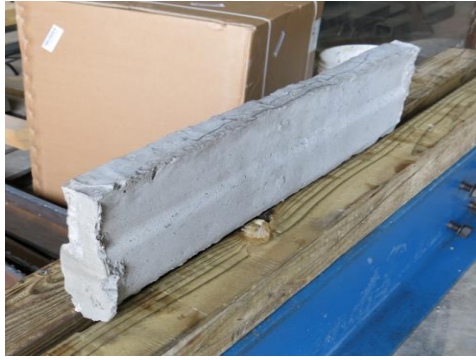
Figure 99: Fully intact shear key after failure of bonded connection

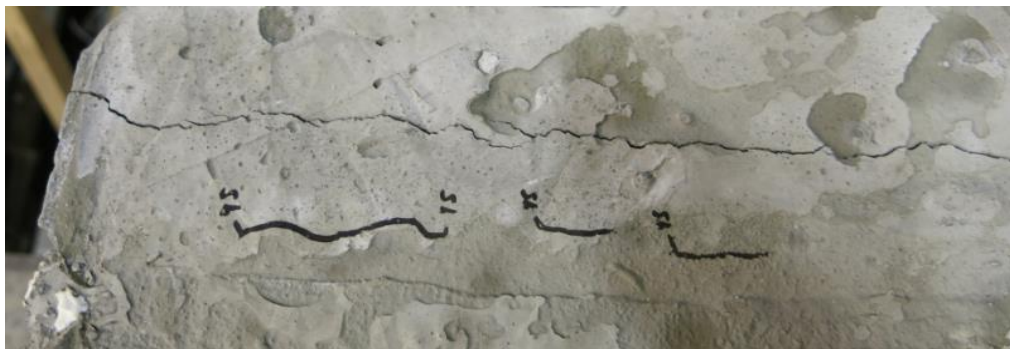
Figure 102: Crack on top of the first specimen after failure
