URBAN STREAM DAYLIGHTING Case Study Evaluations

SPECIAL REPORT

July 2007

VWRRC Special Report SR35-2007

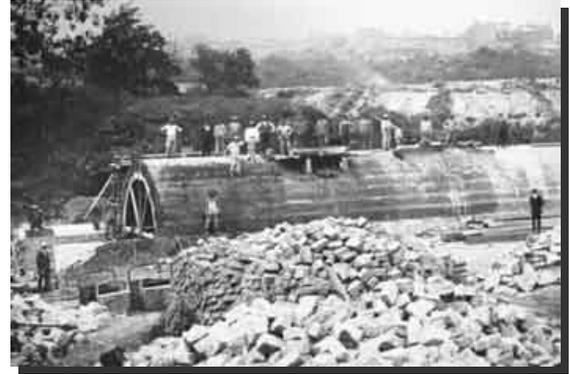
Figure 2. Wingohocking Creek Sewer under construction. 1909

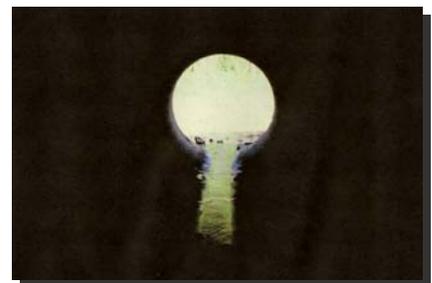
Figure 3. Piped Stream

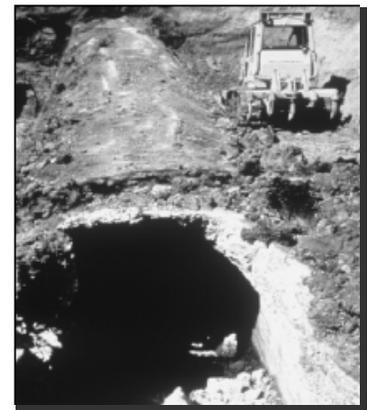
Figure 4. Strawberry Creek daylighting, 1984

Stream daylighting is a relatively new tool, however. “The daylighting of Strawberry Creek at a park in Berkeley, California took place in 1984. While other projects, such as in Napa, California and Urbana, Illinois re-exposed creeks in the 1970s, the Strawberry Creek project is widely considered the archetype of daylighting” (Pinkham, IV). The term ‘daylighting’ is often unfamiliar to

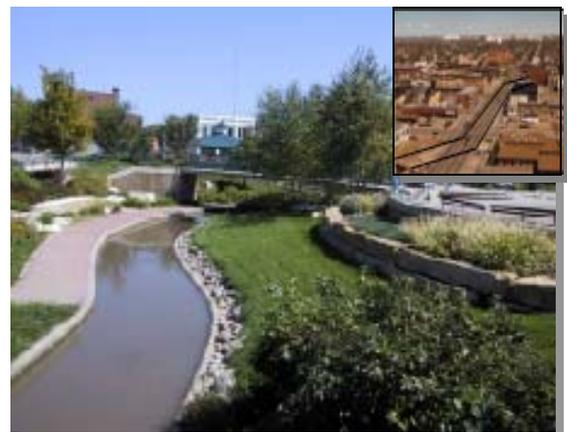
Figure 6. Cow Creek site pre- and post-construction

The second example is Cow Creek running through Avenue A Park in Hutchinson, Kansas. Originally, Cow Creek ran lengthwise directly under Avenue A, which more or less acted as a bridge over the buried stream. The "bridge" needed to be replaced but turned out to be too costly and reconstruction would have interrupted downtown business traffic for up to three years (Pinkham, 22). City engineers decided to reroute Cow Creek altogether and fill in the old streambed, rebuild the road, and completely avoid a bridge (National Park Service).

The daylighted 800-foot-long stream section is now the centerpiece of a new park that includes a walking path right next to the channel, a grassy amphitheater and stage for shows, and a large water play area with fountains fed by city water (Pinkham, 45).

LOCATION	Hydrologic Studies	Design Elements	Monitoring	Evaluation Method	Key Contacts	Comments	Park
Midwest							
Kansas							
Cow Creek Hutchinson, KS (1997)	none reported	10-feet wide concrete channel that is 30 inches deep; Cow Creek's low gradient led city to keep an armored bed for sediment scraping	none reported (passes coliform standards for human contact, but is still posted against entry because of nearby children's water park)	none reported	Hal Munger, City engineer	This project filled in the original creek bed and replaced it with a new one that is not really a creek; the result is a highly controlled and heavily built storm water canal and grass park with ornamental water features.	Yes
Michigan							
Arcadia Creek Kalamazoo, MI (1995)	none specifically reported but vaguely referred to	3 blocks of concrete channels that are 20 ft wide x 12 ft deep open stormwater pond with grassy slopes 6 weirs @ 1.5 ft deep along channel length	none reported	none reported	Downtown Development Authority STS Consultants, Ltd (engineering firm that led the daylighting portion)	Due to large sediment loads and deposits along the low gradient channel, most maintenance costs are for sediment and trash removal); withstands flows of a 500-yr flood now; paid for itself in event revenues	Yes

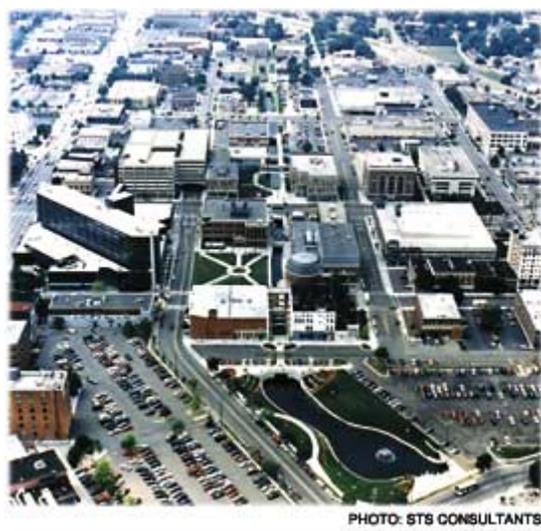
Figure 7. Arcadia Creek Festival Site

Arcadia Creek is especially noteworthy because it represents one of the most highly urbanized locations known to be daylighted. It involved the acquisition and demolition of property, including an existing public parking lot, to make room for the daylighted channel and stormwater pond. It is considered a successful project because the resulting “stream” and “pond” have worked very well to mitigate the urban flooding problems Kalamazoo had been facing for years. Downtown businesses no longer have to pay flood insurance, there is protection from a 500-year storm event, and the city's floodplain map was completely redrawn (Pinkham, 33). Other financial benefits have since manifested: the site now generates approximately \$12 million annually in festival and concert fees, which has more than paid for the \$7.5 million price tag associated with the park's creation as well as its \$50,000-per-year maintenance costs (Pinkham, 33).

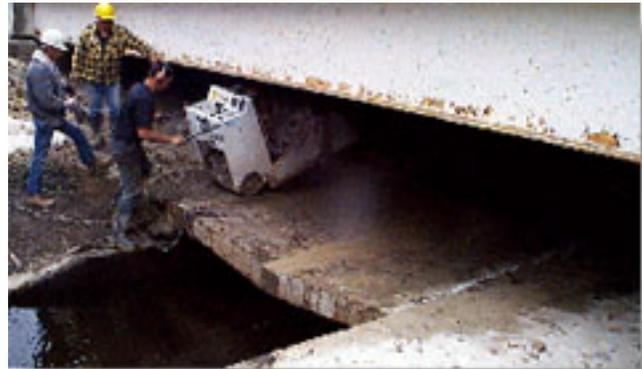
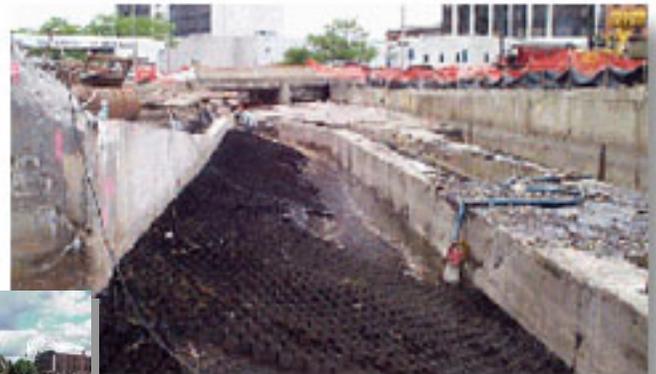
Figure 8. Grand River Cap Removal during and after construction

On the other hand, the Grand River Cap Removal project is noteworthy because it was undertaken in response to a series of deaths. The cause: children being swept into the box culvert, thus the Grand River culvert was deemed an “acute health hazard” (Michigan Department of Environmental Quality). The primary goal was to remove the culvert (or “cap”) and make it possible for a person to escape the river if necessary. After it was completed, the relatively short 300-foot-long daylighted section began to attract commercial and business development along its newly-designated ‘waterfront’ stretch near downtown Jackson (Michigan Department of Environmental Quality).

Michigan							
Grand River Cap Removal Jackson, MI (1998)	none reported	300 feet of capped culvert was removed; river banks were stabilized	none reported	none reported	Michigan Department of Environmental Quality	This was an unusual daylighting project for unfortunate reasons; contaminated soils found on site increased total costs; new stream' is only a concrete canal	No
Minnesota							
Phalen Creek St. Paul, MN (1987)	none reported	2 large underground culverts open into 3 settling ponds; flow diverter passes a constant flow of 2 cfs into stream	none specifically reported; Biocide-treated water from brewer has decreased in quantity since plant closed; macroinvertebrates and amphibians reported.	none reported	St. Paul Garden Club (Olivia Dodge) St. Paul Public Works Department (Pat Byrne)	Considerable sediment deposits into the stream and no dredging schedule is known. This was a very unusual project in a weird location with unique site constraints; but it has initiated several other nearby daylighting and stormwater filtering projects	Yes

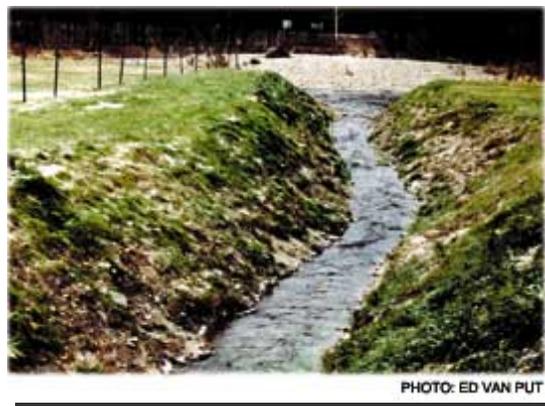
Figure 9. Darbee Brook post-daylighting

Darbee Brook in Roscoe, New York is emphasized because it was a small, ecologically-based project that worked successfully to reintroduce fish passage to a famous fishing stream in the Catskills (Pinkham, 36). The site was on a portion of a public middle school that had culverted Darbee Brook in the 1960s to make room for larger playing fields. Over time, the culvert subsided and caused damage to the fields it was intended to protect. It finally failed in the winter of 1996 after a significant rain / thaw event. The project involved a large government agency for funding (FEMA), along with the New York Department of Environmental Conservation (DEC) and the independent organization Trout Unlimited. A new 160-foot-long open channel was built to divert Darbee Brook from its culvert, and the old pipe was removed and replaced with fill dirt to stabilize the playing fields (Pinkham, 36).

Follow-up monitoring has taken place on the new stream channel and "...electrofishing samples have documented fish entry into the system from the main river as well as utilization of the opened channel by a diverse assembly of aquatic species" (Pinkham, 37). According to DEC consultant Ed Van Put, "This was the first time we could take a stream out of a culvert and make it live again" (Pinkham, 37). An added bonus was its price tag: it was considered far less expensive to daylight the brook at \$9,000 than to replace the existing damaged culvert which was estimated to cost up to \$50,000 (Pinkham, 37).

New York							
Darbee Brook Roscoe, NY (1996)	1.5 sq.mi/agriculture and residential **SCHOOL SITE **	0.5 cfs seasonal low flow 30-40 cfs annual peak	330 linear feet (this was removed culvert length)	160 feet of new channel (this is the total length of stream that is daylighted)	\$9,000	Remove deteriorating culvert that prevented fish passage and damaged school playing fields; FEMA provided funds after huge flood damage occurred, to "prevent damage from any future flooding"	New environmental science summer camp at site; HS level water chemistry class started; other science curricula additions

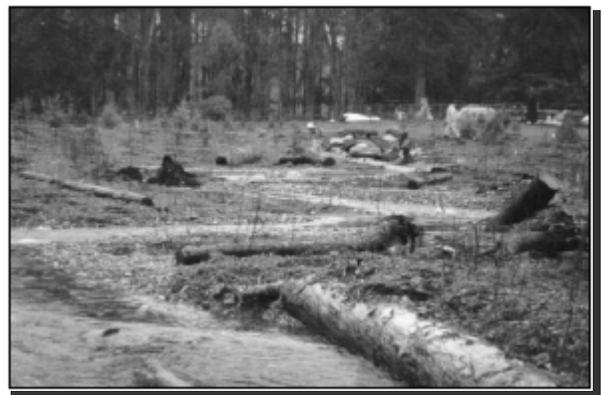
Figure 10. Jenkins Creek restored stream

The watershed management plan emphasized the need to repair and protect aquatic habitat along Jenkins Creek; a fish habitat survey identified salmonids downstream as well as fish passage barriers along the stream's length (Pinkham, 40). Daylighting Jenkins Creek occurred in two phases at two locations: an 800-foot-long channel in the Lake Wilderness Golf Course and a 700-foot-long channel in Lake Wilderness Park (which ran previously underneath a parking lot there). An additional 500 feet of existing surface stream was also restored in this phase.

Both phases required the recreation of a floodplain and designing extra flow capacity into the stream channels themselves, in anticipation of future watershed development (Pinkham, 41). Other ecologically-based structures included bioswales that were put in place near roads and parking lots to intercept pollutants and sediment, and a berm designed above the golf course floodplain to capture nutrient-laden runoff. Gravel bars placed in the creek to divert flow during construction were allowed to remain in place and supply material to the new streambed (Pinkham, 41).

Jenkins Creek Phase 11	see above	re-creation of floodplain stream channel development	Required by King County Dept of Development & Environmental	Stream structures condition report;	King County Surface Water Management Division	Considerable attention given to optimum channel depth and velocity, spawning beds,	Yes

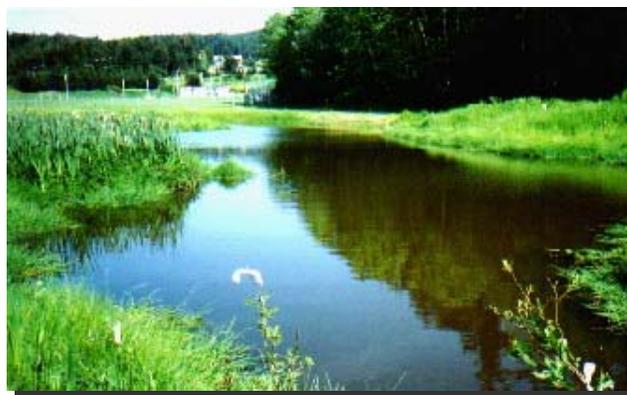
Figure 11. Jolly Giant Creek at Arcata High School

Jolly Giant Creek in Arcata, CA is a successful example of daylighting a stream on school property to reclaim its function and aquatic habitat specifically for students to study. The project was spearheaded by Arcata High School's biology professor and assisted by graduate students in the fisheries department of nearby Humboldt State University.

Pre-design hydrologic studies were carried out by university students, followed by channel and pond designs meant to optimize aquatic habitat and natural channel function. Not only did the completed project provide the outdoor classroom intended by the biology professor, but Jolly Giant Creek has become a valuable new public space and pedestrian greenway (Pinkham, 15). Students participated directly in the daylighting project, and today they continue to monitor the stream and ponds for resident native salmon, trout, and redds (Pinkham, 15). They also use the new greenway as a path on their way to and from school.

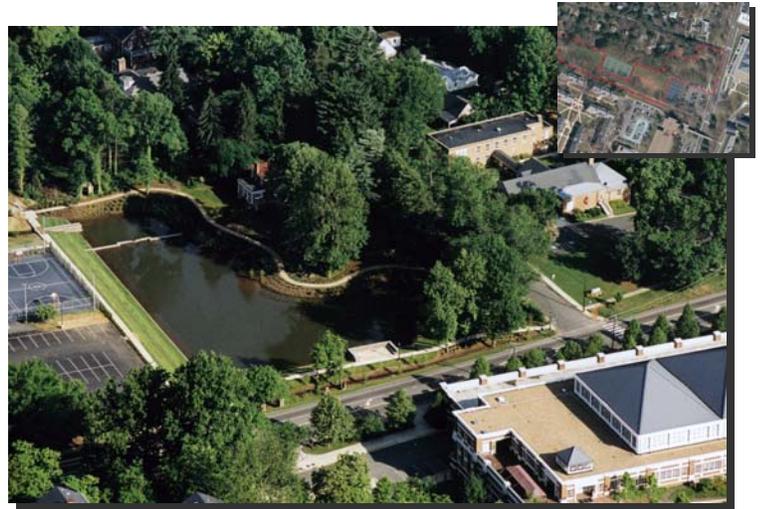
Figure 12. Sedimentation basin at “The Dell” pre- and post-construction

In the case of “The Dell” on the campus of the University of Virginia in Charlottesville, Virginia, the goal was not to restore a fully-functioning stream ecosystem so much as it was to reclaim the history of the site as a former stream corridor and pond. In so doing, architects, stream specialists, and engineers aimed to capture sediment and partial flood waters that might otherwise end up downstream, while providing a newly defined community space on campus that brought people in closer contact with the natural settings surrounding the university (Williams, 2006). By allocating nearby ball fields as floodplains and creating a large sedimentation basin surrounded by native riparian plantings, designers successfully restored the importance of water in the most urban settings and reversed the loss of “cultural space” (Williams, 2006).

The results of these two projects are a reasonably well-blended representation of the definition of “green infrastructure”, in that they attempt to promote ecological function while addressing the existing human context. The physical design of the Dell in particular was deliberately given straight edges on two sides to symbolically include the built environment surrounding the basin as an influencing design factor. Jolly Giant Creek represents the more ecological outcome of the two examples, because it was undertaken with ecology and habitat in mind. The Dell is less so, but has retained successful flood mitigation and sediment deposit functions as intended.

LOCATION	Hydrologic Studies	Design Elements	Monitoring	Evaluation Method	Key Contacts	Comments	Park
South							
Virginia							
The Dell Charlottesville, VA (2004)	Hydrologic modeling of 1-yr and 100-yr events	new pools and riffles log vanes in channel stone overflow weir 2 infiltration rain gardens ball fields as floodplains natural stone boulders at toe	none officially reported, but supposedly some local students are looking at it	none reported	Nelson Byrd Woltz, Landscape Architects: Kennon Williams BioHabitats: Vince Sortman	Kept an existing 48" diameter storm pipe in place to capture major storm overflows; a 100-year storm has 190 cfs; only 35 cfs are allowed to pass through new stream. This is probably more of a "partial flow" daylighting project	Yes
Northeast							
Massachusetts							
West Ox Pasture Brook Rowley, MA (1999)	none reported	grading of new stream banks; banks mulched with hay and planted with native species	none reported	none reported	Tim Purinton (Rowley Conservation Commission) Parker River Clean Water Association	Due to lot configuration, septic system was not relocated, so stream curved away from original course to accommodate this;	No

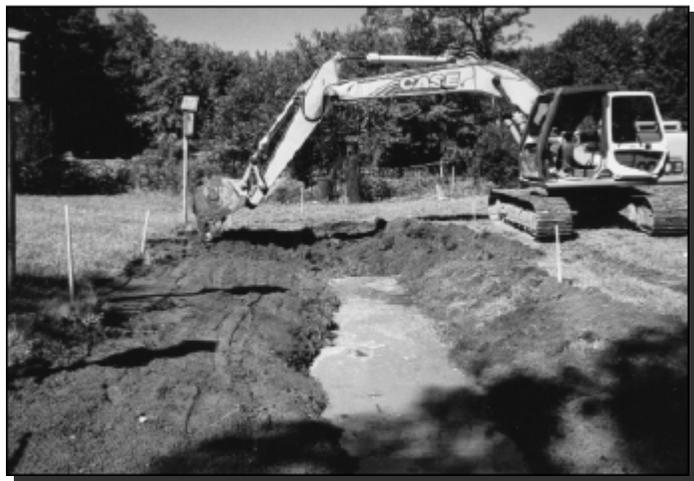
Figure 14. West Ox Pasture Brook during daylighting

The first example is West Ox Pasture Brook in Rowley, Massachusetts. This was a very small (85 linear feet) residential daylighting project undertaken to restore the stream and its riparian habitat near the location of an old septic system. The home owners needed a lot of support during the design and construction process of the daylighted stream. They received substantial aid – from permitting to design to funding - from various groups such as the U.S. Fish and Wildlife Service, Partners for Wildlife, and the Parker River Clean Water Association (Pinkham, 30). Despite the concerns of the owners, they are reportedly happy to have the small stream in their backyard now, and did not pay anything toward the costs of daylighting it.
