In-Situ Recycling: Applications, Guidelines, and Case Study for Local Governments

Master of Science
in
Civil Engineering

The case study documents a local agency's first experience with applying Cold In-place pavement recycling, the obstacles that the agency faced during the design and construction, and the benefits of using this technology. The study highlights the importance of conducting a detailed pavement and site investigation (preferably using non-destructive evaluation equipment, such as Ground Penetrating Radar). Additionally, it shows the potential advantages of having the guidelines, proposes alternate designs, and provides a cost comparison with a conventional design.

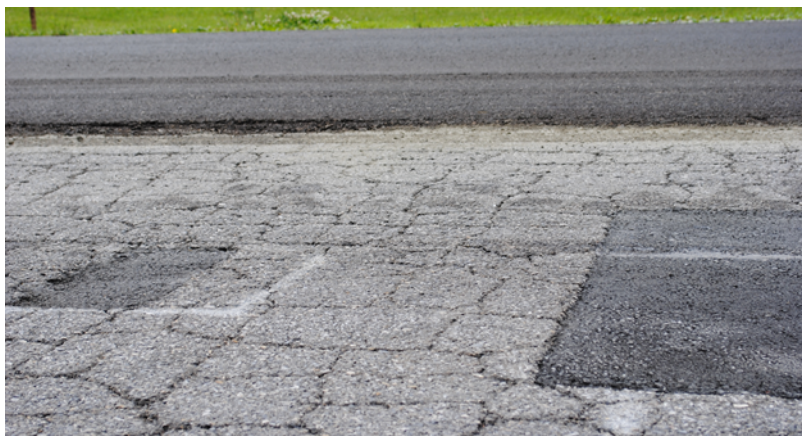
Independence Boulevard is a collector road with approximately 4,700 vehicles per day. Figure 8 shows that Independence Boulevard was in poor condition before recycling, with map or alligator cracking and patching.

Figure 8. Independence Boulevard, Previous Condition, Photo by Todd Walters, 2013, Used with Permission

Independence Boulevard exhibited areas of “significant pavement failure,” including extensive fatigue cracking (Christiansburg Interview). Independence Boulevard was comprised of Christiansburg’s older construction cross-section (Asphalt surface, VDOT No. 1 ballast stone base, choked off with crusher run stone). The asphalt surface was approximately 4” thick, on top of approximately 3” stone (Table 10).

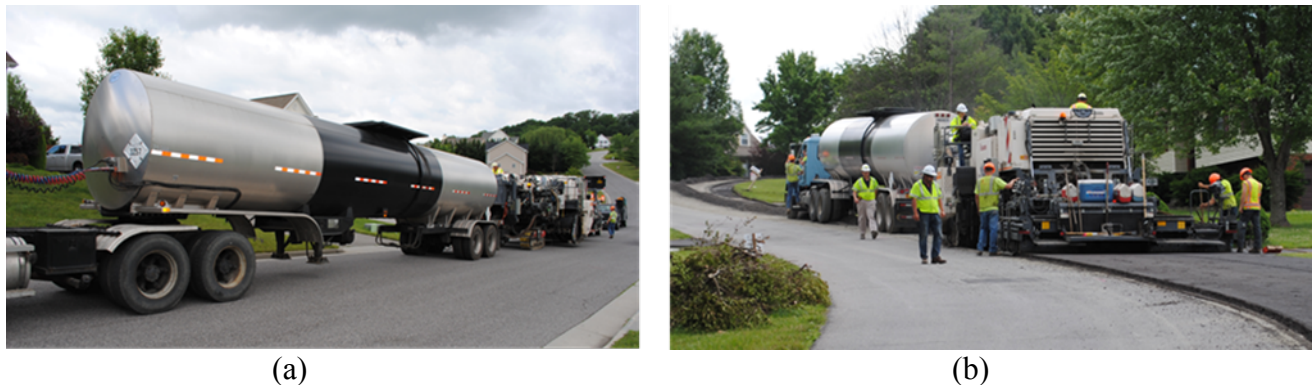
The CIR process included milling 3-4” of the existing pavement; remixing the material in-place with the stabilizer, and laying it again. The recycler was a 2012 Wirtgen 3800 Cold Recycler. Figure 9 shows pictures of the equipment during the recycling of Independence Boulevard

Figure 9. Recycling Equipment, (a) Front View, and (b) Back View, Photos by Todd Walters, 2013, Used with Permission

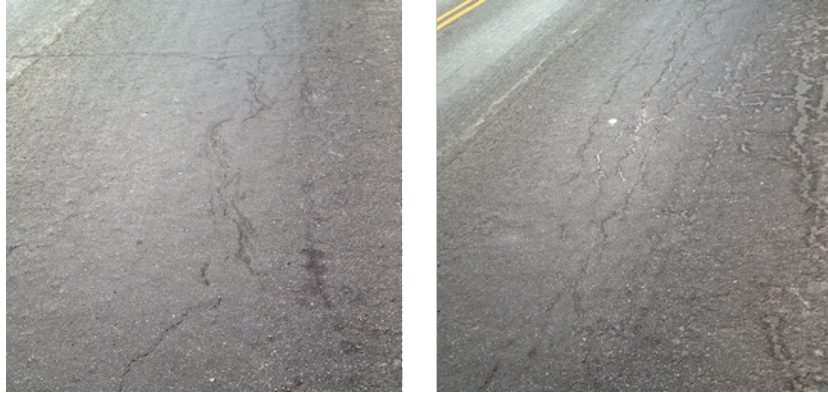
As of March 20, 2014, the street has started to develop local premature cracking and potholes right before the I-81 overpass (Figure 11). The town felt that this distress is most likely a result of insufficient compaction near the overpass, as compaction can be difficult near bridge abutments. Before recycling, drivers had mentioned the “bump up” to the bridge from the pavement. Fill was placed in this area, so another issue could be inadequate compaction of the fill. Slowing traffic at the pavement-overpass transition may have also contributed to the distress.

Figure 11. South Franklin Street Local Premature Cracking (May 2014)

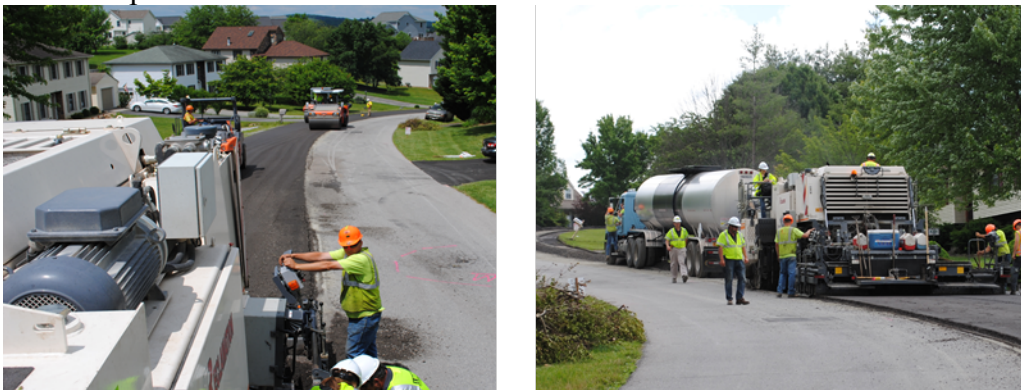
Figure 12. Independence Boulevard Recycling, in progress, Photo by Todd Walters, 2013, Used with Permission

Independence Boulevard was recycled from the entrance to Christiansburg High School to the second intersection with Gold Leaf Dr. The in-situ pavement recycling design for Independence Boulevard was 3” of CIR. Figure 12 contains pictures taken of the recycling performed on Independence Boulevard

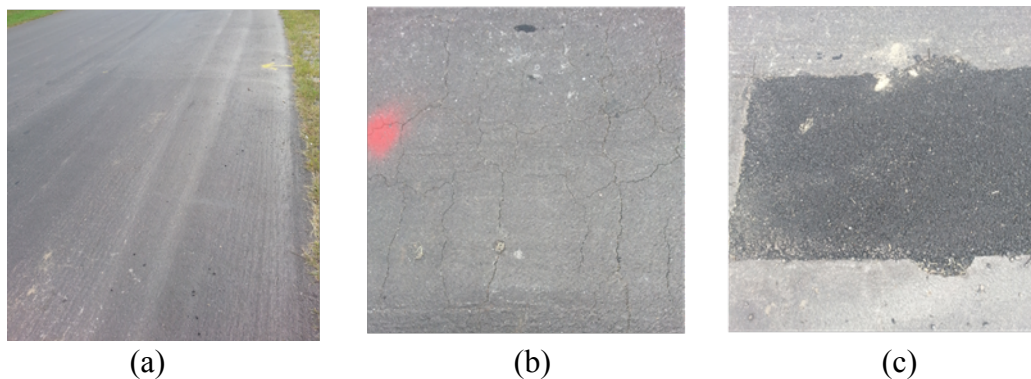
Upon visual inspection, most of Independence Blvd appears to be performing well as of August 2013 (Figure 13a below). There is one portion, at the top of the hill that experienced cracking (seen in Figure 13b). The Town of Christiansburg speculated that the cracking may be due to poor subgrade condition and decided that samples were necessary to determine the problem. Samples were removed from the recycled pavement and were patched with HMA and covered with the modified cape seal (Figure 13c). The samples revealed that the subgrade was in good condition but that there was moisture in the pavement.

Figure 13. Independence Boulevard Recycling (August 2013): (a) overall section, (b) pavement cracking, and (c) sample patching,

The only difference in construction between the section with pavement cracking and the rest of the recycled project was operation of the machinery. On the last day of paving, the recycling train operator had to leave and was substituted with an employee who typically ran milling equipment. The recycling train started at the top of the hill on Independence Boulevard, and as it started down the hill, the asphalt truck in the train was not pumping any asphalt into the mix. This was most likely due to the hill, tilting the liquid in the truck so that it would not flow out of the nozzle. The train stopped recycling at this point, moved forward to the level area of Independence Blvd, and then recycled up the hill instead. This could have caused the moisture and cracking because of the train running over the recently-paved area.

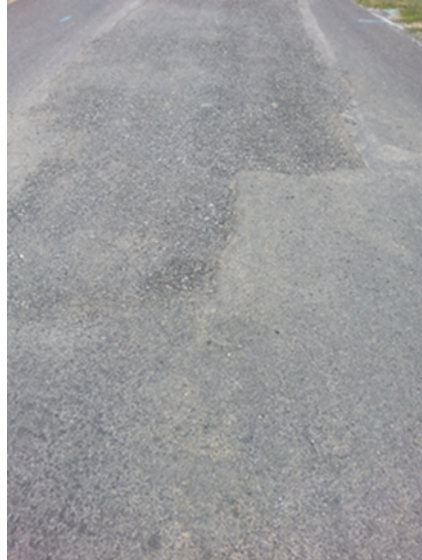
sections of the asphalt were not as thick as expected and the underlying clay (subgrade) was combined into the mix. Once this was observed, construction was stopped on Miller Street. Miller Street had to be overlaid with HMA not long after the recycling was performed.

Figure 14. Miller Street (August 2013): After Recycling, before HMA Overla

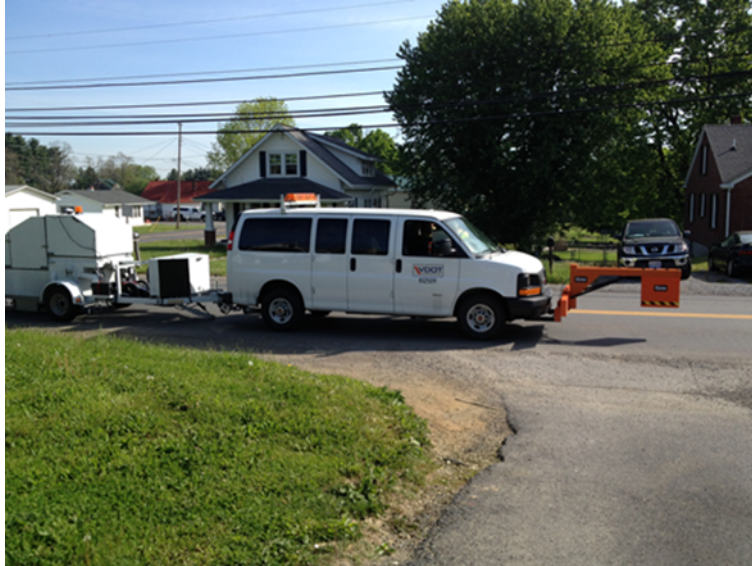
The equipment used for the testing was a KUAB FWD trailer (behind vehicle) and a GSSI 2.0 GHz air-coupled horn antenna (mounted on front of vehicle). The GPR was mounted to the front of a VDOT van and the FWD equipment was towed behind the van with a trailer hitch. The equipment, totaling about 40-45 feet in length, is pictured in Figure 15.

Figure 15. FWD and GPR Testing Equipment

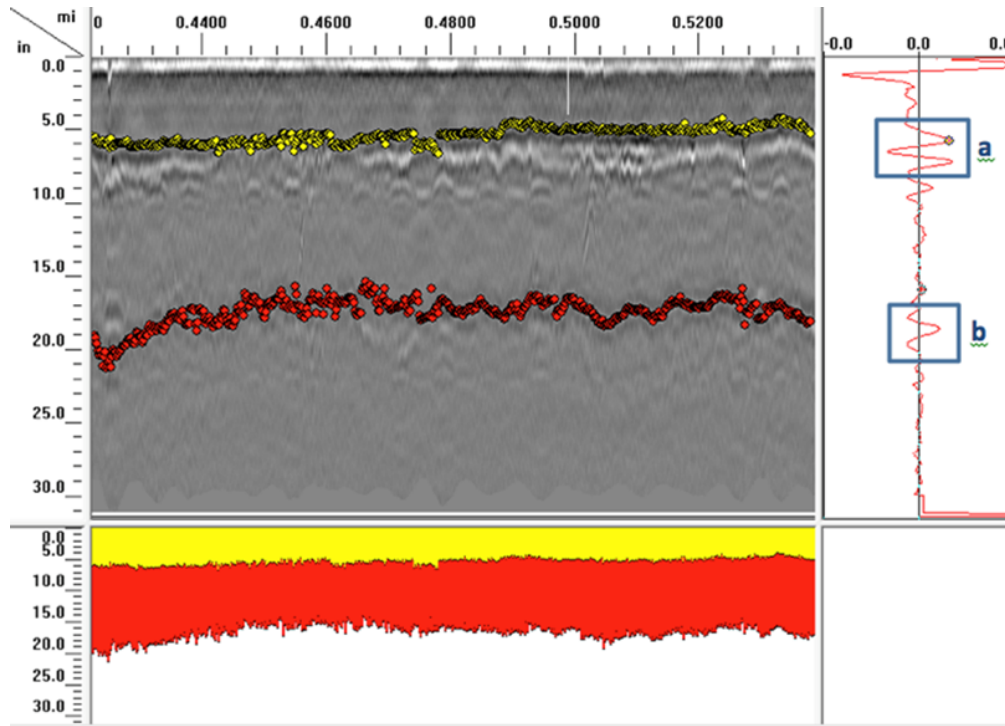
The GPR was evaluated using RADAN 7.0 software. The GPR data was used to evaluate the consistency of the depth of the recycled layer as well as to determine the existence of underlying layers, as the pavement designs were unavailable.

Figure 16. South Franklin Street RADAN 7.0 Profile

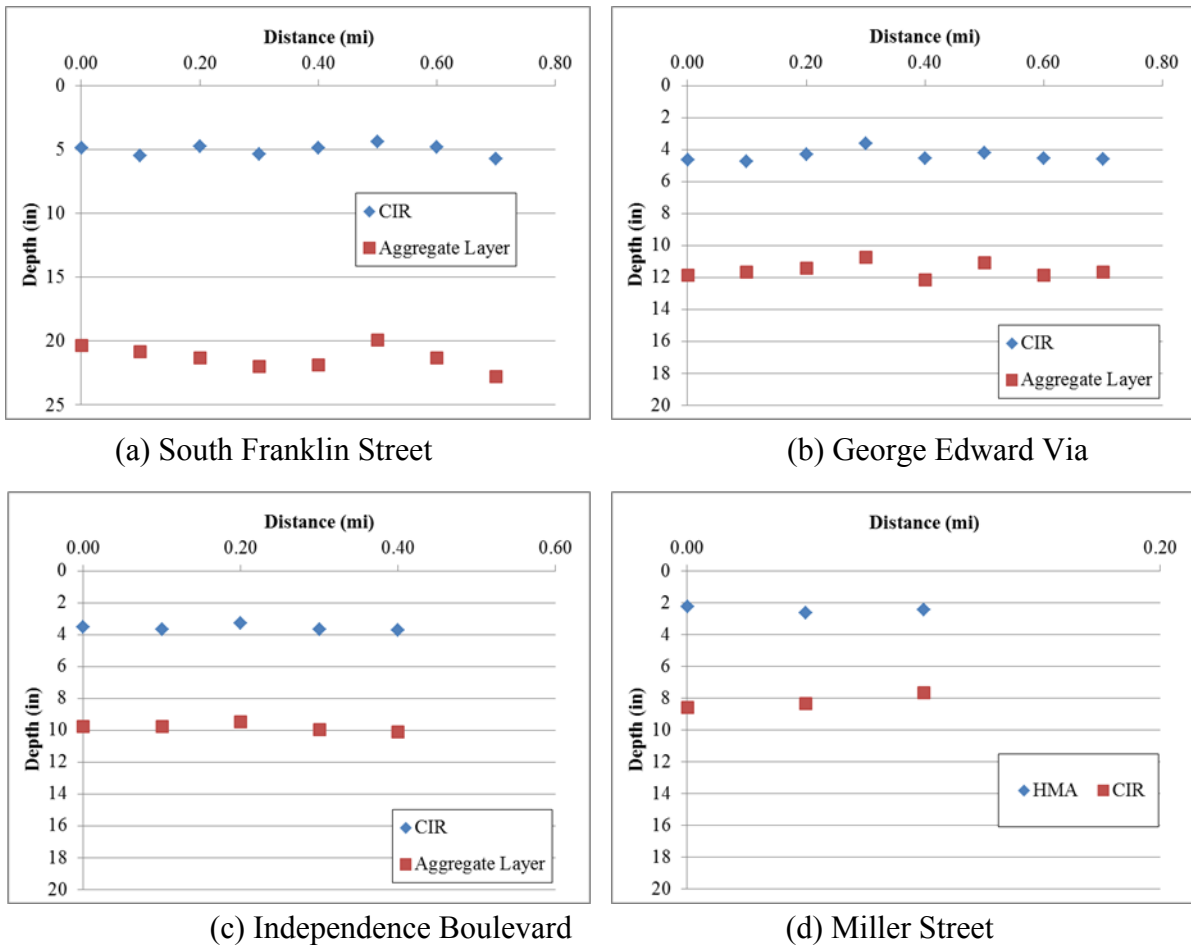
Figure 17 contains plots of layer depths (inches) vs. distance (miles). The average layer depths determined from GPR analysis are presented in Table 11. The pavement surface is at Depth 0” and the bottom of each layer is denoted by the points on the plots.

Figure 17. Recycled Pavement Profiles

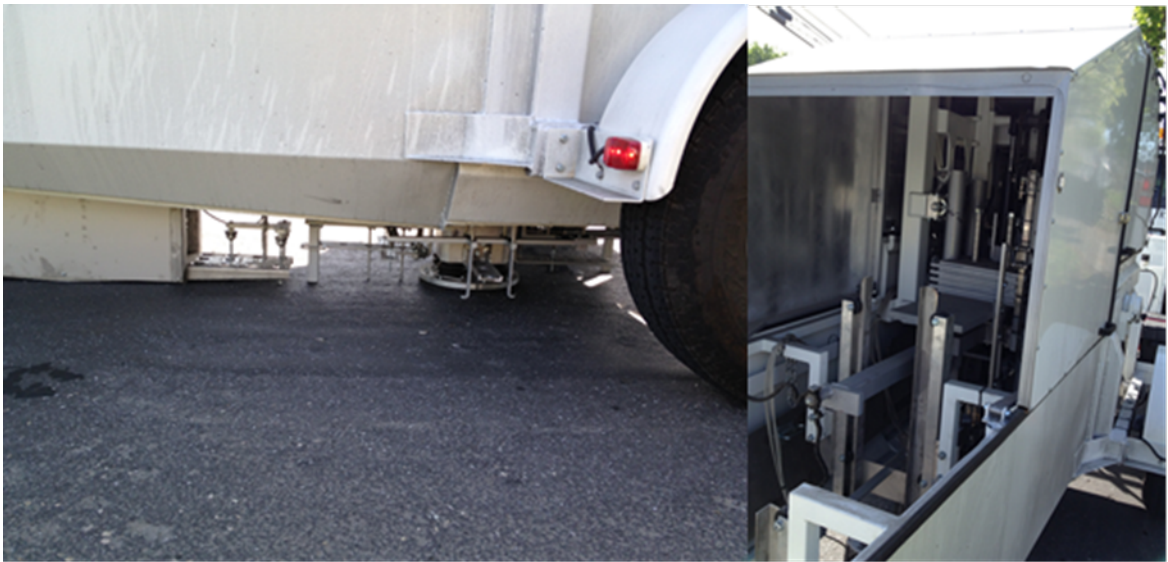
FWD is one of the most common devices used to collect data on pavement surface deflections (Harris, 2004). FWD works by measuring strains as a function of load (Lenngren, 2000). FWD works by applying an impulse load on a pavement surface. The load that is dropped is meant to imitate repeated loading of a truck axle (Lenngren, 2000). The impulse force is created when different weights are dropped; the weights usually are 110 lbs, 220 lbs, 440 lbs, or 660 lbs. The weights are dropped from different heights, ranging from 0.8 in to 15in (Al-Qadi, 2003). This load is transferred to the pavement through a loading plate is measured via a loading cell. Velocity transducers are used to measure the pavement deflections resulting from the dropped load (Al-Qadi, 2003).

Figure 18. FWD Equipment (KUAB Brand)
