IMPACT FRACTURE OF AUSTENITIC

STAINLESS STEELS

Thesis submitted to the Graduate Faculty of the  
Virginia Polytechnic Institute and State University  
in partial fulfillment of the requirements  
for the degree of

Materials Engineering

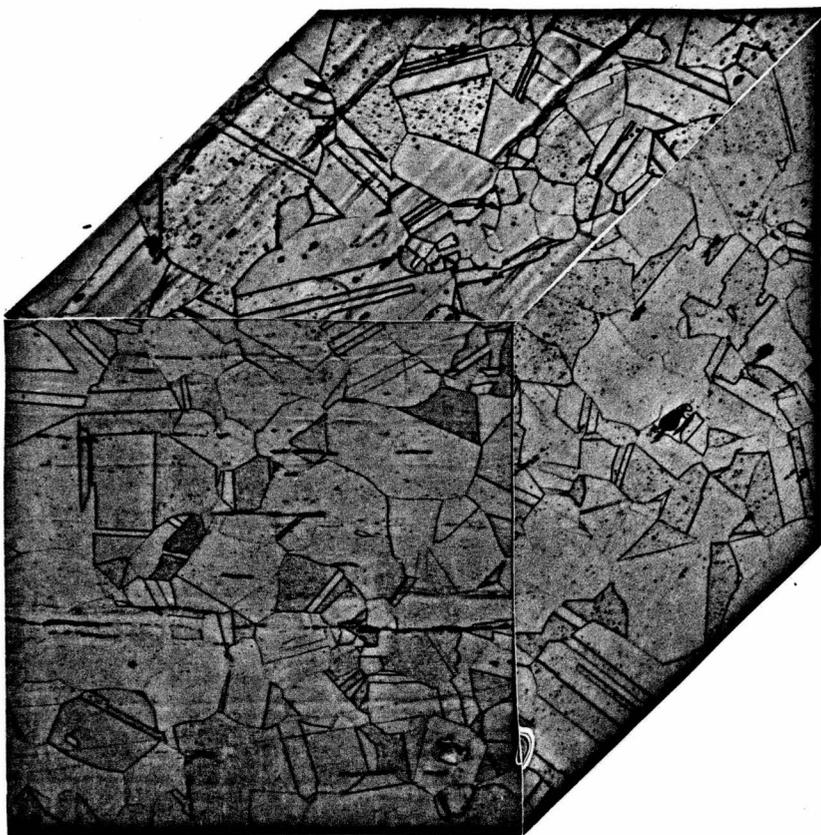
Figure 7. Three-dimensional micrograph of the as-rolled Nitronic-40.

The test specimen for the impact studies were machined from Tenelon and Nitronic 40 austenitic stainless steels having the compositions given in Table I. The typical microstructure of the two as-rolled steels are shown in Figures 6 and 7 and the room temperature mechanical properties are listed in Table III. Modified Charpy V-notch samples (ASTM E23, Type A) of annealed Tenelon and Nitronic 40 were machined of rolled plate and cross-rolled plate respectively. Small holes, 1/16 inch diameter, were drilled in one end of each sample to a depth of half the distance to the notch, (Figure 8). During impact testing at variable temperatures, a thermocouple wire can be inserted into the hole to acquire temperature readings on the specimen at the instant of the test. Nitronic 40, samples were machined from several plates of HERF material which were processed to different strength levels.

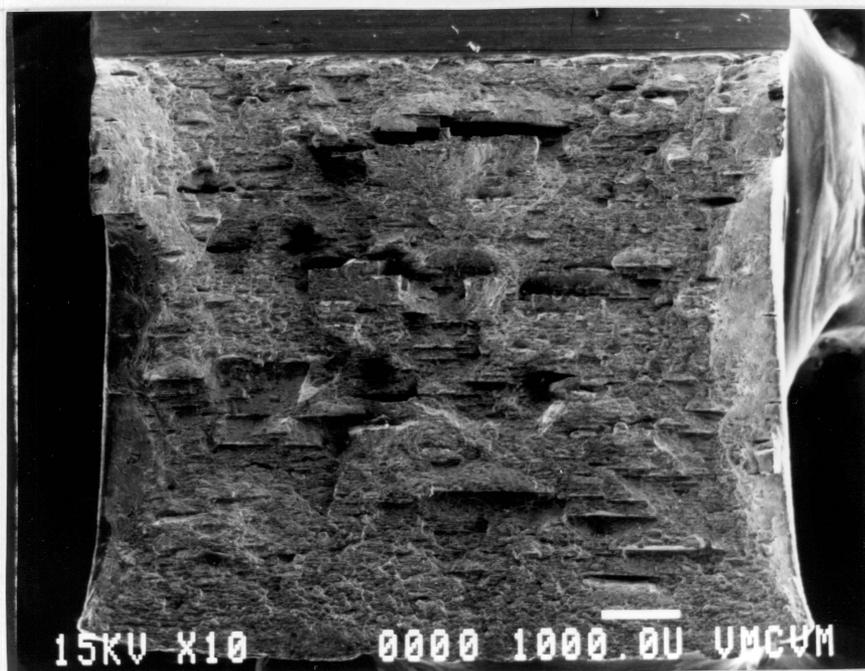
Figure 27. Fracture surface of a rolled-plate, liquid nitrogen impact test, 10X.

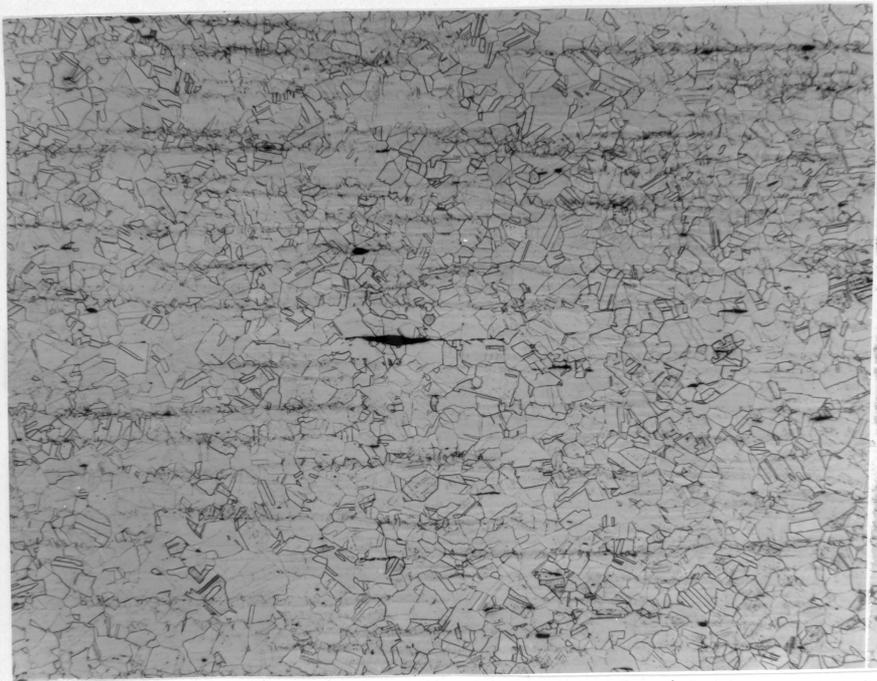
Figure 43. Micrograph showing spread out small inclusions in the as-received Tenelon.

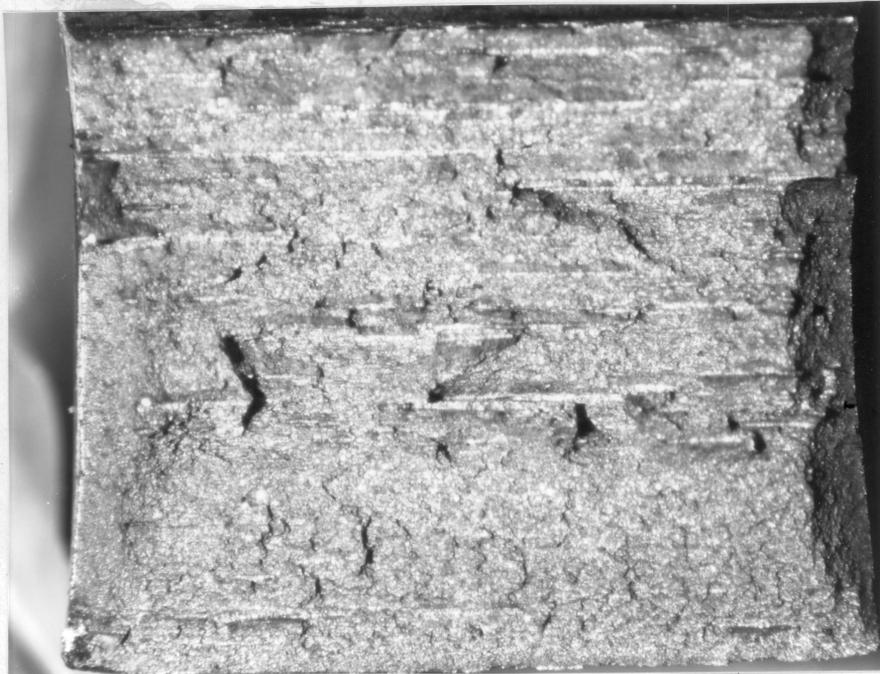
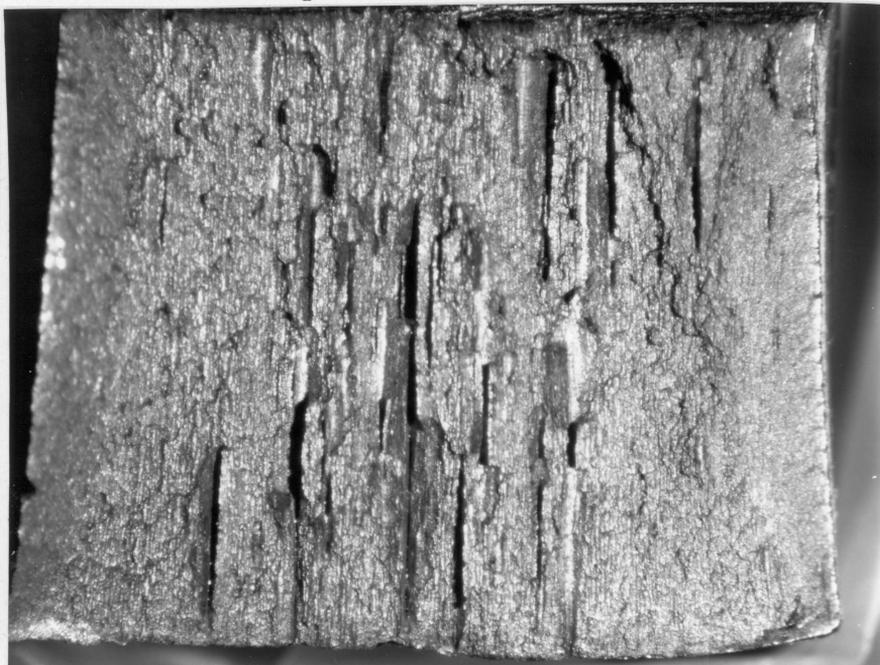
Group 1

Group 2

Figure 44. Micrographs demonstrating relative orientations in impact fracture surfaces.

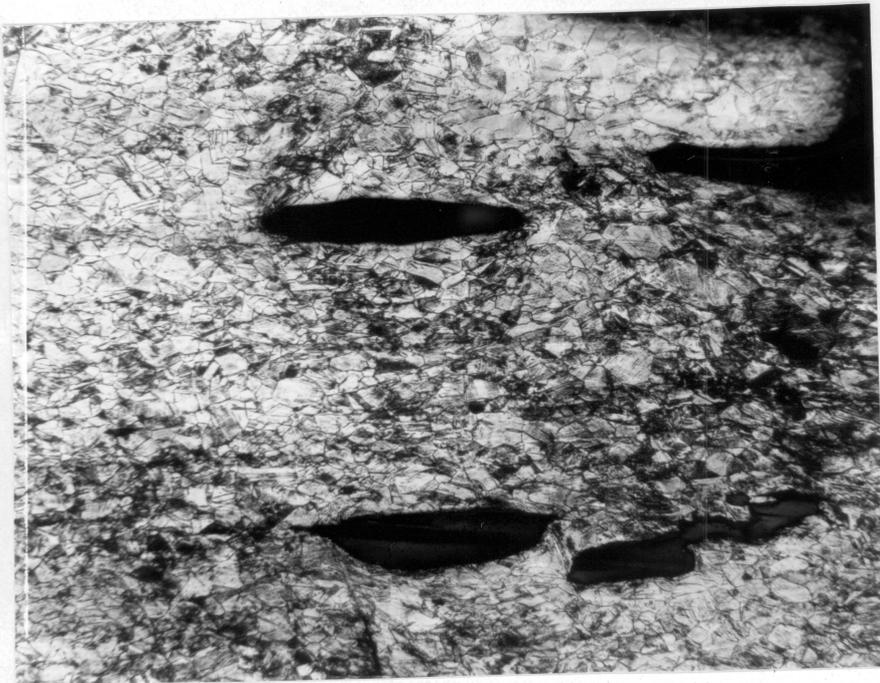
Figure 48. Micrograph showing crack arrest by fracture along inclusion matrix interface.
