Error Mitigation in Roughness Measurements

Thesis submitted to the faculty of the Virginia Polytechnic Institute and State University
in partial fulfillment of the requirements for the degree of

Master of Science
In
Mechanical Engineering

Keywords: roughness, IRI, terrain measurement

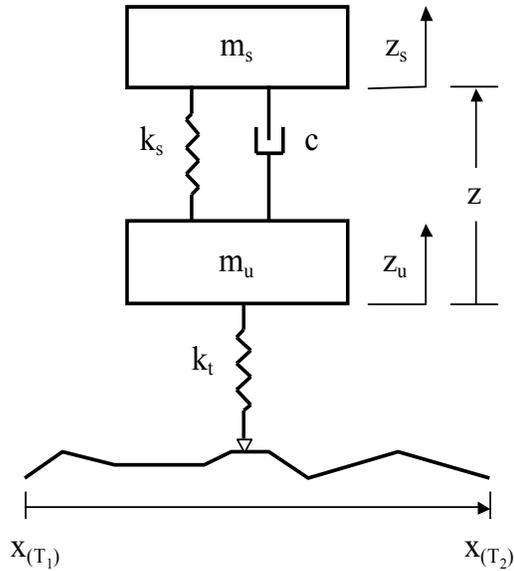
Figure 1: quarter car model

These parameters are normally used in a way such that they are normally the ratio over the sprung mass; as such, the value of the sprung mass is 1. The quarter car is simulated to travel at 80 km/h. The setup of the quarter car model is shown in Figure 1, where z_u and z_s are the positions of the unsprung and sprung masses, z is the suspension travel, and x is the input from the road. Finally, a 250mm filter is applied to the road profile to simulate the contact size of the tire.

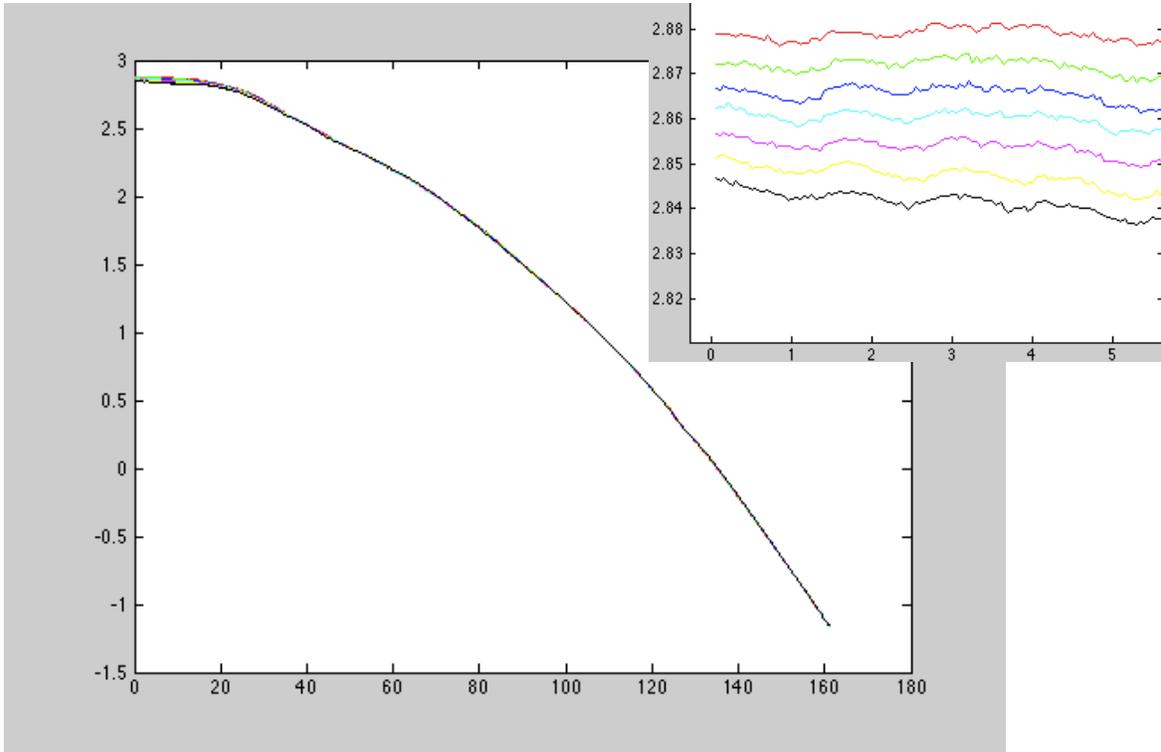
Figure 2: Main St. Road height (m) vs horizontal location (m). The overlaid road is zoomed in on the first 5 meters.

The profiles of the roads are also plotted. Figure 2 shows each of the sewer profiles of Main St. (smooth), Figure 3 shows the profiles of the airport road (medium), and Figure 4 shows the profiles of the brick road (rough).

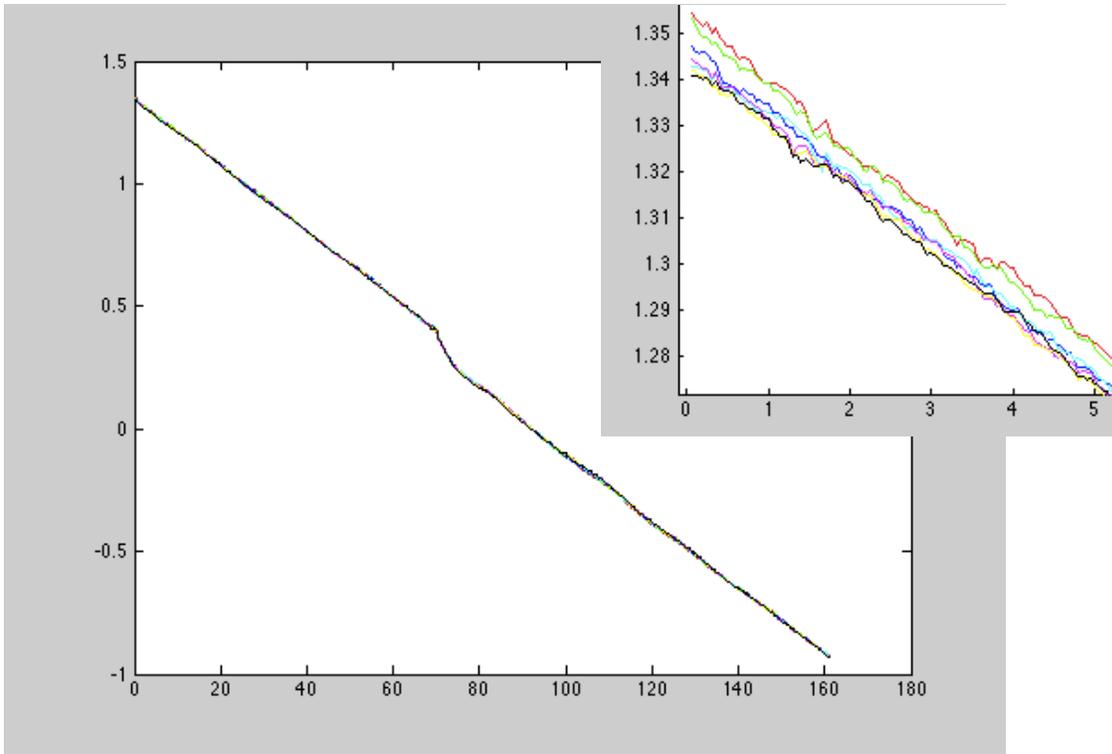
Figure 3: Airport runway. Road height (m) vs horizontal location (m). The overlaid road is zoomed in on the first 5 meters.

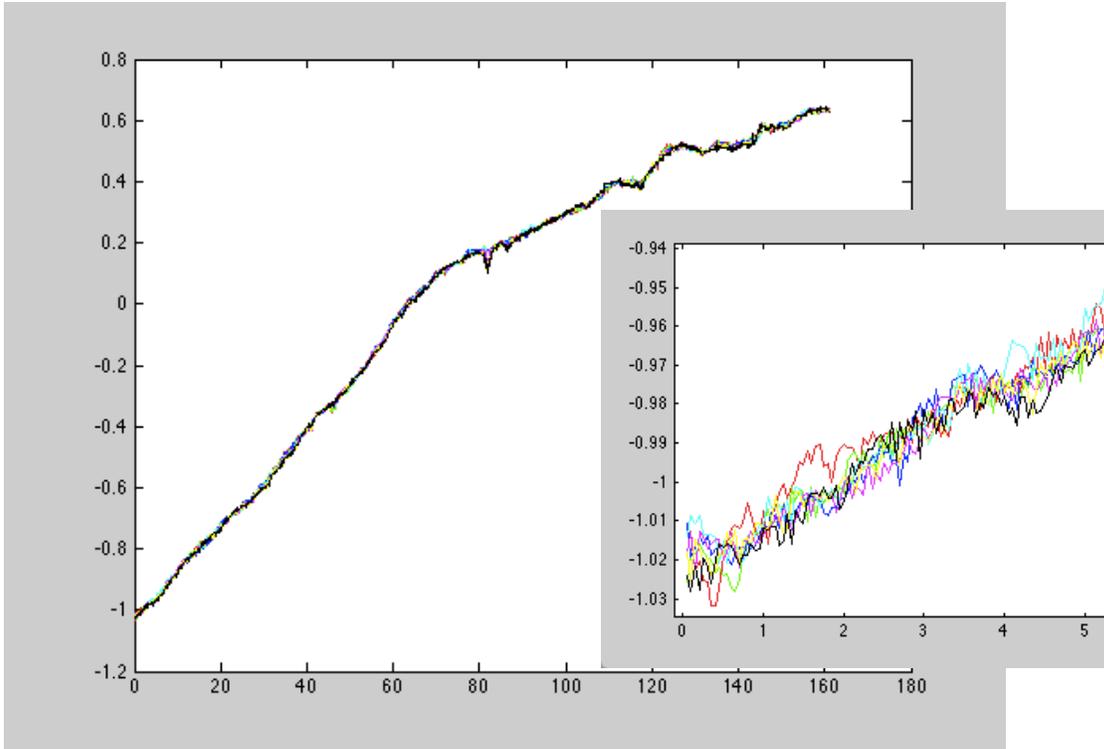
Figure 4: Brick path. Road height (m) vs horizontal location (m). The overlaid road is zoomed in on the first 5 meters.

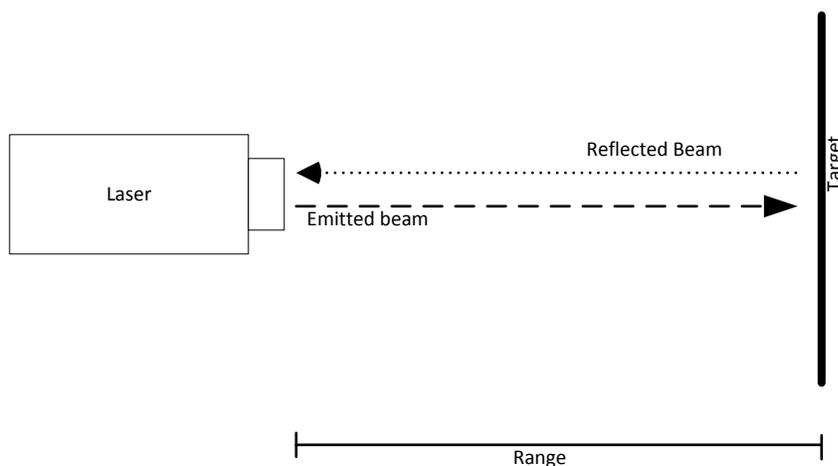
Figure 5: This demonstrates a time of flight laser that uses the total time of travel.

A time-of-flight system uses the speed of light to measure the distance of the object of interest to the sensor. Similar to how radar works, a pulse of light is emitted, which then bounces off the object and back into a sensor. By finding the time between the start and receiving of the pulse, the distance travelled can be calculated [10]. See Figure 5 for a diagram of this type of system.

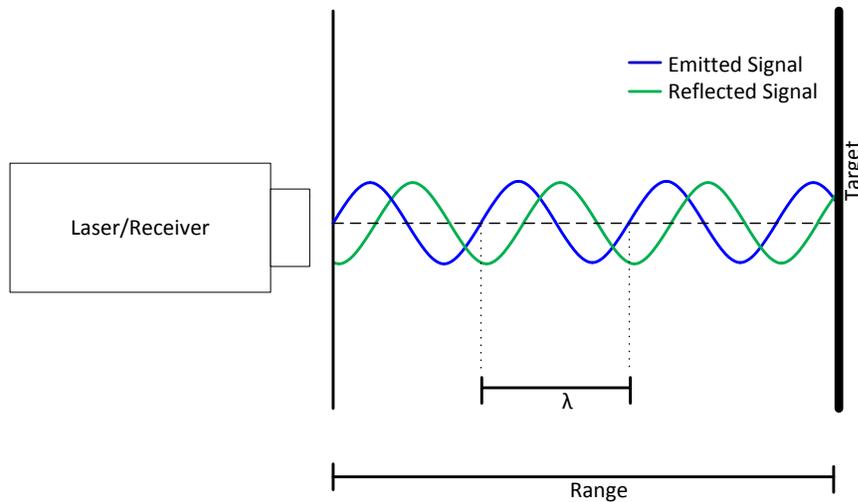
Figure 6: This represents a time of flight laser that measures the phase difference between the emitted and reflected signals.

Another time-of-flight system uses a continuous laser beam with an embedded low-frequency pulse. By finding the difference in the phase between the returning signal and the output signal, a distance can be calculated [10]. This is shown in Figure 6.

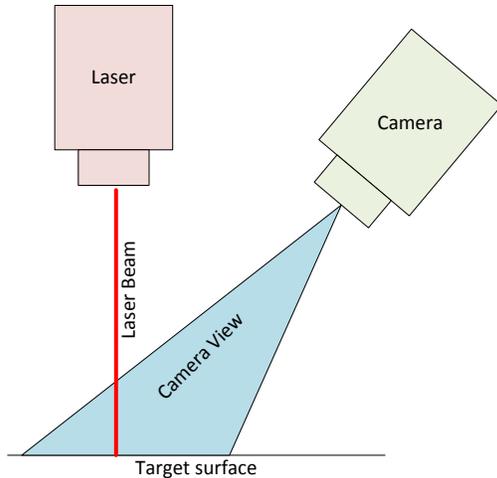
Figure 7: This shows the components of a triangulation laser scanner.

A triangulation laser system uses a laser and a separate camera to measure the distance. As the laser and camera are at known distances and angles to each other, the projection of the laser on the terrain will occur at different locations, depending on its height. From the angular difference that the camera sees, it can then calculate the unknown distance from the known values [12]. A diagram of a triangulation laser system is shown in Figure 7.

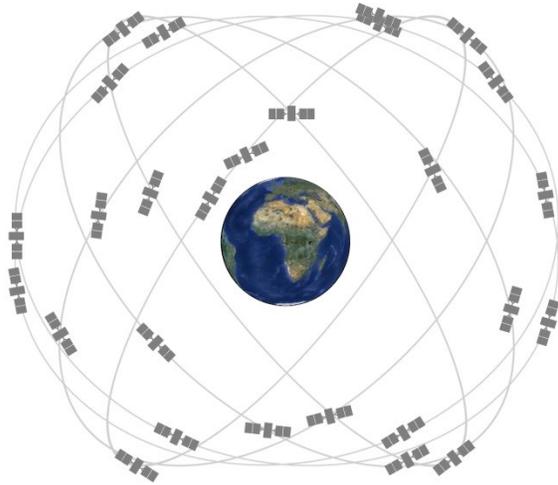
Figure 8: This figure represents the GPS satellites in orbit around the earth.

Each GPS satellite continuously transmits a signal, which is read by a receiver on Earth. A diagram of the GPS satellites is found in Figure 8 [13]. By finding the length of time each signal traveled, the receiver is able to triangulate its exact position on Earth. Because radio signals travel at the speed of light, the satellites require precision timing. Thus, they carry multiple atomic clocks onboard to ensure the proper synchronization of time throughout the system. The receiver is also able to calculate the proper time, given one additional satellite (3 for position plus 1 for time) [14].

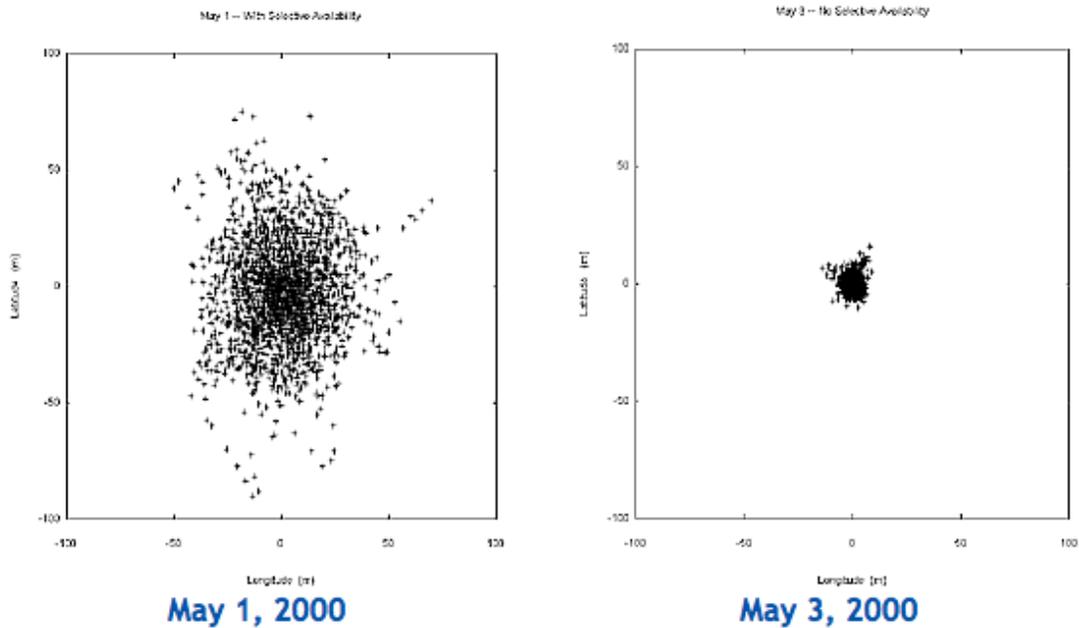
Figure 9: NOAA data on GPS positioning before (left) and after (right) the end of selective availability

In 2000, the US government ended the former policy known as selective availability (SA), which greatly limited civilian usage of GPS by forcibly increasing the signal error [15]. A sample set of data collected by the National Oceanic and Atmospheric Administration shows that before selective availability was ended, 95% of the calculated positions in a day fell in a circle with a radius of 45 meters, while this decreased to 6.3 meters after its expiration, seen in Figure 9 [16]. Modern high-quality civilian GPS receivers can have accuracies of less than 5 meters [17].

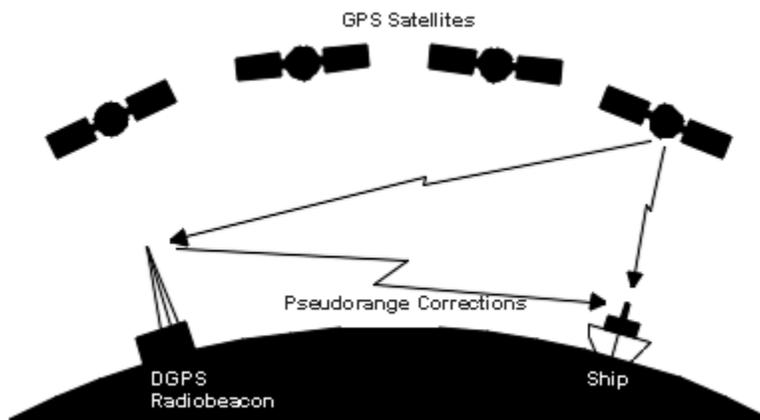
Figure 10: This shows how a base station sends correction information in a DGPS setup

DGPS makes use of signals collected from one base station to improve the accuracy of nearby GPS receivers. Generally, the base station remains at a surveyed location, and its known absolute position can be compared to the calculated position from the GPS satellites or other corrections methods, allowing signal correction information to be generated. This allows for any compatible GPS receiver located nearby to utilize this correction information generated to eliminate error in the signal [19]. These errors may come from a variety of sources, including multipath interference (signals bouncing off nearby objects such that the receiver collects multiple signals), atmospheric interference (slowing of the signal because of different atmospheric conditions), or satellite geometry (the further the satellites are from each other, the better the triangulation solution) [20]. Figure 10 demonstrates one base station providing correction information to a remote receiver [21].

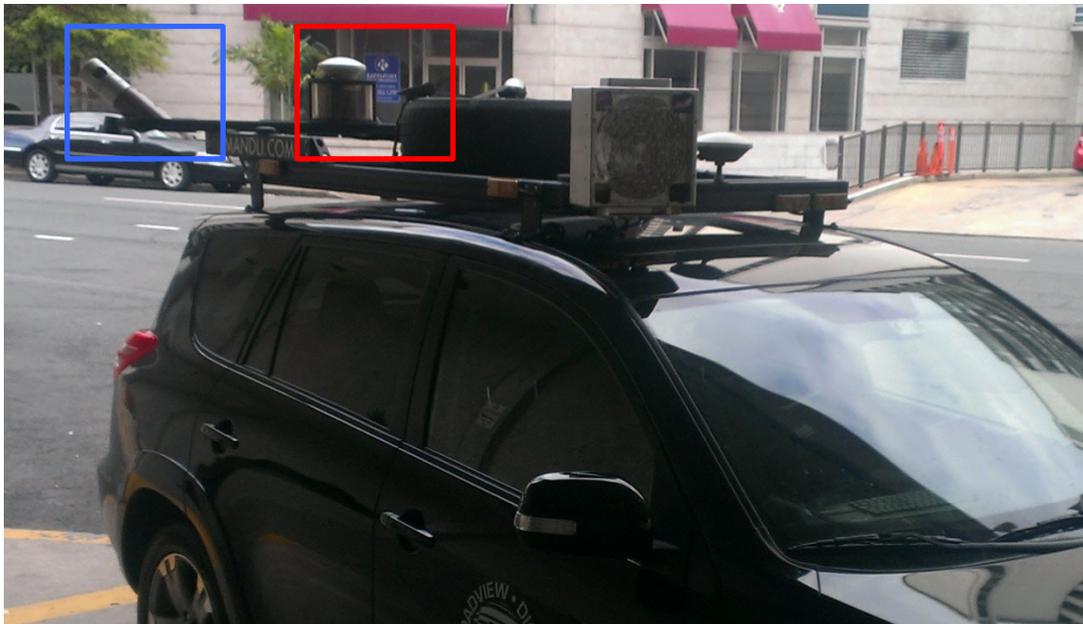
Figure 11: A road profiling system. The INS is in the red box, and a sensor is in the blue box. Note they are connected by a relatively thin piece of metal. Photo by author, 2014.

This chapter addresses errors that are caused by the sensors and how they are affixed to the vehicle. Lasers sensors used in road profiling measure the relative distance from the sensor to the road surface. However, if the vehicle moves vertically (e.g., due to a bump), the collected measurement will no longer reflect the actual road surface. Thus, an INS is used to track the movement of the sensors to cancel all movement. In order for this to be effective, there must a rigid connection between the INS and other sensors. If the sensors move relative to the INS, then it no longer correctly tracks the actual sensor movement. Figure 11 shows a road profiling system where the INS and sensor are connected by a small metal bar. While this may be sufficient during most situations, any large acceleration will very likely cause relative movement between the two sensors.

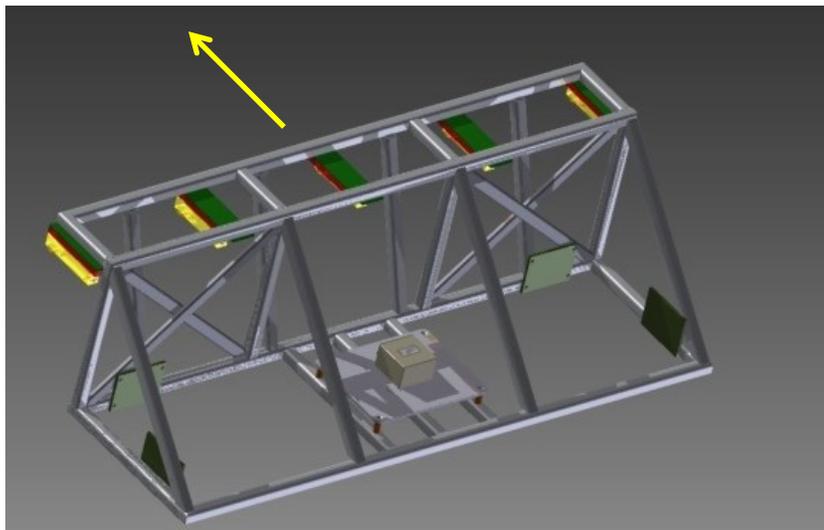
Figure 12: The original design for the mounting frame. This would be mounted in front of the vehicle, where forward is in the direction of the arrow.

The original design, shown below in Figure 12, would allow for the GPS/IMU to be placed at the middle of the frame. The two Roline lasers would be placed on the same level, but in front of the track of the wheels. Finally, it has mounting spots for up to five additional Gocator lasers on the top front of the rack, which would scan a full lane width.

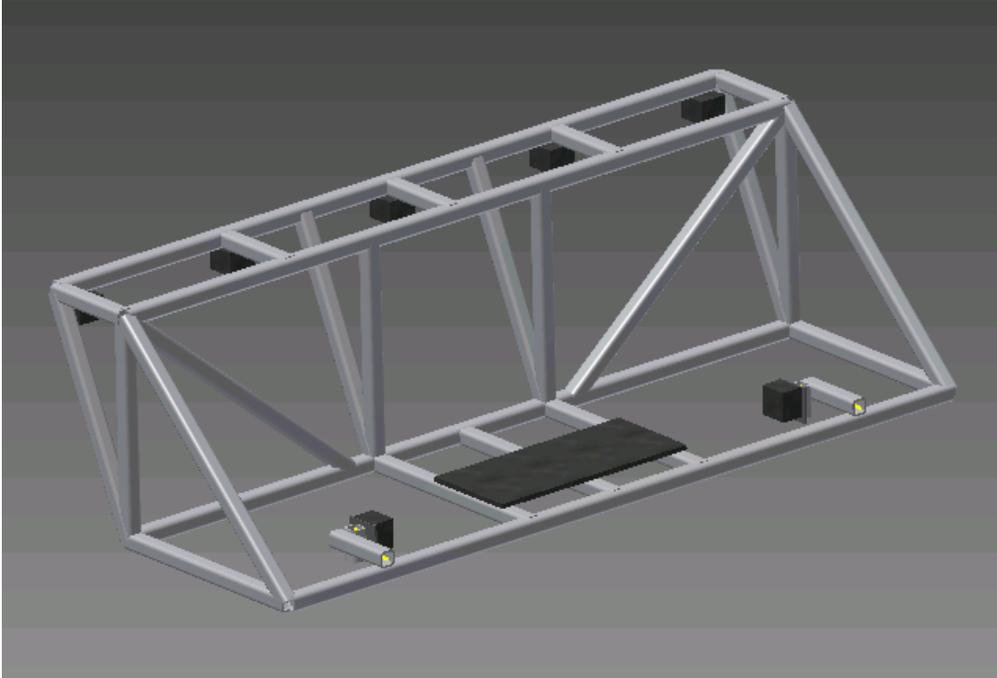
Figure 13: This is the actual design of the mounting frame.

However, due to a miscommunication with the machine shop, the design changed slightly between the design and the constructed frame. The diagonal supports in the front of the frame were placed all the way on the ends. Furthermore, because of the desire to keep the Roline lasers along the track of the wheels, the proposed mounting method was changed. Two supports were added on the bottom part of the frame to allow the Roline lasers to stay in line with the wheels. The new design is shown in Figure 13.

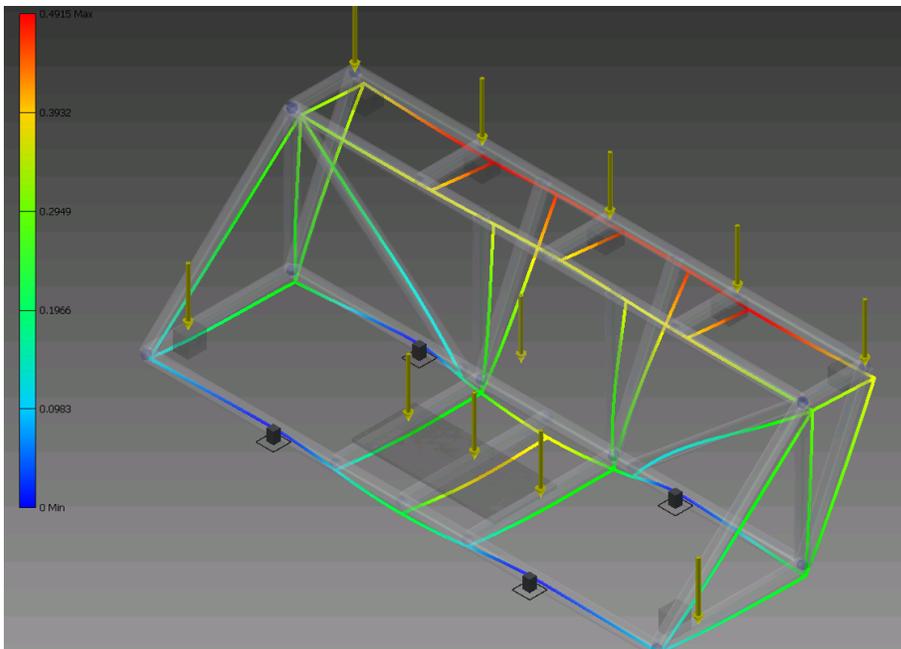
Figure 14: This shows the results of the frame under load.

The maximum deflection was found to be 0.5 mm. This is very unlikely to occur in real world conditions, as it is improbable to achieve acceleration on the order of 5 times that of gravity. While there is not a specific limit for maximum allowable deflection, the

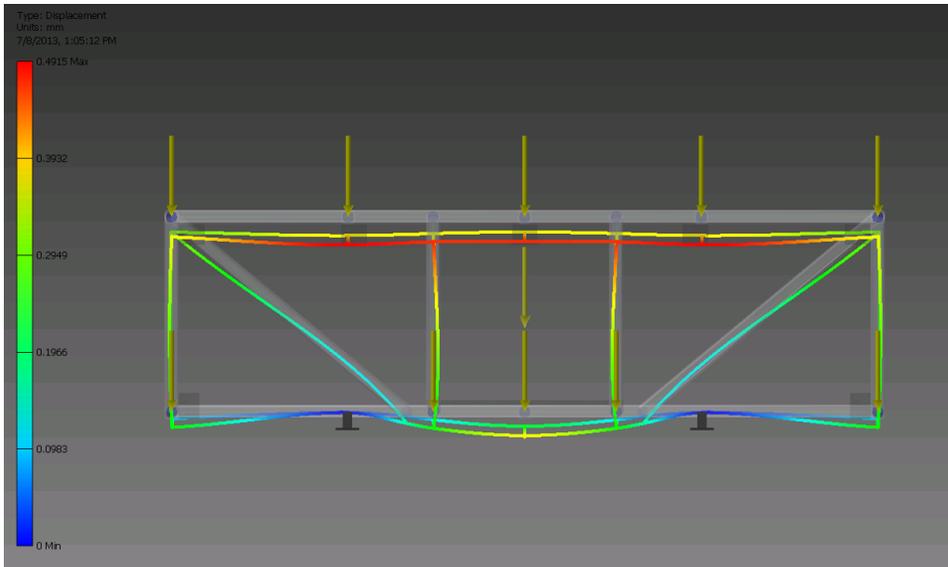
Figure 15: This provides another viewpoint of the frame under load.

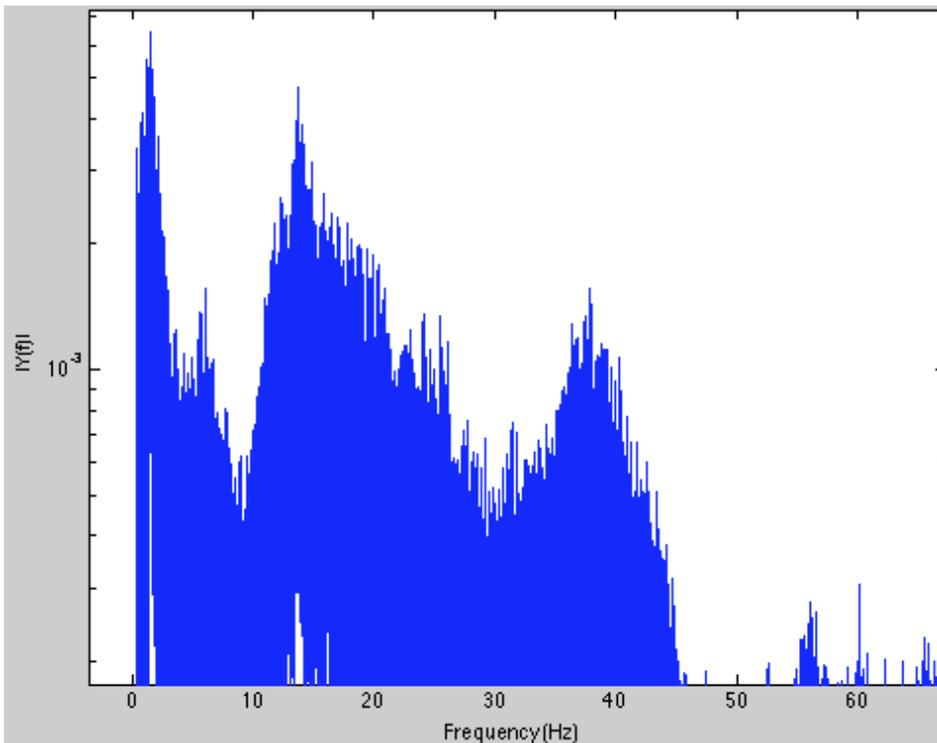
Figure 16: FFT of acceleration data. Note the peaks at 1.5, 6, 13.7, and 35.9 Hz.

Previous vertical acceleration data collected on the Ford Explorer show that the vehicle excitation occurs at 1.5, 6, 13.7, and 35.9 Hz, shown in Figure 16.

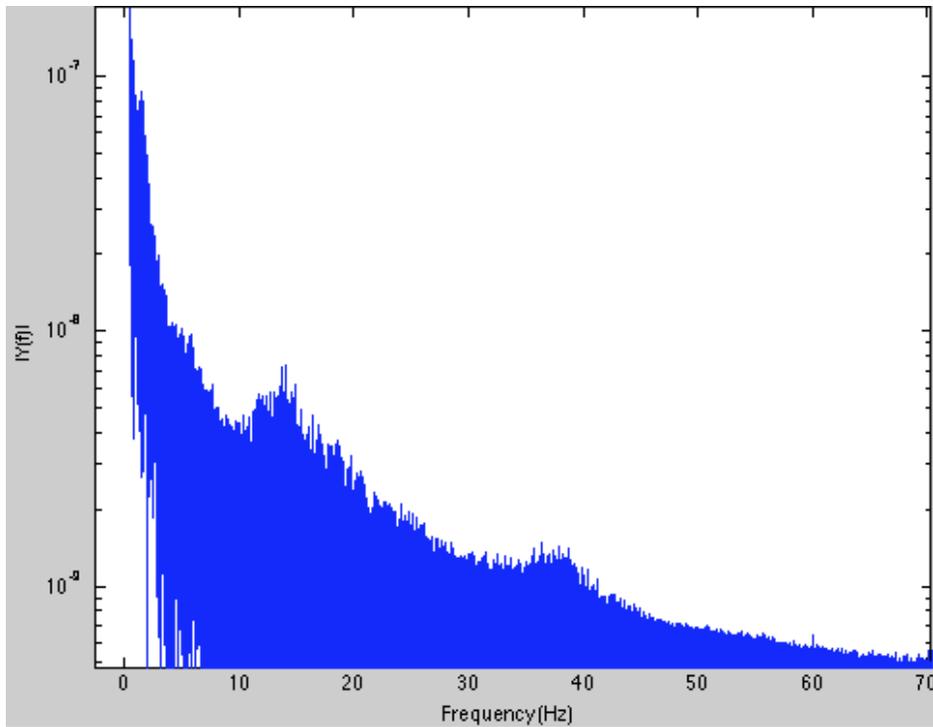
Figure 17: FFT of displacement, taken from accelerometer data.

When this data is integrated into displacement, the peak at 6 Hz drops out, shown in Figure 17.

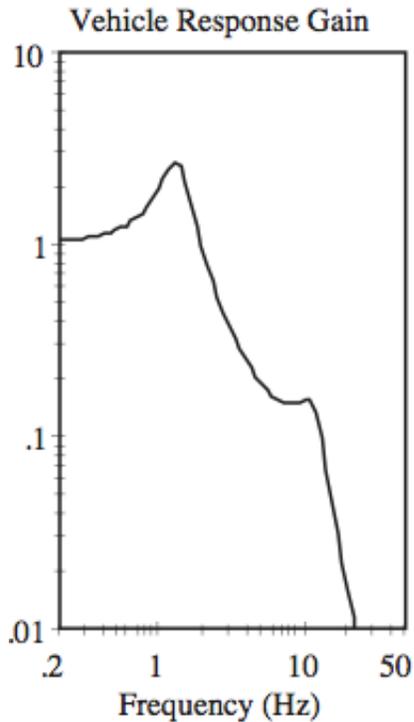
Figure 18: Frequency response of acceleration of the IRI

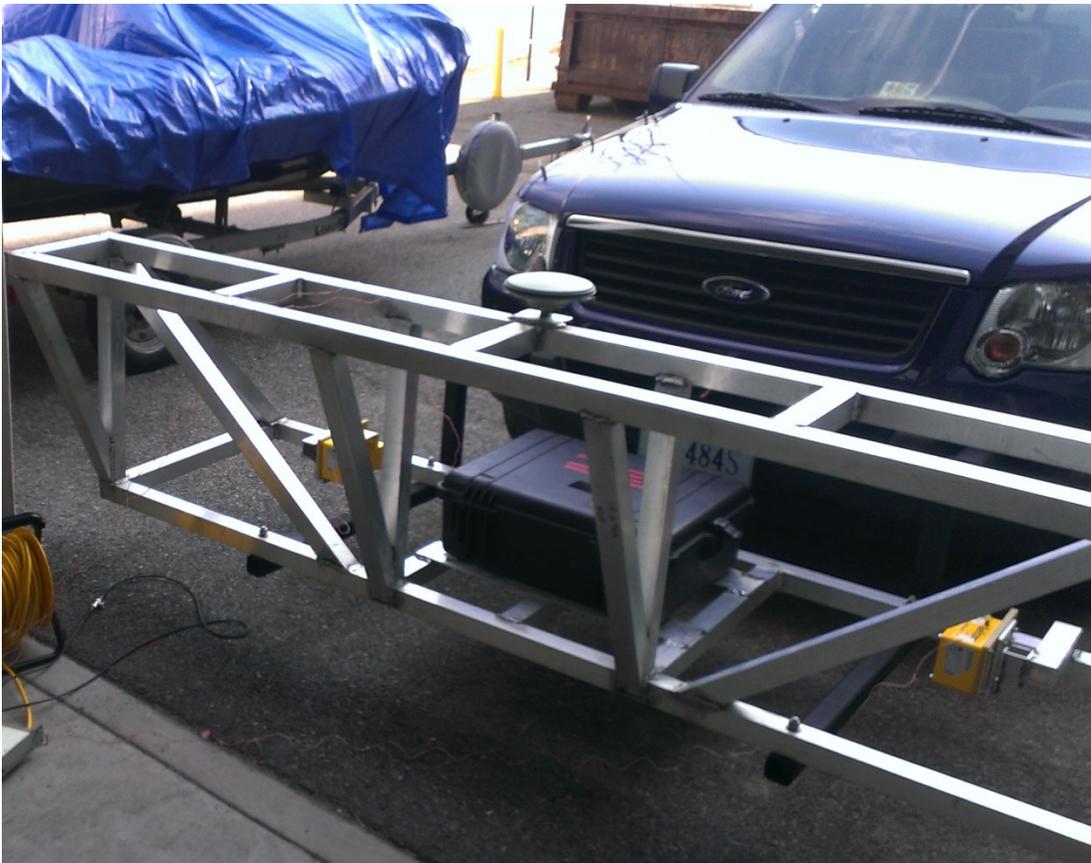
Figure 19: This shows the normal data taking setup of the equipment frame. The two yellow Roline lasers are seen on the sides in the wheel track. The black Pelican case in the middle houses the IMU and GPS receiver, while the circular GPS antenna is on the top of the frame.

Because of the nature of the simulated modal analysis, it is very likely that the real results are considerably different. For example, the four brackets on the bottom of the frame simulate the attachment points of the frame to the vehicle. This was modeled as fixed constraint, while in practice, the system may more closely resemble free vibration. Thus, a modal response test was performed on the constructed frame to find the actual natural frequencies (and hopefully confirm the results of the finite element analysis). To simulate testing conditions, the frame and sensors were attached as they would be in the case of a normal test. Figure 19 shows this setup.

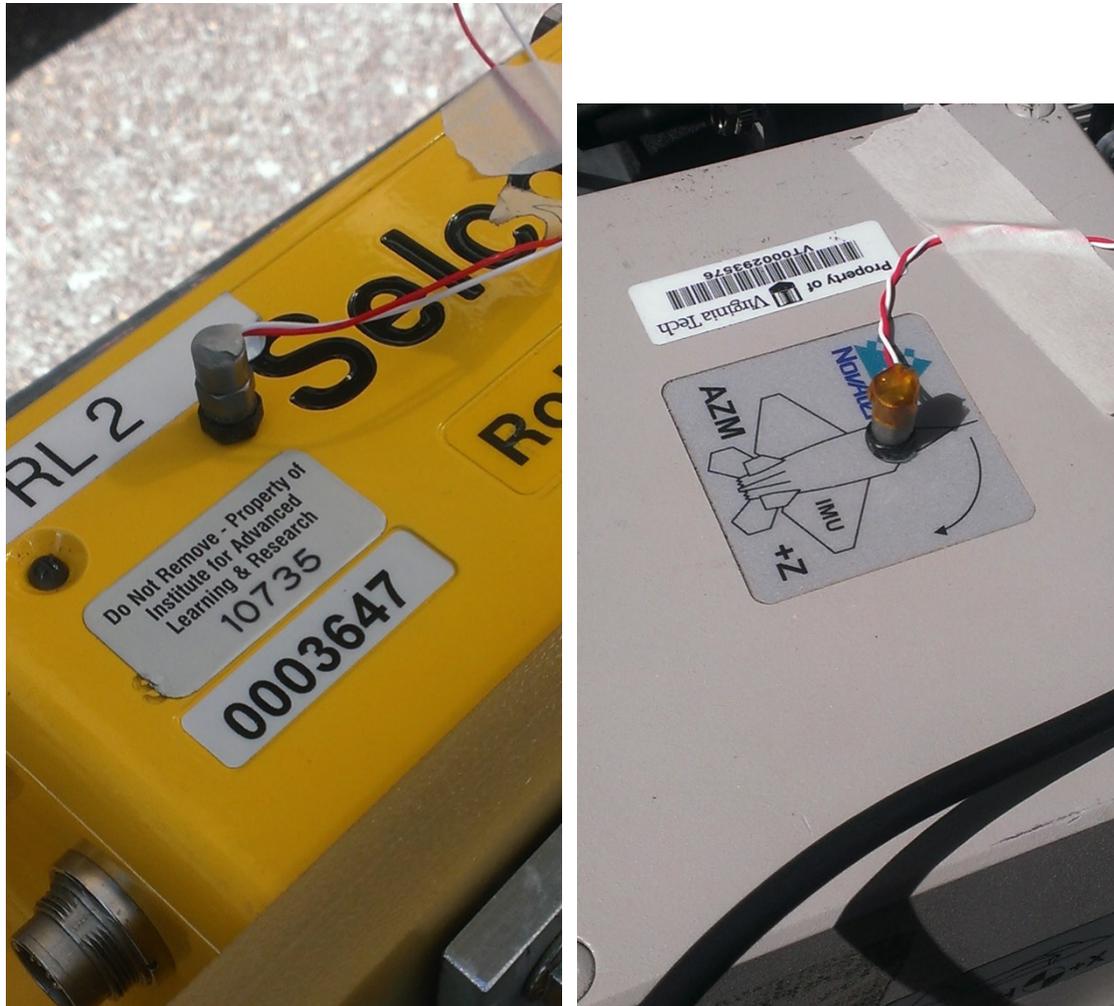
Figure 20: This shows the accelerometers attached to the Roline laser (left) and IMU (right).

Next, since the primary interest lies in the relative movement of the Roline lasers with respect to the IMU, the accelerometers were placed on these three sensors, seen below in Figure 20.

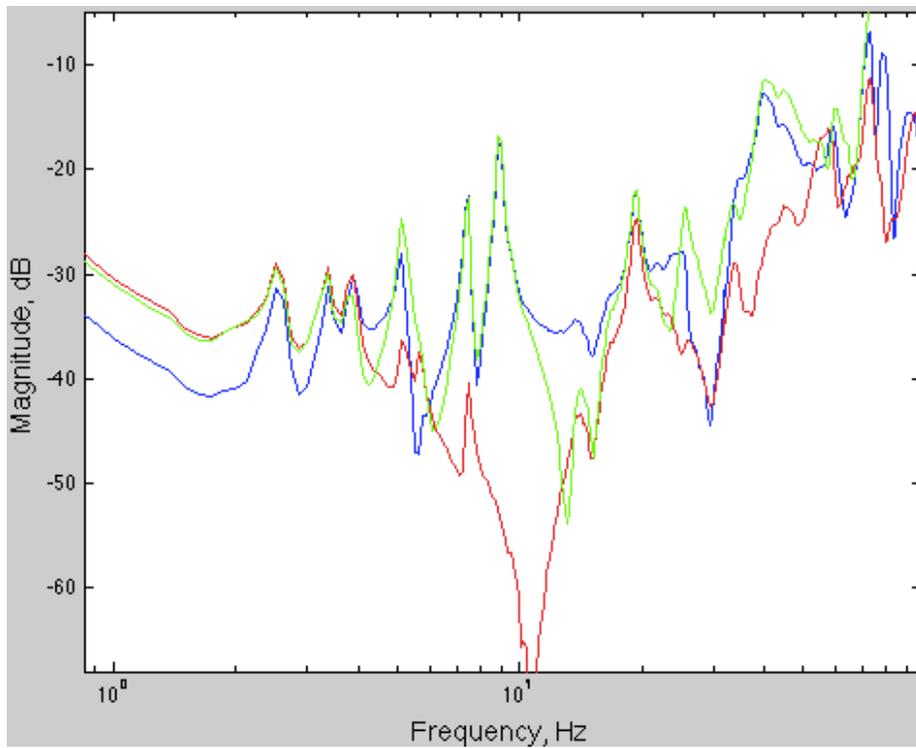
Figure 21: red - IMU; blue - passenger side laser; green - driver side laser. This plot shows the frequency response function of the response, with excitation on the driver's side. 0 dB is scaled to the acceleration from the impact hammer

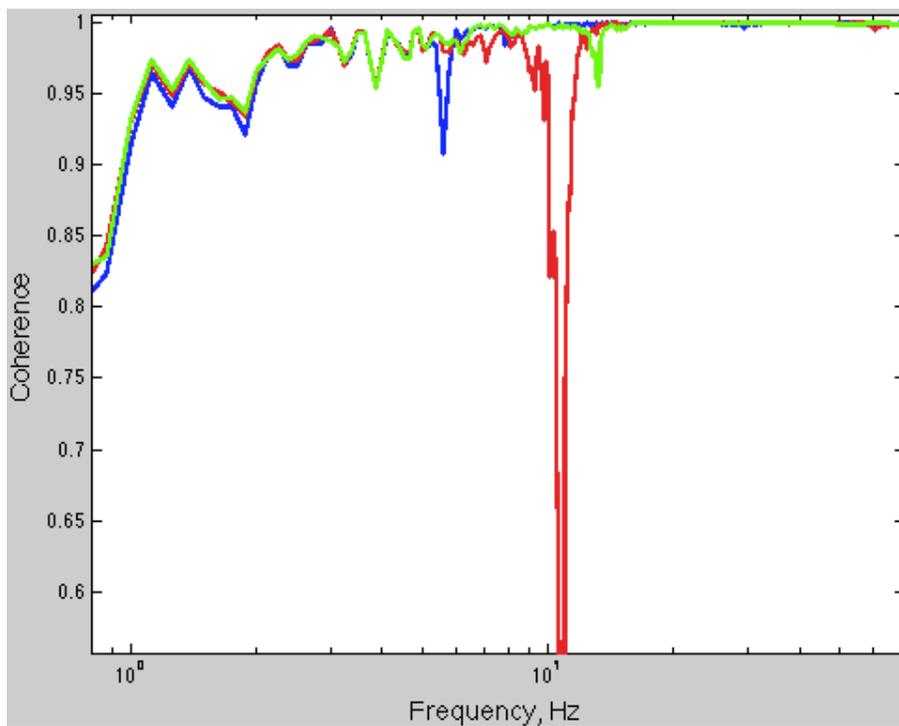
Figure 22: This shows the coherence of the test data over 5 trials; red - IMU; blue - passenger side laser; green - driver side laser

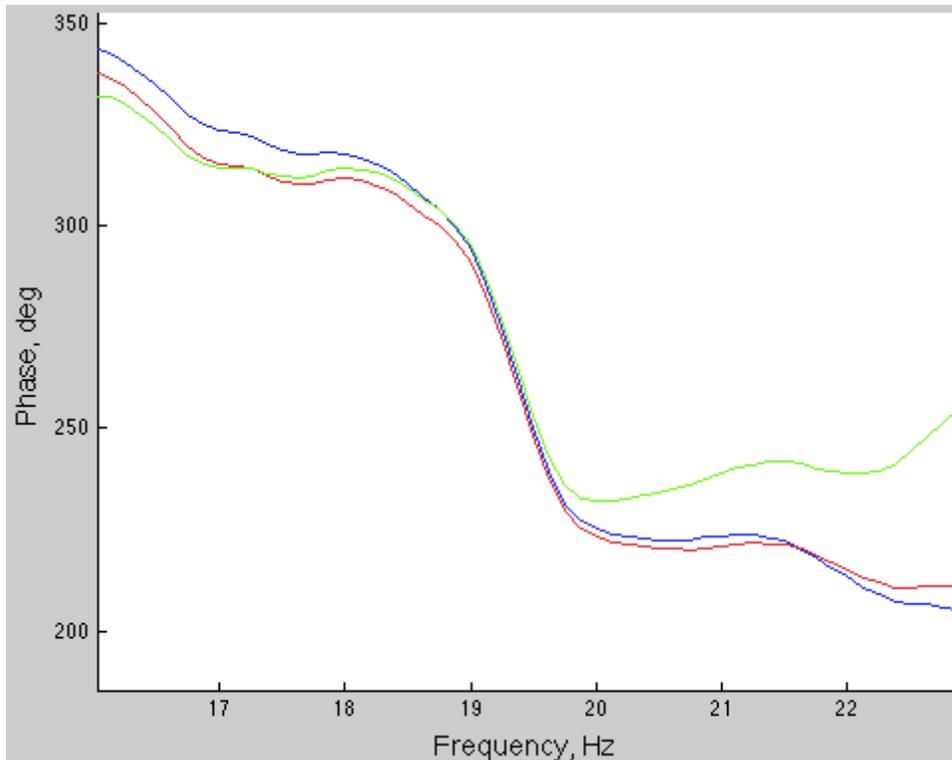
Figure 23: This shows the phase of the response centered around 20 Hz; red – IMU; blue – passenger side laser; green – driver side laser

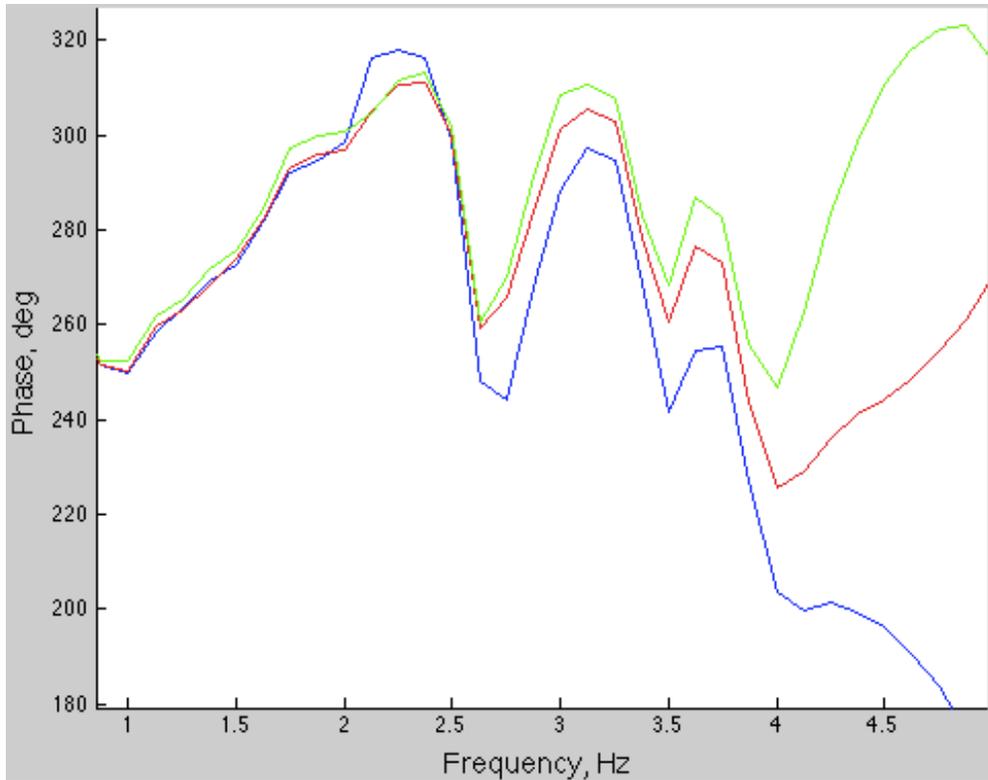
Figure 24: red - IMU; blue - passenger side laser; green - driver side laser; This plot shows the phase response from about 1 to 4.5 Hz.

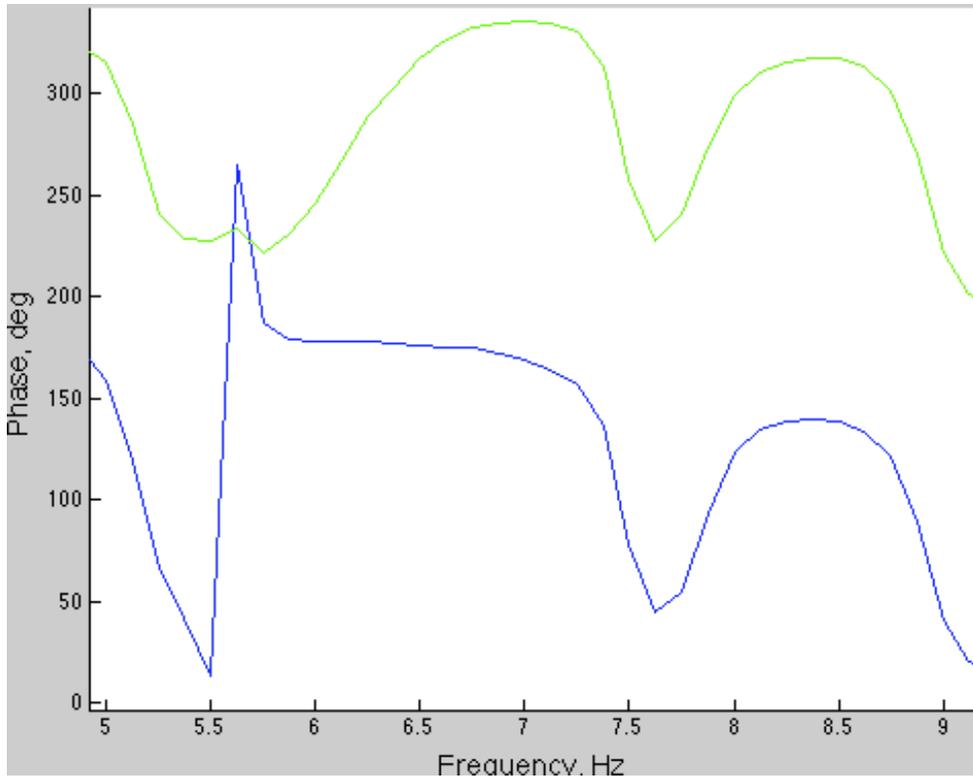
Figure 25: This shows the phase of the response of the two laser; green - driver's side laser; blue - passenger's side laser

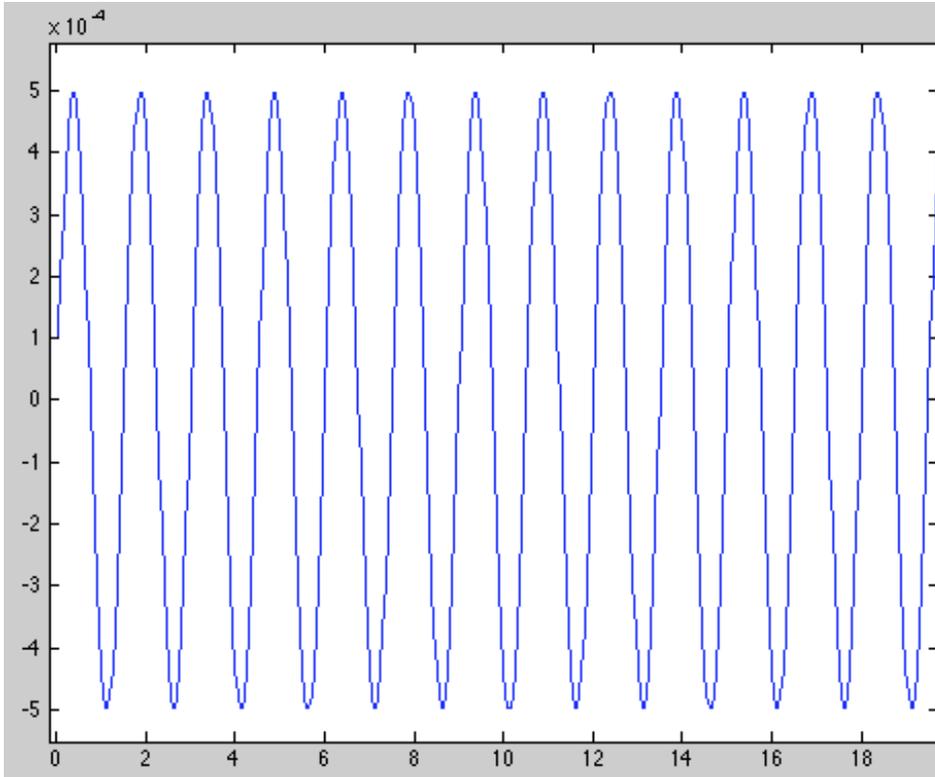
Figure 26: simulated sinusoidal error (zoomed in to 0-30 m). Height (m) vs distance along road (m)

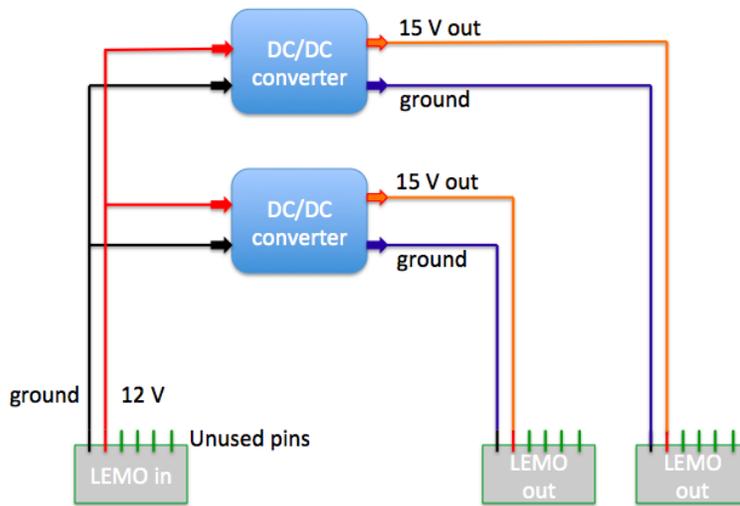
Figure 27: This wiring diagram shows the batteries' nominal 12V converted to 15V for the sensors. The LEMO connectors being used have 6 pins.

accepts a voltage from 7-15 volts (typical 3.7 watts), while the IMU specifies a 15 volt input (typical 8 watts). Furthermore, the amplifier for the accelerometers accepts 9-18 volts (typical 10 watts). Separate DC/DC converters were used to account for potentially higher current draw during startup. This now places the input voltage above the minimum threshold (found through experience to be 10VDC), allowing the equipment to receive a consistent 15 volt input even as the supplied battery voltage drops to 9 Volts. While the minimum input to DC/DC converters is 9 volts, a more consistent supply voltage should allow for better accuracy. A wiring diagram is shown in Figure 27 below.

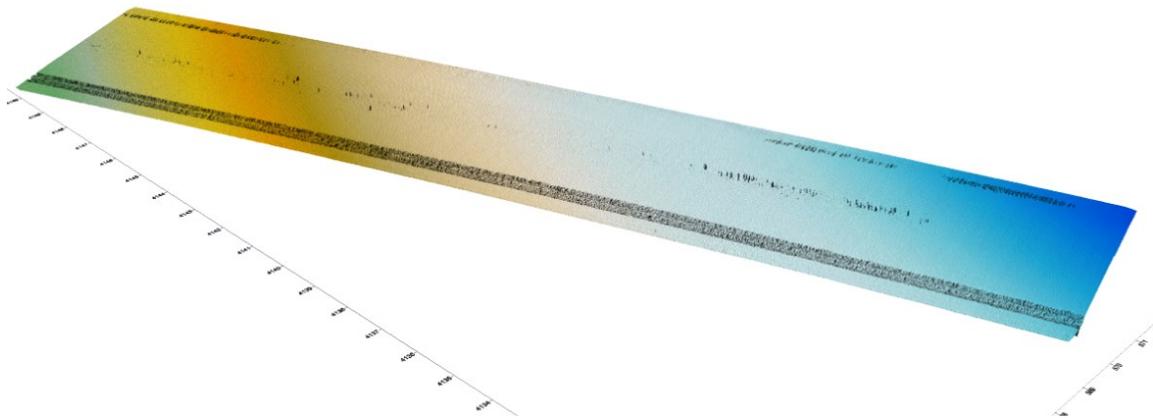
Figure 30: Some noise can be seen in the middle of the road, as well as lane markers on the edges. Units in meters

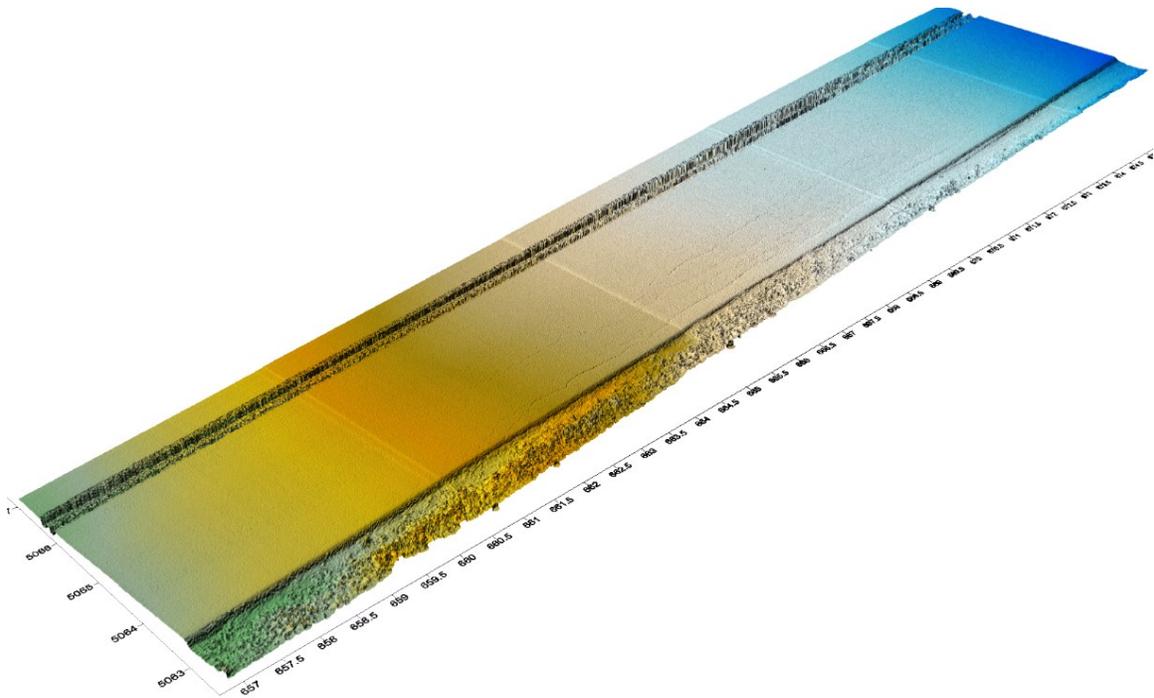
Figure 31: Small horizontal lines showing bumps began appearing in the road – this is similar to the originally reported errors. Units in meters

Approximately halfway through the data collection session, errors similar to what were originally reported began to appear in the data. These errors were only in the data intermittently – a few frames would have the noise, but the rest of the data would be fine. The presence of the noise was particularly concerning because the Profilometer included the DC/DC converters meant to fix this issue. Thus, if the noise kept appearing, either the problem was not effectively fixed, or something else caused different errors. At first, the

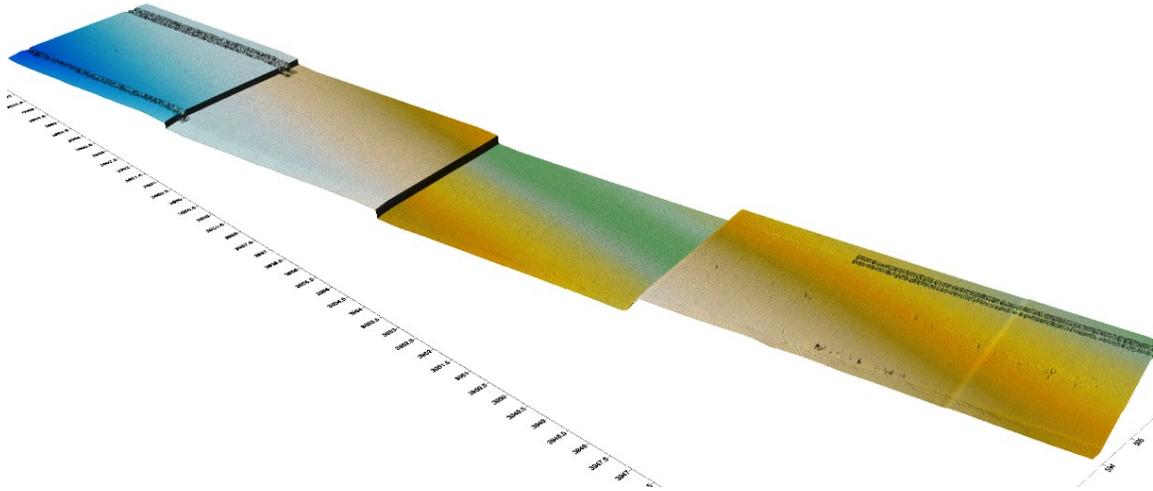
Figure 32: A section of the road scan showing considerable steps in the data at discrete intervals. Units in meters

Again, the appearance of these large steps occurred at regularly spaced intervals, but the appearance of steps was not continuous throughout the data set, but seemingly randomly distributed regions throughout the data. The previous smaller errors also appeared, but usually around these larger step errors. It should be noted again that the majority of the scanned data, even in these later scans, were smooth.

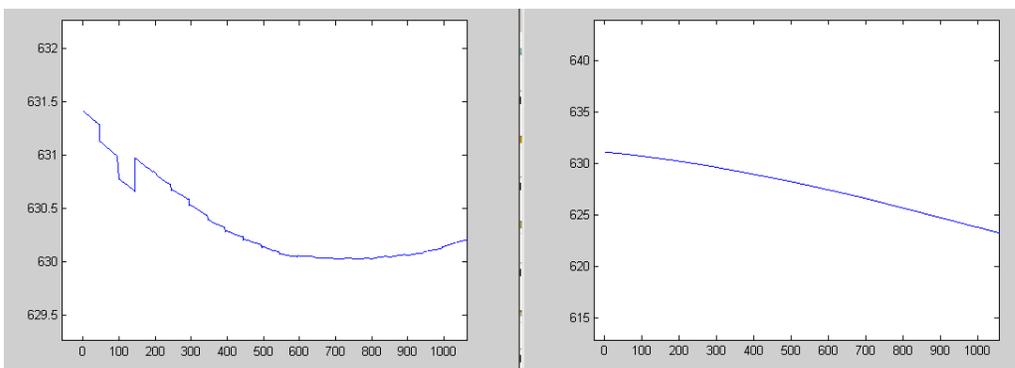
Figure 33: Elevation (m) vs sample number. The plot on the left shows the same data as Figure 32, while the plot on the right is from the first set (Figure 30). The steps in Figure 32 are apparent on the left plot.

To eliminate the possibility of the laser or the accelerometers being the cause of this error, the GPS/IMU data of the noisy scans were compared to the data of the smooth scans. Figure 33 below shows typical plots of elevation versus sample number of the GPS/IMU data for profiles that were noisy (on the left) and for a typical profile that was correct (on the right). The errors in the GPS/IMU correlate to the errors in the profiles. The regular rate of the discrete steps in the data (corresponding to the 2Hz GPS refresh rate) clearly show that the cause of the steps is the GPS/IMU combination.
