Error Mitigation in Roughness Measurements

Thesis submitted to the faculty of the Virginia Polytechnic Institute and State University
in partial fulfillment of the requirements for the degree of

Master of Science
In
Mechanical Engineering

Keywords: roughness, IRI, terrain measurement

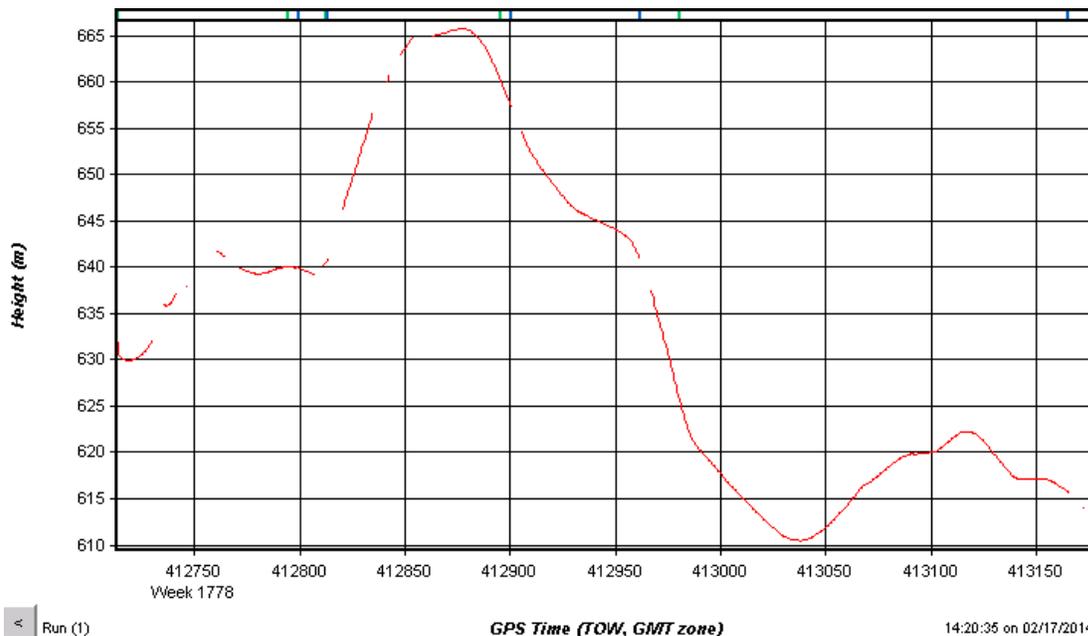
Figure 34: GPS only elevation profile of final run – this is a zoomed in section of a data collection run. elevation (m) vs. GPS time (s)

Next, the GPS and IMU output data were investigated. Figure 34 shows the recorded elevation, solely based upon the GPS data (no IMU), versus time. This data was collected along the route shown in Figure 28. The discontinuities in the plot correspond to missing GPS data (potentially from objects such as trees blocking satellites).

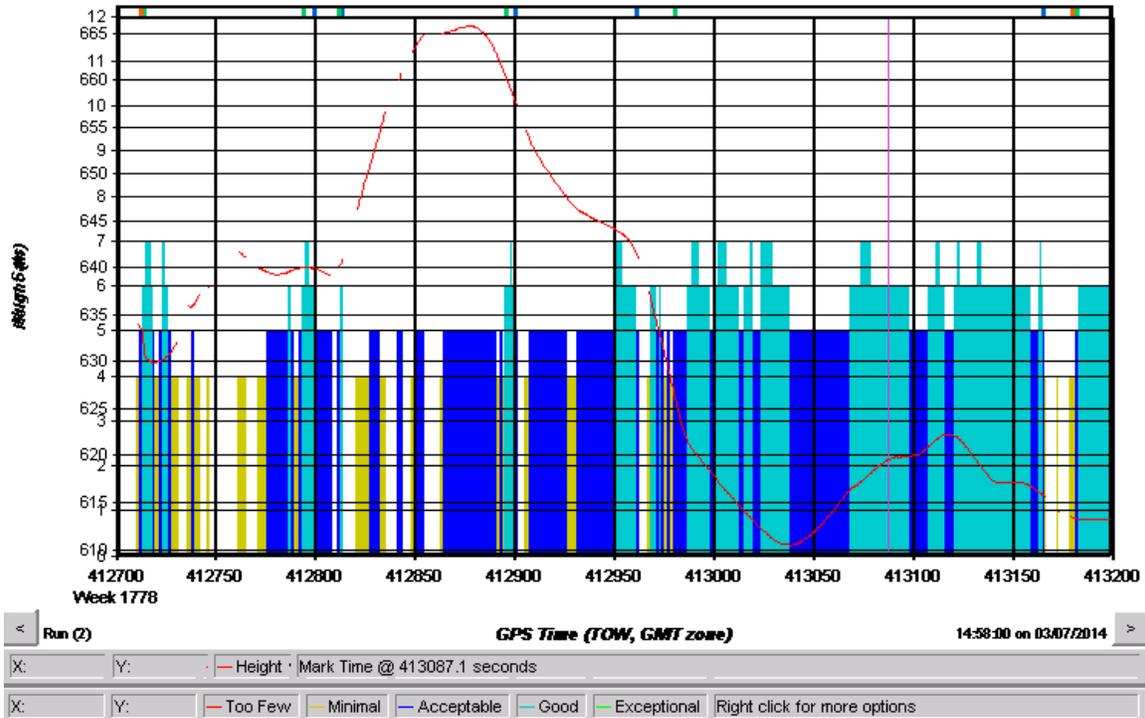
Figure 35: elevation data superimposed on number of shared satellites between remote unit and base station. Number of satellites connected and elevation (m) vs. GPS time (s)

Although not shown on the plot, there is also some missing data immediately prior to starting this data collection run. Thus, it is hypothesized that poor GPS data may lead to noisy results due to drift in the IMU's estimate in location and orientation. Below, in Figure 35, Figure 34 is superimposed onto a plot of the number of shared satellites between the remote unit and base station. It is clear that where there are no shared satellites (most likely because the remote unit lost all reception), there is also no elevation data.

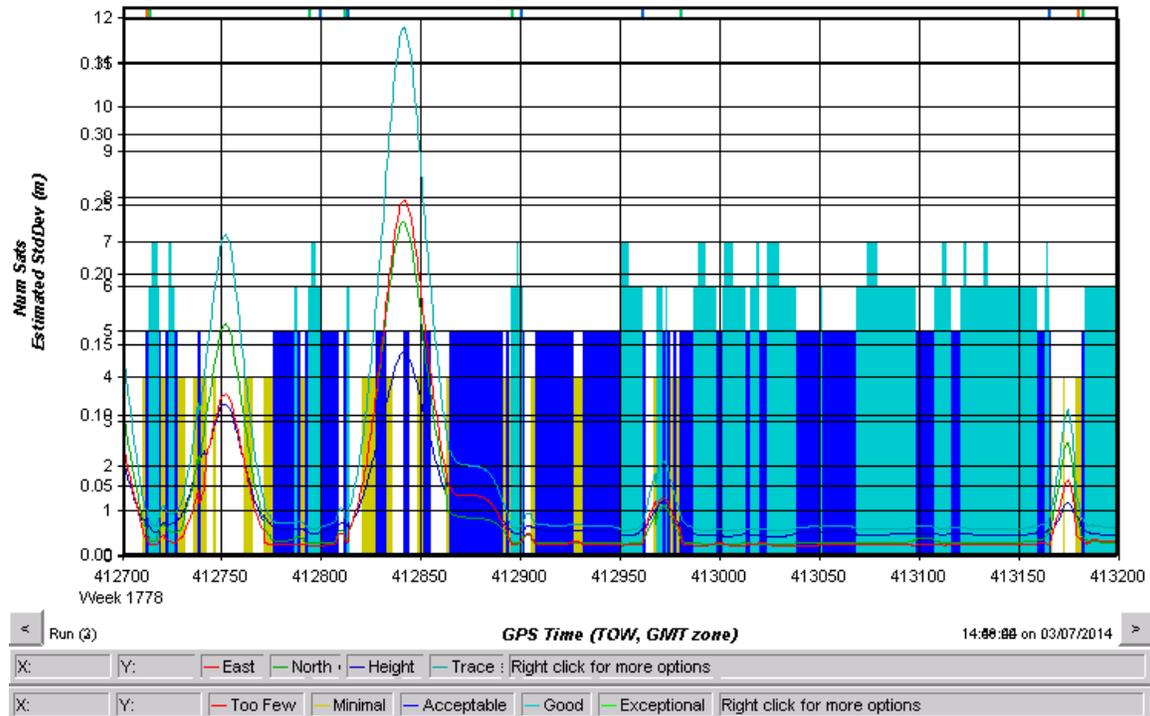
Figure 36: standard deviation of position plotted on shared GPS satellites between base and remote units. Number of satellites connected and estimated error (m) vs. GPS time (s)

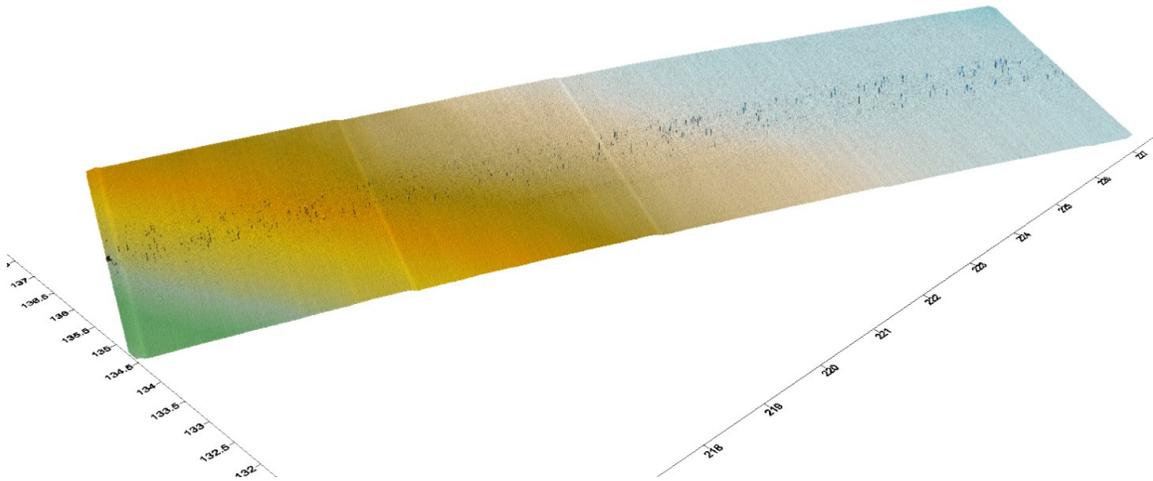
Figure 37: This shows some noise from a scan with the DC/DC converter. Units in meters

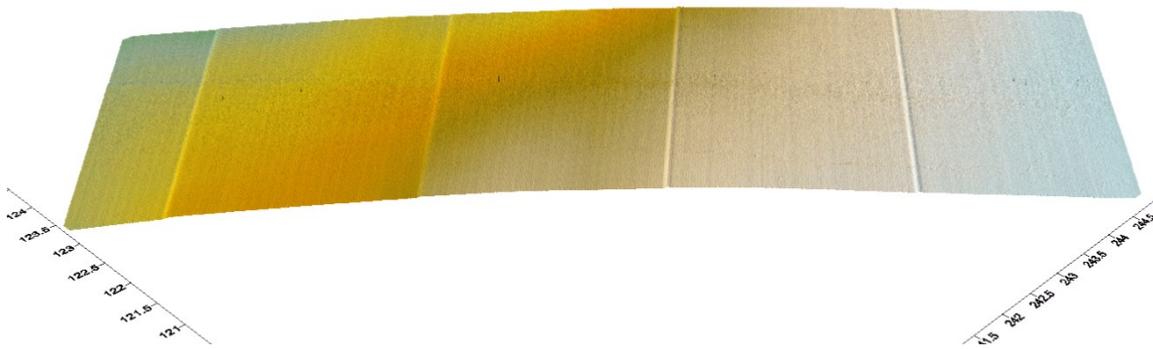
Figure 38: This is a scan without using the DC/DC converter. Noise in the data can also be seen in this plot. Units in meters

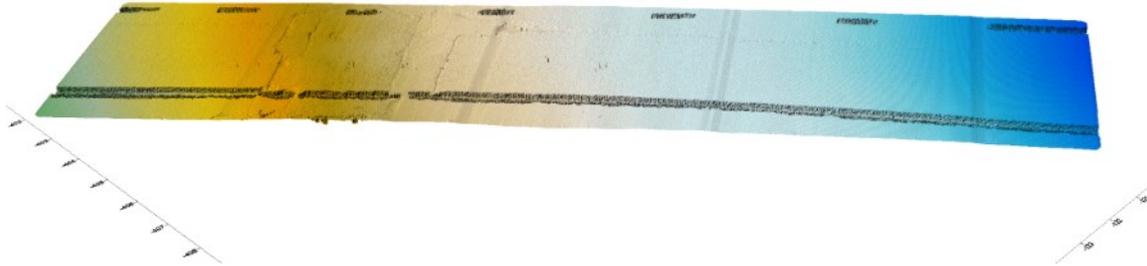
Figure 39: This is data taken with a different receiver. There are some cracks in the road, but there are also bumps due to a noisy GPS/IMU signal. Units in meters

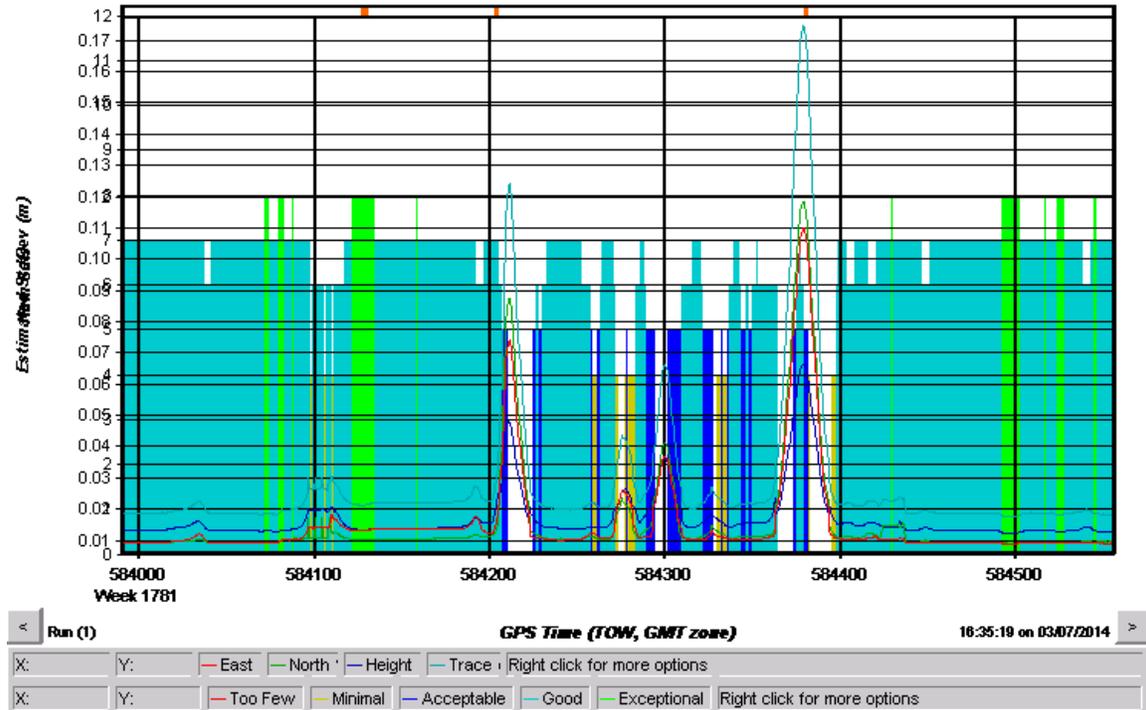
Figure 40: The position deviation overlaid on the number of shared satellites for the run with the DC/DC converter around the Drillfield (original GPS receiver). Number of satellites connected and estimated error (m) vs. GPS time (s)

Plots showing the position deviation and number of shared satellites for three configurations are presented in the following figures. Figure 40 shows the result of using the DC/DC converter and the original (TARDEC) receiver. Figure 41 shows the result of using direct battery power and the original (TARDEC) receiver. Figure 42 shows the result of using the DC/DC converter and a replacement (VTPL) receiver.

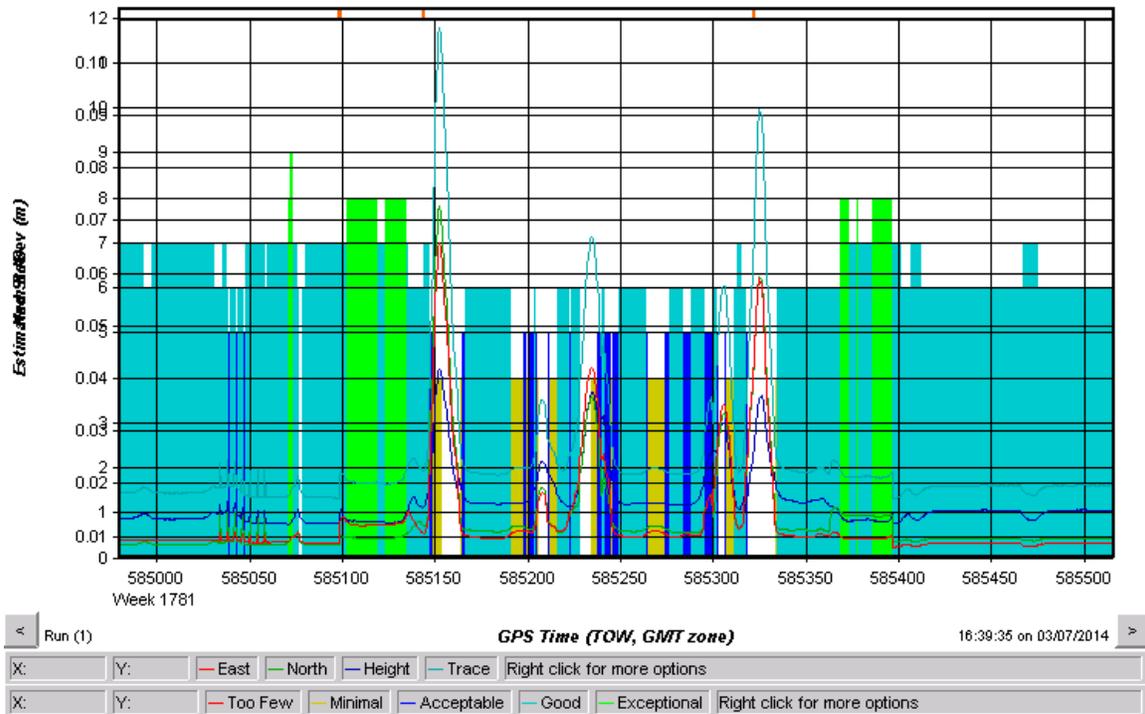
Figure 41: The position deviation overlaid on the number of satellites for the run using direct battery power around the Drillfield (original GPS receiver). Number of satellites connected and estimated error (m) vs. GPS time (s)

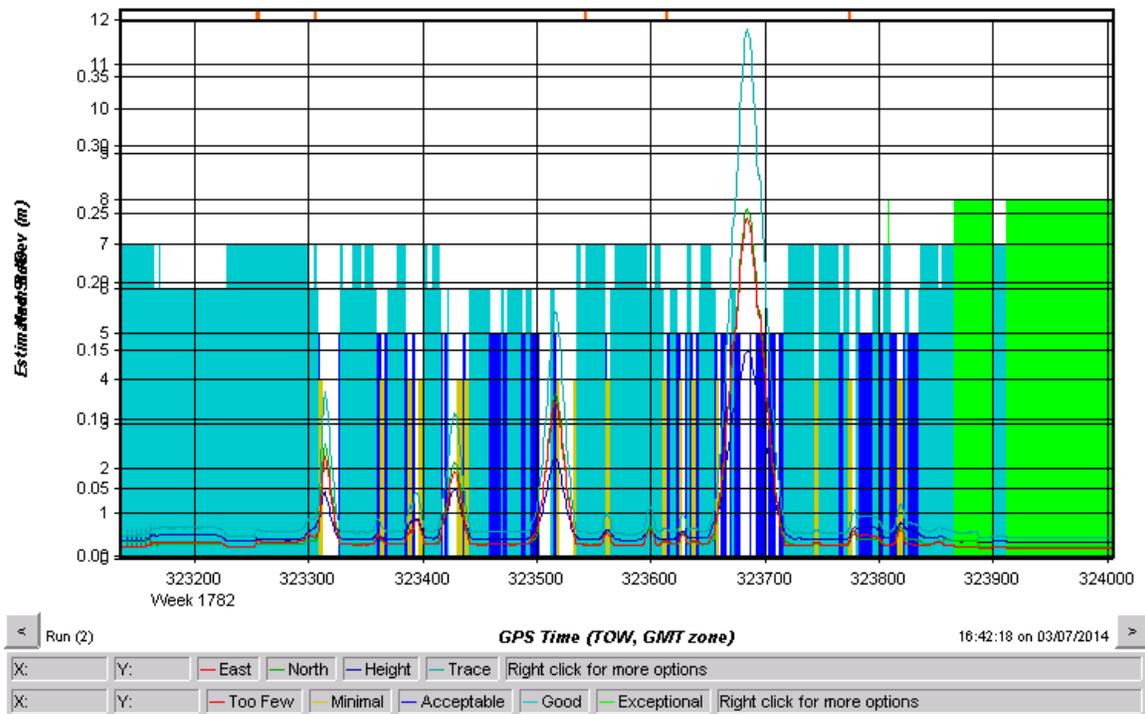
Figure 42: The error overlaid on the number of satellites, using the DC/DC converter with the VTPL GPS receiver. Number of satellites connected and estimated error (m) vs. GPS time (s)

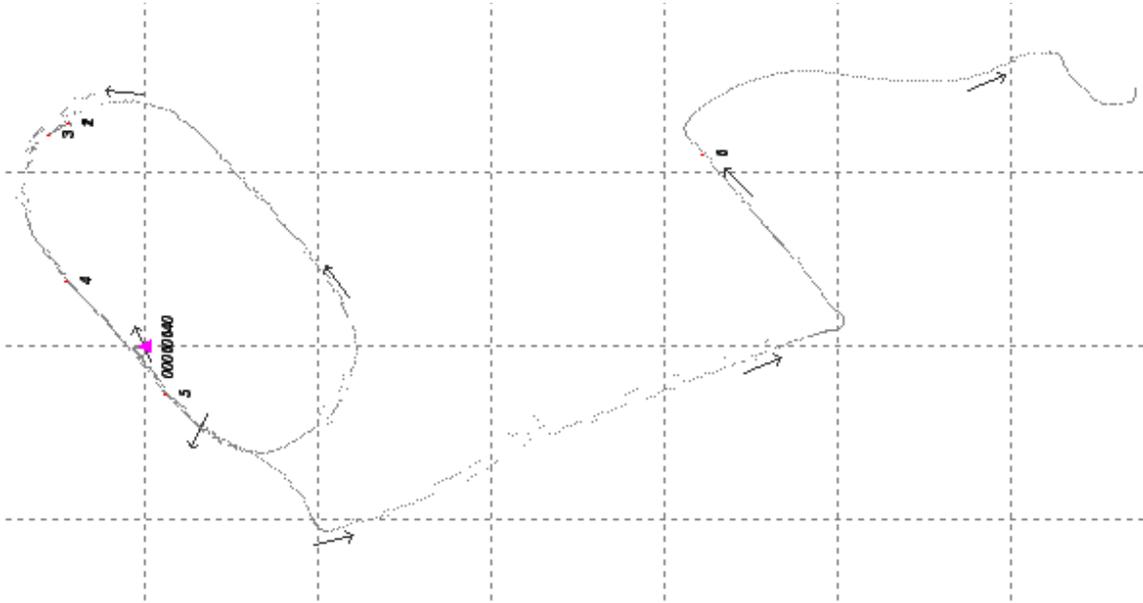
Figure 43: This shows the GPS data with the original antenna.

Finally, the antenna was also replaced with another unit to determine its status. Since the IMU and GPS receiver were ruled out, the focus of this test was to see differences in the quality of GPS data and satellite reception. As stated previously, the noise in the road scans correlated with areas of weak GPS signals. Figure 43 shows the signal before processing with the base station – note that there are areas of no data and also discontinuous points.

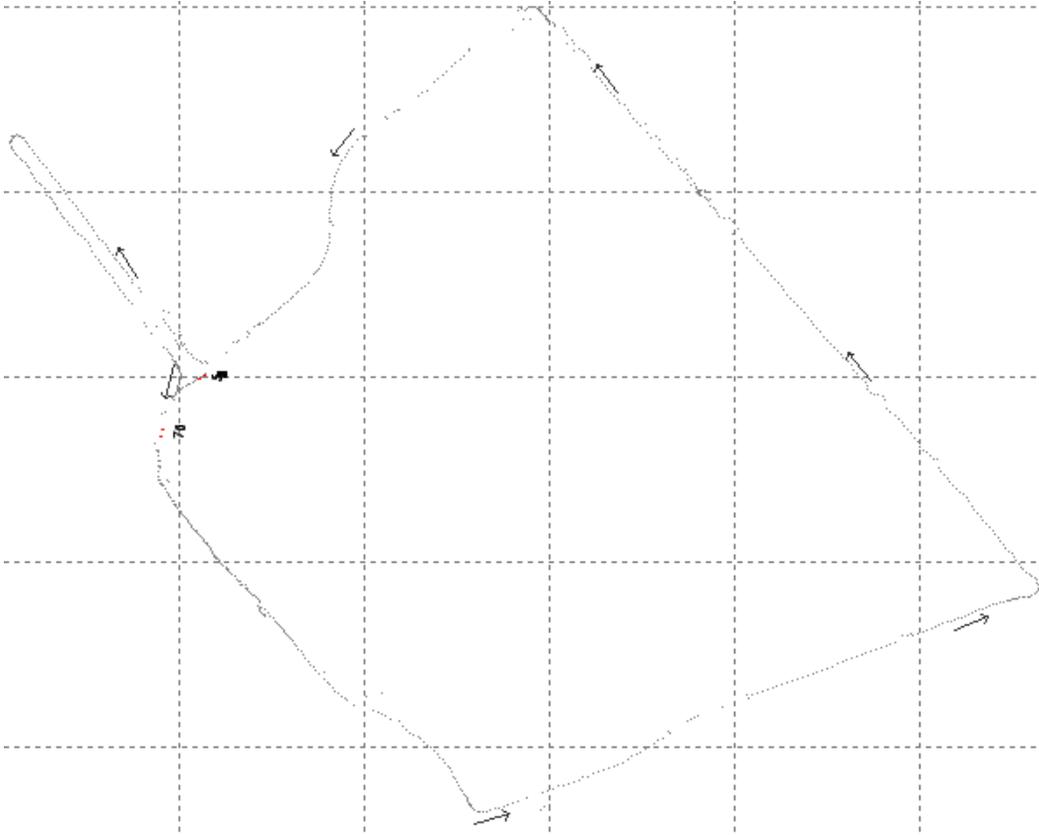
Figure 44: This shows the GPS data with the replaced antenna.

While a slightly different route was driven with the replaced antenna, it also shows discontinuities and holes in the data. This is shown below in Figure 44.

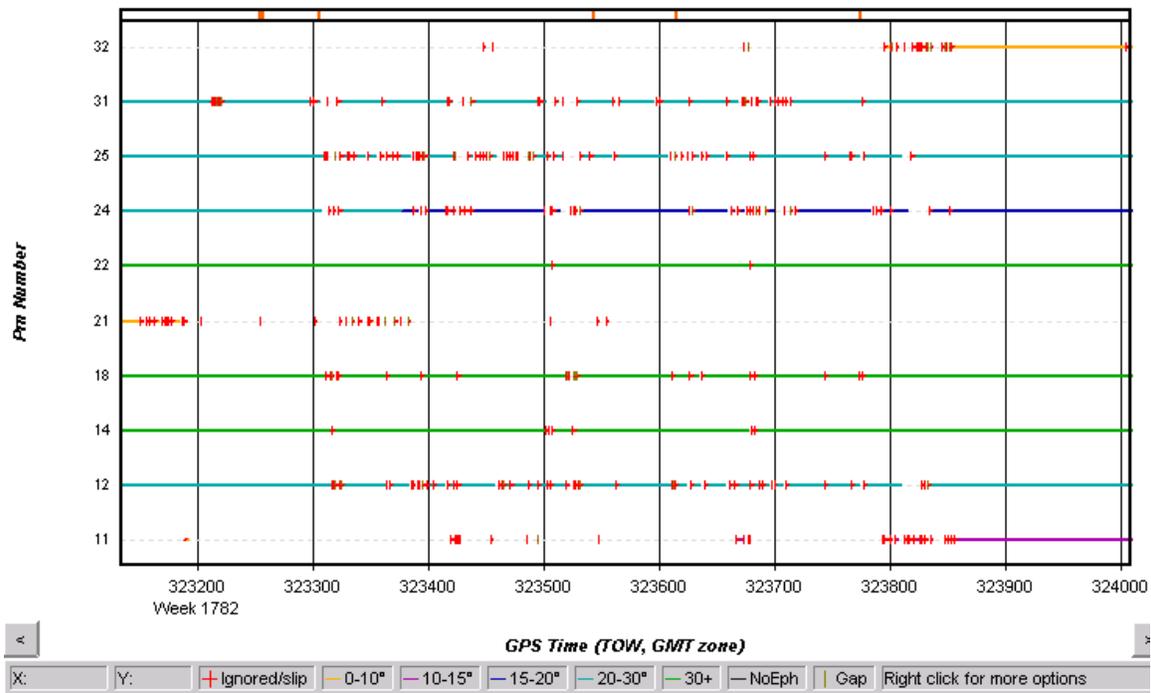
Figure 45: This shows the satellite connectivity with the original antenna.

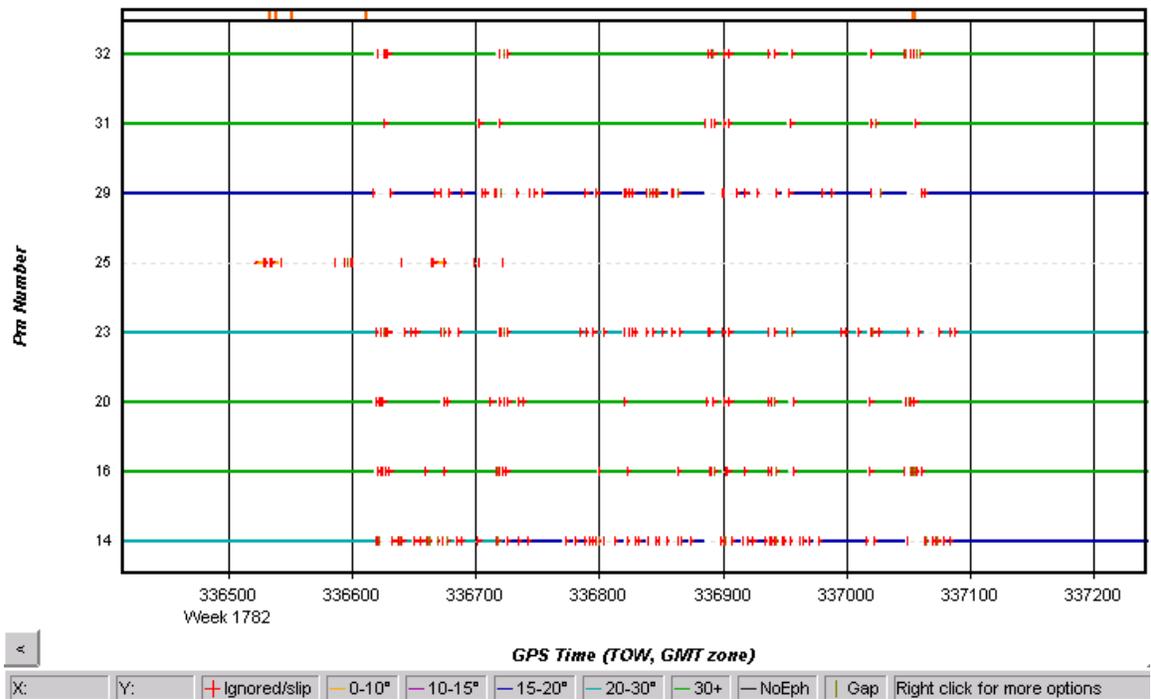
Figure 46: This shows the satellite connectivity with the replaced antenna.

This is compared to Figure 46, which shows the same plot but is taken with the replacement antenna. Note that they both exhibit points where there is poor reception.

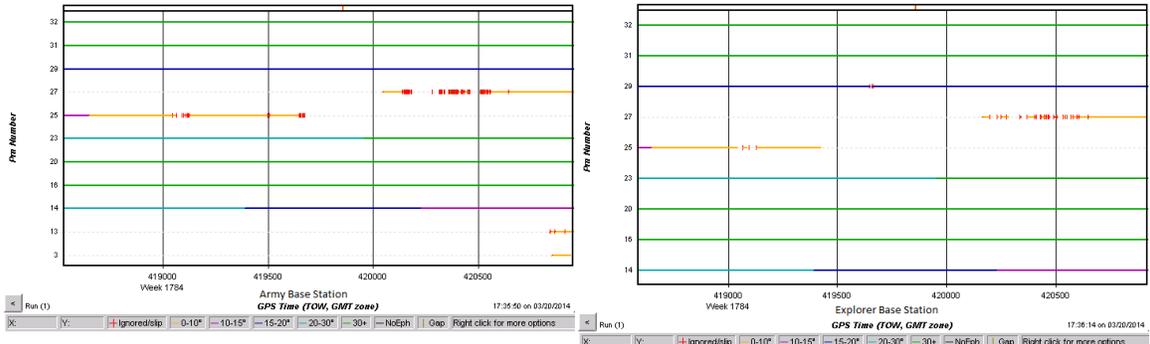
Figure 47: This shows the reception of the Army base station on the left and Explorer base station on the right. Note that there were not any signal gaps in the satellites with the best views (green lines) on either figure.

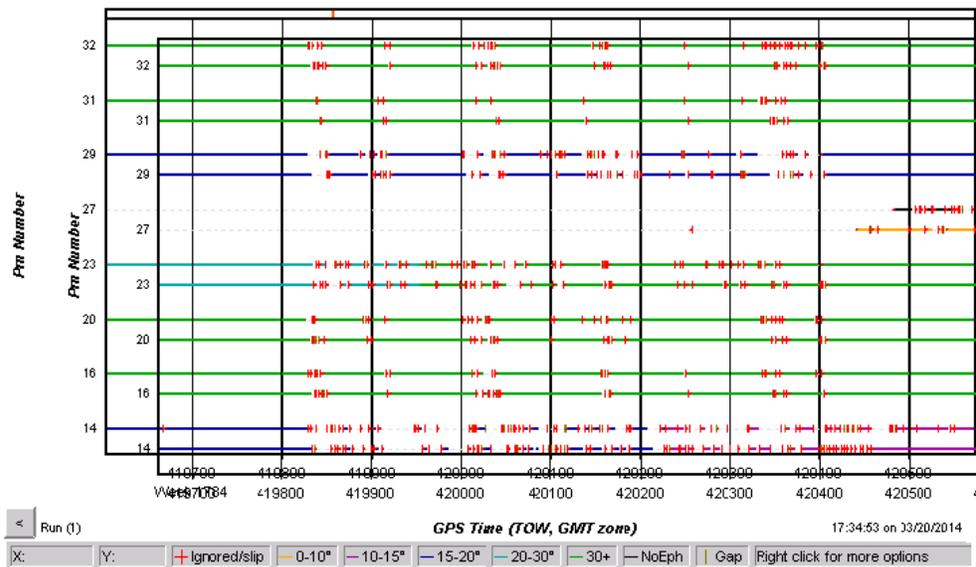
Figure 48: This shows the GPS satellite reception of the 2 remote units overlaid on top of one another.

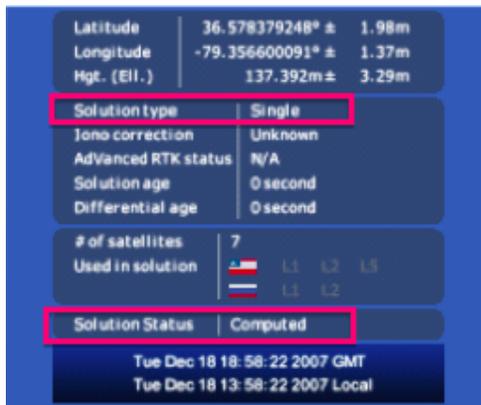
Figure 49: This shows the completed solution of the GPS.

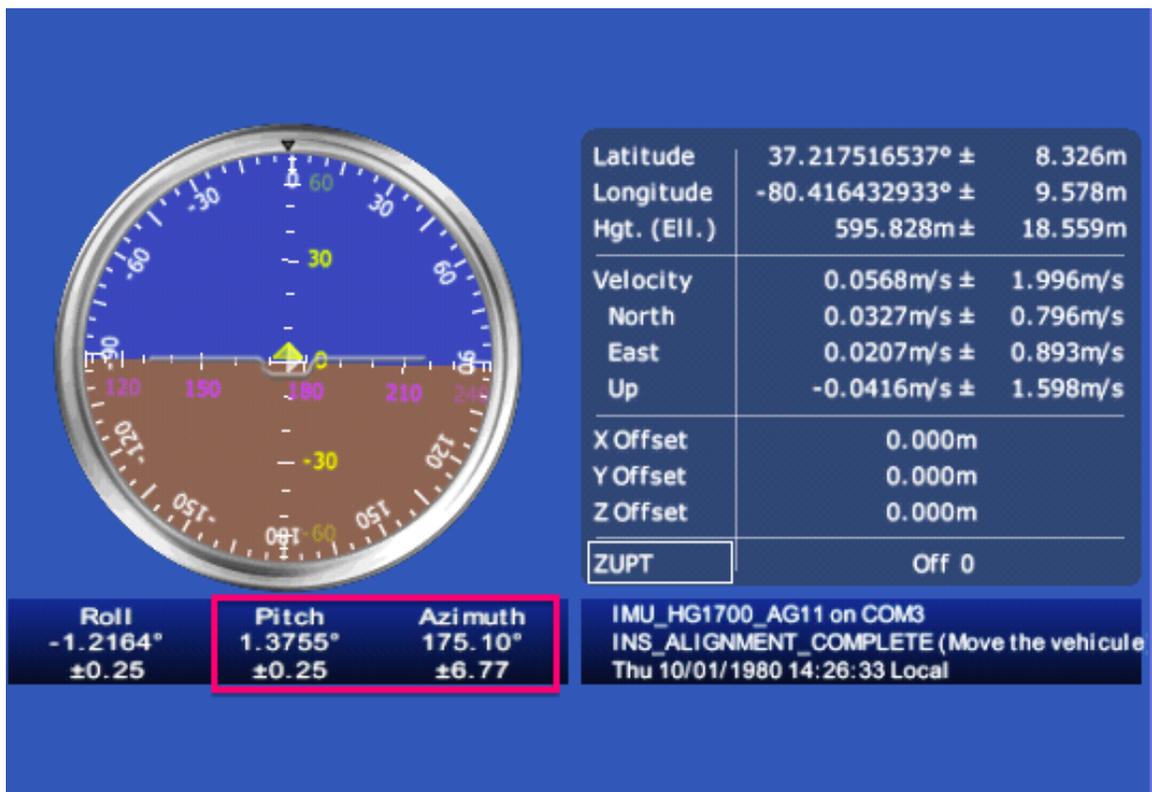
Figure 50: The IMU before any kinematic alignment. Note the high error values.

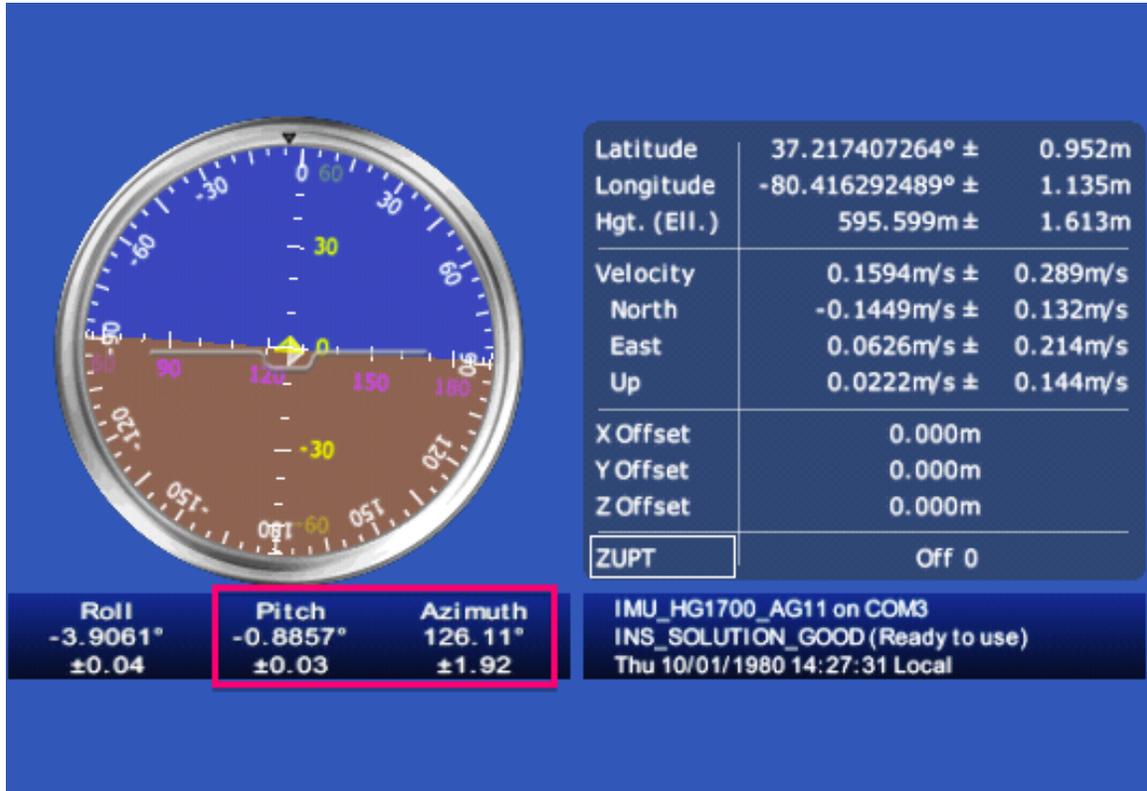
Figure 51: The IMU after the recommended kinematic alignment. The errors have decreased, but are still higher than optimal.

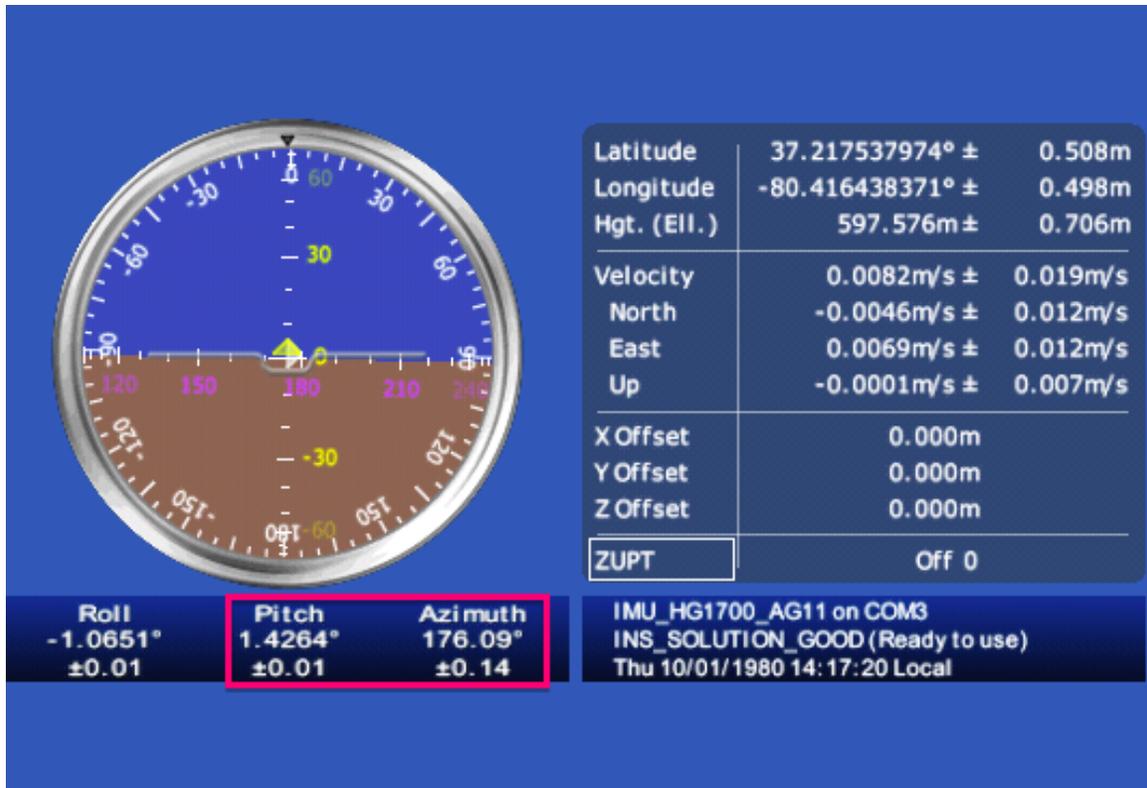
Figure 52: The IMU after the extra alignment (driving in figure 8s). Note the low error in pitch and azimuth.

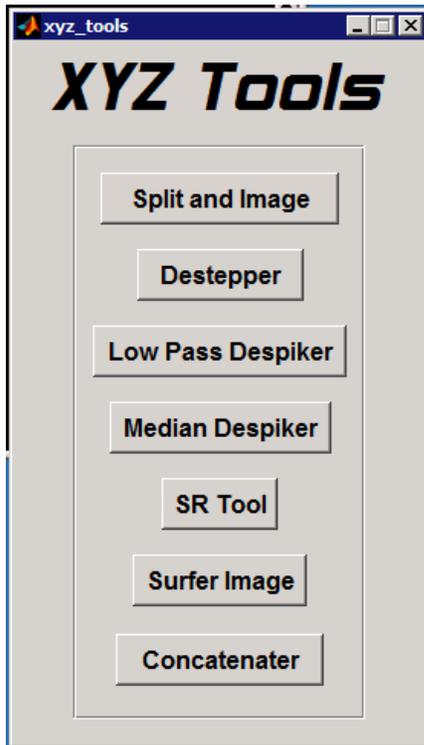
Figure 53: The user interface of XYZ Tools. This allows the user to edit processed terrain data.

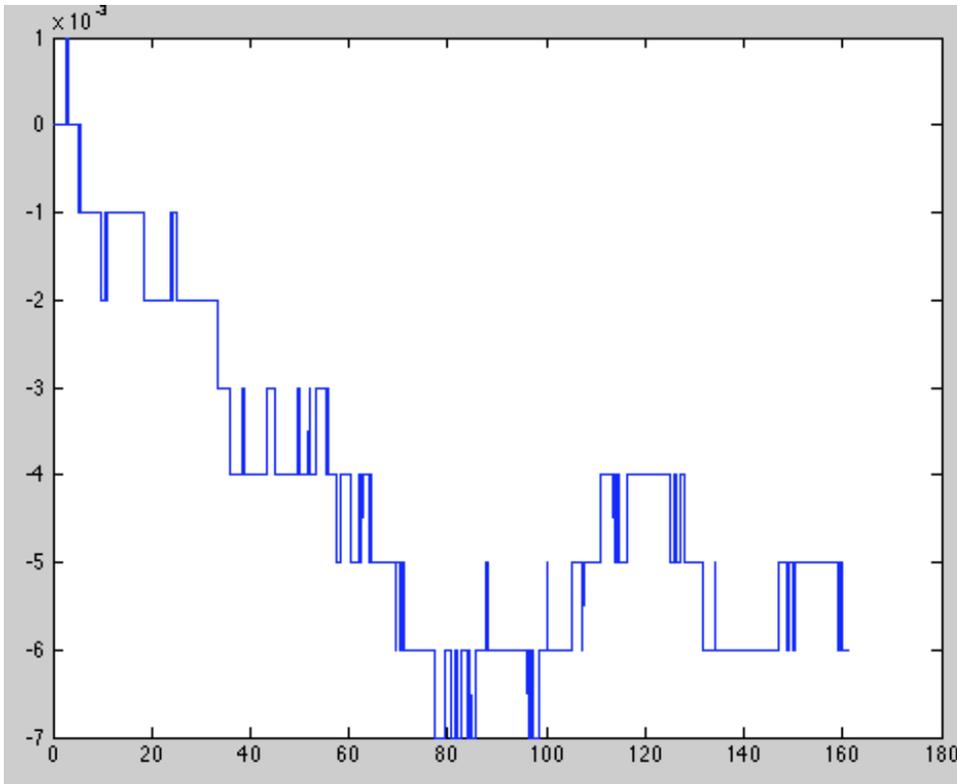
Figure 54: This is the profile of the simulated drift. height (m) vs distance along road (m)

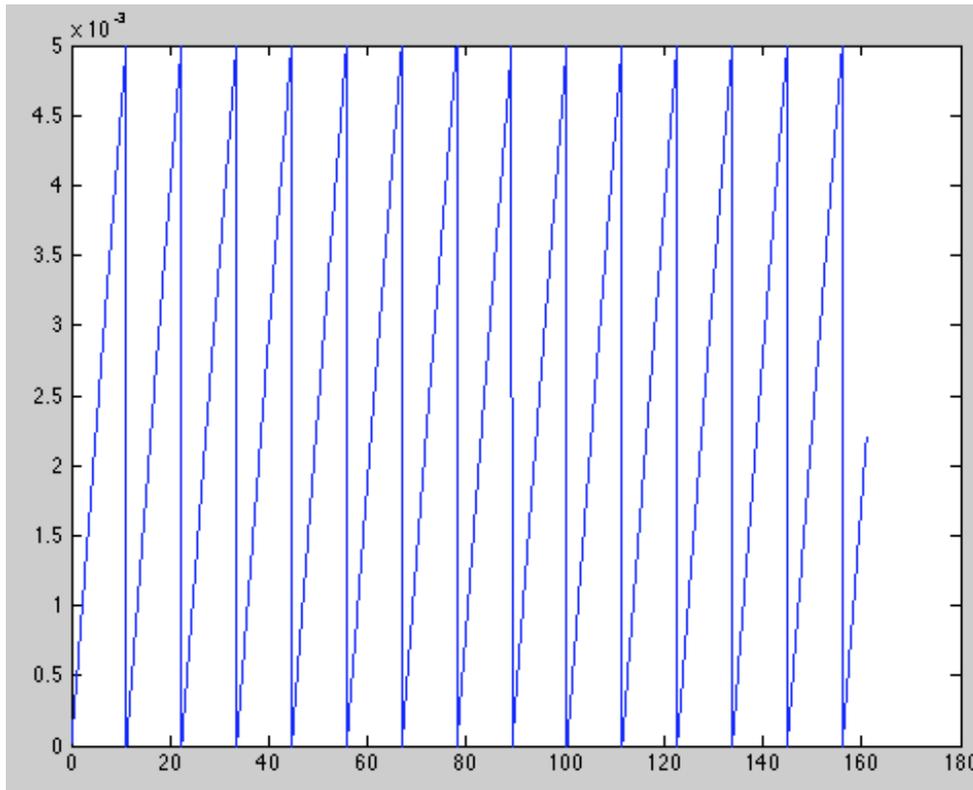
Figure 55: The simulated sawtooth error. It has an amplitude of 5 mm and a frequency of 2 Hz. height (m) vs distance along road (m)

To simulate errors caused by bad INS measurements, a sawtooth pattern will be added to the road (as seen in Figure 59). This often occurs when the GPS signal is lost and

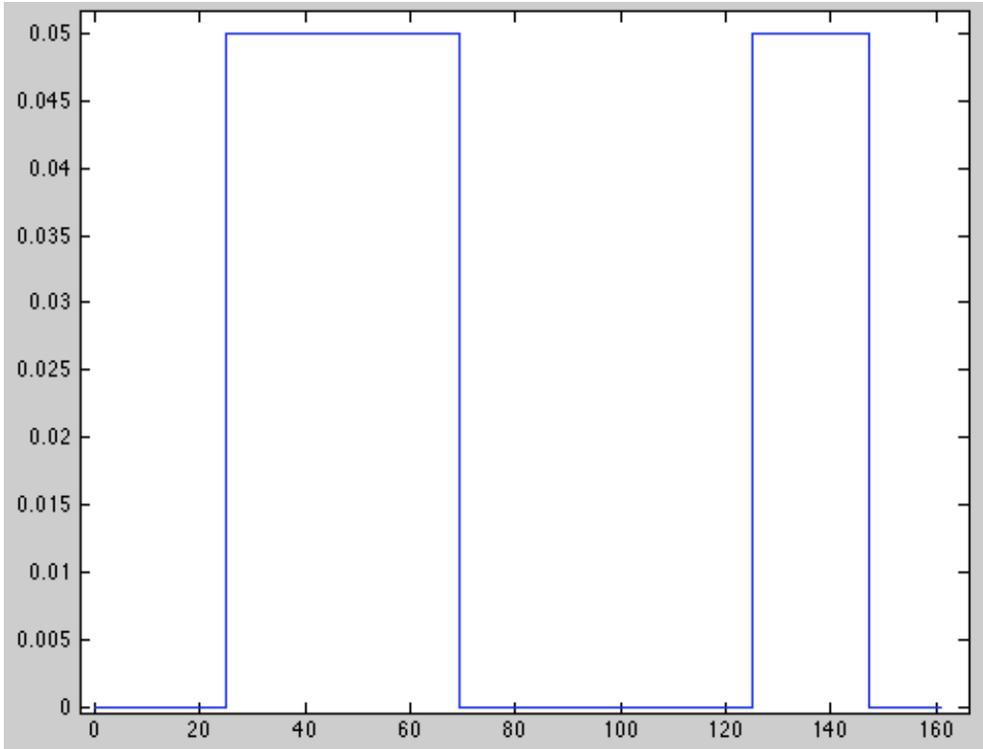
Figure 56: This simulates the step-type error. height (m) vs distance along road (m)

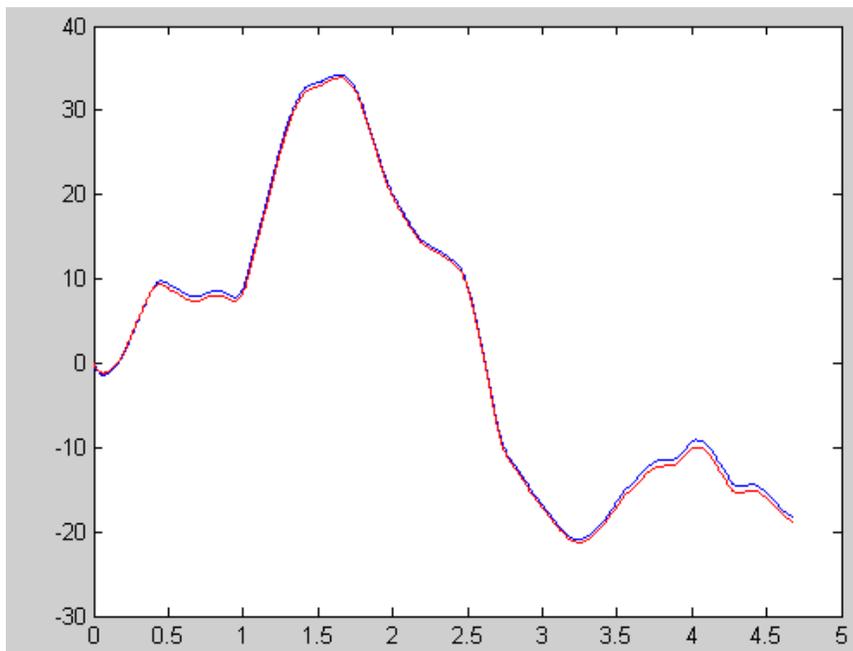
Figure 57: Elevation data of scan; original (blue) compared to filtered (red). Elevation (m) vs scan number (in ten thousands)

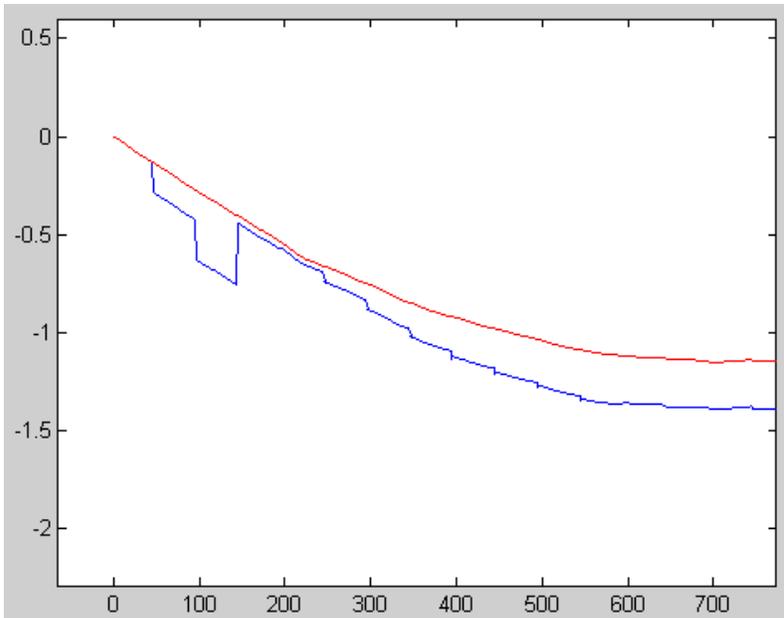
Figure 58: A zoomed in view of the beginning of the scan. A big difference can be seen between the original (blue) and filtered (red) data. elevation (m) vs scan number

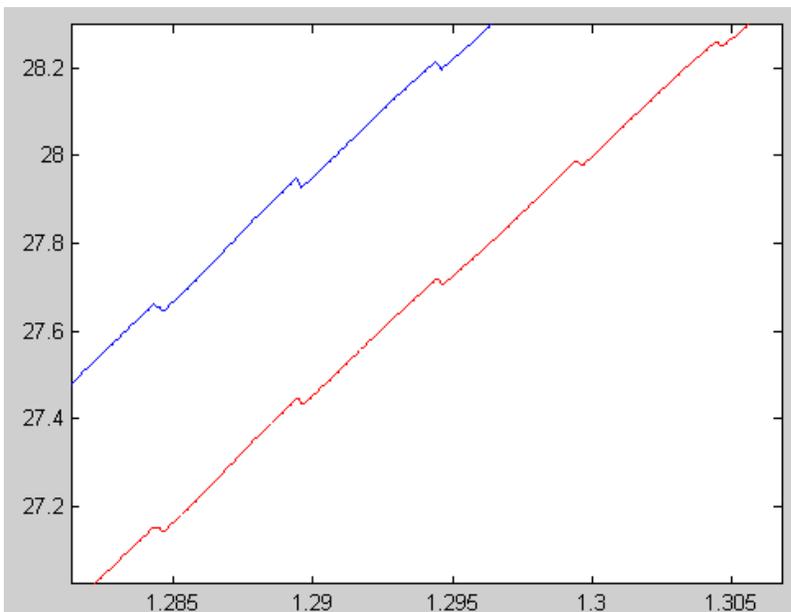
Figure 59: Small values of noise are where the filter does not work well. elevation (m) vs scan number (ten thousands)

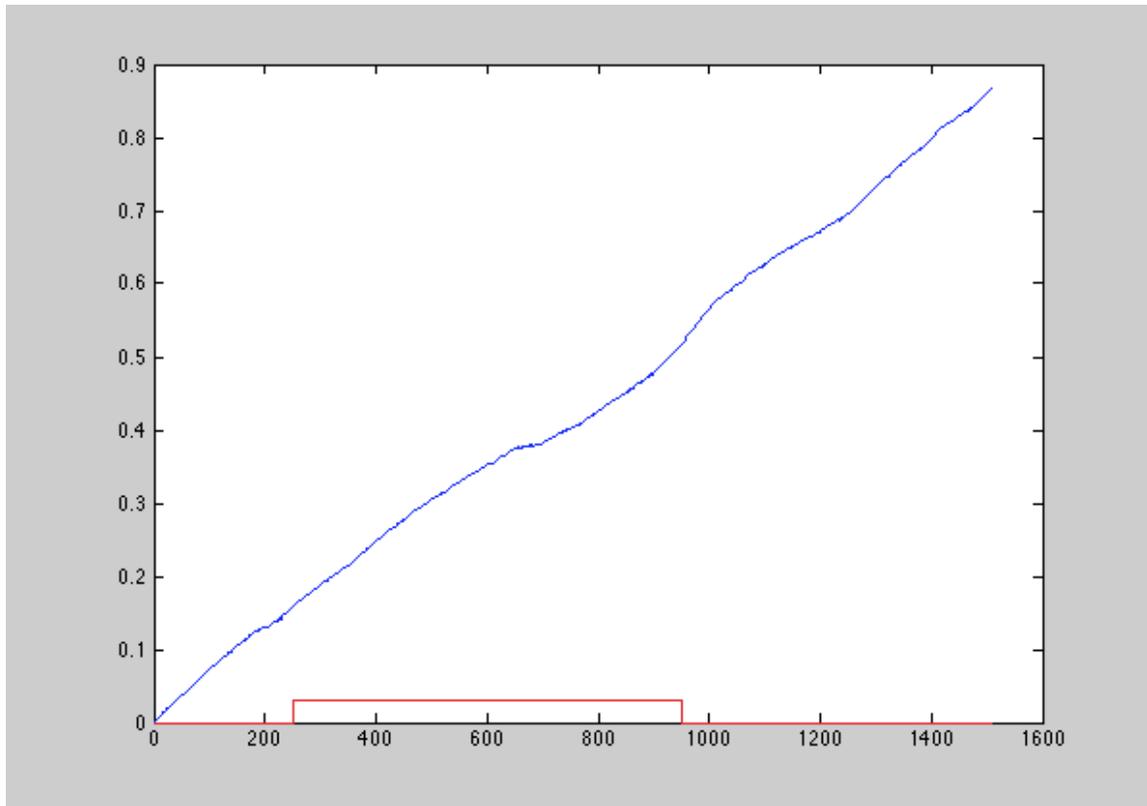
Figure 60: Two road profiles. height (m) vs data point

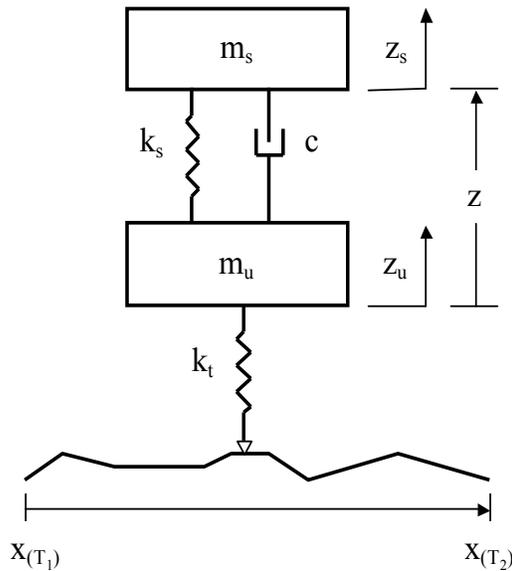
Figure 61: quarter car model. The unsprung mass (m_u) and tire stiffness (k_t) represent the tire, while the sprung mass (m_s) represents a quarter of the body. The properties of the spring are represented by the stiffness (k_s) and damping (c) coefficients, with z being the suspension travel.

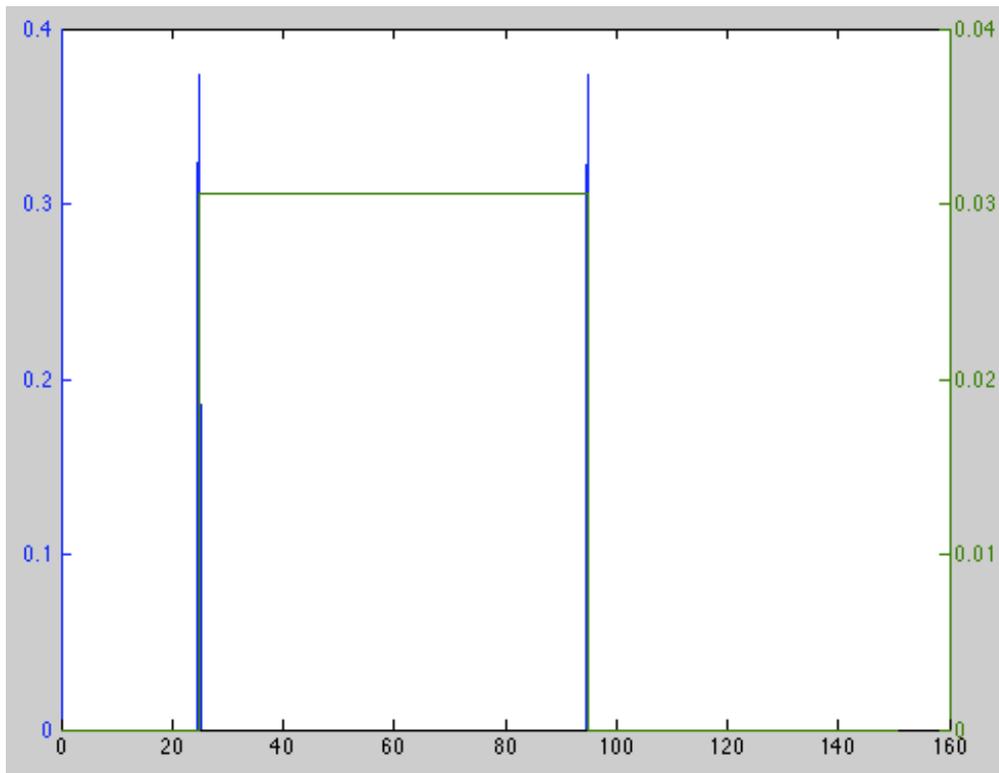
Figure 62: sample road profile 1: CRI (mm/m, blue) and road profile (m, green) vs distance along road (m)

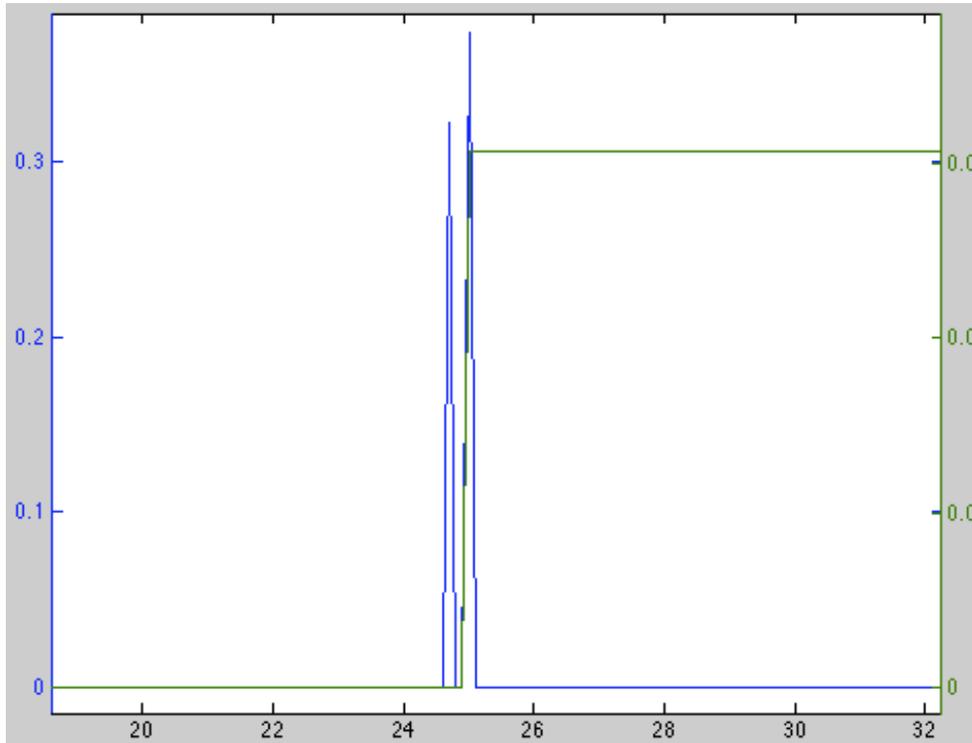
Figure 63: zoomed in at a distance of 25 m; CRI (mm/m, blue) and road profile (m, green) vs distance along road (m)

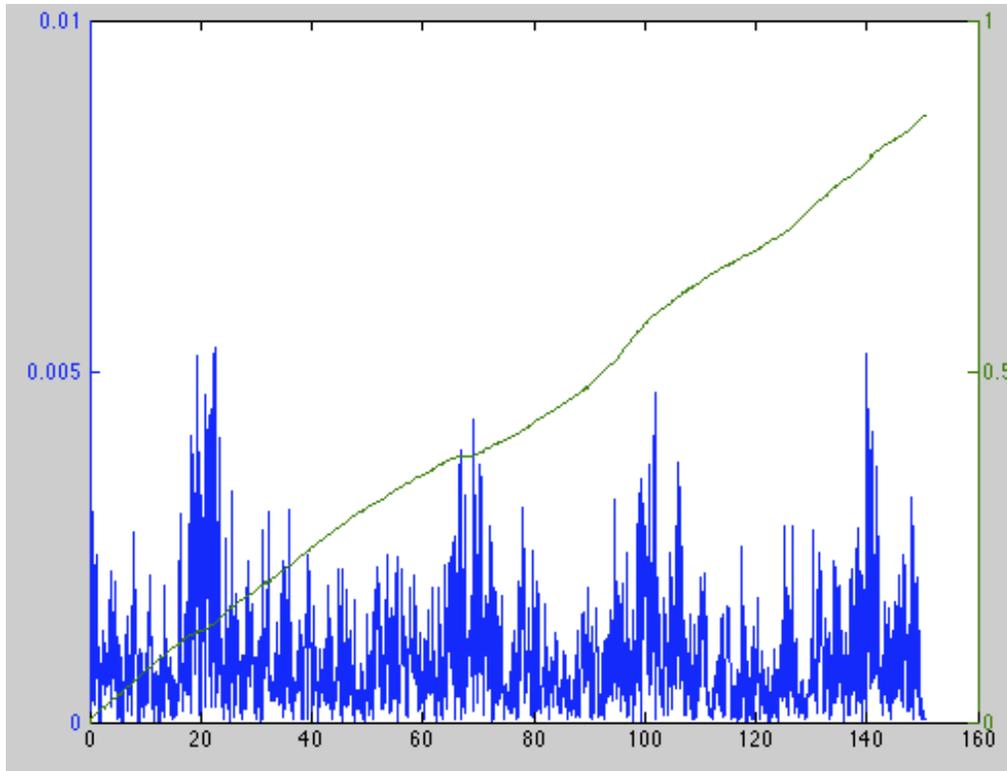
Figure 64: sample road profile 2: CRI (mm/m, blue) and road profile (m, green) vs distance along road (m)

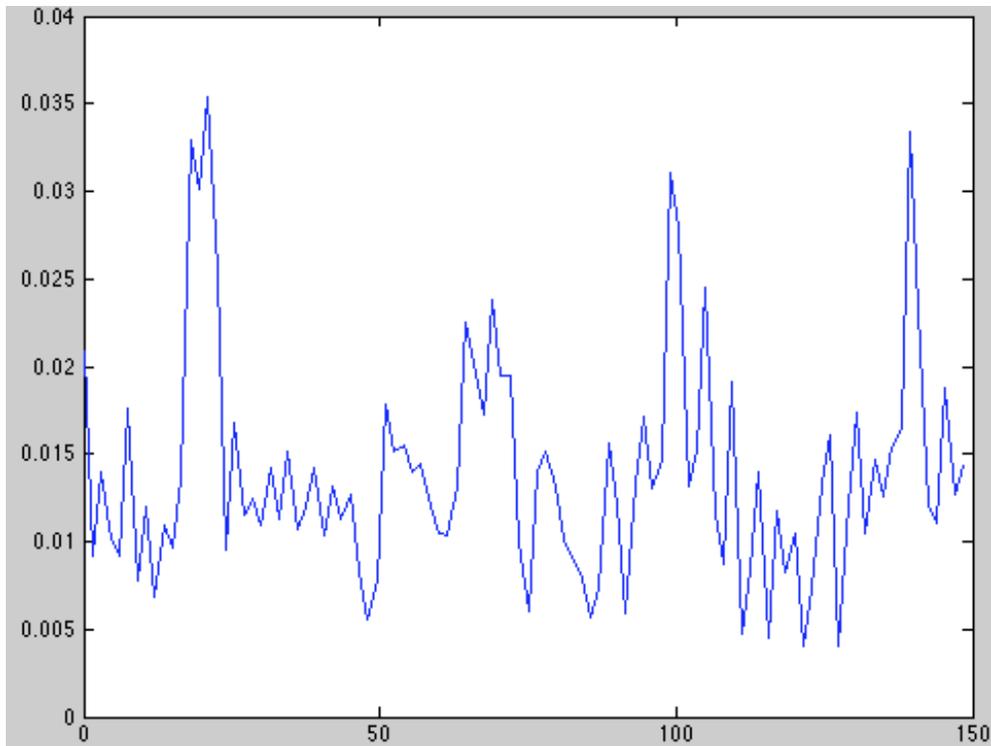
Figure 65: CRI with a sampling width of 15 data points. CRI (mm/m) vs distance (m)
