EARLY LIFE AND IN SERVICE FRICTION CHARACTERISTICS OF RUNWAY SURFACE

I. WIDYATMOKO

URS Infrastructure & Environment UK Limited

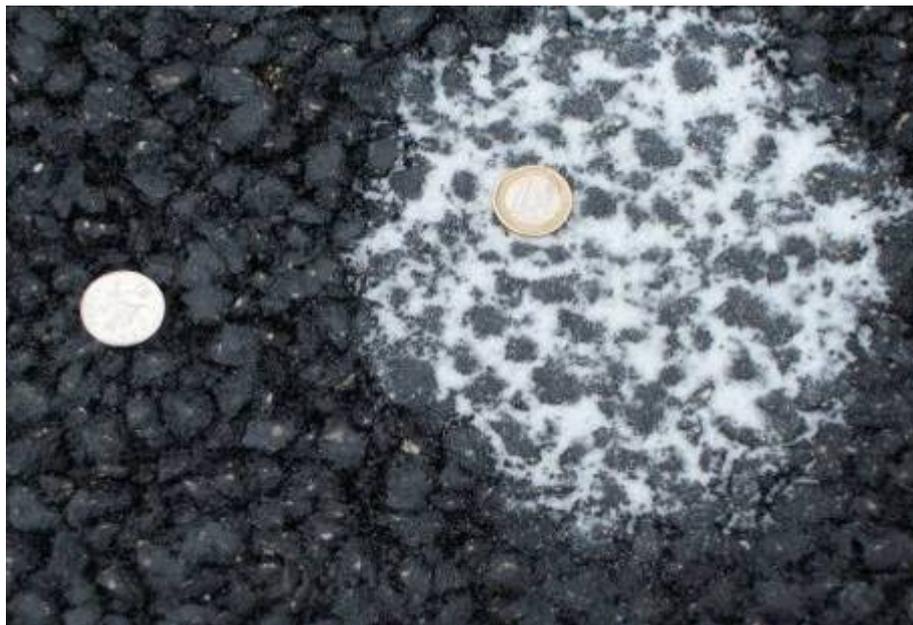
Figure 1 – A Typical Surface Texture of Ungrooved AC-14 BBA D

Table 3 shows that the initial mean texture depth (MTD) of ungrooved AC-14 BBA D meets the CAA requirements of 1mm minimum texture depth [3]; a typical surface appearance is illustrated in Figure 1.

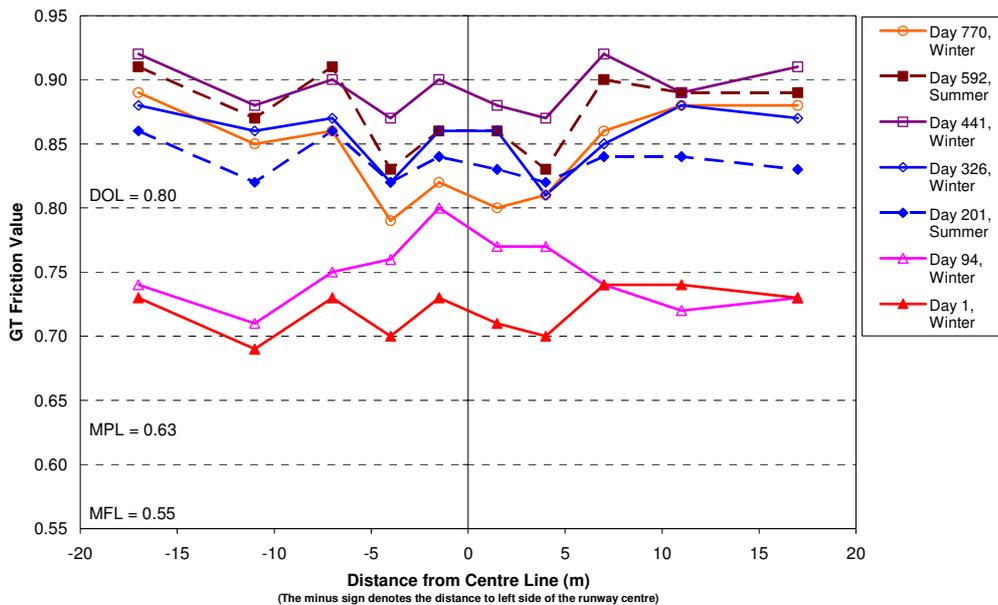
Figure 2 – Changes in Friction Value with time, measured by Grip Tester, at 0.25mm water depth

Figure 2 shows improvement in the surface friction values during the first 2-3 years in service. However, there was a trend of reduction in some friction values during the summer months and/or after 2 years in service. At the time this paper was being drafted, no rubber removal has been carried out to this BBA surfacing; this partly explains the reducing friction value as the rubber deposit building up as illustrated in Figure 4. In any case all friction values remain exceeded the DOL.

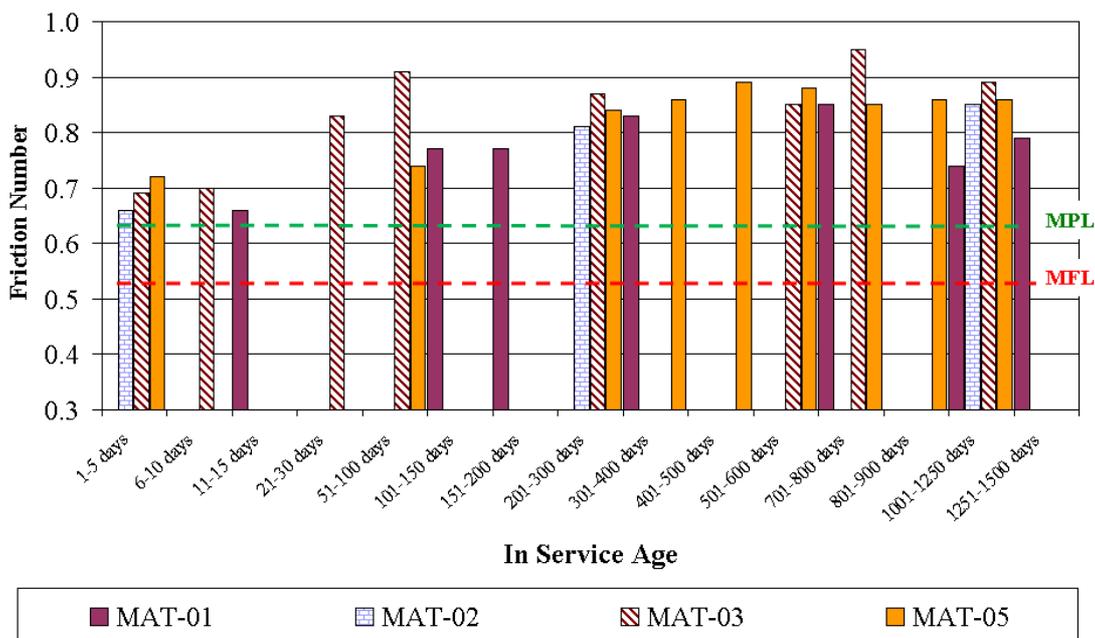
Figure 3 - In Service Friction Values for Grooved BBA

Figure 3 demonstrated that the surface friction increases with age and remains significantly above the MFL even after 4 years in service. Rubber removal would have been carried out when the friction level was approaching MFL, therefore from the financial

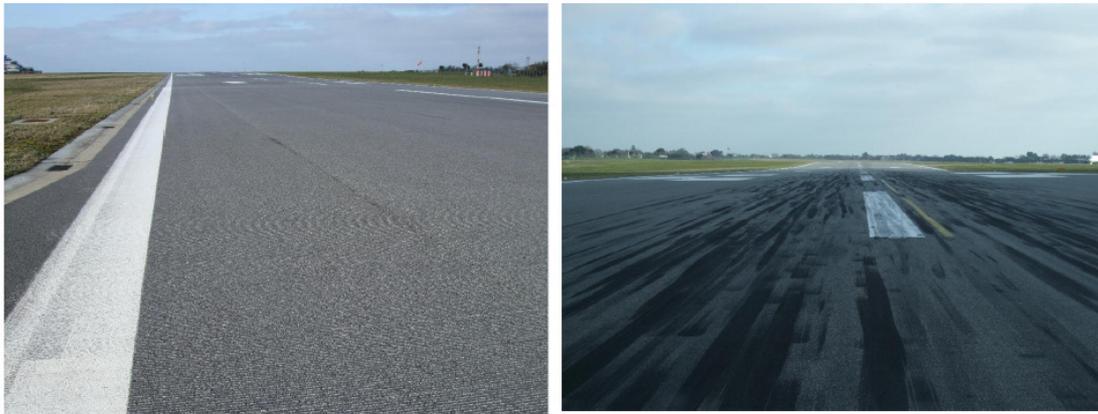
(a) Surface area generally in good condition (b) Localised rubber deposits

Figure 4 - Surface Appearance after 3 years in Service

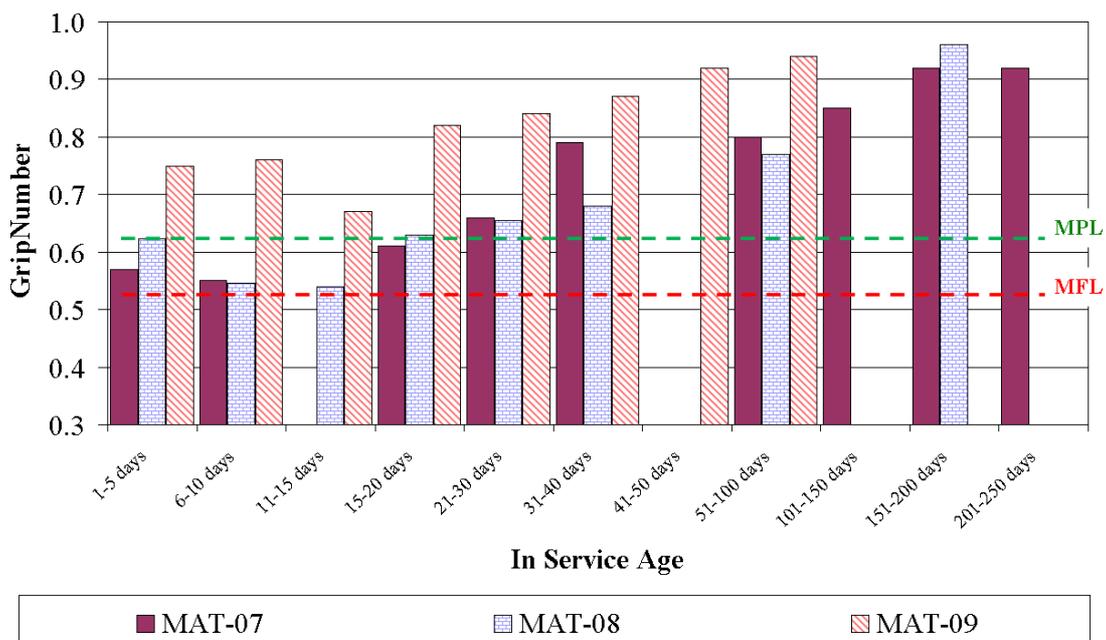
Figure 5 – In Service Friction Values for All BBA (ungrooved) to Date

As previously stated, three UK mainland airports have adopted ungrooved BBA on their runways. The work was completed by Colas with satisfactory wet friction values of the surface course since the opening of these runways to date; a summary is presented in Figure 5. The wet friction values have always been above the MFL immediately after laying. The general trend shows a steady increase in friction value with time and for these three runways, the DOL was achievable within the first 30 days from laying. These results further demonstrate that these ungrooved BBA materials have provided very good wet friction values since the early days and may be regarded as a sound alternative to grooved MA as runway surface course.

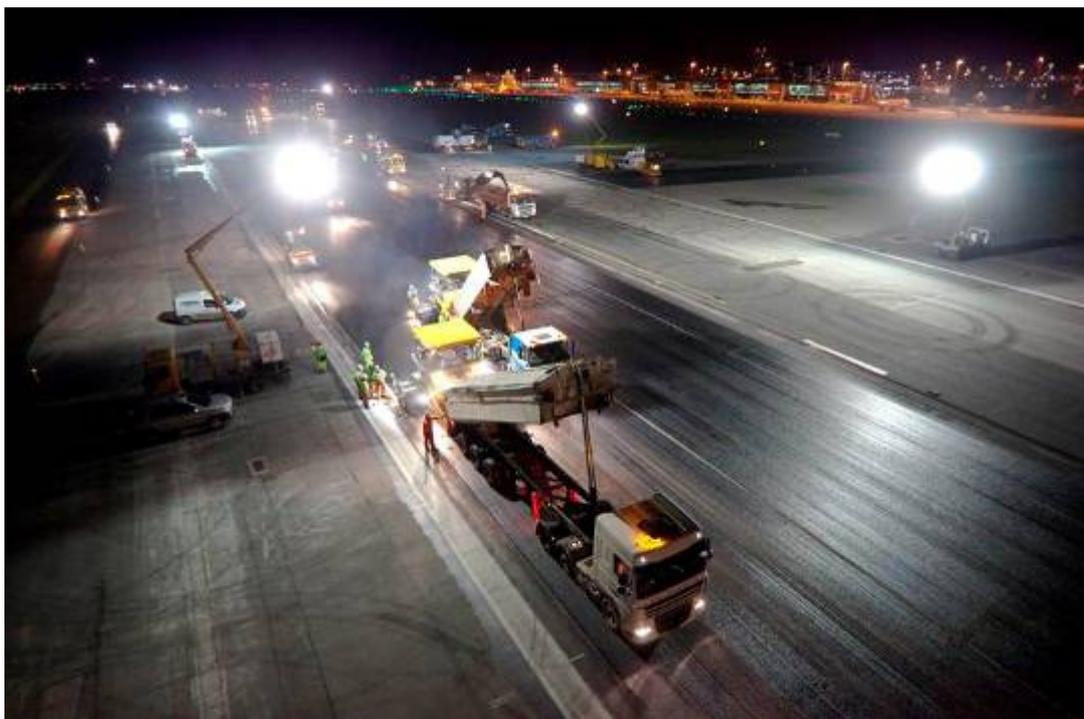
Figure 6 – Laying and compaction of BBA surface course at Manchester Airport (Courtesy of Costain) [11]

The database of BBA performance has been continuously developed for those UK airports where it is in service. A number of airport owners, including MAG, have carried out trials of ungrooved BBA and subsequently adopted this material for their runways. There was also a common agreement regarding the potential financial benefit by adopting this surface course. This has been proven through the ease and speed of laying, the less demanding mix design, better strength (it can be laid as thick layer), maintenance requirements (less onerous) and durability (longer life). The laying operation is illustrated in Figure 6.

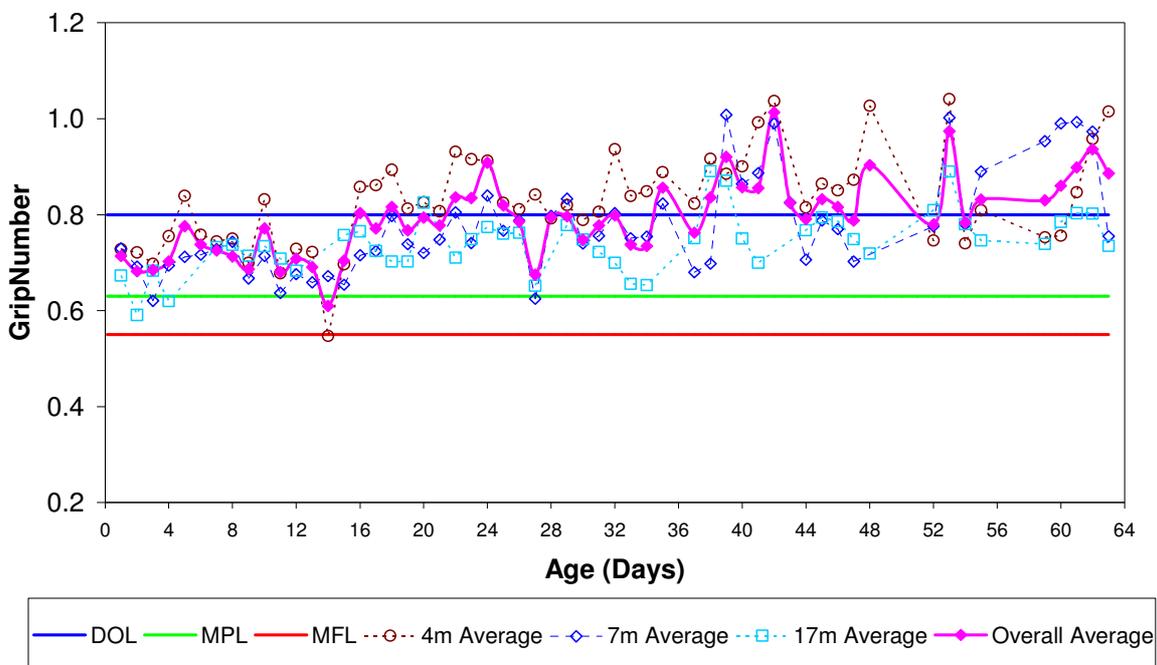
Figure 7 – The Lowest Minimum 100m Rolling Average Friction at 4m, 7m and 17m Offsets [11]

The above results demonstrate rather similar trends as those found on the grooved BBA where the initial friction values exceeded both the MFL and MPL, followed by gradual

value increases with age, as the binder coating the aggregate at the surface has been rubbed off by aircraft trafficking, revealing the microtexture and macrotexture of the surfacing material. As shown by the line for the overall average of the lowest mean 100m rolling average friction values (the 'pink curve'), the DOL was exceeded within the first 18 days. Whilst the general trend in Figure 7 shows a steady increase in friction value with time however, prior to the start of the resurfacing works there were some concerns within MAG about the possibility of the friction falling below the MFL of 0.55 and the impact this would have on operations, particularly in relation to consequential restrictions that would be placed on aircraft take-off weights. Hence, in order to prevent this situation from happening MAG set a minimum 'trigger' friction value of 0.6, below which remedial action to improve the friction level would be considered if it were found that any significant area had fallen below this level.
