**VIRGINIA POLYTECHNIC INSTITUTE
AND STATE UNIVERSITY**

**THE EFFECT OF POWDER ACTUATED FASTENERS ON THE SEISMIC
PERFORMANCE OF PROTECTED ZONES IN STEEL MOMENT FRAMES**

Report No. CE/VPI-ST-13/05

July 2013

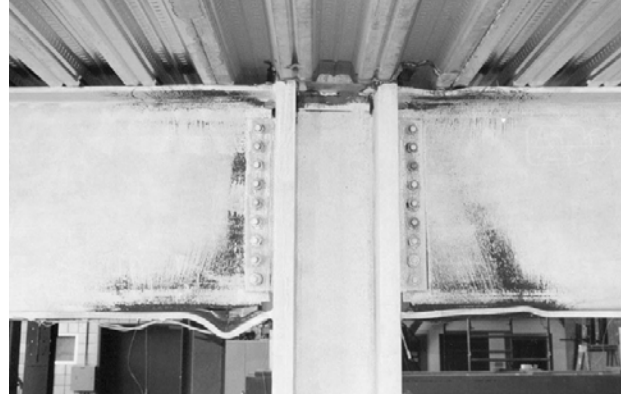
Figure 1.2 - Picture of Beam-to-Column Connection Test with Welded Shear Studs and Composite Floor Slab After Testing (Picture from Uang et al. 2000).

However, the test specimen that experienced fracture at the shear stud was one out of a number of tests on beam-to-column connections with composite slabs and welded shear studs in the protected zone and none of the other specimens experienced a fracture originating at the shear stud (e.g. Uang et al. 2000, Leon et al. 1998, Hajjar et al. 1998, Chen and Chao 2001, and Cifjan et al. 2000). A picture of one of these

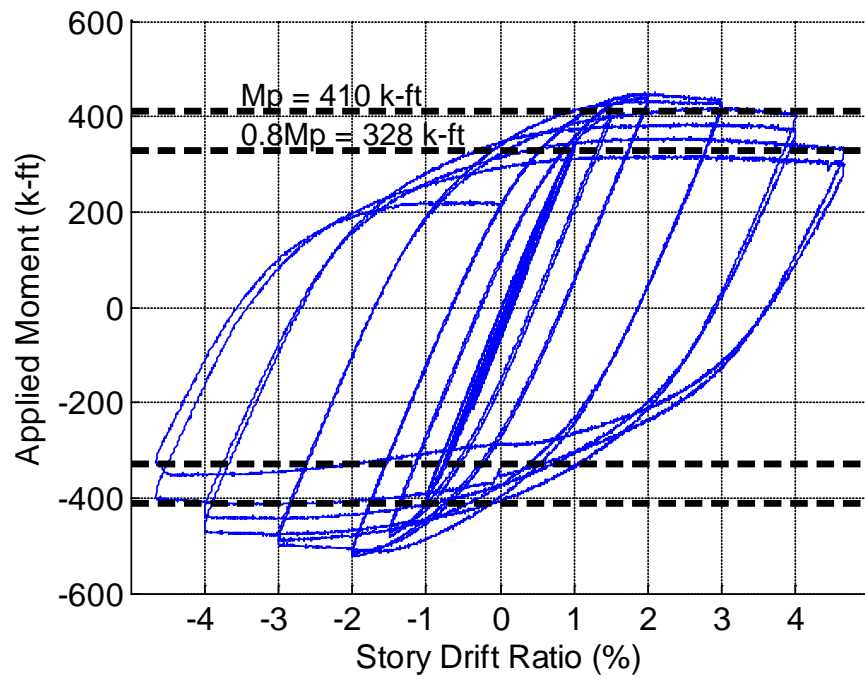
Figure 3.1 - Load-Deformation Response for Specimen 1 (W24x62 with RBS but No Fasteners)

All W24x62 specimens with RBS satisfied the qualification criteria. Furthermore, they all completed at least one full cycle of 4.7% story drift before experiencing significant moment capacity loss due to fracture. The progression of limit states was similar for all specimens in this group starting with significant yielding in the extreme fibers at the reduced section, spread of plasticity, local buckling of the flanges in association with out-of-plane buckling of the web, crack initiation typically at the flange tips on the inside face of the local buckle, and fracture propagation through an entire flange. All specimens experienced some amount of fracturing at the minimum flange section. In all cases, the fractures initiated at the edge of the flange on the inside of a local buckle and propagated toward the center of the beam flange.

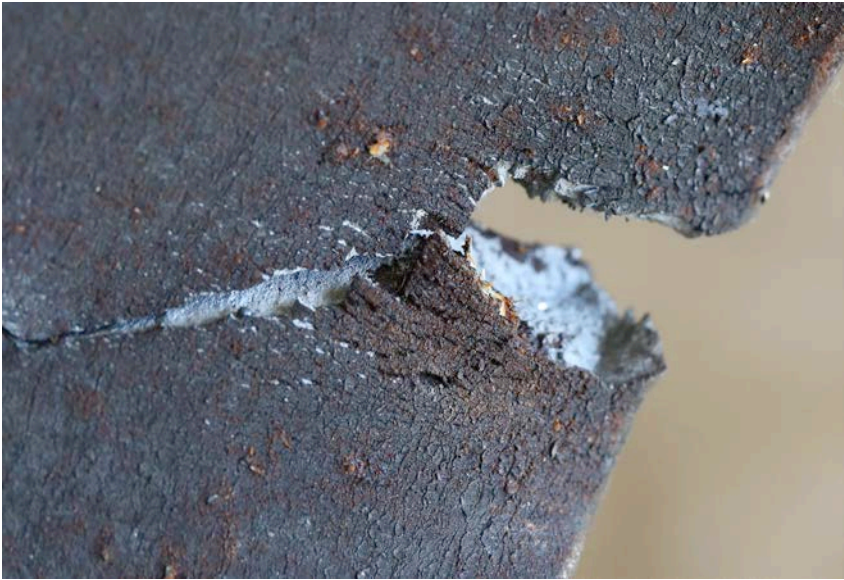
Figure 3.6 – Flange Surface of Fracture Propagation

Although fracture initiation occurred at multiple locations at the bottom flange, fracture propagated primarily from one side leading to brittle fracture through half of the flange width and stopping at the web as shown in Figure 3.6.

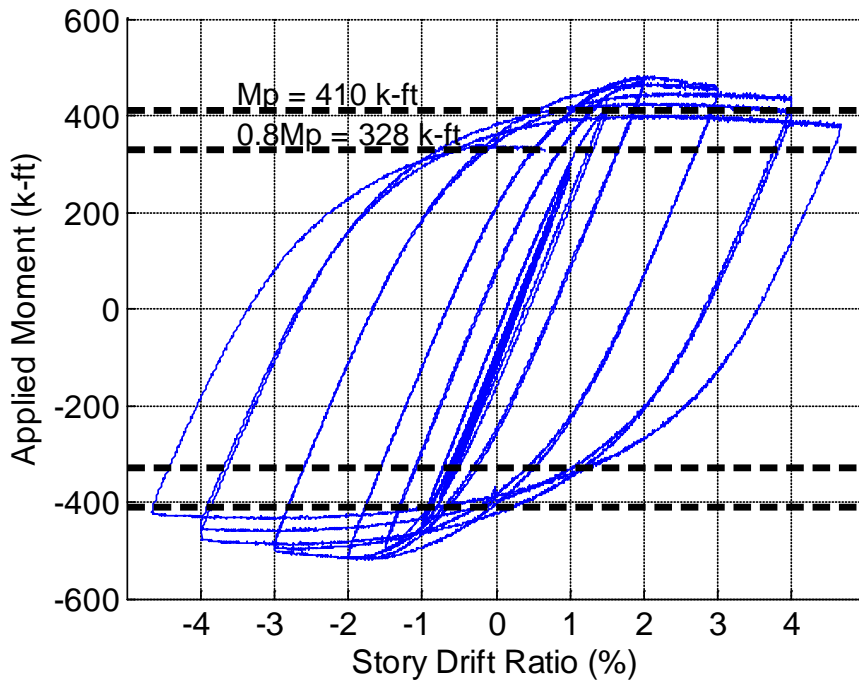
Figure 3.7 - Load Deformation Response for Specimen 2 (W24x62 with RBS and PAF at 12 in.)

Specimen 2 varied from Specimen 1 in the inclusion of four PAFs spaced at 12 in. along the center of the top flange. Figure 3.7 shows the load-deformation behavior of Specimen 2 which also demonstrates that the qualification criteria was satisfied. Pictures of the specimen before testing and prior to fracture are shown in Figure 3.8 and Figure 3.9.

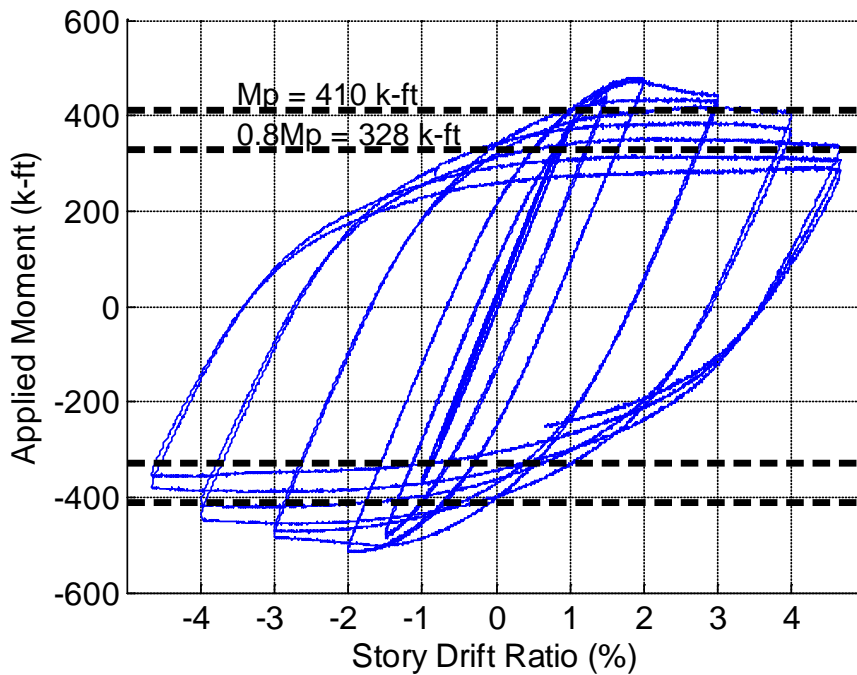
Figure 3.15 – Load-Deformation Response for Specimen 5 (W24x62 with RBS and Puddle Welds)

Specimen 5 included puddle welds on the top flange at 12 in. spacing. Figure 3.15 shows the load-deformation behavior for Specimen 5. Figure 3.15 shows that the qualification criteria was satisfied. Pictures of the specimen before testing and prior to fracture are shown in Figure 3.16 and Figure 3.17.

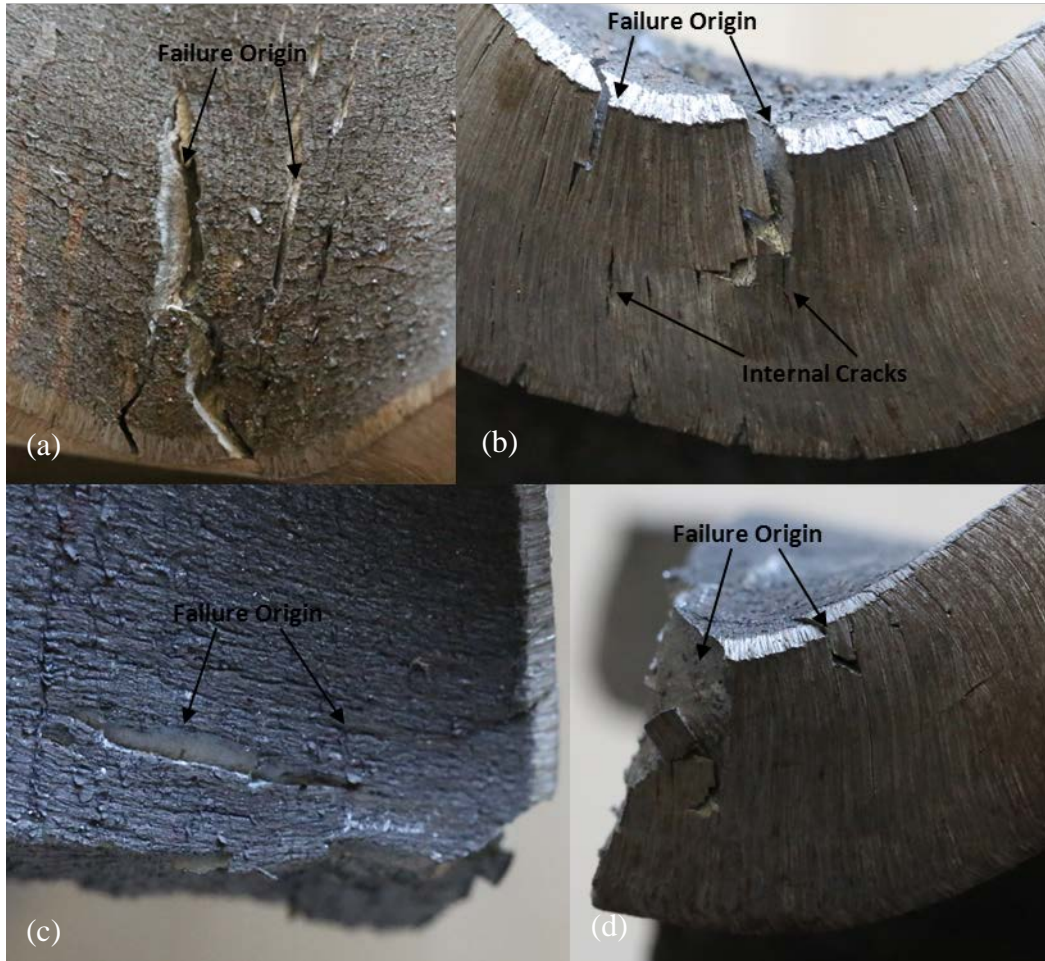
Figure 3.19 – Visible Notches and Internal Cracking at the Flange Tip and at the Flange Surface near the Flange Tip at Two Different Locations. (a) Surface View (b) and Side View of the Bottom Flange with Crack Initiation. (c) Surface View (d) and Side View of the Bottom Flange near the Fractured Area.

Crack initiation occurred at the center of the reduced beam section at different locations of the bottom flange away from the puddle welds during the third cycle at 4.7% story drift. There were visible notches and internal cracking at the flange tip and at the flange surface near the flange tip, and the edge of the flange exhibited multiple failure origins as shown in Figure 3.19. It is expected that these cracks were associated with the compressive plastic deformation, since they are at the compression side of the flange local buckle. Another factor for the crack initiation at the flange tips can be related to surface scratches caused by cutting and handling the RBS before testing since they were observed only at one side of the bottom flange.

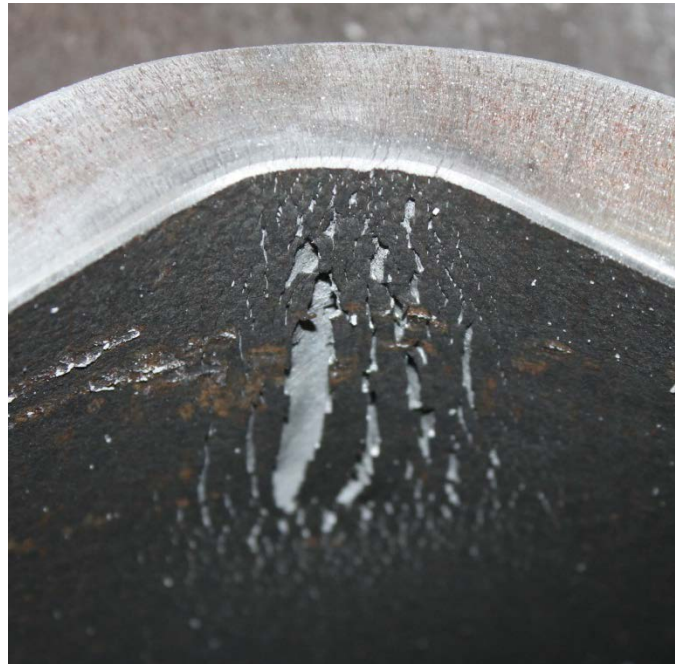
Figure 3.35 – Crack Initiation on Surface of Bottom Flange for Specimen 7 (W36x150 with RBS and No Fasteners)

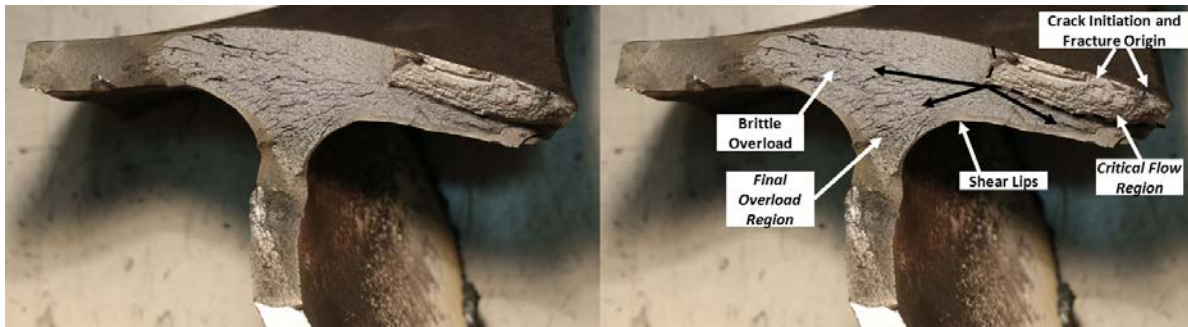
Figure 3.38 – Fatigue Crack Propagation Starting with Crack Initiation Followed by the Critical Flow and Final Overload Regions

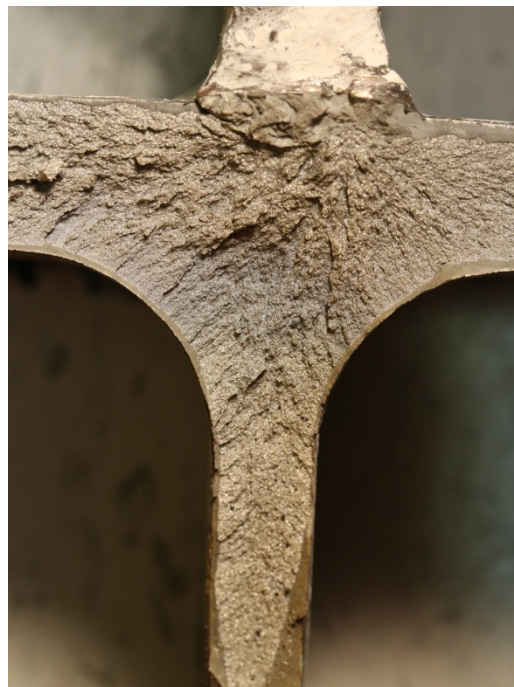
Figure 3.44 – Close-Up of Chevron Markings at the Web and Flange Pointing Back to the Fracture Origin at the Weld Metal of the Stiffener Due to the Brittle Overload Fracture Mode

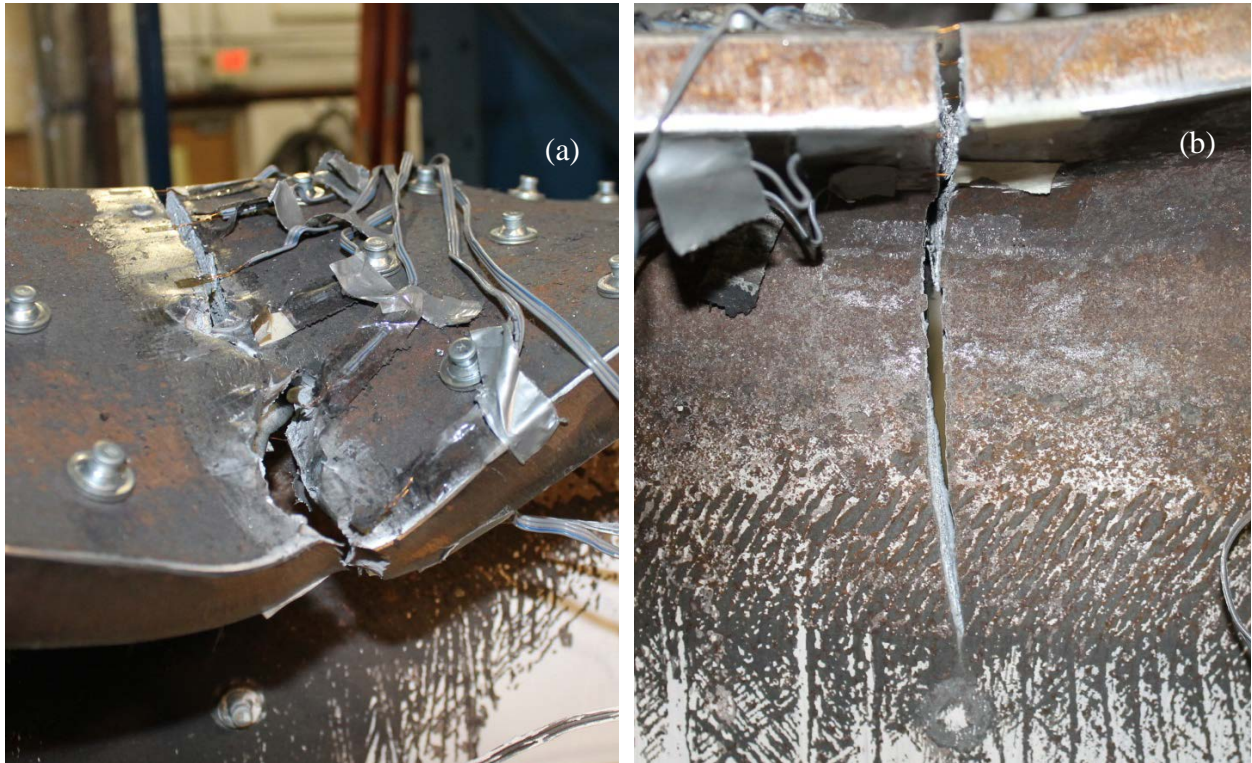
Figure 3.49 – Pictures of Final Top Flange Fracture for Specimen 9 (W36x150 with RBS and Grid of PAF)

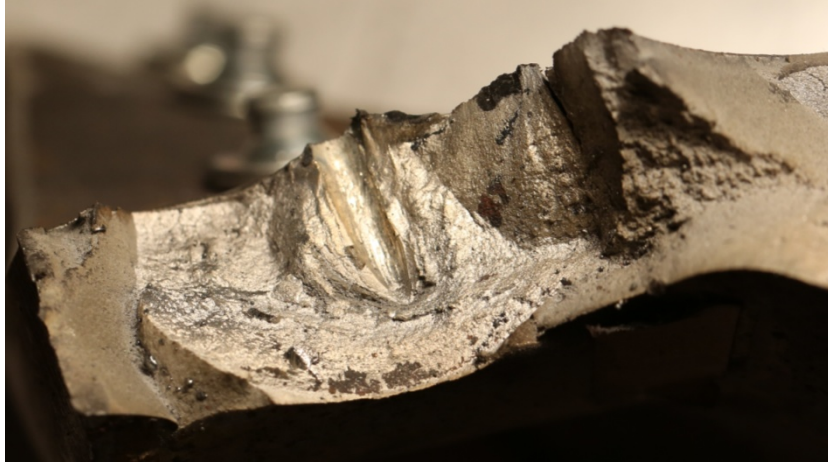
Figure 3.51 – Close-Up of Fracture Initiation Location at Outer PAF

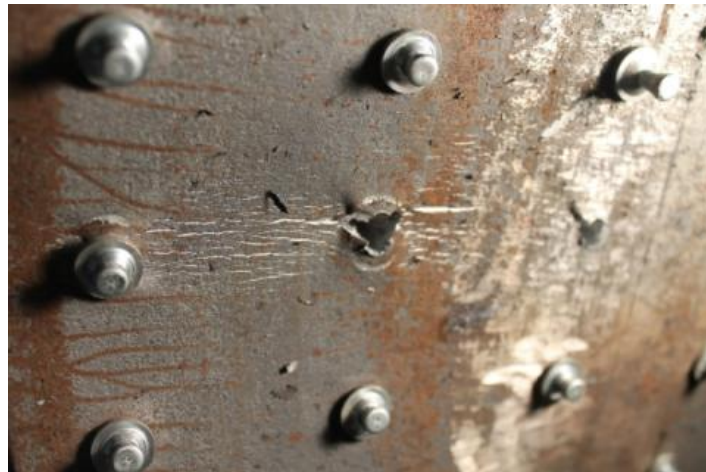
Figure 3.62 – Cracks Forming on the Surface of the Bottom Flange for Specimen 12 (W36x150 with no RBS and Grid of PAF)

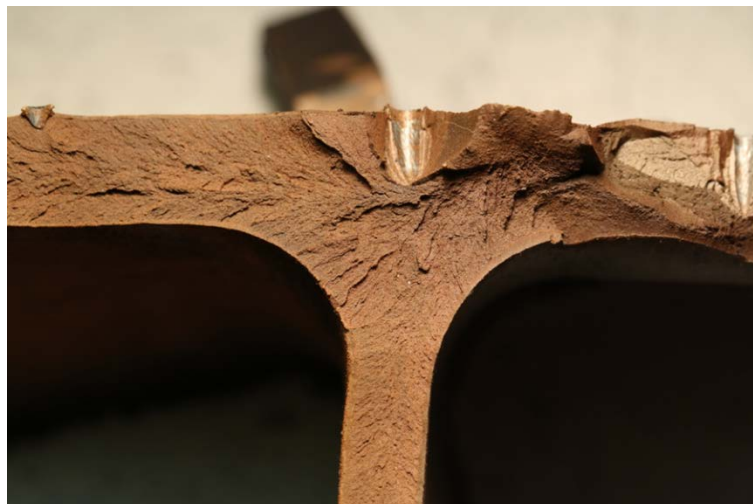
Figure 3.66 – Close-Up of Chevron Markings at the Web and Flange Pointing Back to the Fracture Origin at the PAF Due to the Brittle Overload Fracture Mode

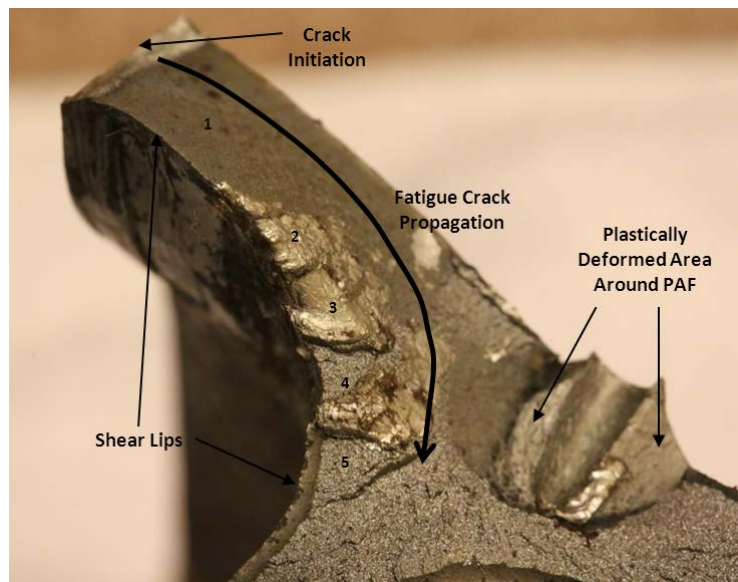
Figure 5.2 – Striation locations and fatigue crack propagation
