Stress-induced Damage and Post-fire Response of Aluminum Alloys

Dissertation submitted to the faculty of the Virginia Polytechnic Institute and State University in partial fulfillment of the requirements for the degree of

Doctor of Philosophy
in
Engineering Mechanics

Keywords: Stress-induced damage; Cavitation; Grain Elongation; Dynamic Recrystallization; Residual Strength; Fire Response

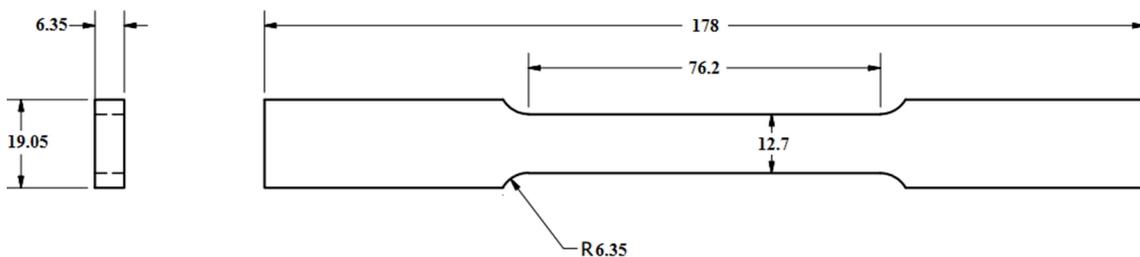
Fig. 1 Tensile test specimen geometry (mm)

The test sample geometry, illustrated in Fig. 1, was selected based on the ASTM standard E21-09. Specimens were machined from the 6.35mm thick as-received plate to dog-bone geometry, as shown in Fig. 1. The overall length of test samples was 178mm with the longitudinal axis of the specimen aligned with the material rolling direction. The sample gage length is 76.2mm with uniform width of 12.7mm. All test samples of each alloy were machined from the same aluminum sheet to keep uniform material properties.

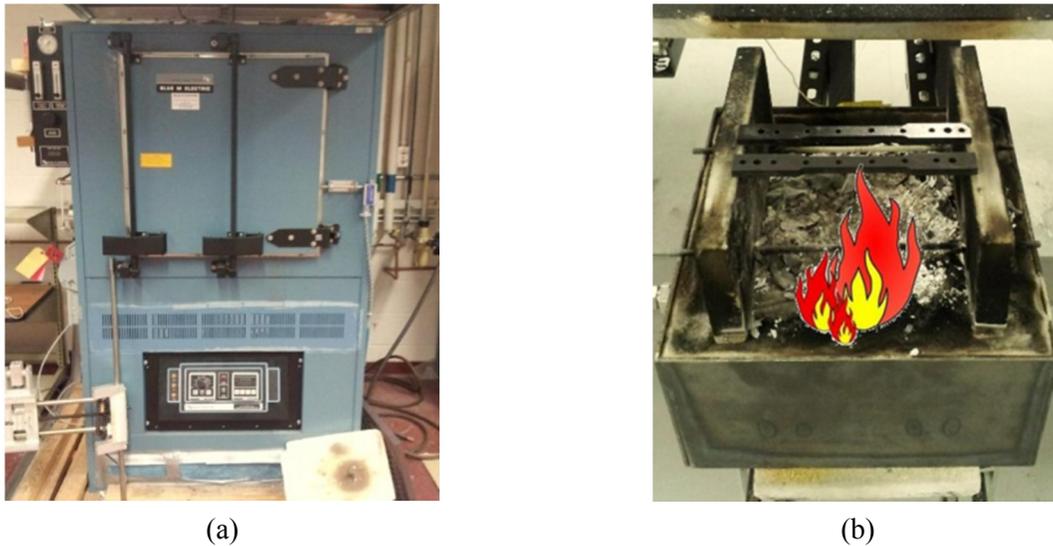
Fig. 2. Heating equipment (a) Blue M Furnace (b) Sand Burner

Specimens were heated from room temperature to pre-selected temperatures (200°C, 300°C, 400°C and 500°C) to simulate fire exposure. Once the target temperature was reached, samples were cooled down immediately to room temperature. Uniaxial tensile tests were then conducted to study the post-fire tensile behavior and residual work hardening rate at various temperatures. Previous work revealed that 400°C was a critical temperature at which grain recrystallization was completed in Al5083 and equilibrium β phase precipitate formation in Al6061; the lowest post-fire yield and ultimate strengths occurred after 400°C exposure [5, 16]. Thus 400°C was selected to study the effect of different heat treatment methods and aging times on residual mechanical properties for Al5083 and Al6061.

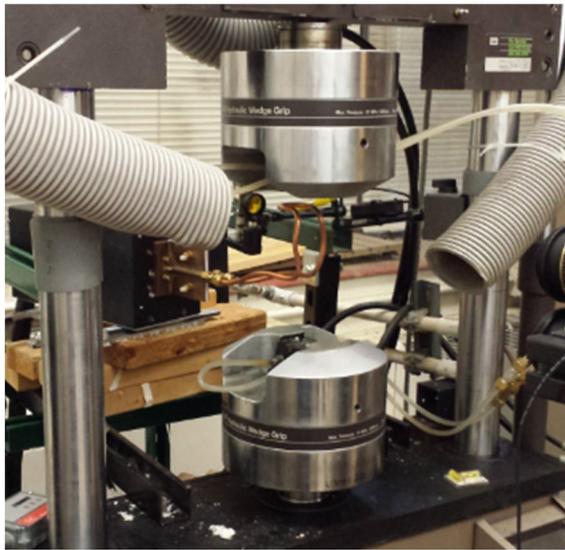
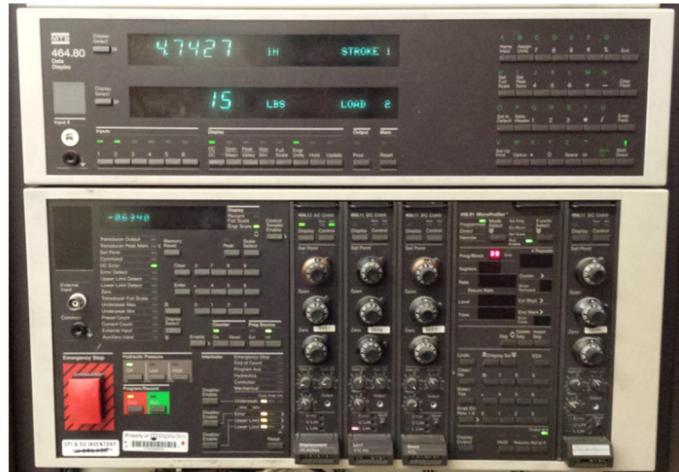
Fig. 4 (a) MTS 880 Load Frame (b) MTS Micro Profiler

tensile load was applied until failure. Tests were performed using displacement control at a rate of 5 mm/min. Sample strain was measured using a MTS 634.11E-54 type extensometer with 1 inch gage length and 50% calibration extension. A Vishay 2310 Signal Conditioning Amplifier is used for convert the voltage in the extensometer to strain signal. Data acquisition was performed through LabView program to record the real time load, stroke, strain and time data during the tensile tests.

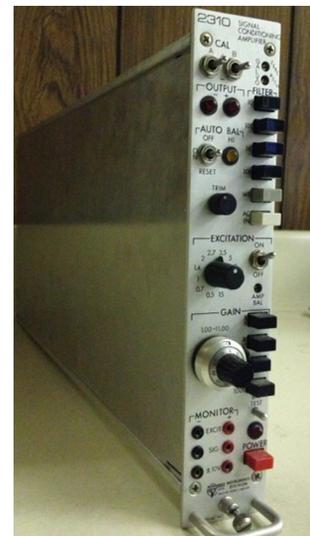
Fig. 5. (a) MTS 634.11E-54 extensometer (b) Vishay 2310 Signal Conditioning Amplifier

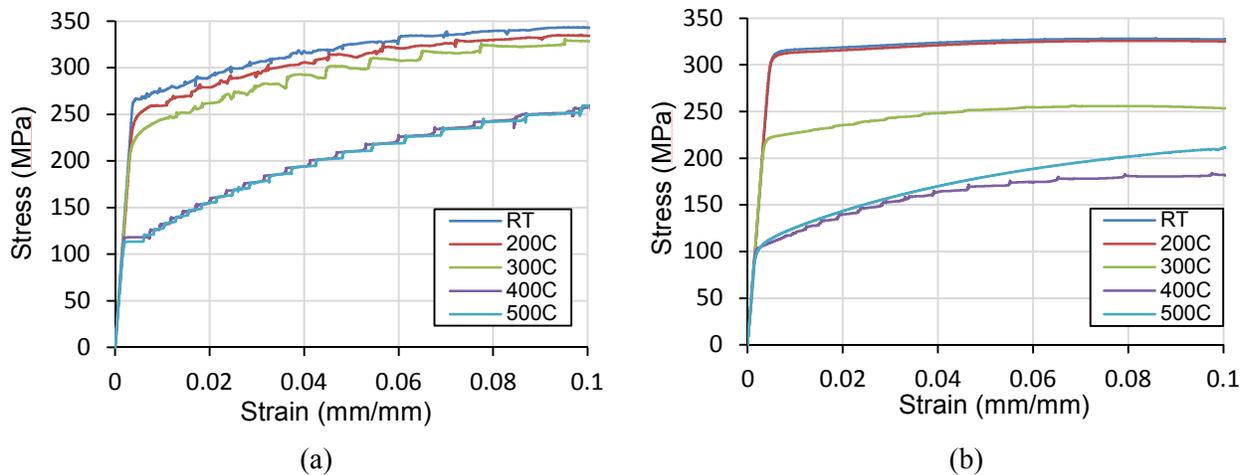
Fig. 6. Post-fire stress-strain relations (a) 5083-H116 (b) 6061-T651

Post-fire stress-strain relations at different exposure temperatures for both alloys are summarized in Fig. 6. For comparison, the as-received stress-strain curves for specimens that have not been heat treated are also plotted. There are some oscillations shown in the plastic region of the Al5083-H116 stress-strain curves, which is attributed to the interaction of dislocations with solute atoms; the behavior is called Portevin–Le Chatelier (PLC) effect. This phenomenon is also known as dynamic strain aging (DSA). The DSA causes spatially inhomogeneous plastic flow over a range of applied strain. When the exposure temperature increases, the oscillations in the plastic region are decreased. For Al6061-T651, only the tensile behavior for samples previously exposed to high temperatures (400°C and 500°C) exhibits similar dynamic strain aging. This behavior is due to the large β precipitate formation in Al6061 for thermal exposure above 400°C [22]. The interaction between β precipitates and dislocations cause the serrated hardening zone in the post-fire tensile stress-strain curves for exposures above 400°C.

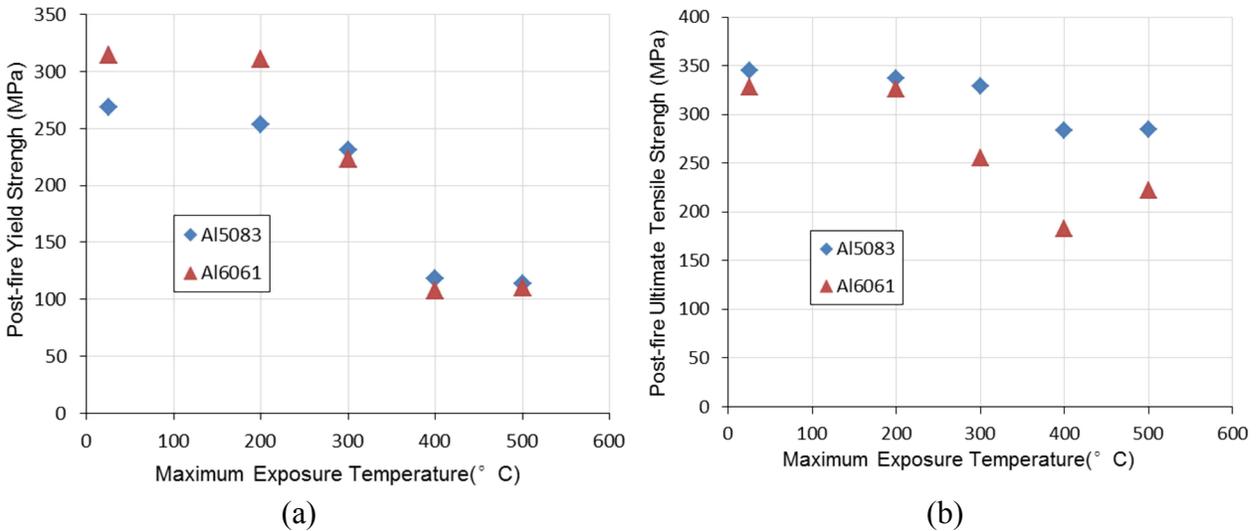
Fig. 7. Post-fire mechanical properties (a) 5083-H116 (b) 6061-T651

in Fig. 7. Thus in the subsequent study, 400°C is selected to study the impact of aging time, heating and cooling rate in the post-fire mechanical properties for both alloy.

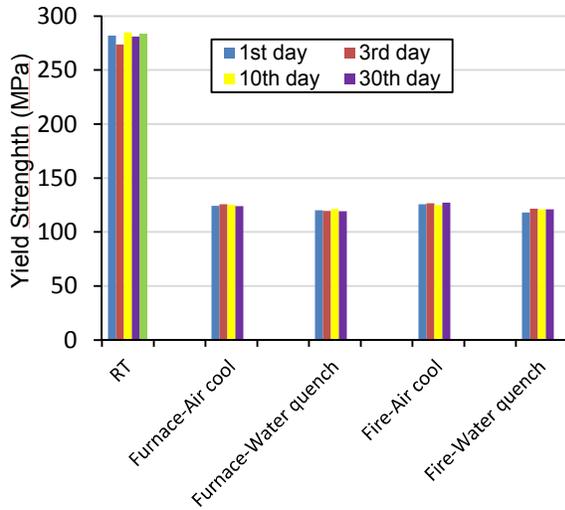
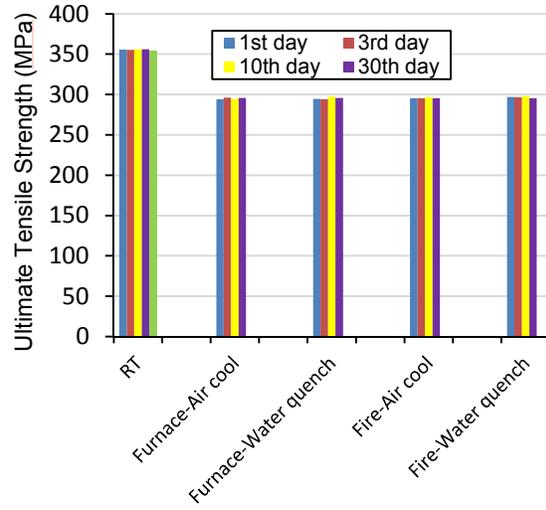
Fig. 8. Post-fire (a) Yield strength and (b) Ultimate tensile strength for 5083-H116

Test results from different heating and cooling methods, aging time are all listed in Fig. 8 and Fig. 9. Compared to as-received strength, the post-fire strength shows significant decrease for both alloys after 400°C exposure. For the post-fire strength after fire damage and cooling back to ambient temperature, the Al5083-H116 data shows similar values for different heating and cooling methods, which means the post fire strength of Al5083 is insensitive to heating rate and cooling rate. In addition, within the same set of columns, the bars also exhibit almost the same values for different aging time, which indicate the aging time does not affect the post-fire mechanical properties. Al6061-T651 data shows similar trends for cooling methods and aging time. However, different heating methods cause dramatic changes in post-fire yield strength and ultimate tensile strength: the furnace heated samples had a post-fire yield strength 80% lower than the as-received; while the fire exposure data decrease was 60% compared to the as received test specimen. For post-fire ultimate tensile strength, furnace heating samples had a 55% decrease in properties while fire exposure samples decrease 45% of the as received strength. These results indicate that the post-fire yield strength and ultimate tensile strength of Al5083-H116 are not sensitive to heating rate, cooling rate and aging time; for Al6061-T651 samples, they are not sensitive to the cooling rate and aging time, but sensitive to heating rate.

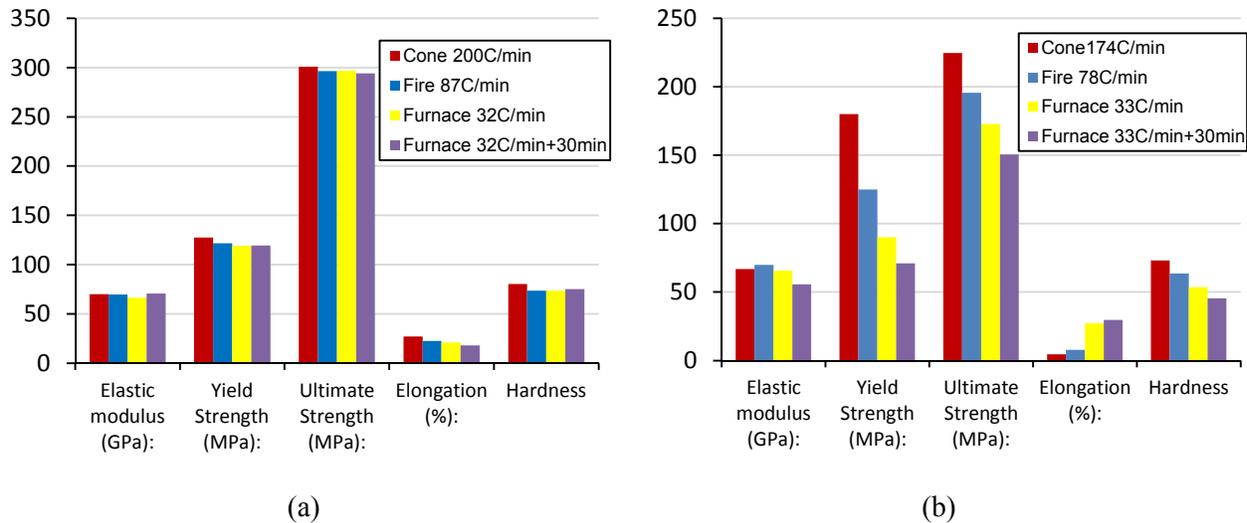
Fig. 10. Heating rate effect on (a) 5083-H116 and (b) 6061-T651

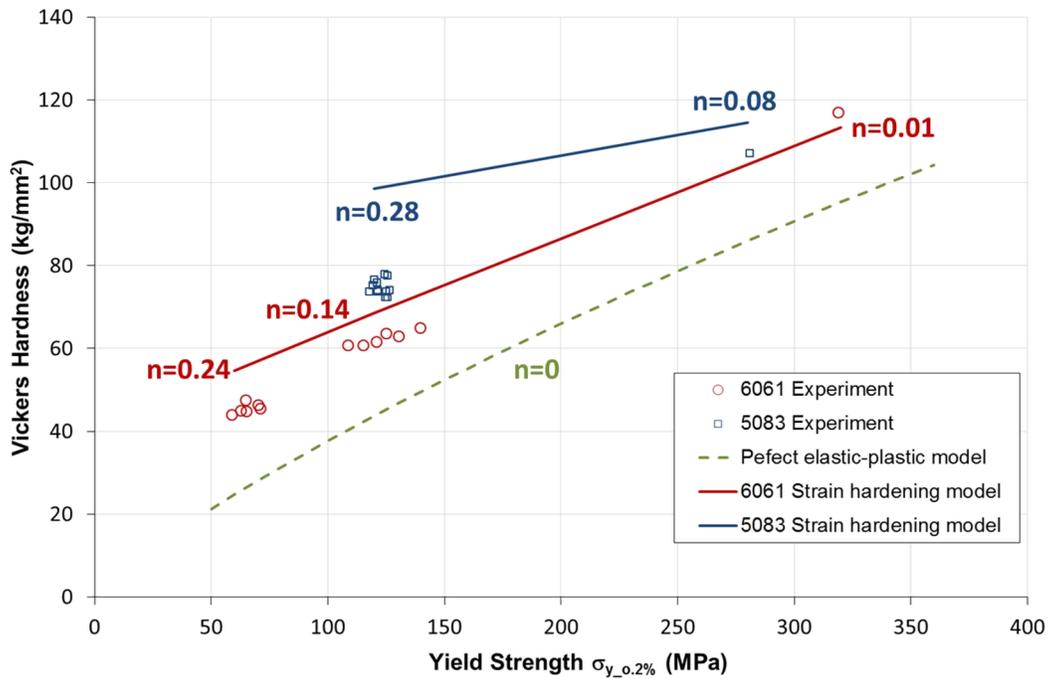
Fig. 11. Vickers hardness correlations with yield strength

simple and convenient test method, Vickers Hardness can be used to estimate the post-fire yield strength and ultimate tensile strength for aluminum alloys after fire exposure.

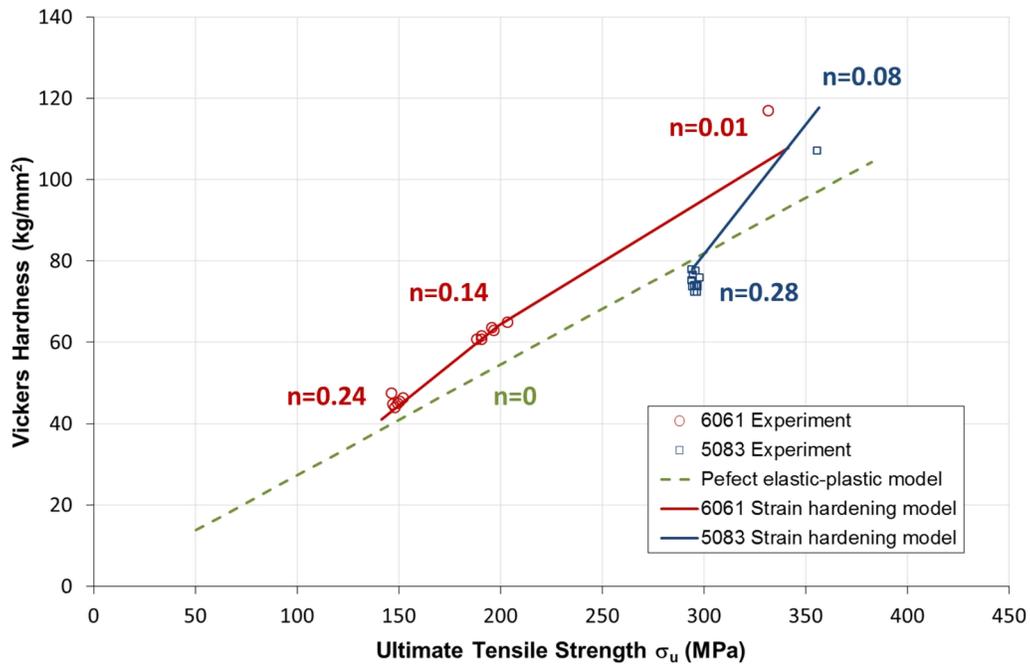
Fig. 12 Vickers hardness correlations with ultimate tensile strength

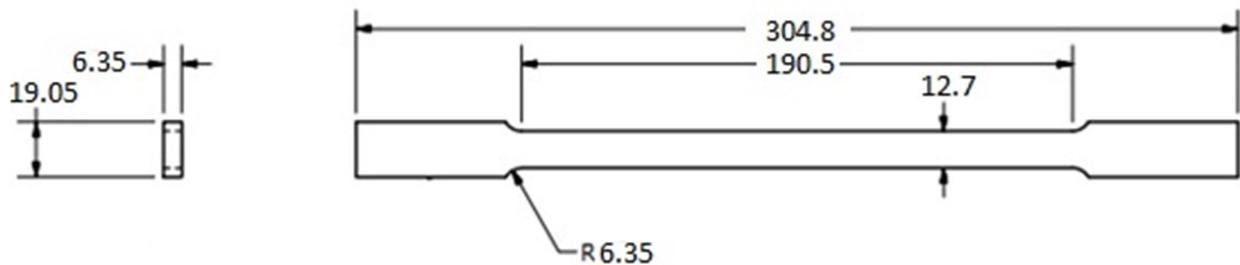
Fig. 13. Tensile test specimen geometry (mm)

The material was supplied by Alcoa in form of 6.35mm inch thick sheets. Test sample geometry was selected based on the ASTM standard E21-09, as illustrated in Fig. 13. Specimens were machined from the as-received plate to dog-bone geometry with the longitudinal axis oriented in the rolling direction. The specimens had an overall length of 304.8mm and uniform thickness of 6.35mm, with a gage length and width of 190.5 and 12.7 mm, respectively. All test samples of each alloy were machined from the same aluminum sheet to keep uniform material properties. Sample geometry is designed by NX Unigraphics software, and then machined using a Tormach PCNC 1100 Mill.

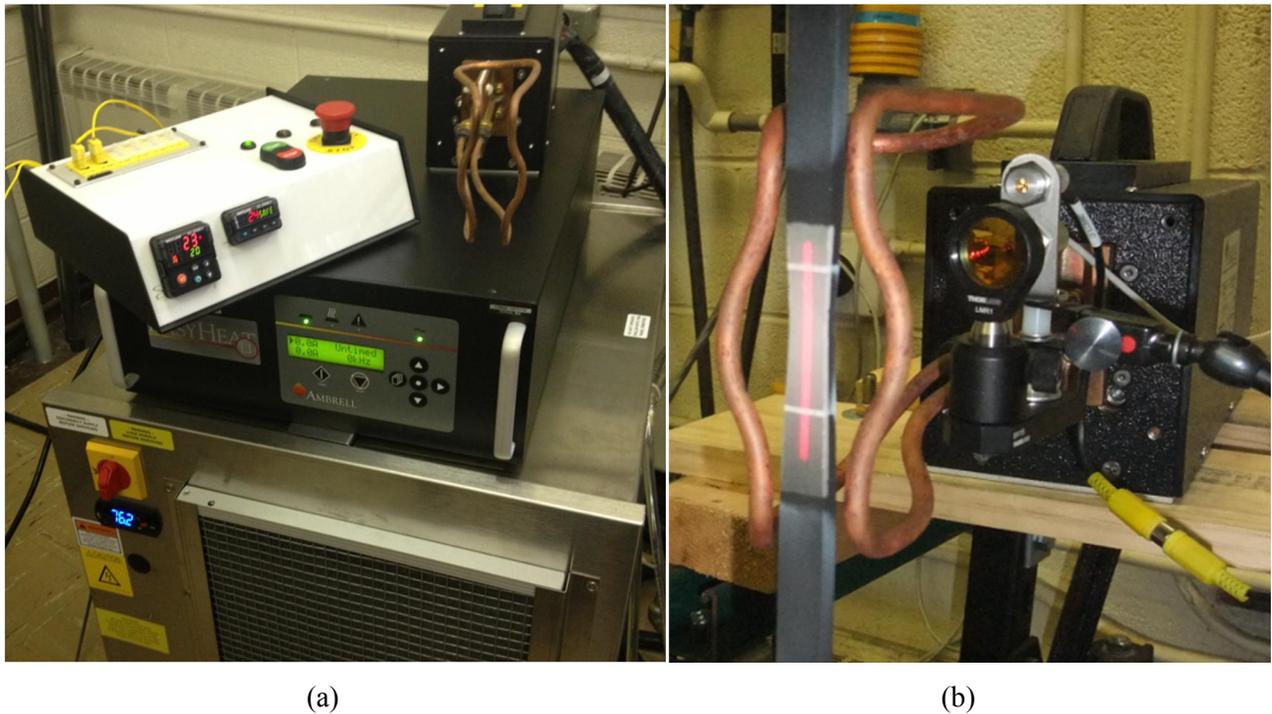
Fig. 14 (a) Ameritherm 5060LI Induction heater (b) Induction heating coil

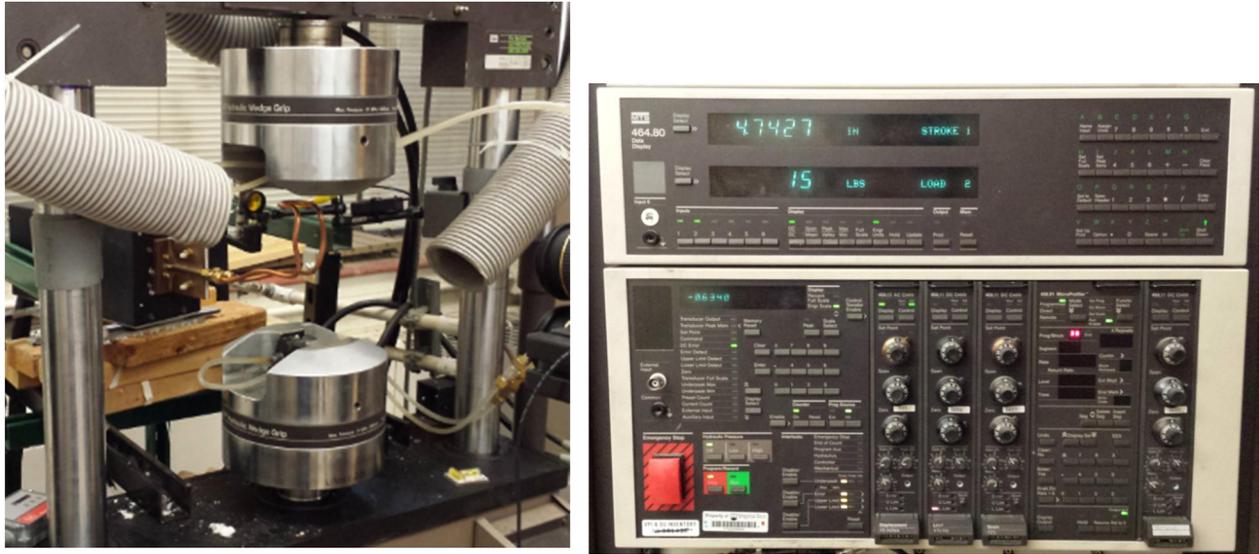
(a) (b)
 Fig. 15 (a) MTS 880 Load Frame (b) MTS Micro Profiler

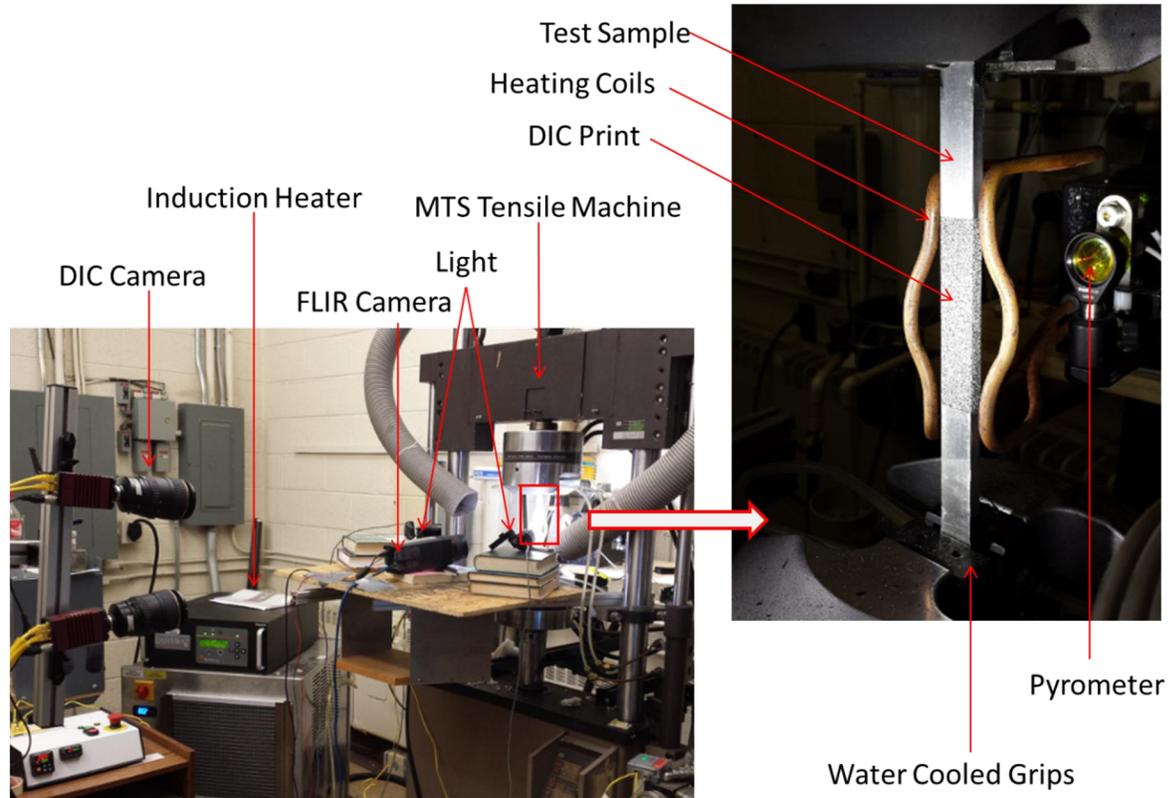
Fig. 16 DIC strain measurement applied in the thermo-mechanical tests

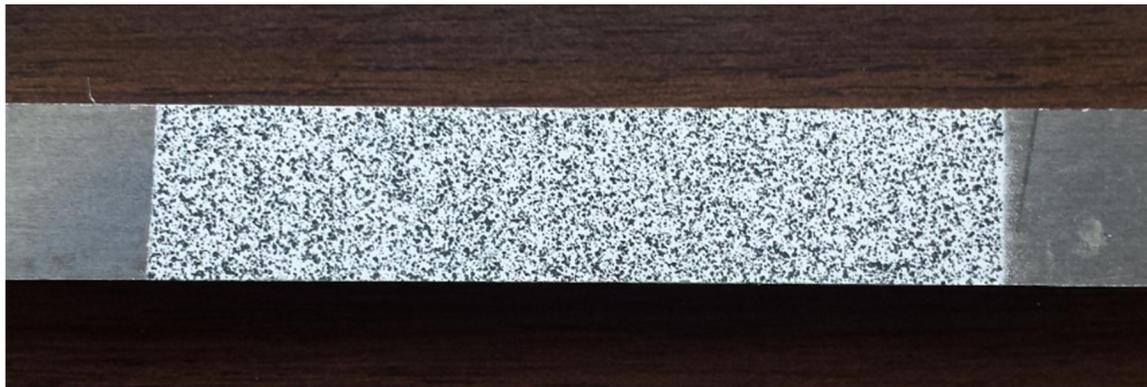
Fig. 17 Paint pattern for DIC test sample

creep strain during thermo-mechanical test. High temperature paint which can remain effective up to 648°C is applied to paint the center region of test sample. The paint pattern of white dots distributed randomly in the black background provides high resolution to the DIC deformation measurement, as shown in Fig. 17.

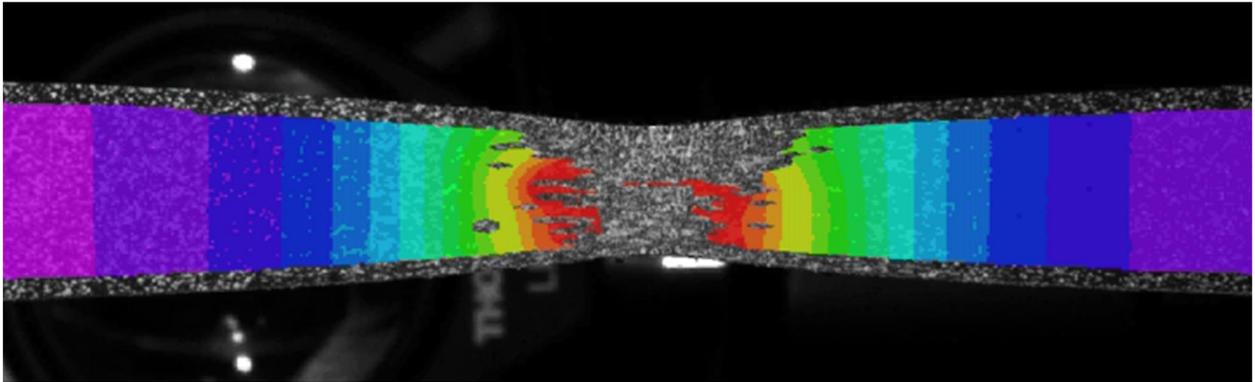
Fig. 18 Strain data lost at high strain for the DIC measurement during creep test

when high temperature paint was applied. Thus the strain information may be lost at the high strain stage before sample failure, as shown in Fig. 18. Another disadvantage is the DIC method cannot provide real-time strain information during the thermo-mechanical tests. All the deformation and strain data are obtained during post-test processing. These two drawbacks prevent the use of DIC to determine the pre-selected strains during creep tests to investigate the stress-induced damage in these experiments.

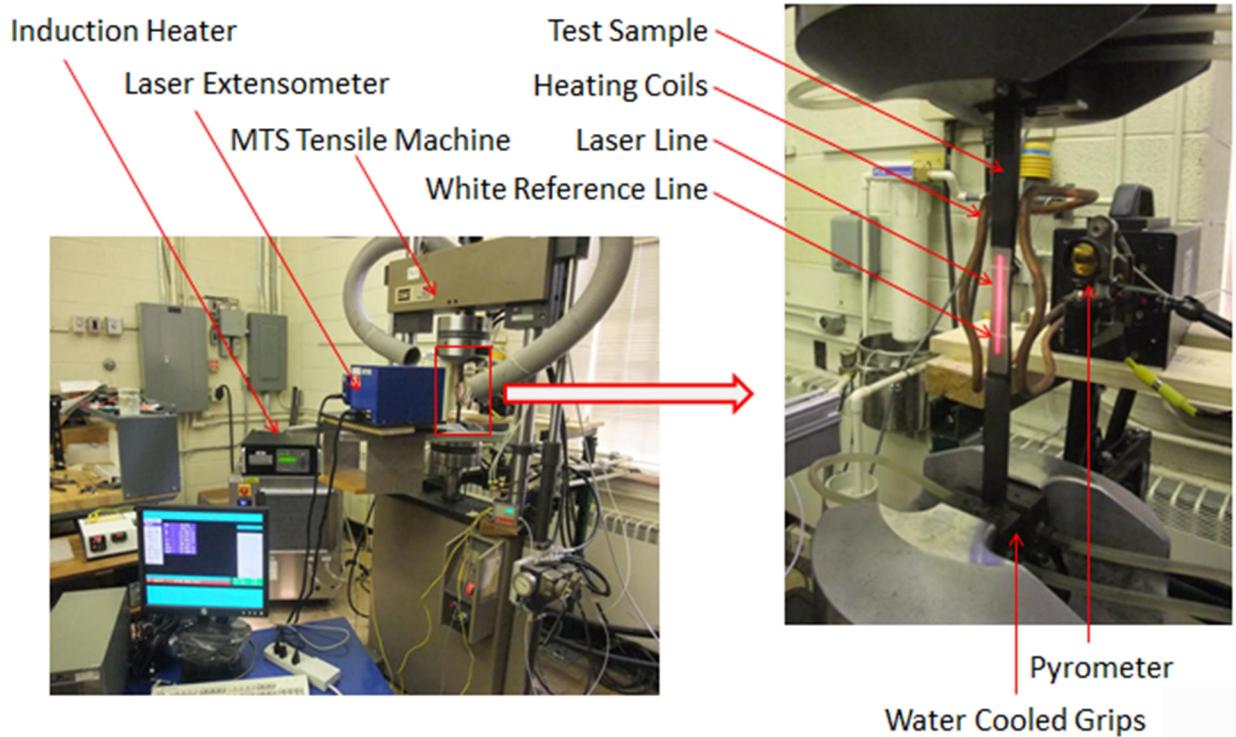
Fig. 19. Laser extensometer strain measurement applied in thermo-mechanical tests

As shown in Fig. 19, a Fiedler Optoelektronik GmbH laser extensometer is applied in the creep tests to measure engineering strain over a 22mm gage length. Real time strain information can be read from the sensor during the creep test; thus suitable strain can be determined to stop the creep and investigate the stress-induced damage at multiple stages.

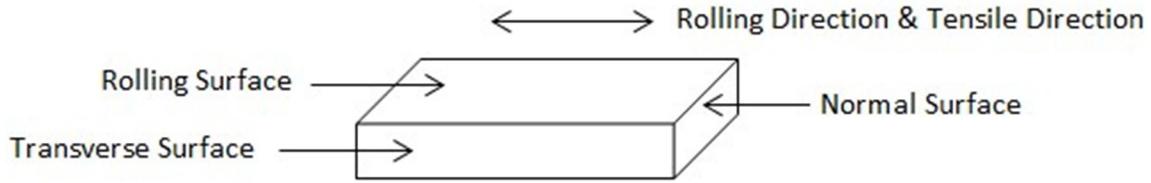
Fig. 20. Sectioning terminology

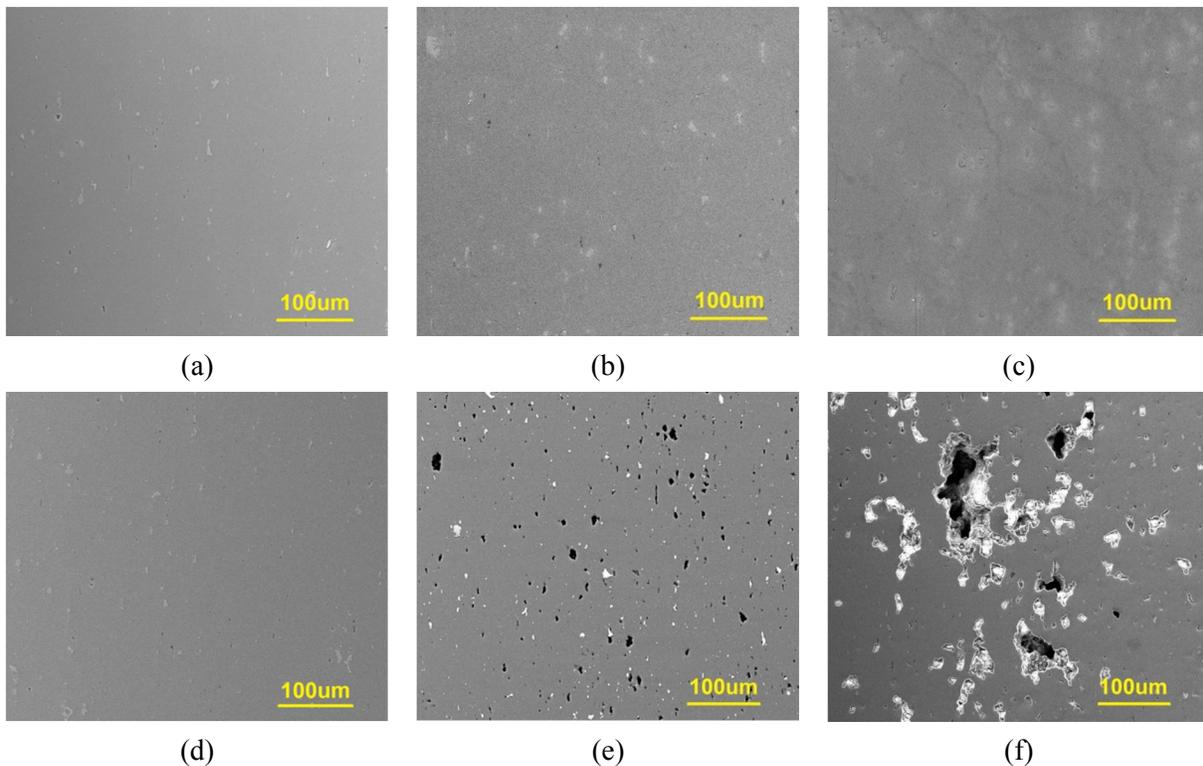
Fig. 21 Cavitation evolution from solely thermal exposure state to thermo-mechanical damaged state (a) 200°C, 2000s, (b) 300°C, 2000s, (c) 400°C, 2000s, (d) 200°C, 140MPa, 2000s, $\epsilon=15\%$, (e) 300°C, 50MPa, 2000s, $\epsilon=100\%$ and (f) 400°C, 17MPa, 2000s, $\epsilon=143\%$

The high temperature properties of Al5083 shows that the material ductility increases with the increase of sample temperature [4]. For the same exposure time, samples at higher temperatures exhibit more plasticity than samples at lower ones. As shown in Fig. 21d, due to the low plastic strain (15%) before sample failure, cavitation has not been developed in the 200°C, 140MPa strained sample yet. However, the material ductility is highly increased after 300°C and 400°C exposure; strains before creep failure are about 136% for 300°C and 150% for 400°C. In Fig. 21e and f, 100% and 143% engineering creep strain samples are shown. The small spherical cavities appear on the 300°C, 100% strained microstructure; while the 400°C, 143% strained sample is close to fracture, large creep strains are produced around the surface of the cavities and the small cavities are driven to coalesce into larger irregular shape and randomly distribute inside the sample [14]. Grain boundary sliding occurs during the large plastic strain also promotes cavities grow into large size.

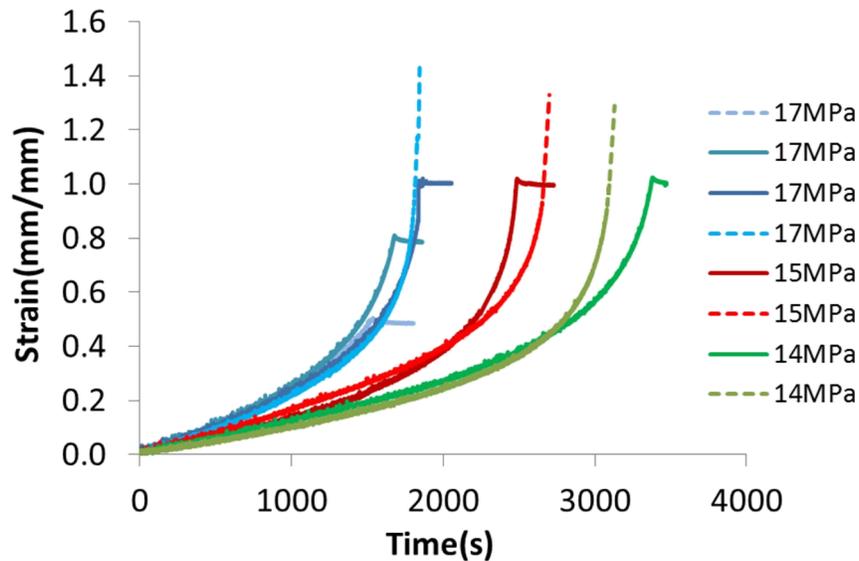
Fig. 22. Creep curves of the fire-load conditioning tests for Al5083 samples

Samples exposed to 400°C temperatures exhibit more cavitation damage than samples exposed to other temperatures. Previous work on the Al5083 alloy revealed that 400°C was a critical temperature at which grain recrystallization was completed, and the lowest post-fire yield and ultimate strengths occurred after 400°C exposure [16]. Thus 400°C was chosen to study the effect of creep stress and strain on microstructural damage in this work. Samples were heated from room temperature to 400°C at a controlled heating rate of 50°C/min. Loads corresponding to an engineering tensile stress of 17MPa, 15MPa, or 14MPa were applied once the sample reached 400°C. Samples were then soaked in constant loading and temperature to achieve specified creep strains. As shown in Fig. 22, the creep tests were interrupted at engineering strains of 50%, 80%, 100%, and 143% for samples subjected to a constant tensile stress of 17 MPa; 100% and 133% axial strain for 15MPa; and 100% and 144% for 14MPa.

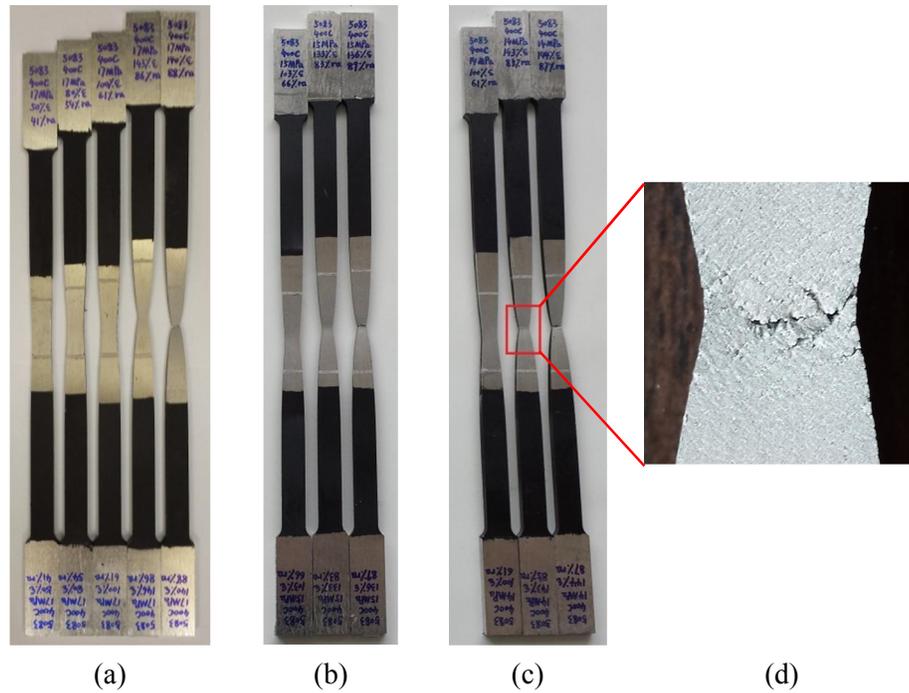
Fig. 23 (a)17MPa, 50%, 80%, 100%, 143% creep strain and fracture samples (b)15MPa, 100%, 133% creep strain and fracture samples (c)14MPa, 100%, 144% creep strain and fracture samples (d) Necking region of just-before-fracture sample

a highly deformed and damaged sample tested at 14MPa. Several cracks are observed on the rolling surface indicating impending failure. Similar cracks are also observed on the neck surface of 17MPa, 143% strain creep sample. These highly damaged samples have similar elongation to the fracture ones shown in the right in Fig. 23 indicating they have reached a state just prior to material failure. For the 15MPa and 133% strain sample, necking is not as severe as those strained to 143% and 144% at 17MPa and 14MPa; no cracking was observed on the sample surface, implying that this sample was approaching failure but had not yet reached the just-before-fracture state.

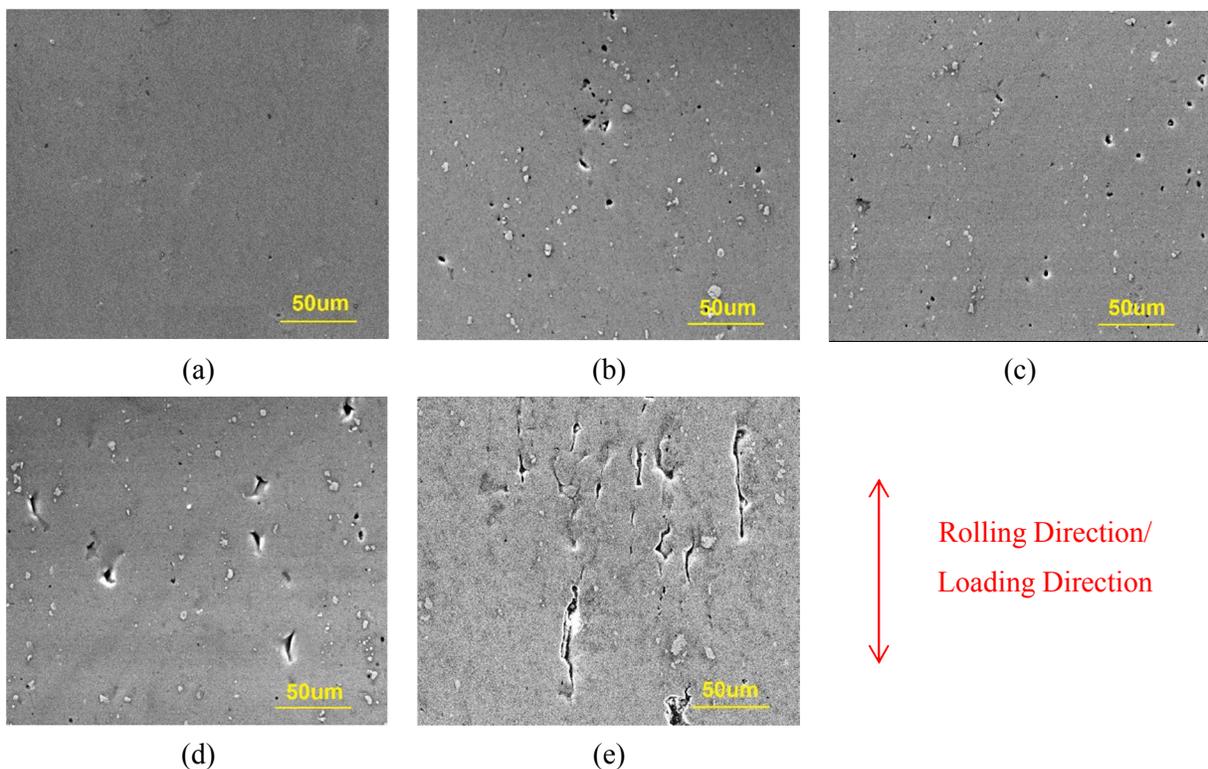
Fig. 24 Cavitation evolution with creep strain for Al5083(SEM, 500x, rolling surface) (a) as-received $\epsilon = 0\%$; and 400°C 17MPa applied stress (b) $\epsilon = 50\%$ (c) $\epsilon = 80\%$ (d) $\epsilon = 100\%$ (e) $\epsilon = 143\%$

Strain localization and necking occurs with the increasing plastic strain. Severe necking coincides with stress-induced damage accumulation in the sample; one of the features is cavity growth. For creep microstructures at strains lower than 100%, the cavities appear mostly spherical shape, randomly distributed on the inner sample surface. The cavity sizes at these strains are relatively small and similar. As the creep strain exceeds 100%, the cavities begin to grow and agglomerate; more cavities with elongated shapes appear in the microstructure. This indicates the cavities are stretched and coalesce at high creep strains. After the sample deforms beyond 100% creep strain and approaches failure, more spherical cavities were stretched and coalesce into crack-like cylindrical cavities parallel to the rolling/loading direction with lengths ranging from 50 μ m-150 μ m and aspect ratios larger than 5.

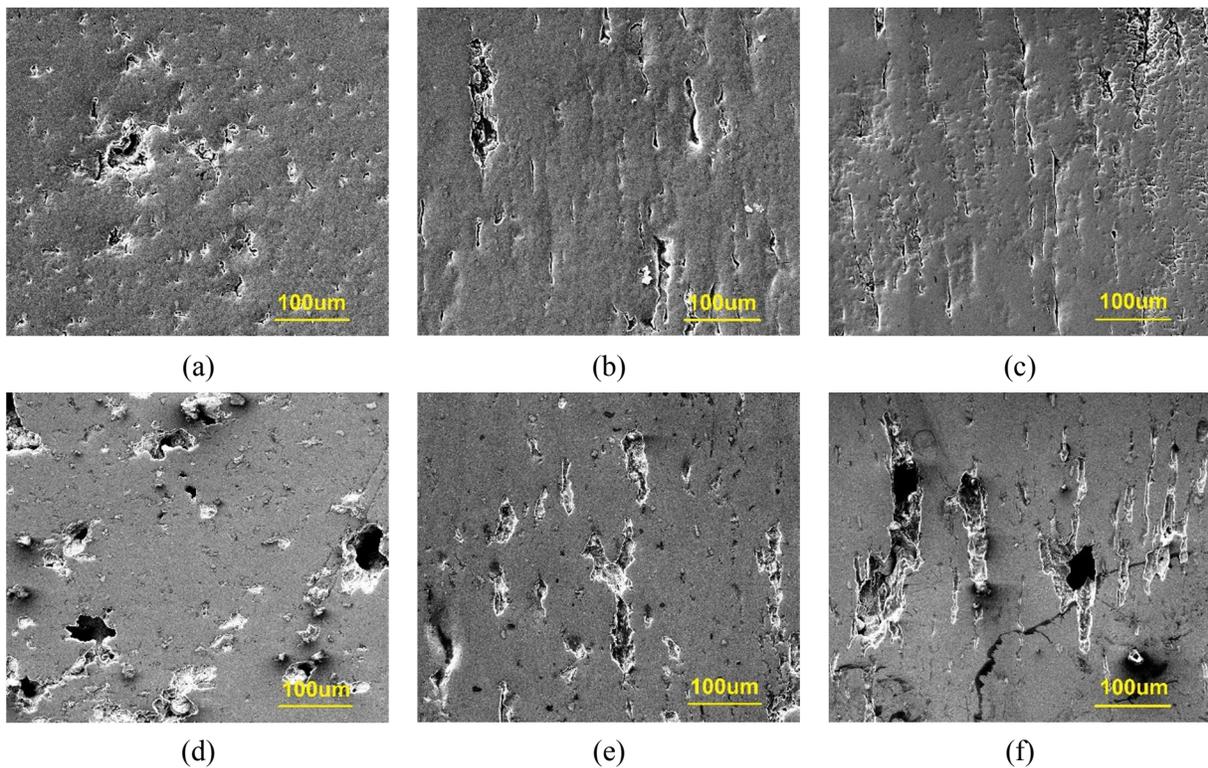
Fig. 25 Just-before-rupture samples creep cavity morphology on each material plane (SEM, 500x)
(a)17MPa, Normal (b)17MPa, Rolling (c)17MPa, Transverse (d)14MPa, Normal (e)14MPa, Rolling
(f)14MPa, Transverse

vertical crack-like cylindrical cavities along the rolling/loading direction, while spherical cavities are randomly distributed on the normal material plane. The cavity morphologies indicate that during high plastic deformation, creep cavities grew from an initial spherical shape into the longer, cylindrical shapes along the rolling/loading direction. Similar cavity morphologies are displayed on all three material planes of the 17MPa and 14MPa samples, indicating similar damage has been developed during the creep tests within 14MPa-17MPa range. Several small cracks are also observed in the microstructure just prior to rupture, as shown in Fig. 25f. These cracks grow transversely to the rolling/loading direction and connect the closely spaced cavities, implying micro-cracks will develop after cavity coalescence and crack propagation causes eventual sample failure.

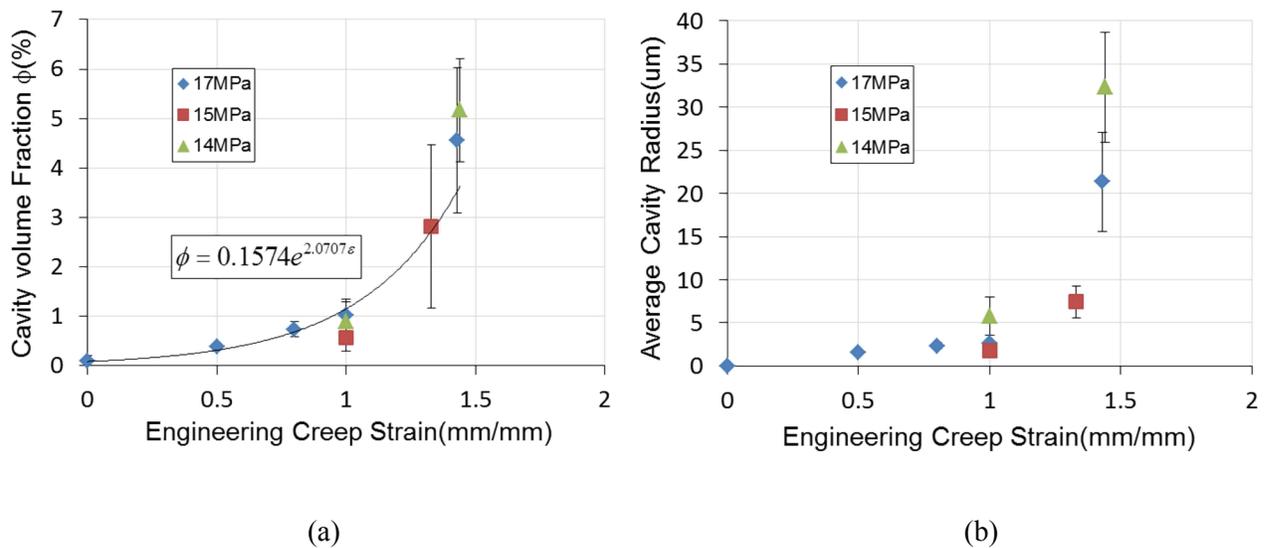
Fig. 26 (a) Cavity volume fraction versus creep strain (b) Average cavity size evolution versus creep strain

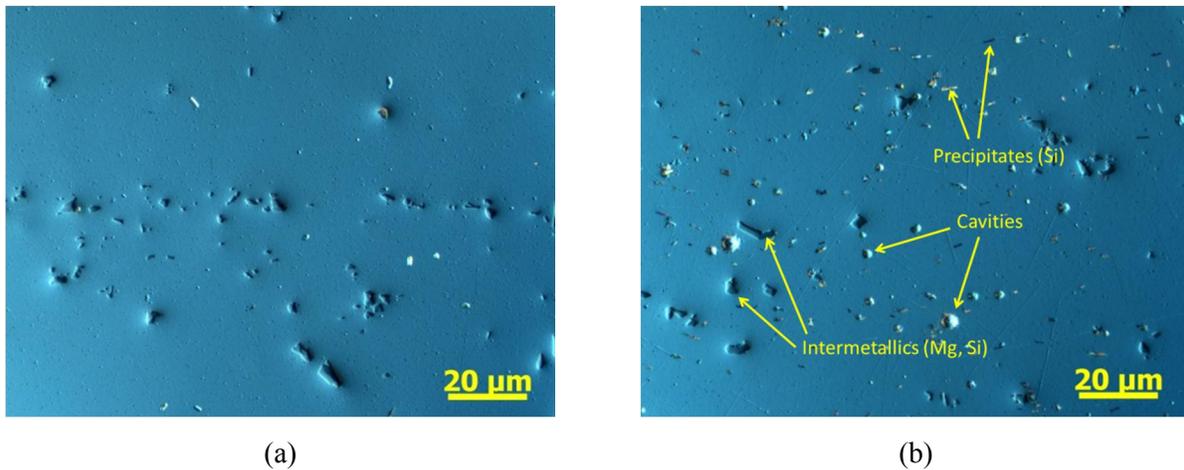
Fig. 27 Microstructures of Al6061 (a) As-received (b) 400°C, 20MPa, $\epsilon = 47\%$

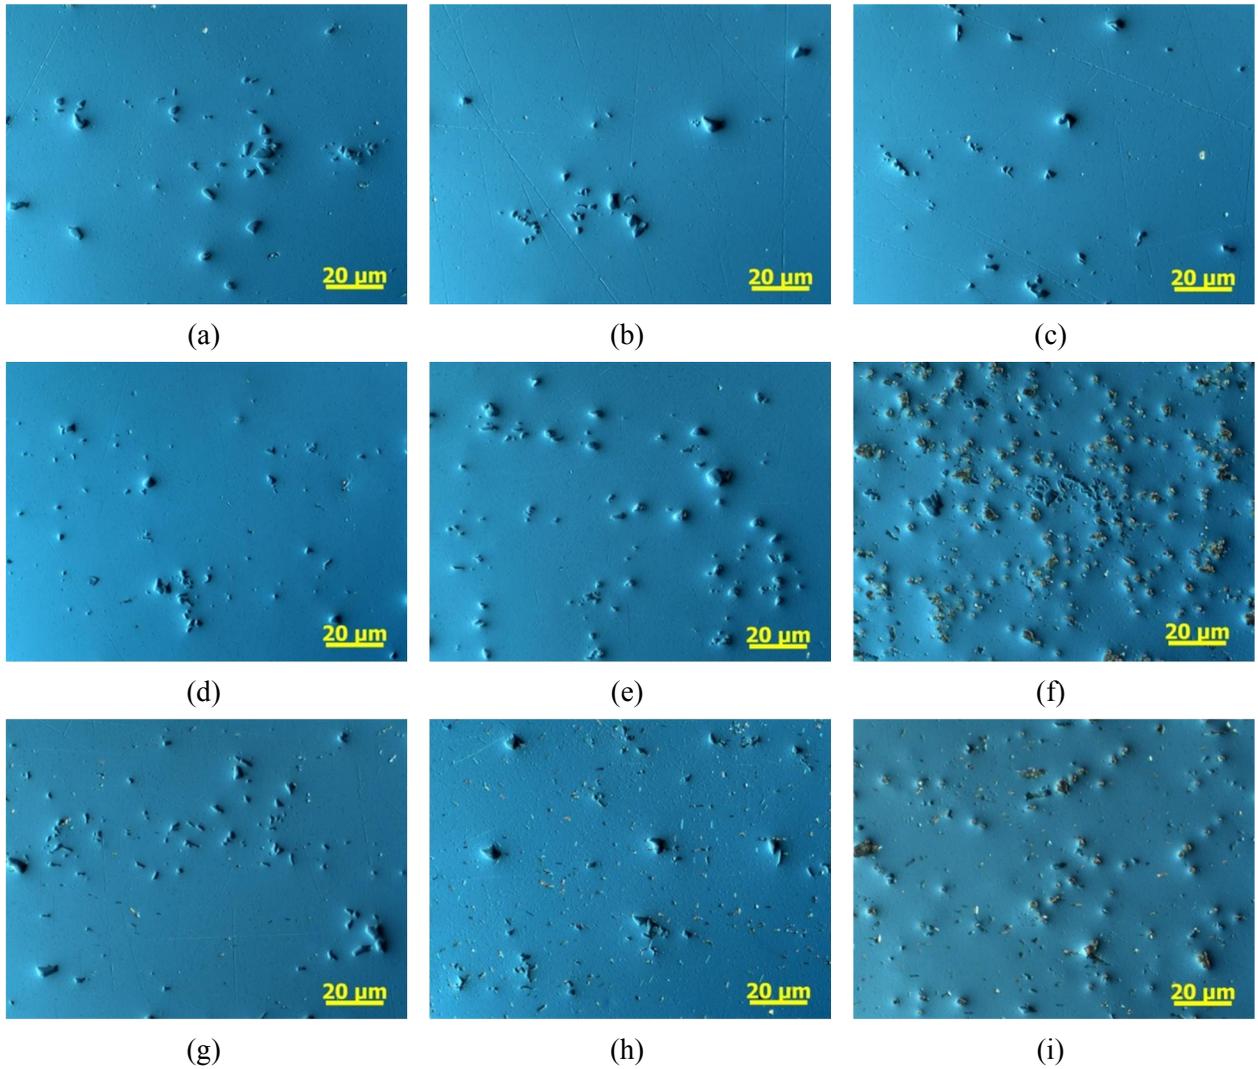
Fig. 28 Cavitation evolution from solely thermal exposure state to thermo-mechanical damaged state
 (a) 200°C, 0MPa, 0s, (b) 200°C, 0MPa, 2000s, (c) 200°C, 220MPa, 1400s, $\epsilon=12\%$
 (d) 300°C, 0MPa, 0s, (e) 300°C, 0MPa, 4000s, (f) 300°C, 80MPa, 4000s, $\epsilon=19\%$
 (g) 400°C, 0MPa, 0s, (h) 200°C, 0MPa, 2900s, (i) 400°C, 20MPa, 2900s, $\epsilon=58\%$

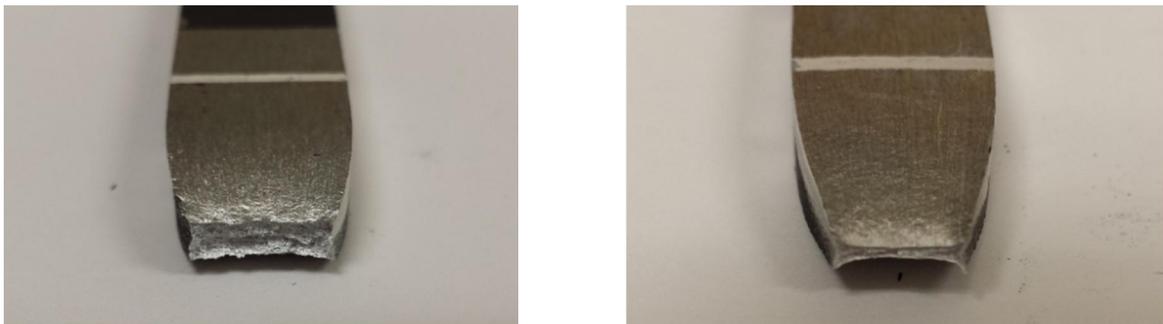
Fig. 29 Fracture surface of thermo-mechanical tested samples (a) 300°C, (b) 400°C

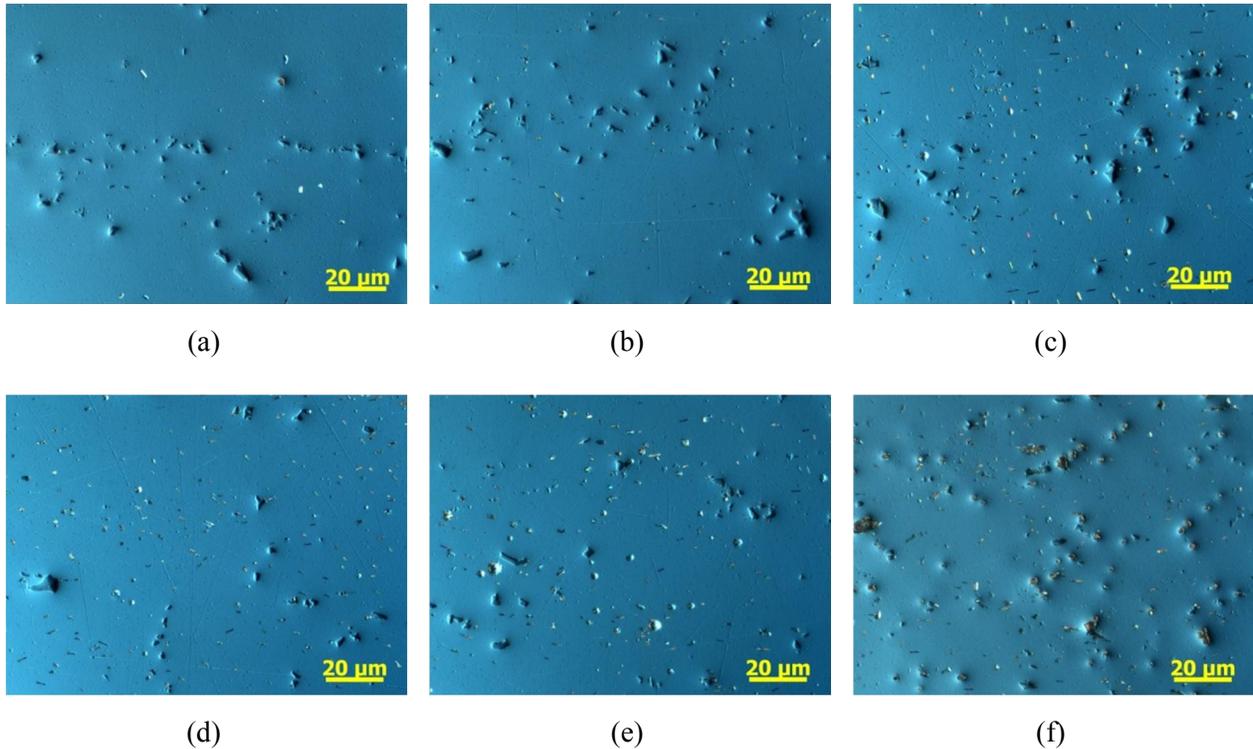
Fig. 30 Cavitation evolution with creep strain (1000x, rolling surface) for Al6061
 (a) As-received $\varepsilon = 0\%$; (b) 400°C, 0MPa, 0s, $\varepsilon = 0\%$;
 and 400°C, 20MPa (c) $\varepsilon = 25\%$ (d) $\varepsilon = 36\%$ (e) $\varepsilon = 47\%$ (f) $\varepsilon = 58\%$

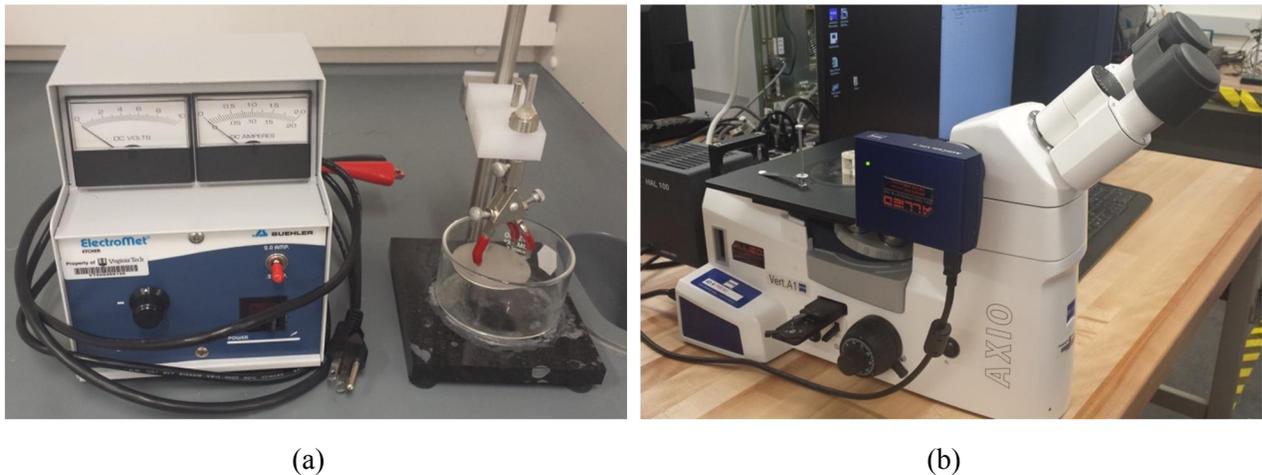
Fig. 31 (a) Buehler ElectroMet Etcher (b) Zeiss Axiovert.A1 MAT Optical Microscope
