Stress-induced Damage and Post-fire Response of Aluminum Alloys

Dissertation submitted to the faculty of the Virginia Polytechnic Institute and State University in partial fulfillment of the requirements for the degree of

Doctor of Philosophy
in
Engineering Mechanics

Keywords: Stress-induced damage; Cavitation; Grain Elongation; Dynamic Recrystallization; Residual Strength; Fire Response

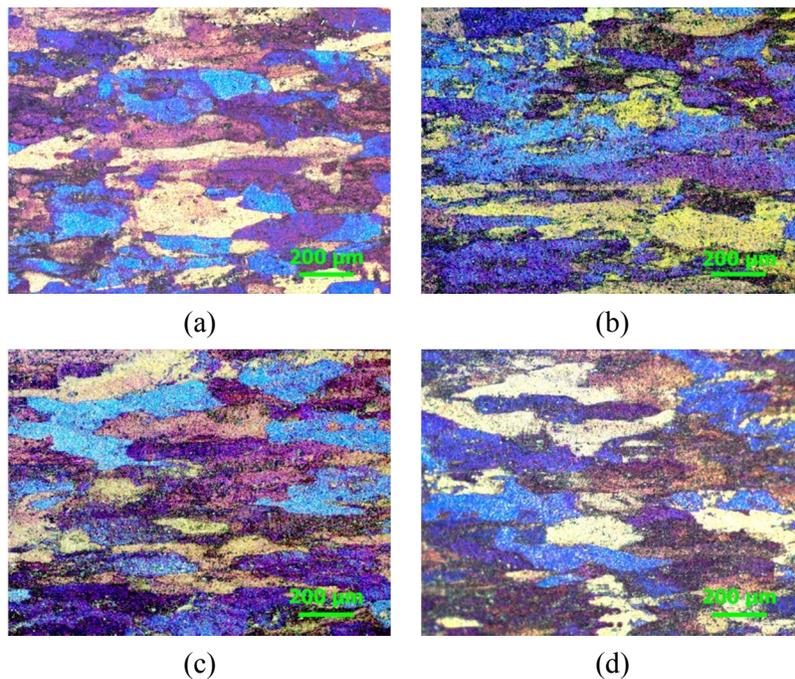
Fig. 32 Al5083 grain structure evolution at 200°C (a) as-received, (b) 200°C, 0MPa, 0s, (c) 200°C, 0MPa, 2000s and (d) 200°C, 140MPa, 2000s, $\epsilon=15\%$

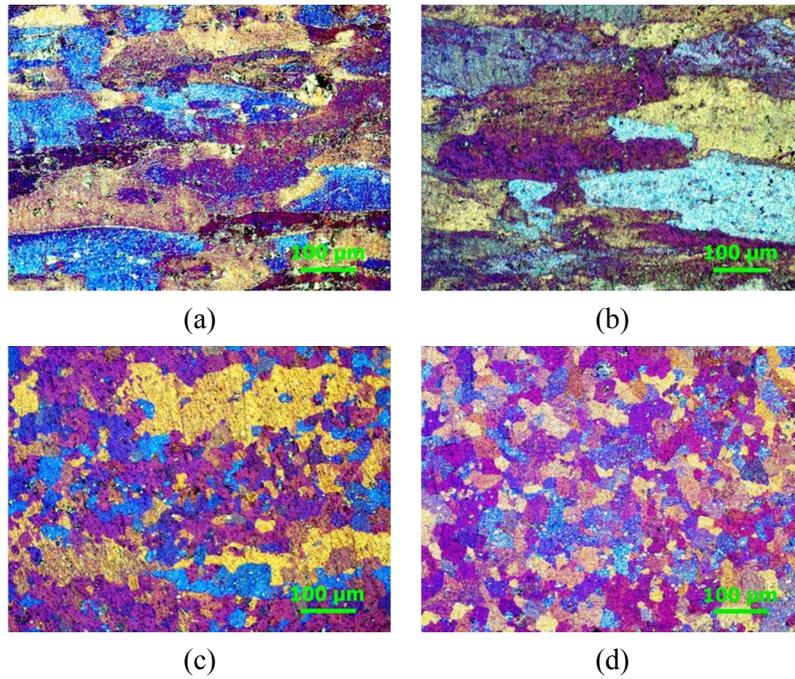
Fig. 33 Al5083 grain structure evolution at 300°C (a) as-received, (b) 300°C, 0MPa, 0s, (c)300°C, 0MPa, 500s and (d) 300°C, 0MPa, 1000s

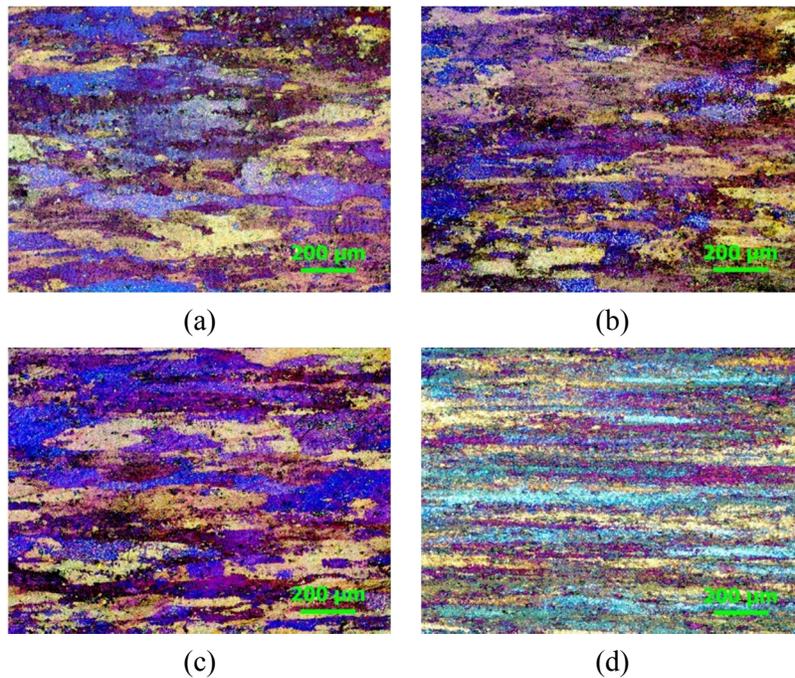
Fig. 34 Al5083 grain structure evolution at 300°C, 50MPa (a) 500s, $\epsilon=13\%$, (b) 1000s, $\epsilon=20\%$, (c) 1500s, $\epsilon=30\%$ and (d) 2000s, $\epsilon=100\%$

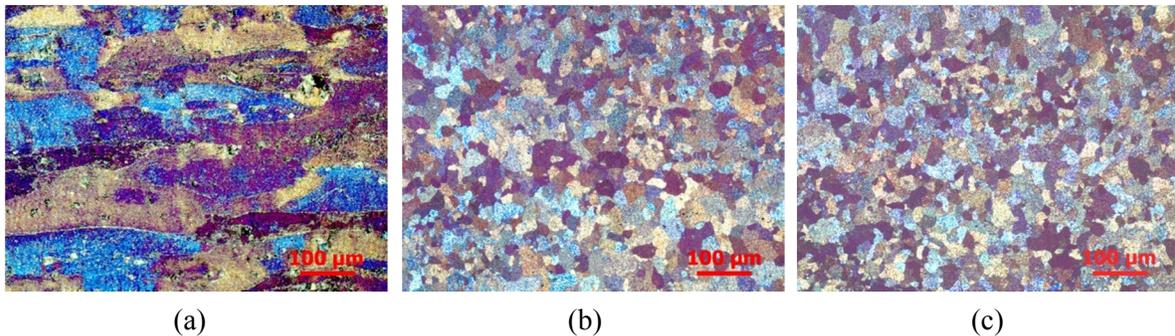
Fig. 35 Al5083 grain structure evolution at 400°C (a) as-received, (b) 400°C, 0s, (c) 400°C, 2000s

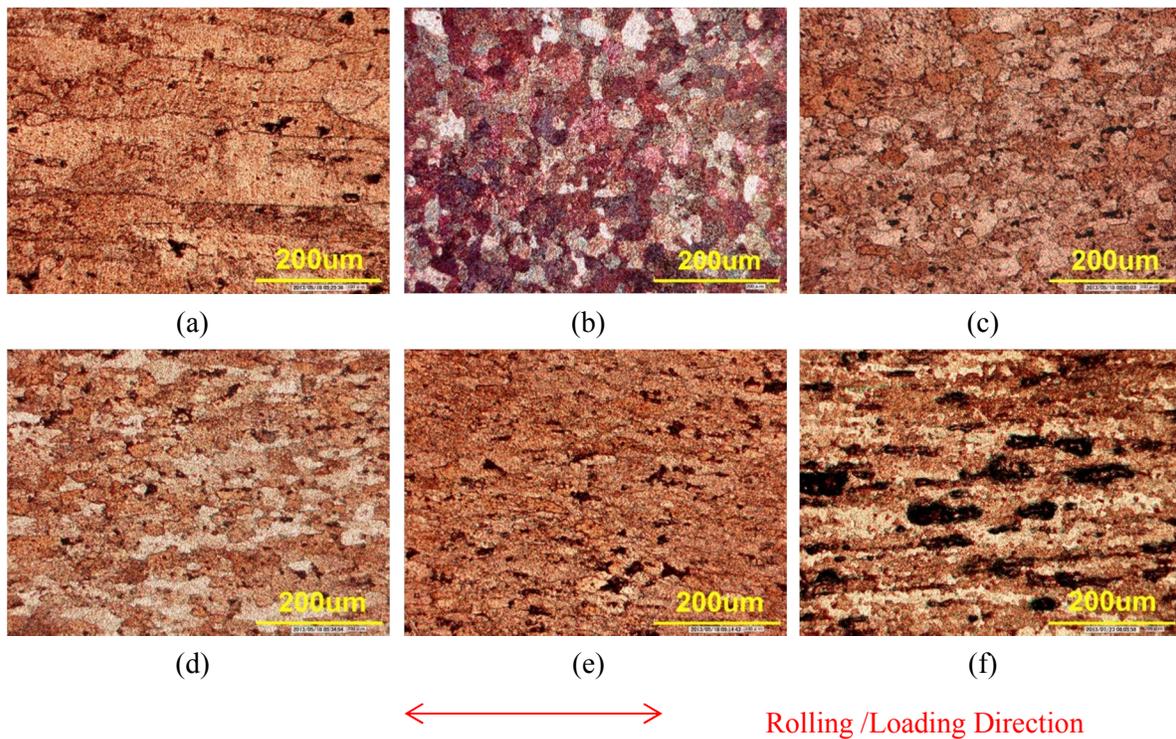
Fig. 36 Al5083 grain structures (560x, rolling surface) of (a) as-received sample (b) 400°C, 0MPa, $\epsilon = 0\%$, and (c)-(f) 400°C, 17MPa creep samples, $\epsilon = 50\%$, 80%, 100% and 143%

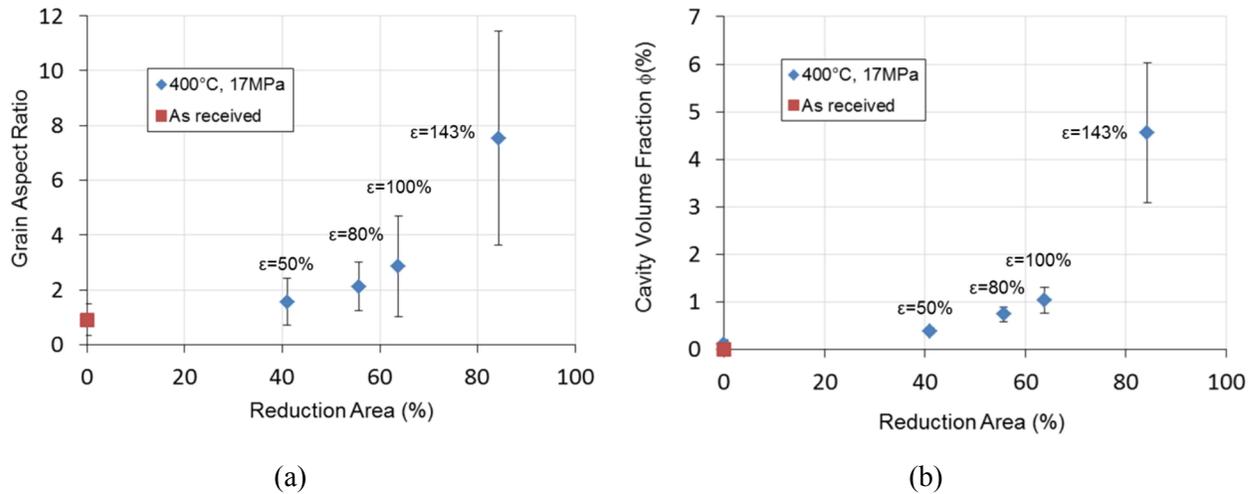
Fig. 37 (a) Al5083 grain aspect ratio(calculated based on rolling surface grains) (b) Al5083 cavity volume fraction for 400°C, 17MPa creep samples

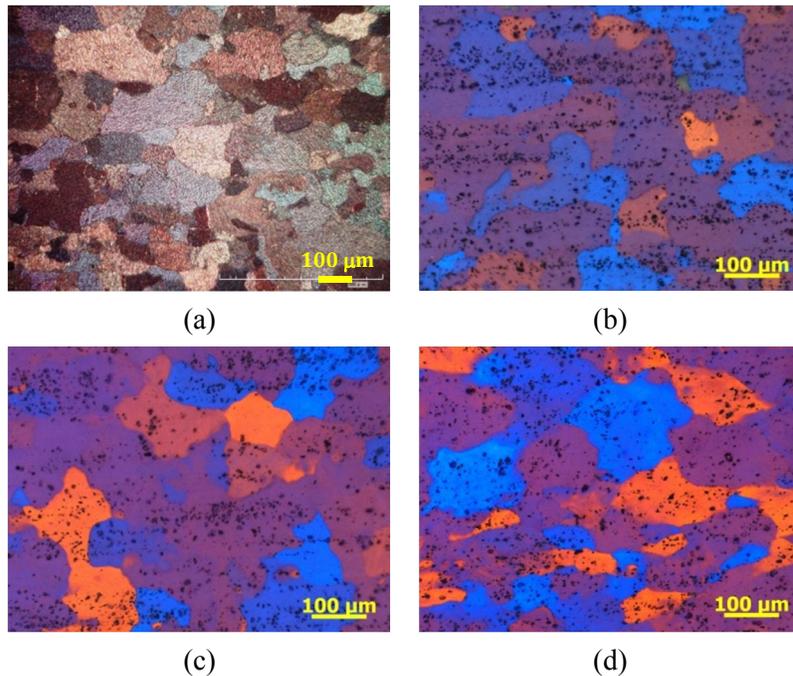
Fig. 38 Al6061 grain structure evolution at 200°C (a) as received, (b) 200°C, 0MPa, 0s, (c)200°C, 0MPa, 1400s and (d) 200°C, 220MPa, 1400s, $\epsilon=12\%$

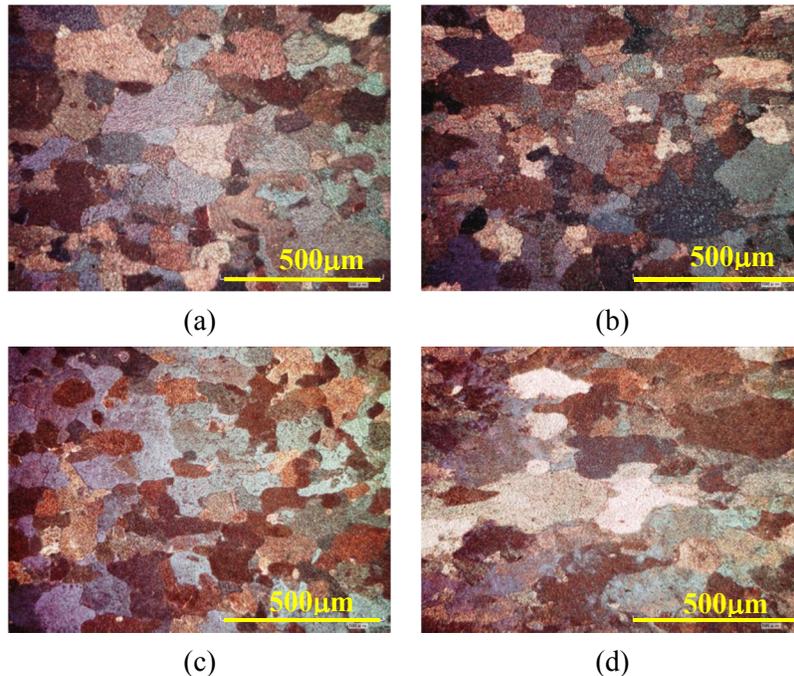
Fig. 39 Al6061 grain structure evolution at 300°C (a) as received, (b) 300°C, 0s, (c)300°C, 4000s and (d) 300°C, 80MPa, 4000s, $\epsilon=19\%$

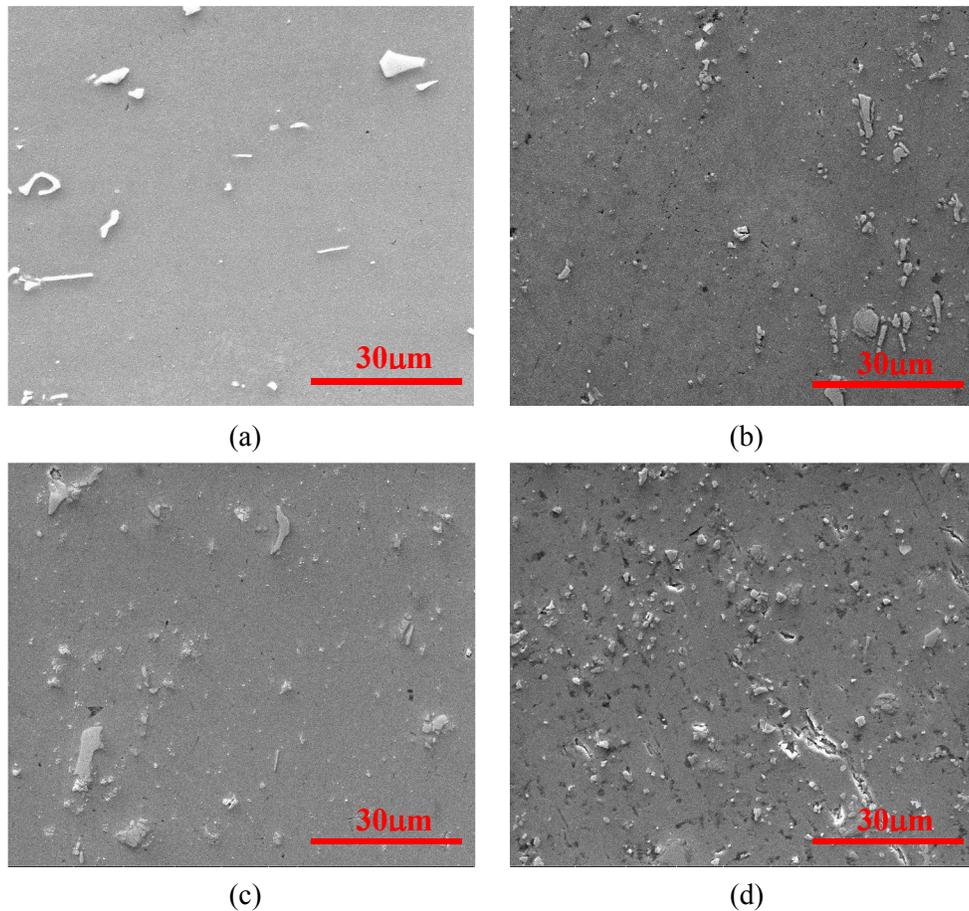
40d does not display any precipitation either. Only some cavities are shown on the microstructure of strained sample.

Fig. 40 Al6061 microstructures (SEM, 2800x, Normal surface) (a) as-received sample (b) 300°C, 0MPa, 0s, (c) 300°C, 0MPa, 4000s, and (d) 300°C, 80MPa, 4000s, $\epsilon = 19\%$

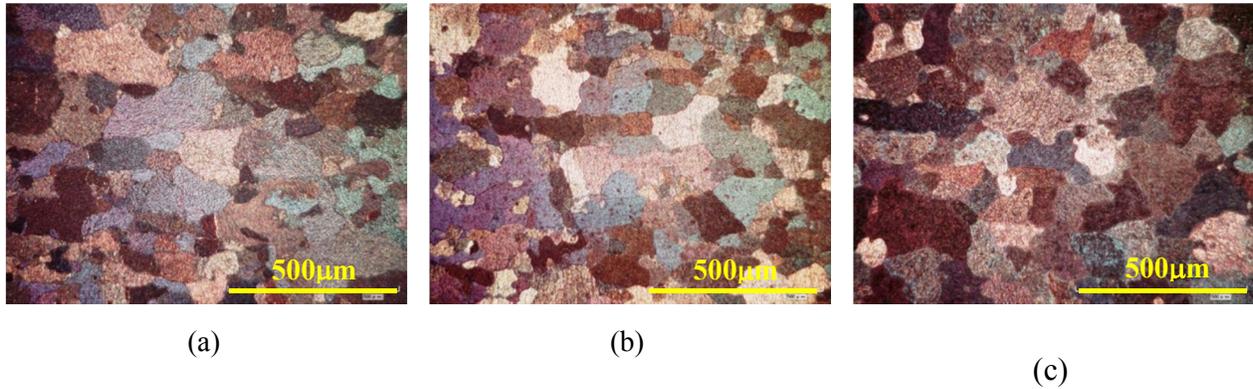
Fig. 41 Al6061 grain structure evolution at 400°C (a) as received, (b) 400°C, 0MPa, 0s, (c) 400°C, 0MPa, 2900s and (d) 400°C, 20MPa, 2900s, $\epsilon=58\%$

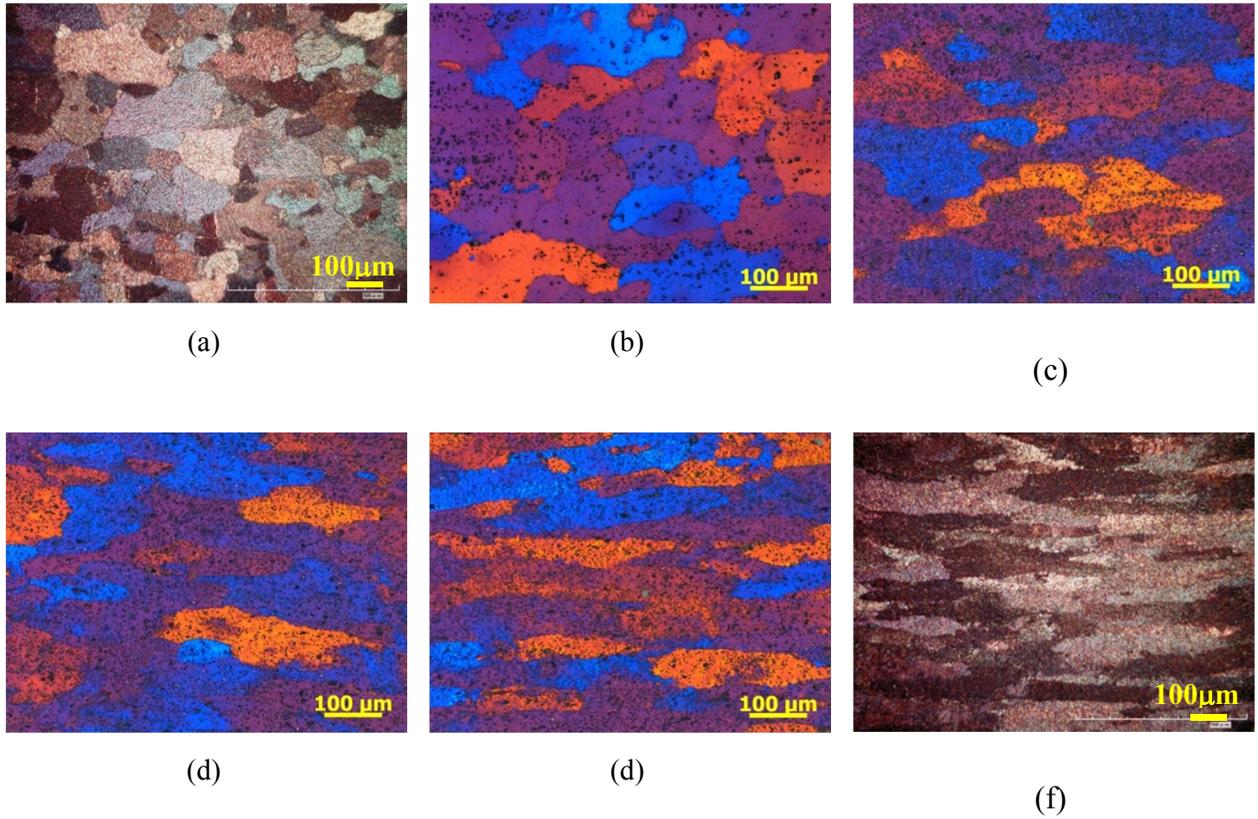
Fig. 42 Al6061 grain structures (200x, rolling surface) of (a) as-received sample (b) 400°C, 0MPa, $\epsilon = 0\%$, and (c)-(f) 400°C, 20MPa creep samples, $\epsilon = 25\%$, 36%, 47% and 58%

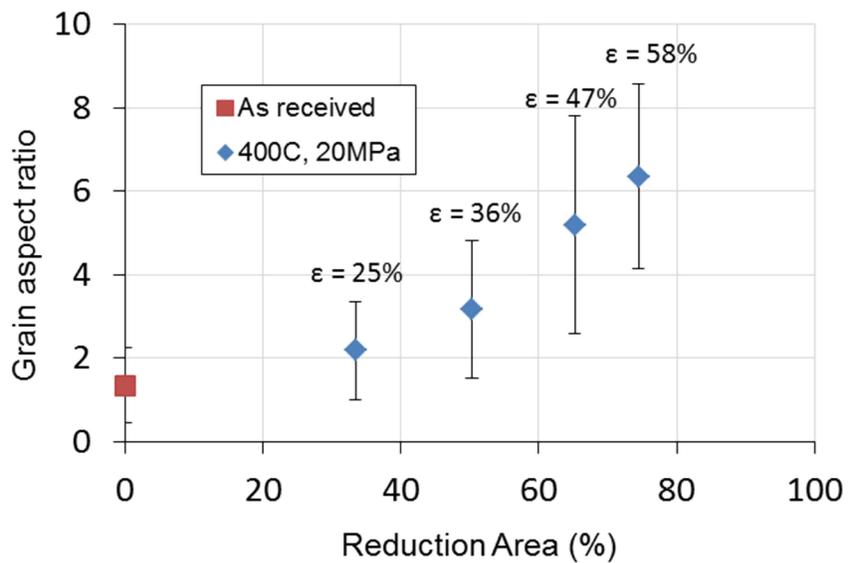
Fig. 43 Al5083 grain aspect ratio (calculated based on rolling surface grains) for 400°C, 20MPa creep samples

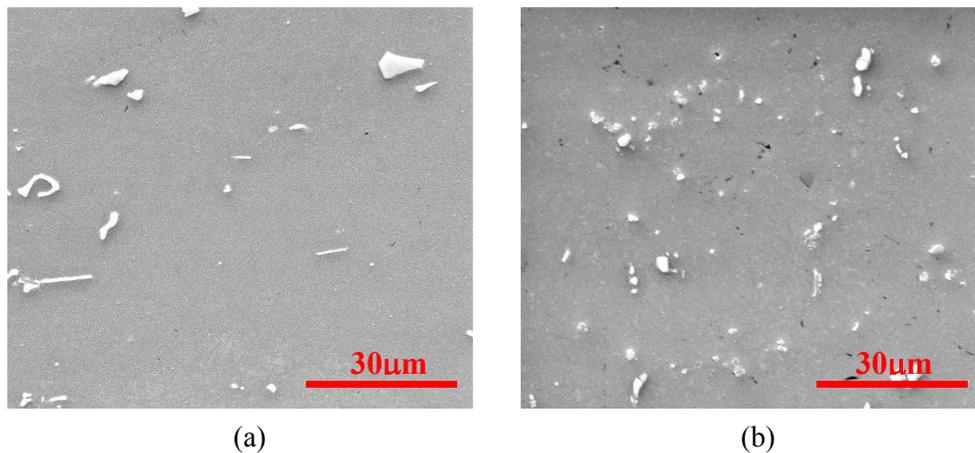
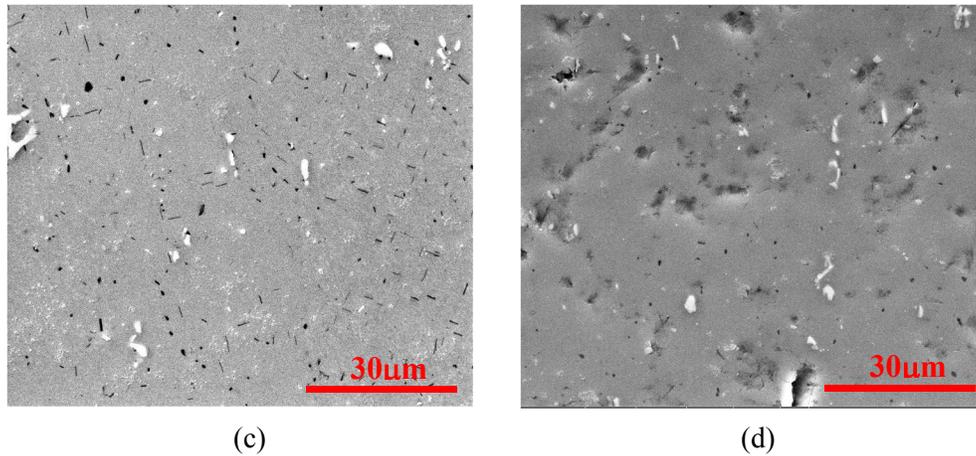
Fig. 44 Al6061 microstructures (SEM, 2800x, Normal surface) (a) as-received sample (b) 400°C, 0MPa, 0s, (c) 400°C, 0MPa, 2900s, and (d) 400°C, 20MPa, 2900s, $\epsilon = 58\%$

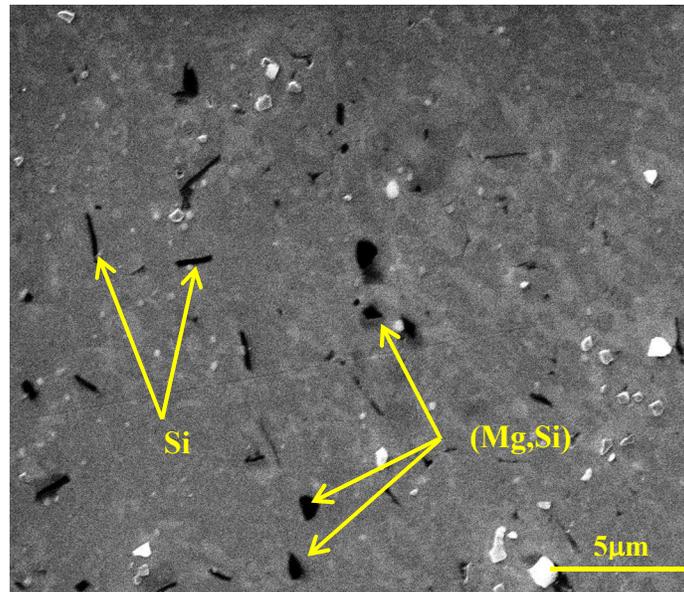
Fig. 45 Precipitates in 400°C, 2900s exposure sample

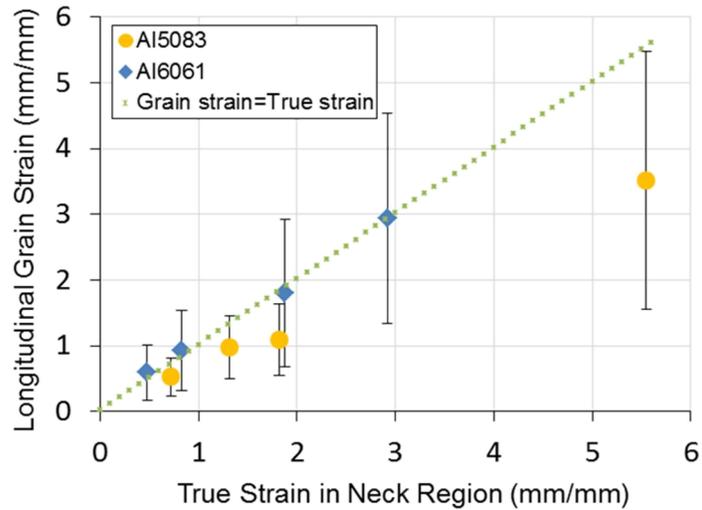
Fig. 46 Relation between longitude grain strain and true strain in the neck region for Al5083 and Al6061

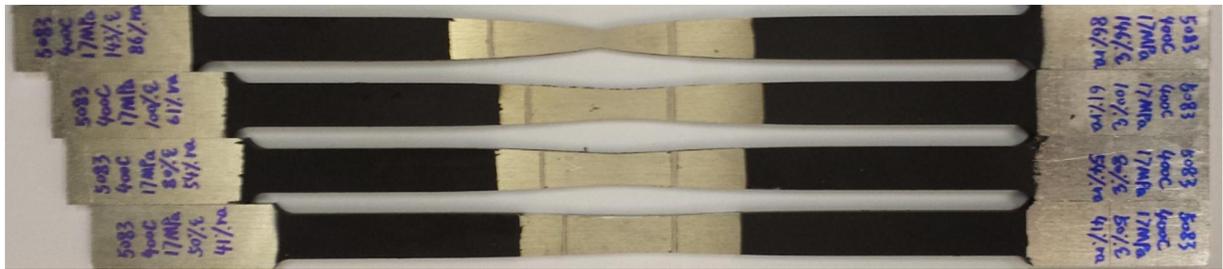
Fig. 47 Post-fire test samples with creep damage in the center

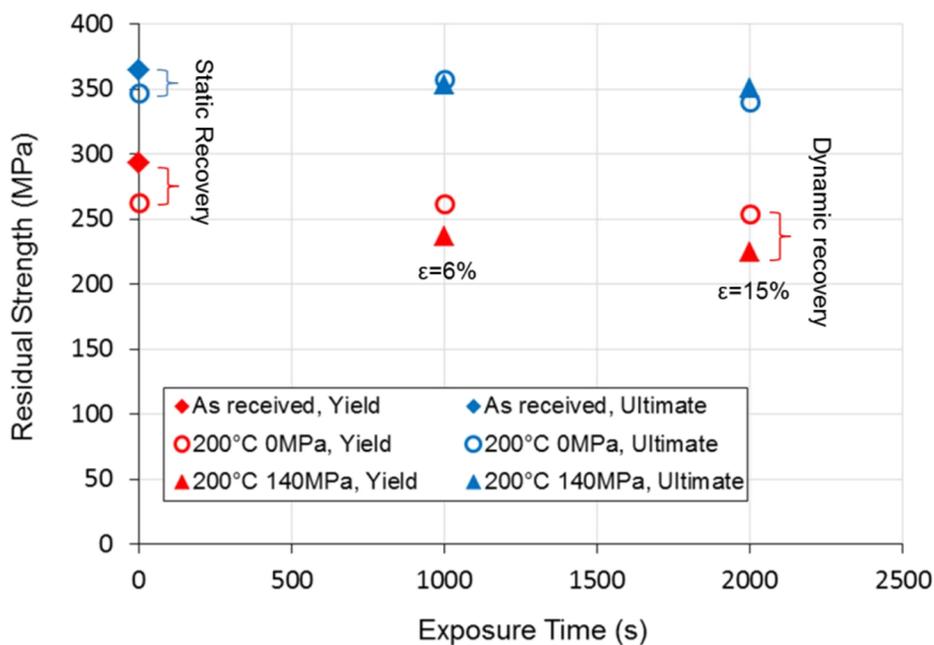
Fig. 48 Post-fire true residual strength of Al5083 after 200°C exposure

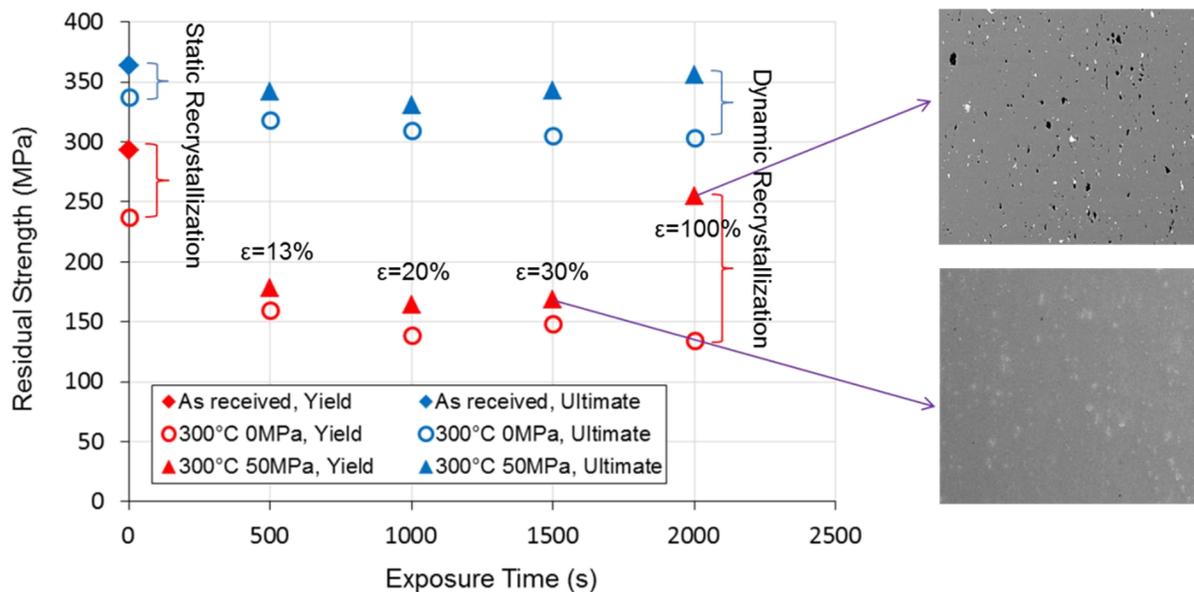
Fig. 49 (a) Post-fire true residual strength of Al5083 after 300°C exposure, (b) Cavitation in 100% strained sample and (c) Microstructure in 30% strained sample

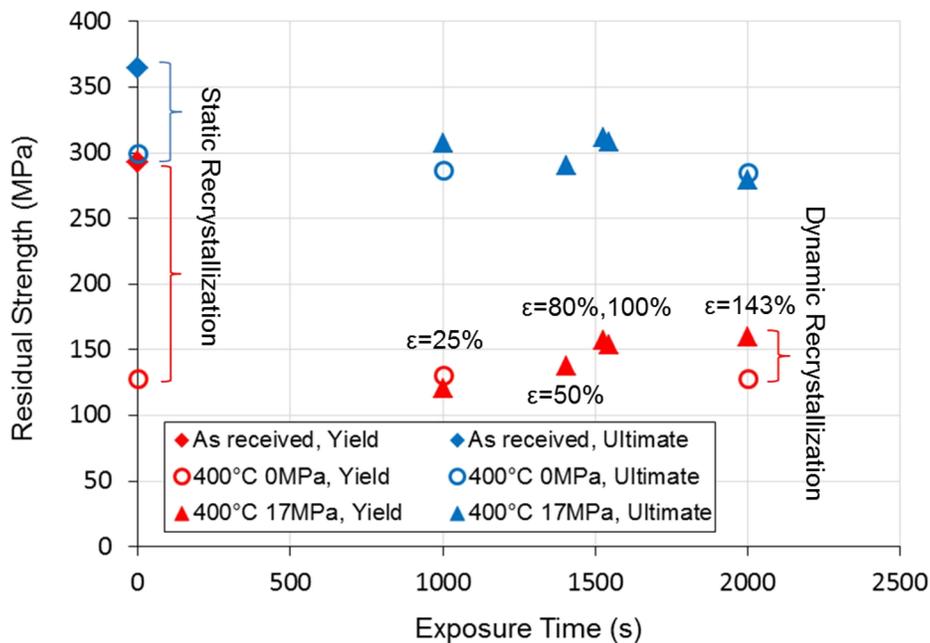
Fig. 50 Post-fire true residual strength of Al5083 after 400°C exposure

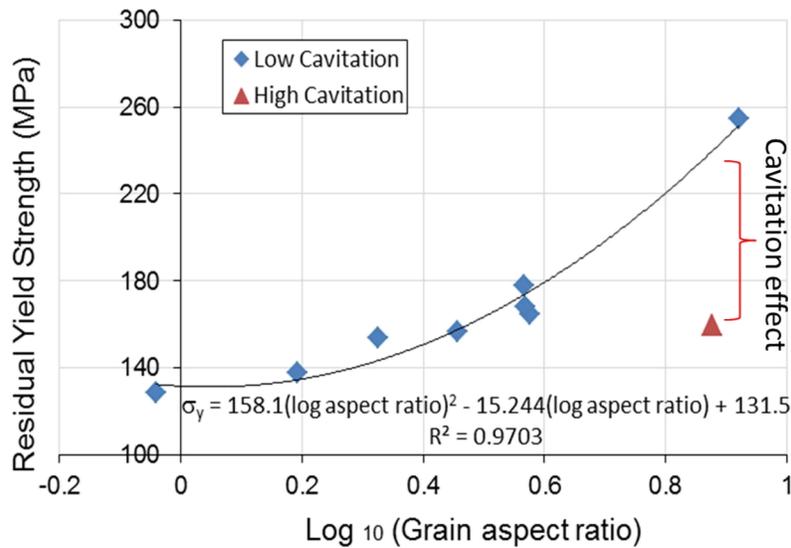
Fig. 51 Post-fire true residual strength of Al5083 as a function of logarithm of grain aspect ratio

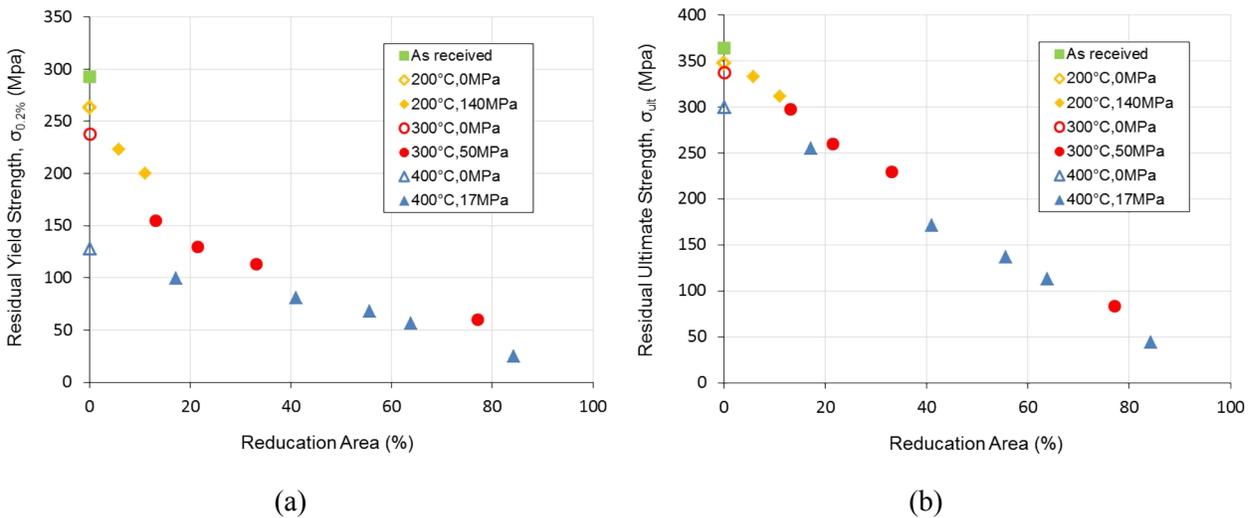
Fig. 52 Engineering residual material strength vs. Cross sectional reduction of area for Al5083

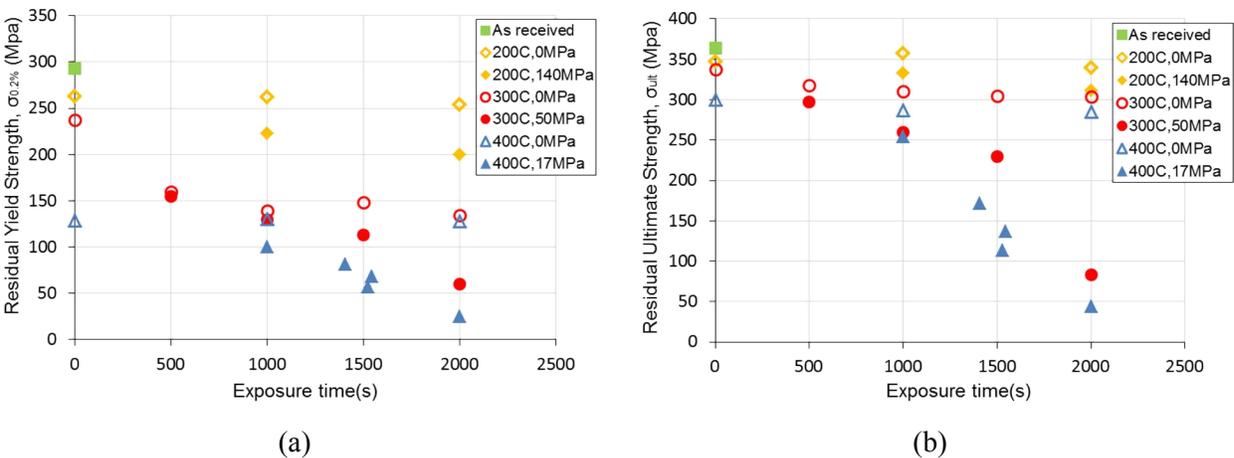
Fig. 53 Engineering residual material strength vs. Exposure Time for Al5083

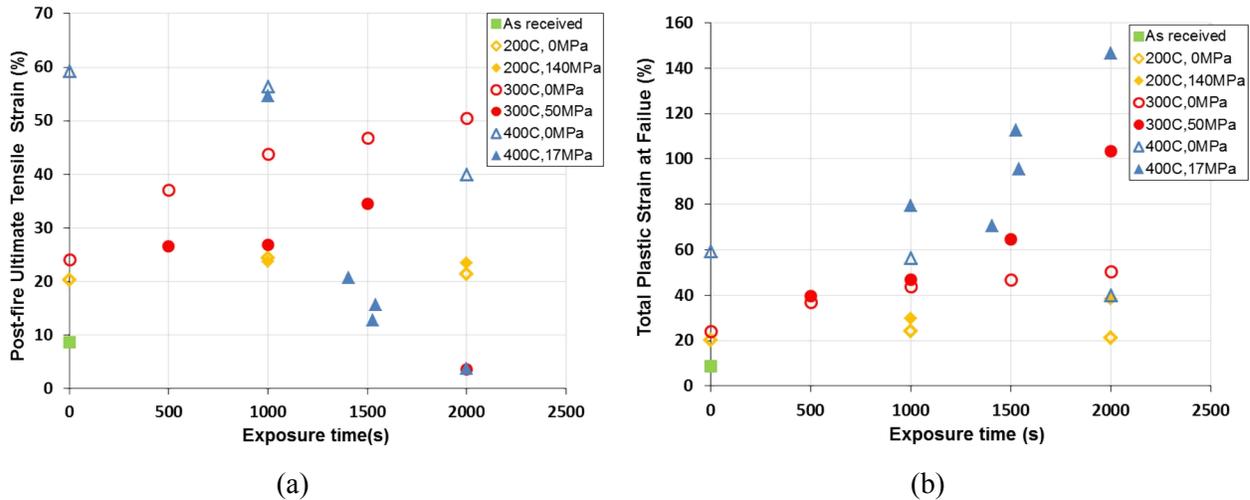
Fig. 54 (a) Post-fire ultimate tensile strain (b) Total plastic stain in both creep and post-fire tensile test for Al5083

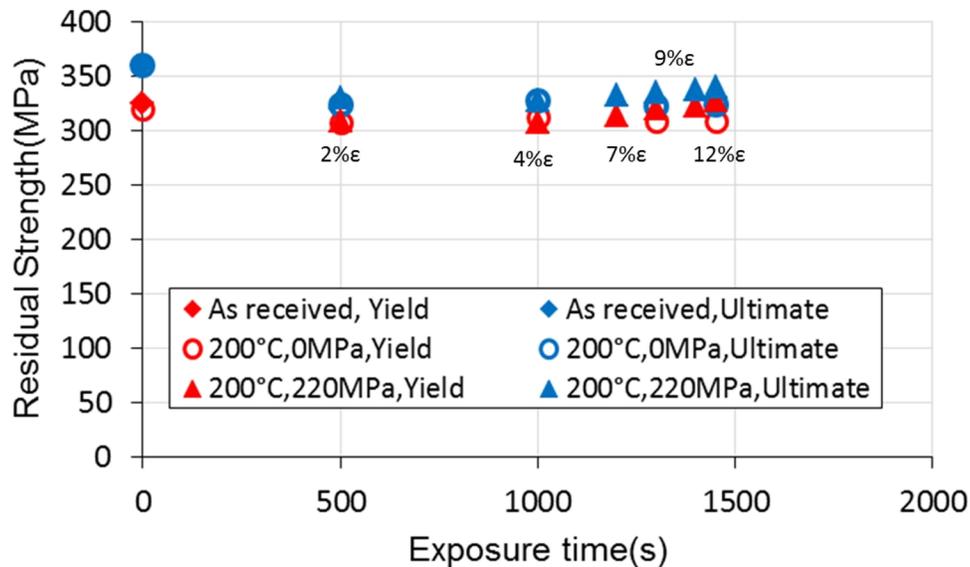
Fig. 55 Post-fire true residual strength of Al6061 after 200°C exposure

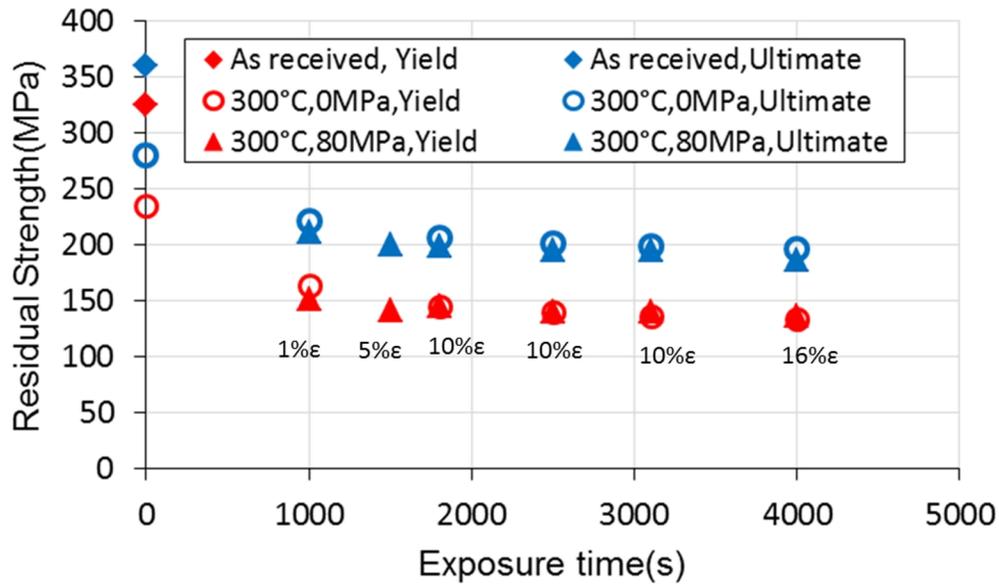
Fig. 56 Post-fire true residual strength of Al6061 after 300°C exposure

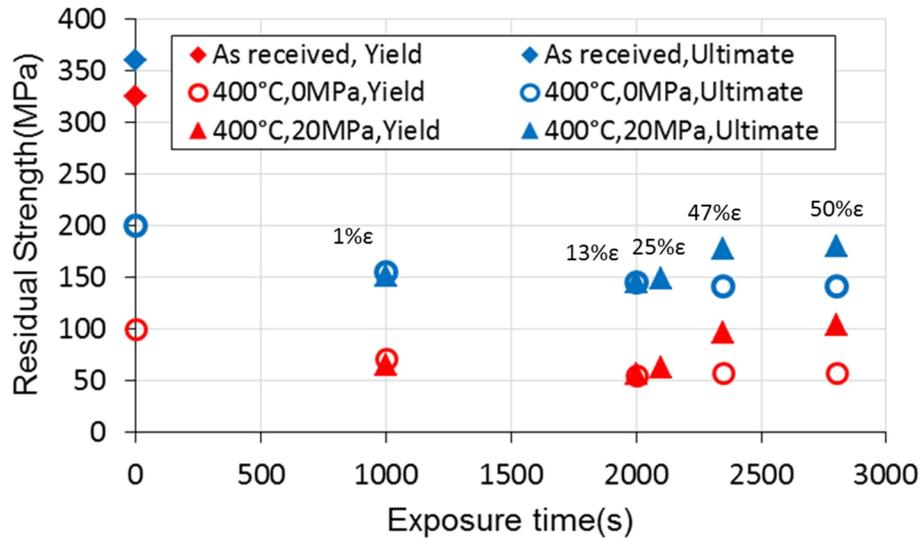
Fig. 57 Post-fire true residual strength of Al6061 after 400°C exposure

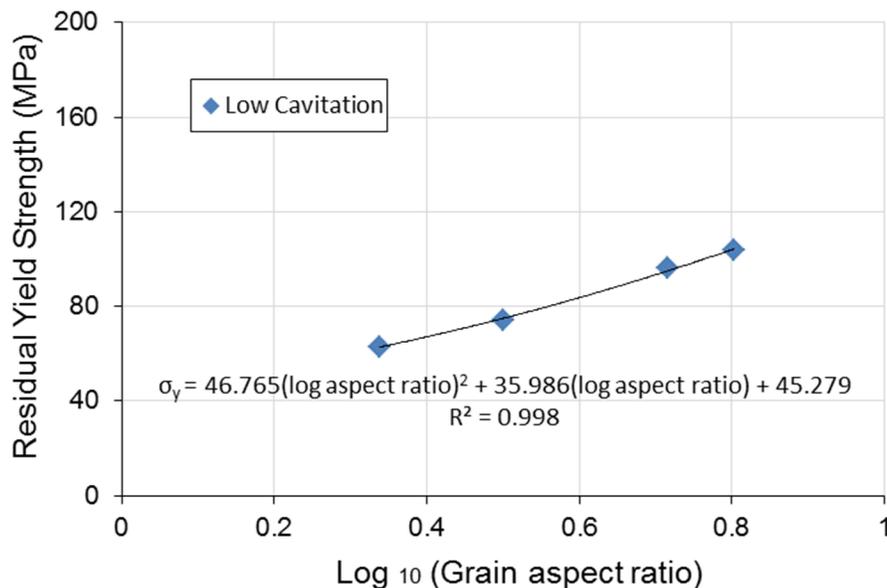
Fig. 58 Post-fire true residual strength of Al6061 as a function of logarithm of grain aspect ratio

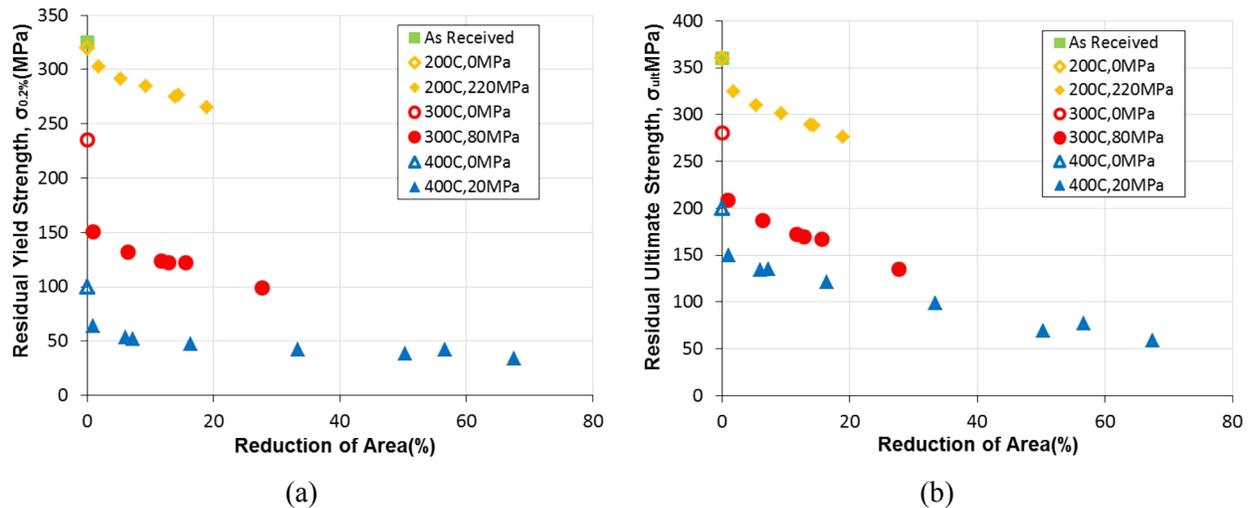
Fig. 59 Engineering residual material strength vs. Cross sectional reduction of area for Al6061

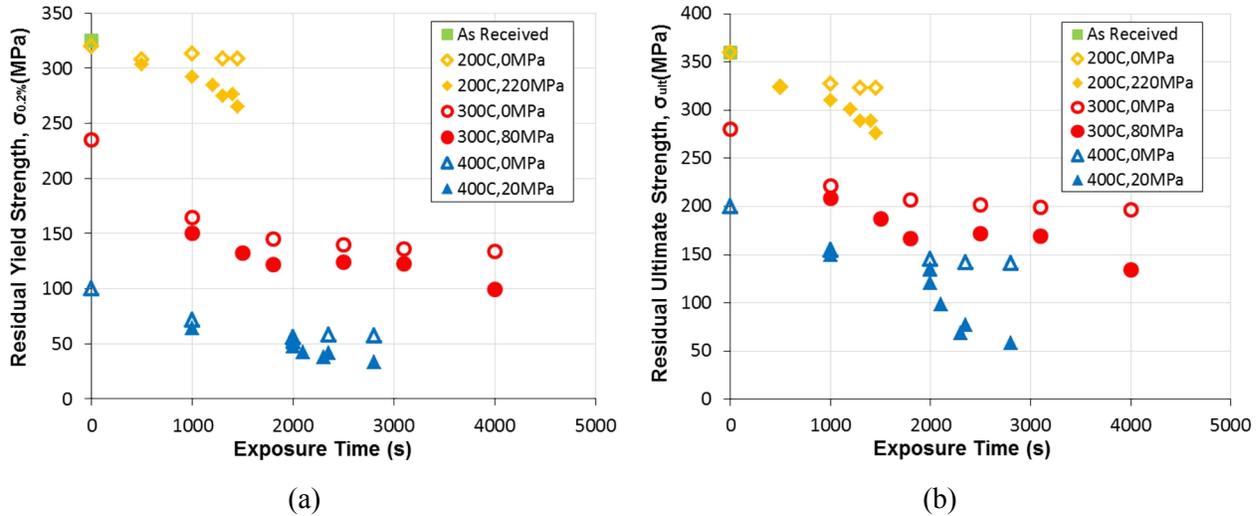
Fig. 60 Engineering residual material strength vs. Exposure Time for Al6061

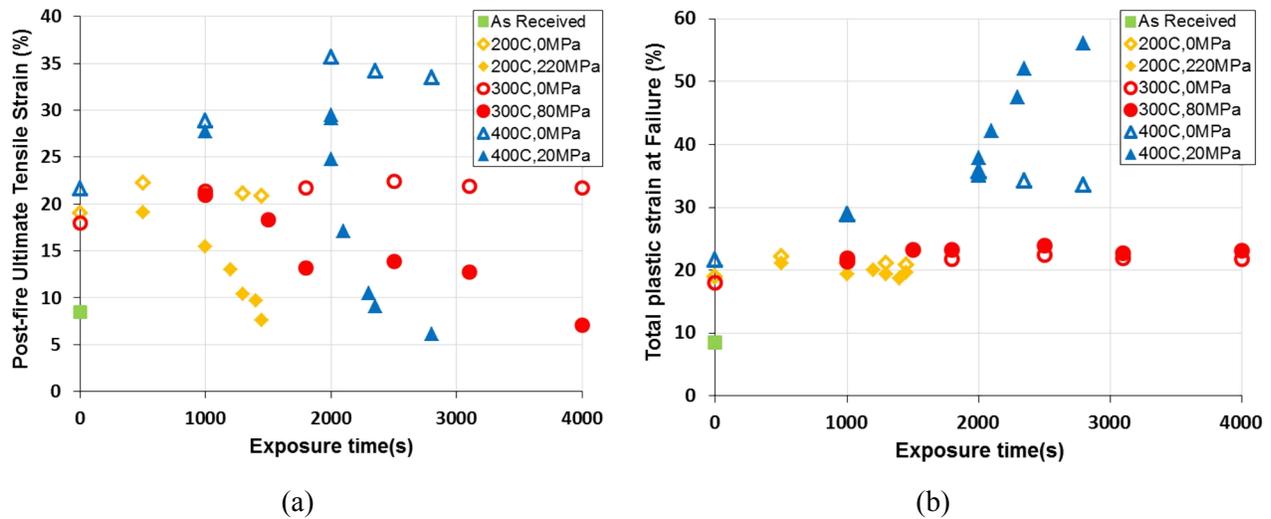
Fig. 61 (a) Post-fire ultimate tensile strain (b) Total plastic stain in both creep and post-fire tensile test for Al6061
