Monitoring Underground Mine Displacement Using Photogrammetry and Laser Scanning

*Dissertation submitted to the faculty of the Virginia Polytechnic Institute and State University in
partial fulfillment of the requirements for the degree of*

Mining Engineering

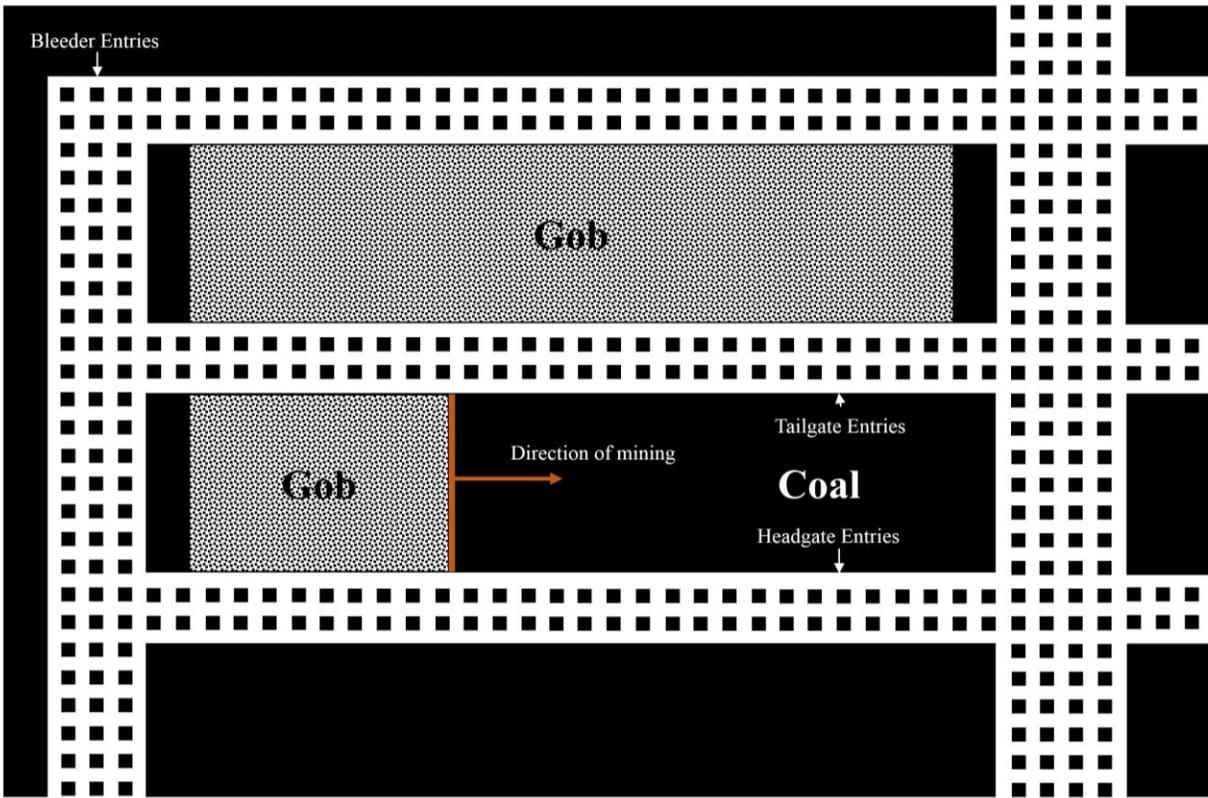
Figure 2.1: Example longwall section layouts

Longwall mining is a mining method commonly applied to ore deposits characterized by large lateral extents and a thin, constant ore thickness, such as coal, potash, or South African gold reefs [10]. Longwall mining differs from room and pillar mining in that the primary coal extraction is performed by retreat mining large panels of coal, as shown in Figure 2.1. The longwall panels vary in length and width, but their length dimension generally greatly exceeds their width. The panels are blocked out by development entries along either side, and then connected by bleeder entries once they have been developed to their final length. Coal is extracted by means of a shearer loader or plow cutting across the face, parallel to the short axis of the panel. The coal then falls onto an armored face conveyor (AFC), to be conveyed to the belt line, which acts as a track for the shearer to move across the face. This system is protected by powered roof supports, called shields, which protect the AFC and personnel at the face, and are capable of advancing along the face in the direction of mining. As the system advances in the direction of mining, the roof above the mined out area begins to collapse behind the shields. This region will be referred to as the *gob* [11].

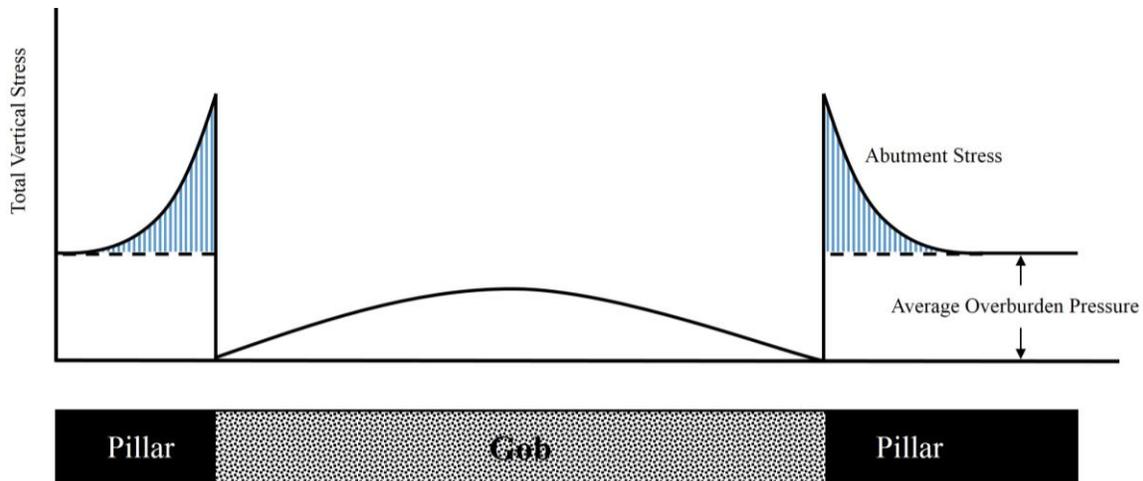
Figure 2.2: Idealized representation of side abutment pressures around the gob

As material is removed, it creates a support deficit, which is then transferred to pillars around the opening. This occurs when creating development entries, and then more load is transferred as adjacent longwall panels are mined. An idealized representation of an abutment stress is shown in Figure 2.2. The stresses transferred to the chain pillars in the gate roads are called side abutment stresses, while the stresses transferred ahead of the face and behind the face are called the front and rear abutment stresses respectively. These abutment stresses are discussed further in Section 2.2.2.

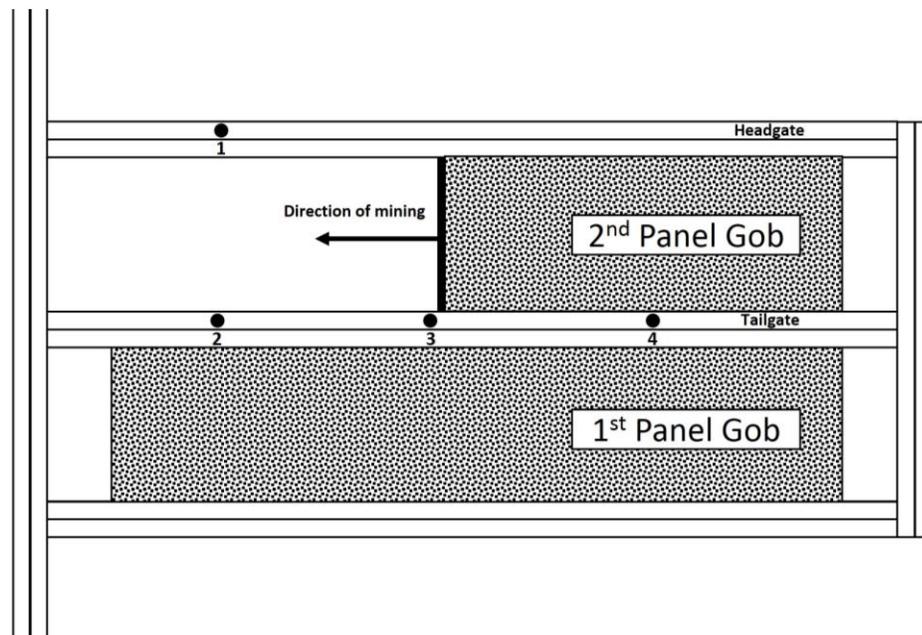
Figure 2.4: Four stages of tailgate loading (after [22])

There are four primary loading conditions that gate roads are subjected to, each shown in Figure 2.4, and listed below [22]:

1. Development loading: neither adjacent panel has been mined sufficiently to create abutment stresses
2. Side abutment: one side of the gate road has been completely mined, but the advancing long wall face is not nearby
3. Side and face abutment: the longwall face has approached the monitoring location
4. Two side abutments: the face has passed and the monitoring point is surrounded by gob on both sides

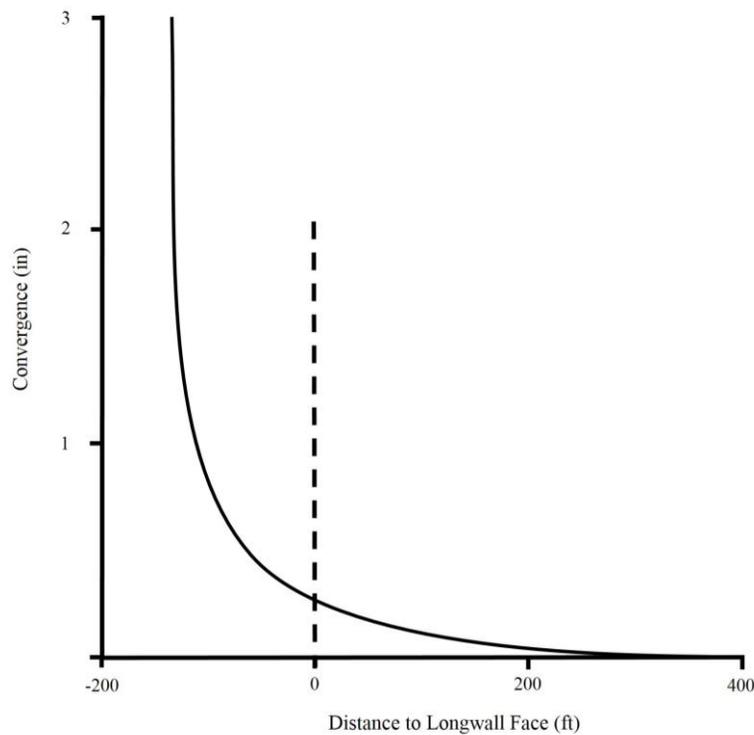
Figure 2.5: Entry convergence as the longwall face approaches (after [11])

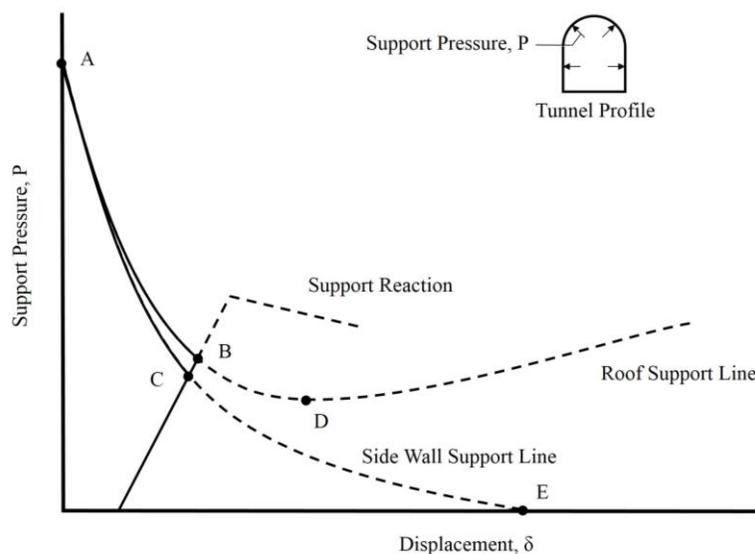
Figure 2.11: Ground Response Curve (after [16])

The ground response curve shows many different stages of ground reaction. Point A represents the in-situ support provided. It is impractical to expect to be able to provide this support before deformation occurs, as the rock will experience relaxation ahead of the excavated surface. Points B and C are the pressures at which the support provided is sufficient to prevent further displacement. Point D is the point along the roof support line where the roof begins to lose its self-supporting capabilities and will require more support pressure as displacement is allowed to continue, until failure. Point E is the point along the side wall support line where no support pressure is required to prevent further displacement. Competent rocks may be capable of supporting themselves without failure after sufficient displacement has taken place, however, if displacement of the rock is undesirable, support can be installed, as at point C, to prevent that displacement.

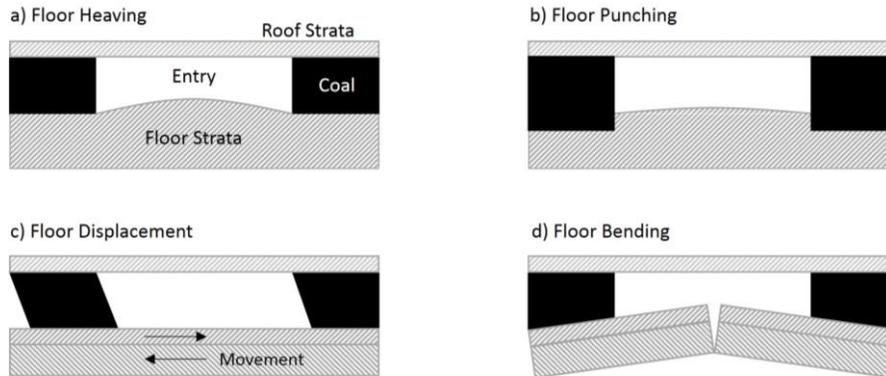
Figure 2.13: Floor behavior

Much like the mine roof, the subcoal strata, or mine floor, is composed of bedded rock layers, and the behavior of the floor unit is dependent on the mechanical properties of these layers. There are four types of floor failure that result from the interaction between the floor and pillars: floor heaving, floor punching, floor displacement, and floor bending [54], each shown in Figure 2.13.

Floor heave may occur where the floor rock has a low strength, high deformability, often in the presence of moisture. While both occur in thick, weak, moist floor strata, observations suggest that floor punching, unlike floor heave, is not due to creep deformations but additional incremental loading. Floor displacement can occur if high horizontal stresses in the subcoal strata exceed the shear resistance of the interface between those strata. This, like the previous floor behaviors, is also compounded by the presence of moisture in the interface. The last floor behavior, bending, can be found with alternating strong and weak floor strata. High horizontal stresses will confine the strong strata while the weak strata is unable to accumulate the stress, and pushes the overlying strata upwards [53].

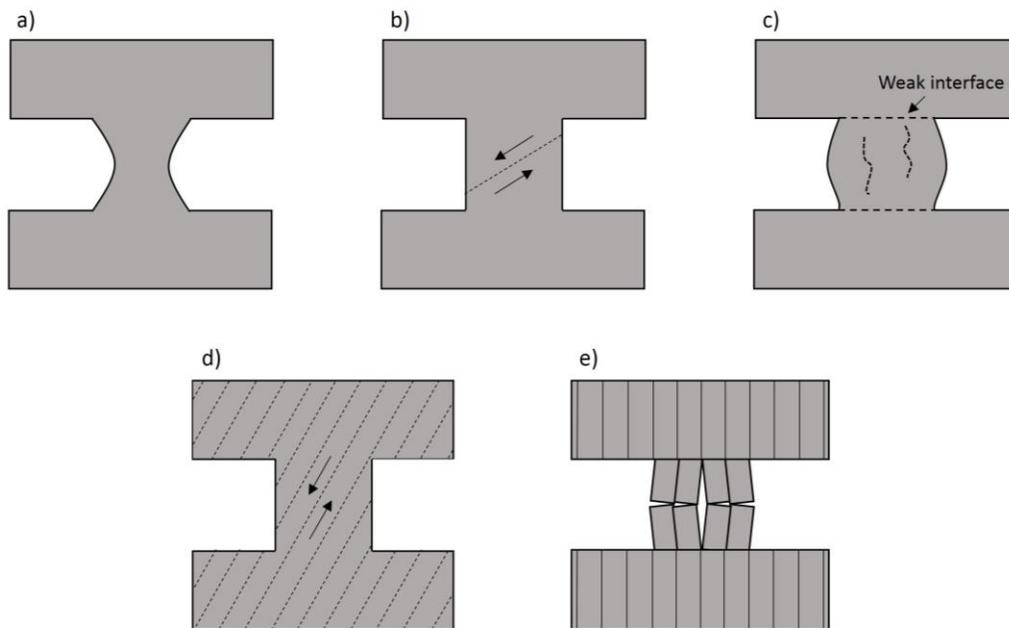
Figure 2.14: Deformational behavior of pillars (after [16])

Figure 2.14a shows pillar spalling, a common pillar behavior in high width/height ratio pillar. This is often an indication that a pillar may be overstressed. Figure 2.14b shows the formation of a dominant shear zone through the pillar, which daylights on both sides providing the possibility of failure along this plane. Figure 2.14c highlights a pillar behavior that may occur when the interface between a pillar and the overlying or underlying strata is weak and does not provide confinement at the top or bottom of the pillar. This allows the pillar to “bulge” or “barrel” which promotes internal fracturing. Figure 2.14d, much like Figure 2.14b, shows a pillar susceptible to failure along discontinuities, although this failure is more related to the geologic structure of the surrounding rock mass and its fracture network rather than one predominant shear

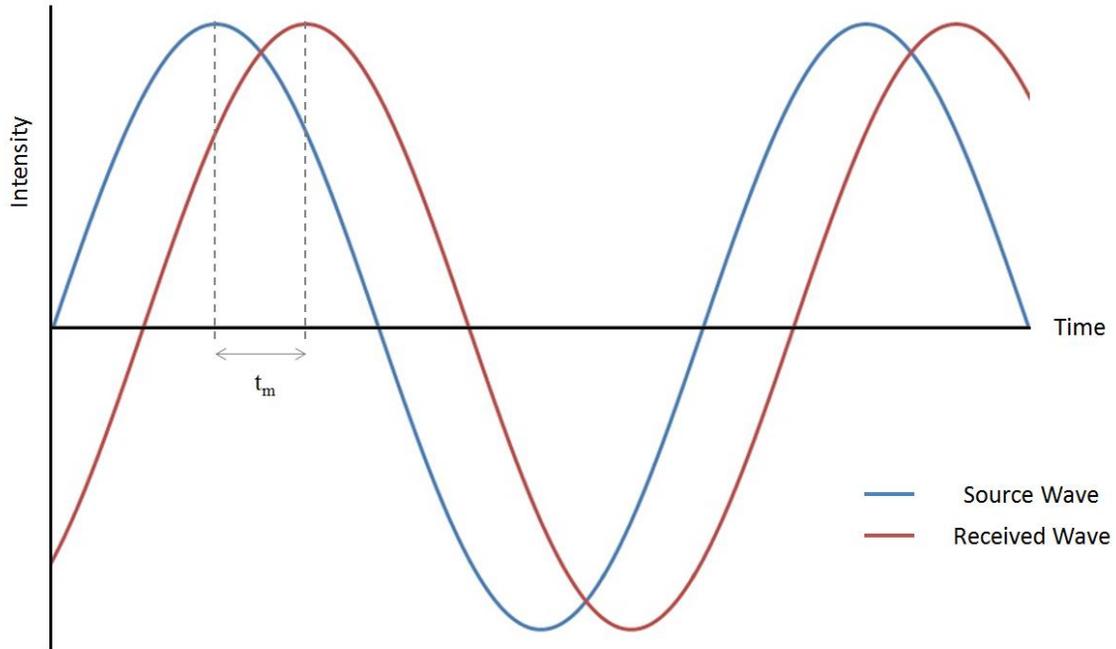
Figure 3.1: Phase Shift distance determination

The FARO Focus3D laser scanner [91] used in this experiment measures distances through “phase shift” technology, which involves the projection of constant waves of varying frequencies. Rather than measuring the time required for a reflection to be recorded after a laser pulse is sent out from the scanner, the phase shift in the waves of infrared light is recorded and used to determine the time traveled, as shown in Figure 3.1, where t_m , the phase shift, is directly proportional to the time it takes the wave to travel the unknown distance at the speed of light.

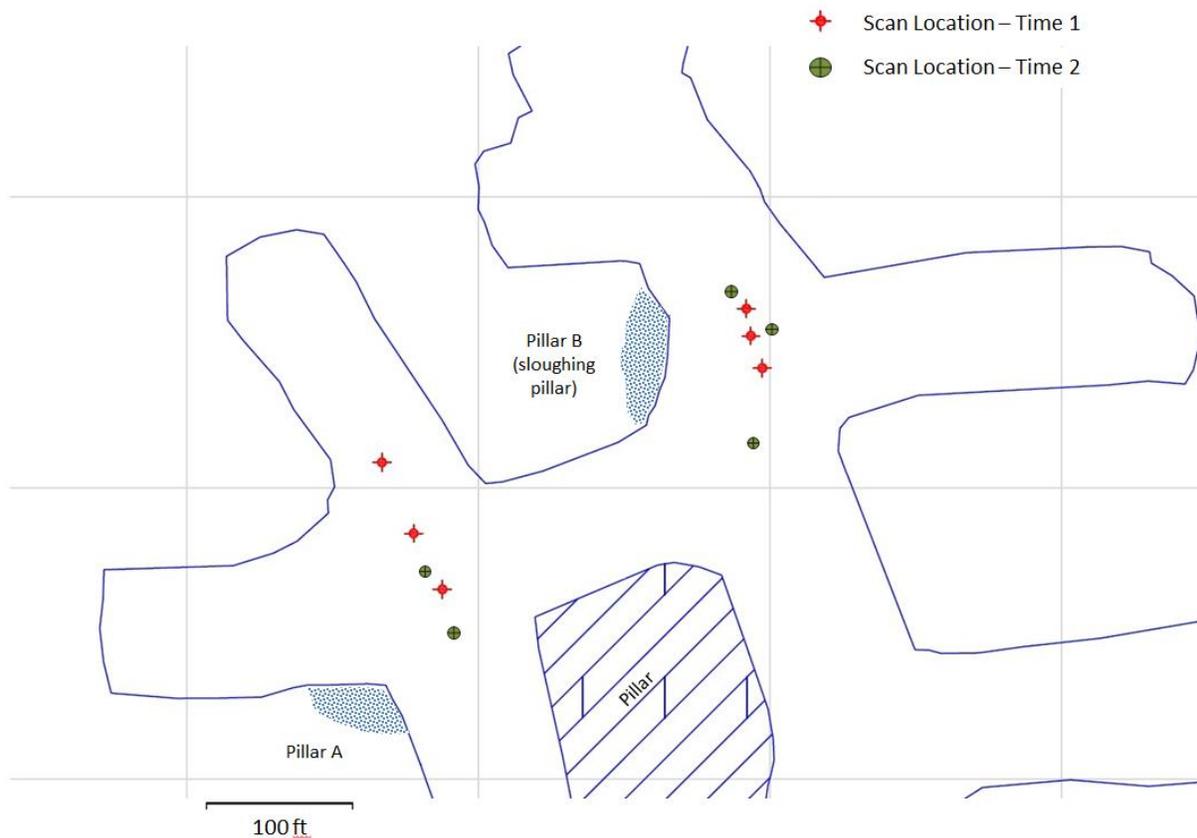
Figure 3.2: Mine map showing laser scanner placements in relation to pillars of interest

Two separate trips were required to the underground limestone mine to gather data for a time difference analysis. The two trips were separated by 42 days. During the first set of scans, a total of six scans were performed, with all six keeping Pillar B visible, shown in Figure 3.2, and three of the scans performed in an intersection adjacent to a working section. These scans were performed at a resolution of 43.7 million points per scan. The second set of scans contains a total of five scans: two including coverage of Pillar A, two including coverage of Pillar B, and one between the two scans. The locations for each scan are given in Figure 3.2. Scans were not performed in the exact same locations because of uncertainty in original scan location, inaccessibility due to the presence of water, and the presence of known survey points.

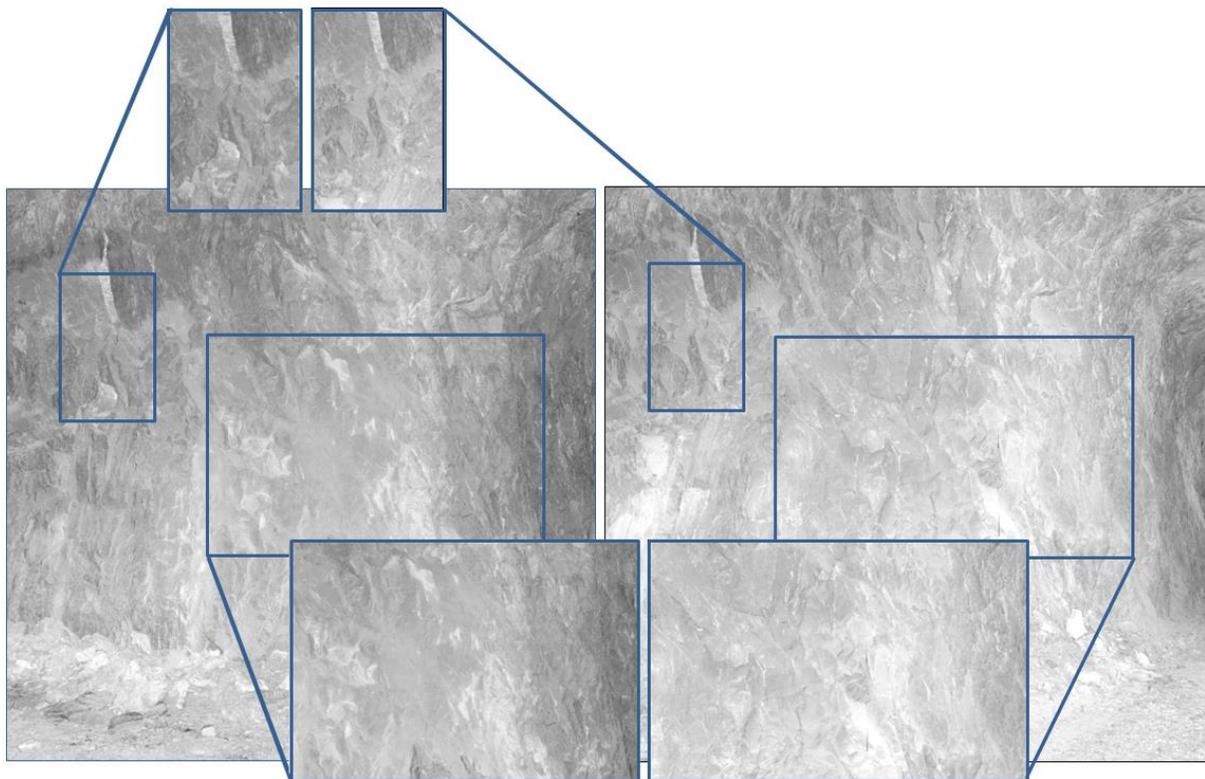
Figure 3.3: Difference between the initial and final scan at Pillar A, with areas of change highlighted

The goal of this study was to determine if roof or rib movement could be detected using time-lapse laser scan data. As no measurable roof or rib convergence was expected at the underground limestone mine, sloughing of material from a pillar or interest was instead used as a proof of concept. The volume of material that had sloughed off during the 42 day period between scans is unknown, however, areas of change can be detected by comparing pictures from the initial scan and the final scan. Figure 3.3 shows the initial state and final state of Pillar A. Figure 3.4 shows the initial and final state of Pillar B.

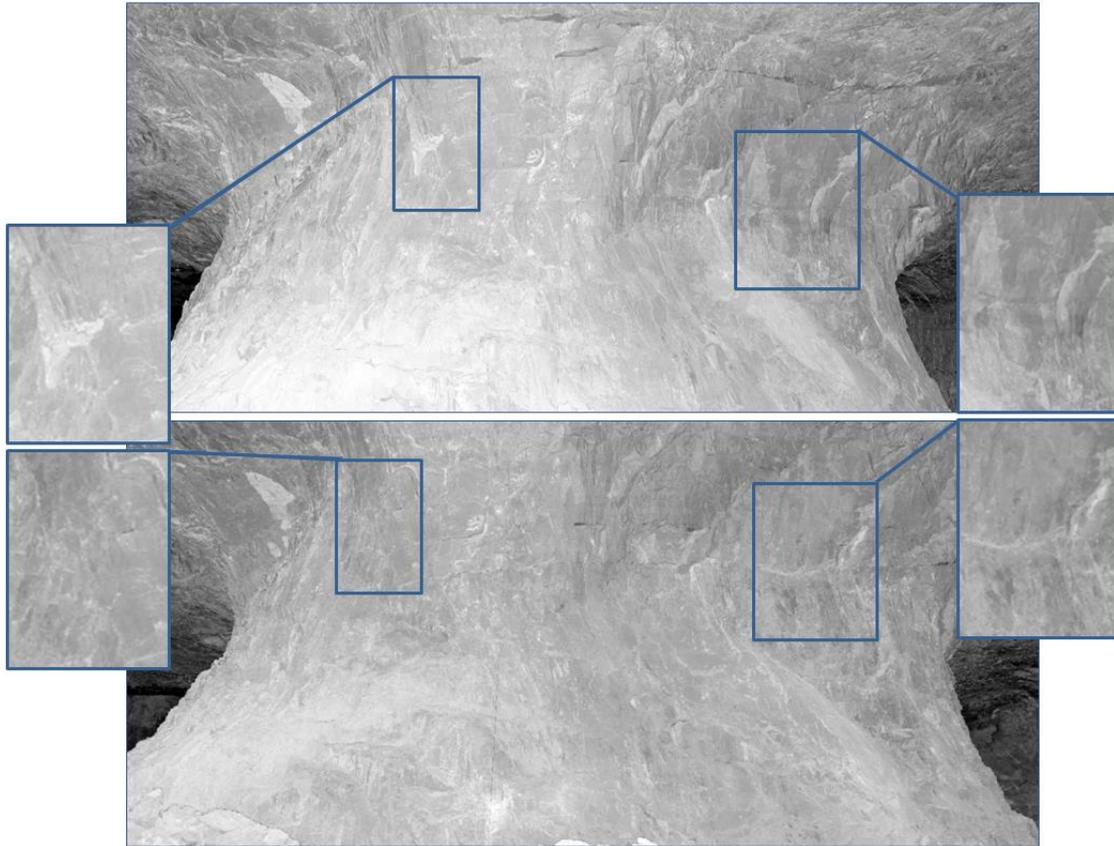
Figure 3.4: Difference between the initial and final scan at Pillar B, with areas of change highlighted

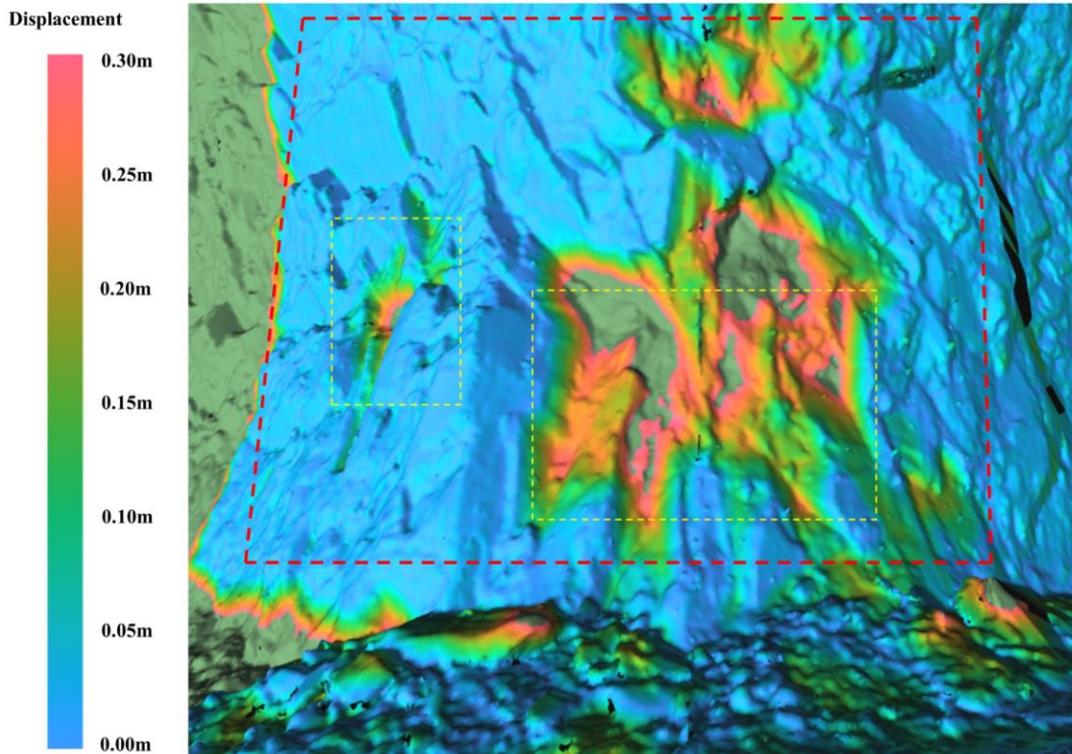
Figure 3.5: Volumetric change on Pillar A with highlighted areas containing noticeable visual change

The magnitude of displacement is visually realized by determining the difference between two surfaces, created by triangulating the initial and final point clouds separately. The change in pillar geometry from the initial to final scan (at the same viewing location shown in Figure 3.3) is shown in Figure 3.5. The change in pillar geometry from the initial to final scan (at the same viewing location shown in Figure 3.4) is shown in Figure 3.6.

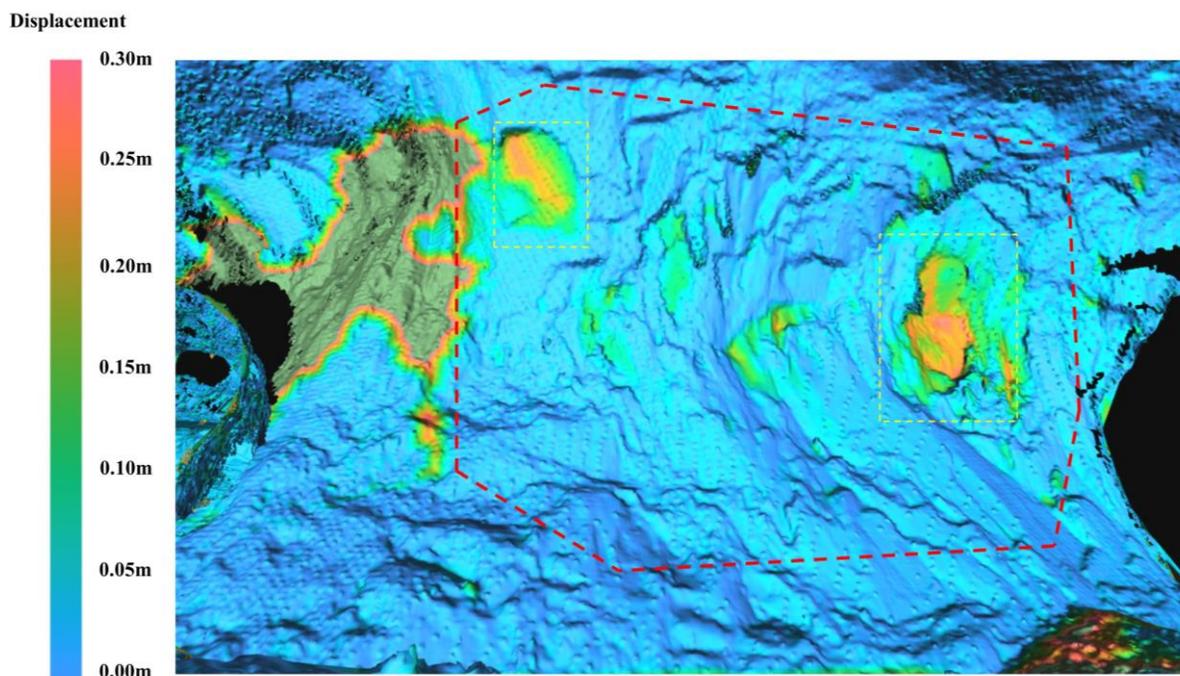
Figure 3.6: Rib deformation on Pillar B with yellow boxes denoting areas containing noticeable visual change from Figure 4, and the red dotted line enclosing the area for deformation calculations

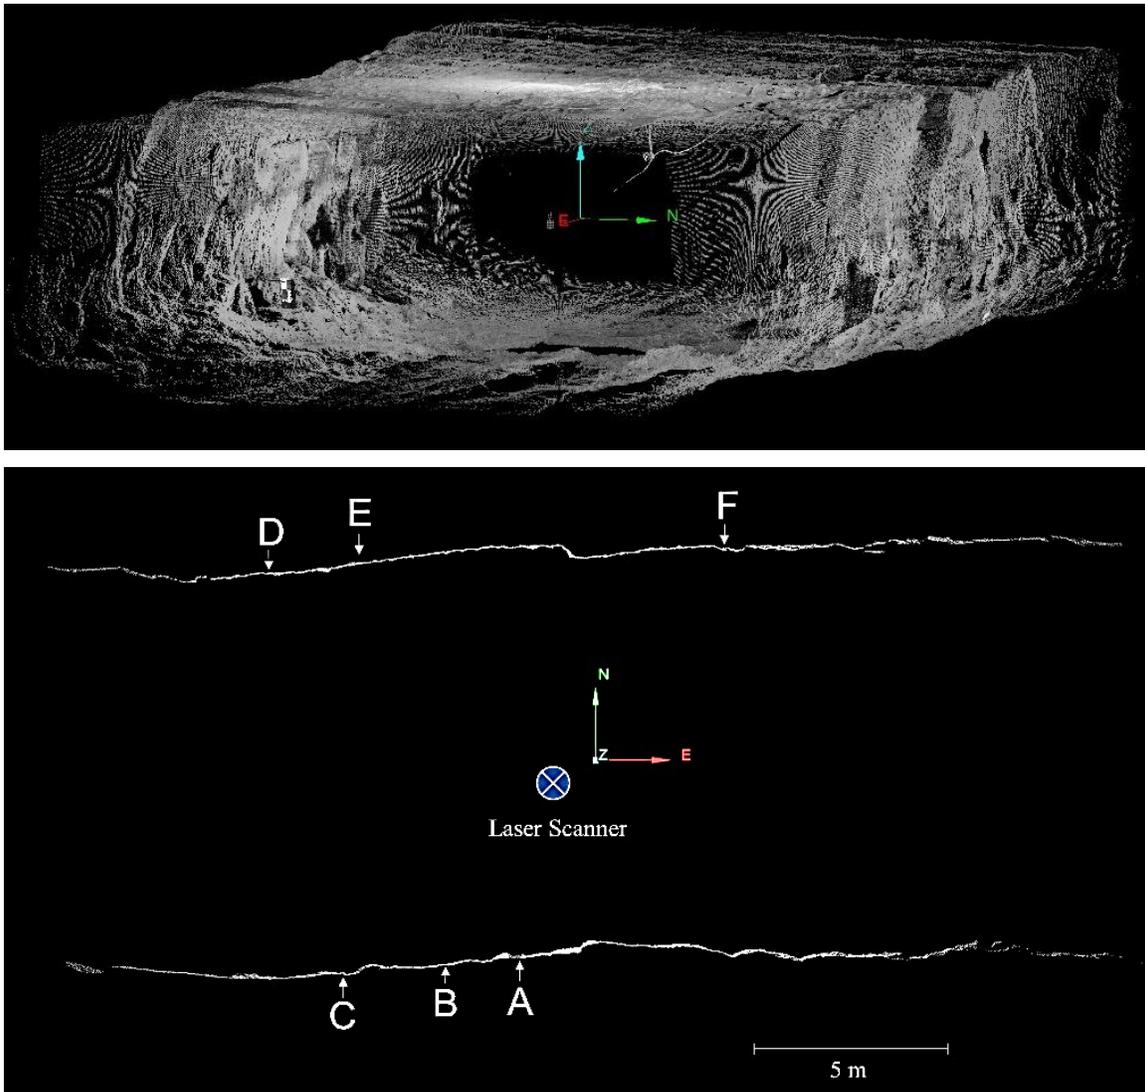
Figure 4.1: Study area and locations of removed coal

removal of coal from the ribs. Coal was removed in six locations, three from a barrier pillar to one side of the entry and three from an interior pillar on the opposite side of the entry as the barrier pillar. Varying amounts of material were removed ranging from tens of cubic centimeters to tens of thousands of cubic centimeters. The locations of the removed material are shown in Figure 4.1, Figure 4.2, and Figure 4.3. The rock dusting of the rib face gives the entry a gray color, and exposing the underlying coal highlights the areas of change in black.

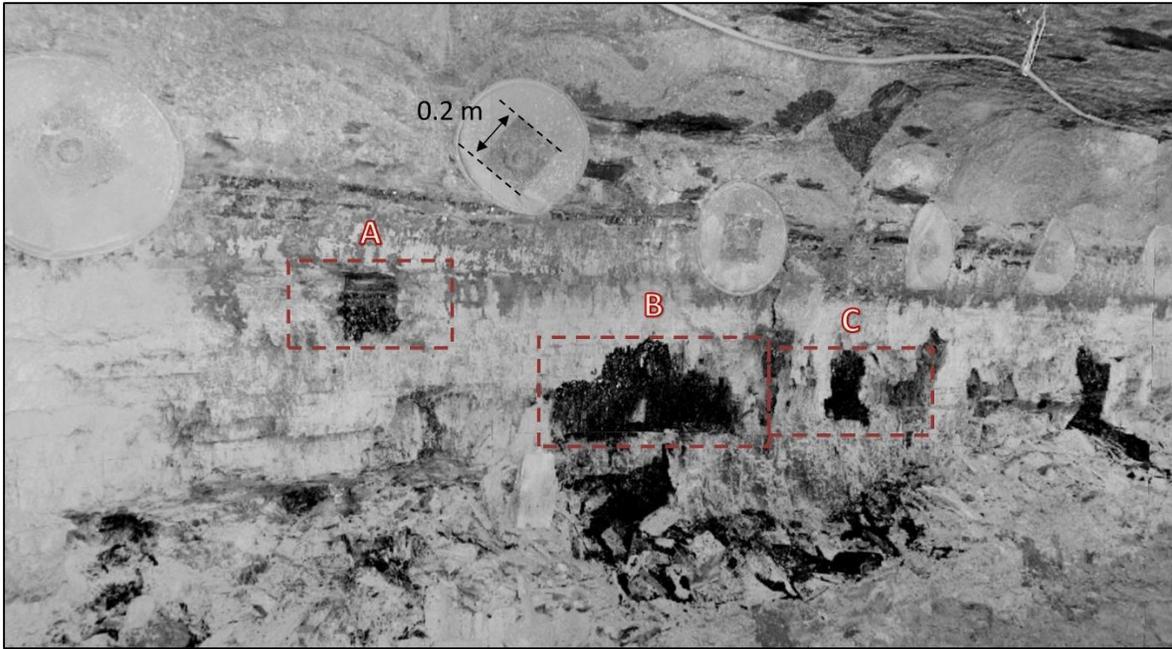
Figure 4.2: Coal removal locations A, B, and C from the barrier pillar

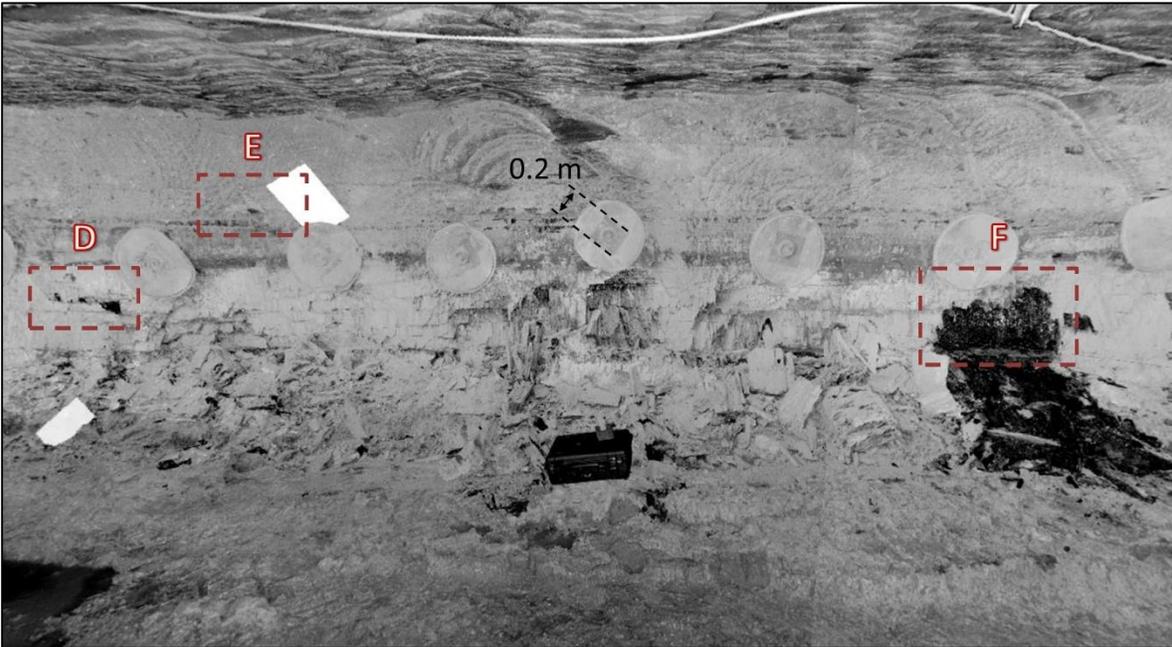
Figure 4.3: Coal removal locations D, E, and F from the interior pillar

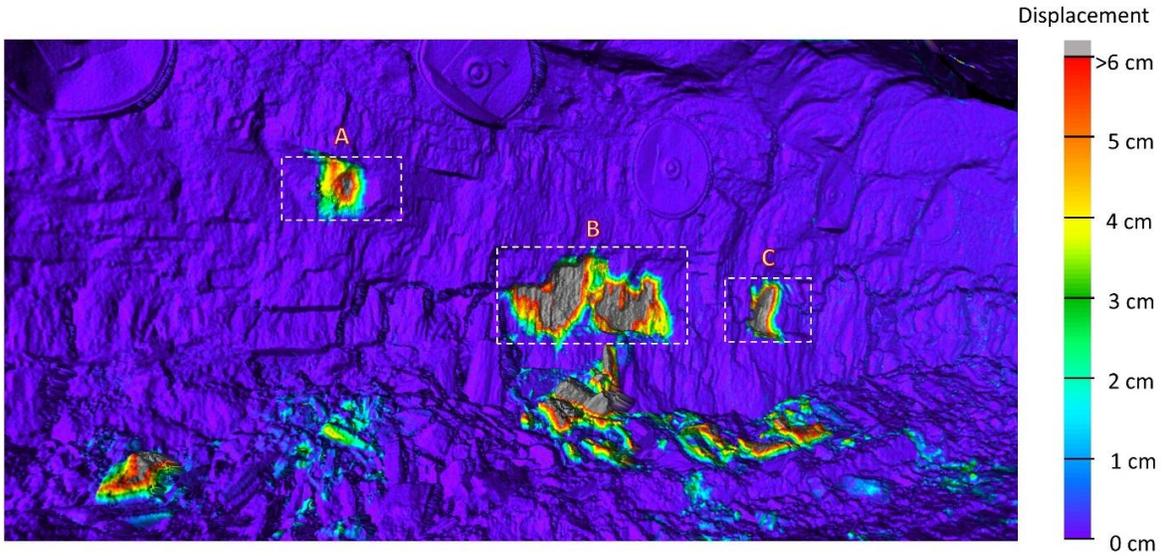
Figure 4.4: Surface change from coal removal on the barrier pillar at locations A, B, and C

The point clouds from each scan were then formed into a three-dimensional surface by converting the individual points into triangle vertices. This triangulated surface was created using the Maptek I-Site [94] software's spherical triangulation feature. The spherical triangulation method projects the points in the scene onto a unit sphere with a chosen center point. A triangulated surface is created in a latitude and longitude coordinate system using Delaunay constraints before being returned to its original coordinate system. This method of triangulation is particularly effective when modeling undercut or overhanging surfaces. I-Site was also used to measure the difference in features between the two triangulation surfaces. Figure 4.4 shows the surface changes on the barrier pillar, while Figure 4.5 shows the surface changes on the interior pillar. The surface change, as colored, represents a distance of each vertex to the nearest vertex in the first scan, not necessarily the perpendicular distance into the wall. The color scale reflects an absolute change in position rather than a signed value. This is most evident when rendering the same colored surface change in both Area F and the area immediately below it, where Area F is experiencing negative surface change (into the wall) through losing material while the area below it is experiencing positive surface change (towards the scanner) by accumulating material.

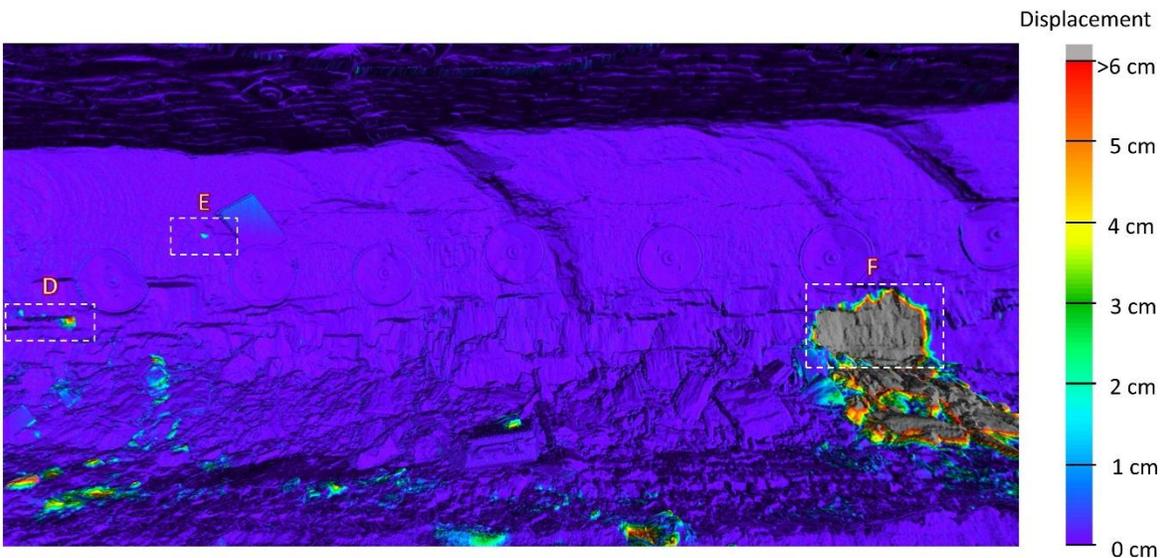
Figure 4.5: Surface change from coal removal on the interior pillar at locations D, E, and F

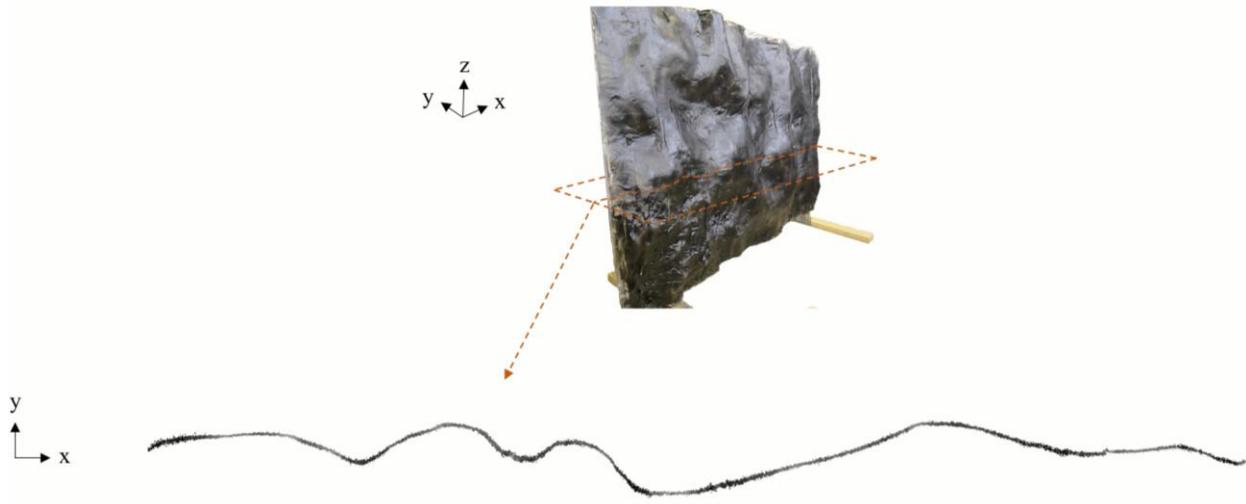
Figure 4.6: Cross-section of the SCR

A synthetic coal rib (SCR) was constructed to determine the precision of laser scanning on a coal rib in an environment where the deformation and convergence are known. It is experimentally difficult to precisely control deformation underground, but the SCR fulfills the need for controlled deformation and an uneven surface capable of providing occlusions and unfavorable curvatures. The SCR, cross section shown in Figure 4.6, extends 1.8 m horizontally, 1.2 m vertically, and has a depth that varies 0-12 cm from its foundation, simulating irregularity in a rib face. Other statistical measures of the SCR can be found in Table 4.2. The SCR is comprised of a wooden frame with overlain wire mesh and composite material, which was sculpted into an irregular shape with reflectance properties similar to that of bituminous coal.

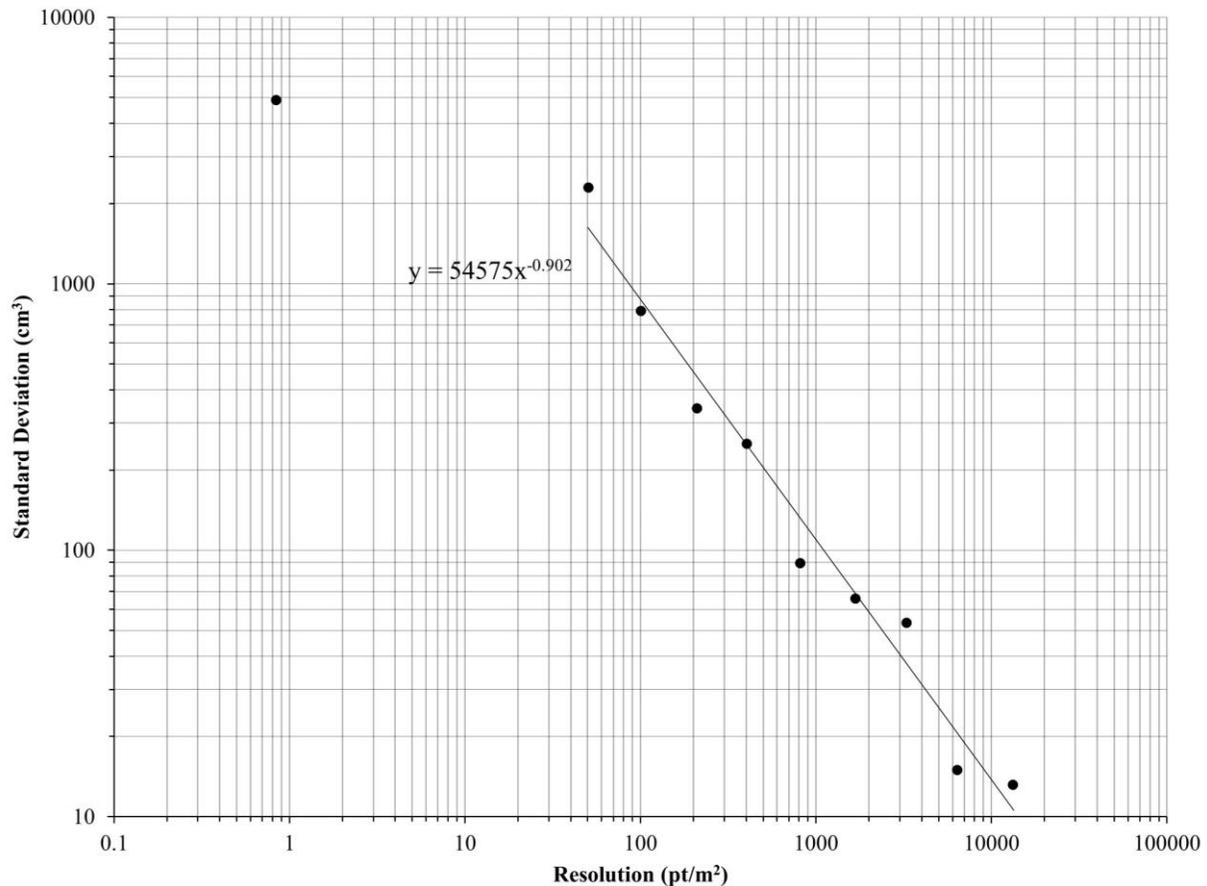
Figure 4.7: Standard deviation of volume calculations for varying scan resolutions

The average volumes displaced for all the different resolutions differ from the true volume of 59550 cm³ by between -1.47 and 0.62 %. However, the average volume displaced would likely approach the true volume, given enough trials, even at the lowest sampling density. The negative values for volume error at 15800 and 7600 points do not necessarily represent an inaccurate set of scans, but may be indicative of a more precise reading of the distance the SCR moved than was originally recorded by line gauge. An indicator of measurement reliability is the standard deviation, which increases significantly as resolution decreases, as illustrated in Figure 4.7. The relative standard deviation of volume change varies from 0.02% at the highest resolution to 8.27% at the lowest resolution.

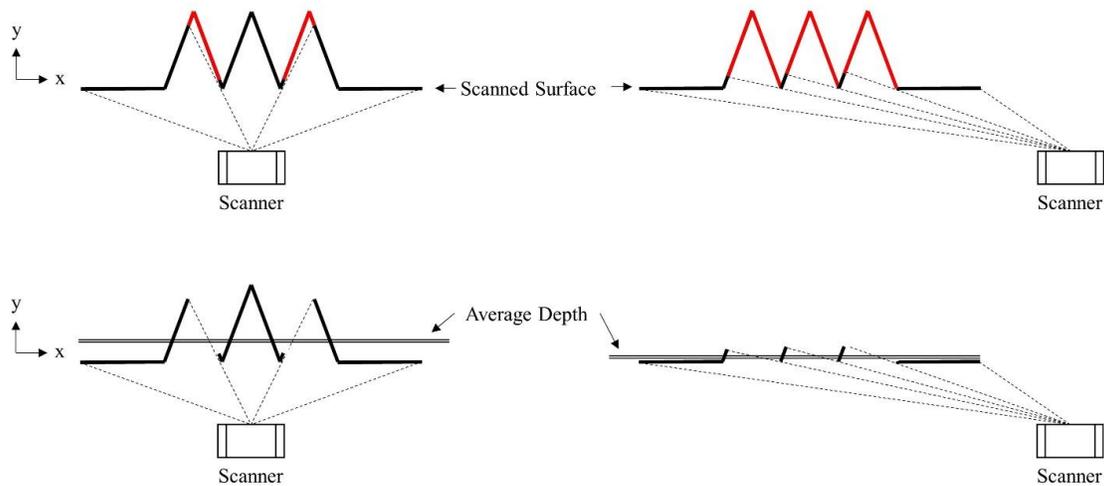
Figure 4.8: Effect of uneven geometry on point cloud coverage

precision to which a surface change can be monitored when subsequent scans are performed from different locations and at high angles of incidence. Errors in volume change calculations due to movement of the scanner are likely to be caused by: surveying errors locating subsequent scanner locations, a reduced resolution of the target area, or an increase or decrease in shadows cast on the area of interest, shown in Figure 4.8. The errors associated with locating the scans can be controlled by ensuring care is taken that references are not disturbed between scans, such as movement due to ventilation air.

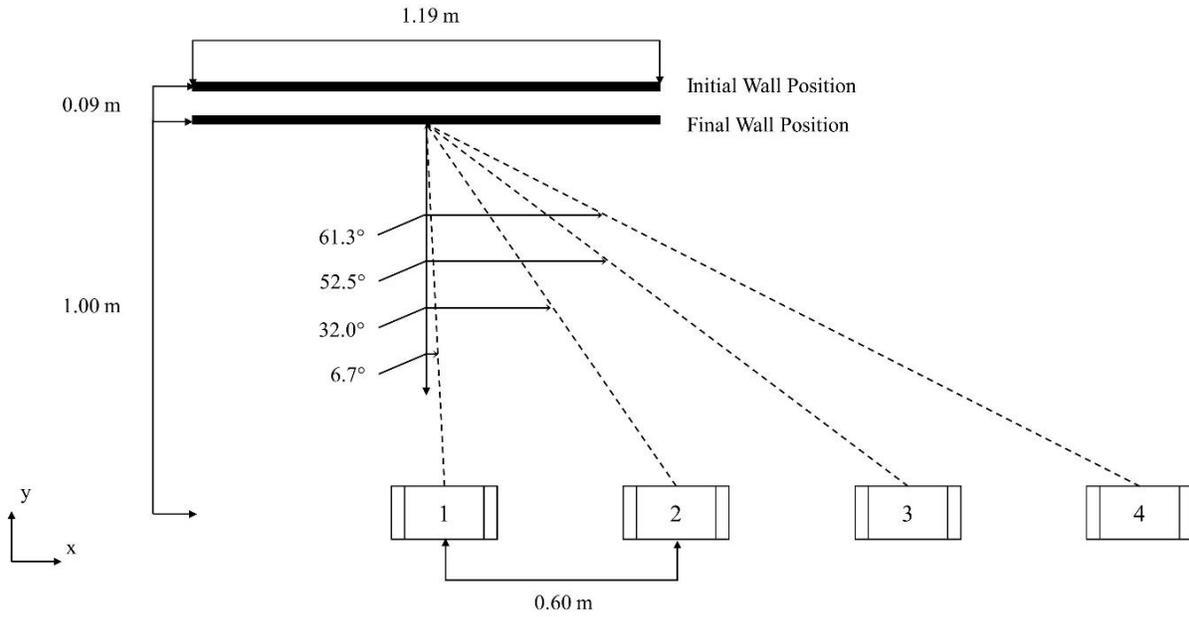
Figure 4.9: Angle of incidence sensitivity test scanner positions

To determine the effect that moving the scanner can have on volume change measurements, the SCR was scanned at a high resolution and then moved 9 cm towards the scan locations. The initial scanner position, after SCR movement, was approximately 1.0 m from the centroid of the SCR (Position 1) with an angle of incidence at the centroid of 6.7° . Subsequent scans were each moved 0.6 m parallel to the SCR after each scan, creating angles of incidence of 32.0° (Position 2), 52.5° (Position 3), and 61.3° (Position 4). These scanner positions are shown in Figure 4.9. In order to maintain similar point densities as the initial test, Position 1, which most resembles the conditions of the first test, was subsampled down to 13000 pts/m², with the other positions maintaining the same percentage decrease in point density. The standard deviations of the volume calculations from those scans are given in Figure 4.10. If the experiment were to be scaled to actual mine geometries, these distances would be represent approximately 27 cm of rib movement, a perpendicular distance of 3 m from the face, and incremental scanner distances of 2 m.

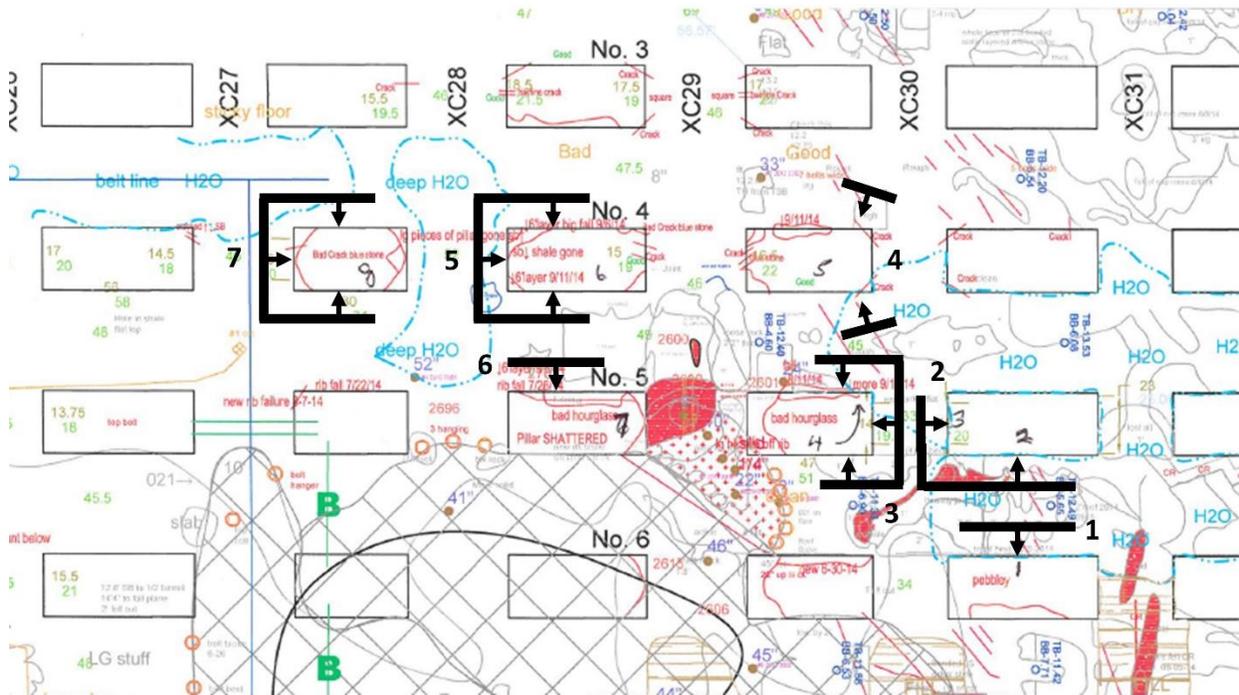
Figure 5.1: Map of the photographed areas of the mine with pillars numbered

A map of the pillars that were photographed is shown in Figure 5.1. The pillars are on the boundary of a collapsed area. The number of photographs taken of each pillar is listed in Table 5.2. With the need to move the light sources, the pictures were not taken continuously surrounding the pillar, but rather in distinct segments, fragmenting the pillar into “sides” instead of one contiguous object. Further displacement of material, through spalling, on these pillars was expected, but the magnitude of material being displaced was unknown.

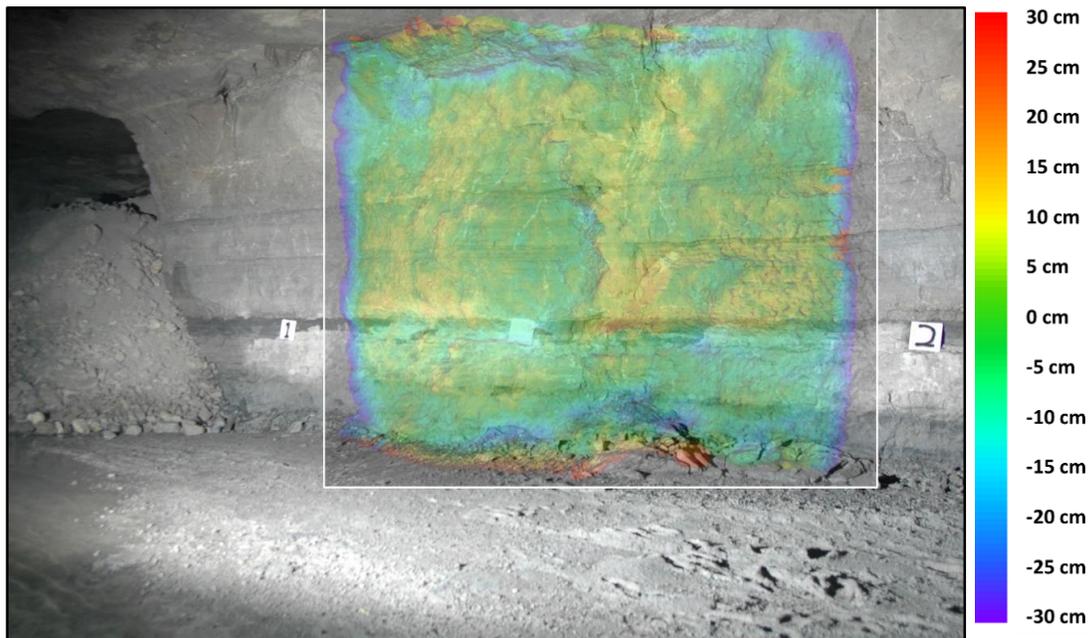
Figure 5.2: Change at Pillar 1 between September 16th and September 26th
