Monitoring Underground Mine Displacement Using Photogrammetry and Laser Scanning

*Dissertation submitted to the faculty of the Virginia Polytechnic Institute and State University in
partial fulfillment of the requirements for the degree of*

Mining Engineering

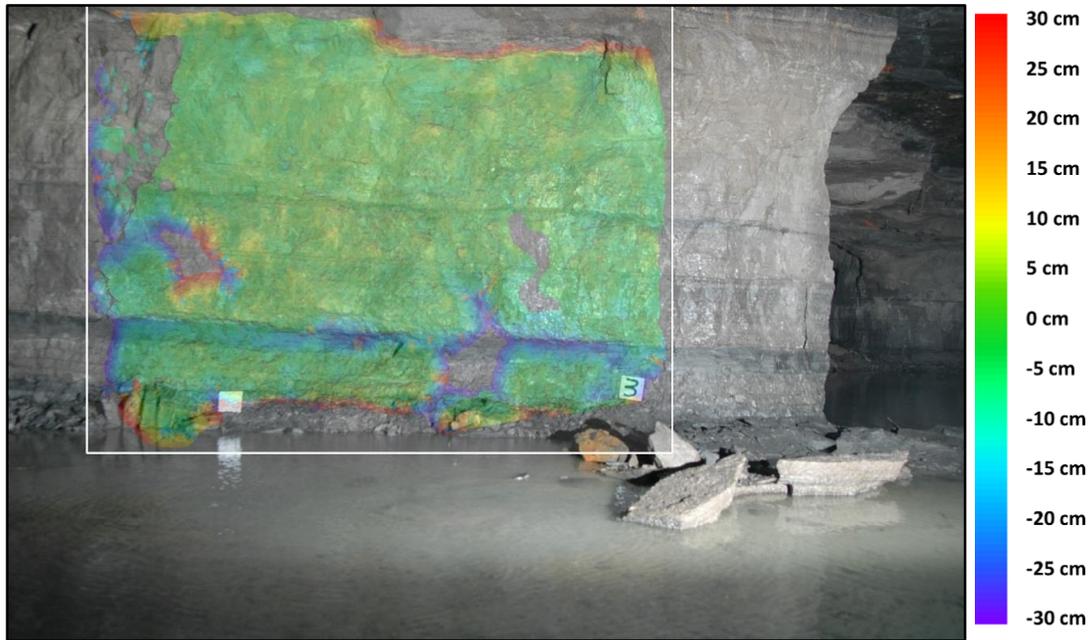
Figure 5.3: Change at Pillar 2 between September 16th and September 26th

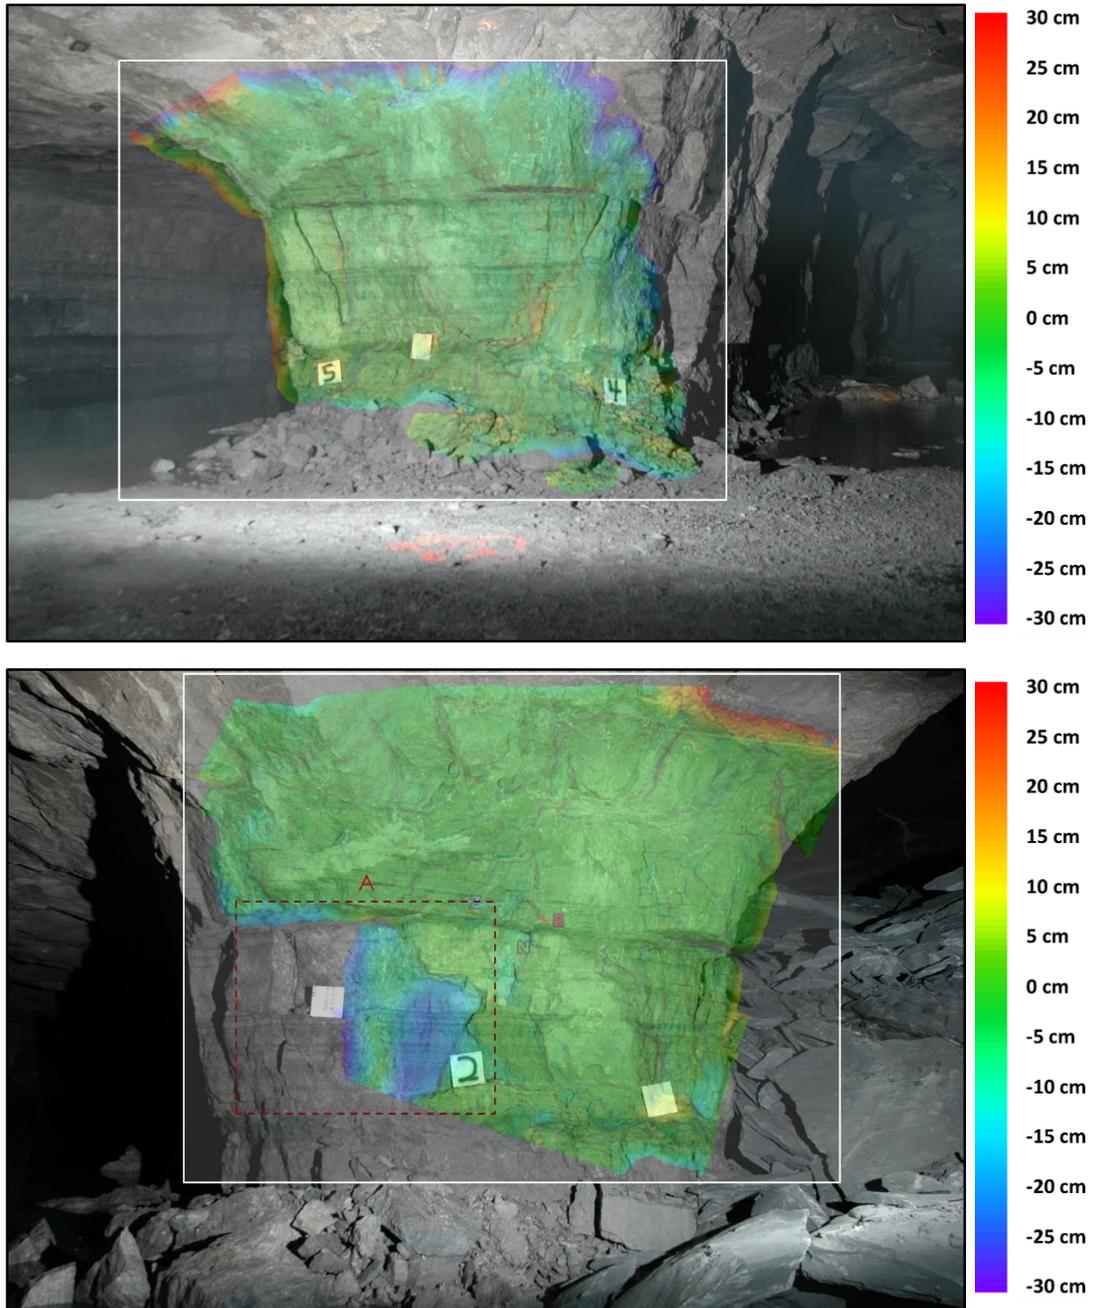
Figure 5.4: Change at Pillar 2 from Sep. 16th to Sep 26th (top) and Sep. 26th to Oct. 28th (bottom)

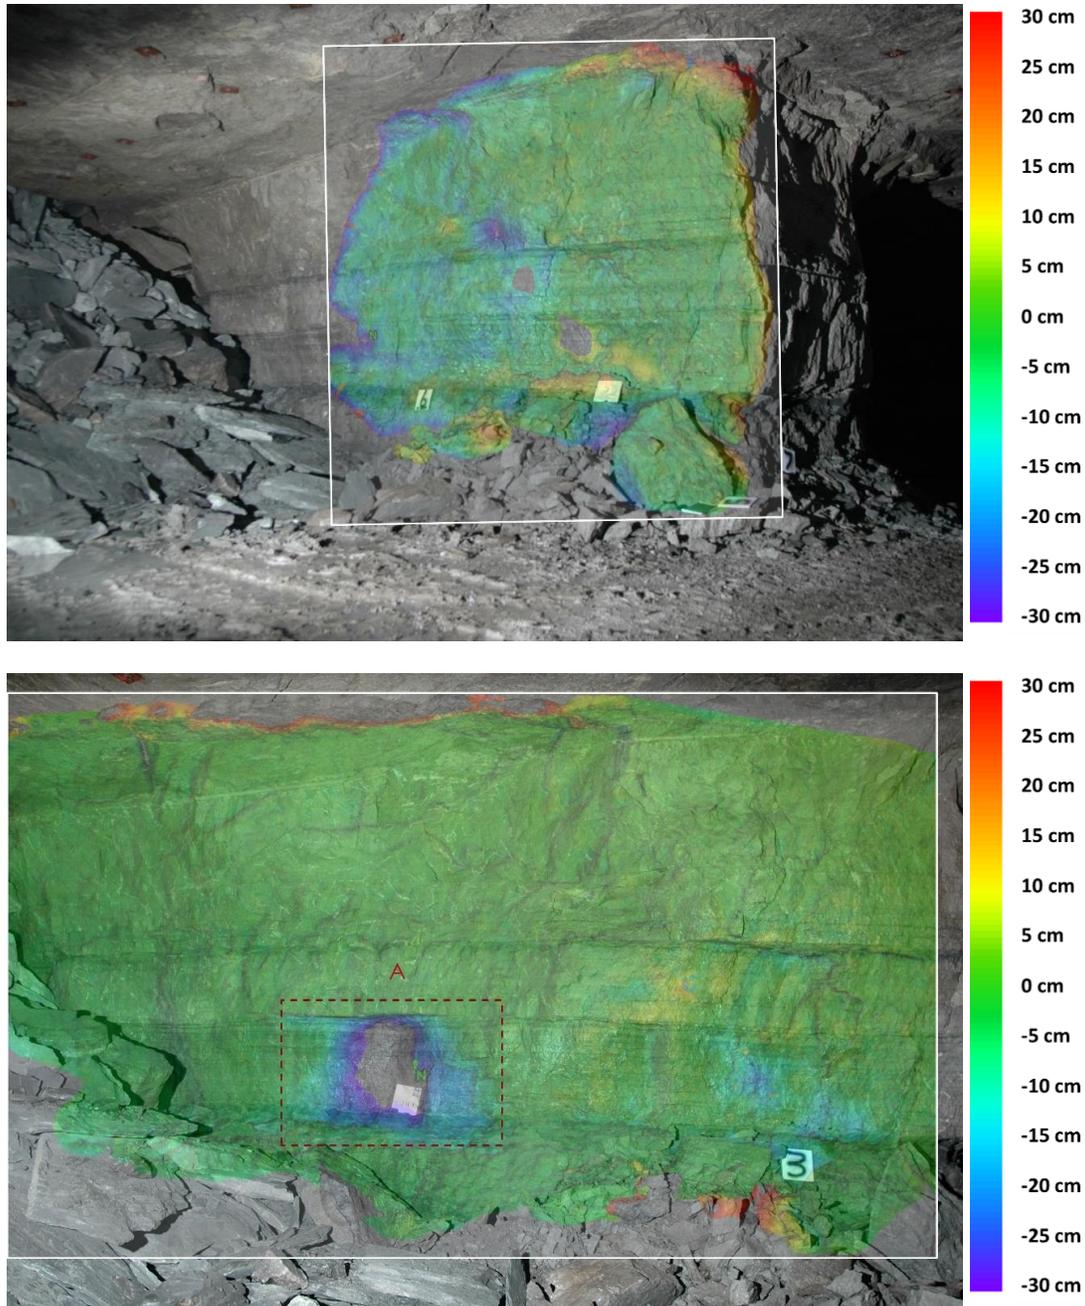
Figure 5.5: Change at Pillar 3 from Aug. 26th to Sep. 26th (top) and Sep. 26th to Oct. 28th (bottom)

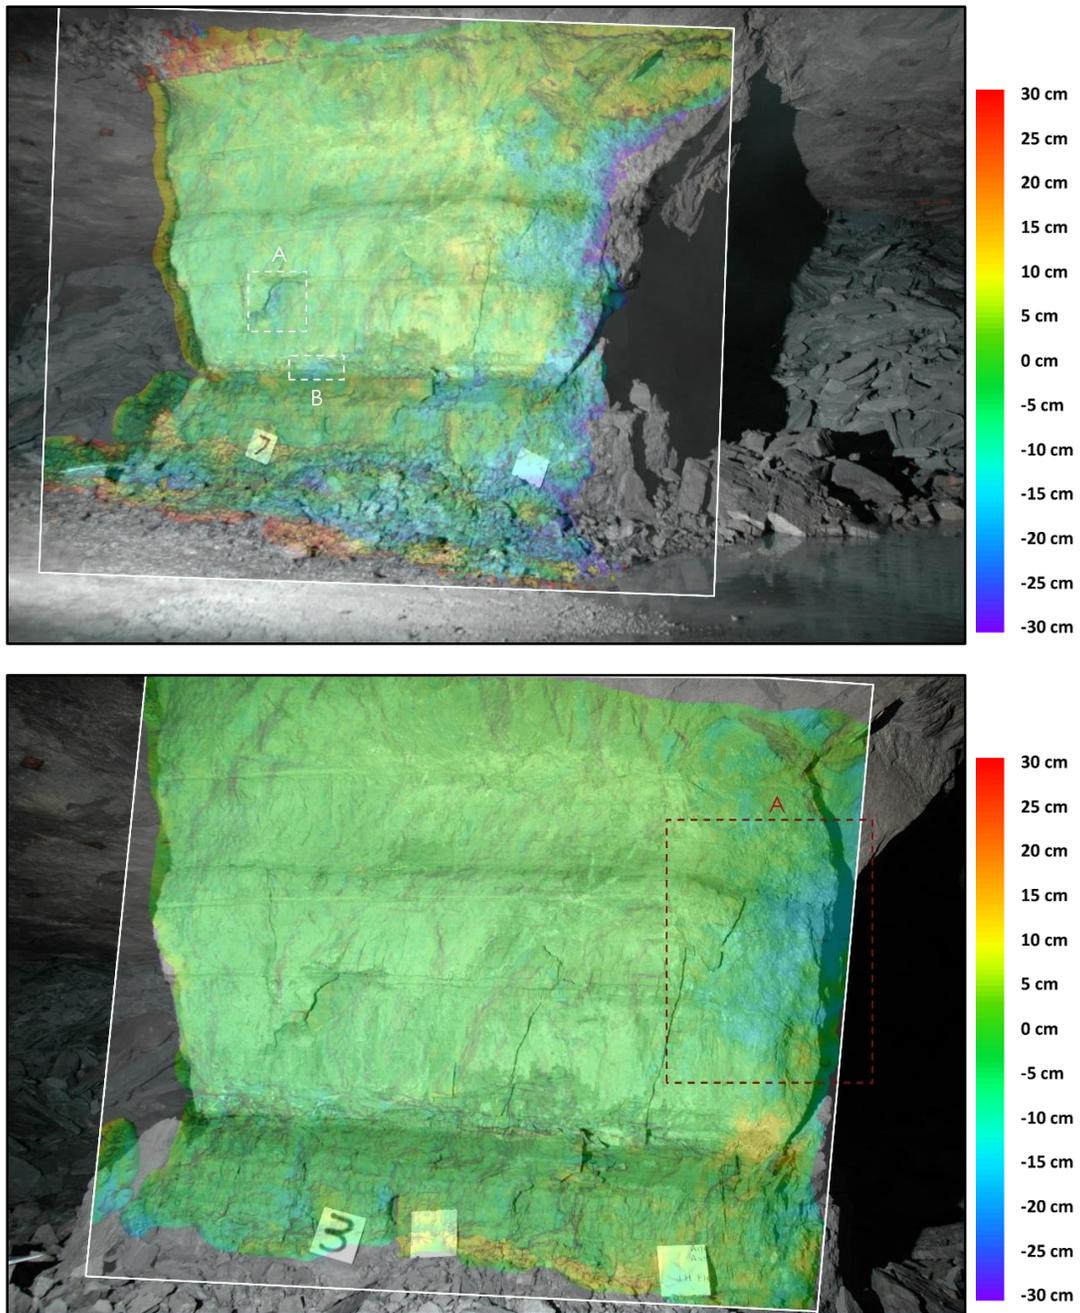
Figure 5.6: Change at Pillar 3 from Aug. 26th to Sep. 26th (top) and Sep. 26th to Oct 28th (bottom)

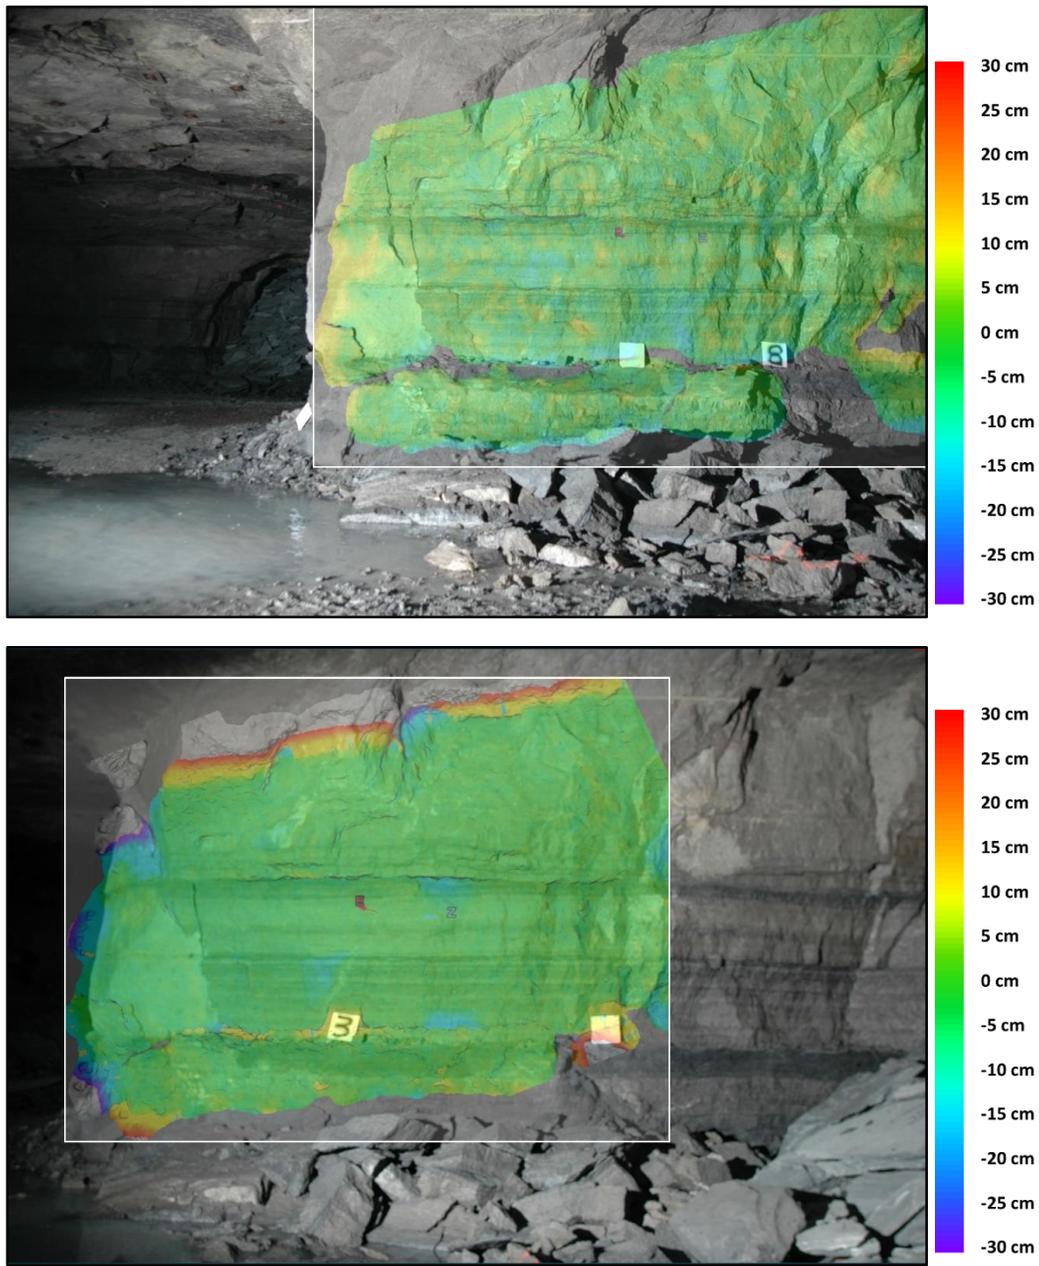
Figure 5.7: Change at Pillar 3 from Sep. 16th to Sep. 26th (top) and Sep. 26th to Oct. 28th (bottom)

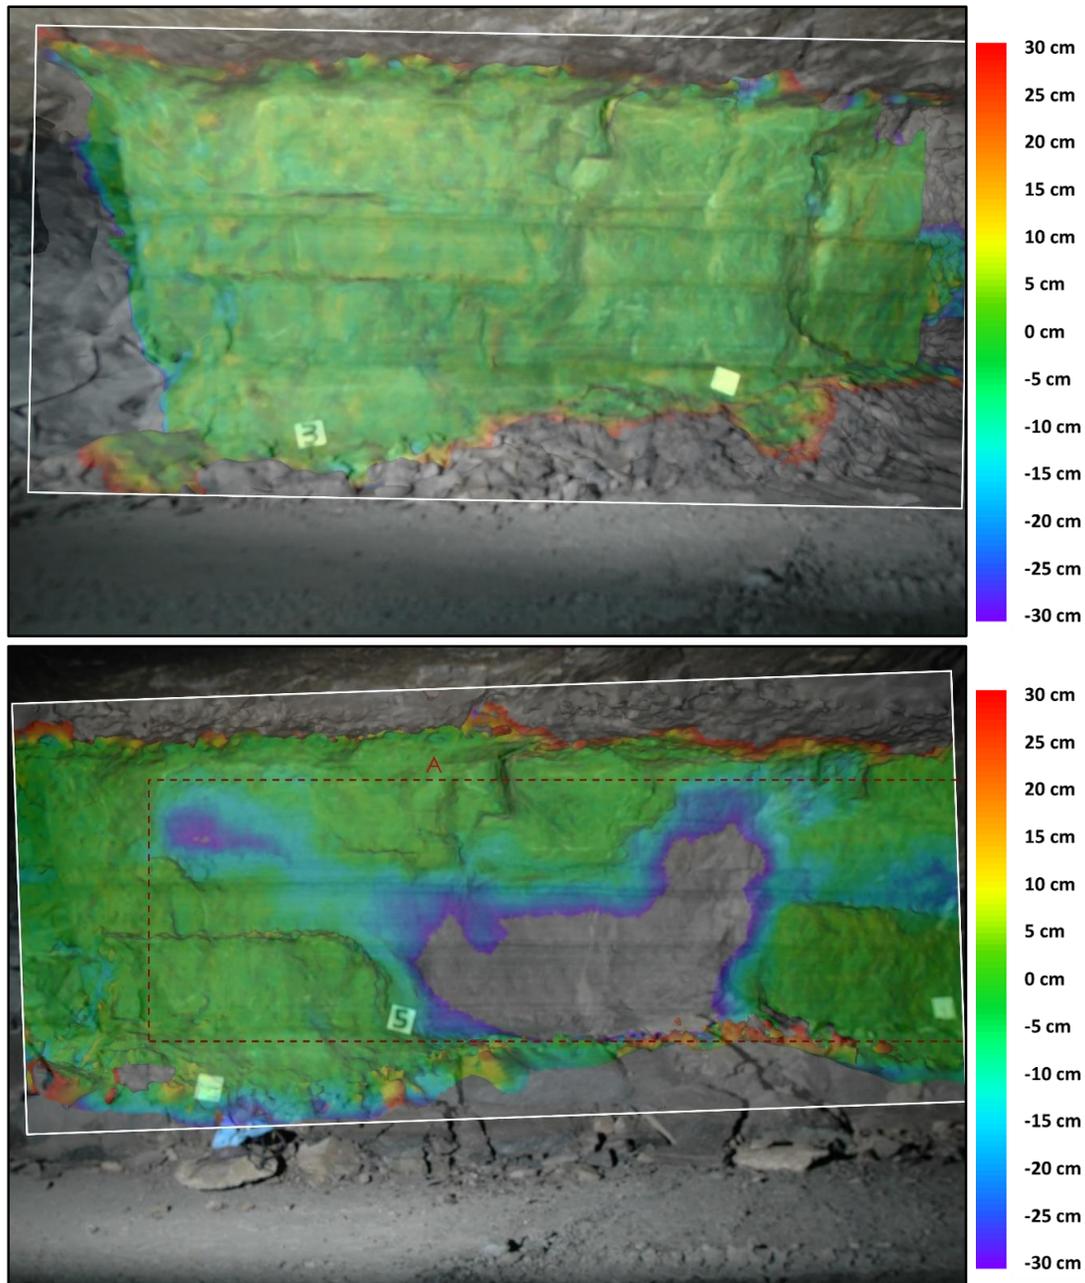
Figure 5.8: Change at Pillar 5 from Sep. 16th to Sep 26th (top) and Sep. 26th to Oct. 28th (bottom)

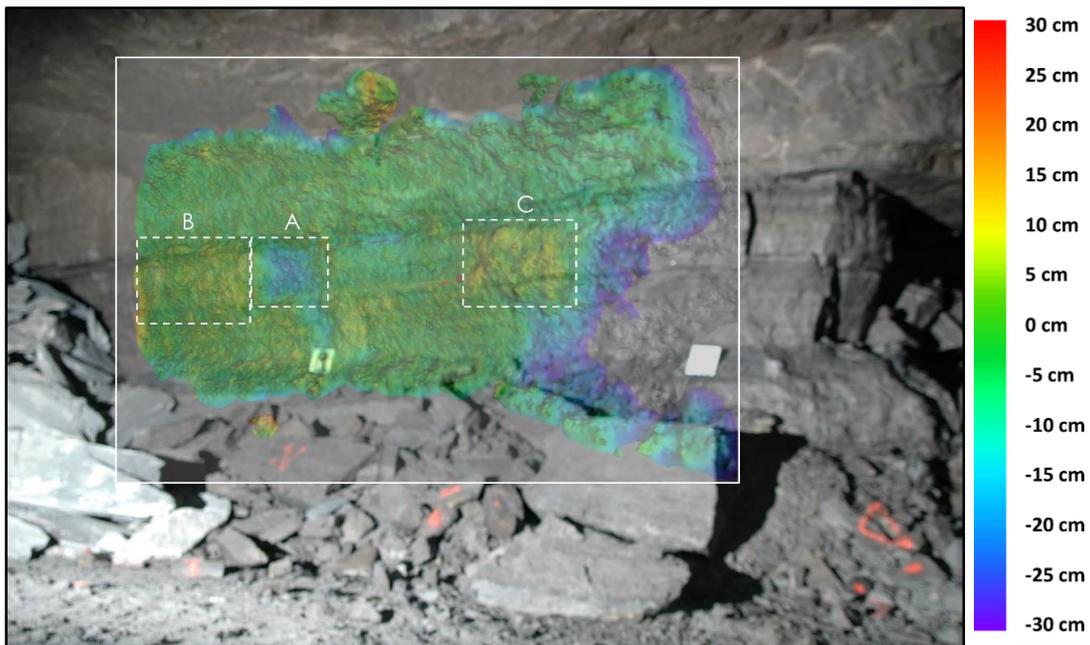
Figure 5.9: Change at Pillar 6 from Aug. 26th to Sep. 16th

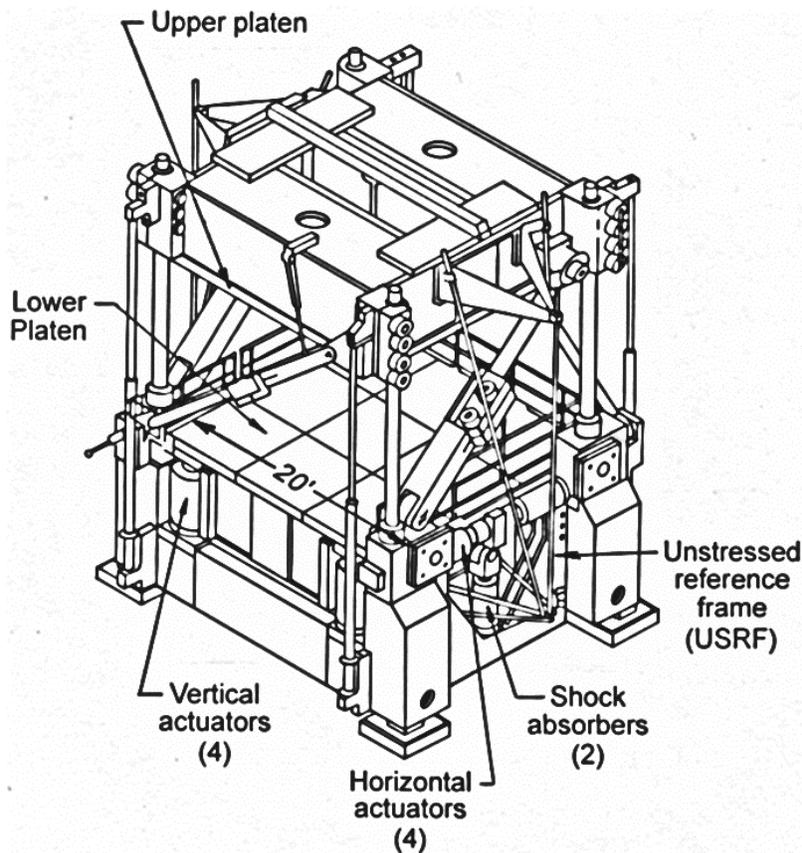
Figure 6.3: Mine Roof Simulator [107]

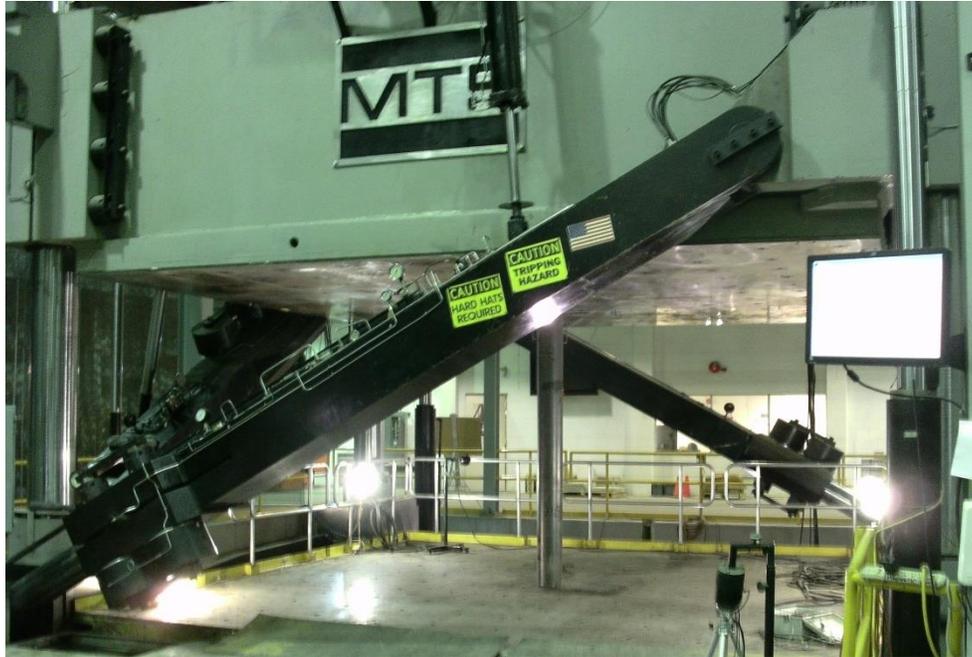
Figure 6.4: Standing support inside the MRS

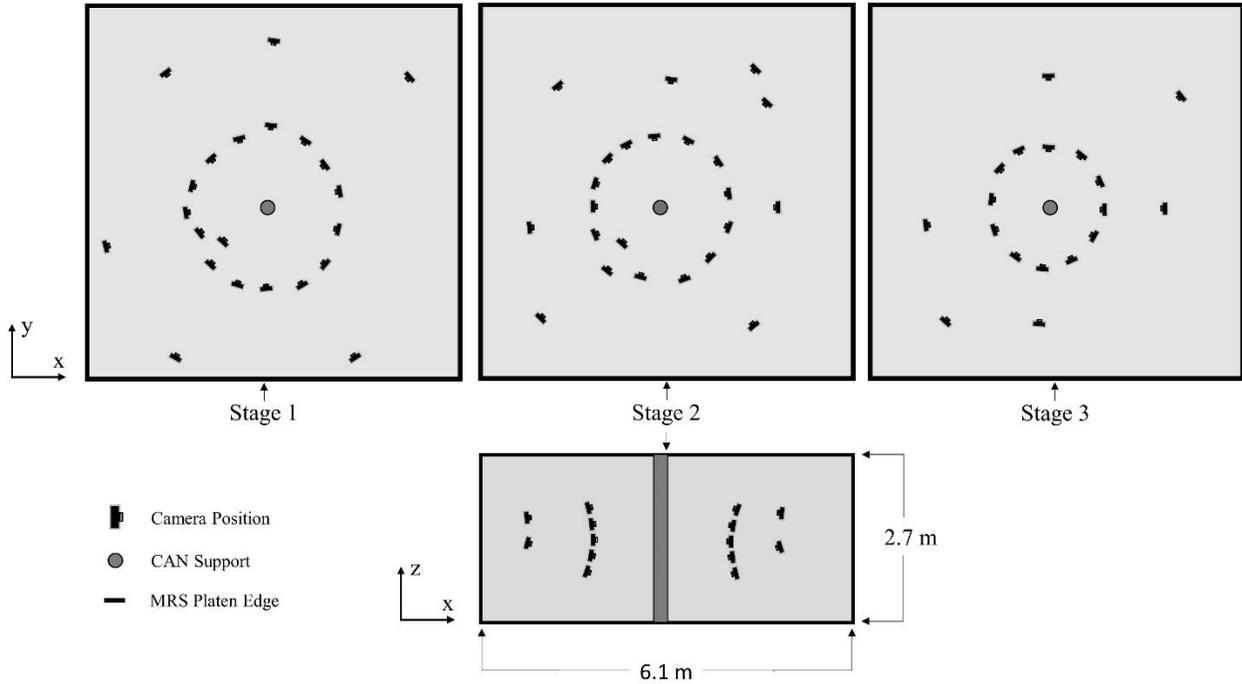
Figure 6.5: Camera positions for Stage 1, 2, and 3

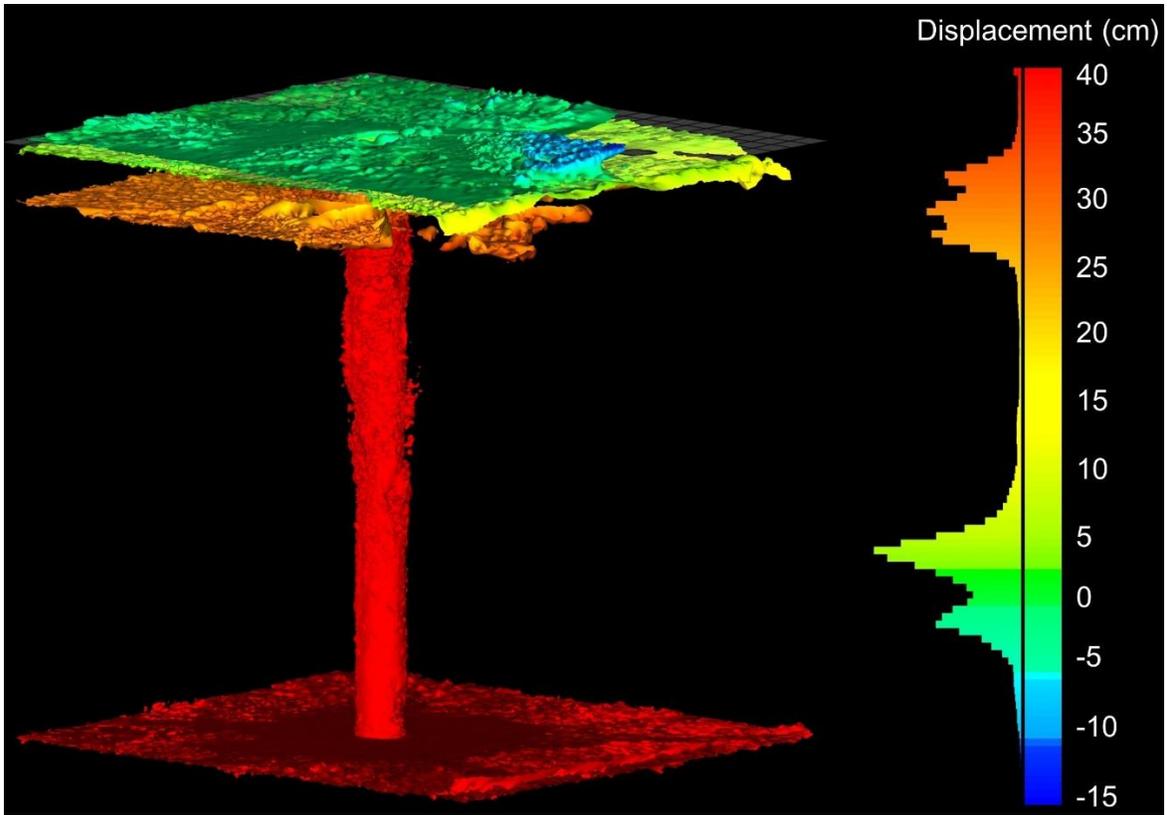
Figure 6.7: Convergence for each stage, measured as the difference between the calculated top platen positions and a construction plane at 274.9 cm

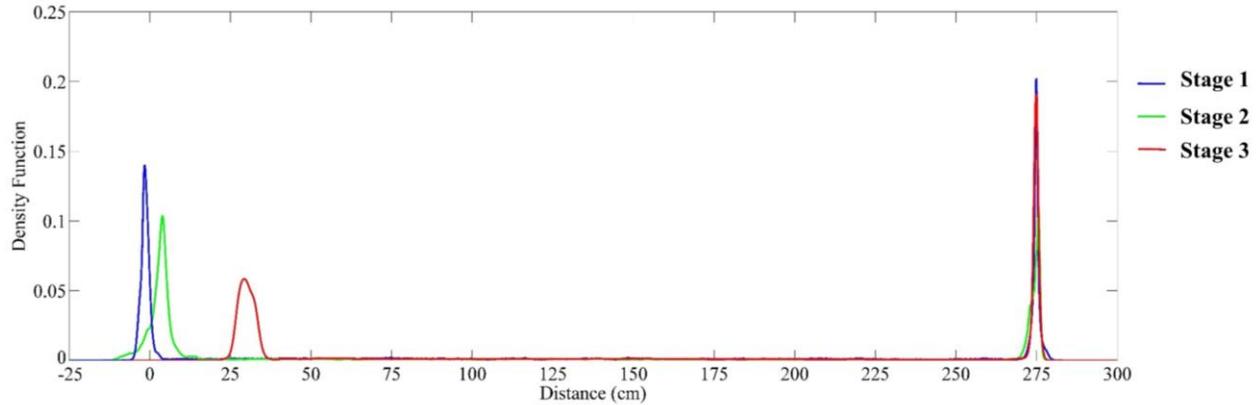
Figure 6.8: Kernel density estimation for the platen positions

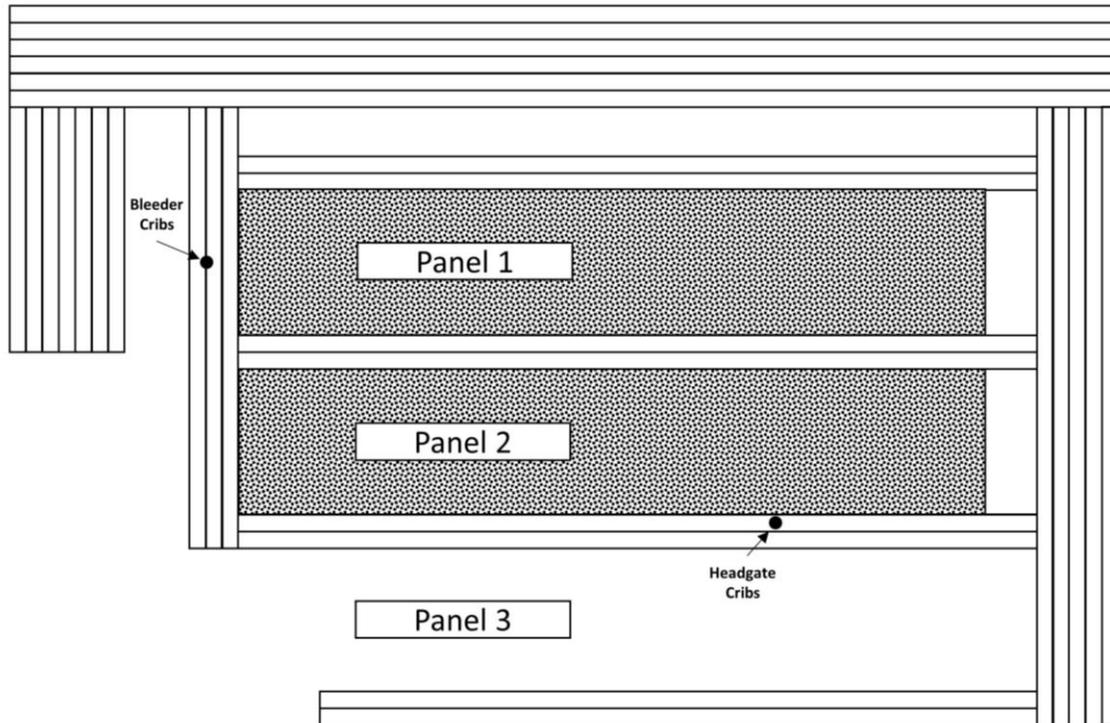
Figure 7.1: Approximate mine layout in the monitoring region. The bleeder cribs are located in the bleeder entries and the headgate cribs are located in what, at the time of monitoring, was the headgate.

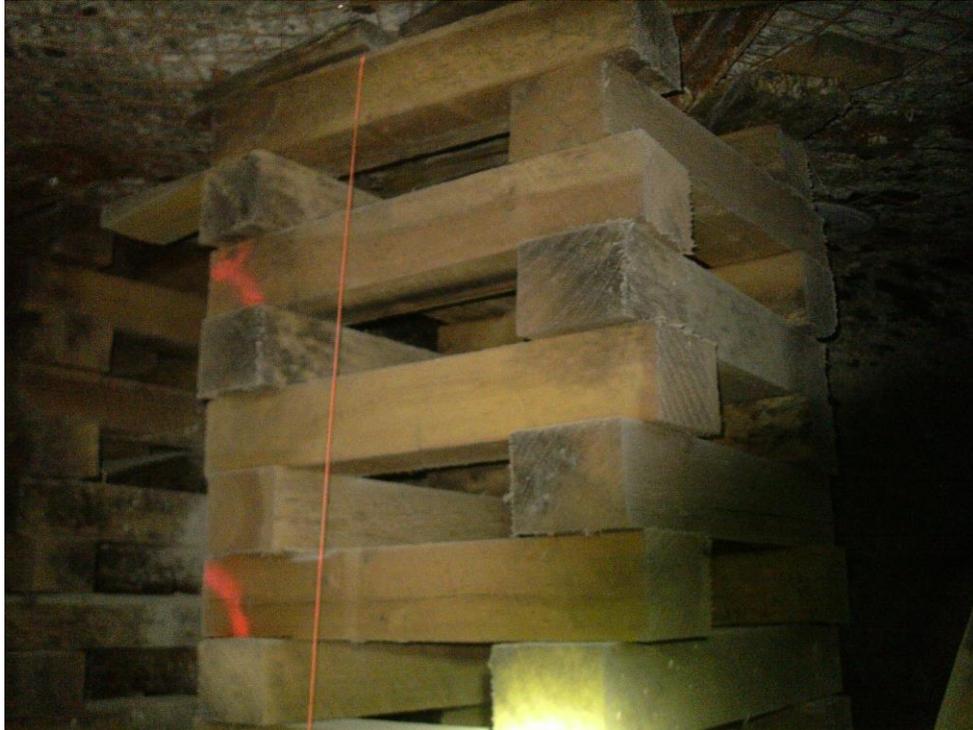
Figure 7.4: Wooden crib photogrammetry subject

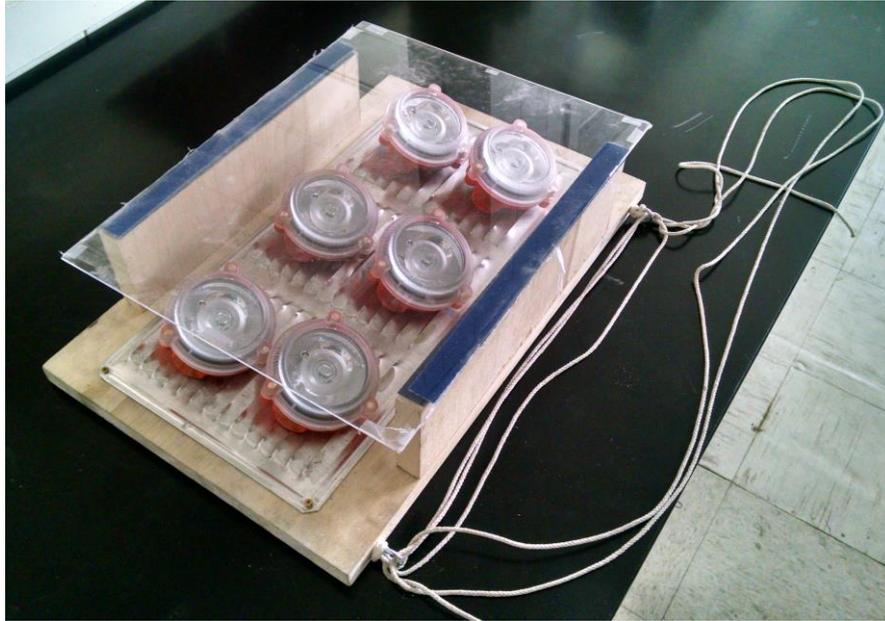
Figure 7.5: Mobile array of cap lamps for use in underground mine illumination

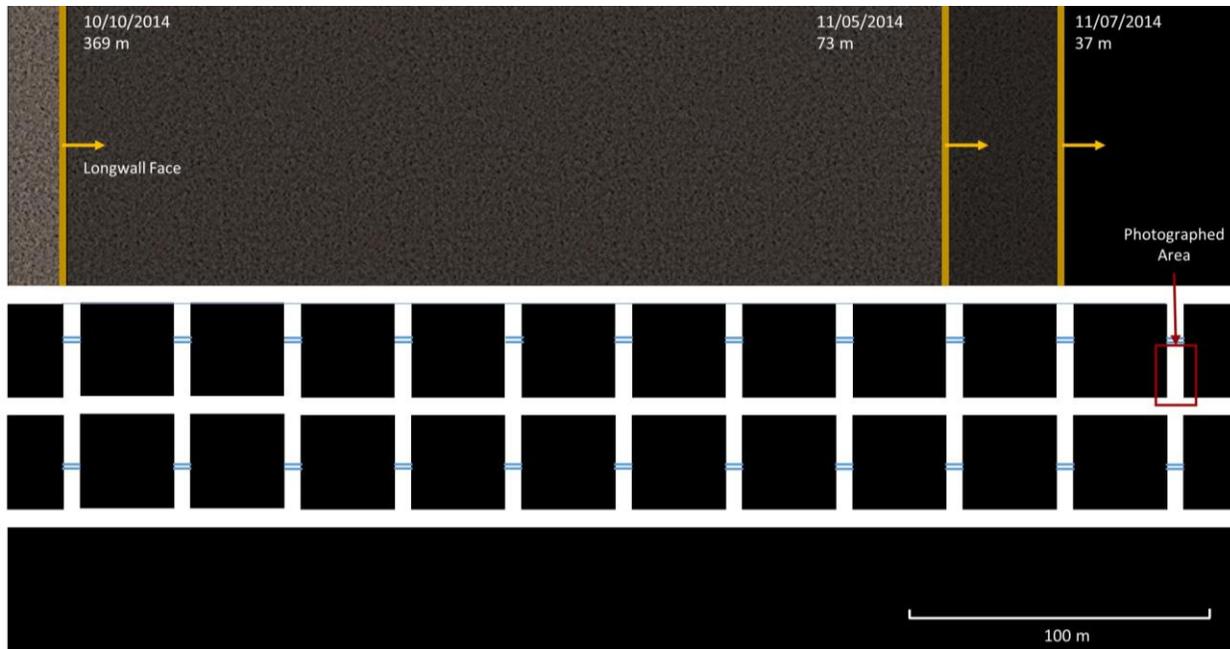
Figure 7.6: Approximate position of the longwall face relative to the photographed crosscut

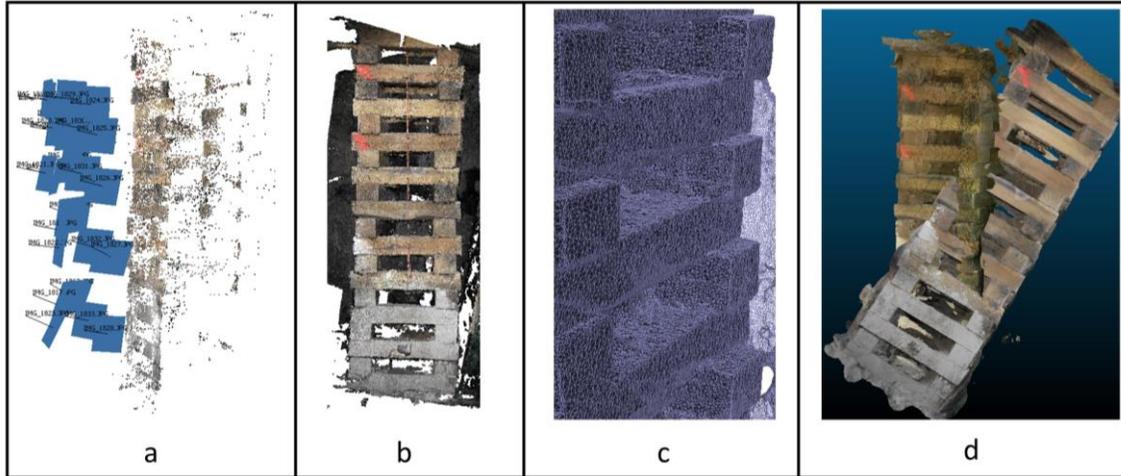
Figure 7.7: Photogrammetry workflow a) constructing a sparse point cloud in PhotoScan, b) generating a dense point cloud in PhotoScan, c) creating a wireframe model in PhotoScan, d) orienting and scaling objects in CloudCompare

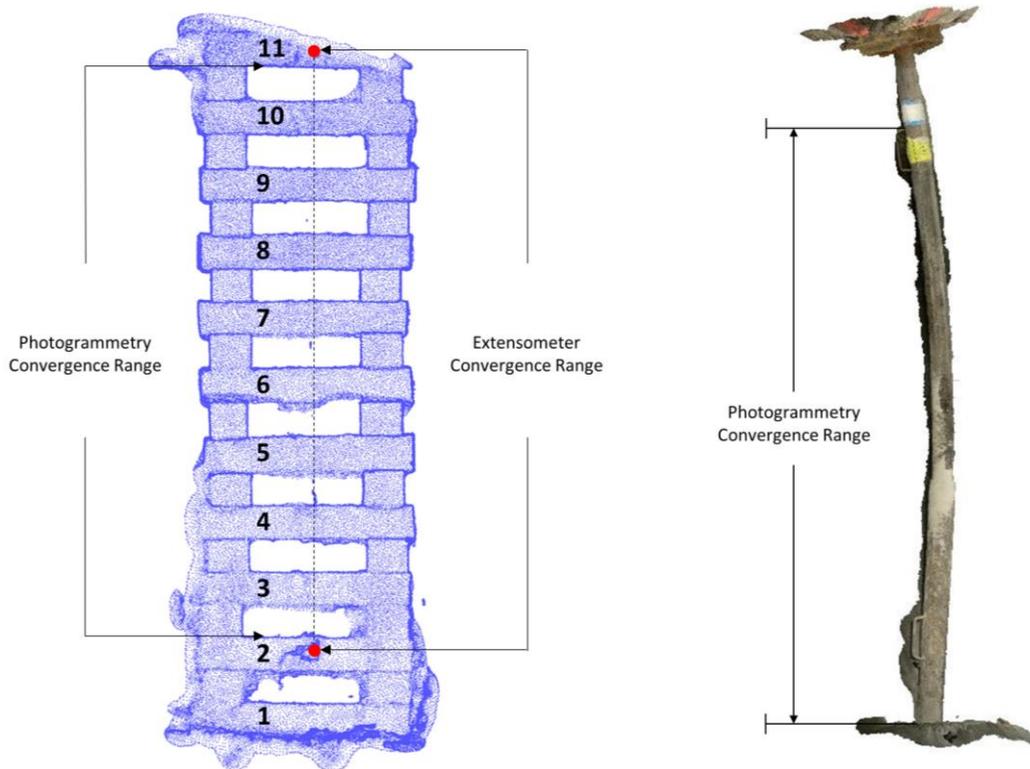
Figure 7.8: Measurement range for the extensometer and photogrammetry

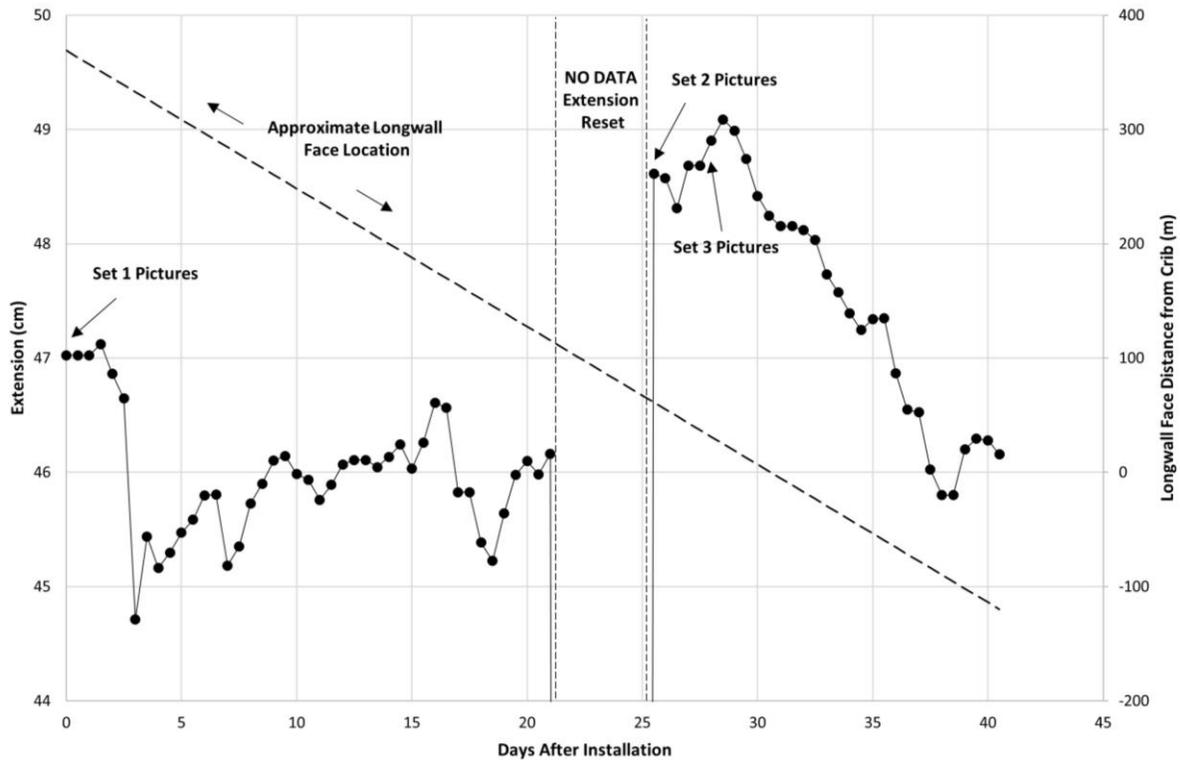
Figure 7.9: Extensometer measurements, at 12-hour intervals, for the convergence of the crib throughout the experiment

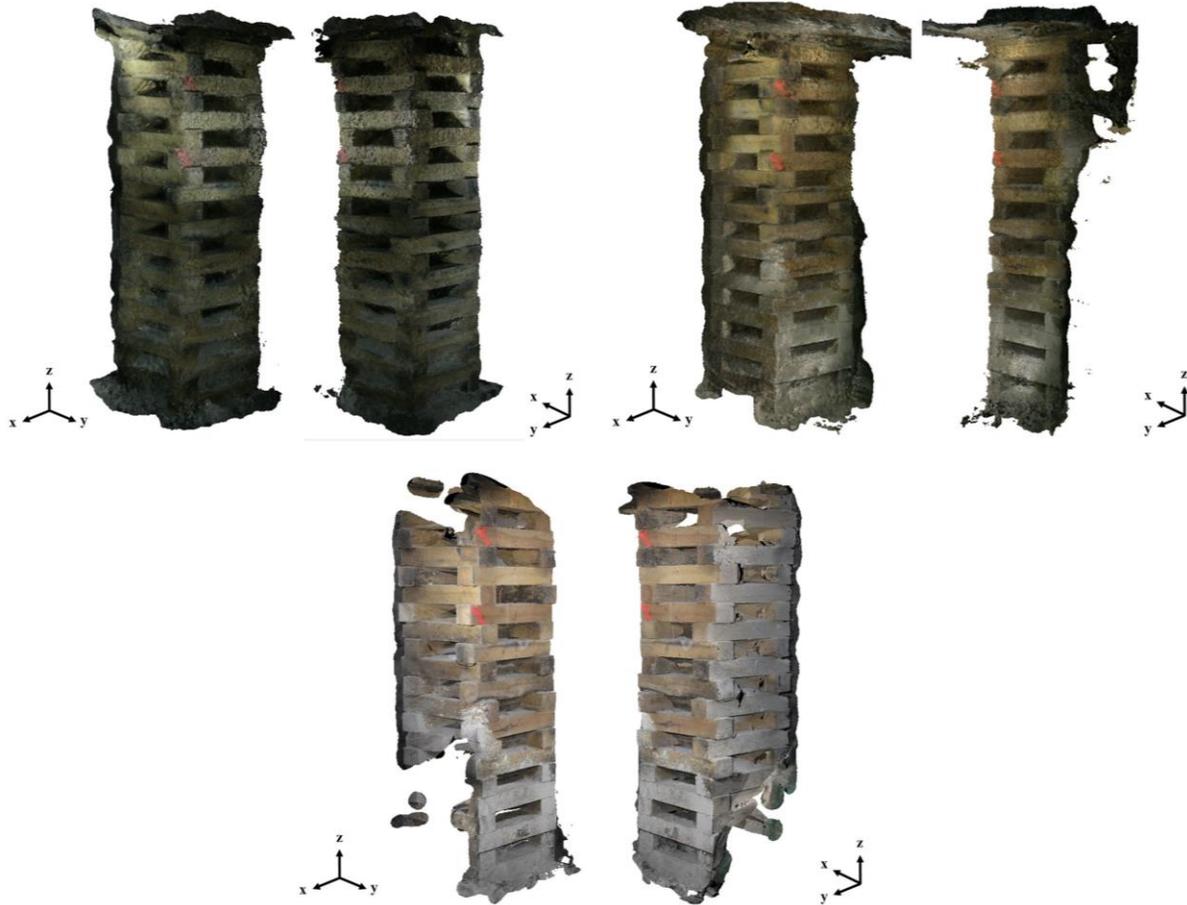
Figure 7.10: Photogrammetric reconstruction of the wooden crib on October 10th (top left), November 5th (top right), and November 7th (bottom)

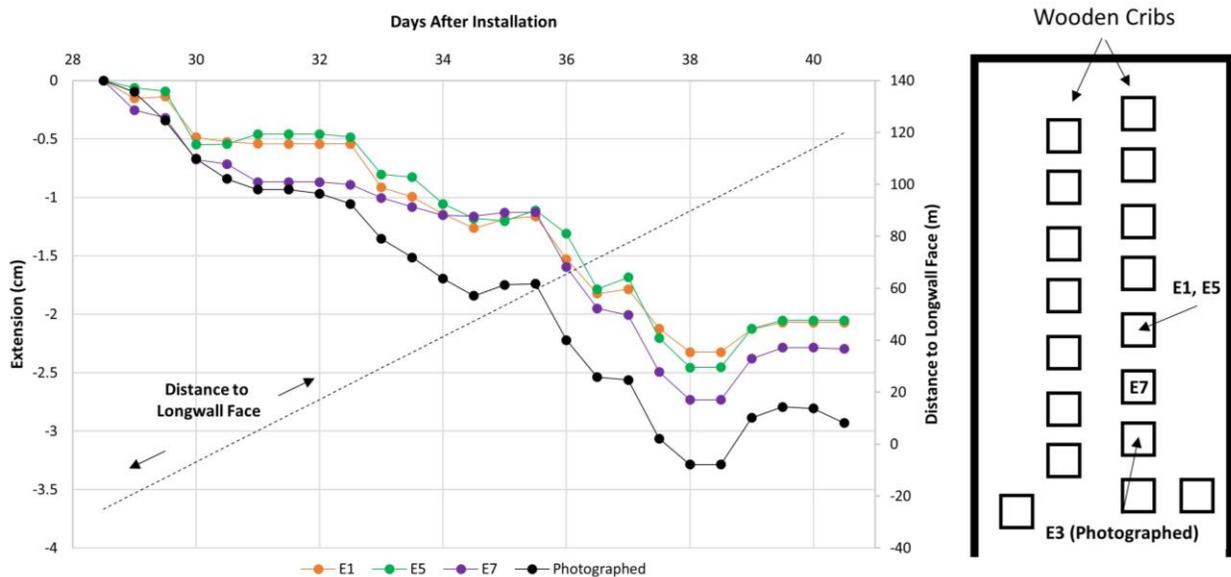
Figure 7.11: Convergence measurements from all four extensometers installed in the monitoring area, starting from the date of a clear abutment stress-induced movement

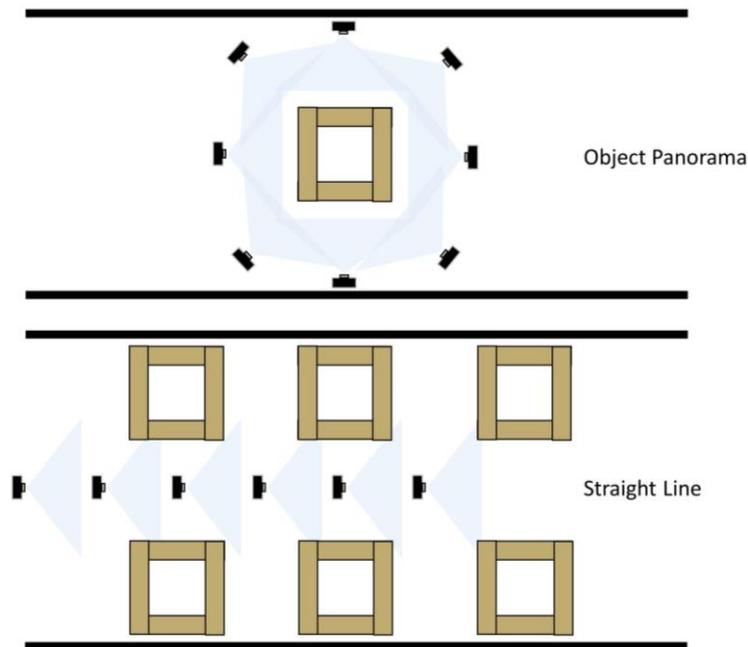
Figure 7.12: The Object Panorama and Straight Line methods of image capture

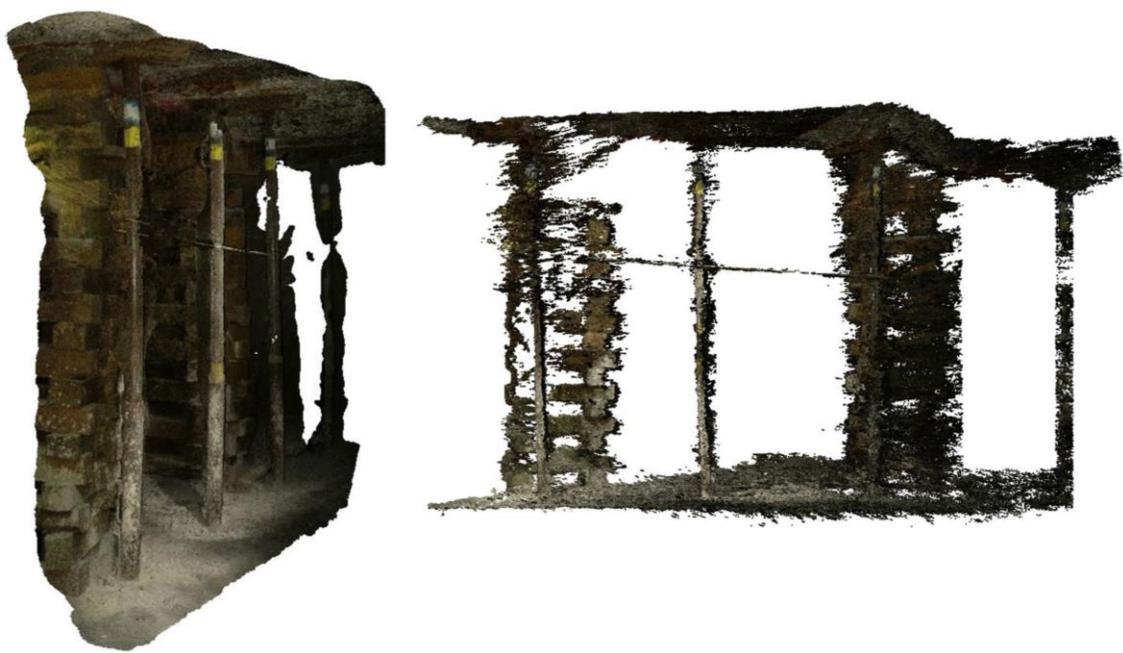
Figure 7.13: A reconstructed standing support triangulation from the camera position (left) and a dense point cloud as viewed perpendicular to the long axis of the crosscut (right).

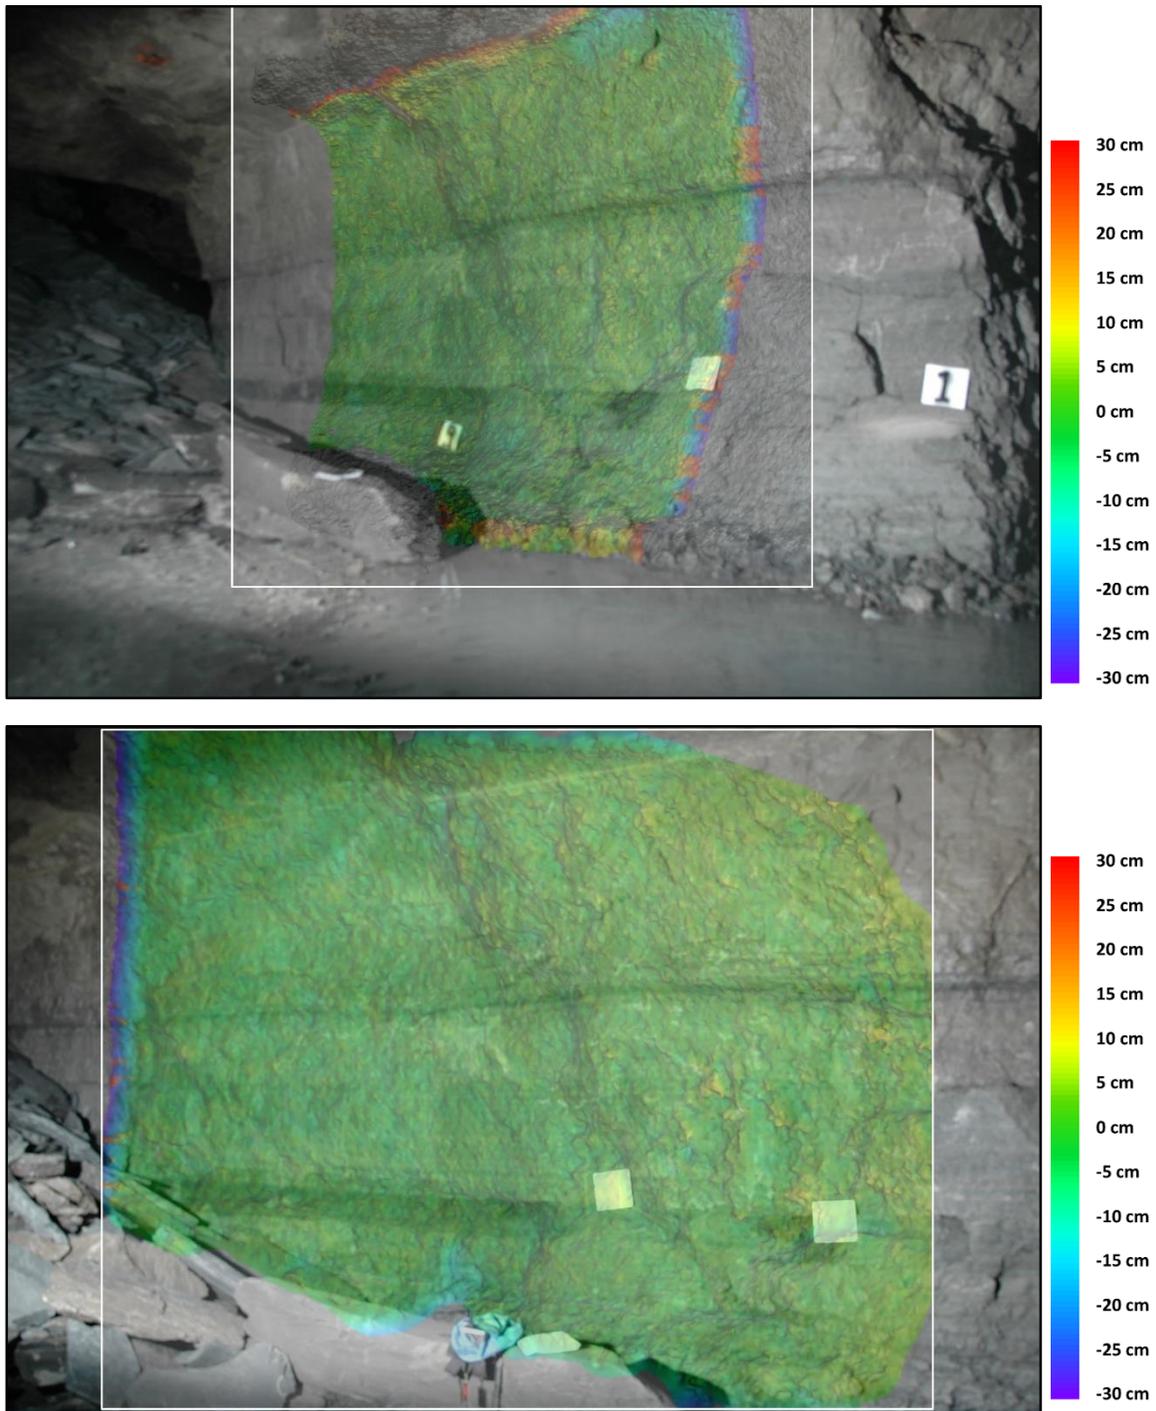
Figure B.1: Change at Pillar 4 from Sep. 16th to Sep 26th (top) and Sep. 26th and Oct. 28th (bottom)

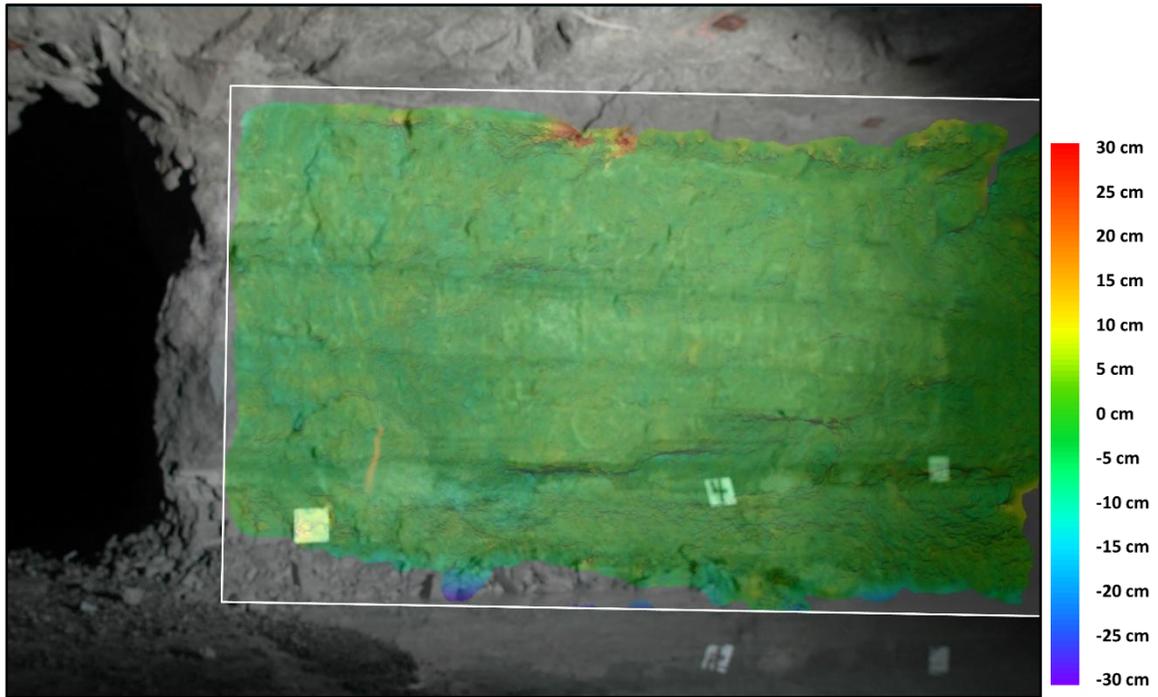
Figure B.2: Change at Pillar 4 from Sep. 26th to Oct. 28th
