Monitoring Underground Mine Displacement Using Photogrammetry and Laser Scanning

*Dissertation submitted to the faculty of the Virginia Polytechnic Institute and State University in
partial fulfillment of the requirements for the degree of*

Mining Engineering

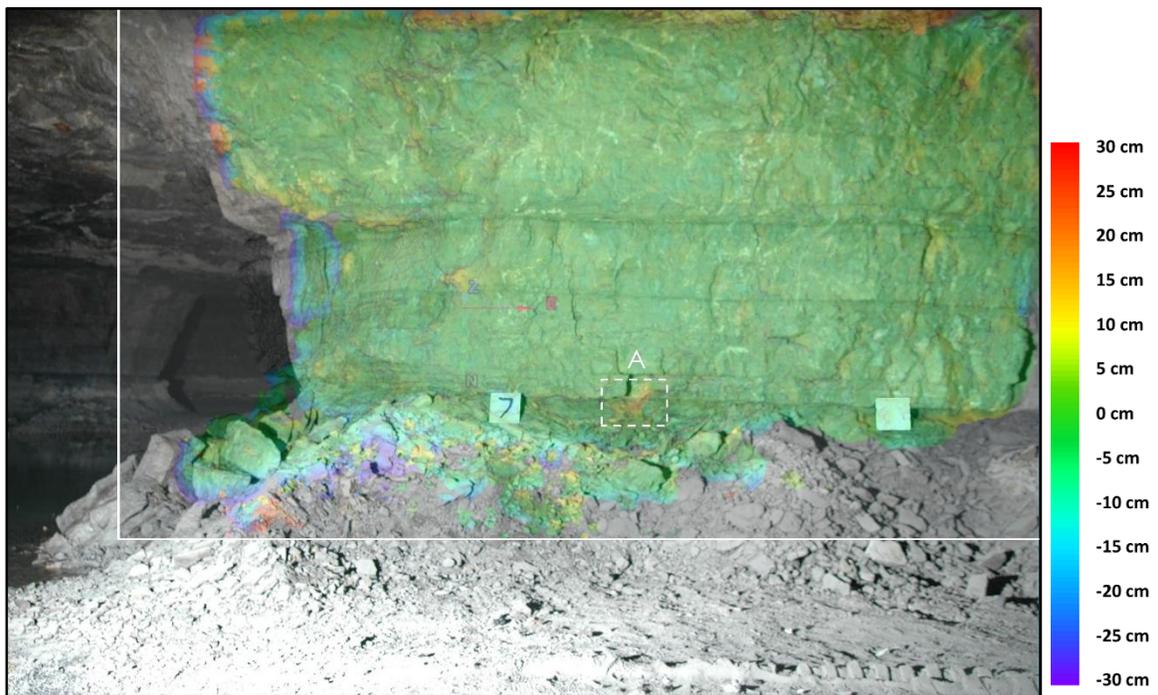
Figure B.3: Change at Pillar 5 from Aug. 26th to Sep. 26th
