CERTIFIED REHABILITATION:

A TOOL FOR THE ARCHITECT

January 1985
Blacksburg, Virginia

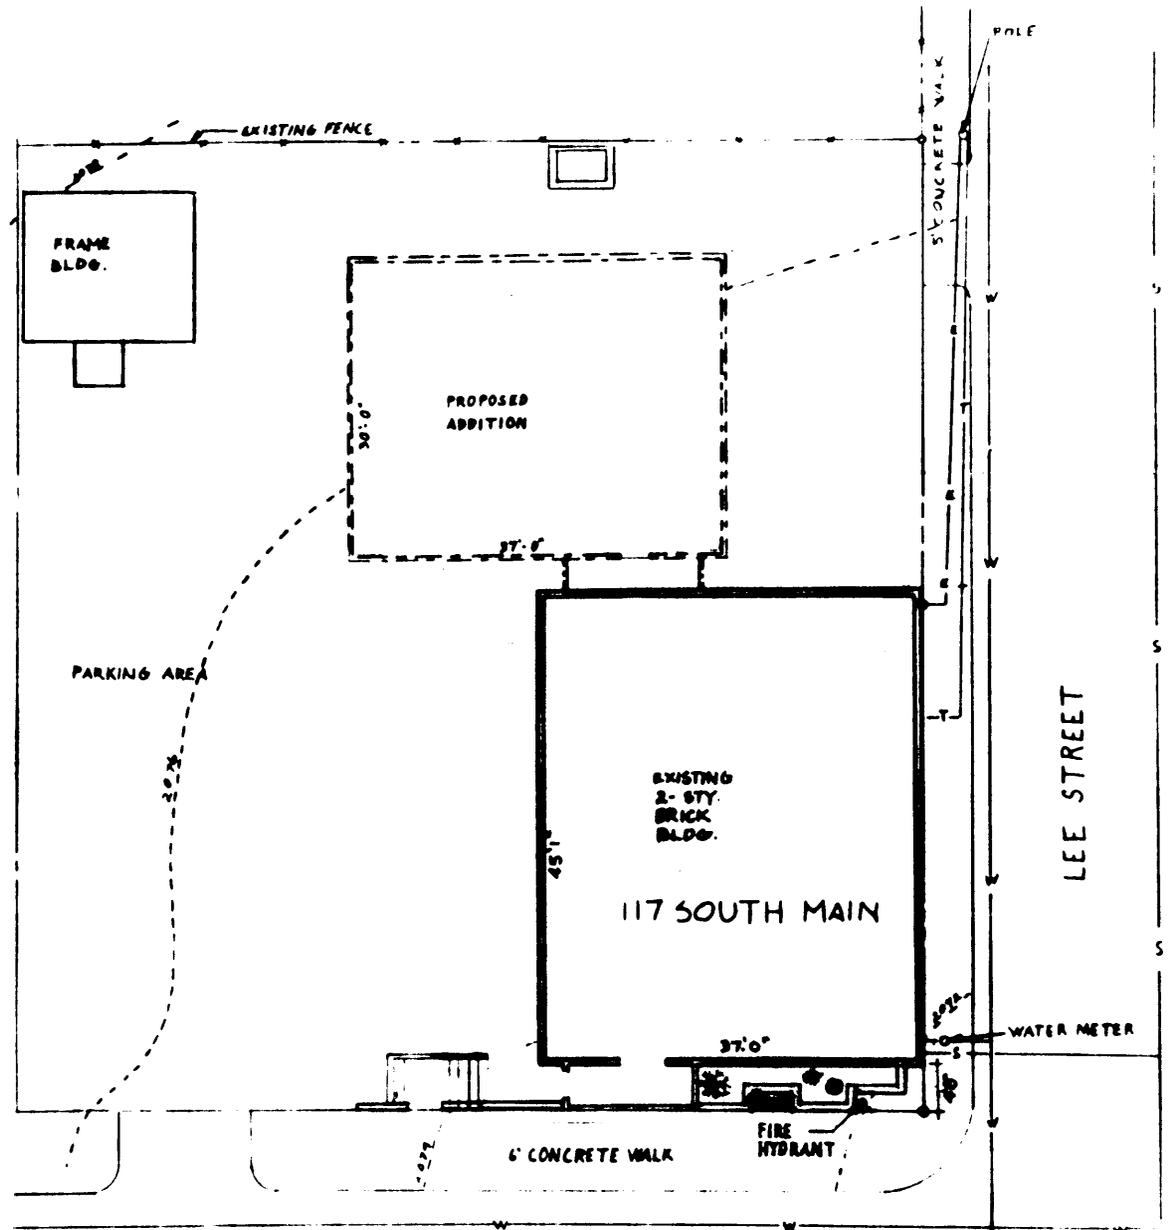
EXISTING SITE PLAN

The site on which the building sets is approximately one-quarter of an acre in size. It is bordered on the west by Main Street, on the south by Lee Street, on the east by the property of the church of God, and adjoining the property of M. S. Grissom on the north. (The deed is located in the Montgomery County Courthouse in Christiansburg, Virginia.) The lot is zoned as part of the central business district, (C-1). "The central business district is intended to encourage the physical concentration of a broad range of individual commercial establishments which together may constitute an area of general commercial activity."

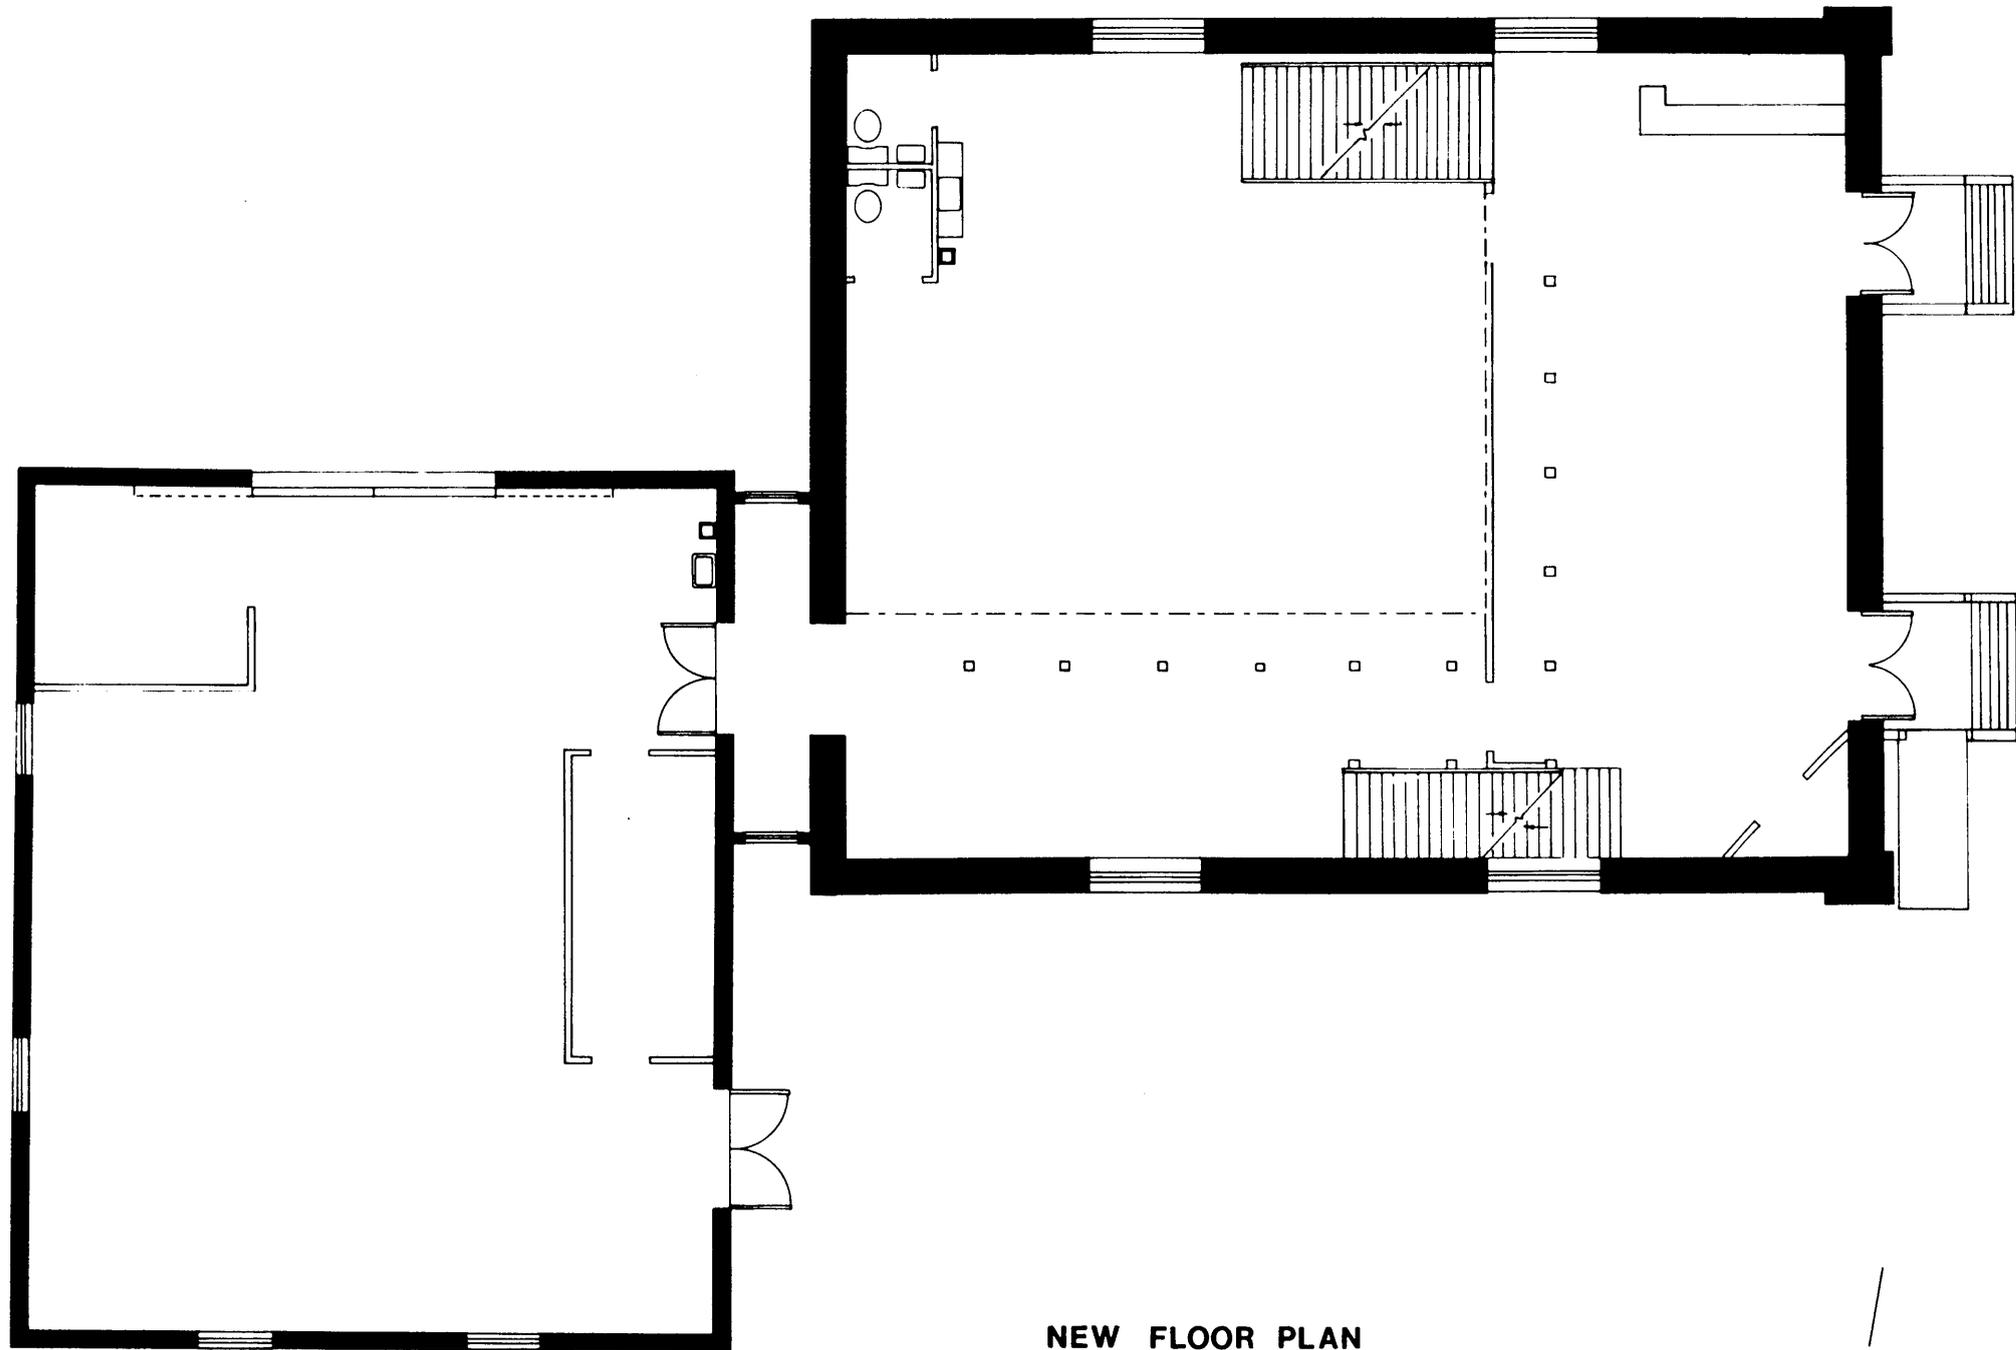
NEW FLOOR PLAN

The proportions for the floor plan of the new building are the same as the old, except the orientation has been rotated ninety degrees. The brick pattern is a running bond. Bricks are of a rough surface, yet are slightly darker in color to those of the original building. A parapet wall is also placed on the addition not to emulate the existing one, but to draw a connection.

The new building's situation on the site and with the old building provides a space for unloading raw materials and equipment on the south (Lee St.) side (a garage door is provided in the new south wall). It's position also creates a small courtyard on the north side which invites activities such as "puppet shows on Saturdays," according to Gene Egger, Prof. of Architecture. Parking spaces are provided along the north side of the property.

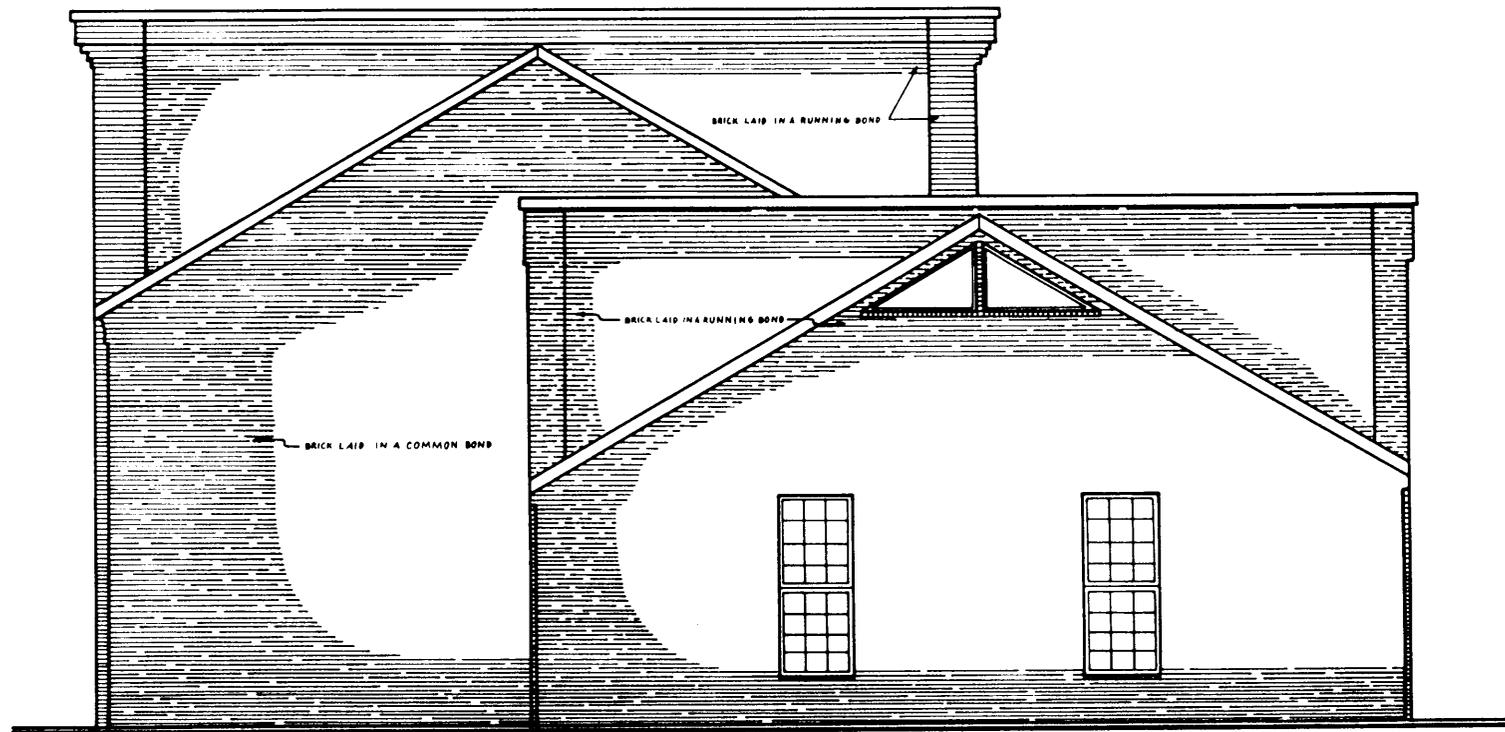
EAST ELEVATION

The connection attaches to the back (east) wall in which enough bricks are removed to construct a 4' x 8' doorway. "Needle bracing" is placed in the permeation to support the load of the wall as the bricks are removed.¹⁹ The doorway framed, the bricks are replaced to meet the doorjamb.

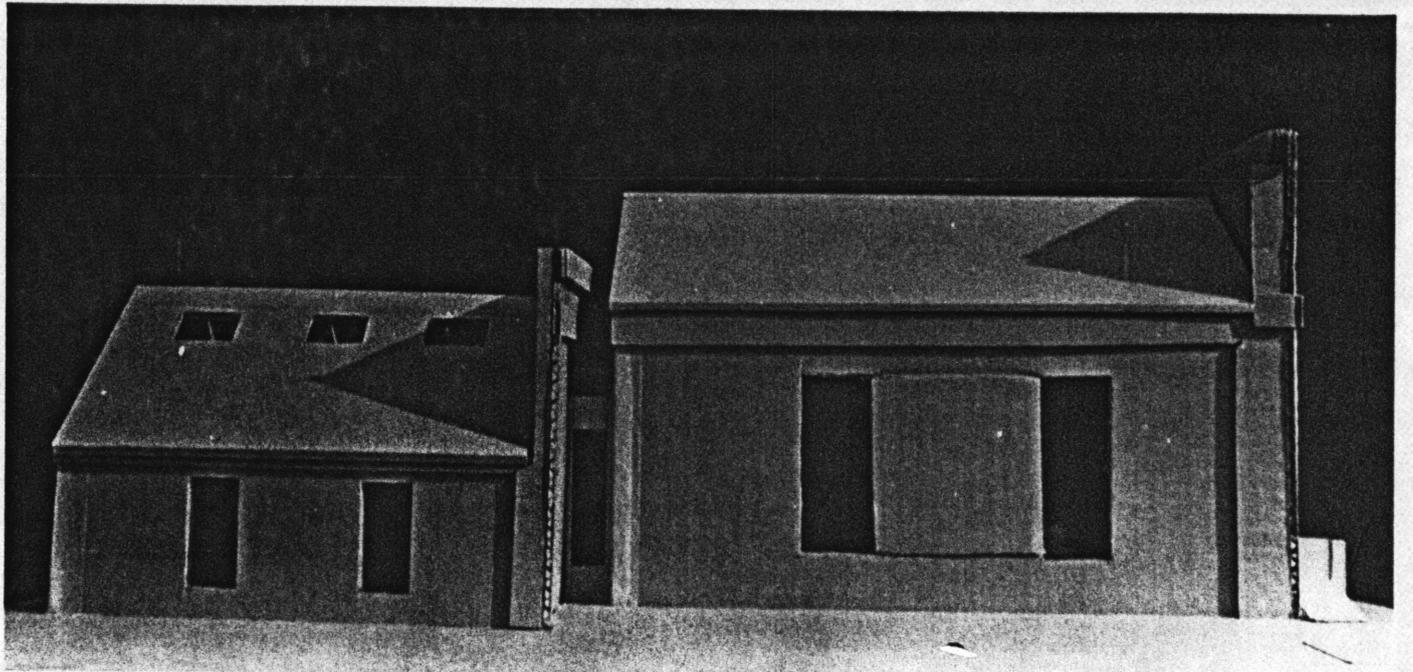
TESTING LOCATIONS

The model was tested by measuring footcandle levels with a J-16 Digital Photometer. Several different model alternatives were tested and observed in a variety of conditions -- under bright sky, cloudy sky, and under the simulated overcast sky of the "daylighting dome" at Virginia Polytechnic Institute and State University. Specific testing points were established in the model and reference measurements were taken throughout testing.

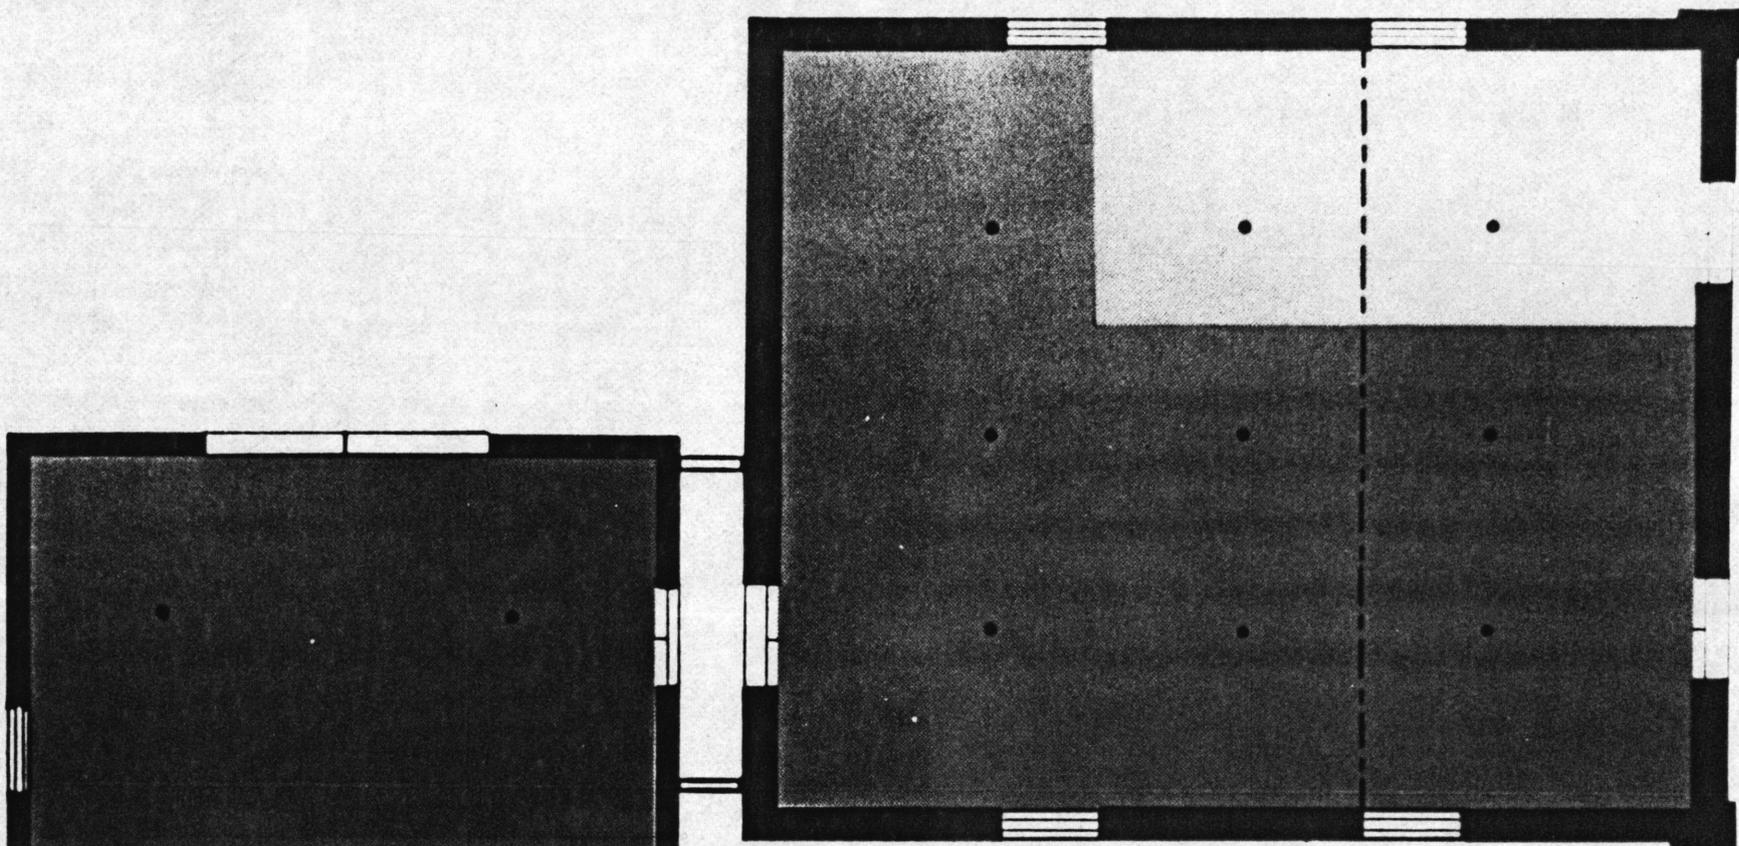
Clear Sky - Addition with Pitched Roof
No Skylights in Existing Roof

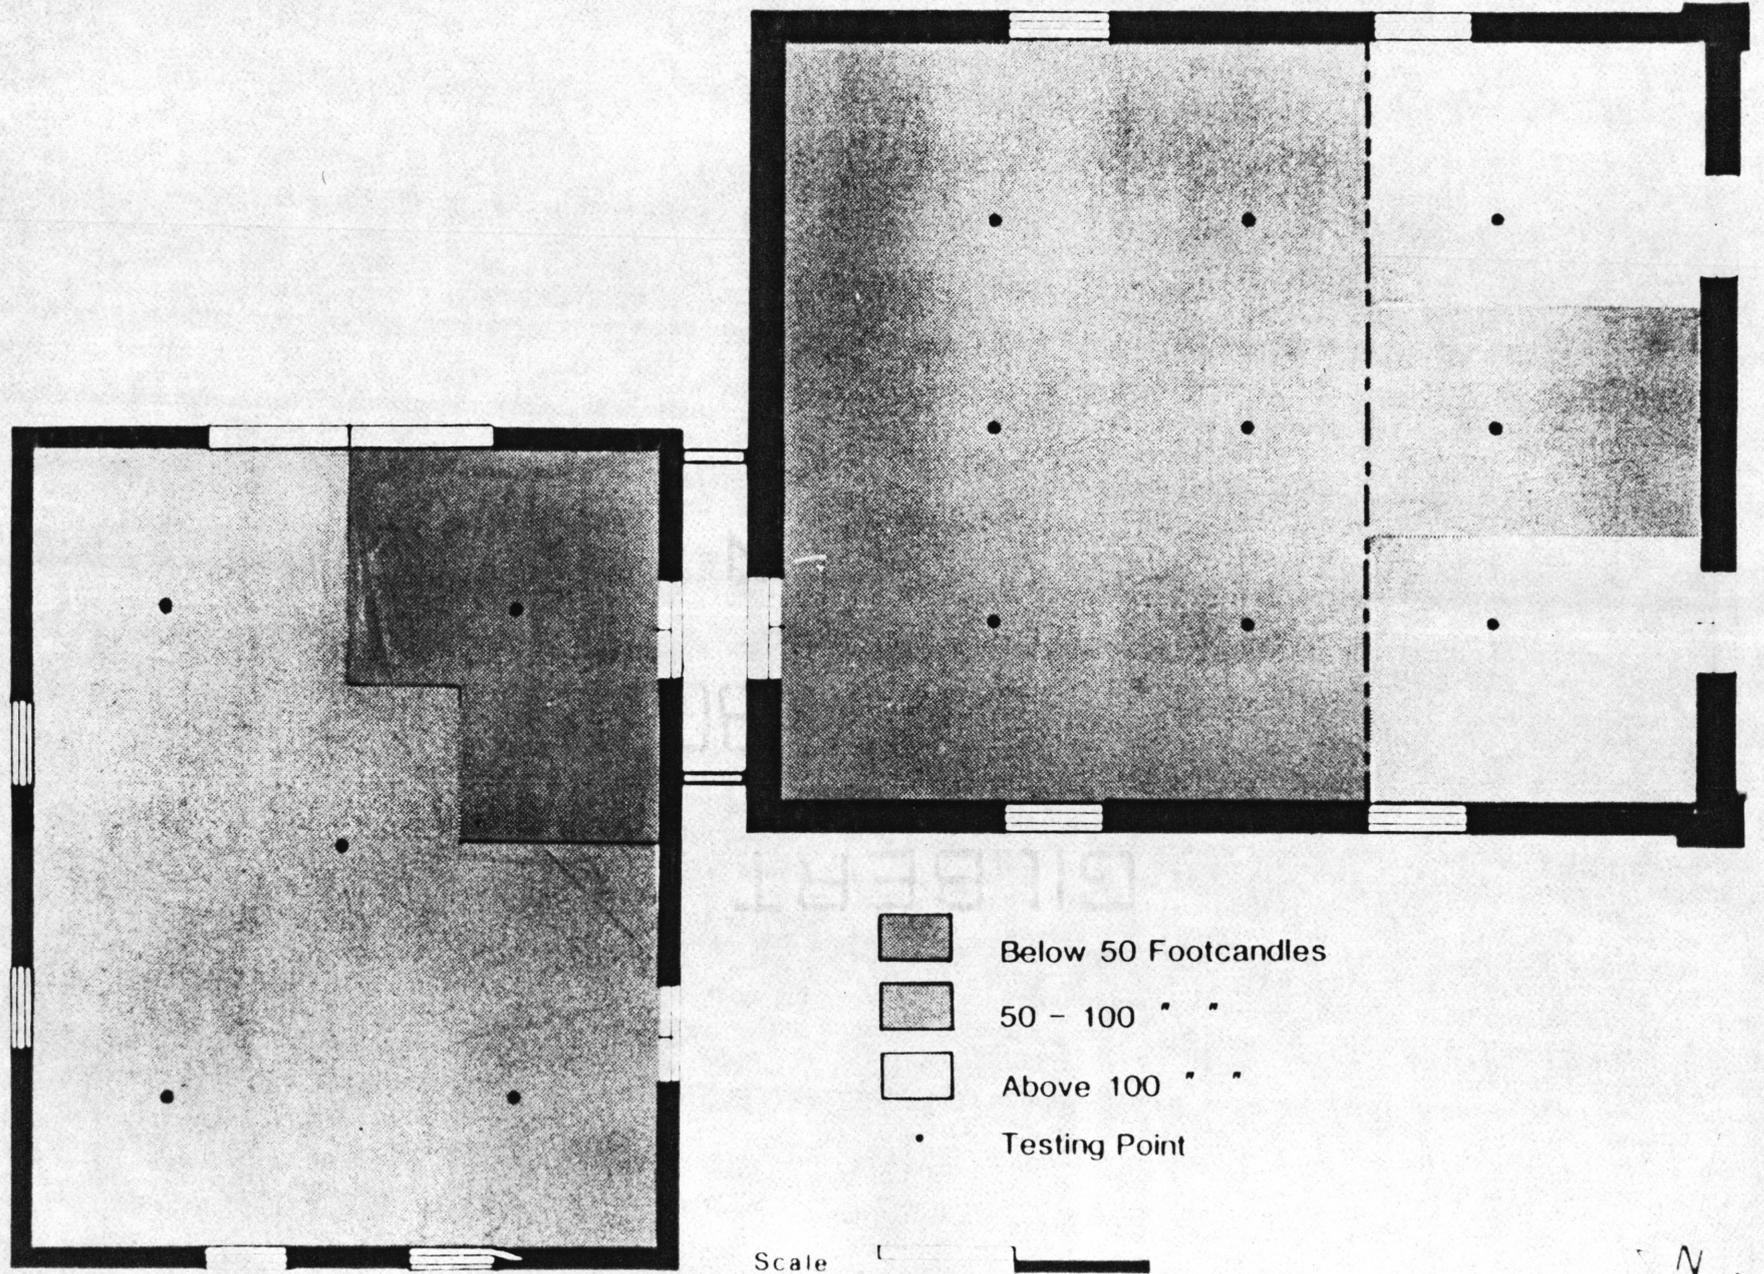
Overcast - Addition with Pitched Roof No Skylights in Existing Roof

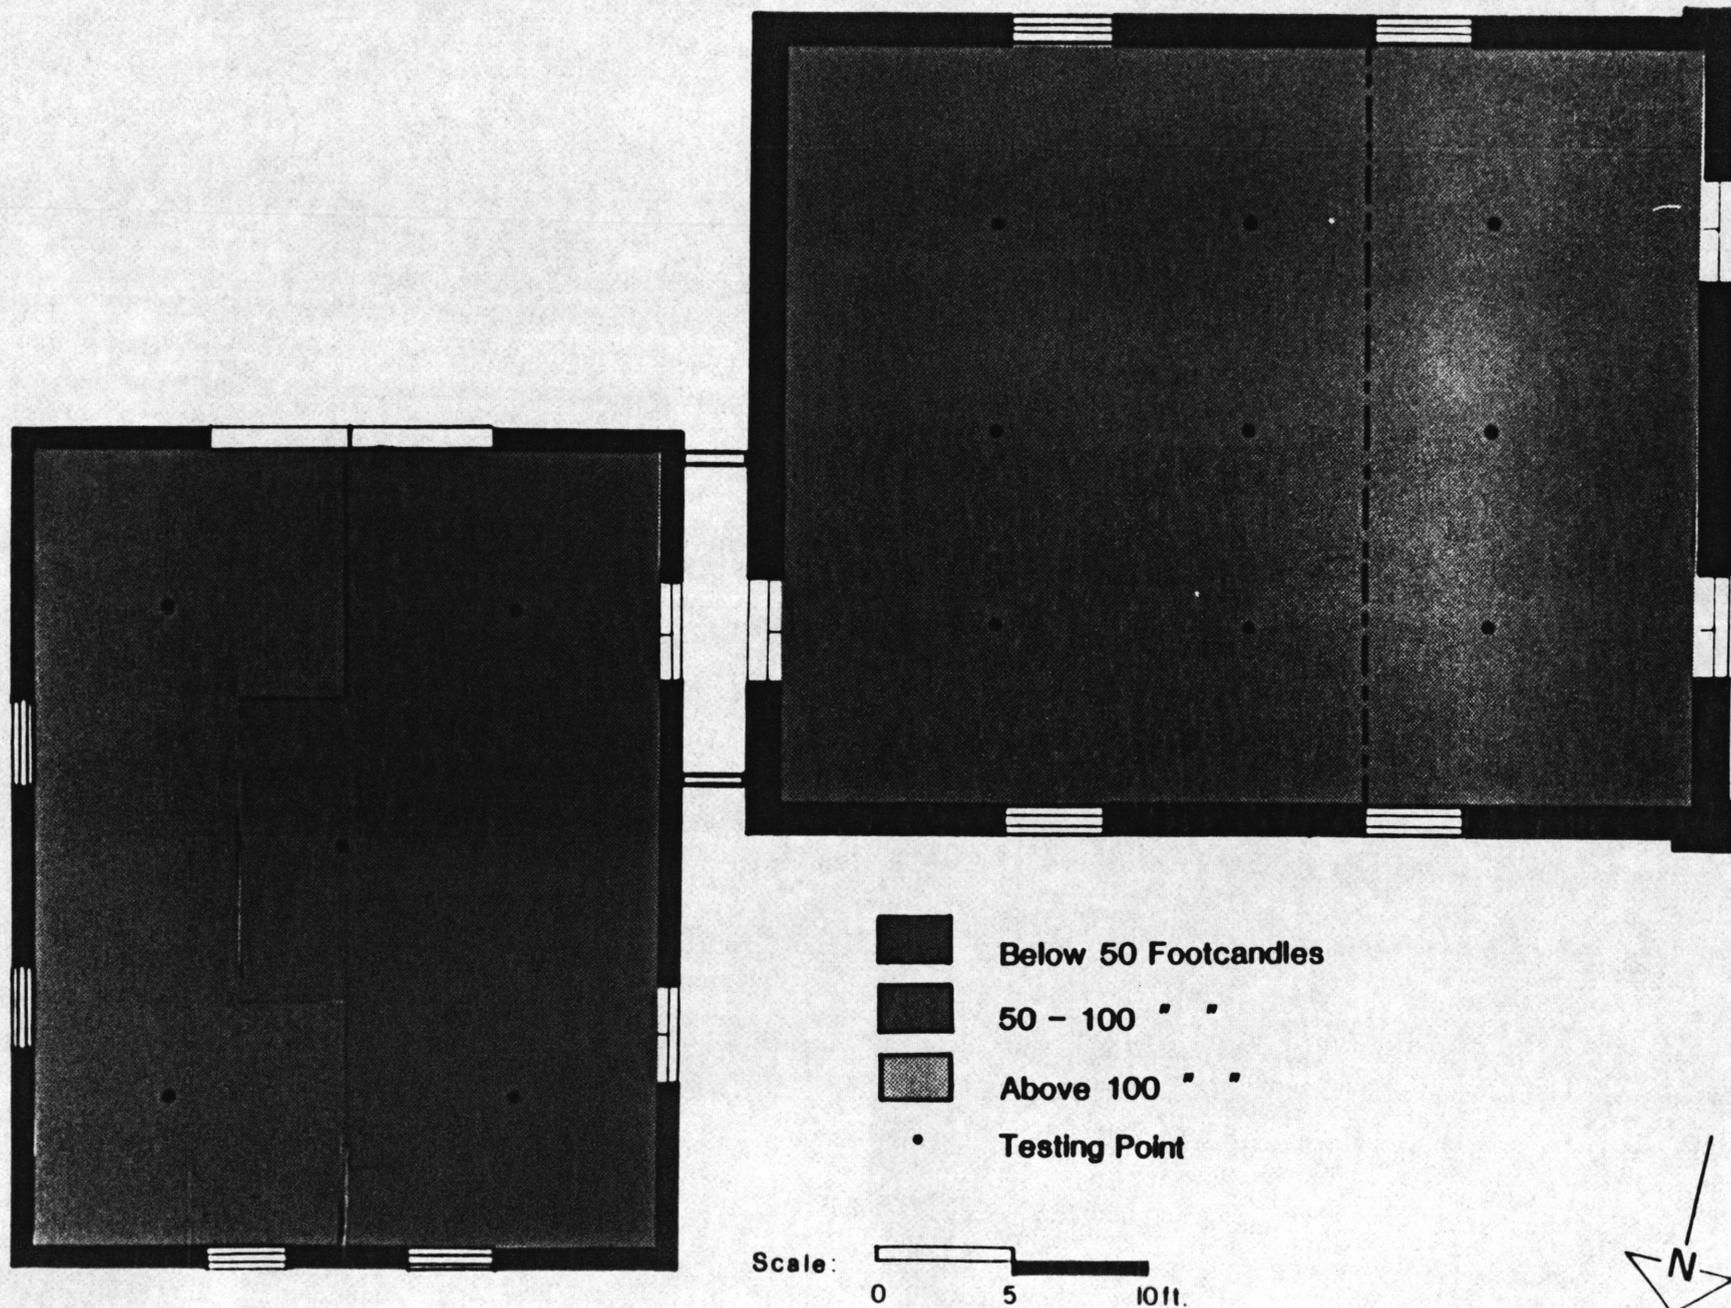
Clear Sky - Addition with No Skylights in Pitched Roof No Skylights in Existing Roof

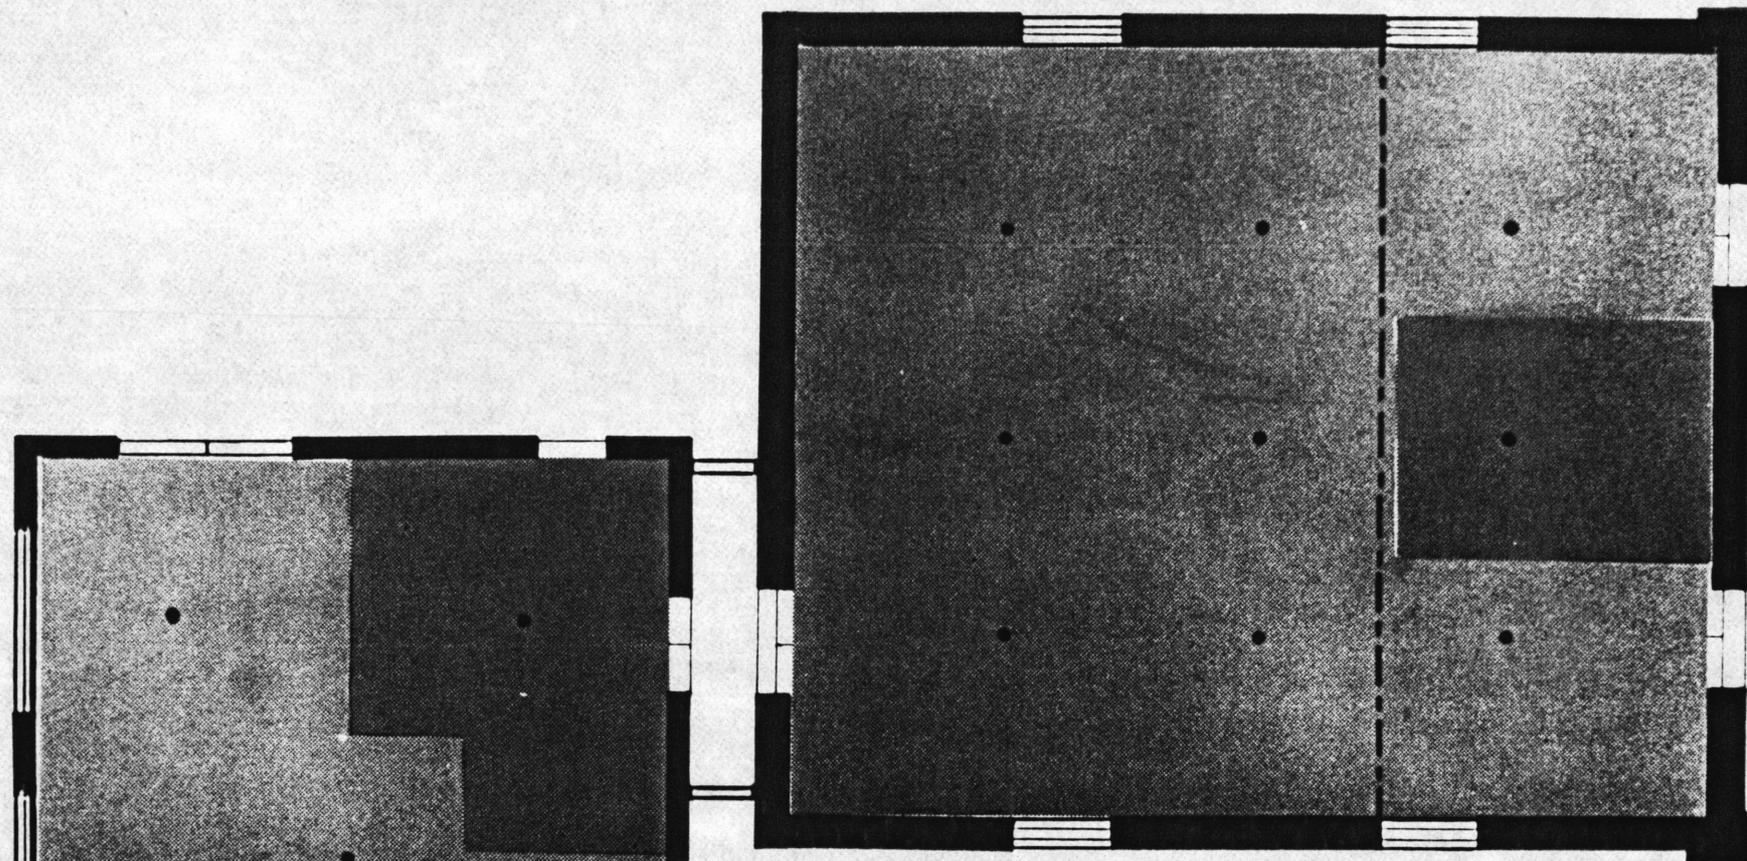
Overcast - Skylights in Existing Roof Addition with Sawtooth Roof

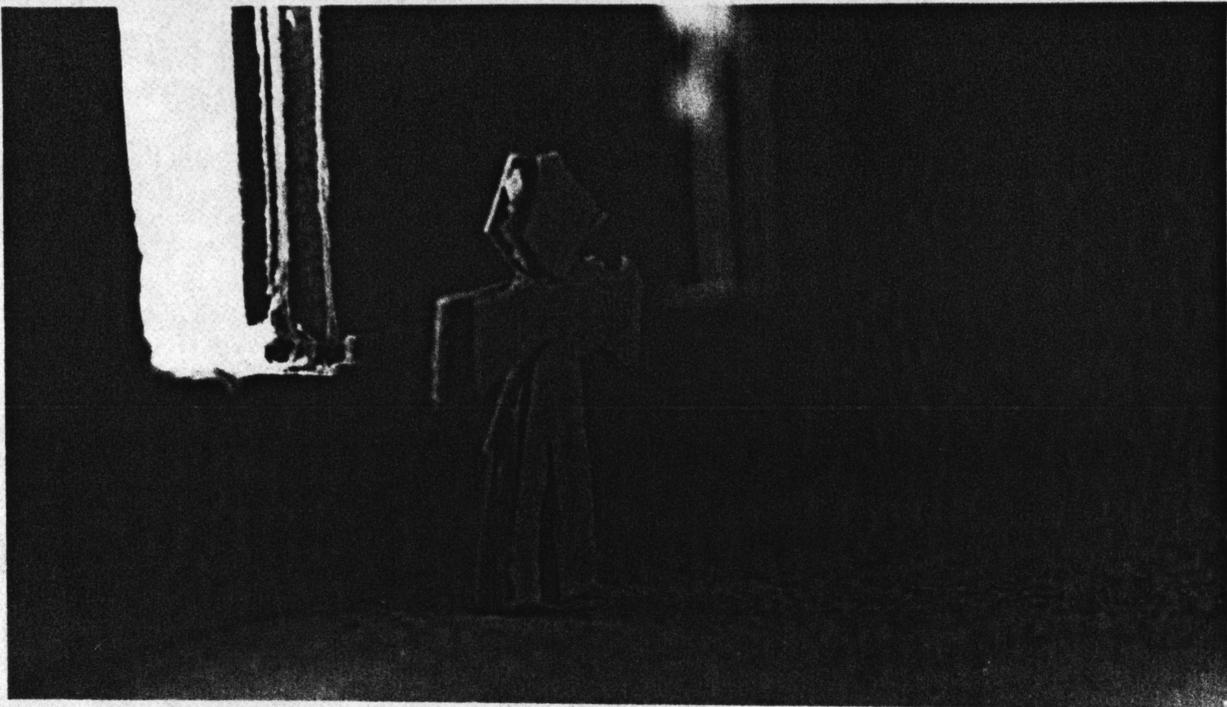
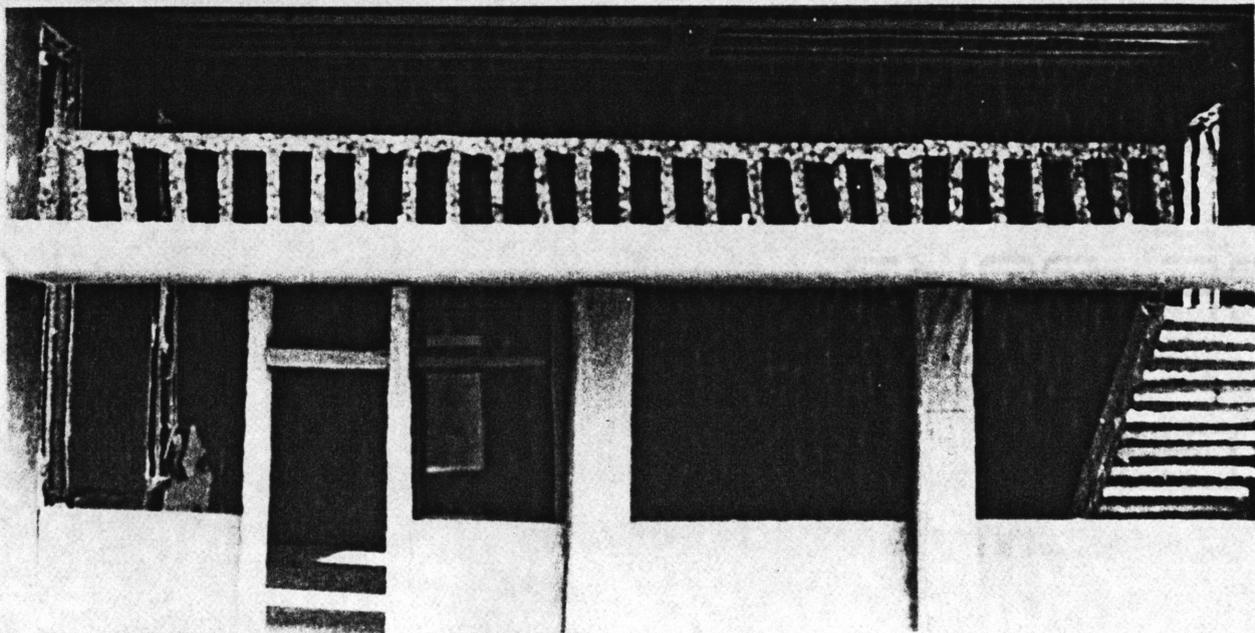
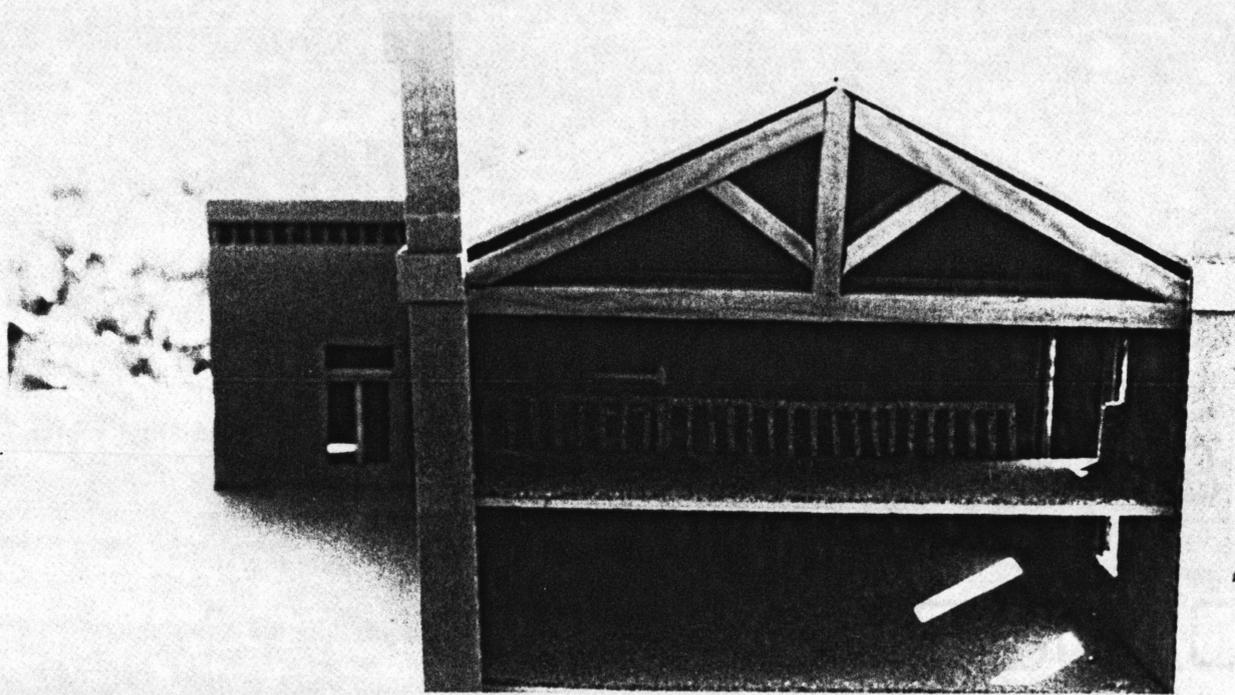
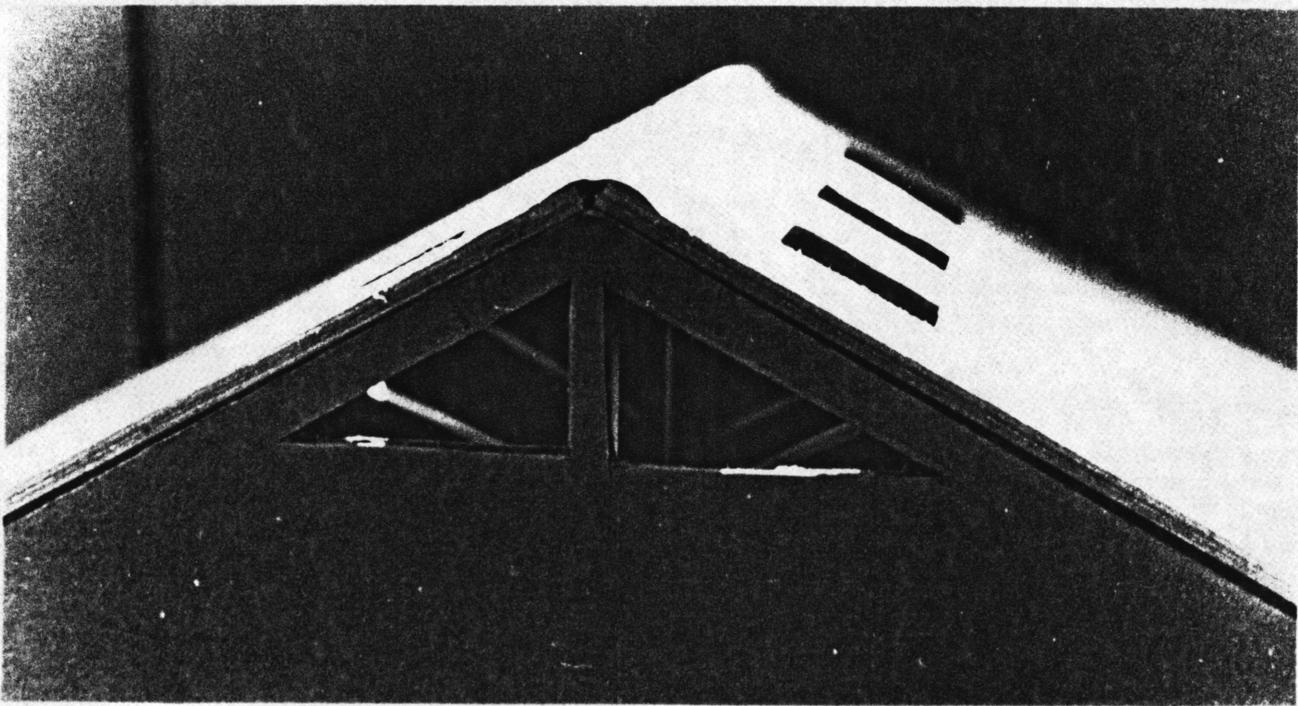
The model was tested with skylights in the existing roof. This alternative, with the truss system exposed, did provide more light; yet, upon speaking with the Virginia Historic Landmarks Commission it was discovered that this alternative might cause denial of certification.

Several addition alternatives were tested. One alternative had a sawtooth roof configuration, one had a pitched roof, and another had a pitched roof with skylights. Upon considering testing results, visual observations, and keeping the "Standards" in mind, the latter alternative was selected.
