A STUDY OF RUNOFF LOSSES FROM DIFFERENT SLOPES  
AND LENGTHS IN A SMALL WATERSHED

A MAJOR THESIS

Submitted in Partial Fulfillment of the Requirements  
for the Degree of  
MASTER OF SCIENCE IN AGRICULTURAL ENGINEERING

Virginia Polytechnic Institute  
Blacksburg, Virginia

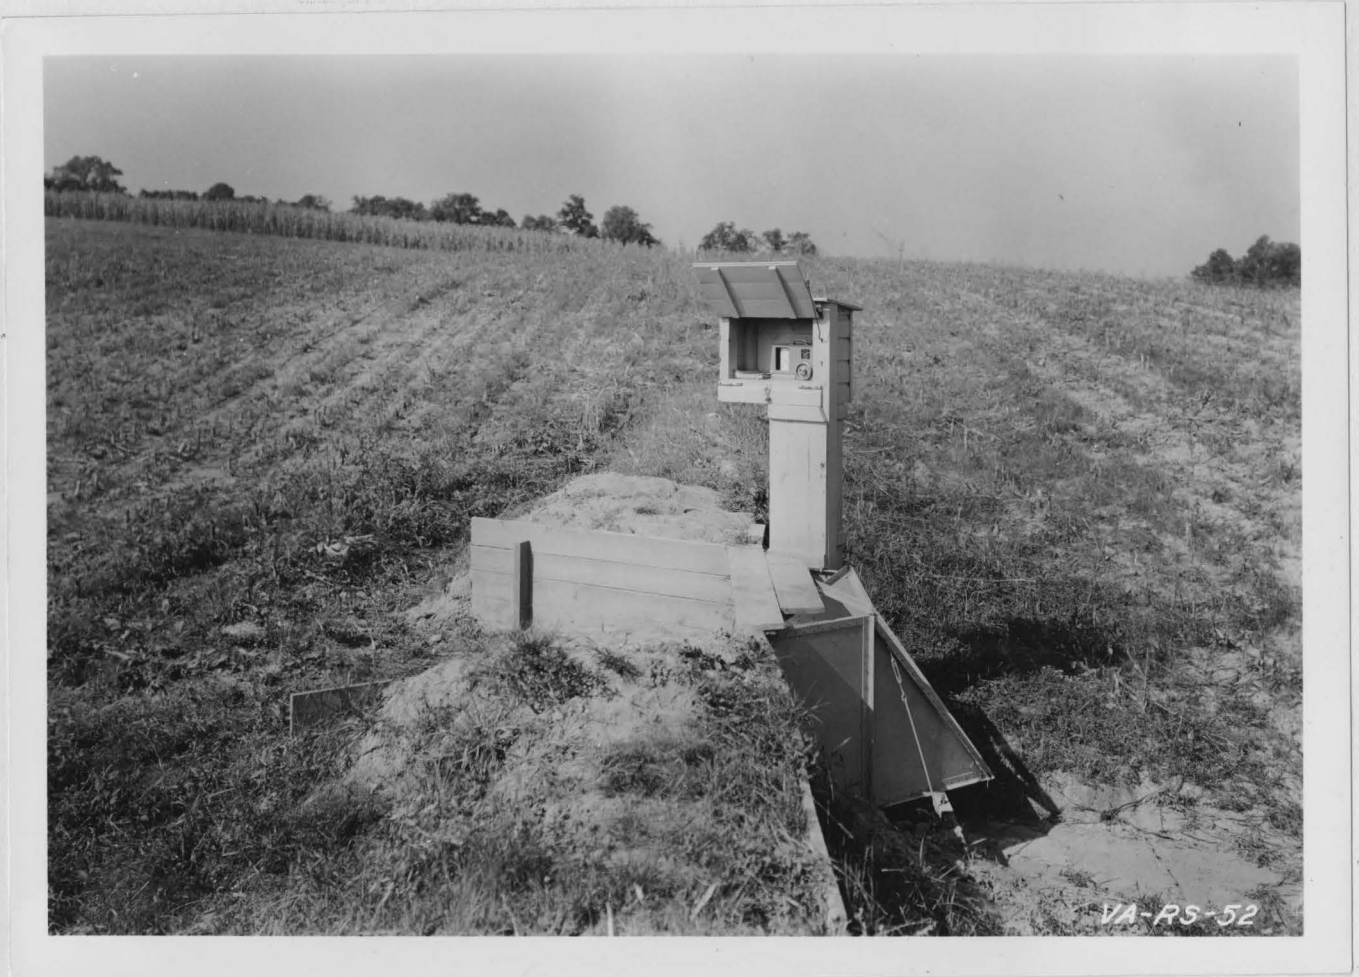
Fig.2 View looking into instrument shelter at gaging station for Watershed No.III, showing Friez Water Level Recorder

Friez Model FW-1 Recorder.- This recorder provides continuous record of stage at the time of runoff. It is equipped with a clock geared to make one full revolution in 6, 12 or 24 hours. Charts are placed on the clock cylinder and a pen registers the stage heights. Fig. 2 shows this recorder in its shelter.

**Runoff Equipment.**- For the measurement of runoff, a Friez Waterstage Recorder was used in this study. The complete installation is shown in Fig. 2, which is a view of the flume and the shelter housing the waterstage recorder, and Fig. 9 is a general view of the measuring station and the watershed.

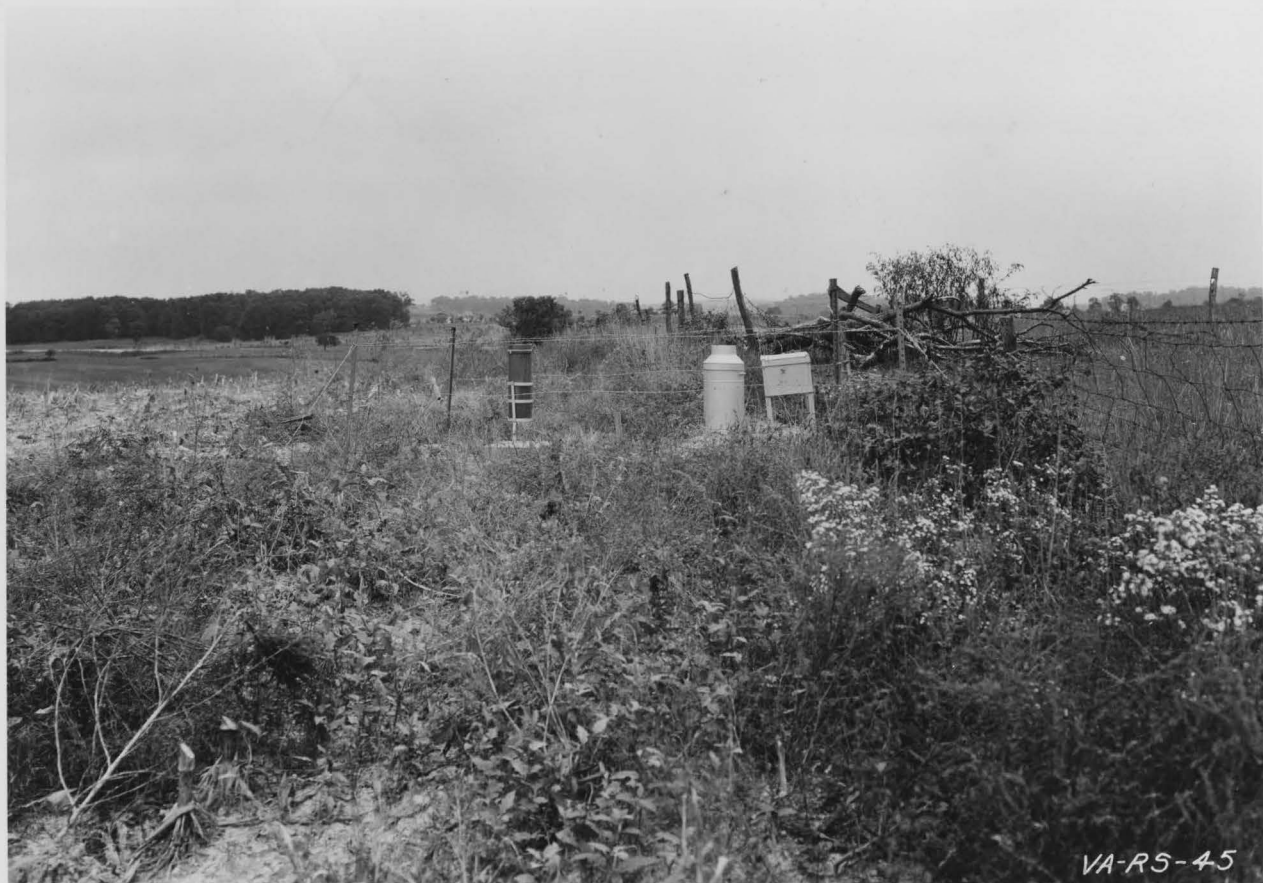
**Fig.3** View of Rainfall Measuring Station, showing standard and recording raingages at the upper reaches of Watershed No. II and No. III

Friez Recording Raingage.- The Friez raingage catches rainfall in a bucket which rests on springs. These springs cause the pen to move on the chart as the rain collects in the bucket. The chart is placed on a clock cylinder geared to make one complete revolution in 6, 12 or 24 hours, as may be desired. As much as 6 inches of rainfall can be registered on the chart. Fig.3 is a photographic view of this and the standard raingage installed on W-II and W-III.

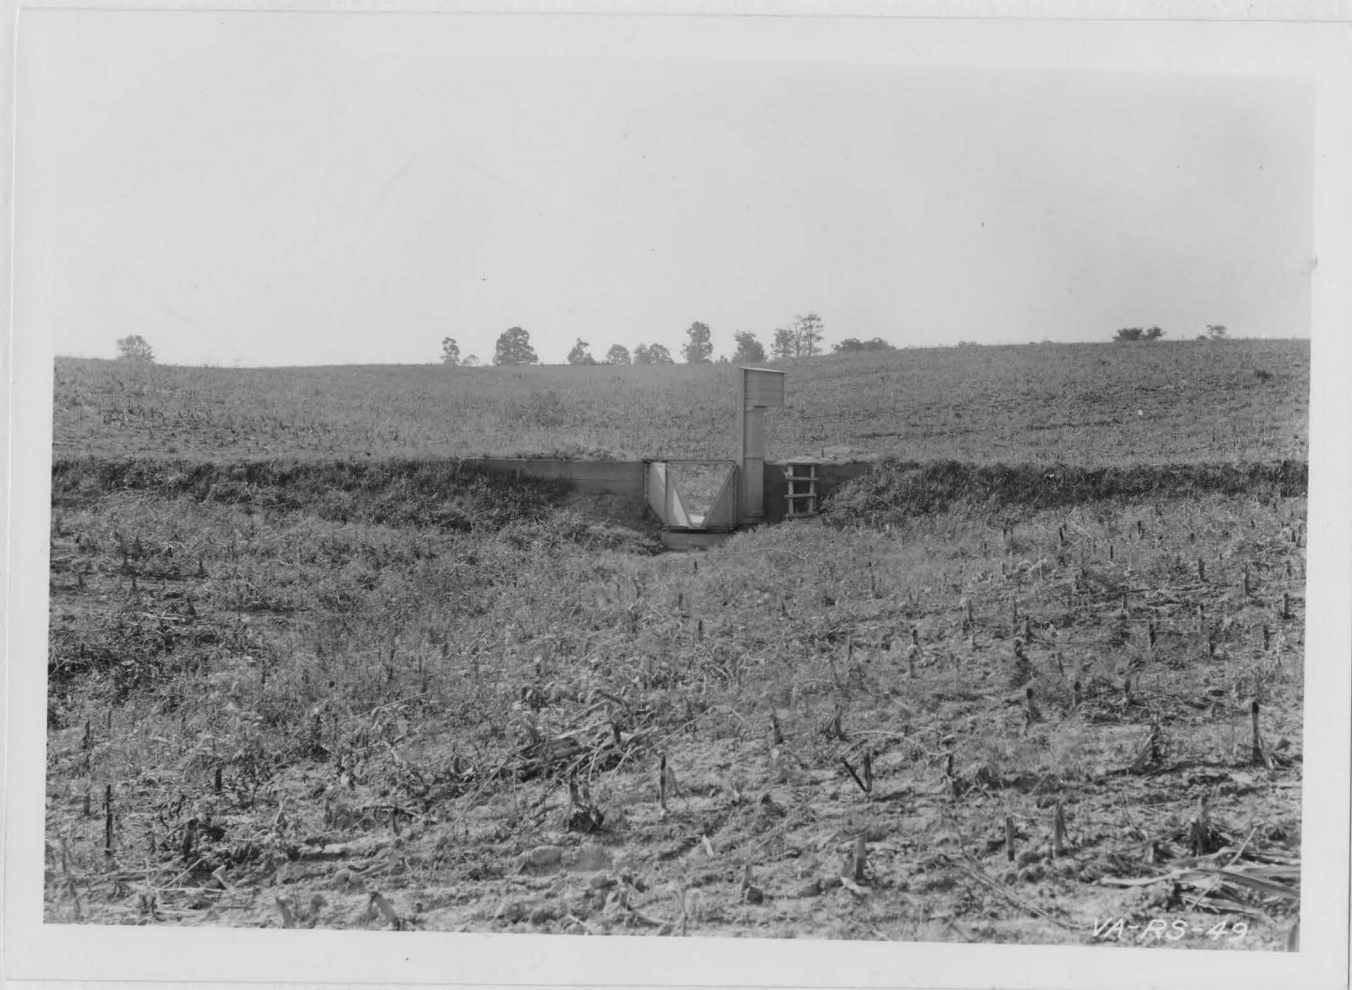
**Fig.9** A general view uphill of Watershed No.II, showing a Type-H Measuring Flume and instrument shelter.

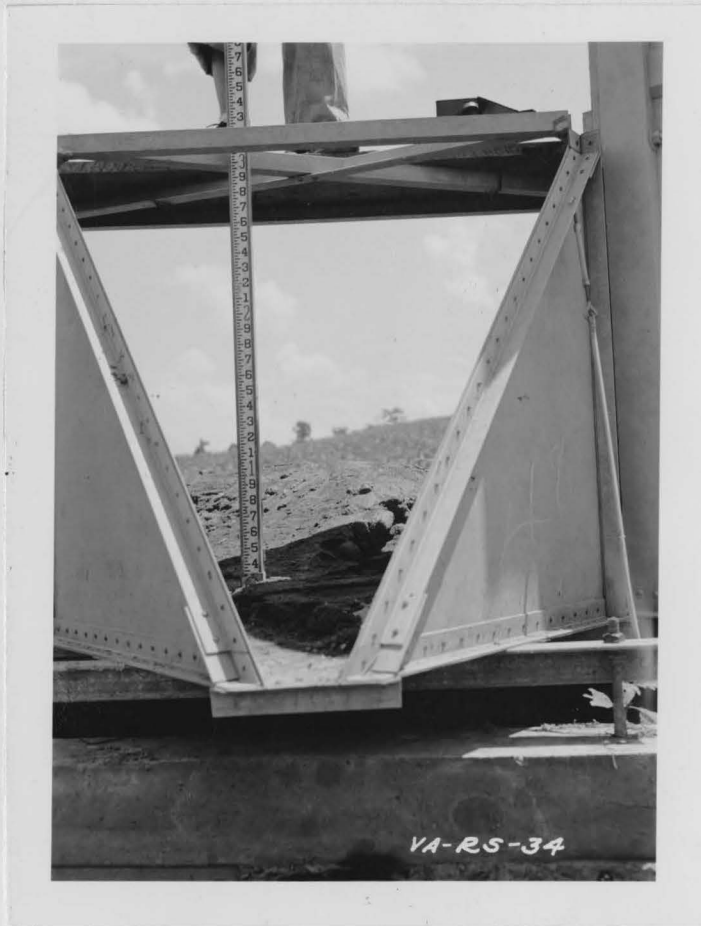
Fig.15 View of silt in flume on Watershed No. II after the storm of June 8, 1939. Philadelphia Rod is resting on flume floor and showing depth of silt in flume.

No definite statement could be made as to the rate of erosion on either watershed. The appreciable deposit of colluvial soil in the draws (43 inches deep) of both watersheds would, however, tell part of the story. Moreover, galls or bald spots at different points are clear evidences of advanced erosion. One such bald spot of a good size may be noticed on Fig.5. It was large enough to be mapped. It is interesting to note that this spot is situated on the slope of the watershed which has a northerly direction. There were other such spots, but they were too small to map. When the watersheds are in wheat or corn, these spots stand out clearly. Erosion is so advanced on them that 75% or more of the top soil has been washed away. No special effort was made to determine the amount of soil removed by runoff water, as no practical methods could be used on areas so large. The soil map, Fig.5, is probably the best picture of the condition of the watersheds in respect to erosion. The soil ranges from virgin in the woods (D -1), where even the "A<sub>c</sub>" horizon is present and where no erosion other than the slow natural one is present, to D -4, where over 75% of the top soil has been removed by runoff water. The main cause for the accelerated erosion shown by the galls on both watersheds is the poor cultural practice of making furrows parallel with the slopes of the land, i.e. up and down the slopes. This cause for erosion could be eliminated by a change of method in plowing the land, making furrows which run parallel to the contours of the land. Erosion at the present or past rates would undoubtedly expand the areas from which the top soil has been washed away.
