A STUDY OF OIL-FILM PERFORMANCE
BETWEEN PISTON RINGS AND CYLINDER WALL
BY THE ELECTRICAL MEASUREMENTS

Thesis submitted to the Graduate Faculty of the
Virginia Polytechnic Institute
in candidacy for the degree of

in
MECHANICAL ENGINEERING

May, 1961

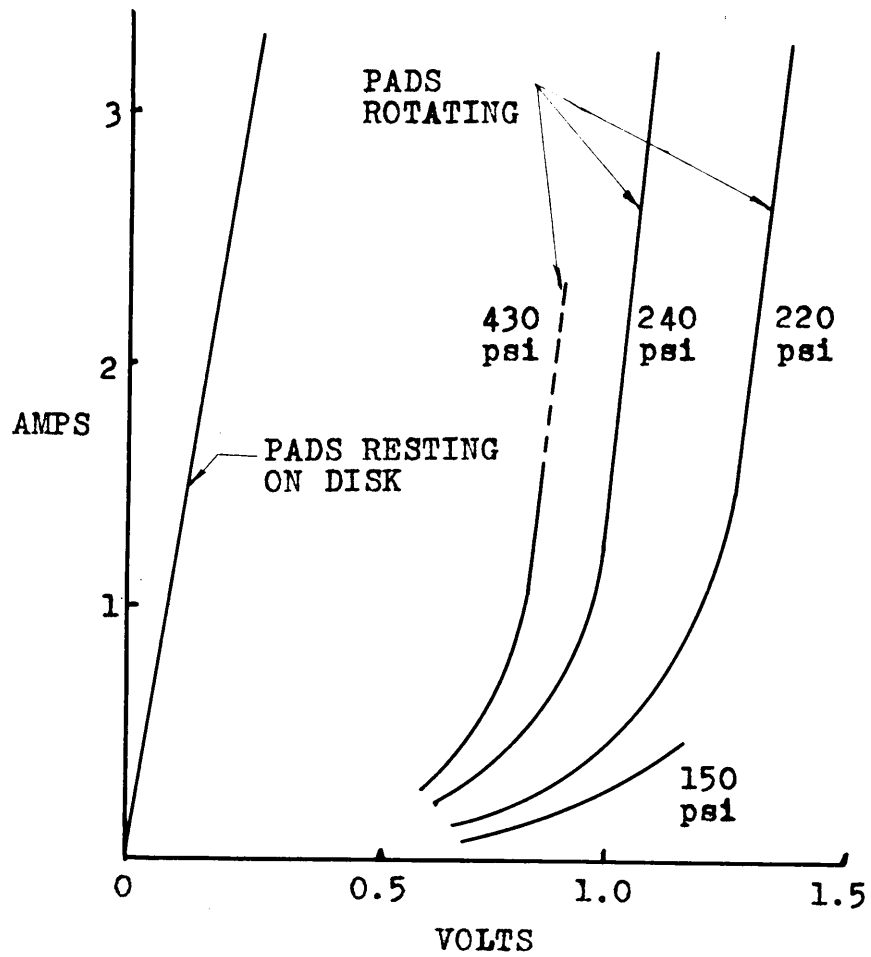
FIGURE 1: THE ELECTRICAL CHARACTERISTICS OF OIL FILM BETWEEN CHROMIUM AND STEEL AT SEVERAL LOADING PRESSURES. (9)

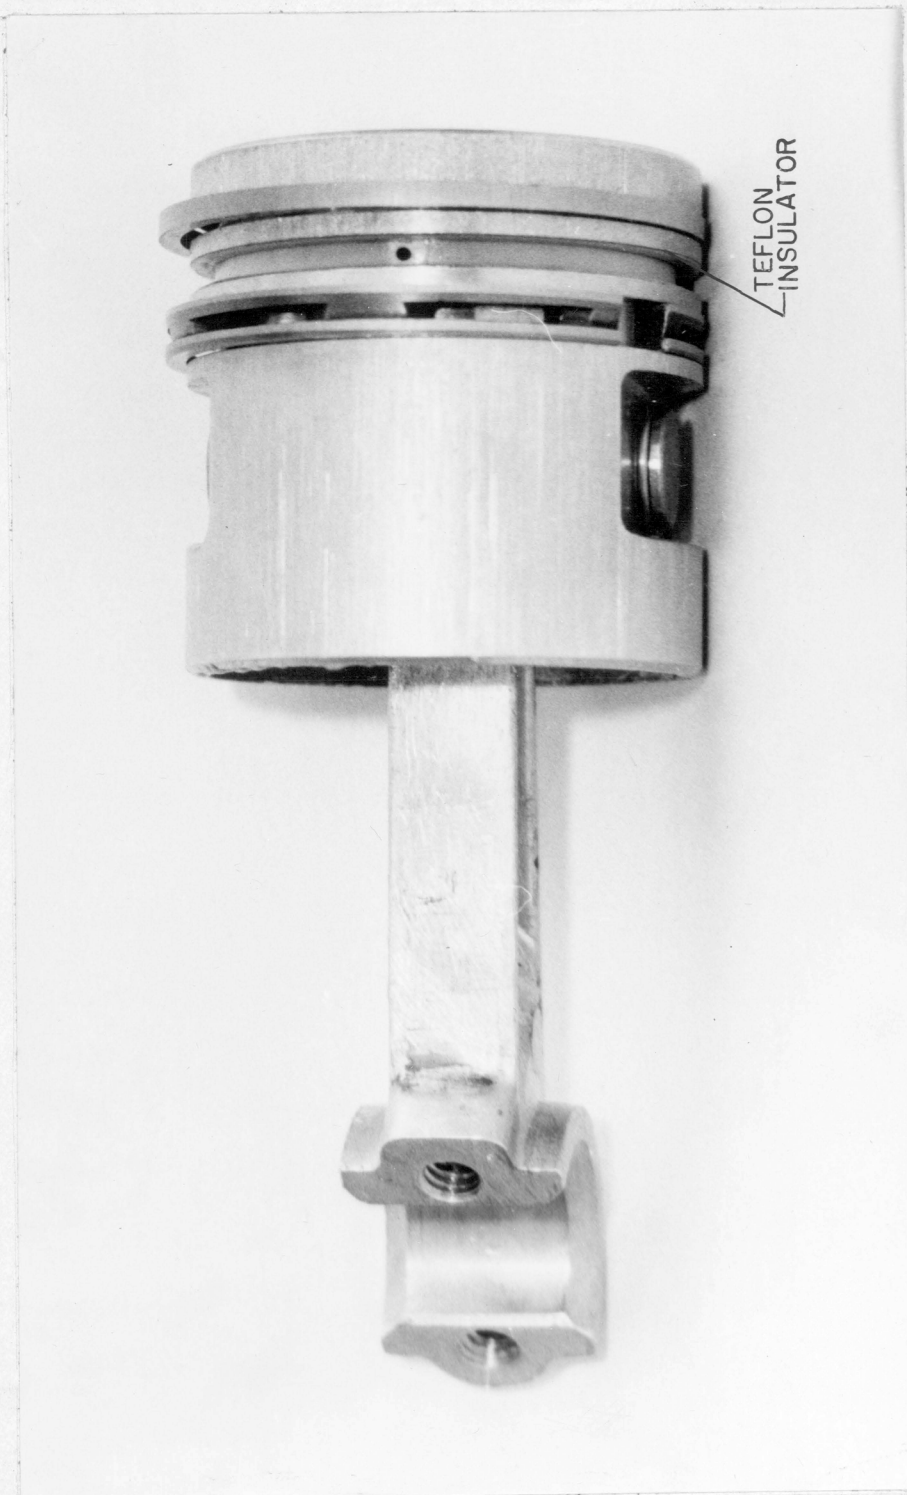
Figure 7. Photographic view of the piston after insulation.

The arrangement of Teflon tapes in the ring-groove is shown in Figure 5(b). The photographic view of the piston after insulation is shown in Figure 7. The area in the vicinity of the hole was not covered by Teflon strip but coated with silicone cement.

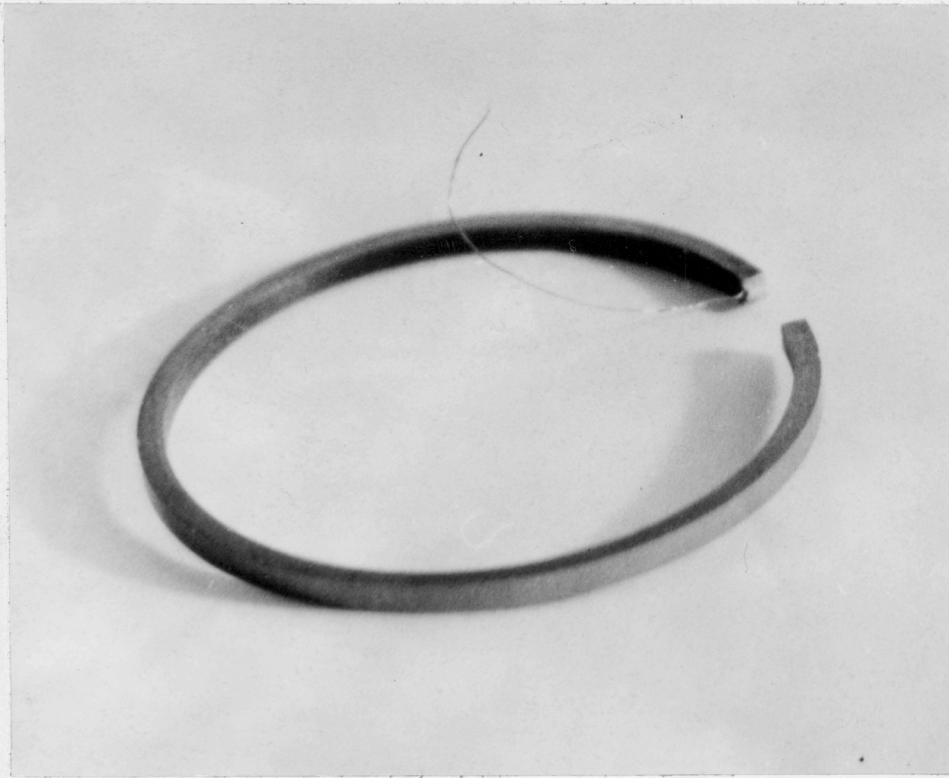
Figure 6. The Ring and the Connection of the Wire.

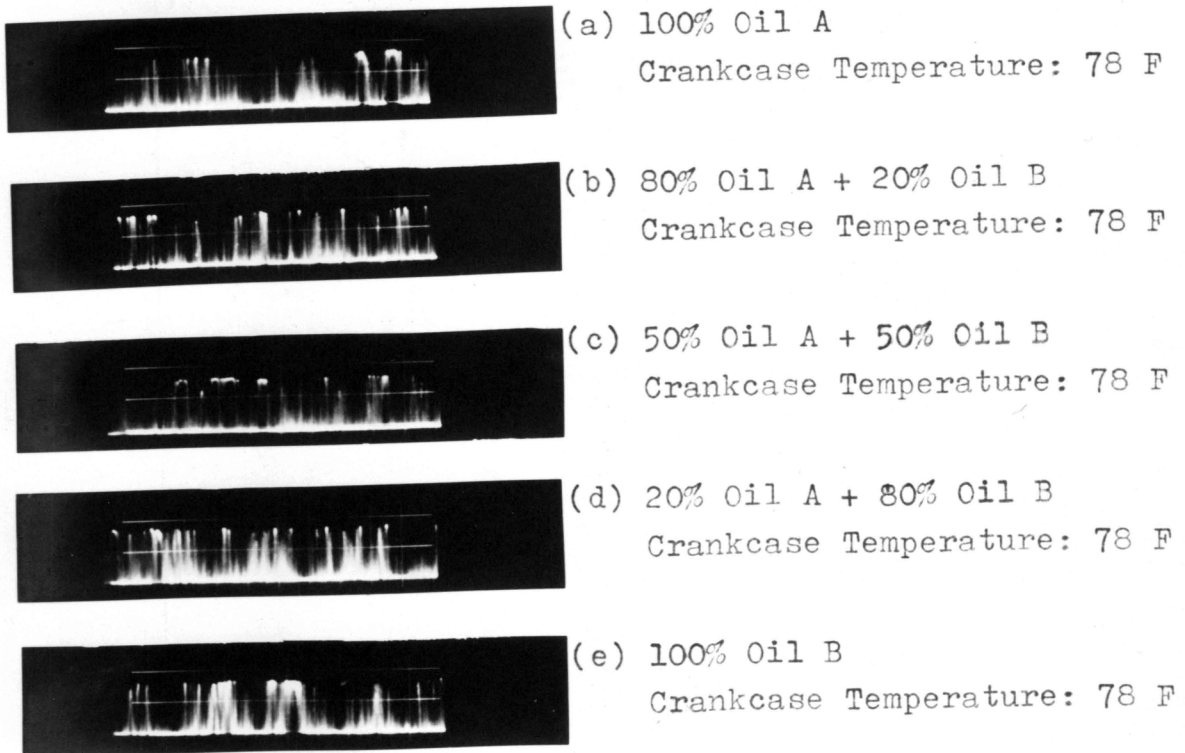
Types of Oil: Oil A - SAE 30
Oil B - SAE 30

Figure 21: The Effect of Oil Mixtures on Oil Film Performance

Three kinds of commercial lubricating oils were blended together. Oil A was paraffin-based mineral oil. Oil B was straight mineral oil. Oil C was mineral oil plus corrosion and wear inhibitor. The results are shown in Figure 21 and Figure 22. No appreciable change in oil film characteristics could be found. The tests were performed using oil mixtures at room temperature as well as at elevated temperature.
