**ANALYTICAL MODELING OF THE REPAIR OF IMPACT-DAMAGED
PRESTRESSED CONCRETE BRIDGE GIRDERS**

Master of Science
In
Civil Engineering

Keywords: Bridge Repair, Analytical Modeling, FEM, FRP, FRCM, Splices

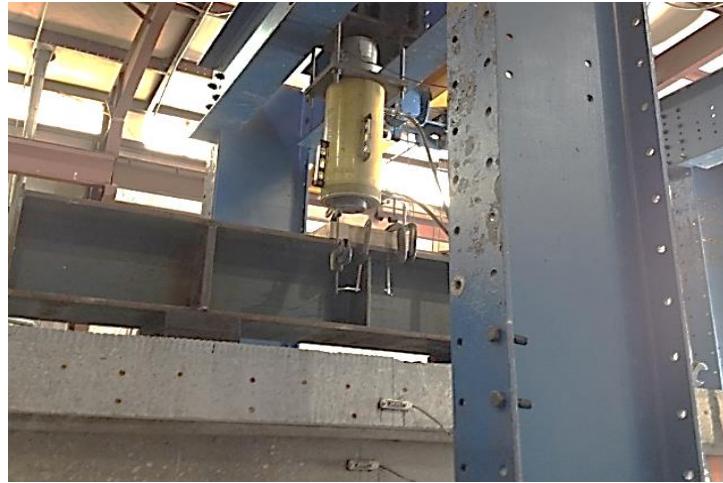
Figure 3.8: Test 1 Loading System

The girder used in Test 1 sustained damage during removal and transportation from the bridge site to the laboratory. As a result, shear cracking occurred causing a 16 ft portion of the girder to separate from Girder A. This portion was later used to gather samples of concrete, reinforcing bar, and strand materials for testing. The remaining 44 ft portion of the girder was used as a control to gather the undamaged and unrepaired properties of girder section being investigated. The left support was placed in a region that would normally be the midspan of the girder, and have minimal shear reinforcement. Minimizing the potential for shear failure was considered in the test set-up. Supports were placed to create a 35 ft simple span and the two point loads were offset 3 ft toward the right support, as shown in Figure 3.2. Test 1 was a flexural test of a 35 ft simple span length. The section was supported on two W21x101 steel sections with transverse stiffeners as supports. A pin bearing was placed on one steel section and a roller bearing was placed on the other. The girder was placed on top of the pin and roller bearings. A frame was used to hold a 400 ton hydraulic actuator above the load points. The actuator exerted a force on a 6 ft long steel spreader beam resting on two neoprene and steel laminate bearings that translated the load into a constant moment region between two load points. Figure 3.8 shows the loading system setup with the actuator, spreader beam, load frame, and laminate bearings.

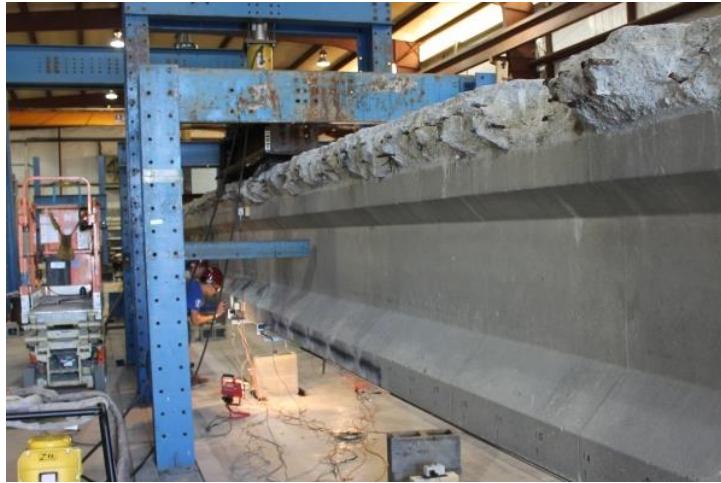
Figure 3.13: Test 2 Setup

Test 2 was a flexural test of a 58 ft simple span length. Figure 3.13 is a picture along the length of the beam showing an overview of the setup. Data was continuously recorded using a high speed data acquisition system. Figure 3.14 shows the instrumentation layout. For the purposes of modeling the test results, the most important data acquired was the load applied and displacement at the center of the beam. Three potentiometers were attached to the bottom of the girder to measure vertical deflection during the test. A 400 kip load cell was placed between the actuator and the load frame to measure the applied load.

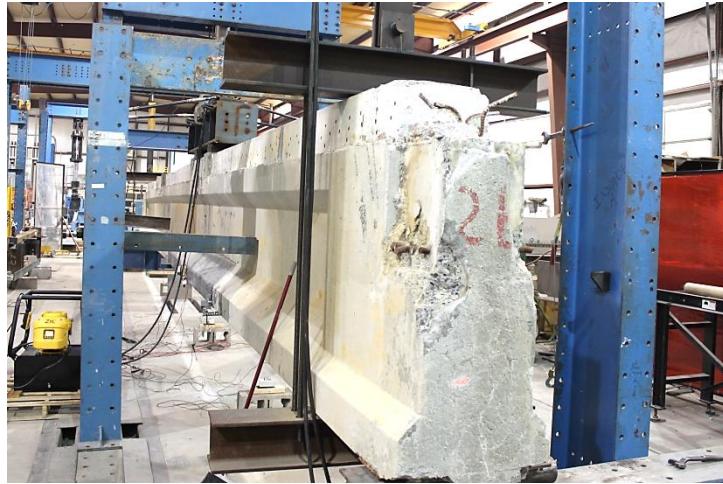
Figure 3.18: Test 3 Setup

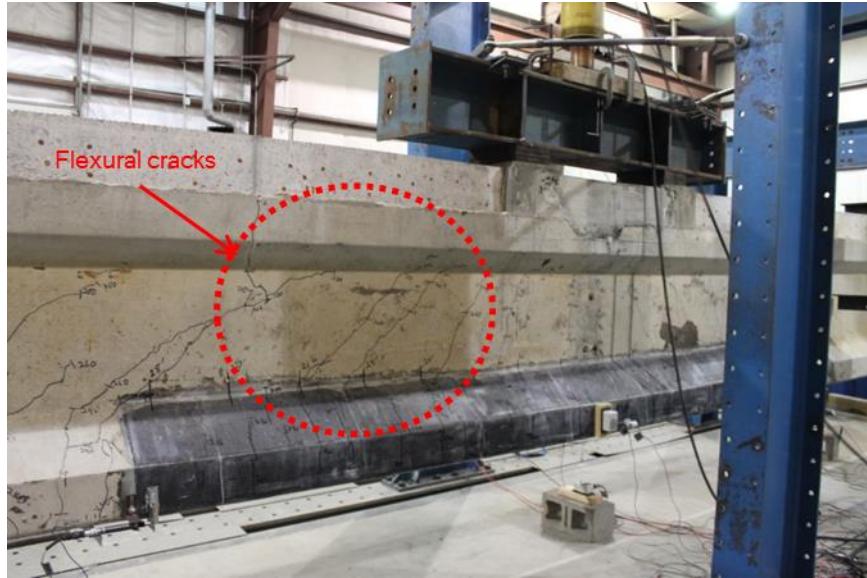
Figure 3.22: Test 3.1 Cracking Near Peak Load

The girder was tested on October 21, 2014. Initially, the rate of loading was managed to ensure there were no effects from sudden or impact loading. The load was applied at approximately 20 kip increments. At each increment, the girder was allowed to settle and cracks were inspected, highlighted, and marked. The test was stopped at a load level of 312 kips and 3.16 in of deflection due to the flexural cracking approaching the four strand splice repair section to be tested in Test 4. Inspection of the specimen after the test led to the observation that shear cracks in the web of the girder started to form in locations with minimal shear reinforcement as shown in Figure 3.21. The conclusion was to stop testing in order to avoid damaging the four strand splice repair section, propagating shear cracking, and adversely affecting the results of Test 4, though flexural failure was not imminent. Figure 3.22 shows the cracking observed at the load point near the peak load prior to stopping the test. The iteration of Test 3 was conducted on December 18, 2014. The test was stopped at a load level of 180 kips due to the actuator slipping and no longer exerting a consistent vertical force. Due to the lack of new information gleaned from this iteration, results from Test 3, iteration 2 are not included in this thesis.

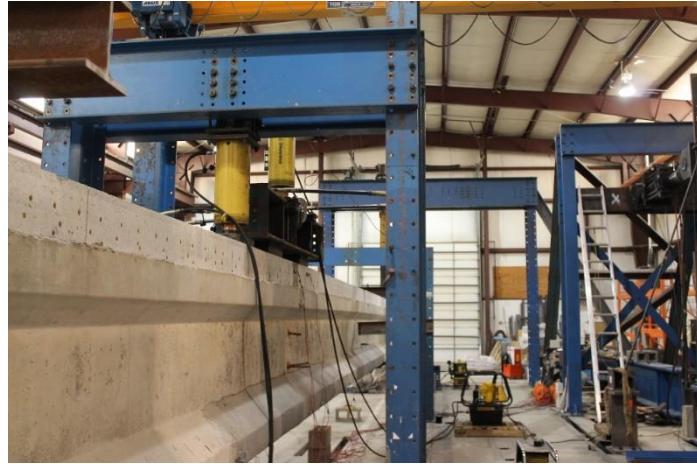
Figure 3.29: Test 5 Setup

Professional subcontractors conducted the repair for Test 5 with a high strength, quick set concrete patch and Ruredil X Mesh Gold FRCM composite. Ruredil X Mesh Gold FRCM is a 0.0017 in thick PBO fabric with Ruredil X Mesh M750 mortar (Ruredil X Mesh Gold, 2012). After the concrete patch was placed and allowed to cure, the FRCM was installed. Test 5 was a flexural test of a 52 ft simple span length. Figure 3.29 shows the test setup along the length of the girder. Data was continuously recorded using a high speed data acquisition system. Figure 3.30 shows the instrumentation layout along the length of the girder. Three potentiometers were attached to the bottom of the girder to measure vertical deflection during the test. A 400 kip load cell was placed between the actuator and the load frame to measure the applied load.

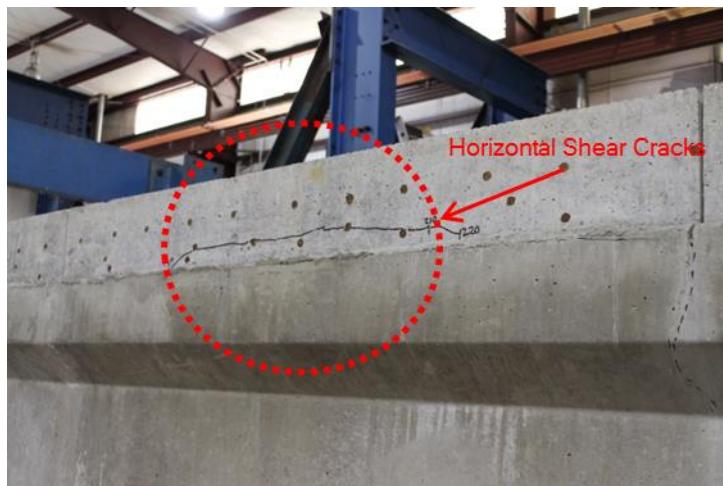
Figure 3.31: Horizontal Shear Cracking in Deck of Test 5

During the second run, the test was stopped at a load level of 222 kips and 3.00 in of deflection when it was observed that horizontal shear cracking began to propagate in the deck. Horizontal shear cracking was observed in vicinity of the concrete deck near 1 in saw cuts in the concrete deck that were made when the girder was removed from the rest of the bridge deck. The horizontal shear cracking is shown in Figure 3.31. In order to ensure that test would not fail in horizontal shear and to make sure the region of Test 6 was unaffected, the test was stopped and the saw cuts were filled in with repair concrete. No second attempt of the Test 5 repair was run. The subsequent analysis revealed the strain in the FRCM would not reach a point of failure, and therefore the failure mode would be concrete crushing. It was determined that re-conducting the test would not show more about the FRCM material. Figure 3.32 shows the cracking observed at the load point near the peak load prior to stopping the test.

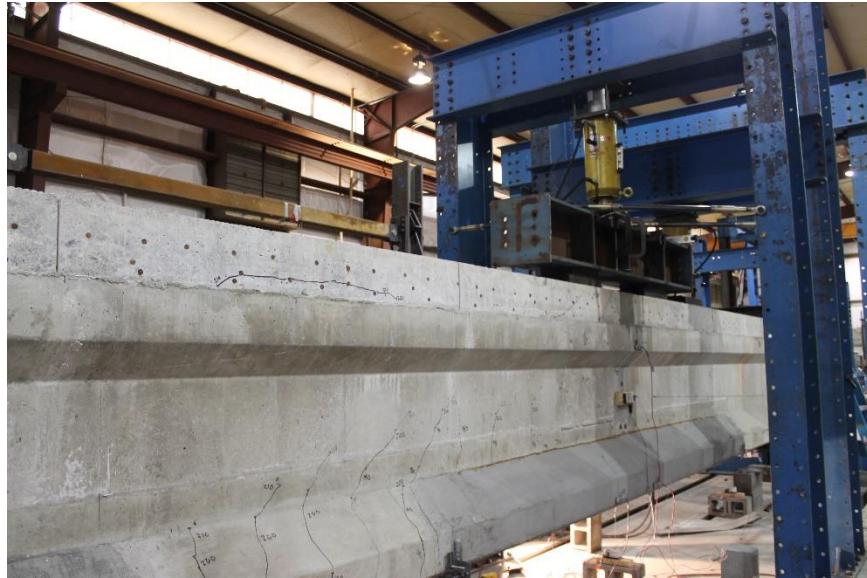
Figure 3.32: Cracking Patterns near Maximum Applied Load in Test 5

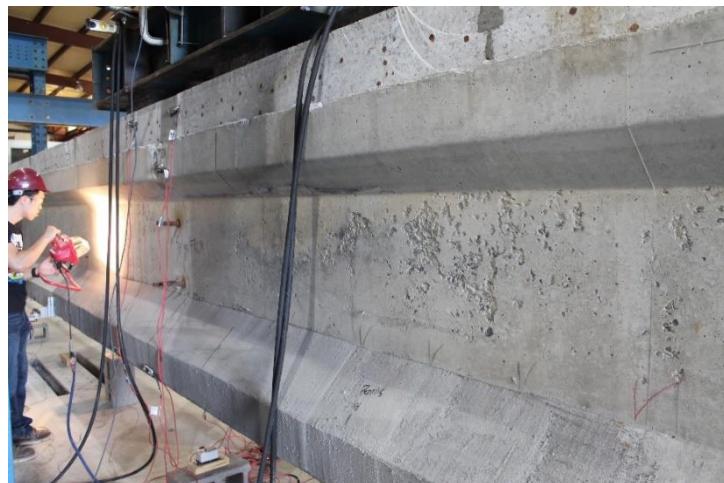
Figure 3.33: Test 6 Setup

Test 6 was a flexural test of a 52 ft simple span length. Figure 3.33 shows the test setup along the length of the girder. Data was continuously recorded using a high speed data acquisition system. Figure 3.34 shows the instrumentation layout along the length of the girder. Three potentiometers were attached to the bottom of the girder to measure vertical deflection during the test. A 400 kip load cell was placed between the actuator and the load frame to measure the applied load.
